**ALBERTA TRANSPORTATION AND  
ECONOMIC CORRIDORS GRMP  
NORTH CENTRAL (ATHABASCA AND FORT  
McMURRAY DISTRICTS)  
INSTRUMENTATION MONITORING- FALL 2024**

Site Number	Location	Name	Hwy	km
NC103 (NC024-3)	HWY 41:23 C1 7.89	Kehiwin Lake	41:23	km 7.8
<b>Legal Description:</b> 9-25-58-7 W4		<b>UTM Co-ordinates</b>		
		12U E 506737.94	N	5988417.59

<b>Current Monitoring:</b>	11-Sep-2024	<b>Previous Monitoring</b>	7-Jun-2024
<b>Instruments Read By:</b>	Mr. Niraj Regmi, G.I.T and Mr. Nixon Mationg, of Thurber

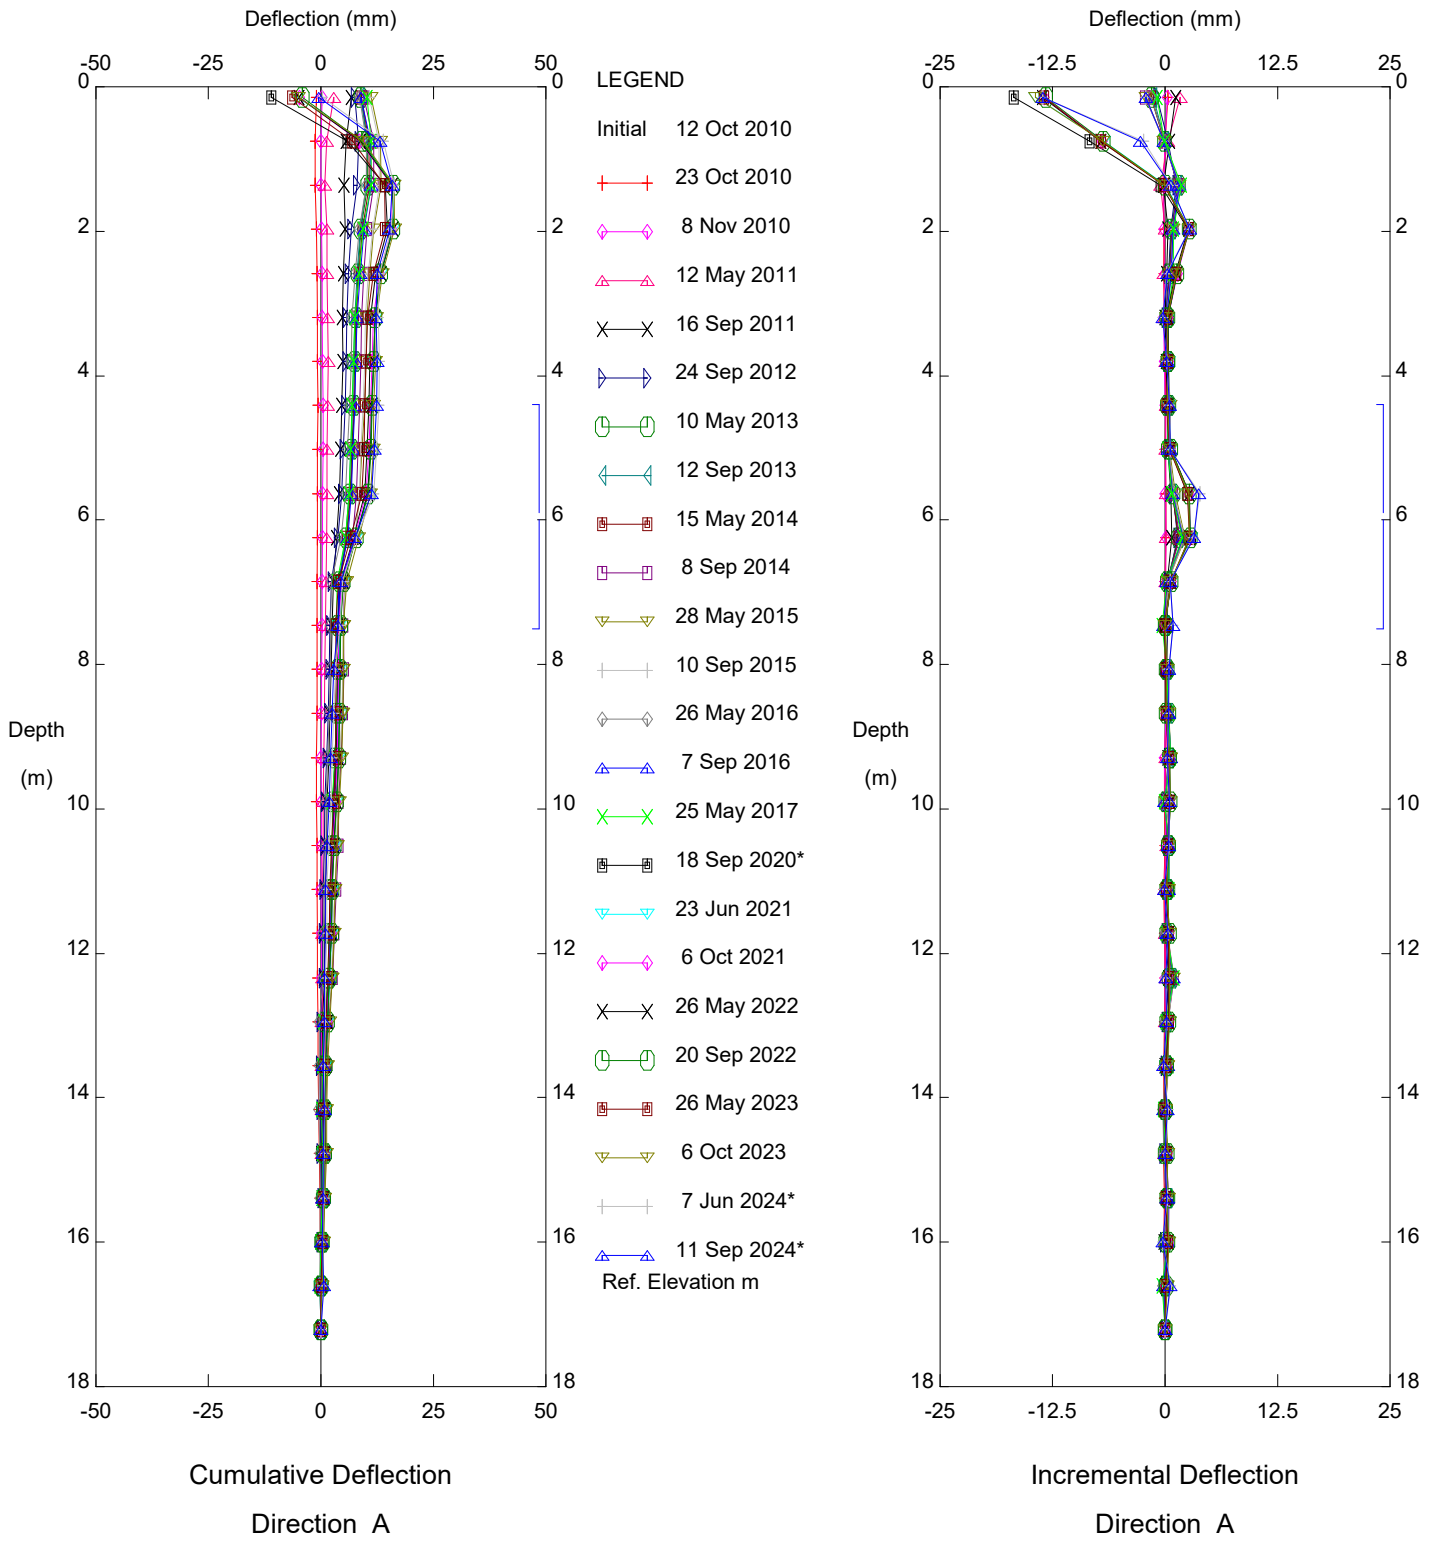
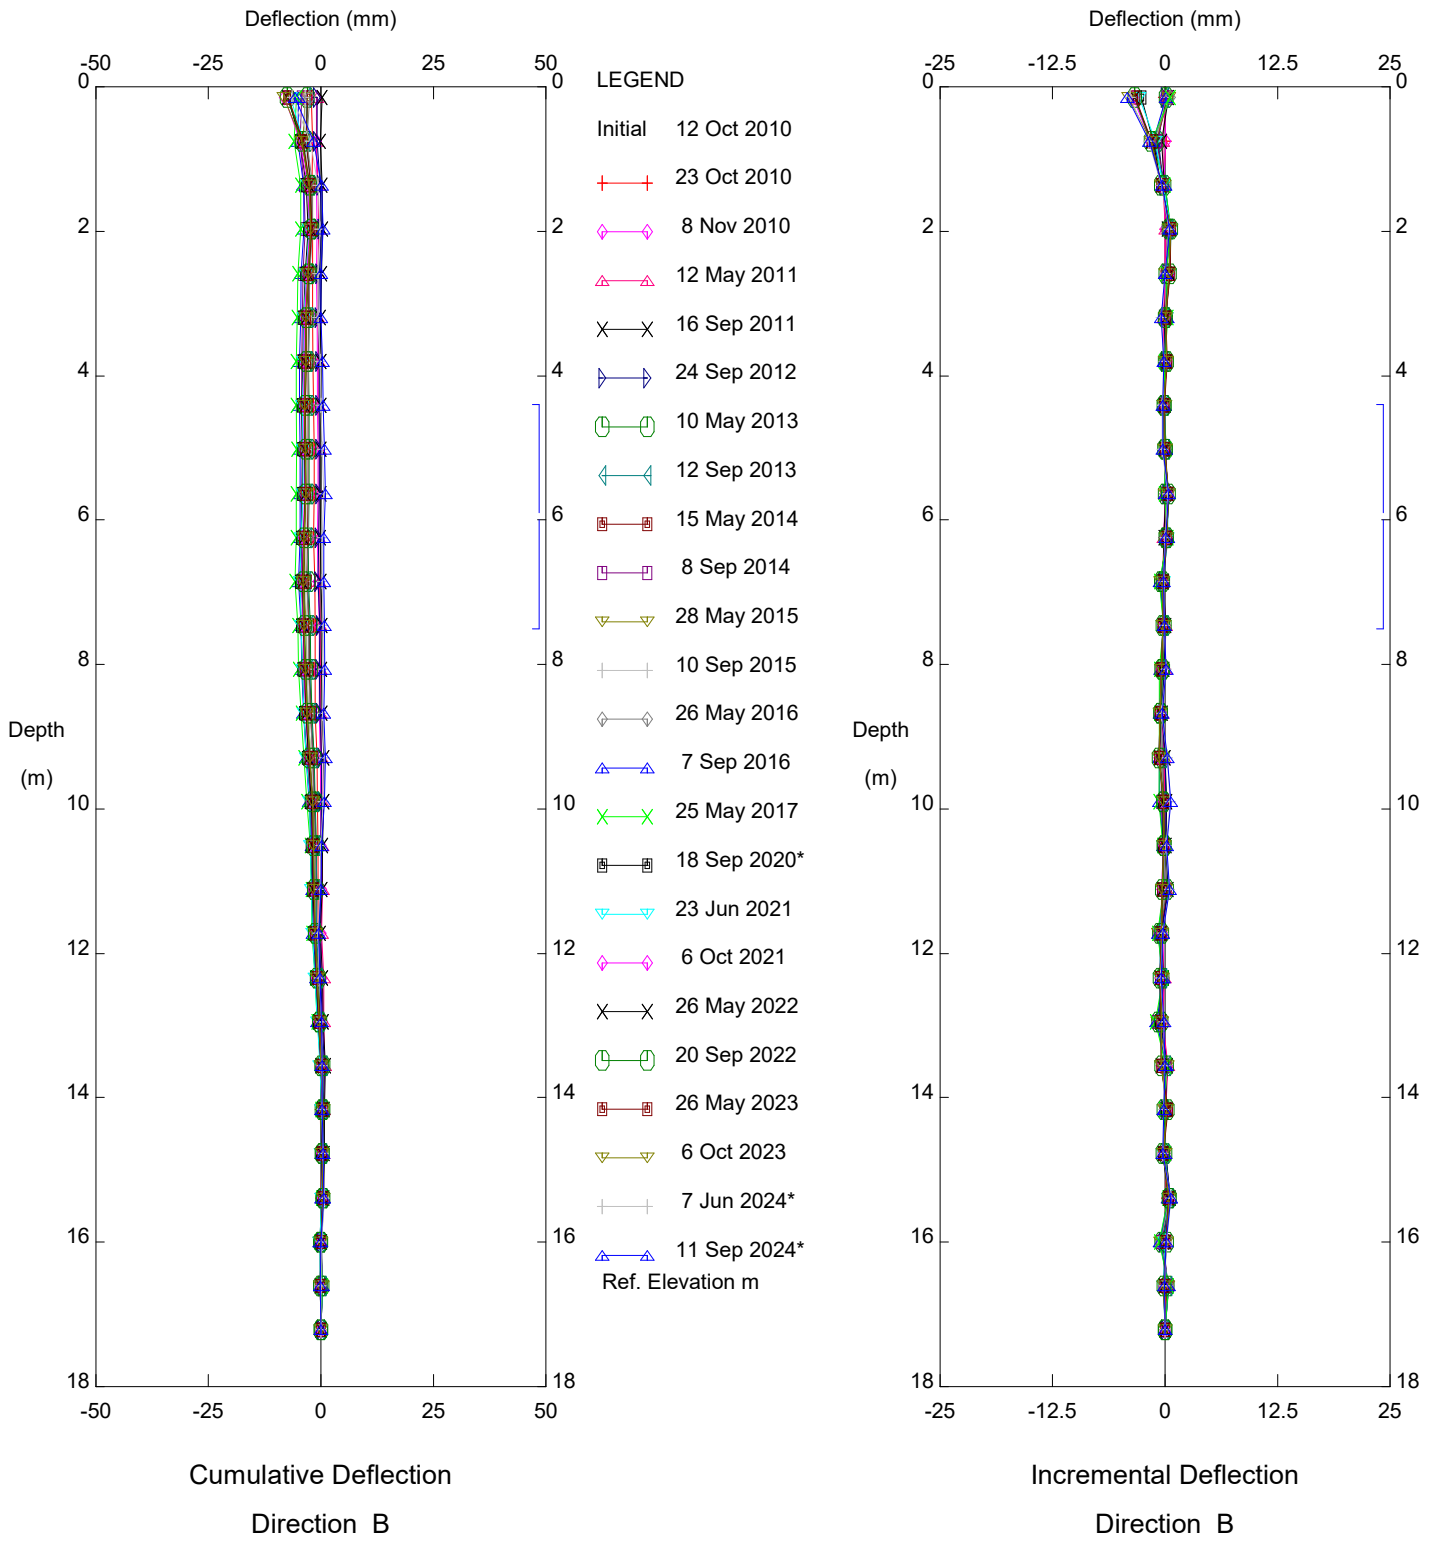
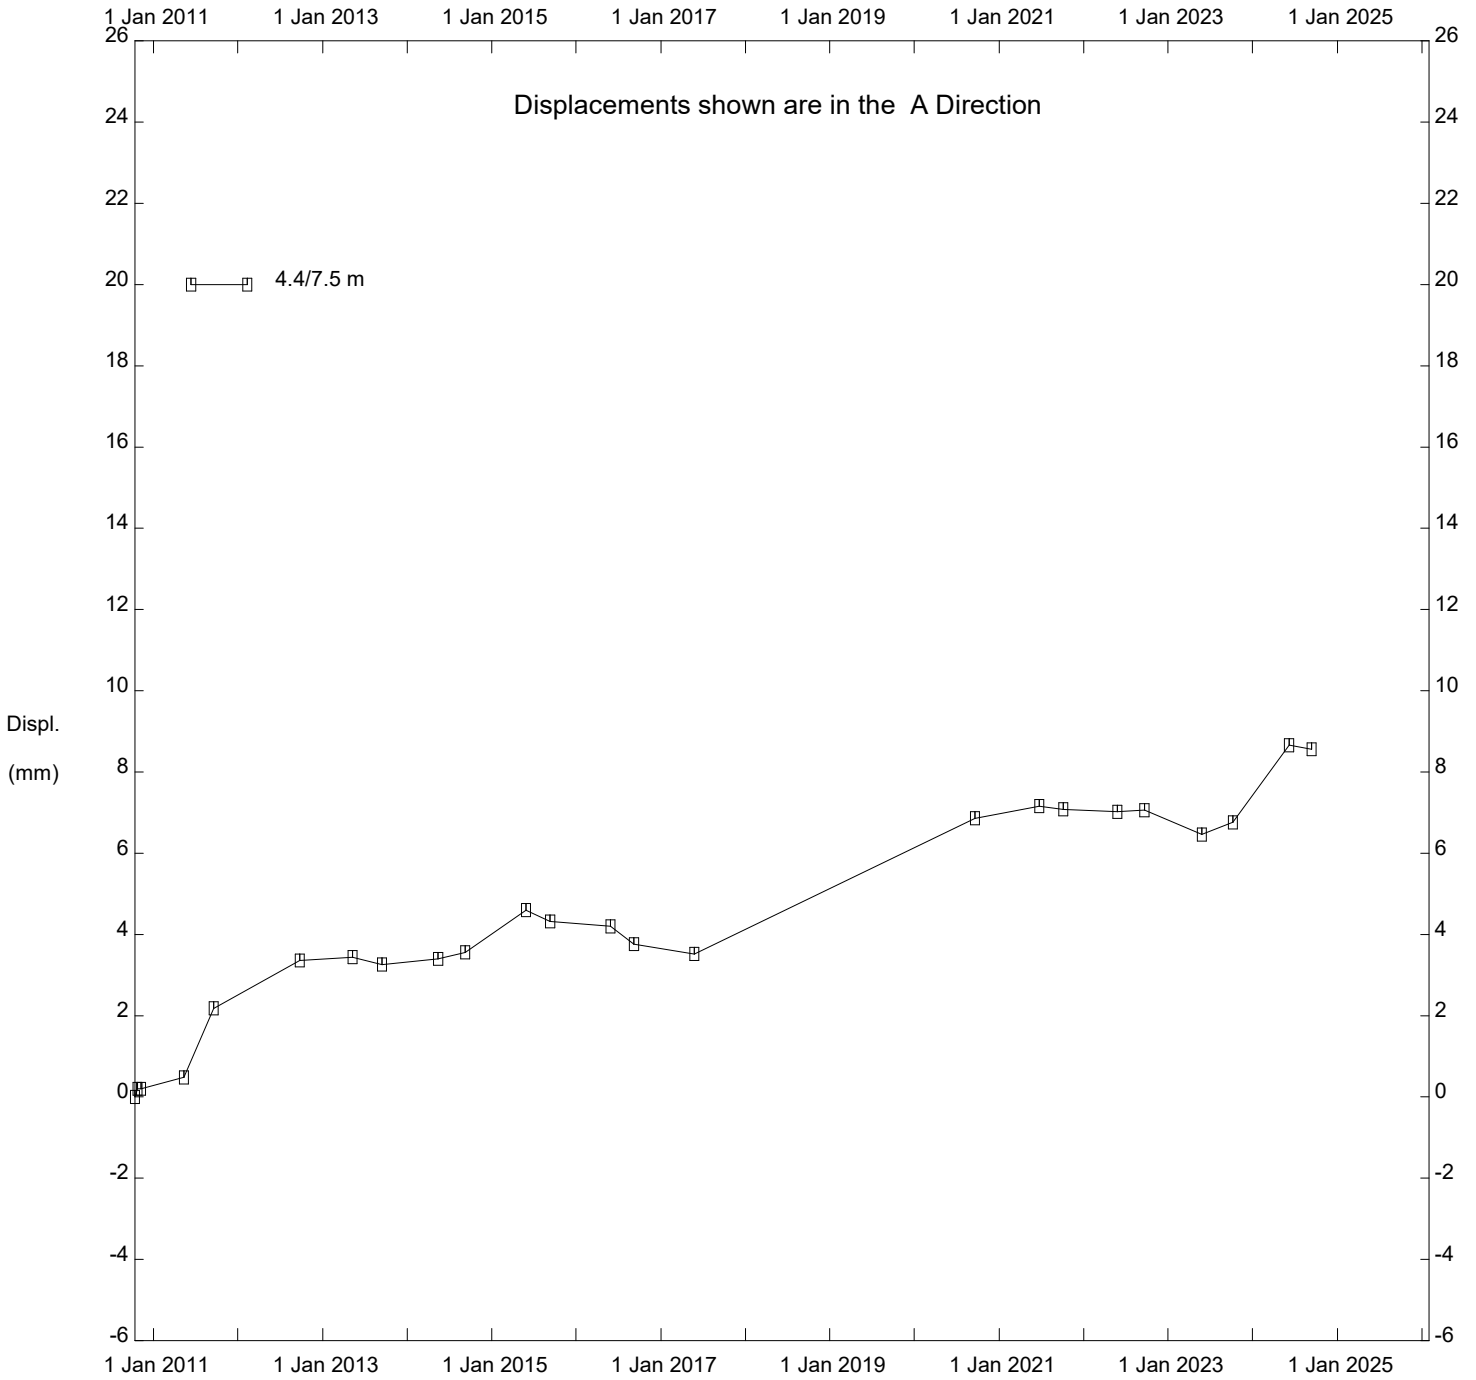
Hwy 41:23 Kehewin Lake (NC103), Inclinometer SI10-1

Discussion	
<b>Zones of New Movement:</b>	None
<b>Interpretation of Monitoring Results:</b>	<p>SI10-1, installed in the east highway ditch, showed no discernible movement since the spring of 2024 readings. SI10-3, installed at the bottom of the slope downslope of the pile wall location, showed a rate of movement of 5.5 mm/yr since the spring of 2024 readings. SI11-1 showed a rate of movement of 1.2 mm/yr over 0.7 to 14.8 m depth. SI11-2 showed a rate of movement of 1.9 mm/yr over 0.7 m to 14.7 m depth. SI11-3 showed a rate of movement of 2.3 mm/yr over 0.5 to 14.6 m depth since the spring of 2024 readings. SI11-4 showed a rate of movement of 2.6 mm/yr over 0.8 to 14.9 m depth.</p> <p>The cumulative movements in the SIs installed in the piles were as follows:</p> <ul style="list-style-type: none"> <li>• SI11-1 = 3.0 mm pile head movement over 0.7 to 14.8 m depth</li> <li>• SI11-2 = 0.9 mm pile head movement over 0.7 to 14.7 m depth</li> <li>• SI11-3 = -6.9 mm pile head movement over 0.5 to 14.6 m depth</li> <li>• SI11-4 = -7.7 mm pile head movement over 0.8 m to 14.9 m depth</li> </ul>

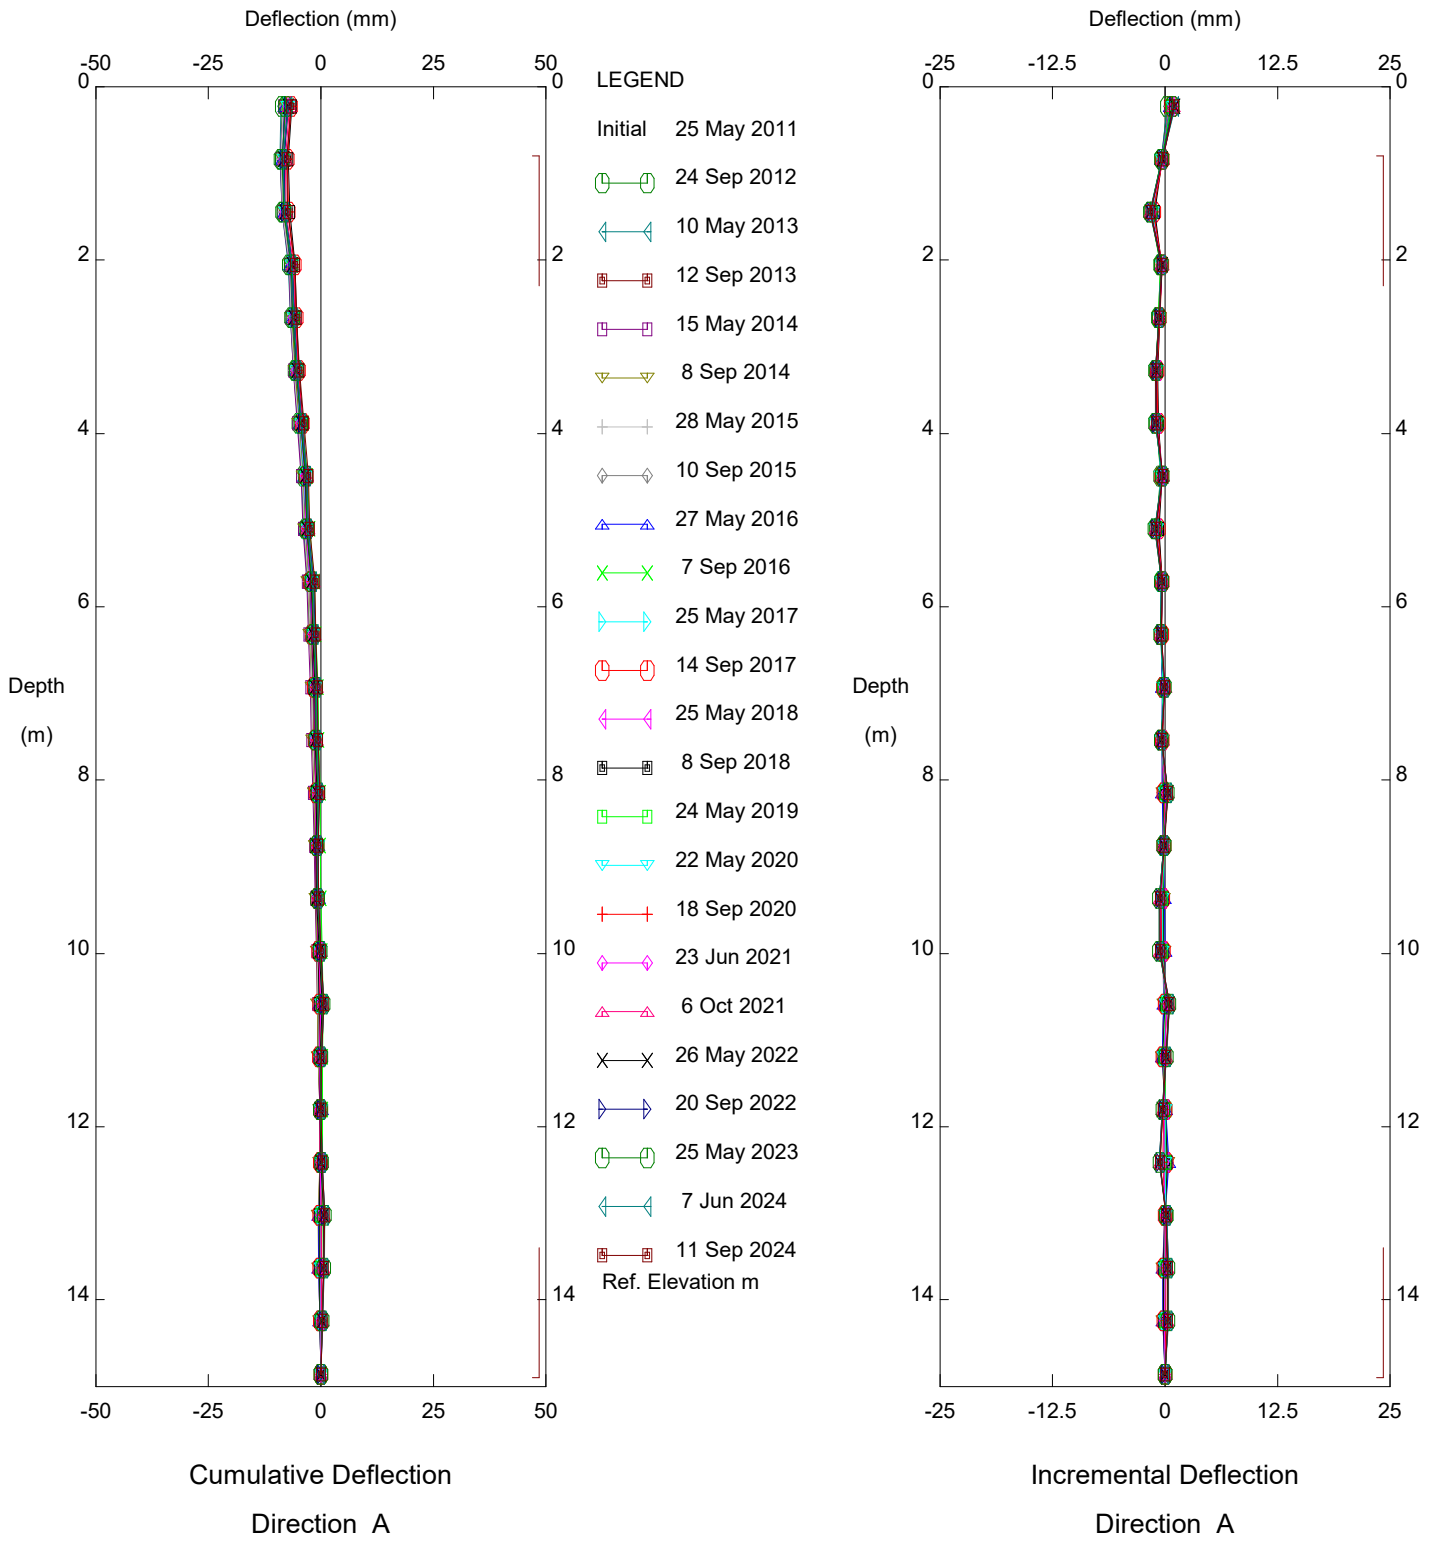
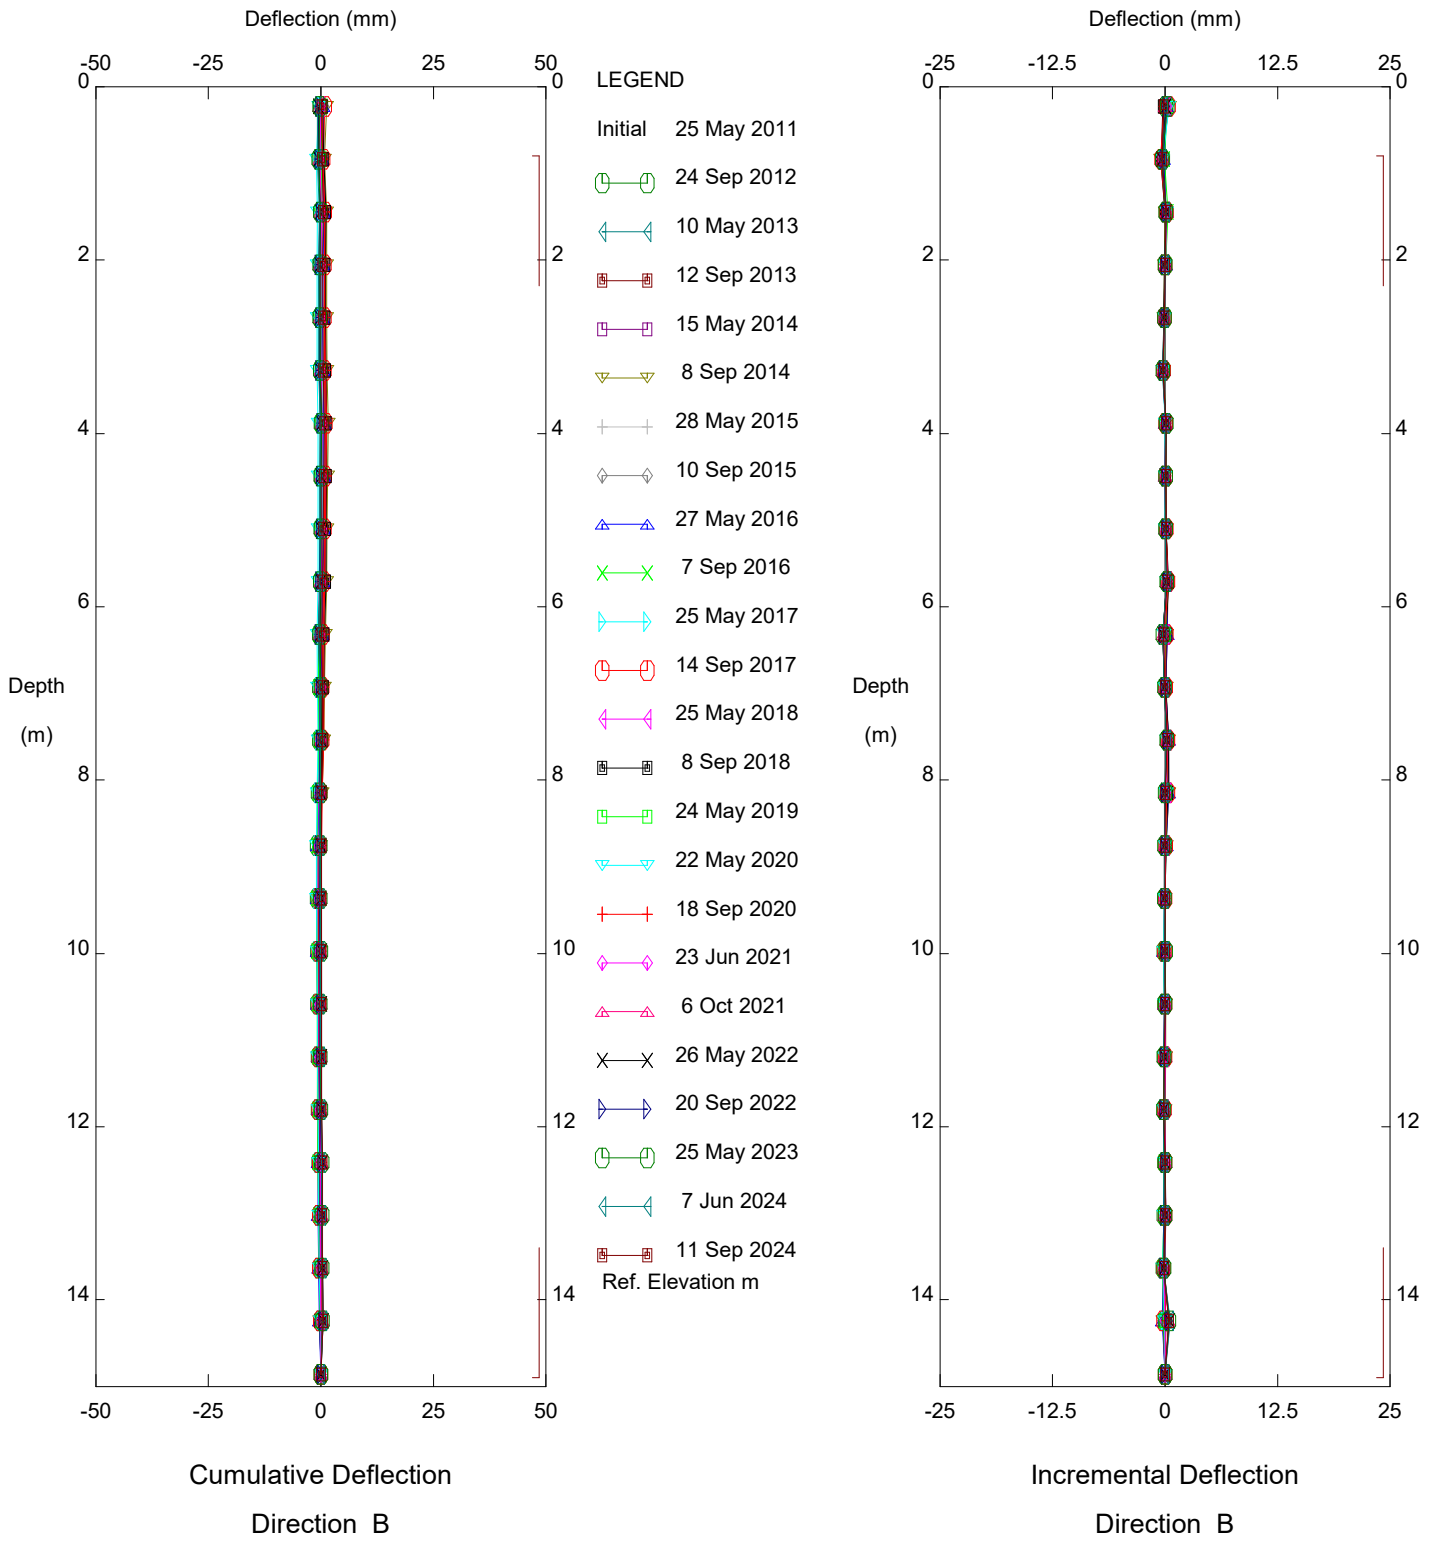
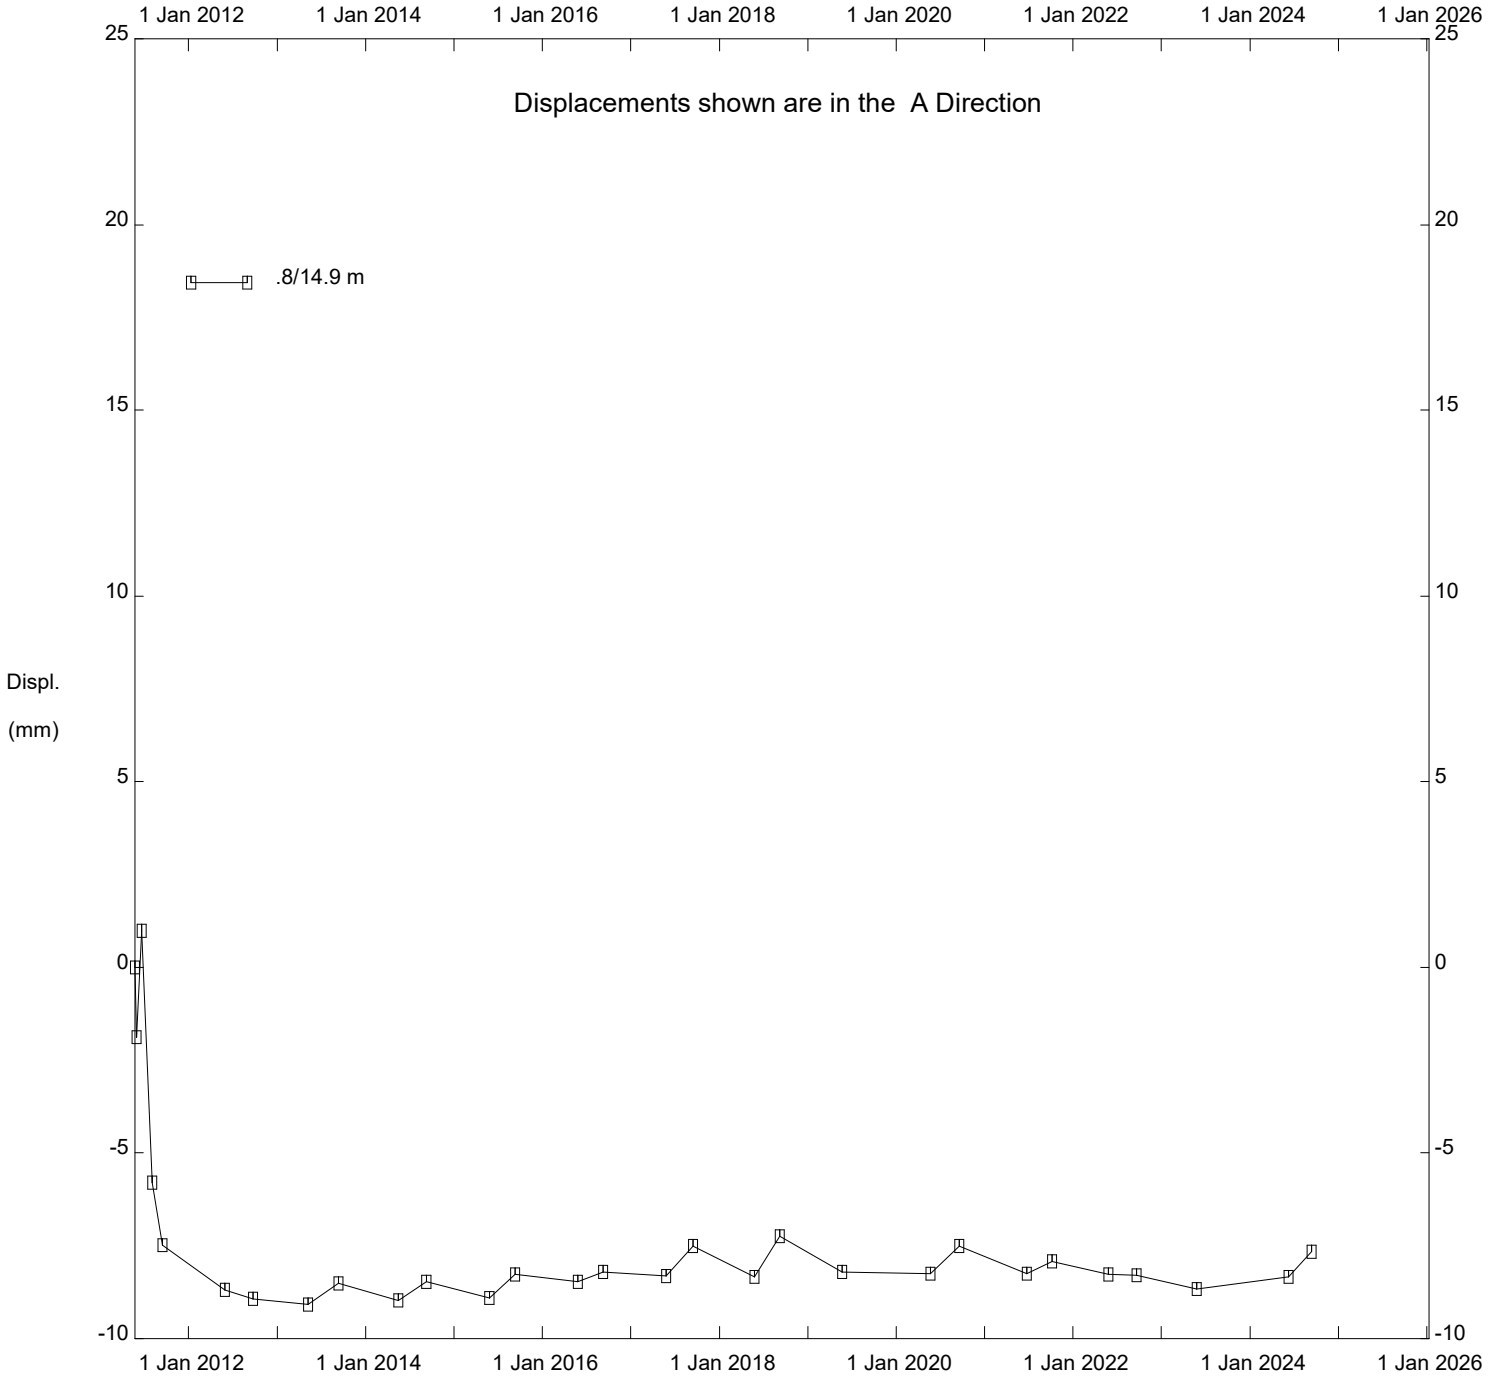
Hwy 41:23 Kehiwin Lake (NC103), Inclinometer SI11-4 (P60)

SI11-4 (Pile 60)	May 25, 2011	-7.7 over 0.8 m to 14.9 m depth in 349° direction	48.5 on June 21, 2011	Operational	June 7, 2024	0.7	2.6	2.3

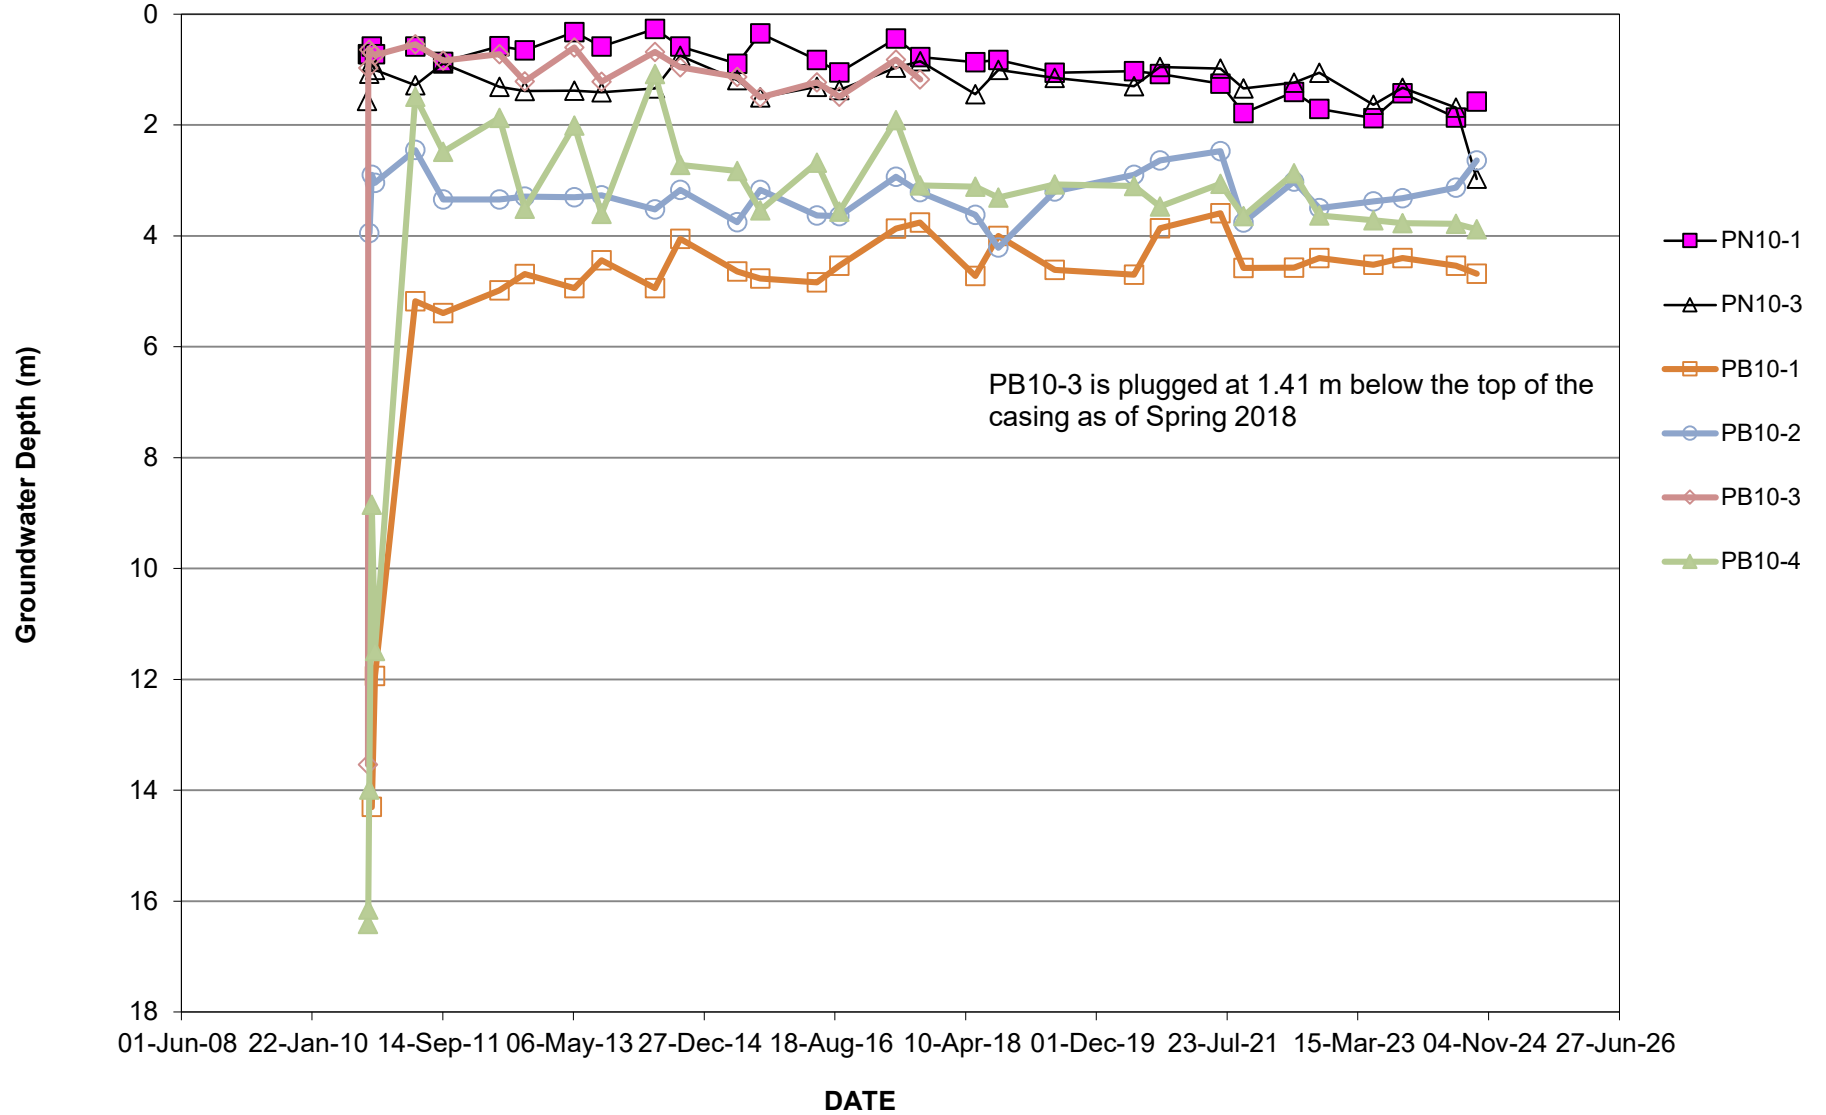
**FIGURE NC103-1  
PIEZOMETER DATA FOR HWY 41:23, KEHIWIN LAKE (KM 7.8)**

<p>Pneumatic piezometer PN10-1 showed an increase in groundwater level of 0.28 m since the spring of 2024 readings. PN10-3 showed a decrease in groundwater level of 1.28 m since the spring of 2024 readings. The current groundwater level in PN10-3 is the lowest recorded in the instrument since it was initialized.</p> <p>Standpipe piezometer PB10-1 and PB10-4 showed decreases in groundwater level of 0.14 m, and 0.10 m, respectively, since the spring of 2024 readings. Standpipe piezometer PB10-2 showed an increase in groundwater level of 0.49 m since the spring of 2024 readings.</p> <p>Load cells VC1706, VC1708, VC1712, and VC1713 showed decreases in the measured load by 2.31 kN, 1.55 kN, 2.88 kN, and 1.20 kN, respectively since the spring of 2024 readings. Load cells VC1707, VC1709, and VC1715 showed increases in measured loads by 0.16 kN, 7.02 kN, and 16.62 kN, respectively. VC1714 showed an increase in the measured load of 90.69 since the spring of 2024 readings, however, this significant increase could be attributed to the inconsistency of the number of operating wires between the spring of 2024 and the fall of 2024.</p> <p>The current measured load in VC1715 is the highest ever recorded in this load cell. Load cell VC1715 has shown a trend of gradually increasing loads for several reading cycles, indicating the load cell may be malfunctioning. The load in VC1715 is about 47.4 percent higher than the lock off load. The remaining load cells have shown decreases in measured loads, when compared to the lock off load, ranging from 10.3 percent to 39.3 percent. However, the load cells with the largest variations in load values have lost one or more vibrating wire channels over several reading cycles. In addition, the reductions in the loads have not been consistent with the observed movement patterns of the walls, based on the slope inclinometer readings.</p> <p>If significant reductions in anchor loads occur in the future in response to the wall deflection towards west, the anchors will need to be restressed to maintain the wall's lateral deflection within the design limit.</p>
