**ALBERTA TRANSPORTATION AND
ECONOMIC CORRIDORS GRMP
NORTH CENTRAL (ATHABASCA AND FORT
MCMURRAY DISTRICTS)
2024 SITE INSPECTION**

Site Number	Location	Name	Hwy	km
NC103-2	Approximately 7.9 km north of Hwy 29 (North of Elk Point)	KEHIWIN LAKE	41:23	7.9
Legal Description		UTM Co-ordinates (NAD 83)		
9-25-58-07 W4		12 N 5988463.22	E	506745.73

NC103-2: HWY41:23 KEHIWIN LAKE WEST SIDE SLOPE SLUMP (km 7.9)

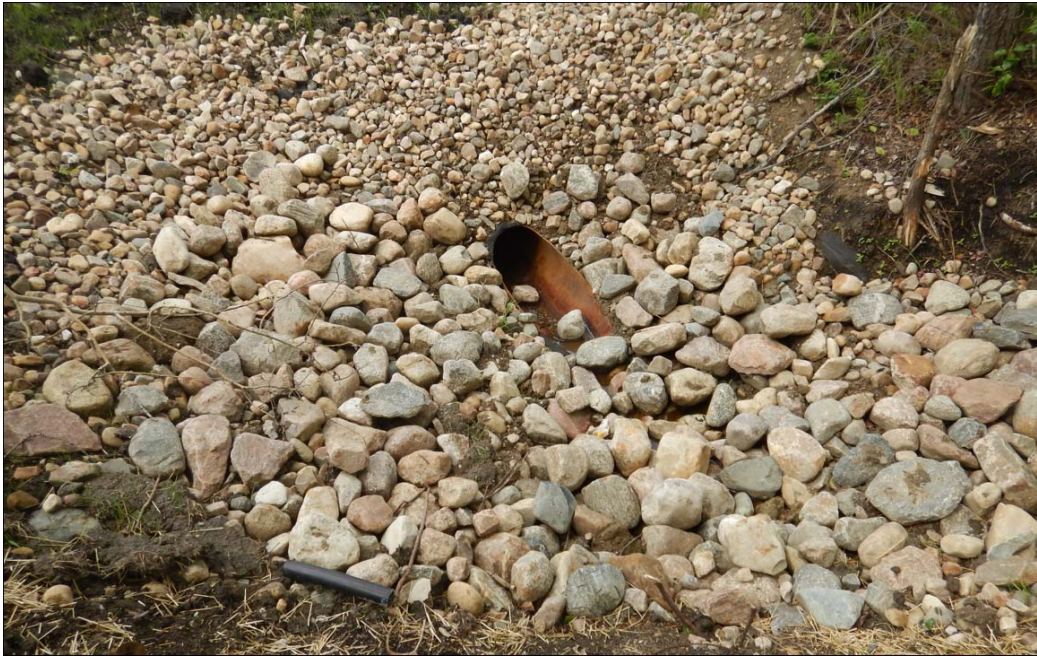
The repairs carried out by Inline in the spring of 2024 are performing satisfactorily. Although, the centre line culvert exhibits slight sagging under the highway, this is likely caused by a minor variation in the culvert grade between the inlet and the pile wall section and the portion between the pile wall and the outlet. This change in grade within the culvert is unlikely to affect the stability of the highway embankment at this location.

Photo No. 1 – Old 600 mm CSP Centre-Line Culvert was lined with 500 mm SWSP Culvert in the Spring of 2024

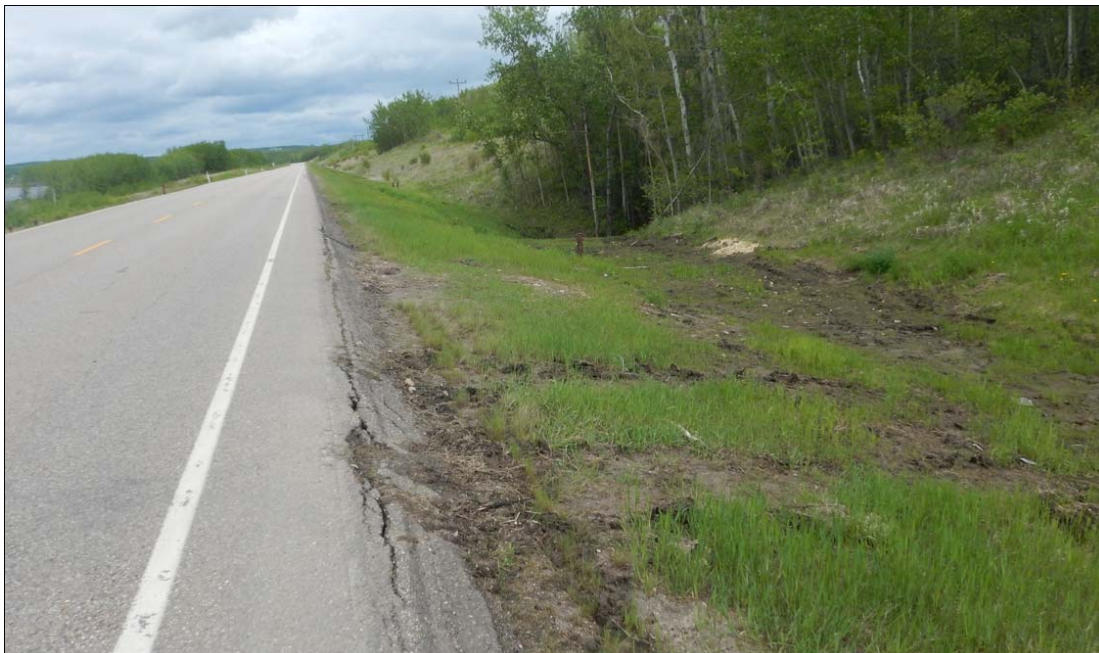
Observations:	Description	Worse?
<input checked="" type="checkbox"/> Pavement Distress	Damage of edge of pavement at two locations. Refer to Photo No. 2 and 2 a	<input checked="" type="checkbox"/>
<input type="checkbox"/> Slope Movement		<input type="checkbox"/>
<input type="checkbox"/> Erosion		<input type="checkbox"/>
<input type="checkbox"/> Seepage		<input type="checkbox"/>
<input checked="" type="checkbox"/> Bridge/Culvert Distress	New culvert appears to be slightly sagging	<input type="checkbox"/>
<input checked="" type="checkbox"/> Other	Sink hole about 500 mm wide, 200 mm long, and 300 mm deep on the east side slope (hydrovac hole completed by In-line to expose the Telus line)	<input checked="" type="checkbox"/>

Photo No. 2 – Looking at the highway southeast side slope upslope of the 600 mm CSP culvert inlet location. Note asphalt surface outside of the white line was damaged during construction

The damaged edge of pavement sections should be repaired to reduce the likelihood of the retrogression of the asphalt cracking into the driving lanes.

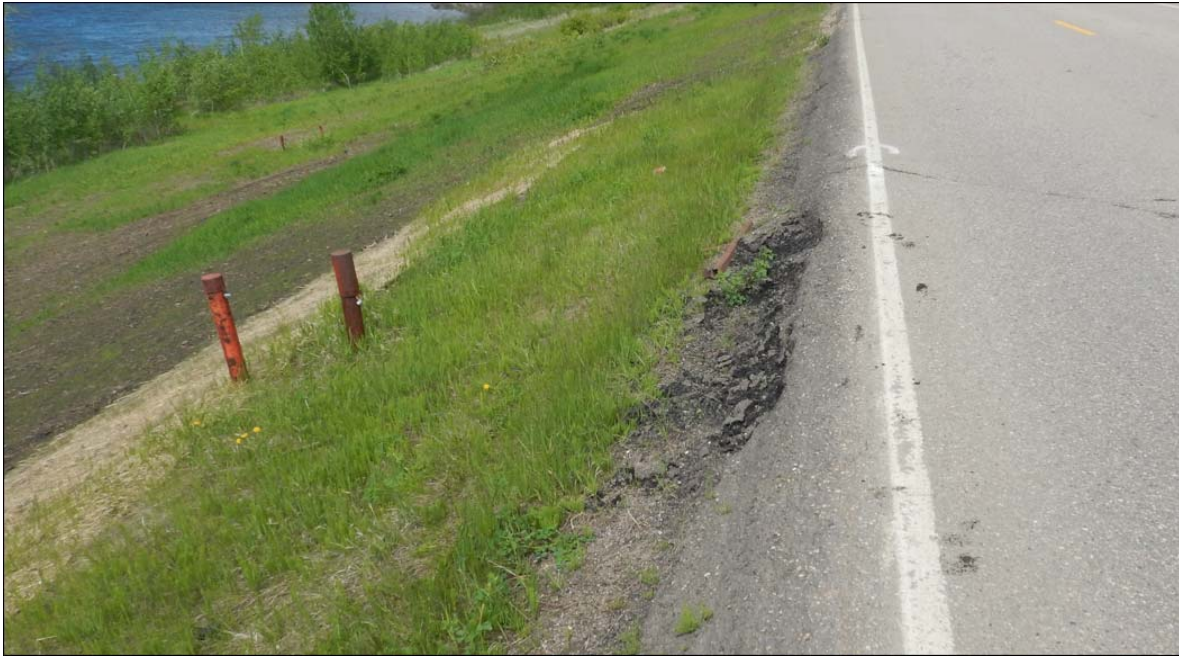
Photo No. 2a – Looking at the highway northwest side slope upslope of the 600 mm CSP culvert outlet location. Asphalt surface outside of the white line was likely damaged during construction

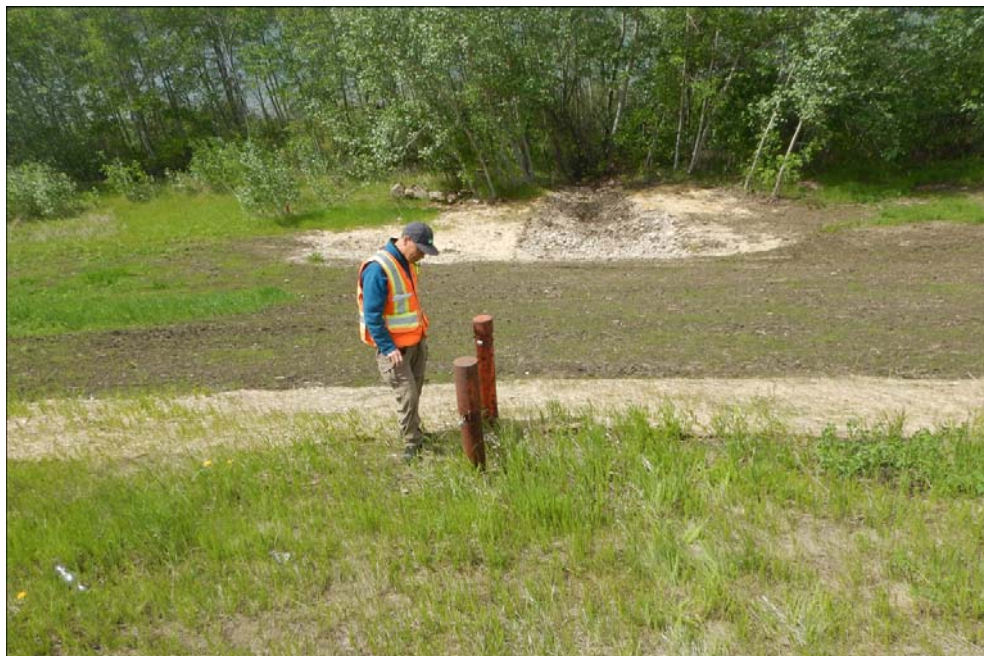
Photo No. 3 – Looking west at the area of the 2024 slump repairs downslope of the pile wall location. Note vegetation starting to grow between the pile wall and the riprap channel

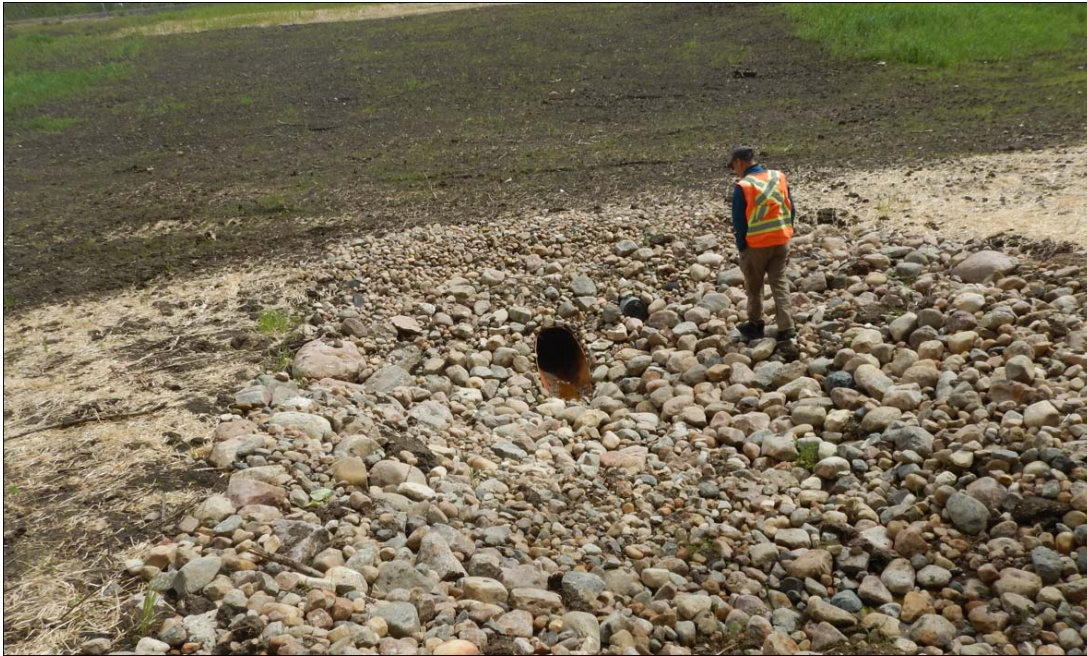
Photo No. 4 – Looking east at the new SWSP culvert outlet downslope of the pile wall location

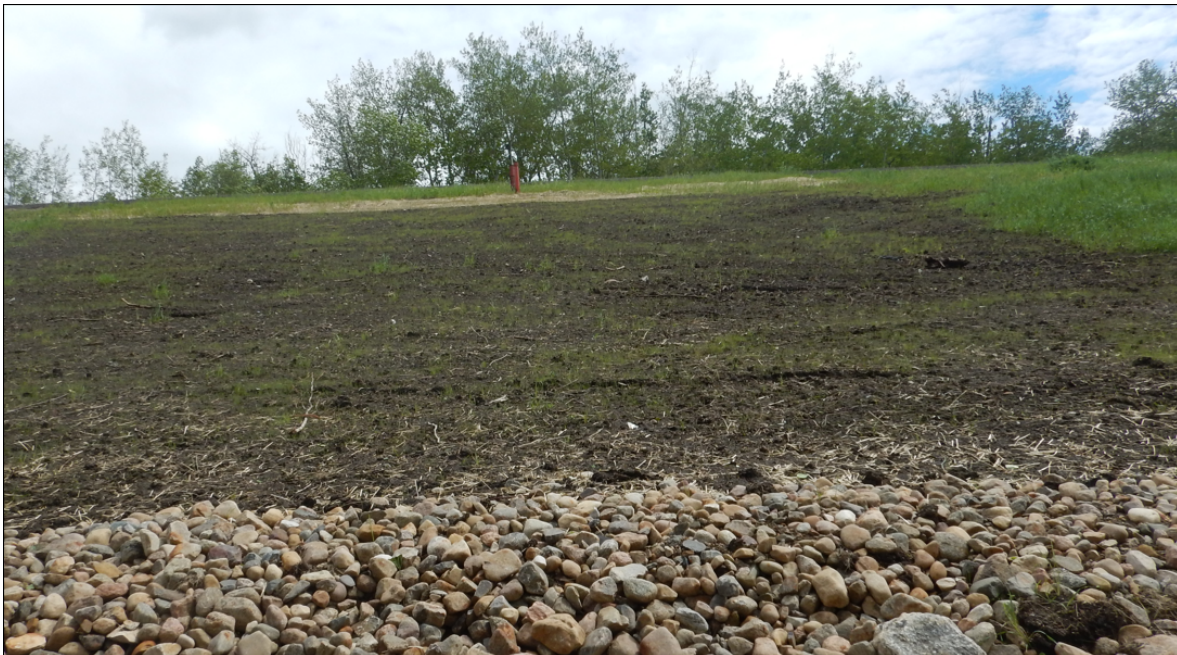
Photo No. 5 – Looking east at the area of the 2024 slump repairs downslope of the pile wall location.

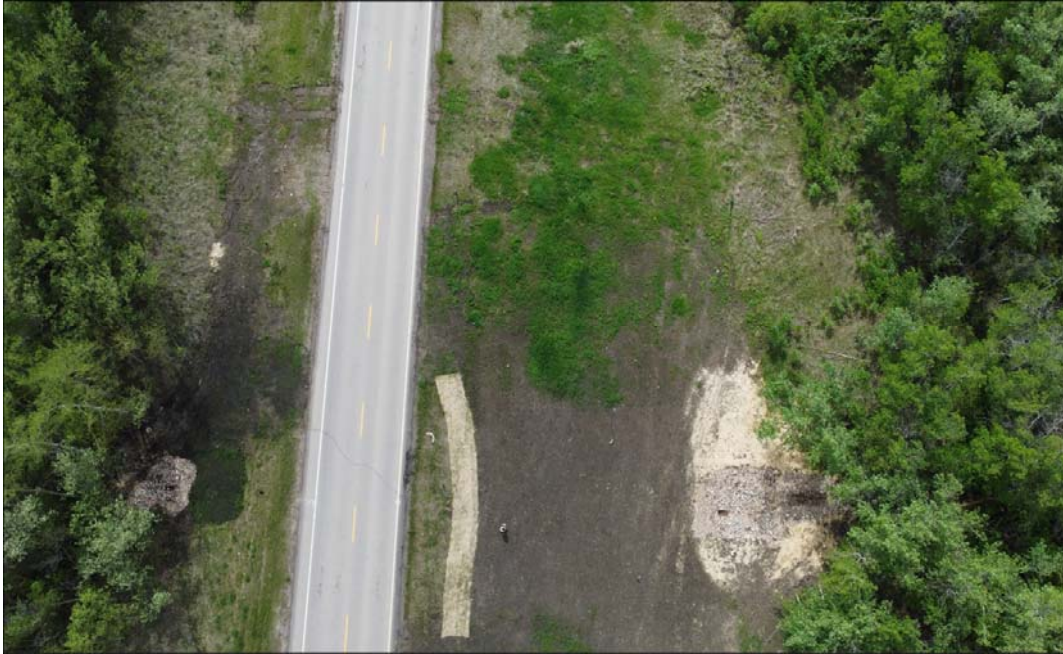
Photo No. 6 – Aerial photo covering both sides slopes of the highway and the extent of the 2024 repairs completed by In-Line Construction
