**ALBERTA TRANSPORTATION
GEOHAZARD ASSESSMENT PROGRAM
NORTH CENTRAL REGION – ATHABASCA
2019 INSPECTION**

Site Number	Location	Name	Hwy	km
NC024-4 (NC24C)	Approximately 7.7 km north of Hwy 29 (North of Elk Point)	KEHIWIN LAKE	41:23 (previously 28:16)	7.7
Legal Description		UTM Co-ordinates (NAD 83)		
NE-25-58-7-W4M		12 N 5988325	E	506652

Date	PF	CF	Total
Previous Inspection:	May 9, 2018	8	4	32
Current Inspection:	June 12, 2019	8	4	32
Road AADT:	1540	Year:	2019	
Inspected By:	Tarek Abdelaziz, José Pineda (Thurber) Rishi Adhikari, Arthur Kavulok, Calvin Kissel (TRANS)			
Report Attachments:	<input checked="" type="checkbox"/> Photographs <input checked="" type="checkbox"/> Plans <input type="checkbox"/> Maintenance Items

**NC024-4 (NC24C): HWY 41:23 LANDSLIDE (km 7.7)
SITE PLAN SHOWING SITE FEATURES AND
INSTRUMENT LOCATIONS**

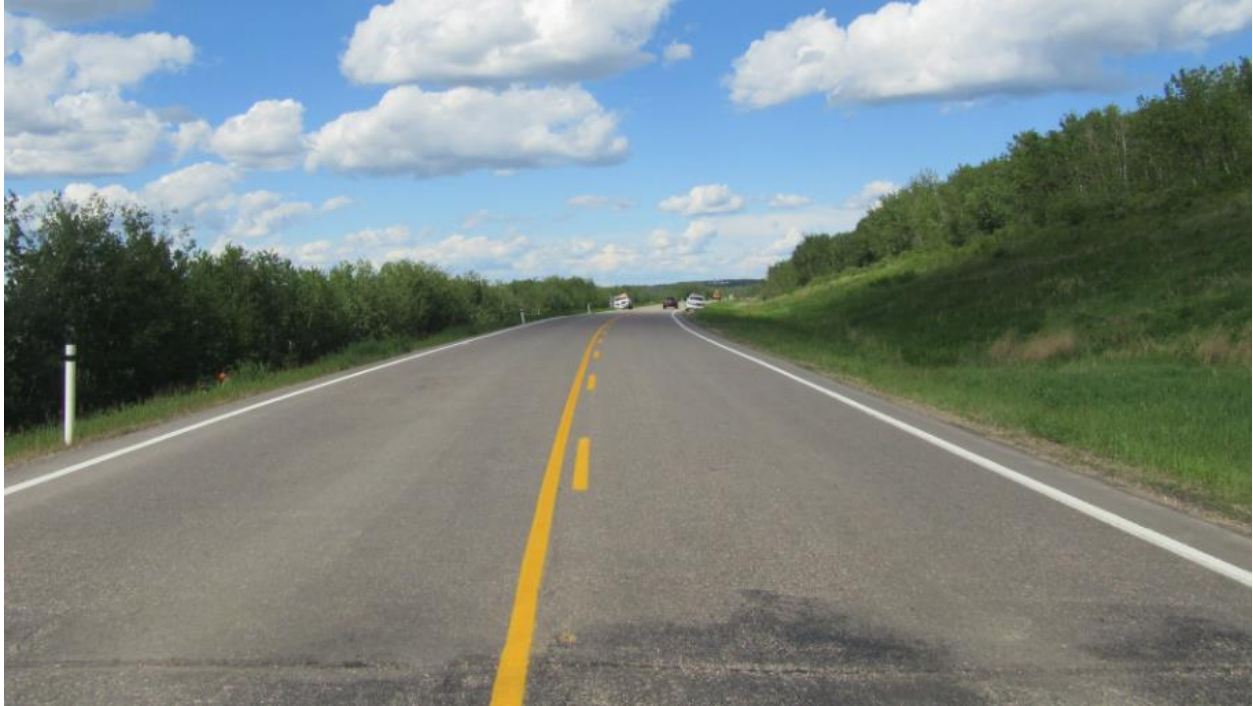
Photo No. 1 - Looking north at highway surface; no reflective cracks or dips noted in 2019

The local MCI should watch closely for the development of any cracks in the highway section above the NC24C pile wall extension and notify us immediately. Cracks should generally be sealed to reduce ground water infiltration into the landslide mass.

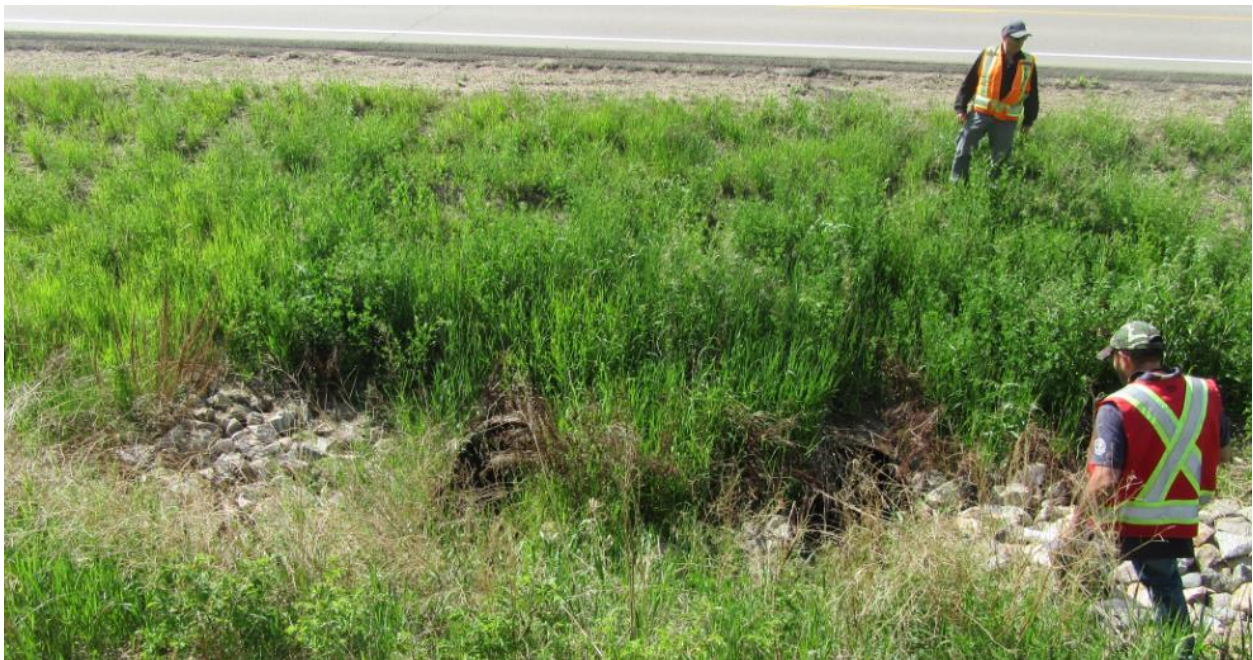
Photo No.2 - Looking at twin culverts (northwest); water flows into most eastern pipe

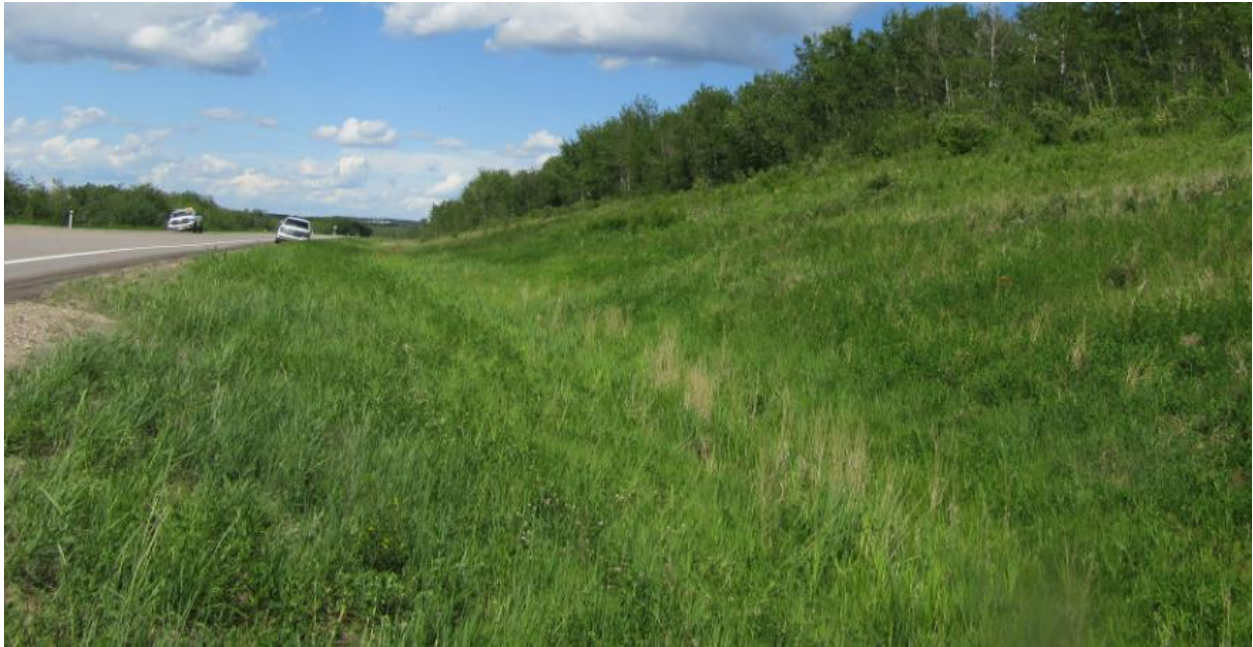
Photo No.3 - Looking north at the TRM lined ditch; water flows south towards the twin culverts and vegetation grew in the ditch and backslope

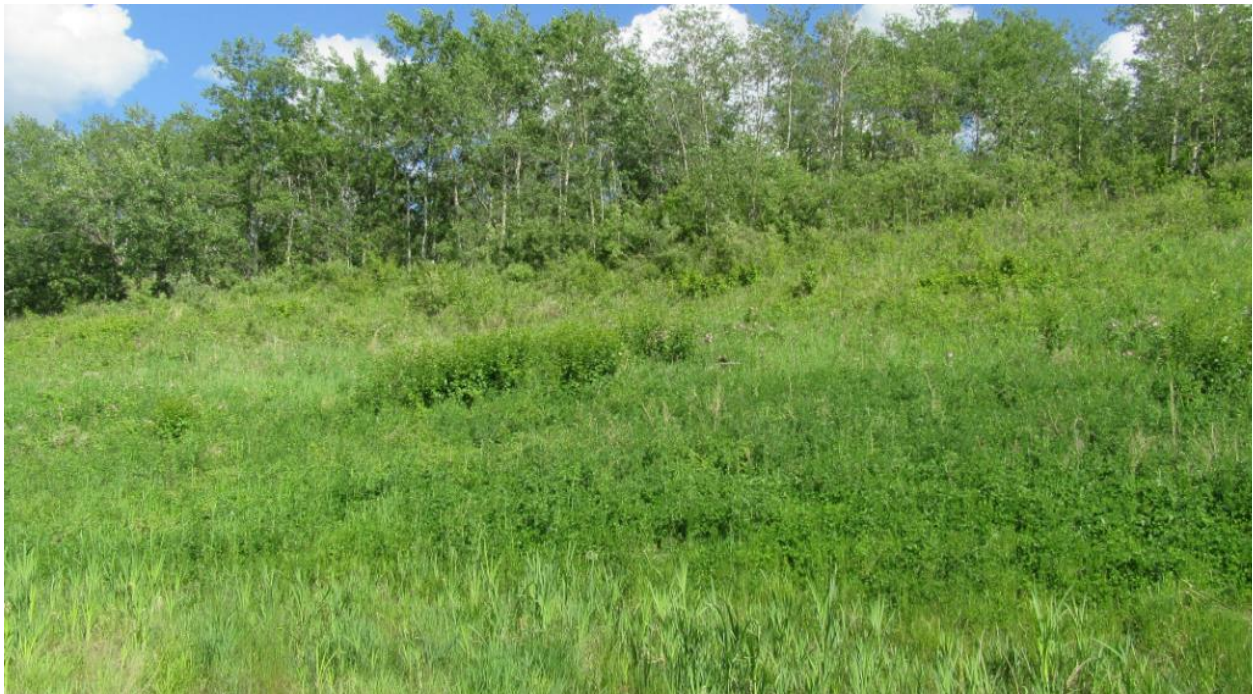
<input checked="" type="checkbox"/> Seepage	Seepage from the face of the backslope is draining across the highway through C2 Culvert	<input type="checkbox"/>
<input type="checkbox"/> Bridge/Culvert Distress		<input type="checkbox"/>
<input checked="" type="checkbox"/> Other	Sharp drop off on the west side of highway due to previous ACP patches	<input type="checkbox"/>

Photo No.4 - Looking east at backslope seepage zone; vegetation grew between 2018 and 2019

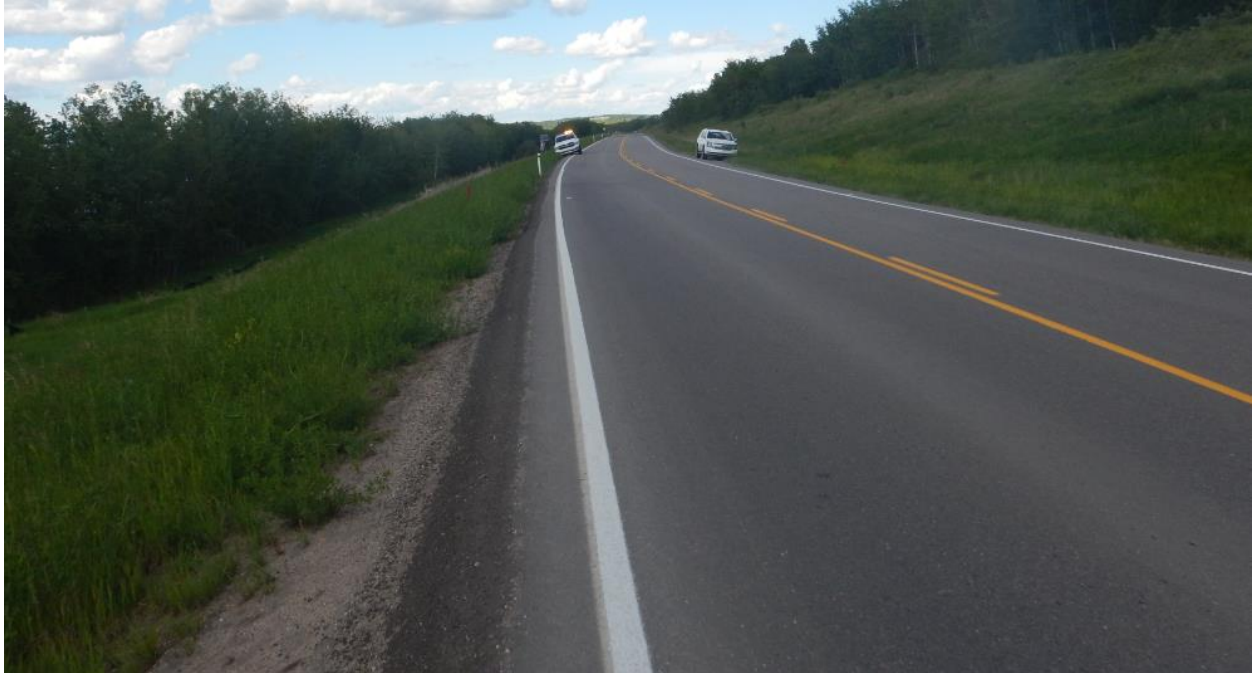
The existing sharp drop off near the edge of pavement constitutes a safety hazard to runaway vehicles.

Photo No.5 - Looking north at a sharp drop off along the western edge of the road; vegetation grew on the highway side slope

Consideration should be given for placing the least amount of fill off the highway surface to smoothen the existing sharp drop off and eliminate the existing hazard. Otherwise, sharp shoulders warning signs should be erected to warn the motorists of the existing hazard.

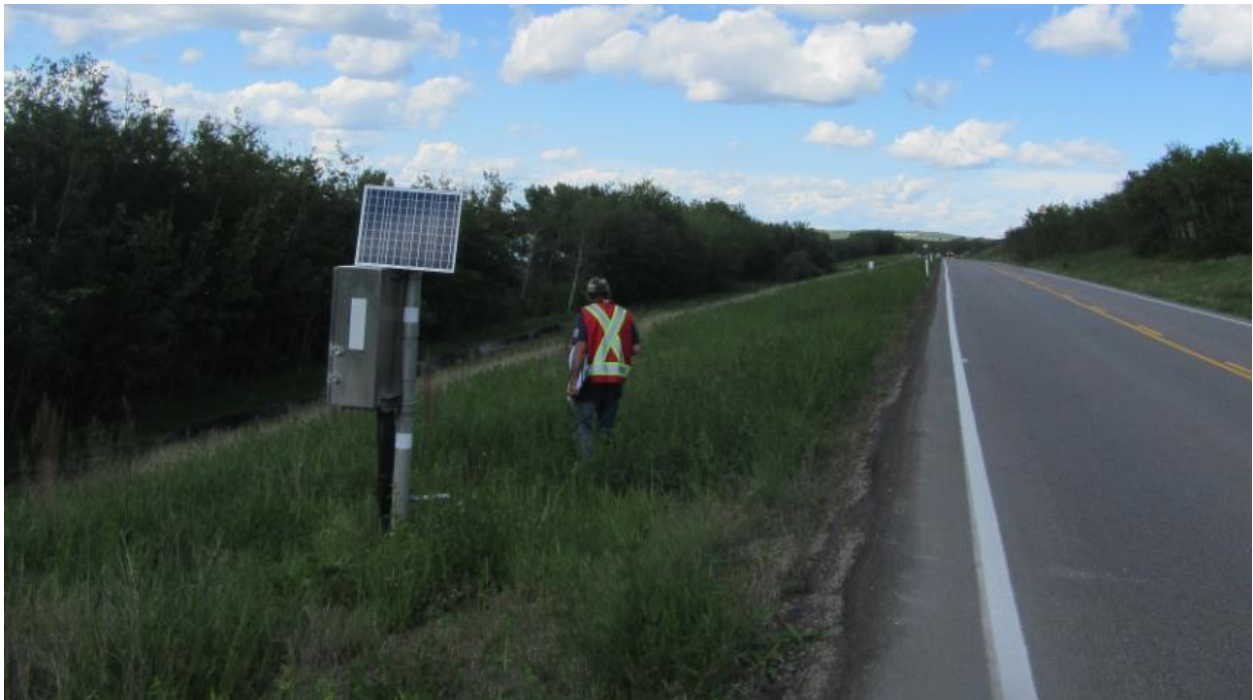
Photo No.6 - Looking at data logger DT1 installed at pile 146 location; vegetation grew at previously noted subsidence at the base of the data logger

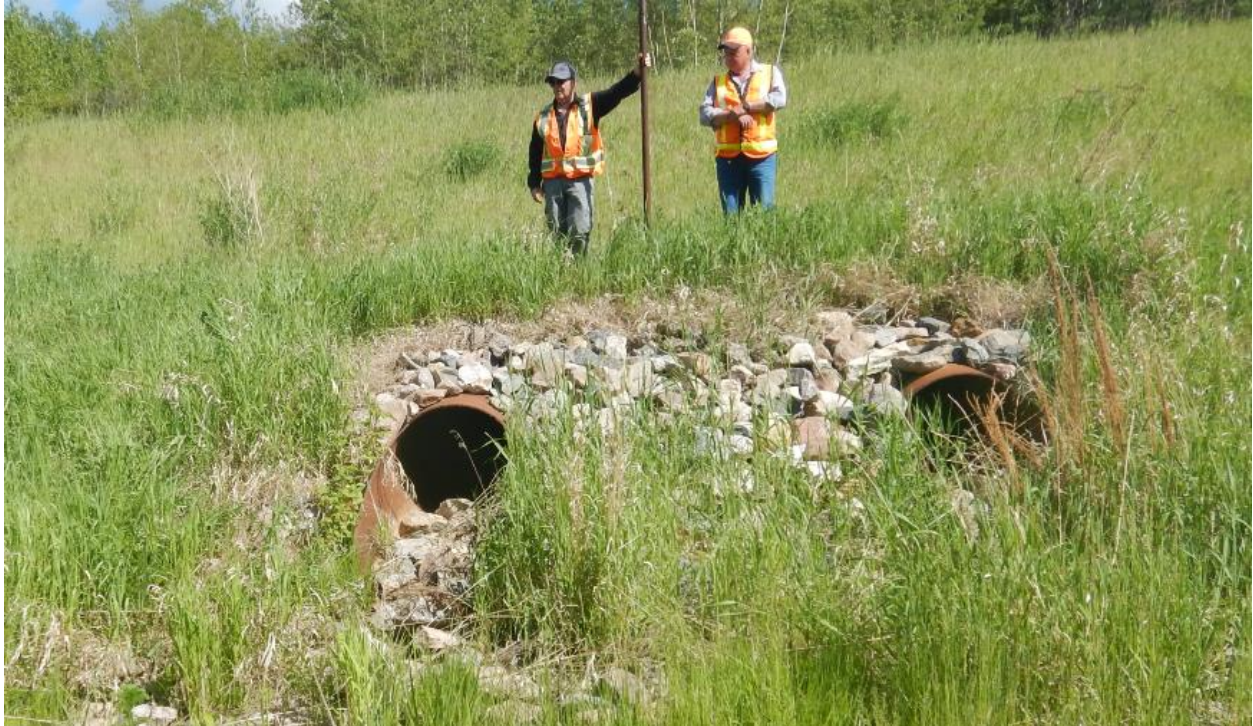
Photo No.7 - Looking at the outlets of the twin culverts; water flows downstream of the pipes toward the bush

Accumulated sediment behind the silt fence, located between the outlet of the twin pipes and the bush, should be cleared to avoid damming of culvert flow. The silt fence will need to be maintained for a few years and then be removed after vegetation is established in this area.
