**ALBERTA TRANSPORTATION  
GEOHAZARD ASSESSMENT PROGRAM  
NORTH CENTRAL REGION – ATHABASCA AND  
FORT MCMURRAY DRISTRICTS  
2021 SITE INSPECTION**

Site Number	Location	Name	Hwy	km
NC104	Approximately 7.7 km north of Hwy 29 (North of Elk Point)	<b>KEHIWIN LAKE</b>	41:23	7.7
Legal Description		UTM Co-ordinates (NAD 83)		
NE-25-58-7-W4M		12 N 5988325	E	506652

**NORTH CENTRAL REGION  
(ATHABASCA AND FORT McMURRAY DISTRICTS)  
2021 GEOHAZARD ASSESSMENT  
NC104: HWY 41:23 LANDSLIDE (km 7.7)  
SITE PLAN SHOWING SITE FEATURES AND  
INSTRUMENT LOCATIONS**

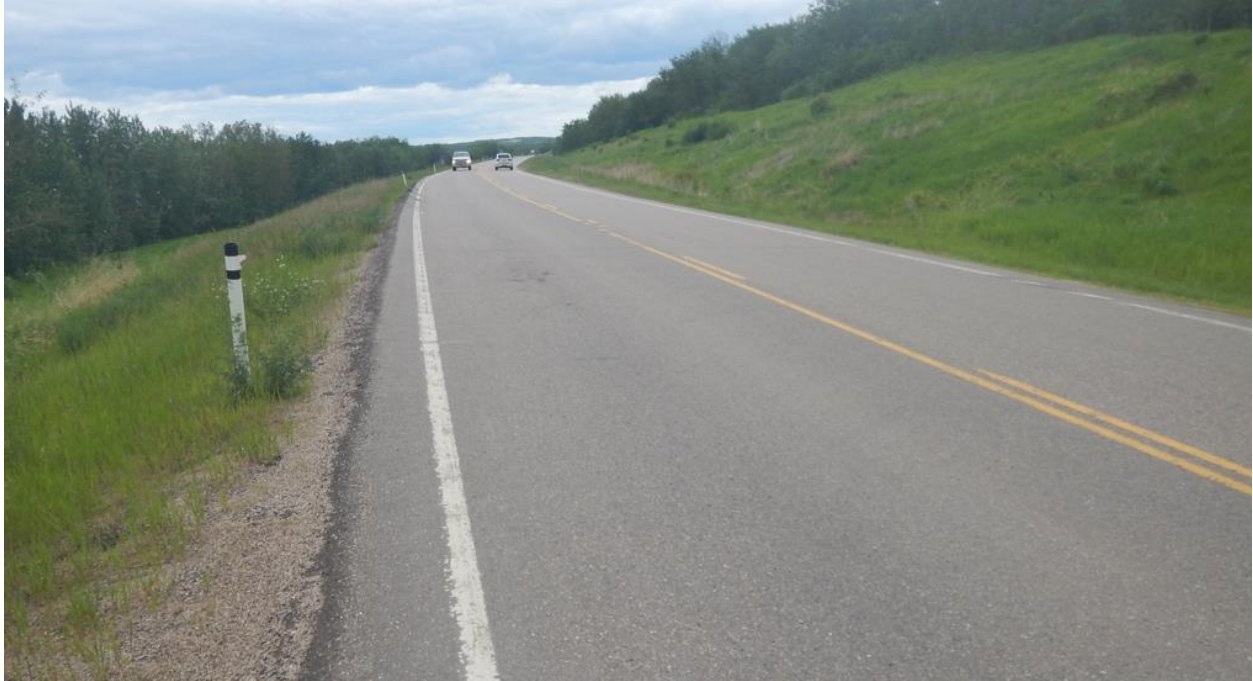
Photo No. 1 - Looking north at highway surface; no reflective cracks or dips noted in 2021

The local MCI should watch closely for the development of any cracks in the highway section above the pile wall extension and notify us immediately. Cracks should generally be sealed to reduce ground water infiltration into the landslide mass.

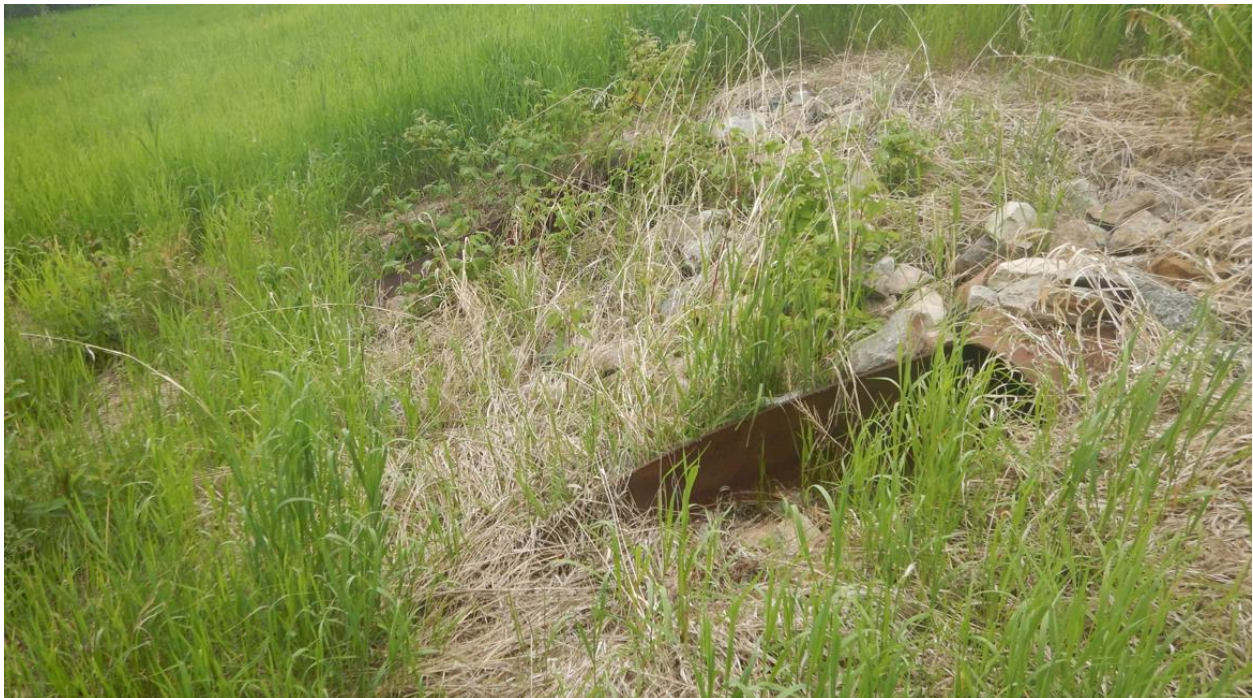
Photo No.2 - Looking northeast at the twin culverts outlets; Sediment and silt fence cleared; no flow in 2021

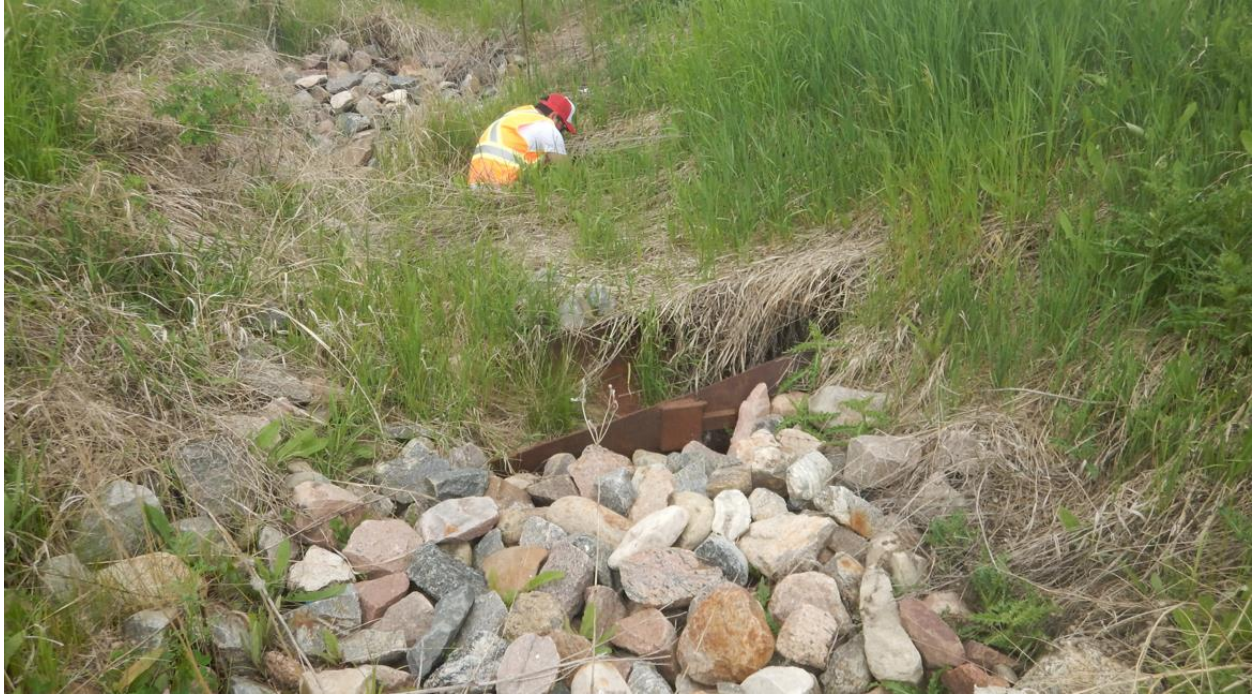
Photo No.3 - Looking at the twin culverts inlets; no flow in 2021

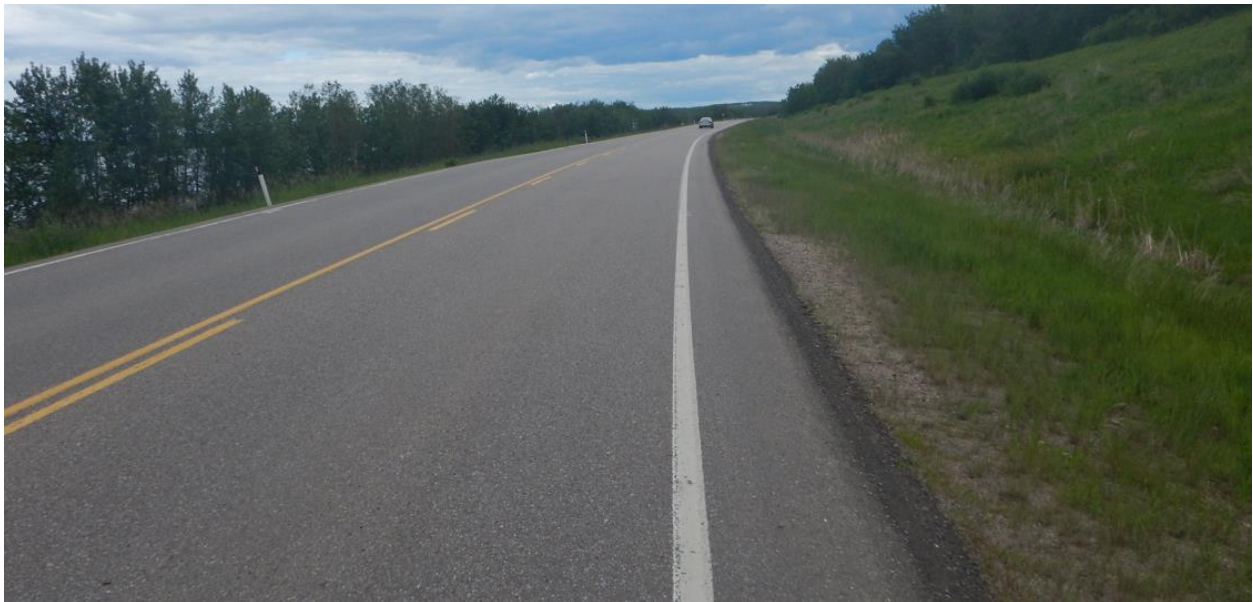
Photo No.4 - Looking north at the TRM lined ditch; no water flowing; note cattails in the ditch area

The local MCI should also check whether the south ditch is draining towards the C2 pipe and the twin culverts. If water is ponding within the ditch, consideration should be given to re-grading the ditch to promote positive drainage.

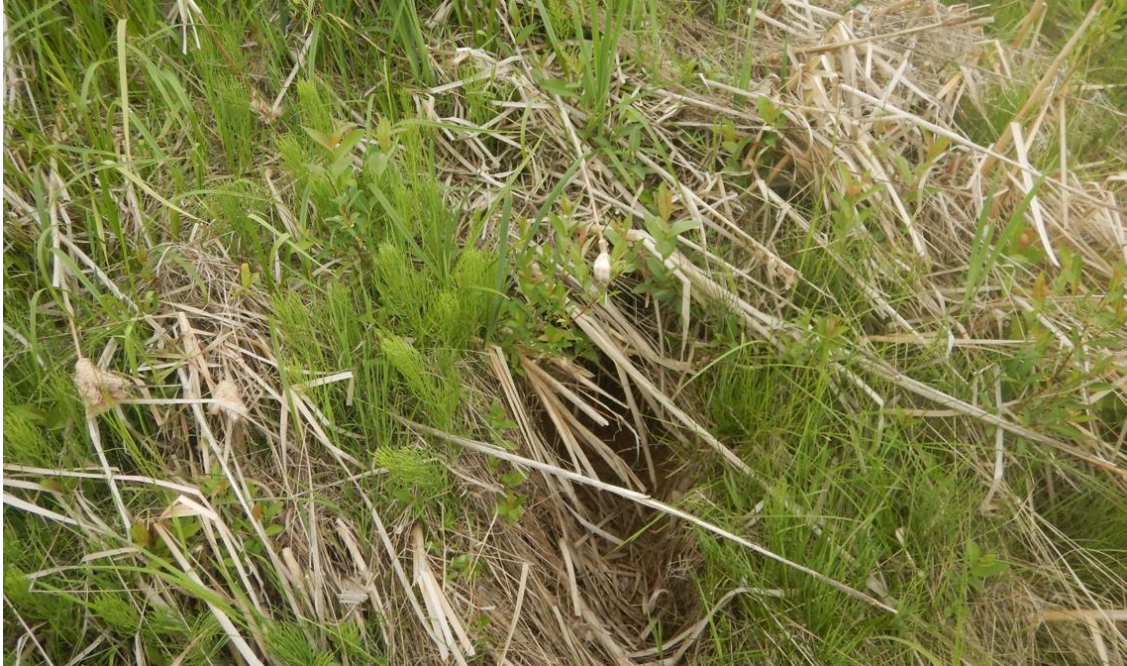
Photo No.5 - Looking at culvert C2 inlet; no flow in 2021

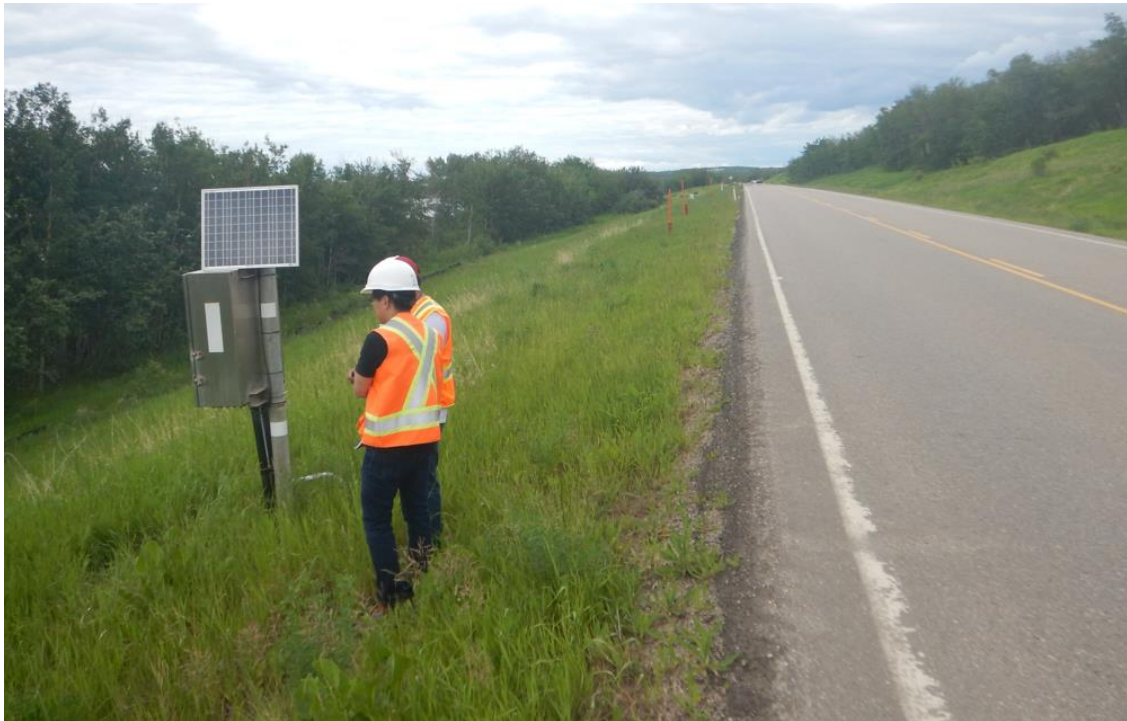
Photo No.6 - Looking at data logger DT1 installed at pile 146 location; vegetation grew at previously noted subsidence at the base of the data logger

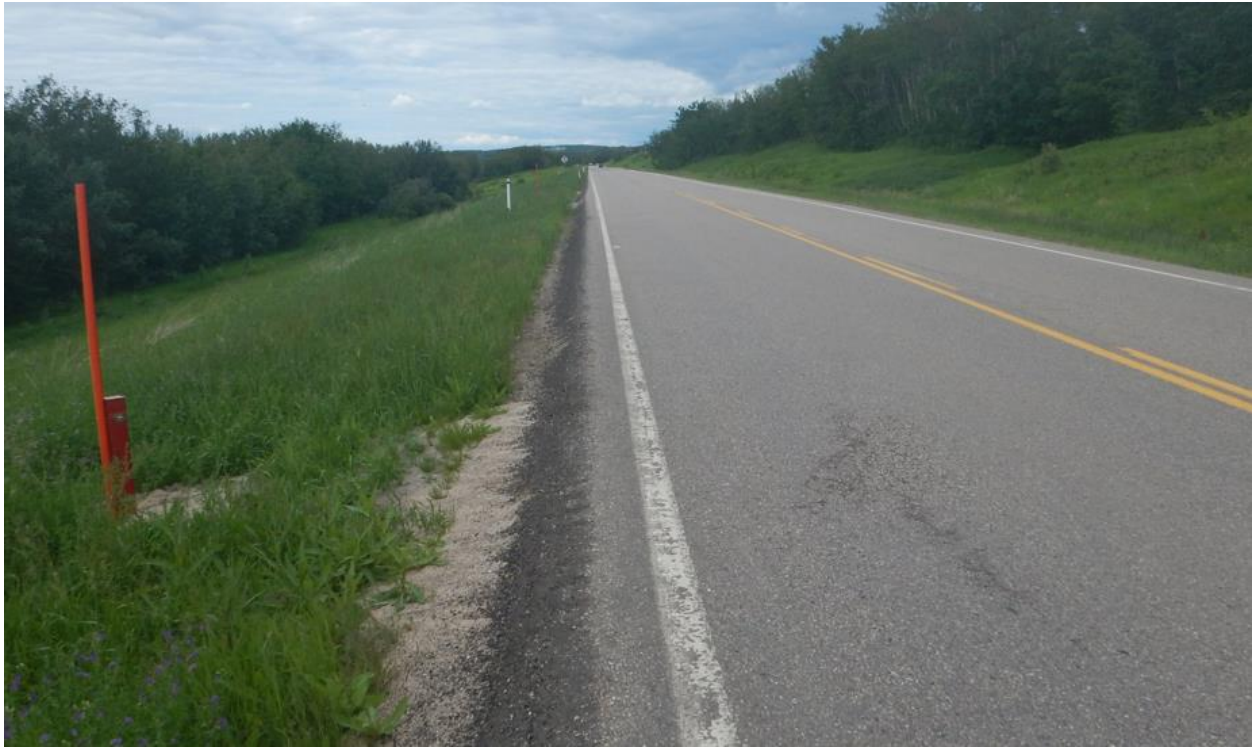
Photo No.7 – Looking north at sharp drop off shoulder on the west side slope

Consideration should be given for placing the least amount of fill off the highway surface to smoothen the existing sharp drop off and eliminate the existing hazard. Otherwise, sharp shoulders warning signs should be erected to warn the motorists of the existing hazard.

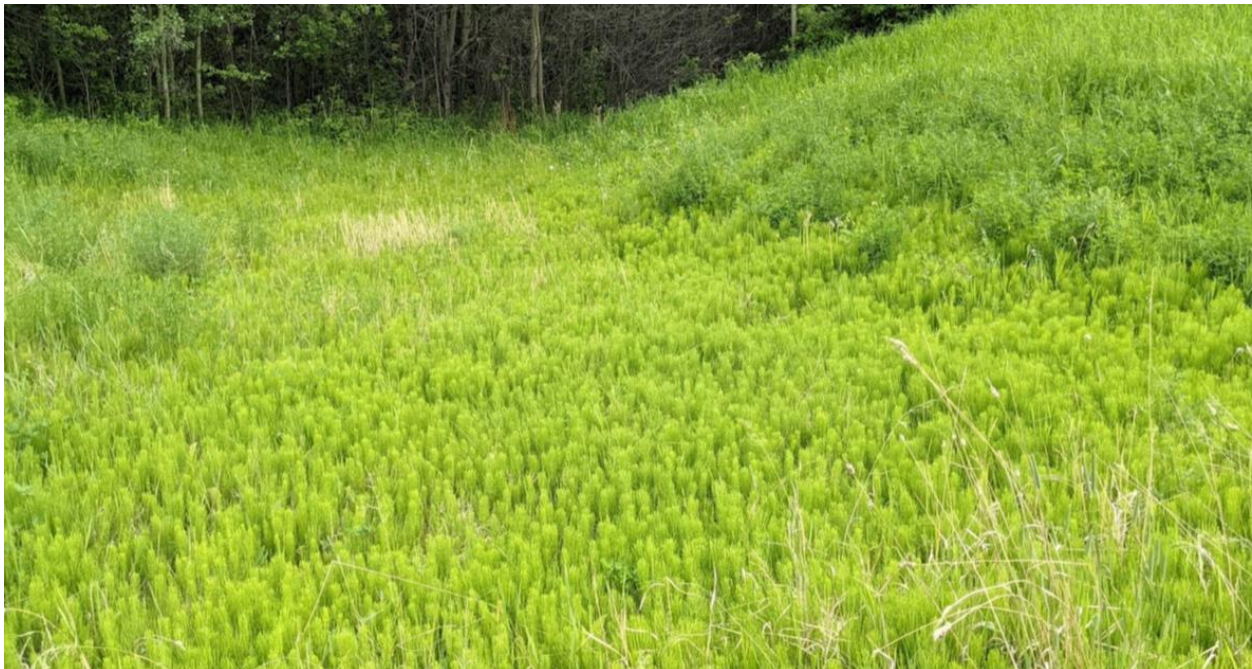
Photo No. 8 – Looking at gully lined with TRM; note lush vegetation but no flow in 2021

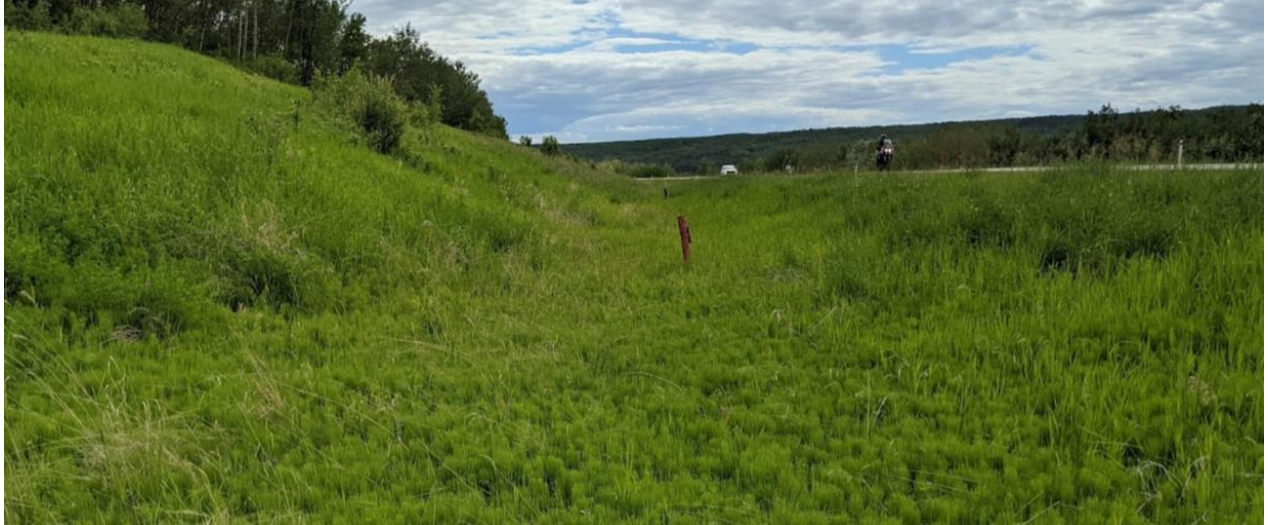
Photo No. 9 – Looking south at TRM lined ditch; note lush vegetation but no flow in 2021

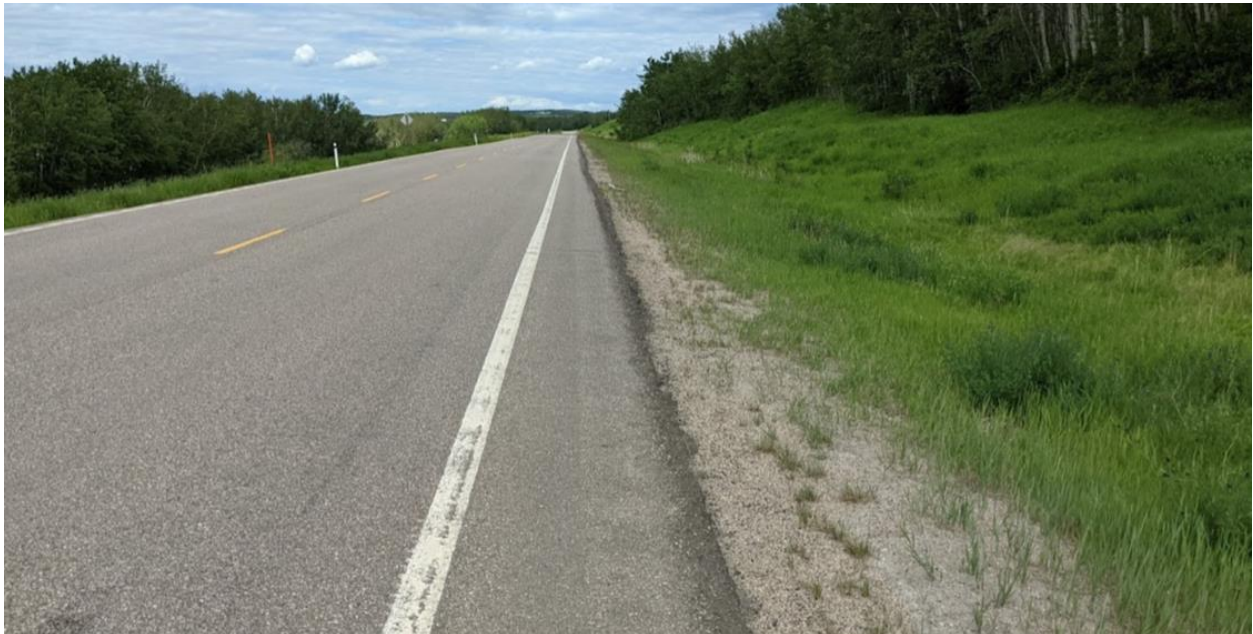
Photo No. 10 – Looking north at the highway surface from the northern limit of the site
