July 5, 2022

**ALBERTA TRANSPORTATION GRMP (CON0022163)  
NORTH CENTRAL (ATHABASCA AND FORT McMURRAY DISTRICTS)  
INSTRUMENTATION MONITORING RESULTS – SPRING 2022**

**SECTION C**

**SITE NC104 (NC024-4): HWY 41:23 KEHIWIN LAKE (km 7.7)**

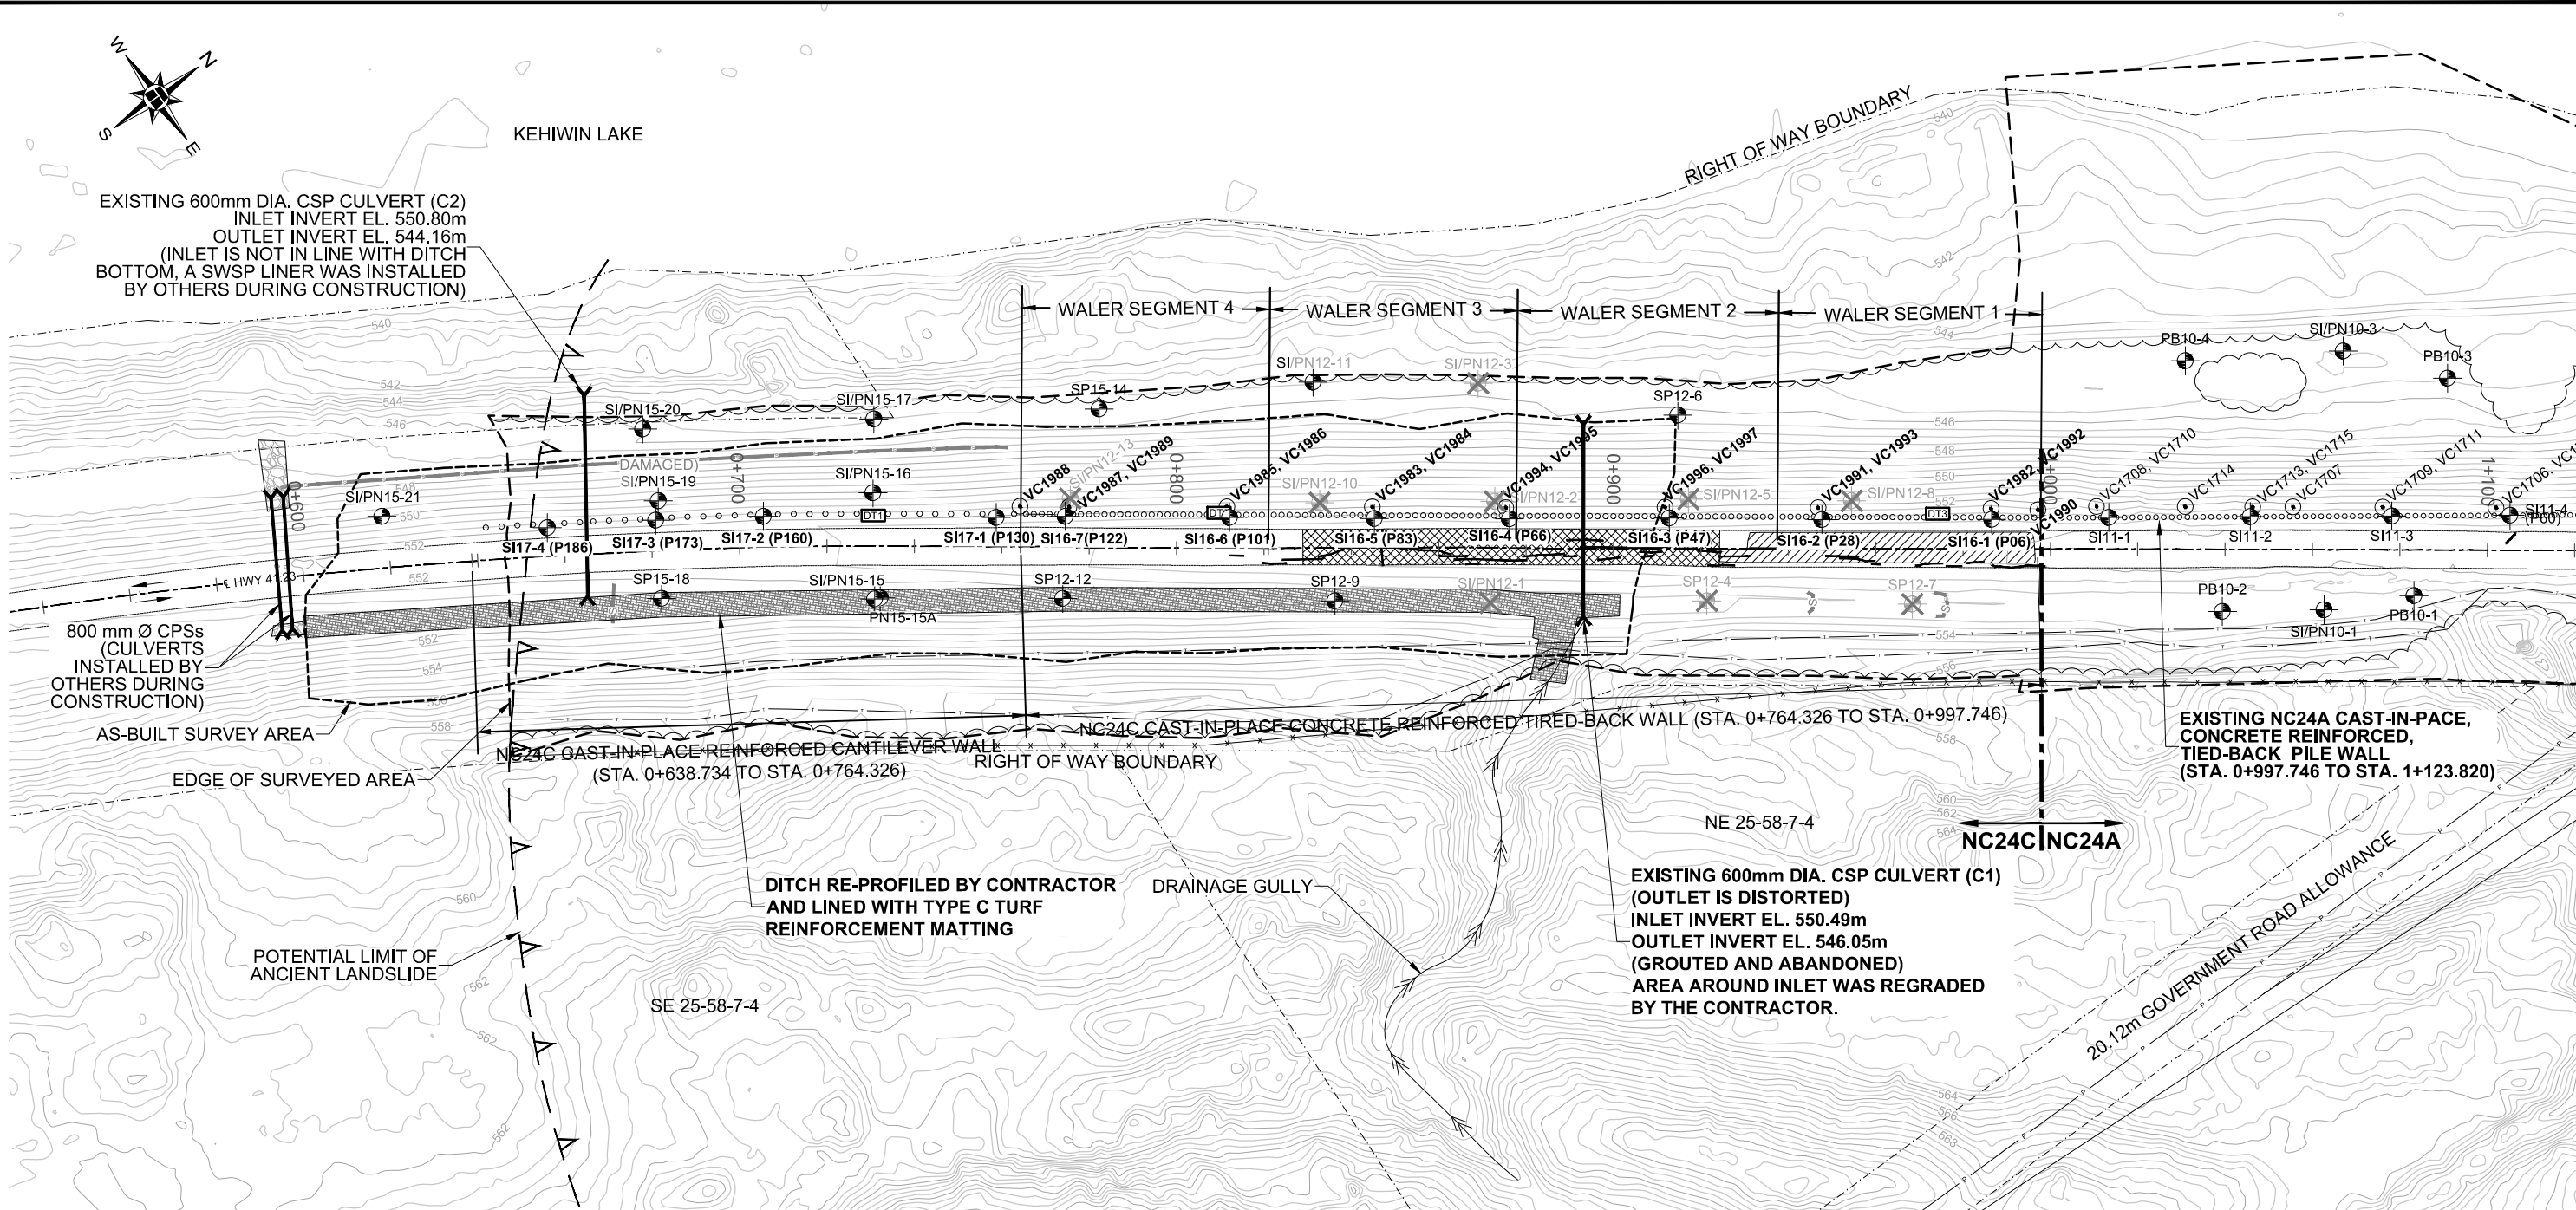
EXISTING 600mm DIA. CSP CULVERT (C2)  
 INLET INVERT EL. 550.80m  
 OUTLET INVERT EL. 544.16m  
 (INLET IS NOT IN LINE WITH DITCH  
 BOTTOM, A SWSP LINER WAS INSTALLED  
 BY OTHERS DURING CONSTRUCTION)

800 mm Ø CSPs  
 (CULVERTS  
 INSTALLED BY  
 OTHERS DURING  
 CONSTRUCTION)
