**ALBERTA TRANSPORTATION AND ECONOMIC CORRIDORS  
GEOHAZARD ASSESSMENT PROGRAM  
NORTH CENTRAL REGION – ATHABASCA AND  
FORT MCMURRAY DRISTRICTS  
2023 SITE INSPECTION**

Site Number	Location	Name	Hwy	km
NC104	Approximately 7.7 km north of Hwy 29 (North of Elk Point)	<b>KEHIWIN LAKE</b>	41:23	7.7
Legal Description		UTM Co-ordinates (NAD 83)		
NE-25-58-7-W4M		12 N 5988325	E	506652

Date	PF	CF	Total
<b>Previous Inspection:</b>	June 25, 2021	11	4	44
<b>Current Inspection:</b>	May 18, 2023	11	4	44
<b>Road WAADT:</b>	1,220	<b>Year:</b>	2022	
<b>Inspected By:</b>	José Pineda, Tarek Abdelaziz (Thurber) Kristen Tappenden, Amy Driessen, Arthur Kavulok (TEC)			
<b>Report Attachments:</b>	<input checked="" type="checkbox"/> Photographs <input checked="" type="checkbox"/> Plans <input type="checkbox"/> Maintenance Items

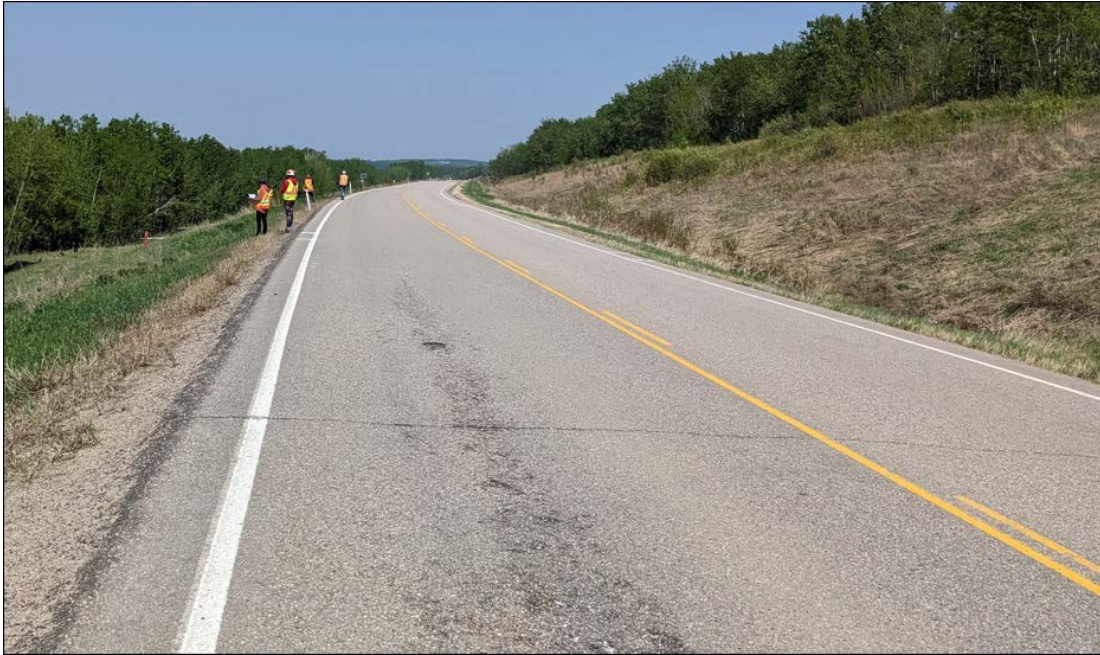
**Photo No. 1 - Looking north at highway surface; no reflective cracks or dips noted at the south end of the site**

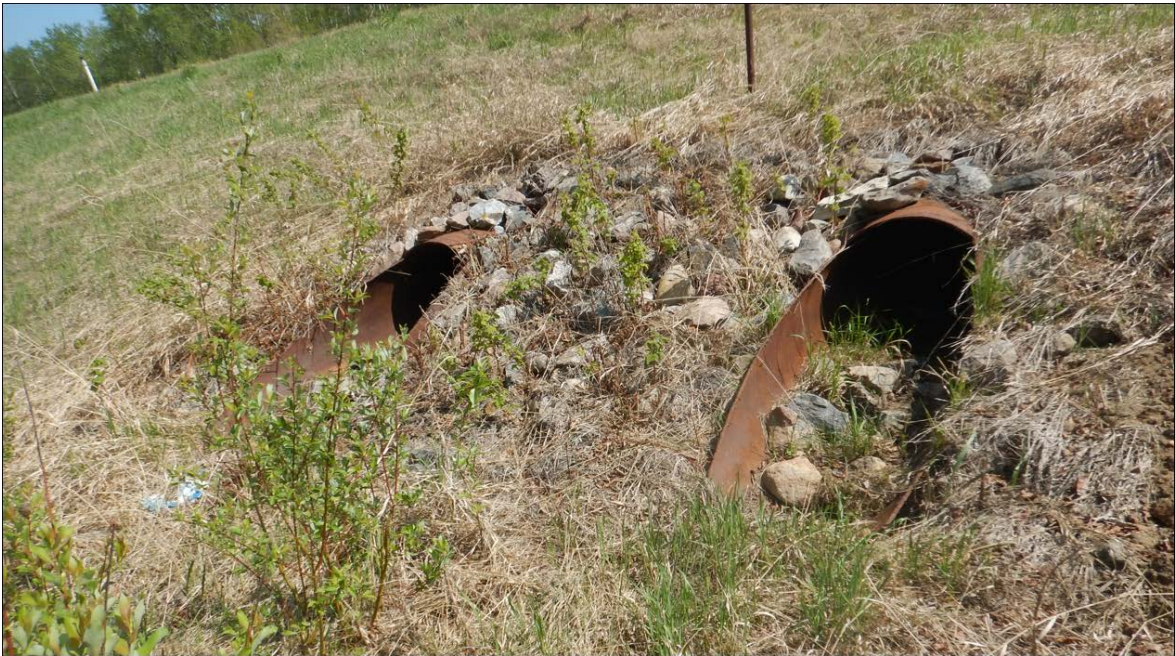
**Photo No.2 - Looking northeast at the twin culverts outlets; Sediment and silt fence cleared; no flow in 2023**

The local MCI should also check whether the south ditch is draining towards the C2 pipe and the twin culverts. If water is ponding within the ditch, consideration should be given to re-grading the ditch to promote positive drainage.

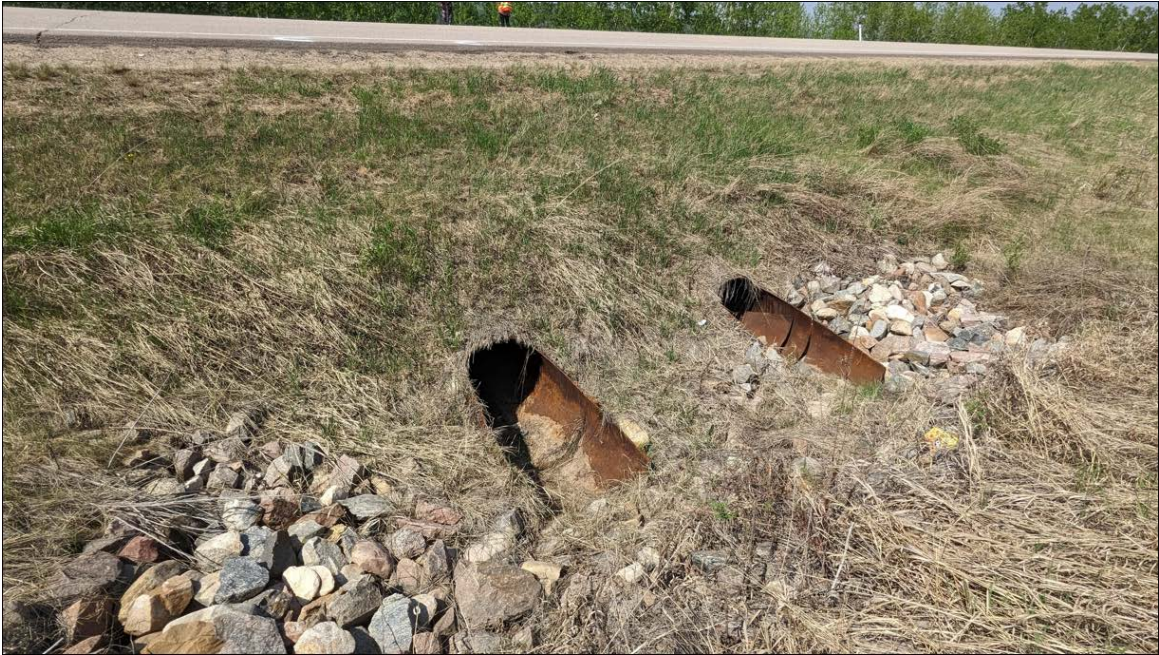
**Photo No.3 - Looking at the twin culverts inlets; no flow**

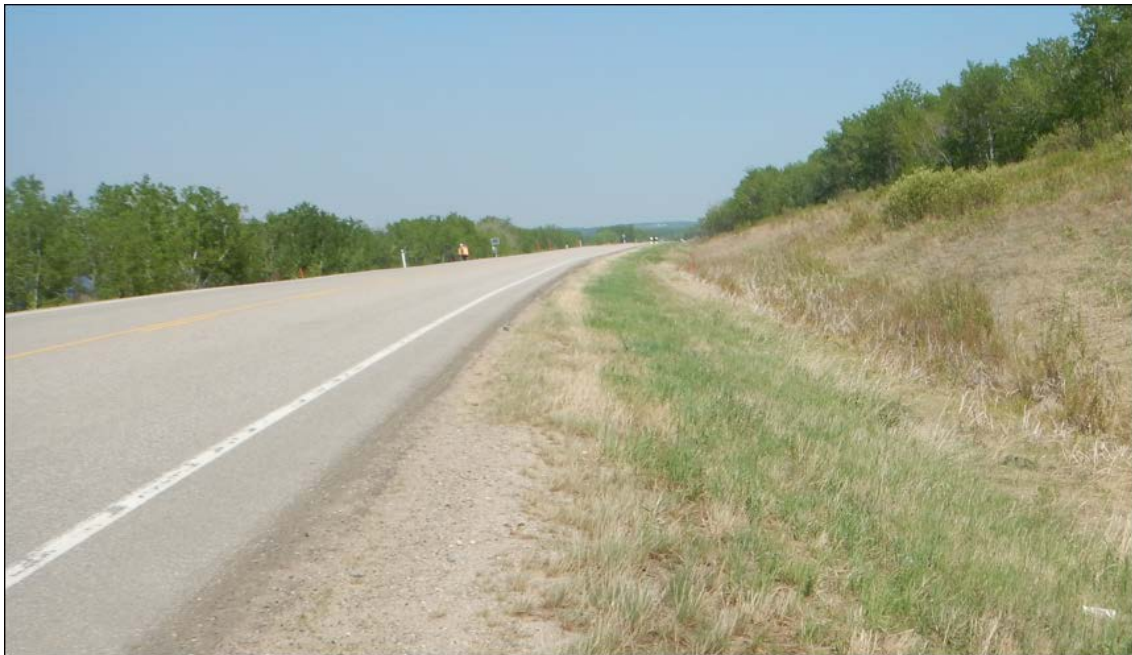
**Photo No.4 - Looking north at the TRM lined ditch; no water flowing; note cattails in the ditch area**

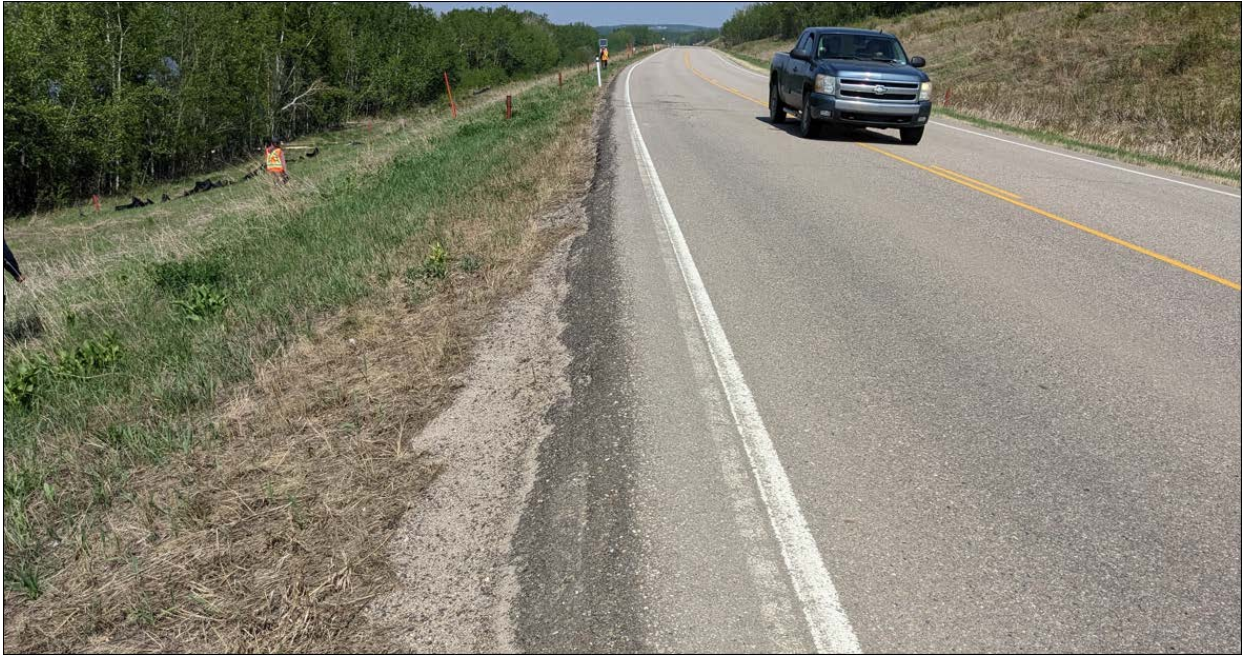
**Photo No.5 – Looking north at sharp shoulder drop off on the west side slope**

Consideration should be given for placing the least amount of fill off the highway surface to smoothen the existing sharp drop off and eliminate the existing hazard. Otherwise, sharp shoulders warning signs should be erected to warn the motorists of the existing hazard.

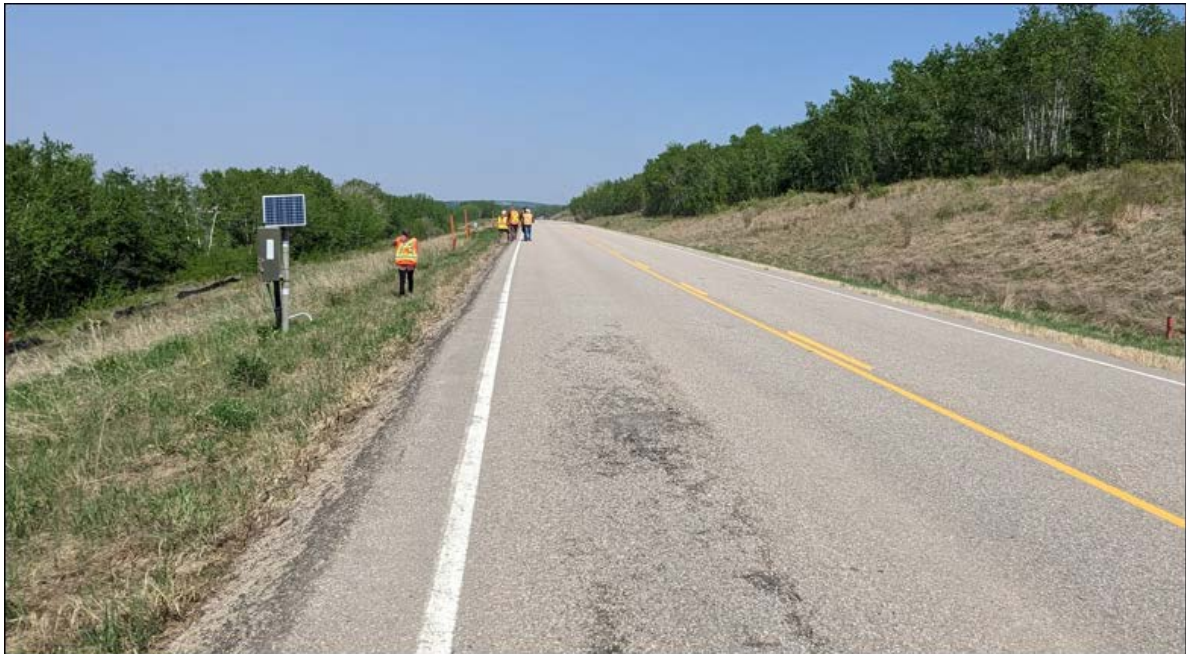
**Photo No.6 - Looking at data logger DT1 installed at pile 146 location; vegetation grew at previously noted subsidence at the base of the data logger**

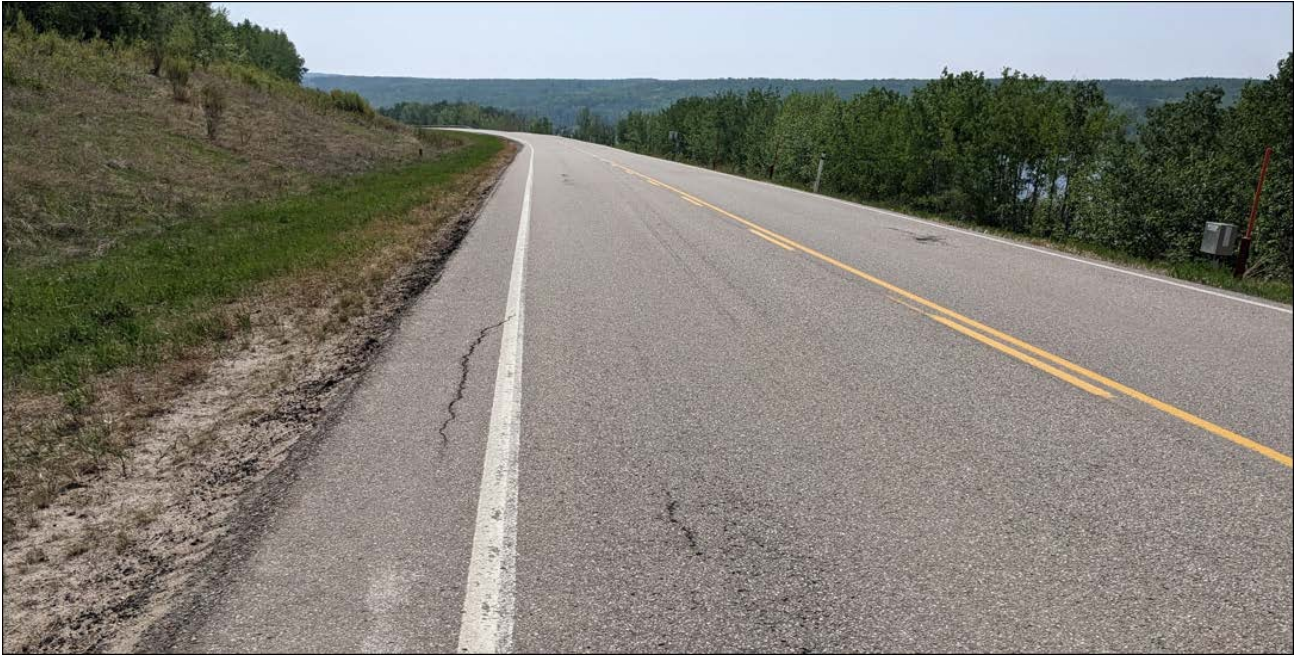
**Photo No.7 – Looking south at reflective cracks 10 to 20 mm wide, no drop**

The local MCI should watch closely for the development of new cracks or widening or existing cracks in the highway surface. Open cracks should generally be sealed to reduce surface water infiltration into the landslide mass.

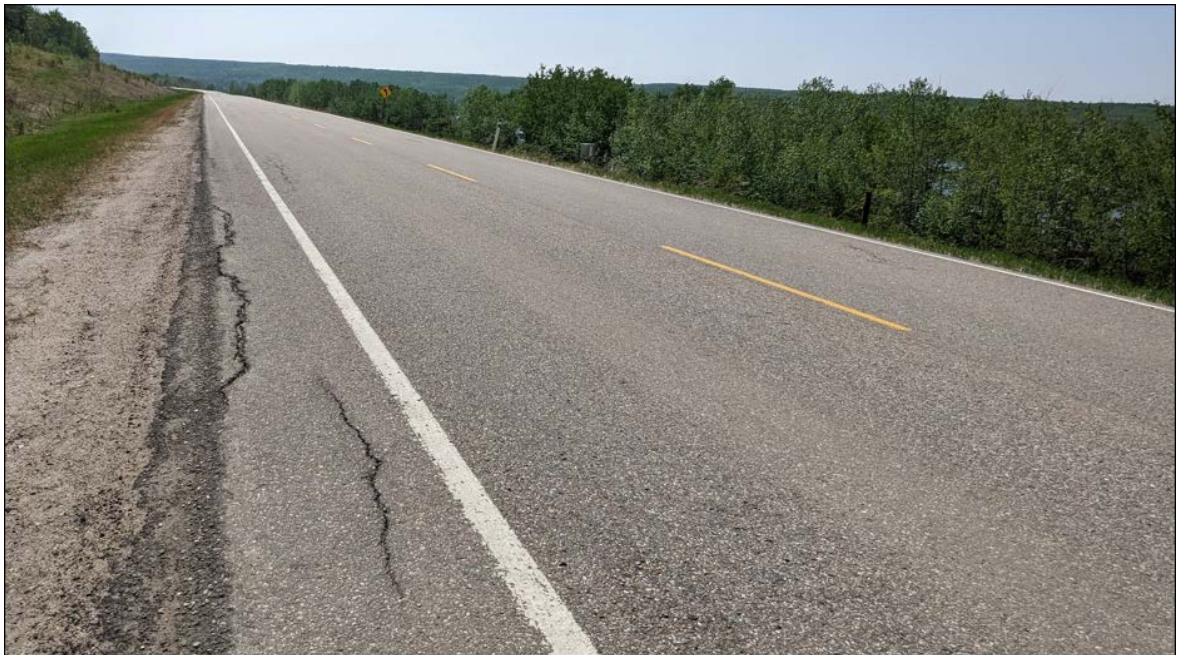
**Photo No. 8 – Looking south at reflective cracks 10 to 20 mm wide, no drop**

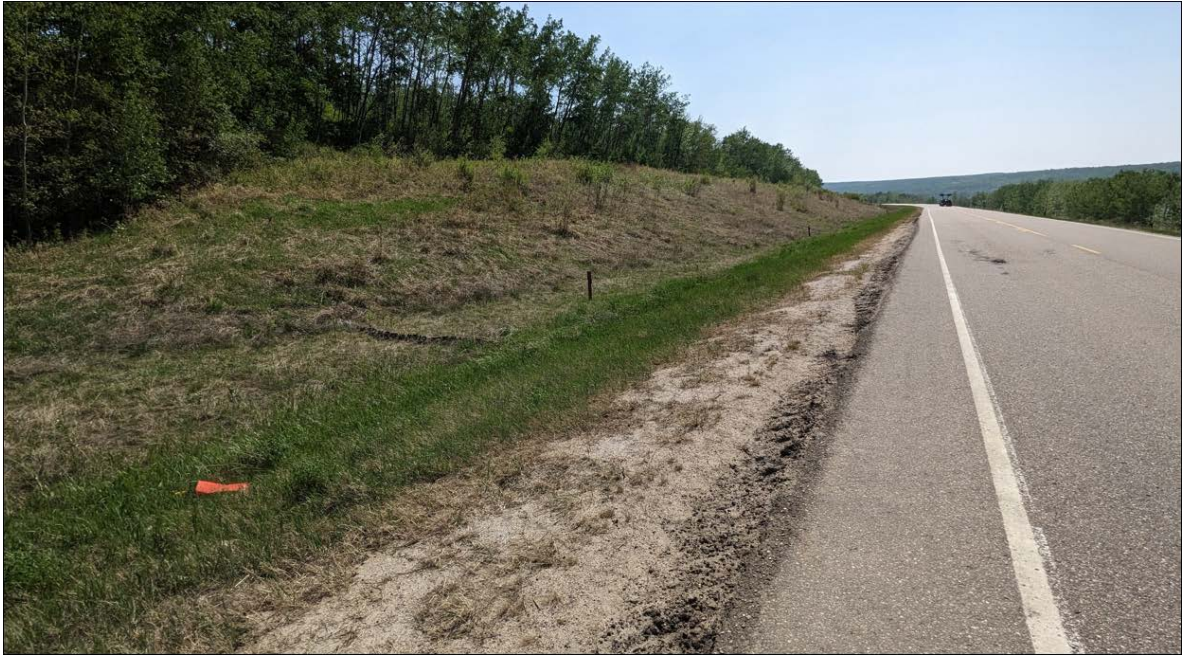
**Photo No. 9 – Looking south at ditch and a gully lined with TRM**
