**ALBERTA TRANSPORTATION AND  
ECONOMIC CORRIDORS GRMP  
NORTH CENTRAL (ATHABASCA AND FORT  
McMURRAY DISTRICTS)  
INSTRUMENTATION MONITORING- SPRING 2024**

Site Number	Location	Name	Hwy	km
NC104 (NC024-4)	HWY 41:23 C1 7.66	Kehiwin Lake	41:23	Km 7.7
<b>Legal Description:</b> 9-25-58-7 W4		<b>UTM Co-ordinates</b>		
		12U E 506556	N	5988265

<b>Current Monitoring:</b>	6-June-2024	<b>Previous Monitoring</b>	25-May-2023
<b>Instruments Read By:</b>	Mr. Niraj Regmi, G.I.T and Mr. Nixson Mationg, of Thurber

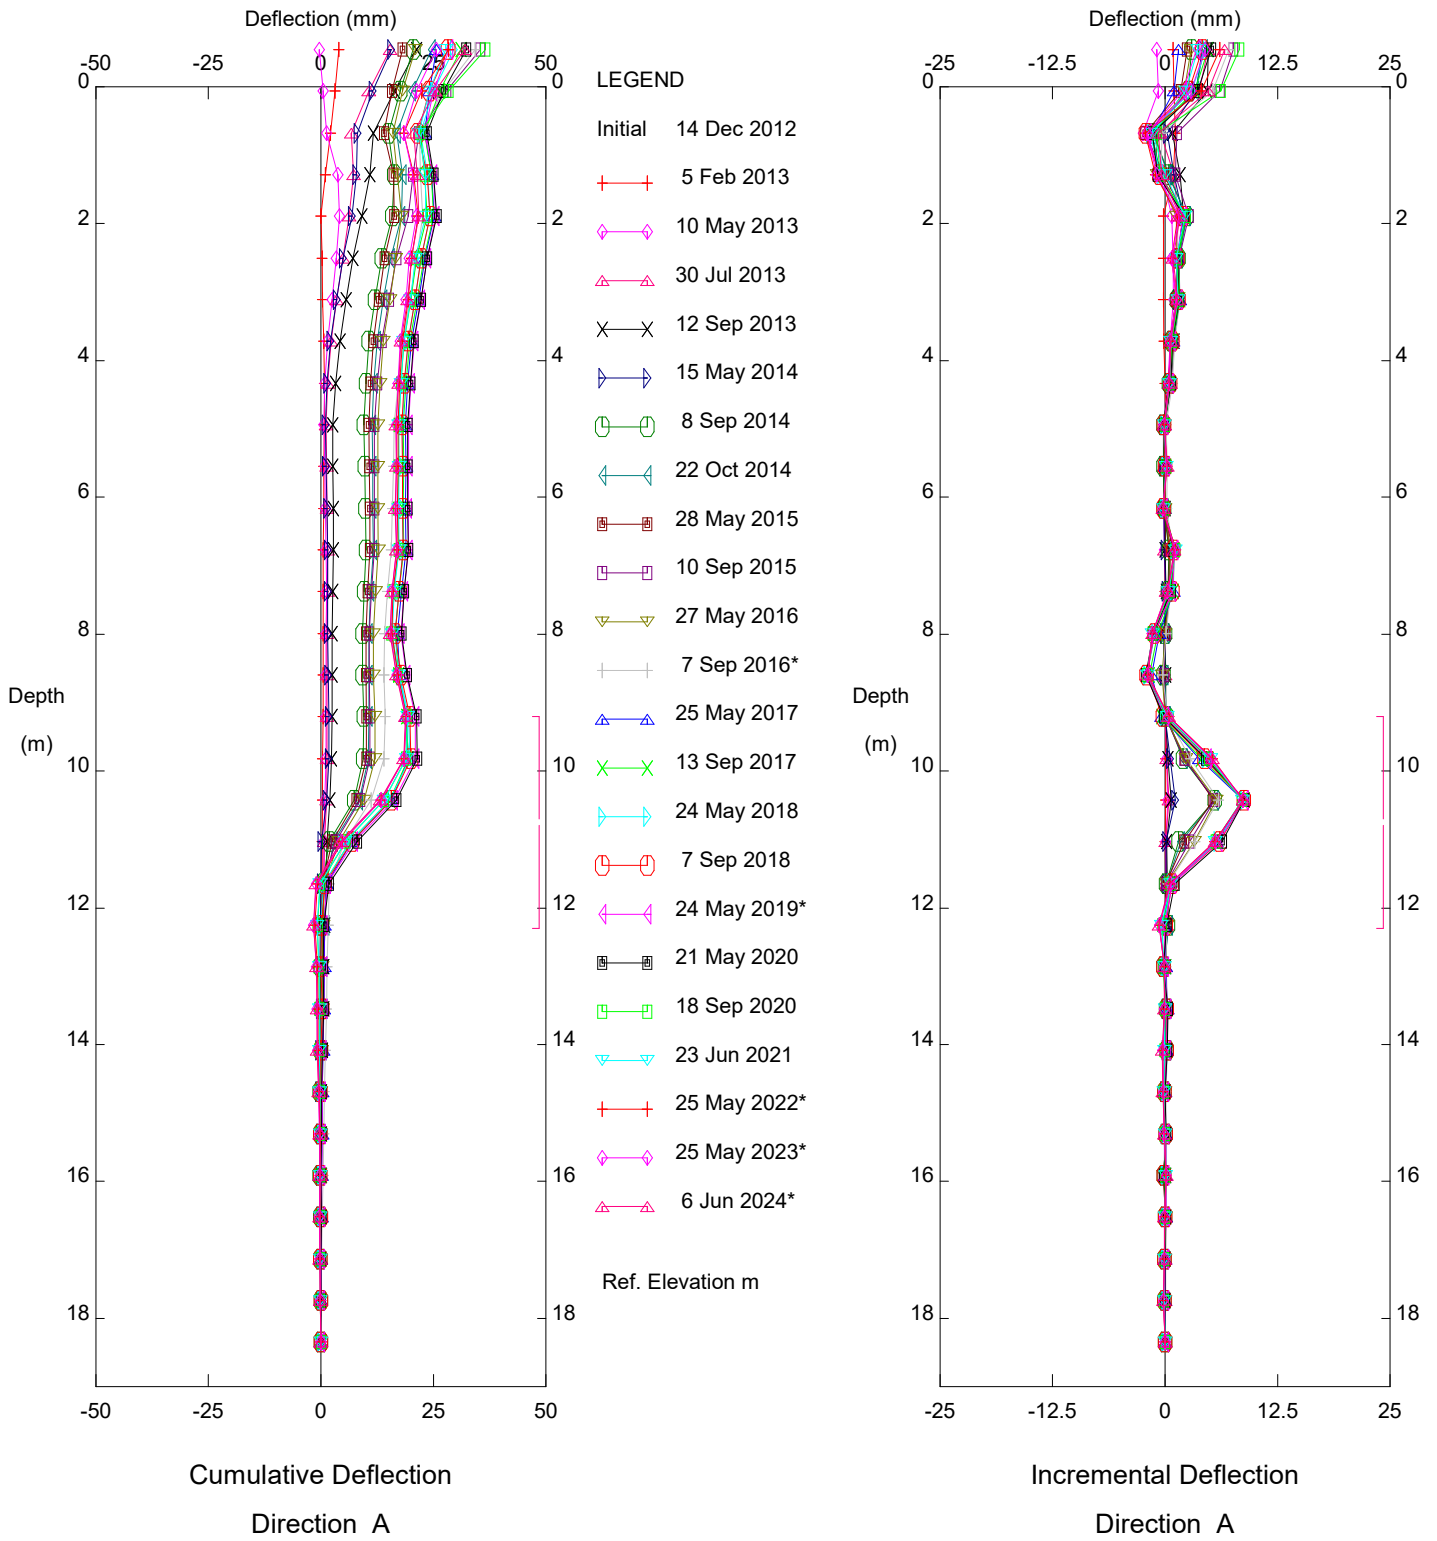
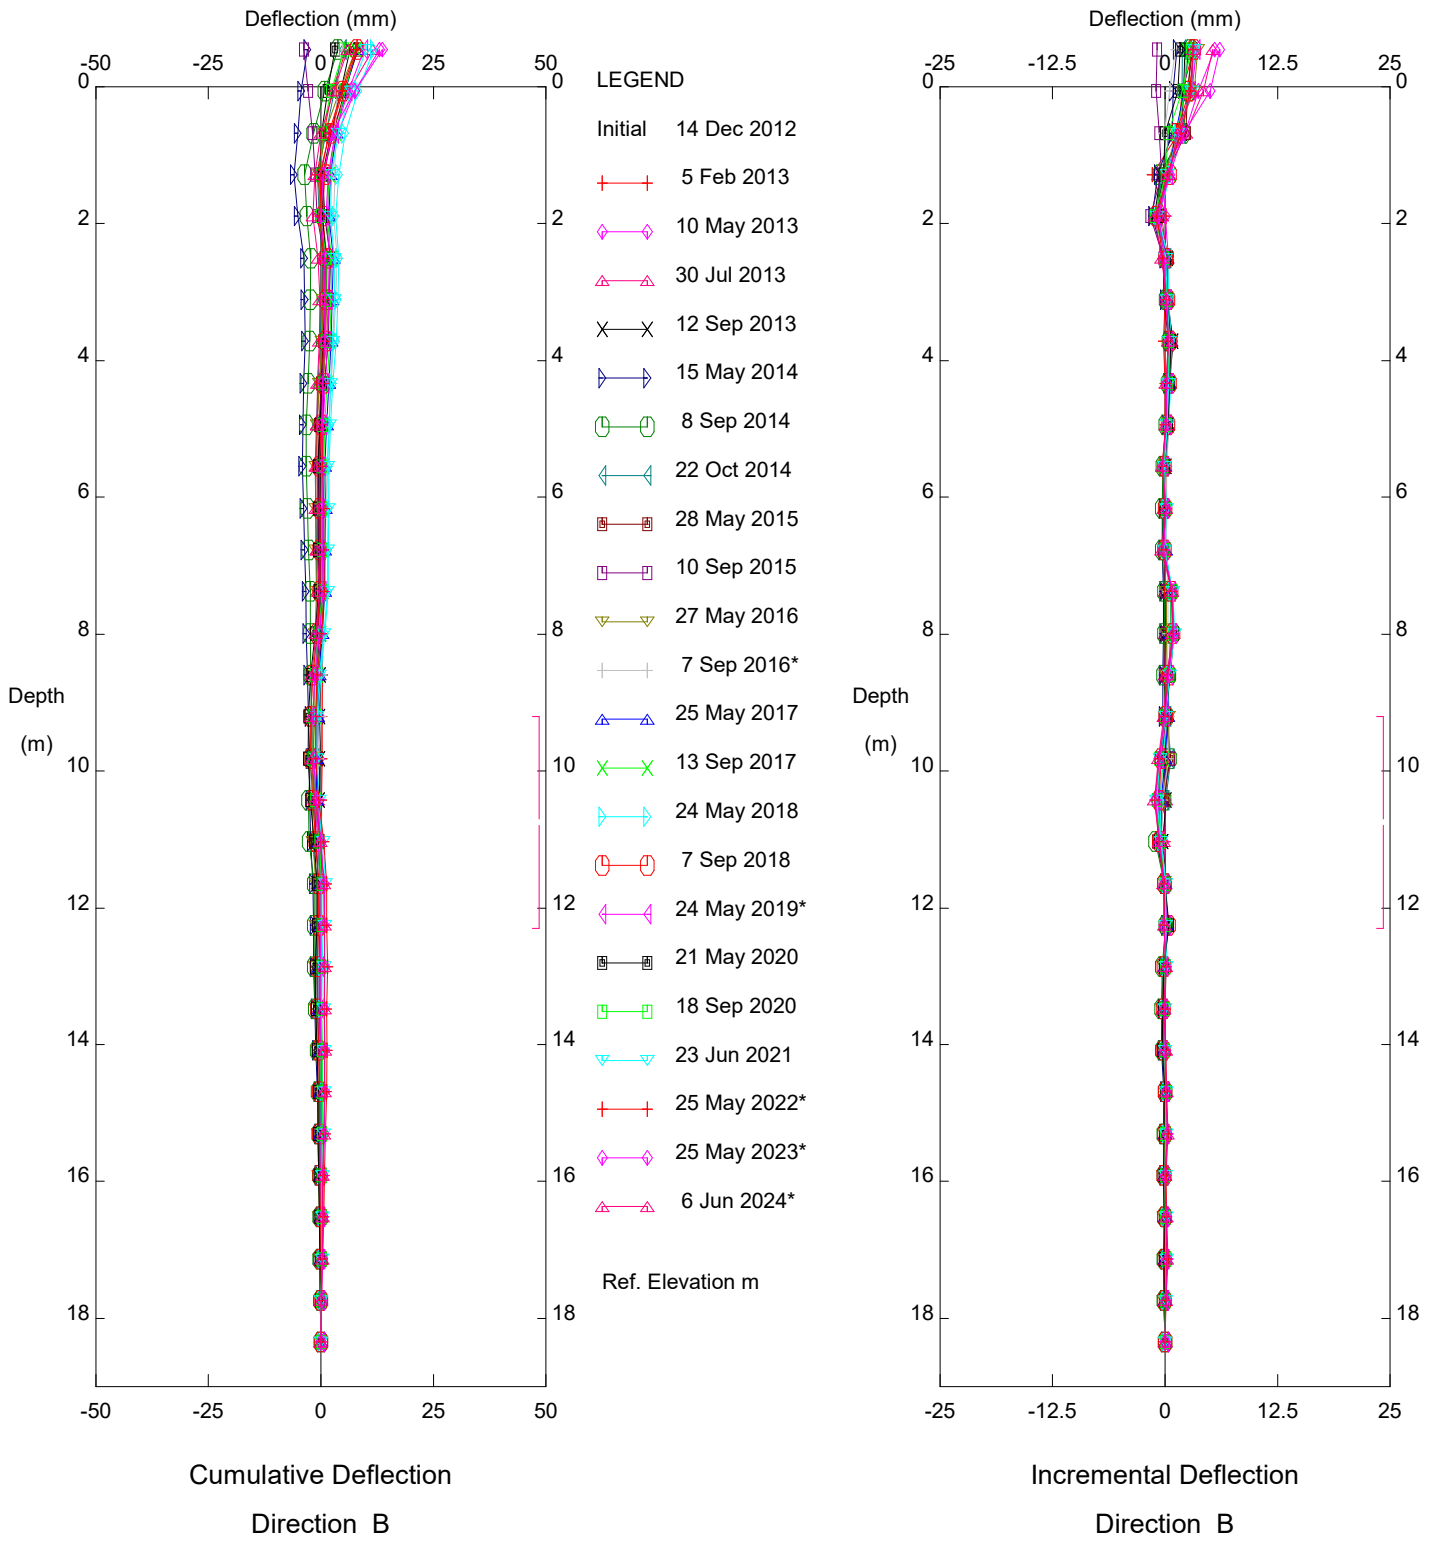
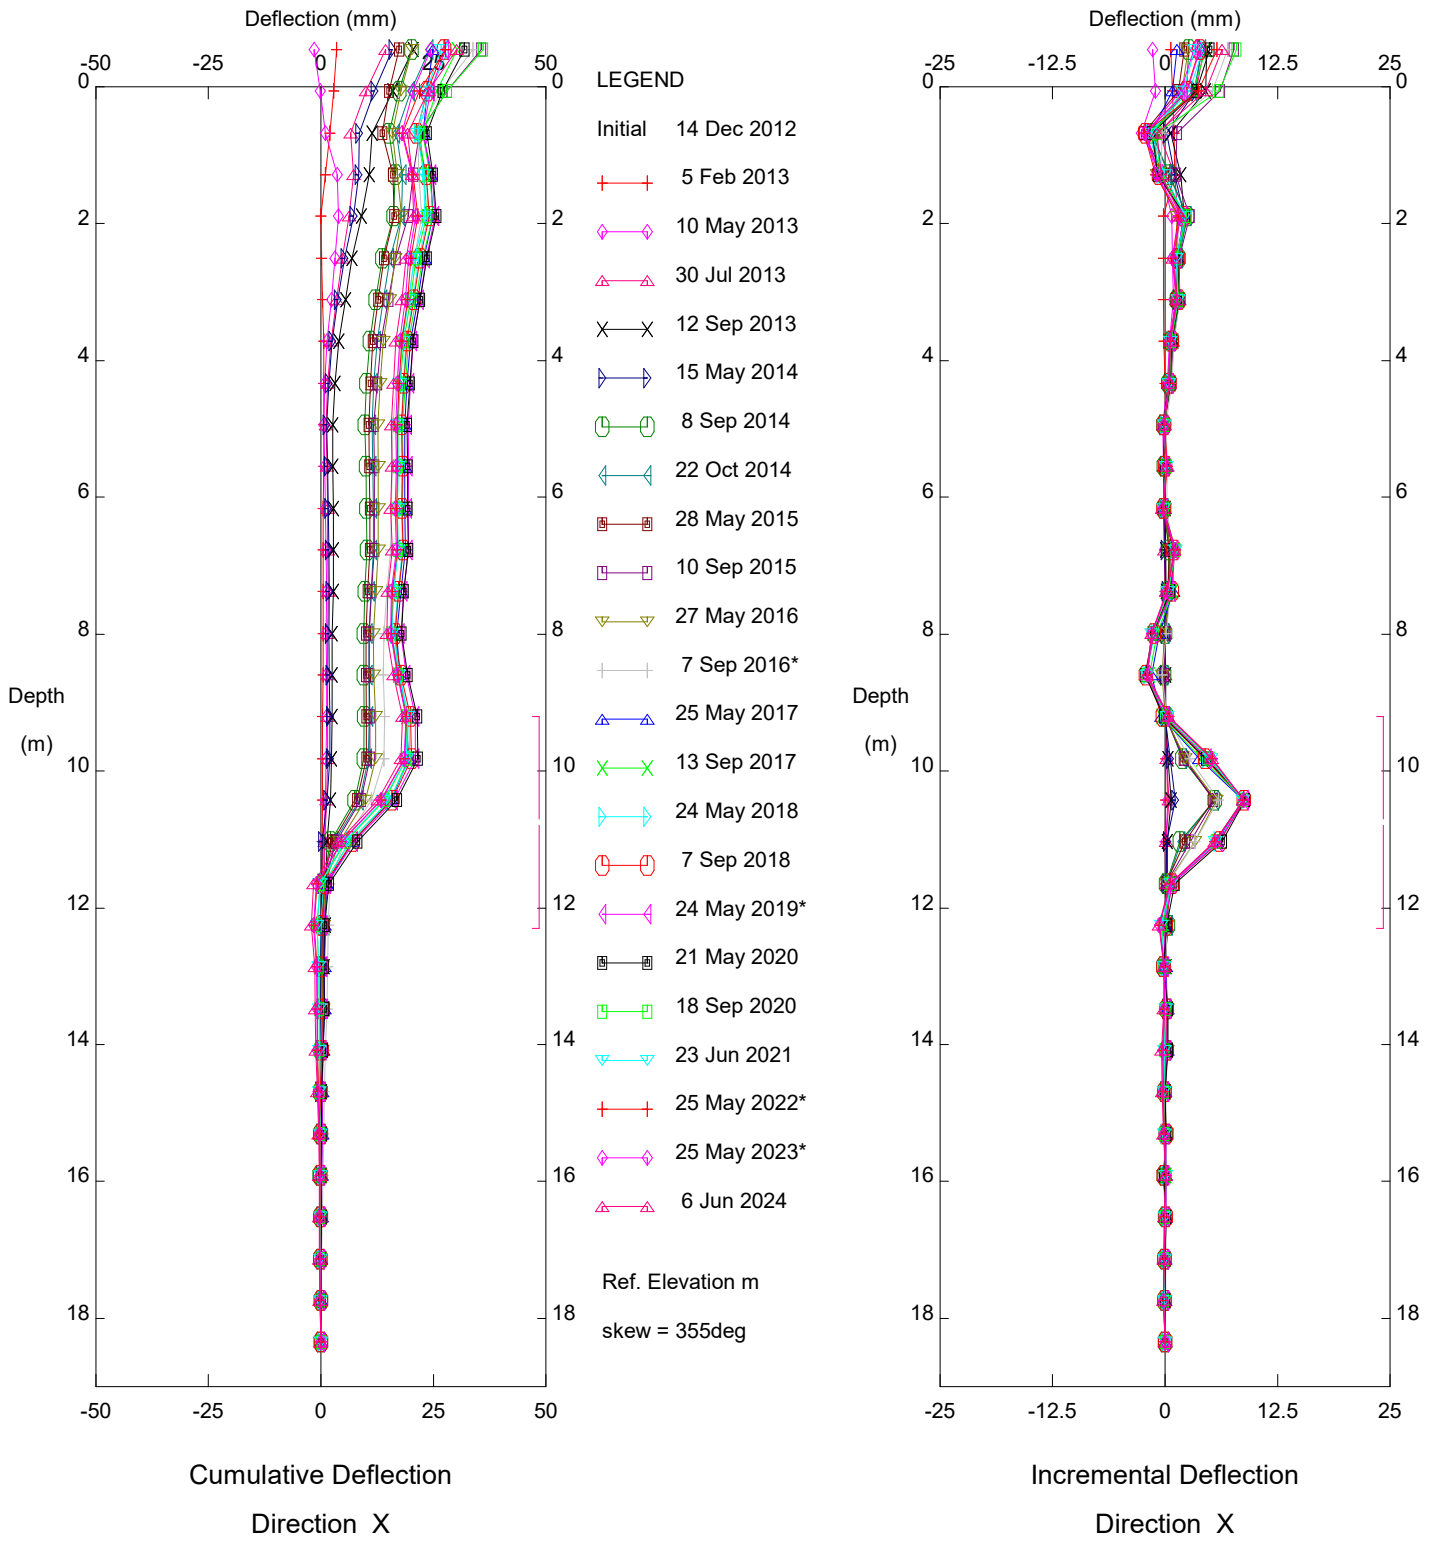
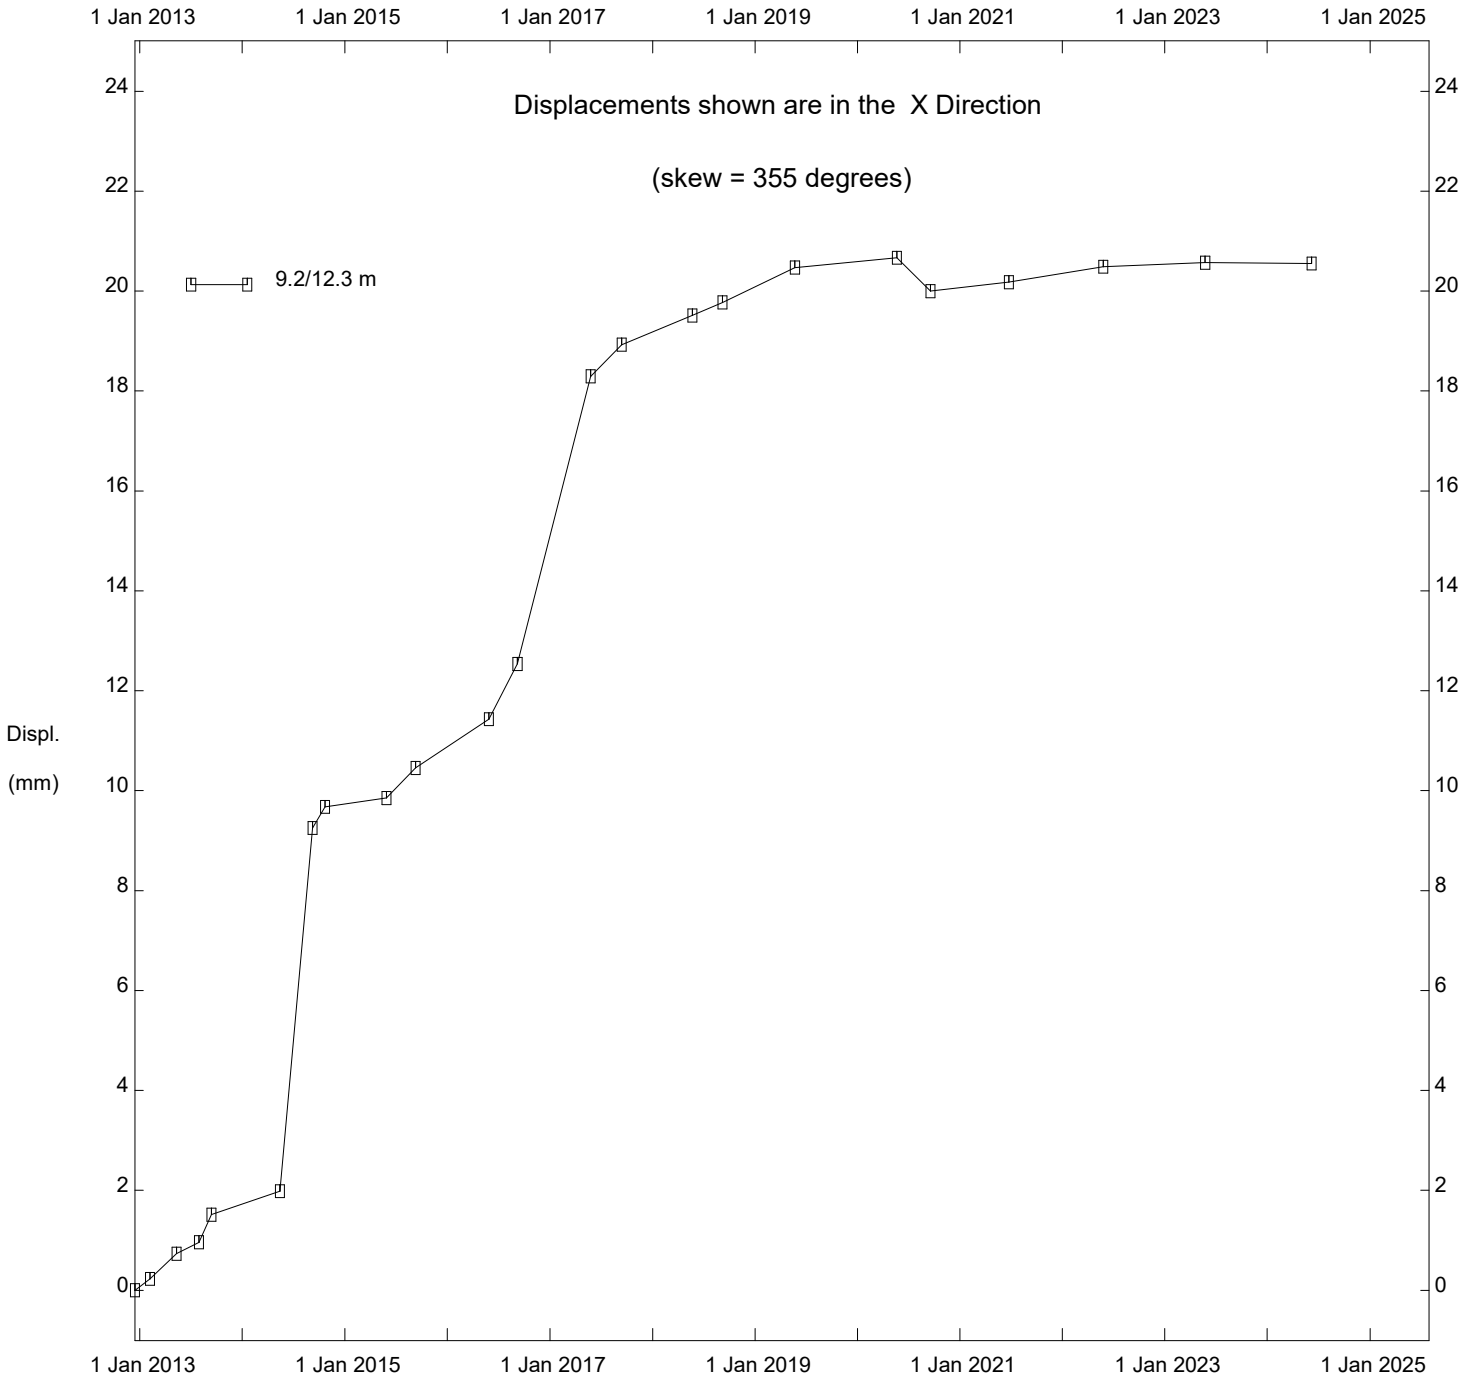
Hwy 41:23 Kehiwin Lake (NC104), Inclinometer SI12-11

Slope inclinometer SI12-11, installed at the bottom of the slope, showed no discernible movement over 9.2 m to 12.3 m depth since the spring of 2023 readings. SI15-17 installed at the bottom of the slope showed no discernible movement over 9.2 m to 11.0 m depth. SI15-20, also installed at the bottom of the slope, showed no discernible movement over 8.6 m to 10.4 m depth since the spring of 2023 readings.

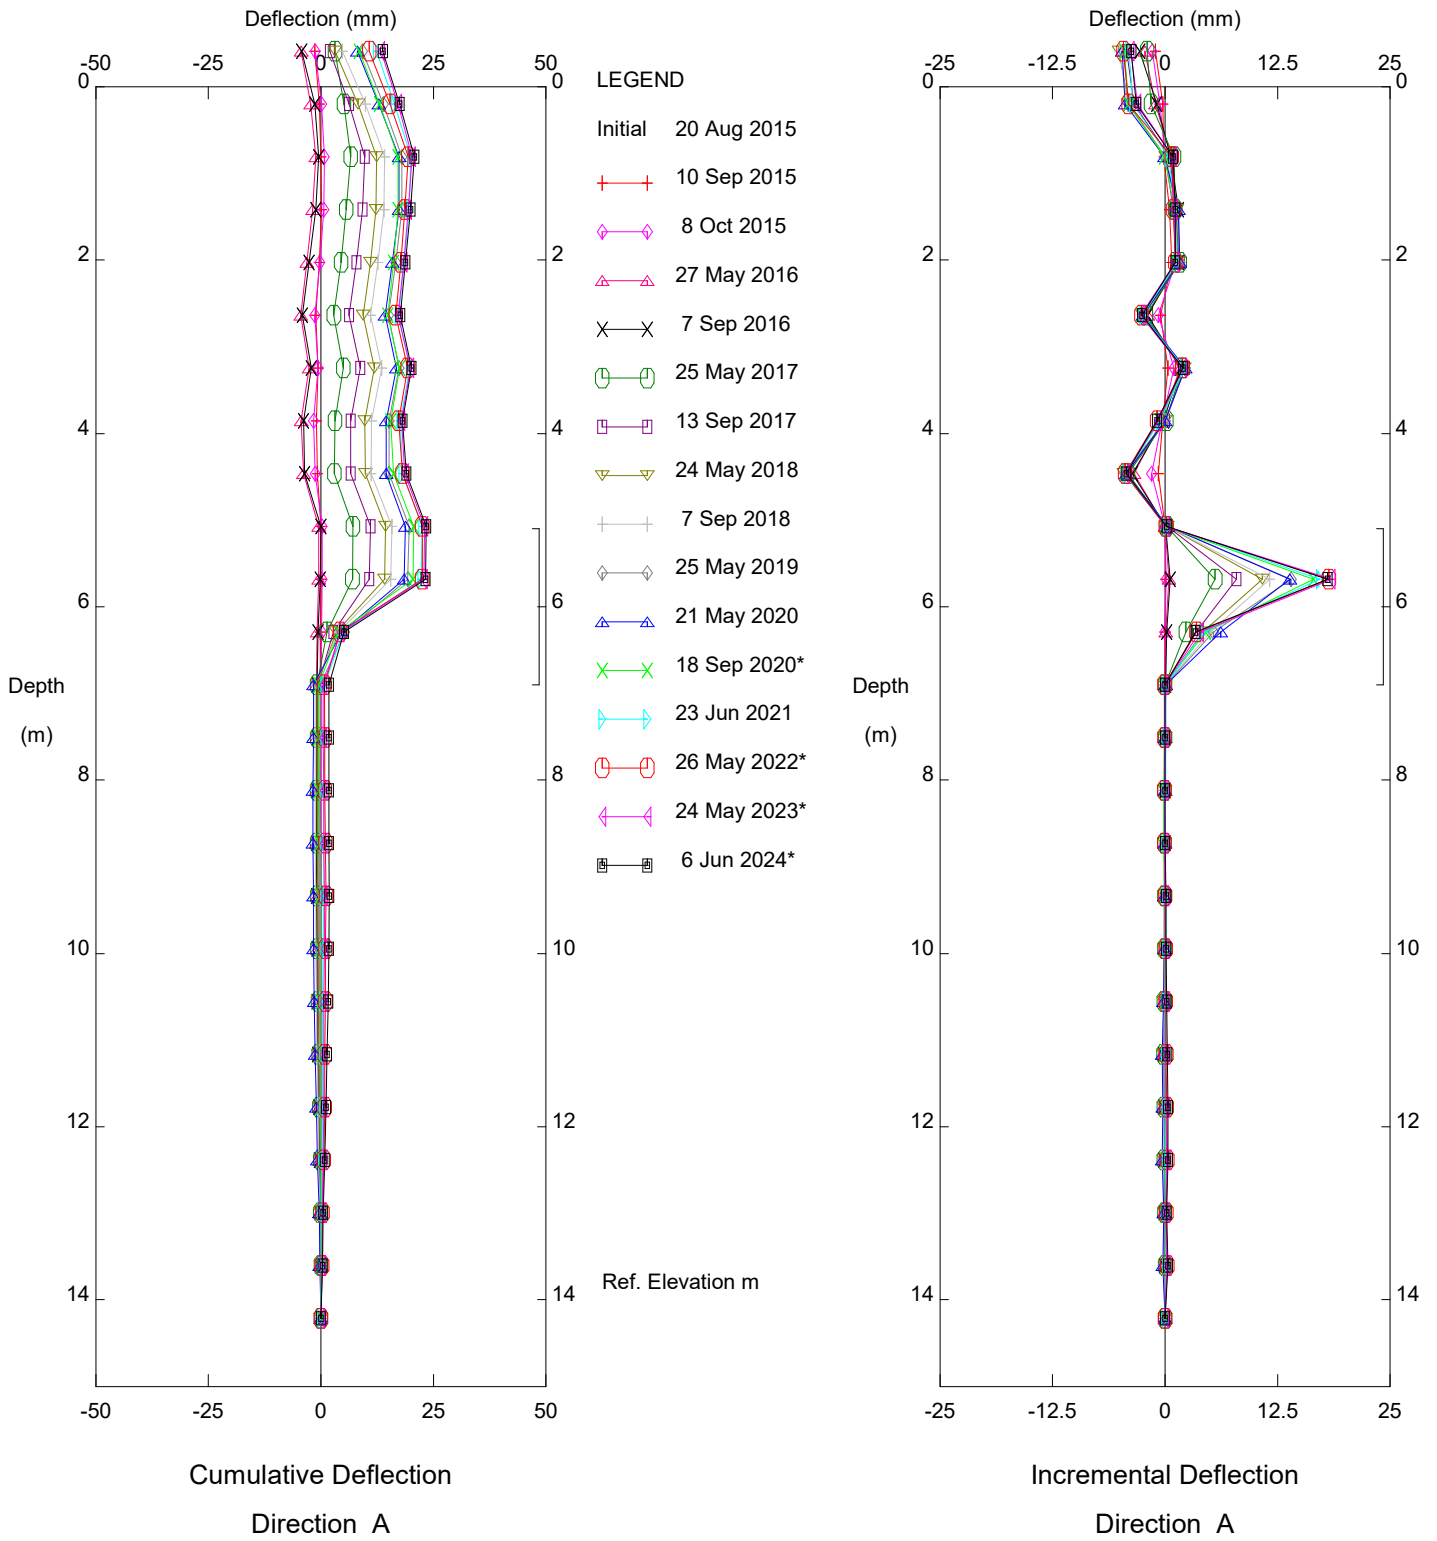
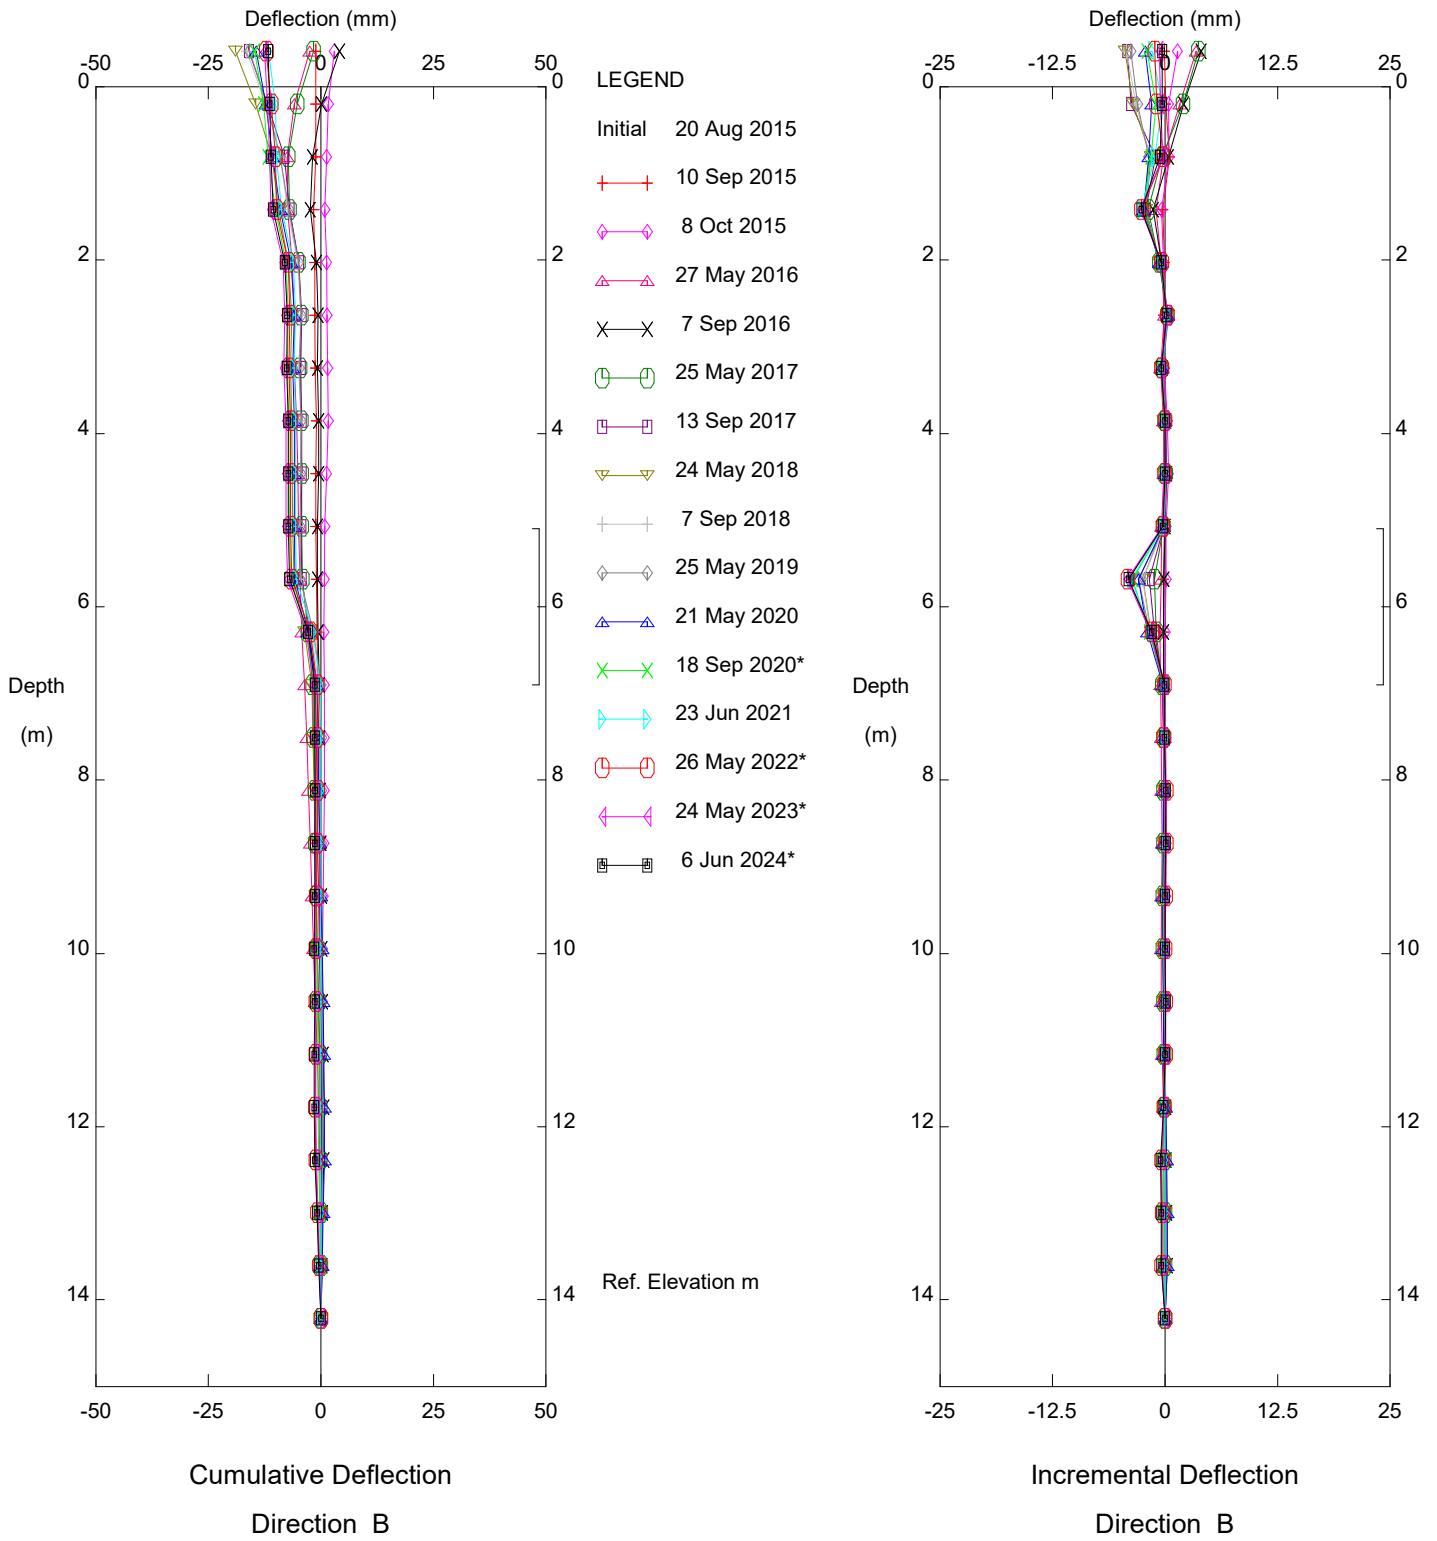
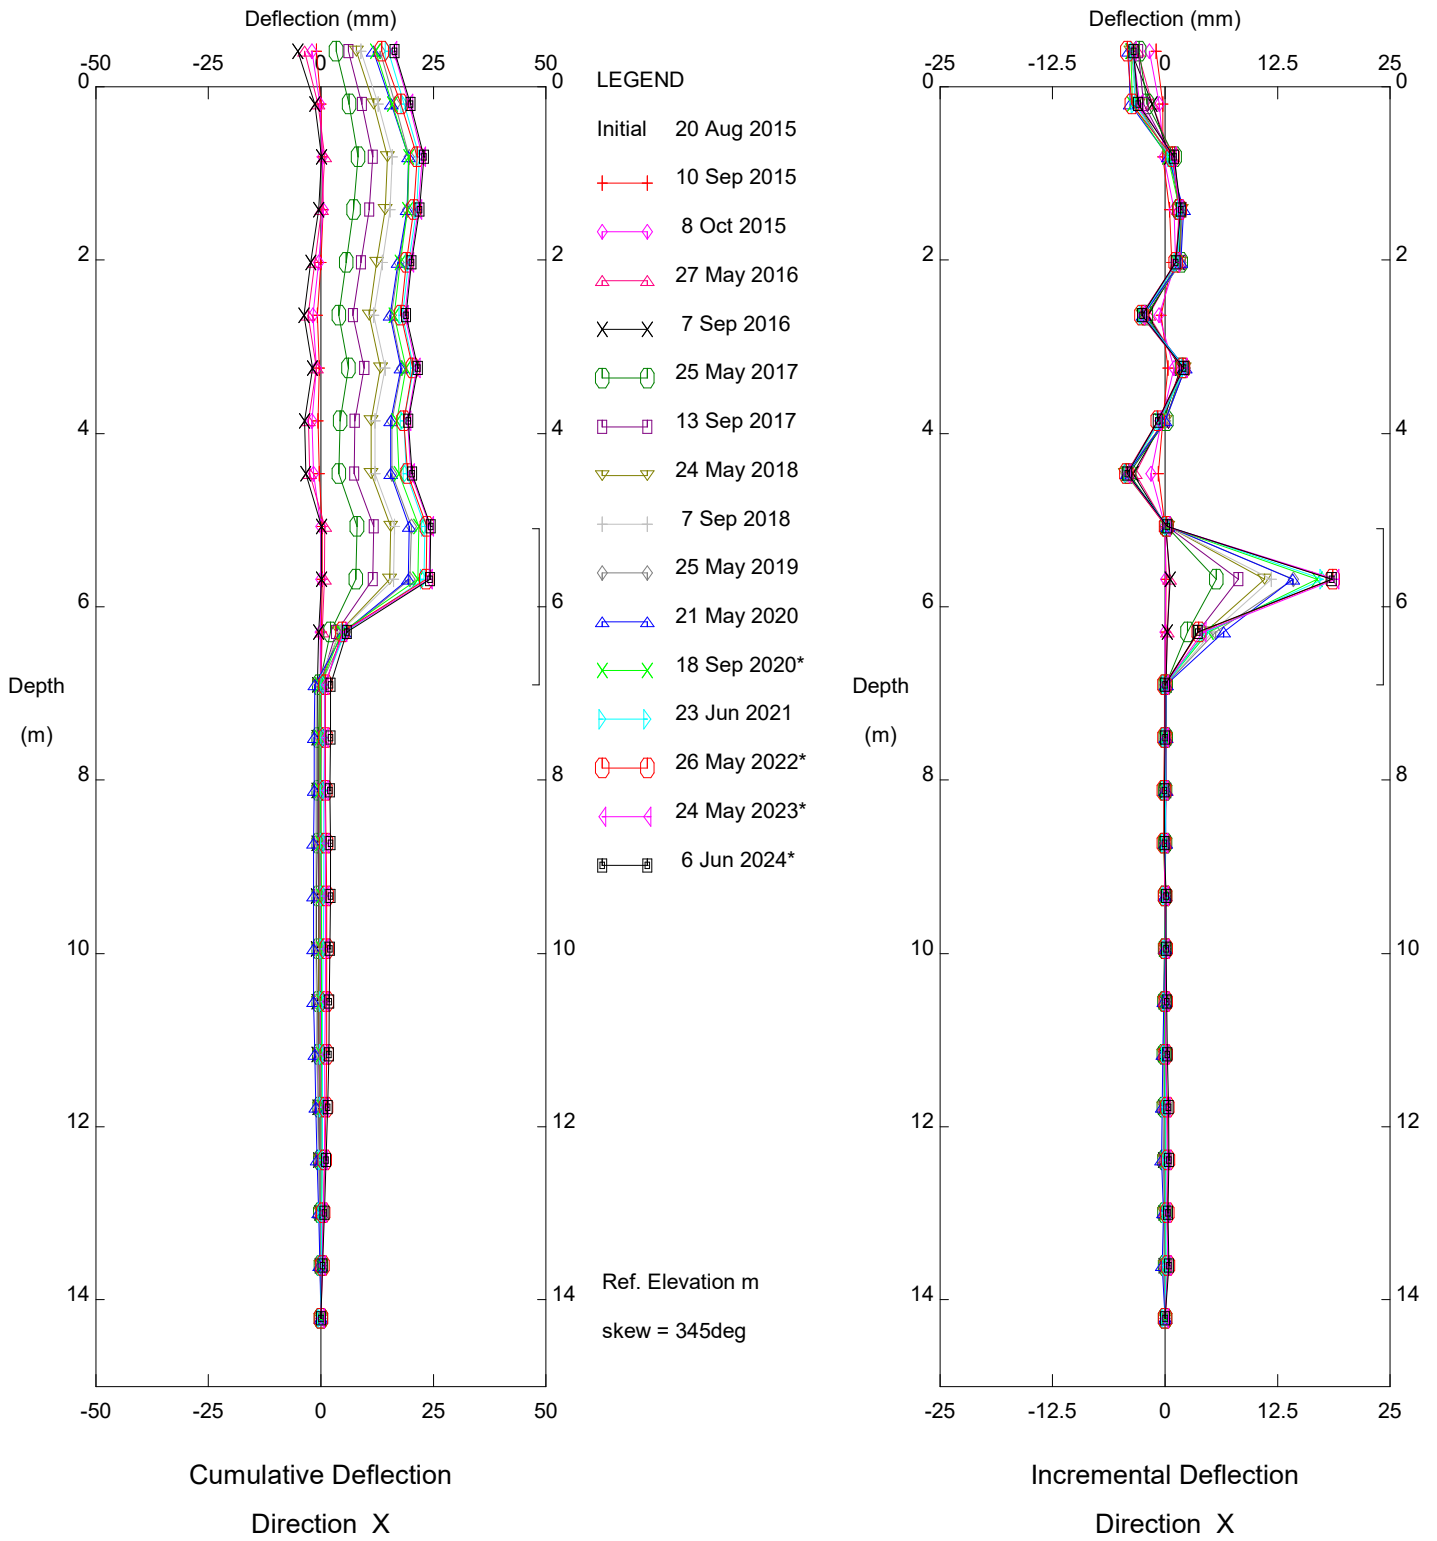
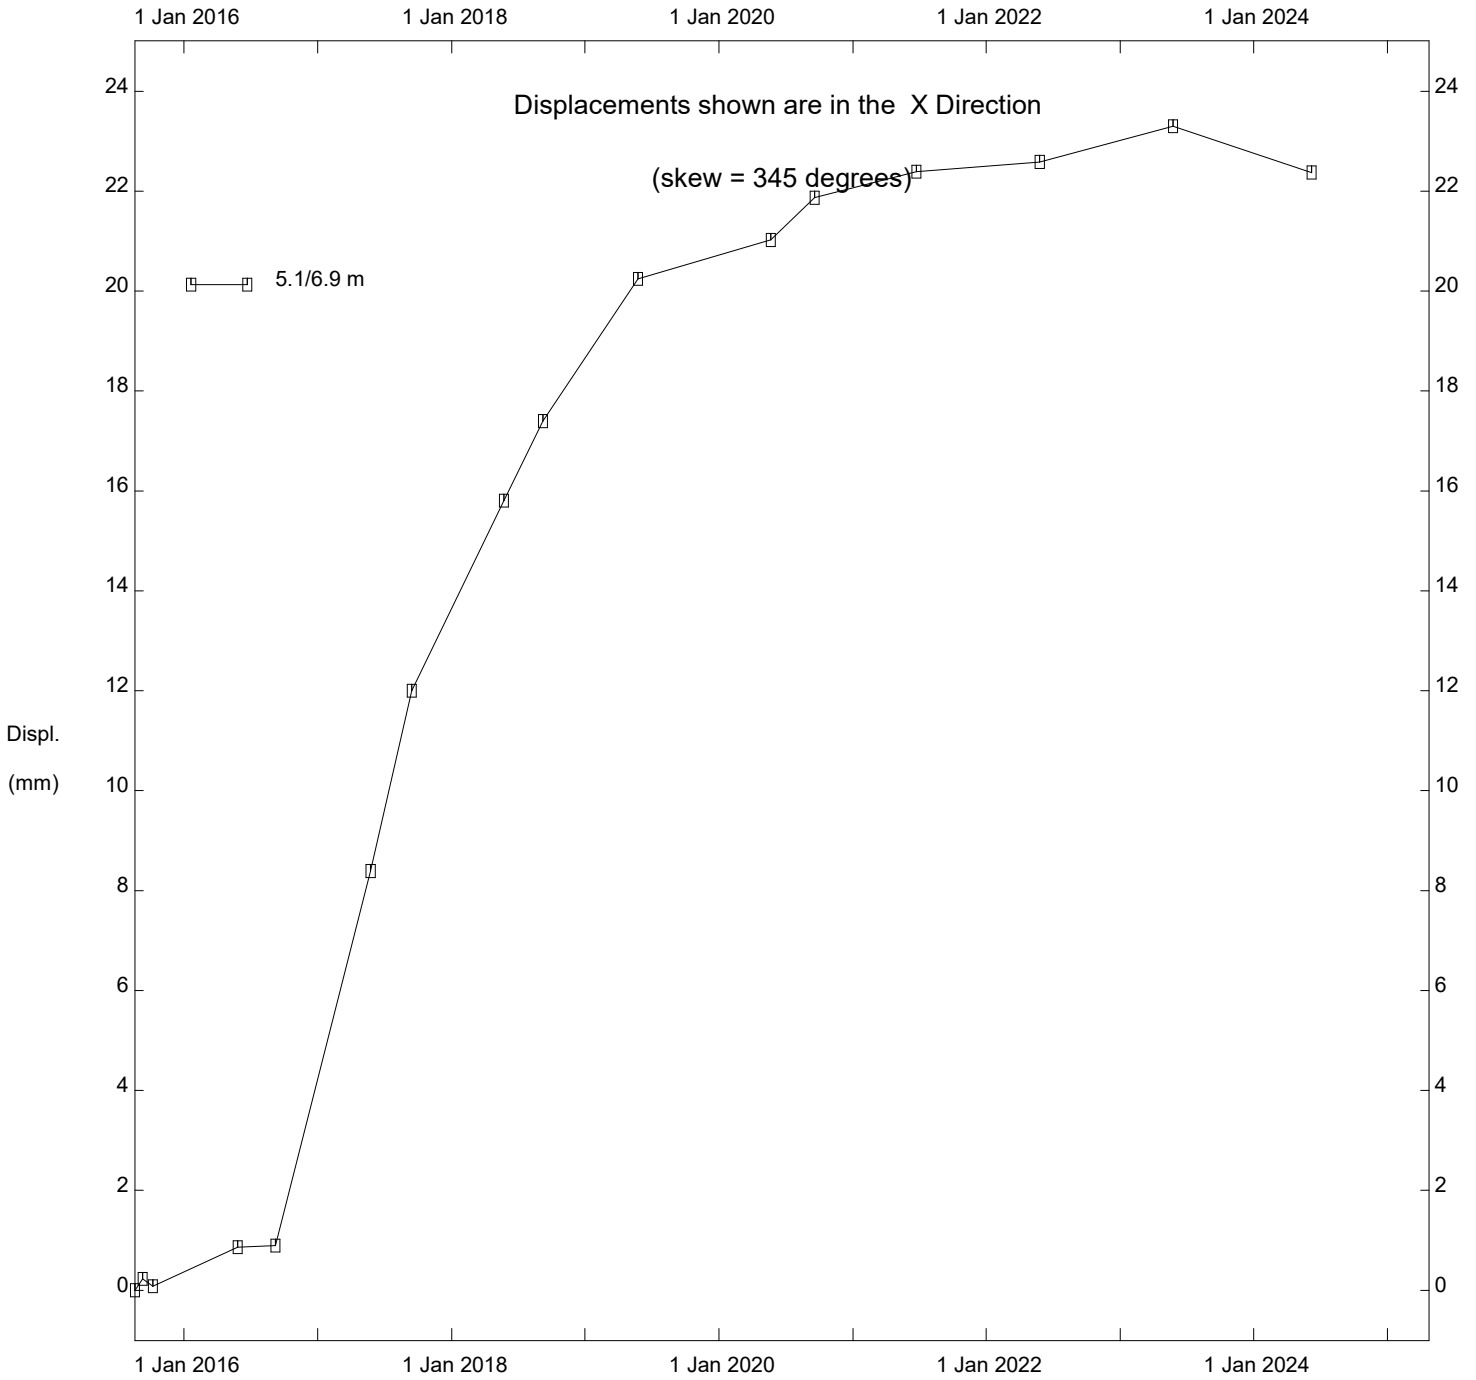
Hwy 41:23 Kehiwin Lake (NC104), Inclinometer SI15-15

Slope inclinometer SI15-15, installed in the highway east ditch within the southern limit of the site, showed no discernible movement over 5.1 m to 6.9 m depth since the spring of 2023 readings.
