**ALBERTA TRANSPORTATION AND  
ECONOMIC CORRIDORS GRMP  
NORTH CENTRAL (ATHABASCA AND FORT  
McMURRAY DISTRICTS)  
INSTRUMENTATION MONITORING- SPRING 2024**

Site Number	Location	Name	Hwy	km
NC104 (NC024-4)	HWY 41:23 C1 7.66	Kehiwin Lake	41:23	Km 7.7
<b>Legal Description:</b> 9-25-58-7 W4		<b>UTM Co-ordinates</b>		
		12U E 506556	N	5988265

<b>Current Monitoring:</b>	6-June-2024	<b>Previous Monitoring</b>	25-May-2023
<b>Instruments Read By:</b>	Mr. Niraj Regmi, G.I.T and Mr. Nixson Mationg, of Thurber

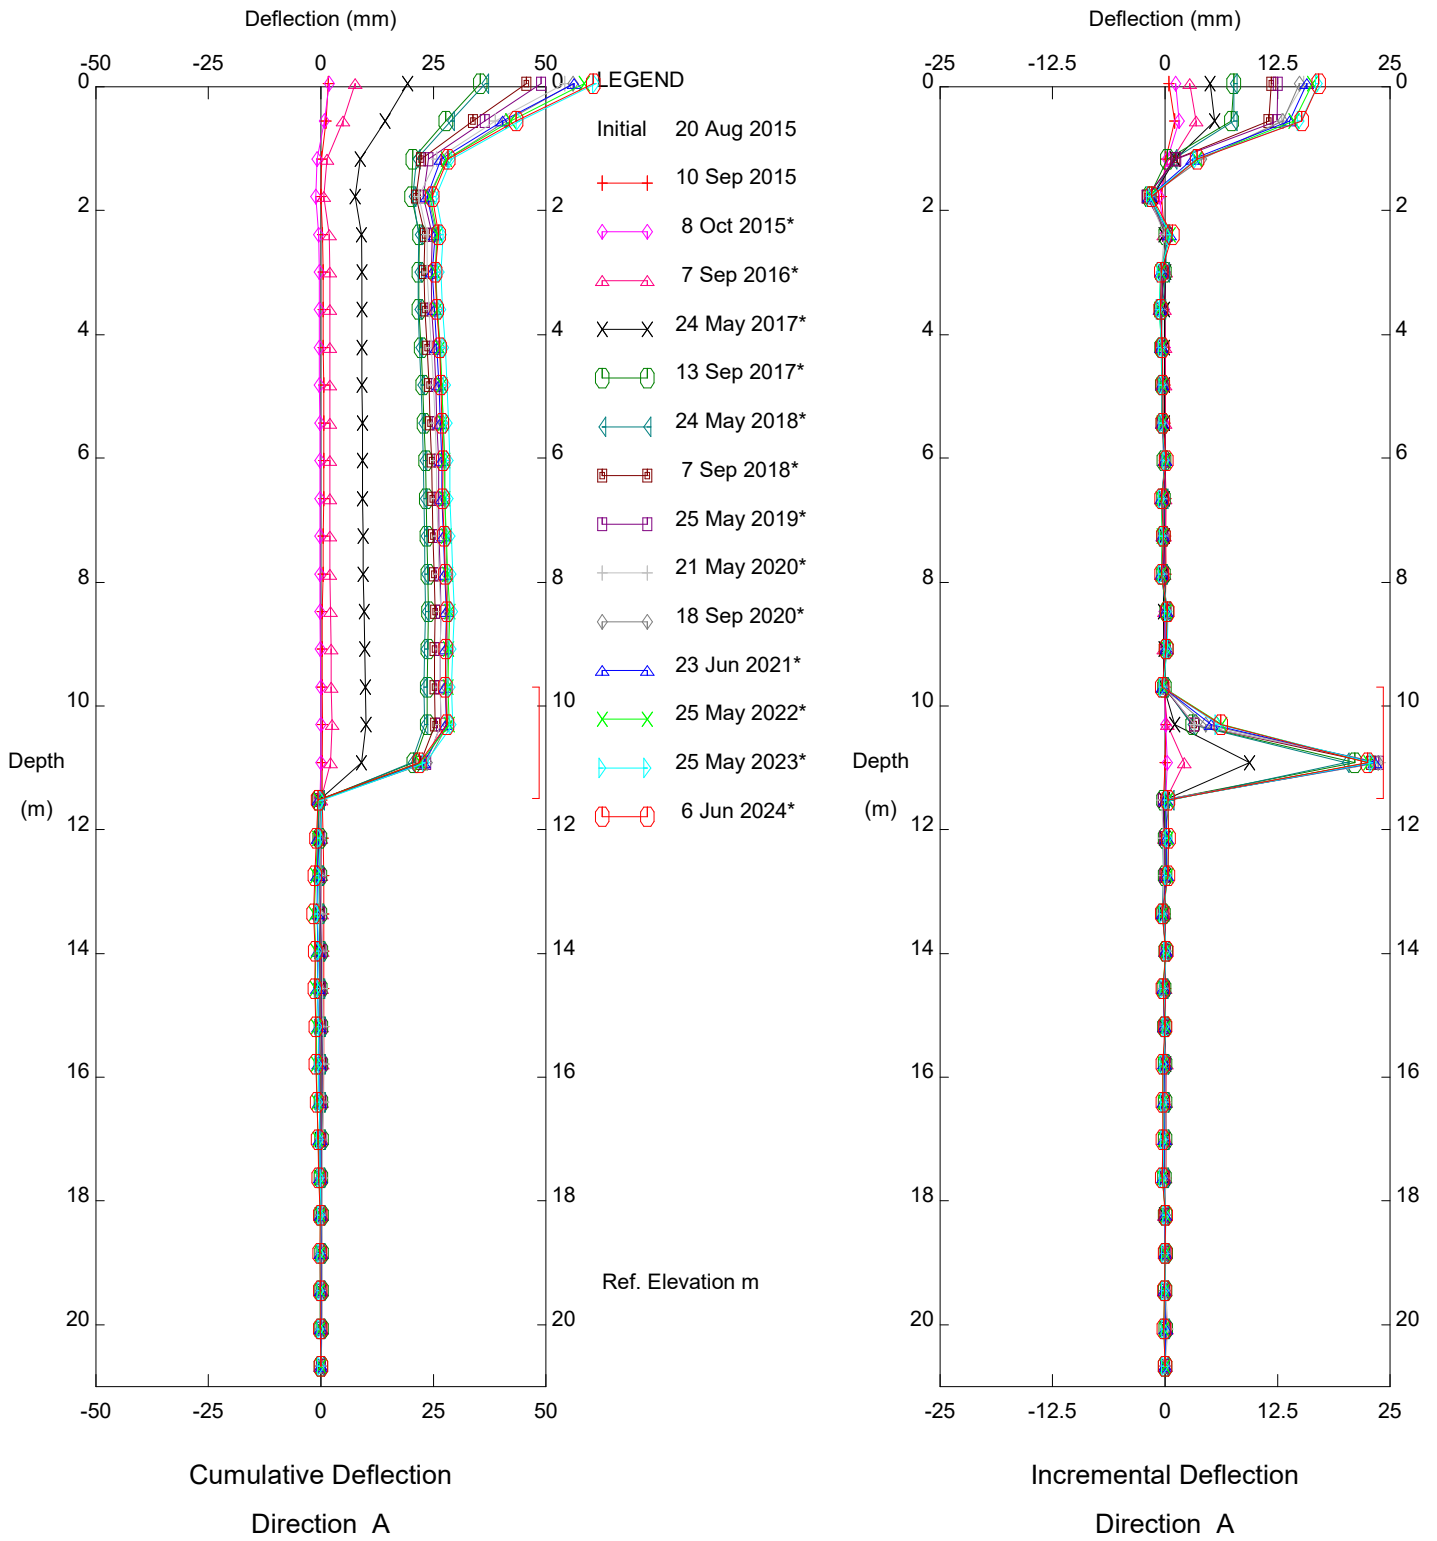
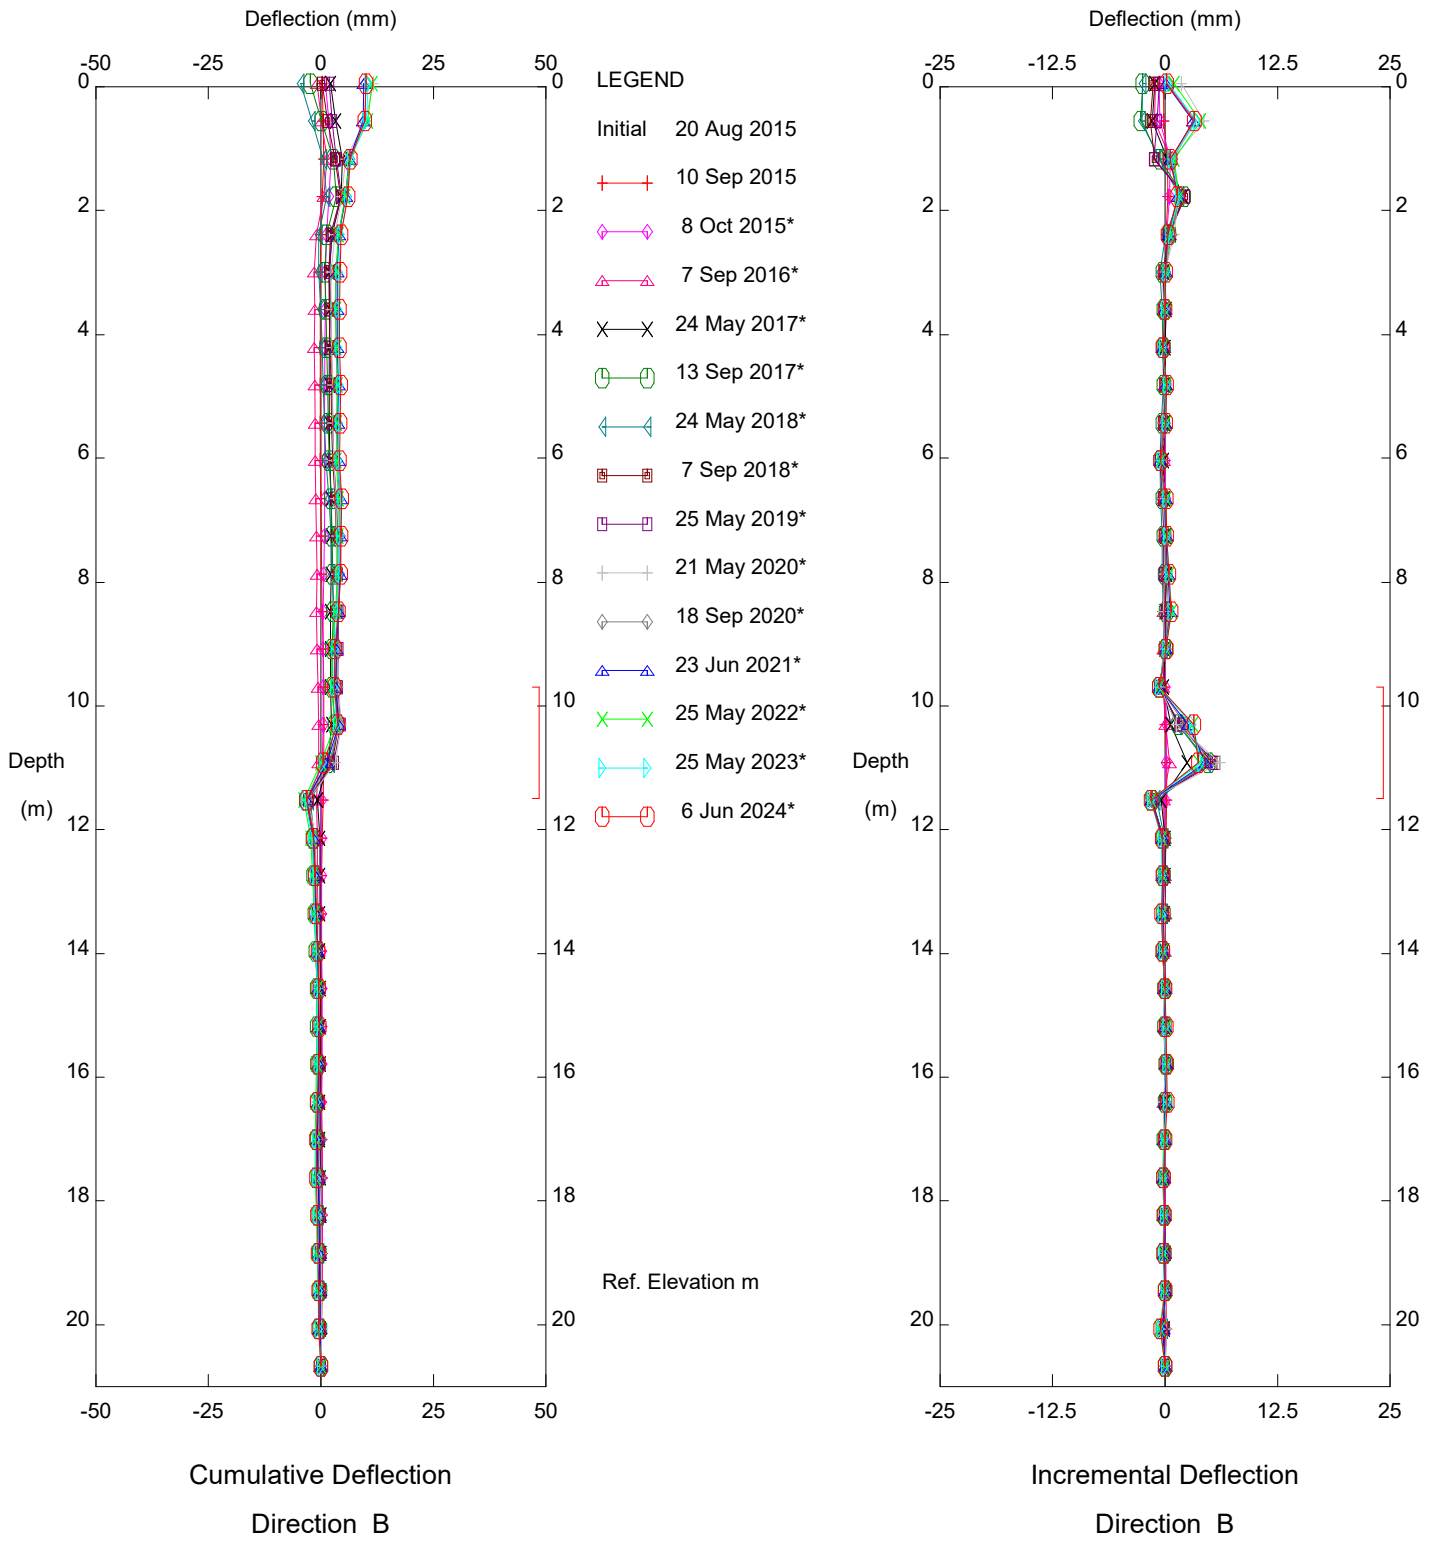
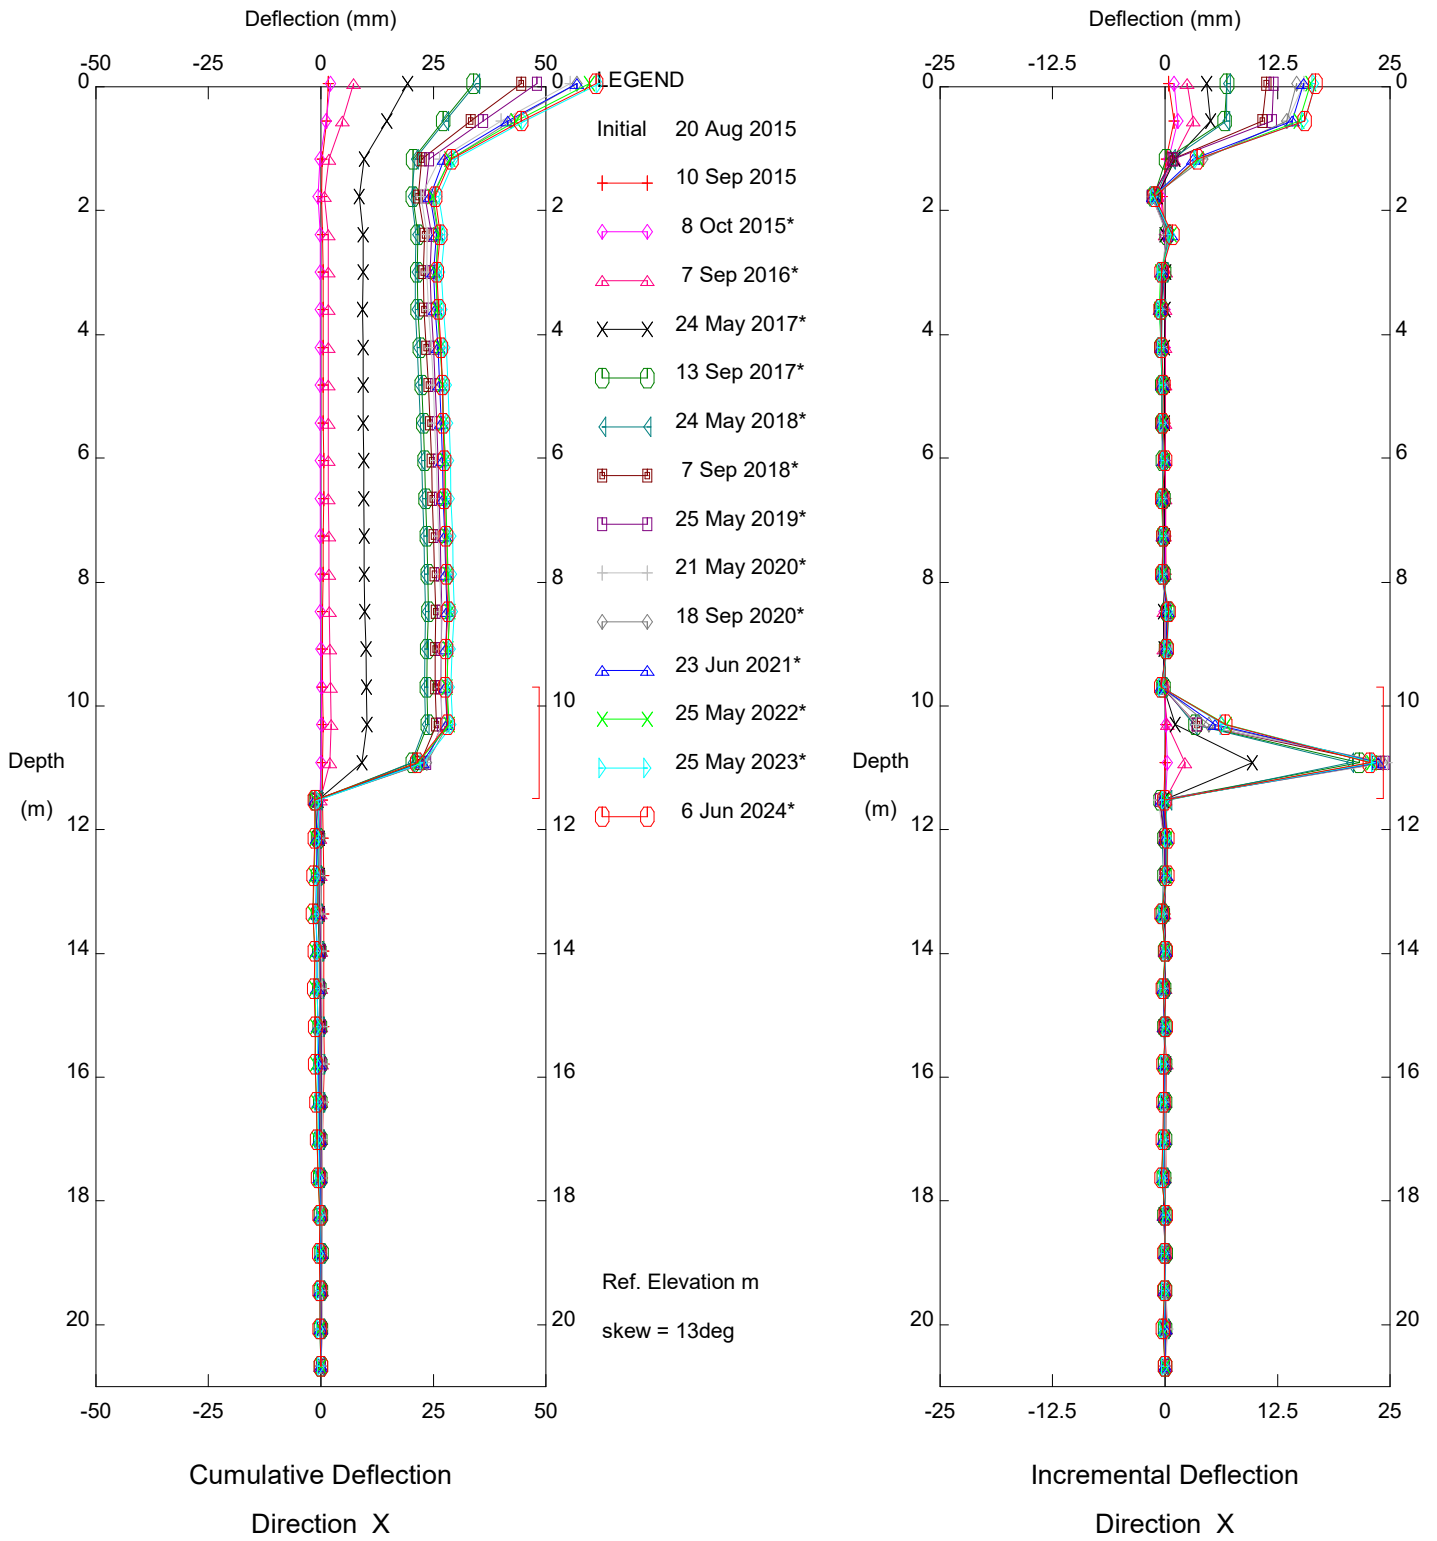
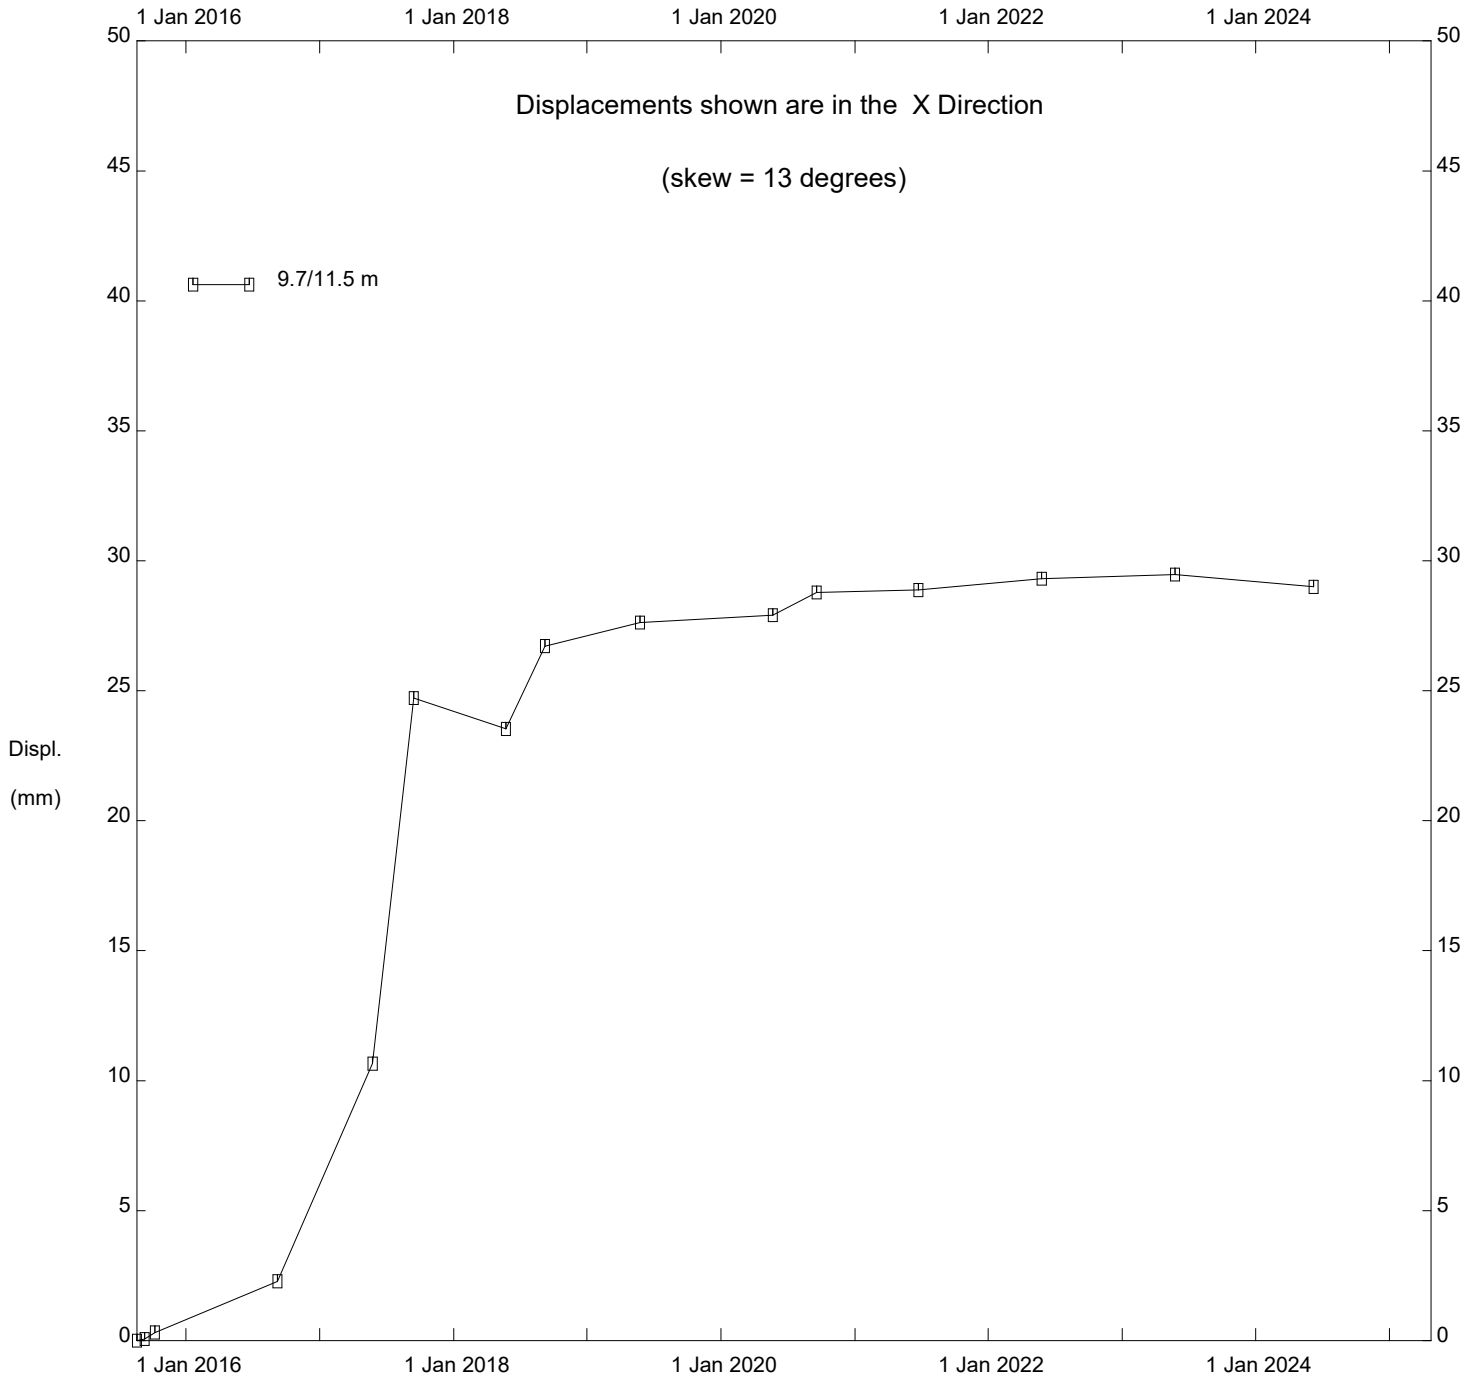
Hwy 41:23 Kehiwin Lake (NC104), Inclinometer SI15-16

Slope inclinometers SI15-16 and SI15-21, installed along the west edge of the highway, showed no discernible movement over 9.7 m to 11.5 m depth and 0.4 mm/yr over 8.5 m to 10.4 m depth, respectively, since the spring of 2023 readings.

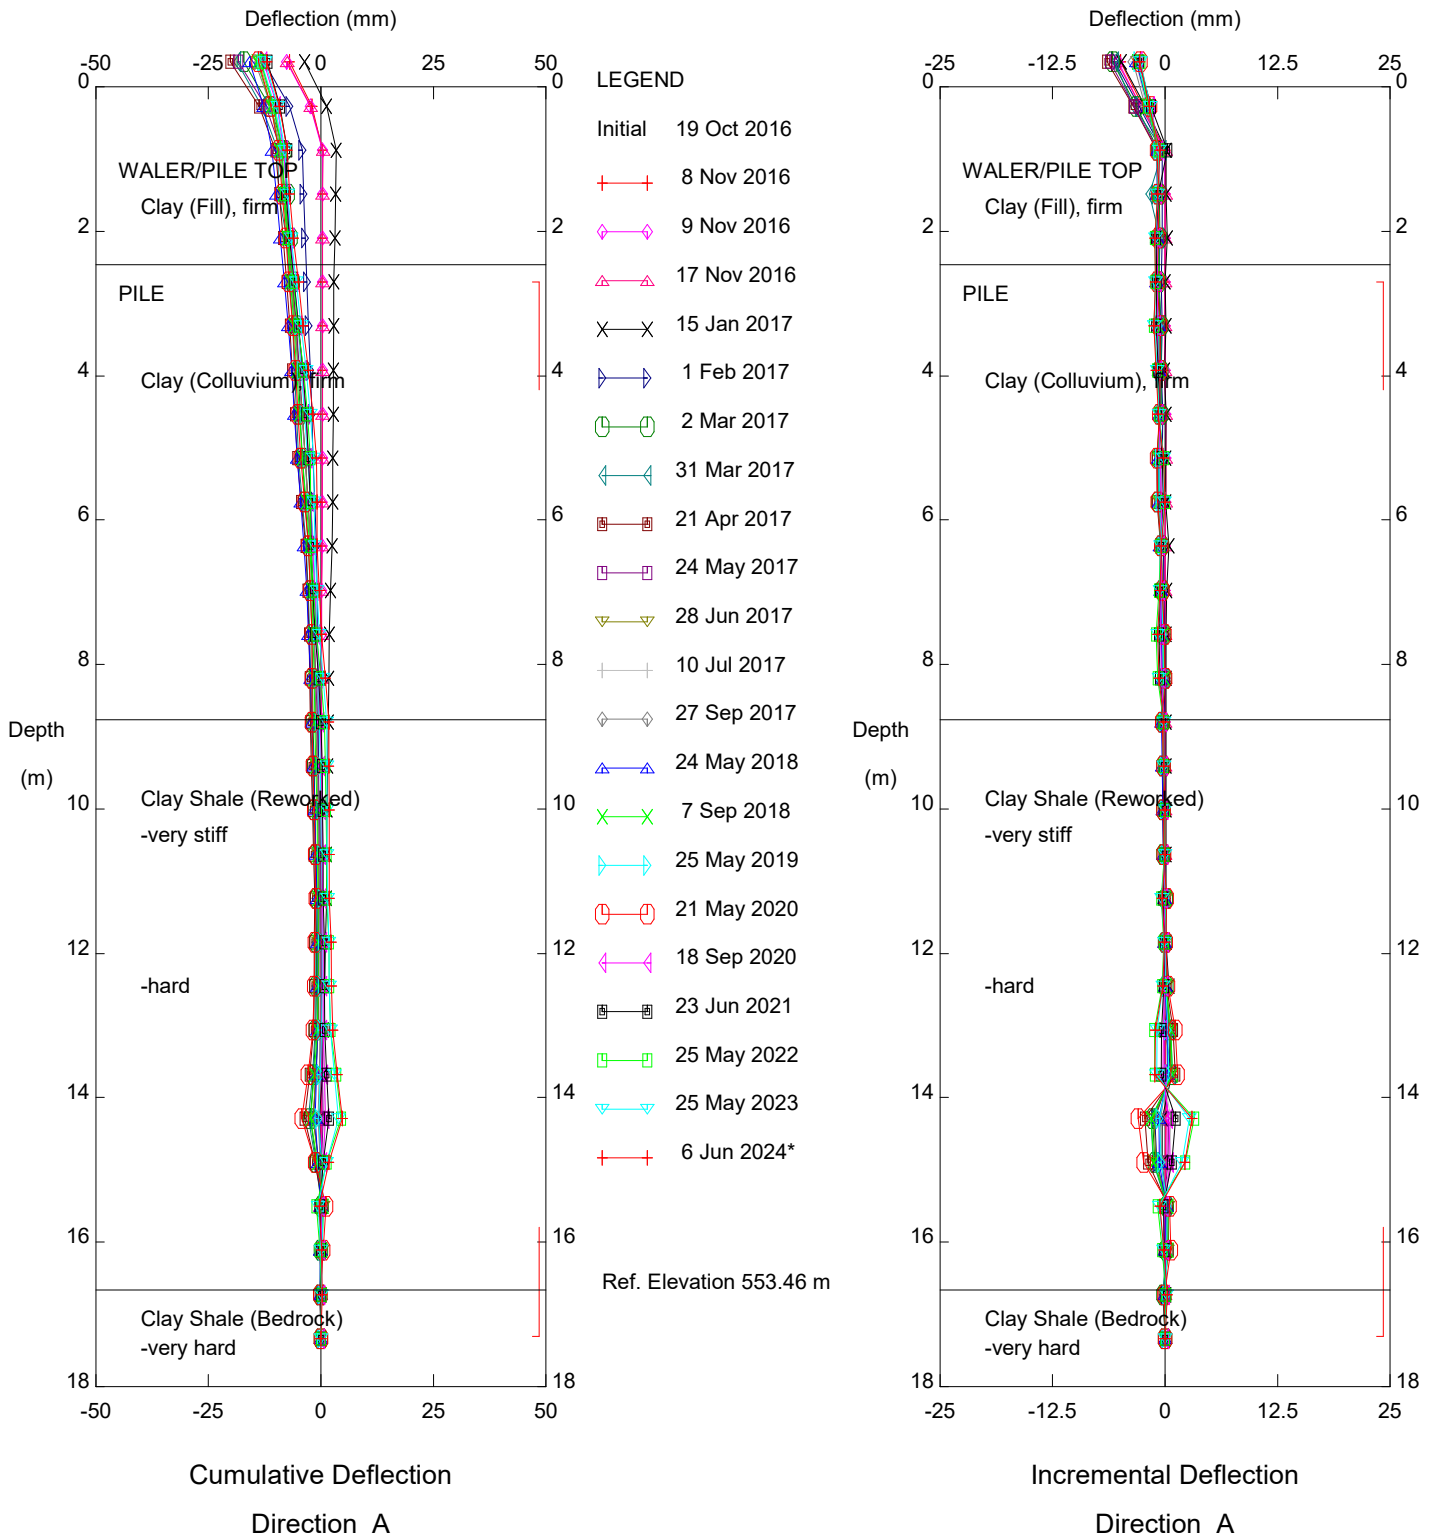
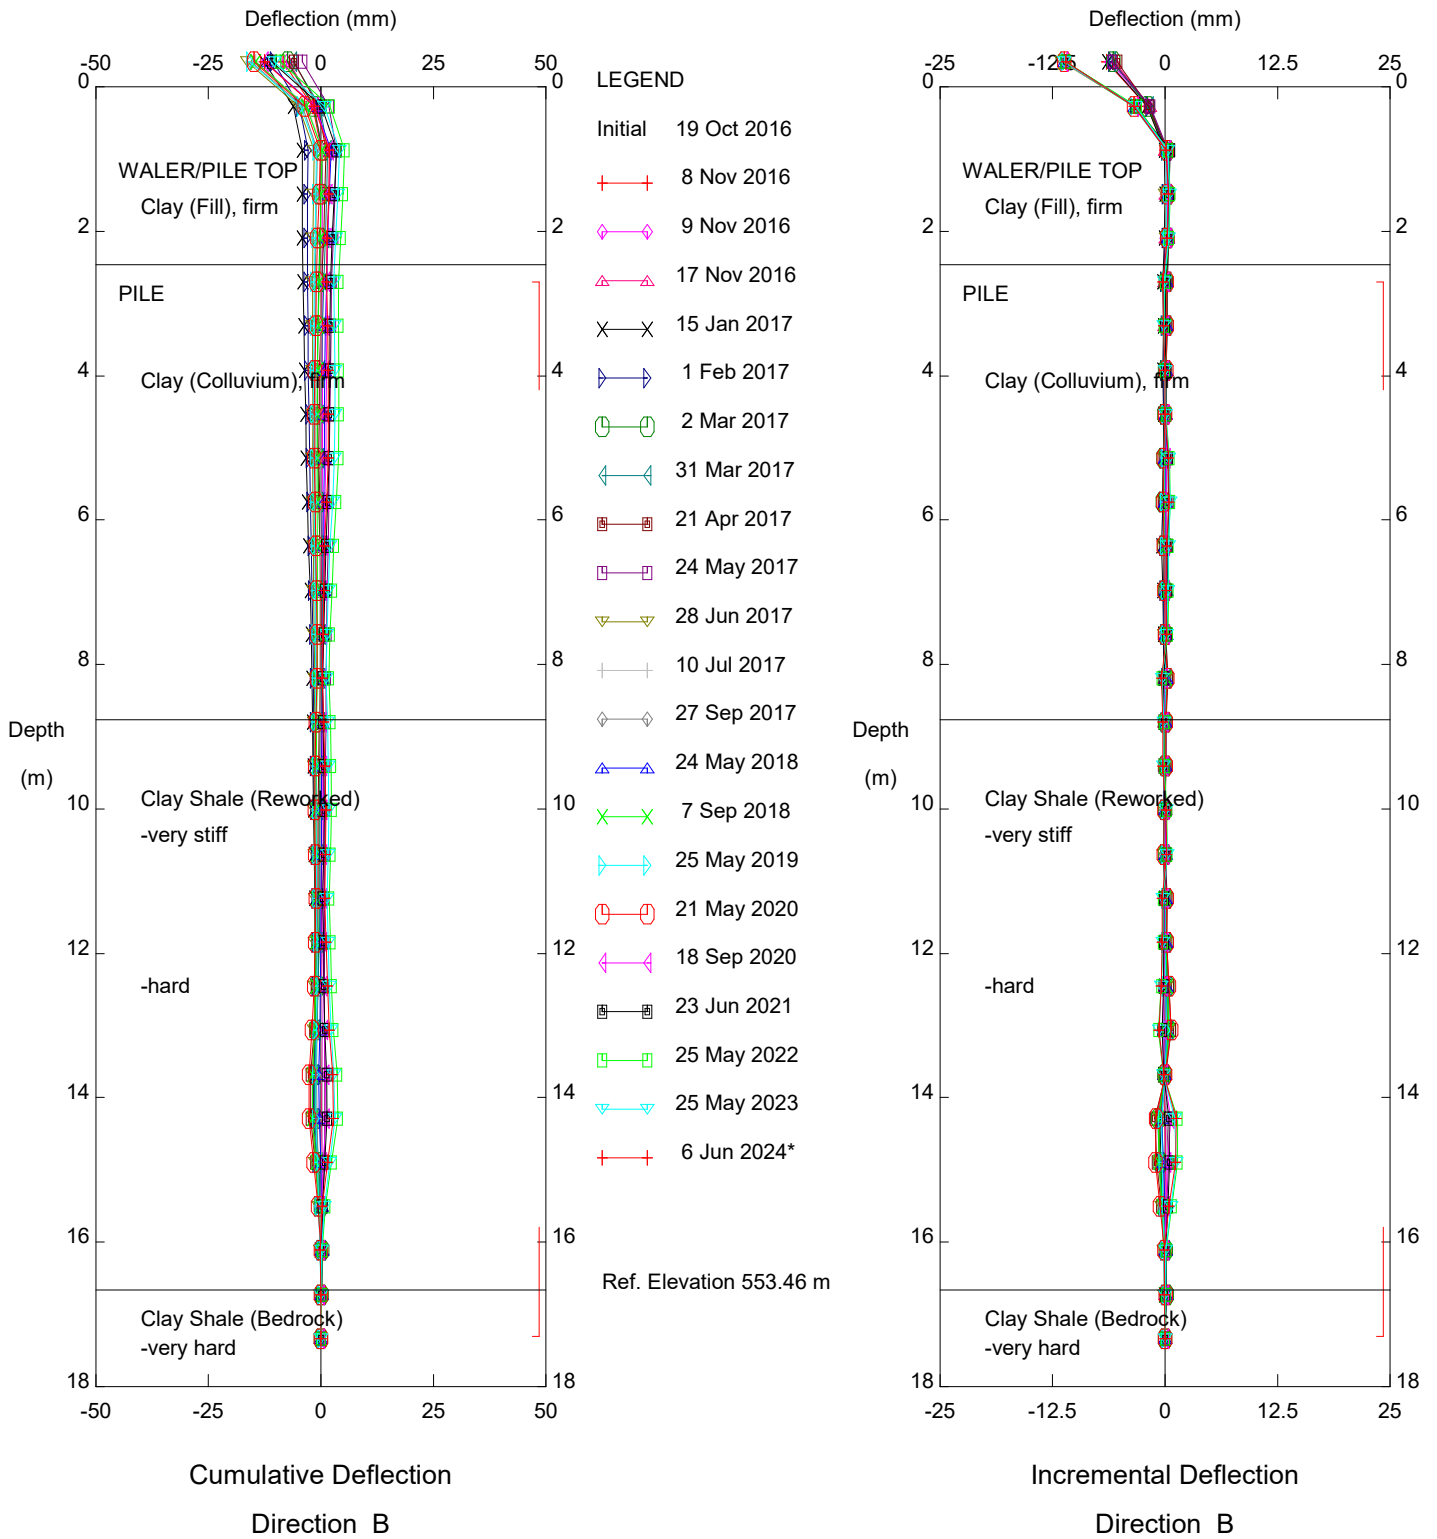
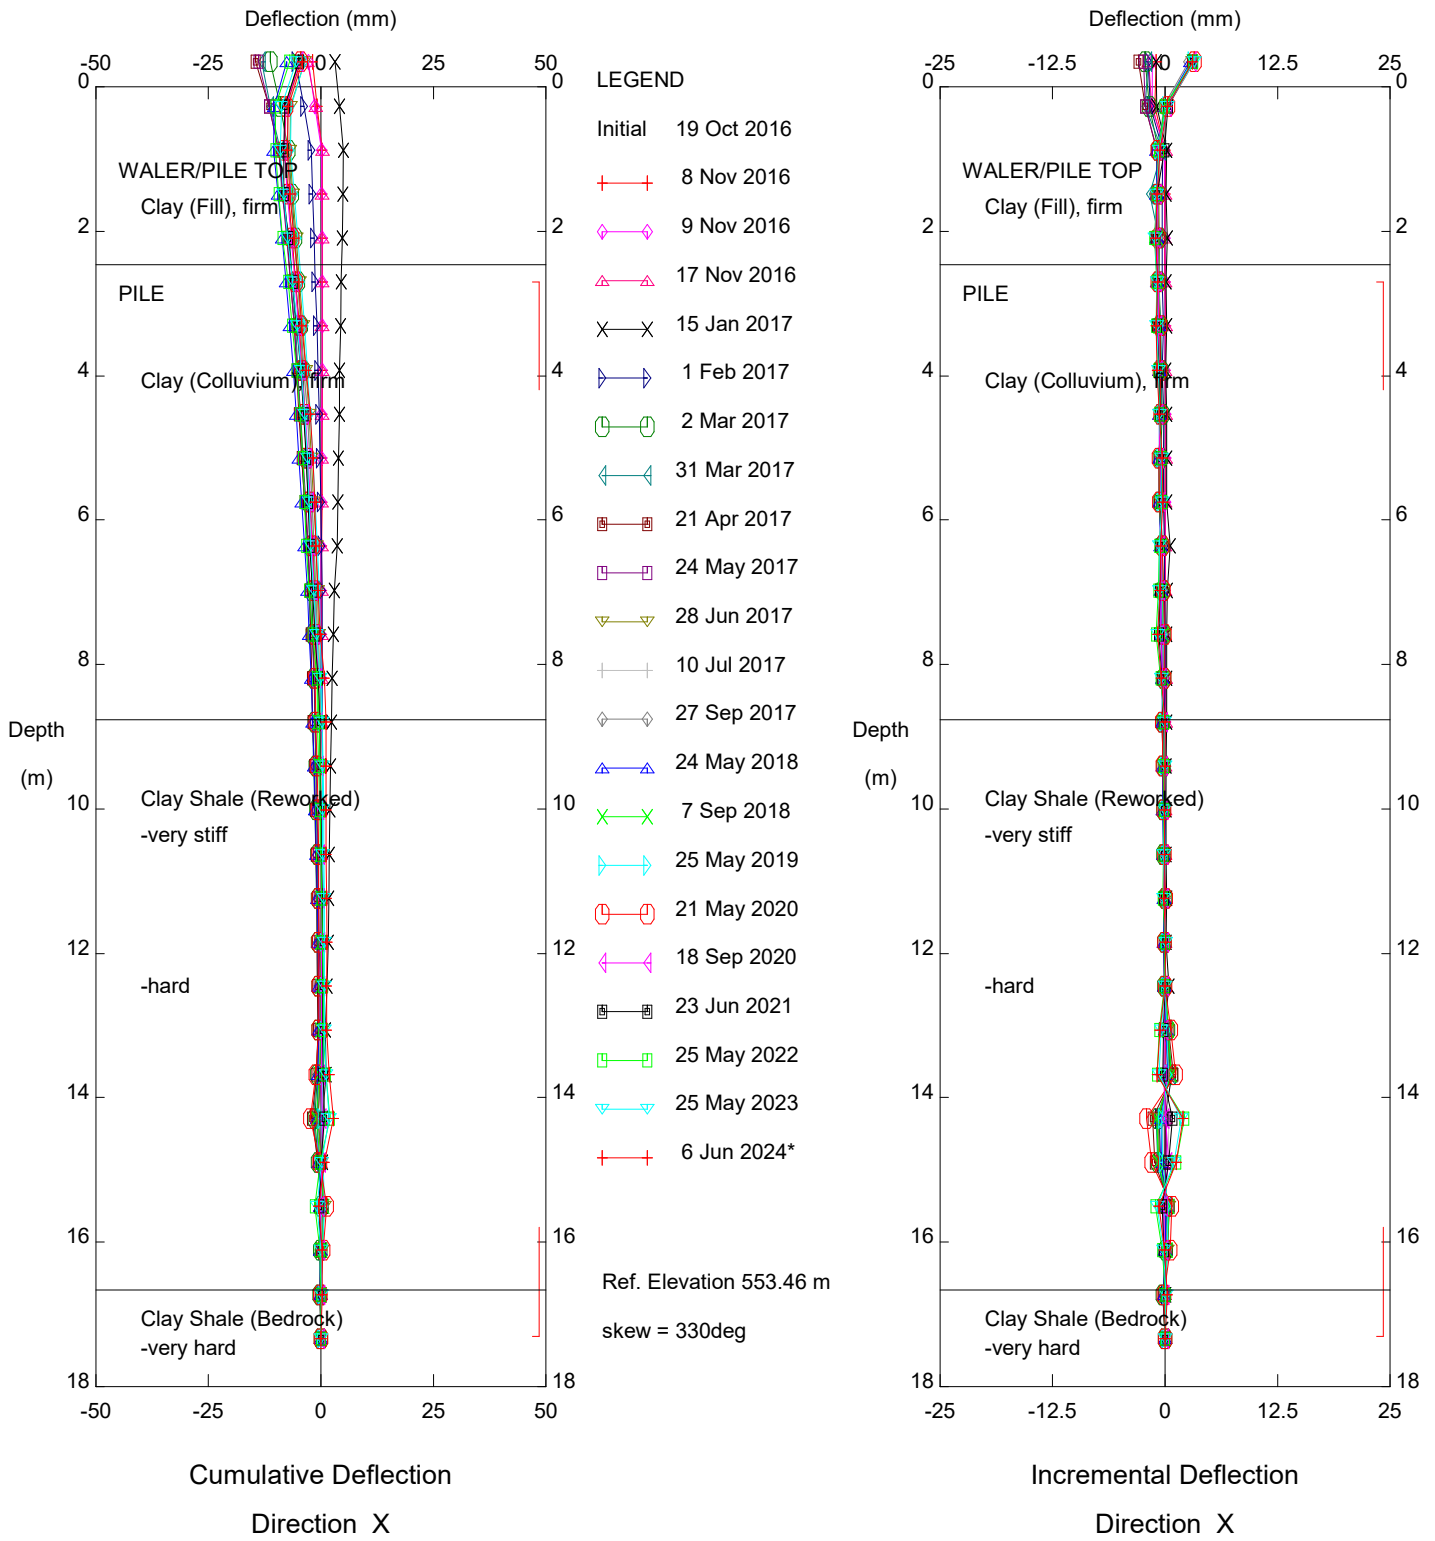
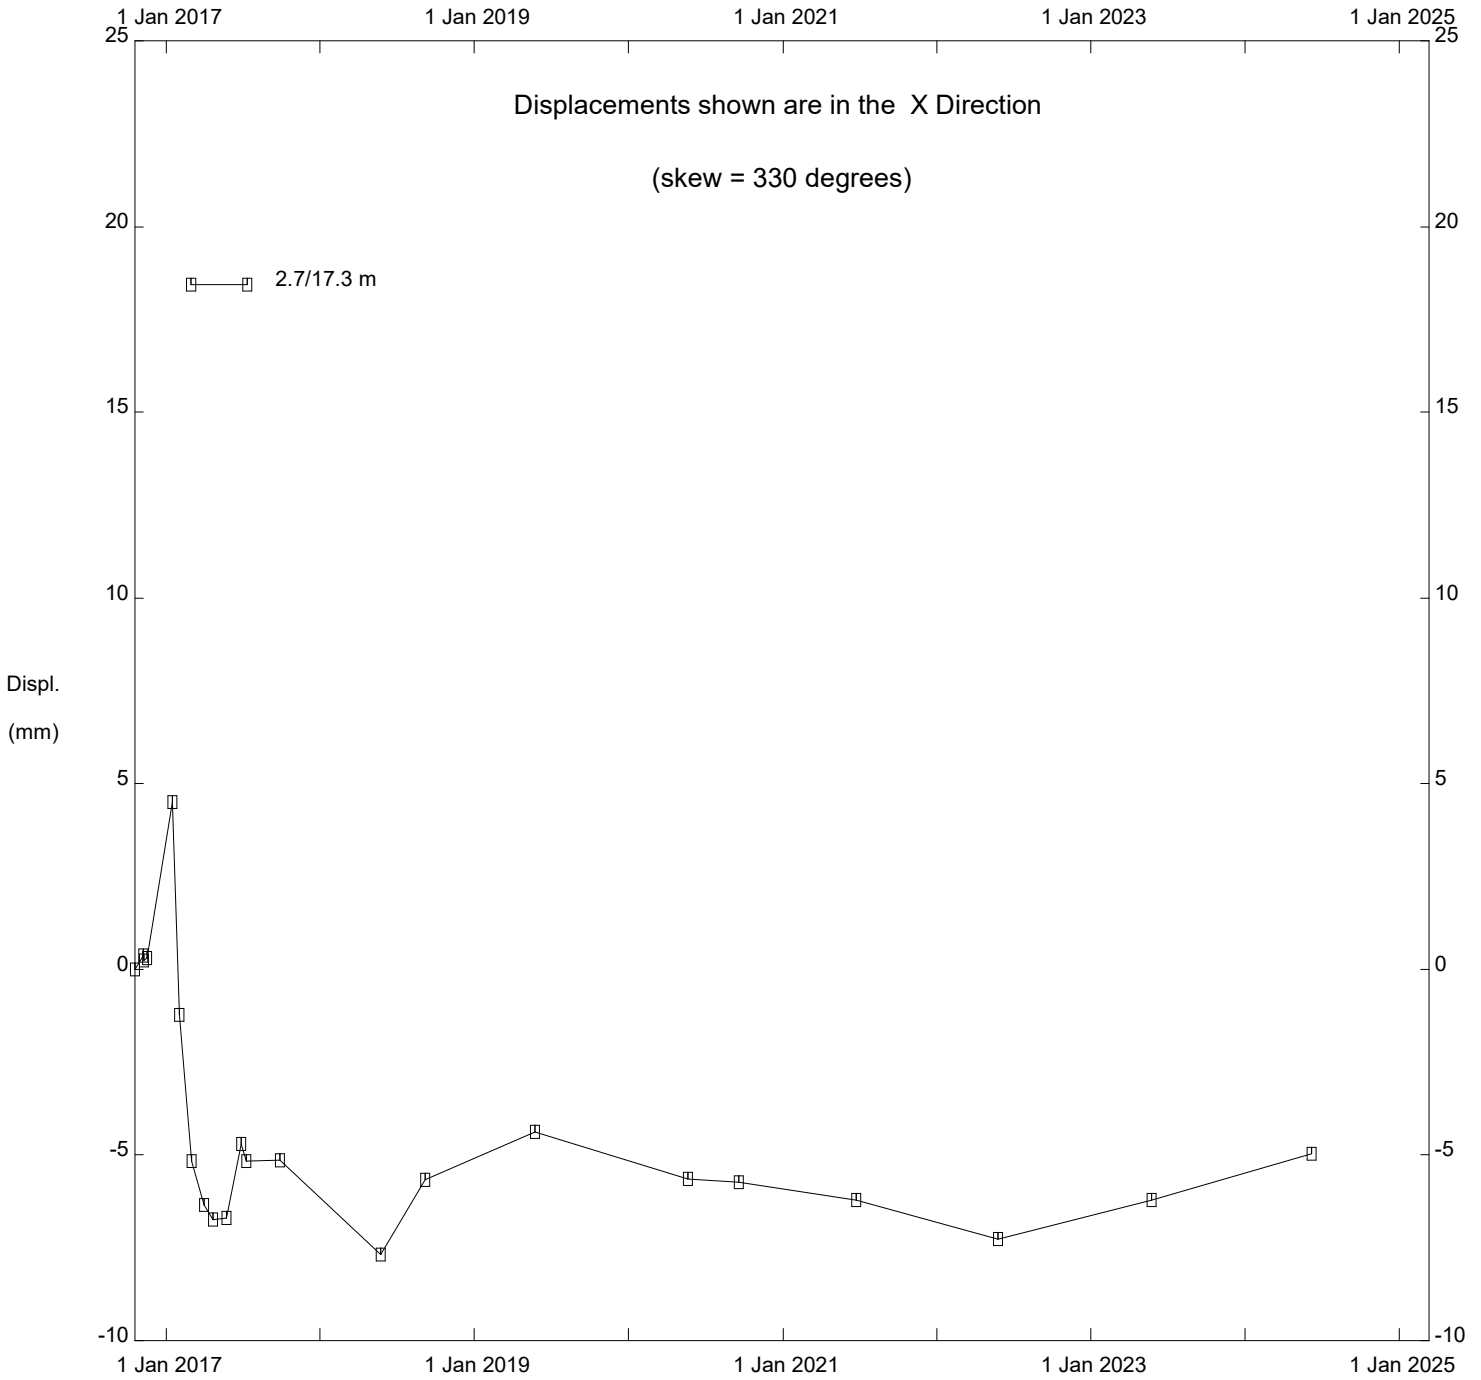
Hwy 41:23 Kehiwin Lake (NC104), Inclinometer SI16-1 (P06)

For the tied-back pile wall, SI16-1, SI16-2, SI16-3, and SI16-5 have shown total pile head movements in the upslope direction of 5.0 mm, 3.6 mm, 3.4 mm, and 1.5 mm, respectively. SI16-6 has shown a total pile head movement of 4.1 mm in the downslope direction. SI16-7 has not shown any discernible movement since it was reinitialized on September 18, 2020.
