**ALBERTA TRANSPORTATION AND  
ECONOMIC CORRIDORS GRMP  
NORTH CENTRAL (ATHABASCA AND FORT  
McMURRAY DISTRICTS)  
INSTRUMENTATION MONITORING- SPRING 2024**

Site Number	Location	Name	Hwy	km
NC104 (NC024-4)	HWY 41:23 C1 7.66	Kehiwin Lake	41:23	Km 7.7
<b>Legal Description:</b> 9-25-58-7 W4		<b>UTM Co-ordinates</b>		
		12U E 506556	N	5988265

<b>Current Monitoring:</b>	6-June-2024	<b>Previous Monitoring</b>	25-May-2023
<b>Instruments Read By:</b>	Mr. Niraj Regmi, G.I.T and Mr. Nixson Mationg, of Thurber

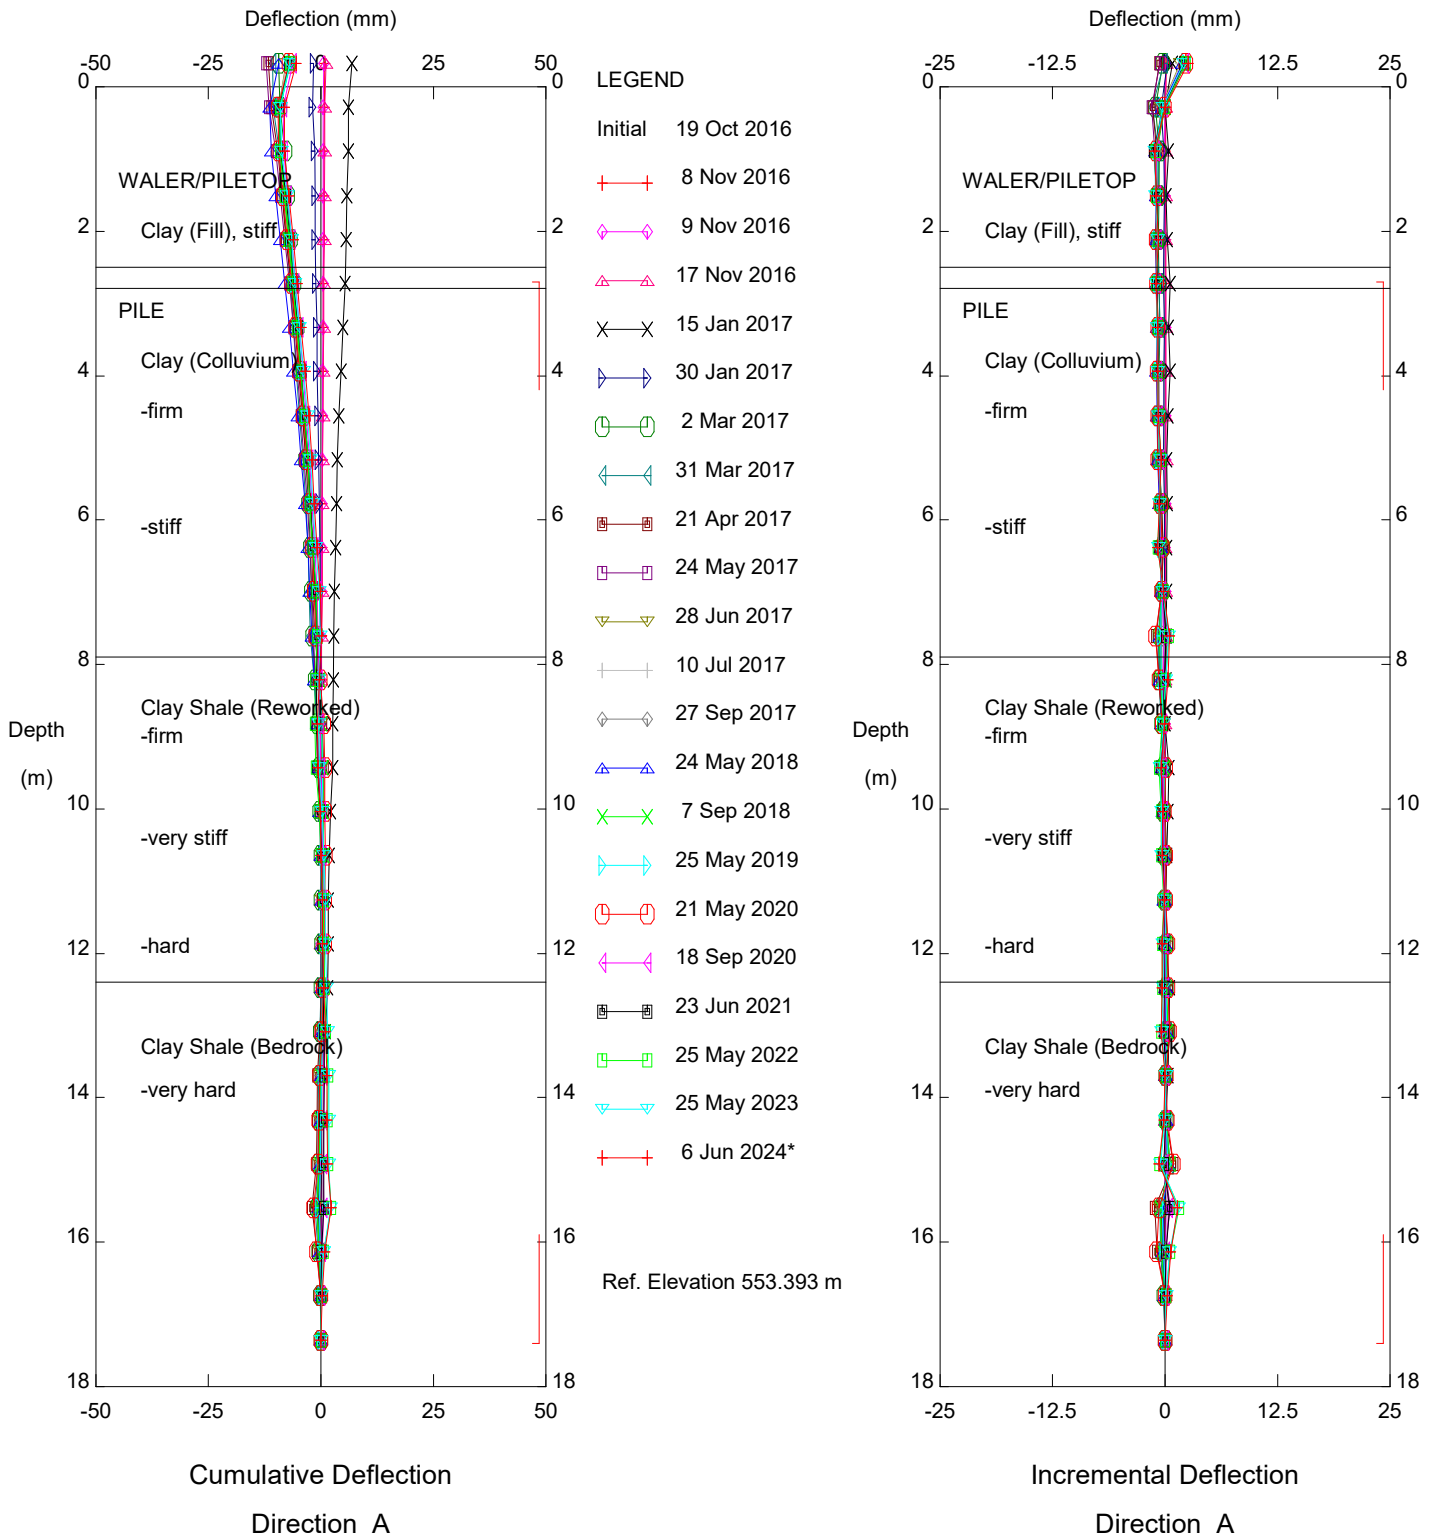
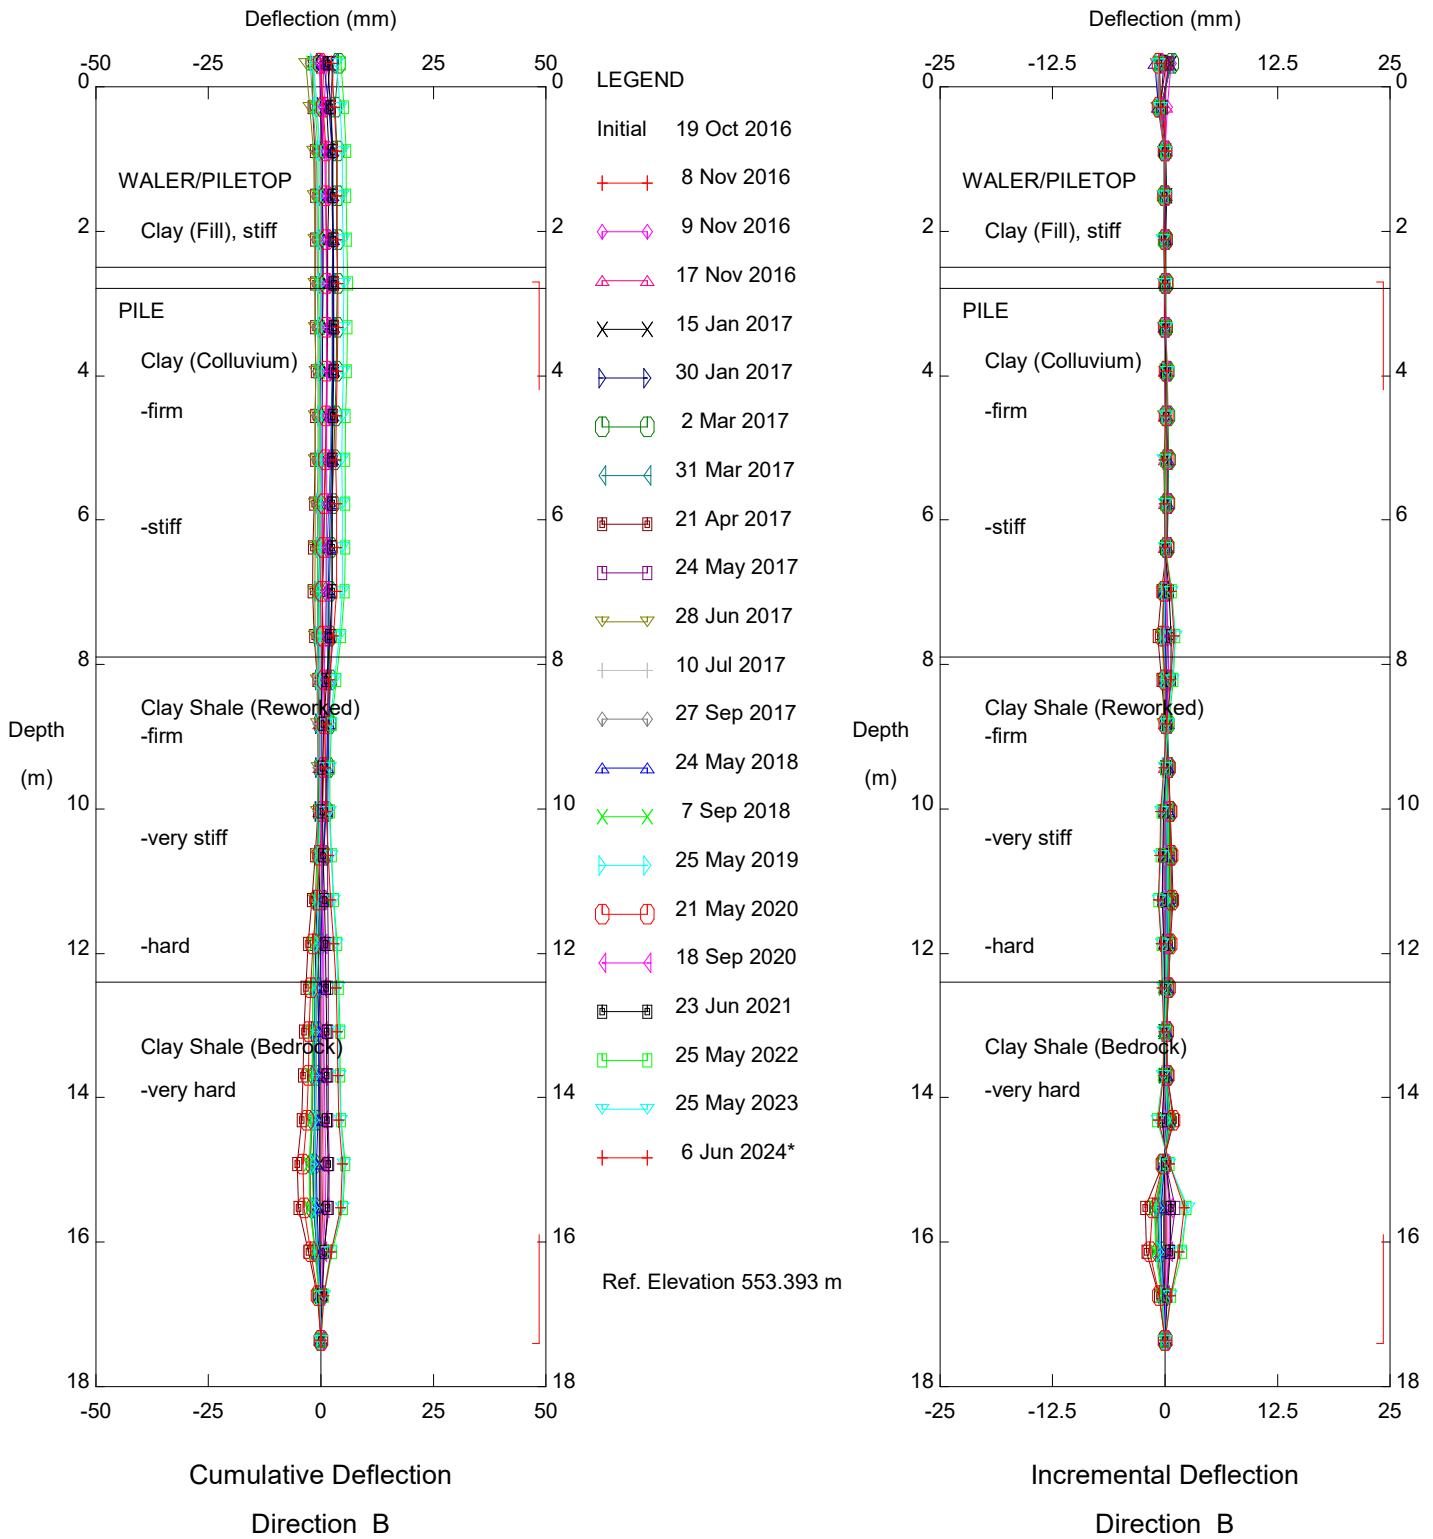
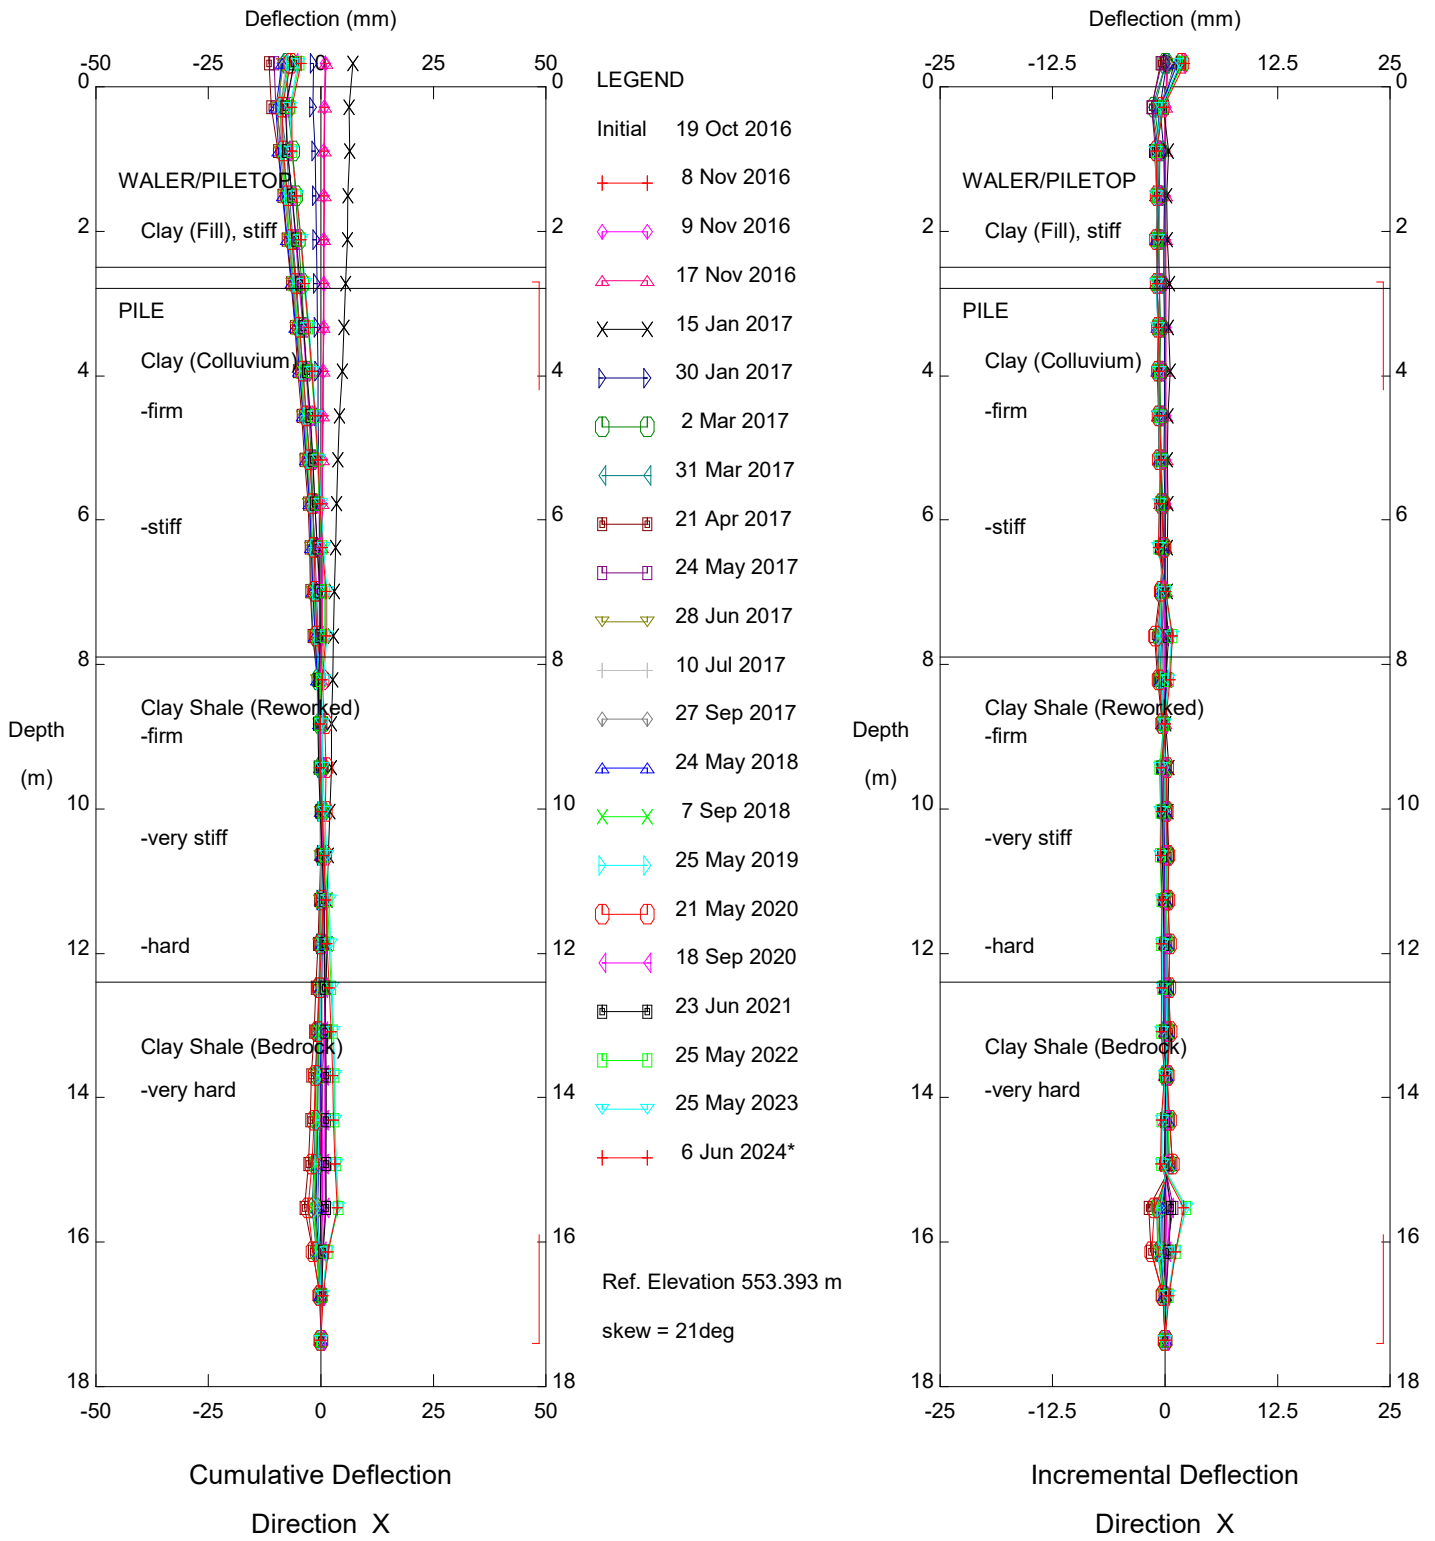
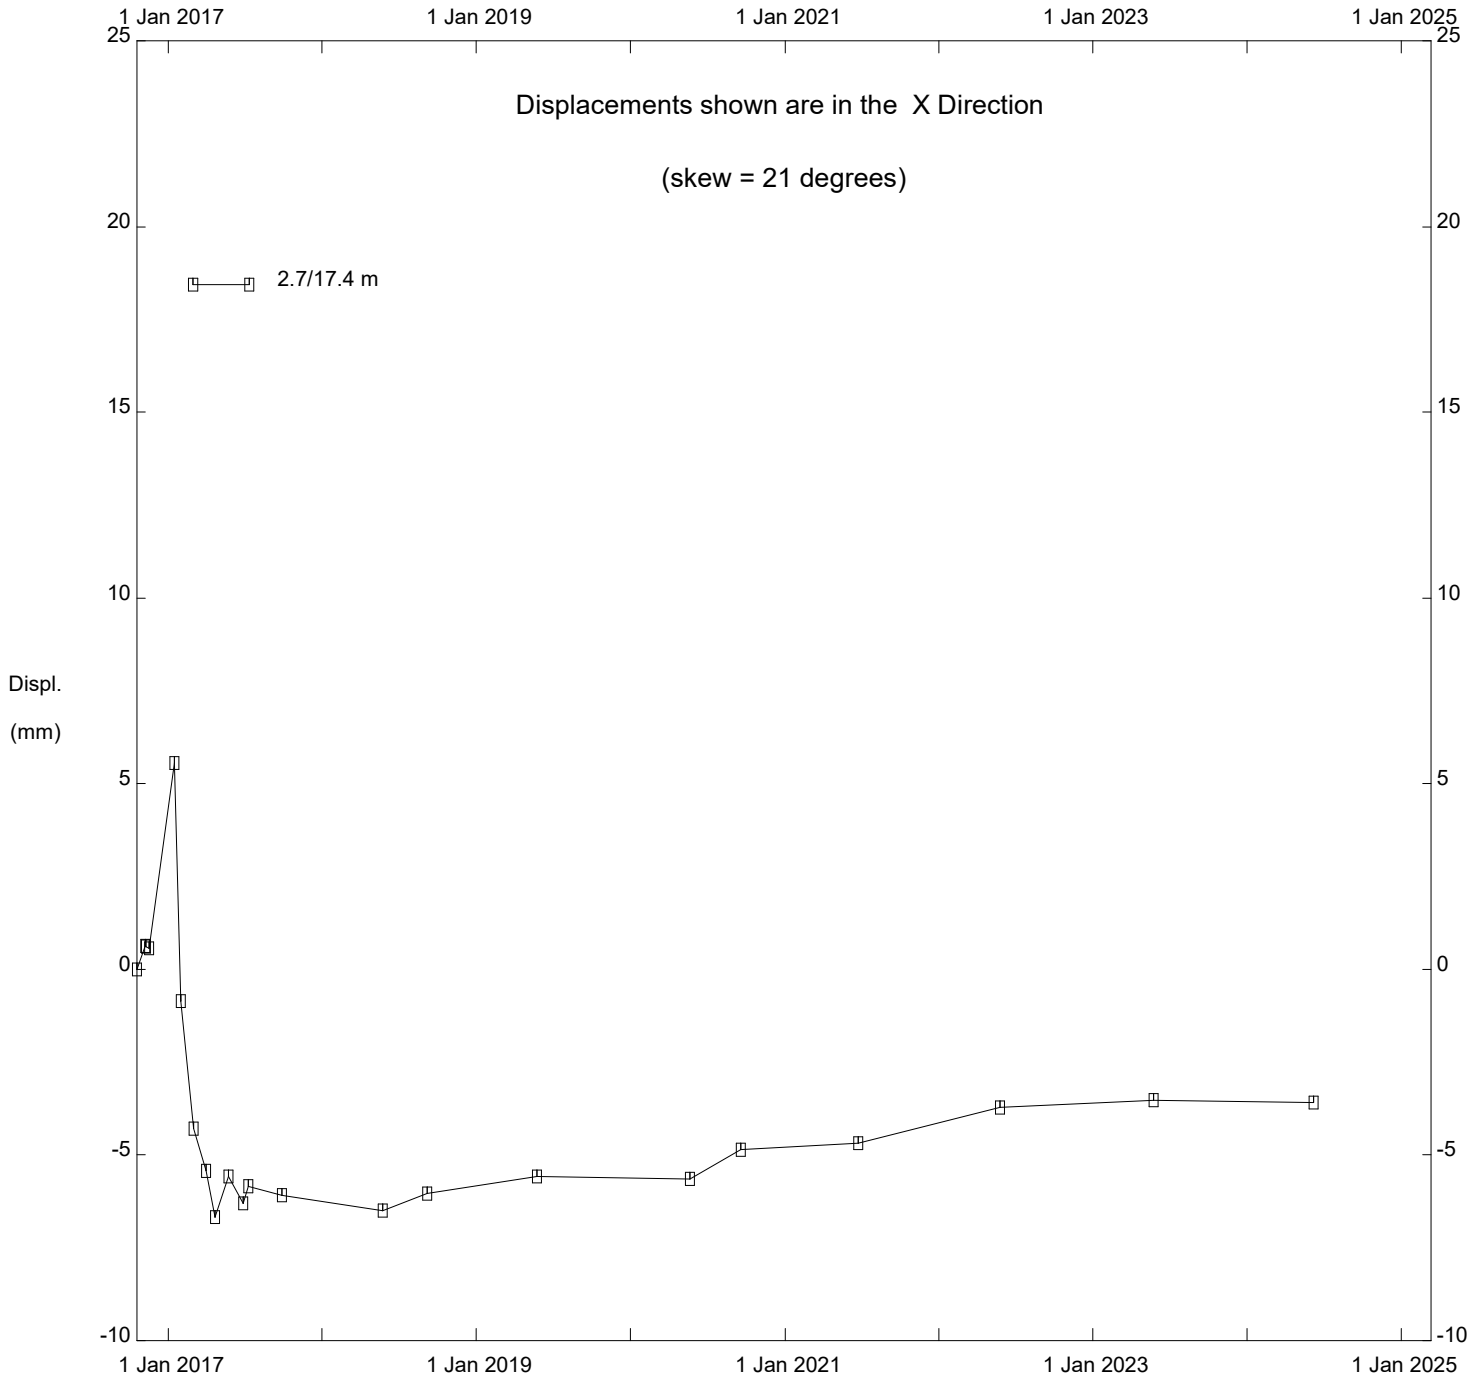
Hwy 41:23 Kehiwin Lake (NC104), Inclinometer SI16-2 (P28)

For the tied-back pile wall, SI16-1, SI16-2, SI16-3, and SI16-5 have shown total pile head movements in the upslope direction of 5.0 mm, 3.6 mm, 3.4 mm, and 1.5 mm, respectively. SI16-6 has shown a total pile head movement of 4.1 mm in the downslope direction. SI16-7 has not shown any discernible movement since it was reinitialized on September 18, 2020.

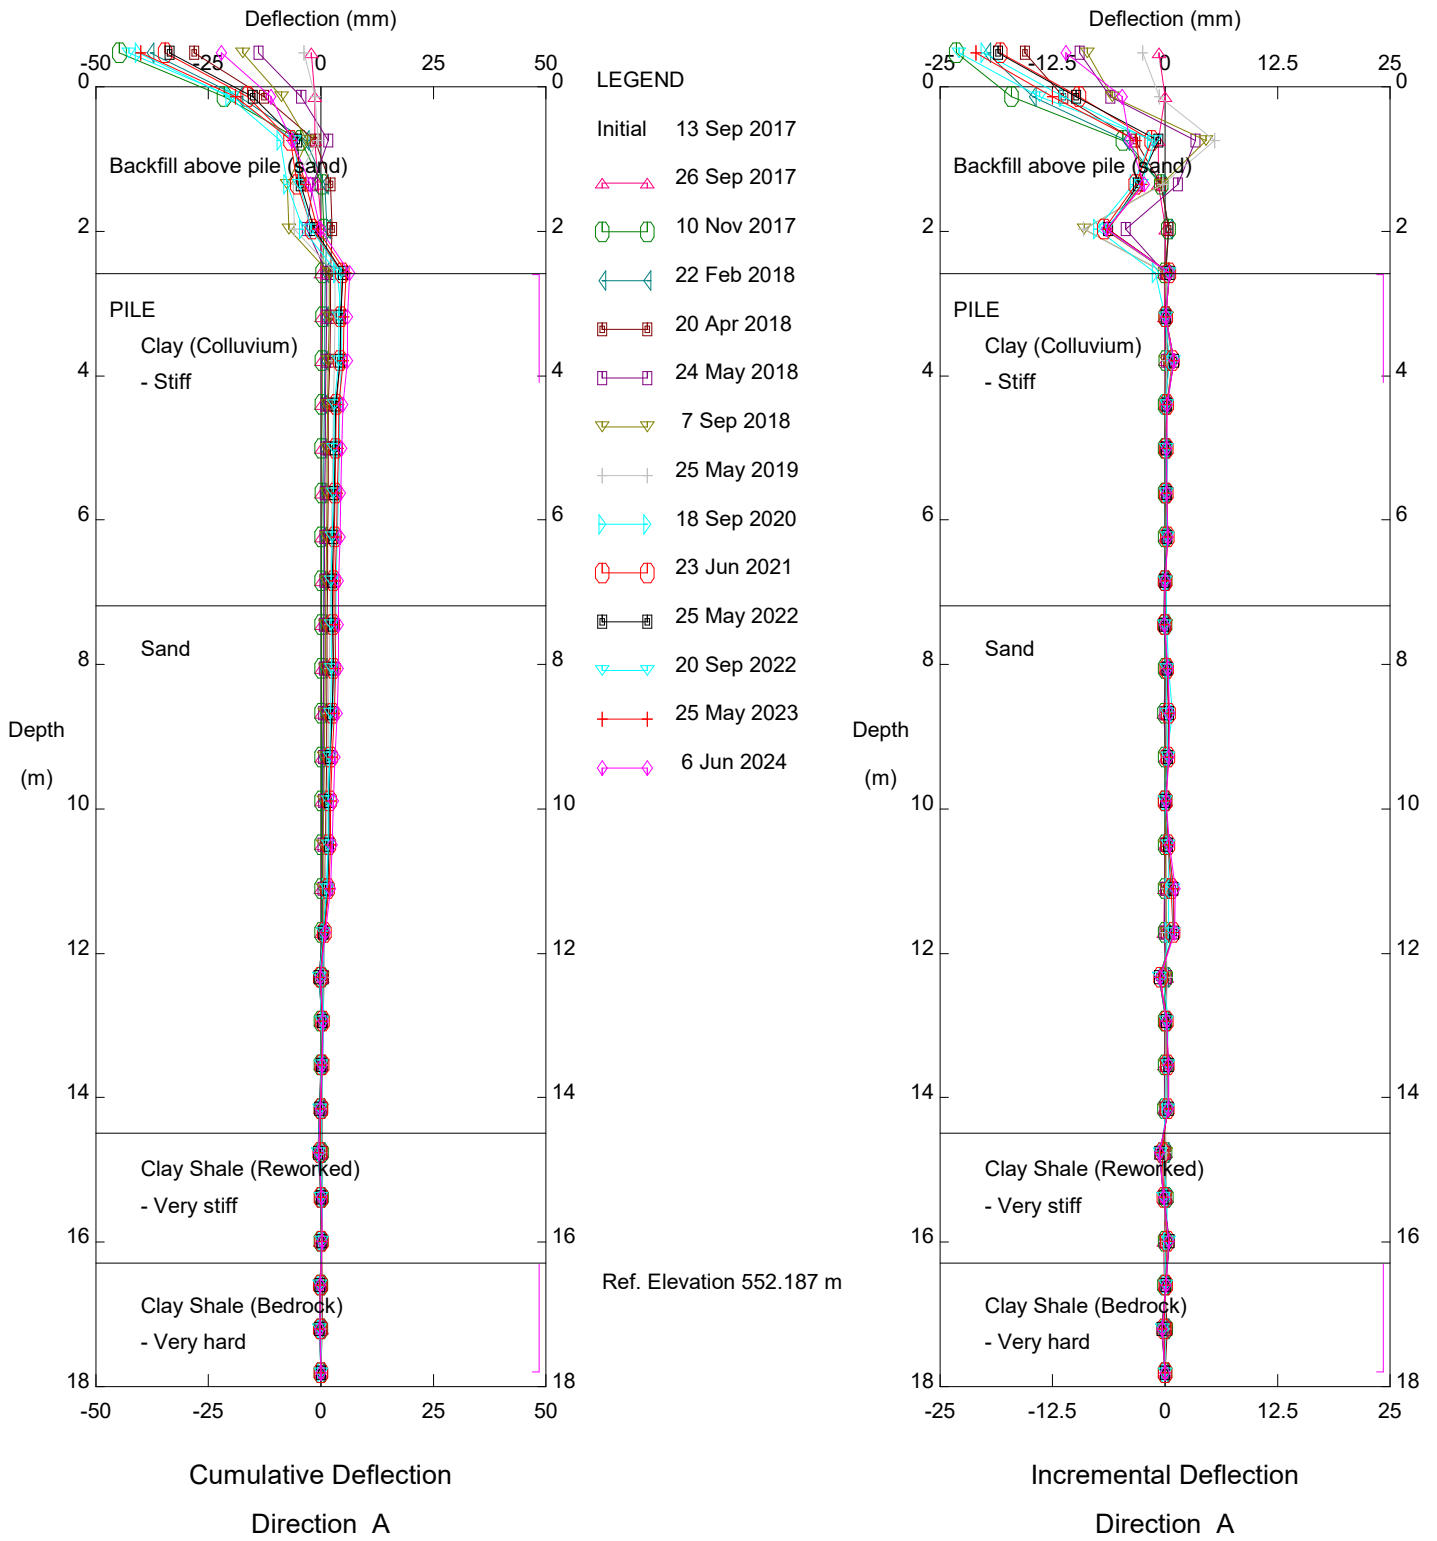
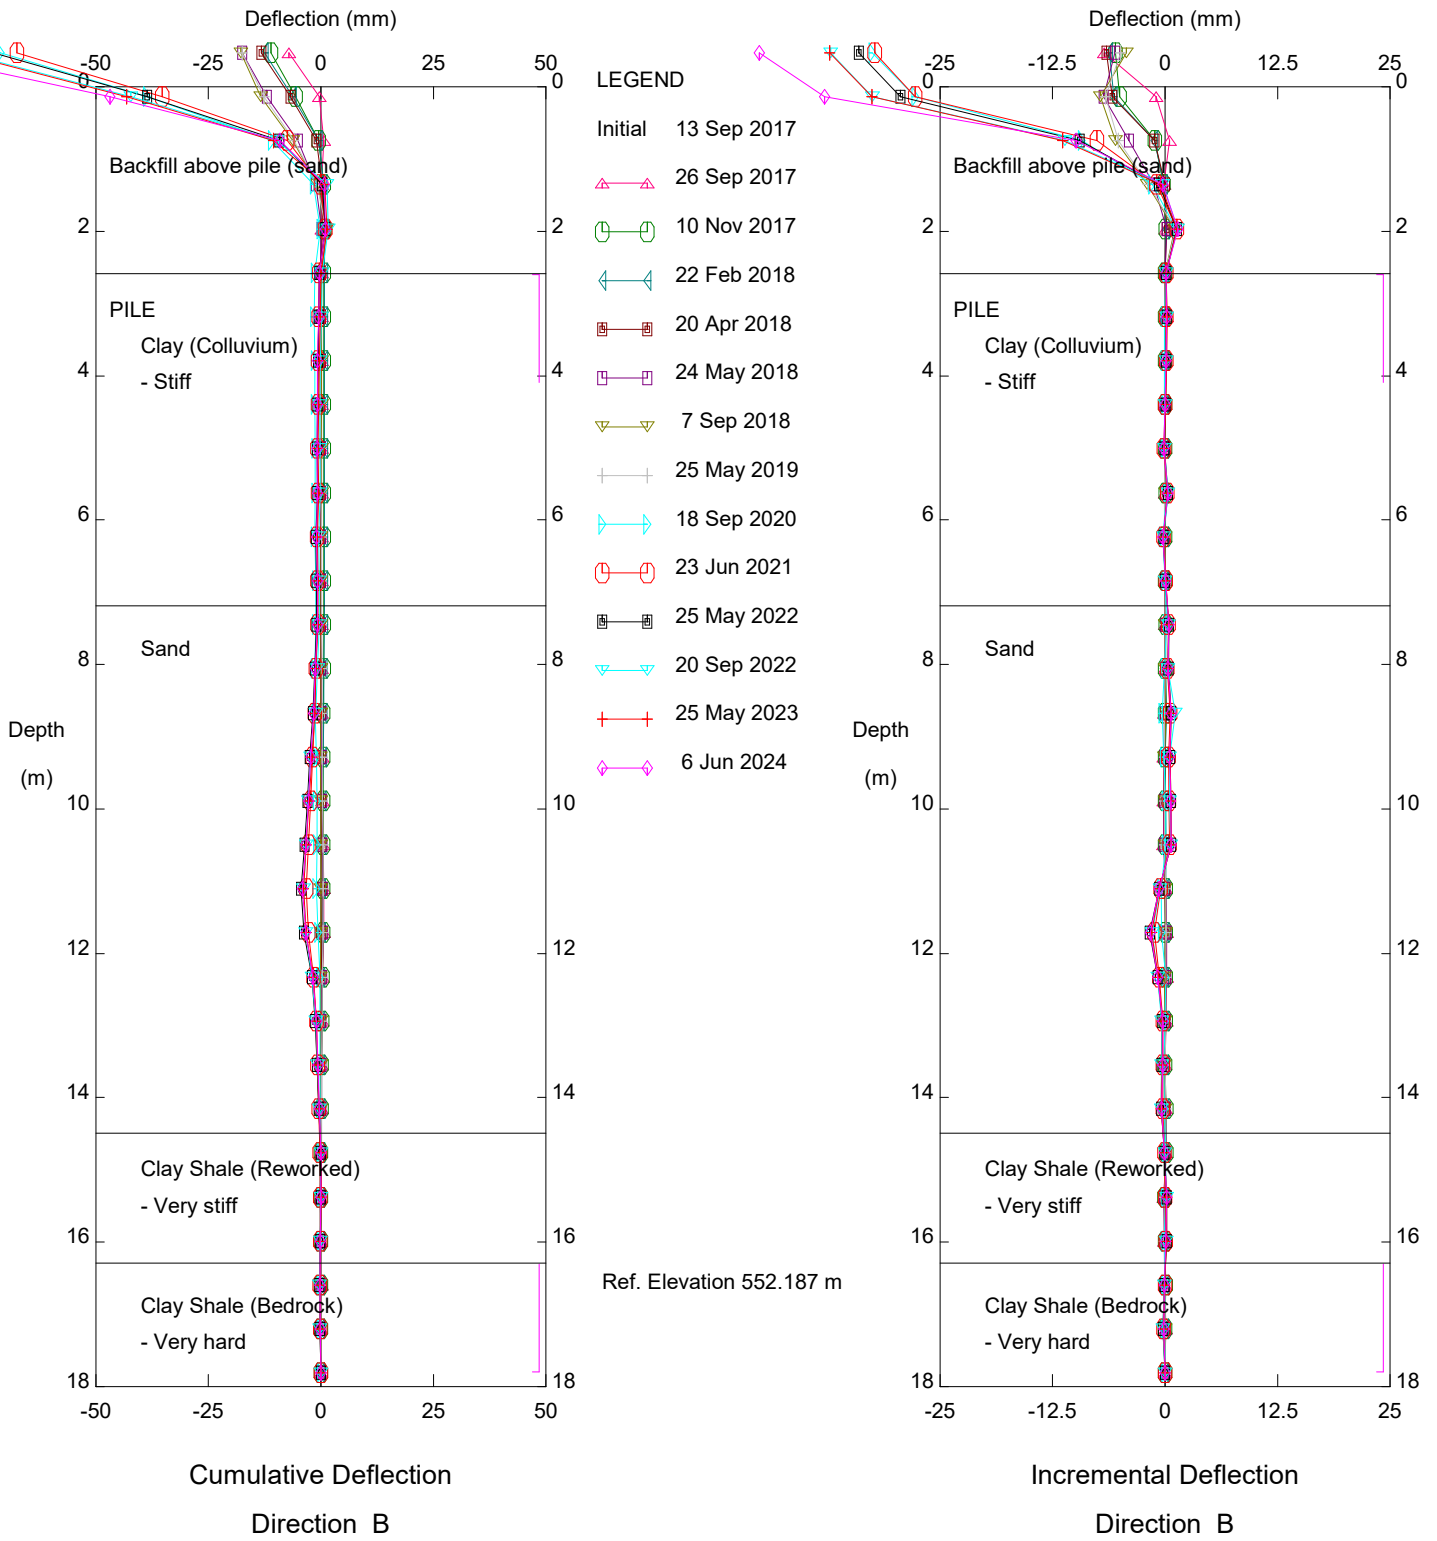
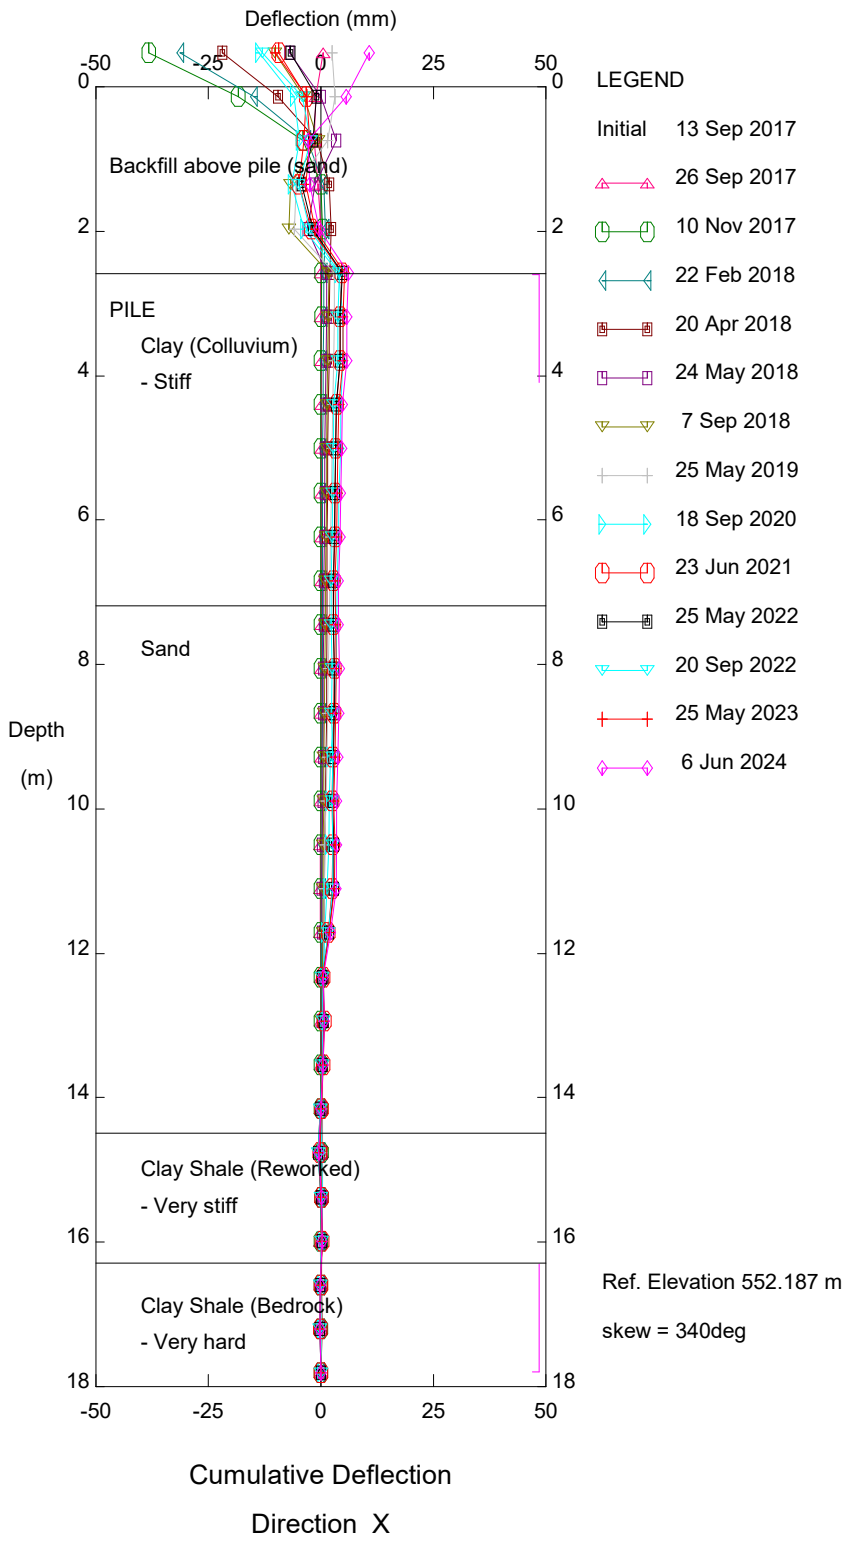
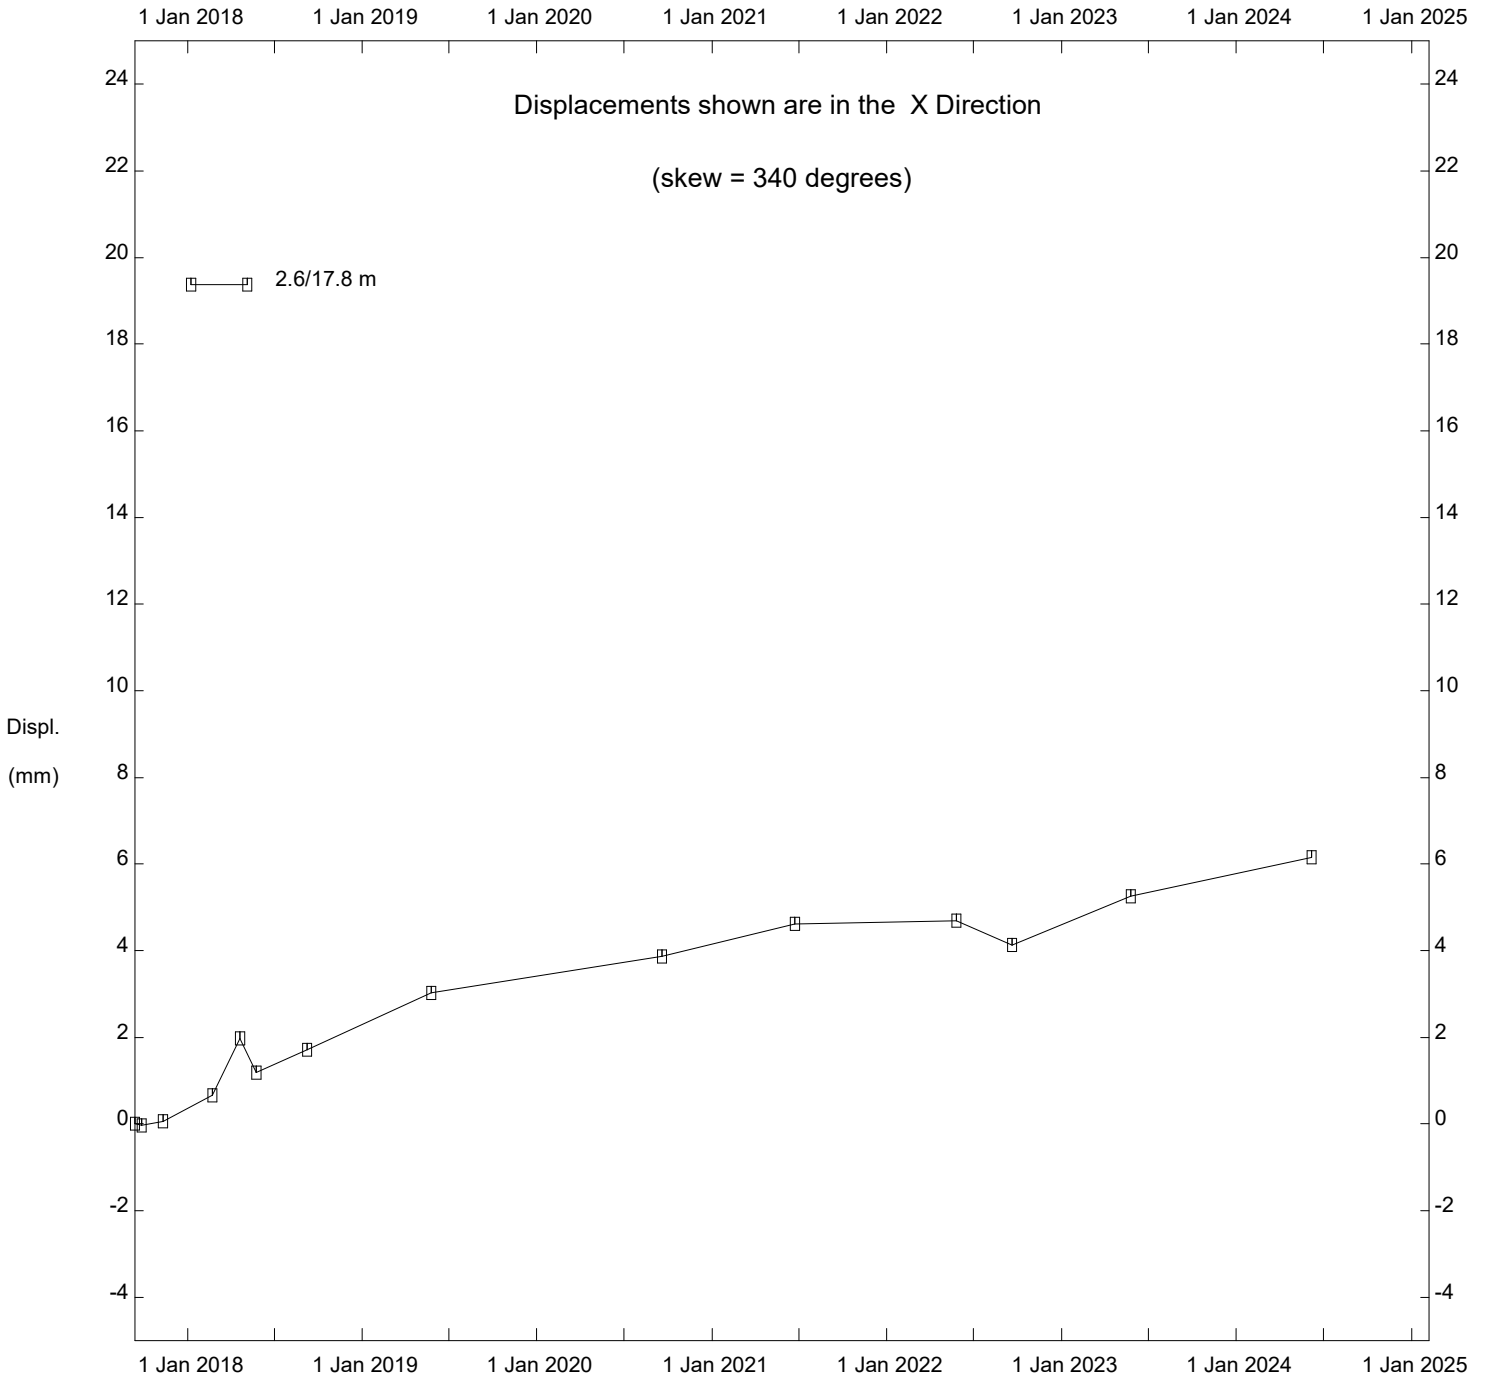
Hwy 41:23 Kehiwin Lake (NC104), Inclinometer SI17-1(P130)

For the interim cantilever pile wall, SI17-1, SI17-2, and SI17-4 showed rates of movement over the length of their respective piles of 0.9 mm/yr, less than 1 mm/yr, and 0.3 mm/yr, respectively, since the spring of 2023 readings. SI17-3 showed no discernible movement over the length of the pile. SI17-1, SI17-2, SI17-3, and SI17-4 have shown total pile head movements of 6.2 mm, 10.4 mm, 16.3 mm and 10.9, respectively, since they were initialized.
