**ALBERTA TRANSPORTATION AND  
ECONOMIC CORRIDORS GRMP  
NORTH CENTRAL (ATHABASCA AND FORT  
McMURRAY DISTRICTS)  
INSTRUMENTATION MONITORING- SPRING 2024**

Site Number	Location	Name	Hwy	km
NC104 (NC024-4)	HWY 41:23 C1 7.66	Kehiwin Lake	41:23	Km 7.7
<b>Legal Description:</b> 9-25-58-7 W4		<b>UTM Co-ordinates</b>		
		12U E 506556	N	5988265

<b>Current Monitoring:</b>	6-June-2024	<b>Previous Monitoring</b>	25-May-2023
<b>Instruments Read By:</b>	Mr. Niraj Regmi, G.I.T and Mr. Nixson Mationg, of Thurber

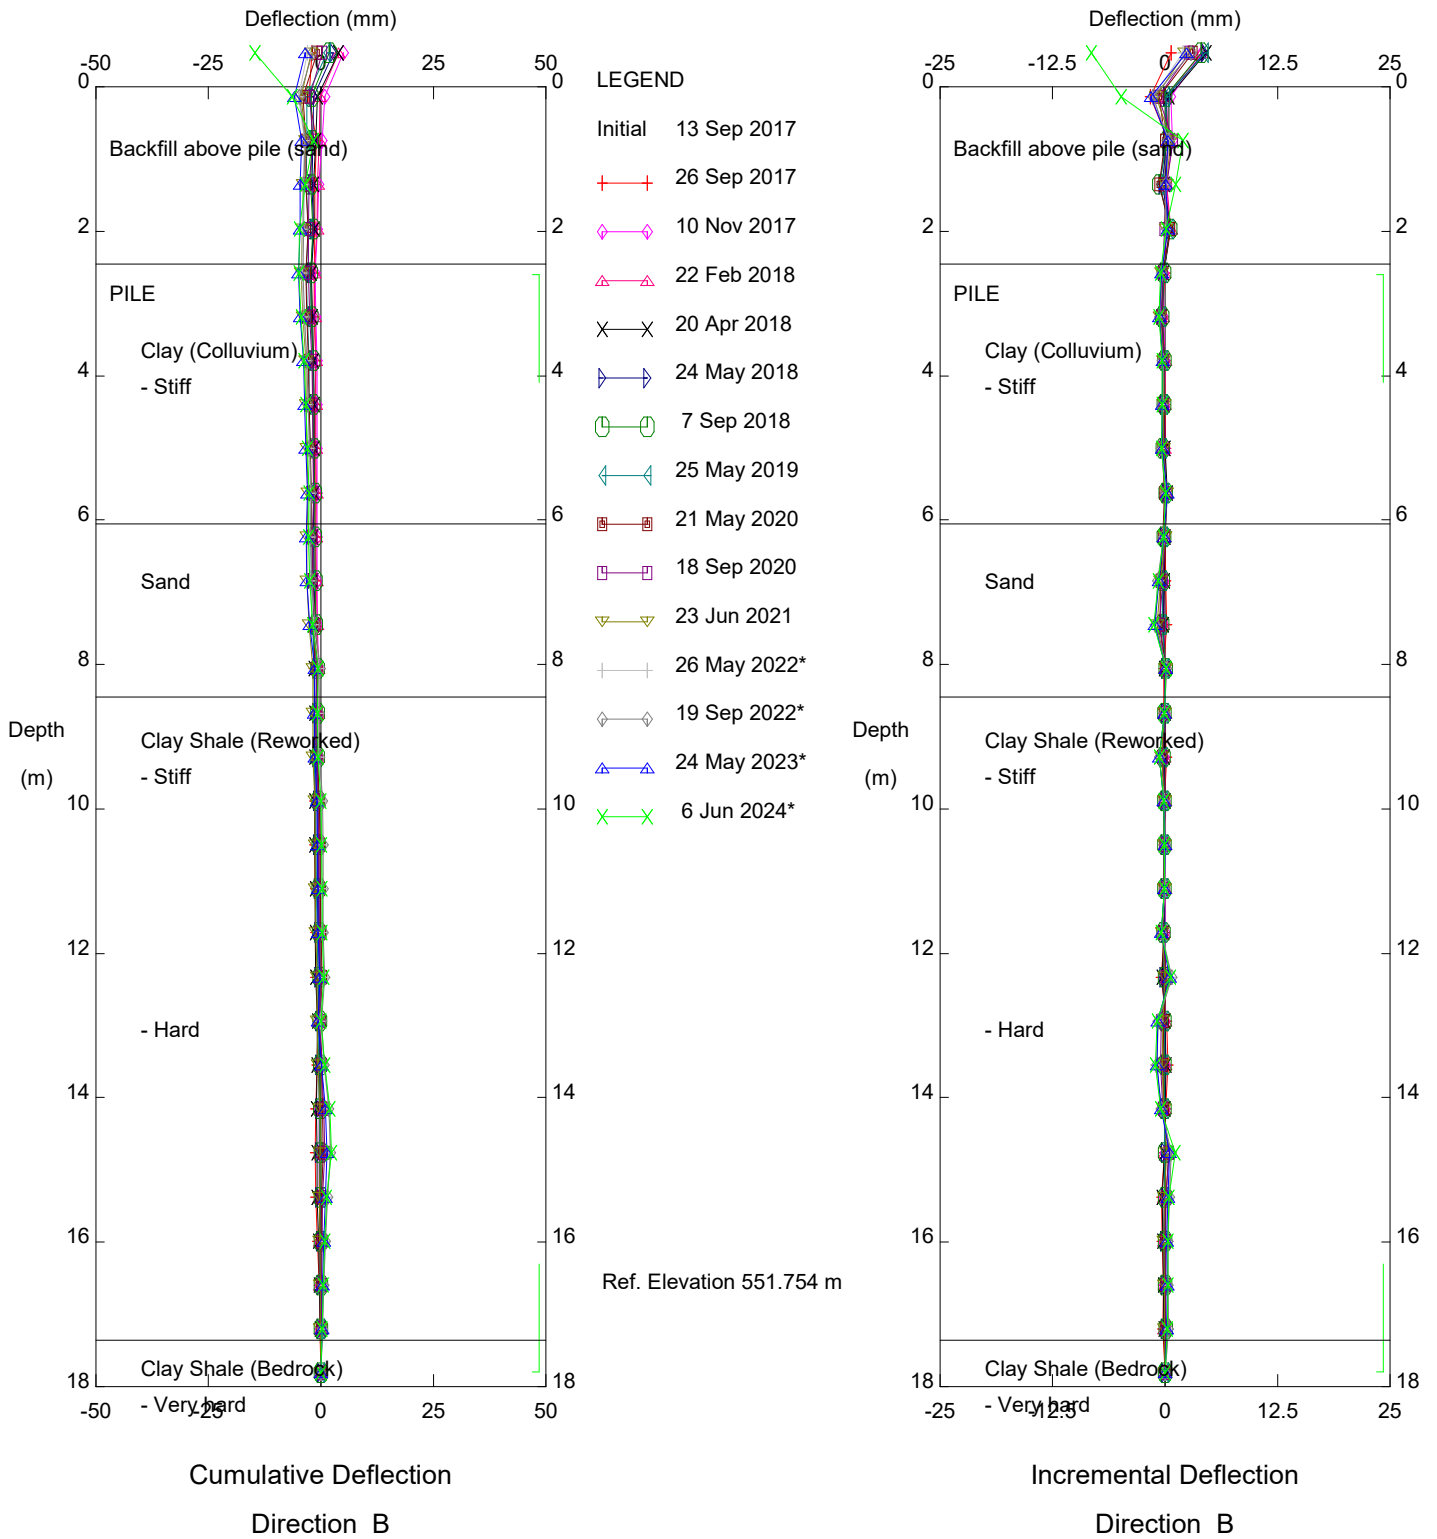
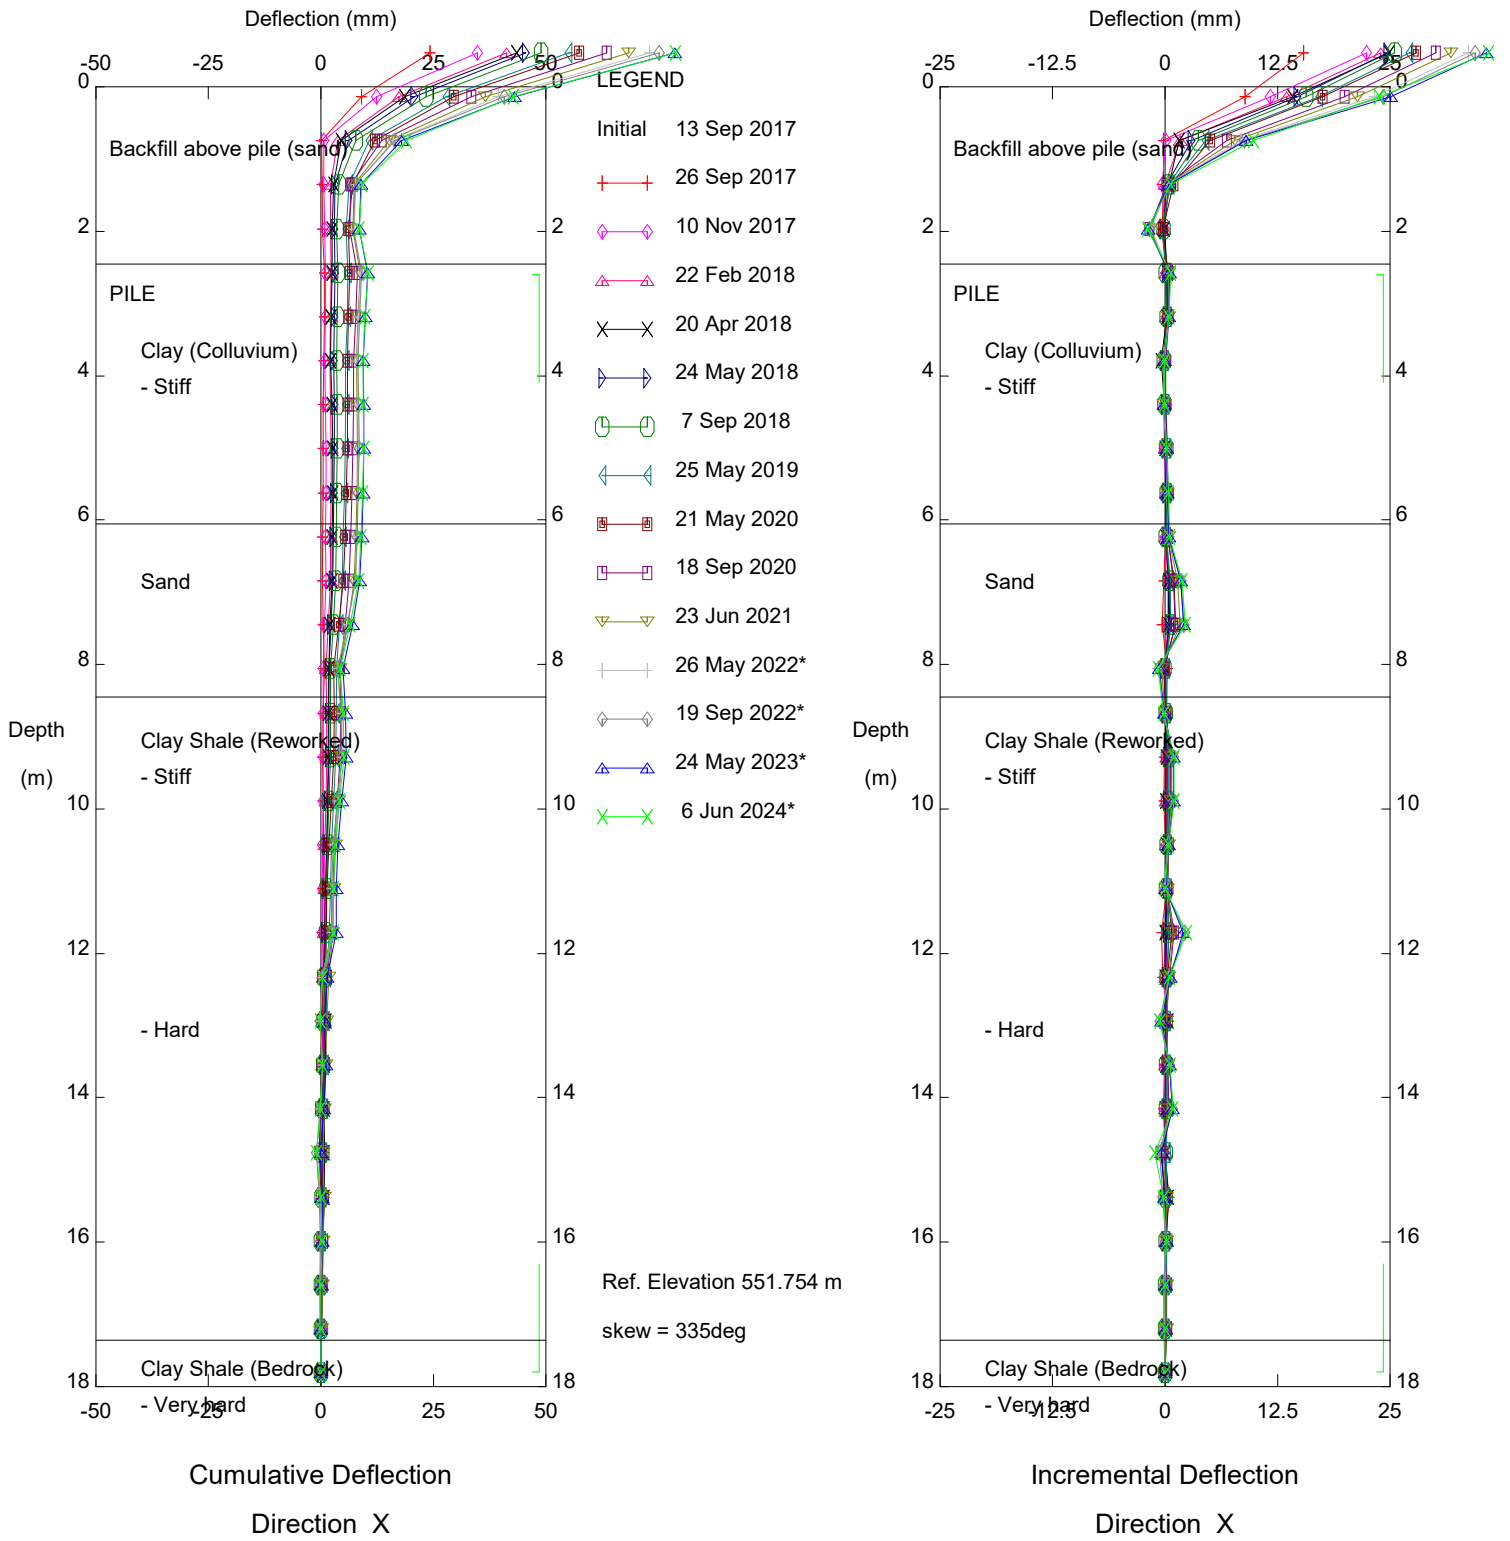
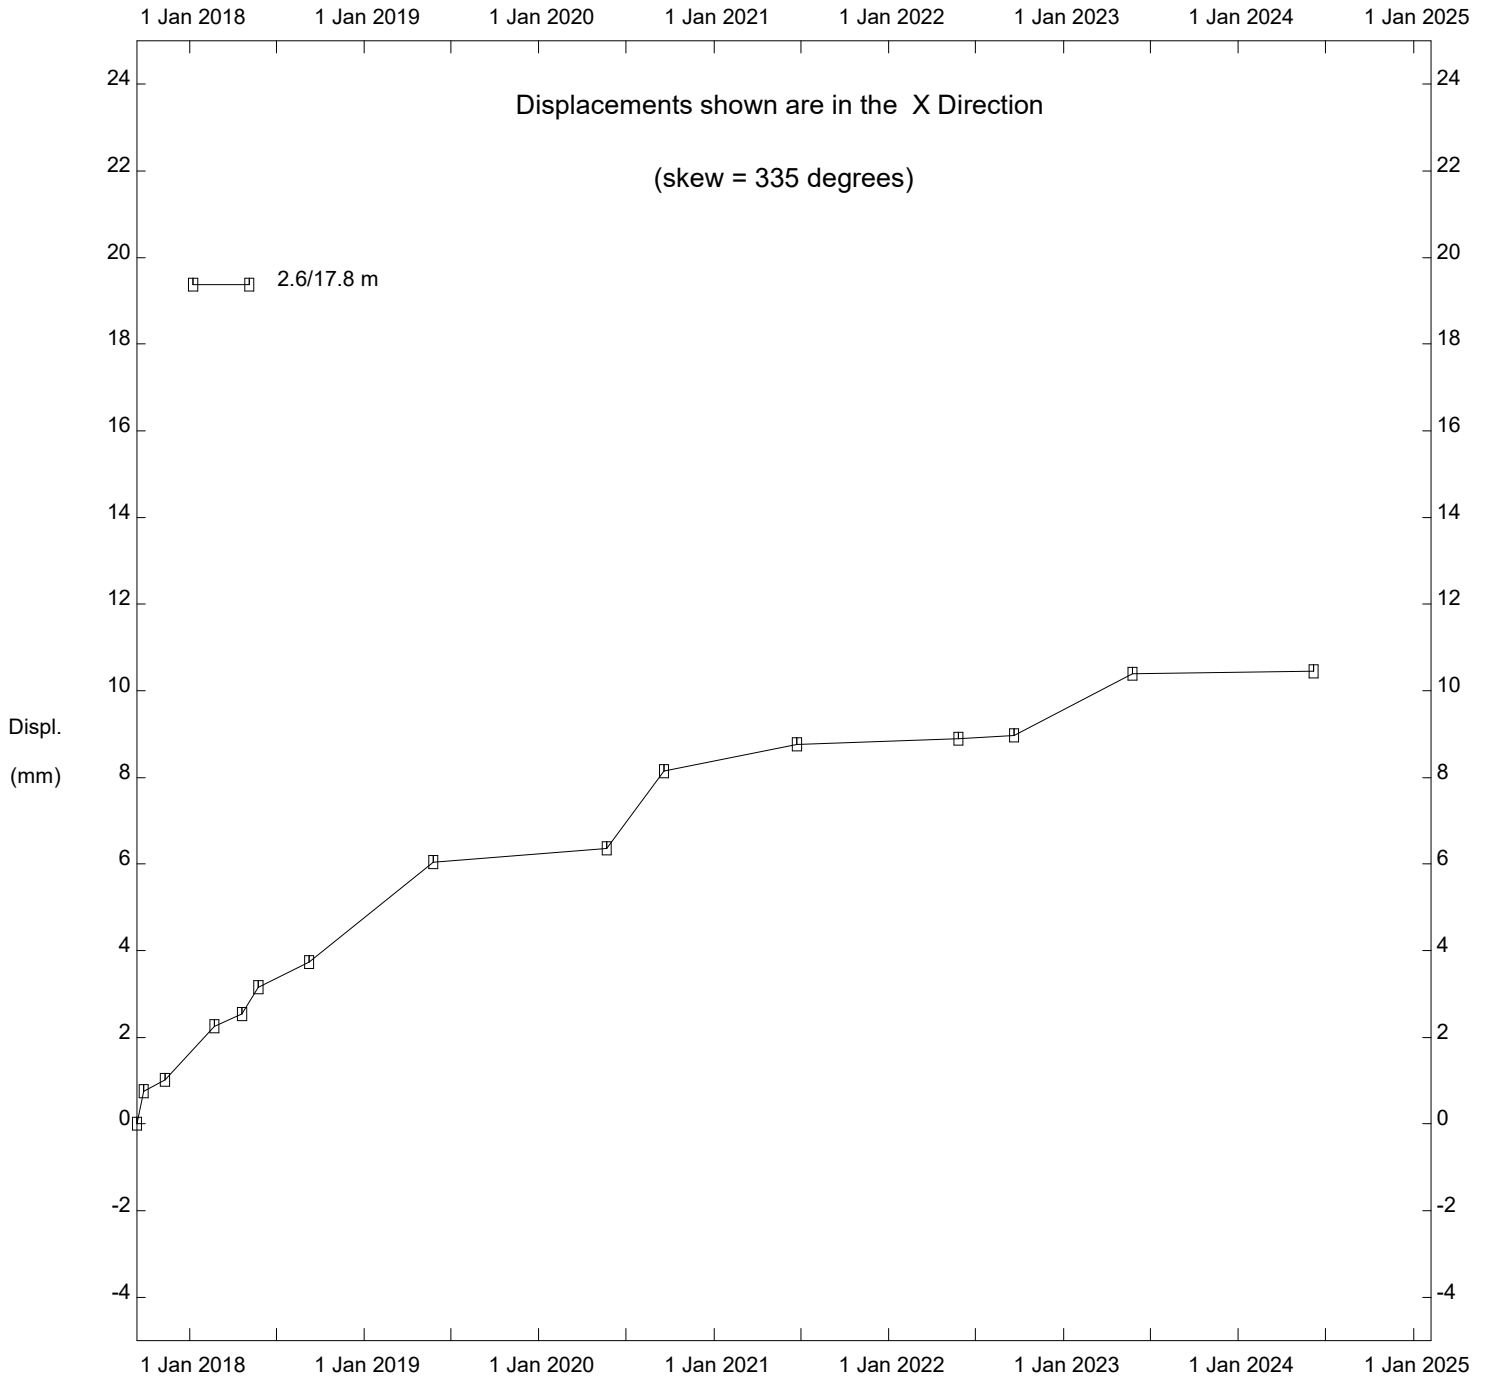
Hwy 41:23 Kehiwin Lake (NC104), Inclinometer SI17-2(P160)

For the interim cantilever pile wall, SI17-1, SI17-2, and SI17-4 showed rates of movement over the length of their respective piles of 0.9 mm/yr, less than 1 mm/yr, and 0.3 mm/yr, respectively, since the spring of 2023 readings. SI17-3 showed no discernible movement over the length of the pile. SI17-1, SI17-2, SI17-3, and SI17-4 have shown total pile head movements of 6.2 mm, 10.4 mm, 16.3 mm and 10.9, respectively, since they were initialized.

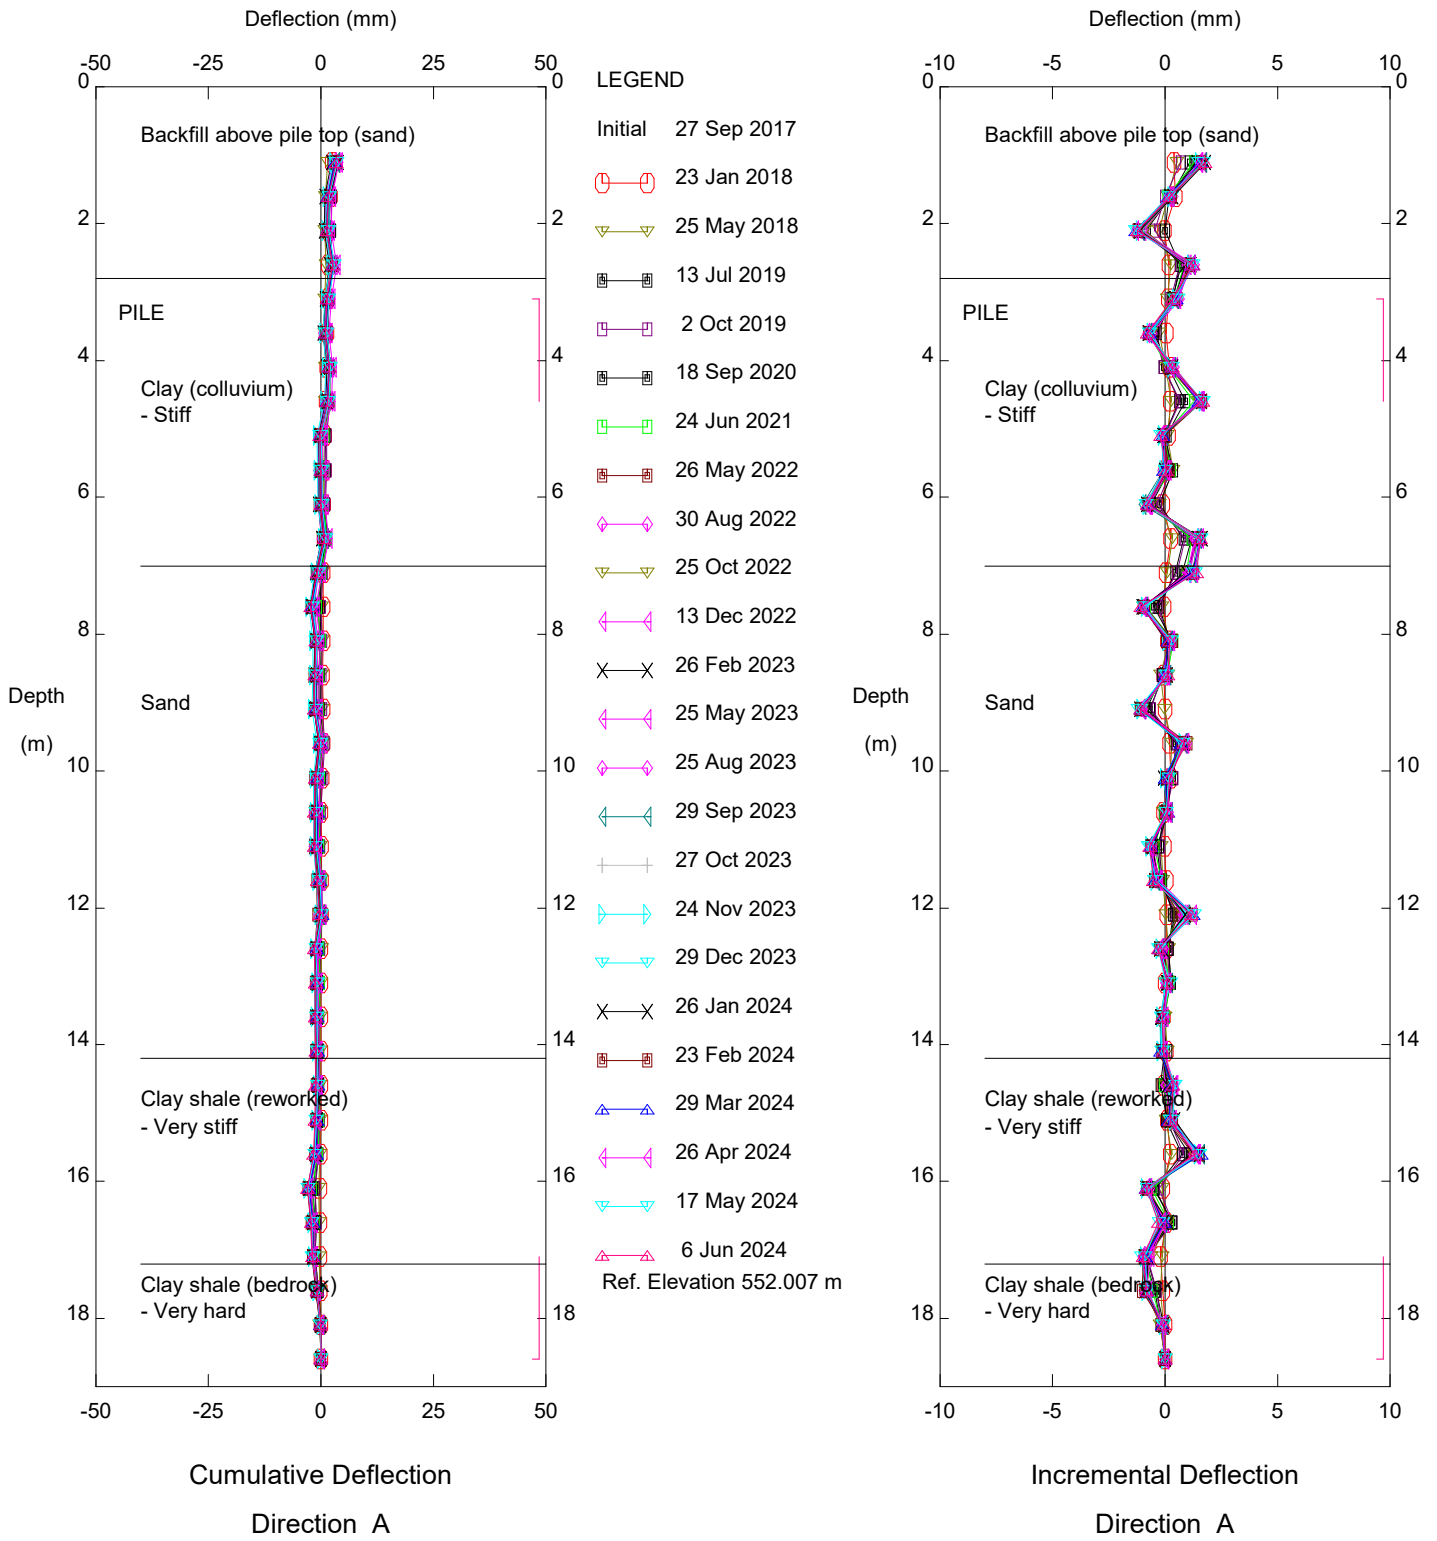
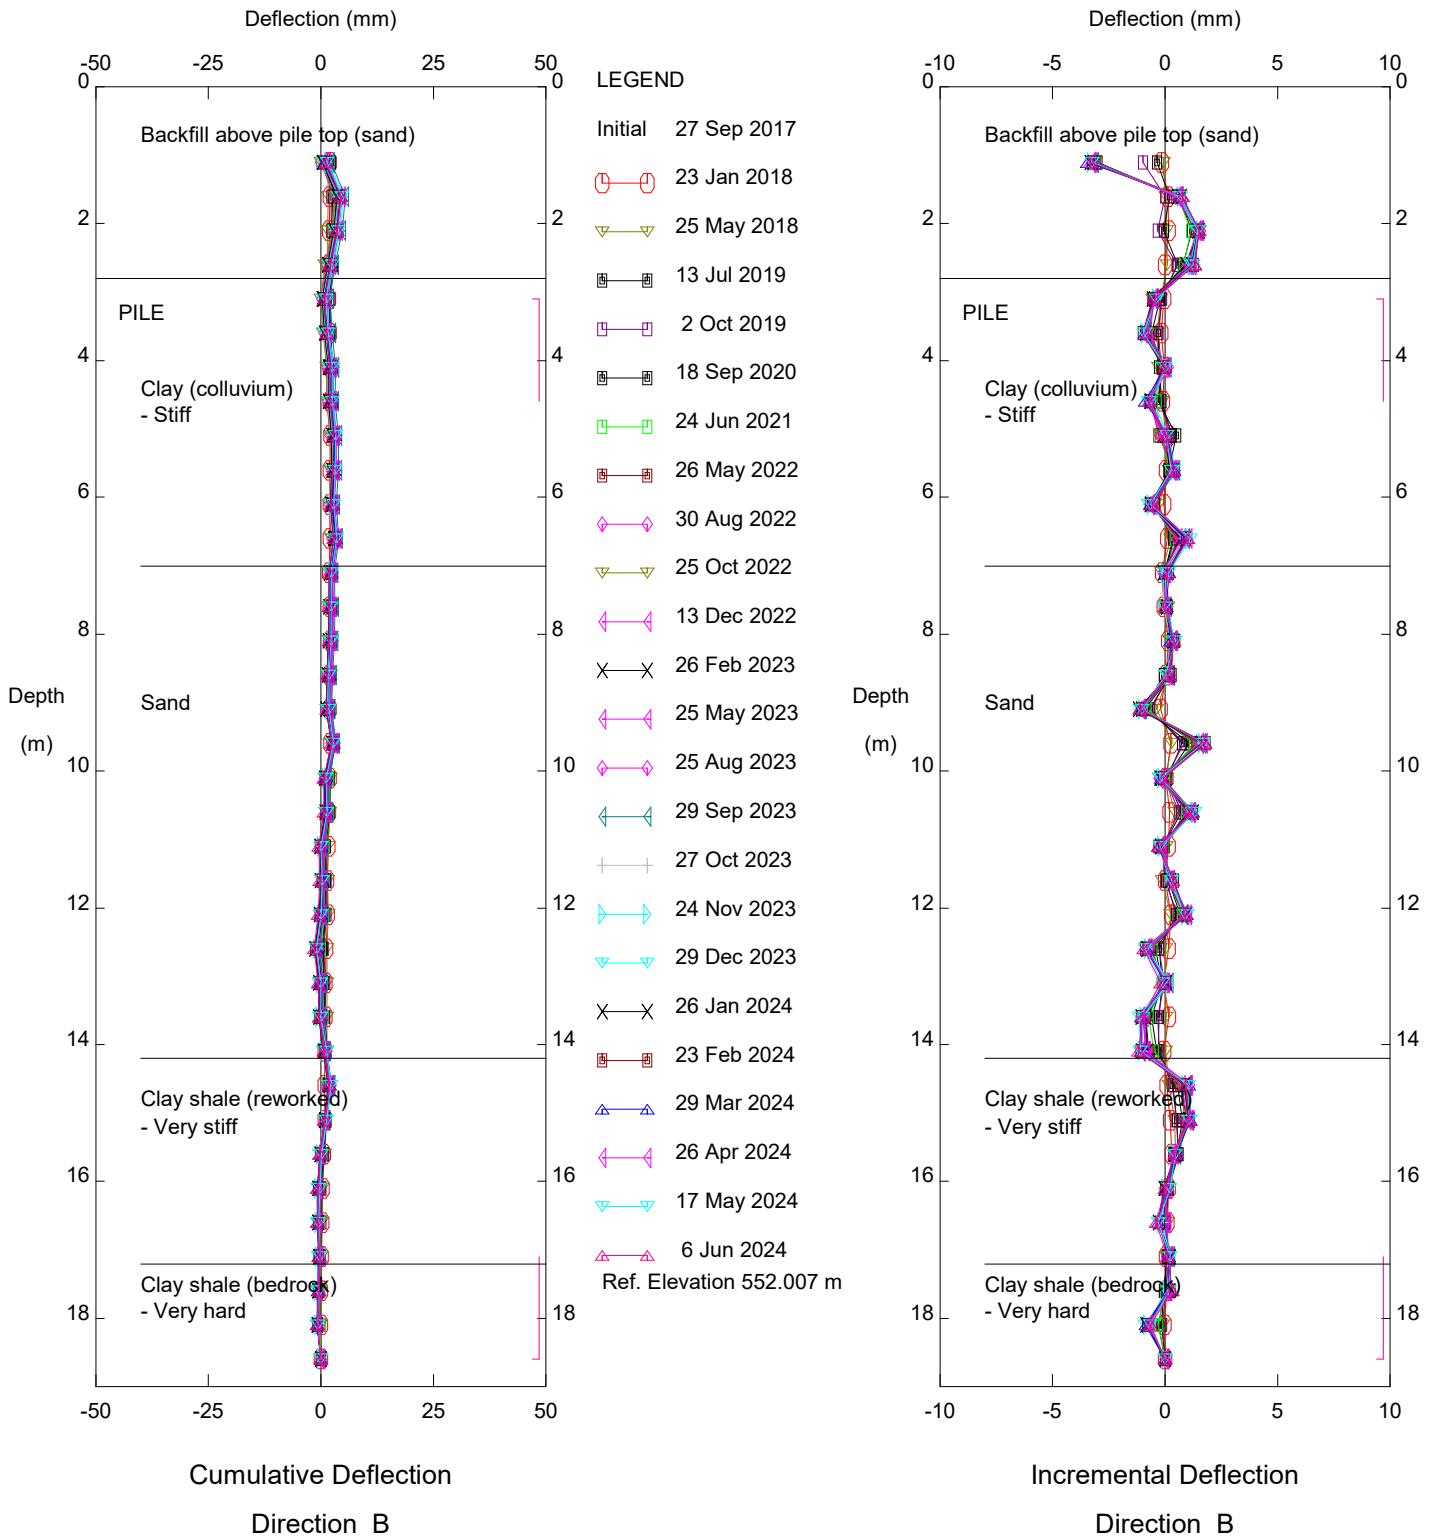
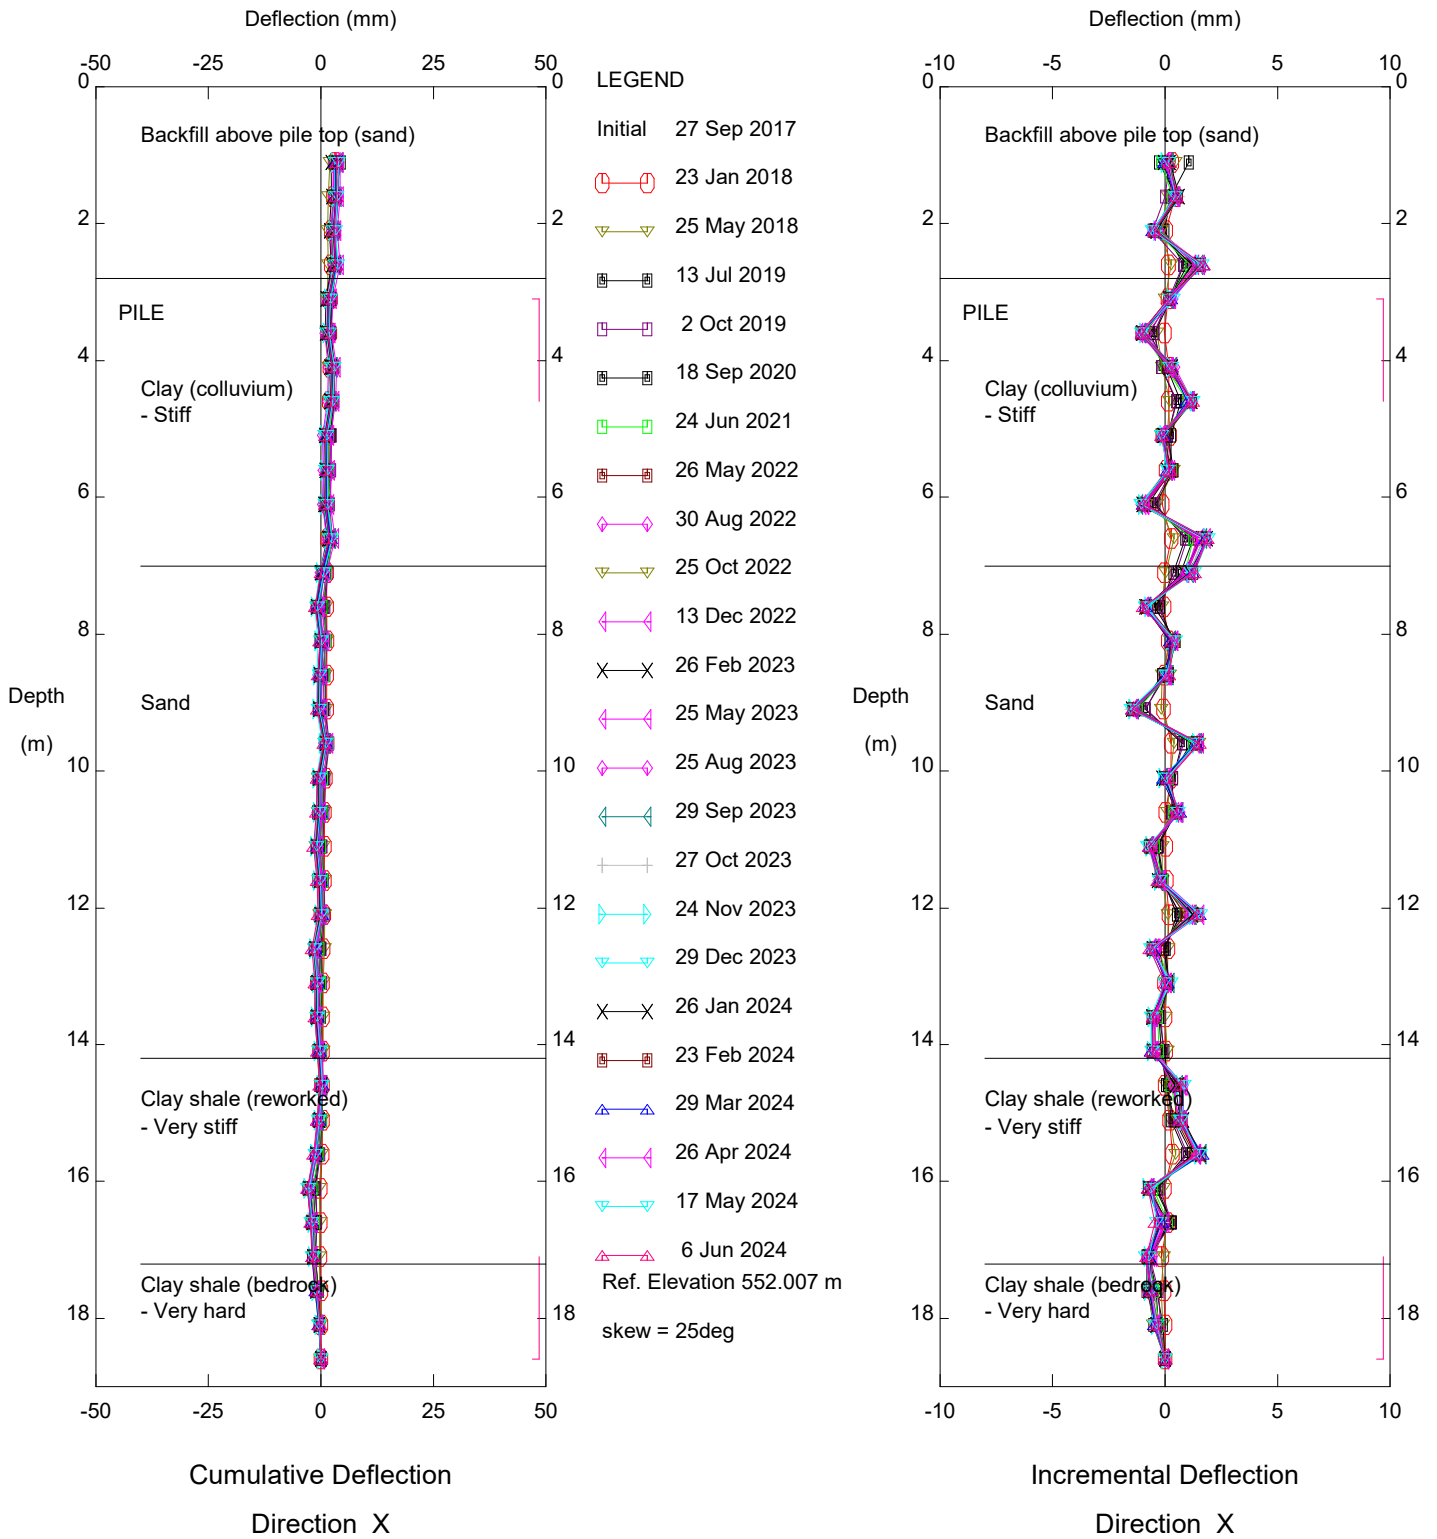
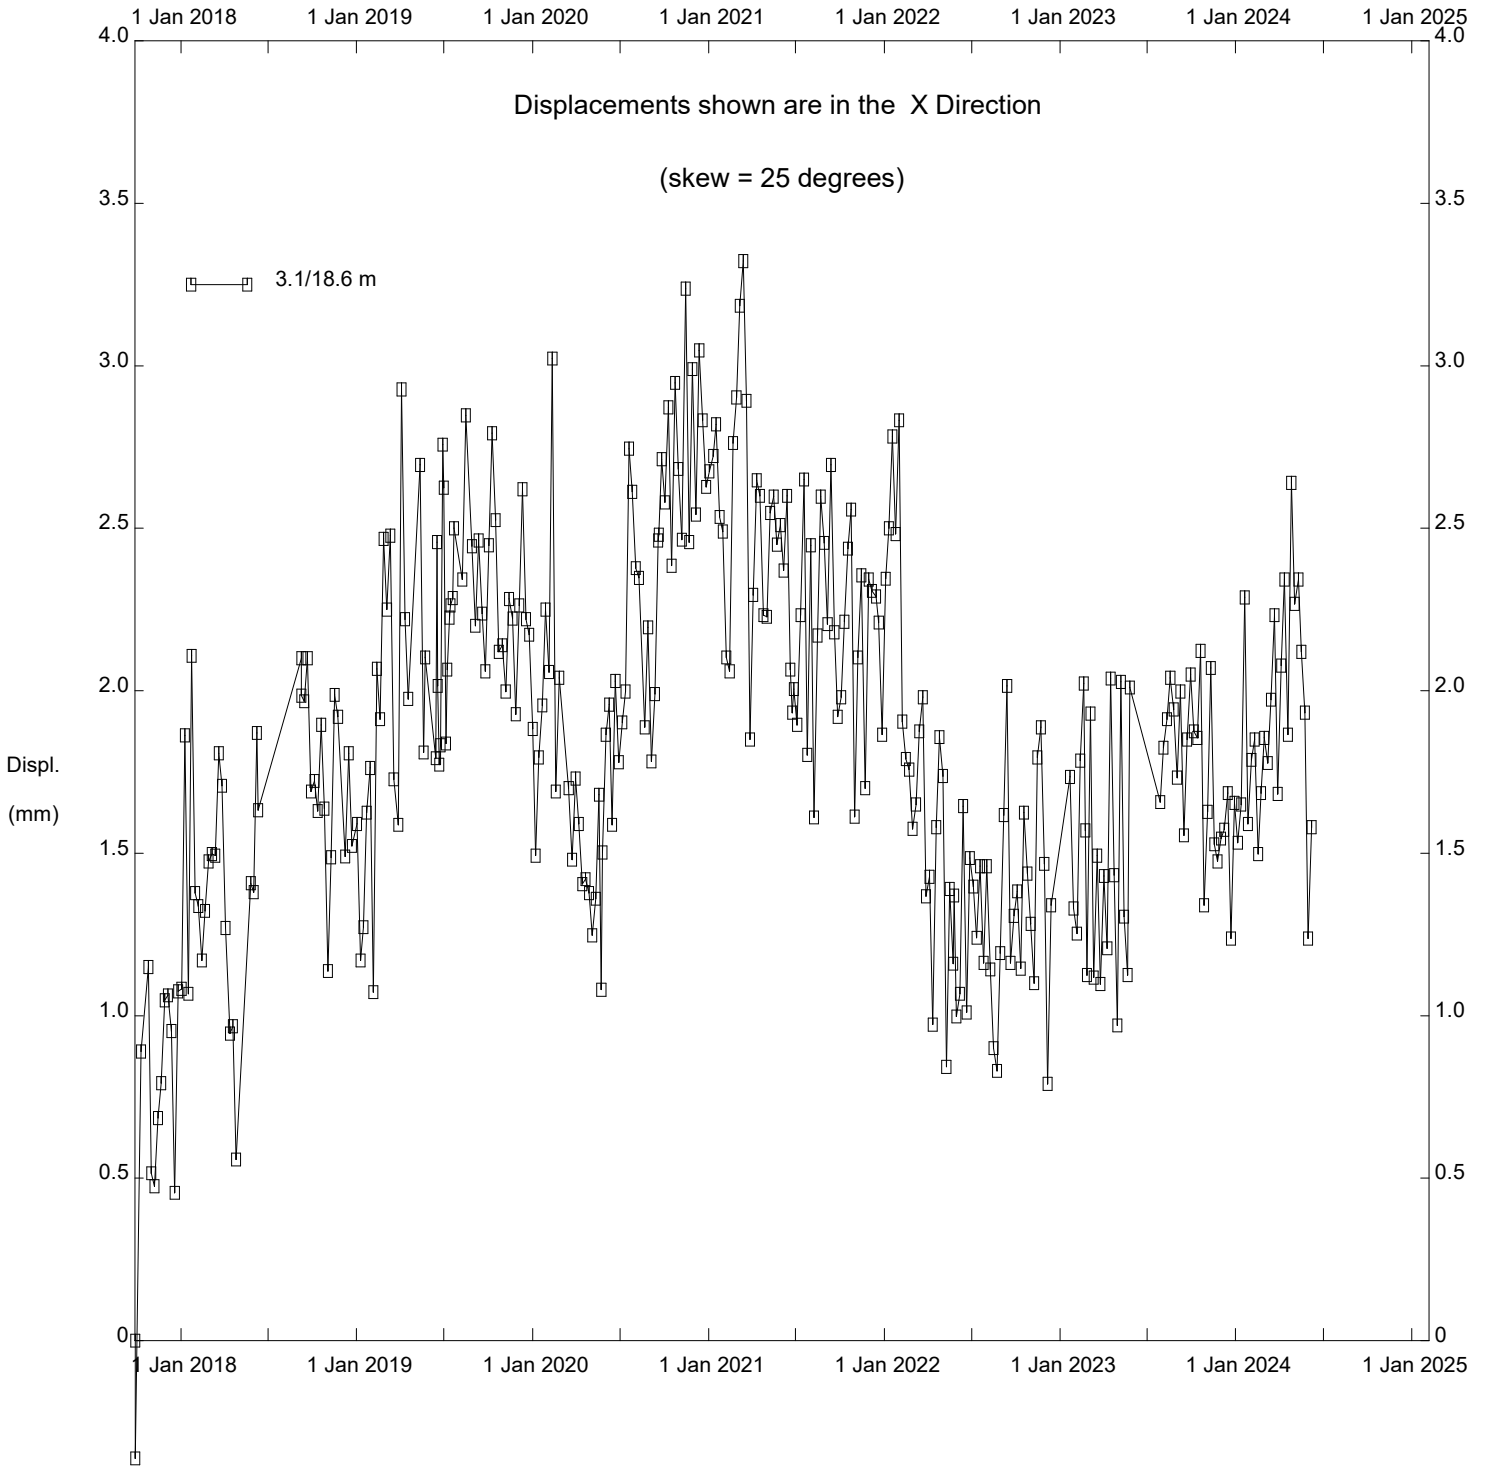
Hwy 41:23 Kehiwin Lake (NC104), Inclinometer SAA17-1(P146)

SAA17-1, installed in pile P146 of the NC104-4 wall extension (i.e., interim pile wall), showed no discernible movement since the spring of 2023 readings. SAA17-1 has shown a total pile head movement of 1.6 mm in the downslope direction since it was installed.

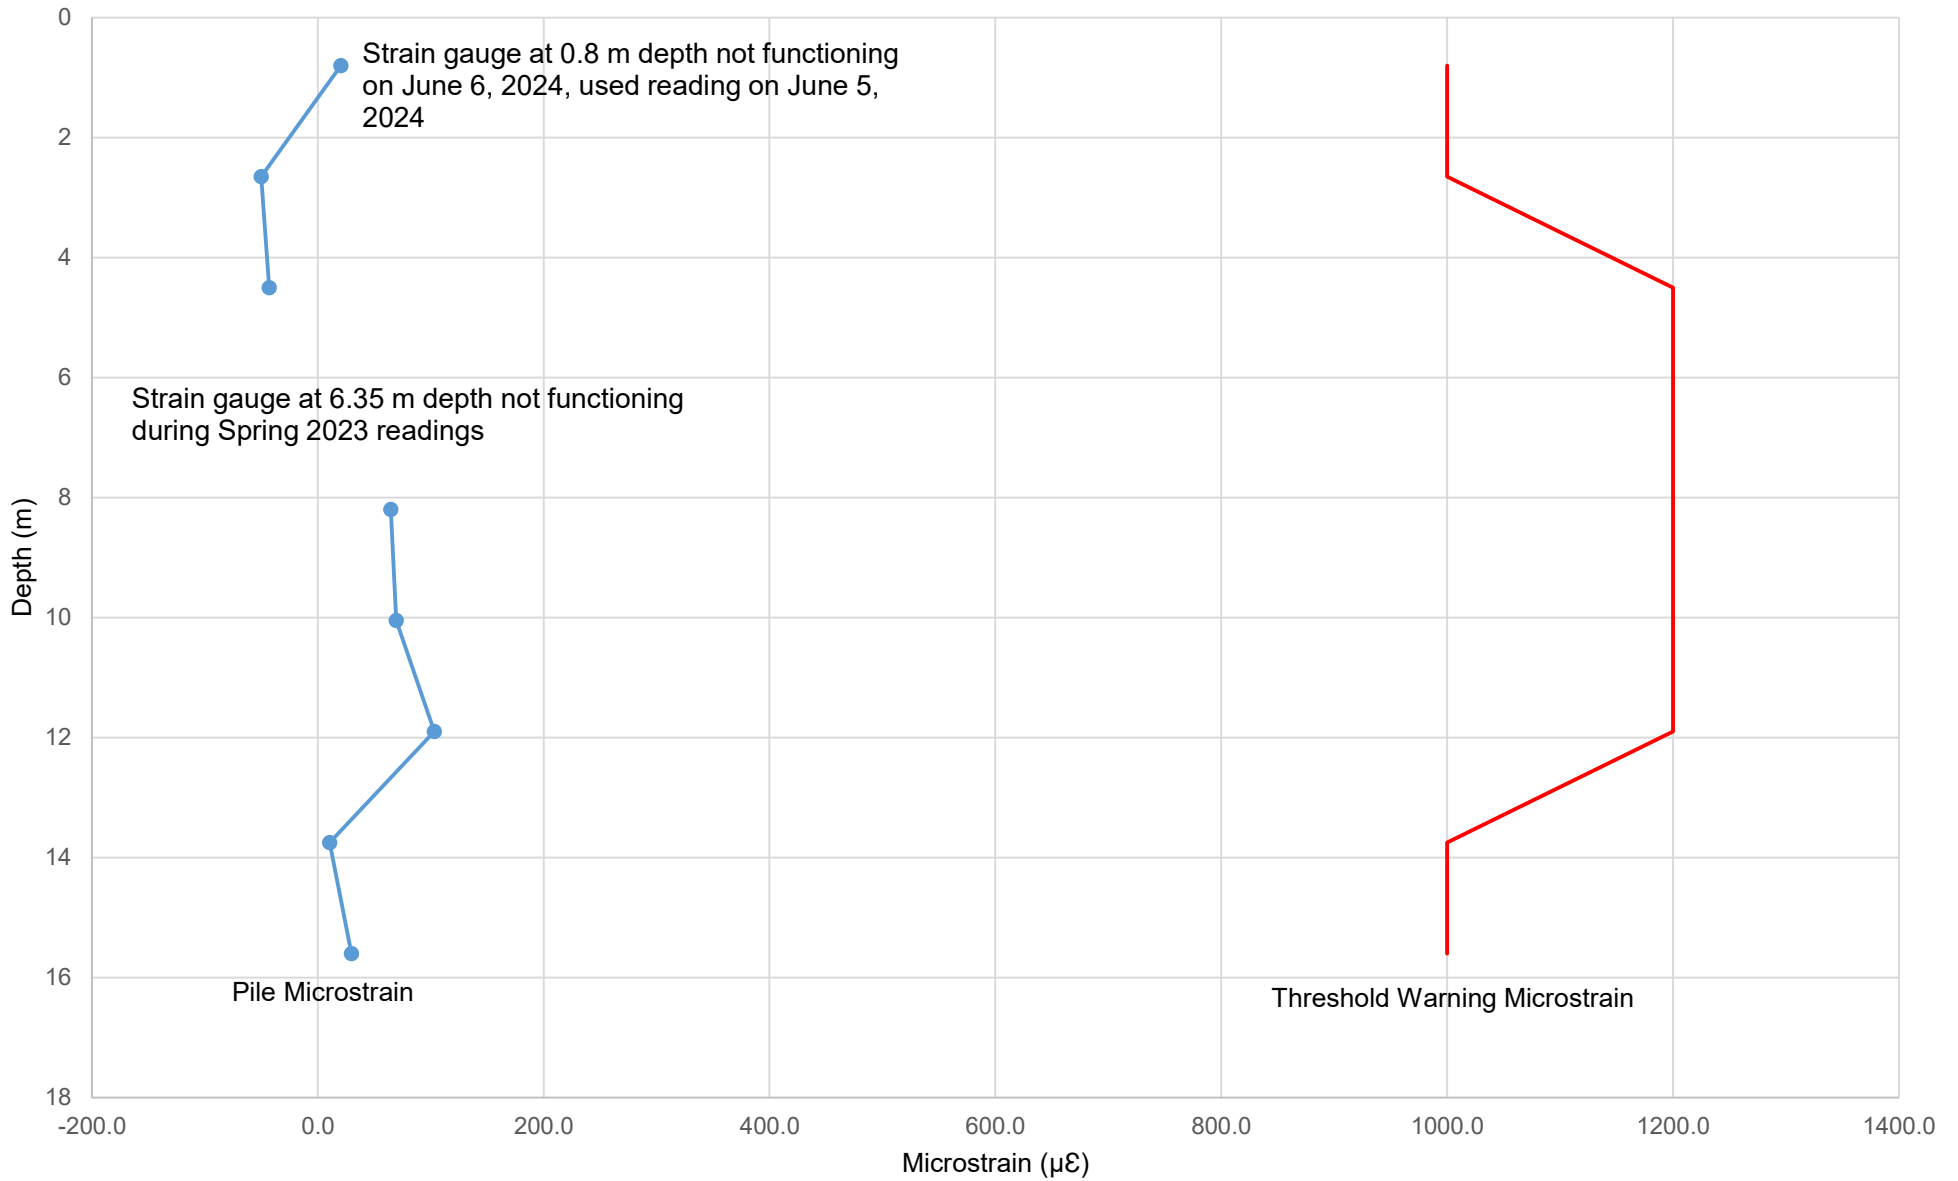
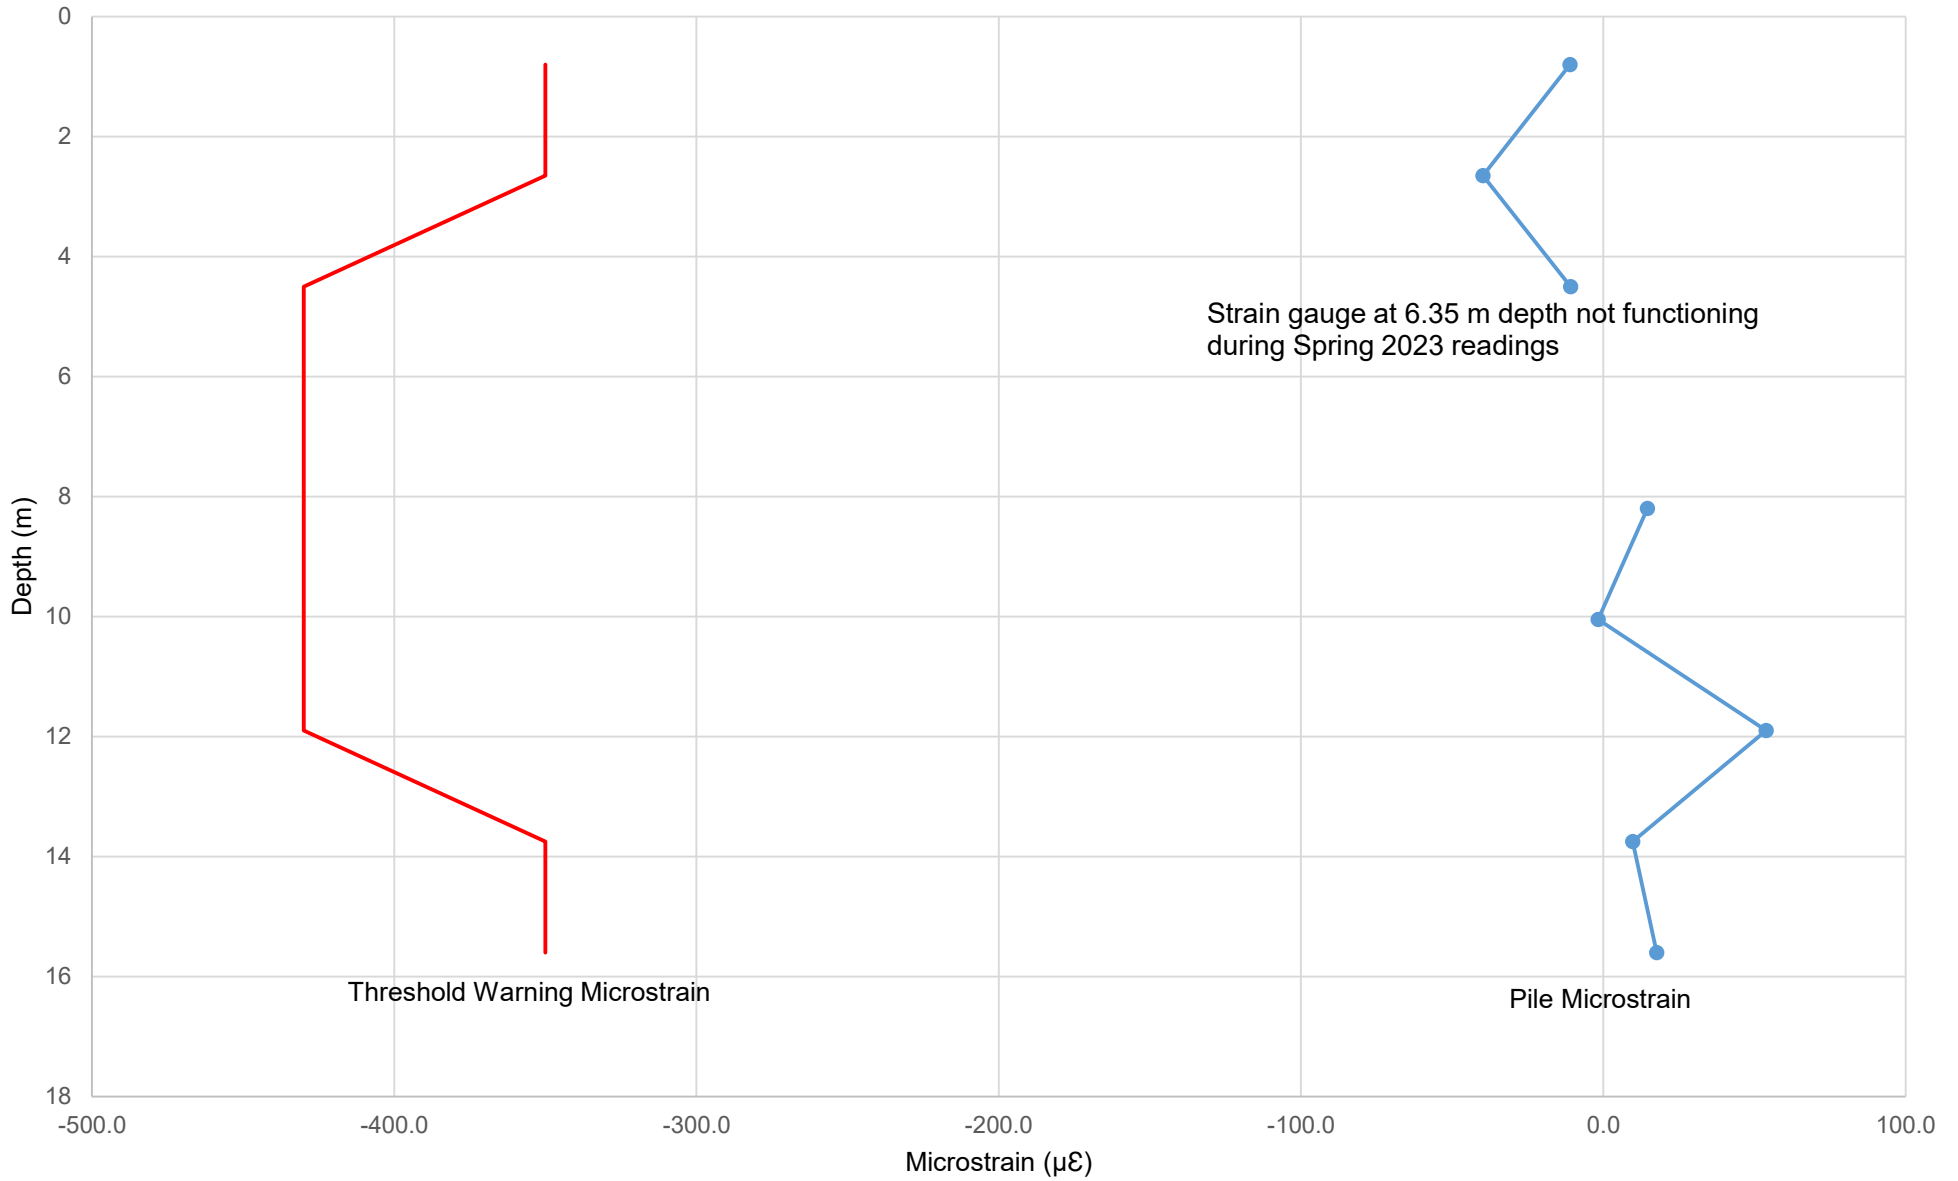
**FIGURE NC104-1**  
**STRAIN GAUGE DATA FOR HWY 41:23, KEHIWIN LAKE (KM 7.7) - PILE P146 UPSLOPE**

The strain gauges installed at 6.55 m below the top of the pile on both the upslope and downslope pile faces were not functioning during the readings, and the strain gauge installed at 0.8 m on the upslope pile face was functioning intermittently. The reading on June 5, 2024 was used for the strain gauge installed at 0.8 m on the upslope pile face. Overall, the strain gauges showed relatively small changes in micro-strain since the previous readings in the spring of 2023 except for the 0.8 m depth upslope strain gauge which showed an increase in total microstrain of 45.0  $\mu\epsilon$  since the spring of 2023 readings. This may be due to it not functioning correctly.
