**ALBERTA TRANSPORTATION AND  
ECONOMIC CORRIDORS GRMP  
NORTH CENTRAL (ATHABASCA AND FORT  
McMURRAY DISTRICTS)  
INSTRUMENTATION MONITORING- SPRING 2024**

Site Number	Location	Name	Hwy	km
NC104 (NC024-4)	HWY 41:23 C1 7.66	Kehiwin Lake	41:23	Km 7.7
<b>Legal Description:</b> 9-25-58-7 W4		<b>UTM Co-ordinates</b>		
		12U E 506556	N	5988265

<b>Current Monitoring:</b>	6-June-2024	<b>Previous Monitoring</b>	25-May-2023
<b>Instruments Read By:</b>	Mr. Niraj Regmi, G.I.T and Mr. Nixson Mationg, of Thurber

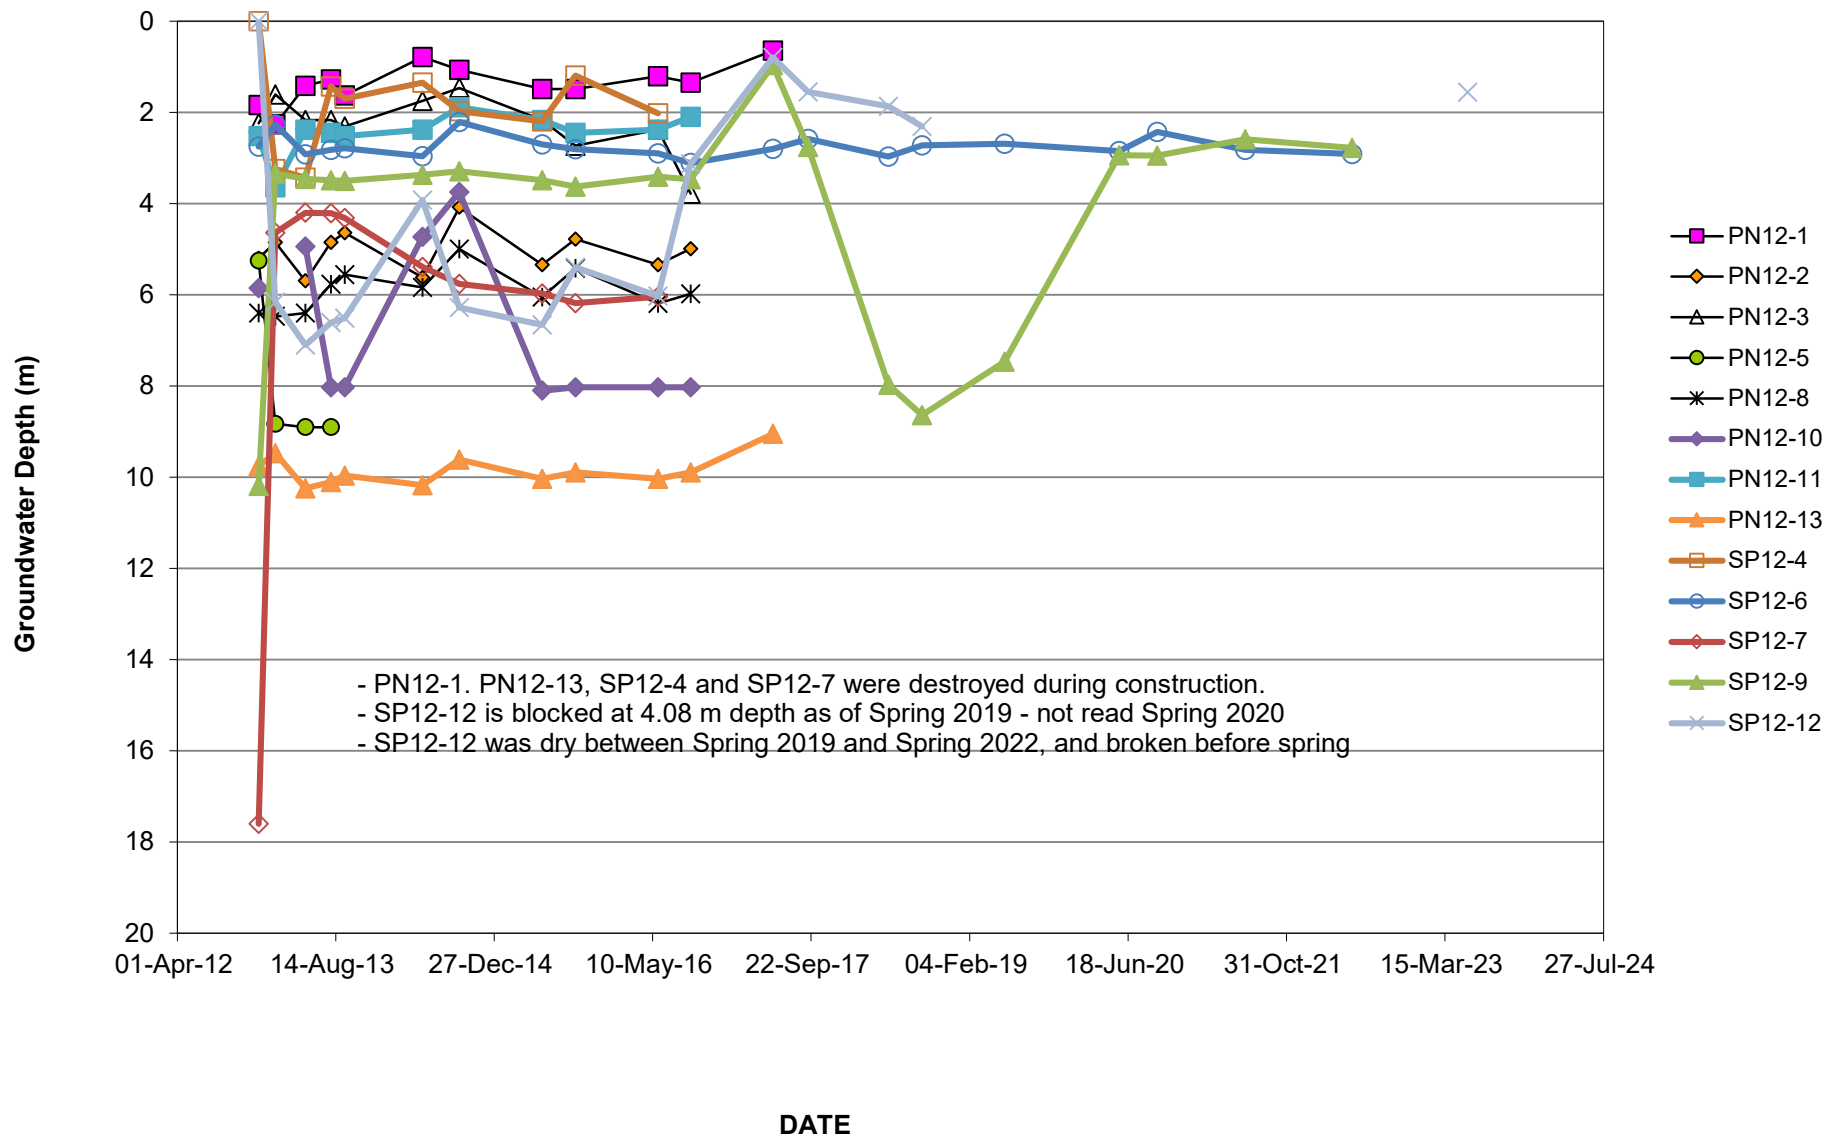
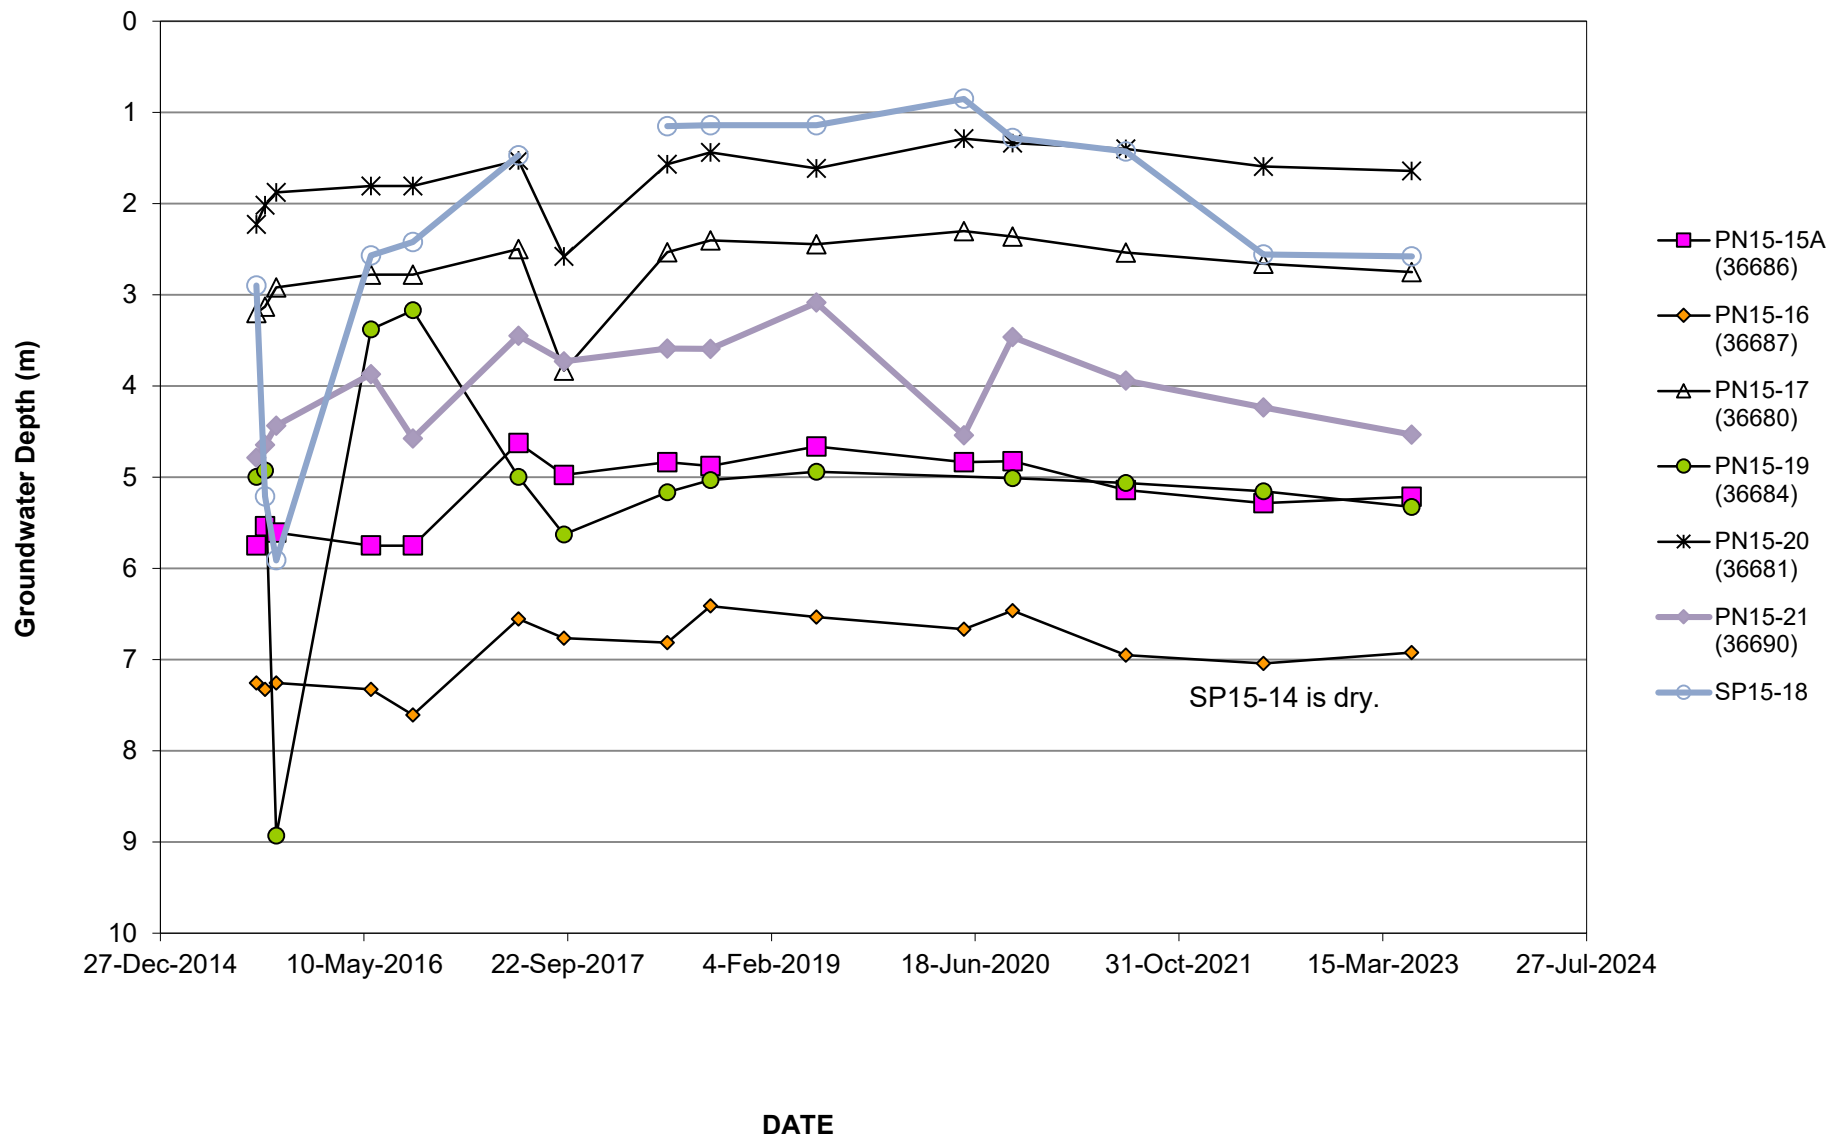
**FIGURE NC104-3  
PIEZOMETER DATA FOR HWY 41:23, KEHIWIN LAKE (KM 7.7)**

All of the pneumatic piezometers showed decreases in groundwater level ranging from 0.17 m in PN15-21 to 0.37 m in PN15-16 since the spring of 2023 readings.

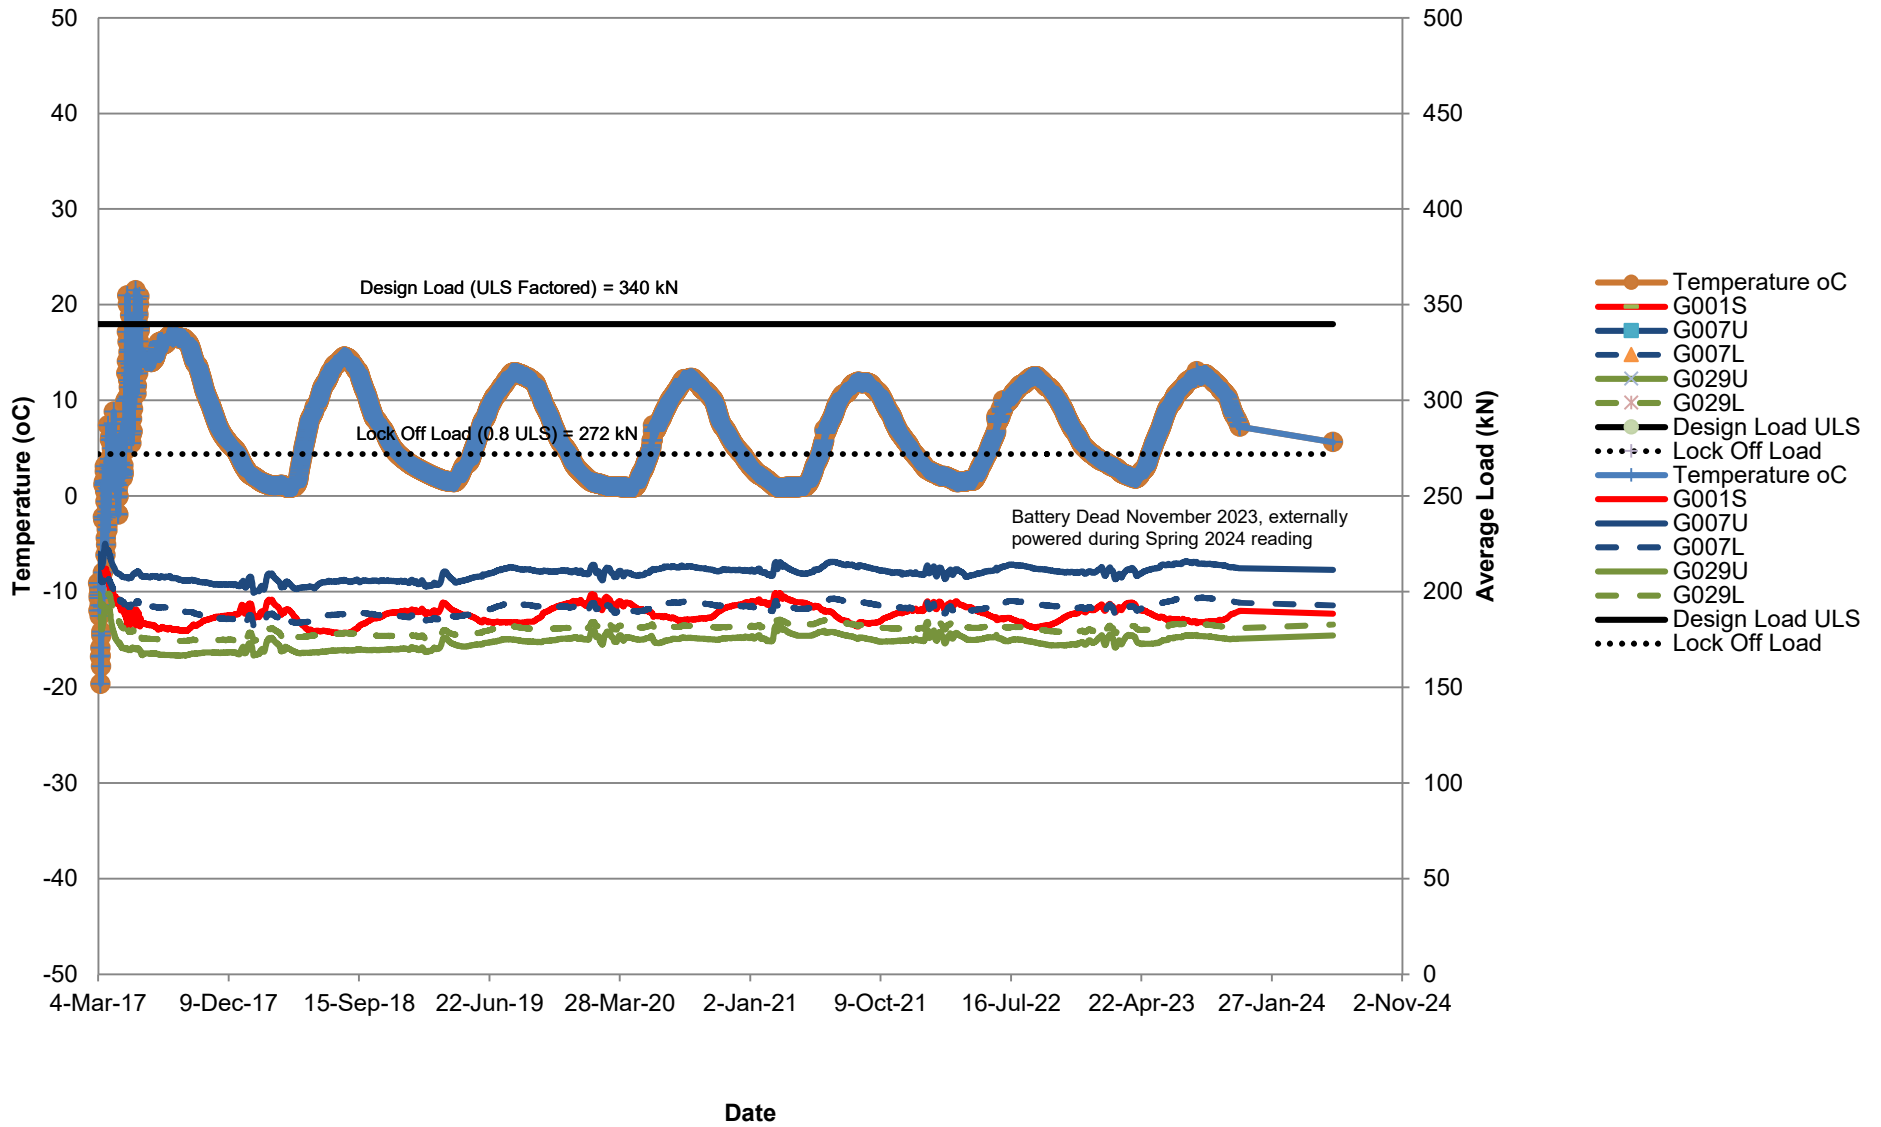
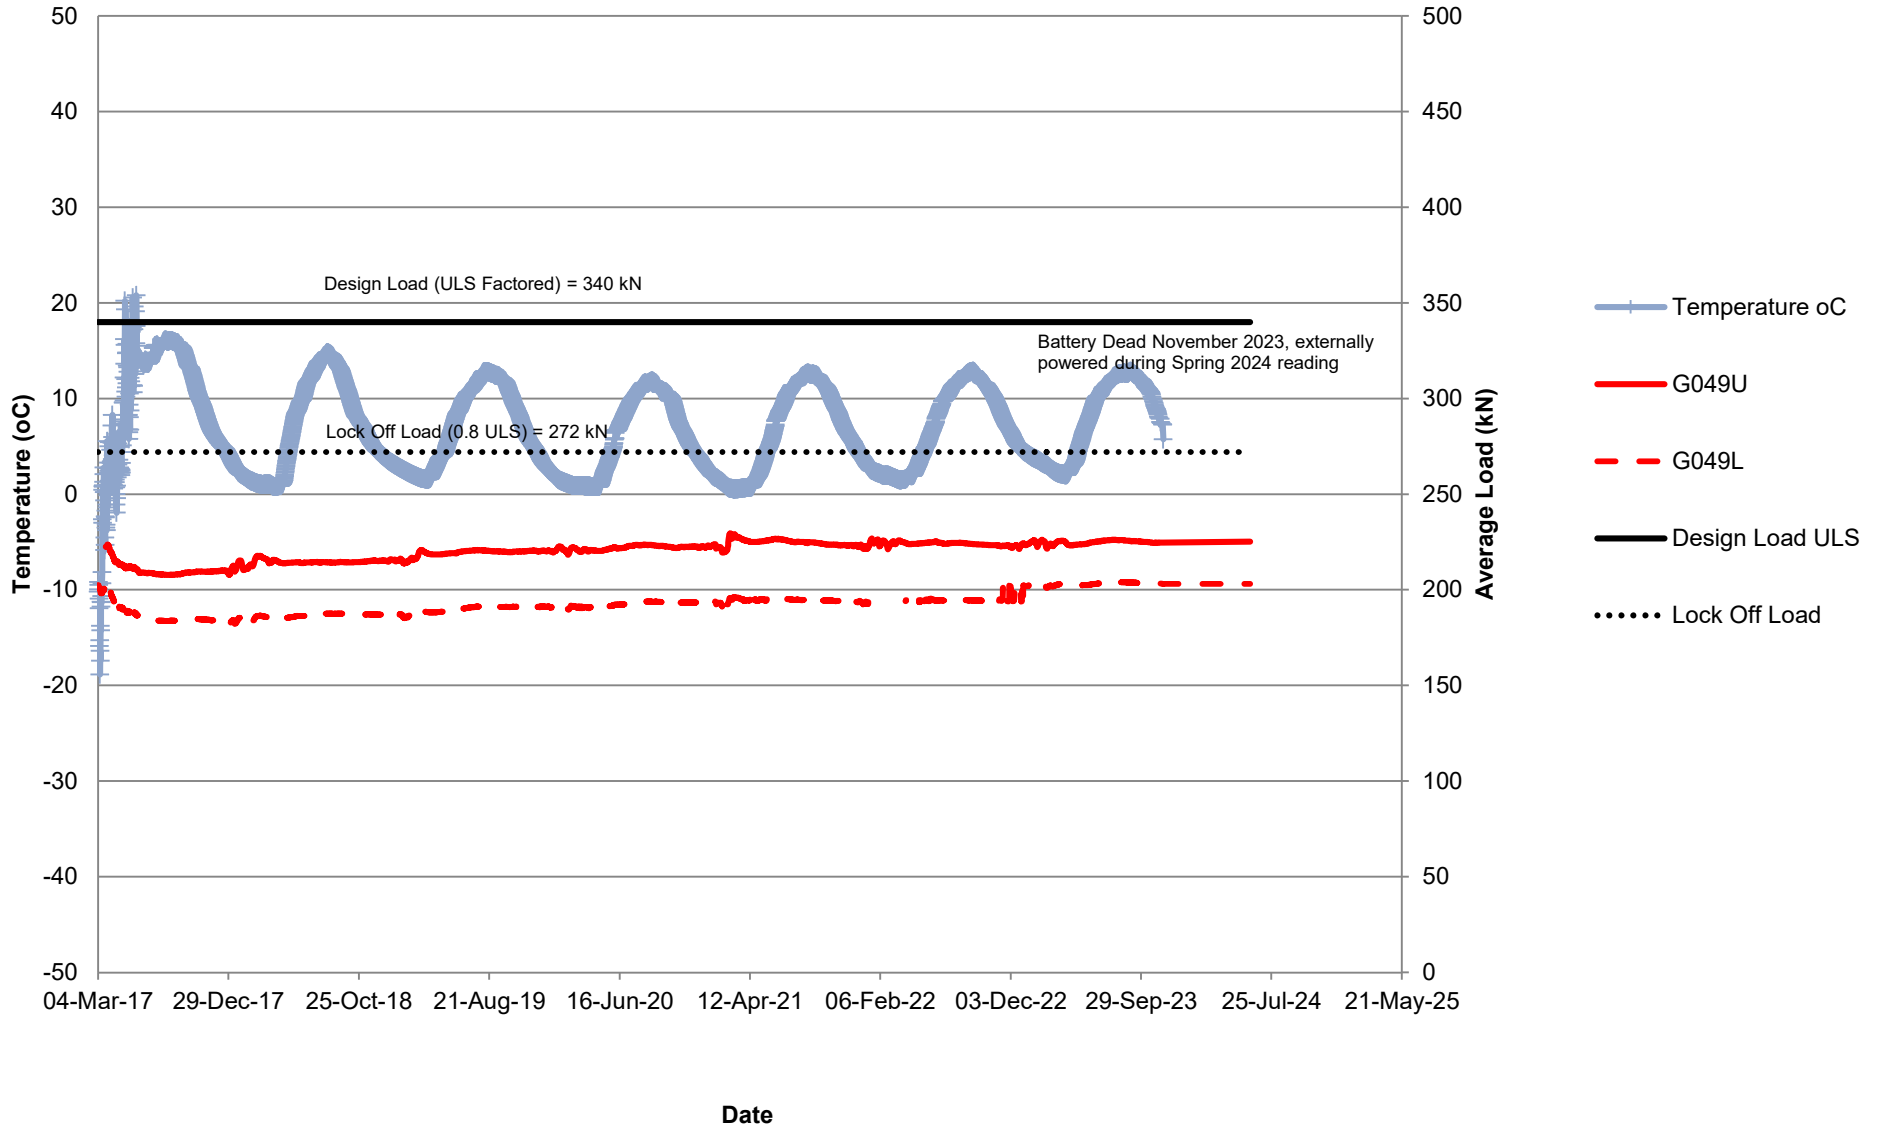
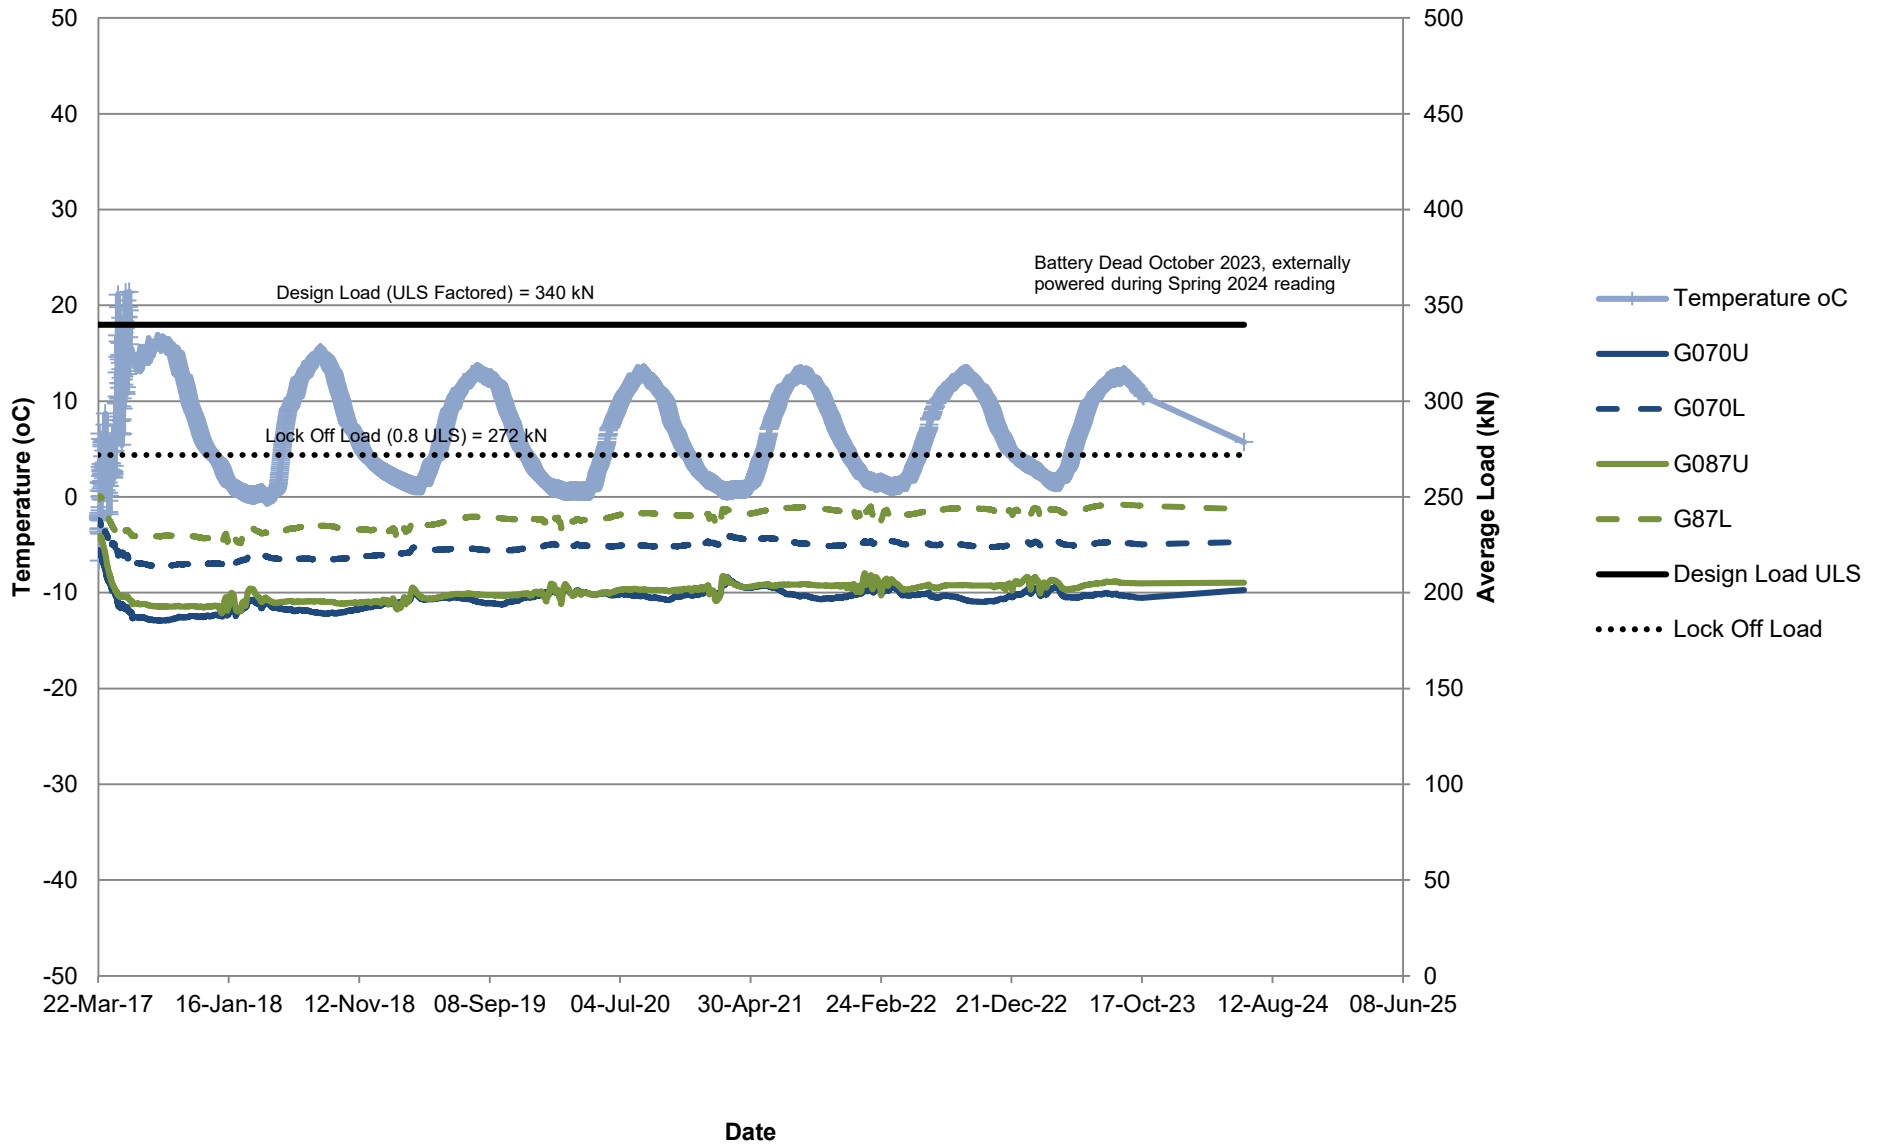
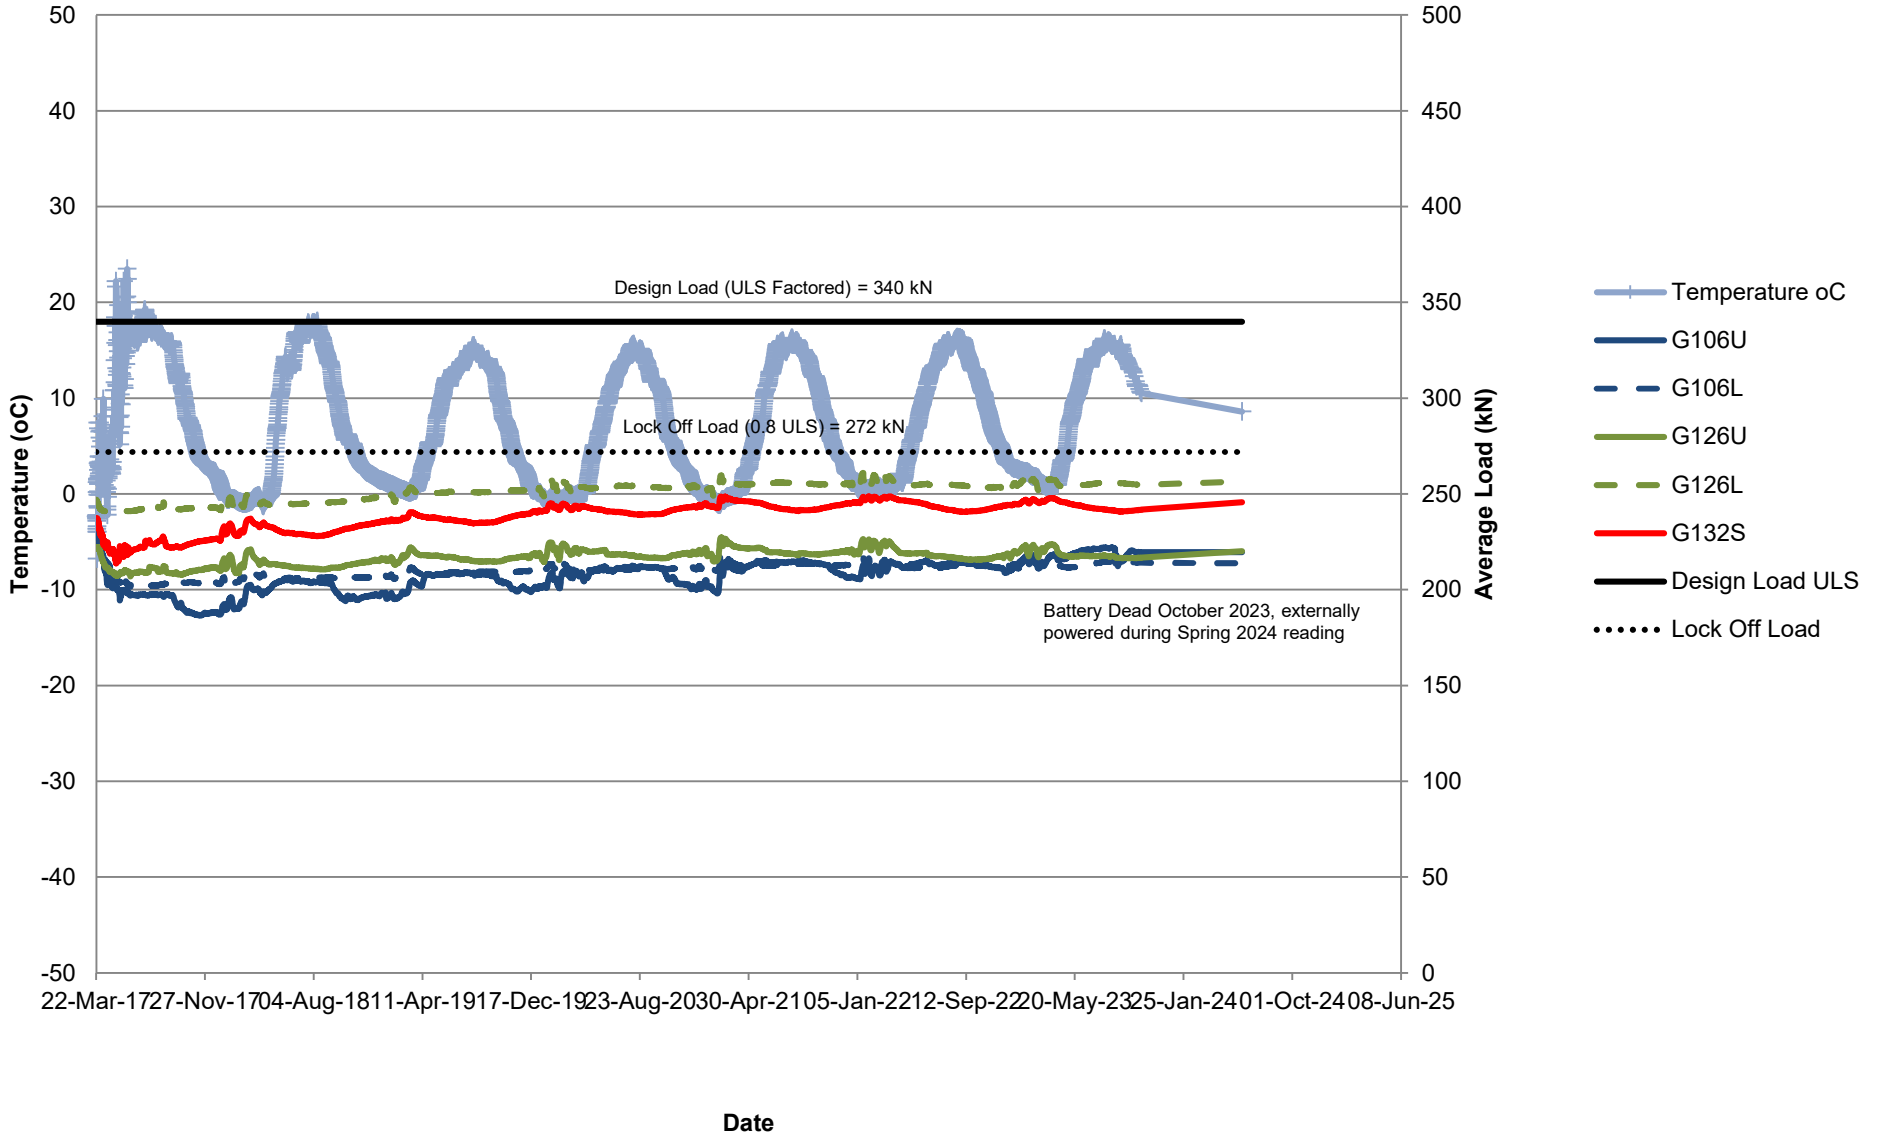
**FIGURE NC104-5**  
**LOAD CELL DATA FOR HWY 41:23, KEHIWIN LAKE (KM 7.7) - WALL SEGMENT 1**

<p>The battery in the north load cell data logger died on November 20, 2023, and the battery in the south load cell datalogger died on October 20, 2023. Both dataloggers recorded a reading while powered up for downloading. Hence, the most recent data from the dataloggers was taken on June 6, 2024.</p> <p>The Load cells showed relatively small changes in measured load since the spring of 2023 readings. The change in load ranged from a decrease in measured load by 0.89 kN in VC1982 to an increase in measured load by 3.95 kN in VC1993.</p> <p>Load cells VC1996 and VC1985 currently have only two vibrating wire channels properly functioning, and hence the readings for these instruments are somewhat skewed when compared to the previous readings.</p> <p>Overall, the load cells are currently registering a trend of stable to slowly increasing measured loads, with seasonably higher loads measured during the winter months.</p> <p>Overall, the instrument readings show that the pile walls constructed in 2016-2017 have been effective in stabilizing the failed approach fill slope.</p>

<b>Future Work:</b>	All instruments should be read again in the spring of 2025.
<b>Instrumentation Repairs:</b>	<p>The batteries in the load cell dataloggers should be replaced to enable readings to continue after the fall of 2024.</p> <p>Standpipe piezometer SP12-12 will require mechanical excavation to repair. This repair would not be economical, and therefore it is recommended to remove this instrument from the monitoring program.</p>
<b>Additional Comments:</b>
