August 20, 2021

**ALBERTA TRANSPORTATION GRMP (CON0022163)
NORTH CENTRAL (ATHABASCA AND FORT McMURRAY DISTRICTS)
INSTRUMENTATION MONITORING RESULTS – SPRING 2021**

SITE NC069: HWY 63:02 SLOPE REPAIR SOUTH OF WANDERING RIVER

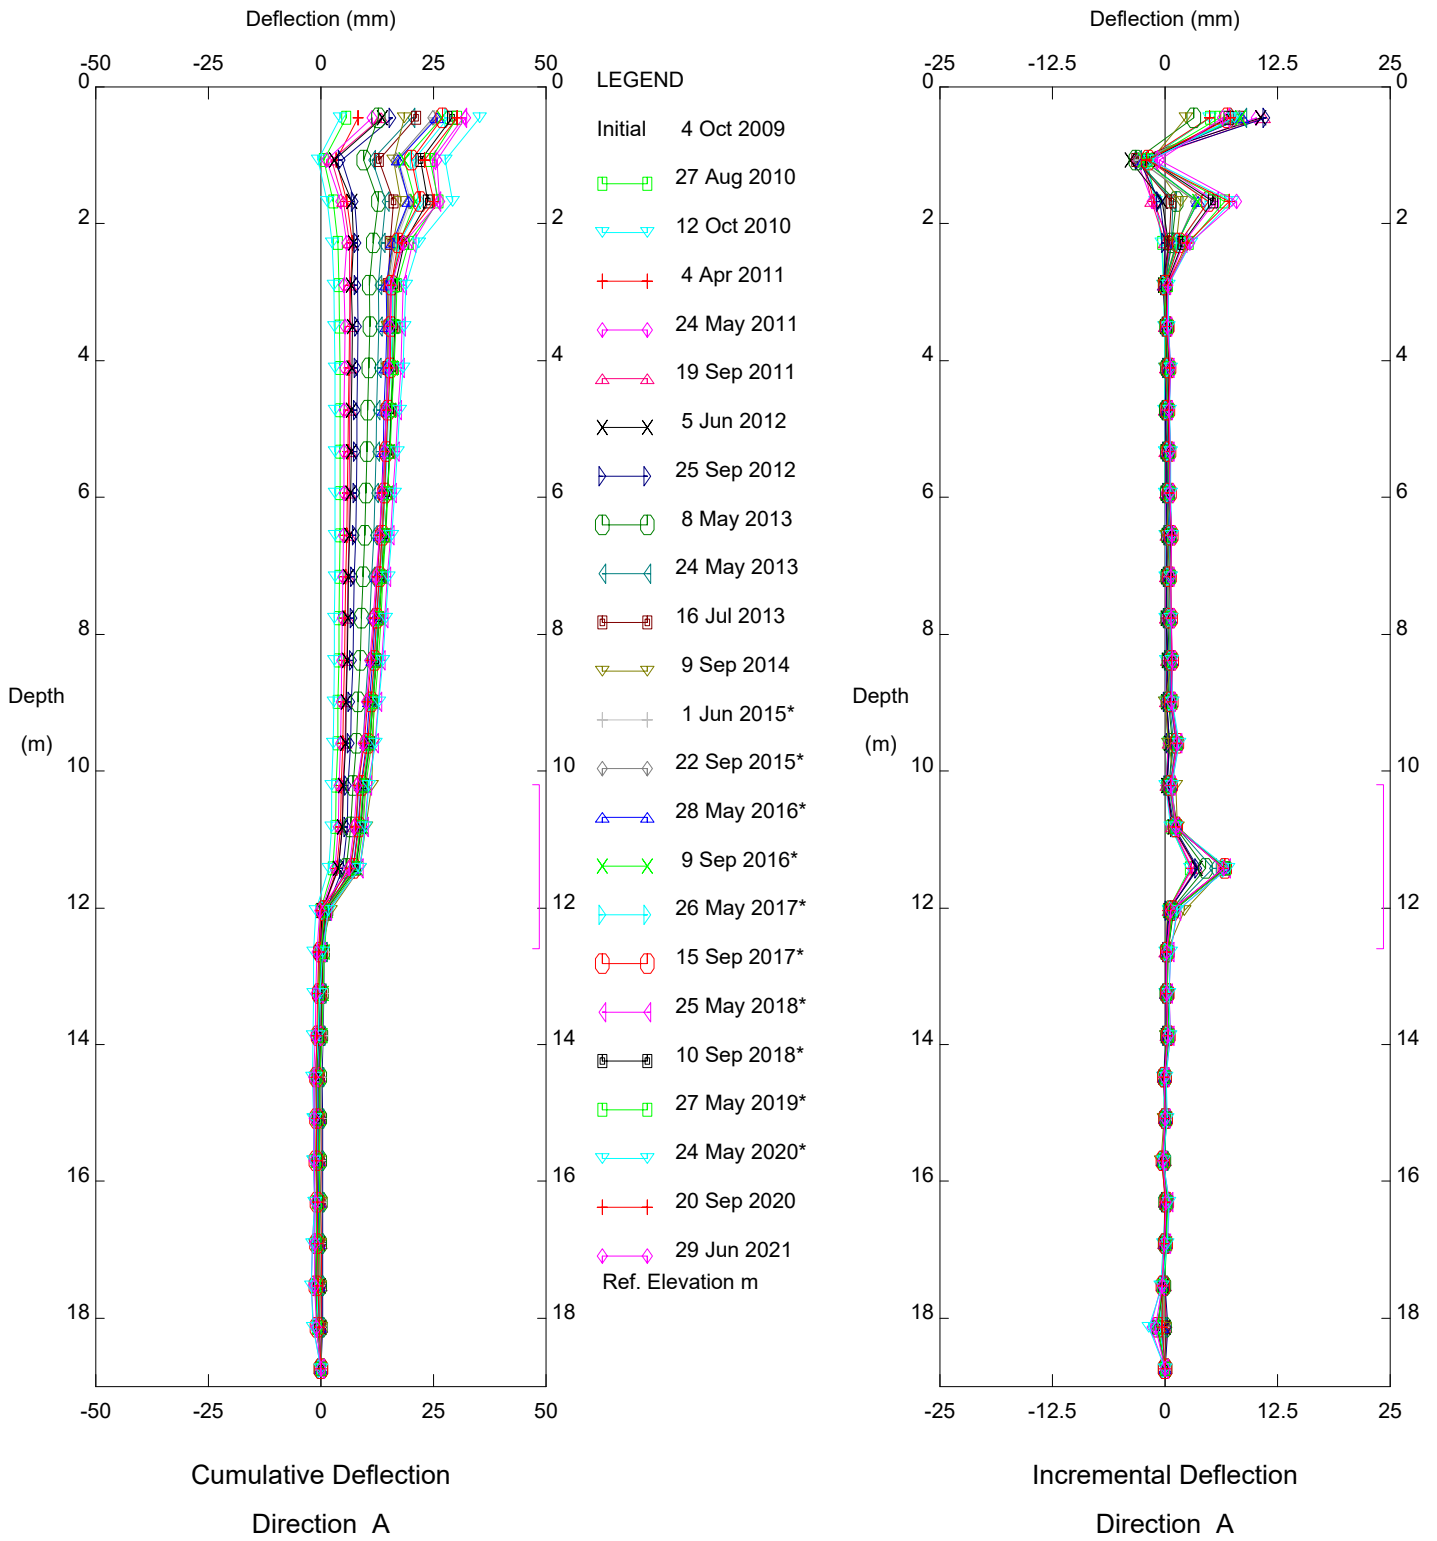
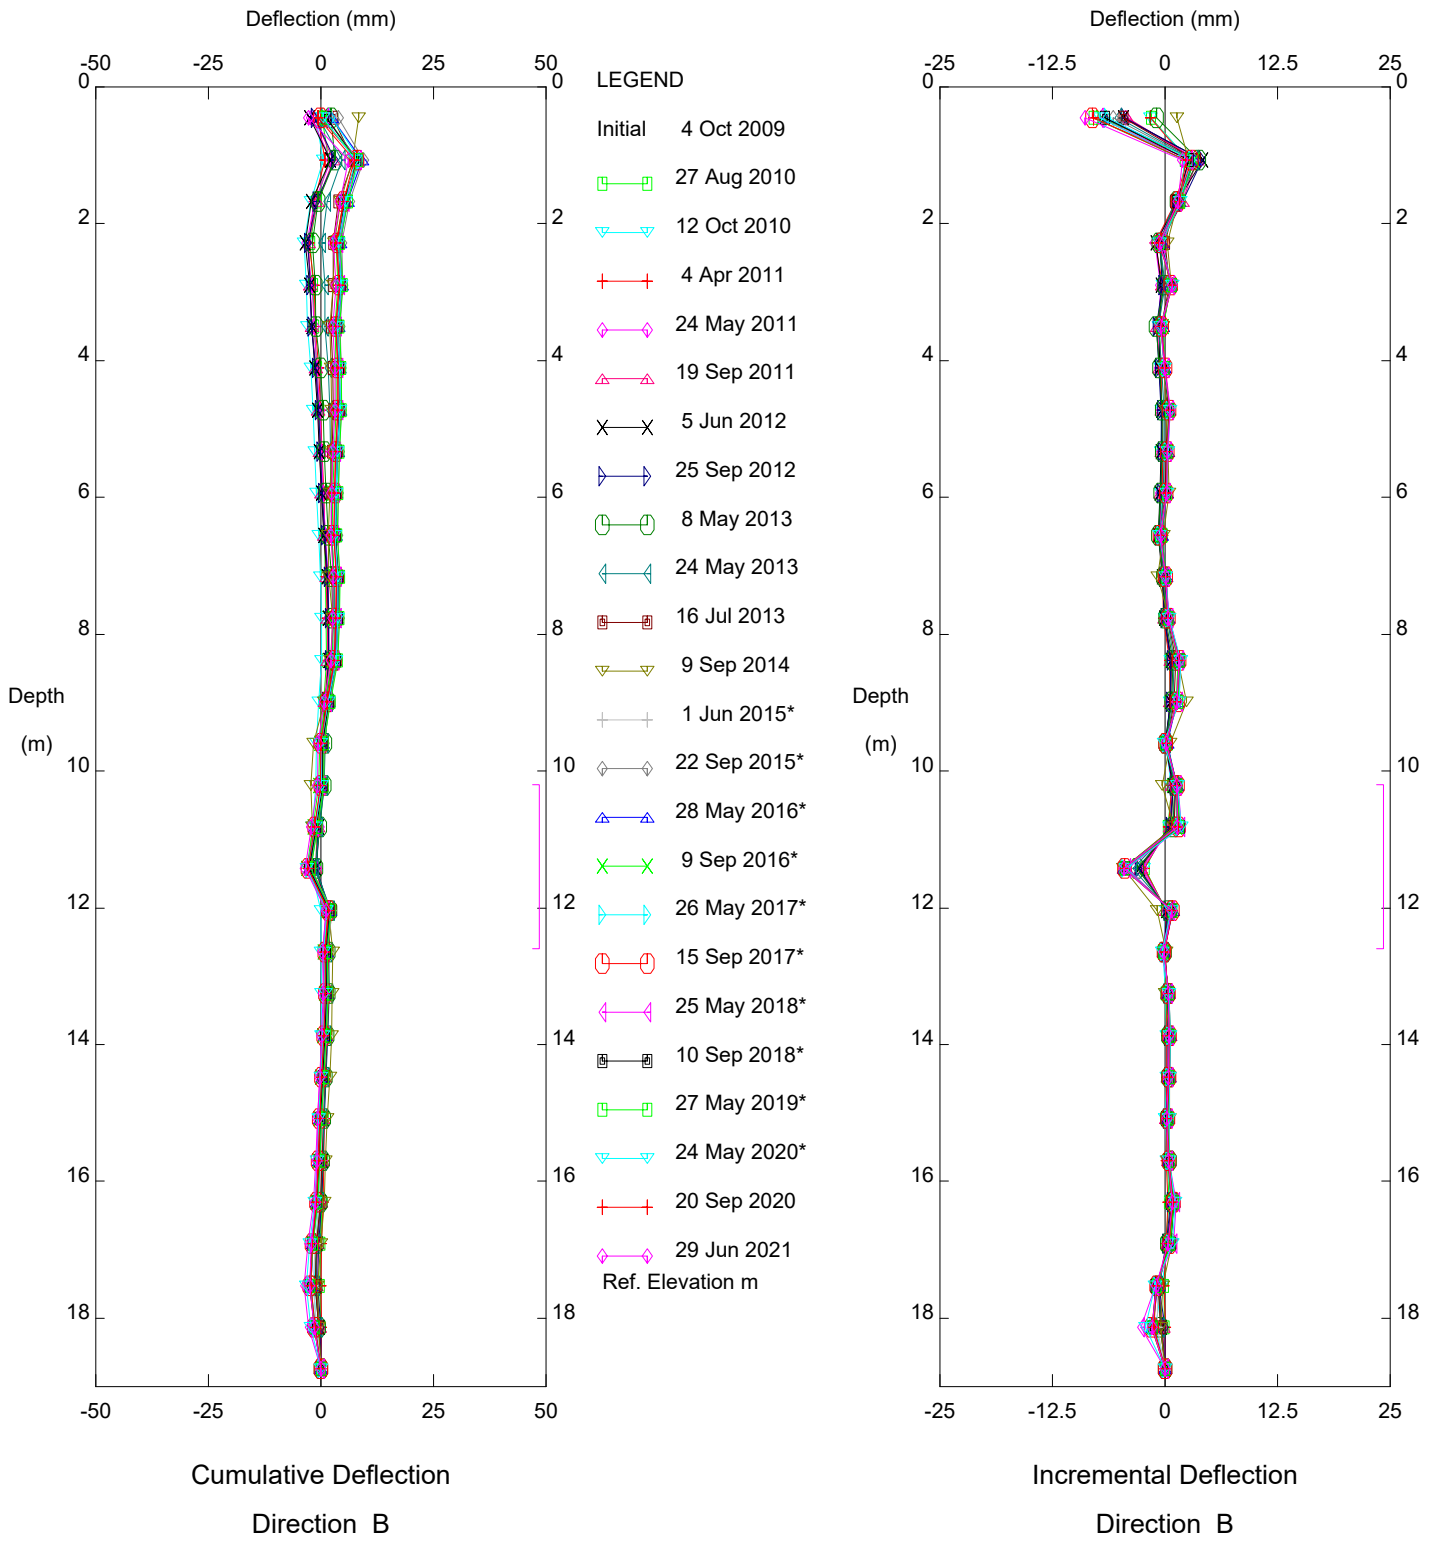
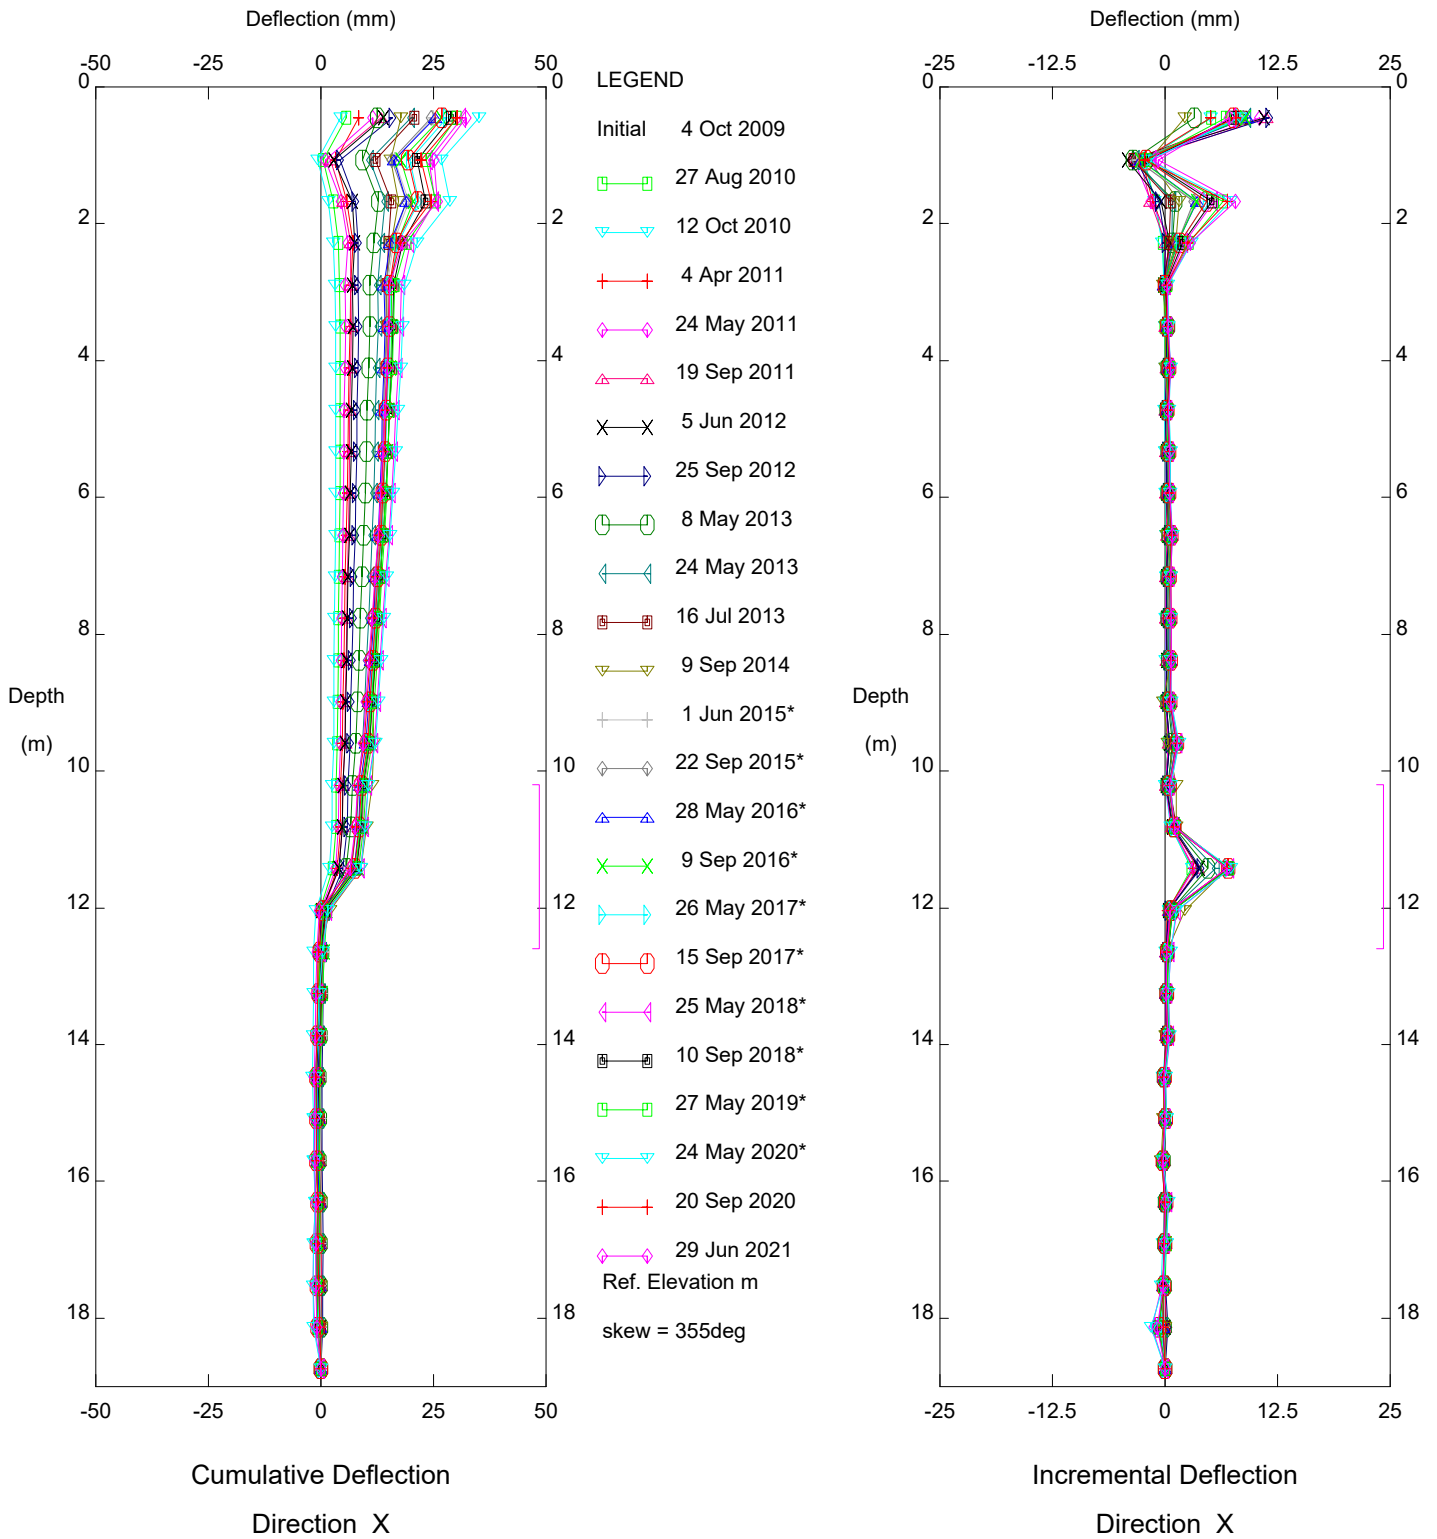
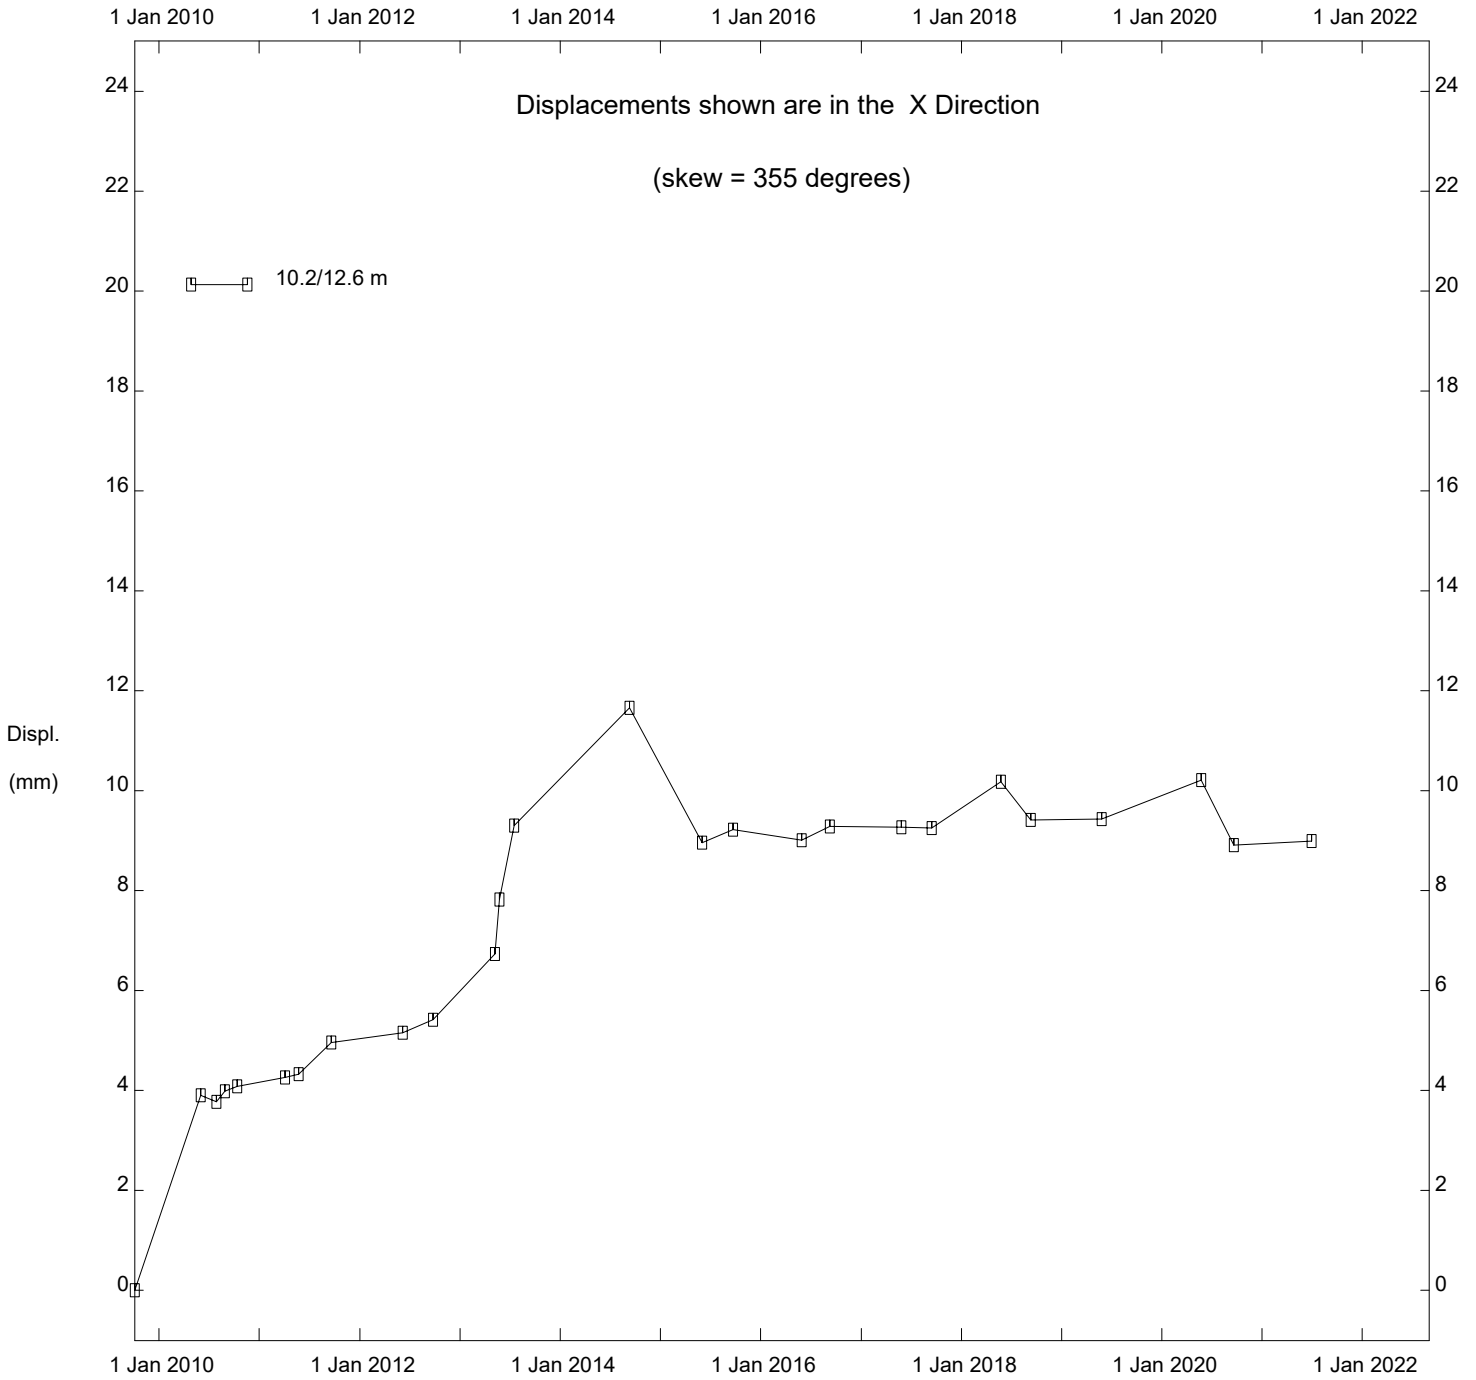
HWY 63:02 South of Wandering River, Inclinometer SI09-1

Slope inclinometer SI09-1, installed near the southern limit of the east landslide on the highway surface, showed a rate of movement of 0.1 mm/yr over 10.2 m to 12.6 m depth since the fall of 2020 readings. SI09-4, installed in the vicinity of the crest of the west landslide area, showed a rate of movement of 0.5 mm/yr over 10.3 m to 12.1 m depth since the fall of 2020 readings. SI10-1, installed near the northern limit of the east landslide on the highway surface, showed a rate of movement of 0.3 mm/yr over 3.3 m to 6.4 m depth since the fall of 2020 readings. SI13-14, installed within the footprint of the toe berm constructed in 2013 to stabilize the west landslide area, showed a rate of movement of 0.3 mm/yr over 7.5 m to 10.5 m depth since the fall of 2020 readings. Overall, the SIs have shown creep rates of movement over their respective movement zones over the past several years.

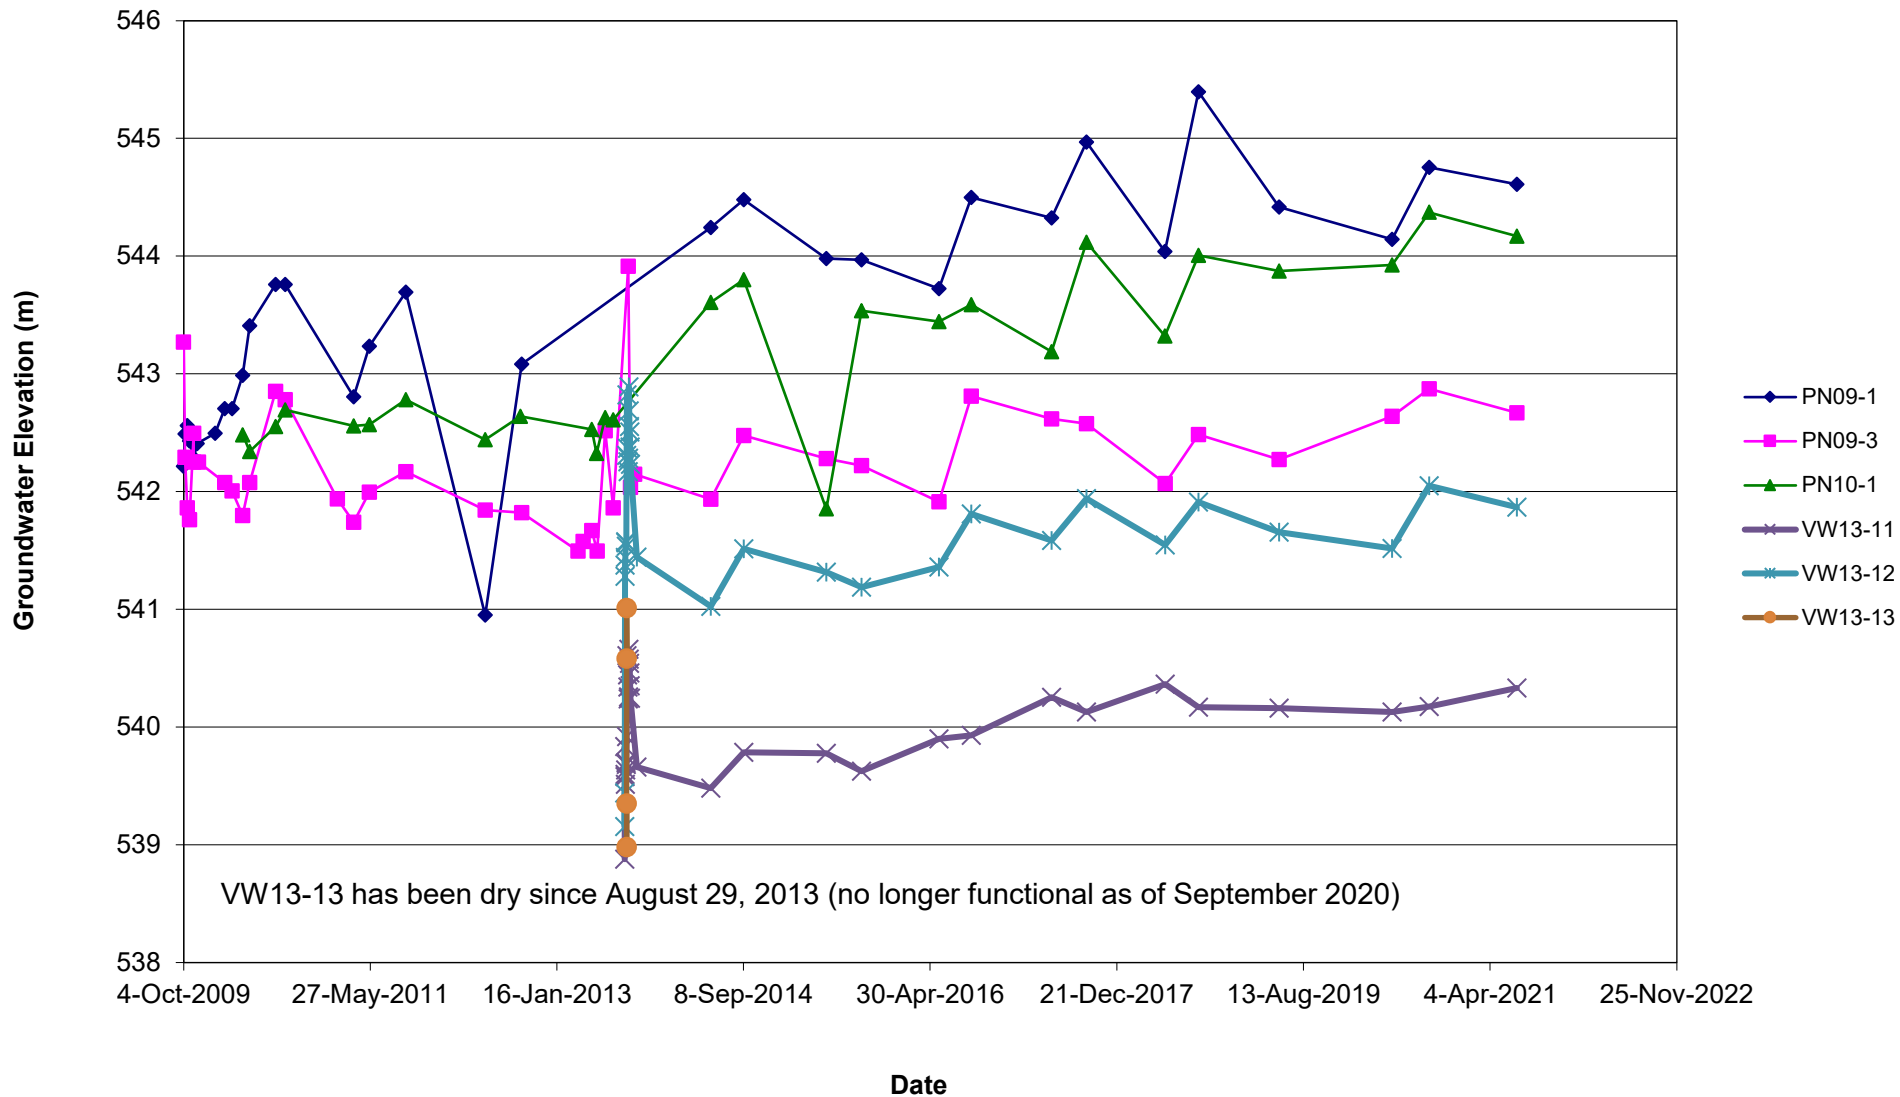
**FIGURE NC069-1
PIEZOMETRIC ELEVATIONS FOR HWY 63:02 SLOPE REPAIR**

The groundwater level decreased in PN09-1, PN09-3 and PN10-1 by 0.14 m, 0.20 m and 0.20 m, respectively, since the fall of 2020 readings. Table NC069-2 summarizes the pneumatic piezometer readings.

Vibrating wire piezometer VW13-11 showed an increase in groundwater level of 0.16 m since the fall of 2020 readings, while VW13-12 showed a decrease in groundwater level of 0.18 m over the same time period. Table NC069-3 summarizes the vibrating wire piezometer readings.
