**ALBERTA TRANSPORTATION
GEOHAZARD ASSESSMENT PROGRAM
NORTH CENTRAL REGION – ATHABASCA &
FORT MCMURRAY DISTRICTS
2022 INSPECTION**

Site Number	Location	Name	Hwy	km
NC 069-1	14 km south of Wandering River	S. of Wandering River- BF 76427	63:02	32
Legal Description		UTM Co-ordinates (NAD 83)		
SW-27-70-17-W4M		12 N 6105290	E 403588

**NORTH CENTRAL REGION
(ATHABASCA AND FORT MCMURRAY DISTRICTS)
2022 GEOHAZARD ASSESSMENT
NC069-1: HWY 63:02 (km 32) - BF76427
SITE PLAN SHOWING SITE FEATURES**

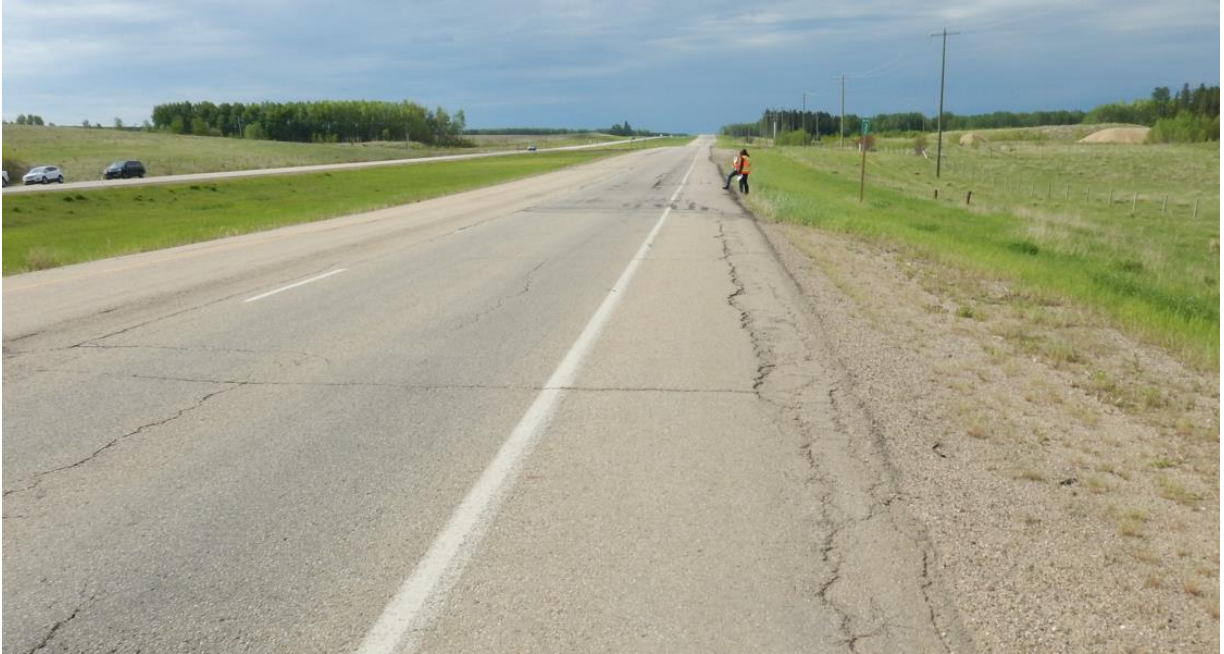
Photo No. 1 – General view of the highway SBLs condition (looking south); note presence of highway cracks (on former highway SBL) to the northern limit of the west landslide

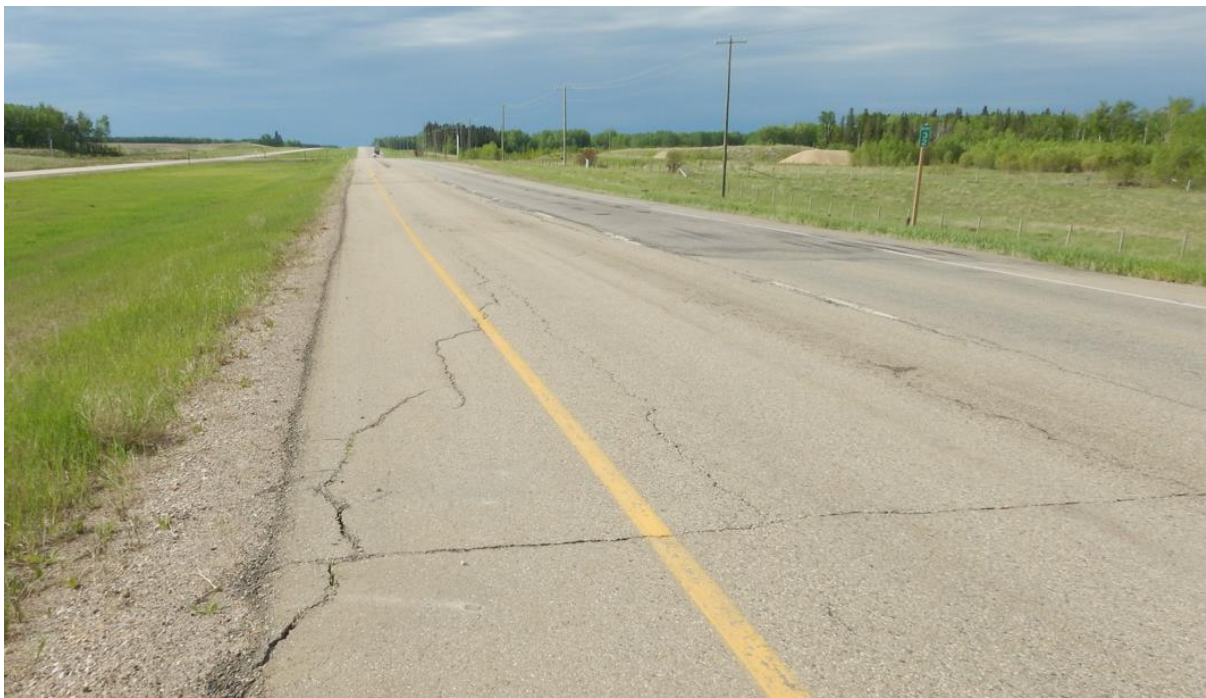
Photo No. 2 – Looking south at open diagonal and longitudinal cracks on the former highway NBL surface from the north limit of the east landslide

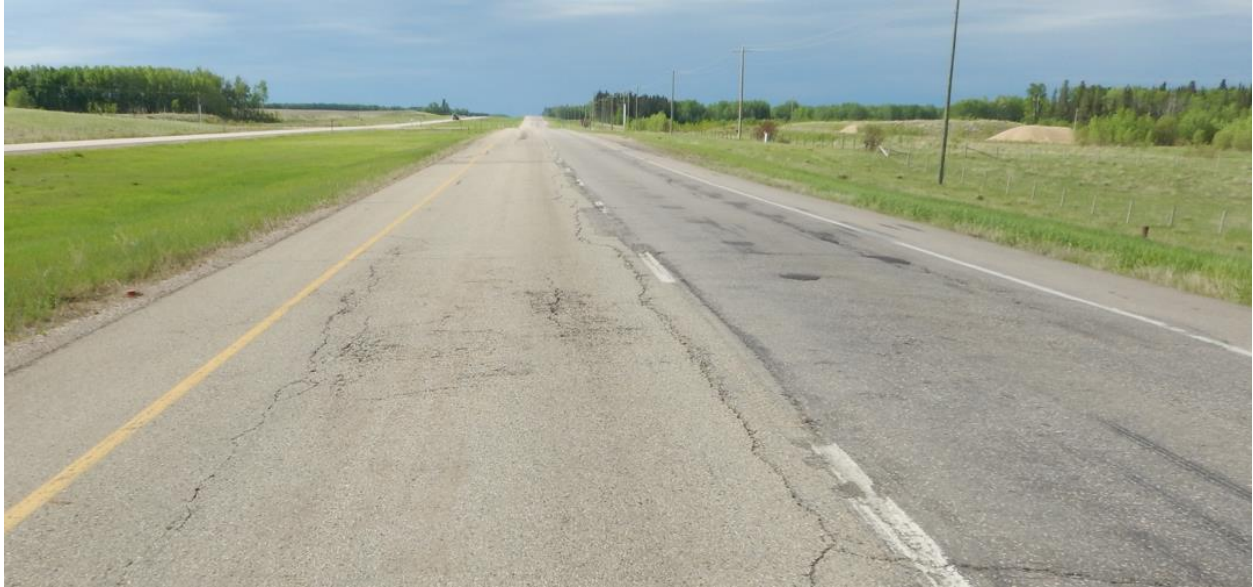
Photo No. 3 – Looking south at an open longitudinal reflective crack within the middle section of the east landslide; not the presence of a 40 to 50 mm elevation difference between the highway lanes (2015 patch created a lip between the lanes)

Consideration should be given to milling the 2015 ACP patch and placing a new patch on the highway SBLs. The new patch should provide a smooth ride to motorists and eliminate the safety hazard, associated with uneven pavement surfaces within the site.

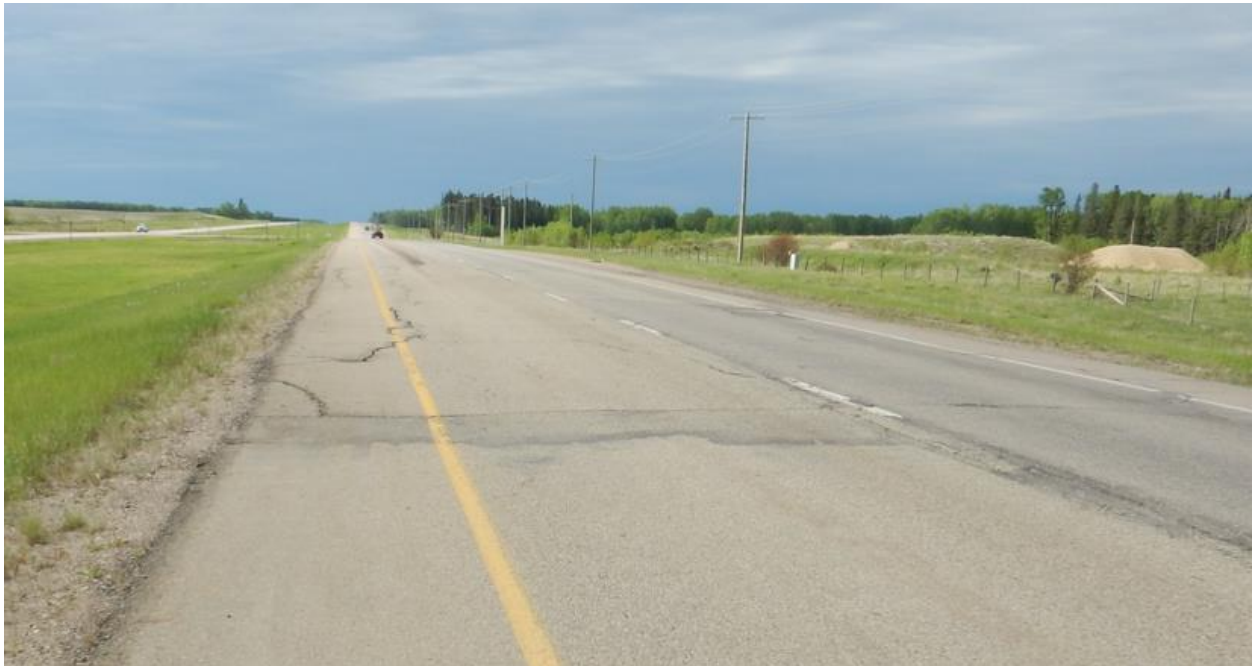
Photo No. 4 – Looking south from the southern limit of the east landslide at reflective diagonal crack on the existing patch

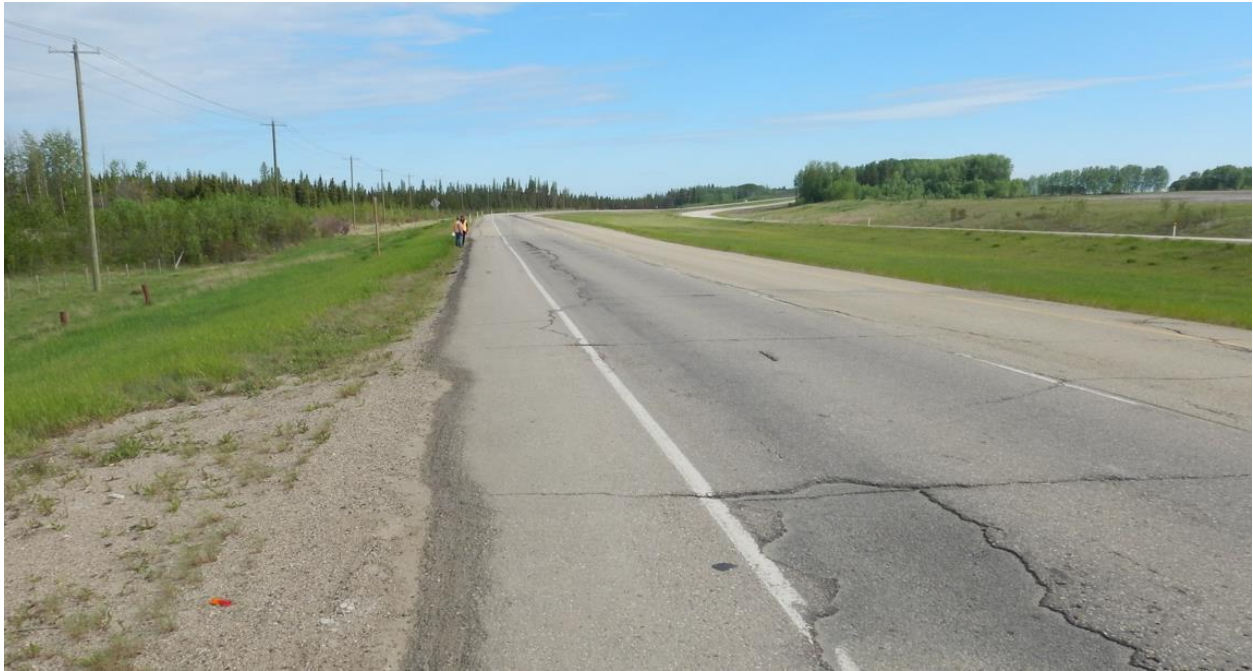
Photo No. 5 – East landslide (looking north from the northern limit of the landslide)

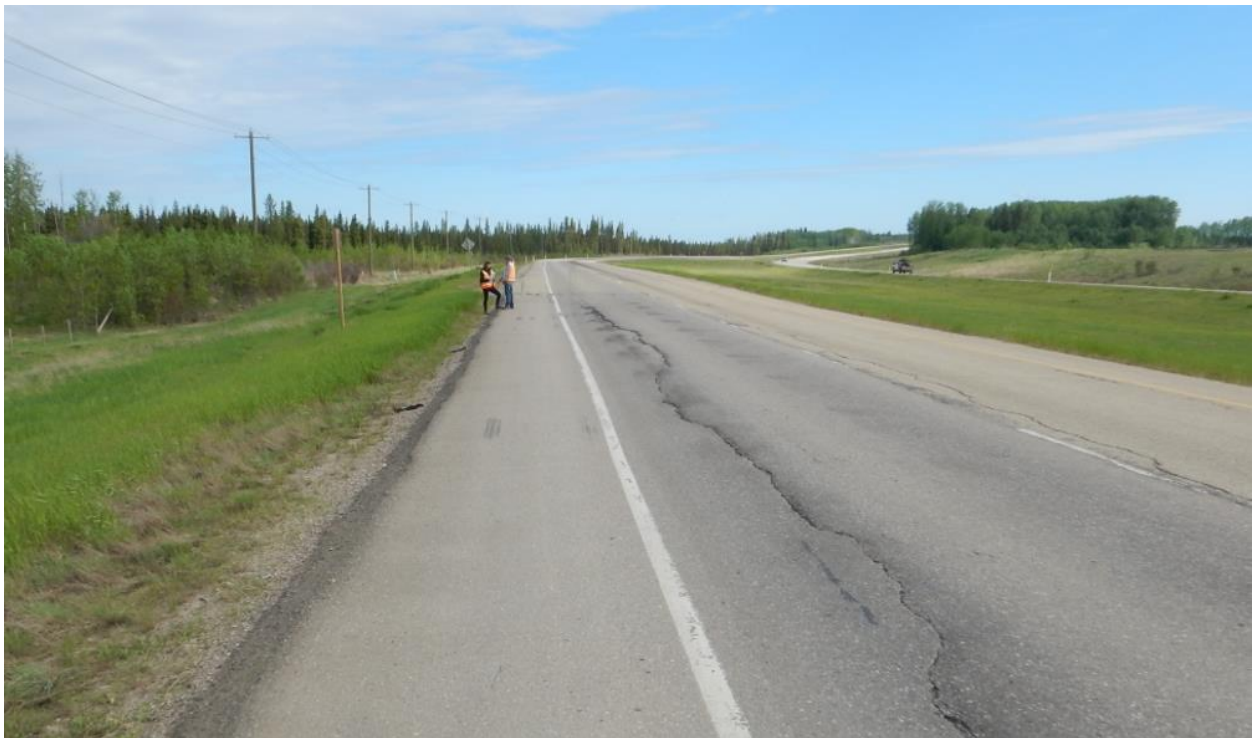
Photo No. 6 – Looking north at the east landslide reflective cracks on the highway surface

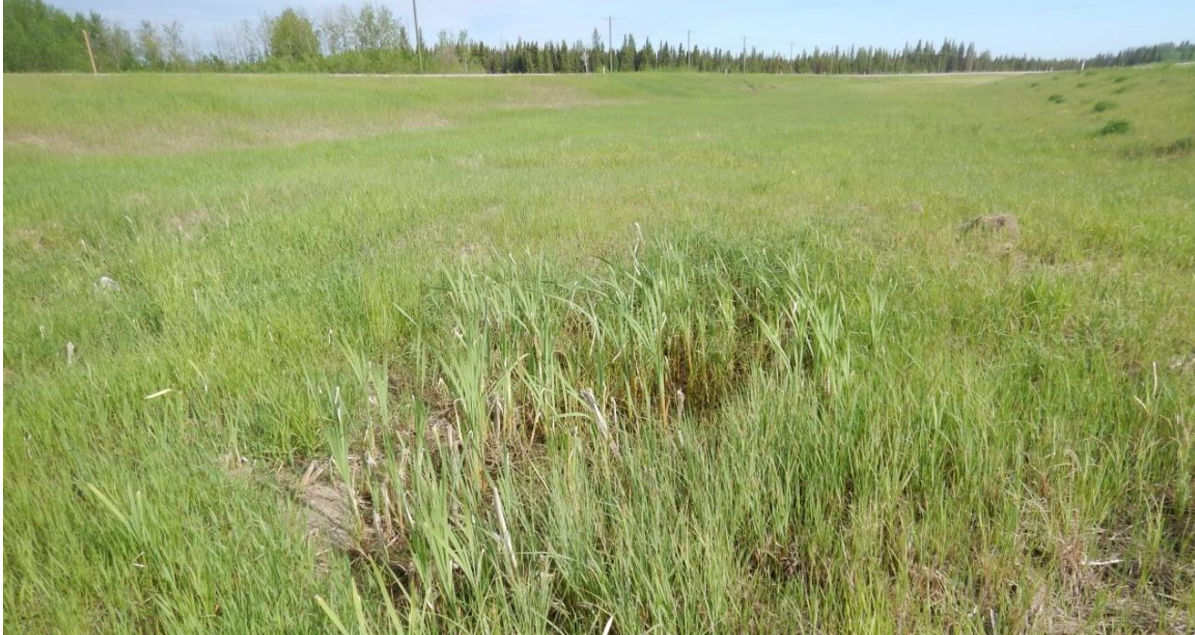
Photo No. 7 – Looking north at one of the sinkholes developed in the highway median

The sinkholes should be backfilled with compacted gravel or clay. Prior to backfilling the sinkholes, it is recommended that the bottom and the sides of the sink holes be cleaned of loose materials and debris.

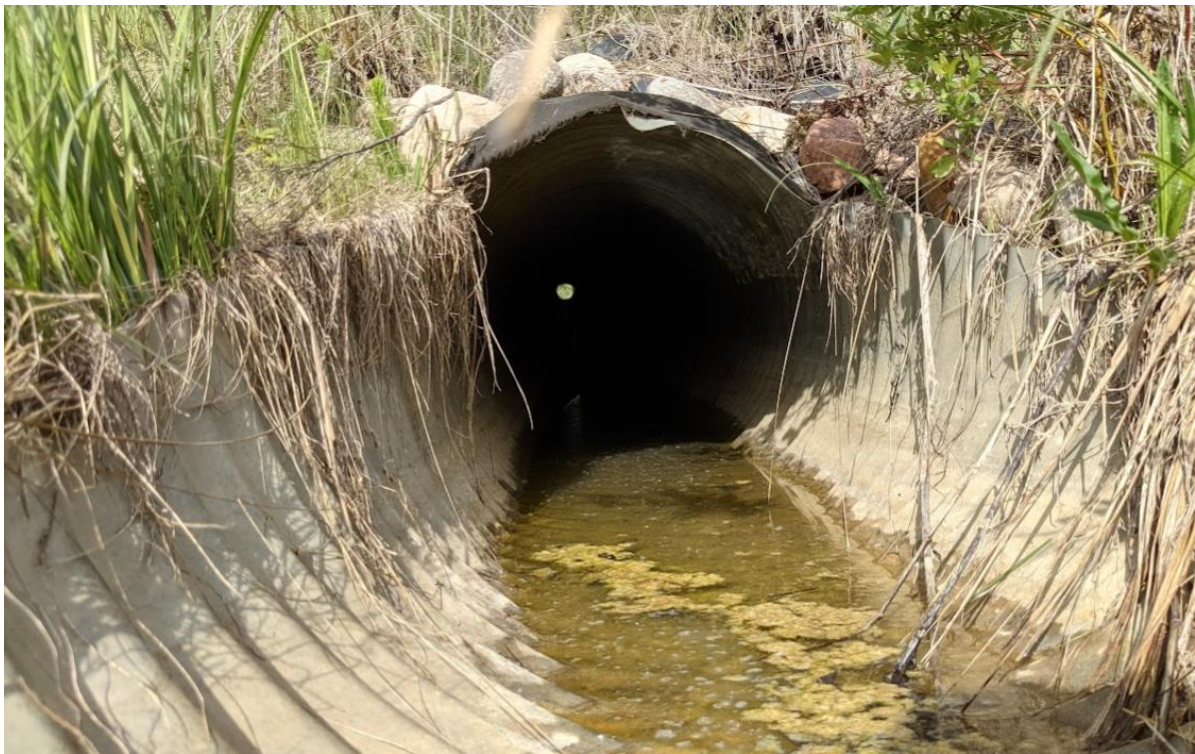
Photo No. 8 – Looking inside the outlet of the 600 mm diameter CSP culvert installed below the NBLs; water is ponding inside the pipe

A CCTV inspection should be undertaken for the existing 600 mm diameter culvert below the highway NBL. Based on the inspection results, it may be required to either replace or line the pipe to enhance surface drainage in the highway median.

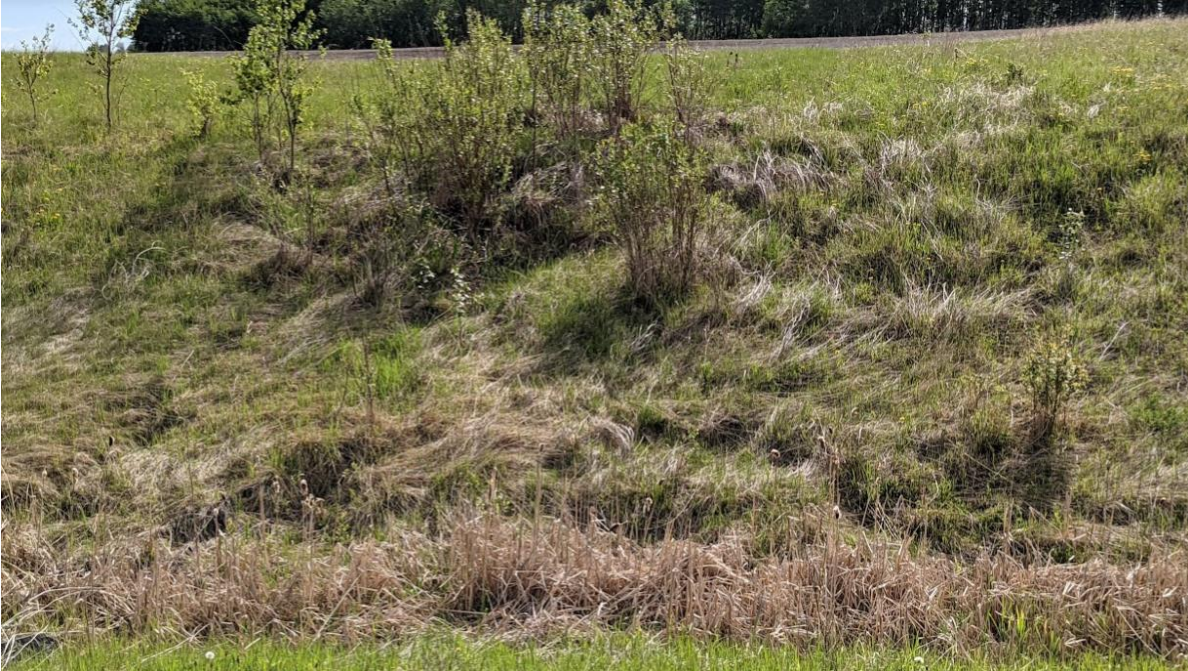
The highway east back slope slump is completely covered with vegetation and does not seem to be as active as observed in 2017.

Photo No. 9 – Looking northeast at the backslope slump area observed in 2017; vegetation has grown within the slump area

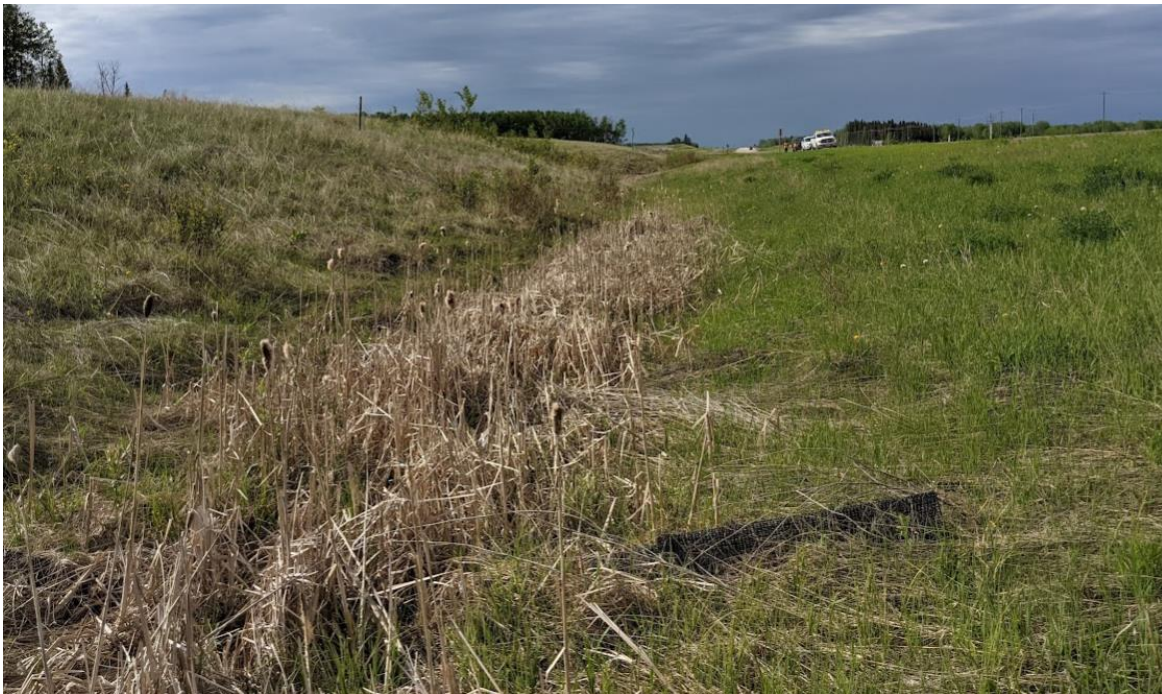
The ongoing erosion along south facing ditch to the east of the highway NBLs does not appear to be as active as observed in 2020 as vegetation continues to grow in this area.

Photo No. 10 – South facing channel; looking at synthetic ditch barrier; note vegetation has grown and erosion in this area is no longer visible

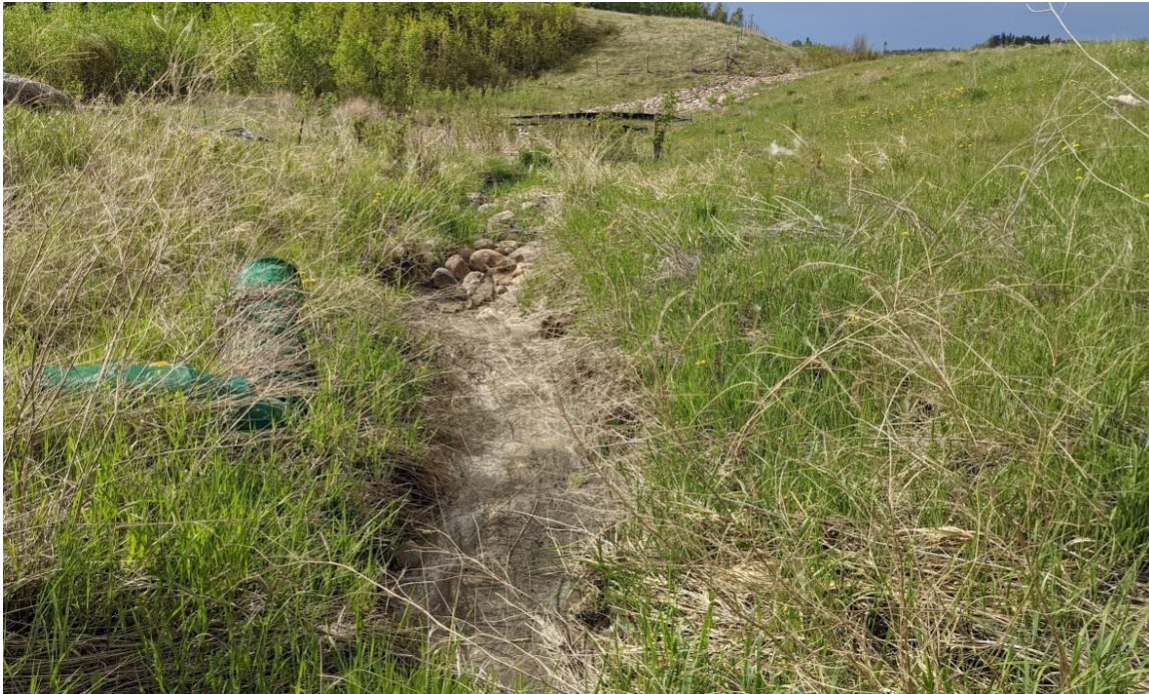
Photo No. 11 – Looking south at a gully approximately 900 mm wide x 400 mm deep; note vegetation is starting to cover the gully in this zone

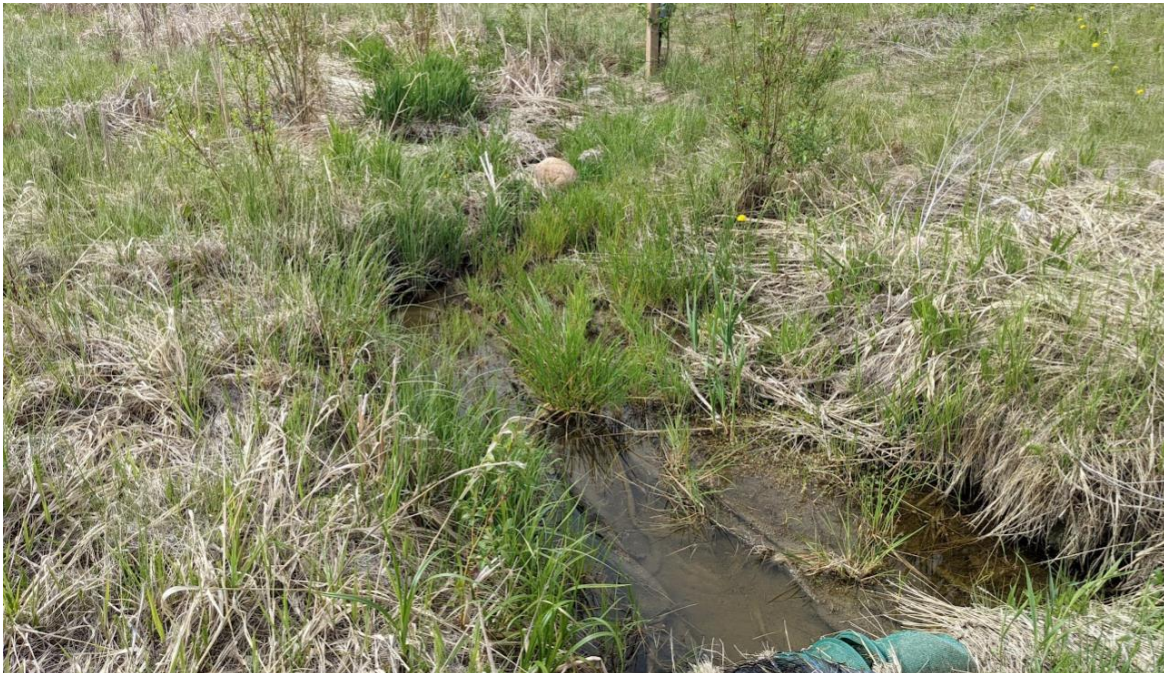
Photo No. 12 – South facing channel: erosion along the ditch (4 m long x 2 m wide x 0.6 m deep) has not significantly grown since 2020

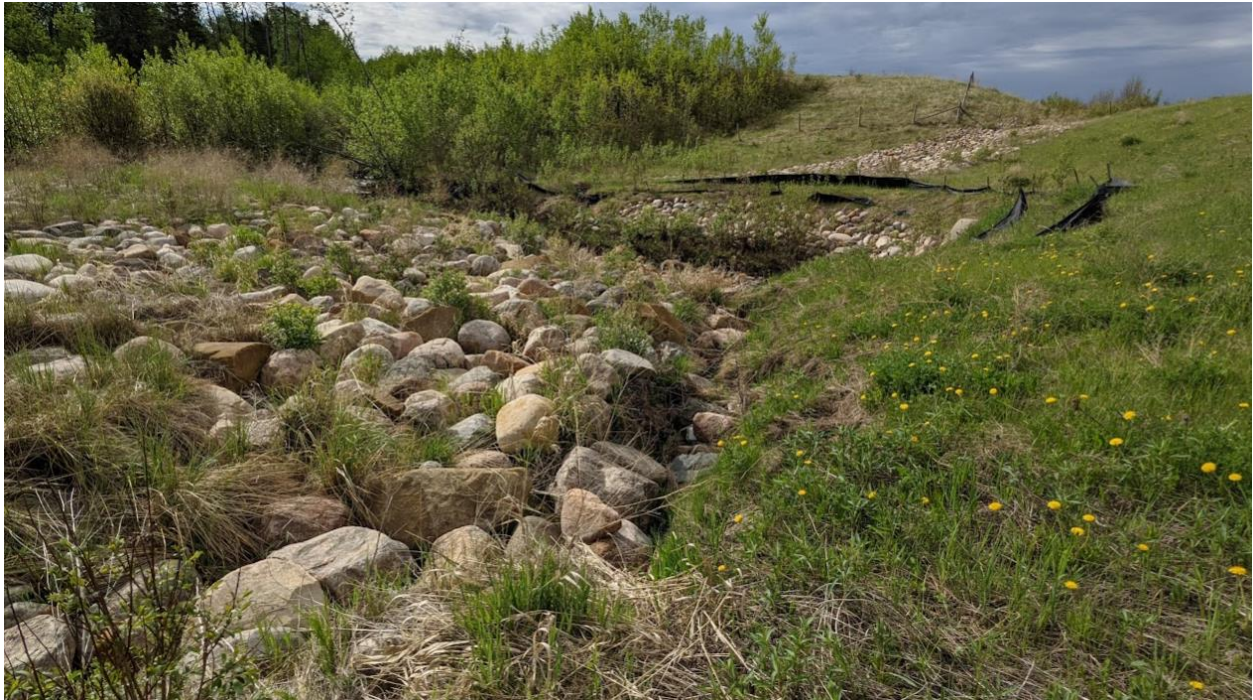
Photo No. 13 – Erosion gully developed on the west edge of the channel has been filled with riprap

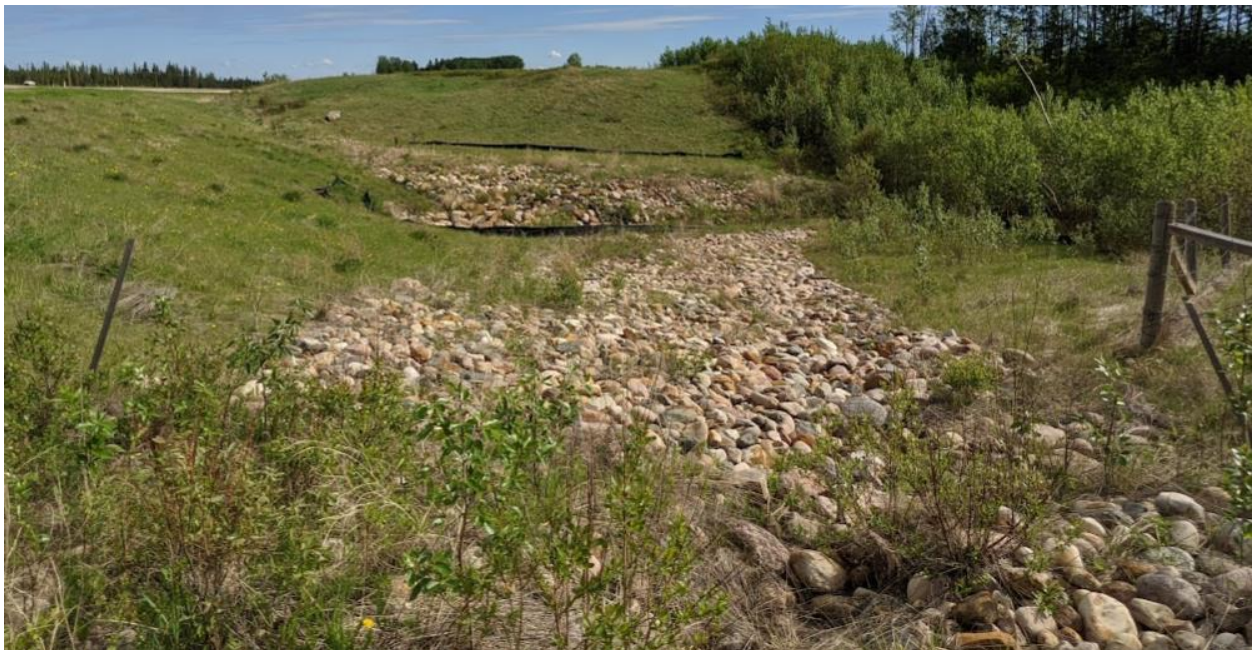
Photo No. 14 – looking northeast along the riprap lined north facing drainage channel
