**ALBERTA TRANSPORTATION AND
ECONOMIC CORRIDORS GRMP
NORTH CENTRAL (ATHABASCA AND FORT
McMURRAY DISTRICTS)
2024 SITE INSPECTION**

| Site Number | Location | Name | Hwy | km |
|---|---|---|---|---|
| NC 069-1 | 14 km south of Wandering River | S. of Wandering River- BF 76427 | 63:02 | 32 |

**NORTH CENTRAL REGION
(ATHABASCA AND FORT MCMURRAY DISTRICTS)
2024 GEOHAZARD ASSESSMENT
NC069-1: HWY 63:02 (km 32) - BF76427
SITE PLAN SHOWING SITE FEATURES**

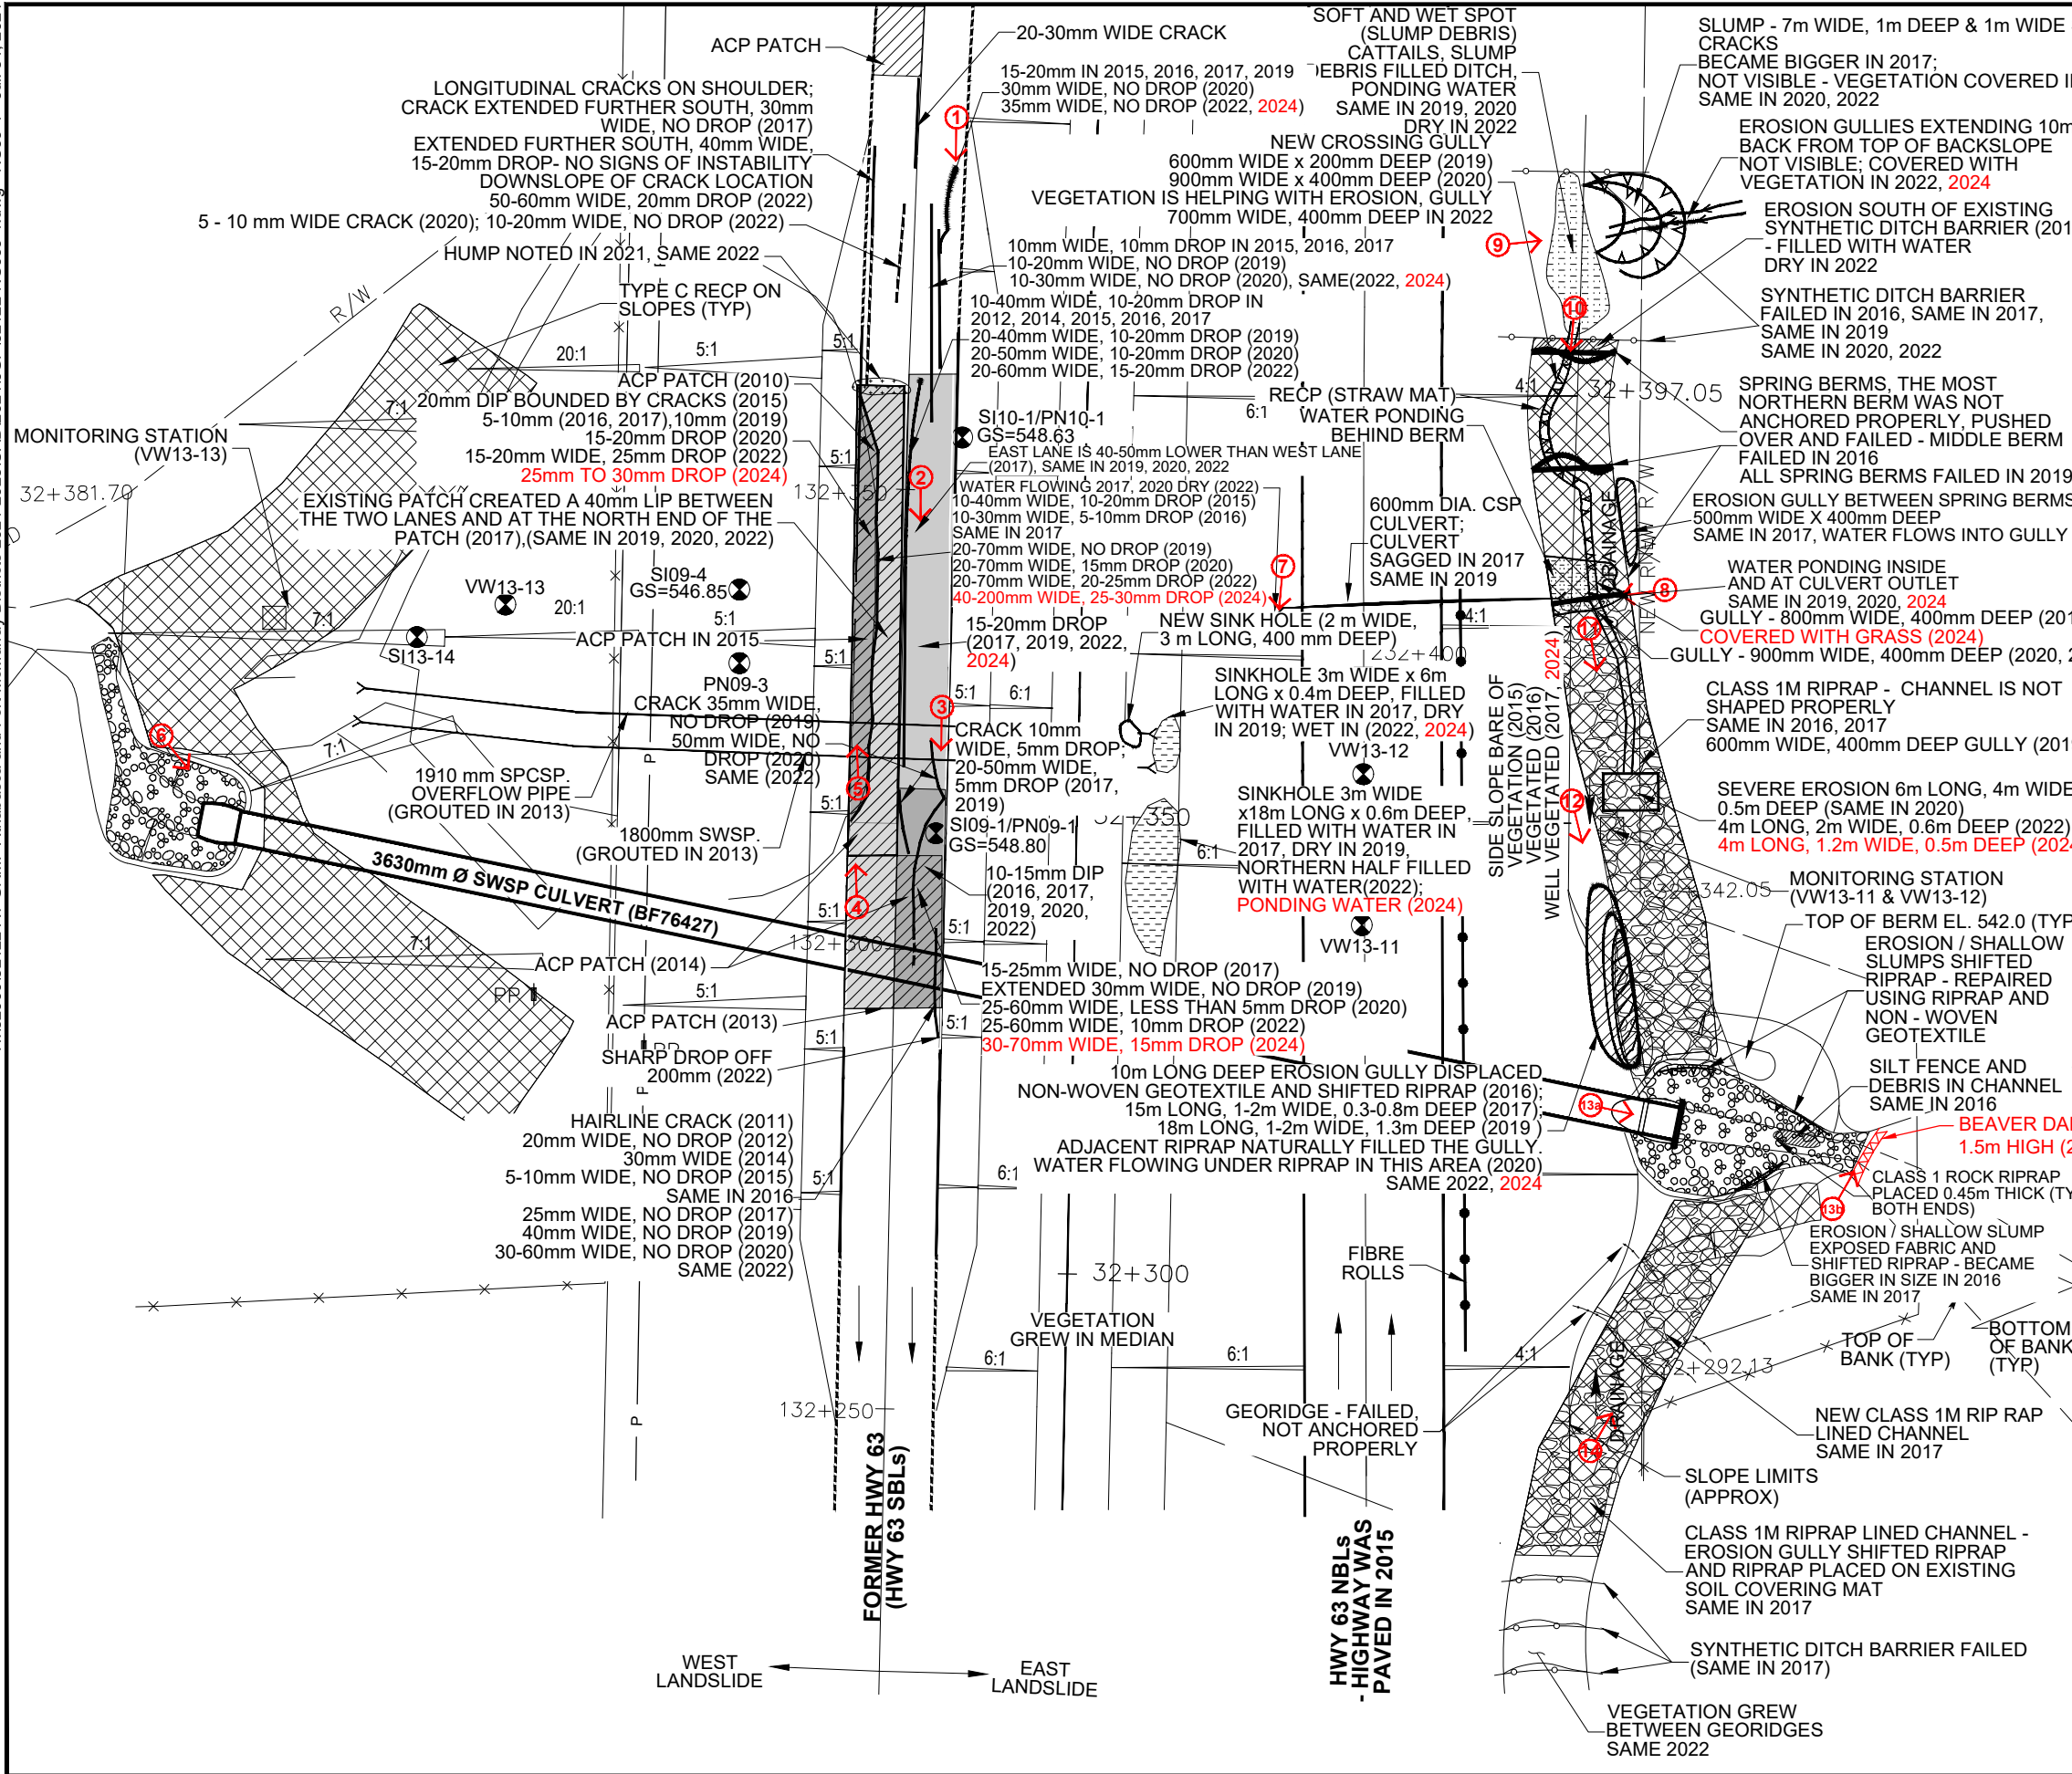
DWG No. NC069-1

Assessment (Refer to attached Figure):

In general, the remedial measures have been effective in stabilizing the east and west landslides of the highway SBLs.

The highway surface conditions appear to have deteriorated due to the ongoing creep movements of the landslides, as evidenced by further opening of cracks and the more distinct dips on the southbound lanes. The existing dips on the SBLs continue to create a rough ride to travellers.

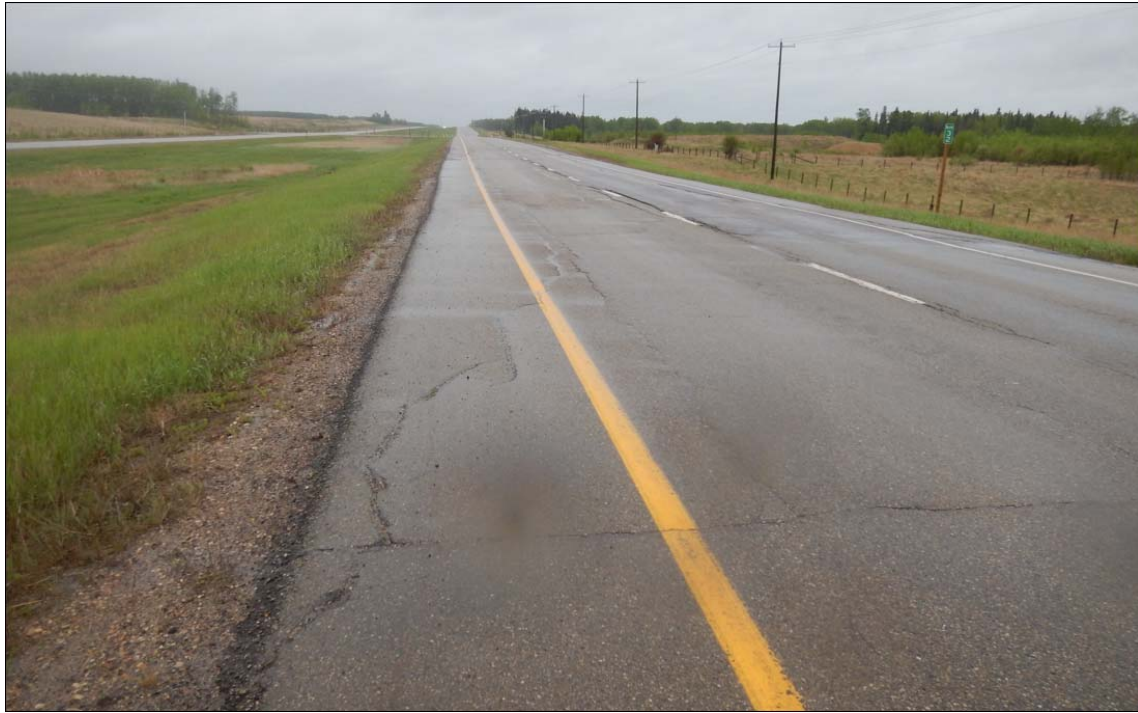
| | <p>June 2010; ACP overlay on the former highway SBL in 2014 and 2015</p> <p>East Landslide: ACP overlay on the southern limits of the NBL of former highway in 2014</p> <p>Erosion issues identified in 2014 were addressed by others: The erosion within the diversion channel at the inlet of the new pipe and along the south facing drainage channel to the north of the pipe were repaired; South facing drainage Channel: erosion control included extension of existing soil covering mat further north, armouring the southern segment of the channel using Class 1M riprap, inclusion of spring berms along the channel within the segment covered with the erosion mat; North facing Draining channel: erosion control included placement of a Class 1M riprap over existing soil covering mat, and installation of geo-ridge berms within the northern portion covered with the erosion blanket; fibre rolls installed along the crest of the east slope of the NBL above the inlet of the pipe.</p> <p>One of the erosion issues identified in 2015 was addressed by others under the contract for the highway twinning project. The erosion gully developed within the north facing drainage channel above the culvert inlet location was repaired through the extension of the riprap channel to the bottom of the slope towards the diversion channel.</p> | |
|---|--|---|
| <input checked="" type="checkbox"/> Slope Movement | <p>West Landslide (western lane of highway SBLs): 40 to 200 mm wide reflective landslide cracks with up to 25 mm drop across crack surfaces</p> <p>East Landslide (eastern lane of highway SBLs): 30 to 70 mm wide landslide cracks with up to 15 mm drop across crack surfaces</p> | <input checked="" type="checkbox"/> |

Photo No. 1 – Looking south at open diagonal and longitudinal cracks on the former highway NBL surface from the north limit of the east landslide

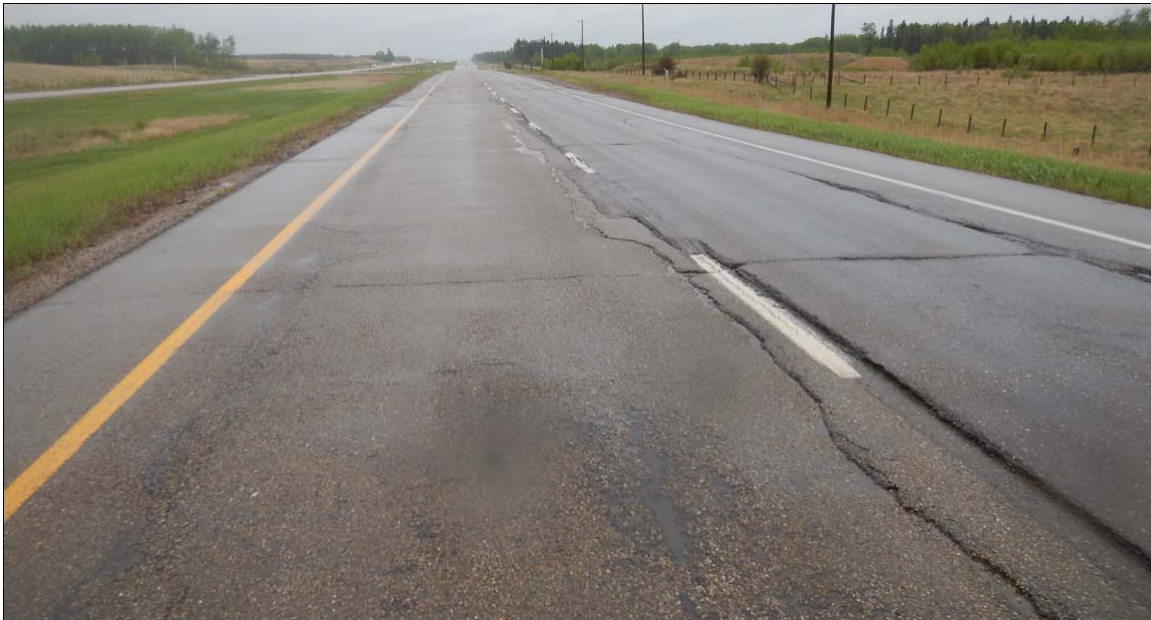
Photo No. 2 – Looking south at an open longitudinal reflective crack within the middle section of the east landslide; note the presence of a 40 mm elevation difference between the two lanes

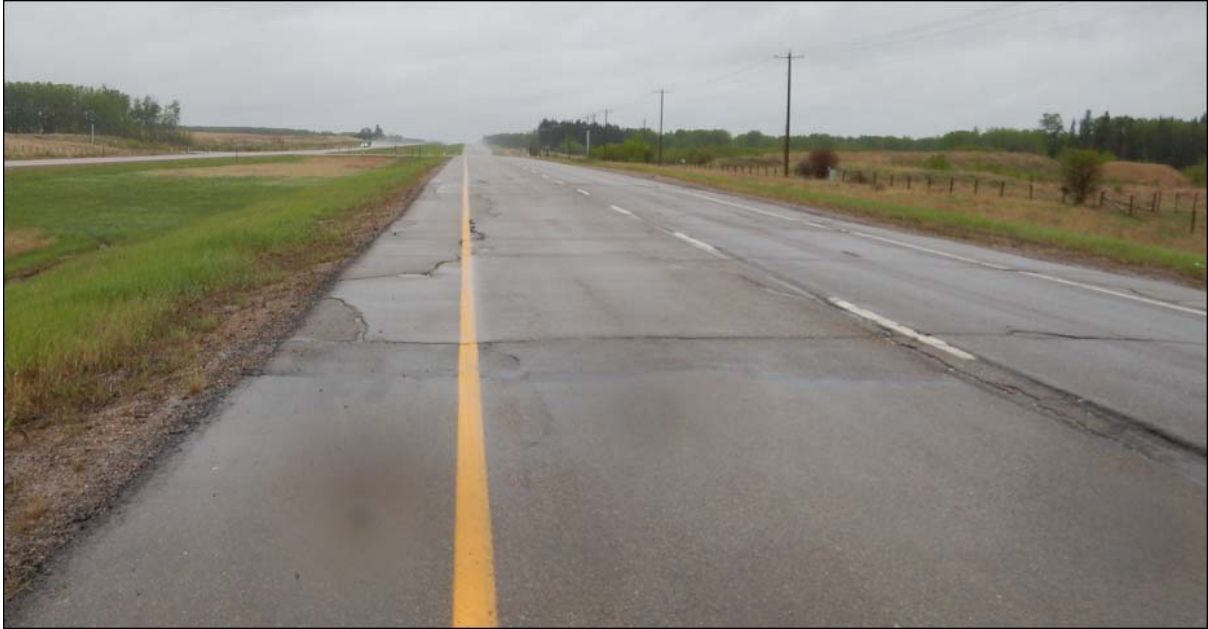
The top surface elevation of the patch placed in 2015 along the most western lane of the old highway is about 40 to 50 mm higher than the top surface elevation of the pavement surface outside the boundaries of the patched area. This has resulted in an uncomfortable ride on the highway surface and constitutes a major safety hazard to the motorists. The existing dip on the highway lanes has also aggravated the situation.

Photo No. 3 – Looking south from the southern limit of the east landslide at reflective diagonal crack on the existing patch

Consideration should be given to milling the 2015 ACP patch and placing a new patch on the highway SBLs. The new patch should provide a smooth ride to motorists and eliminate the safety hazard, associated with uneven pavement surfaces within the site.

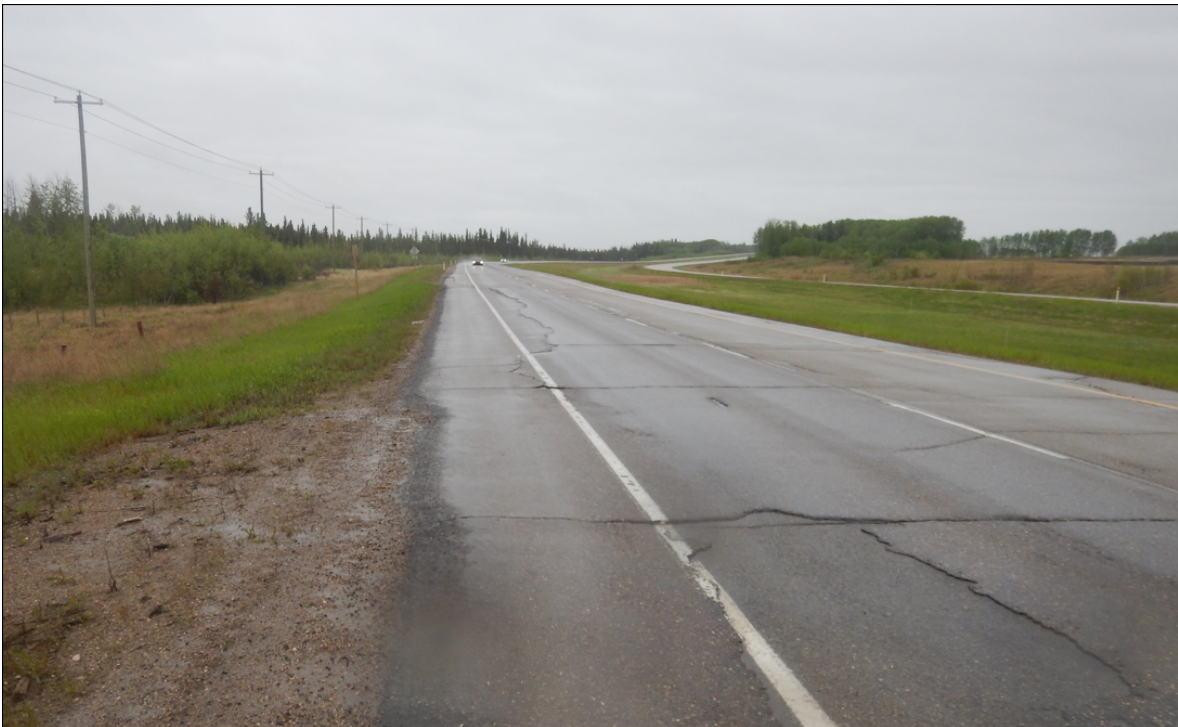
| | <p>June 2010; ACP overlay on the former highway SBL in 2014 and 2015</p> <p>East Landslide: ACP overlay on the southern limits of the NBL of former highway in 2014</p> <p>Erosion issues identified in 2014 were addressed by others: The erosion within the diversion channel at the inlet of the new pipe and along the south facing drainage channel to the north of the pipe were repaired; South facing drainage Channel: erosion control included extension of existing soil covering mat further north, armouring the southern segment of the channel using Class 1M riprap, inclusion of spring berms along the channel within the segment covered with the erosion mat; North facing Draining channel: erosion control included placement of a Class 1M riprap over existing soil covering mat, and installation of geo-ridge berms within the northern portion covered with the erosion blanket; fibre rolls installed along the crest of the east slope of the NBL above the inlet of the pipe.</p> <p>One of the erosion issues identified in 2015 was addressed by others under the contract for the highway twinning project. The erosion gully developed within the north facing drainage channel above the culvert inlet location was repaired through the extension of the riprap channel to the bottom of the slope towards the diversion channel.</p> | |
|---|--|---|
| <input checked="" type="checkbox"/> Pavement Distress | <p>West Landslide (western lane of highway SBLs): 25 to 30 mm dip for about 50 m</p> <p>East Landslide (eastern lane of highway SBLs): 15 to 20 mm dip for about 90 m</p> <p>Western Lane of highway SBLs: The existing patch on the western lane is 40 to 50 mm higher than surrounding pavement surfaces.</p> | <input checked="" type="checkbox"/> |

Photo No. 4 – West landslide (looking north from the southern limit of the landslide); note the dip developed on the highway surface within the limits of the landslide

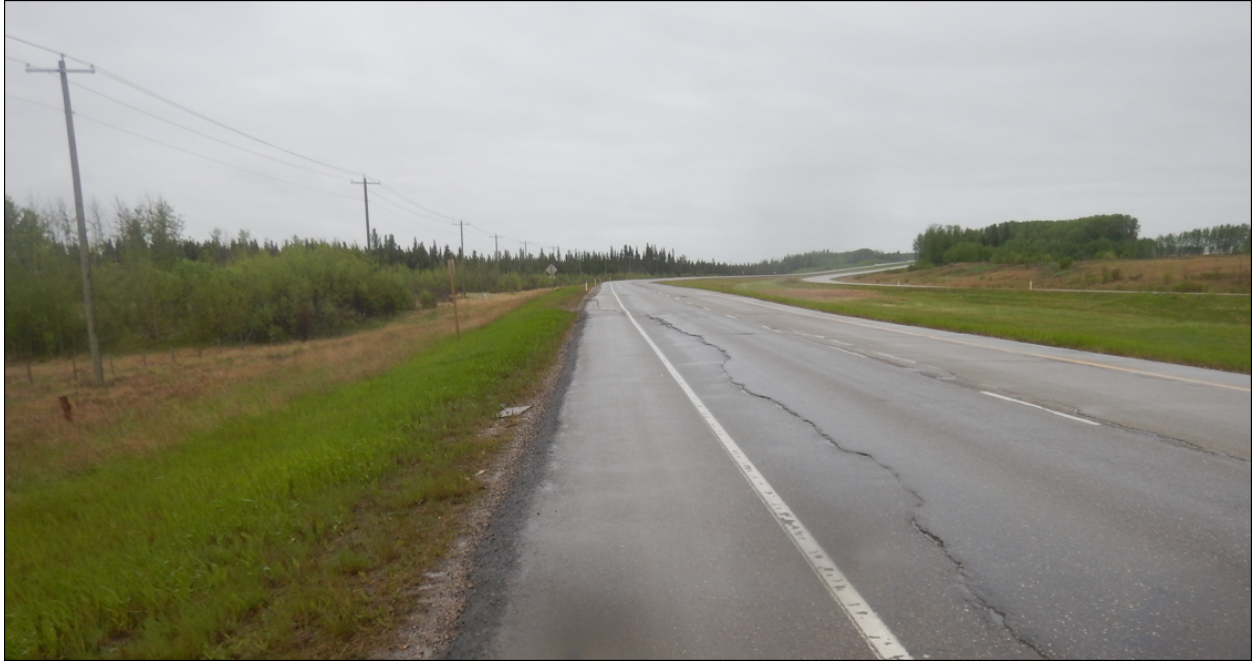
Photo No. 5 – Looking north at the west landslide reflective cracks on the highway surface

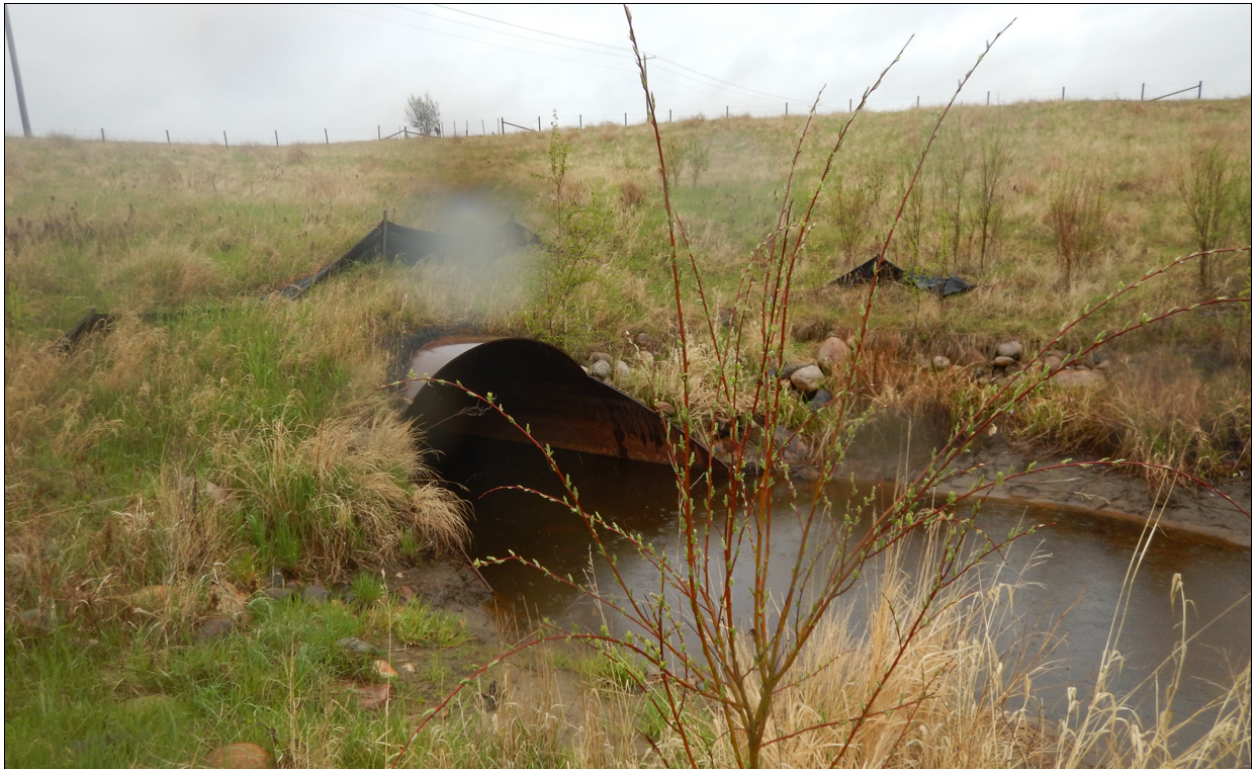
Photo No. 6 – Looking at the outlet of the SWSP centerline culvert

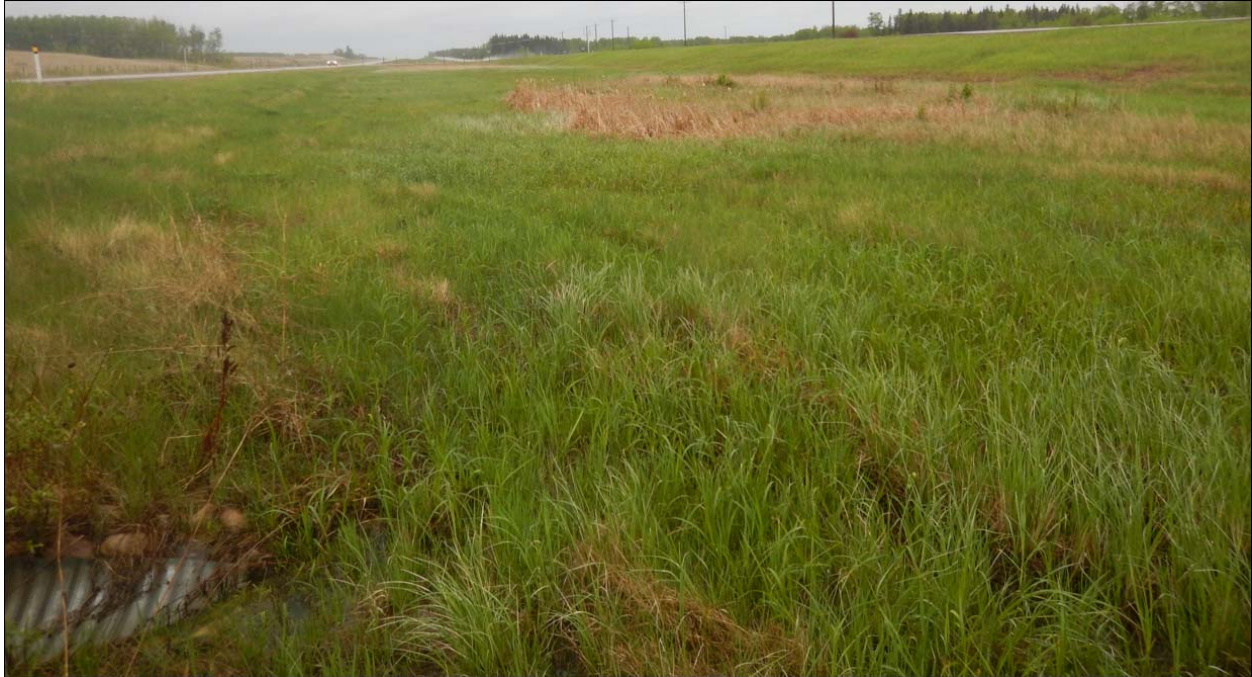
Photo No. 7 – Looking south at highway median. Heavy flow into the 600 mm diameter CSP culvert

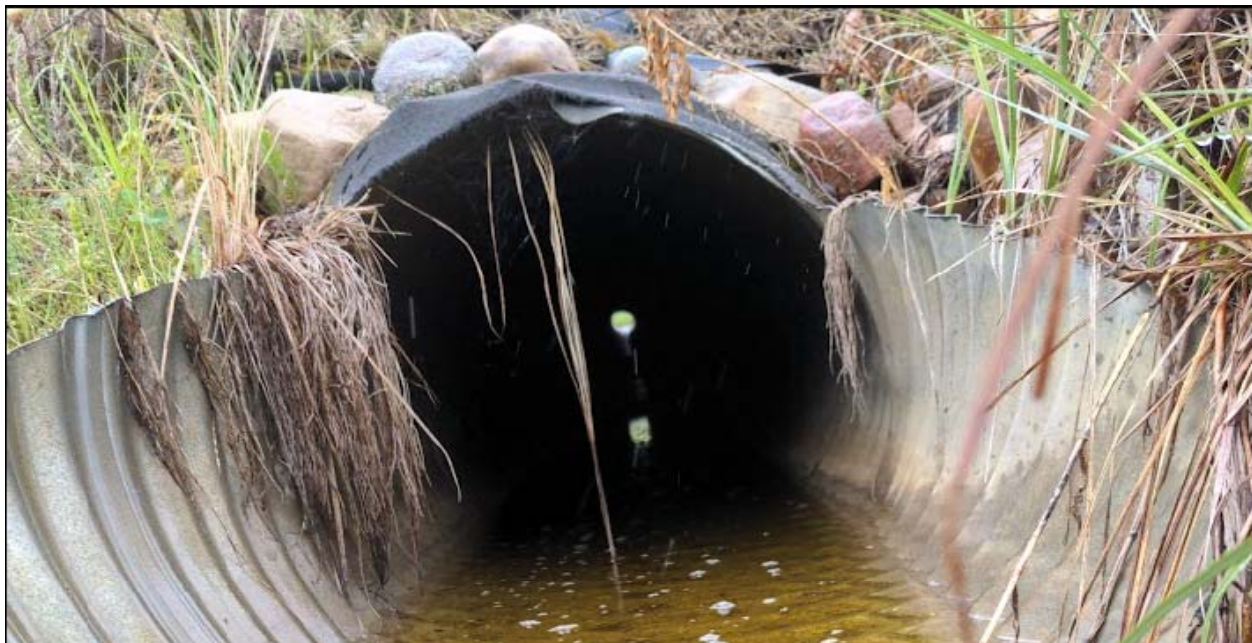
| <input checked="" type="checkbox"/> Bridge/Culvert Distress | The 600 mm diameter culvert below the highway NBLs has sagged and water is ponding inside the pipe | <input type="checkbox"/> |

Photo No. 8 – Looking inside the outlet of the 600 mm diameter CSP culvert installed below the NBLs; water is still ponding inside the pipe

A CCTV inspection should be undertaken for the existing 600 mm diameter culvert below the highway NBL. Based on the inspection results, it may be required to either replace or line the pipe to enhance surface drainage in the highway median.

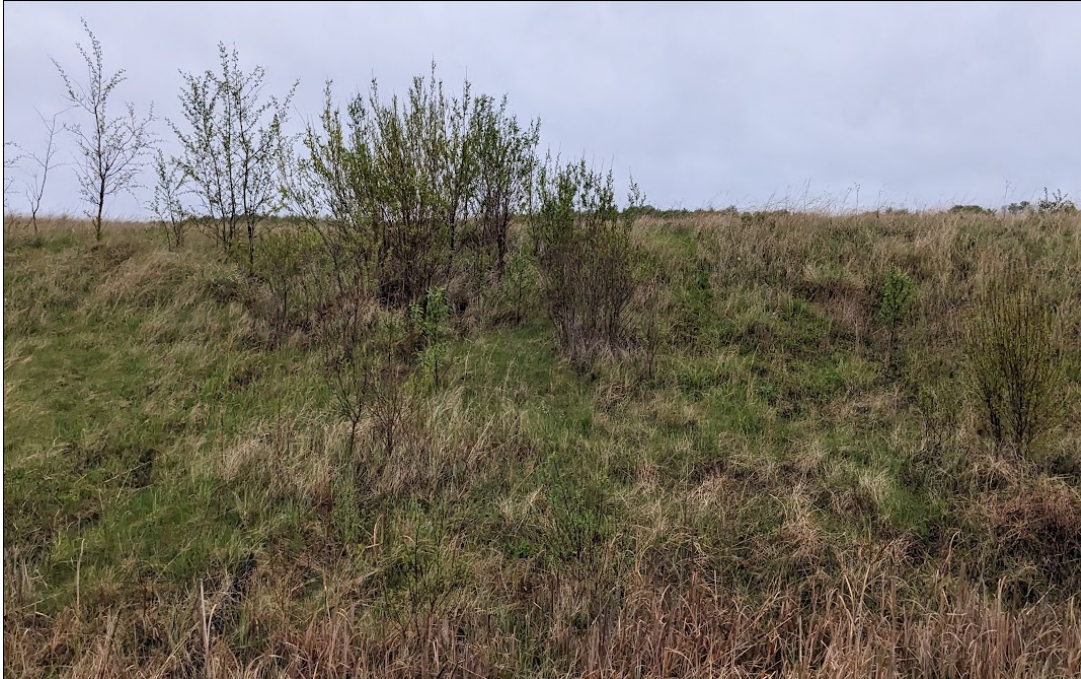
The highway east back slope slump is completely covered with vegetation and does not seem to be as active as observed in 2017.

Photo No. 9 – Looking northeast at the backslope slump area observed in 2017; vegetation has grown within the slump area. Slump is not longer visible.

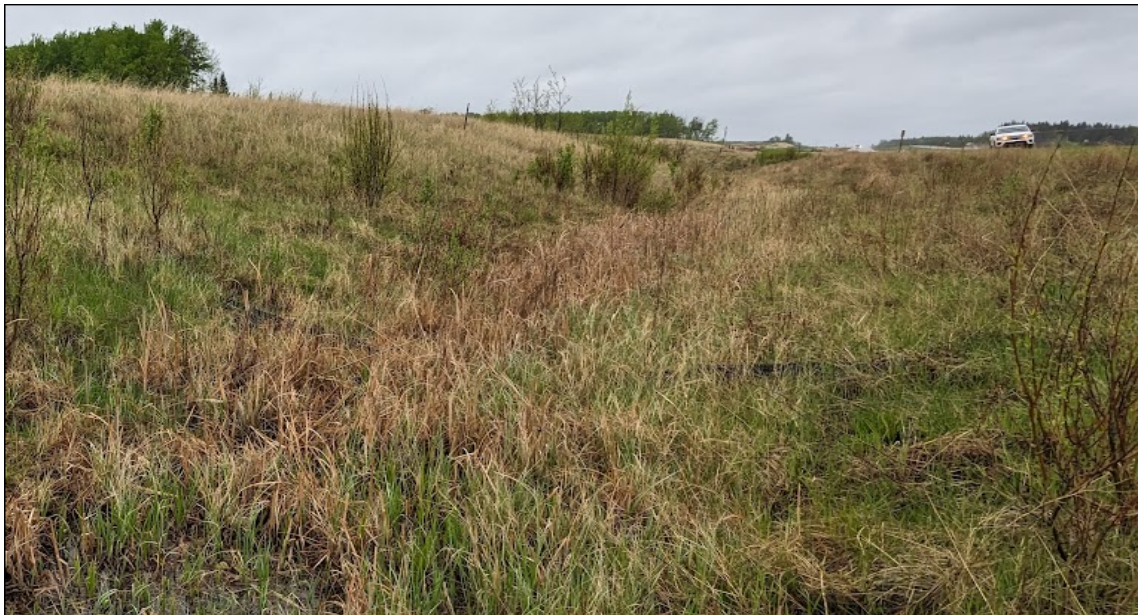
The existing erosion along south facing ditch to the east of the highway NBLs does not appear to be as active as observed in the past as vegetation continues to grow in this area.

Photo No. 10 – South facing channel: Vegetation has grown within the upslope section of the channel and erosion is no longer visible

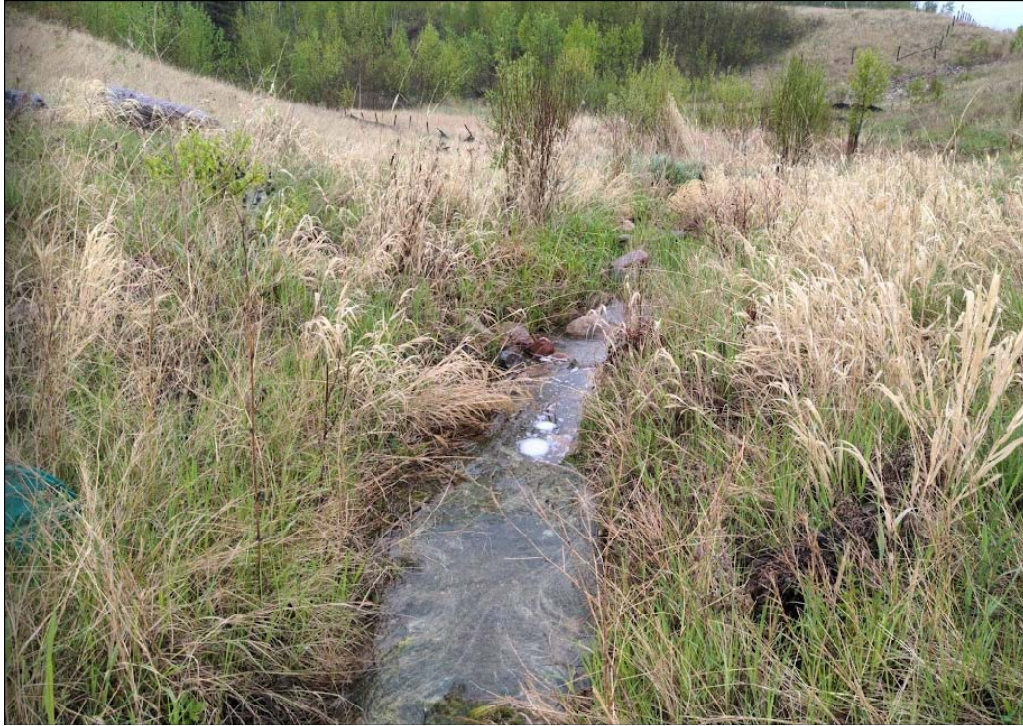
Photo No. 11 – South facing channel: Looking south at a gully approximately 900 mm wide x 400 mm deep; note vegetation is starting to cover the gully in this zone

Consideration should be given to placing riprap within the erosion gullies developed within the south facing channel, located to the east of the highway NBLs.

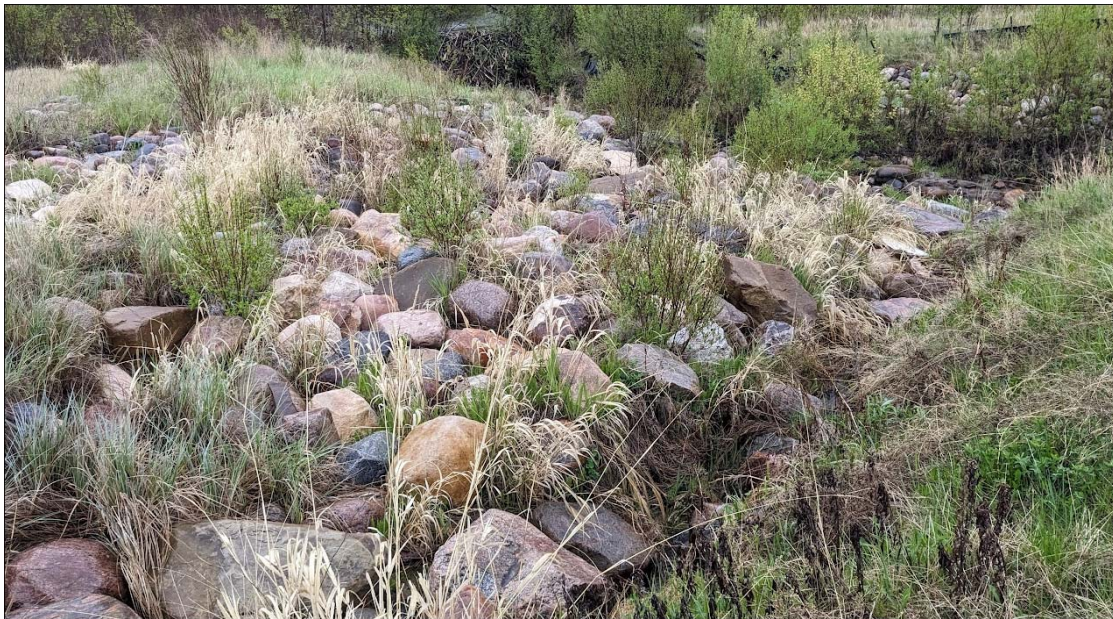
Photo No. 12 – South facing channel: Erosion gully developed on the west edge of the channel has been filled with riprap

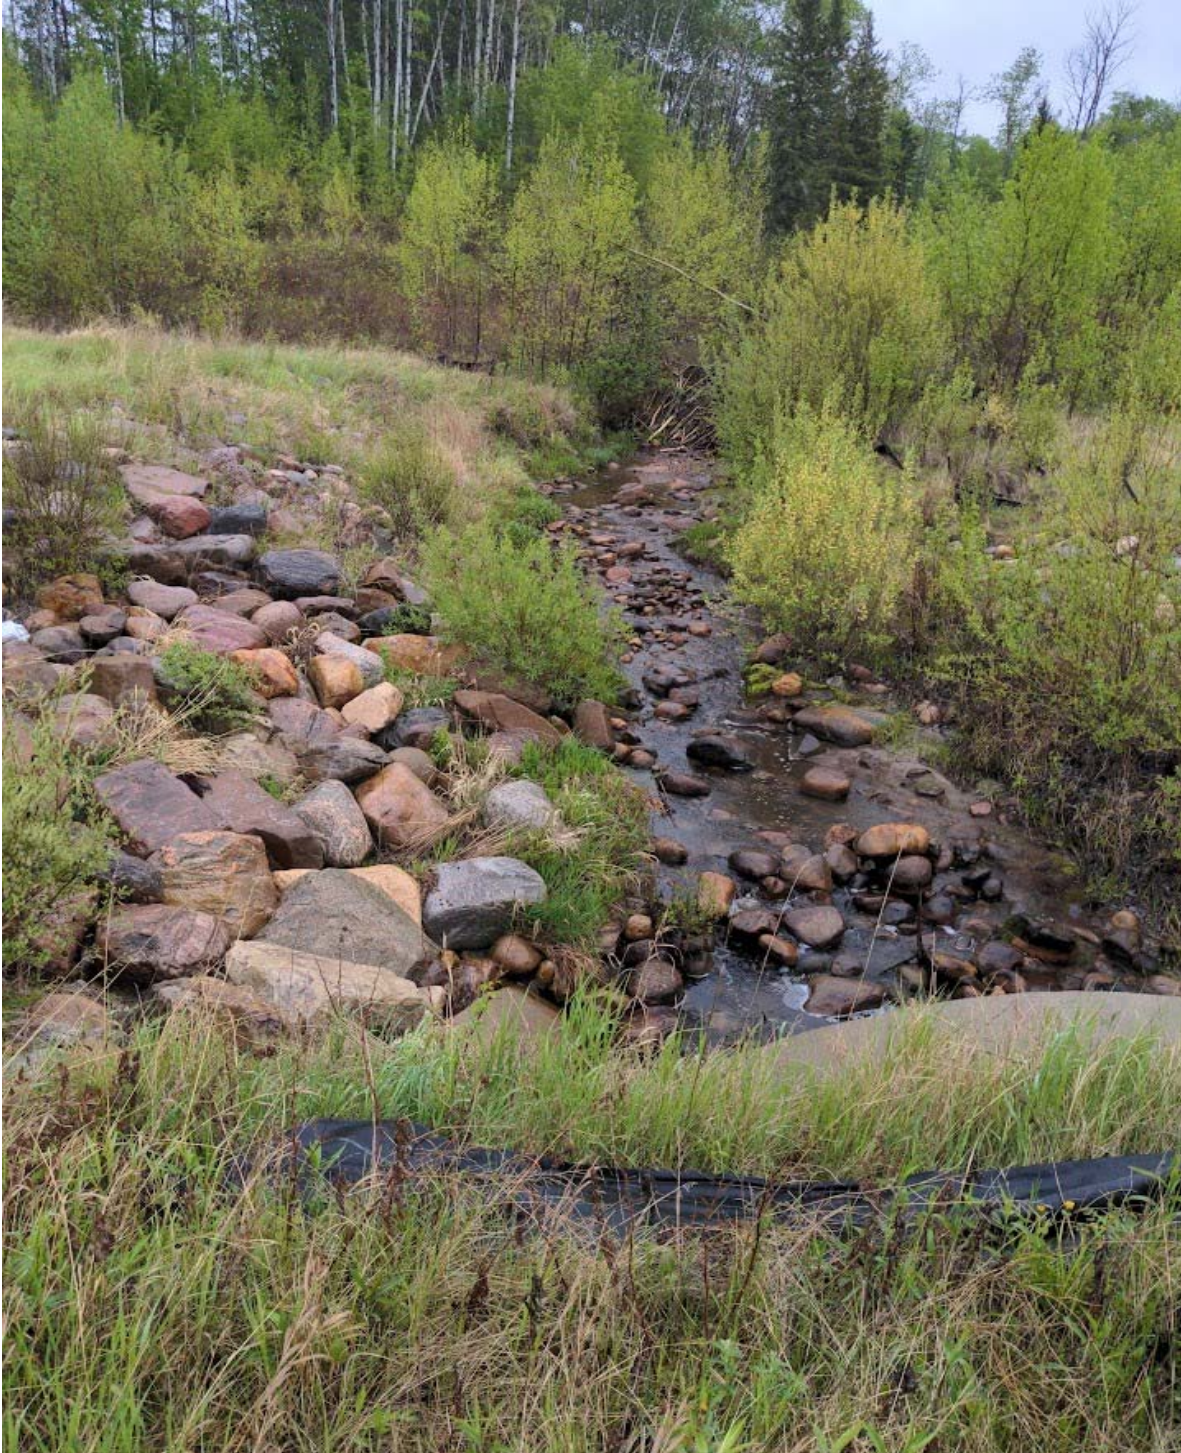
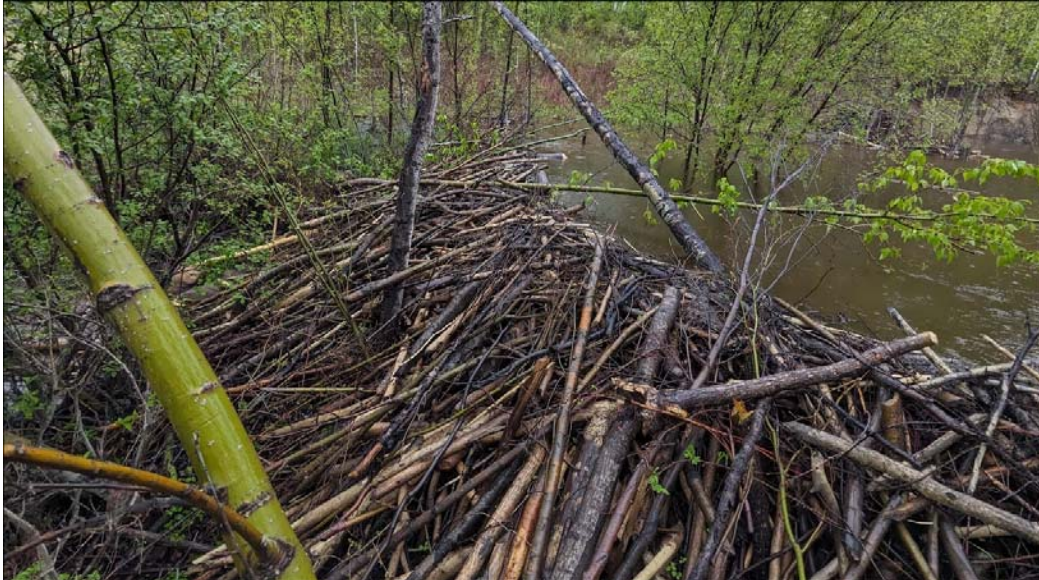
| <input checked="" type="checkbox"/> Other | Beaver Dam approximately 1.5 m high noted at eastern edge of the Class 1 rock riprap upstream of 3630 mm diameter SWSP culvert | <input checked="" type="checkbox"/> |

The beaver dam located upstream of the 3630 mm diameter SWSP culvert inlet is creating a significant rise in this water course. In addition, if a sudden breach of the dam occurs, the beaver dam may trigger erosion beyond the extent of the riprap.

Photo No. 13a – Looking east at an existing beaver dam (approximately 1.5 m high), upstream of the SWSP inlet location

Photo No. 13b – A closer look at the beaver dam in Photo 13a

The beaver dam noted upstream of the 3630 mm diameter SWSP culvert inlet should be removed.

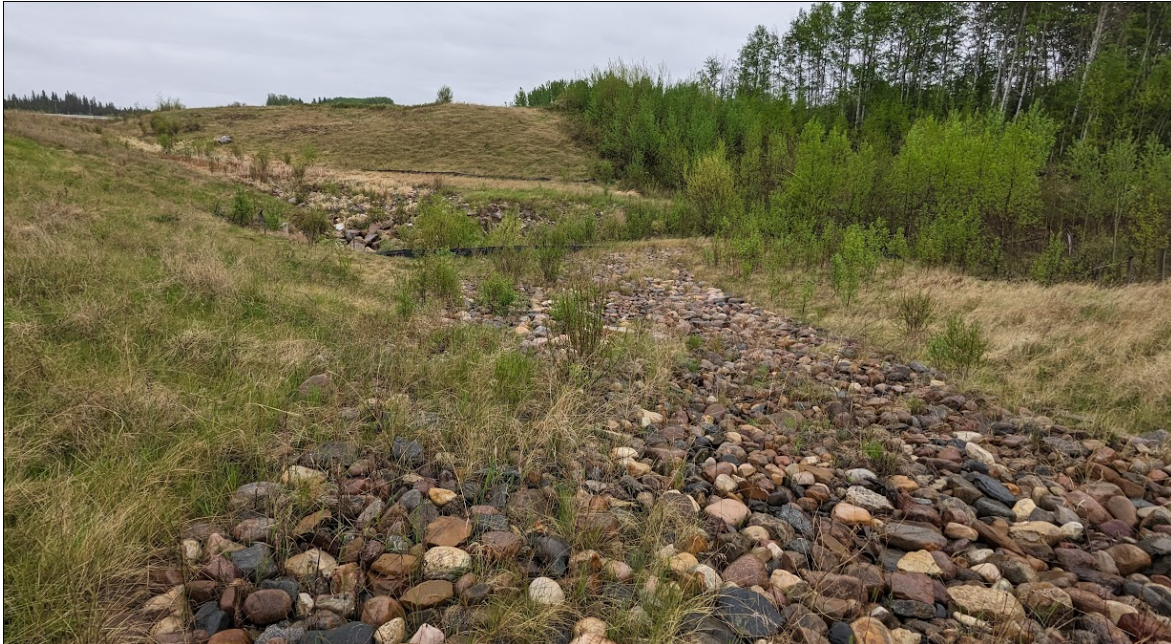
Photo No. 14 – Looking northeast along the riprap lined north facing drainage channel
