ALBERTA TRANSPORTATION AND
ECONOMIC CORRIDORS GRMP
NORTH CENTRAL (ATHABASCA AND FORT
McMURRAY DISTRICTS)
INSTRUMENTATION MONITORING- SPRING 2024

Site Number	Location	Name	Hwy	km
NC069	HWY 63:02 L1 32.020	South of Wandering River	63:02	Km 32
Legal Description: 3-27-70-17 W4		UTM Co-ordinates		
		12U E 403599	N	6105301

Current Monitoring:	13-June-2024	Previous Monitoring	Between 27-May-2023 and 02-Jun-2023
Instruments Read By:	Mr. Niraj Regmi, G.I.T and Mr. Nixon Mationg, of Thurber

SITE NC069: HWY 63:02 SLOPE REPAIR SOUTH OF WANDERING RIVER

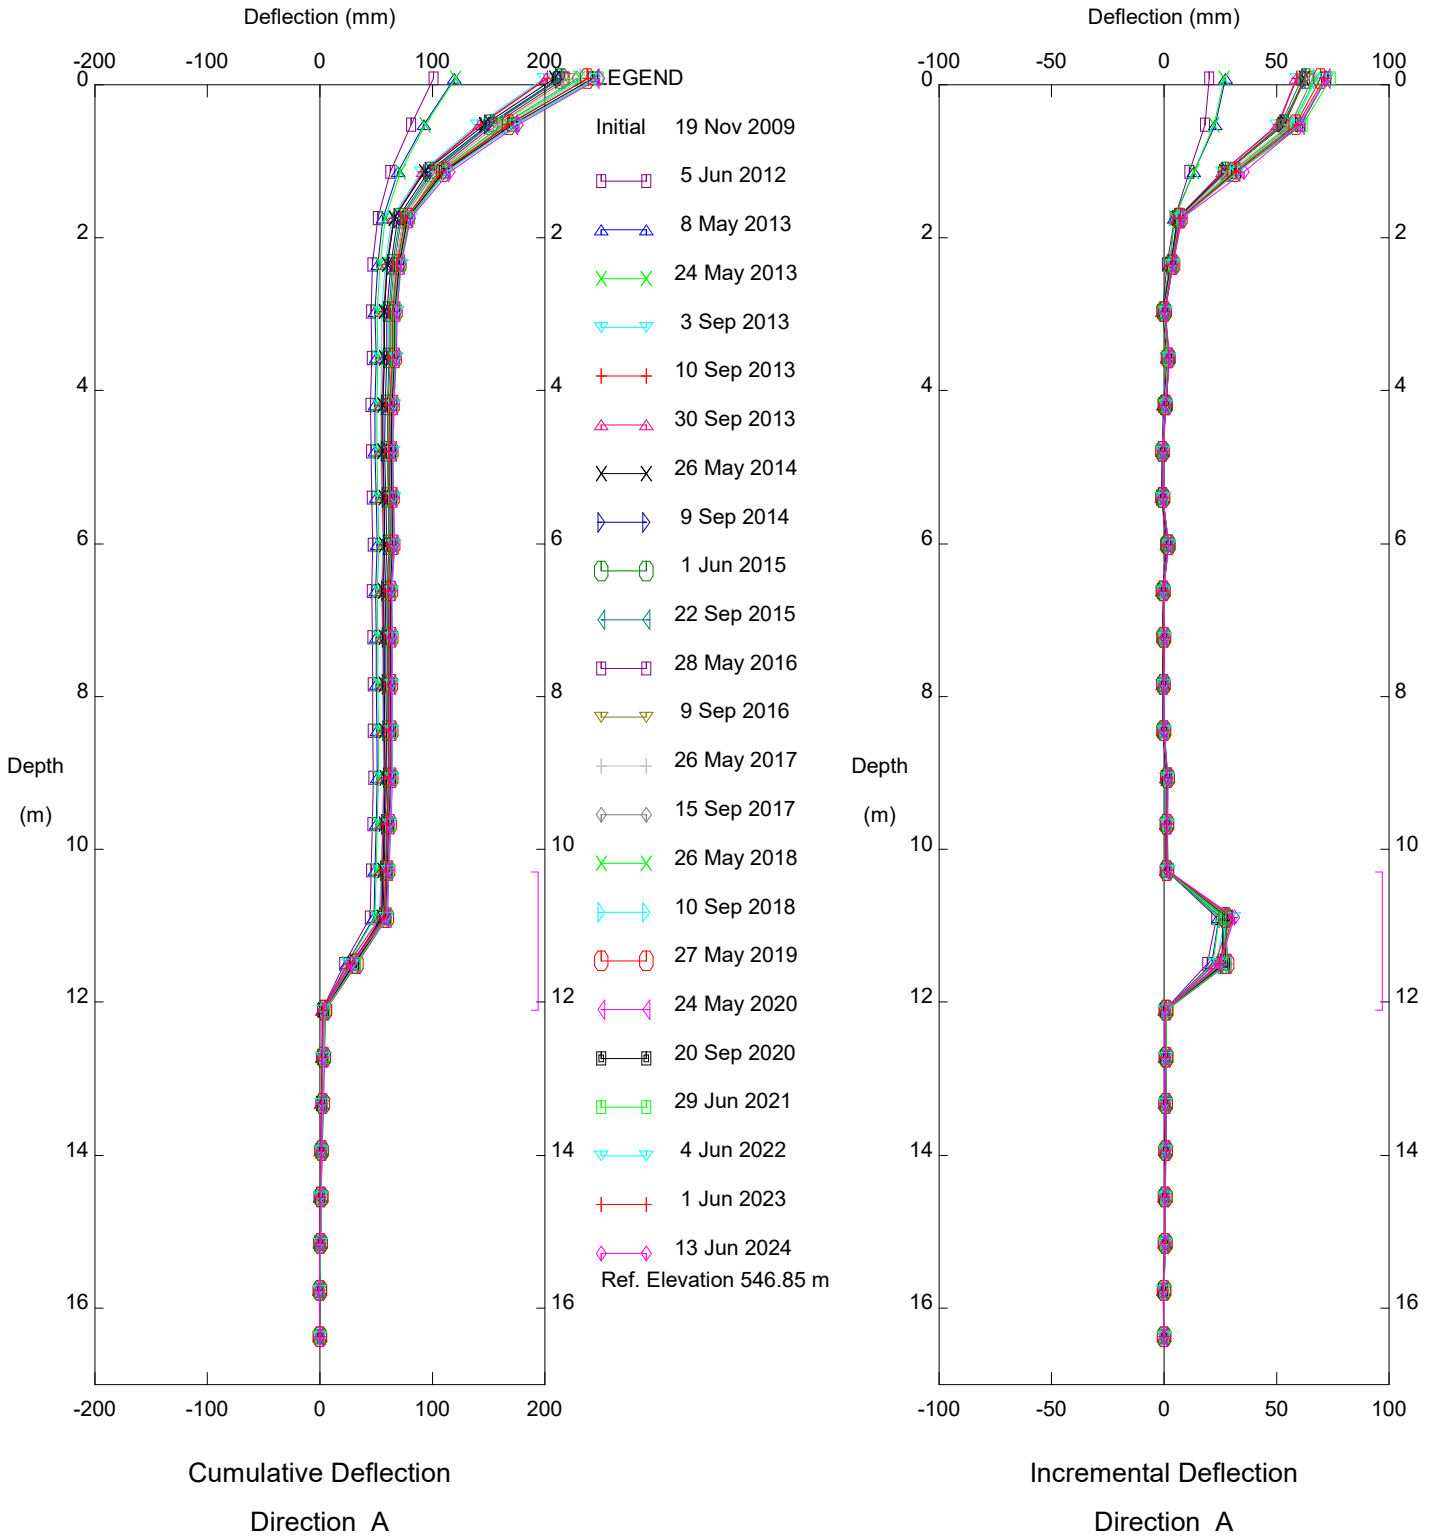
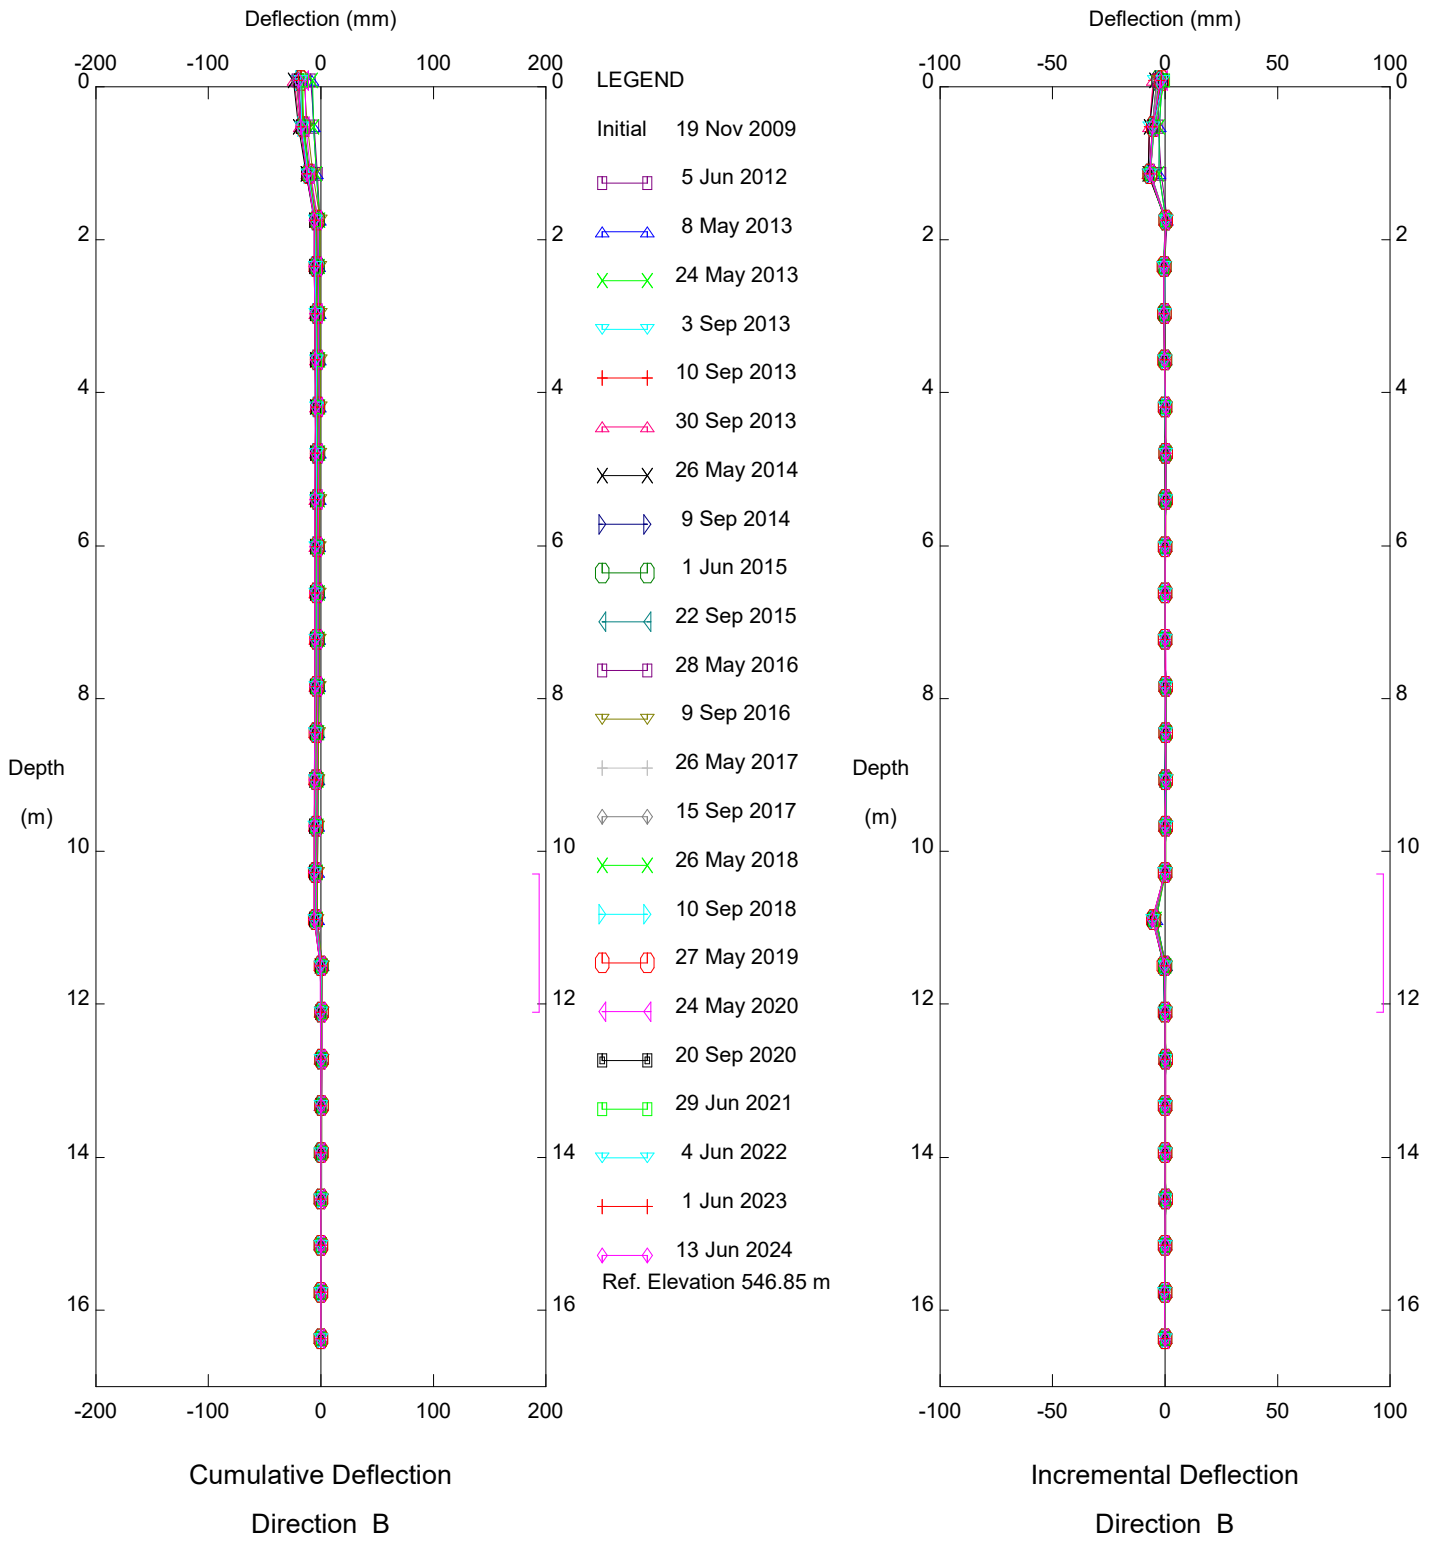
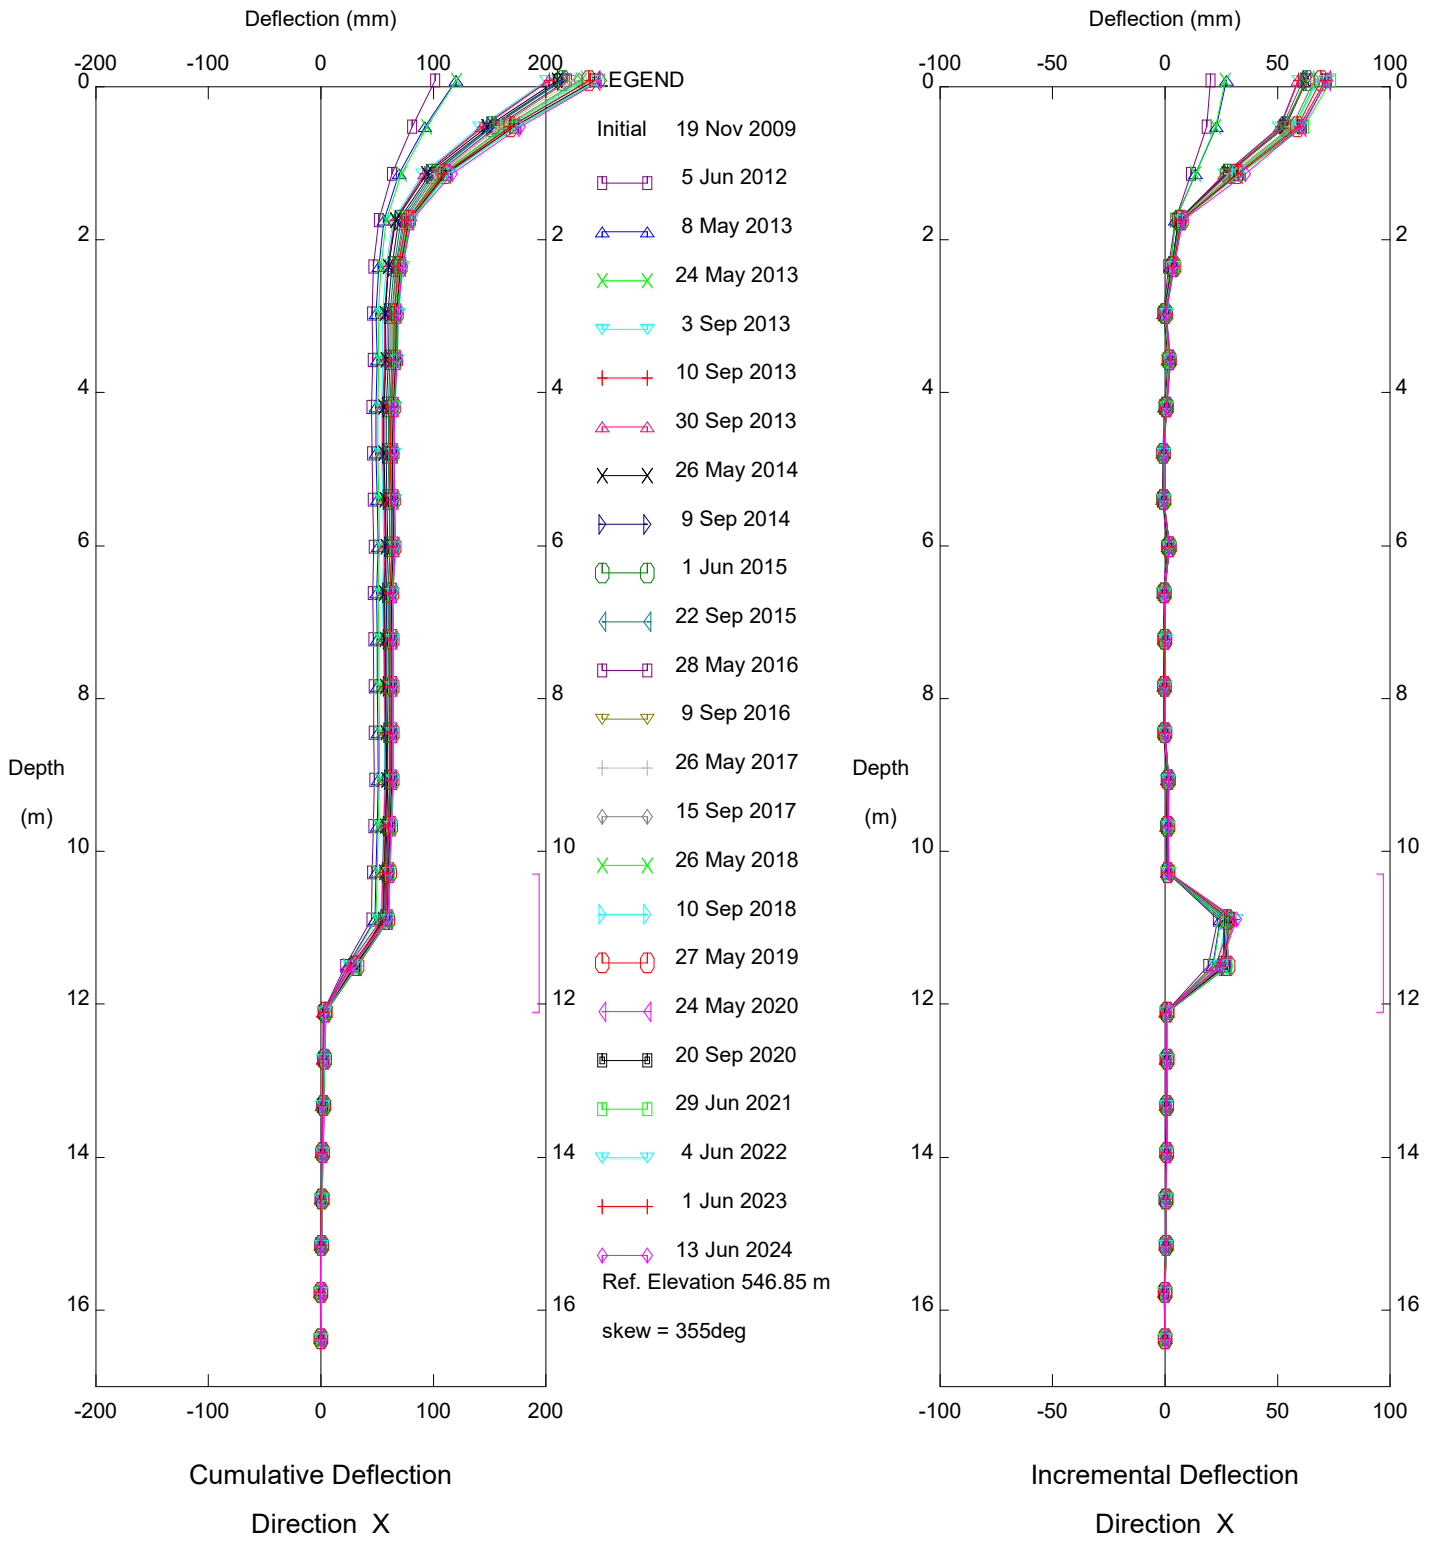
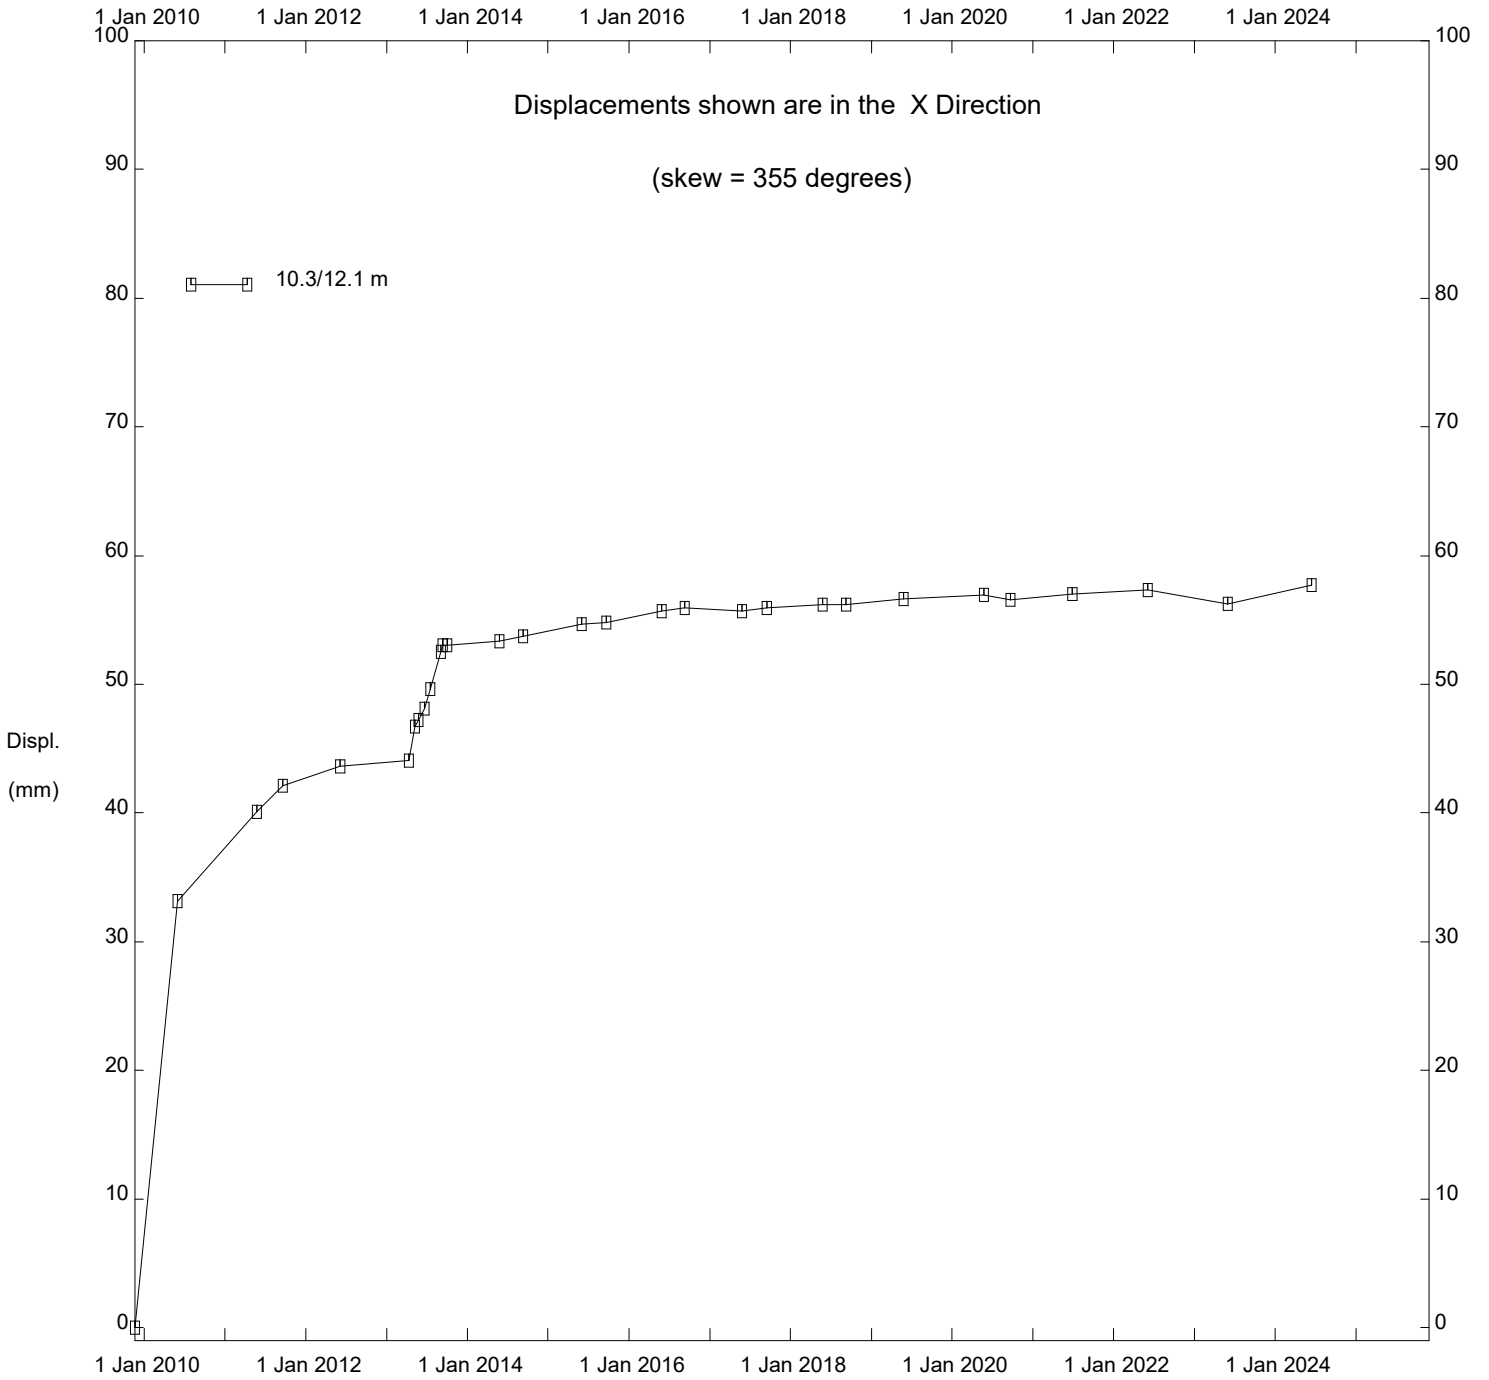
HWY 63:02 South of Wandering River, Inclinometer SI09-4

Discussion	
Zones of New Movement:	None
Interpretation of Monitoring Results:	<p>SI09-4, installed in the vicinity of the crest of the west landslide area, showed a rate of movement of 1.4 mm/yr since the spring of 2023 readings. SI10-1, installed near the northern limit of the east landslide on the highway surface, showed no discernible movement since the spring of 2023 readings. SI13-14, installed within the footprint of the toe berm constructed in 2013 to stabilize the west landslide area, showed a rate of movement of 0.5 mm/yr since the spring of 2023 readings. Overall, the SIs have shown creep rates of movement over their respective movement zones over the past several years.</p> <p>The groundwater level increased in PN09-3 by 0.23 m since the spring of 2023 readings.</p>

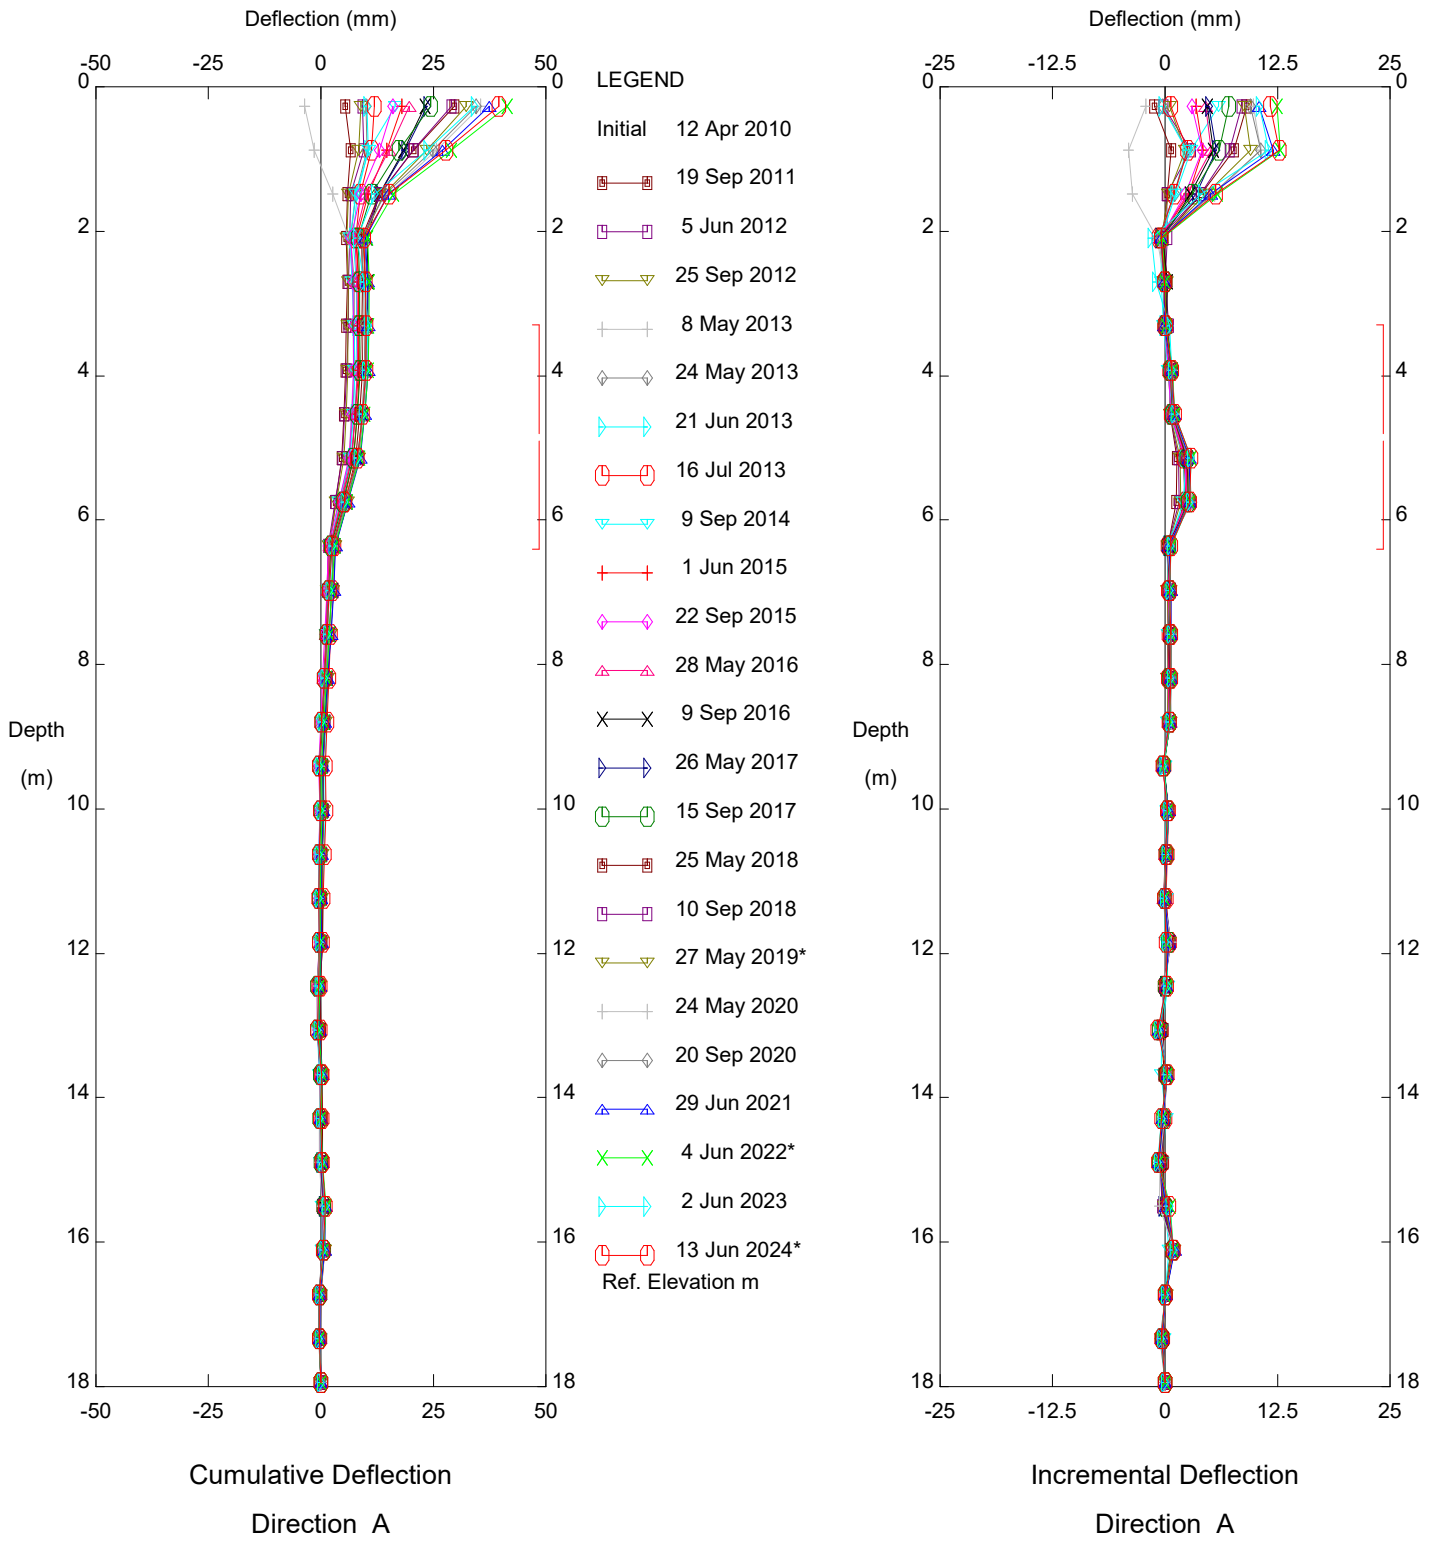
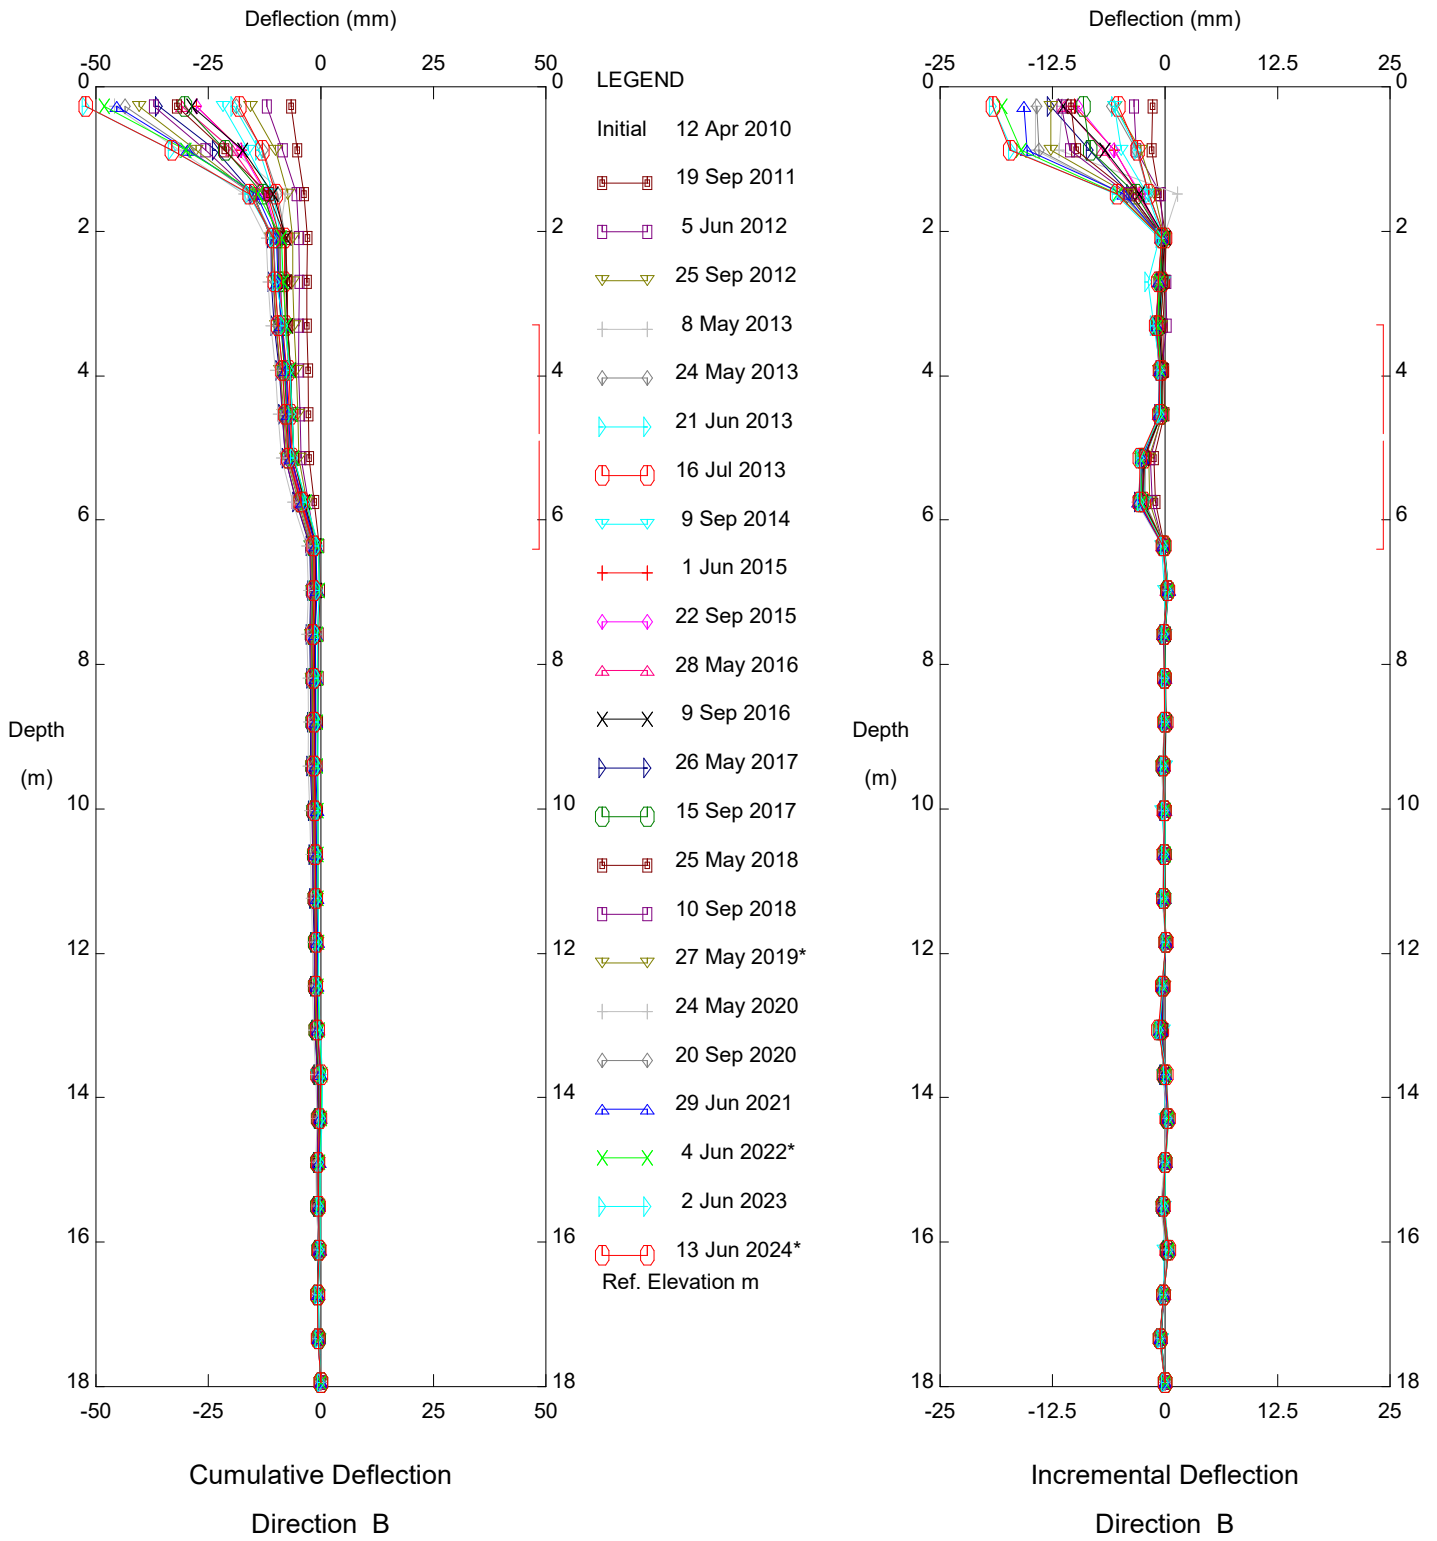
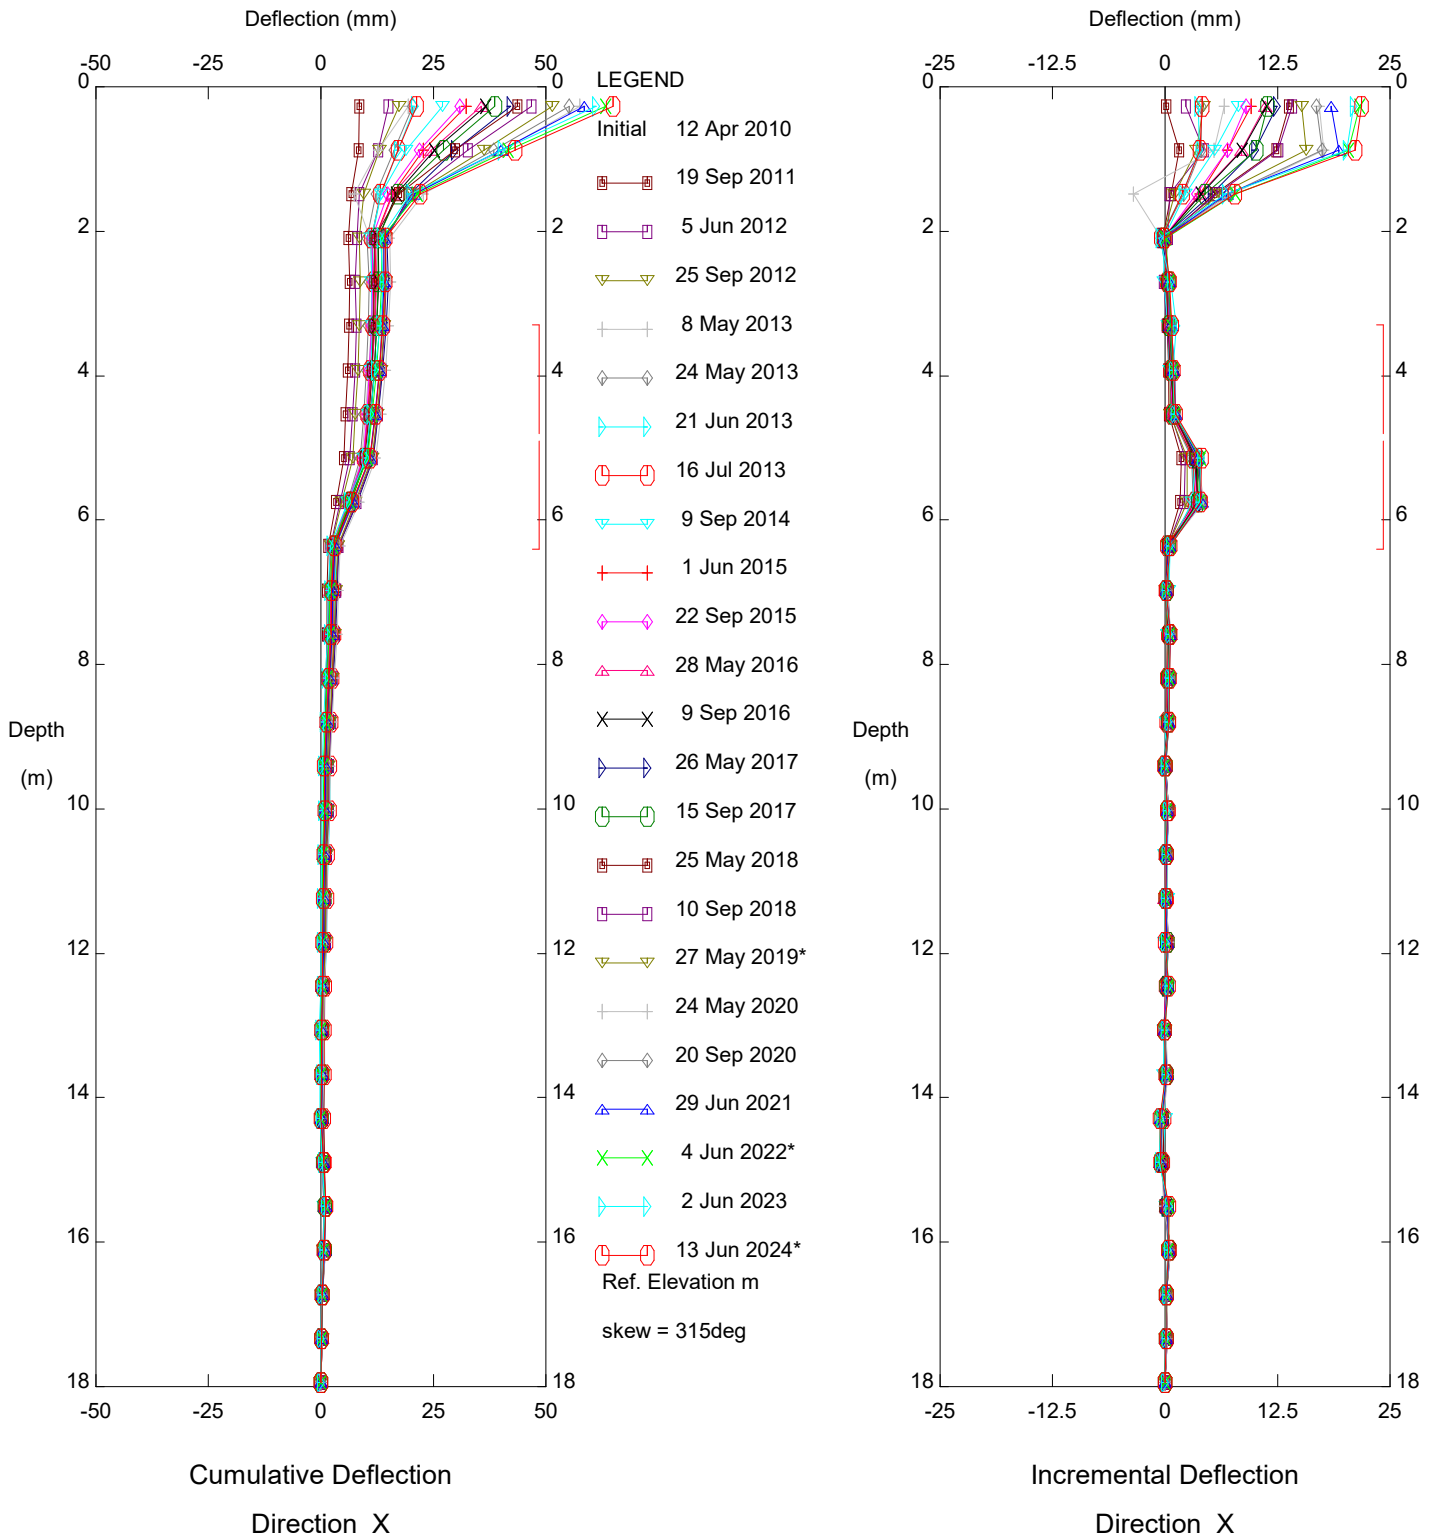
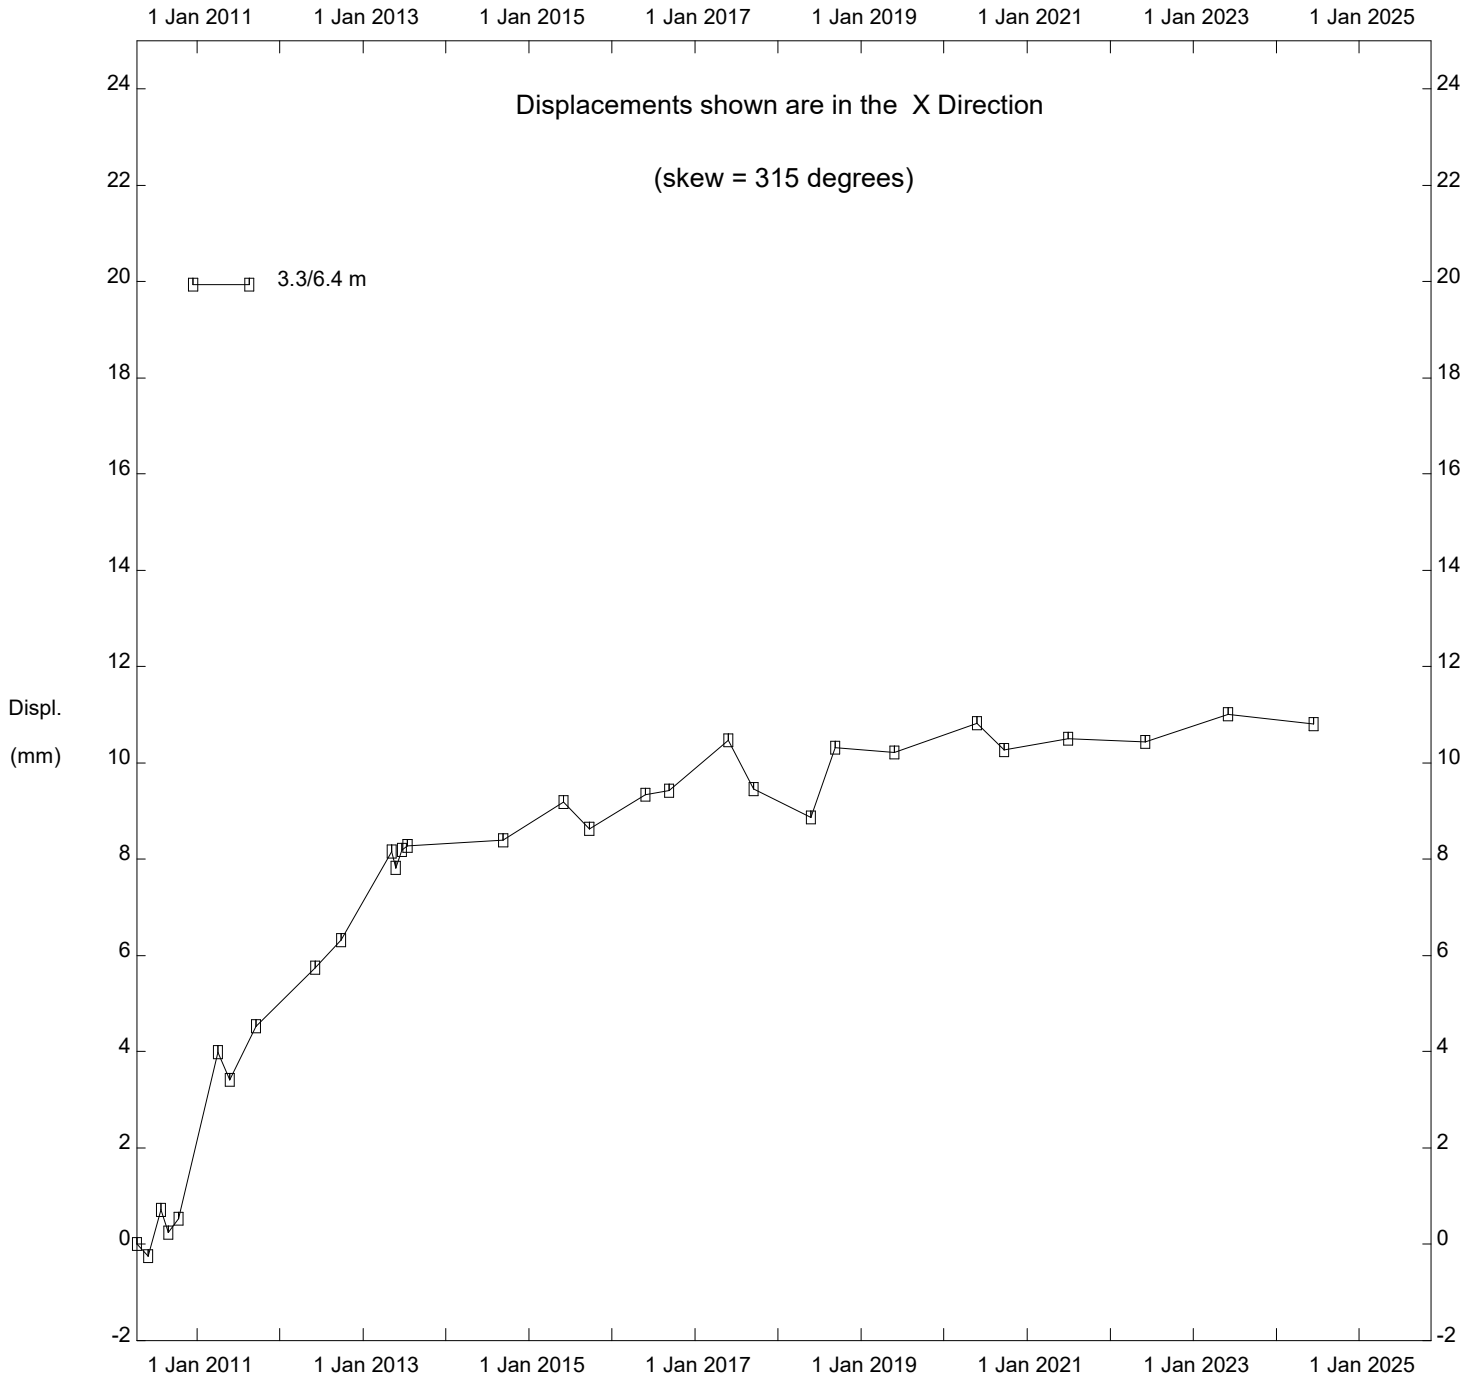
HWY 63:02 South of Wandering River, Inclinometer SI10-1

SI09-4 was installed on November 17, 2009 to replace SI09-3. It has a red stick-up protector in the west ditch.
SI10-1 casing breaking apart @ 10 ft. use dummy probe/ camera for next reading.
Confirm if PN09-1 functioning
PN10-1 cut off damaged, requires mechanical excavation

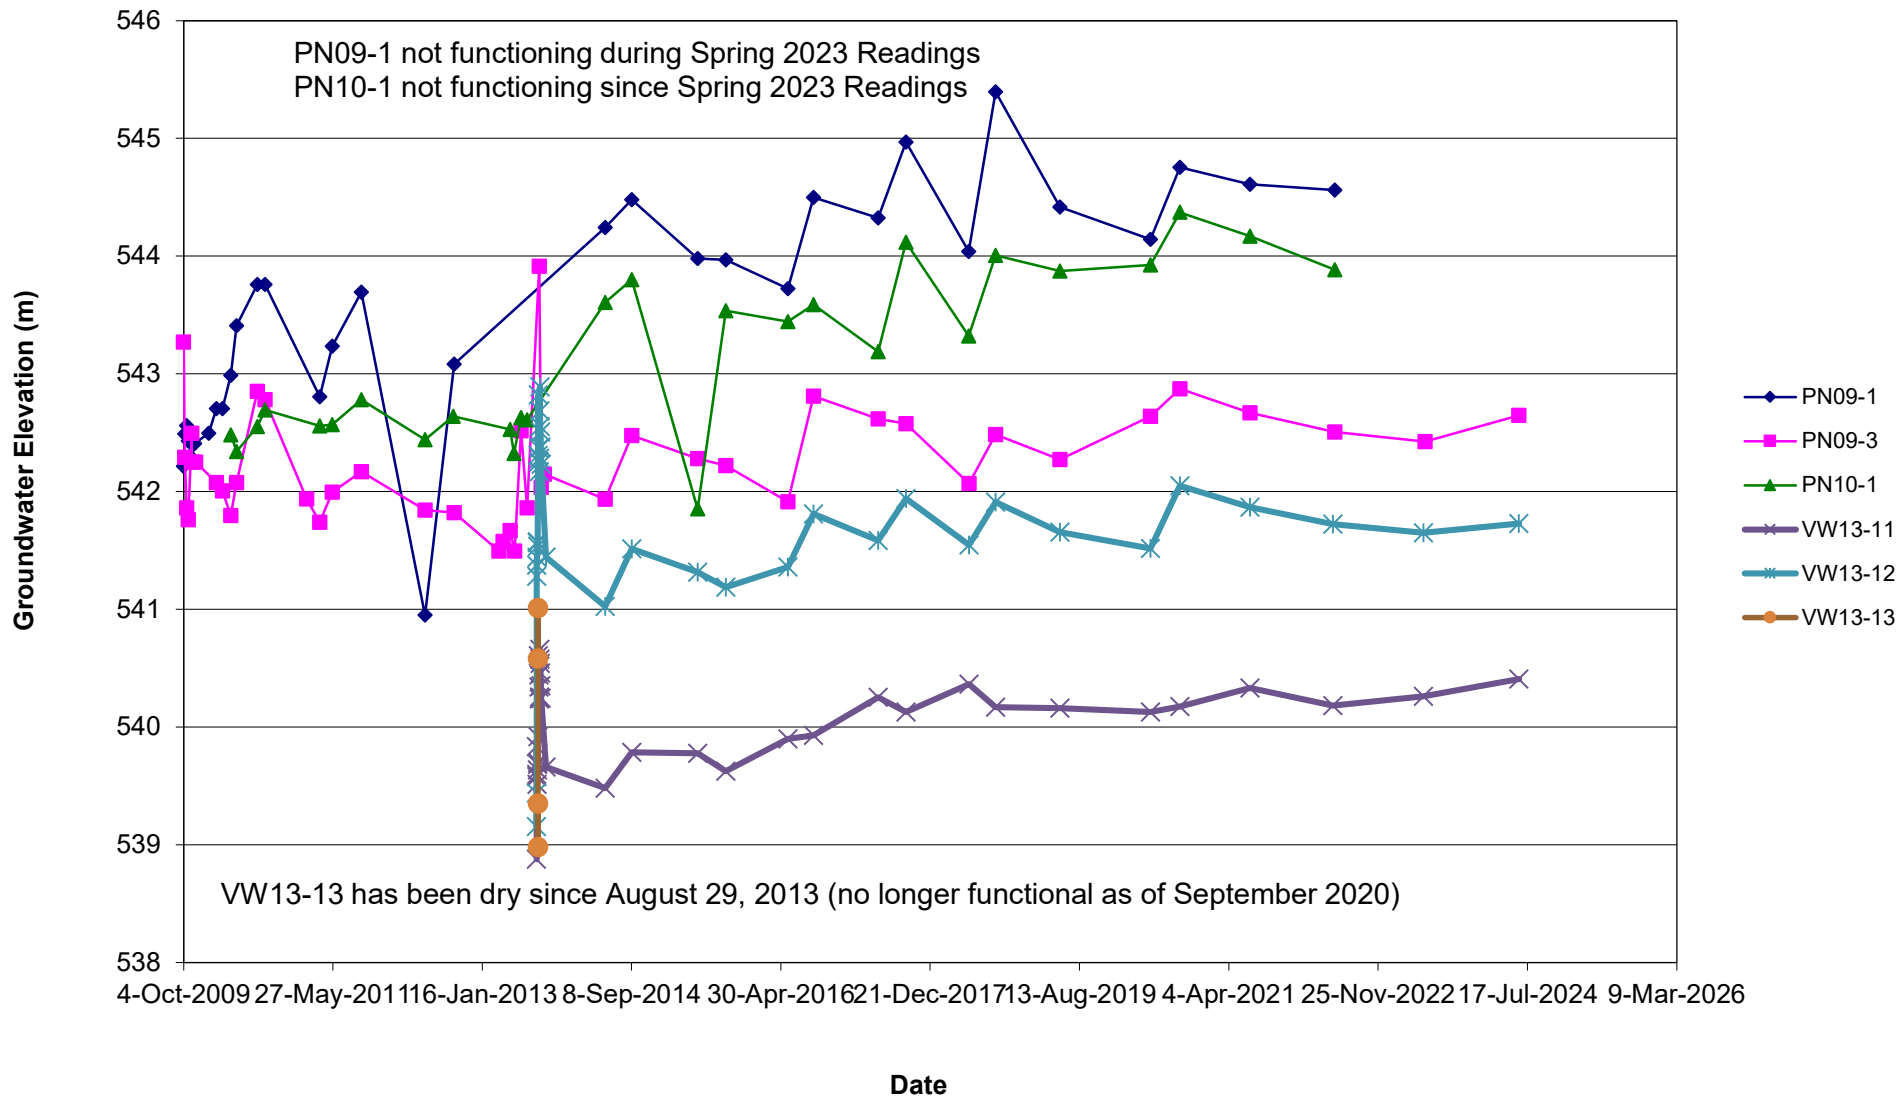
**FIGURE NC069-1
PIEZOMETRIC ELEVATIONS FOR HWY 63:02 SLOPE REPAIR**

Vibrating wire piezometers VW13-11 and VW13-12 showed increases in groundwater level of 0.15 m and 0.08 m, respectively, since the spring of 2023 readings.
Future Work:	The instruments should be read again in the spring of 2025. Pneumatic Piezometer PN09-1 has malfunctioned for two reading cycles in a row and should be removed from future readings.
Instrumentation Repairs:	Pneumatic piezometer PN10-1 could be repaired during the spring of 2025 readings. However, this instrument will require mechanical or hydrovac excavation to repair, as it is placed inside a steel flush mount protector. Additionally, traffic accommodation would be required to complete this instrument repair.
Additional Comments:
