**ALBERTA TRANSPORTATION
GEOHAZARD ASSESSMENT PROGRAM
NORTH CENTRAL REGION – ATHABASCA &
FORT MCMURRAY DISTRICTS
2021 SITE INSPECTION**

| Site # | Location | Name | Hwy | km |
|---|---|--|---|---|
| NC008 | 15.6 Km North of Hwy 63 & 55 Intersection | La Biche River (0.8 to 0.9 km North of Bridge) | 63:02 | 15.6 |

| | Date | PF | CF | Total |
|---|--|---|---|---|
| Current Inspection: | June 24, 2021 | 10 | 4 | 40 (New Landslide) |

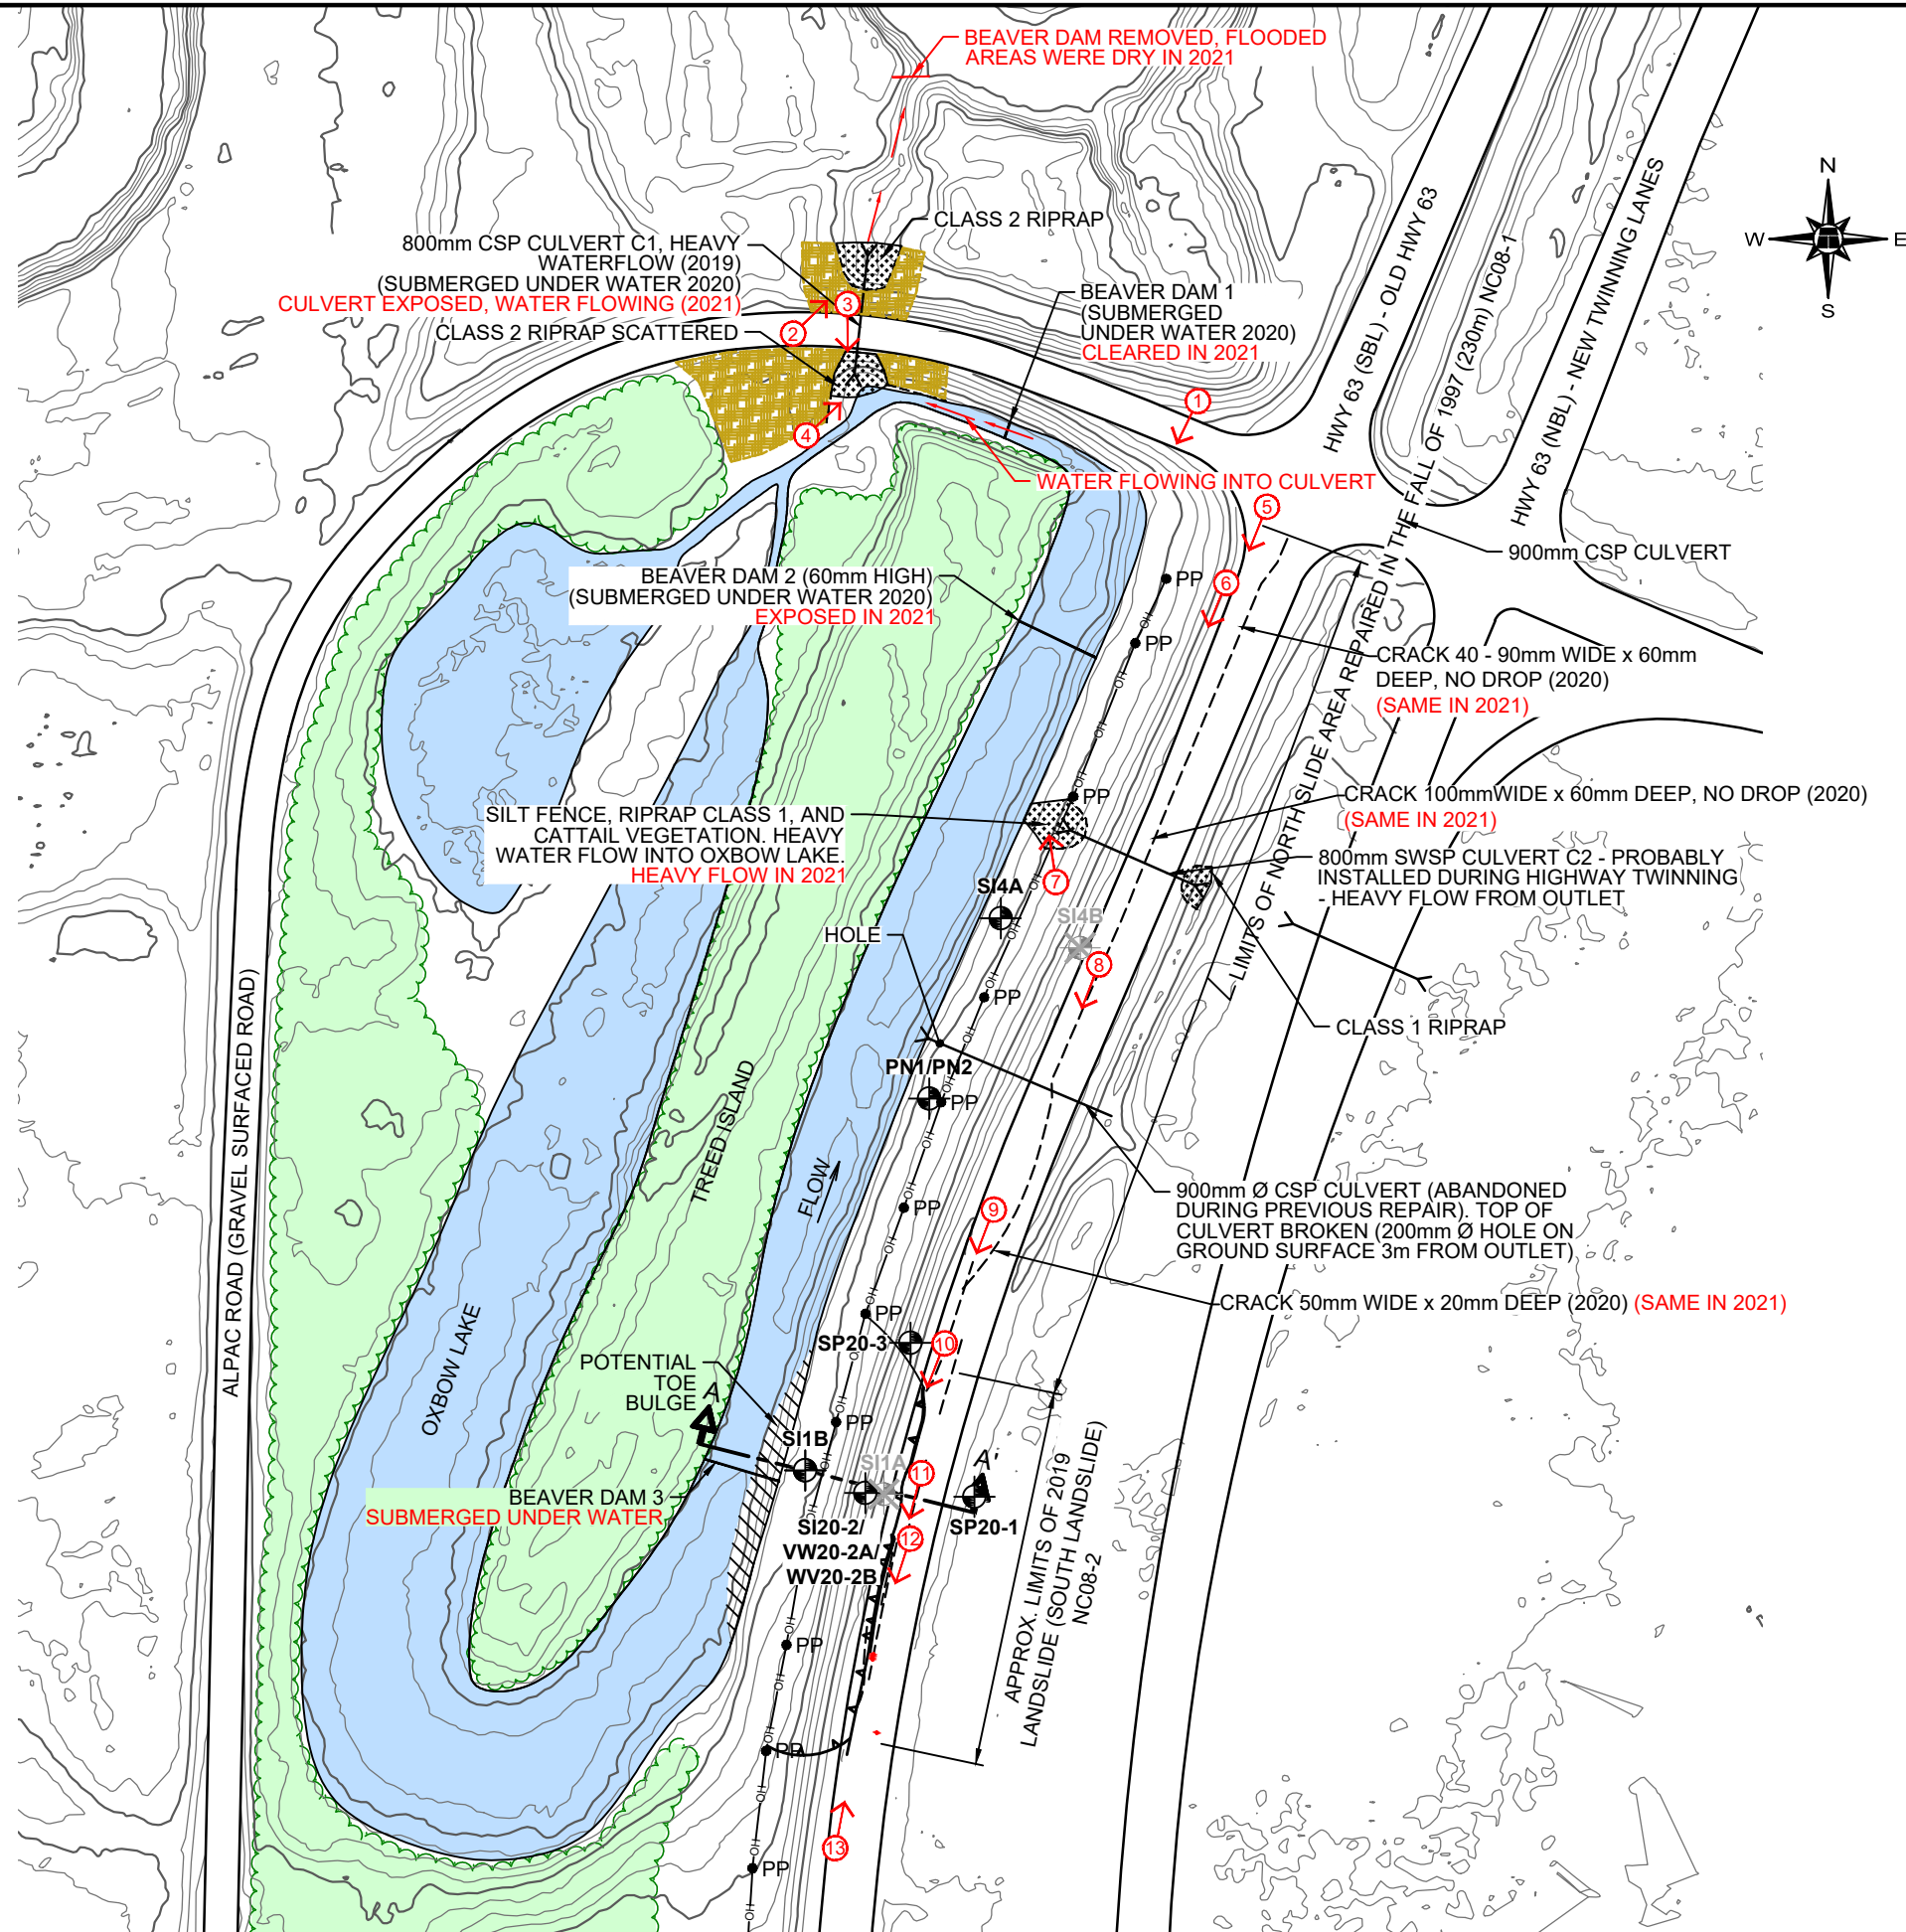
FIGURE NC008-A

NC008: HWY 63:02 LA BICHE RIVER (km 15.6)
SITE PLAN SHOWING EXISTING FEATURES

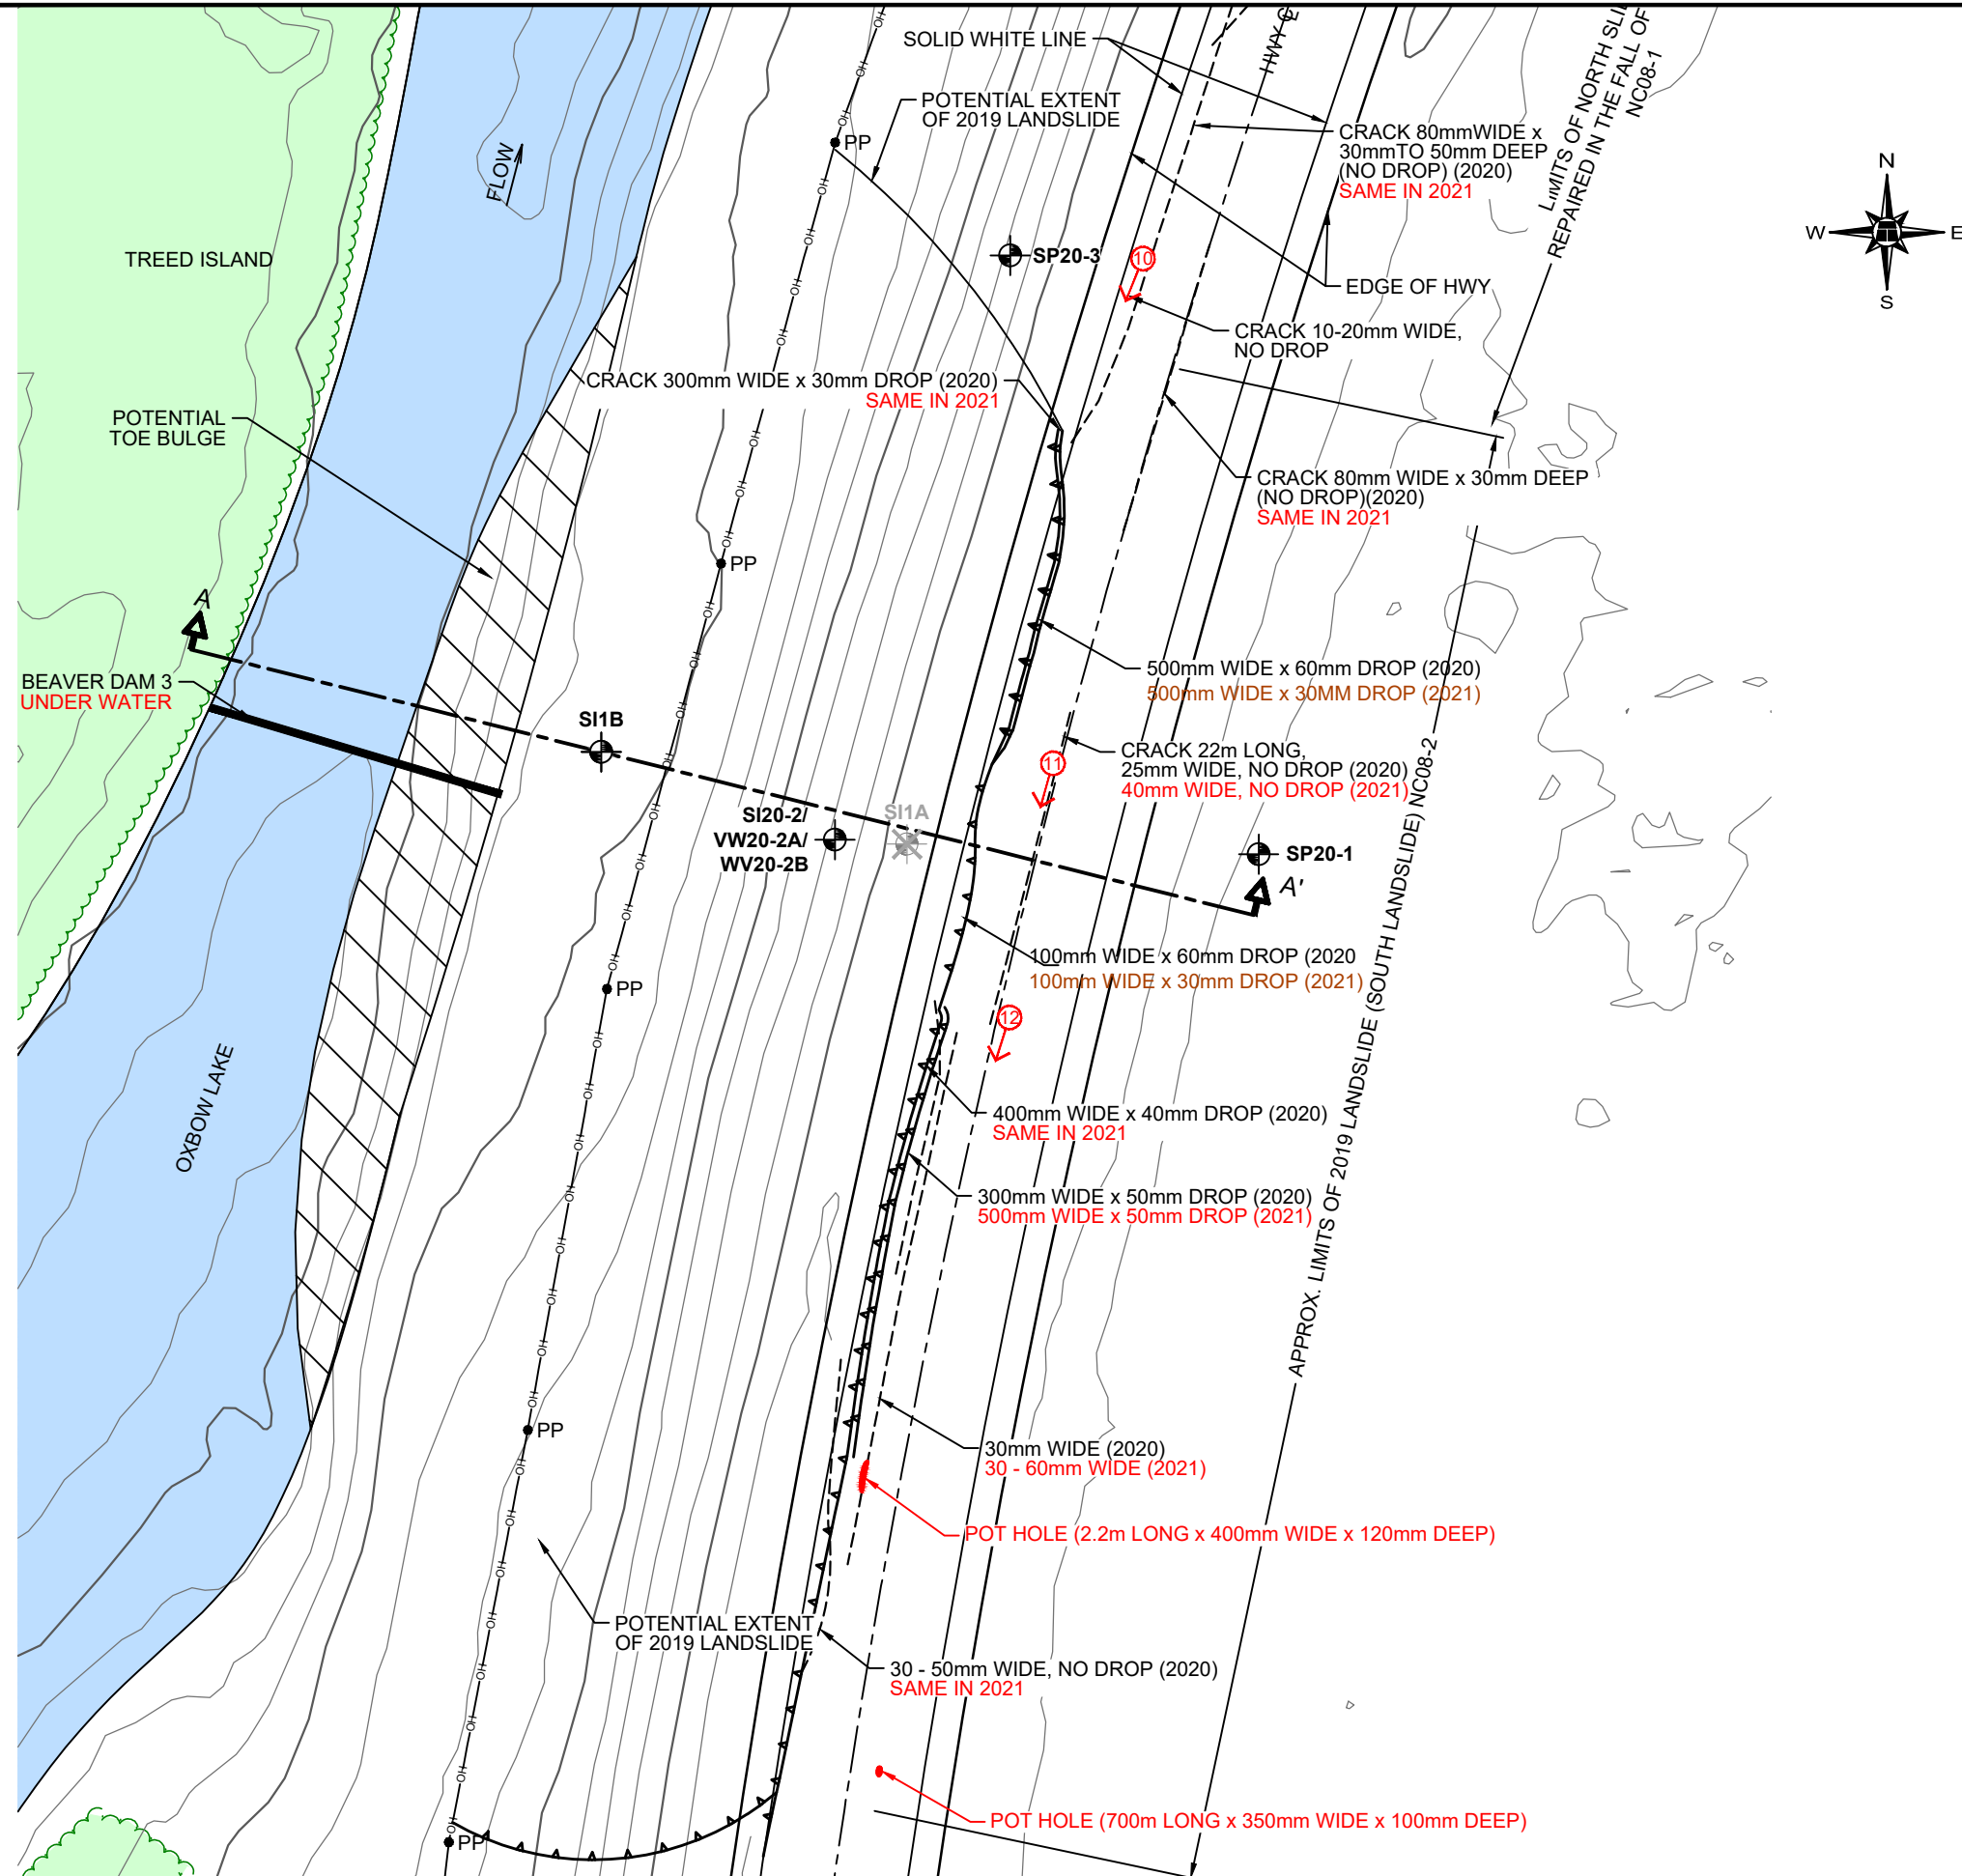
FIGURE NC008-B

**NC008: HWY 63:02 LA BICHE RIVER (km 15.6)
SITE PLAN SHOWING THE SOUTH SLIDE AREA**

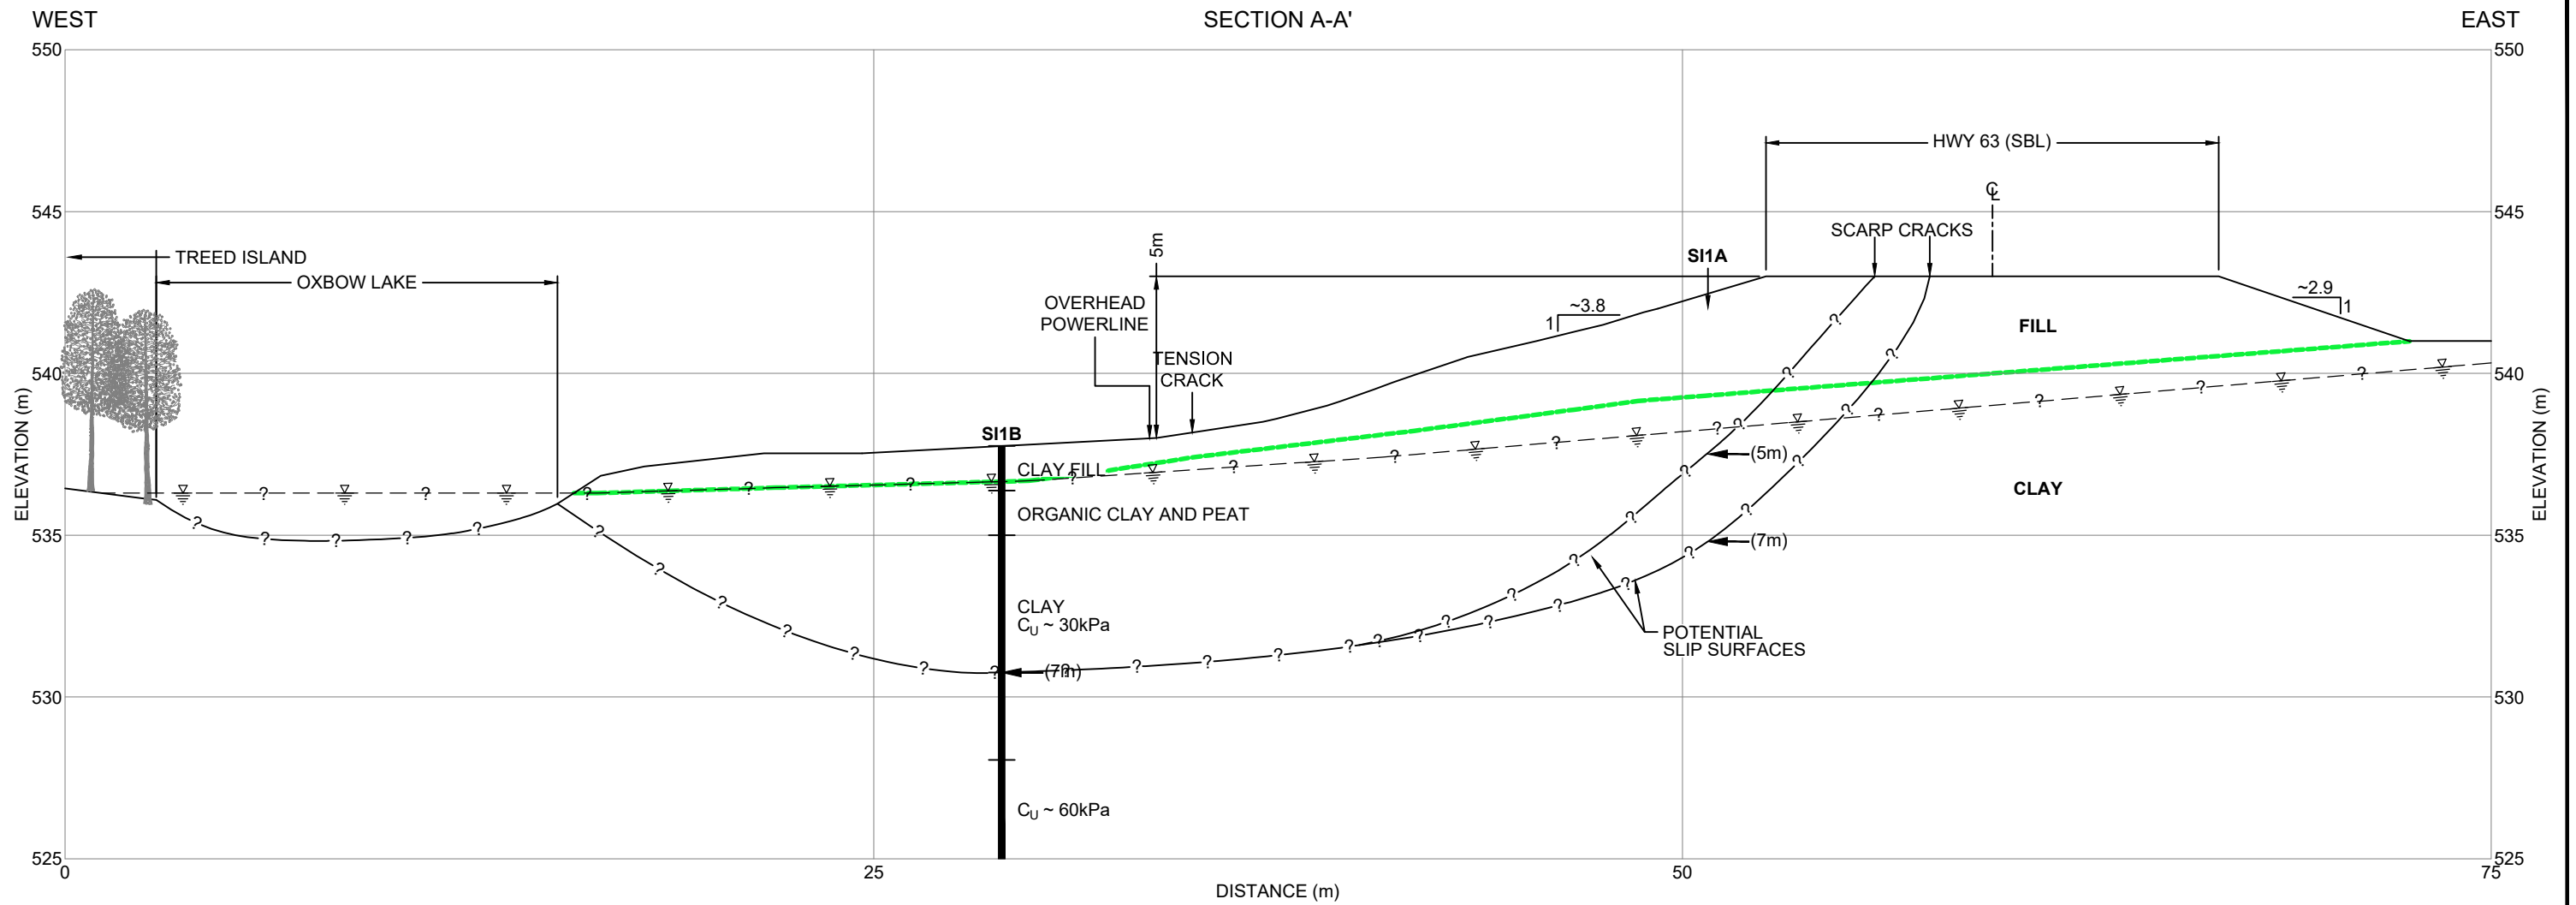
FIGURE NC008-C

**NORTH CENTRAL REGION
(ATHABASCA AND FORT McMURRAY DISTRICTS)
2021 GEOHAZARD ASSESSMENT
NC008: HWY 63:02 LA BICHE RIVER (km 15.6)
CROSS-SECTION A-A'**

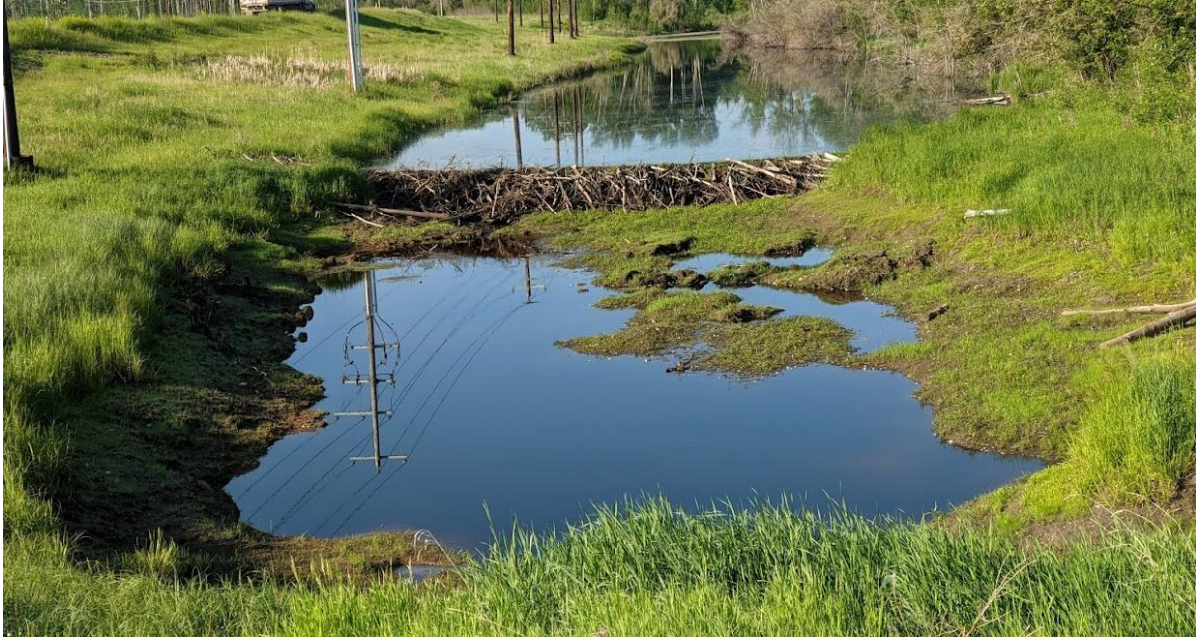
| <input checked="" type="checkbox"/> Other | <p>Three beaver dams were previously noted within the Oxbow Lake. Beaver dam 1 was cleared in 2020; beaver dam 2 was exposed; beaver dam 3 was still submerged under water.</p> <p>Previously submerged Culvert C1 below the ALPAC road was visible due to the removal of the beaver dam to the north of the culvert outlet location. Water was free flowing into the culvert to drain the Oxbow Lake and flooded area noted in 2020; continuous heavy flow from culvert C2 below highway 63 south bound lanes.</p> <p>Power poles and buried phone cables flags were noted within the active landslide area</p> | <input type="checkbox"/> |

Photo No. 1 – Looking south at the Oxbow Lake. Beaver dam 2, which was submerged under water in 2020, was visible during the 2021 site visit

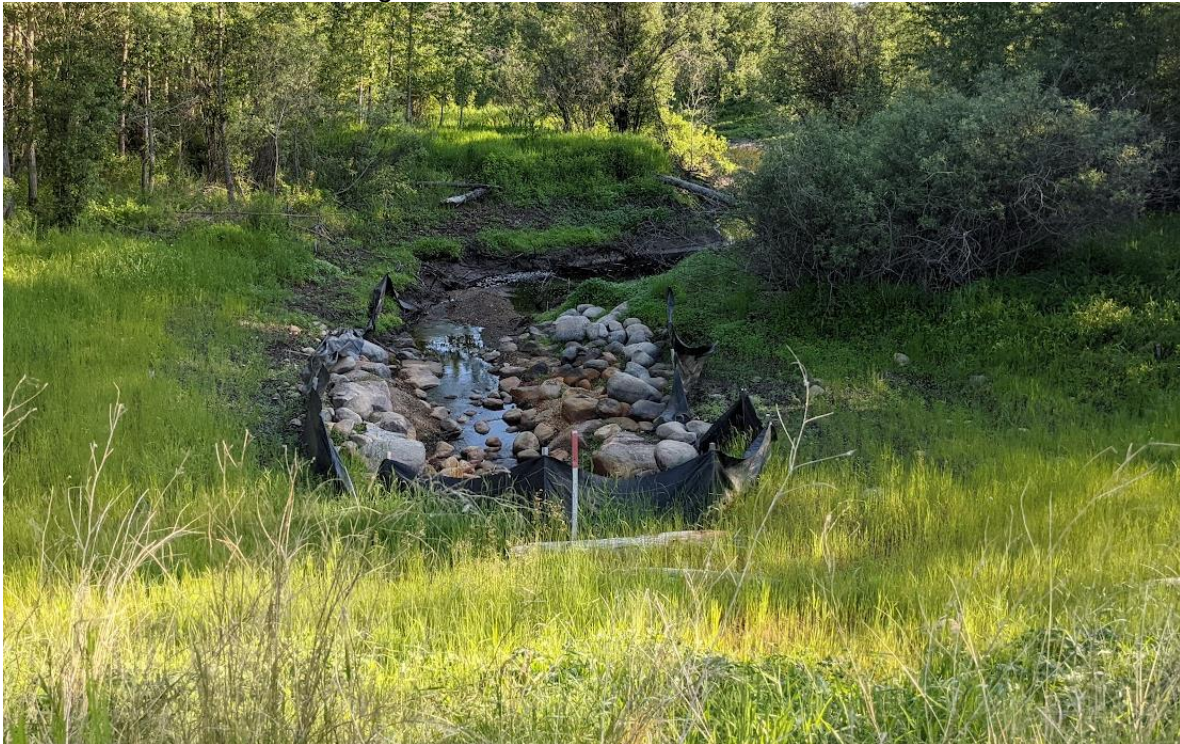
Photo No. 2 – Looking northeast at Culvert C1 outlet. Note that beaver dam, located downstream of the culvert outlet, was cleared so water was flowing freely along the channel

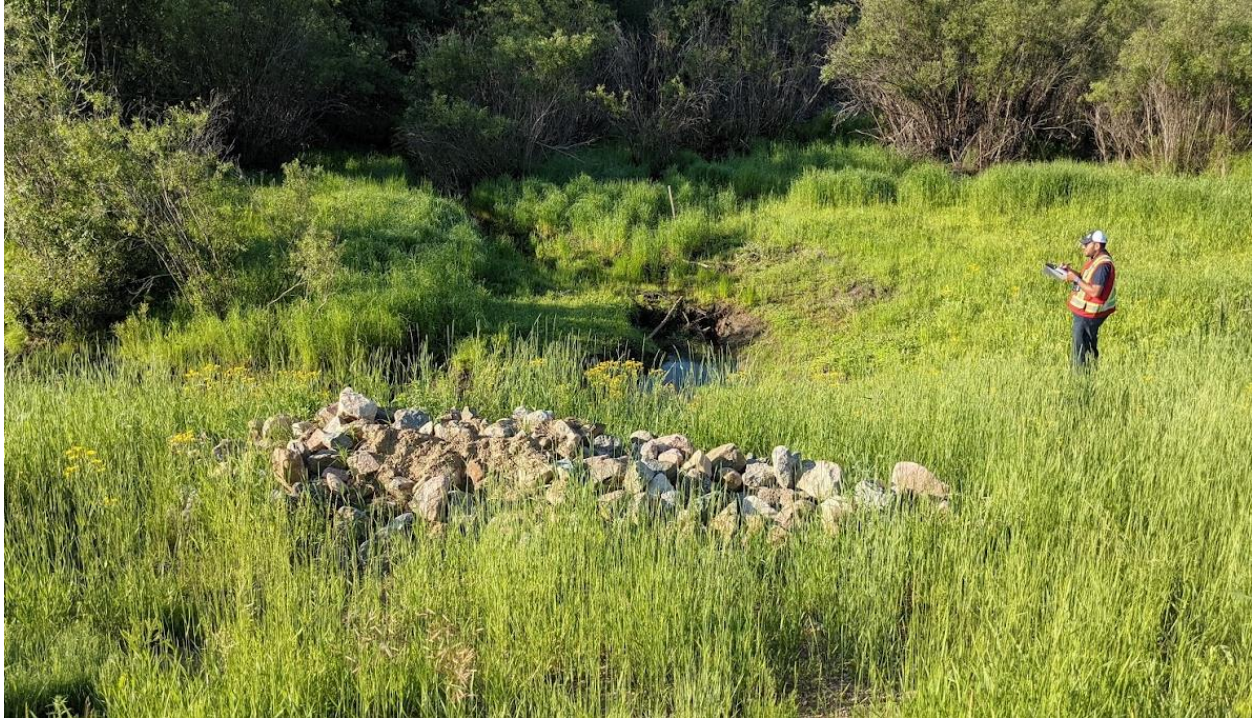
Photo No. 3 – Looking south towards CSP culvert C1 outlet; note that this area was submerged under water in 2020

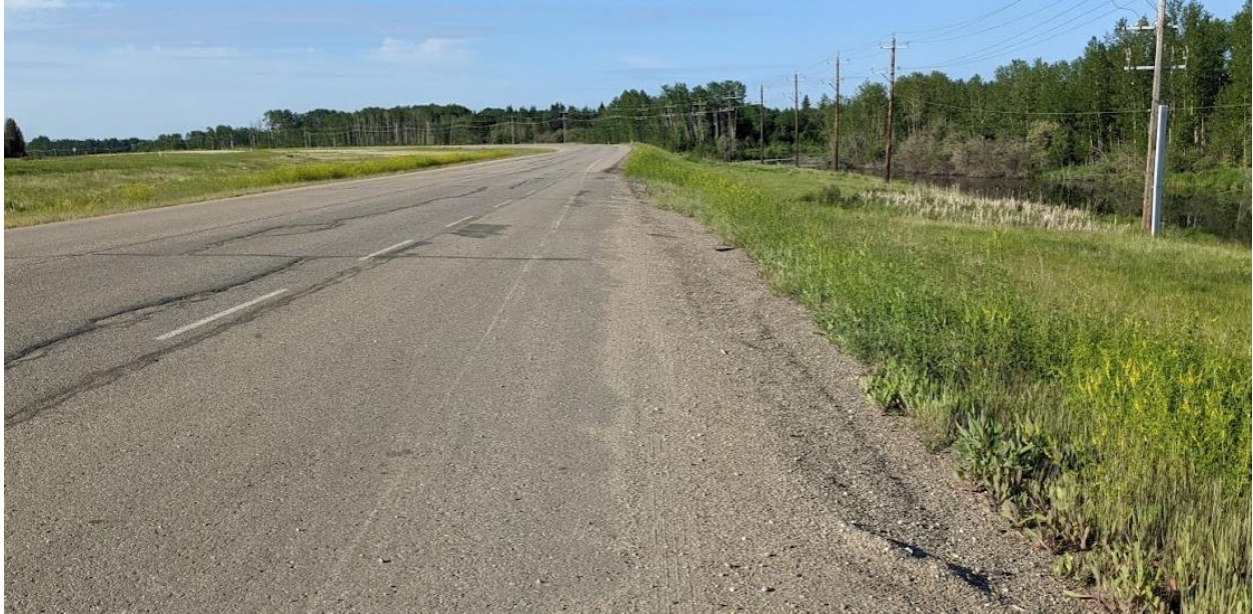
Although the highway cracks were spray patched last year after the 2020 site visit, they opened again, and multiple potholes were also visible on the highway surface. This created rough driving conditions on the highway surface.

Photo No. 5 – Looking south at highway open cracks within the limits of the repaired area in 1997 (previously known as NC08-1)

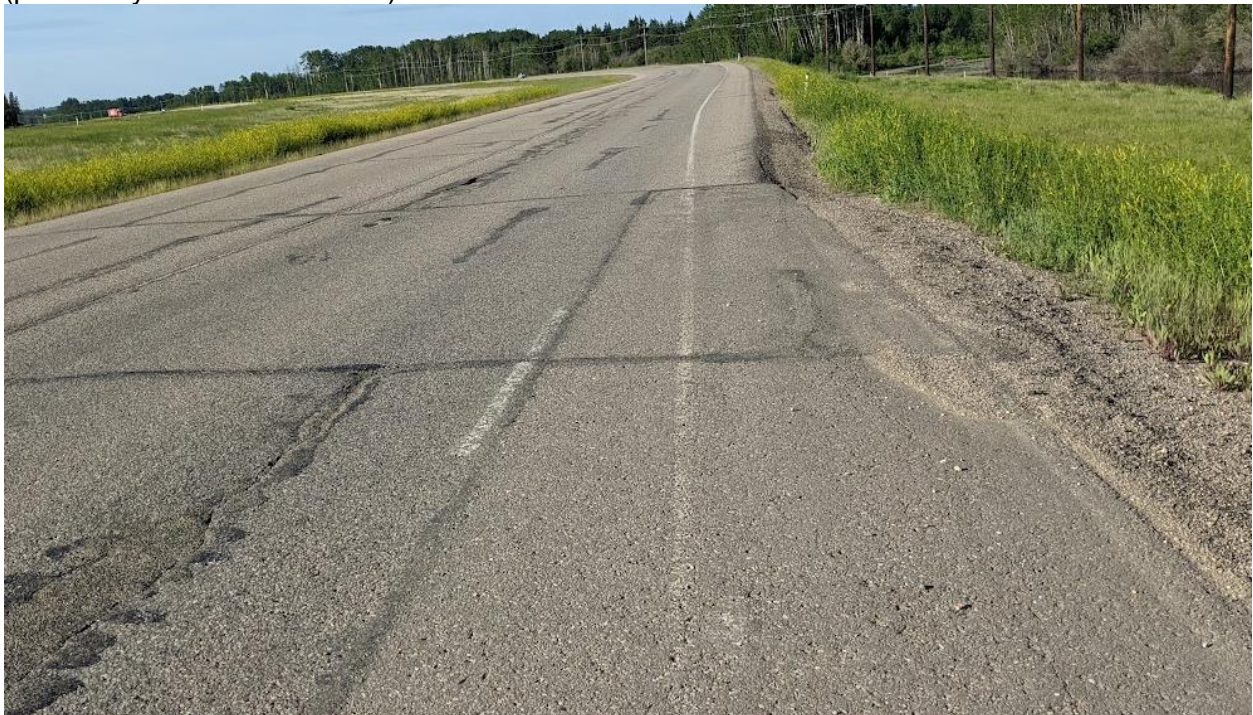
Photo No. 6 – Looking south at highway open cracks and potholes within the limits of the NC08-1 repaired area

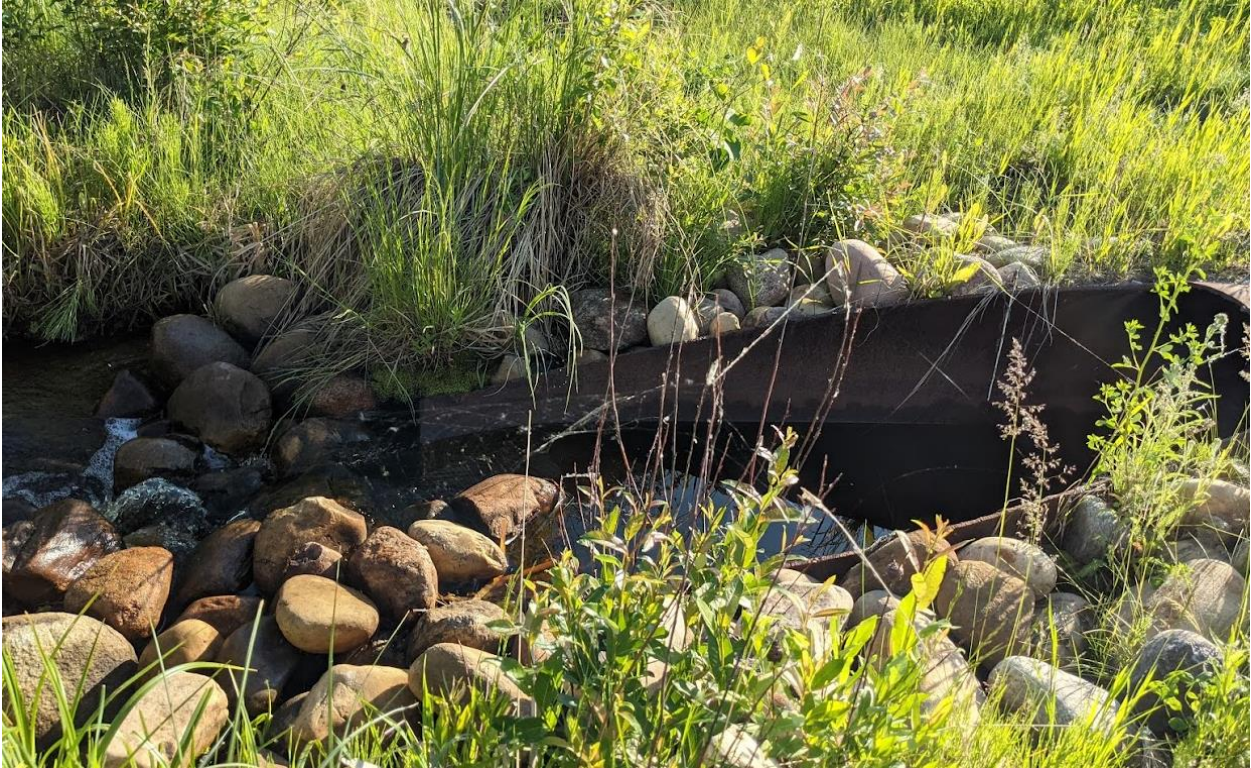
Photo No. 7 – Looking north at 900 mm diameter SWSP Culvert C2 outlet; heavy flow in 2021

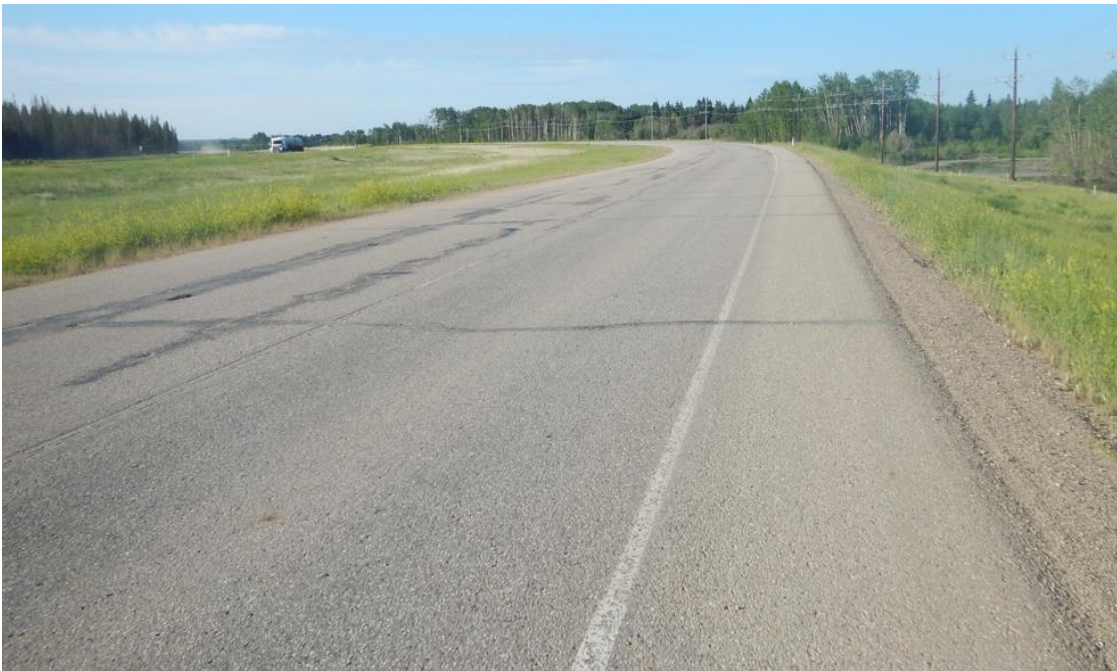
Photo No. 8 – Looking south at highway open cracks within the limits of the repaired area in 1997 (NC08-1)

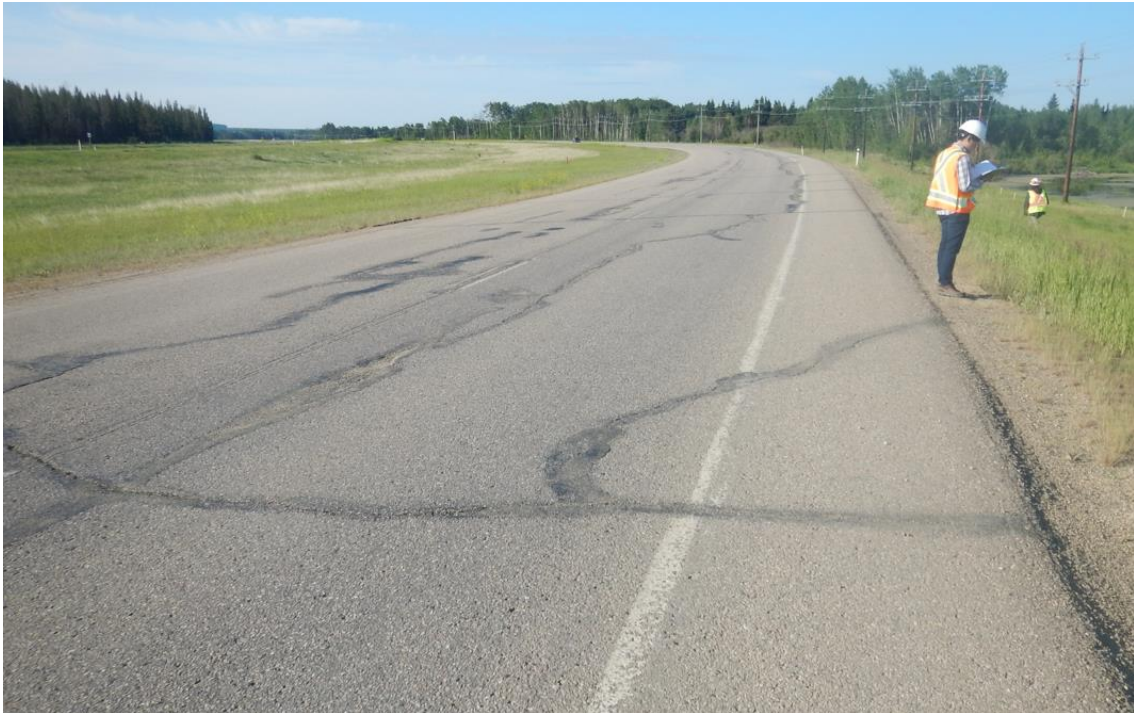
Photo No. 9 – Looking south at the southern flank cracks of the NC08-1 repaired landside. Note that cracks were spray patched in 2020

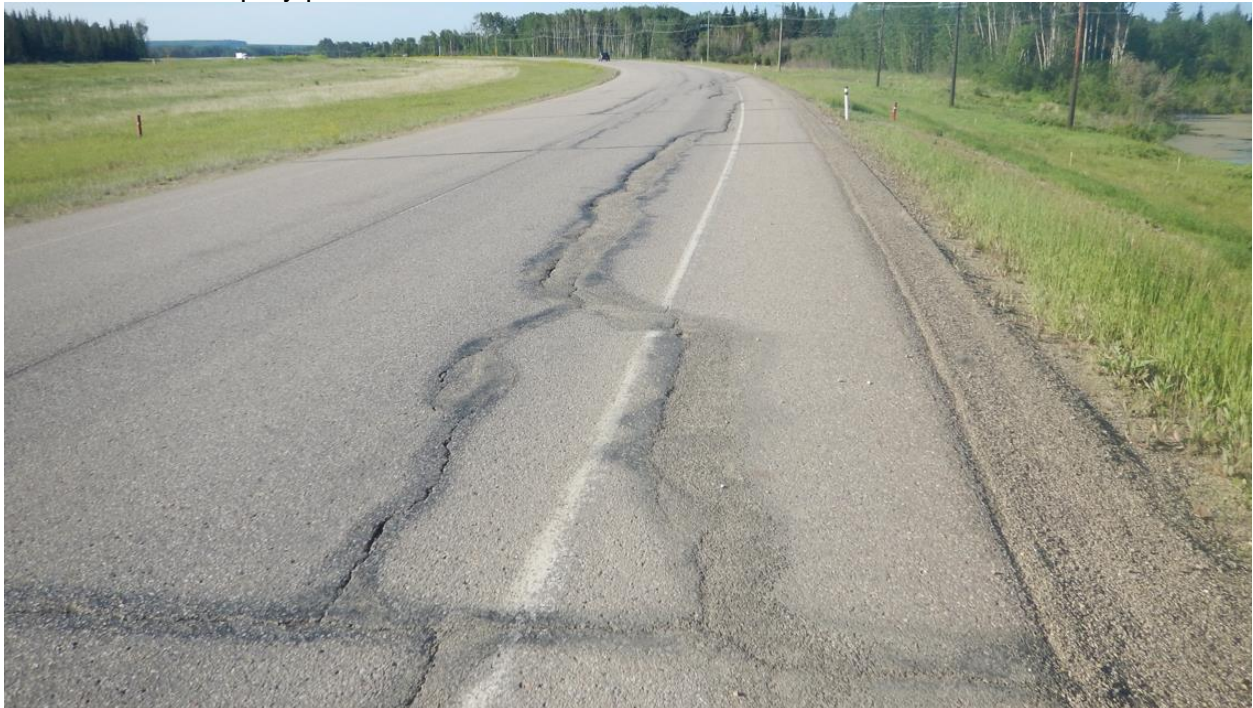
At the new landslide location, the drop noted on the highway most western lane continues to create rough driving conditions and constitutes a safety hazard to motorists.

Photo No. 10 – Looking south at the northern flank of the new landslide (previously known as NC08-2); note exiting drop within the highway lane

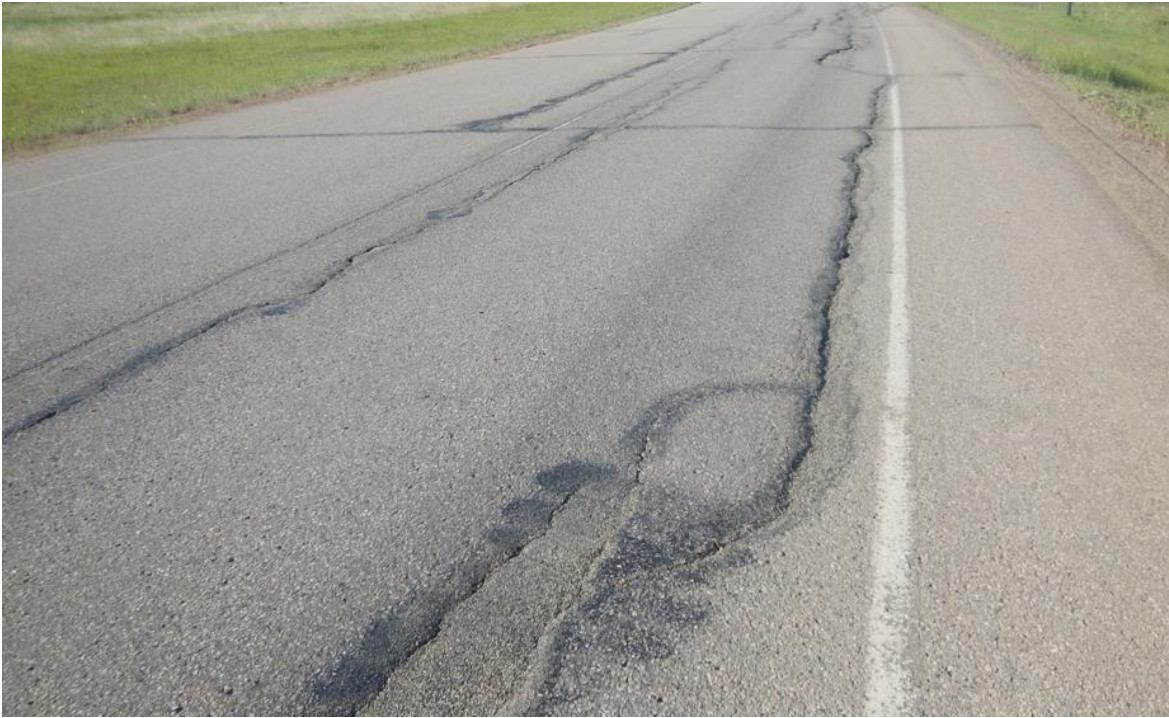
Photo No. 11 – Looking south at highway cracks at the central portion of the south landslide (NC08-2)

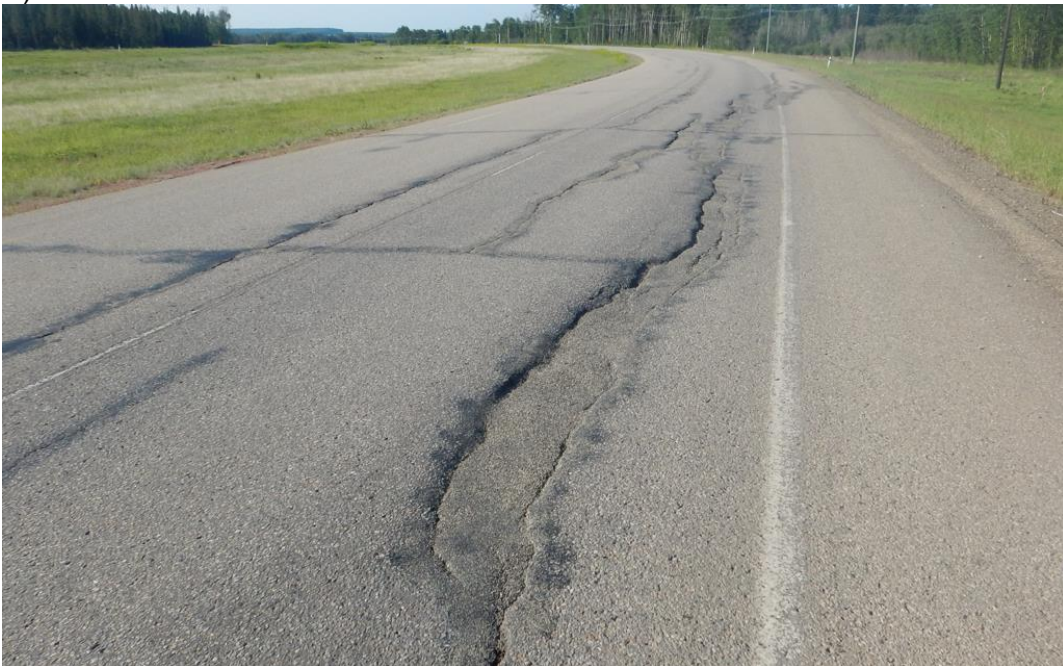
Photo No. 12 – Looking south at highway cracks near the southern flank of the south landslide (NC08-2)

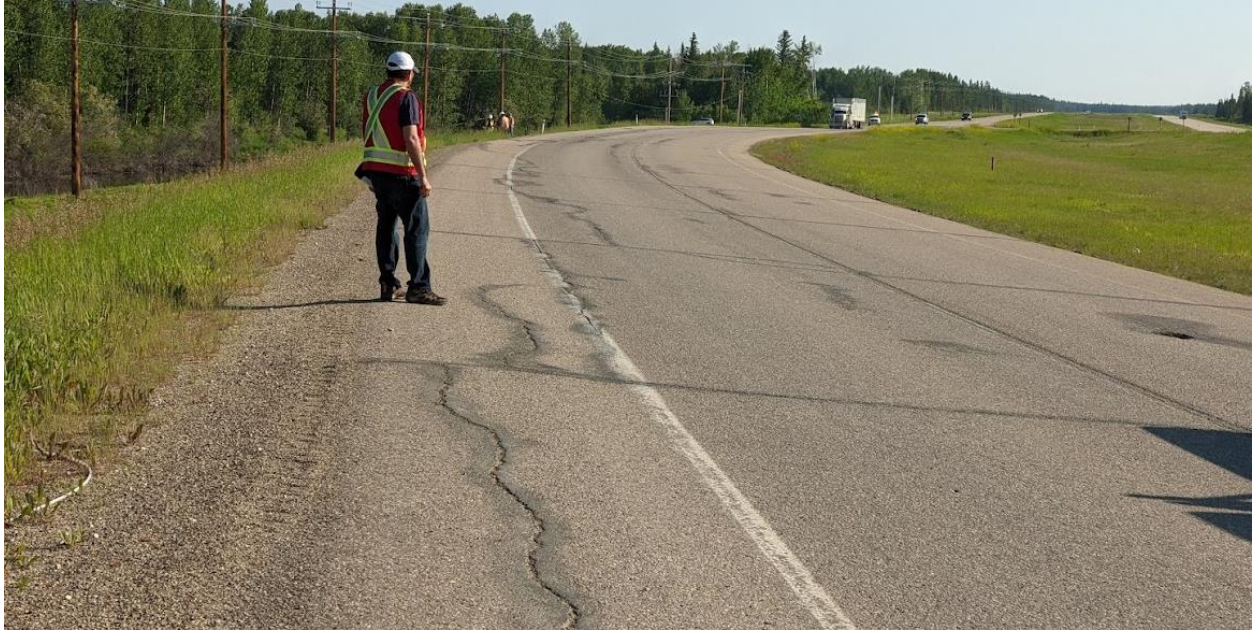
Photo No. 13 – Looking north at highway cracks near the south flank of the south landslide (NC08-2)
