October 26, 2022

**ALBERTA TRANSPORTATION GRMP (CON0022163)  
NORTH CENTRAL (ATHABASCA AND FORT McMURRAY DISTRICTS)  
INSTRUMENTATION MONITORING RESULTS – FALL 2022**

**SECTION C**

**SITE NC008: HWY 63:02 NORTH OF LA BICHE RIVER**

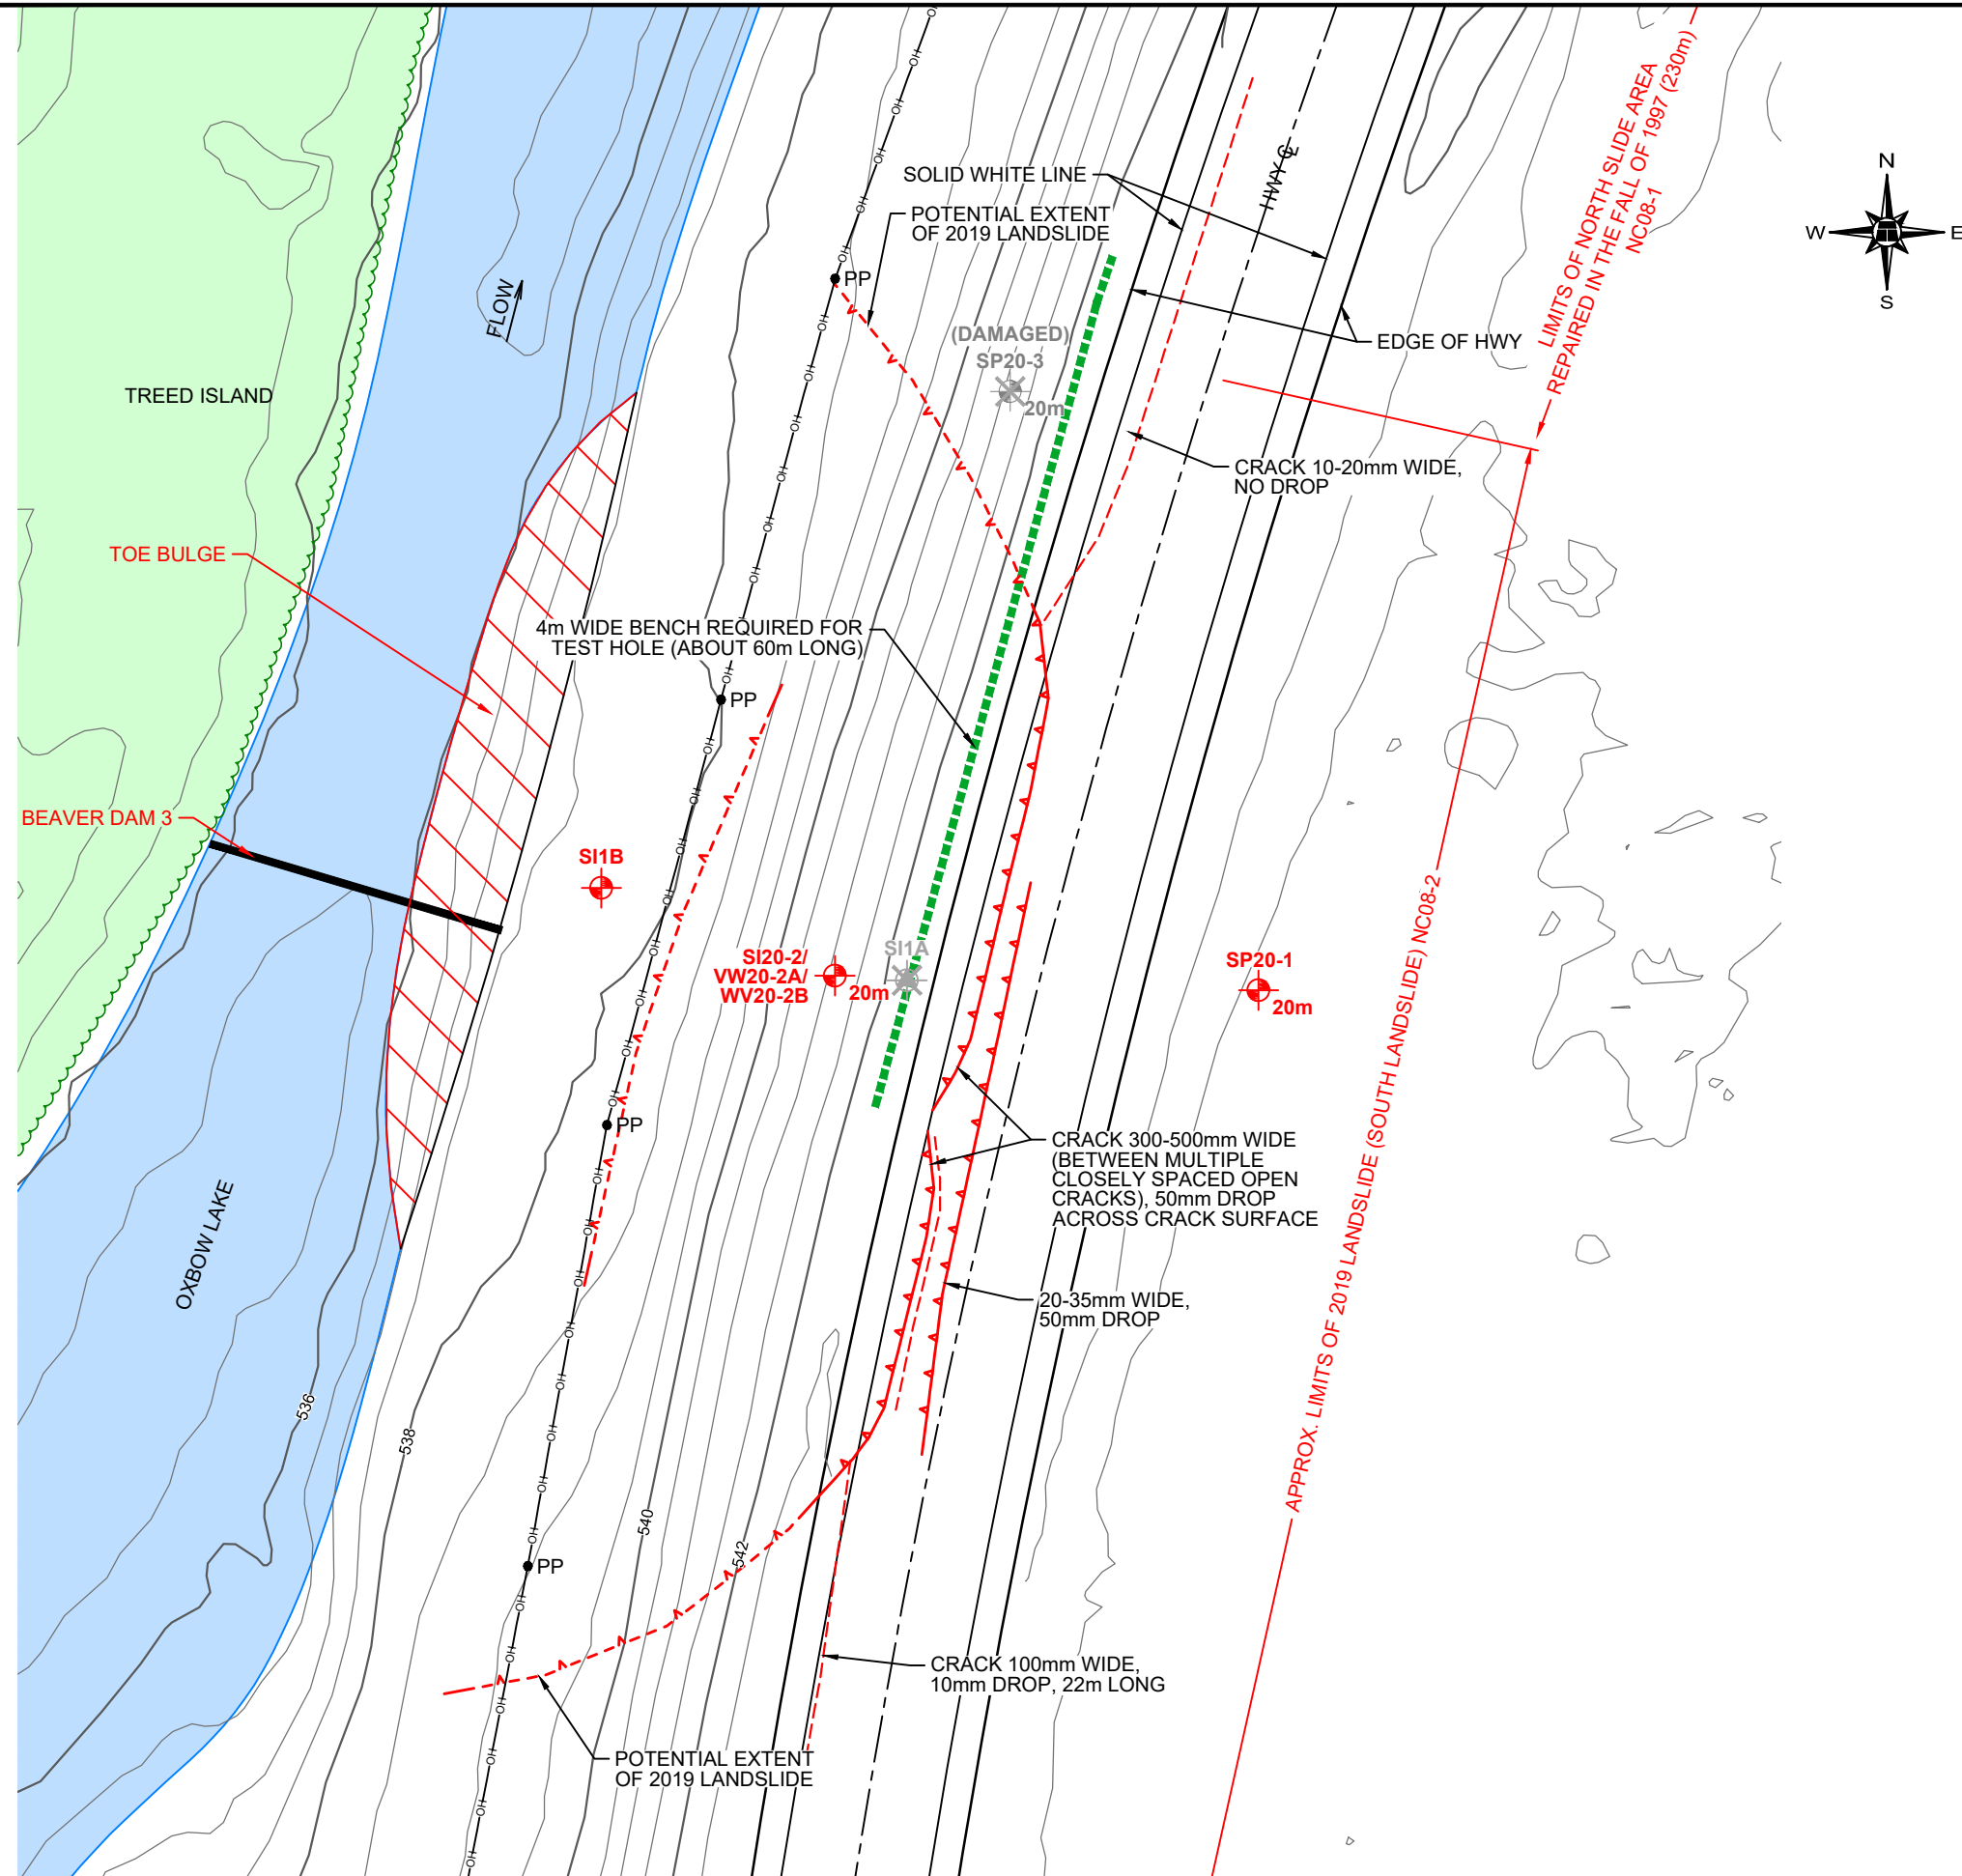
SP20-3 was damaged by a mower since the spring of 2022 readings. It was determined that the piezometer was damaged at 3 m below the top of the casing, so it is likely not economical to repair this instrument. It is recommended to delete this instrument from the readings program.

SP20-3 is damaged by lawn mower, joint at 10 ft was not connected. Repair not possible. See photograph.

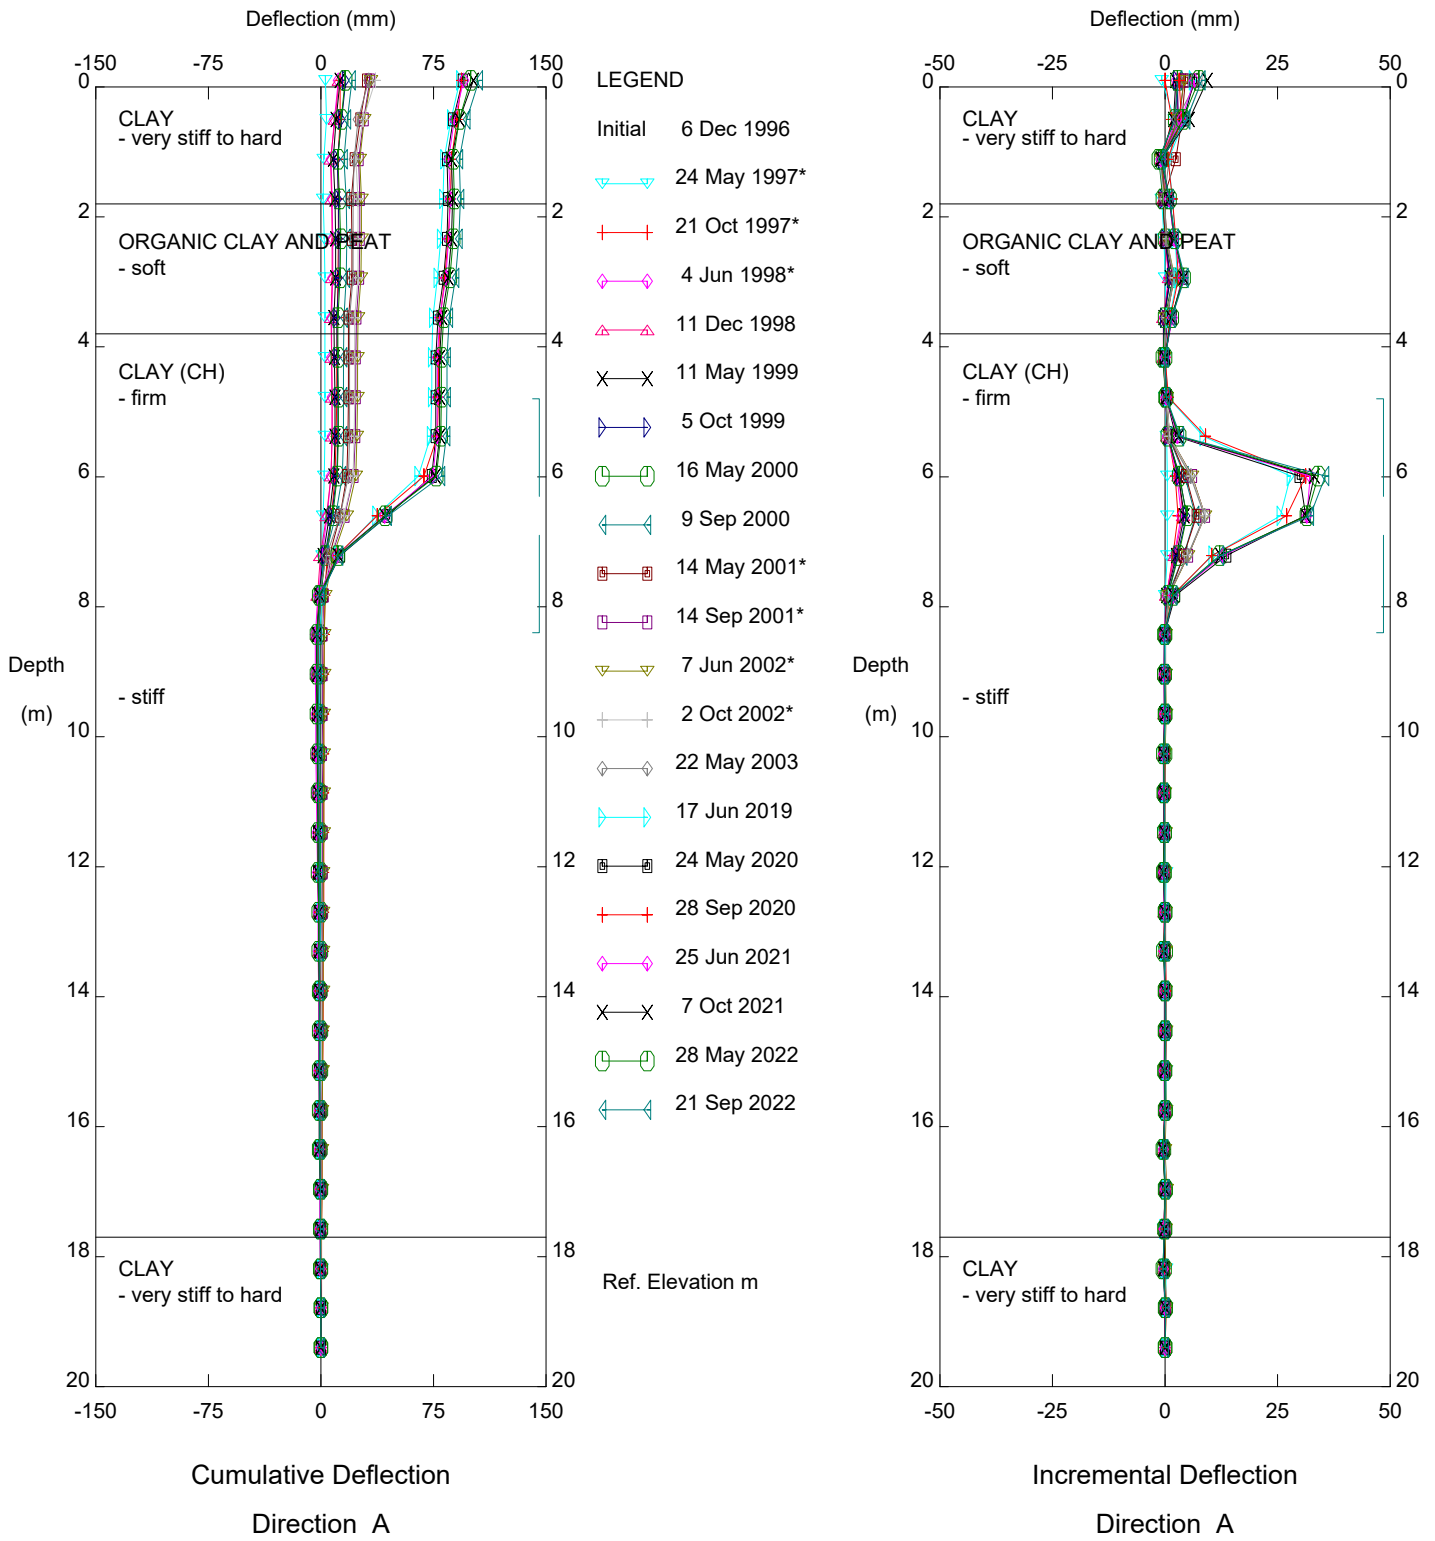
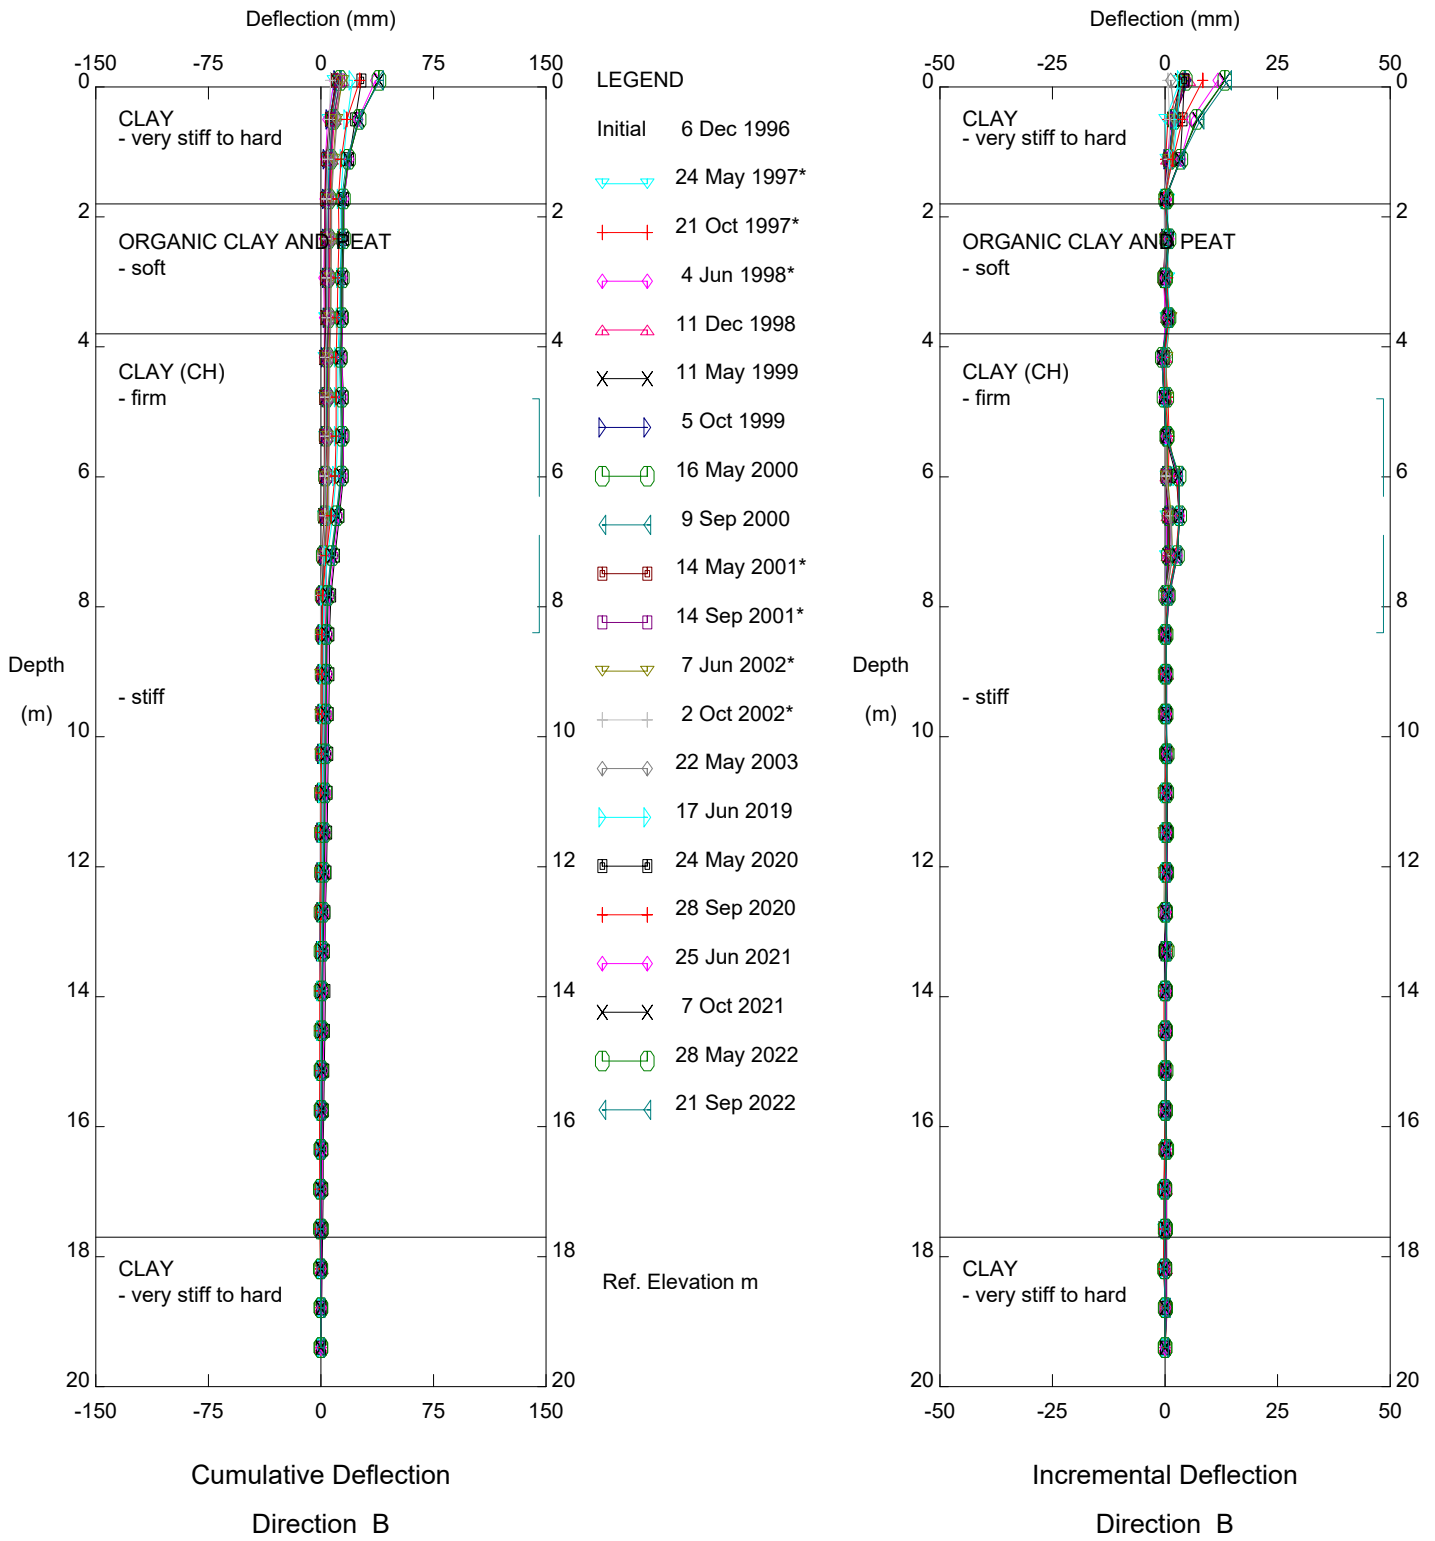
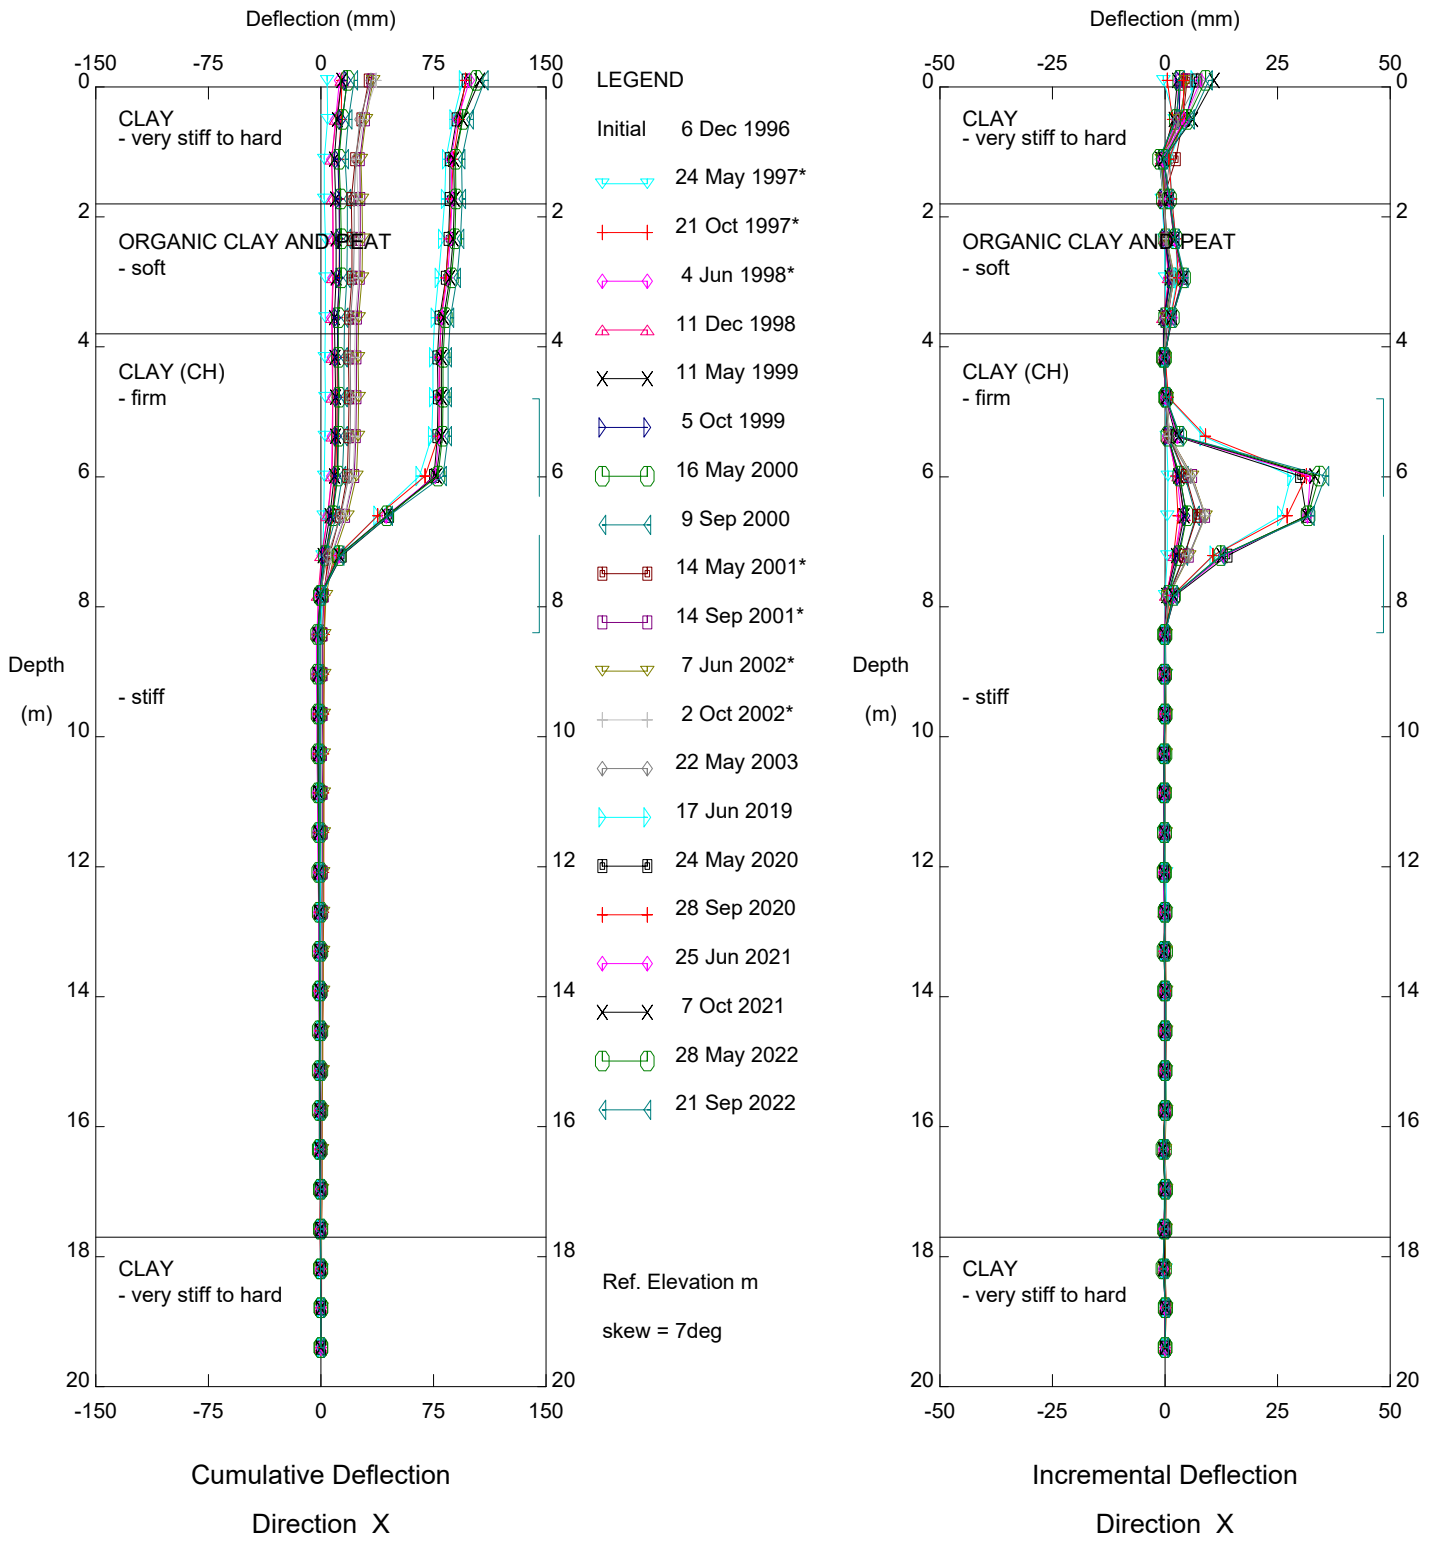
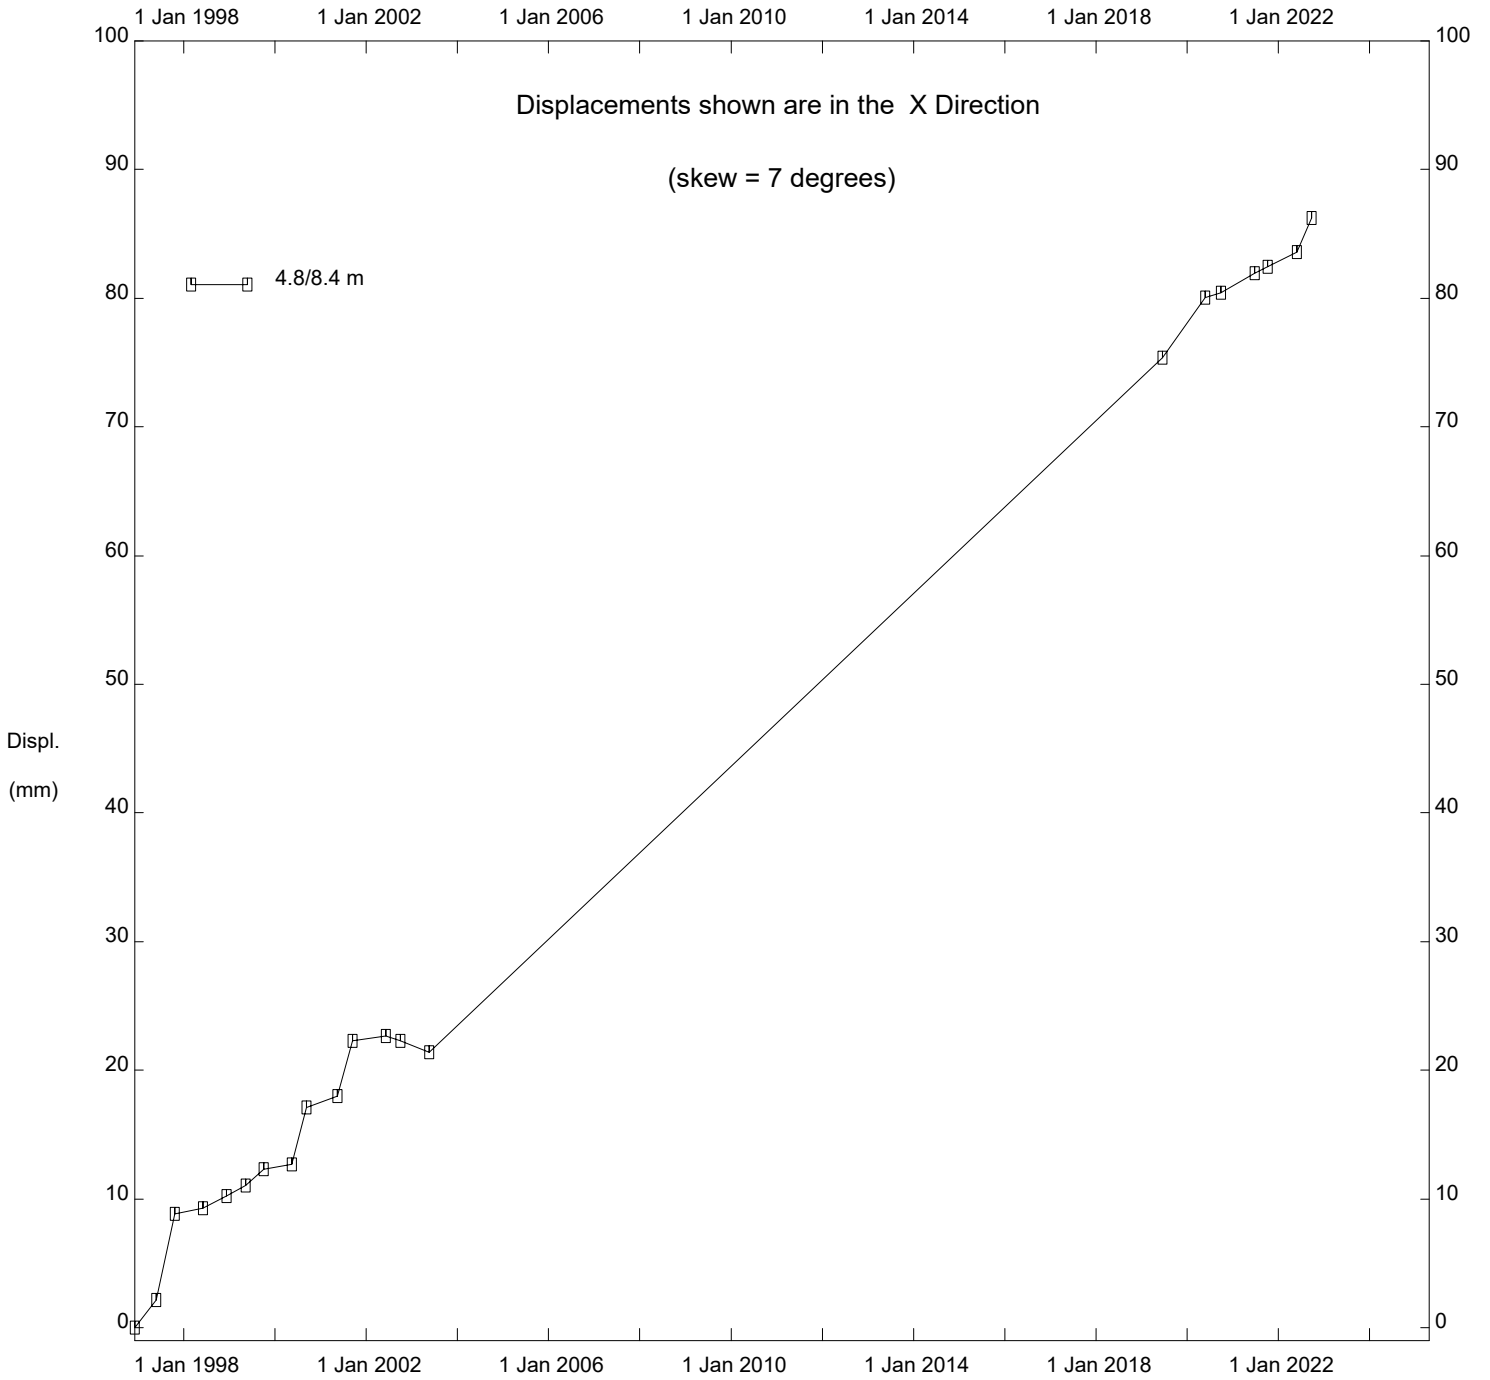
Labiche River, Inclinometer SI#1B

SI1B showed a rate of movement of 8.4 mm/yr over 4.8 m to 8.4 m depth since the spring of 2022 readings. SI20-2 showed a rate of movement of 9.1 mm/yr over 3.8 m to 7.4 m depth since the spring of 2022 readings. The SIs showed accelerated movement rates compared to the past several readings cycles, which likely corresponds to the elevated groundwater levels observed in the piezometers. The movement zones in both SIs are within the native high plastic clay below the highway embankment fill.

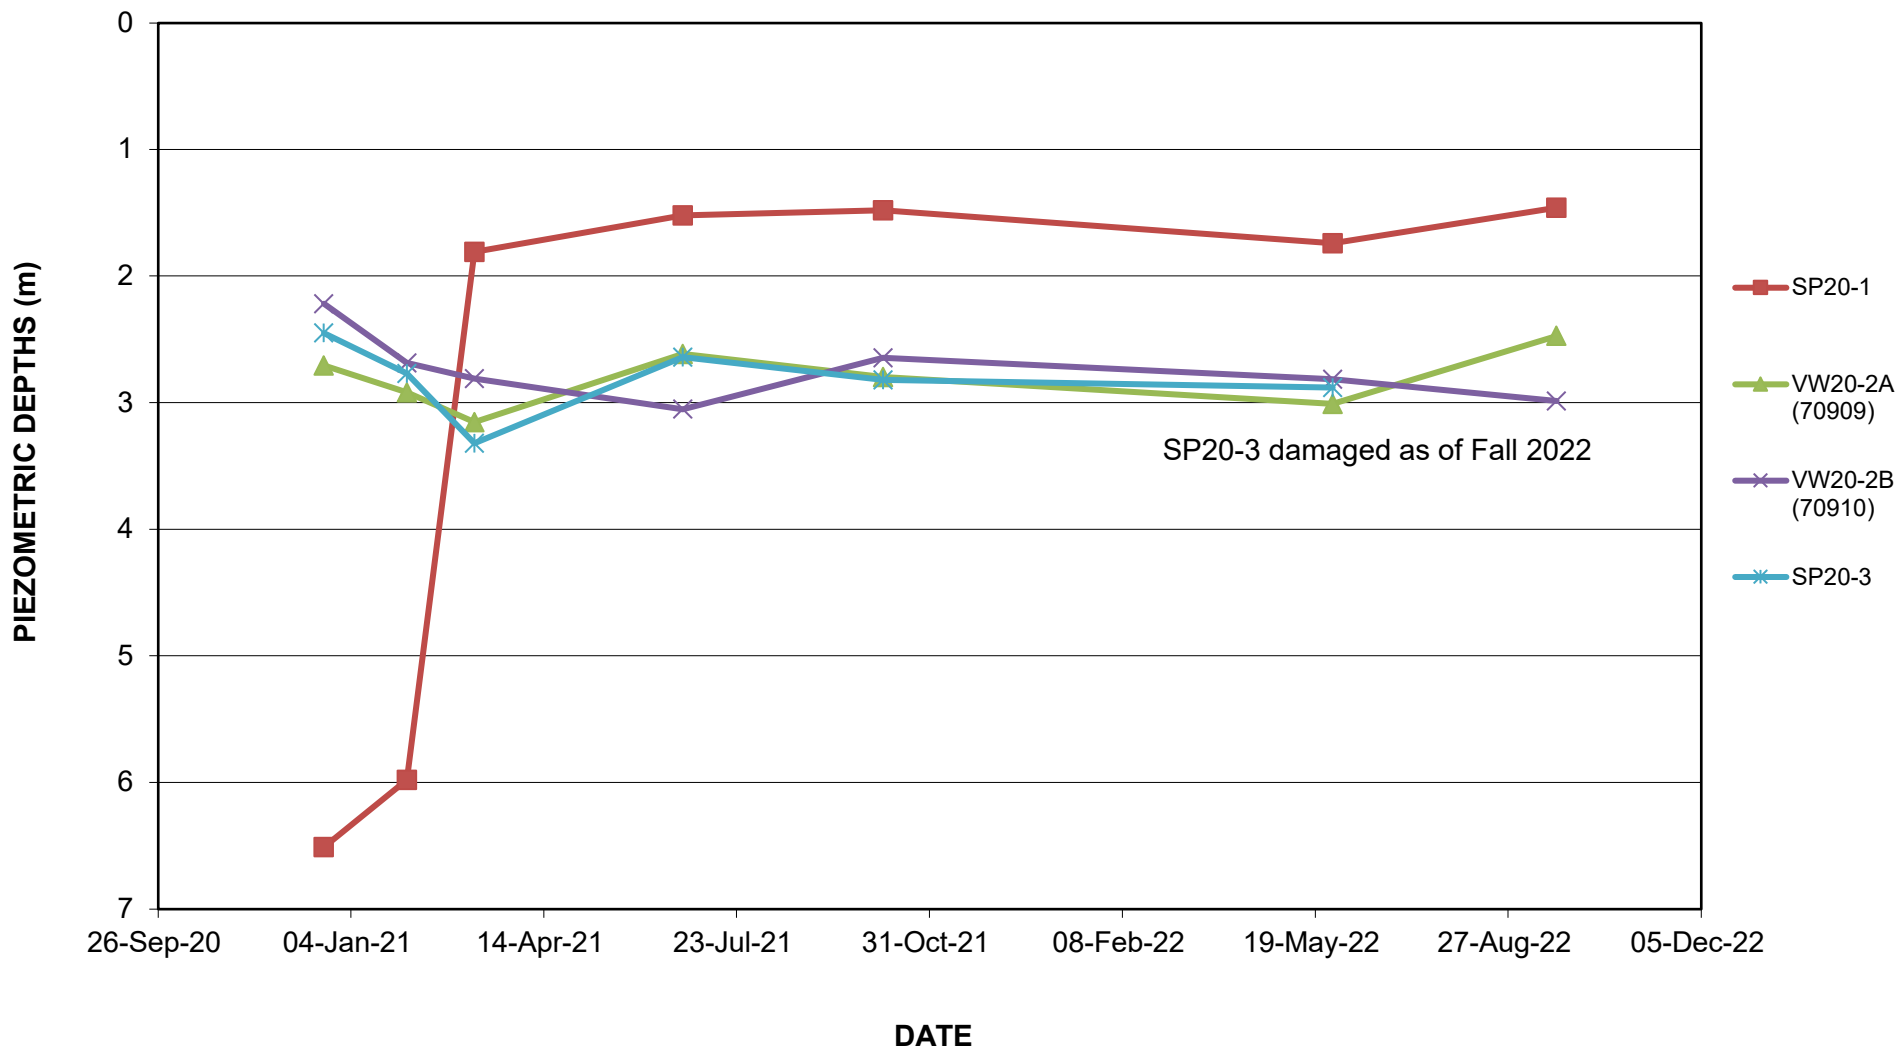
**FIGURE NC008-1  
 HWY 63:02 NORTH OF LA BICHE RIVER BRIDGE (KM 15.6)  
 VIBRATING WIRE AND STANDPIPE PIEZOMETER DATA**

Standpipe piezometer SP20-1 showed an increase in groundwater level of 0.28 m compared to the spring of 2022 readings and is currently showing the highest groundwater level measured in the instrument since initialization. The standpipe piezometer readings are summarized in Table NC008-3.

Vibrating wire piezometers VW20-2A and VW20-2B showed increases in groundwater level of 0.54 m and 0.48 m, respectively, since the spring of 2022 readings. Both piezometers are showing the highest groundwater levels measured in the respective instruments since initialization. The vibrating wire piezometer readings are summarized in Table NC008-4. The standpipe, pneumatic, and vibrating wire piezometer readings are plotted on Figure NC008-1 in Appendix A.
