**ALBERTA TRANSPORTATION
GEOHAZARD ASSESSMENT PROGRAM
NORTH CENTRAL REGION – ATHABASCA &
FORT MCMURRAY DISTRICTS
2022 SITE INSPECTION**

Site #	Location	Name	Hwy	km
NC008	15.6 Km North of Hwy 63 & 55 Intersection	La Biche River (0.8 to 0.9 km North of Bridge)	63:02	15.6
Legal Description		UTM Co-ordinates (NAD 83)		
3-69-17 W4		12	N 6089536	E 403480

**NC008: HWY 63:02 LA BICHE RIVER (km 15.6)
SITE PLAN SHOWING EXISTING FEATURES**

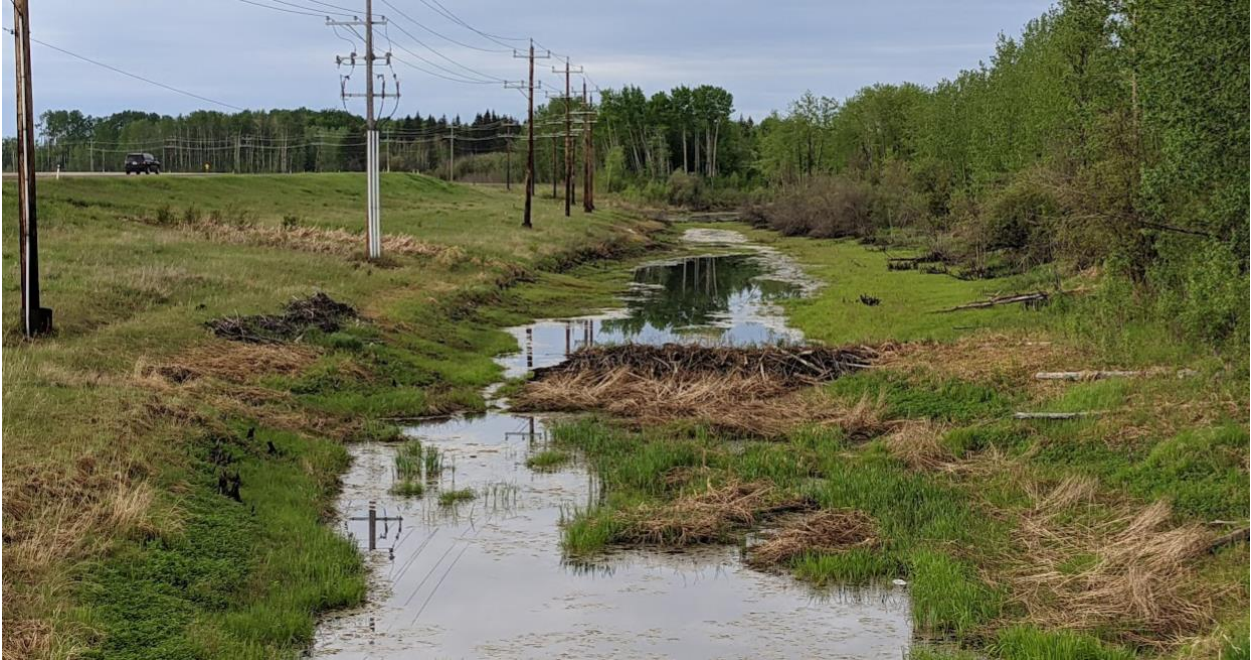
The water level in the lake was noted to be low, and this may have enhanced the stability of the landslide at this time. It appears that the NE corner of Beaver Dam 2 was breached, resulting in at least 1.2 m drop of the water level in the lake.

Photo No. 1 – Looking south at the Oxbow Lake. NE cover of Beaver Dam 2 was breached; water levels dropped by at least 1.2 m behind the dam

- (c) Place speed reduction signs, as needed, prior to the placement of the ACP patch at NC08-2 location.
- (d) Consider removing all beaver dams within the Oxbow Lake to reduce water levels within the highway embankment.

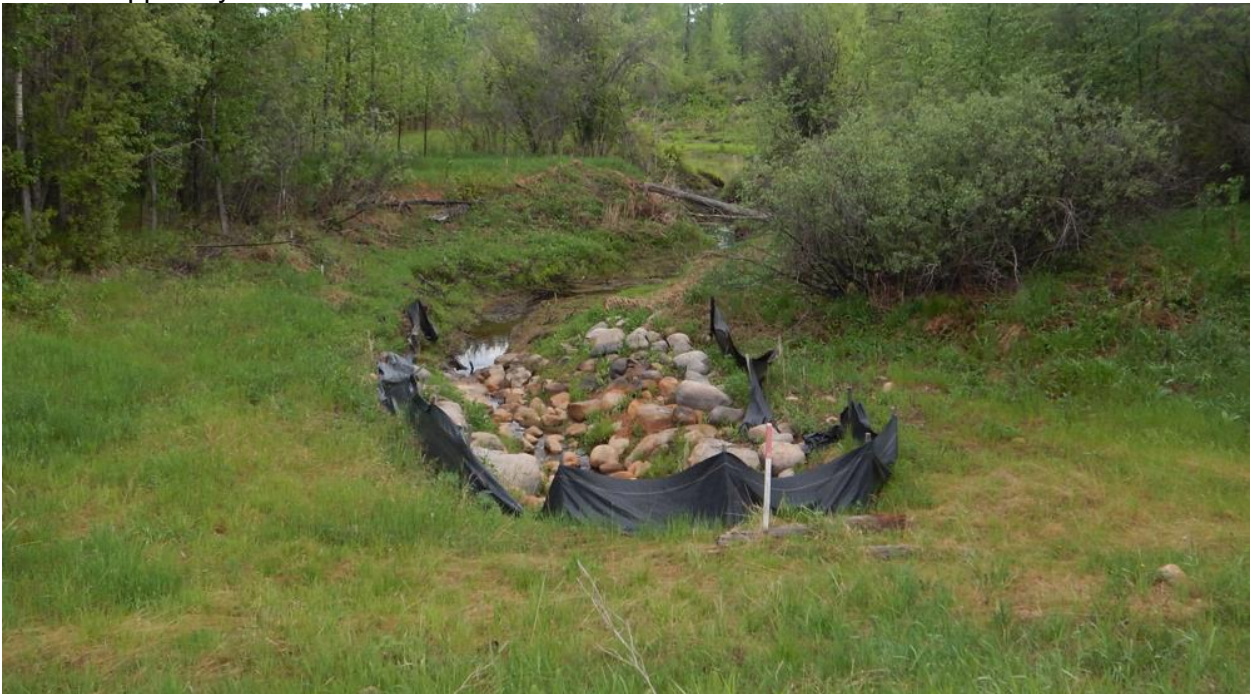
The flooded area, noted in 2020 within the northern limit of the site, drained through Culvert C1 after the removal of the beaver dams. This help reducing water levels within the Oxbow Lake and the likelihood of flooding the ALPAC road. If the beaver dams are not kept under control, progressive rise in water levels in future years could result in washout of the ALPAC road and saturation of highway 63 embankment fills (depending on the beaver dam's height and water levels in the lake).

Photo No. 2 – Looking northeast at Culvert C1 outlet; water continues to flow freely along the channel

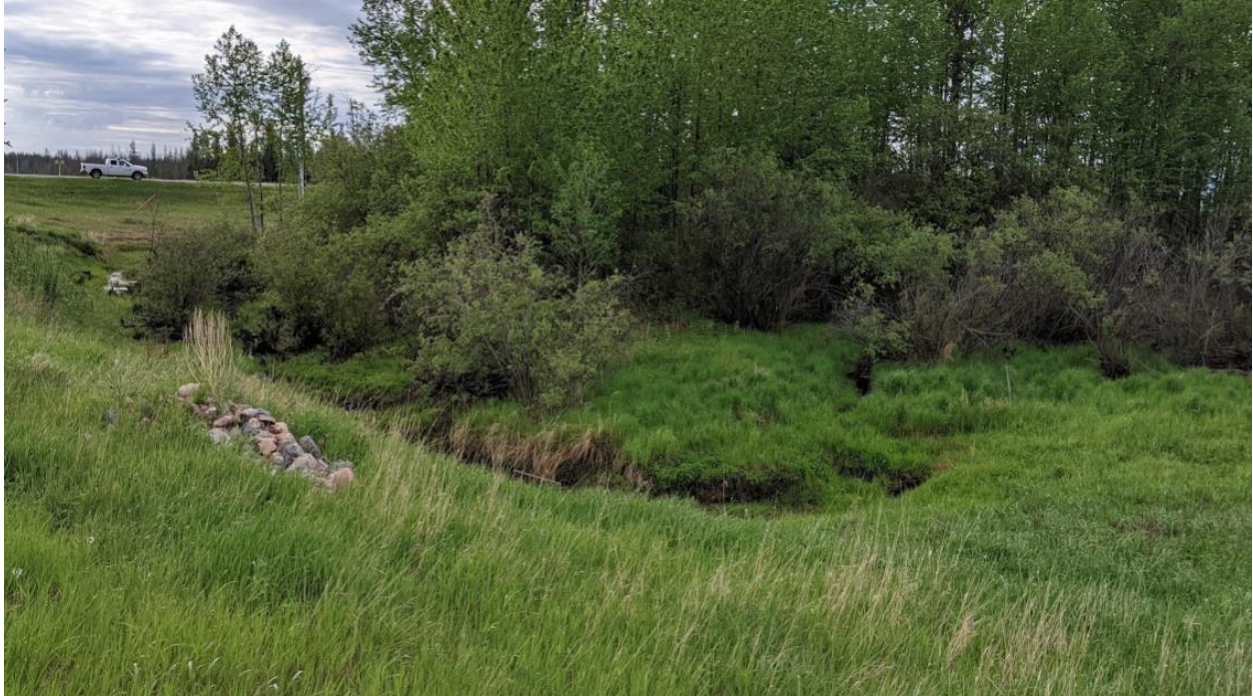
Photo No. 3 – Looking east towards CSP culvert C1 outlet; note that this area was submerged under water in 2020

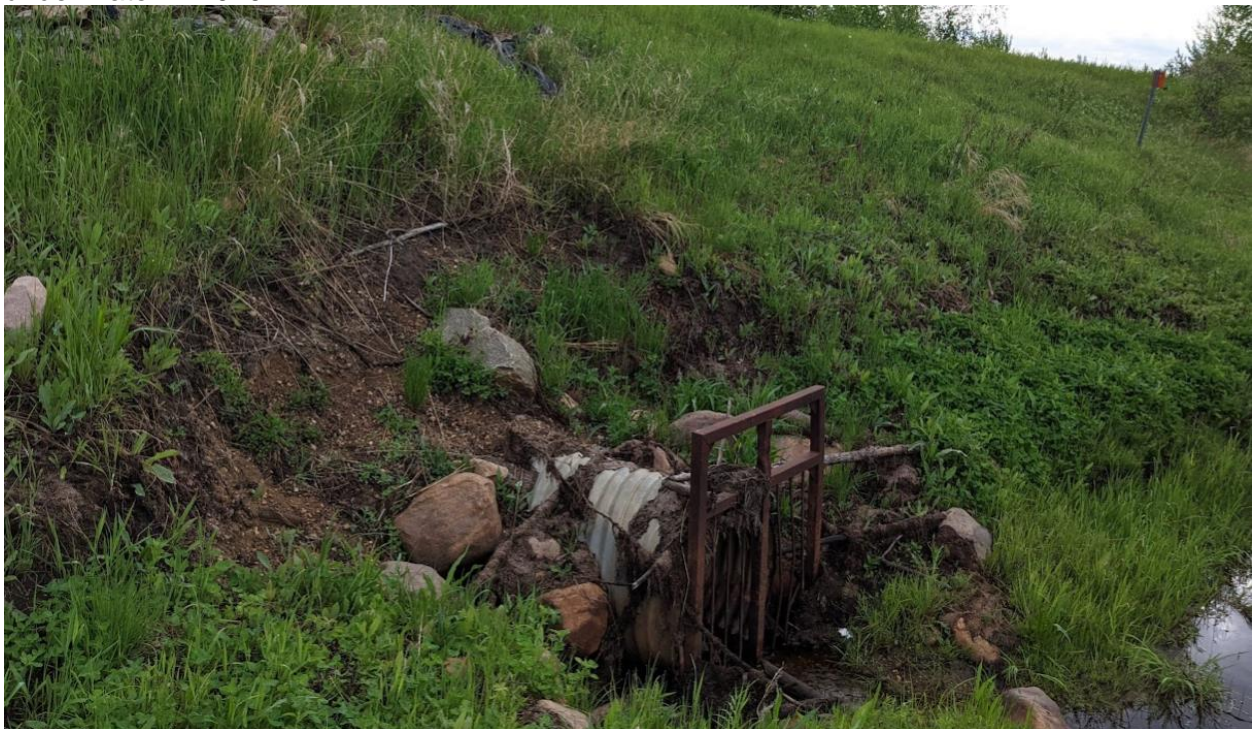
Photo No. 4 – Looking northeast at Culvert C1 inlet location

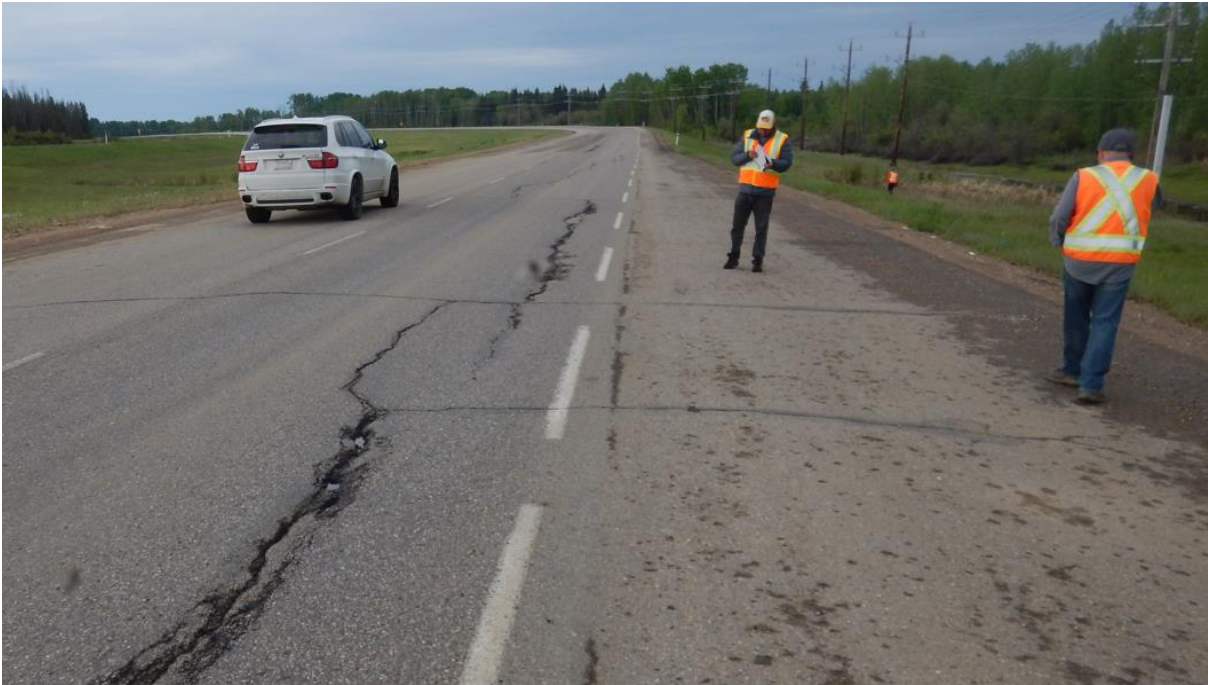
The highway condition continued to deteriorate within the limits of the NC08-1 site. The presence of wide cracks, and multiple wide and deep potholes created rough driving conditions on this section of the highway.

Photo No. 5 – Looking south at highway open cracks within the limits of the repaired area in 1997 (previously known as NC08-1)

funds are available, the highway surface at NC08-1 (old landslide) location should also be patched to improve highway rideability.

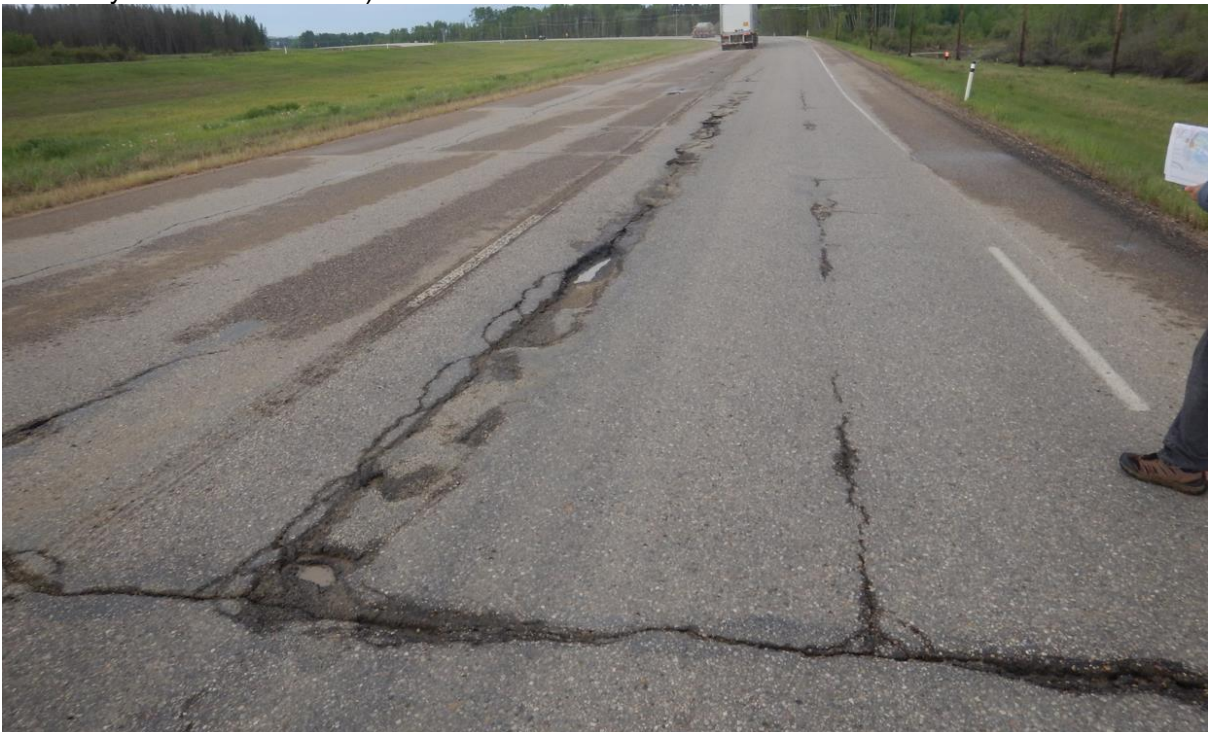
Photo No. 6 – Looking south at highway open cracks and potholes within the limits of the NC08-1 repaired area

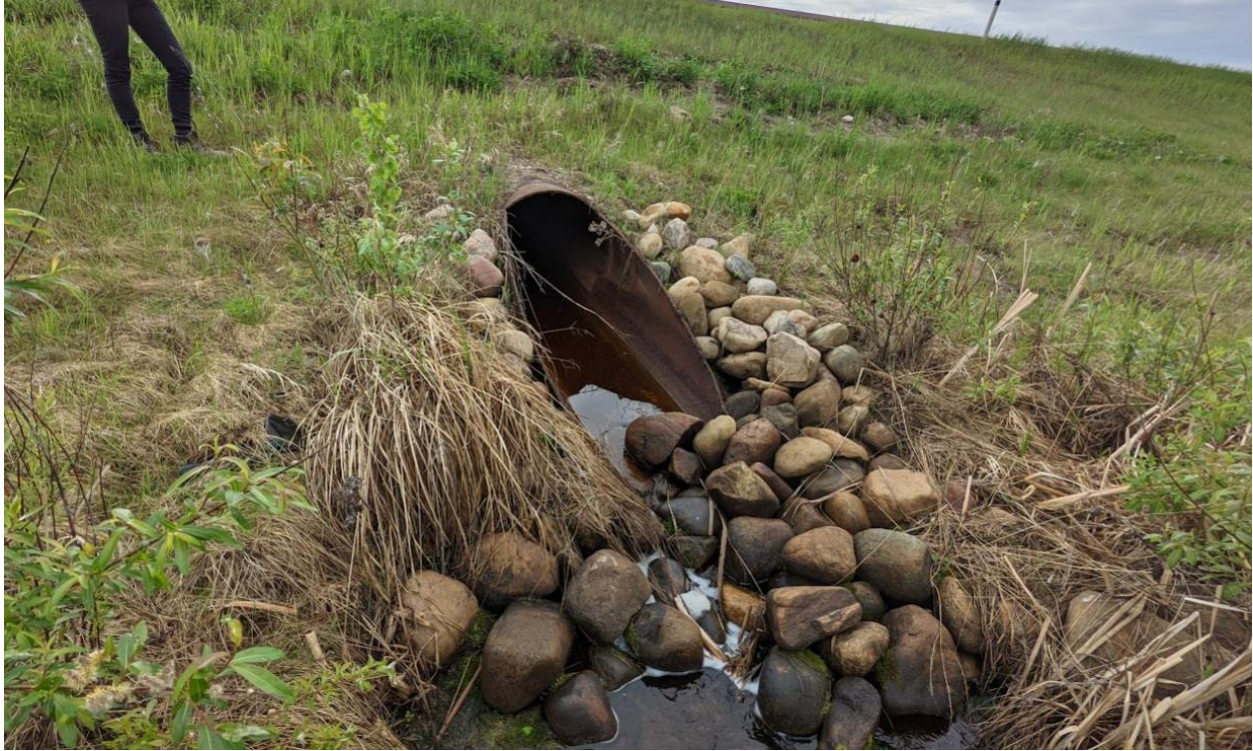
Photo No. 7 – Looking at 900 mm diameter SWSP Culvert C2 outlet; heavy flow in 2022

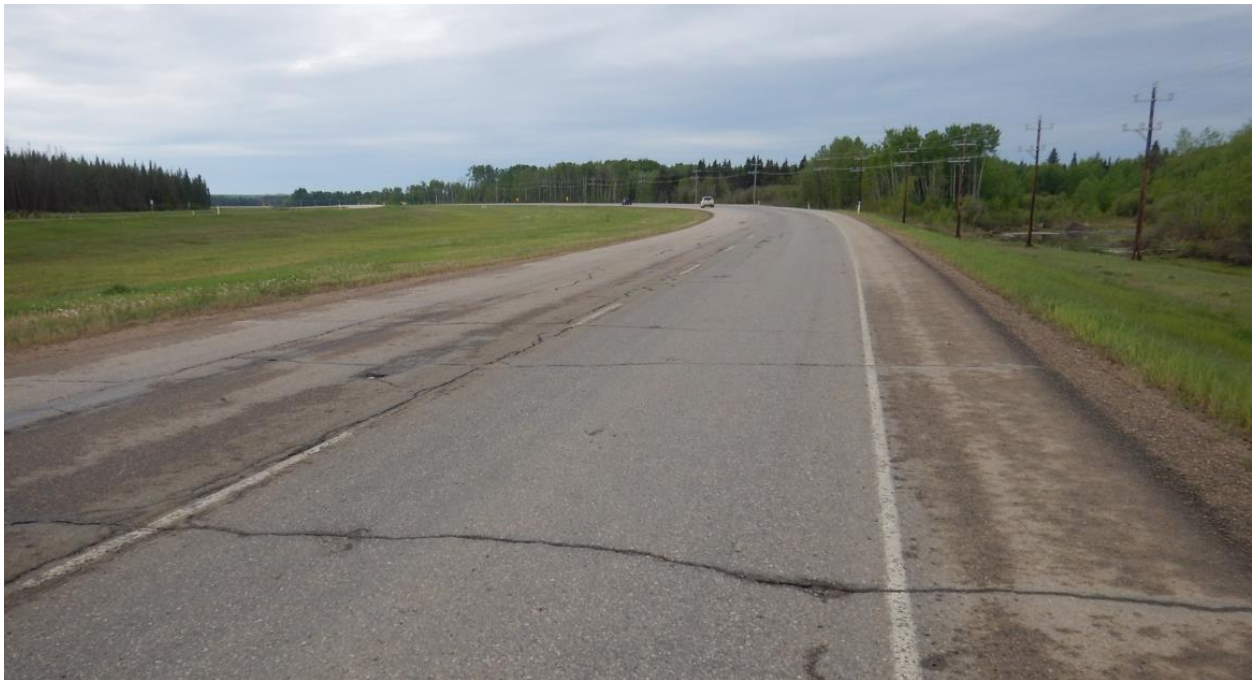
Photo No. 8 – Looking south at highway open cracks within the limits of the repaired area in 1997 (NC08-1)

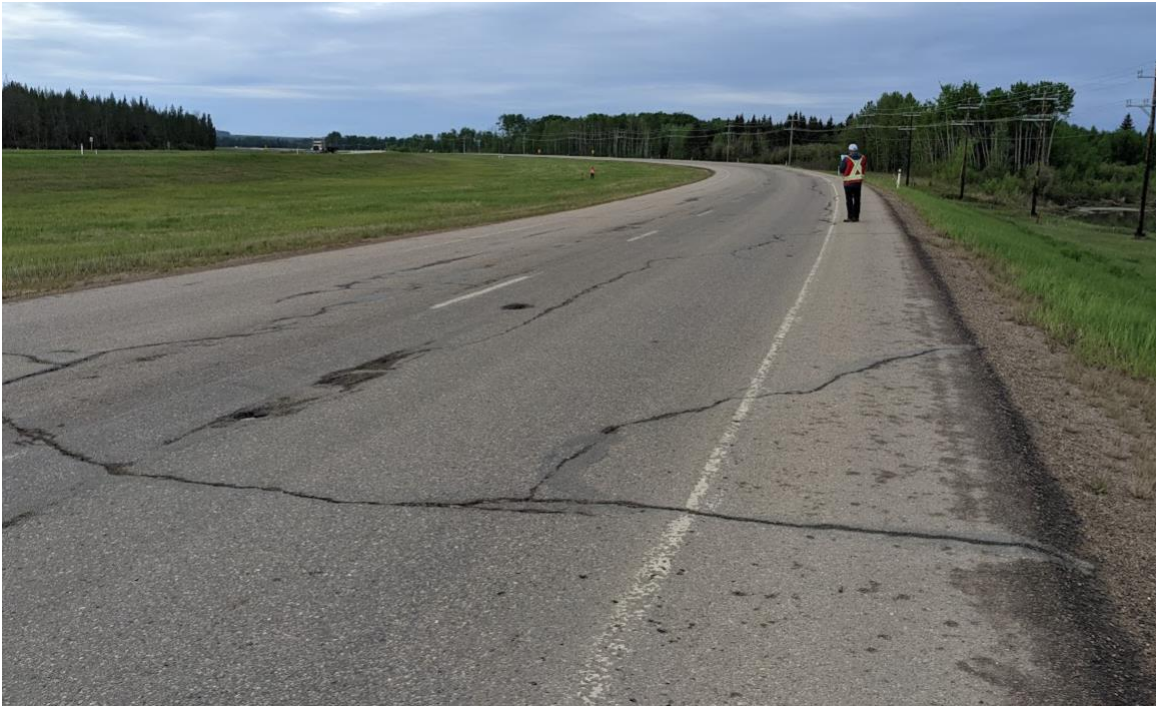
Photo No. 9 – Looking south at the southern flank cracks of the NC08-1 repaired landslide

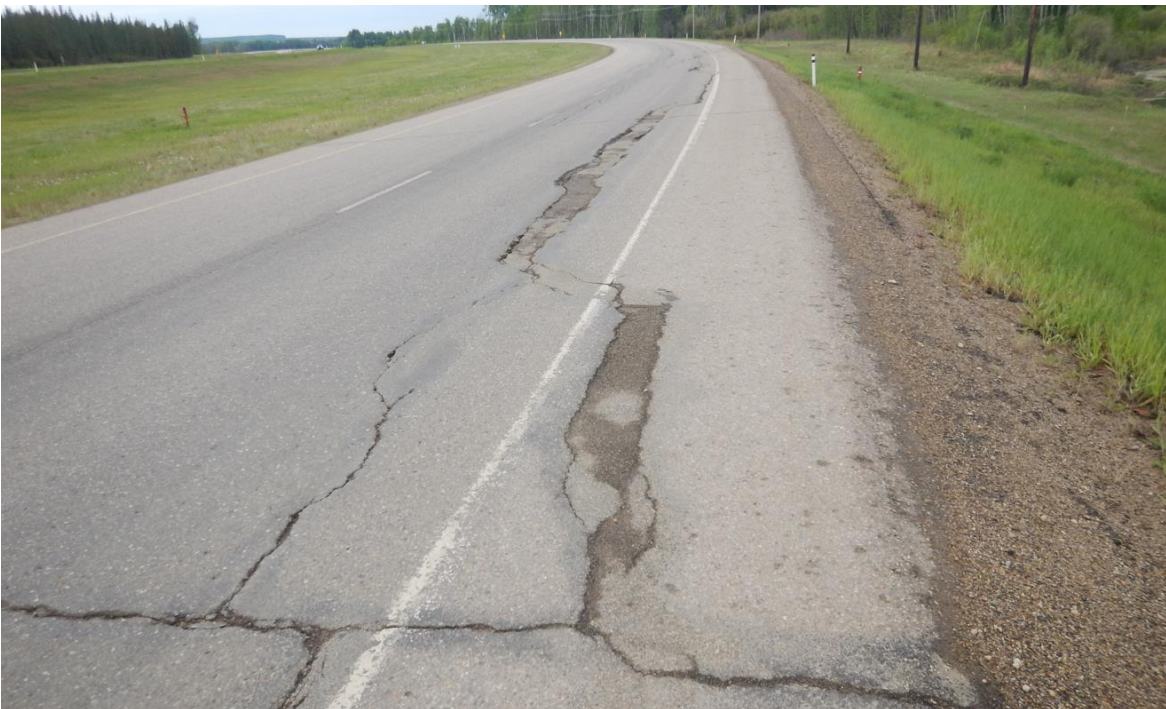
At the new landslide location, the drop noted on the highway most western lane continues to create rough driving conditions and constitutes a safety hazard to motorists.

Fill placement on the top of the weak high plastic clay foundation and high groundwater levels within the clay fill and native clay are the main triggers for the new landslide movement. The presence of beaver dams within the Oxbow resulted in high ground water levels within the landslide mass and aggravated the situation.

Photo No. 10 – Looking south at the northern flank of the new landslide (NC08-2); note exiting drop within the highway lane

- (a) Monitor the highway periodically for signs of distress and watch closely for the development of additional cracks and highway dip (particularly after prolonged rainfall events). The highway surface cracks at NC08-1 and NC08-2 locations should be sealed to prevent surface water infiltration into the landslide masses. The potholes along the highway surface should also be filled with ACP to prevent further deterioration to the highway surface conditions.
- (b) Consideration should be given to placing ACP patch within the limits of the NC08-2 (new landslide) site to eliminate existing dip and provide a smooth ride to motorists. If additional

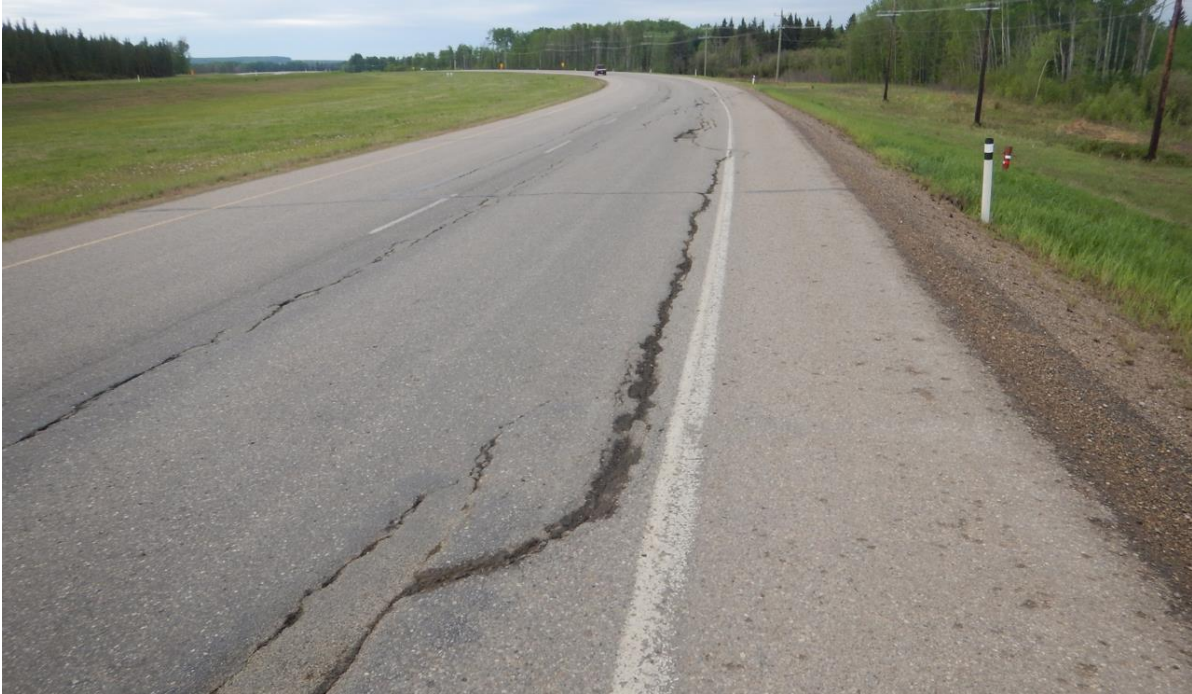
Photo No. 11 – Looking south at highway cracks within the central portion of the NC08-2 landslide

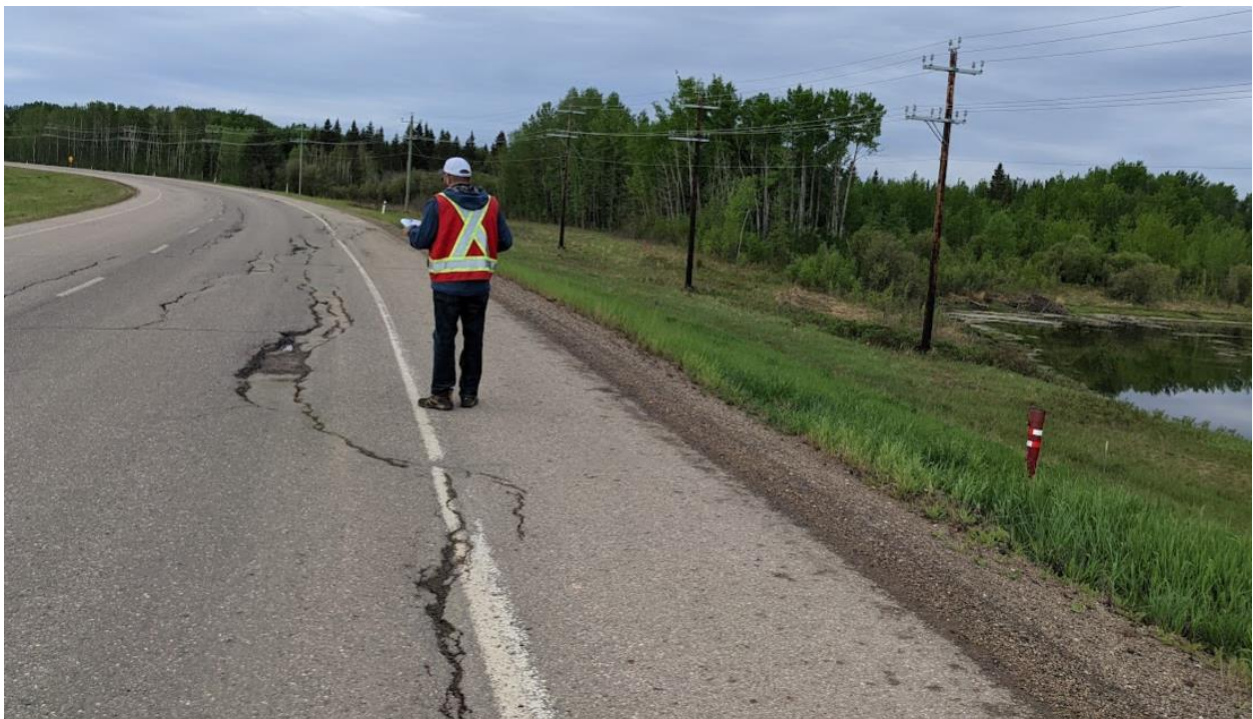
Photo No. 12 – Looking south at highway cracks near the southern flank of the NC08-2 landslide

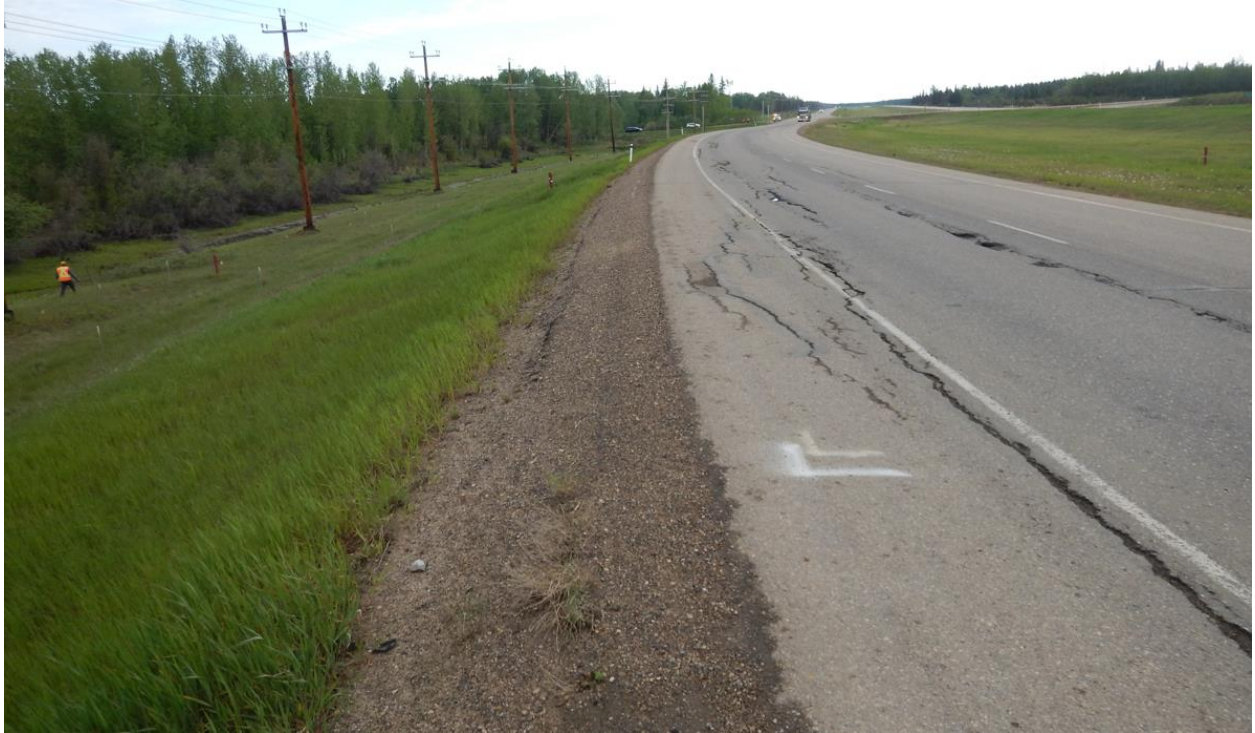
Photo No. 13 – Looking north at highway cracks near the southern flank of the NC08-2 landslide

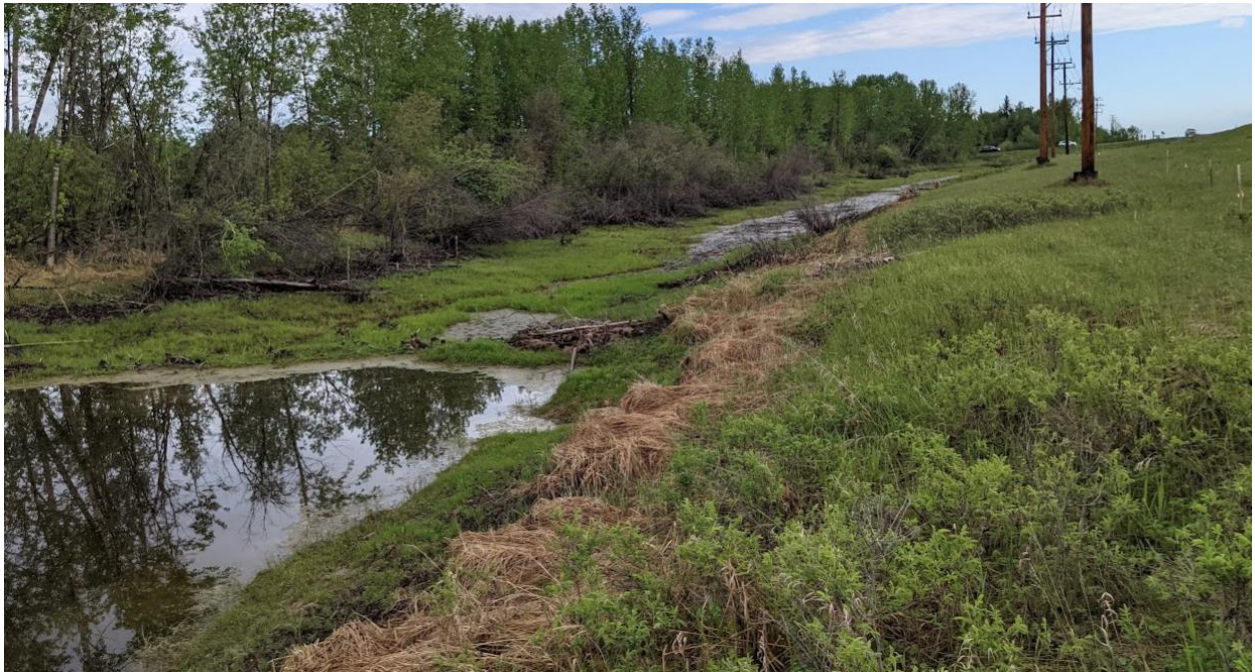
<input type="checkbox"/> Bridge/Culvert Distress		<input type="checkbox"/>
<input checked="" type="checkbox"/> Other	<p>Three beaver dams were previously noted within the Oxbow Lake. Beaver dam 1 was cleared in 2020; beaver dam 2 was exposed and water flows from within the NE corner of the dam; beaver dam 3 was exposed in 2022.</p> <p>Previously submerged Culvert C1 below the ALPAC road was visible due to the removal of the beaver dam to the north of the culvert outlet location. Water was free flowing into the culvert to drain the Oxbow Lake and flooded area noted in 2020; continuous heavy flow from culvert C2 below highway 63 south bound lanes.</p> <p>Power poles and buried phone cables flags were noted within the active landslide area</p>	<input type="checkbox"/>

Photo No. 14 – Looking north at Beaver Dam 3
