**ALBERTA TRANSPORTATION AND ECONOMIC CORRIDORS
GEOHAZARD ASSESSMENT PROGRAM
NORTH CENTRAL REGION – ATHABASCA &
FORT MCMURRAY DISTRICTS
2023 SITE INSPECTION**

Site #	Location	Name	Hwy	km
NC008	15.6 Km North of Hwy 63 & 55 Intersection	La Biche River (0.8 to 0.9 km North of Bridge)	63:02	15.6
Legal Description		UTM Co-ordinates (NAD 83)		
3-69-17 W4		12	N 6089536	E 403480

**NC008: HWY 63:02 LA BICHE RIVER (km 15.6)
SITE PLAN SHOWING EXISTING FEATURES**

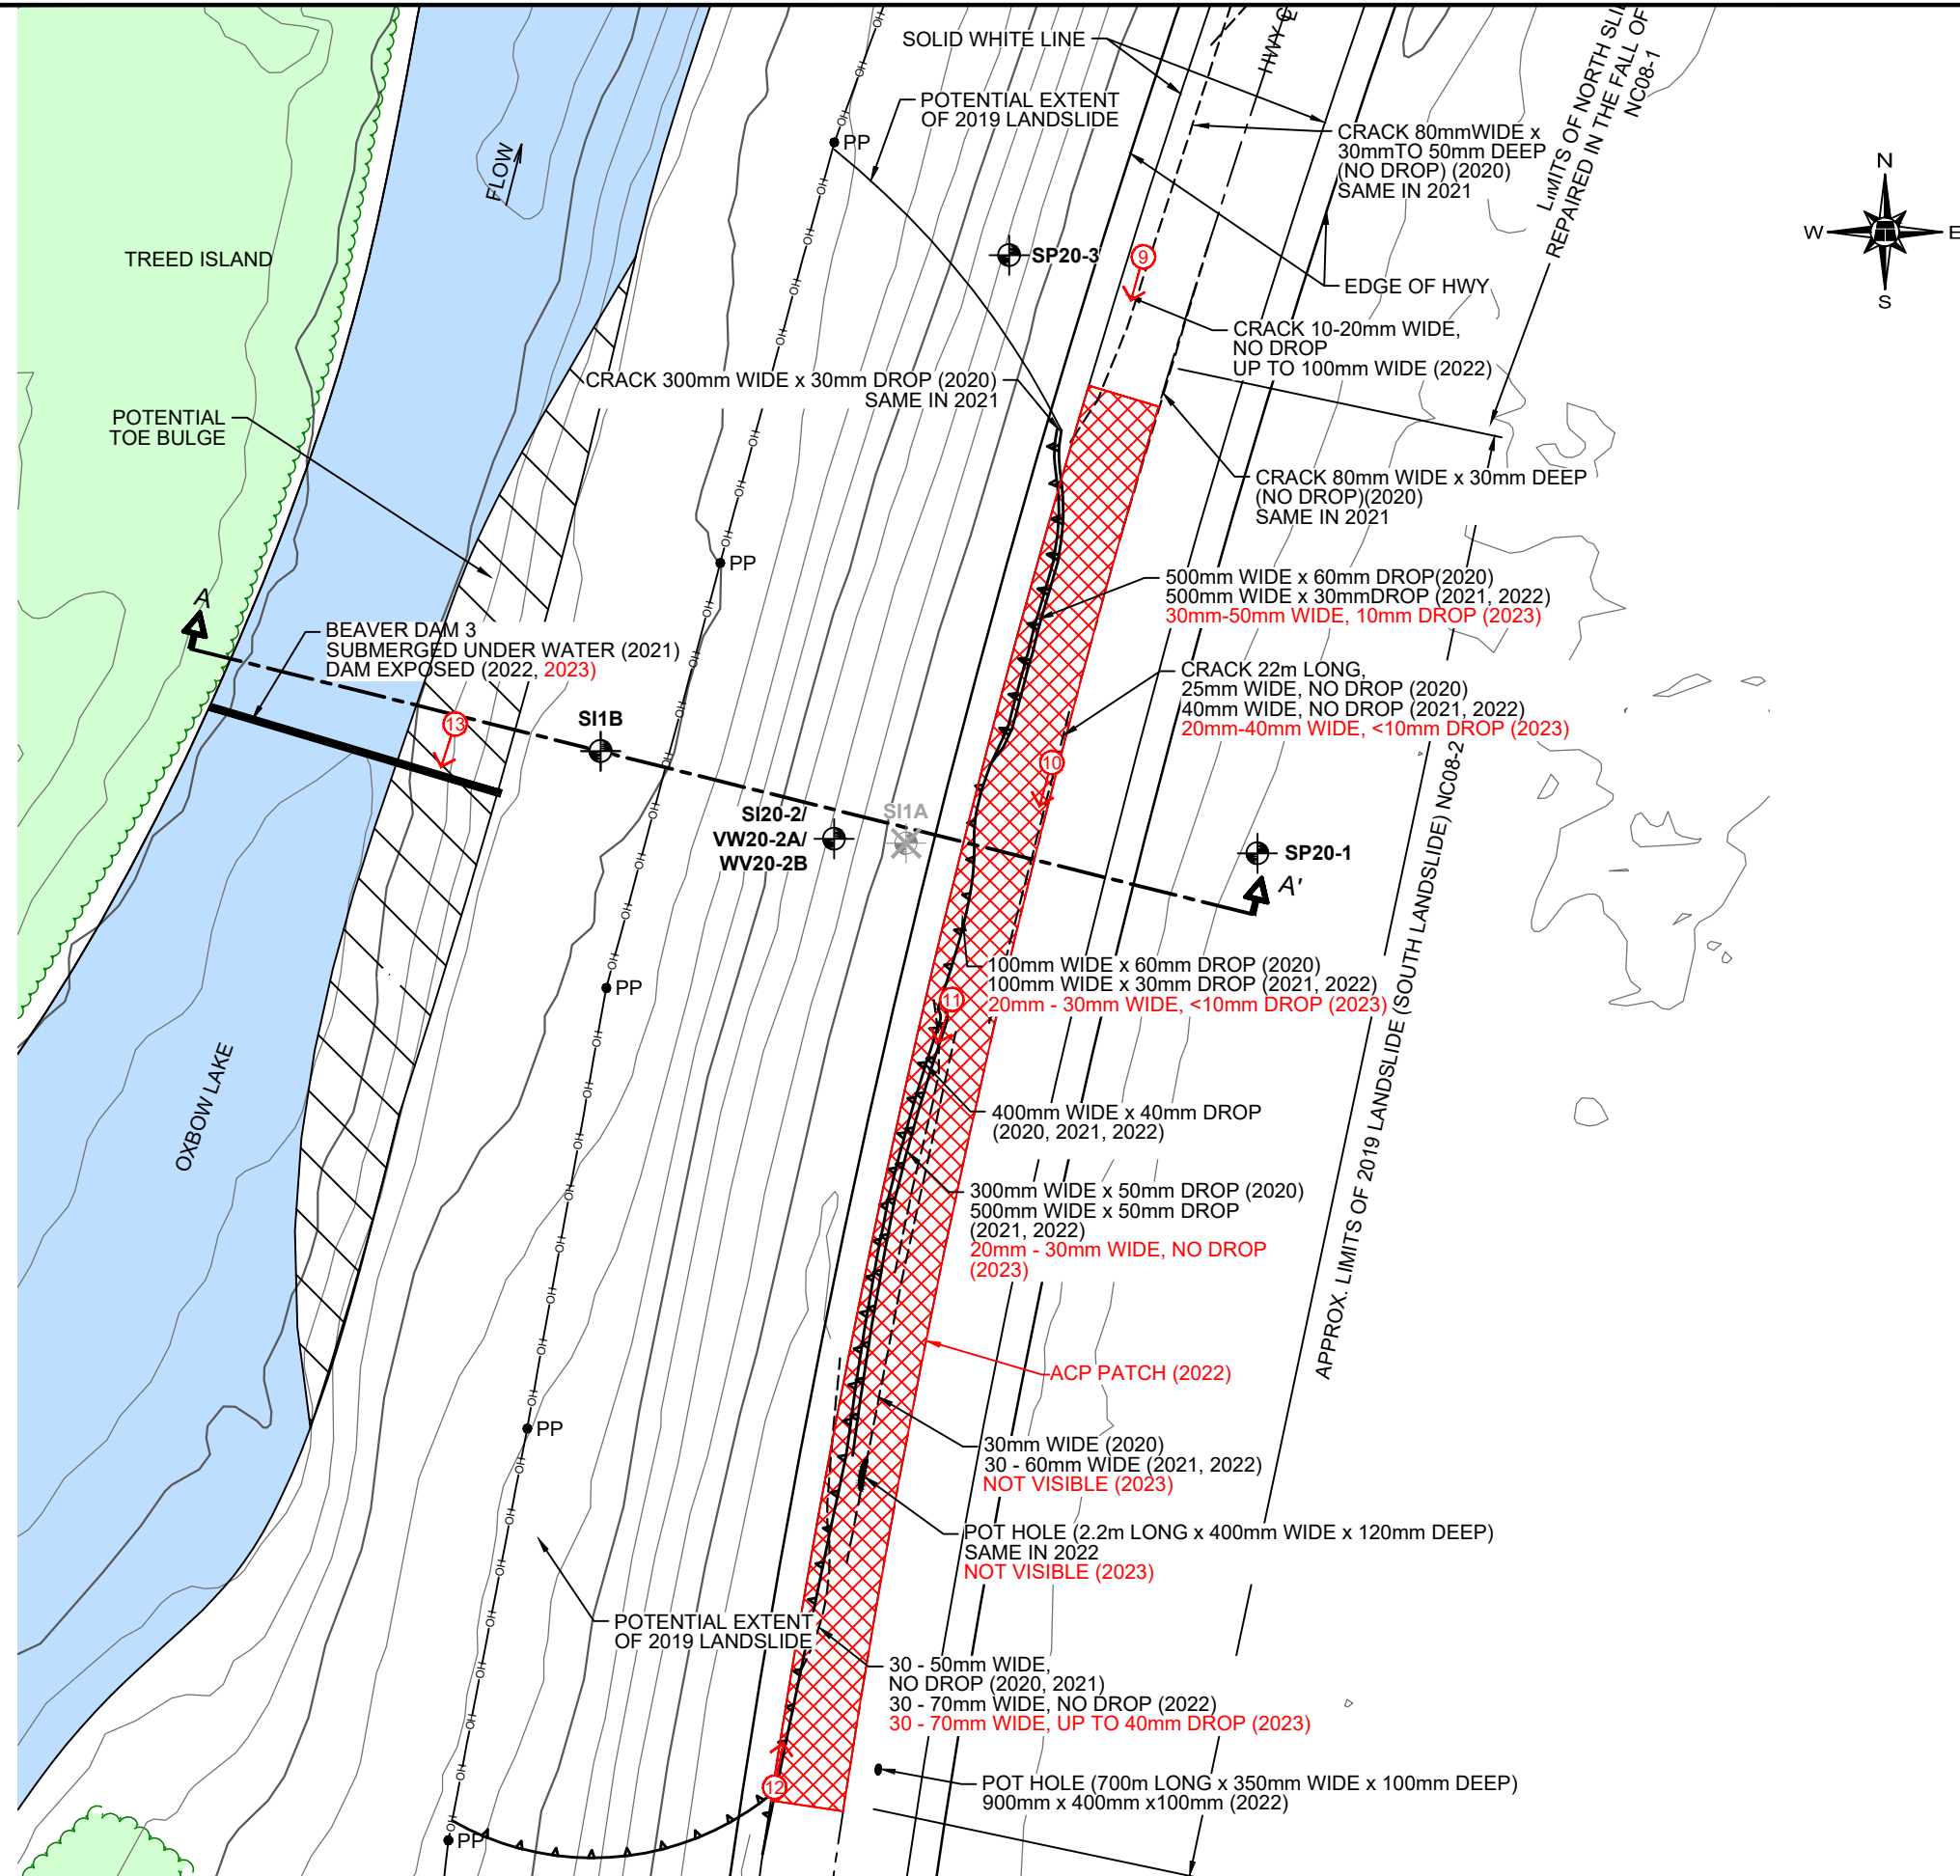
FIGURE NC008-B

**NC008: HWY 63:02 LA BICHE RIVER (km 15.6)
SITE PLAN SHOWING THE SOUTH SLIDE AREA**

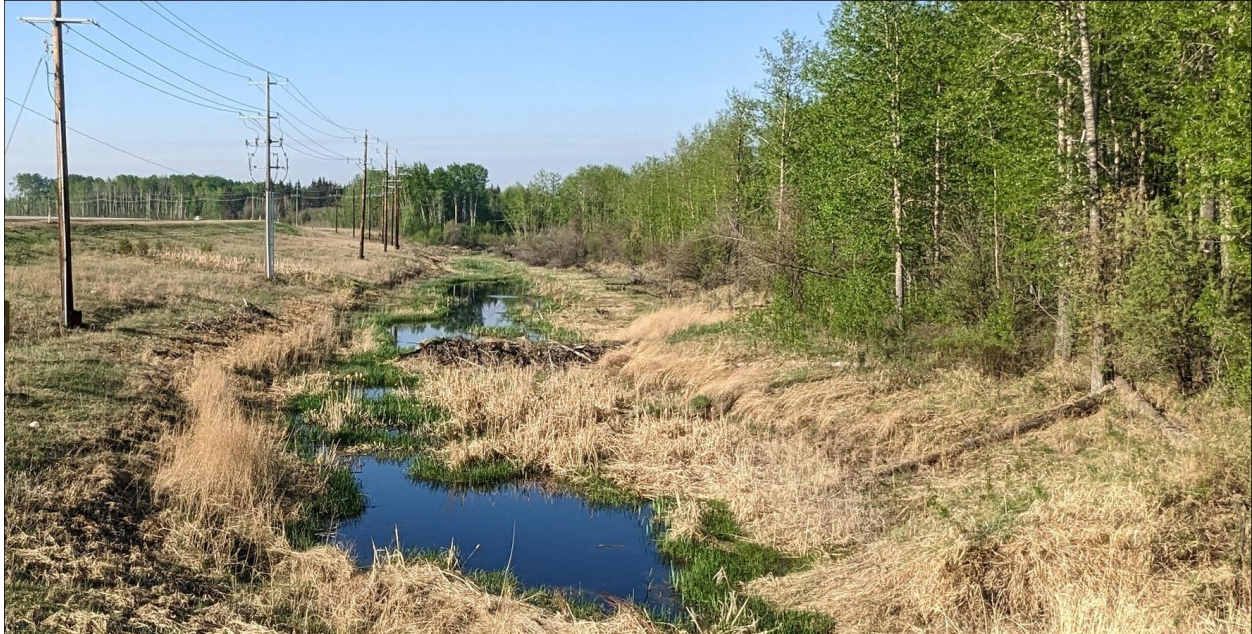
Fill placement on the top of the weak high plastic clay foundation and high groundwater levels within the clay fill and native clay are the main triggers for the landslide movement. It is likely that the presence of beaver dams within the oxbow lake resulted in high ground water levels within the landslide mass and aggravated the situation in the past.

The observed water levels in the oxbow lake in 2022 and 2023 were much lower than in the past, and this appears to have reduced the rate of movement of the landslide over the last couple of years.

Photo No. 1 – Looking south at Oxbow Lake. NE corner of Beaver Dam 2 was breached; water levels dropped by at least 1.2 m behind the dam

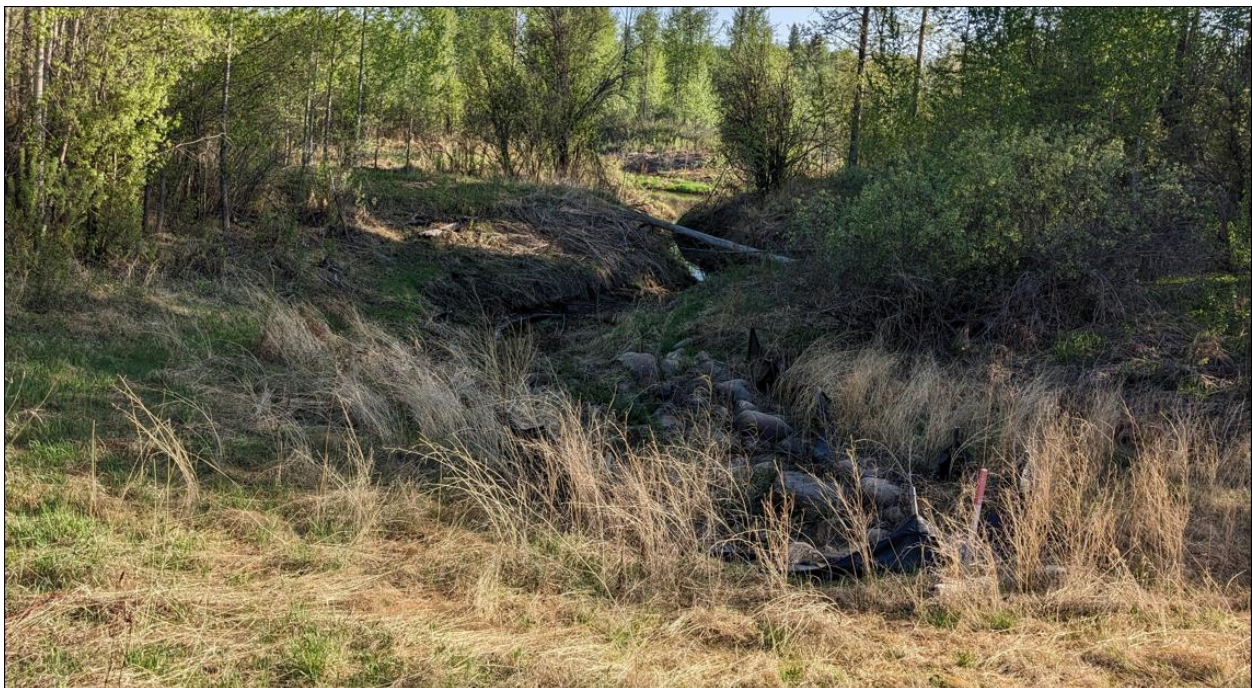
The flooded area, noted in 2020 within the northern limit of the site, drained through Culvert C1 after the removal of the beaver dams. This helped reducing water levels within the oxbow lake and the likelihood of flooding the ALPAC road. If the beaver dams are not kept under control, progressive rise in water levels in future years could result in washout of the ALPAC road and saturation of highway 63 embankment fills (depending on the beaver dam's height and water levels in the oxbow lake).

Photo No. 2 – Looking northeast at Culvert C1 outlet; water continues to flow freely along the channel

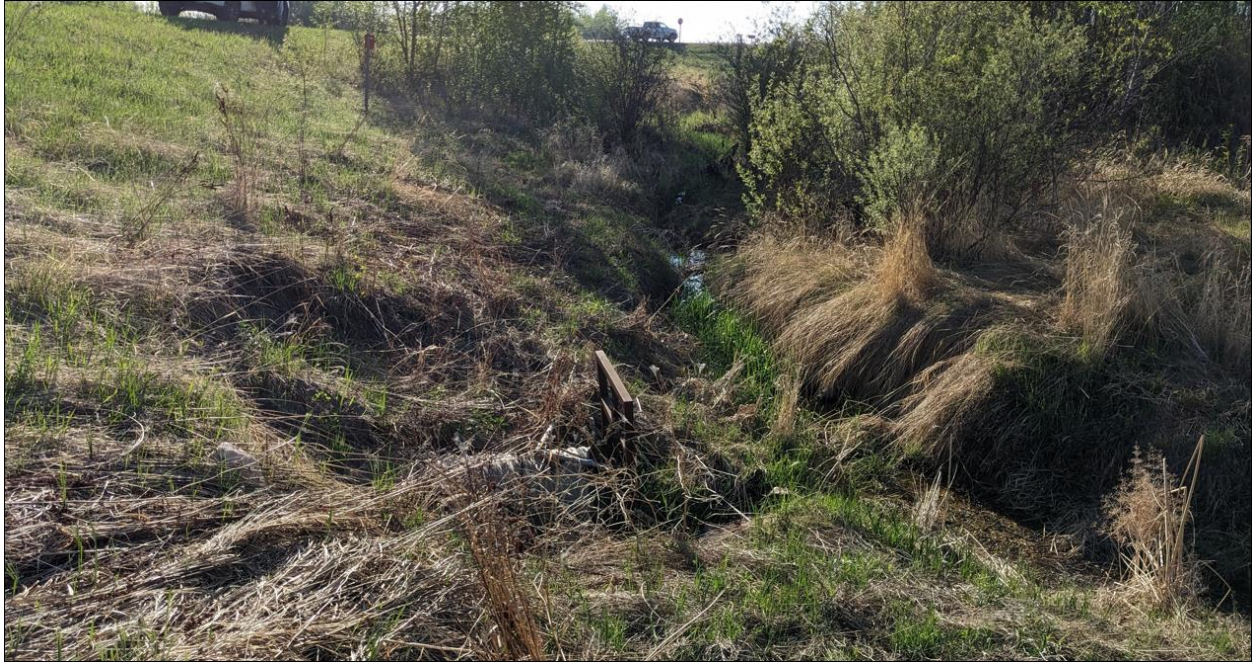
Photo No. 3 – Looking east towards CSP culvert C1 outlet

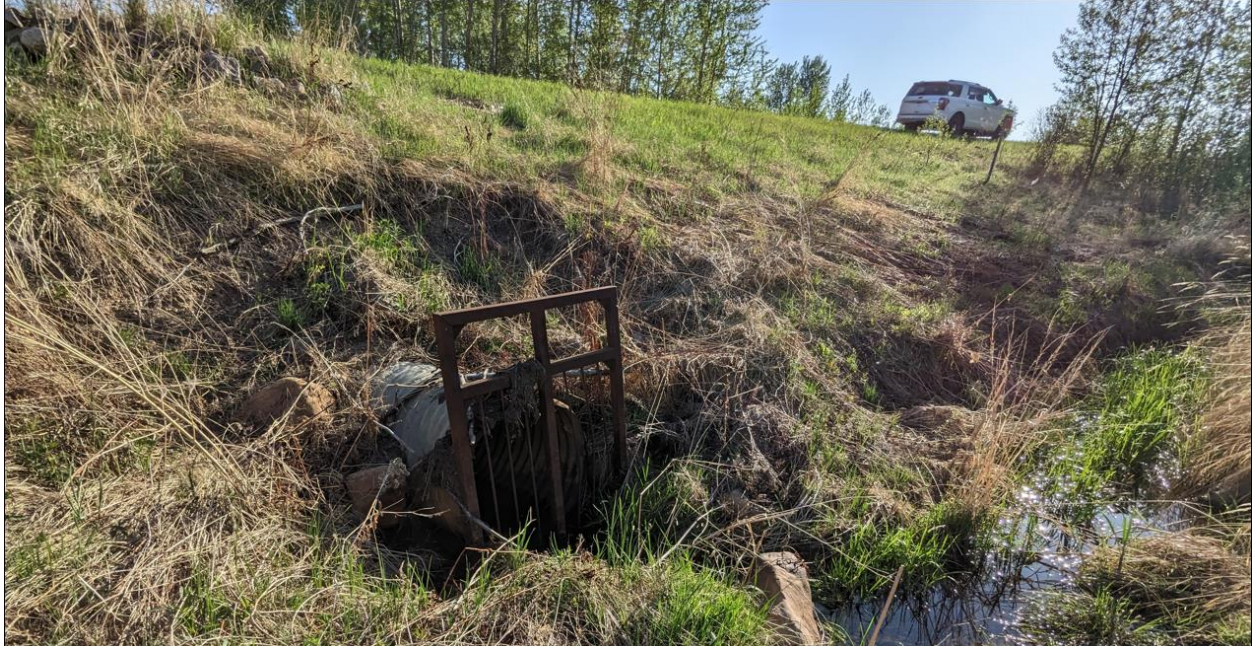
Photo No. 4 – Looking northeast at Culvert C1 inlet location

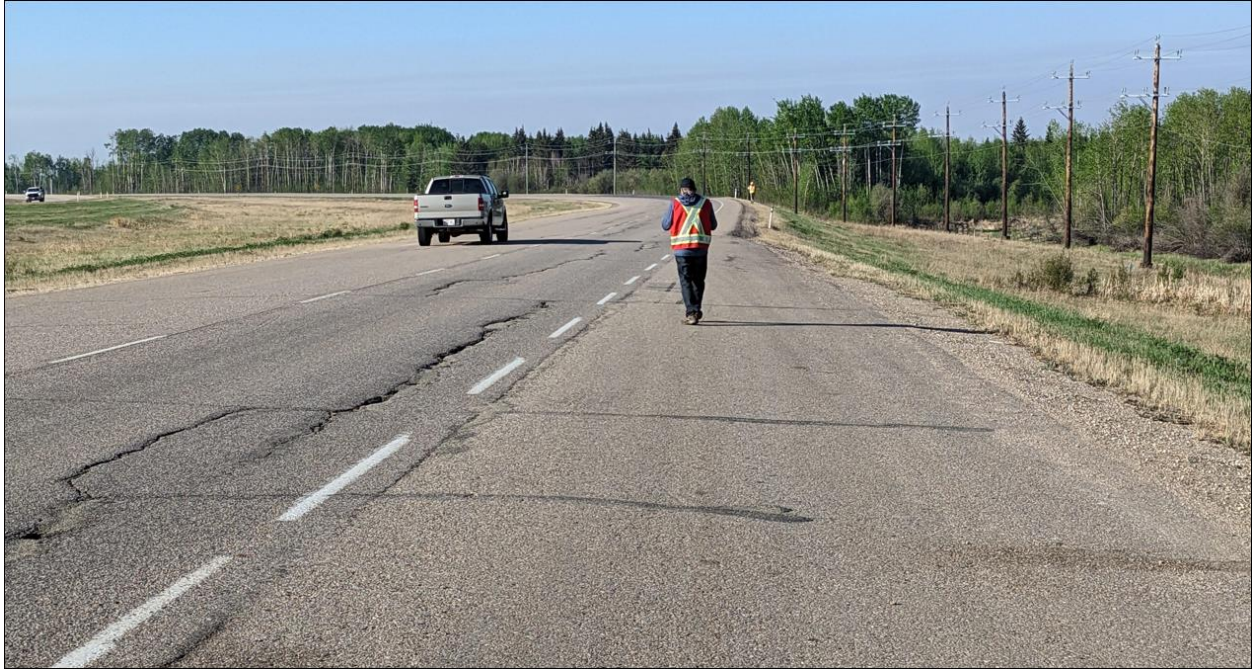
The highway surface is in a bad condition within the limits of the NC008-1 site, and this continued to create a rough ride to motorists.

Photo No. 5 – Looking south at highway open cracks within the limits of the repaired area in 1997 (previously known as NC08-1)

- (a) Monitor the highway surface periodically for signs of distress and watch closely for the development of additional cracks and highway dip (particularly after prolonged rainfall events). The highway surface cracks at NC008-1 and NC008-2 locations should be sealed to prevent surface water infiltration into the landslide masses. The potholes along the highway surface should also be filled with ACP to prevent further deterioration of the highway surface conditions.
- (b) Consideration should be given to placing ACP patch within the limits of the NC008-1 (old landslide) location to improve highway rideability.
- (c) Consider removing all beaver dams within the oxbow lake to further reduce water levels within the highway embankment.

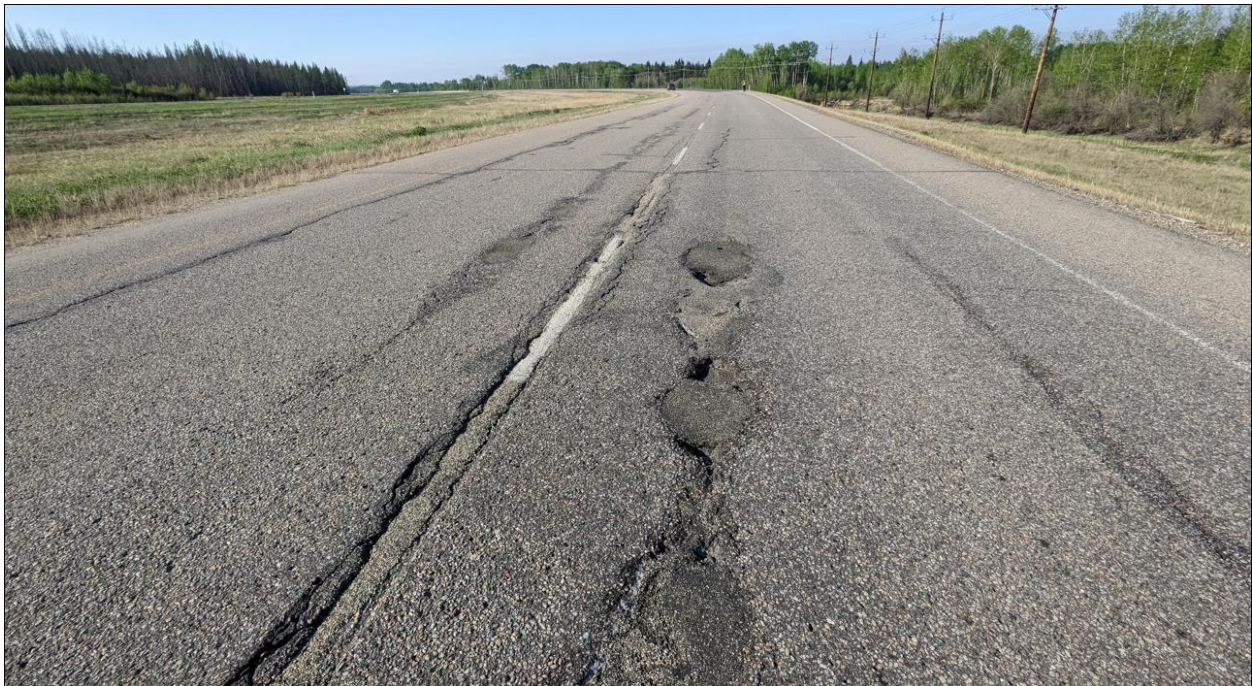
Photo No. 6 – Looking south at highway open cracks and potholes within the limits of the NC08-1 repaired area

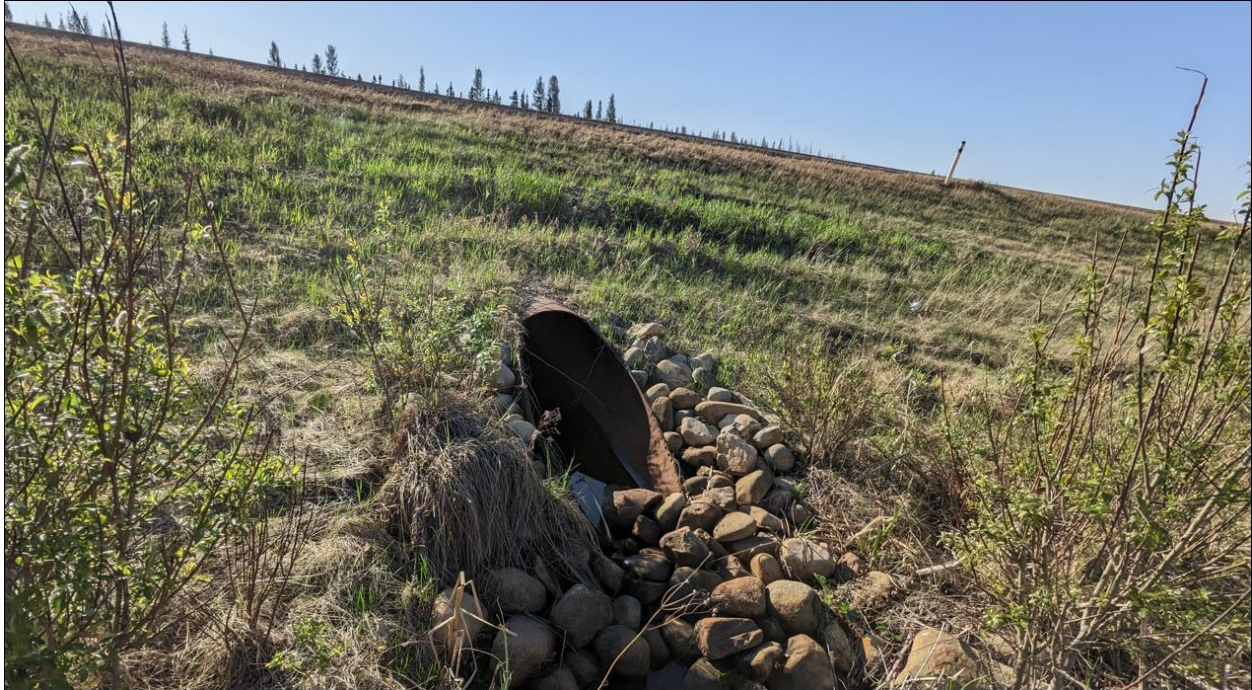
Photo No. 7 – Looking at 900 mm diameter SWSP Culvert C2 outlet; heavy flow in 2023

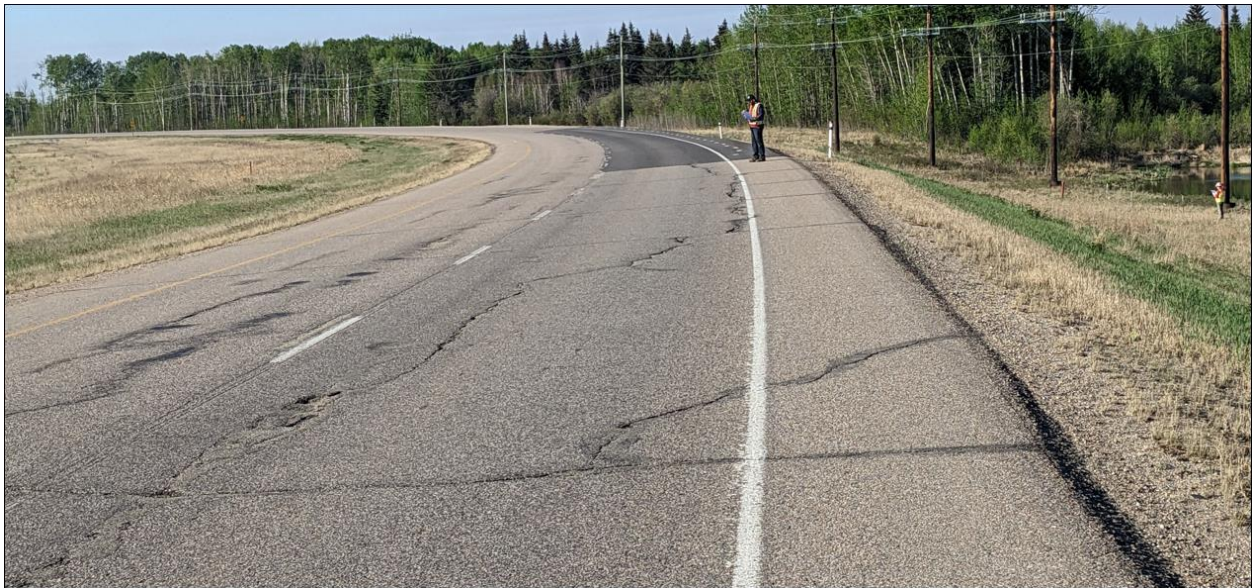
Photo No. 8 – Looking south at the southern flank cracks of the NC08-1 repaired landslide

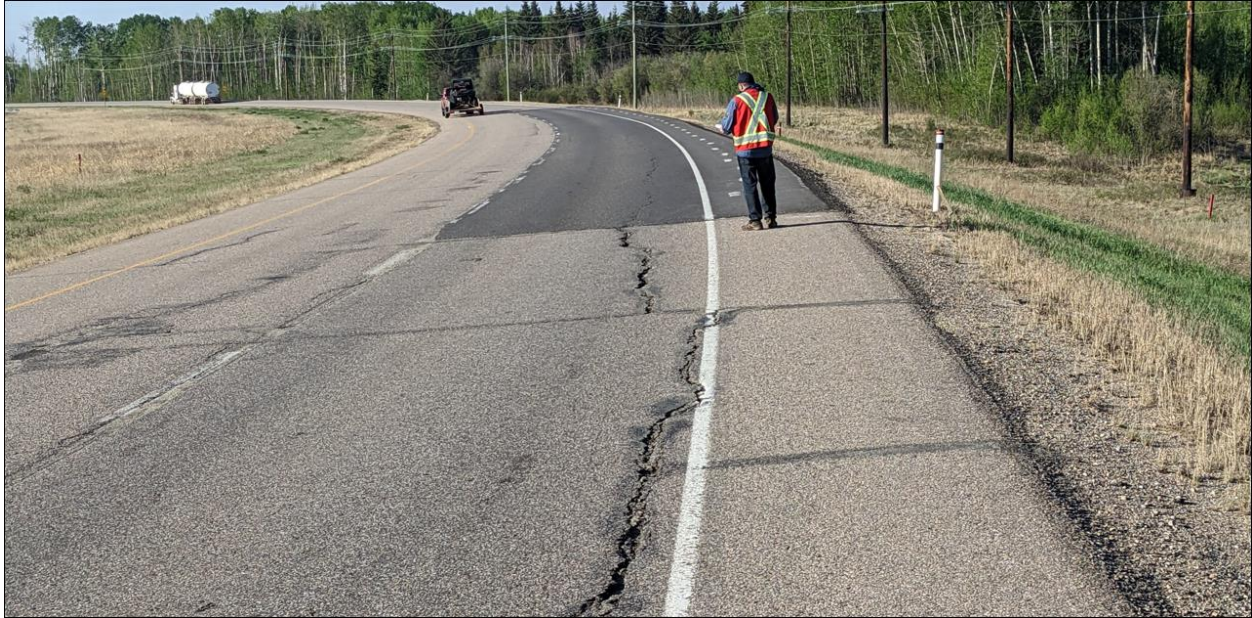
The ACP patch placed in 2022 improved the highway driving condition within the NC008-2 landslide area. However, landslide cracks reflected on the highway surface and these cracks are expected to get worse and will contribute to faster deterioration of the highway surface condition until long-term repairs take place.

Photo No. 9 – Looking south at the northern flank of the new landslide (NC08-2); note new ACP patched placed in 2022 already showing reflecting cracks

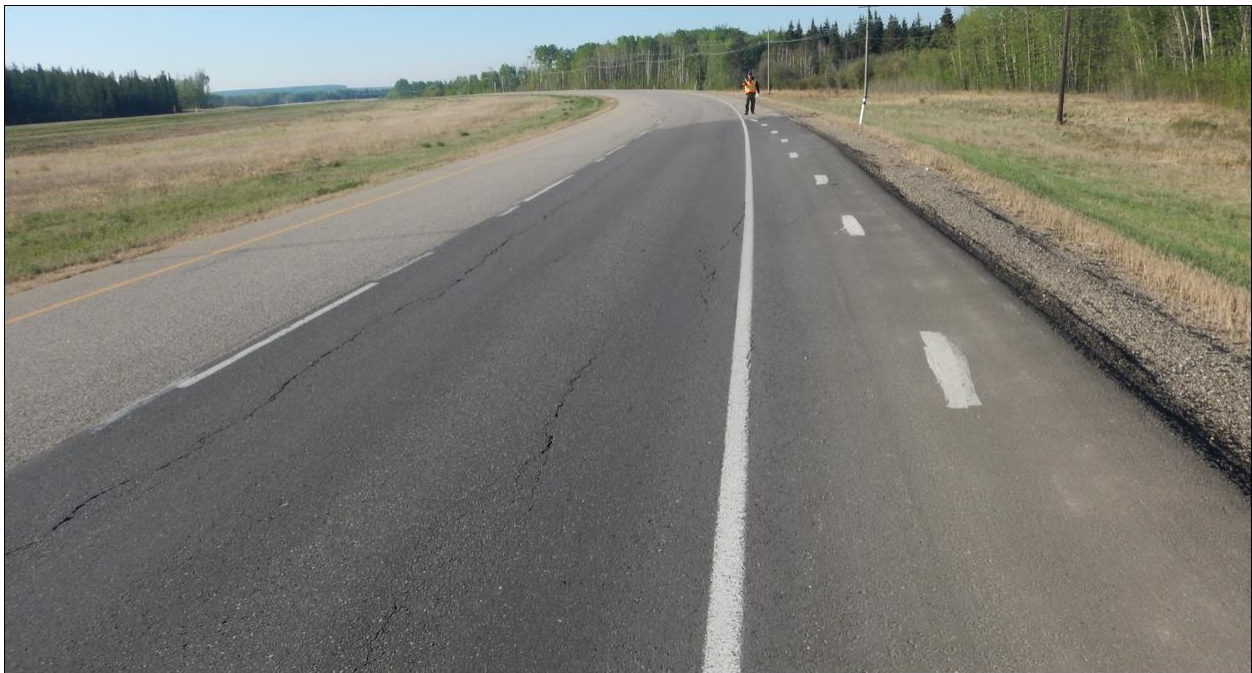
Photo No. 10 – Looking south at reflective cracks within the central portion of the NC08-2 landslide

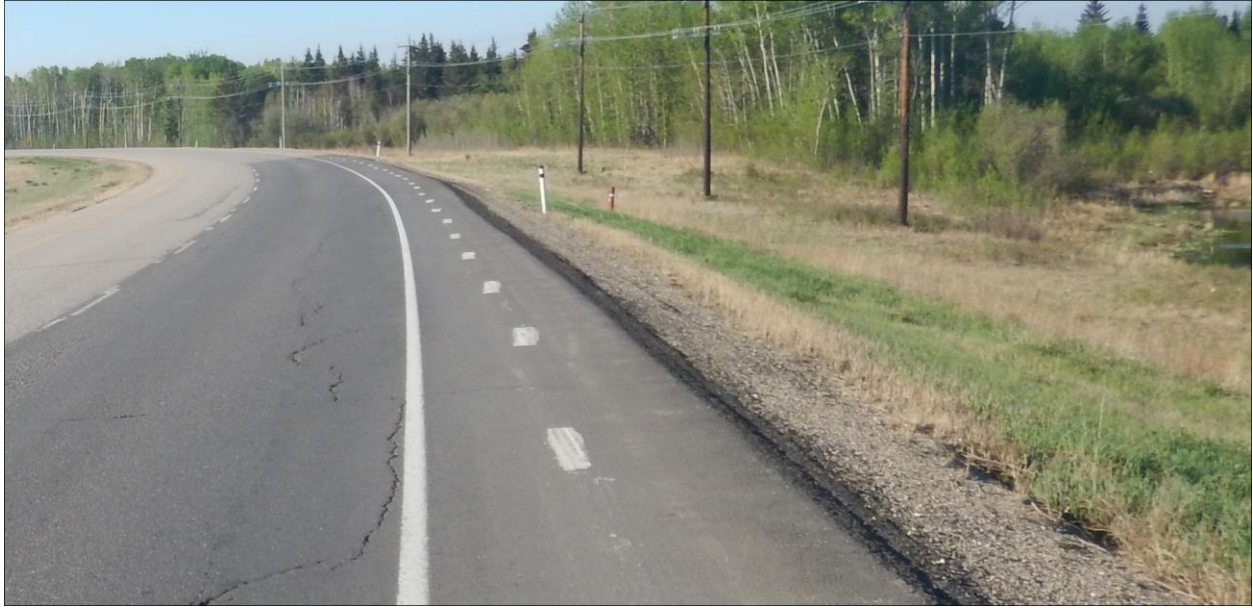
Photo No. 11 – Looking south at reflective cracks near the southern flank of the NC08-2 landslide

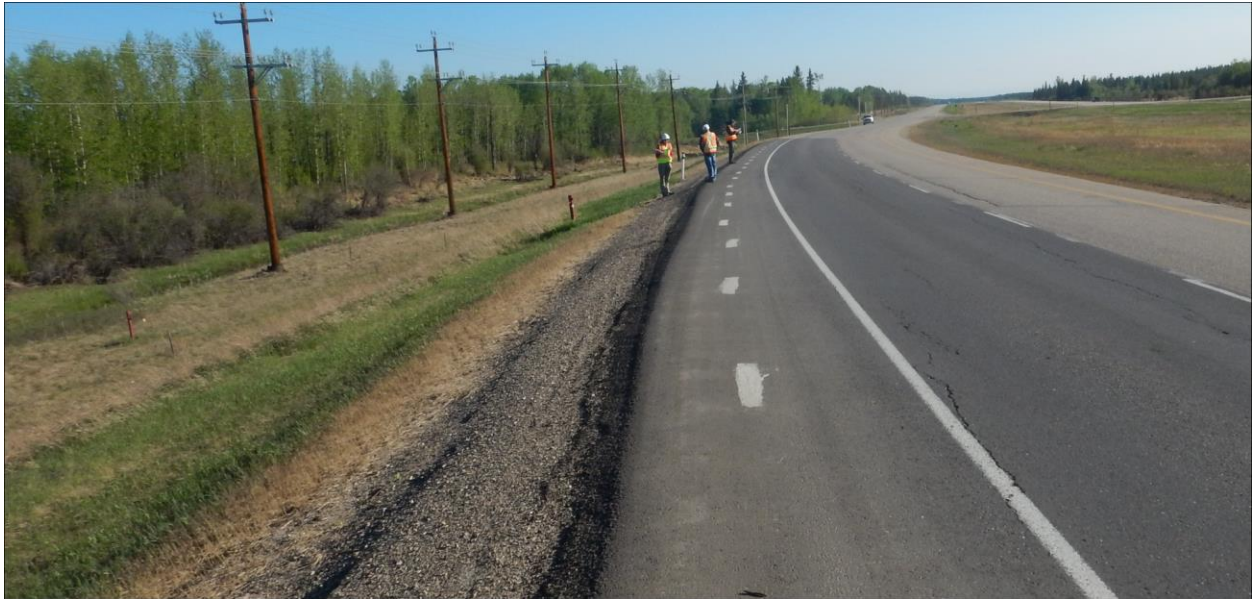
Photo No. 12 – Looking north at reflective cracks near the southern flank of the NC08-2 landslide

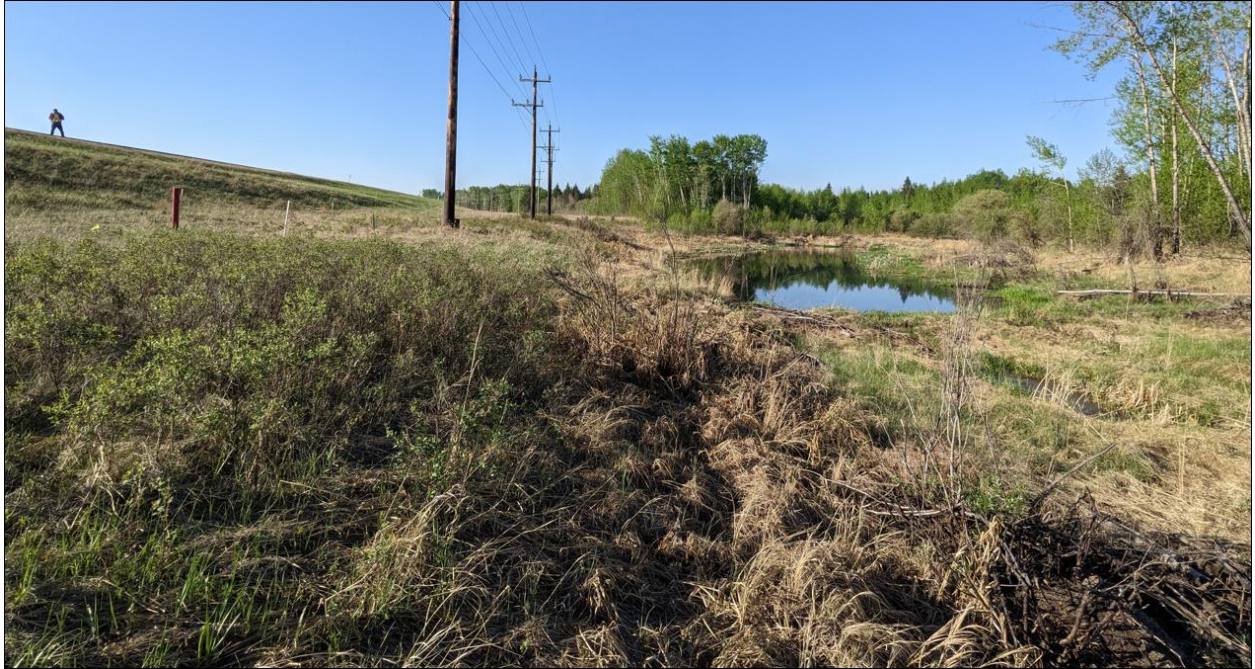
Photo No. 13 – Looking south at Beaver Dam 3
