**ALBERTA TRANSPORTATION AND
ECONOMIC CORRIDORS GRMP
NORTH CENTRAL (ATHABASCA AND FORT
McMURRAY DISTRICTS)
INSTRUMENTATION MONITORING- FALL 2024**

Site Number	Location	Name	Hwy	km
NC008	HWY 63:02 L1 15.635	North of La Biche River	63:02	km 15.6
Legal Description: 7-3-69-17 W4		UTM Co-ordinates		
		12U E 403478	N	6089488

Current Monitoring:	16-Sep-2024	Previous Monitoring	8-Jun-2024
Instruments Read By:	Mr. Niraj Regmi, G.I.T and Mr. Nixson Mationg, of Thurber

SITE NC008: HWY 63:02 NORTH OF LA BICHE RIVER

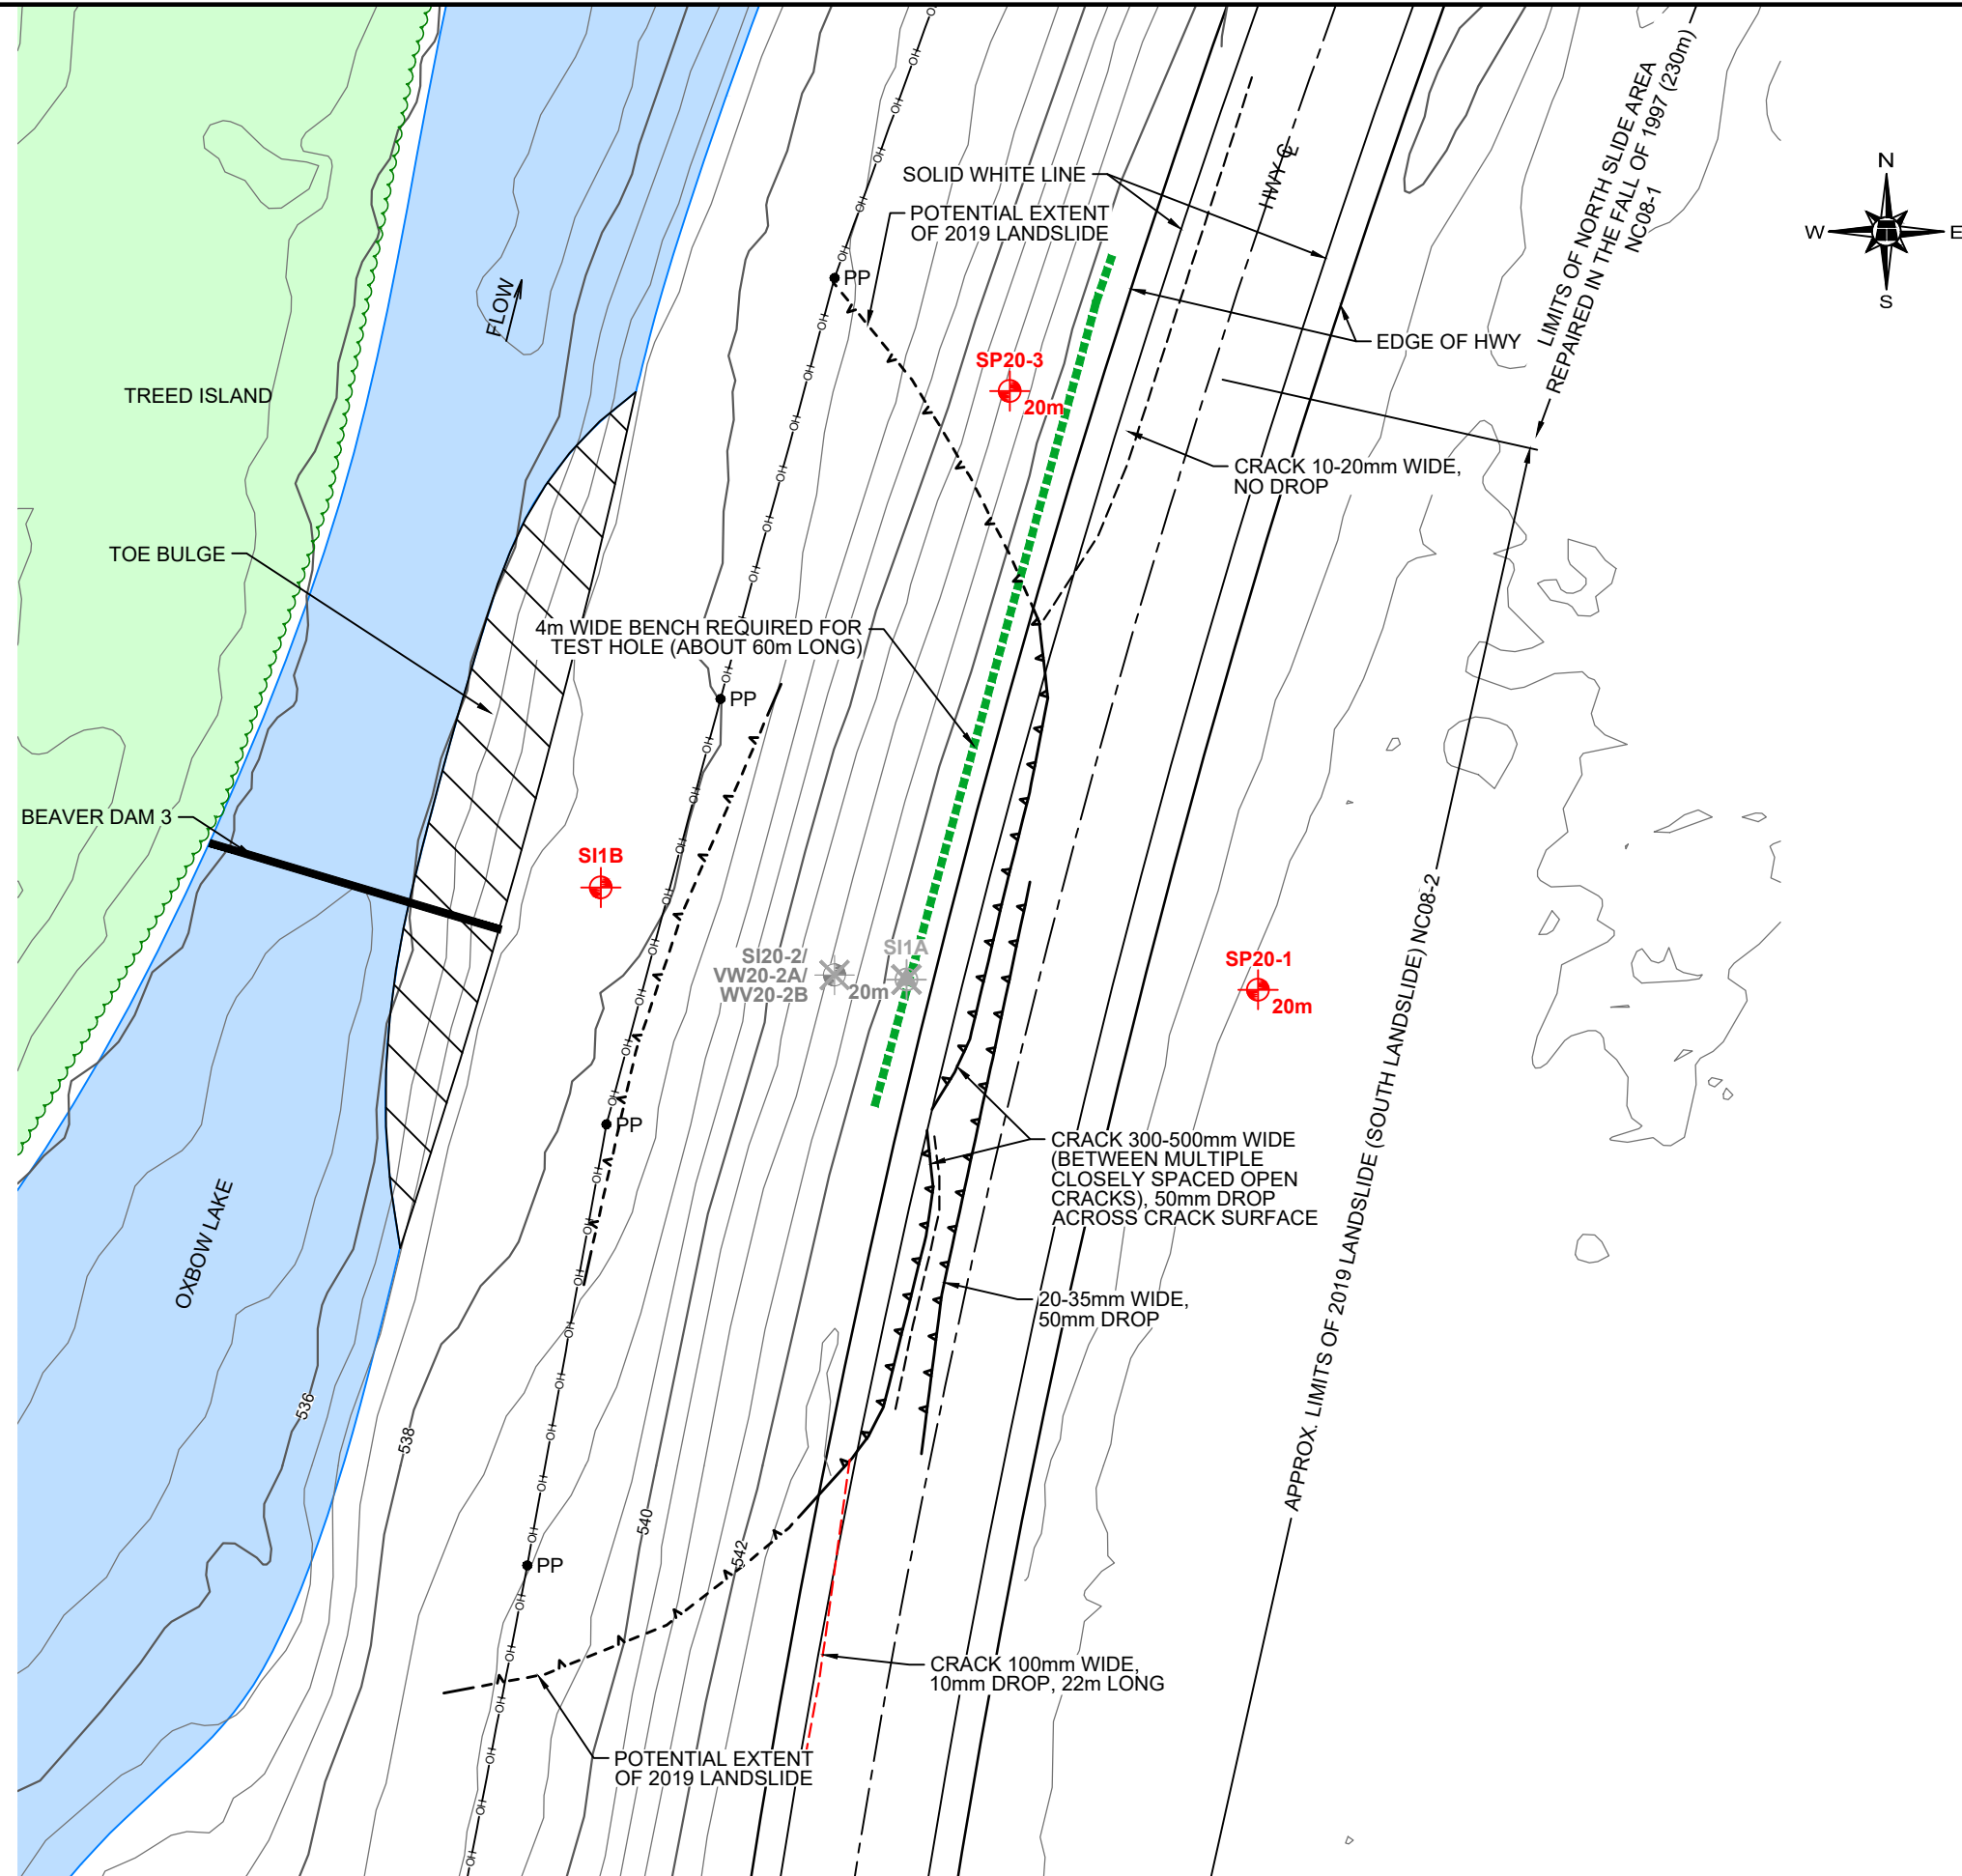
DWG No. 32122-NC008

**NC008 HWY 63:02 LA BICHE RIVER
SITE PLAN SHOWING APPROXIMATE
INSTRUMENT LOCATIONS**

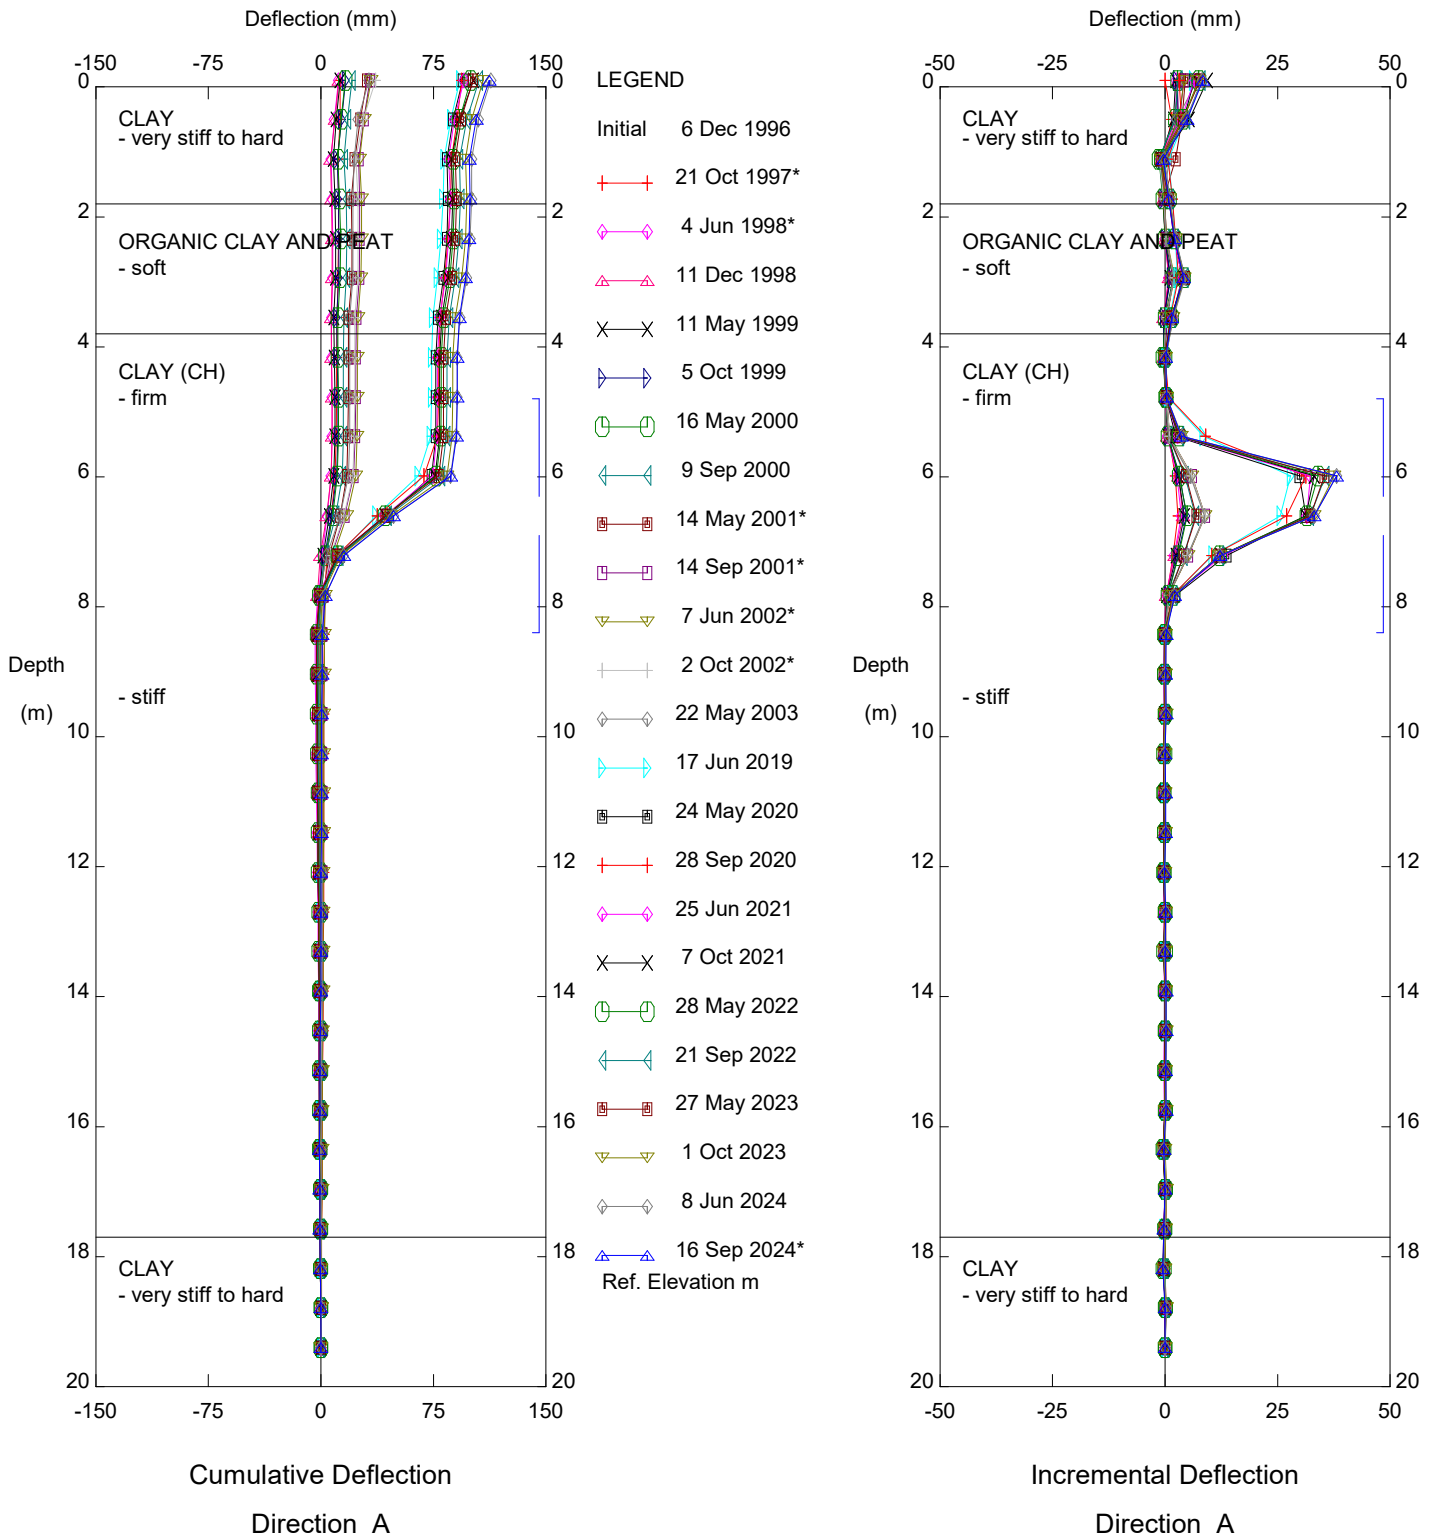
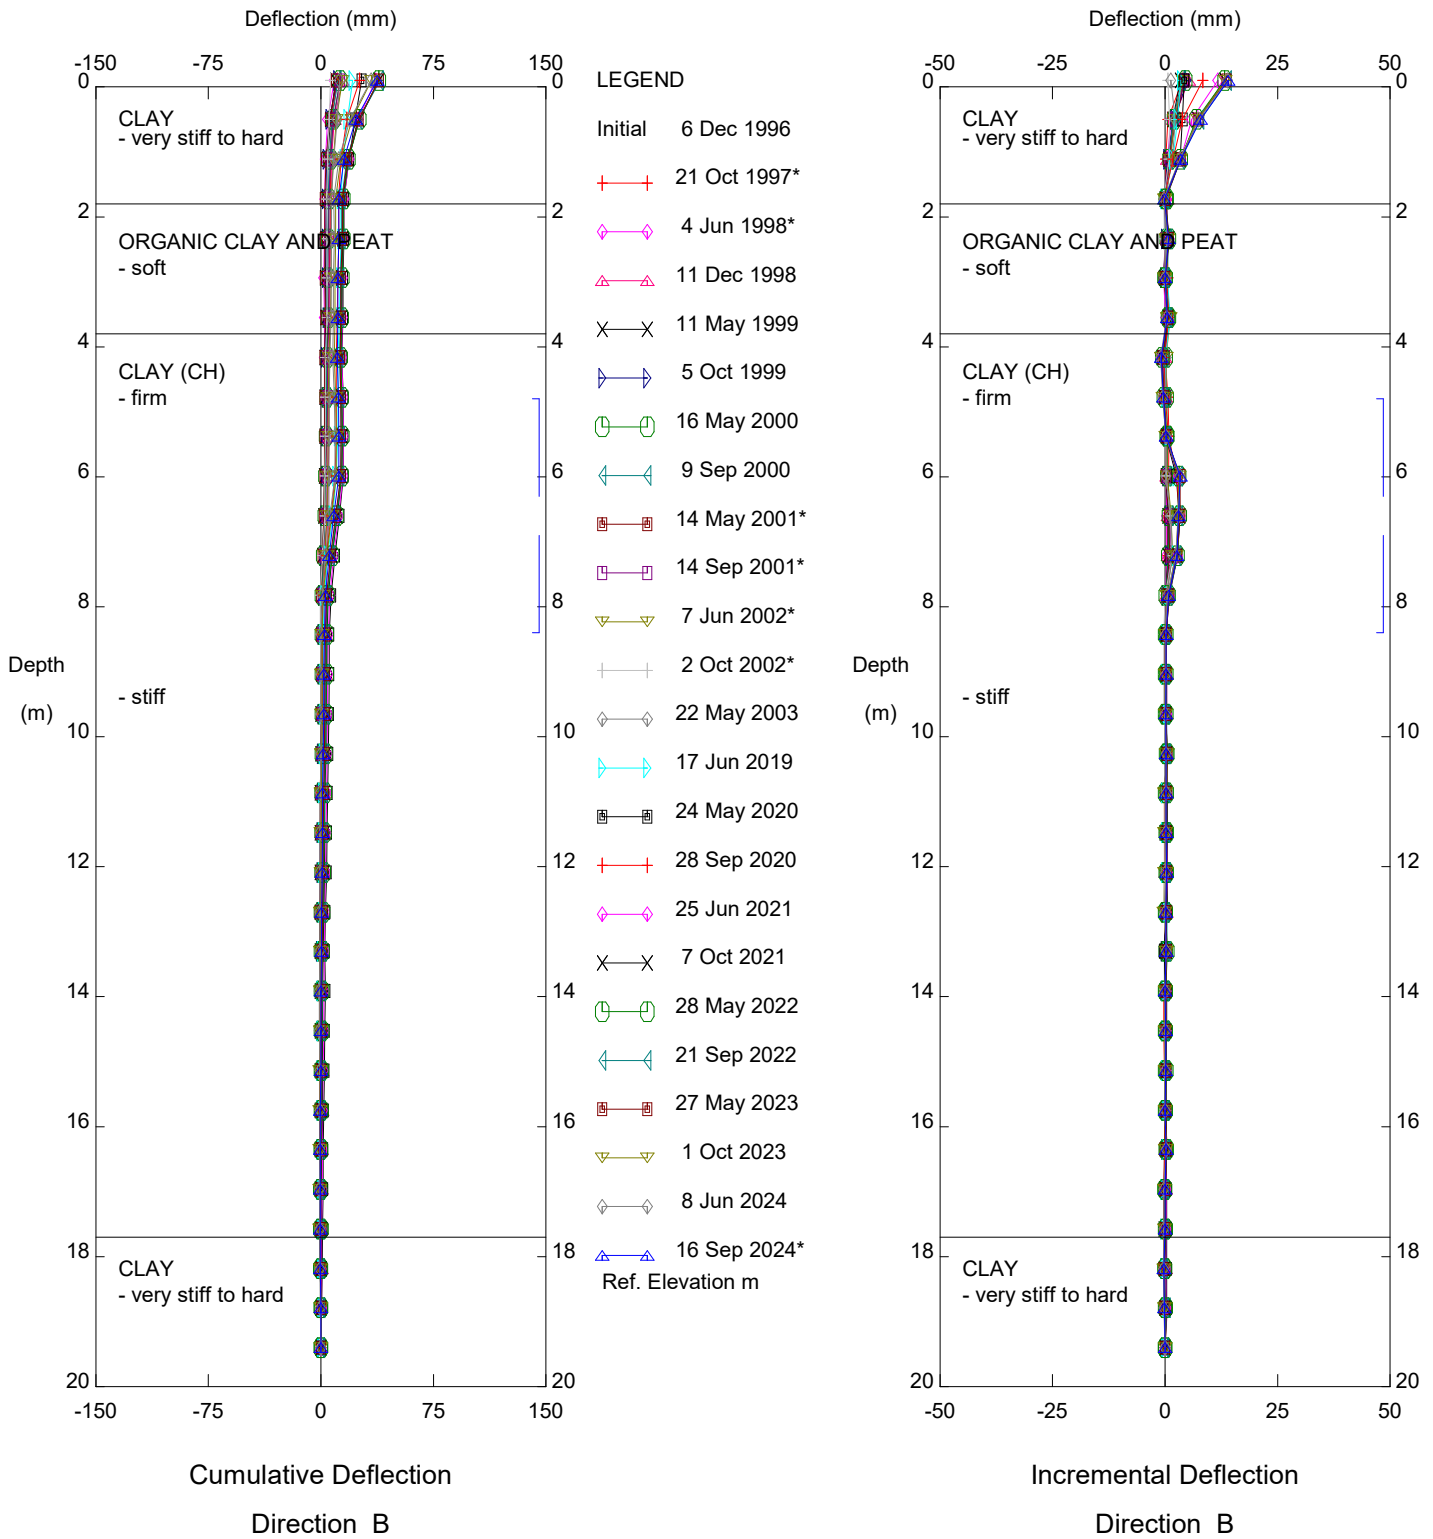
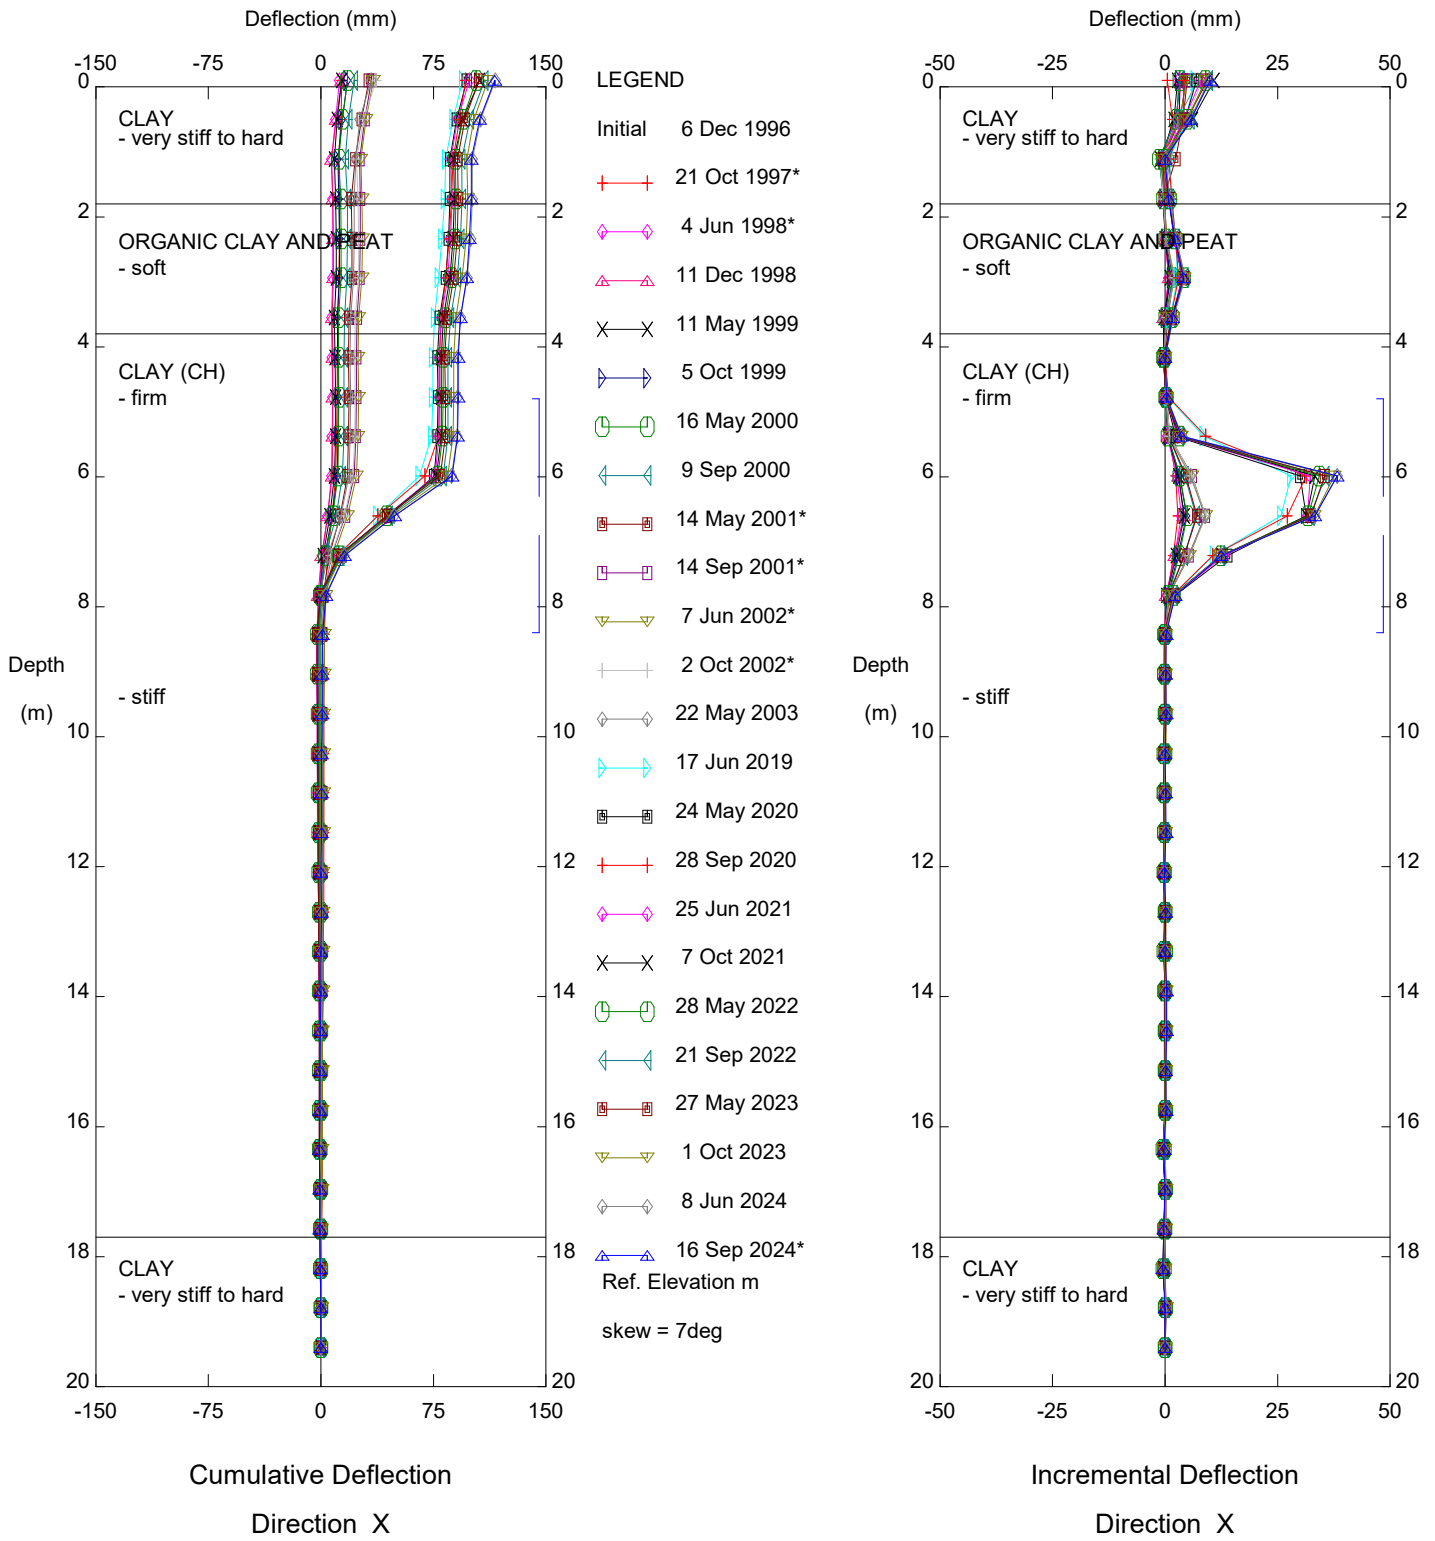
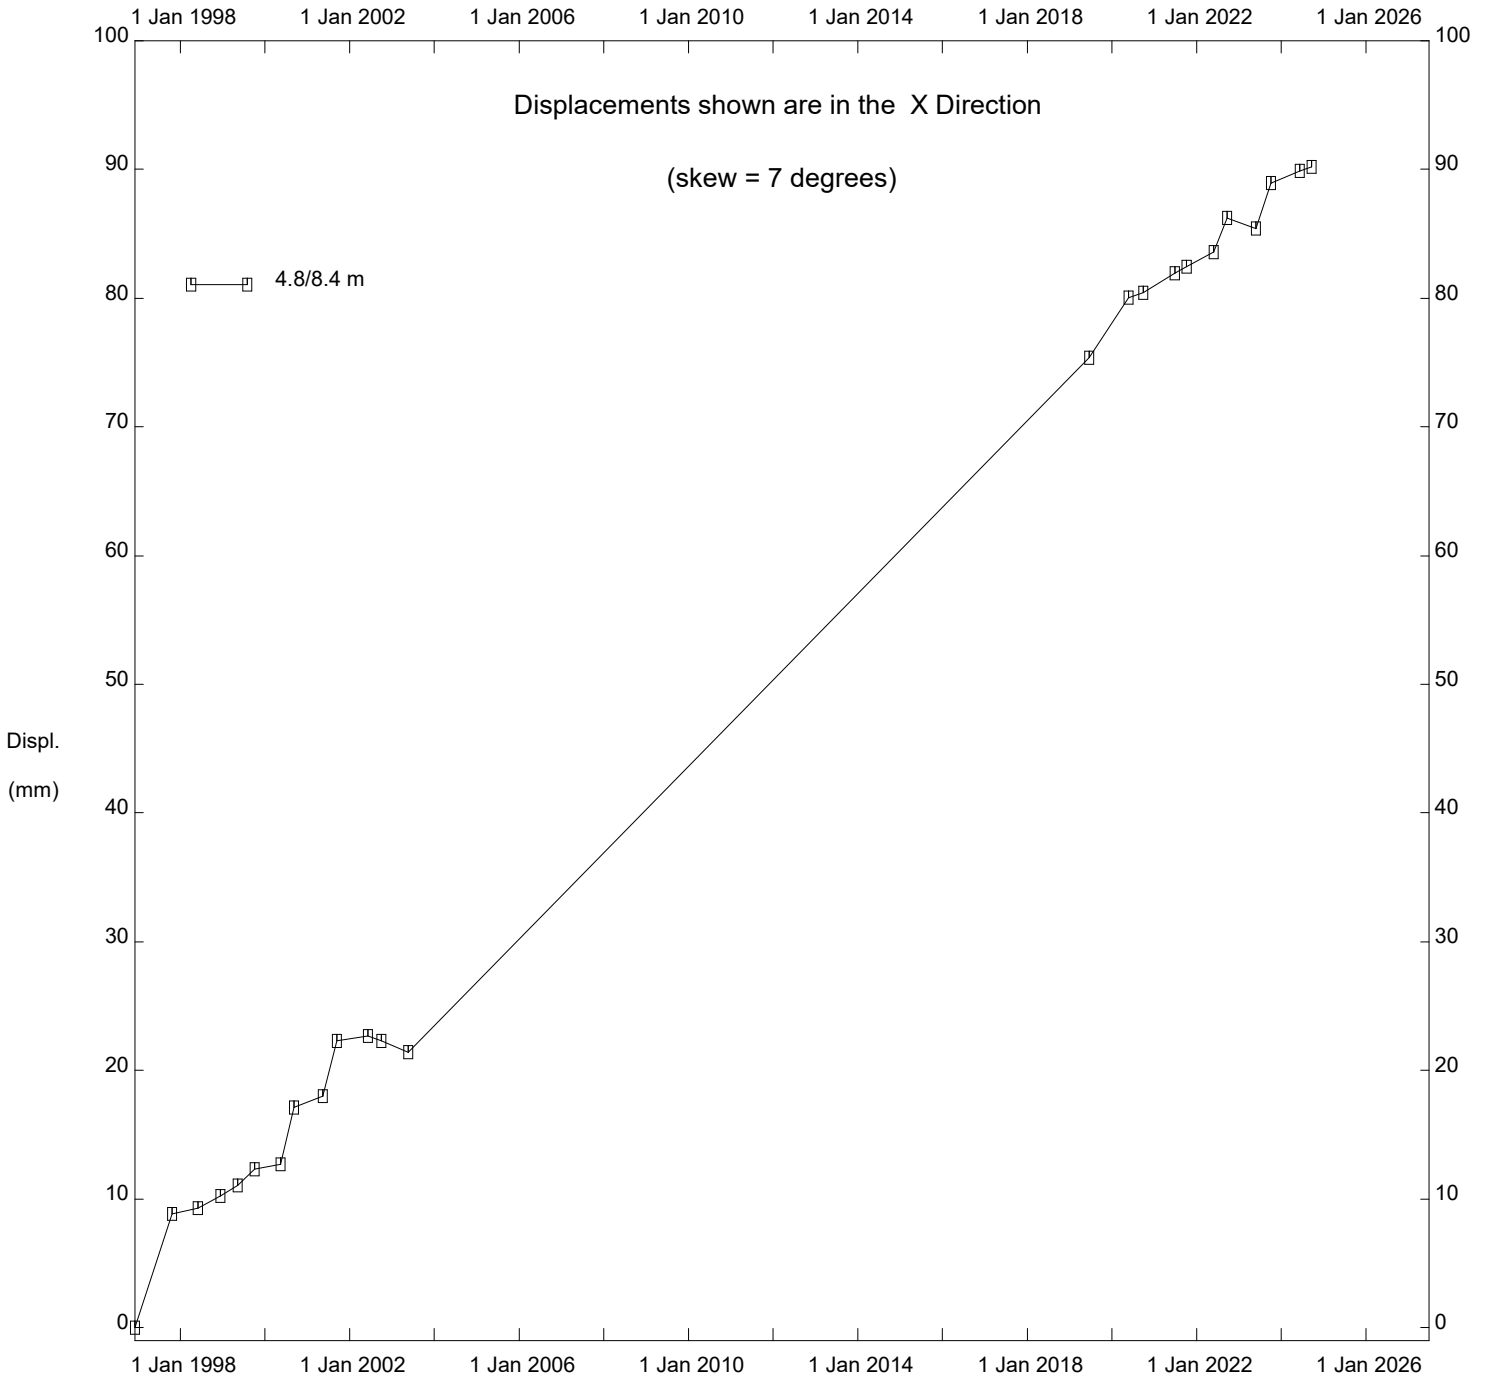
Labiche River, Inclinometer SI#1B

Discussion	
Zones of New Movement:	None
Interpretation of Monitoring Results:	SI1B showed a rate of movement of 1.0 mm/yr over 4.8 m to 8.4 m since the spring of 2024 readings. This corresponds to a decrease in the rate of movement by 0.4 mm/yr. Standpipe piezometer SP20-1 showed an increase in groundwater level of 0.24 m compared to the spring of 2024 readings.
Future Work:	The instruments should be read again in the spring of 2025.
Instrumentation Repairs:	SI20-2, VW20-2A and VW20-2B are critical instruments and consideration should be given to repairing these instruments in the spring of 2025.
Additional Comments:
