**ALBERTA TRANSPORTATION AND  
ECONOMIC CORRIDORS GRMP  
NORTH CENTRAL (ATHABASCA AND FORT  
MCMURRAY DISTRICTS)  
2024 SITE INSPECTION**

Site #	Location	Name	Hwy	km
NC008	15.6 Km North of Hwy 63 & 55 Intersection	La Biche River (0.8 to 0.9 km North of Bridge)	63:02	15.6
<b>Legal Description</b>		<b>UTM Co-ordinates (NAD 83)</b>		
3-69-17 W4		12	N 6089536	E 403480

Date	PF	CF	Total
<b>Previous Inspection:</b>	May 17, 2023	11	4	44 (New Landslide)
<b>Current Inspection:</b>	June 4, 2024	11	4	44 (New Landslide)
<b>Road WAADT:</b>	3,970	<b>Year:</b>		2023
<b>Inspected By:</b>	José Pineda, Tarek Abdelaziz (Thurber) Rocky Wang (TEC)			
<b>Report Attachments:</b>	<input checked="" type="checkbox"/> Photographs <input checked="" type="checkbox"/> Plans <input type="checkbox"/> Maintenance Items

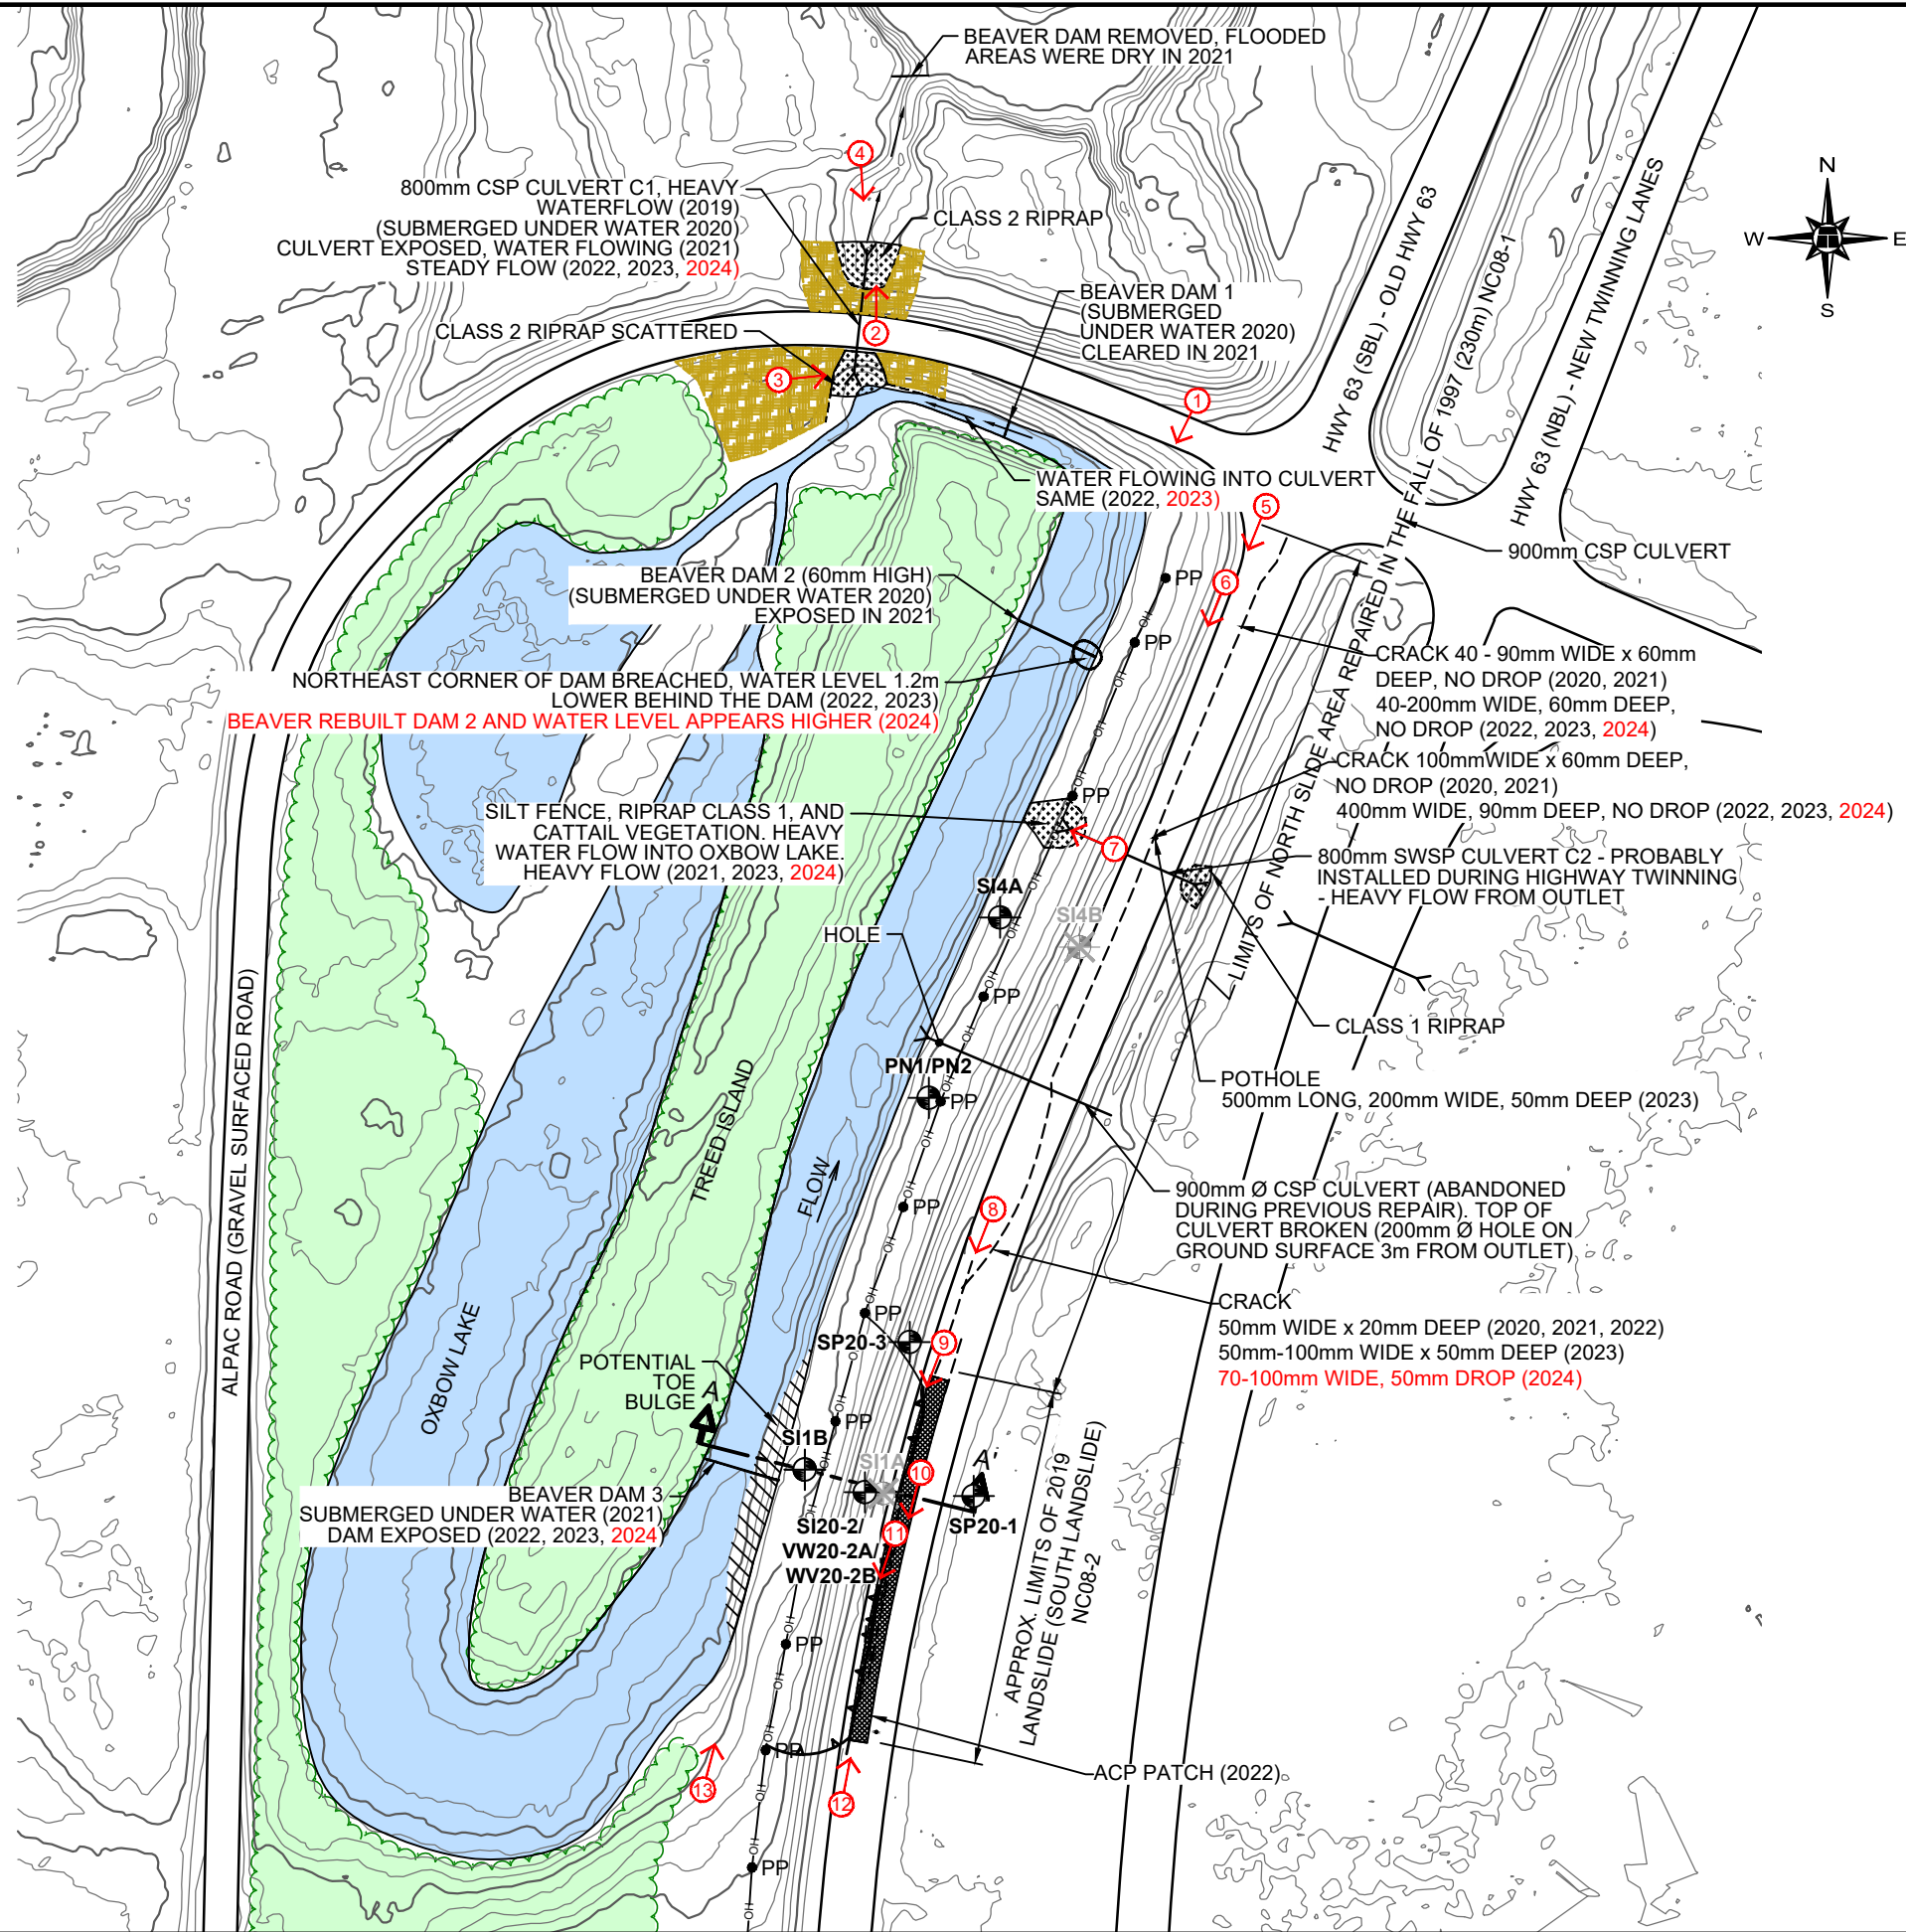
**FIGURE NC008-A**

**NC008: HWY 63:02 LA BICHE RIVER (km 15.6)  
SITE PLAN SHOWING EXISTING FEATURES**

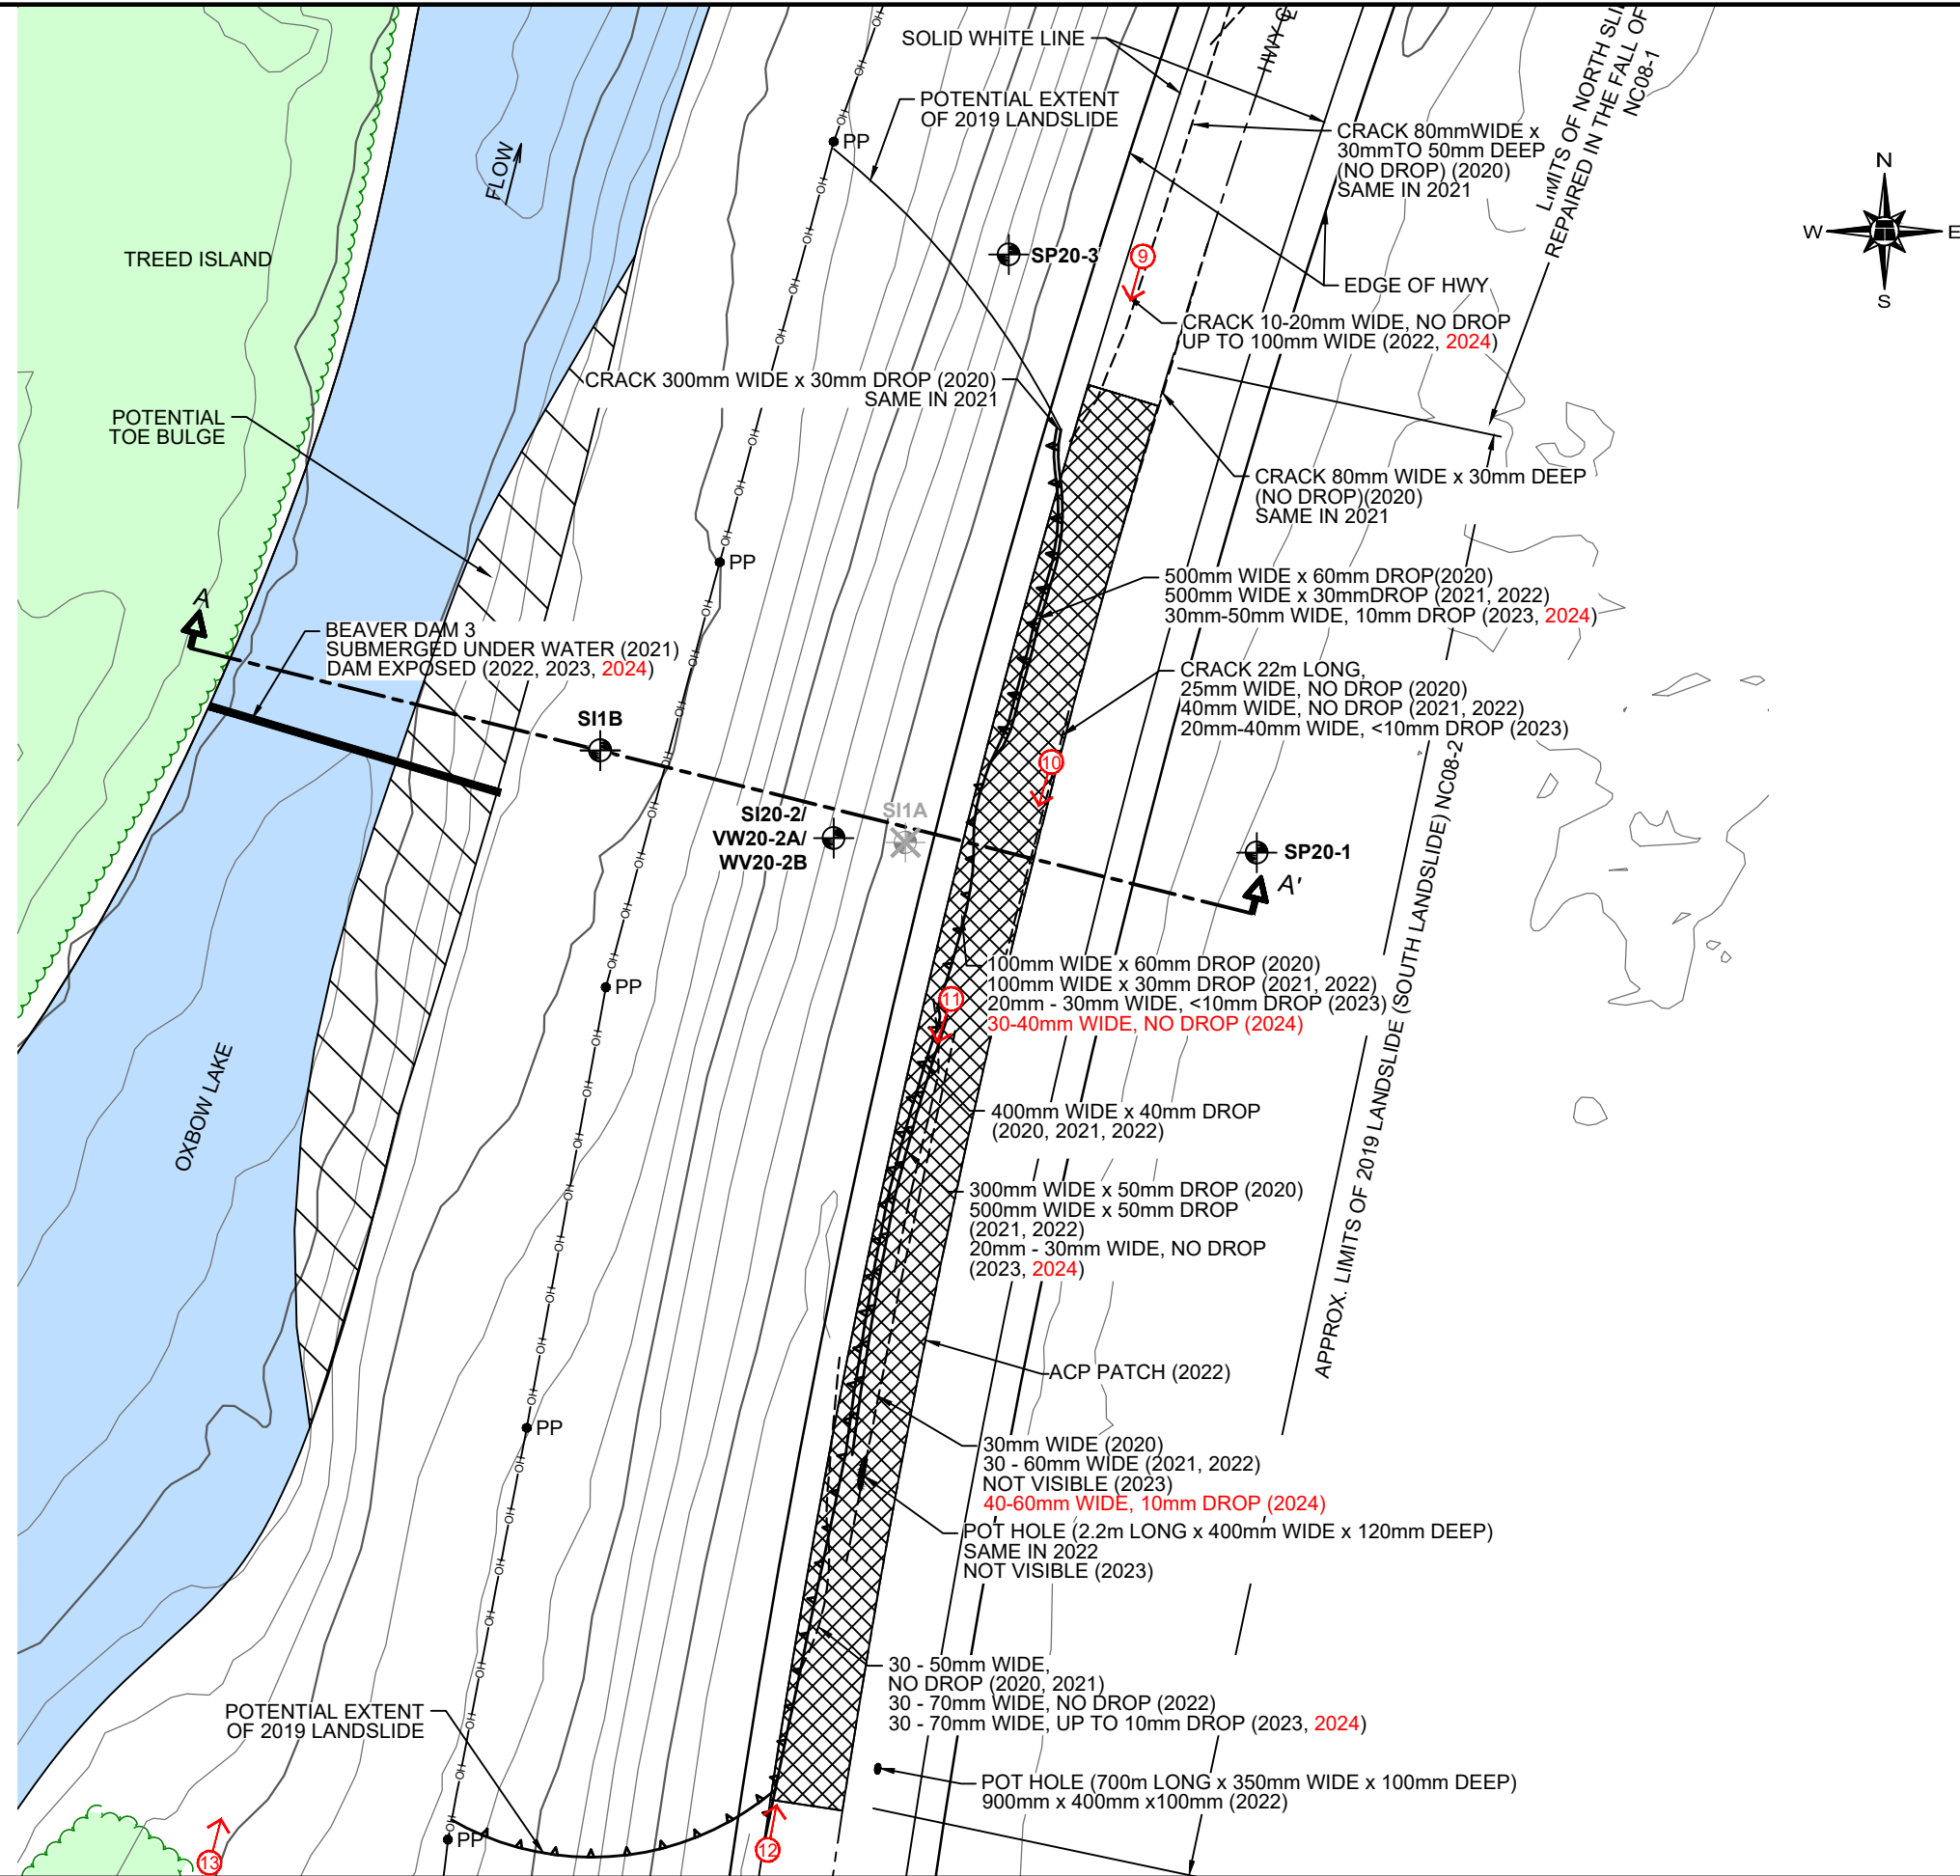
**FIGURE NC008-B**

**NC008: HWY 63:02 LA BICHE RIVER (km 15.6)  
SITE PLAN SHOWING THE SOUTH SLIDE AREA**

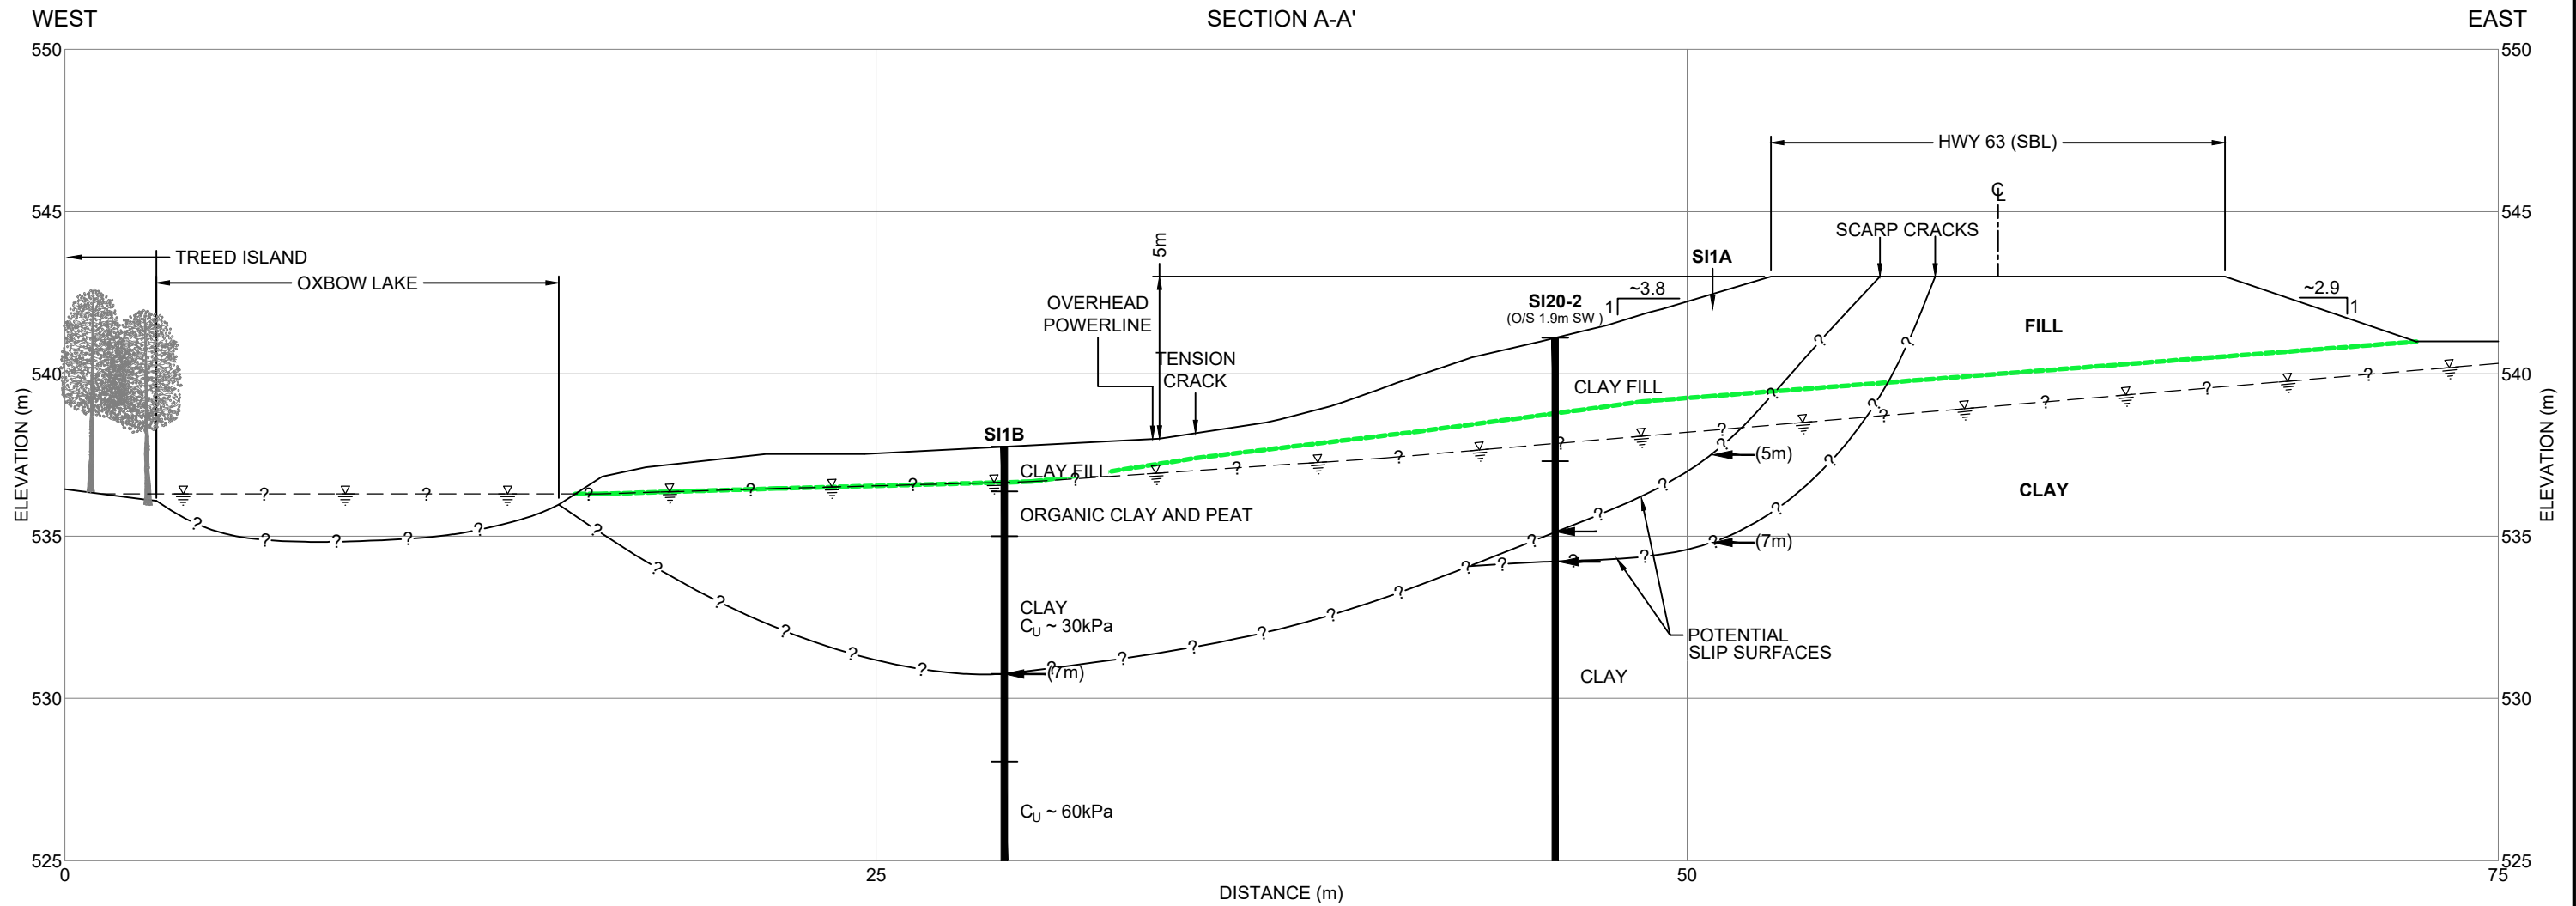
**FIGURE NC008-C**

**NC008: HWY 63:02 LA BICHE RIVER (km 15.6)  
CROSS-SECTION A-A'**

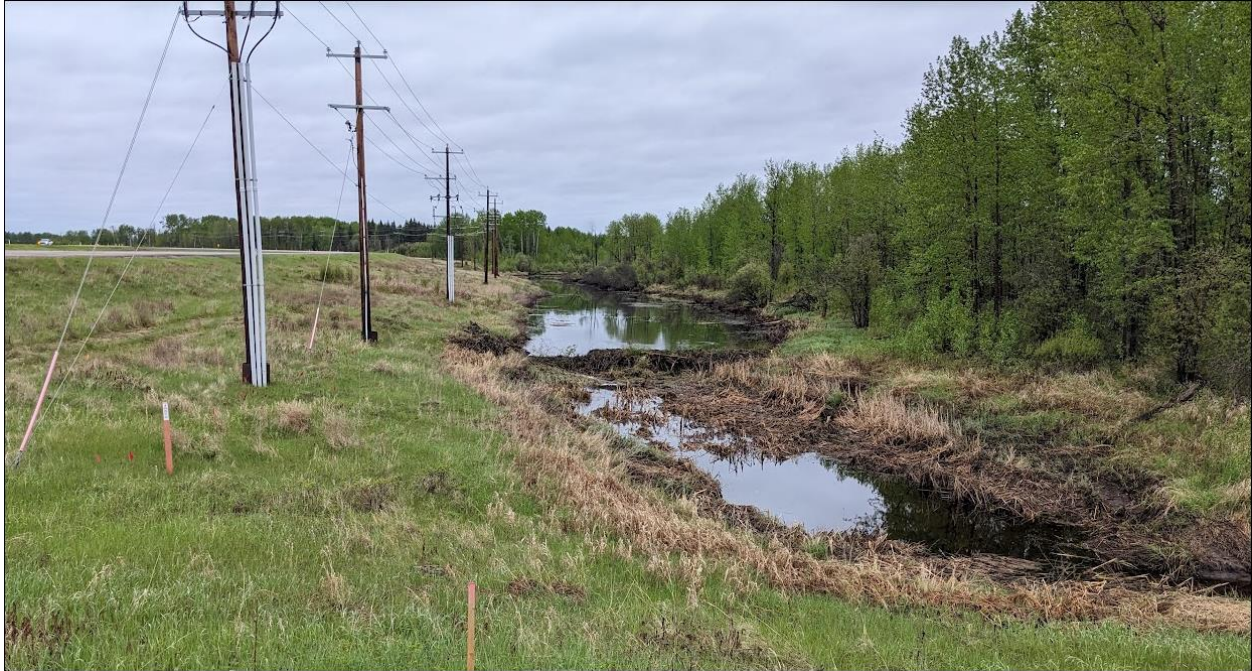
Fill placement on the top of the weak high plastic clay foundation and high groundwater levels within the clay fill and native clay are the main triggers for the landslide movement. It is likely that the presence of beaver dams within the oxbow lake resulted in high ground water levels within the landslide mass and aggravated the situation in the past.

The observed water levels in the oxbow lake between 2022 and 2024 were much lower than in the past, and this appears to have reduced the rate of movement of the landslide over the past few years.

Photo No. 1 – Looking south at Oxbow Lake. NE corner of Beaver Dam 2 rebuilt; water levels appear higher behind the Dam in 2024

- (a) Monitor the highway surface periodically for signs of distress and watch closely for the development of additional cracks and highway dip (particularly after prolonged rainfall events). The highway surface cracks at NC008-2 location should be sealed to prevent surface water infiltration into the landslide mass.
- (b) Consideration should be given to placing ACP patch within the limits of the NC008-2, if the existing dip becomes worse, to improve highway rideability.
- (c) Consider removing all beaver dams within the oxbow lake to further reduce water levels within the highway embankment.

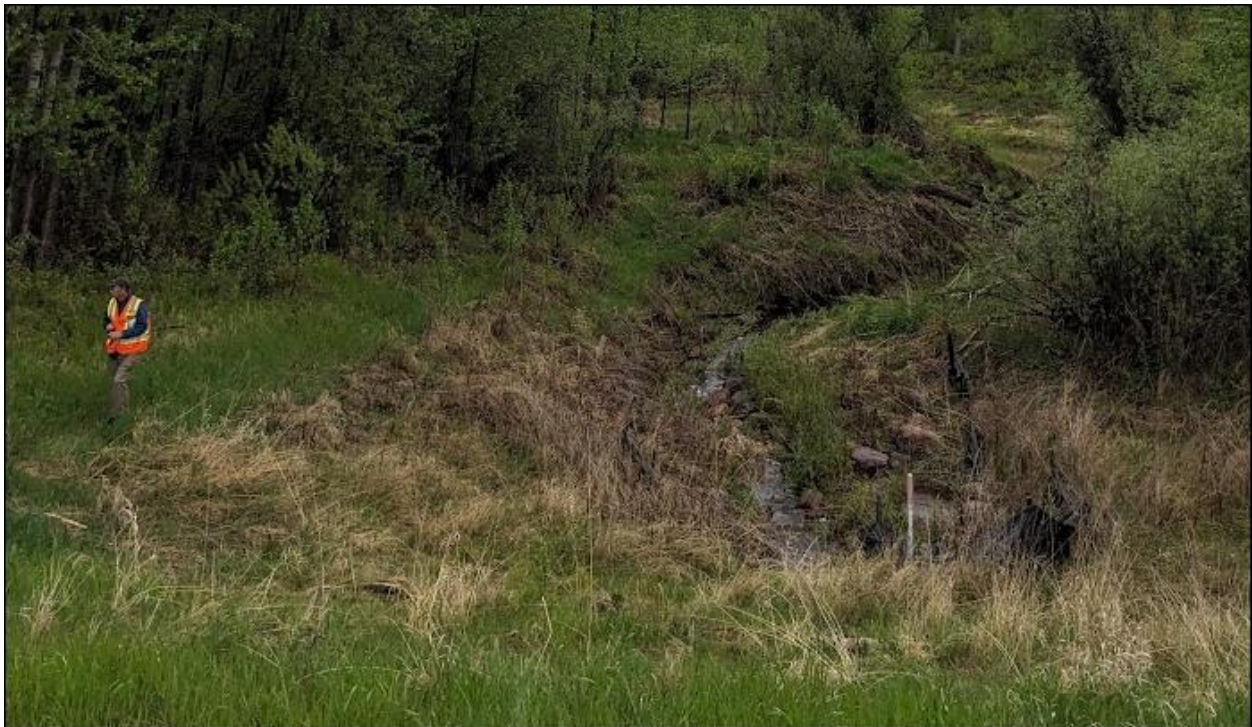
Photo No. 2 – Looking north at Culvert C1 outlet; water continues to flow freely along the channel

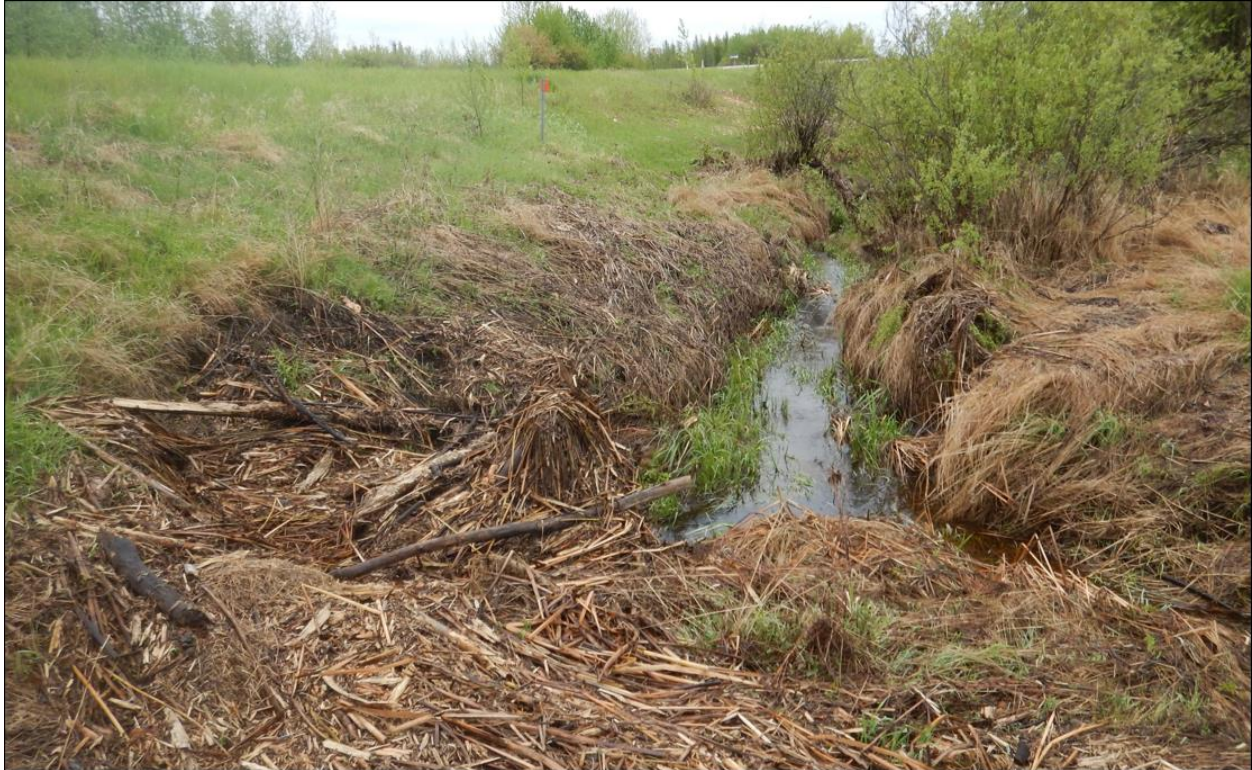
Photo No. 3 – Looking east towards CSP culvert C1 inlet

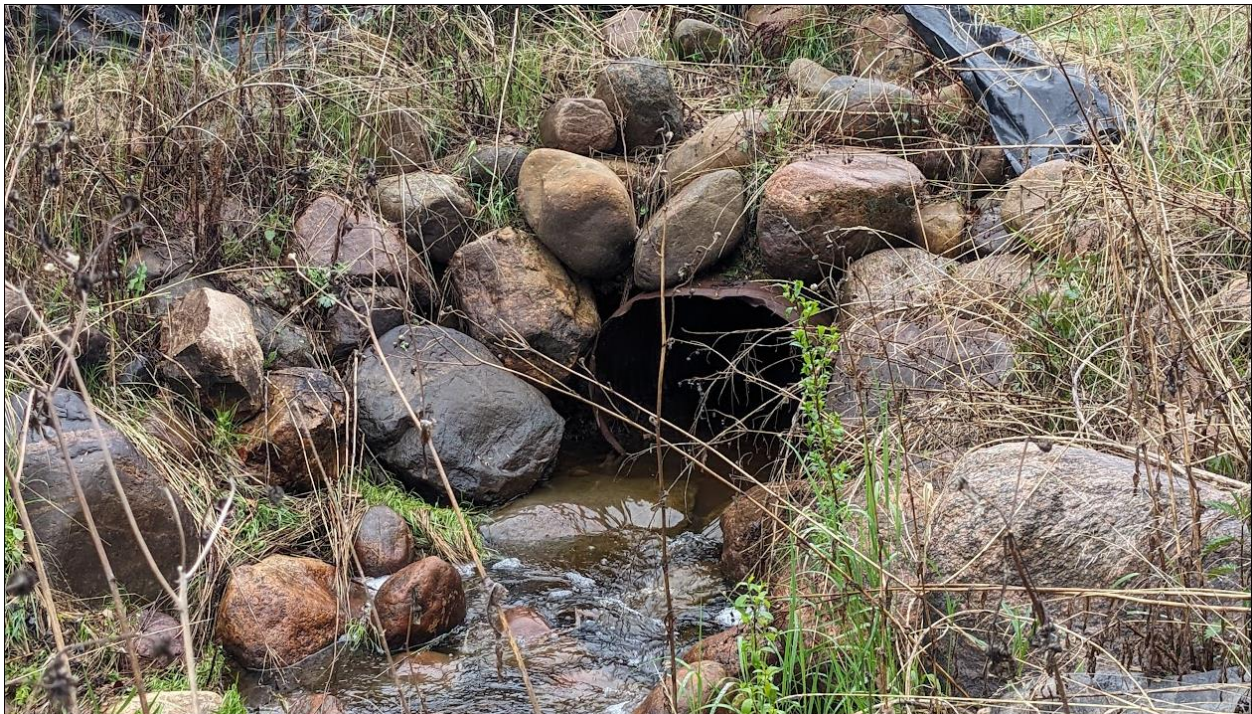
Photo No. 4 – Steady Water Flow at Culvert C1 outlet location

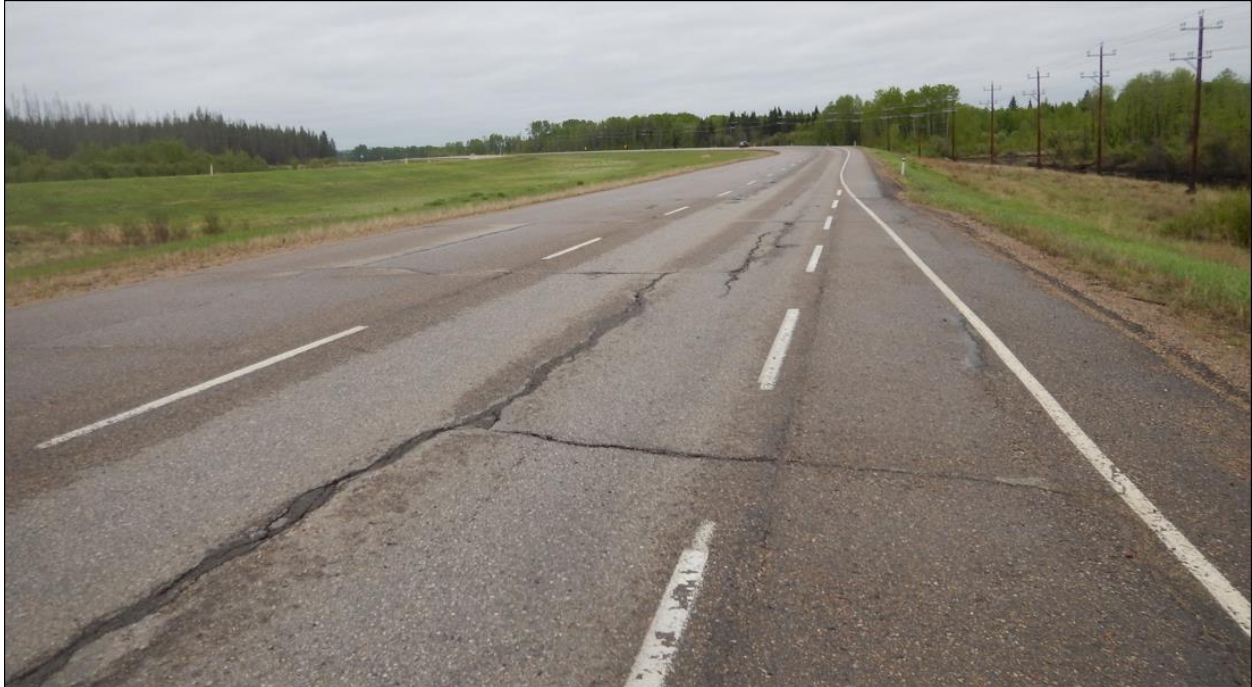
Photo No. 5 – Looking south at highway open cracks within the limits of the repaired area in 1997 (previously known as NC08-1)

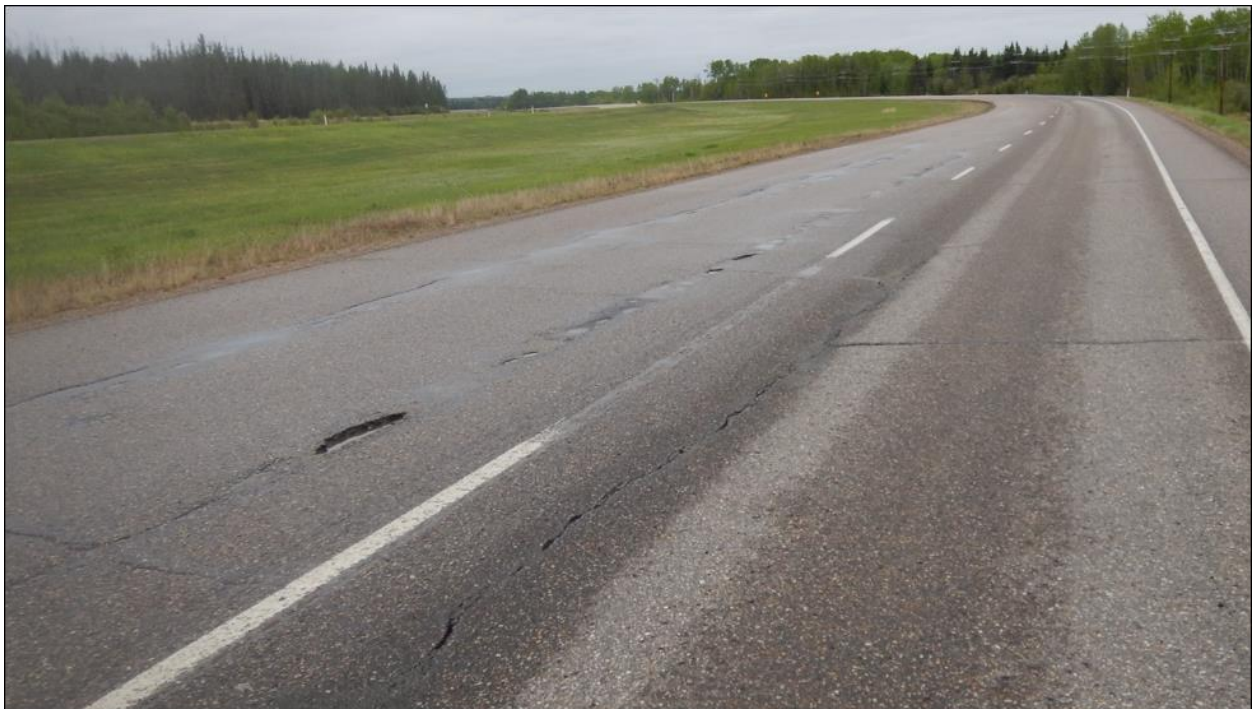
Photo No. 6 – Looking south at highway open cracks and potholes within the limits of the NC08-1 repaired area

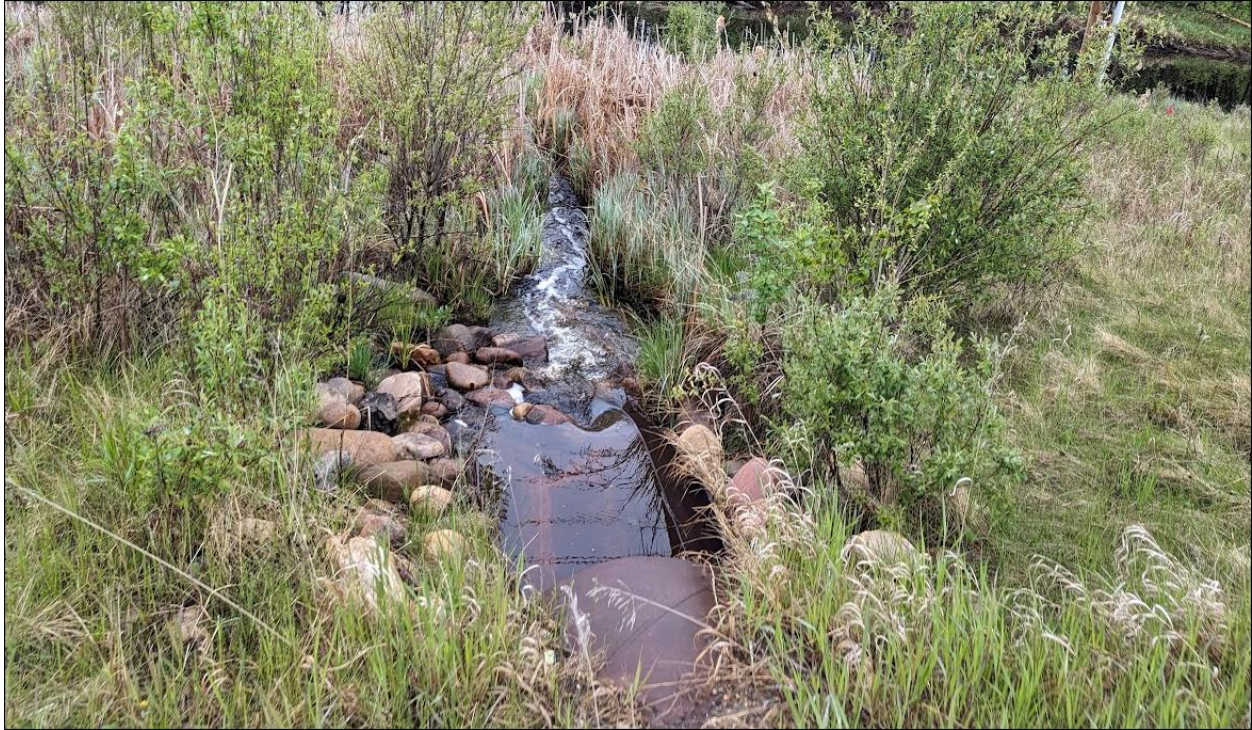
Photo No. 7 – Looking at the 900 mm diameter SWSP Culvert C2 outlet; heavy flow in 2024

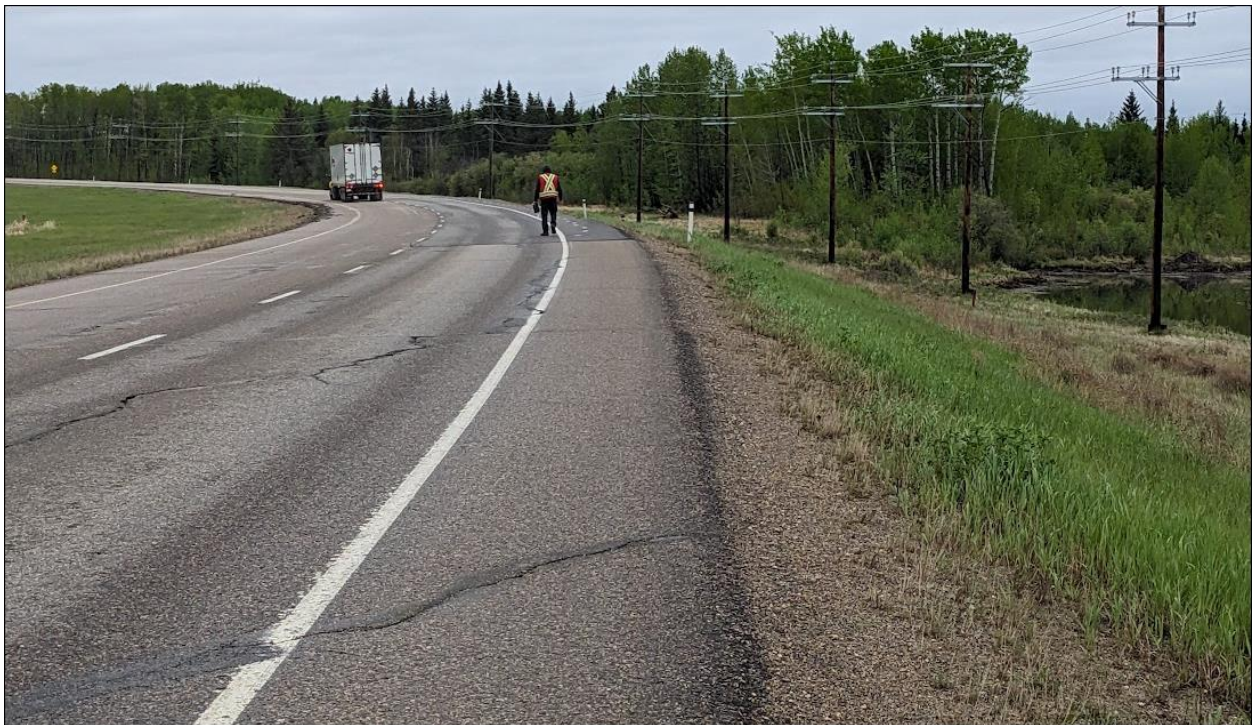
Photo No. 8 – Looking south at the southern flank cracks of the NC08-1 repaired landslide

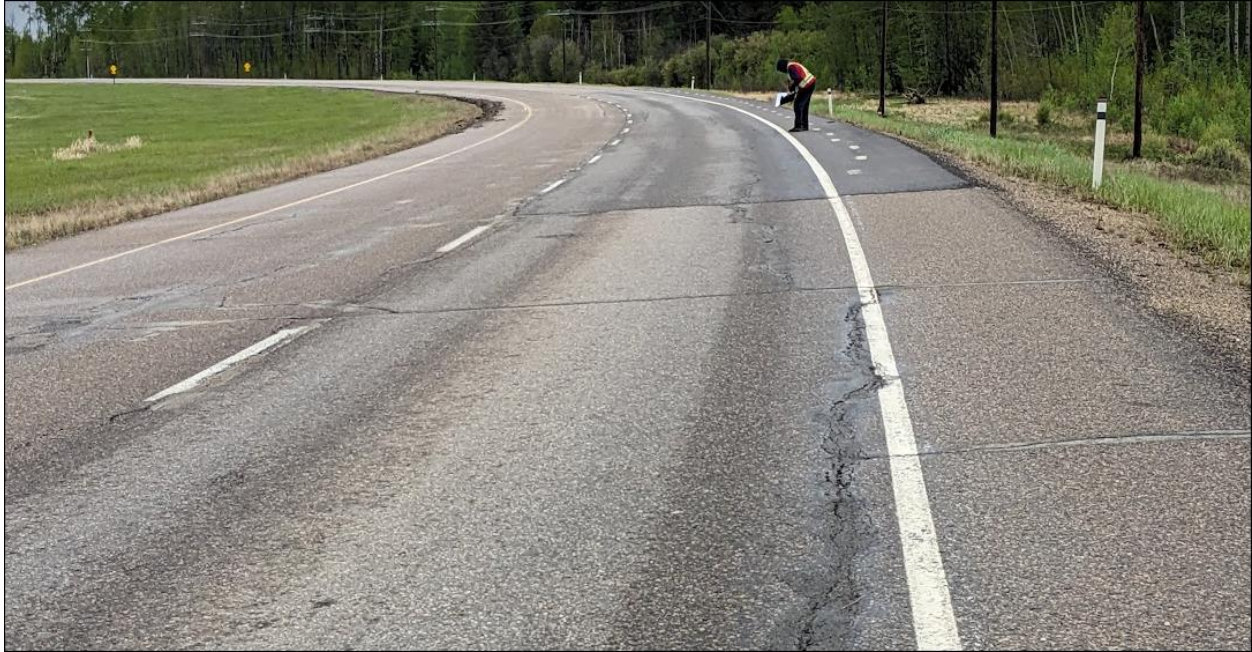
The ACP patch placed in 2022 improved the highway driving condition within the NC008-2 landslide area. However, landslide cracks reflected on the highway surface and these cracks are expected to get worse and will contribute to faster deterioration of the highway surface condition until long-term repairs take place.

Photo No. 9 – Looking south at the northern flank of the new landslide (NC08-2); new ACP patch placed in 2022 showing reflective cracks (20 mm to 70 mm wide)

Based on a preliminary engineering assessment prepared by Thurber in 2024, TEC has selected a long-term repair option consisting of two rows of driven steel pile walls parallel to the highway alignment. The estimated cost to construct the pile walls is in the range of \$ 3,500,000.

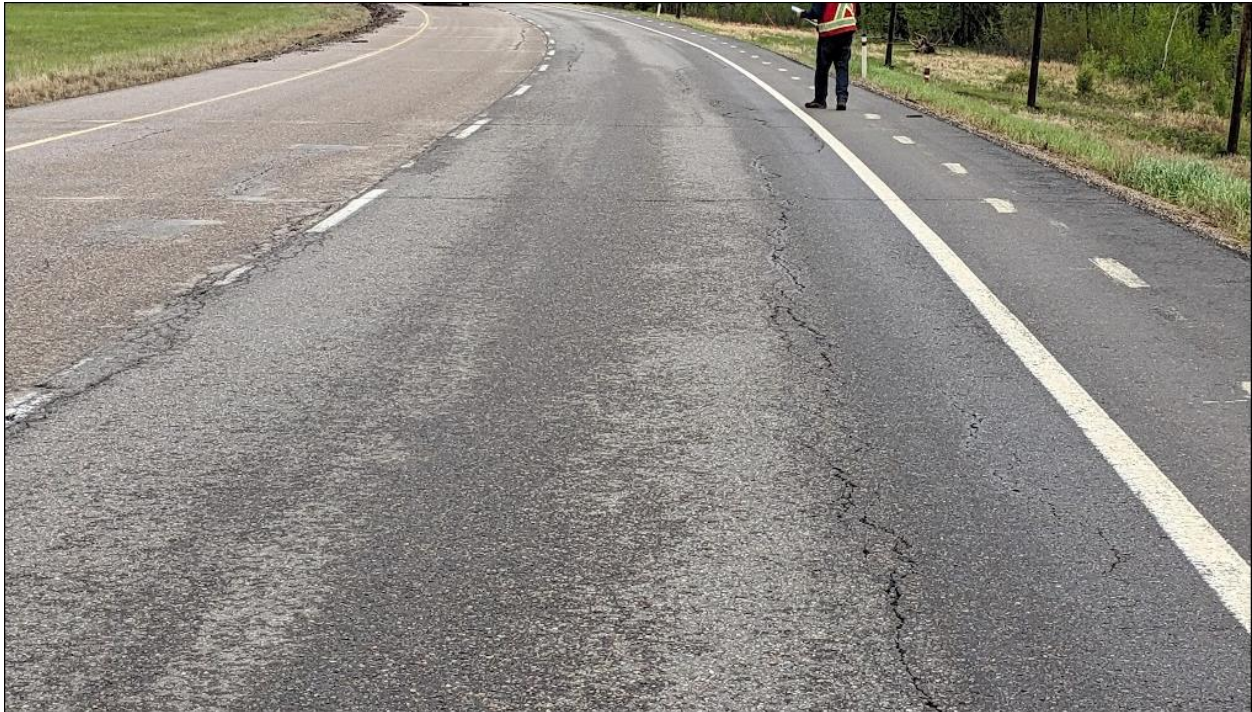
Photo No. 10 – Looking south at reflective cracks within the middle section of the NC08-2 landslide

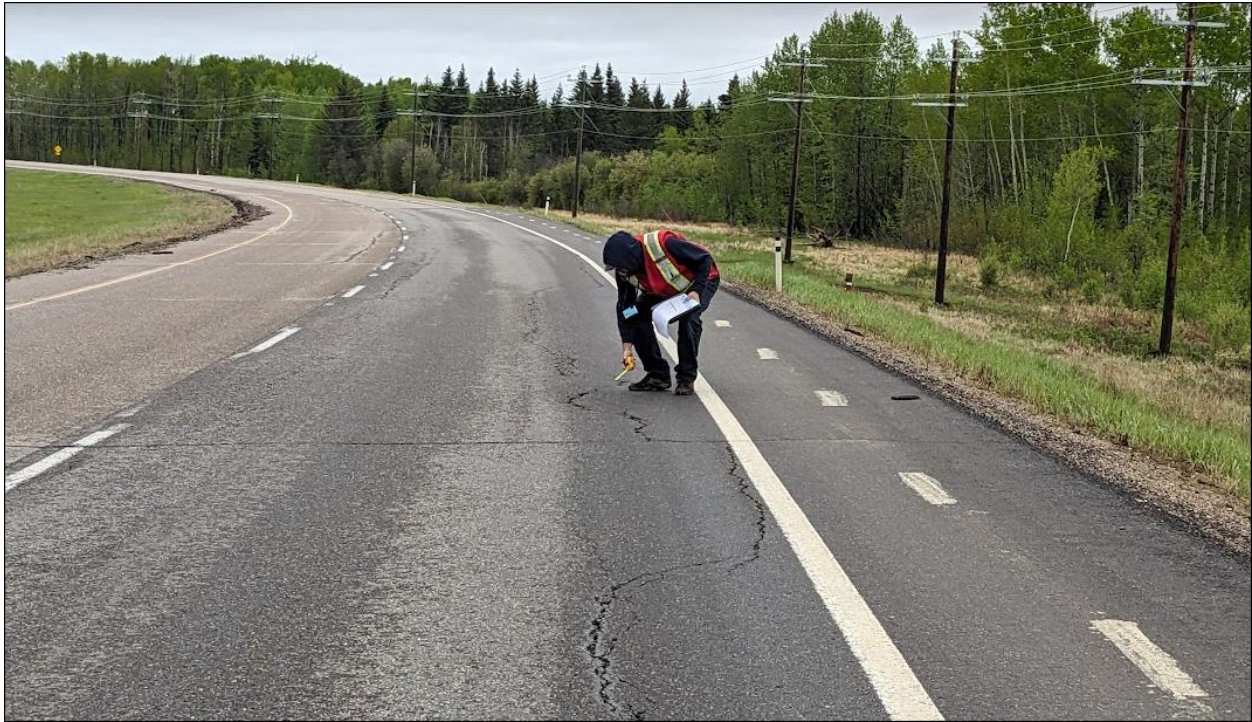
Photo No. 11 – Looking south at, 30-40 mm wide with no drop, reflective cracks near the southern flank of the NC08-2 landslide

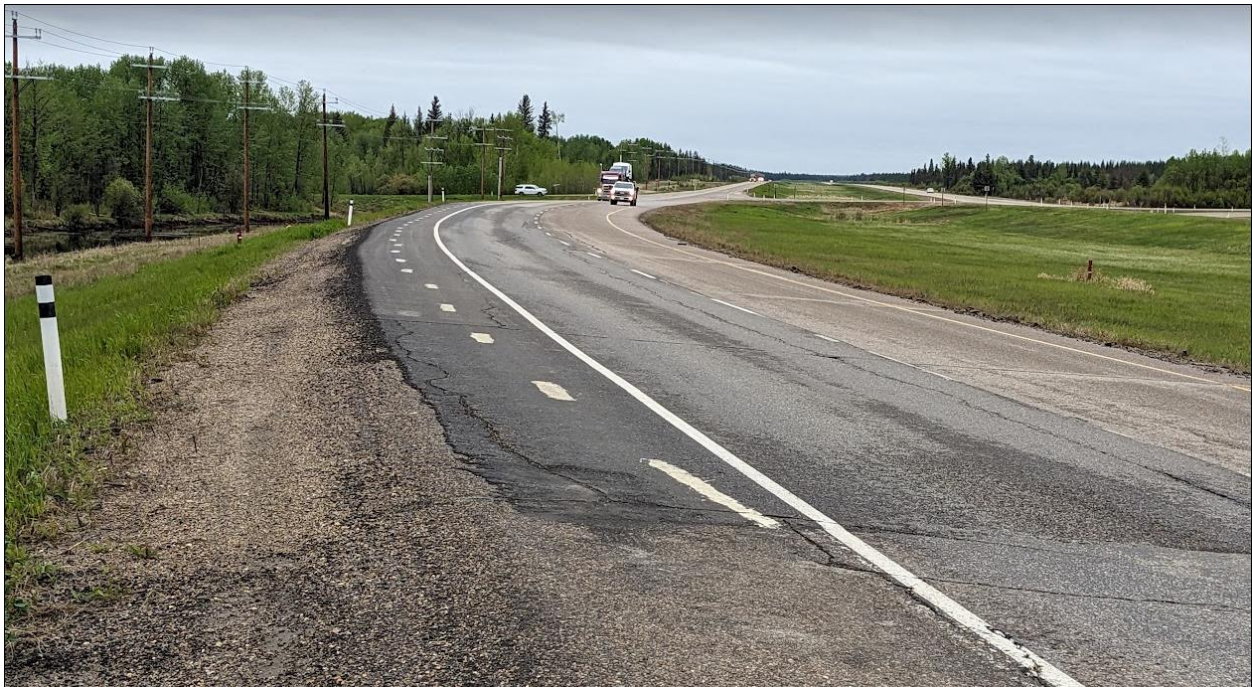
Photo No. 12 – Looking north at reflective cracks, 30-70 mm wide with 10 mm drop, near the southern flank of the NC08-2 landslide

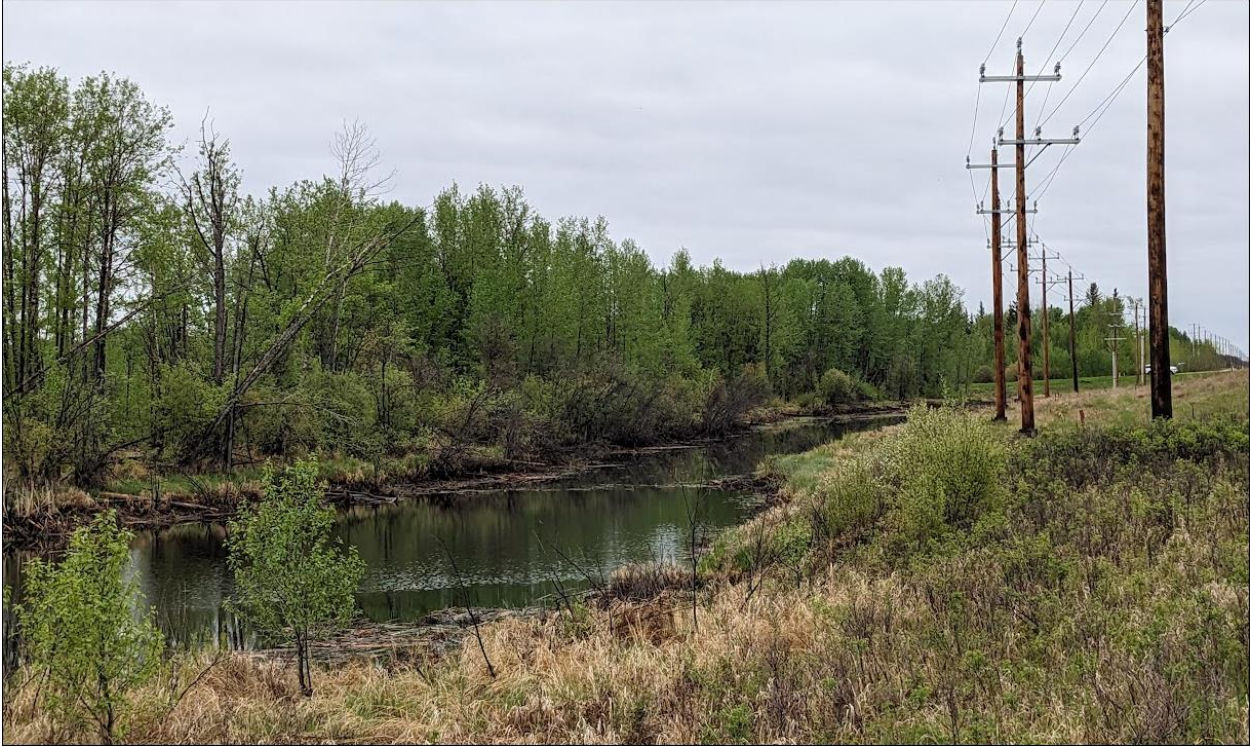
Photo No. 13 – Looking north at Beaver Dam 3 and Landslide Toe Bulge
