**ALBERTA TRANSPORTATION AND
ECONOMIC CORRIDORS GRMP
NORTH CENTRAL (ATHABASCA AND FORT
McMURRAY DISTRICTS)
INSTRUMENTATION MONITORING- SPRING 2024**

Site Number	Location	Name	Hwy	km
NC008	HWY 63:02 L1 15.635	North of La Biche River	63:02	Km 15.6
Legal Description: 7-3-69-17 W4		UTM Co-ordinates		
		12U E 403478	N	6089488

Current Monitoring:	8-Jun-2024	Previous Monitoring	01-Oct-2023
Instruments Read By:	Mr. Niraj Regmi, G.I.T and Mr. Nixson Mationg, of Thurber

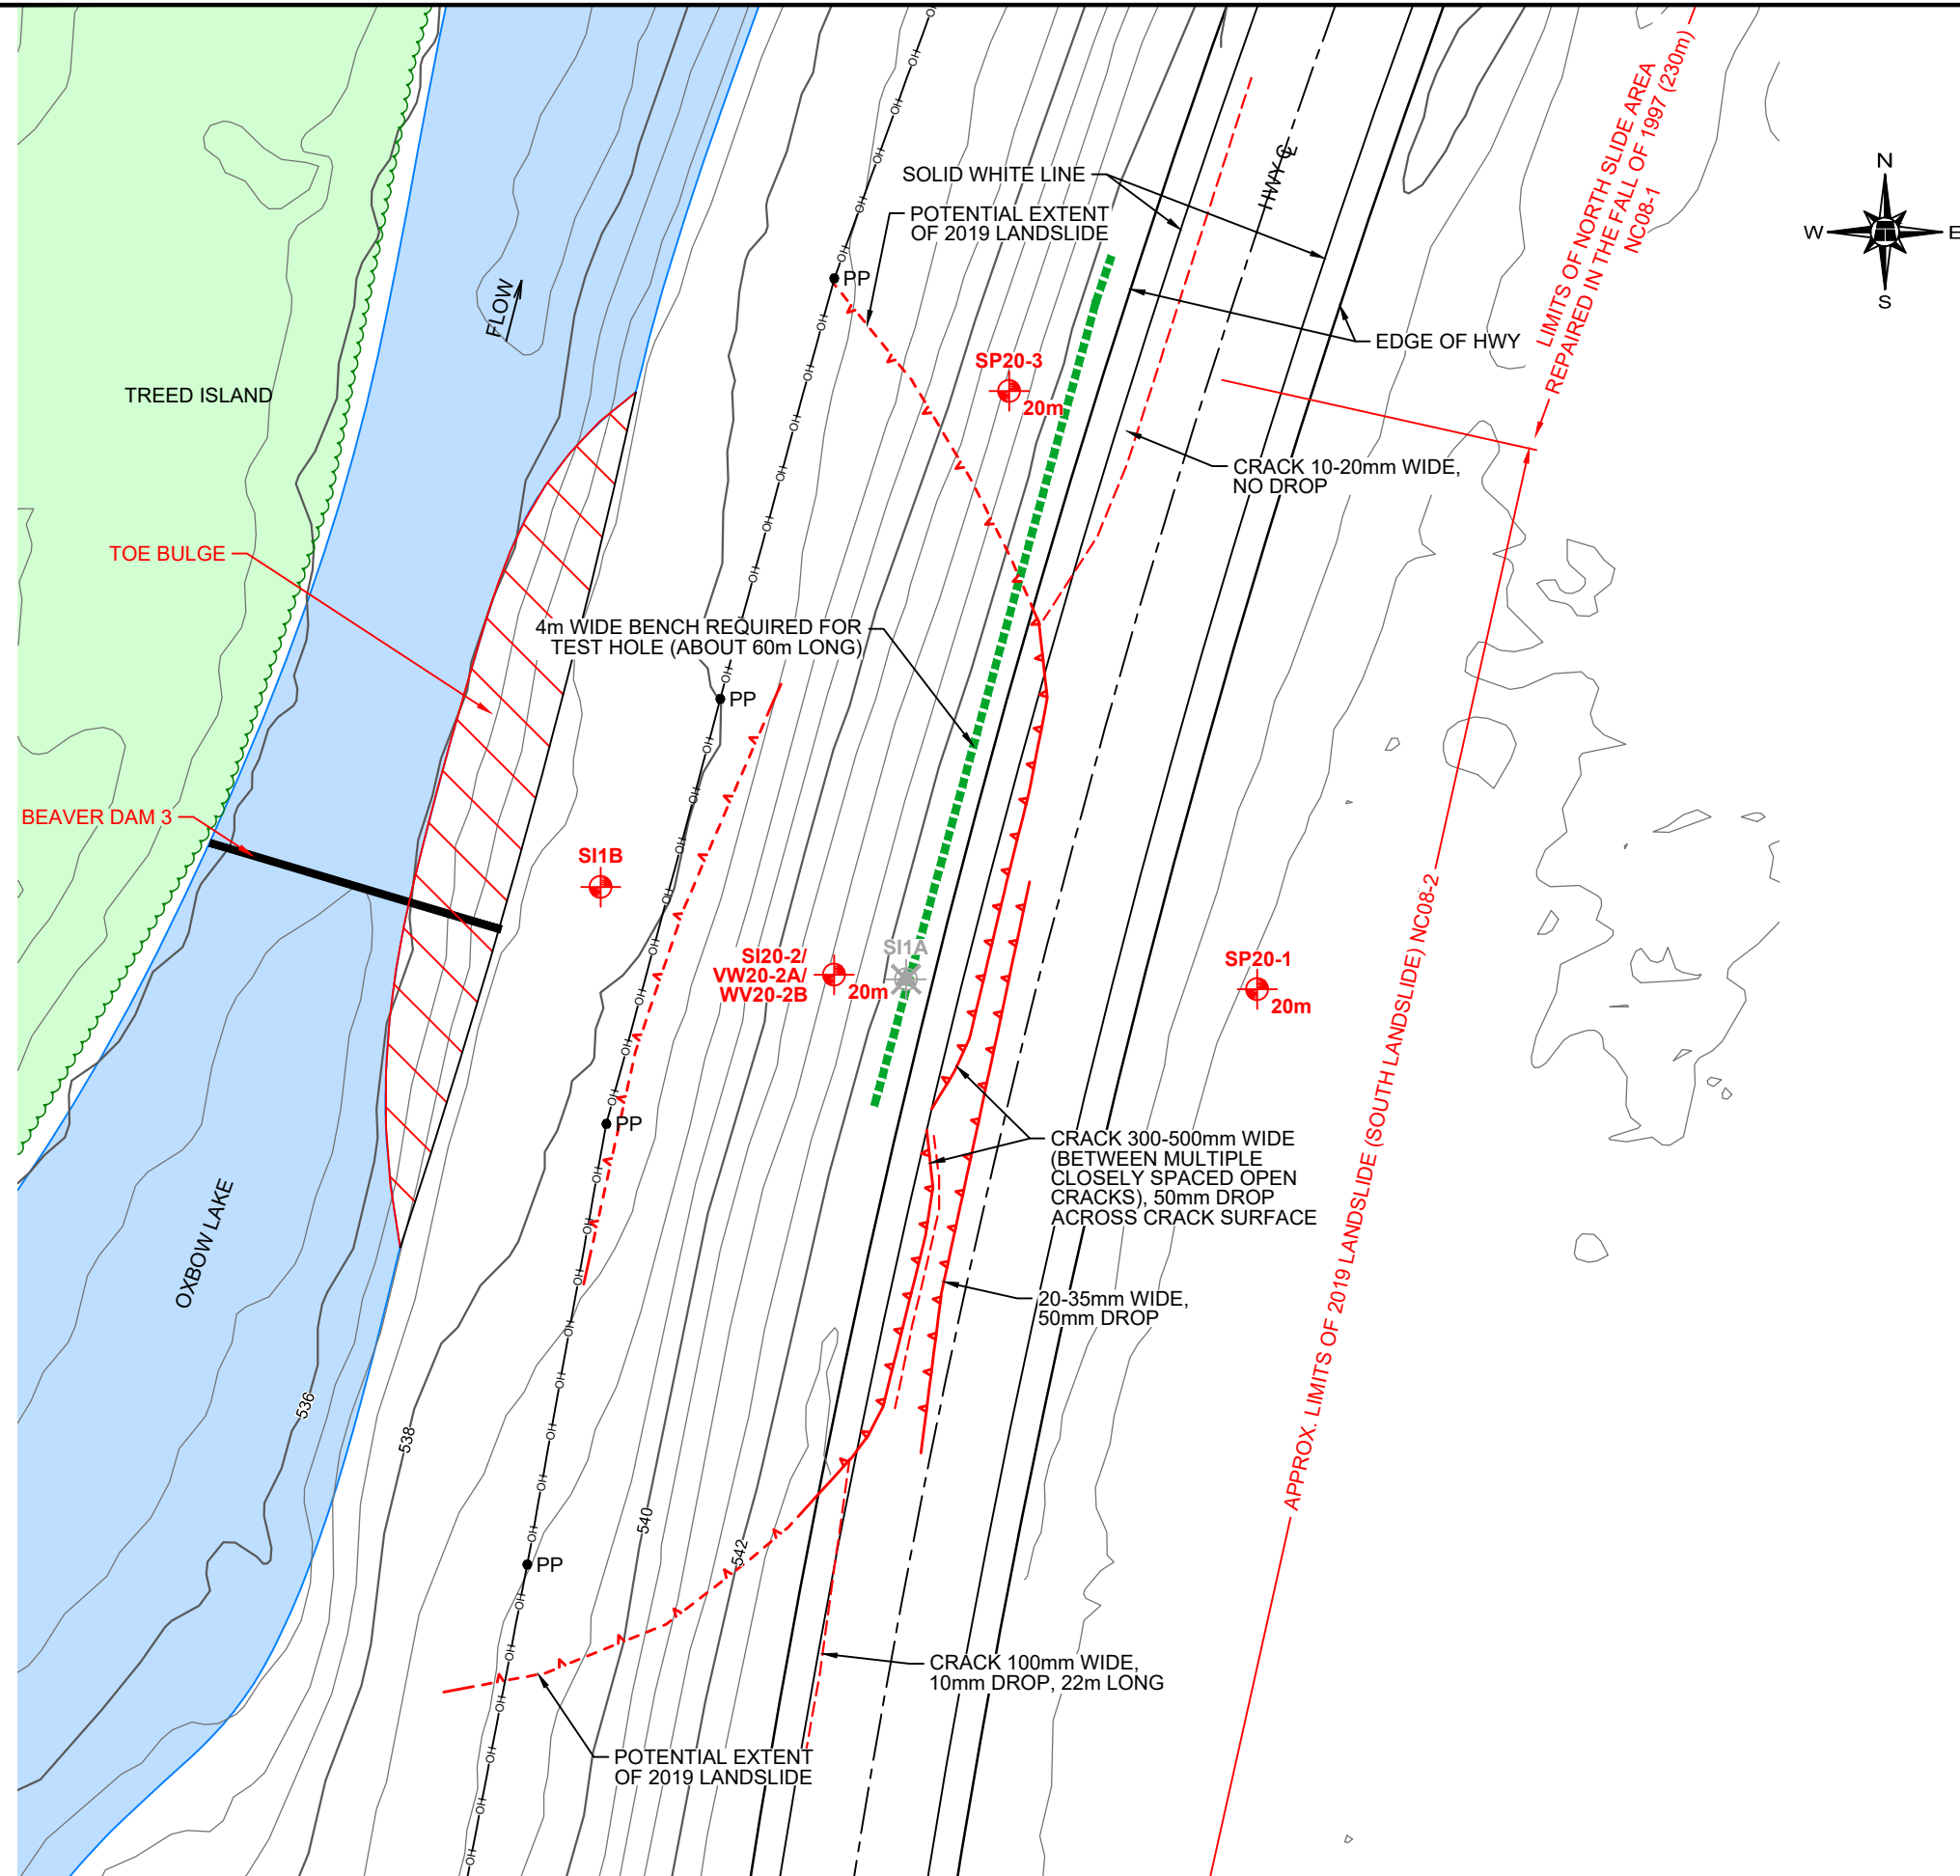
DWG No. 32122-NC008

1. SITE FEATURES ARE APPROXIMATE
2. TOPOGRAPHY IS BASED ON 2008 LIDAR DATA
3. JULY 3, 2019 OBSERVATIONS SHOWN IN RED
4. POTHOLES AND 10-20mm WIDE REFLECTIVE CRACKS ARE VISIBLE ON SOUTHBOUND LANES WITHIN THE LIMITS OF PREVIOUSLY REPAIRED AREA (NC08-1)
5. OVERHEAD POWERLINES WERE RELOCATED TO THE WEST SIDE OF THE OLD HIGHWAY 63 DURING HIGHWAY TWINNING PROJECT

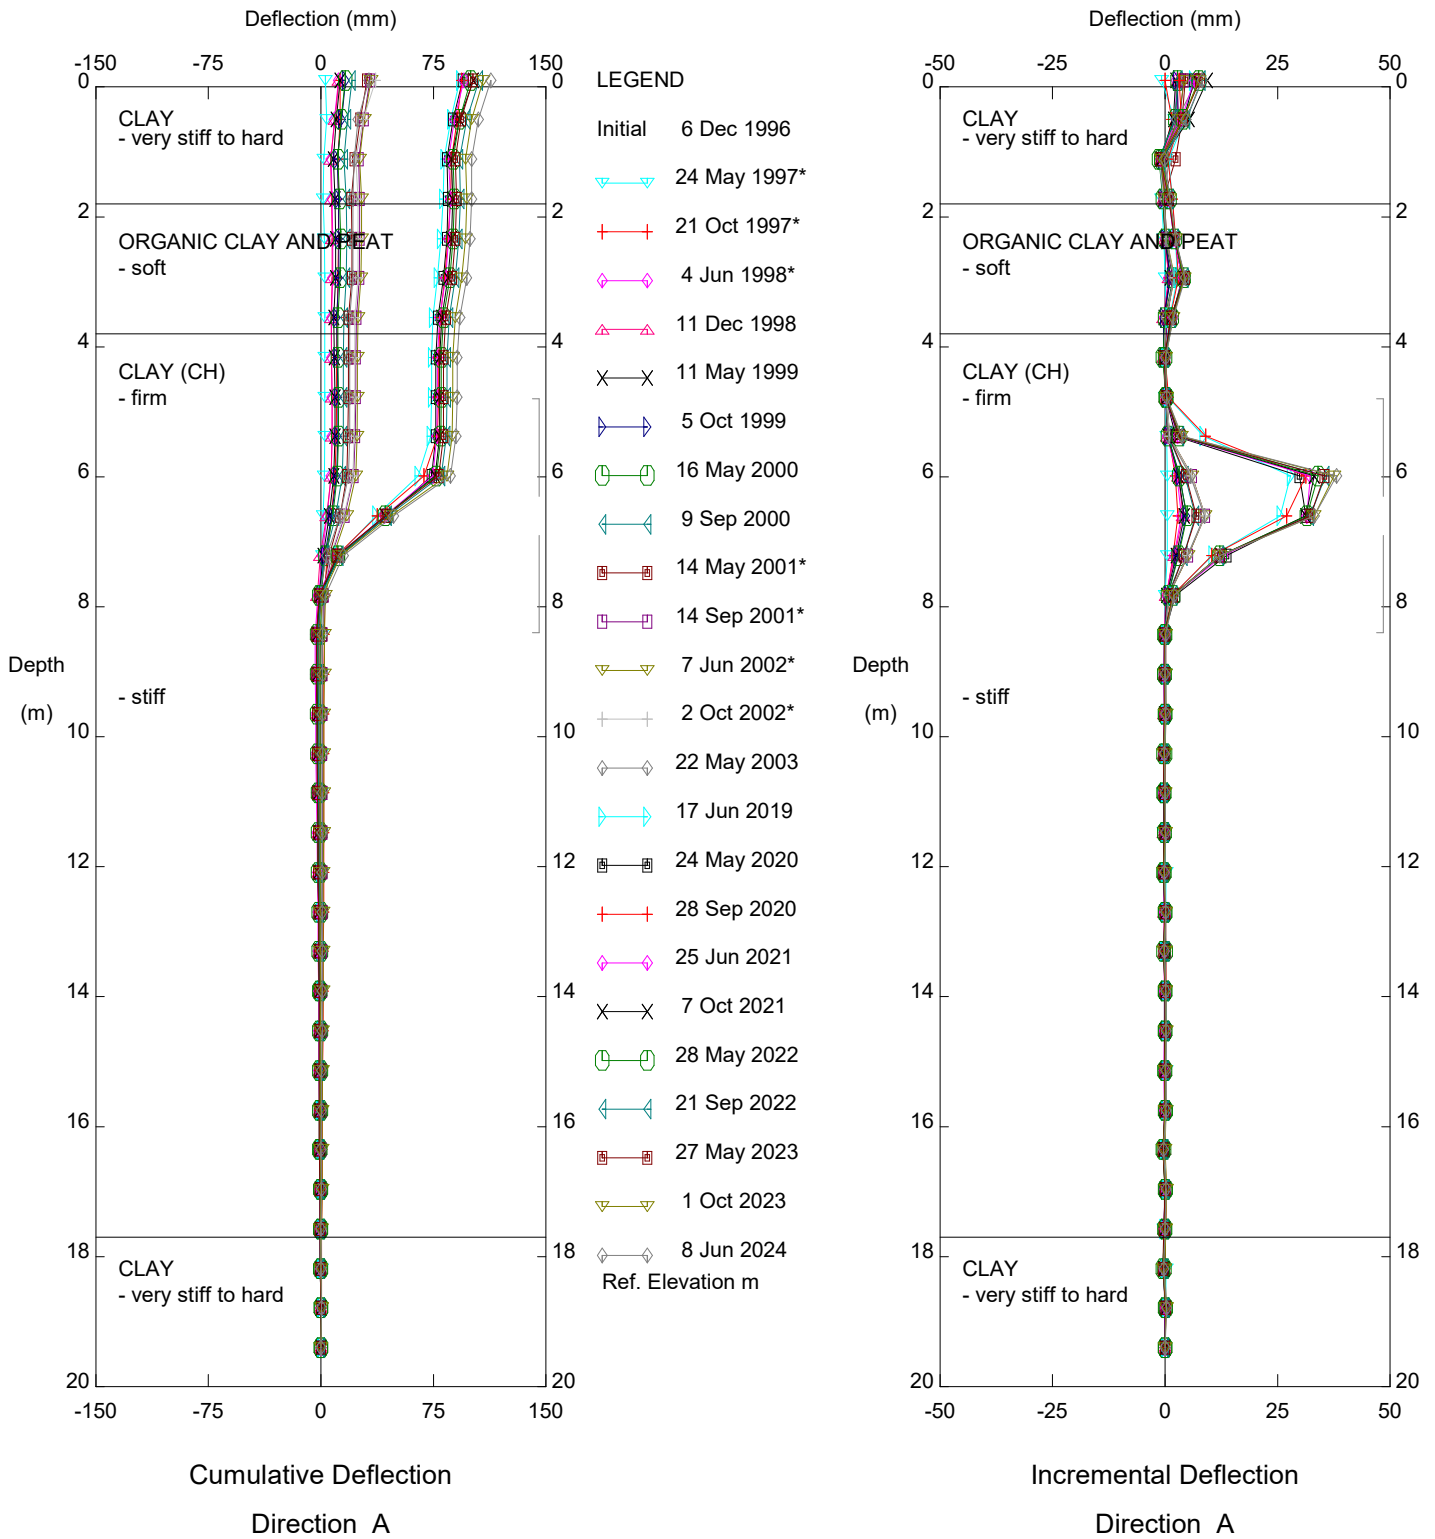
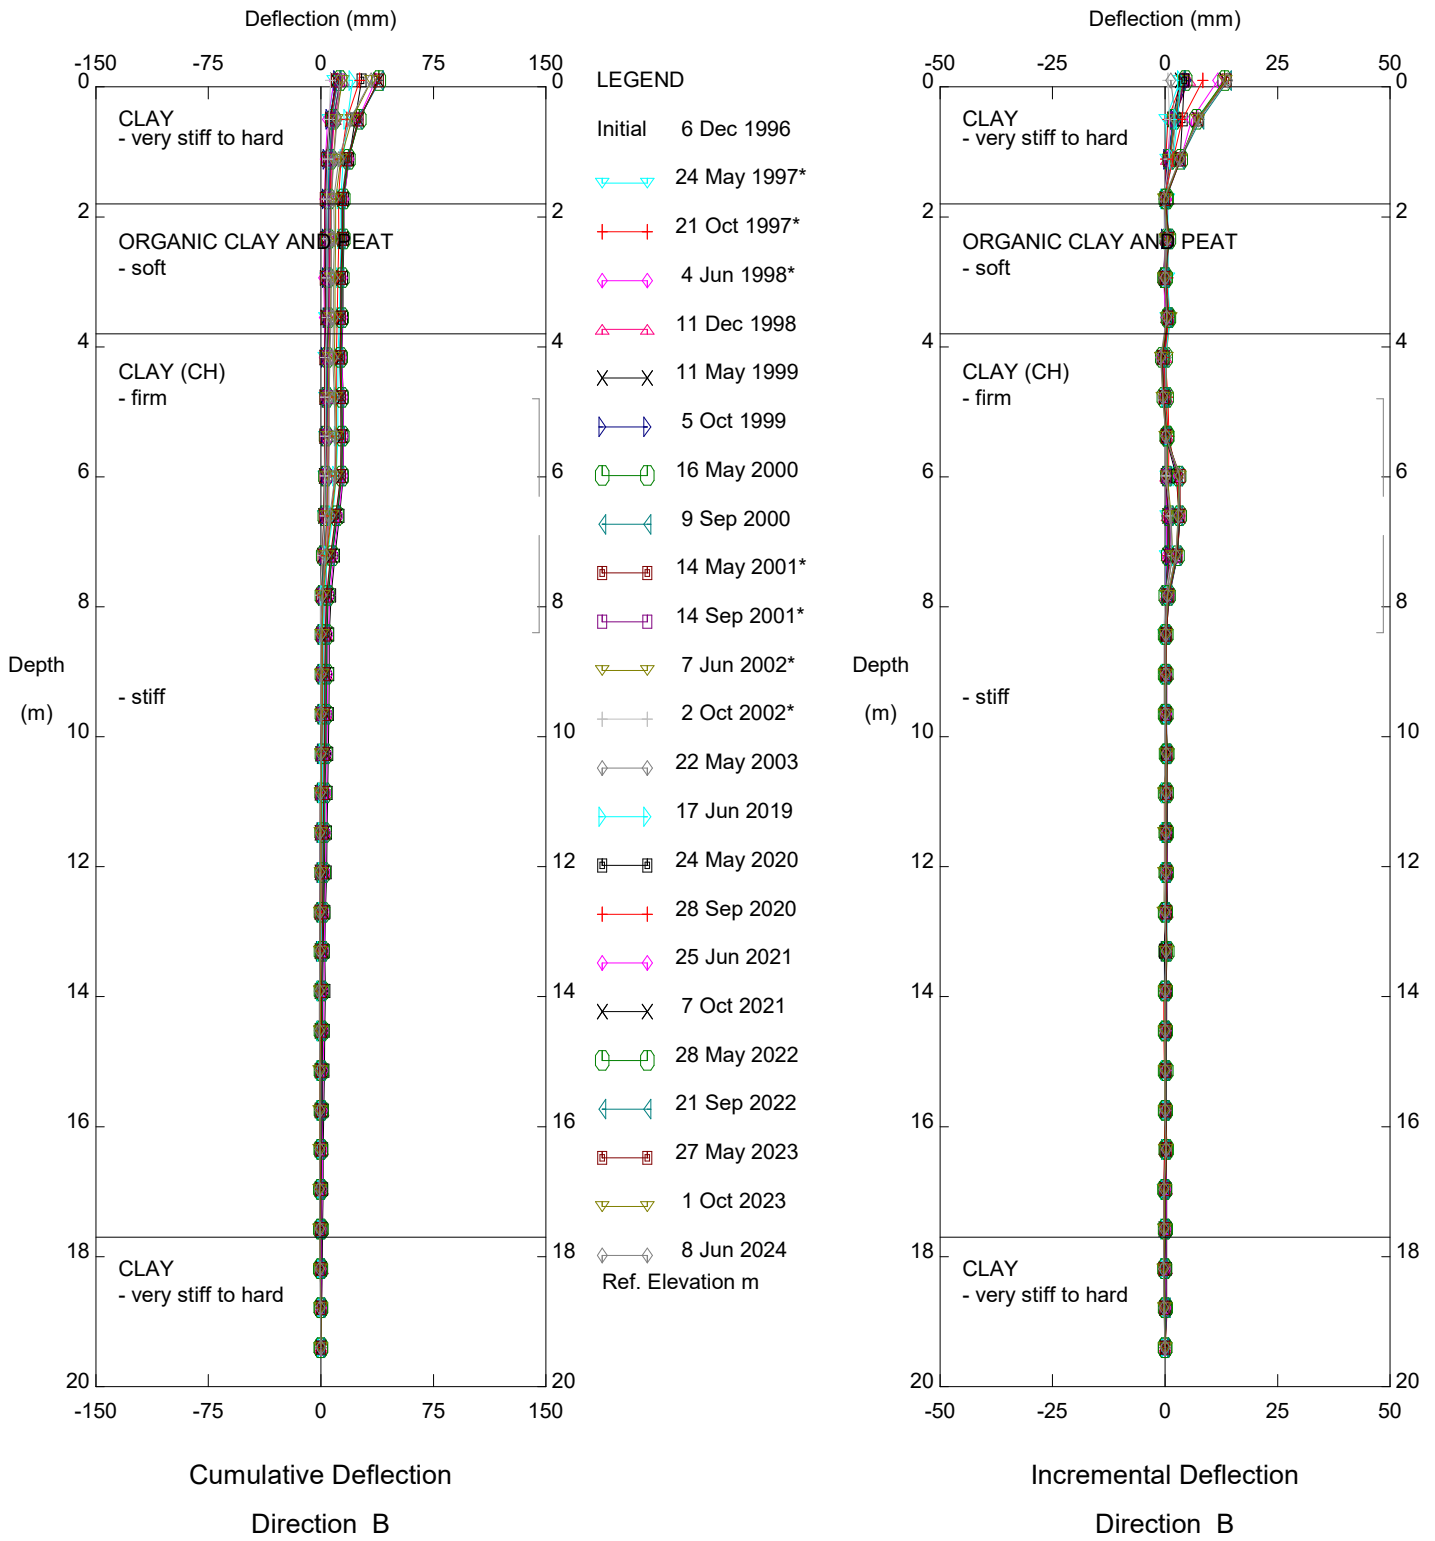
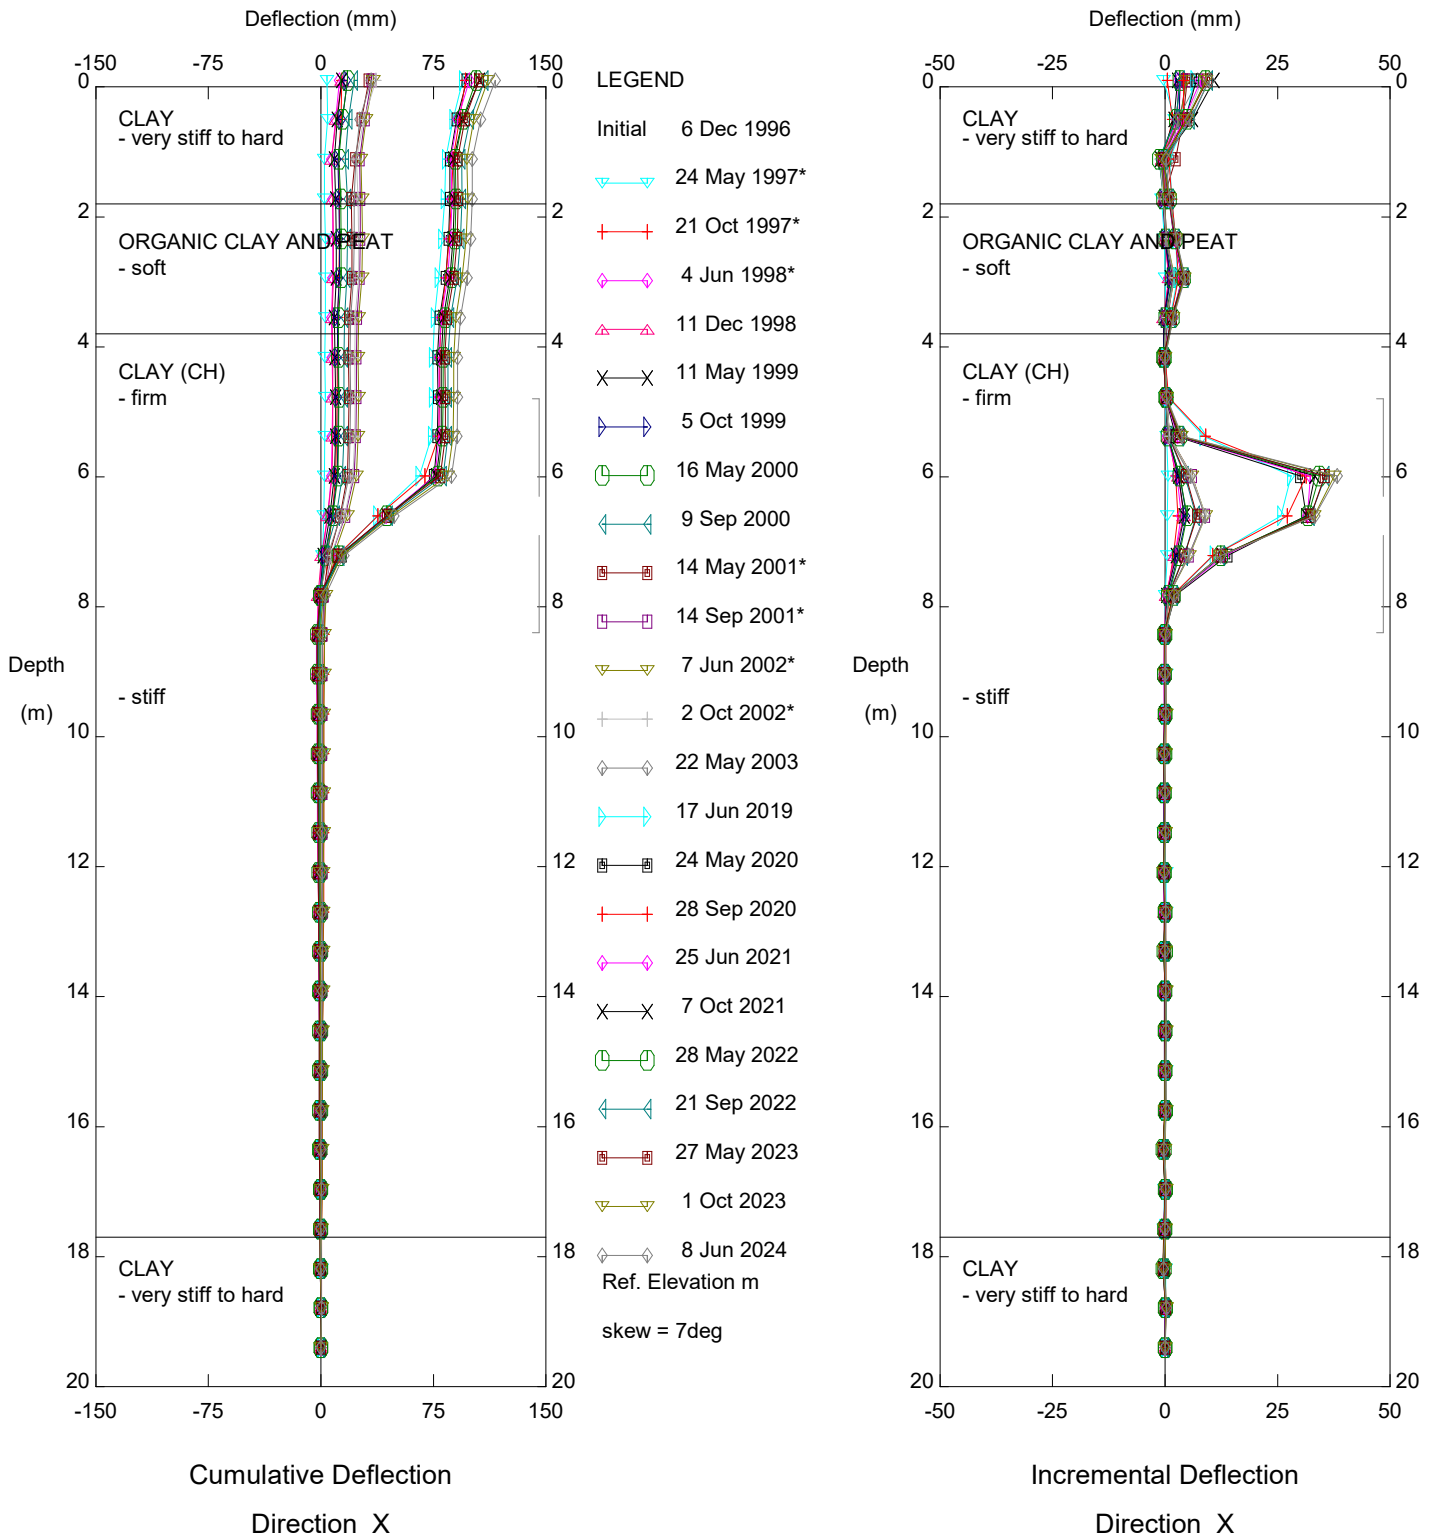
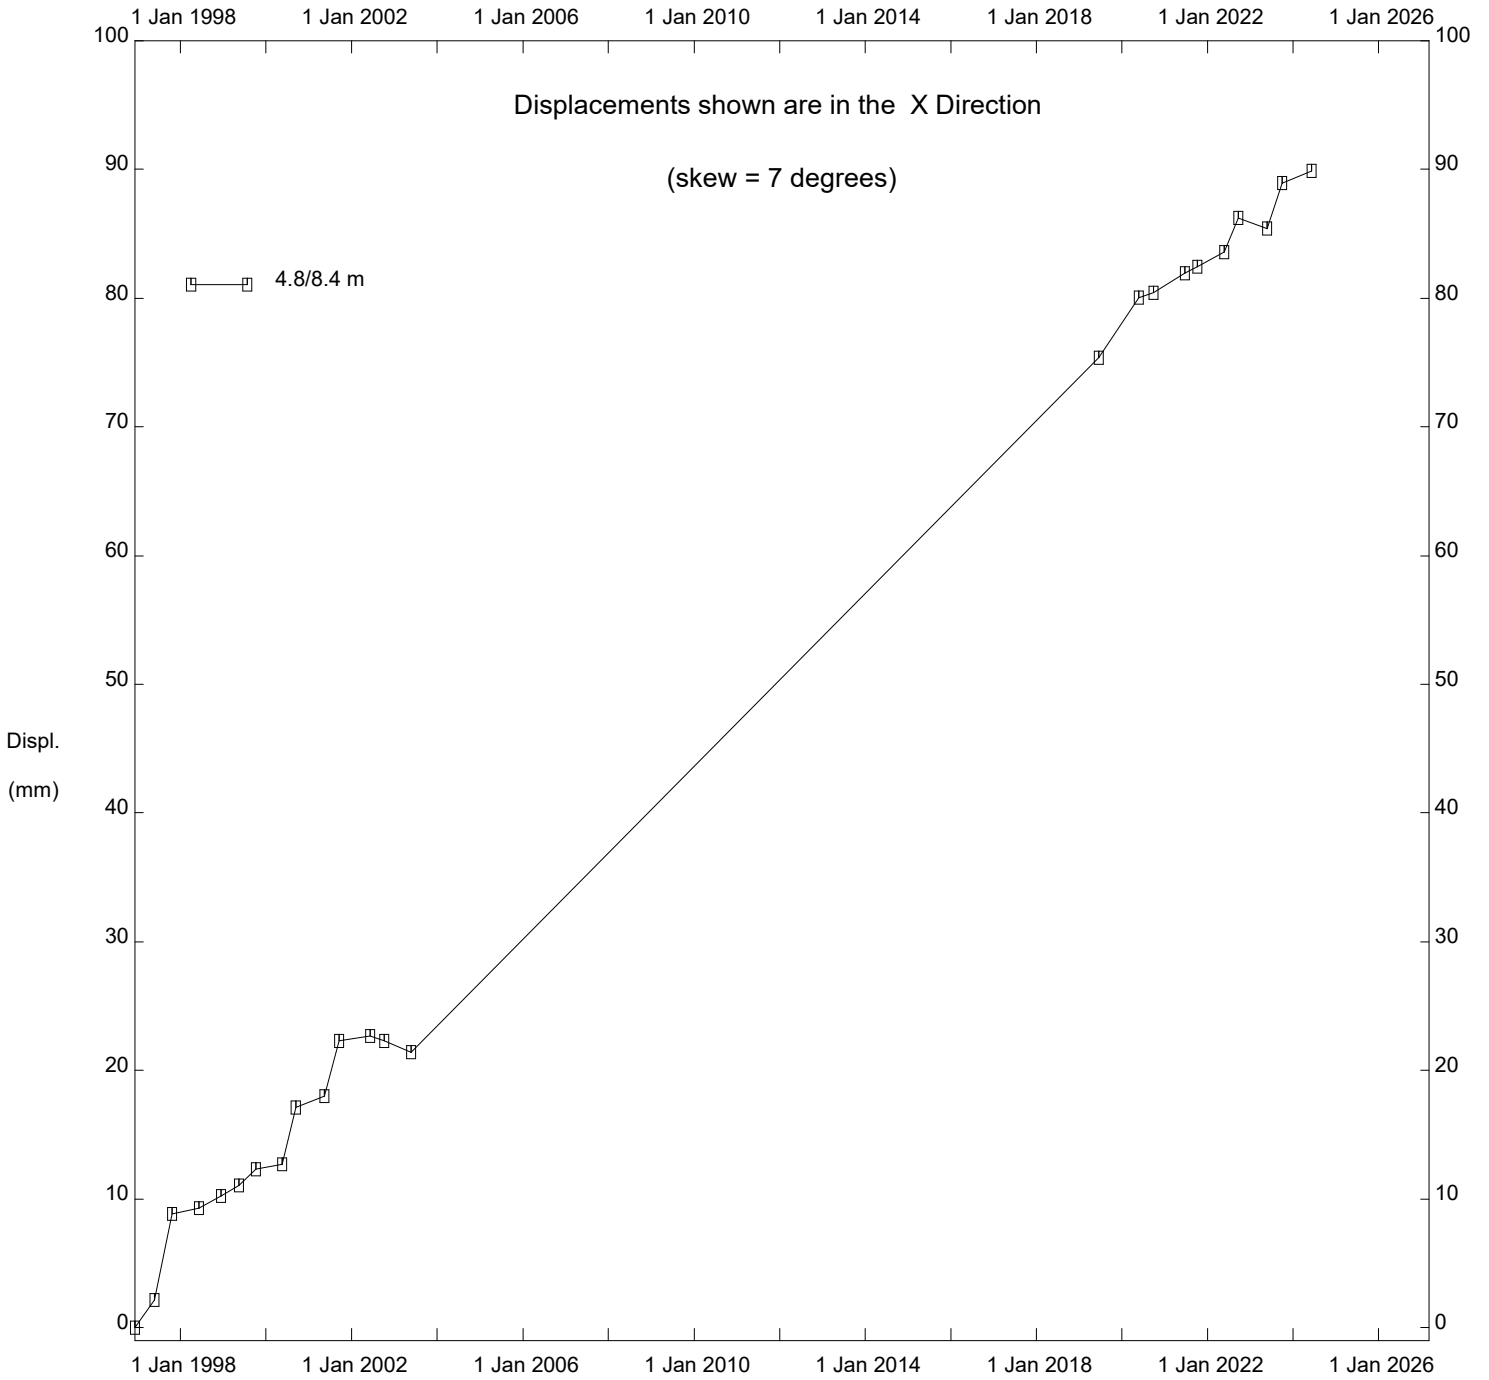
Labiche River, Inclinometer SI#1B

Discussion	
Zones of New Movement:	None
Interpretation of Monitoring Results:	<p>SI1B showed a rate of movement of 1.4 mm/yr over 4.8 m to 8.4 m since the fall of 2023 readings. SI20-2 showed a rate of movement of 1.4 mm/yr over 3.8 m to 7.4 m depth since the fall of 2023 readings. This corresponds to a decrease in the rate of movement by 8.8 mm/yr, and 6.9 mm/yr since the fall of 2023 readings in SI1B and SI20-2, respectively. The movement zones in both SIs are within the native high plastic clay below the highway embankment fill.</p> <p>Standpipe piezometer SP20-1 showed a decrease in groundwater level of 0.25 m compared to the fall of 2023 readings.</p> <p>Vibrating wire piezometer VW20-2A showed an increase in groundwater level of 0.02 m since the fall of 2023 readings. The groundwater level recorded in VW20-2A is the highest recorded in this instrument. VW20-2B showed a decrease in groundwater level of 0.06 m since the fall of 2023 readings.</p>

16.1 over 6.0 m to 8.4 m in 302° direction	6.3 in May 1997			N/A	N/A	N/A
SI1B	December 6, 1996	89.9 over 4.8 m to 8.4 m depth in 246° direction	16.3 in October 1997	Operational	October 1, 2023	1.0	1.4	-8.8
SI4A	October 21, 1997	54.3 over 0.5 m to 2.4 m depth in 271° direction	17.7 in May 2003	Not read*	Sep. 28, 2020	N/A	N/A	N/A
SI4B	October 21, 1997	27.8 over 1.1 m to 2.9 m depth in 308° direction	20.8 in June 1998	Presumed destroyed	May 22, 2003	N/A	N/A	N/A

Future Work:	The instruments should be read again in the fall of 2024.
Instrumentation Repairs:	No instrument repairs are required at this time.

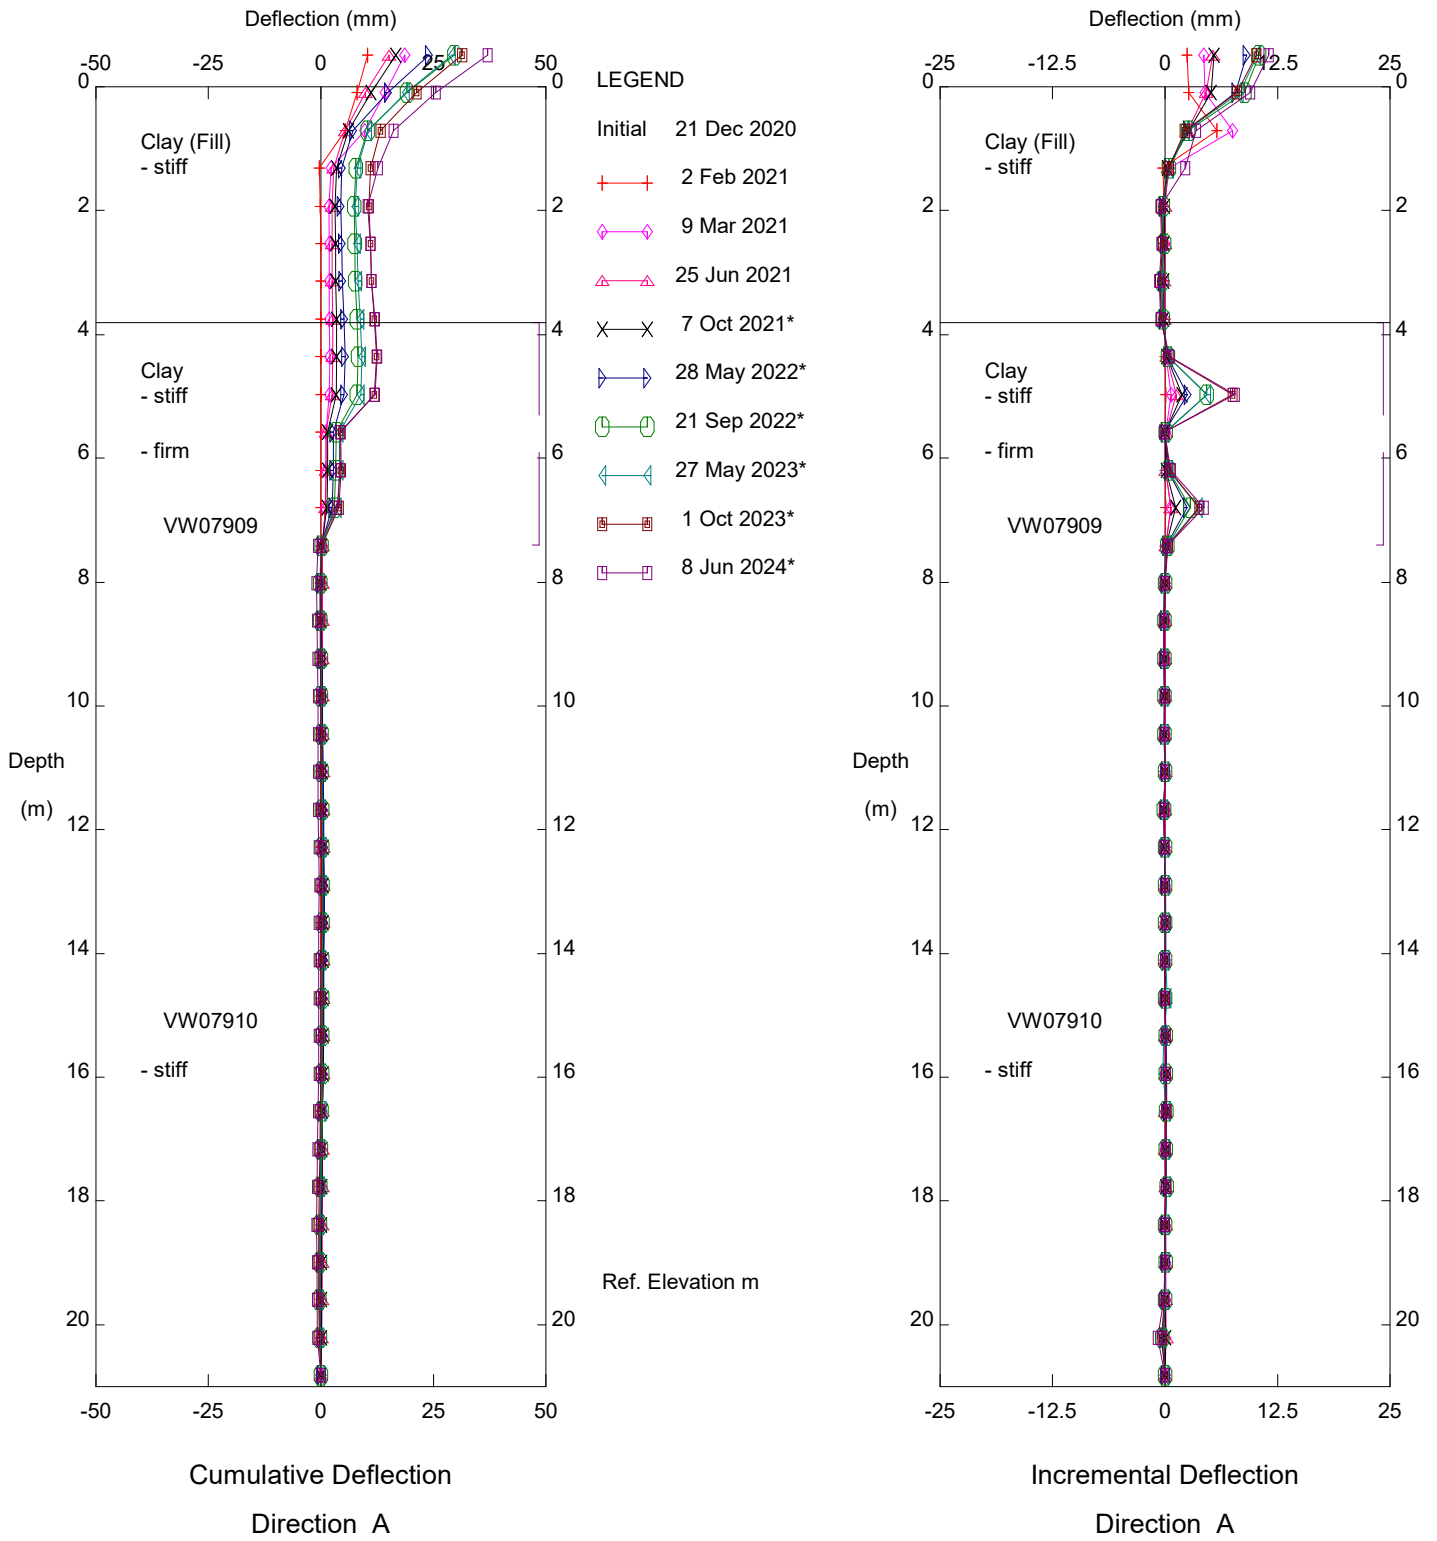
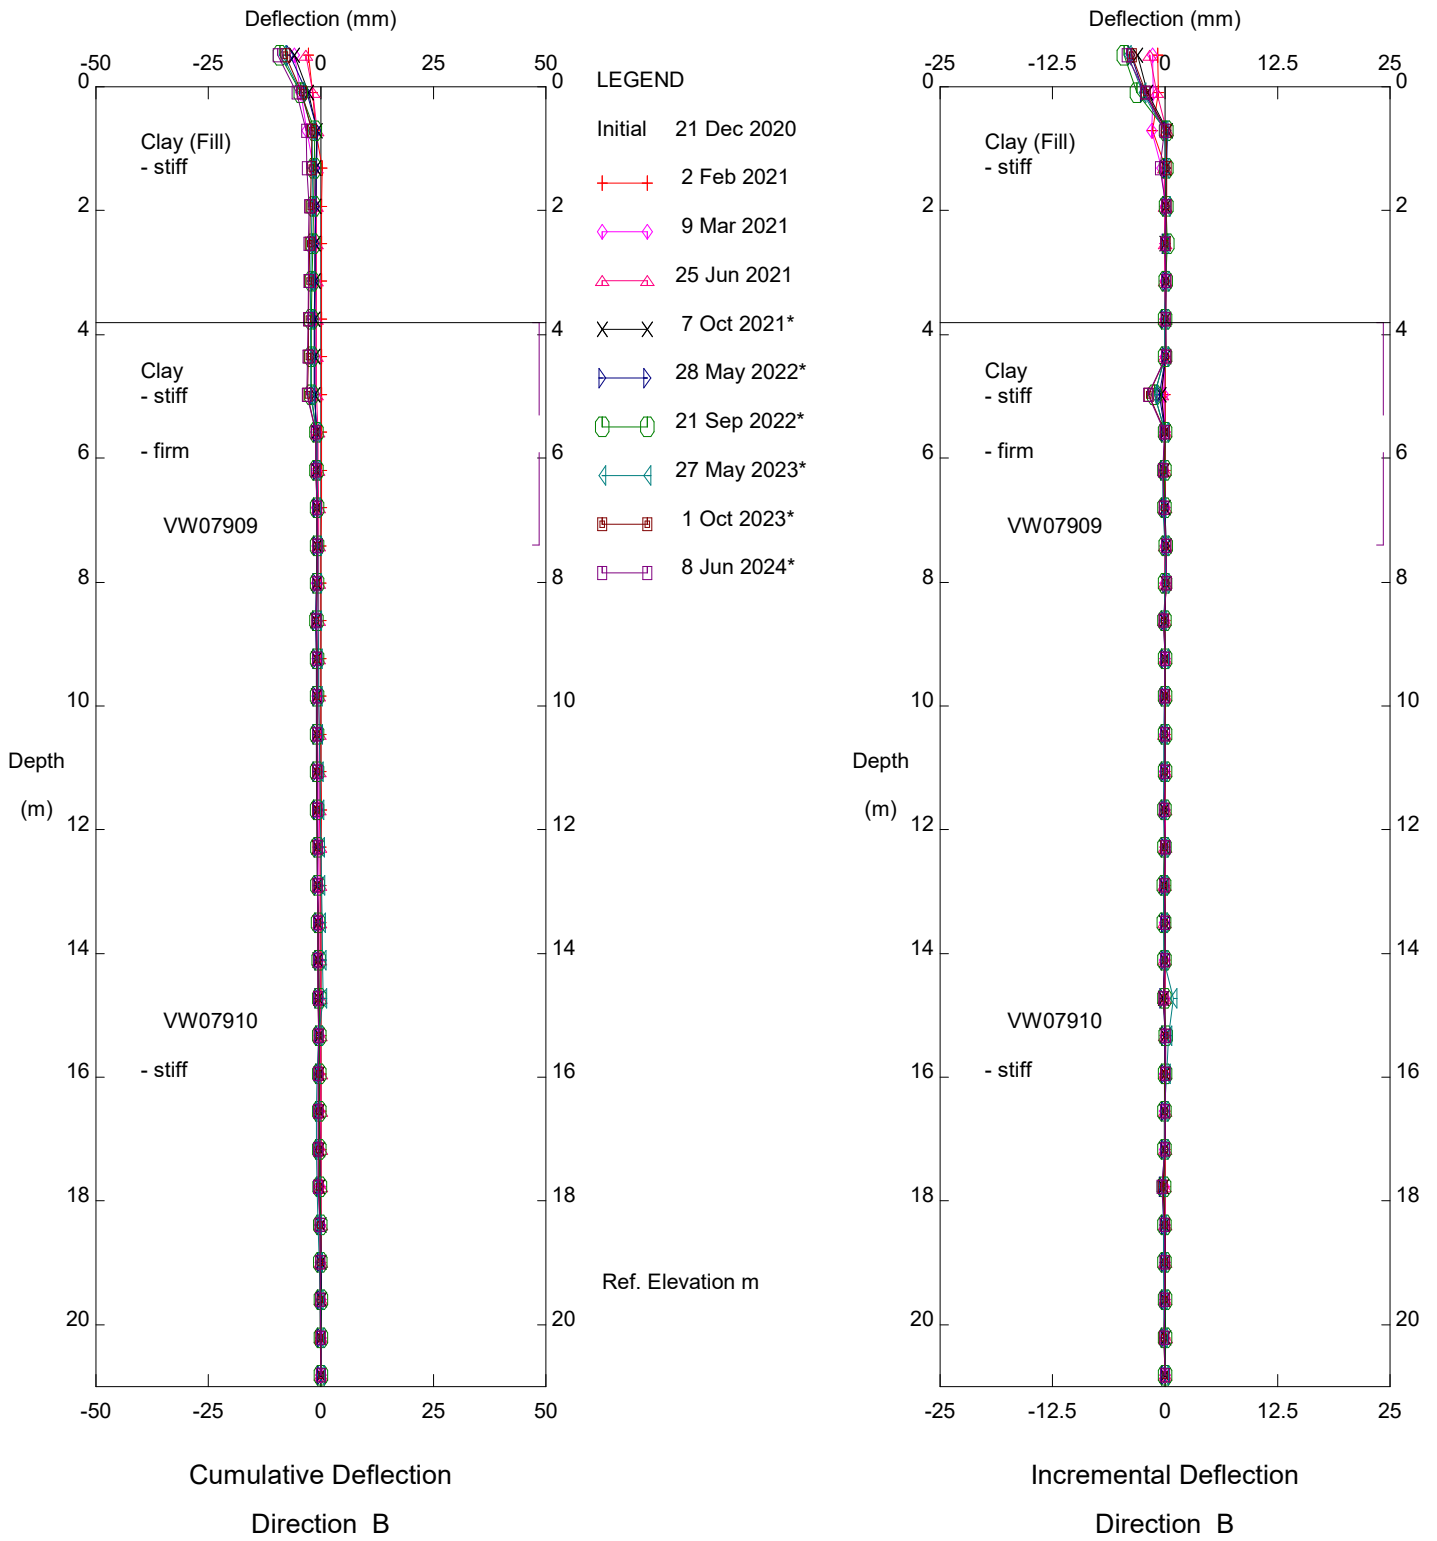
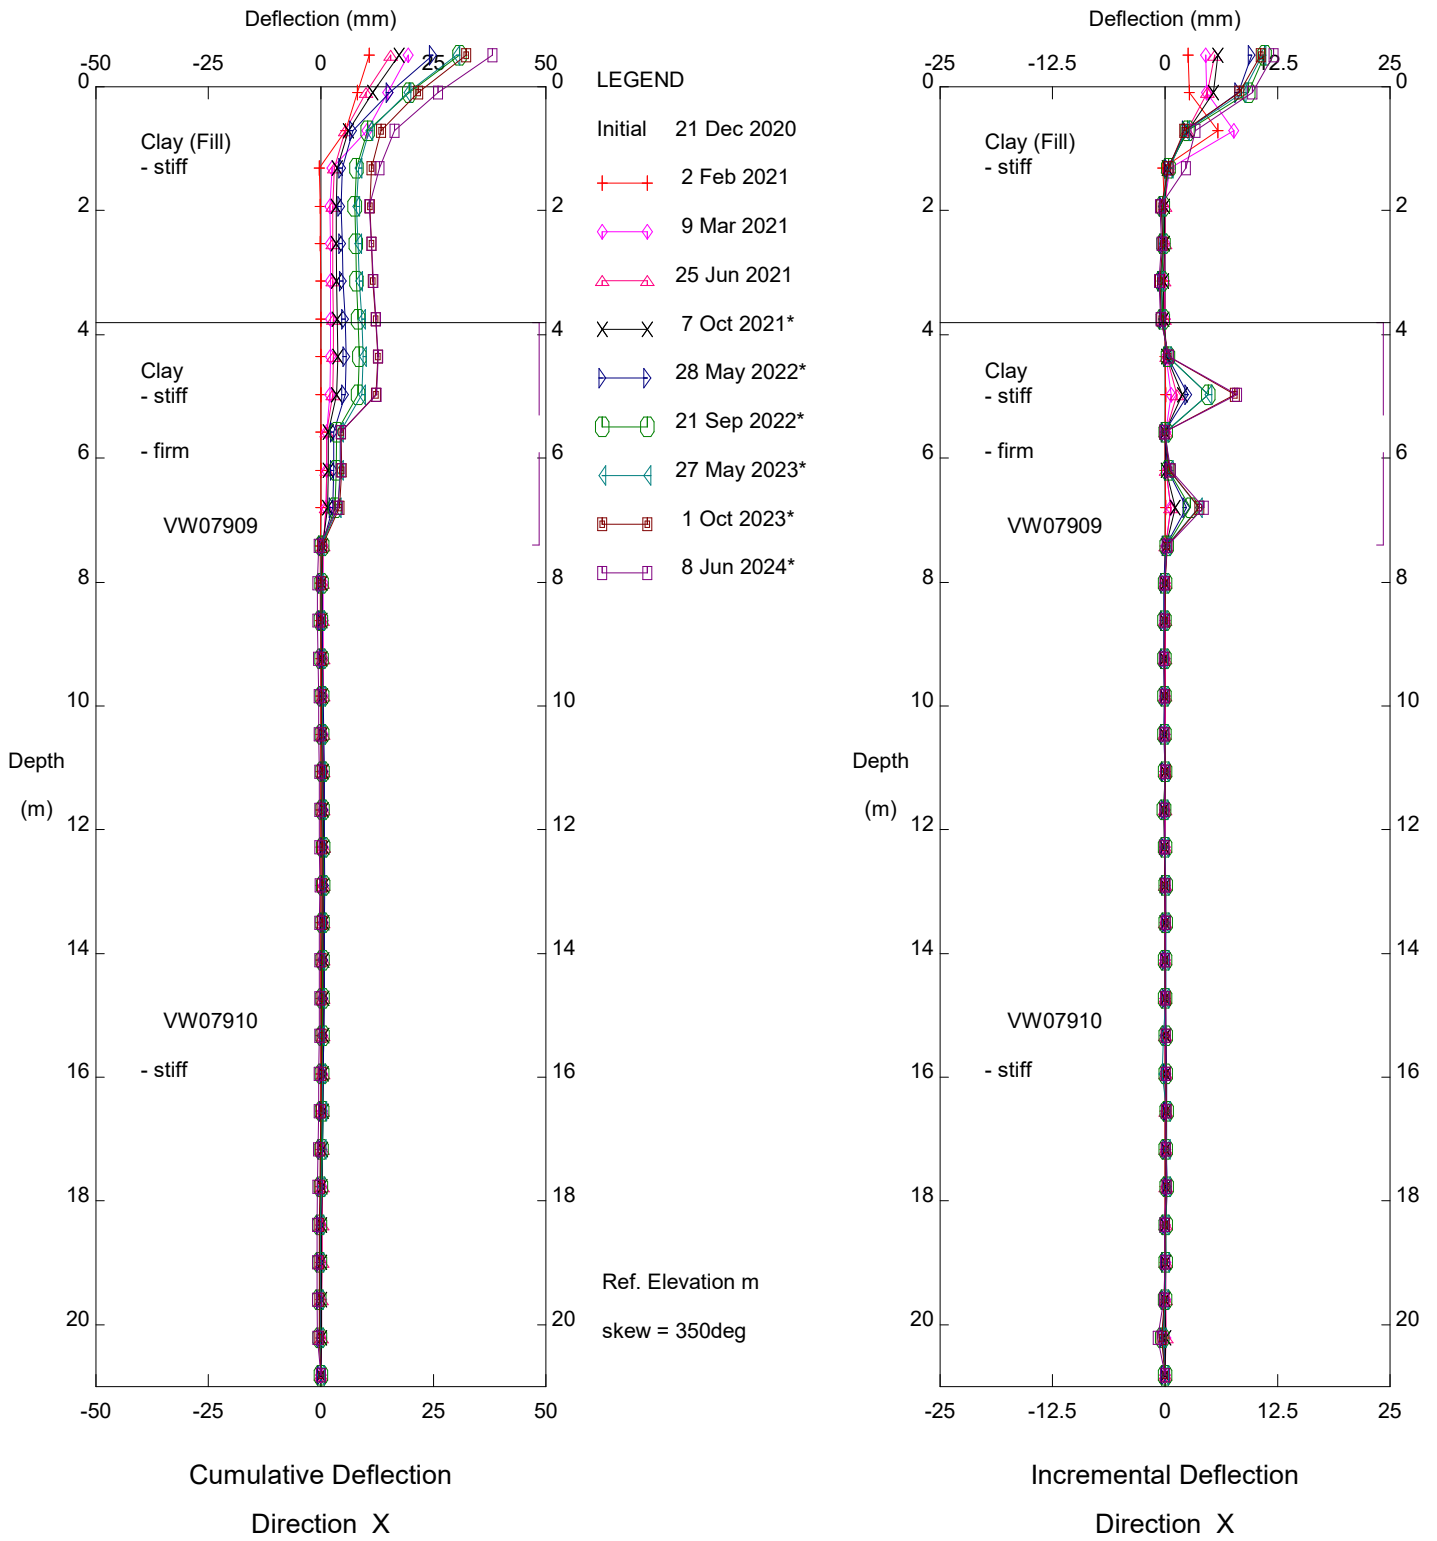
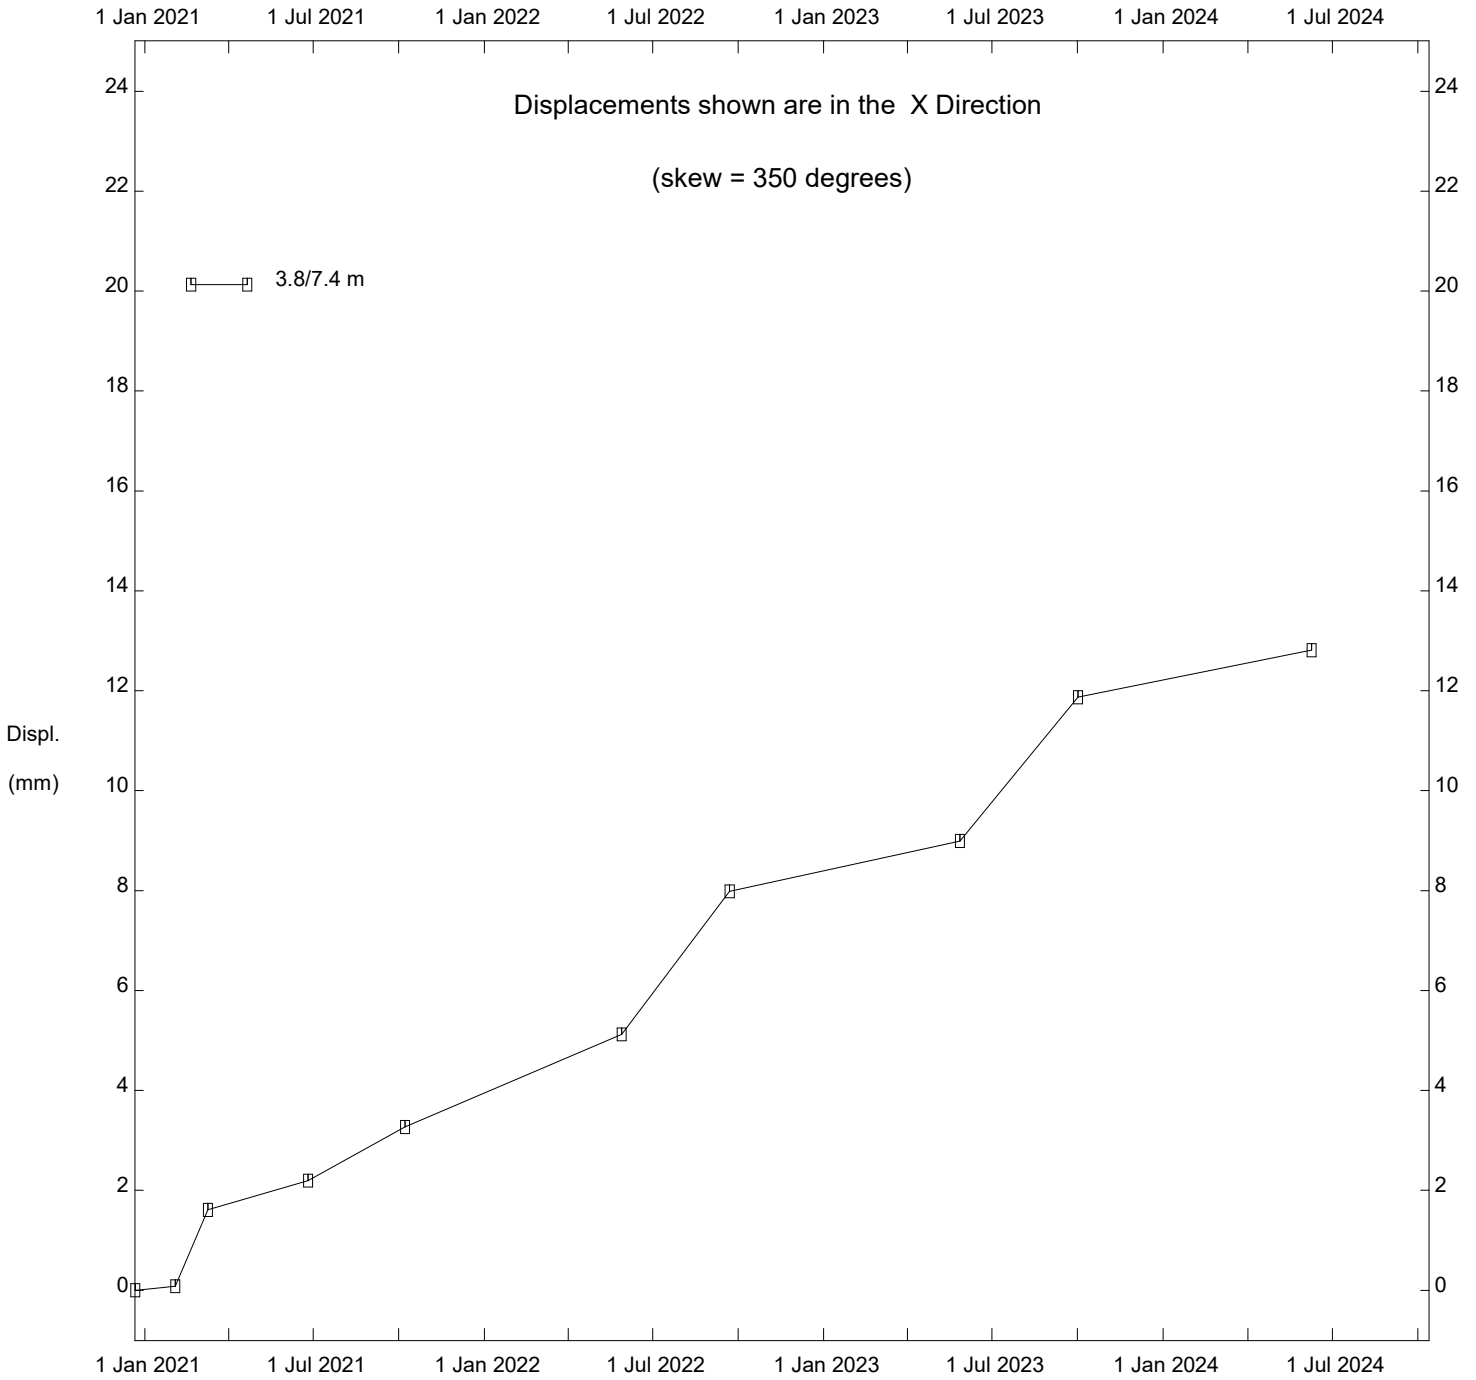
Hwy 63:02 NC08-2 La Biche River, Inclinometer SI20-2

16.5 over 5.9 m to 7.8 m depth in 308° direction	10.3 in June 1998			N/A	N/A	N/A
SI20-2	December 21, 2021	12.8 over 3.8 m to 7.4 m depth in 297° direction	15.8 in March 2021	Operational	October 1, 2023	1.0	1.4	-6.9
