**ALBERTA TRANSPORTATION AND
ECONOMIC CORRIDORS GRMP
NORTH CENTRAL (ATHABASCA AND FORT
McMURRAY DISTRICTS)
INSTRUMENTATION MONITORING- SPRING 2024**

Site Number	Location	Name	Hwy	km
NC008	HWY 63:02 L1 15.635	North of La Biche River	63:02	Km 15.6
Legal Description: 7-3-69-17 W4		UTM Co-ordinates		
		12U E 403478	N	6089488

Current Monitoring:	8-Jun-2024	Previous Monitoring	01-Oct-2023
Instruments Read By:	Mr. Niraj Regmi, G.I.T and Mr. Nixson Mationg, of Thurber

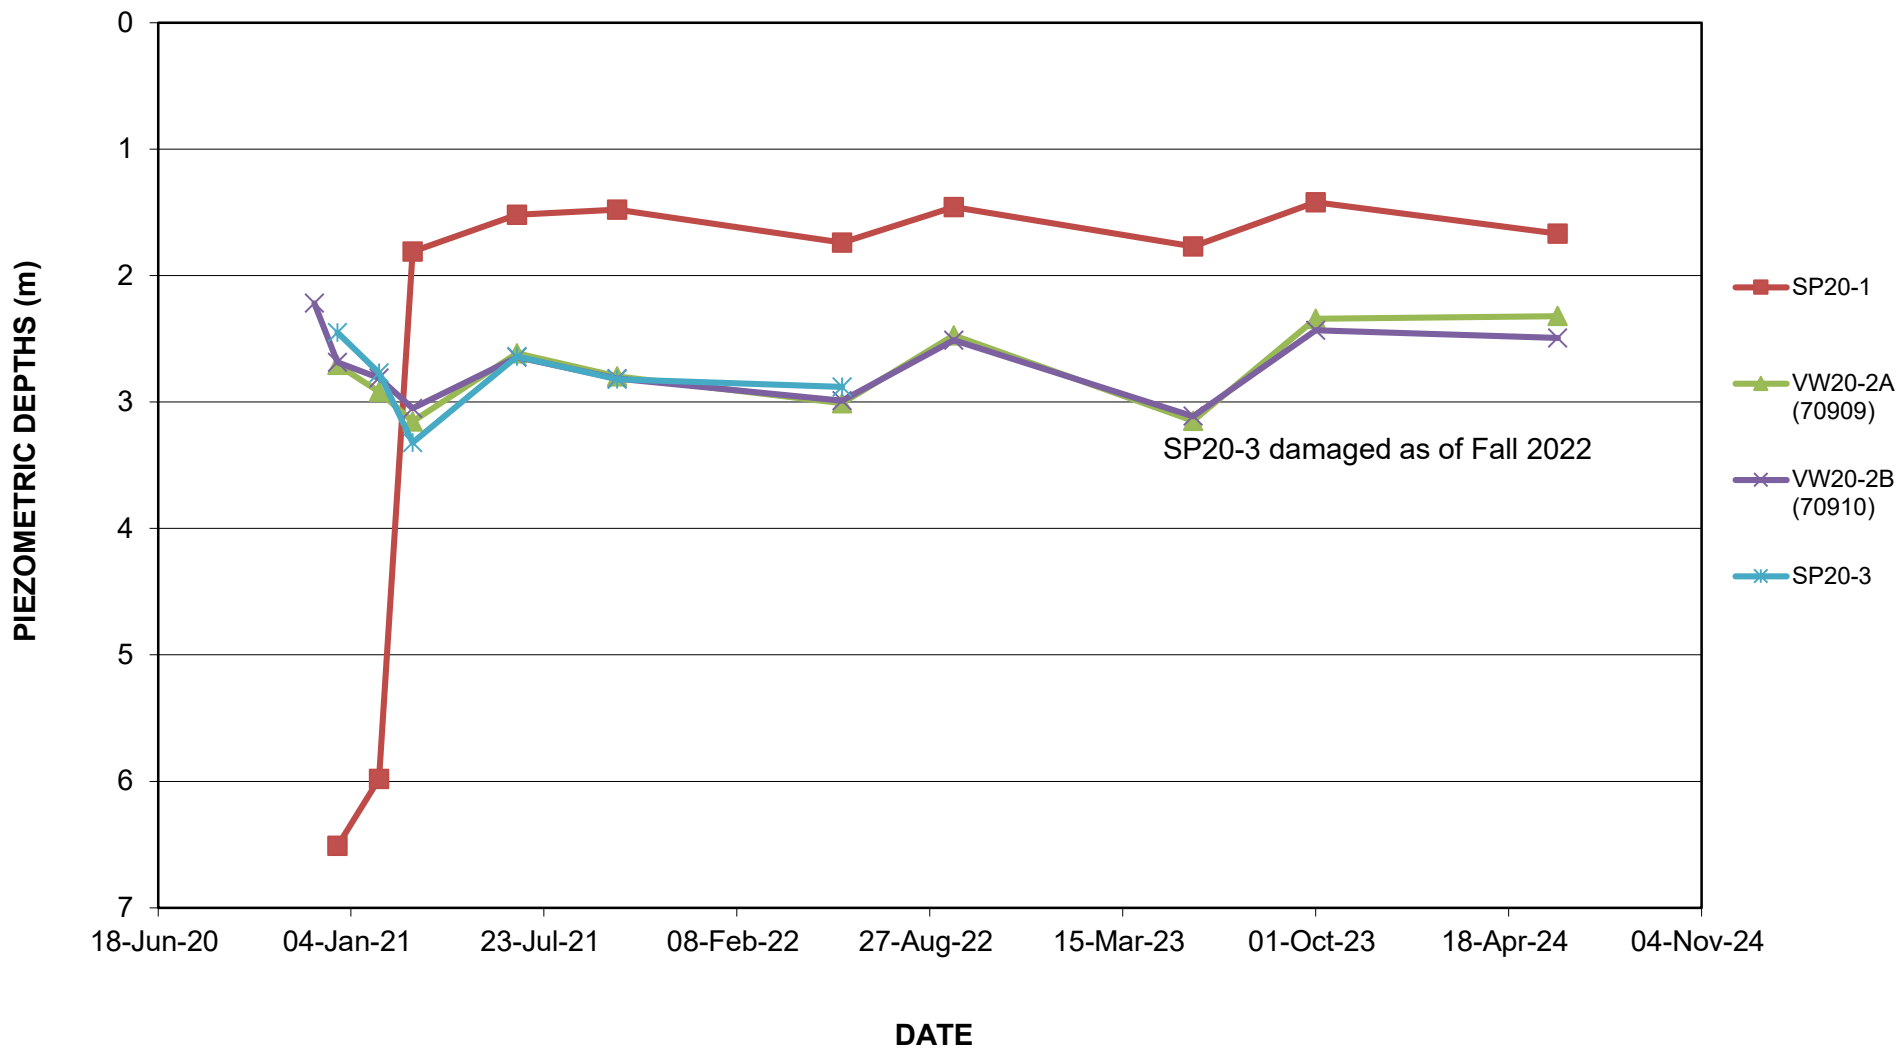
**FIGURE NC008-1
 HWY 63:02 NORTH OF LA BICHE RIVER BRIDGE (KM 15.6)
 VIBRATING WIRE AND STANDPIPE PIEZOMETER DATA**

INSTRUMENT #	DATE INITIALIZED	TIP DEPTH (m)	GROUND ELEV. (m)	CURRENT STATUS	HIGHEST MEASURED GROUNDWATER LEVEL BGS (m)	CURRENT GROUNDWATER DEPTH BGS (m)	PREVIOUS GROUNDWATER DEPTH BGS (m)	CHANGE IN WATER LEVEL SINCE PREVIOUS READING (m)
SP20-1	Nov. 28, 2020	20.70	-	Operational	1.42 on October 1, 2023	1.67	1.42	-0.25
SP20-3	Nov. 26, 2020	20.80	-	Damaged	2.45 on December 21, 2020	N/A	2.88	N/A

INSTRUMENT #	DATE INITIALIZED	TIP DEPTH (m)	GROUND ELEV. (m)	CURRENT STATUS	HIGHEST MEASURED GROUNDWATER LEVEL BGS (m)	CURRENT GROUNDWATER DEPTH BGS (m)	PREVIOUS GROUNDWATER DEPTH BGS (m)	CHANGE IN WATER LEVEL SINCE PREVIOUS READING (m)
VW20-2A (70909)	December 21, 2020	7.32	-	Operational	2.32 on June 8, 2024	2.32	2.34	0.02
VW20-2B (70910)	December 21, 2020	15.09	-	Operational	2.43 on October 1, 2023	2.49	2.43	-0.06
