**ALBERTA TRANSPORTATION
GEOHAZARD ASSESSMENT PROGRAM
NORTH CENTRAL REGION – ATHABASCA &
FORT MCMURRAY DISTRICTS
2021 SITE INSPECTION**

Site Number	Location	Name	Hwy	km
NC087	20.75 km north of the junction of Hwy 55 and 63	FISCHER TRAIL SLIDE	63:02	20.75
Legal Description		UTM Co-ordinates (NAD 83)		
SE-22-69-17-W4M		12 N 6094104.70	E	404166.89

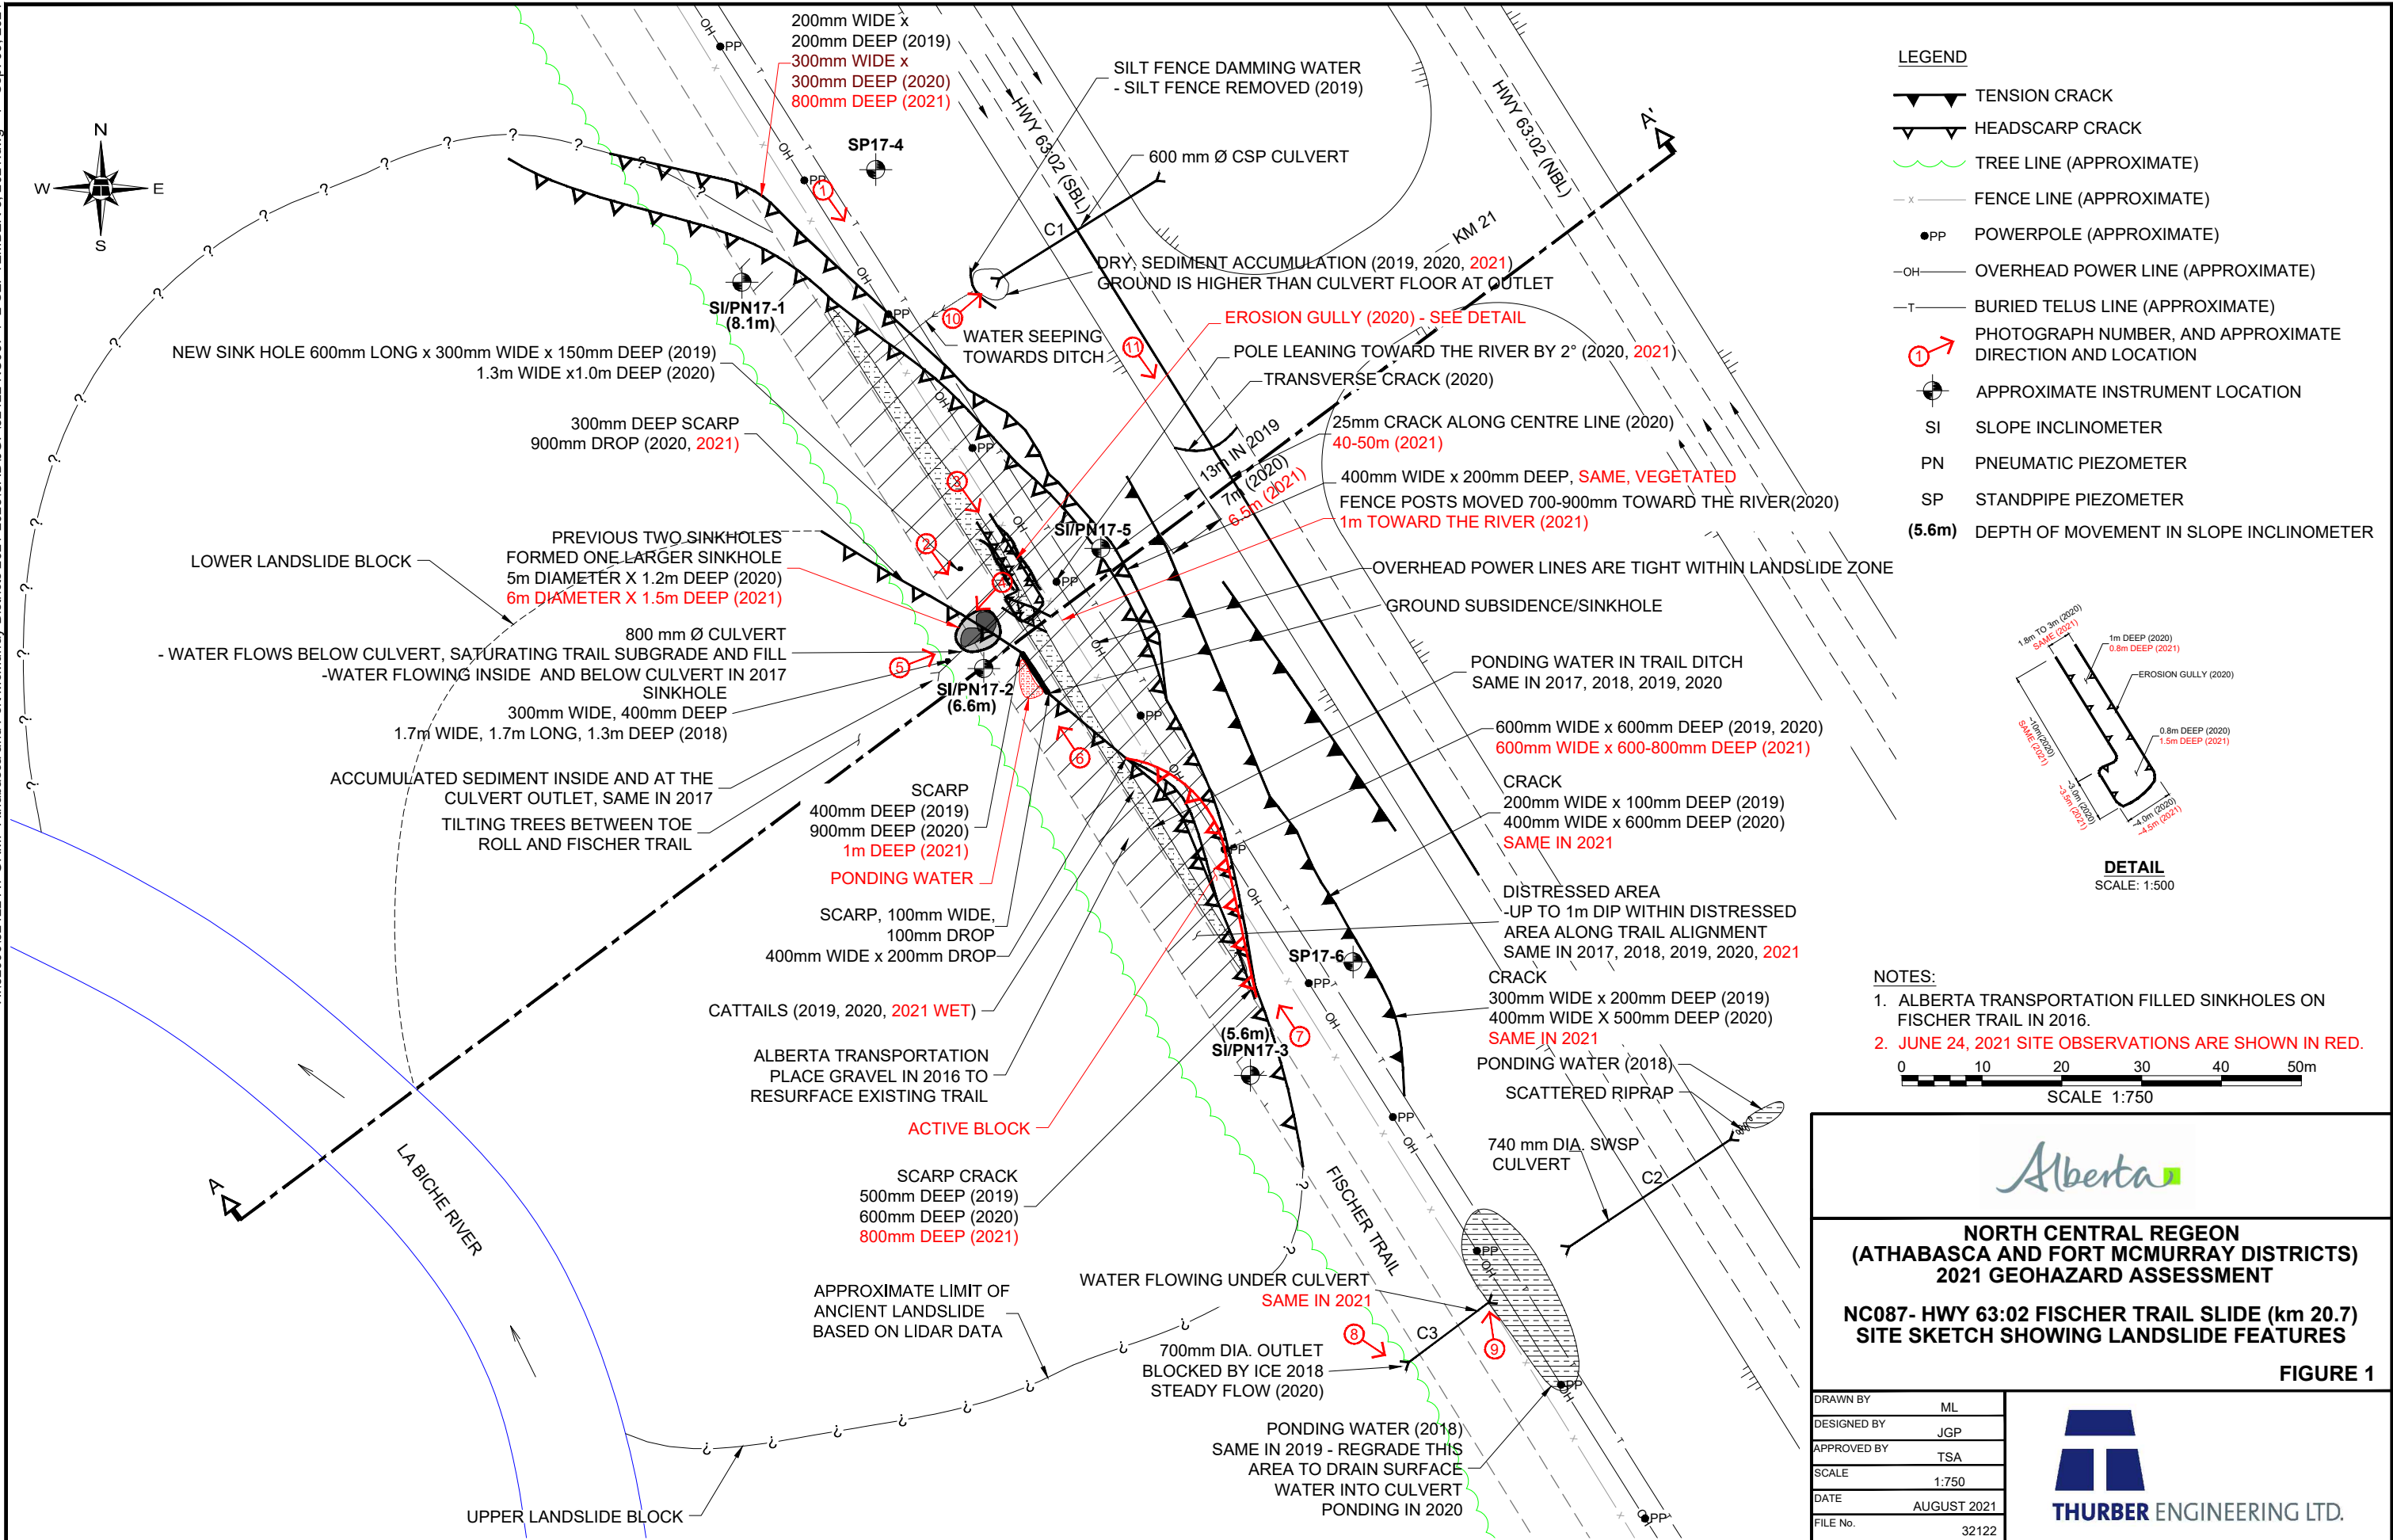
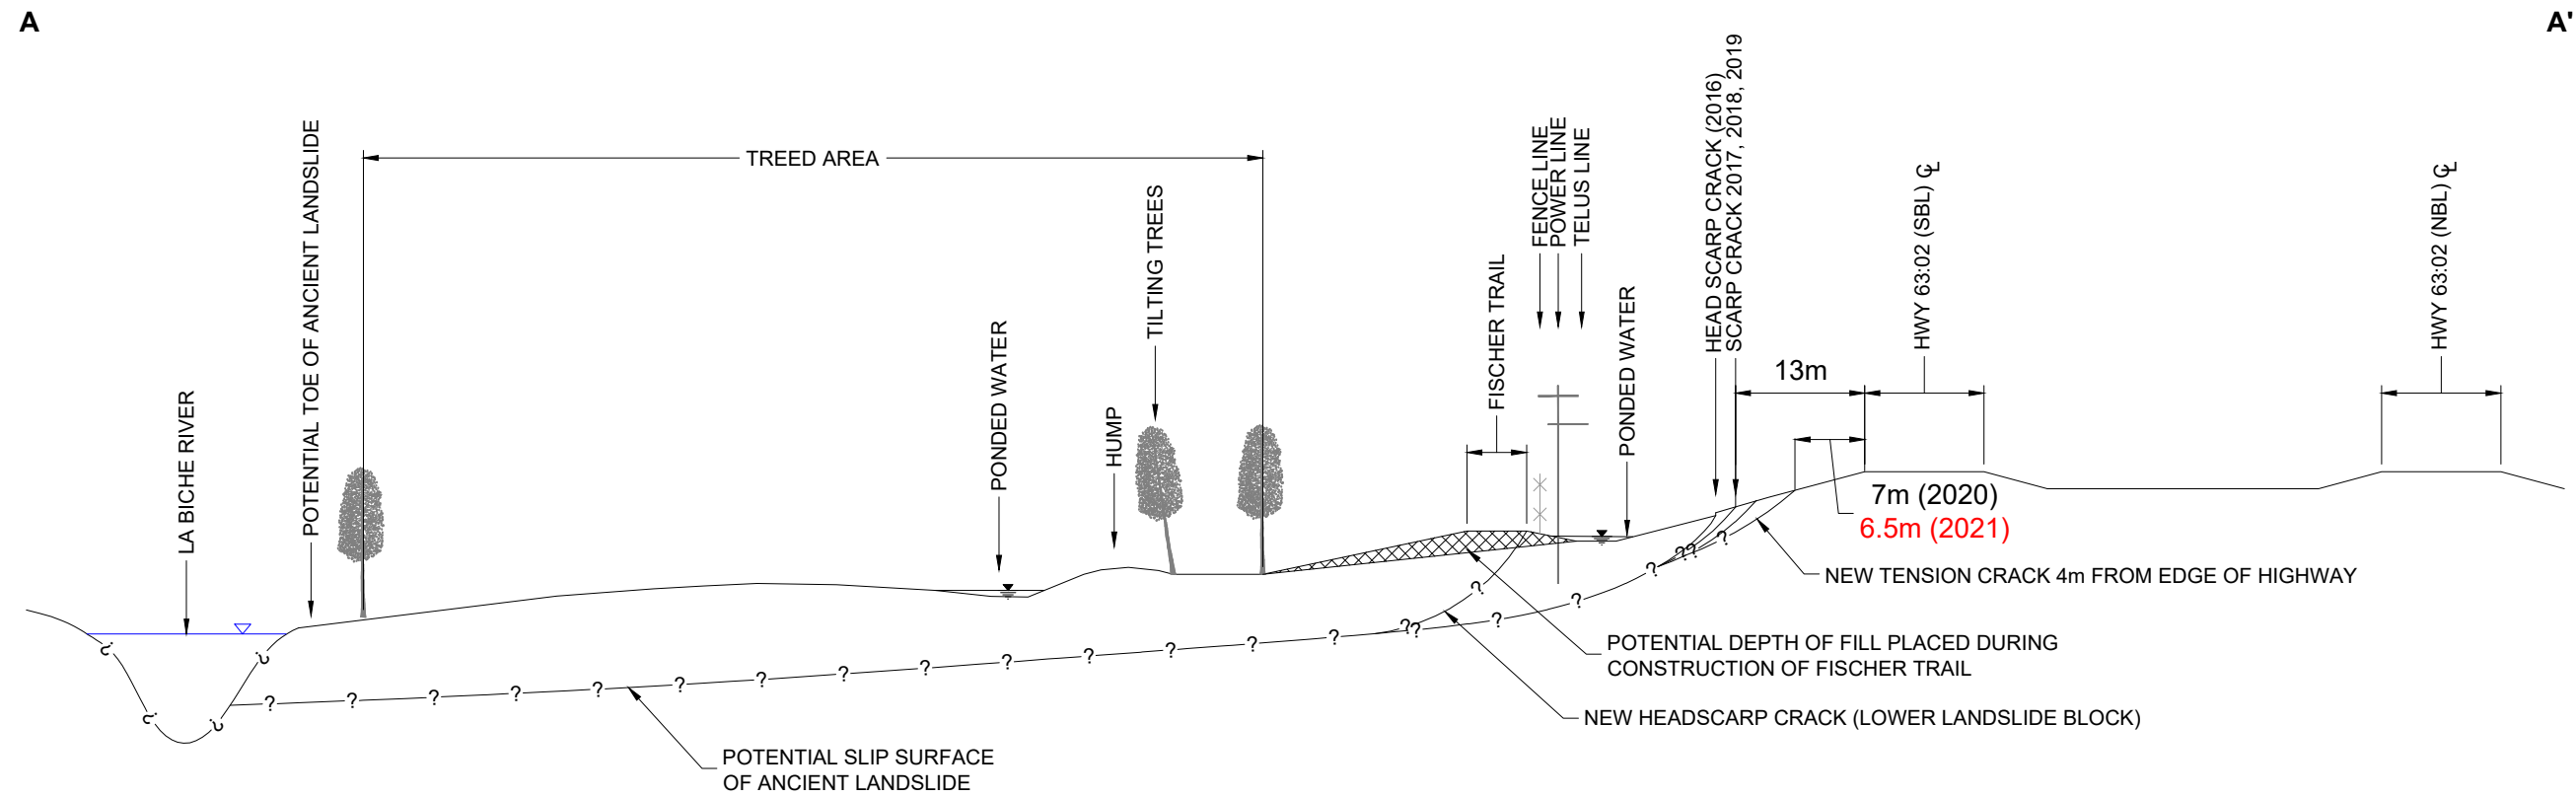
FIGURE 2

**NC087- HWY 63:02 FISCHER TRAIL SLIDE (km 20.7)
 CROSS-SECTION A-A'**

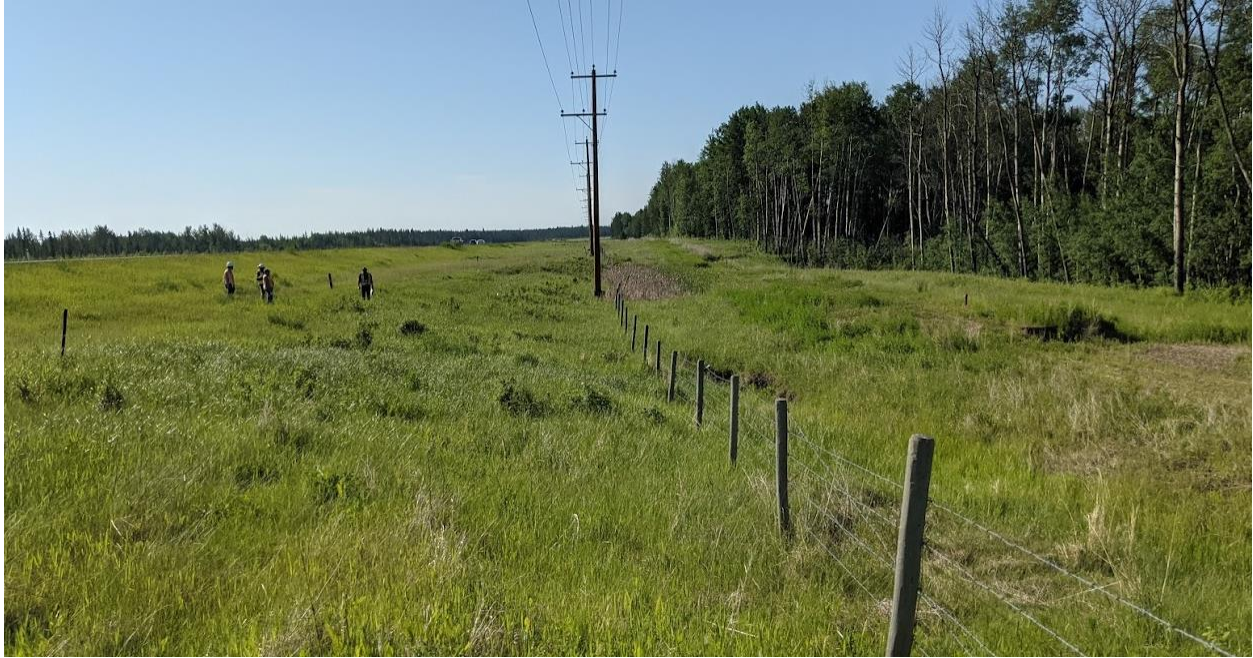
Based on the above site observations, and LiDAR information, the distress observed along Fischer trail and the side slope of the highway SBLs reflects an actively moving deep-seated landslide (i.e., upper landslide block). The depth of movement ranges from 5.6 to 8.1 m below the trail surface. The upper landslide continues to cause severe distress of the trail surface and is retrogressing to the highway surface.

Photo No.1 – Head scarp crack of upper landslide block (Looking South)

- AT should contact the County, the trail owner, and utility companies to let them know about existing hazard.
- The local MCI should periodically monitor the head scarp crack for further opening or drop and measure the distance between the head scarp crack and the edge of the highway.
- Clear sedimentation and regrade the ground surface near culvert C1 outlet; inspect and maintain culverts C2 and C3 as needed to prevent further ponding of water in the highway west ditch and water flow under C3.

It is understood that AT has no obligation to maintain the trail. Hence, the long-term measure may include the construction of a pile wall between the head scarp crack and the west edge of the highway to shelter the highway from potential retrogression of the head scarp crack into the highway surface. The ballpark cost of this option, excluding engineering, would be in the range of \$850,000 for a steel pile wall and \$2.0 Million for a tangent cast-in-place cantilever pile wall. It should be noted that this option will not address the impact of future movements downslope of the wall on existing trail and utility lines within the landslide mass.

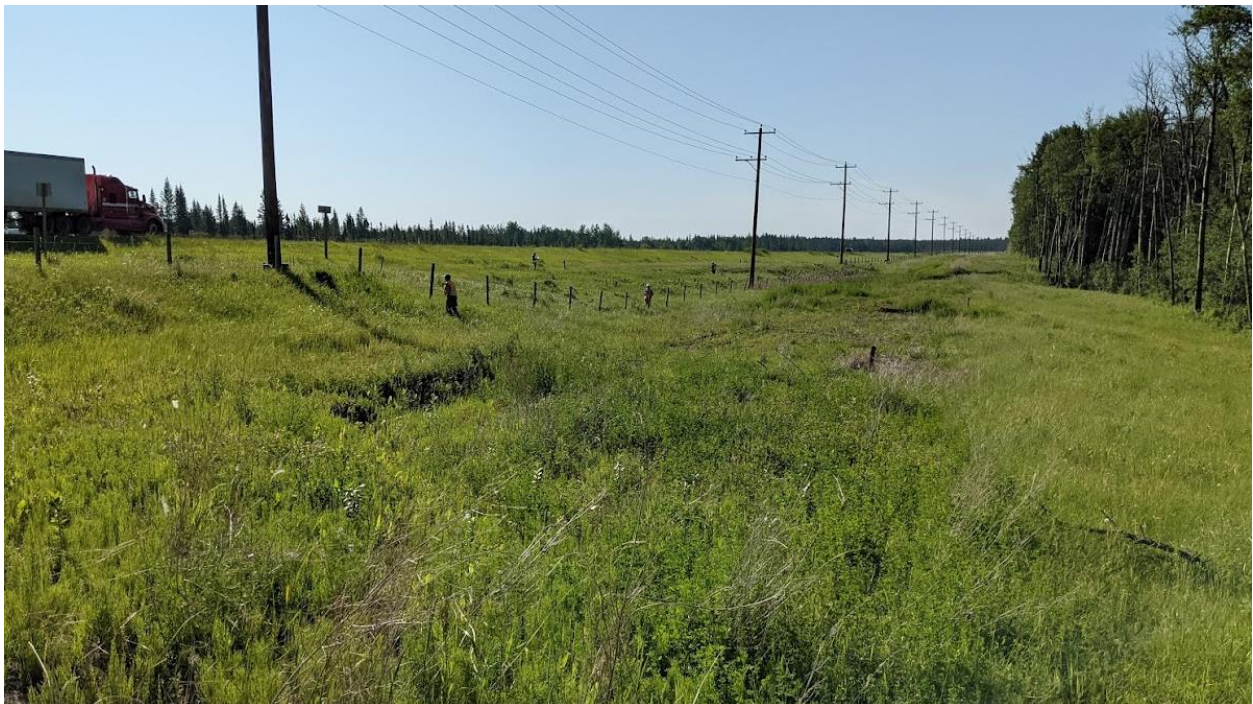
A secondary landslide block (i.e. a lower landslide block of smaller size) has been developed and it is only impacting the trail surface. The lower landslide block appears to be very active, and the scarp cracks of the landslide bounds the most distressed area of the trail surface.

Photo No.2 – Northern flank of lower landslide block (Looking South)

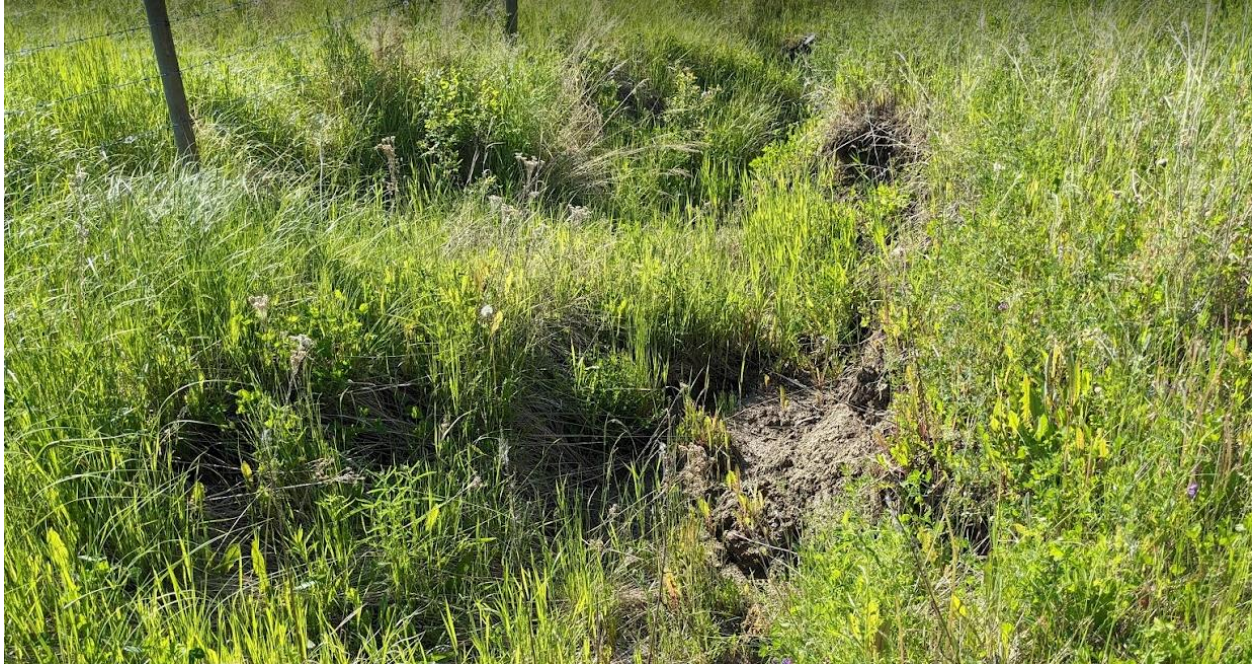
Photo No.3 – Erosion gully along Fischer Trail ditch (Looking South)

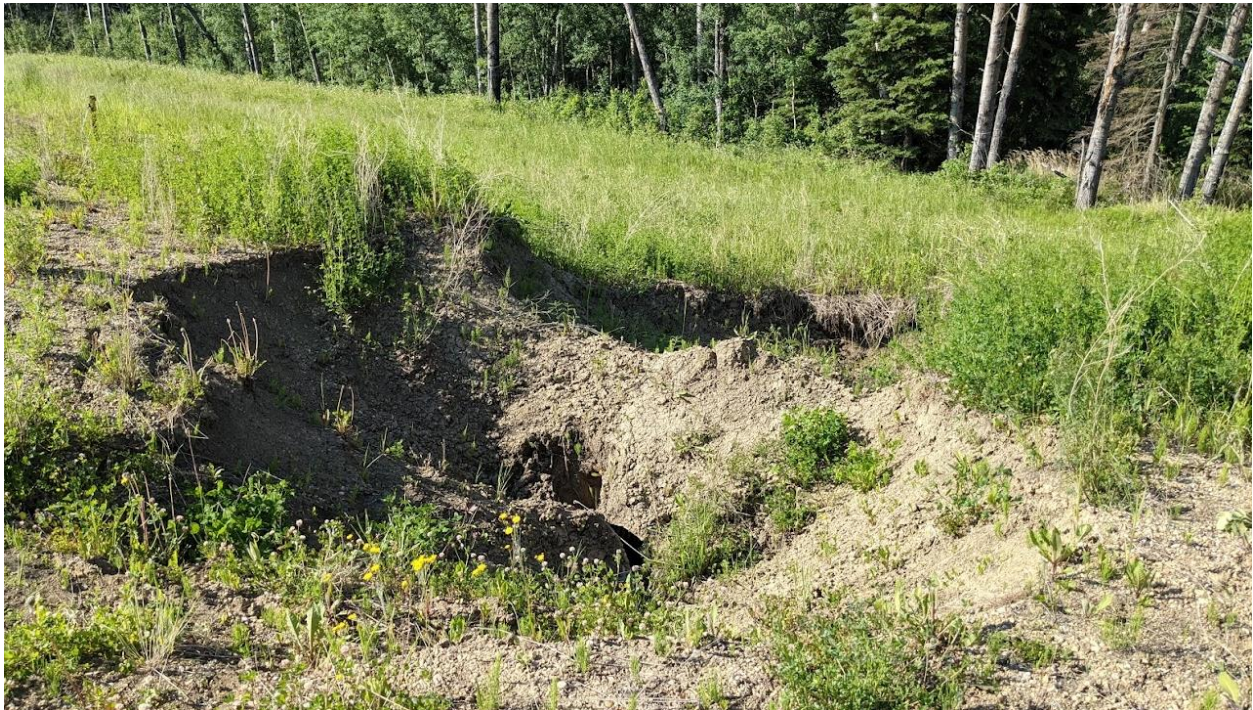
The surface water in the trail ditch flows below the separated 800 mm diameter culvert, resulting in the saturation and washout of trail fill and subgrade and possibly recharging of the landslide mass. It is likely that the uncontrolled discharge of surface water below the trail will result in the formation of additional sinkholes and potentially complete failure of the trail.

Photo No.4 – Sinkhole above the 800 mm diameter culvert; looking at the culvert separation area near the outlet location (6 m diameter x 1.5 m deep)

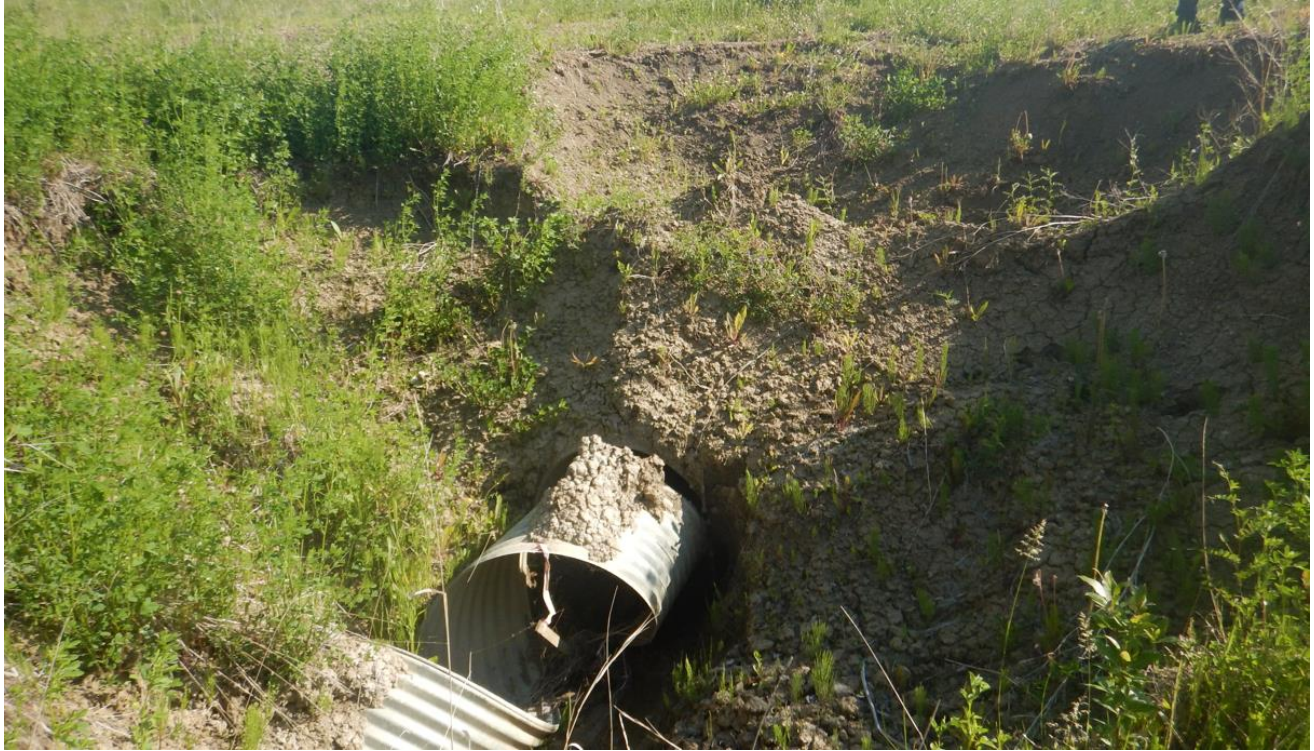
Photo No.5 – Looking at ruptured section of pipe at sinkhole location

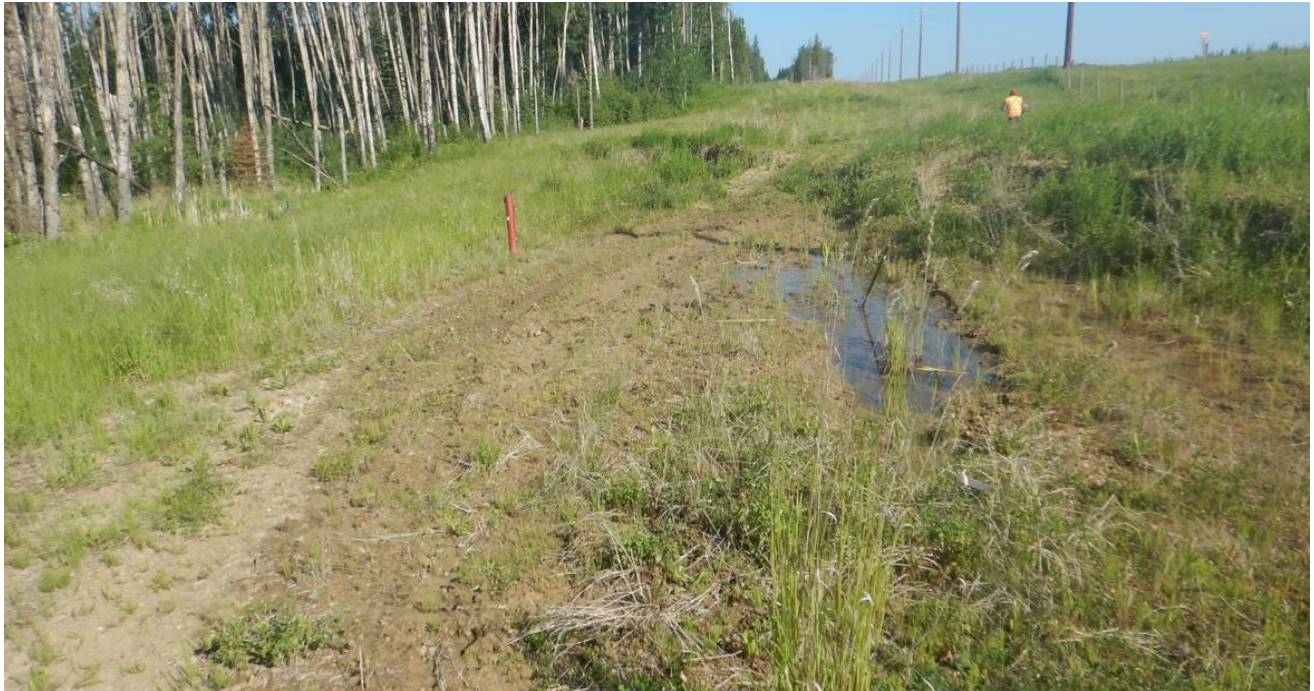
Photo No.6 – Looking north at lower landslide block; water is ponding beside the 1 m deep head scarp crack

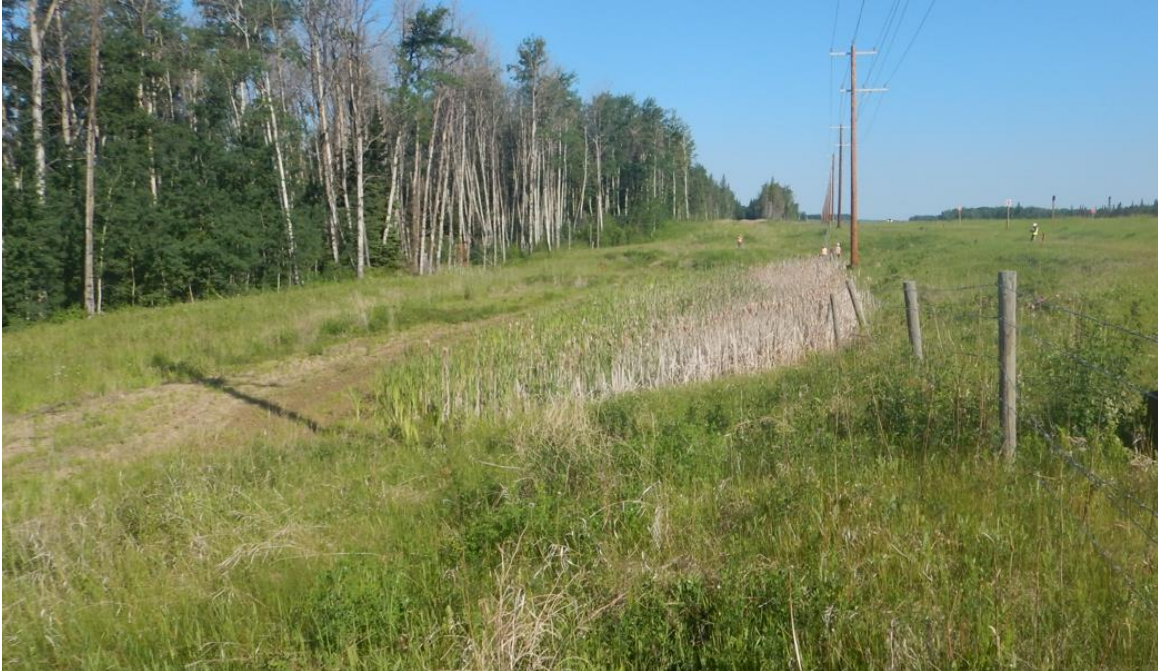
Photo No.7 – Southern flank of upper and lower landslide blocks (Looking North); note standing water within the flank and lateral shifting of existing fence

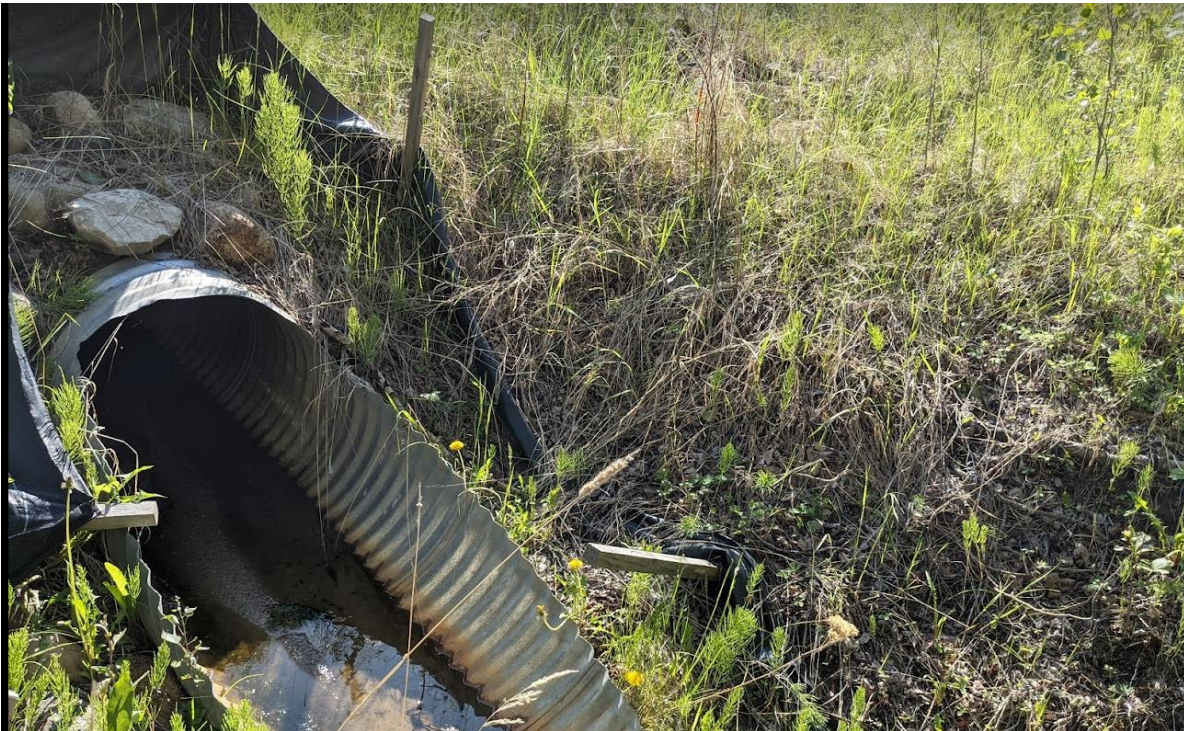
Photo No.8 – 700 mm diameter CSP culvert C3 outlet; note sediment accumulation inside the culvert; minor flow from the outlet of the culvert was noted in 2021

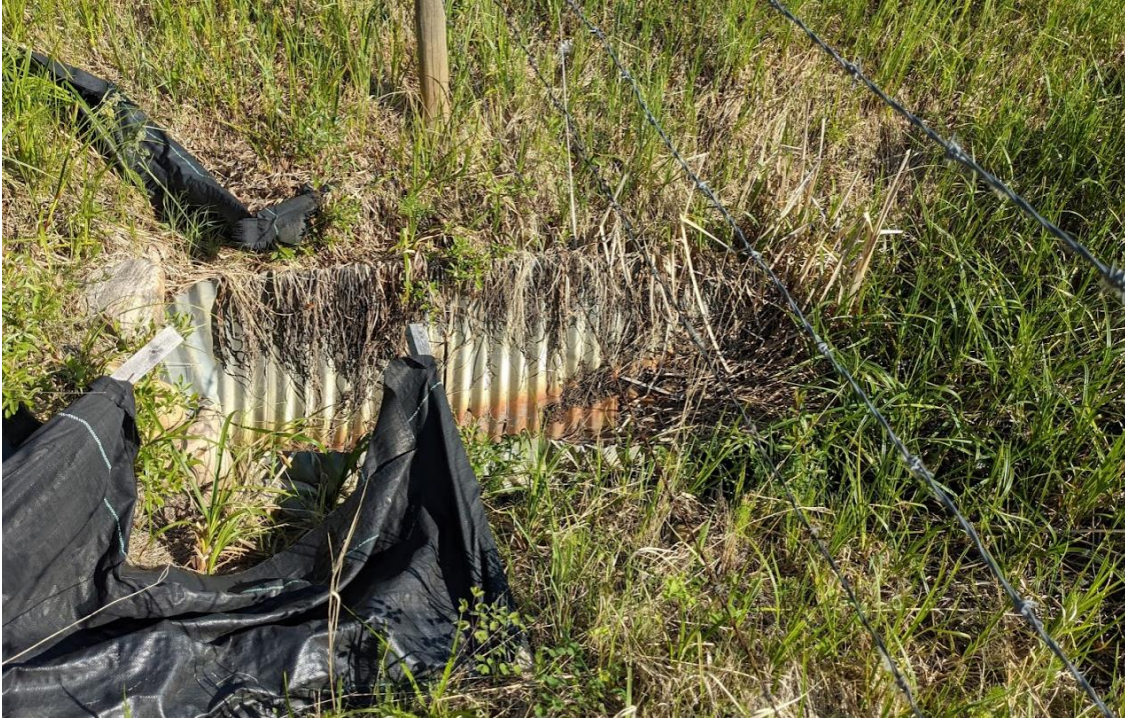
Photo No. 9 – 700 mm diameter CSP culvert C3 inlet; water is flowing under culvert

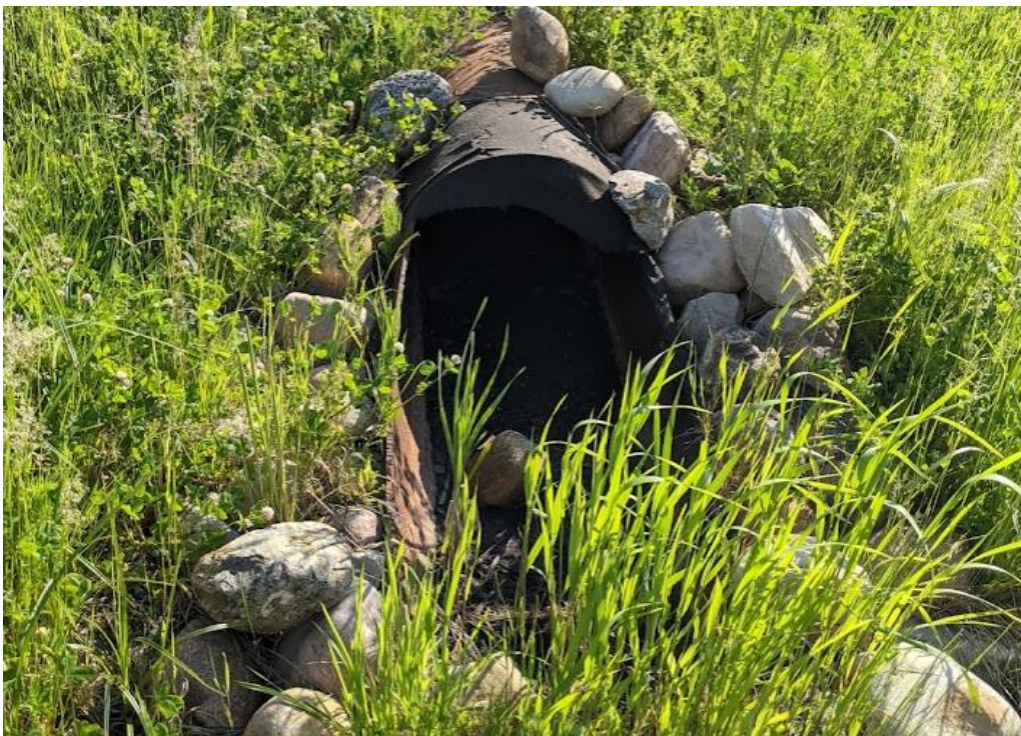
Photo No.10 – Outlet of 800 mm diameter culvert C1; note sediment at the culvert outlet; ground surface is a bit higher than the culvert invert at outlet

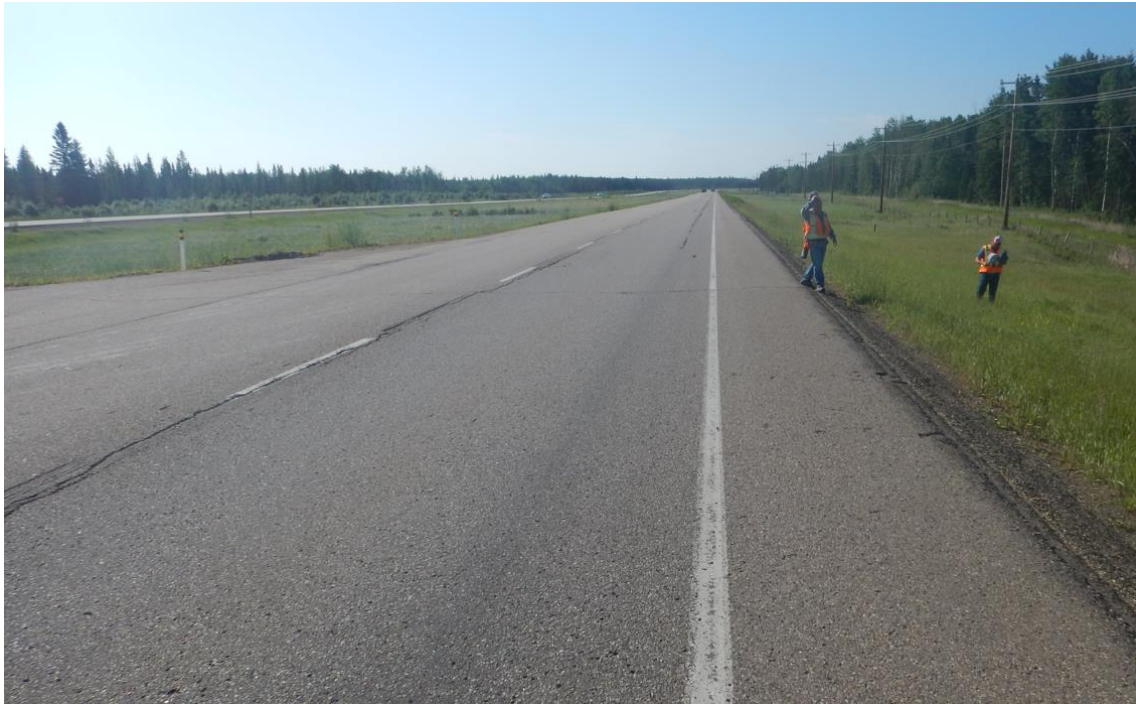
Photo No. 11 – Looking south at highway southbound lanes; landslide is not currently impacting the highway surface; head scarp crack is about 6.5 m away from the edge of pavement
