October 26, 2022

**ALBERTA TRANSPORTATION GRMP (CON0022163)  
NORTH CENTRAL (ATHABASCA AND FORT McMURRAY DISTRICTS)  
INSTRUMENTATION MONITORING RESULTS – FALL 2022**

**SITE NC087: HWY 63:02 FISCHER TRAIL (km 20.67)**

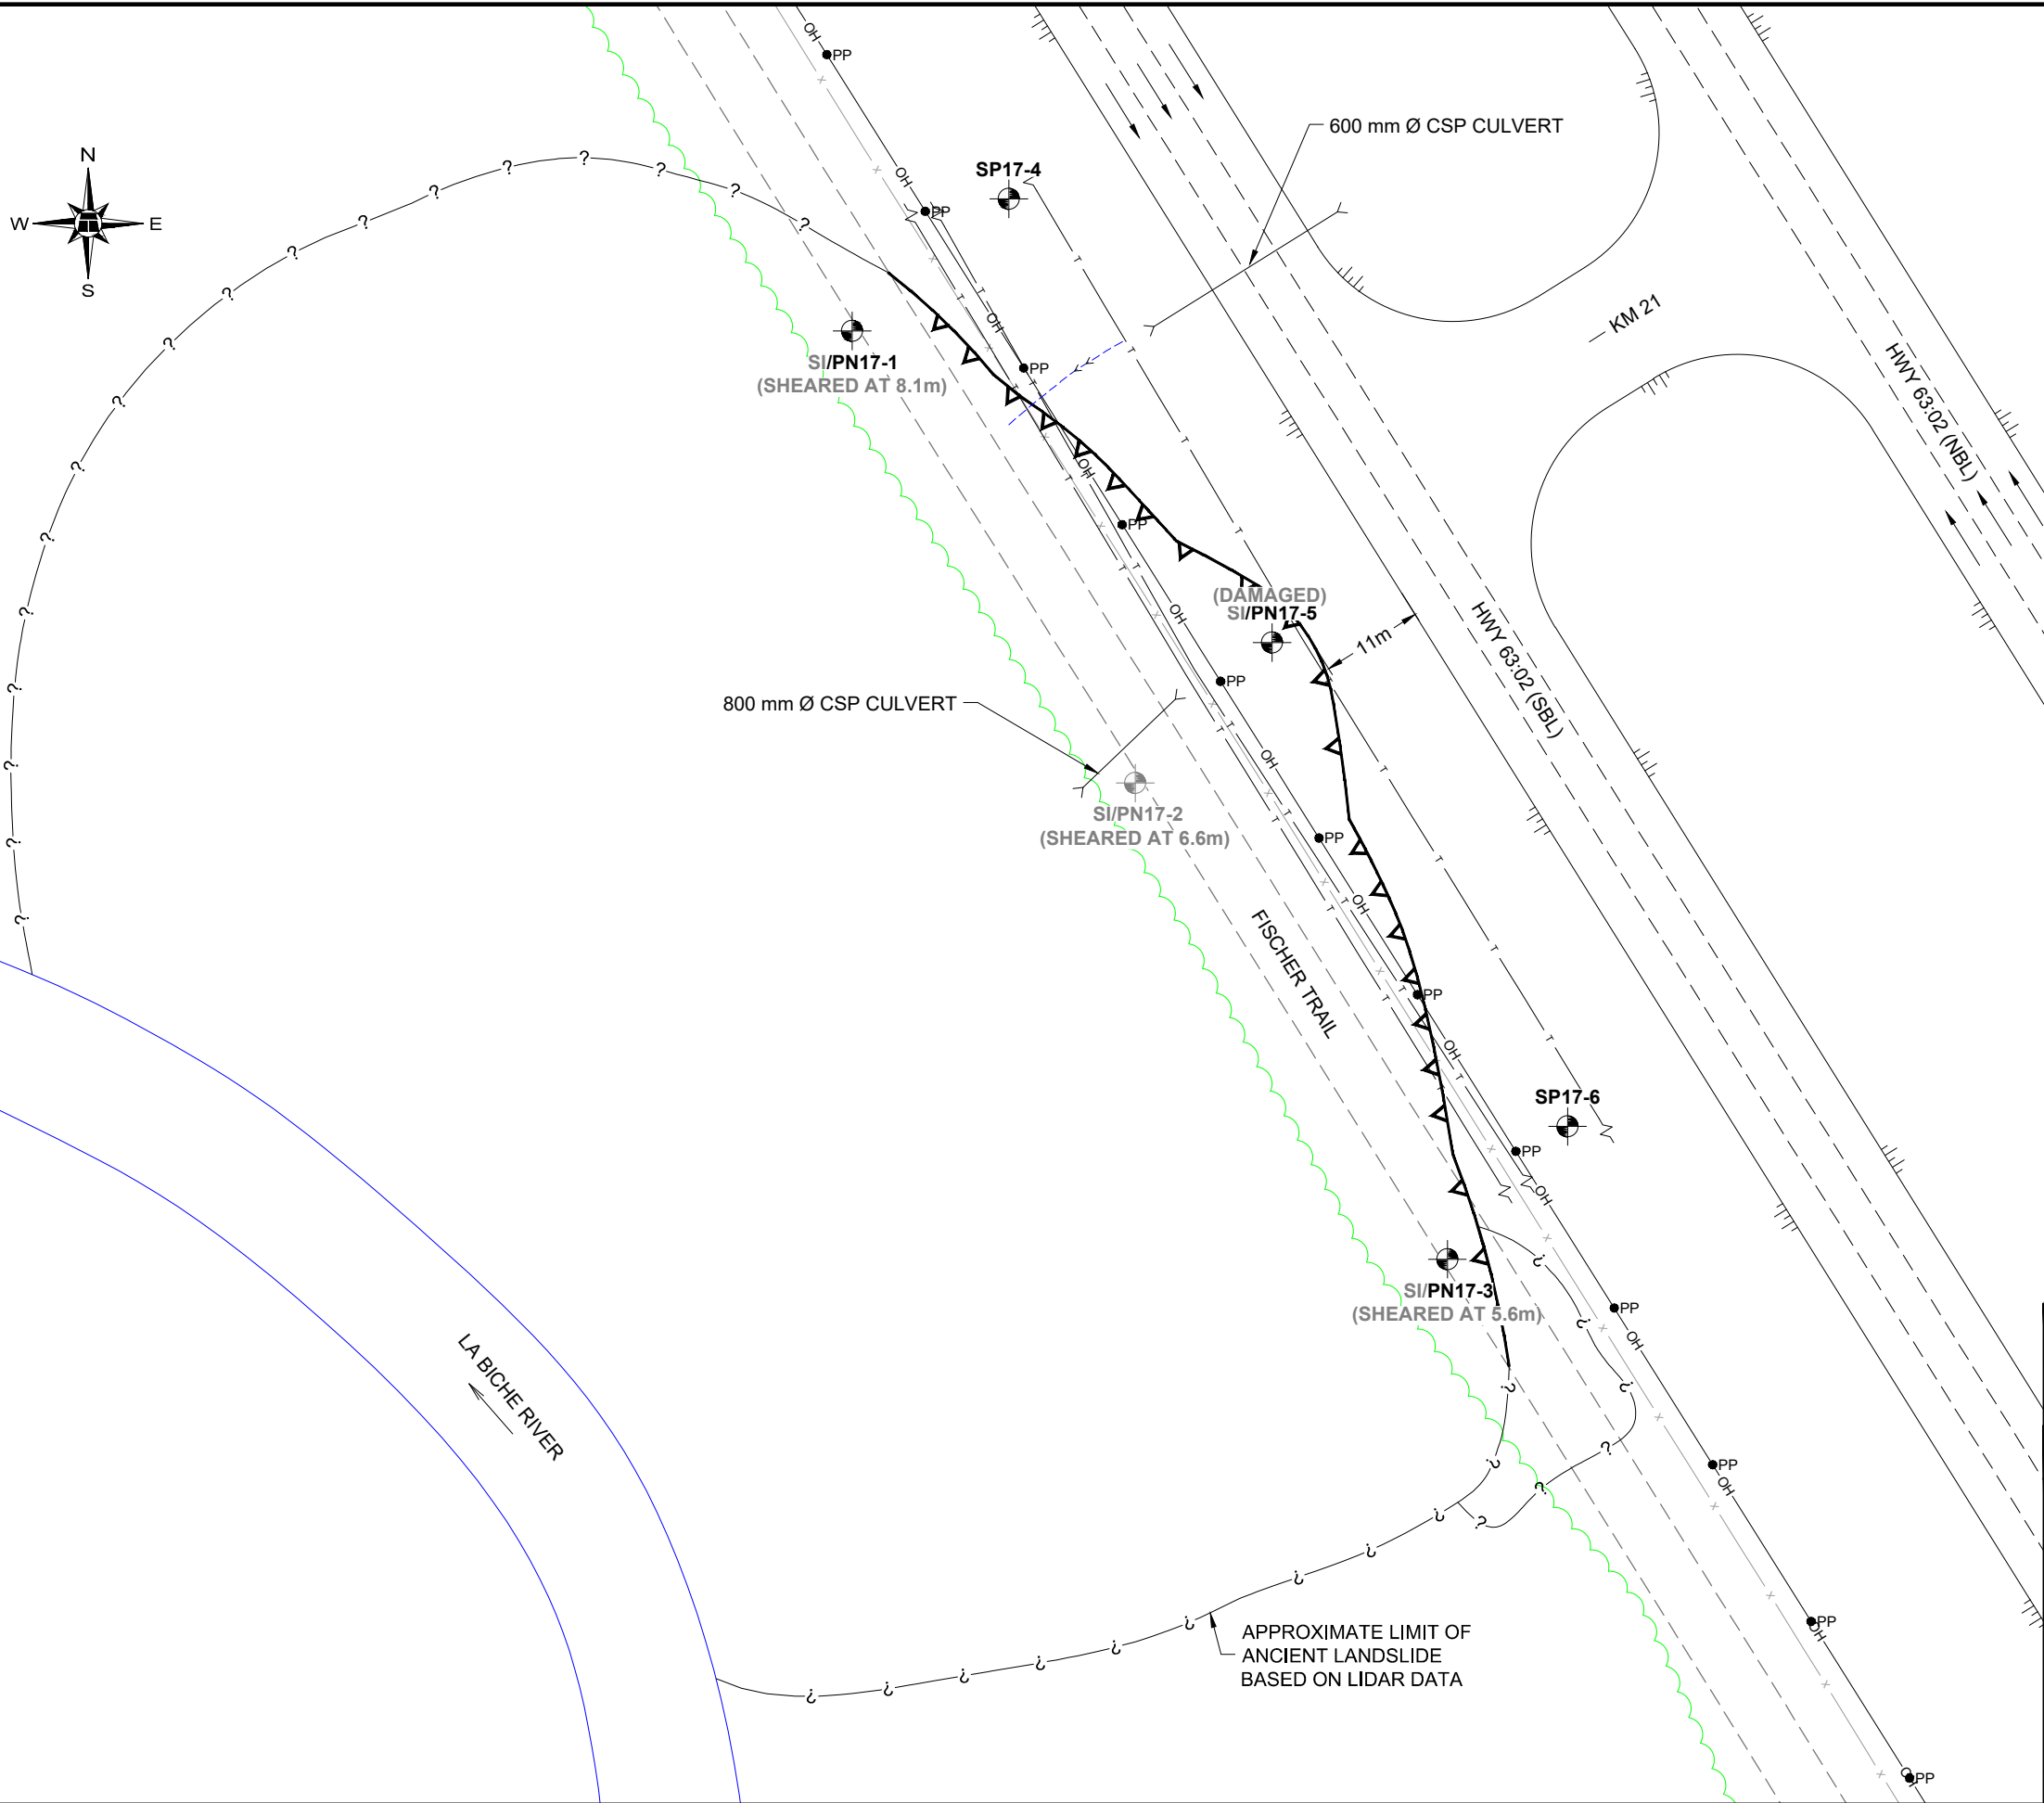
DWG No. 32122-NC087

**NC087: HWY 63:02 FISCHER TRAIL SLIDE  
SITE PLAN SHOWING APPROXIMATE  
INSTRUMENT LOCATIONS**

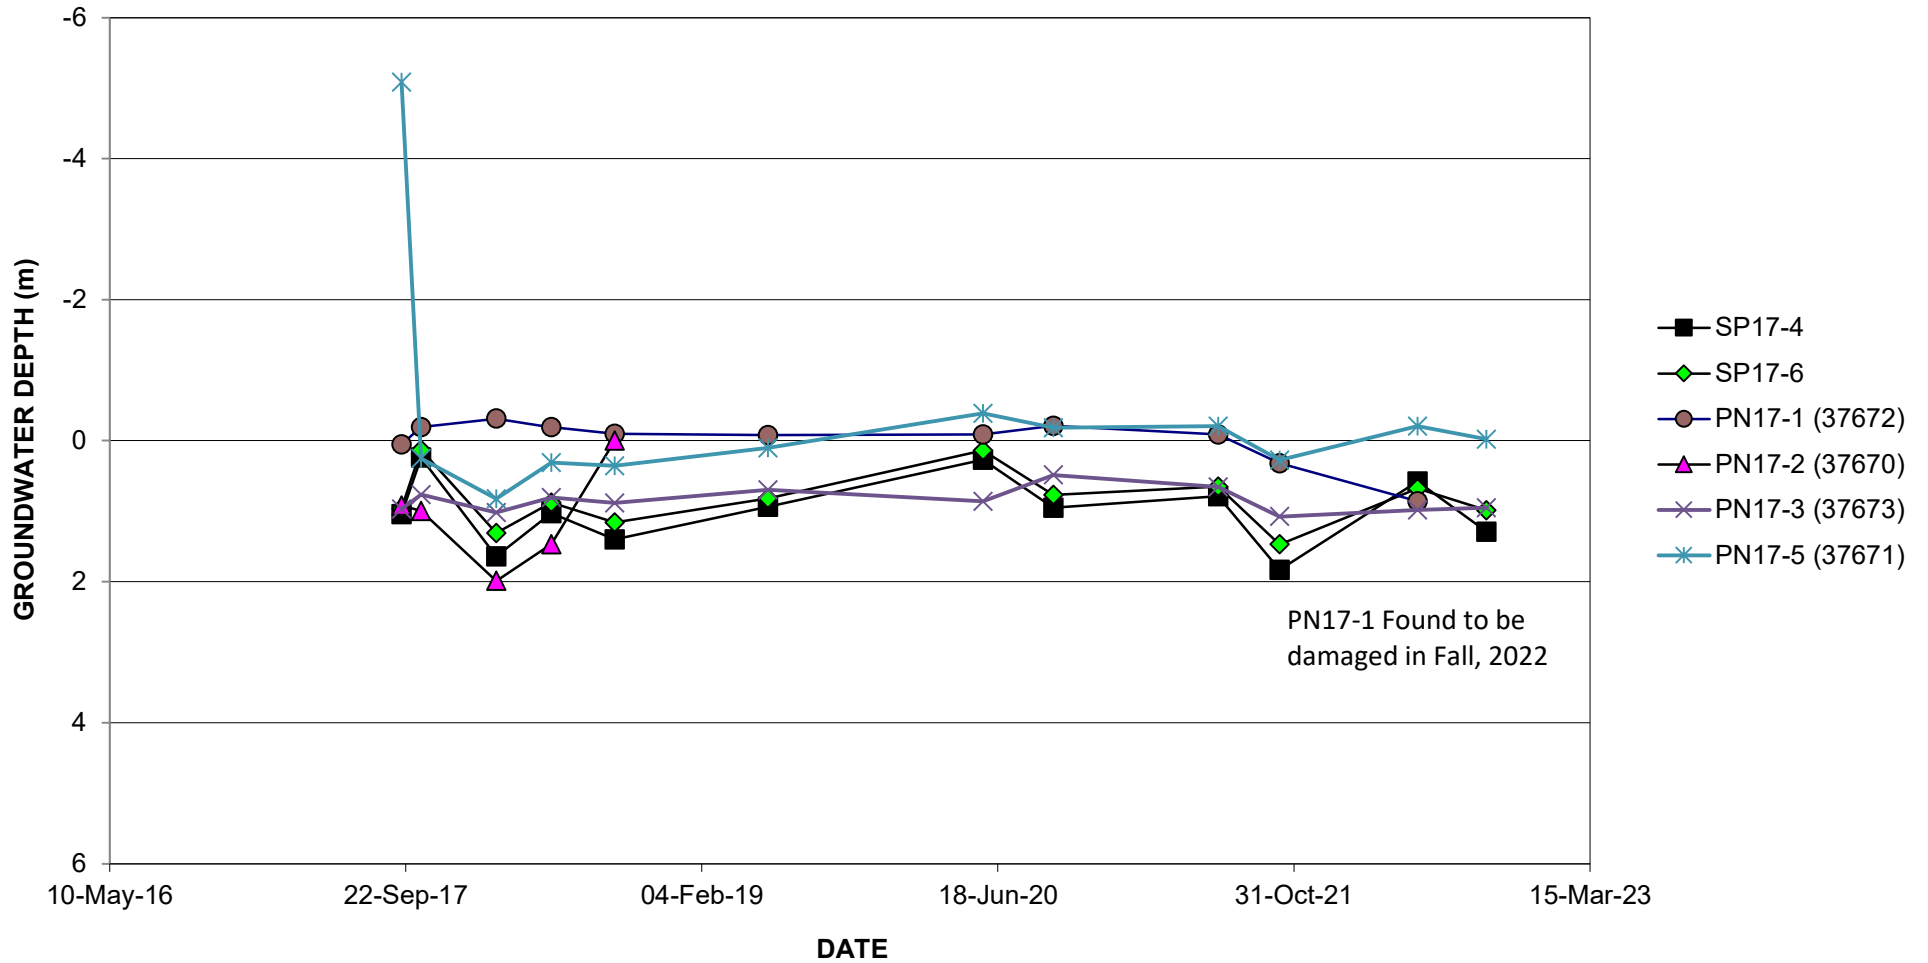
**FIGURE NC087-1  
PIEZOMETER DATA FOR HWY 63:02 - FISCHER TRAIL**

The groundwater level in pneumatic piezometer PN17-3 increased by 0.03 m since the spring of 2022 readings. The groundwater level in pneumatic piezometer PN17-5 decreased by 0.19 m since the spring of 2022 readings. PN17-5 showed an above-ground (artesian) groundwater level of 0.02 m. The pneumatic piezometer readings are summarized in Table NC087-2.

Standpipe piezometers SP17-4 and SP17-6 showed decreases in groundwater level of 0.71 m and 0.31 m, respectively, since the spring of 2022 readings. The standpipe piezometer readings are summarized in Table NC087-3.

The piezometer readings are plotted on Figure NC087-1 in Appendix A.
