**ALBERTA TRANSPORTATION AND ECONOMIC CORRIDORS
GEOHAZARD ASSESSMENT PROGRAM
NORTH CENTRAL REGION – ATHABASCA &
FORT MCMURRAY DISTRICTS
2023 SITE INSPECTION**

| Site Number | Location | Name | Hwy | km |

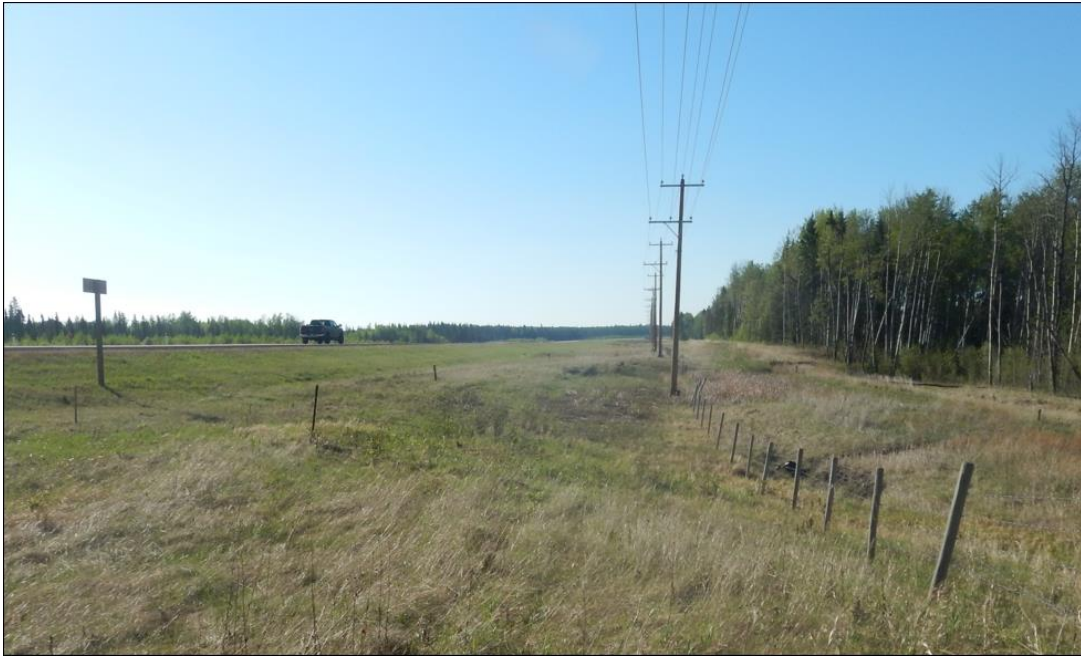
Photo No.1 – Head scarp crack of upper landslide block (Looking South)

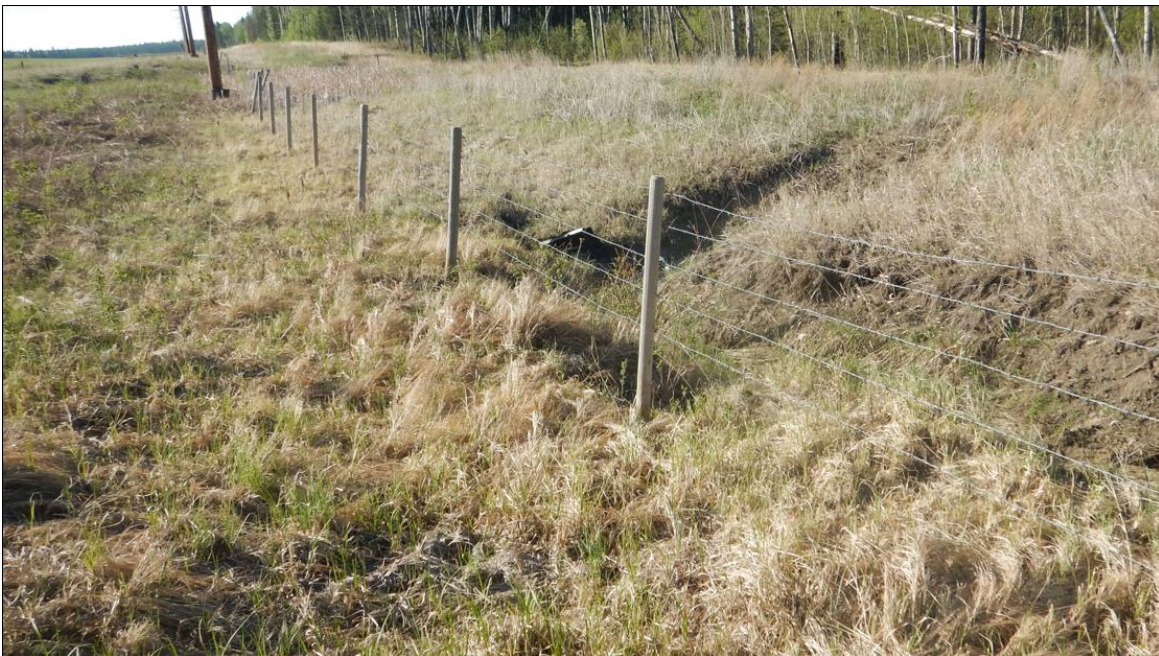
Photo No.2 – Sinkhole above the 800 mm diameter culvert; looking at the culvert inlet

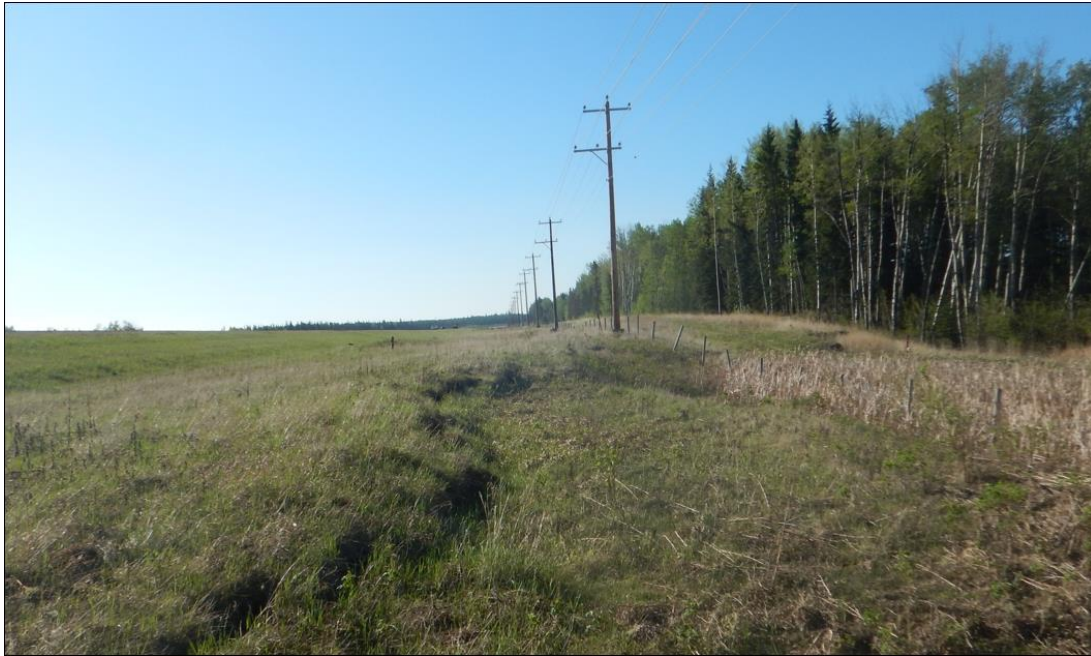
Photo No.3 – Looking south at the southern flank of the landslide (700 mm wide cracks, up to 1 m drop); water ponding along the ditch between the trail and the fence (note cattails in this area)

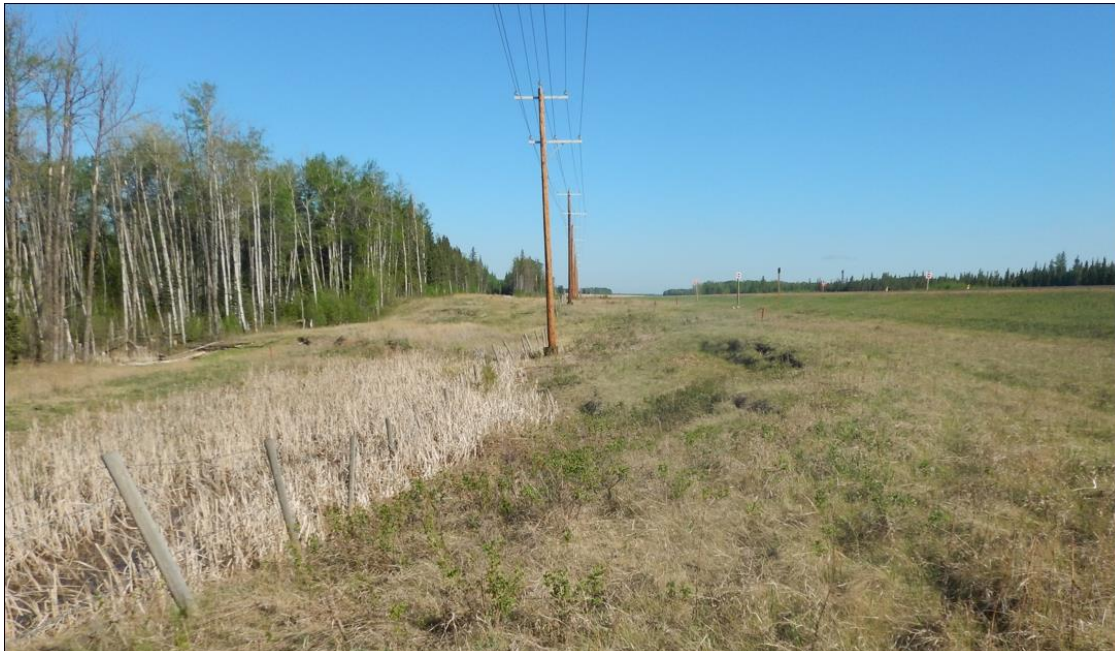
Photo No.4 –Looking north at the southern flank of upper and lower landslide blocks; note standing water within the flank and lateral shifting of existing fence; landslide is well vegetated.

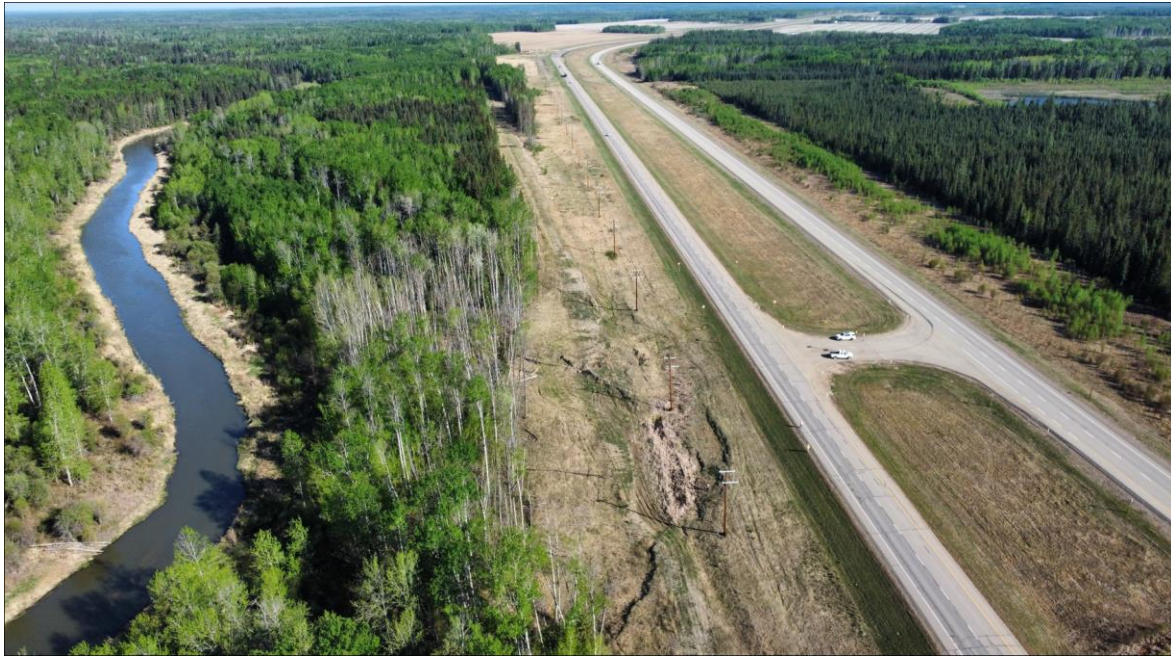
Photo No. A5 (aerial photo) – Looking north at the active landslide mass to the west of Hwy 63. Note head-scarp crack between the edge of pavement and power lines, fresh quad tracks within Fischer trail, dead/tilting trees within landslide mass, and toe of the landslide narrowing of the river channel at the river bend.

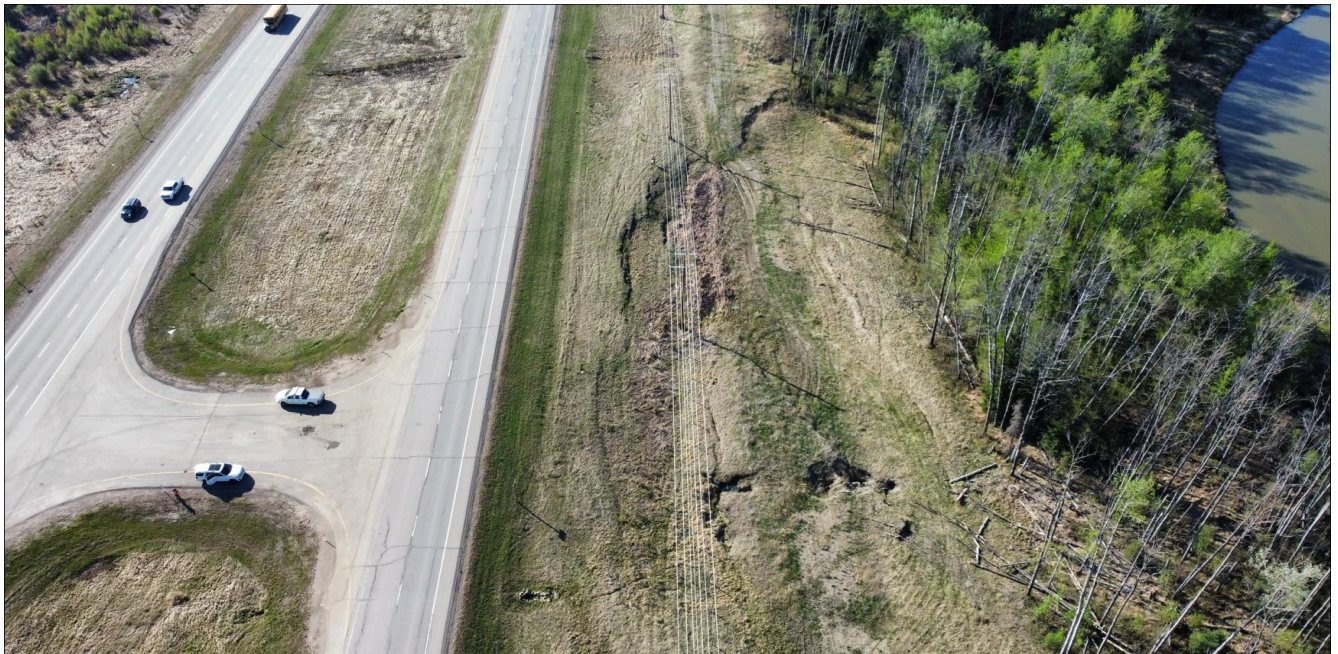
Photo No. A6 (aerial Photo)– Looking south at landslide area. Note deadfall and sink holes within Fisher Trail on the northern portion of the landslide mass.

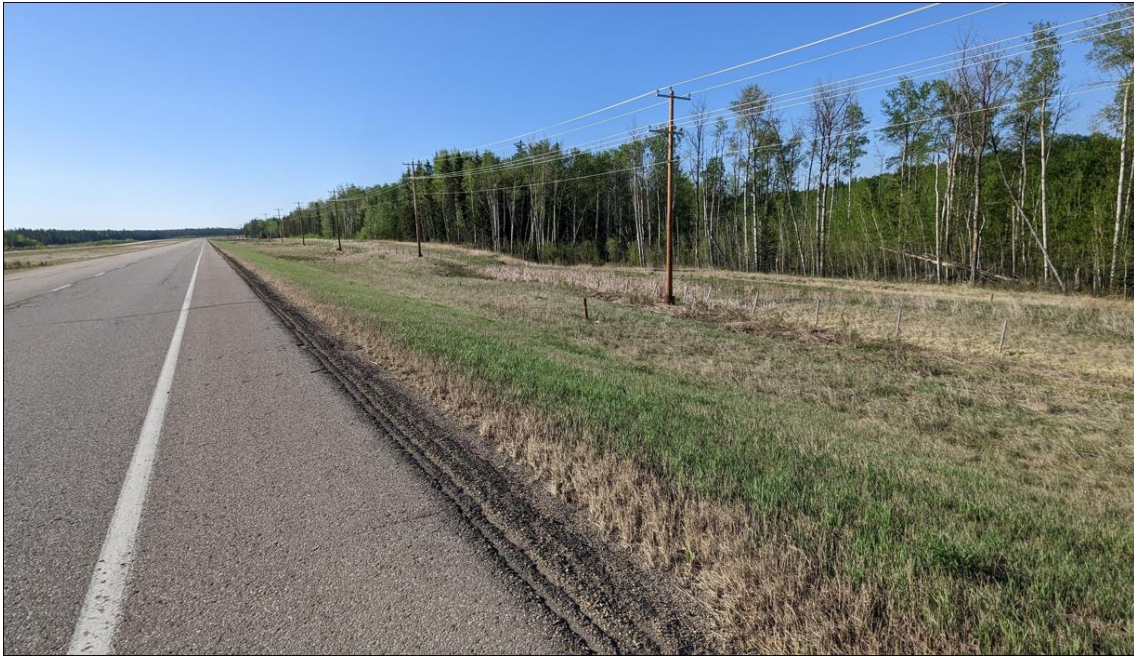
Photo No. 7 – Looking south at highway southbound lanes; landslide is not currently impacting the highway surface; head scarp crack is about 6.5 m away from the edge of pavement.
