ALBERTA TRANSPORTATION AND
ECONOMIC CORRIDORS GRMP
NORTH CENTRAL (ATHABASCA AND FORT
McMURRAY DISTRICTS)
INSTRUMENTATION MONITORING- SPRING 2024

Site Number	Location	Name	Hwy	km
NC087	HWY 63:02	Fischer Trail	63:02	Km 20.67
Legal Description: 8-22-69-17 W4		UTM Co-ordinates		
		12U E 404181	N	6094051

Current Monitoring:	8-Jun-2024	Previous Monitoring	1-Oct-2023
Instruments Read By:	Mr. Niraj Regmi, G.I.T and Mr. Nixon Mationg, of Thurber

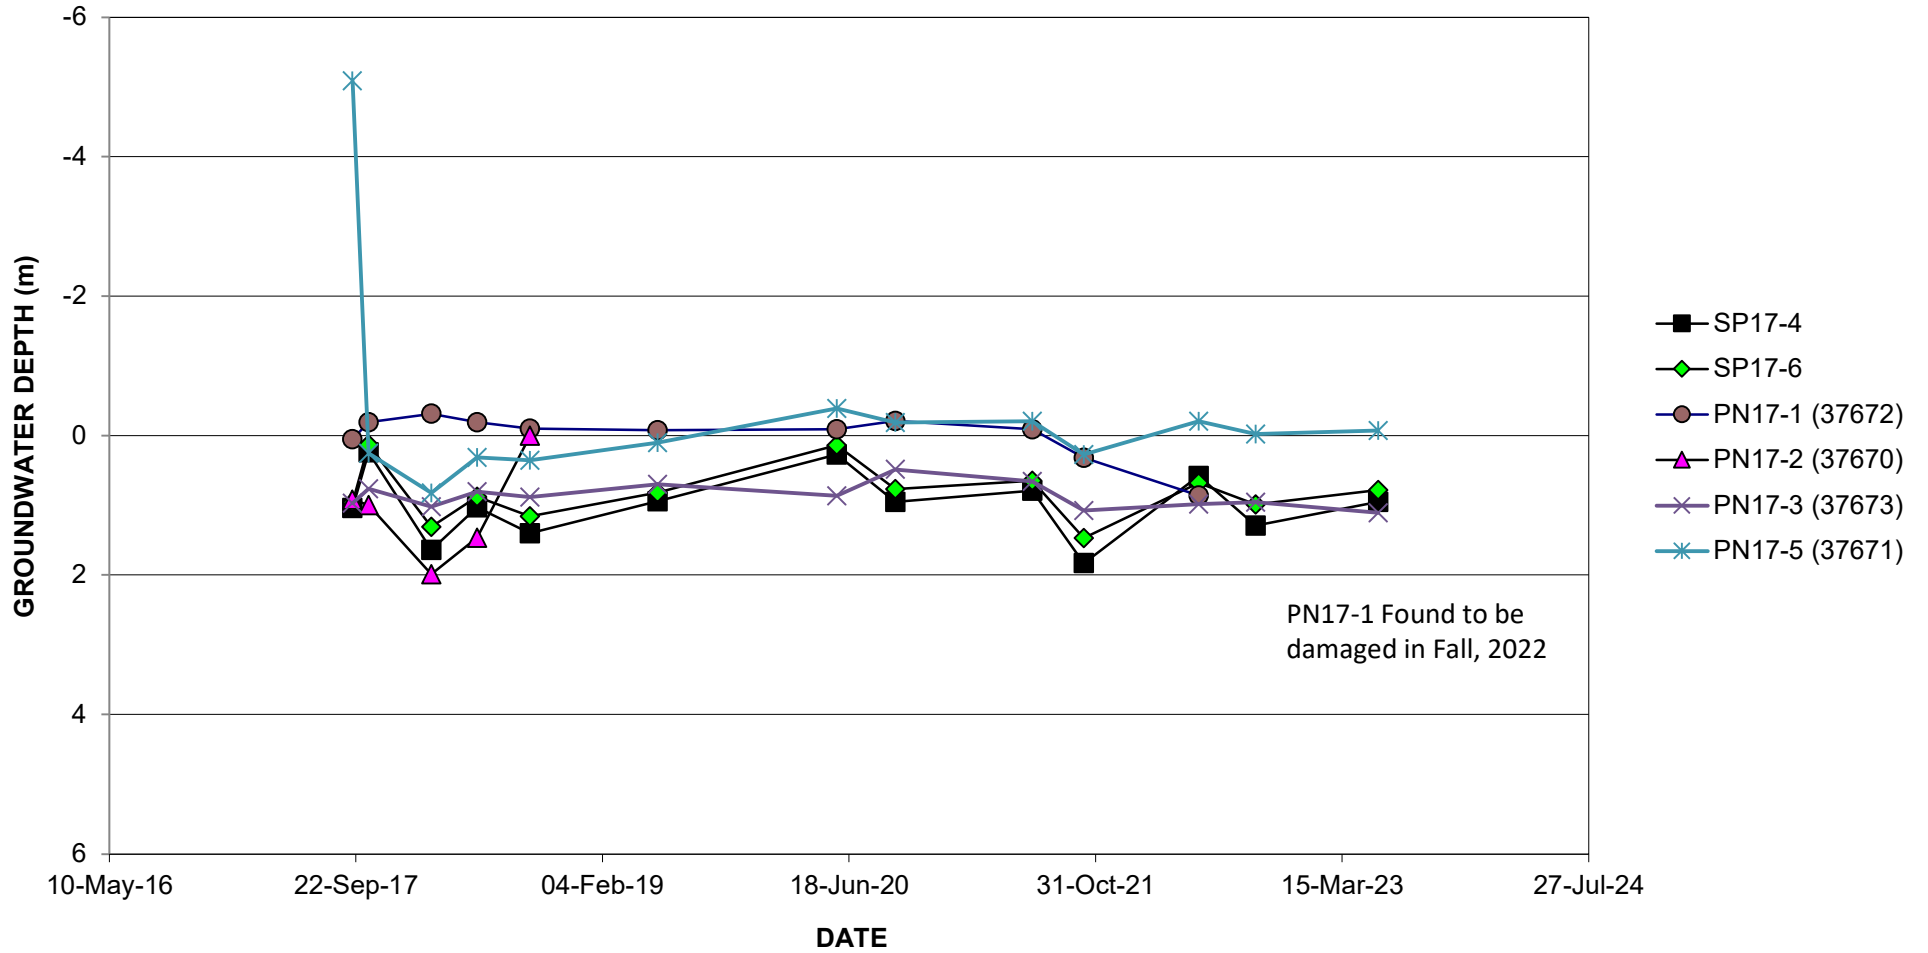
**FIGURE NC087-1
PIEZOMETER DATA FOR HWY 63:02 - FISCHER TRAIL**

Discussion	
Zones of New Movement:	None
Interpretation of Monitoring Results:	<p>The groundwater level decreased by 1.10 m in PN17-3 since the fall of 2023 readings. PN17-5 showed an increase in groundwater level of 0.21 m since the fall of 2023 readings, corresponding to an above-ground (artesian) groundwater level of 0.32 m.</p> <p>Standpipe piezometers SP17-4 and SP17-6 showed increases in groundwater level of 0.78 m and 0.65 m, respectively, since the fall of 2023 readings.</p>
Future Work:	The instruments should be read again in the fall of 2024.
Instrumentation Repairs:	No instrument repairs are required at this time.
Additional Comments:
