GEOHAZARD ASSESSMENT PROGRAM
NORTH CENTRAL REGION – ATHABASCA
2020 INSPECTION

Site Number	Location	Name	Hwy	km
NC091-1 NC091-2	NBL - 5 to 6 Km south of Wandering River	HWY 63-02 BACKSLOPE SLUMPS	63:02	39.27 and 40.28
Site		UTM Co-ordinates (NAD 83)		
NC091-1: 6 km south of Wandering River		NC091-1 12 N6113146.92	E405688.87	
NC091-2: 5 km south of Wandering River		NC091-2 12 N6112146.20	E405659.10

**2020 GEOHAZARD ASSESSMENT
 NORTH CENTRAL REGION (ATHABASCA AREA)**

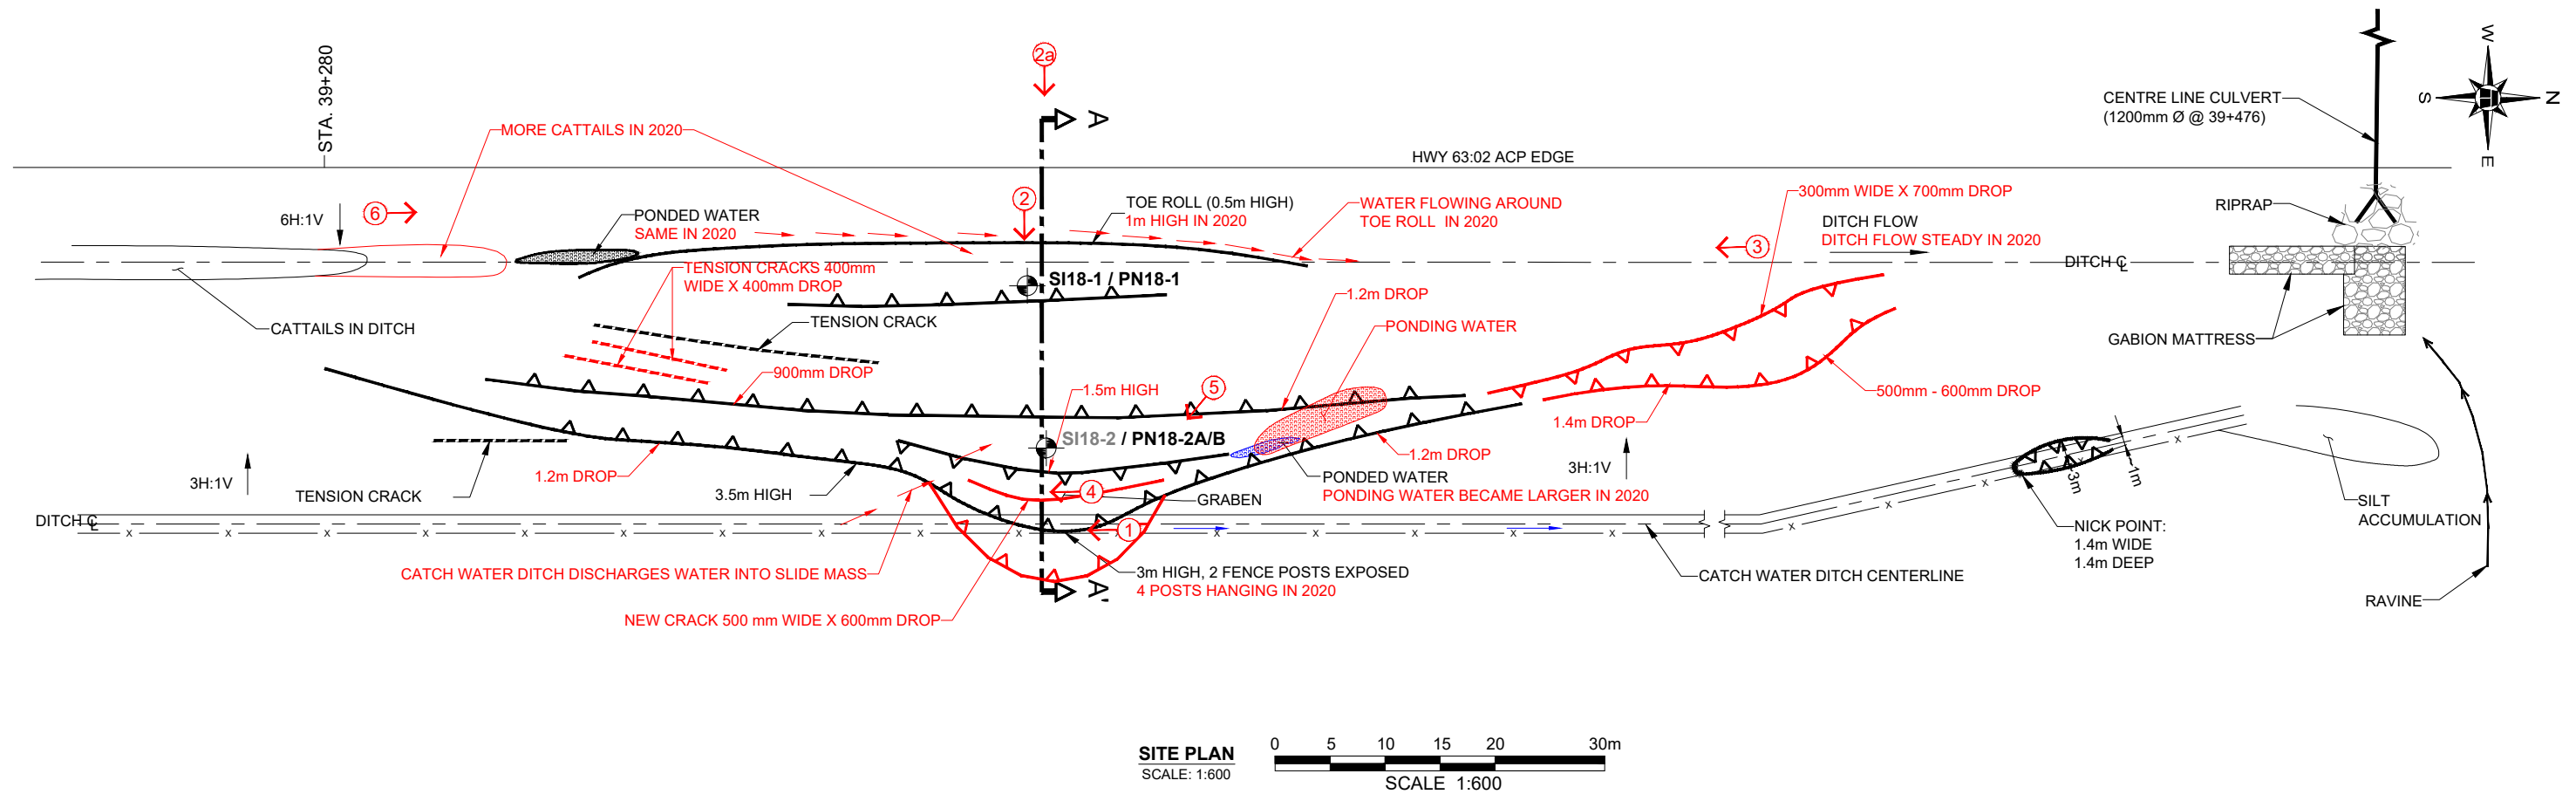
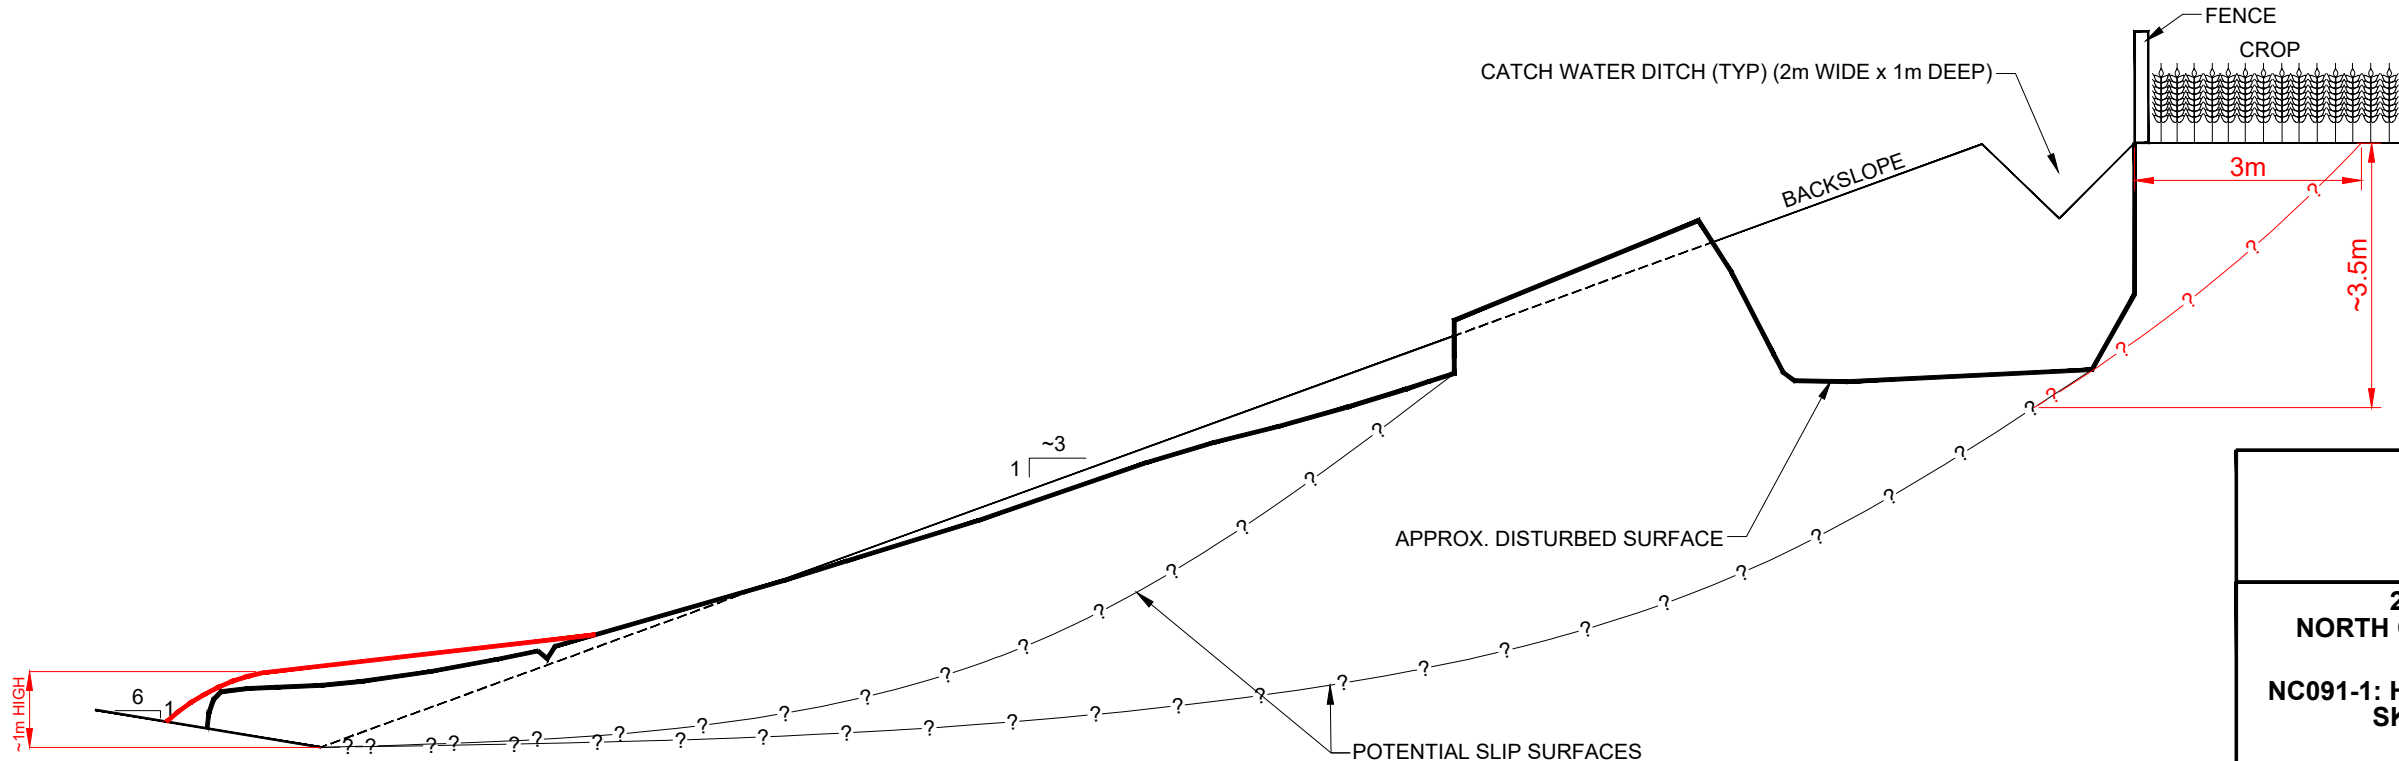
FIGURE 1

**NC091-1: HWY 63:02 KM 39.35 - BACKSLOPE SLUMP
 SKETCH SHOWING SITE FEATURES**

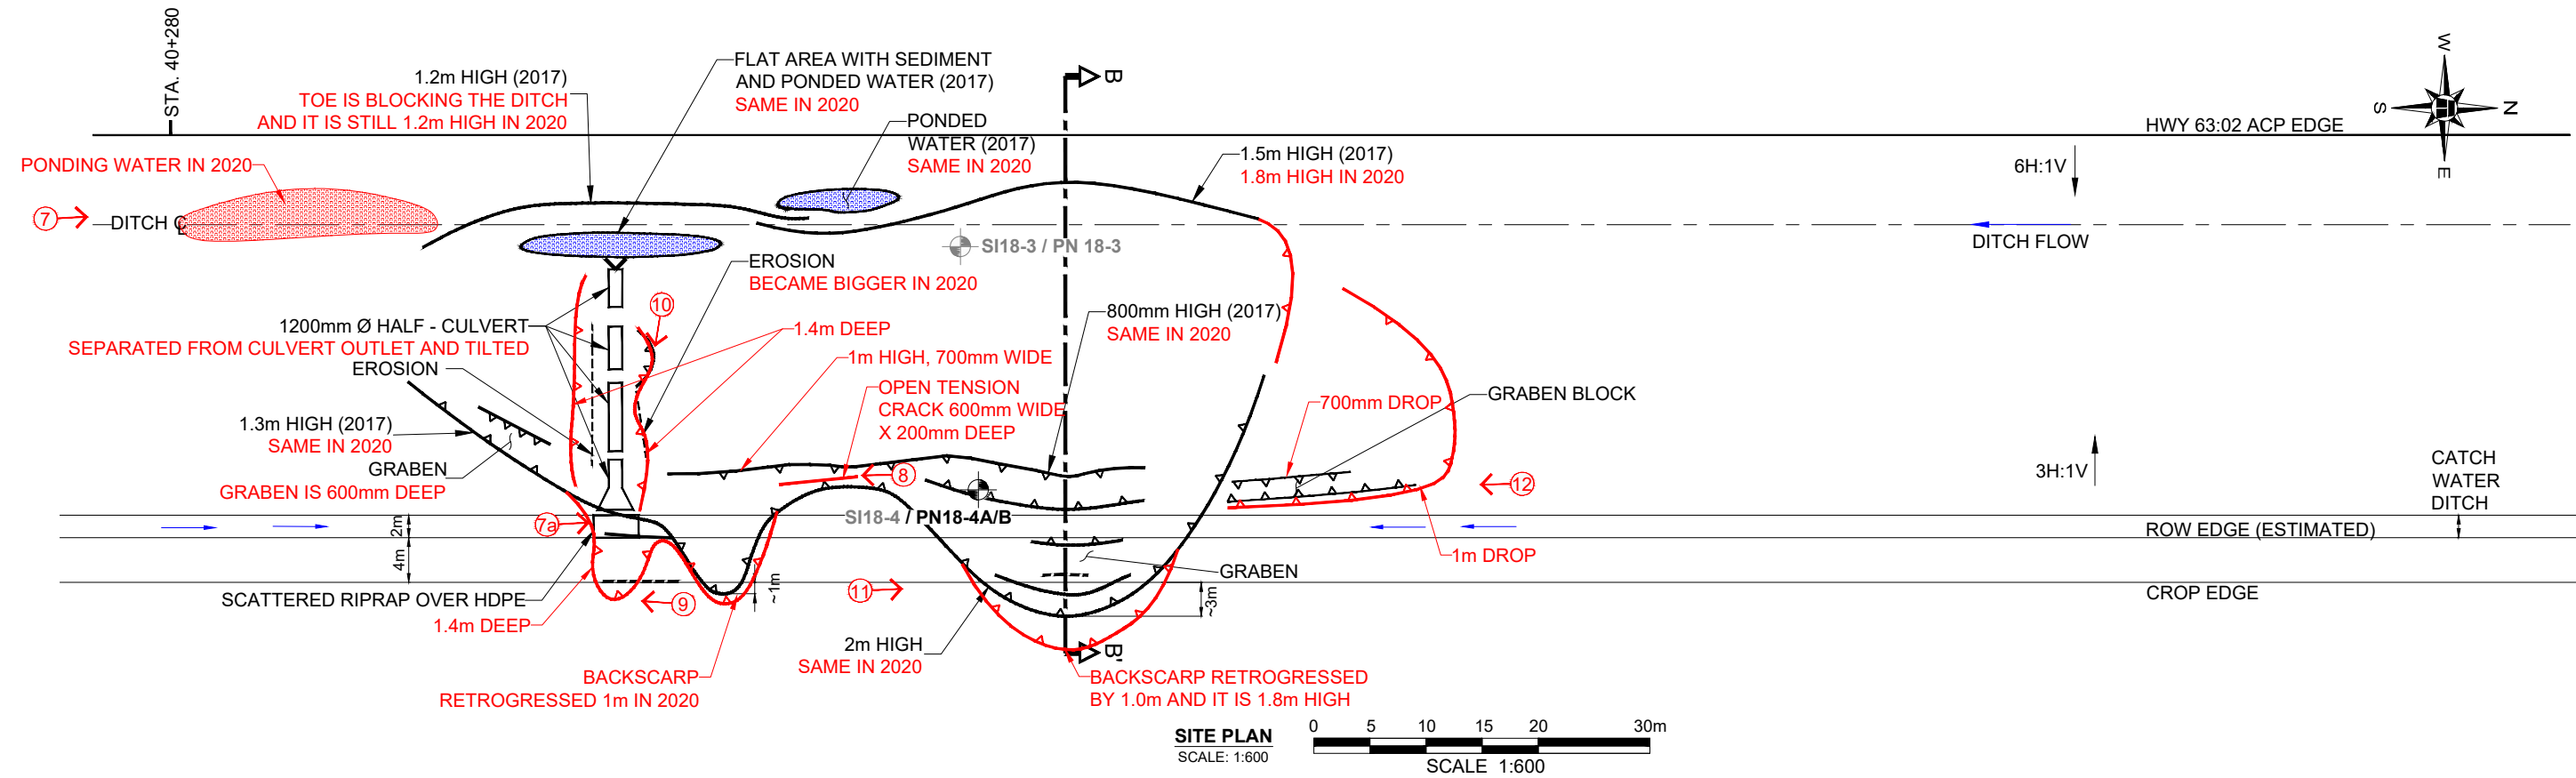
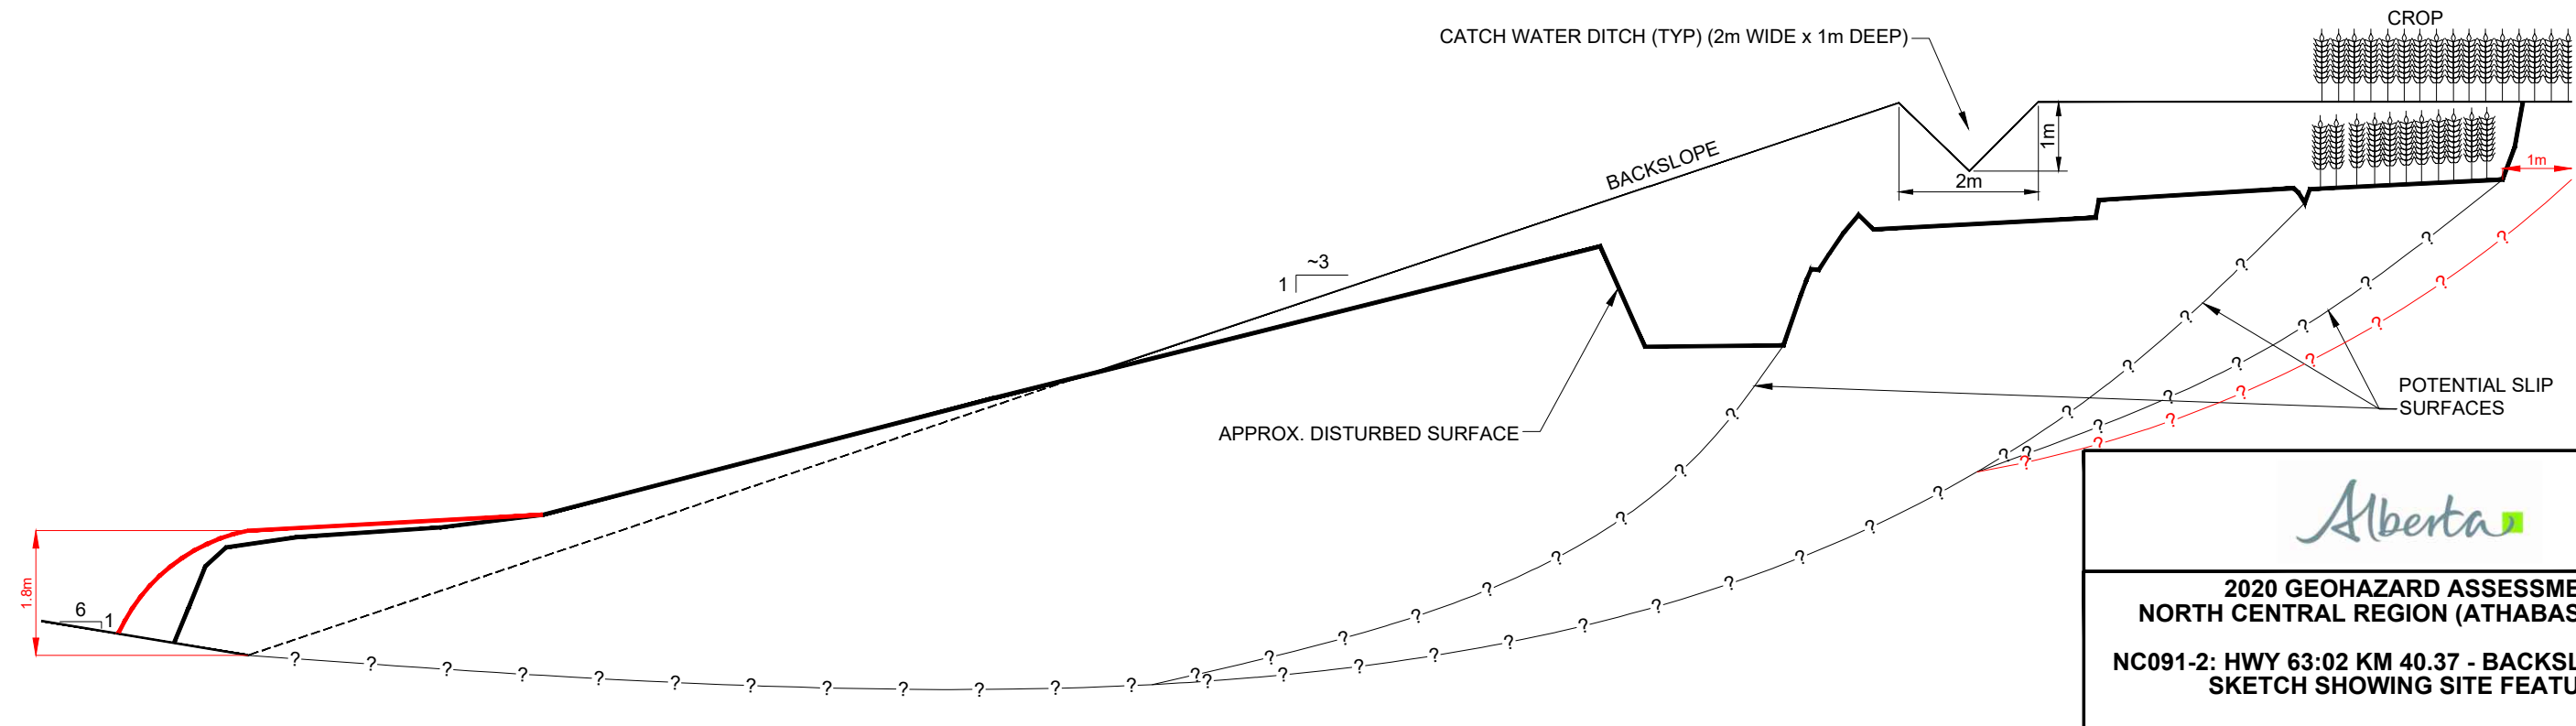
FIGURE 2

**2020 GEOHAZARD ASSESSMENT
 NORTH CENTRAL REGION (ATHABASCA AREA)
 NC091-2: HWY 63:02 KM 40.37 - BACKSLOPE SLUMP
 SKETCH SHOWING SITE FEATURES**

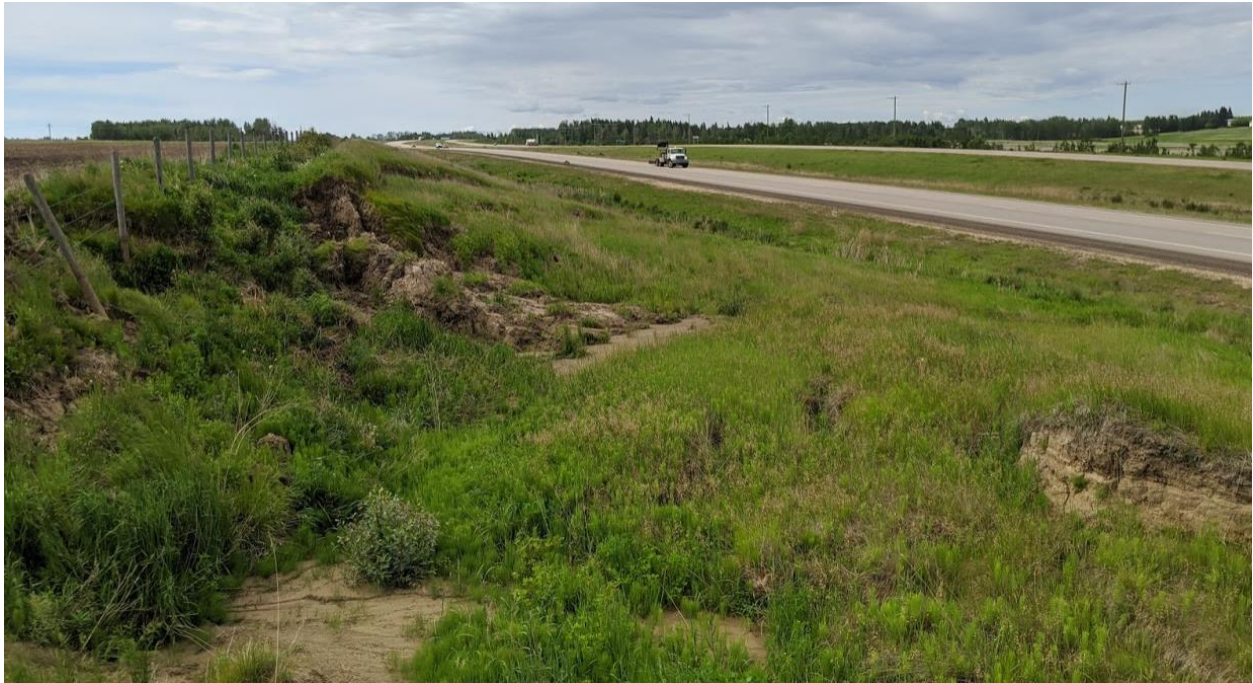
Photo No. 1- NC091-1: Looking south where the landslide cuts through catch water ditch; catch water ditch discharges water into the landslide mass

At both sites, the catch water ditch will need to be reconstructed using low to medium plastic clay, realigned to be a few meters away from the top of the slope in the vicinity of the landslides, and lined with an impervious barrier to prevent further erosion and saturation of the slopes. At Site 2, it is possible to re-grade the catch water ditch to drain towards a centerline culvert located south of the site at approximate km 40.090. During construction, the catch water ditch flow will need to be temporarily diverted away from the slope repair area.

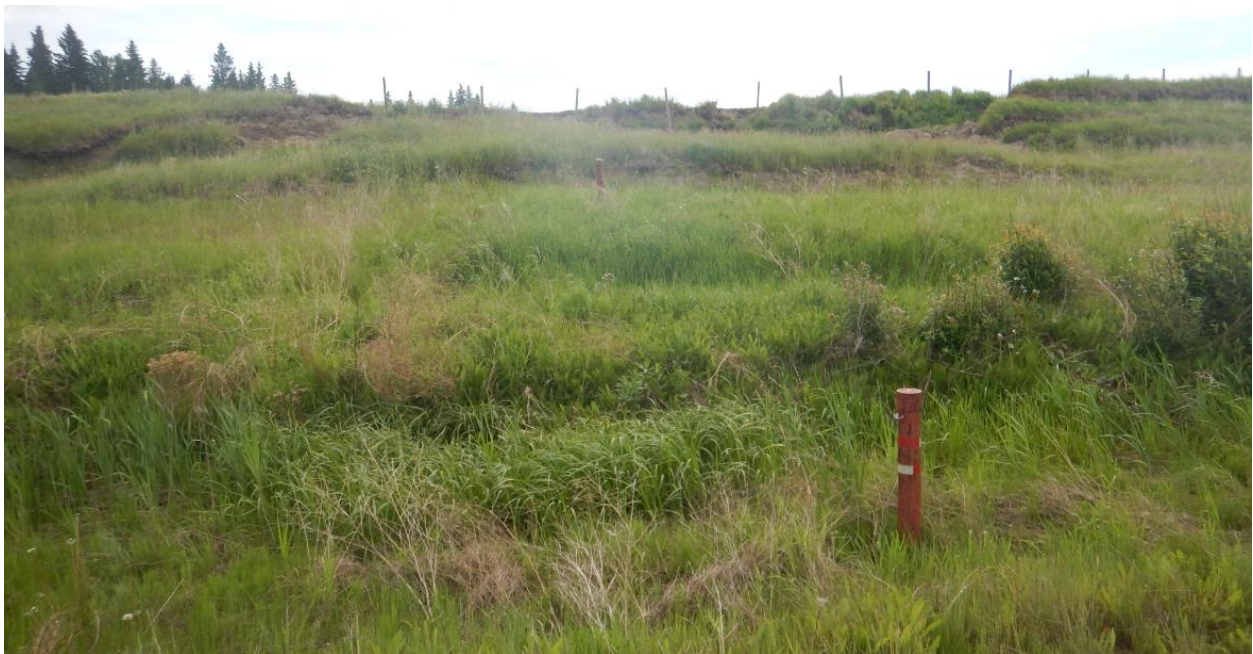
Photo No. 2- NC091-1: Looking east at multiple scarp cracks within the slope

(b) seal open cracks in the slope surface to reduce surface water infiltration into the slide mass. A small track mounted equipment could be used to smoothen the slope surface and fill in any dips without causing significant changes in grade.

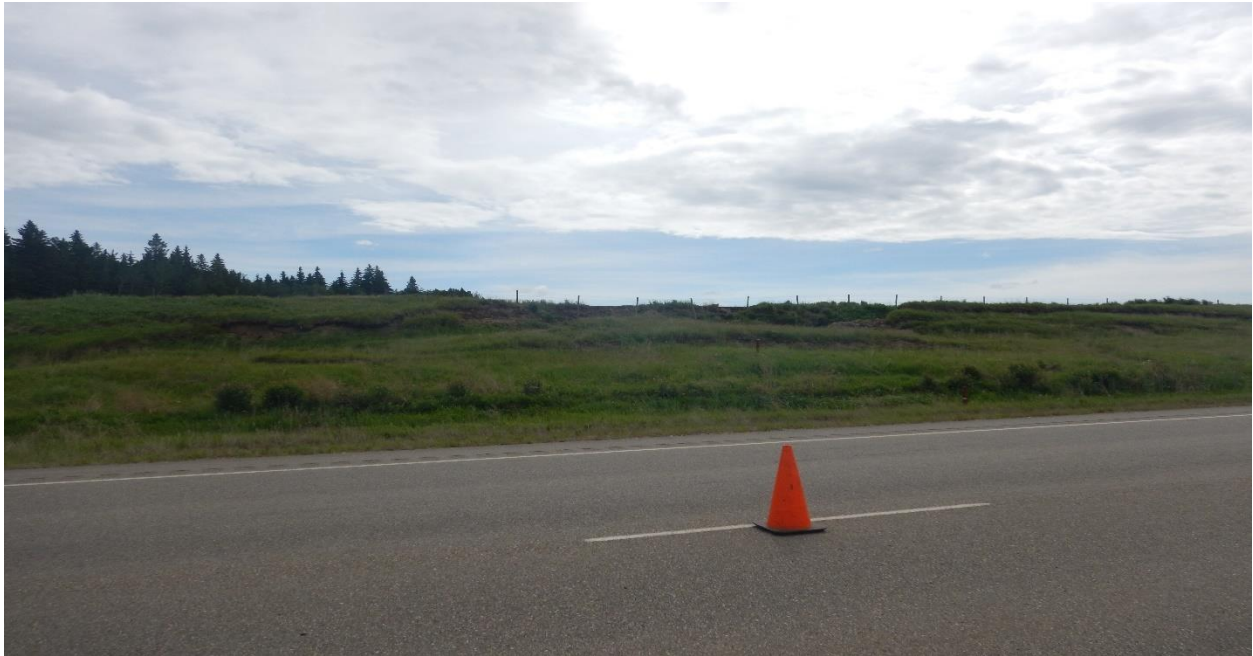
Photo No. 2a- NC091-1: Looking east at the landslide mass

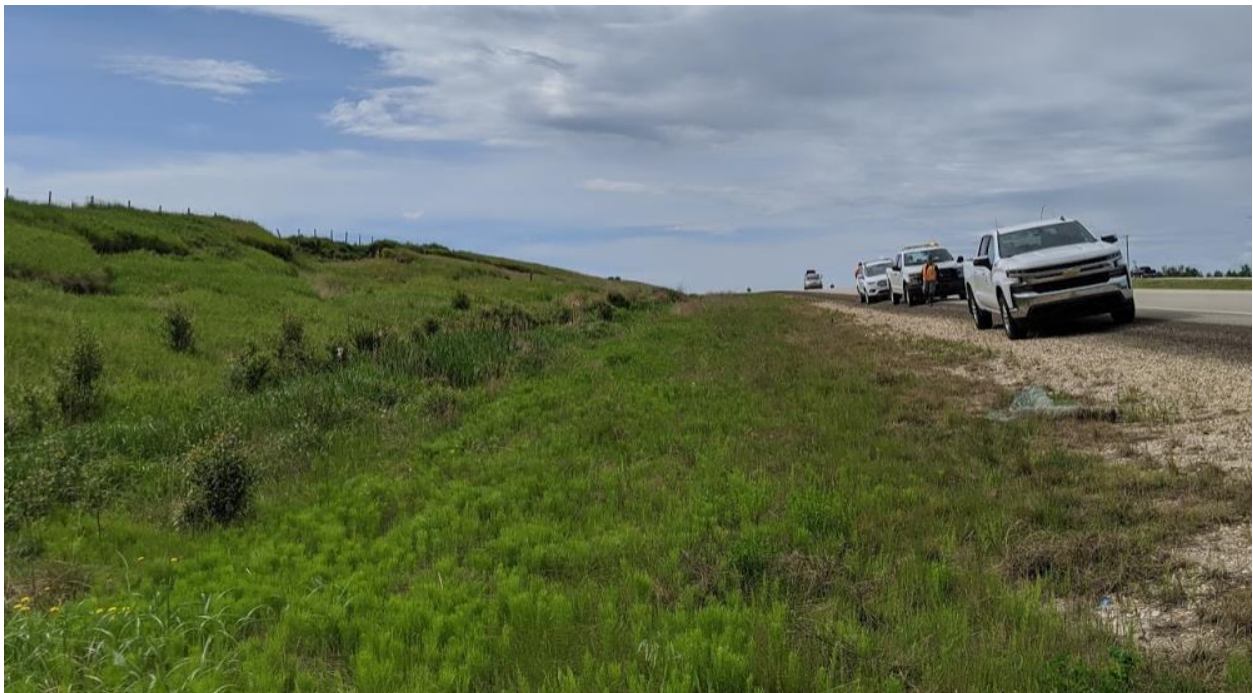
Photo No.3 - NC091-1: Looking south at the landslide mass

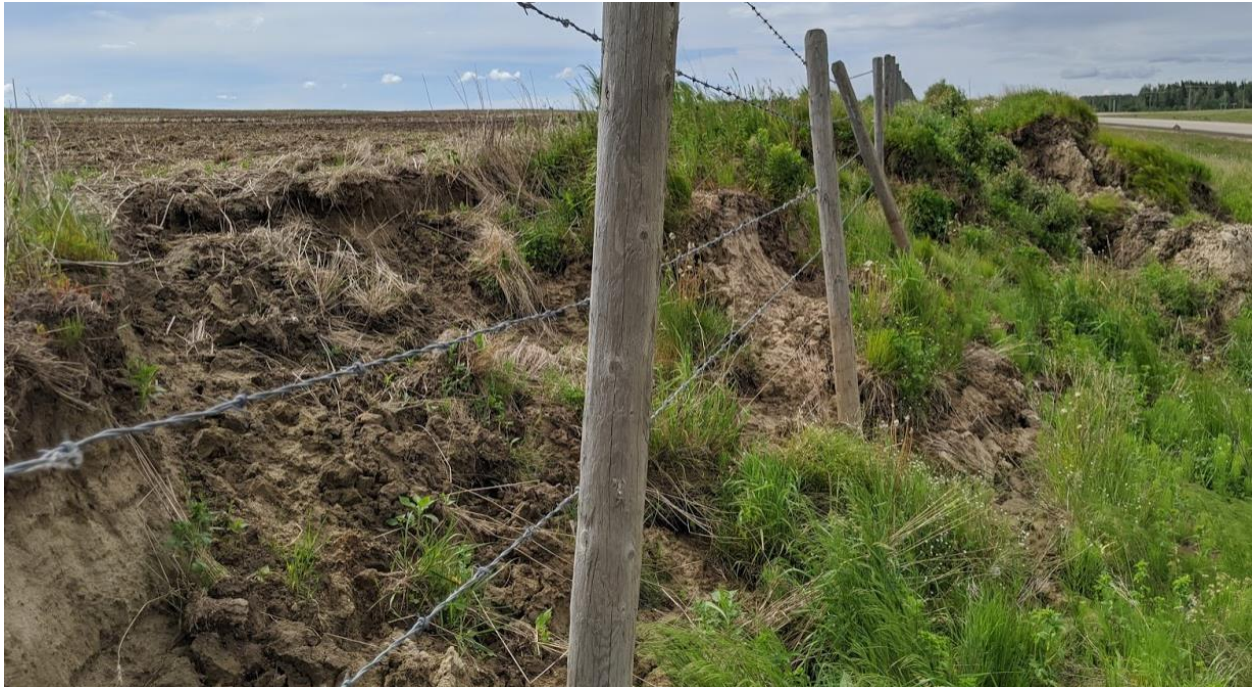
Photo No. 4 - NC091-1: Looking south at the head scarp crack from central portion of slide

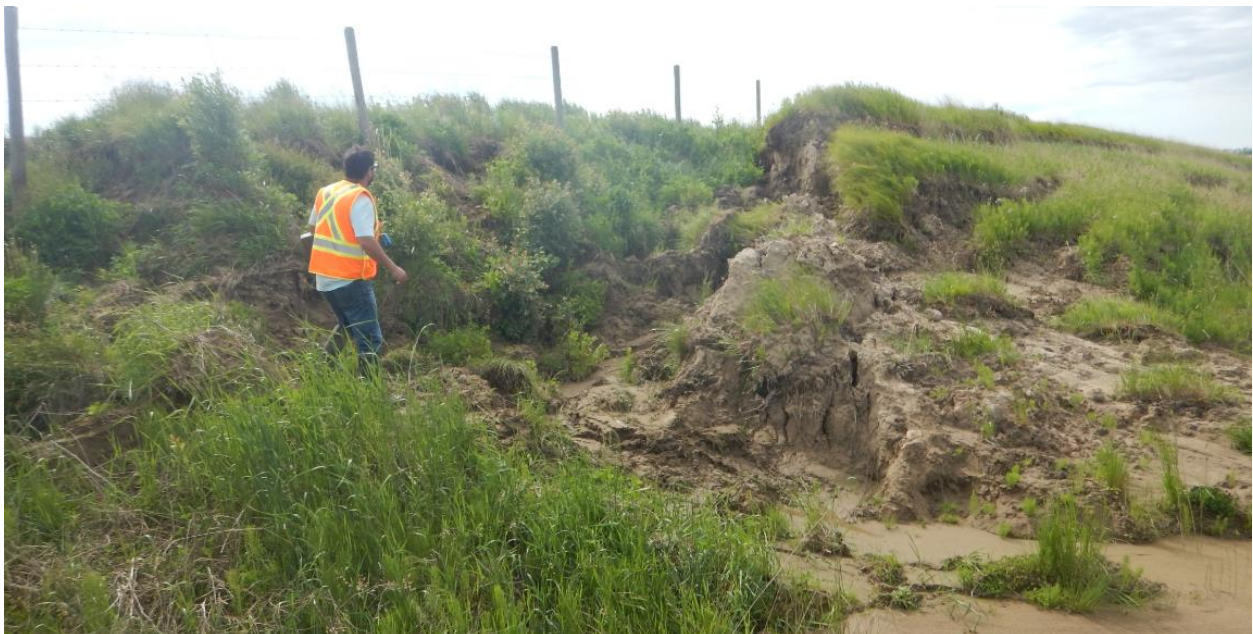
Photo No. 5 - NC091-1: Looking southeast at exposed sandy soils of backslope.

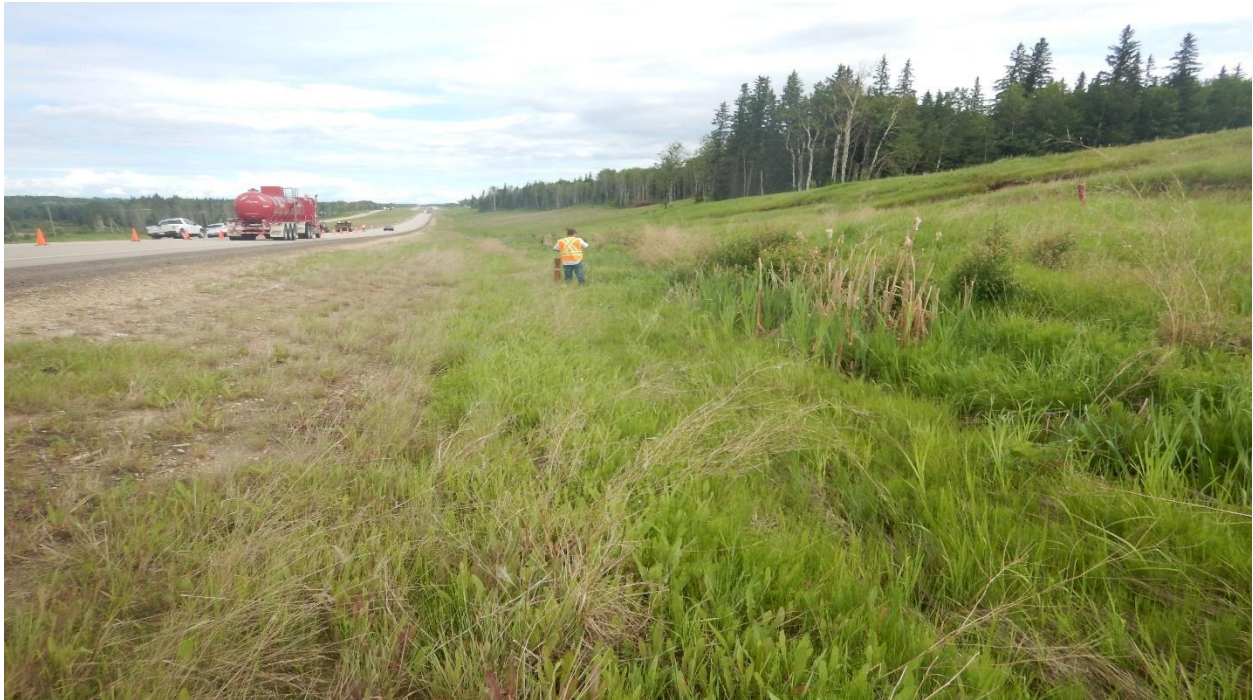
Photo No. 6 – NC091-1: Looking north at a distinct toe roll in the ditch

<p>Recommendations:</p> <p><u>Short-Term</u></p> <p>The owners of the land parcels located near the top of the backslope at both slump locations should be advised of the risk that exists at these locations.</p> <p>The local MCI should consider the following:</p> <p>(a) undertake slight grading of the highway ditch at the slump locations, as needed, to promote surface drainage. Excavated material from the ditch should be pushed back against the toe of the</p>

slope. Excessive removal of landslide debris from the toe of the slope could result in accelerated movement, and

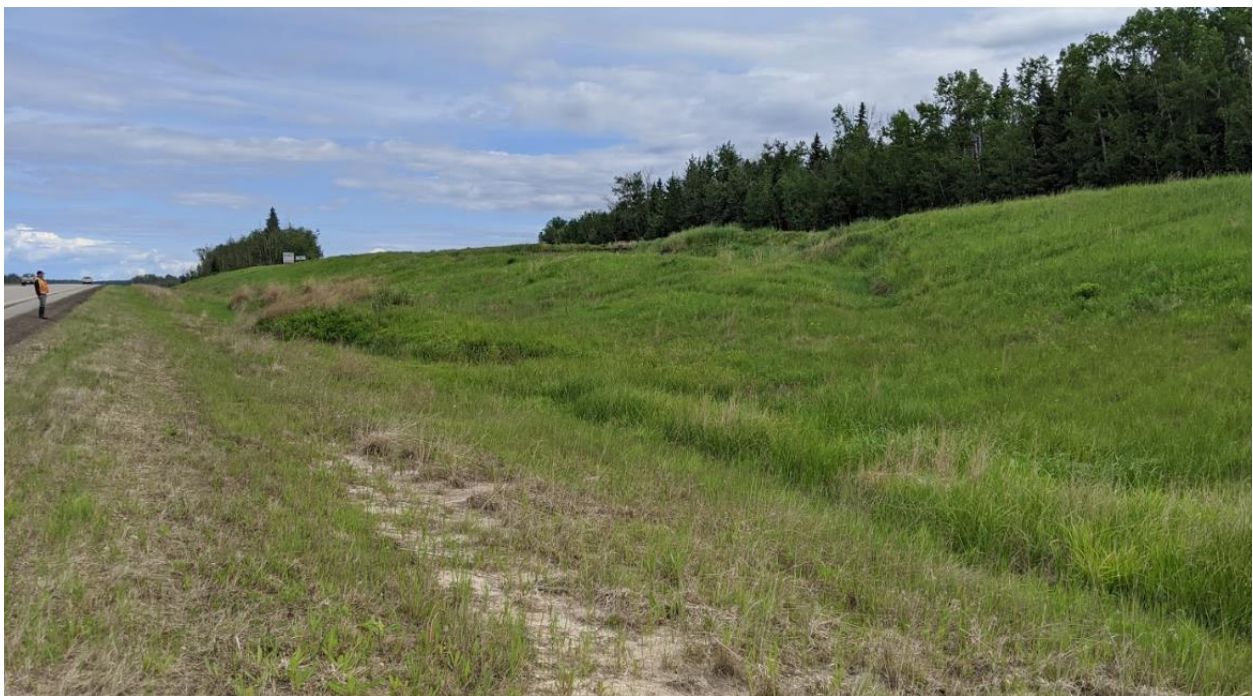
Photo No. 7 – NC091-2: Looking north at the landslide mass; note the presence of a distinct toe roll in the ditch

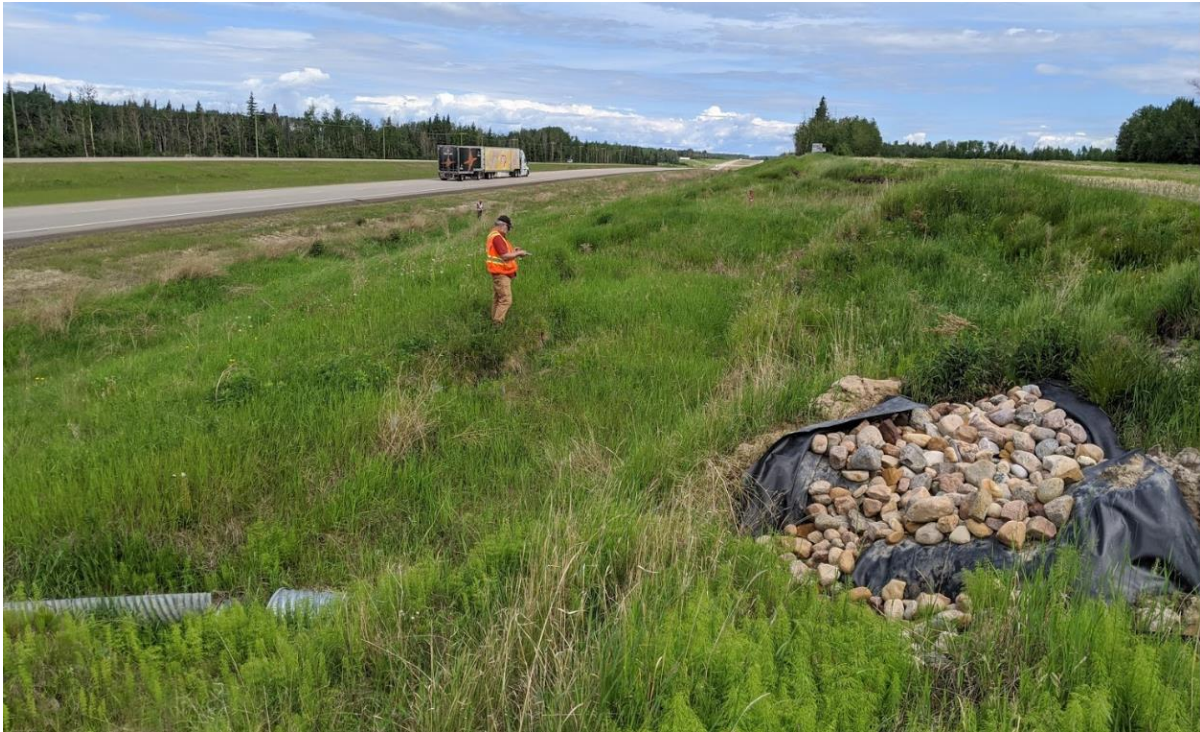
Photo No. 7 a– NC091-2: Looking north from the culvert riprap apron at the top of the slope.

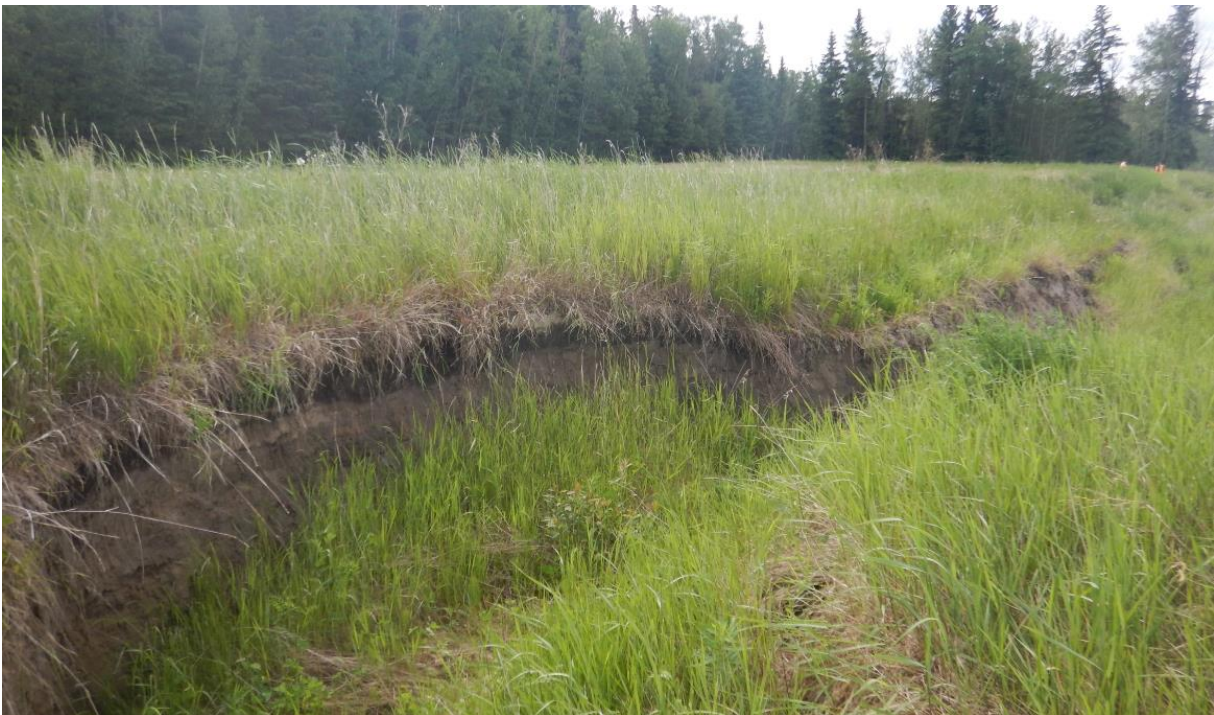
Photo No. 8 – NC091-2: Exposed sandy soils at main scarp.

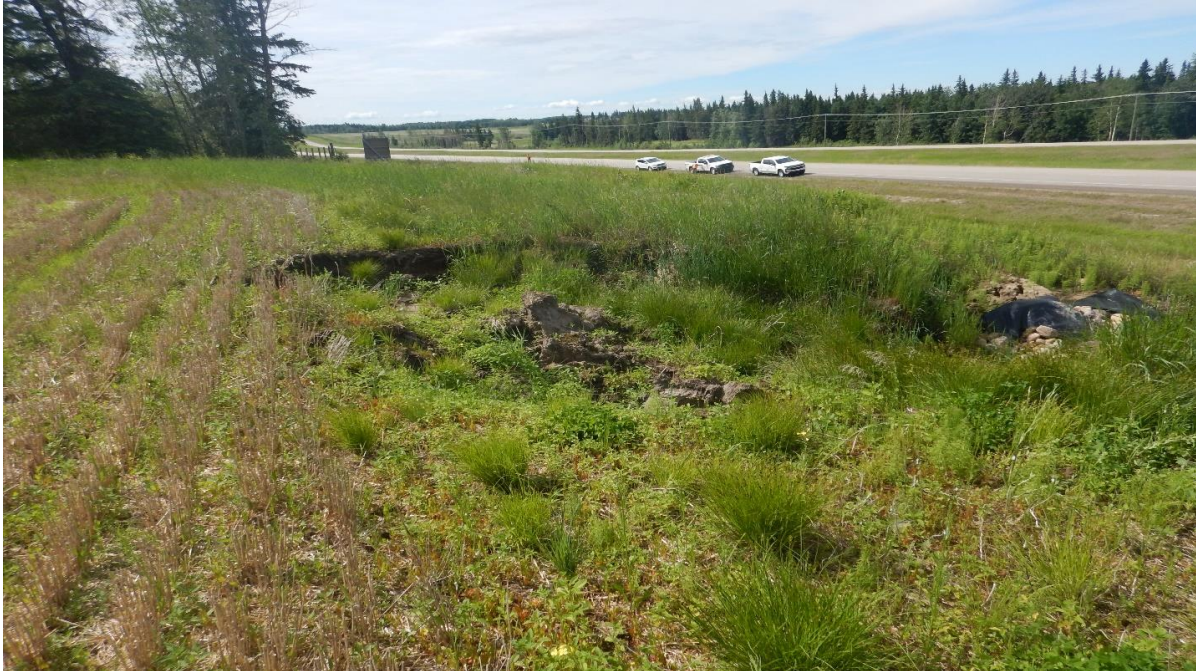
<input checked="" type="checkbox"/> Other	NC091-2: Severe erosion around the half pipe and the riprap apron; erosion extended to the south of the catch water ditch into private land; half pipe got completely separated from culvert near the top of the slope	<input checked="" type="checkbox"/>
<p>Instrumentation (4SIs and 6PNs):</p> <p>Two slope inclinometers were installed in February 2018 at each site. At site NC091-1: SI18-1 was installed near the toe roll and SI18-2 near the crest of the slide. SI18-2 was sheared off at about 3.0 m depth below ground surface a few months after installation. SI18-1 has a current rate of movement of 4 mm/yr at 1.4 m depth and the change in movement since the previous readings in Spring 2019 is 7.4 mm/yr. At site NC091-2: SI18-3 was installed near the toe roll and SI18-4 near the crest of the slide. SI18-4 was sheared off at about 2.5 m below the top of casing a few months after installation. SI18-3 was damaged, likely by a lawnmower, and has not been read since the spring of 2019.</p> <p>At NC091-1: Groundwater levels ranged between 2.5 m at PN18-2A (near surface clay), 8.4 m at PN18-2B (soils underlying clay), and 9.8 m at PN18-1. The water levels decreased since the previous readings by 1.5 m, 1.37m and 0.02 m in PN18-1, PN18-2A, and PN18-2B, respectively. At NC091-2: Groundwater levels ranged between 2.3 m at PN18-4A (near surface clay) to 12.7 m at PN18-4B (soils underlying clay). The water levels decreased since the previous readings by 0.22 m and 0.1 m in PN18-4A, and PN18-4B, respectively.</p>

Photo No. 9 – NC091-2: Looking south at erosion developed within the crest of the slope at the riprap apron location

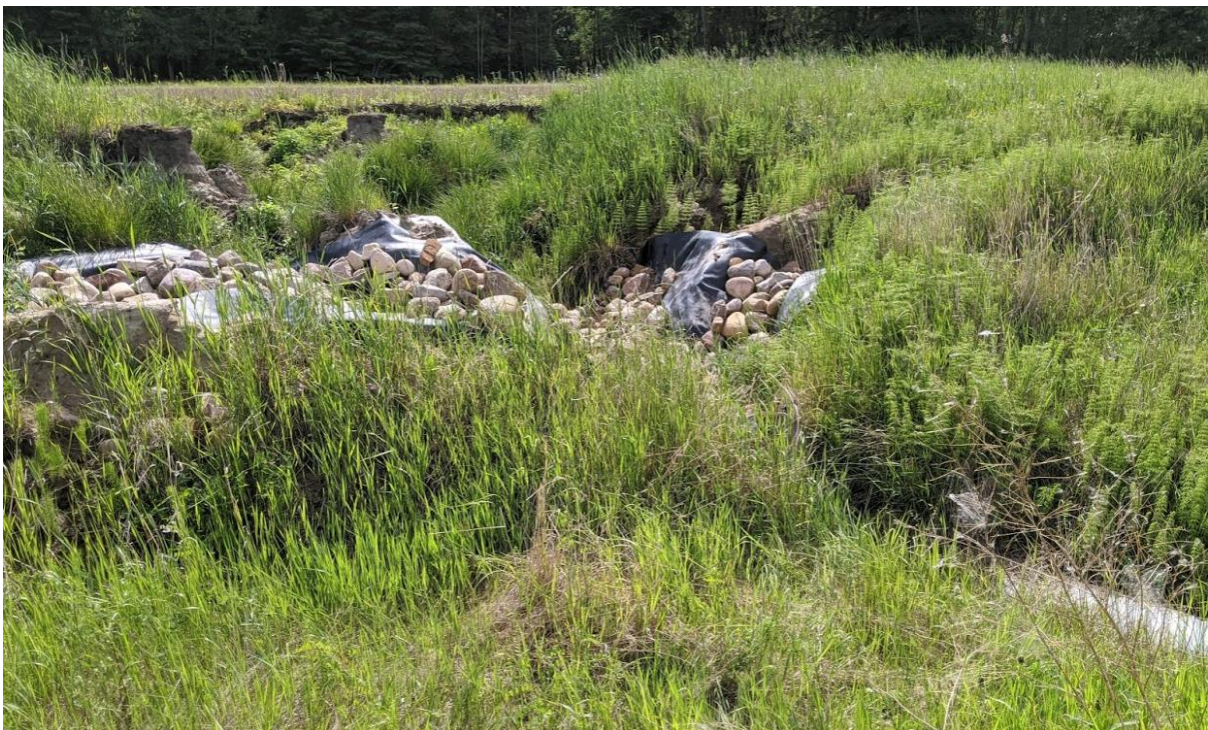
Photo No. 10 – NC091-2: Looking east at scarp through the riprap apron and into the adjacent field (south scarp).

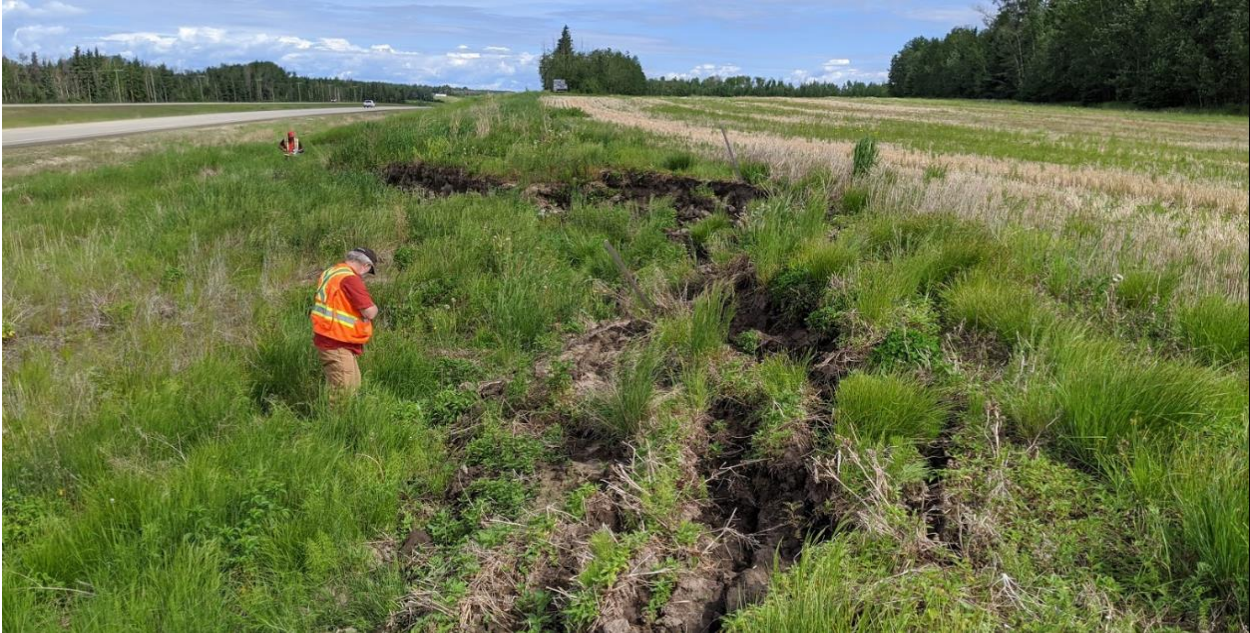
Photo No. 11 – NC091-2: The second portion of the scarp that cuts into the adjacent field (north portion).

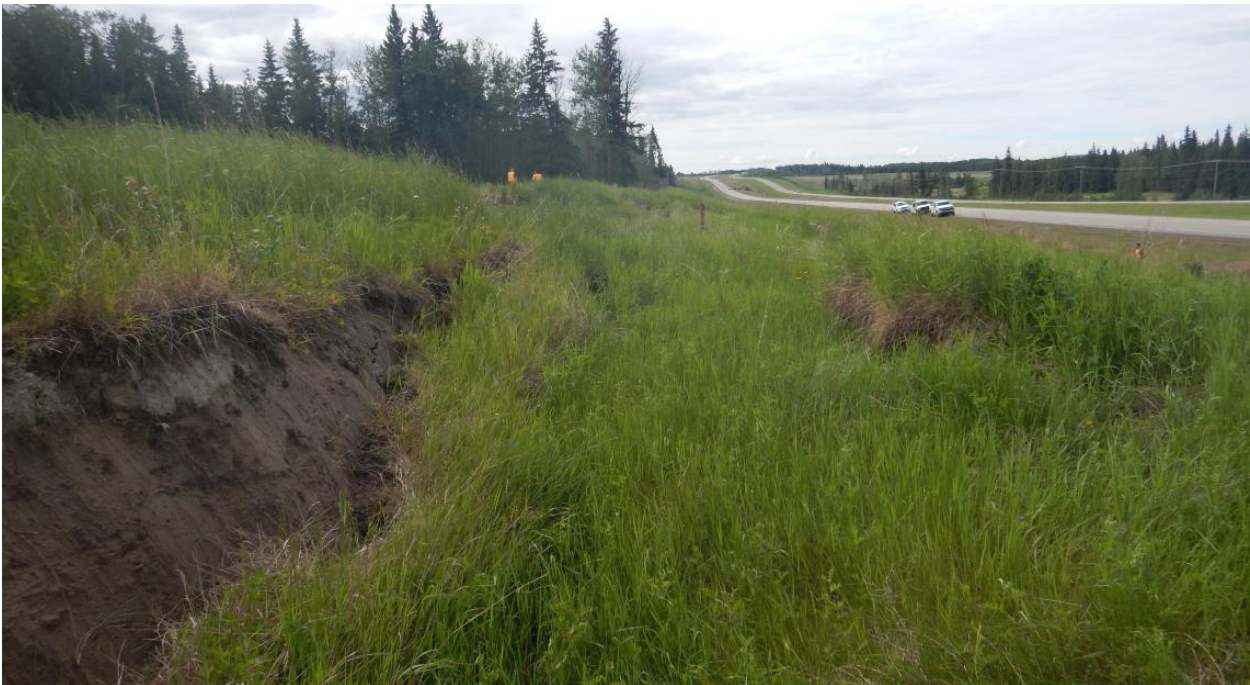
Photo No. 12 – NC091-2: Looking south from north portion at the graben block below the main scarp.
