**ALBERTA TRANSPORTATION  
GEOHAZARD ASSESSMENT PROGRAM  
NORTH CENTRAL REGION – ATHABASCA &  
FORT MCMURRAY DISTRICTS  
2022 SITE INSPECTION**

Site Number	Location	Name	Hwy	km
NC091-1 NC091-2	NBL - 5 to 6 Km south of Wandering River	<b>HWY 63-02 BACKSLOPE SLUMPS</b>	63:02	39.27 and 40.28
<b>Legal Description</b>		<b>UTM Co-ordinates (NAD 83)</b>		
NC091-1: 6 km south of Wandering River		NC091-1 N6113146.92	E405688.87	
NC091-2: 5 km south of Wandering River		NC091-2 N6112146.20	E405659.10

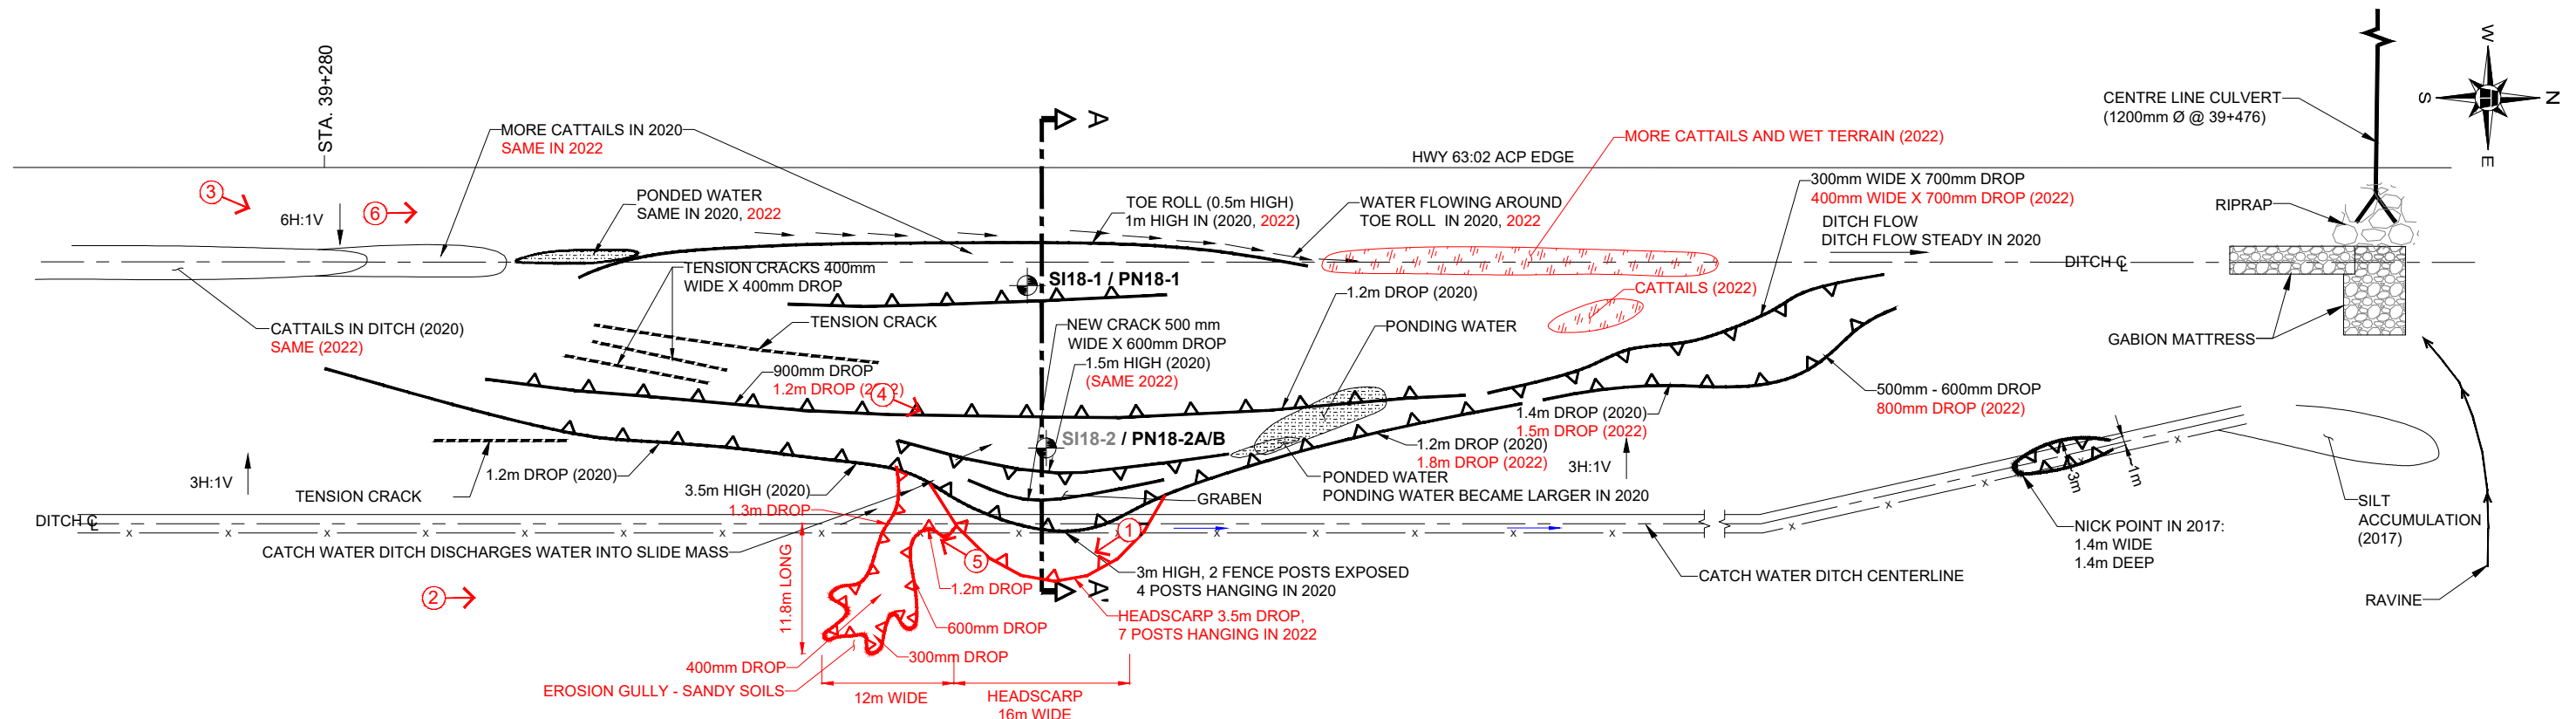
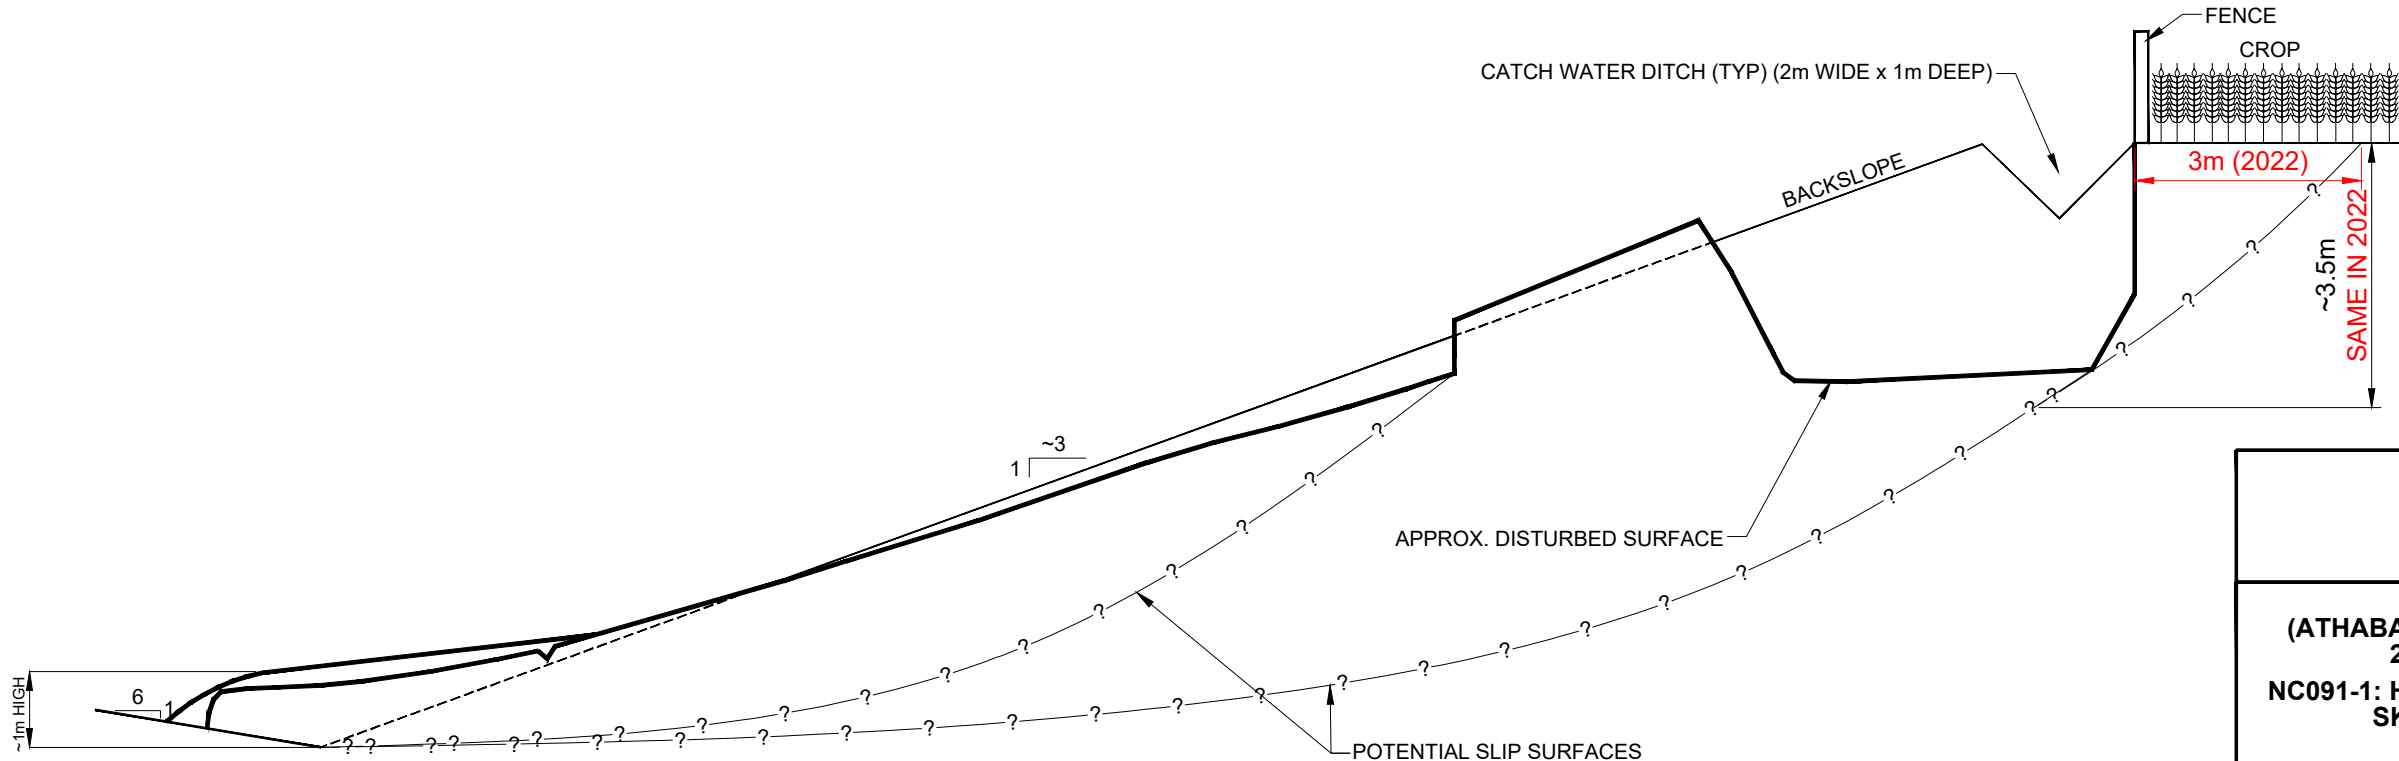
**FIGURE 1**

**NORTH CENTRAL REGION  
(ATHABASCA AND FORT MCMURRAY DISTRICTS)  
2022 GEOHAZARD ASSESSMENT  
NC091-1: HWY 63:02 KM 39.35 - BACKSLOPE SLUMP  
SKETCH SHOWING SITE FEATURES**

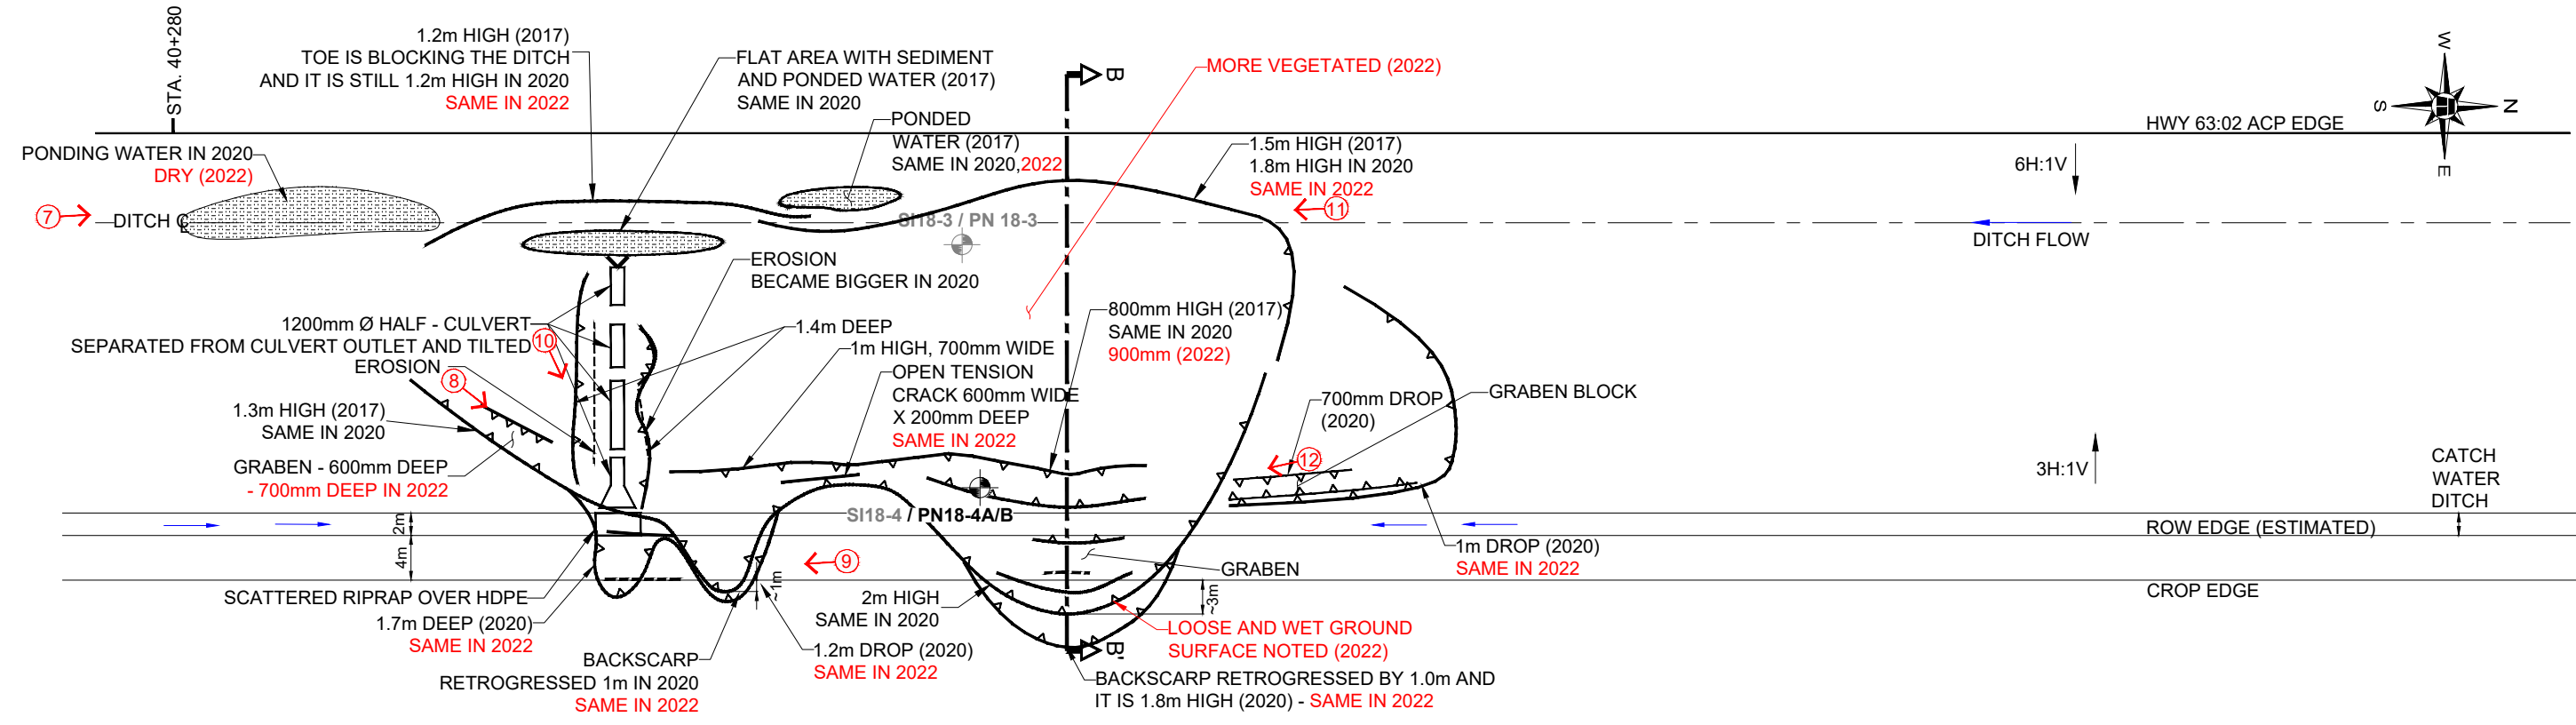
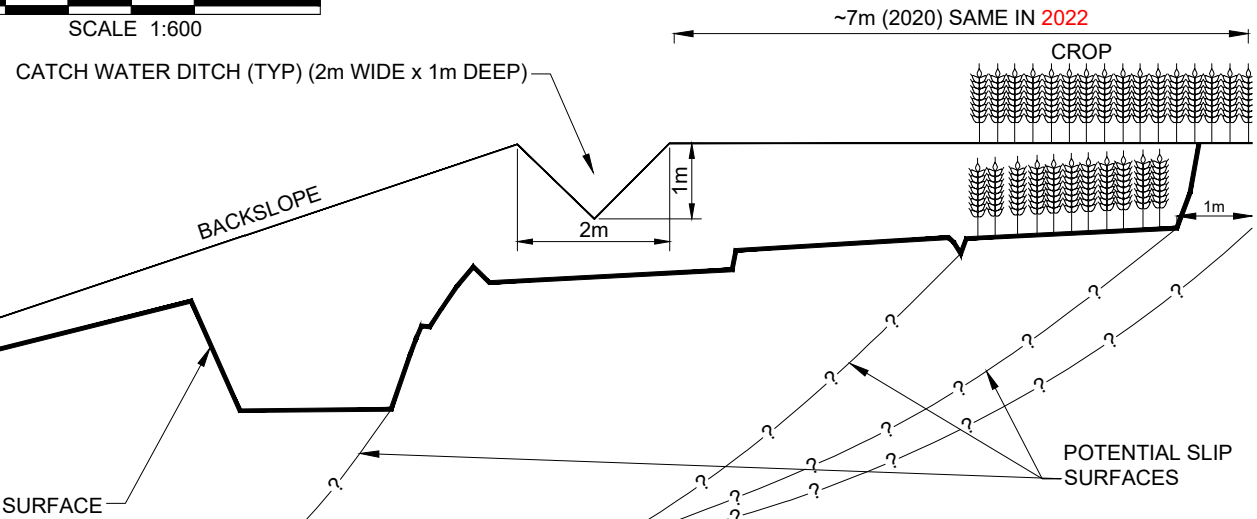
**FIGURE 2**

**NC091-2: HWY 63:02 KM 40.37 - BACKSLOPE SLUMP  
SKETCH SHOWING SITE FEATURES**

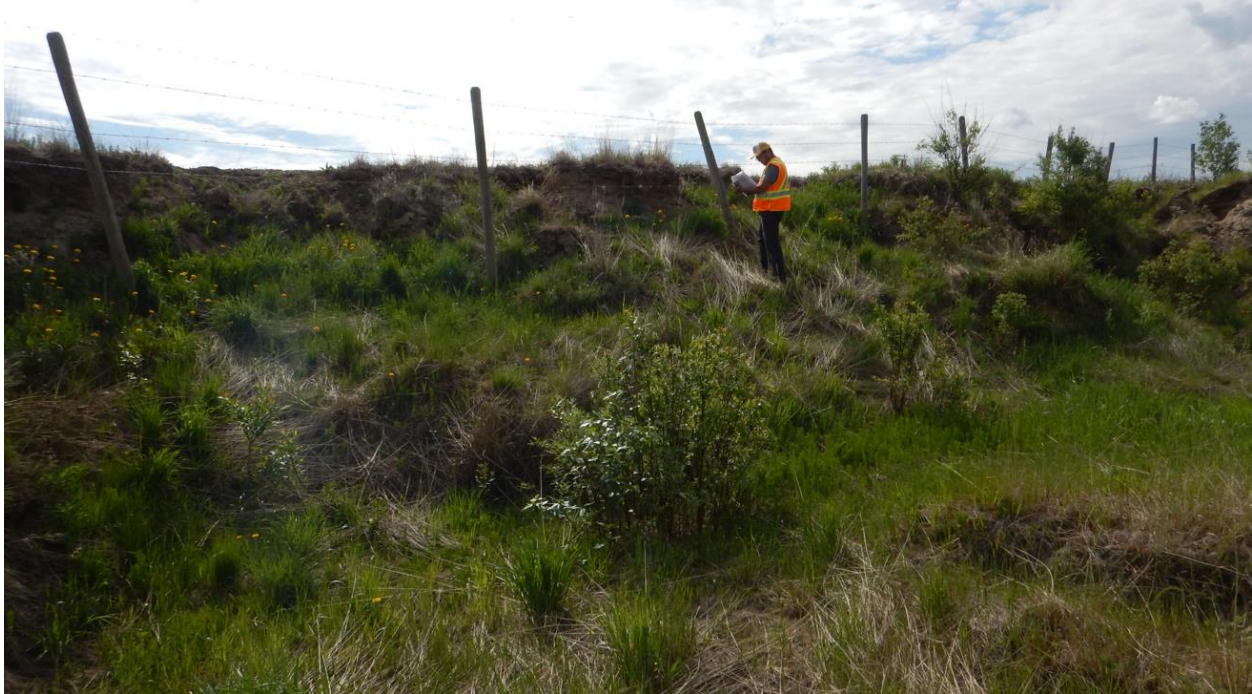
It is anticipated that both slumps will continue to be active and retrogress to cause further loss of private lands. Future prolonged heavy rainfall events are anticipated to increase groundwater levels in the landslides resulting in accelerated movements. In addition, the existing catch water ditches near the crest of both landslides have been impacted by the landslides and water is being discharged into both landslide masses. Surface water discharge into the landslide mass at both sites will continue to elevate groundwater levels in the slopes.

Photo No. 1- NC091-1: Looking southeast where the landslide cuts through catch water ditch; catch water ditch discharges water into the landslide mass

At both sites, the catch water ditch will need to be reconstructed using low to medium plastic clay, realigned to be a few meters away from the top of the slope in the vicinity of the landslides, and lined with an impervious barrier to prevent further erosion and saturation of the slopes. At NC091-2, it is possible to re-grade the catch water ditch to drain towards a centerline culvert located south of the site at approximate km 40.090. During construction, the catch water ditch flow will need to be temporarily diverted away from the slope repair area.

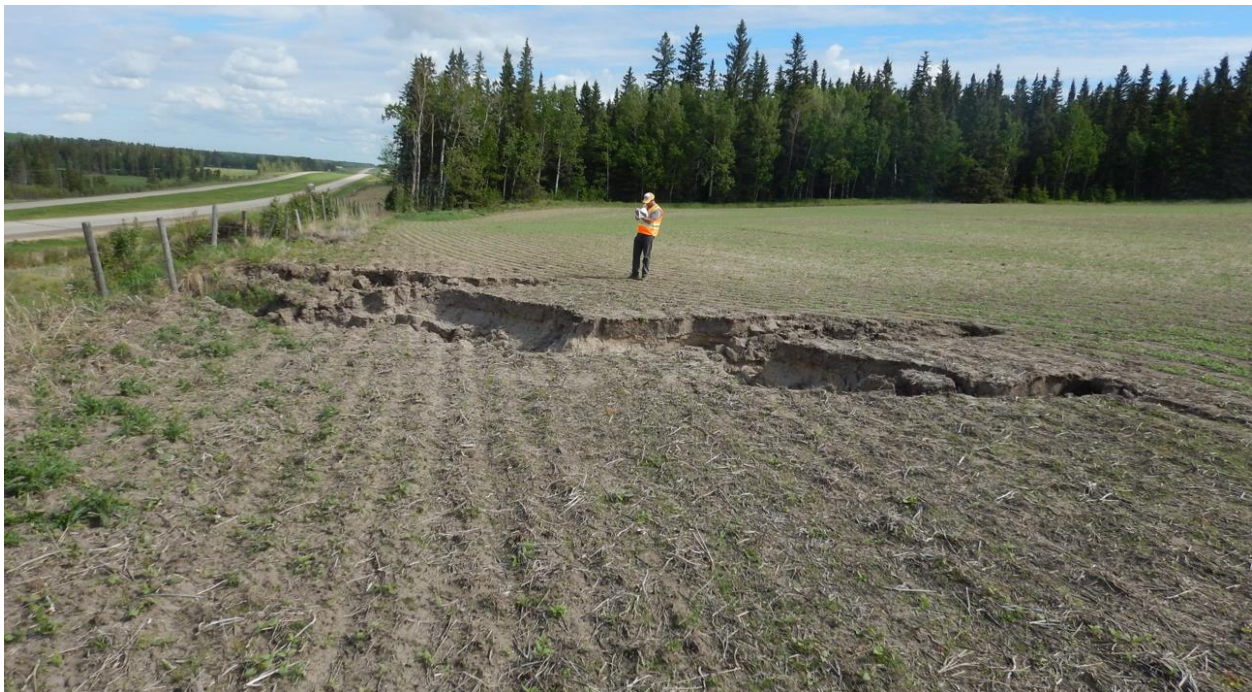
<input checked="" type="checkbox"/> Other	<p><b>NC091-1:</b> A severe erosion gully developed within the farmer's field; the gully is about 12 m long x 12 m wide with 1.3 m drop at the deepest location.</p> <p><b>NC091-2:</b> Severe erosion around the half pipe and the riprap apron; erosion extended to the south of the catch water ditch into private land; half pipe got completely separated from culvert near the top of the slope; landslide mass became more vegetated than observed in 2020.</p>	<input checked="" type="checkbox"/>
---	--	-------------------------------------

The presence of open wide cracks and erosion gullies within the private properties is a safety concern.

Photo No. 2- NC091-1: Looking north at a 12 m long erosion gully developed within the farmer's field; note the presence of sandy soils within the exposed surfaces of the gully walls

(c) place a snow fence around areas impacted by the landslide within the private lands or backfill these areas to eliminate existing hazard. However, this can only take place after consultation with the landowner(s).

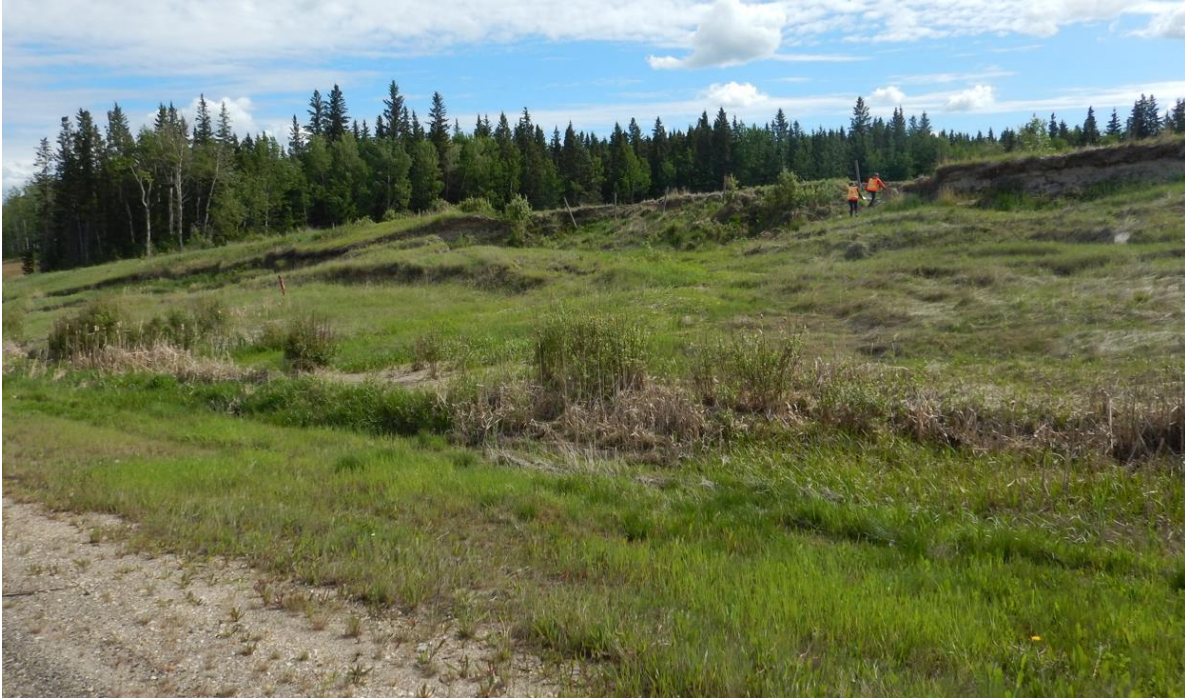
Photo No. 3- NC091-1: Looking northeast at the landslide mass; note the presence of multiple tension cracks in the slope and cattails in the highway ditch

(b) seal open cracks in the slope surface to reduce surface water infiltration into the slide mass. A small track mounted equipment could be used to smoothen the slope surface and fill in any dips without causing significant changes in grade,

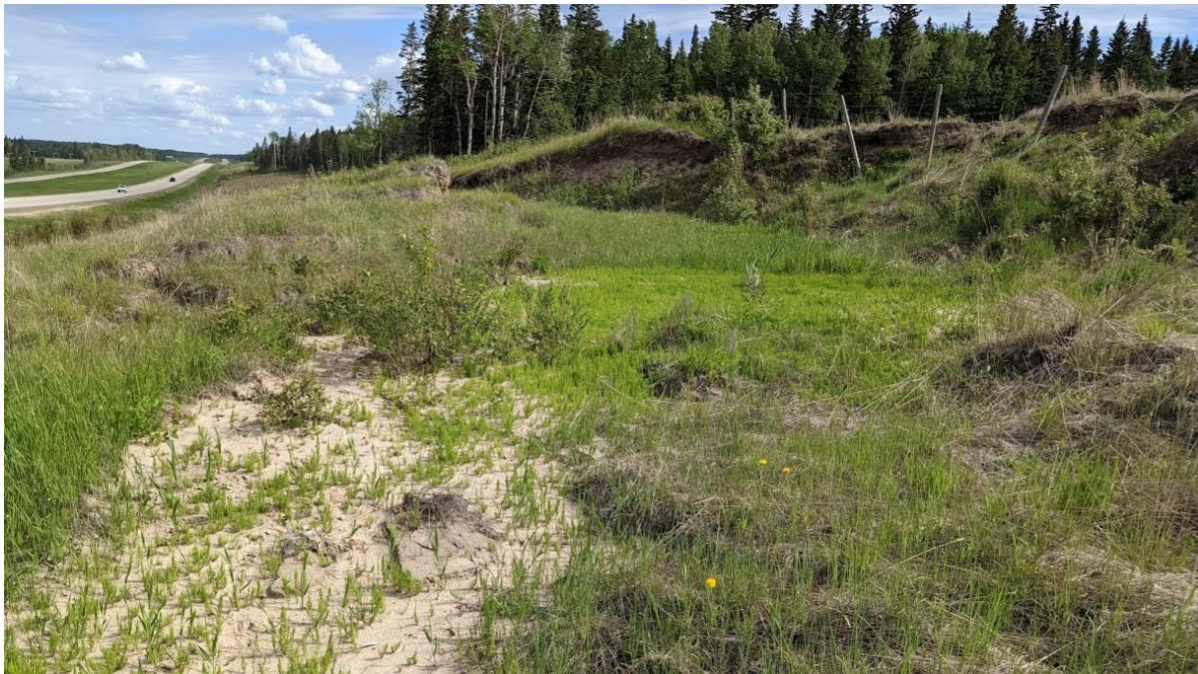
Photo No.4 - NC091-1: Looking northeast at the north flank of landslide; 3.5 m deep cracks and seven barbed wire posts hanging in 2022

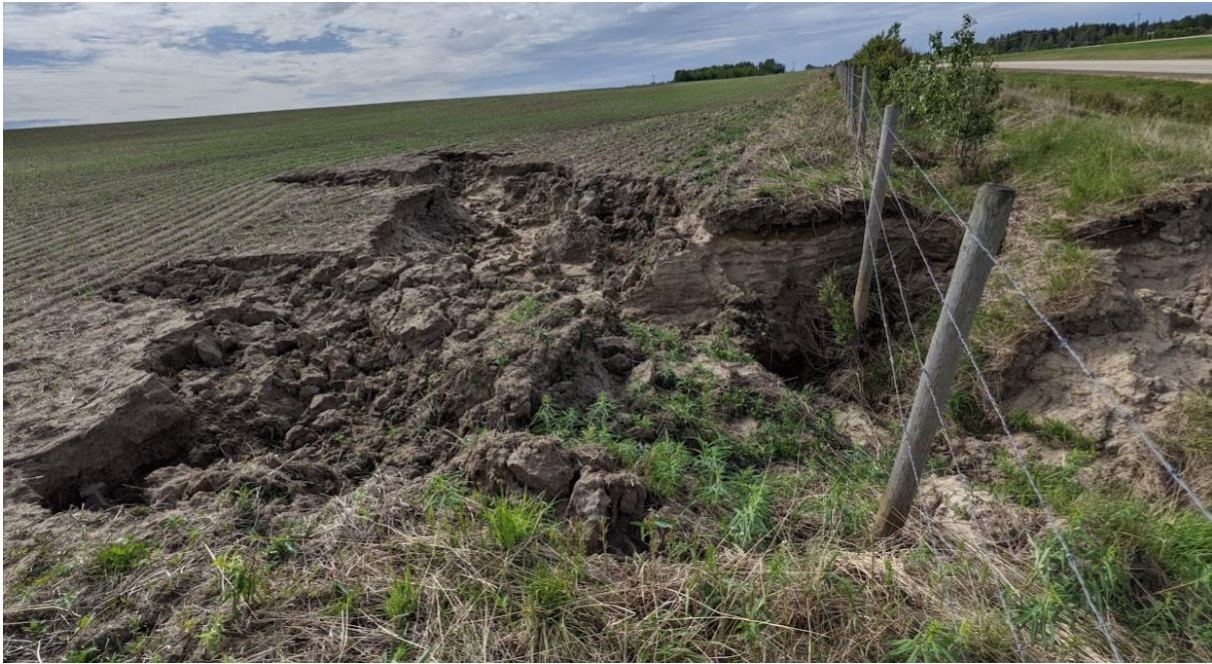
Photo No. 5 - NC091-1: Looking southwest at the head scarp crack and the erosion gully developed within the farmer's field

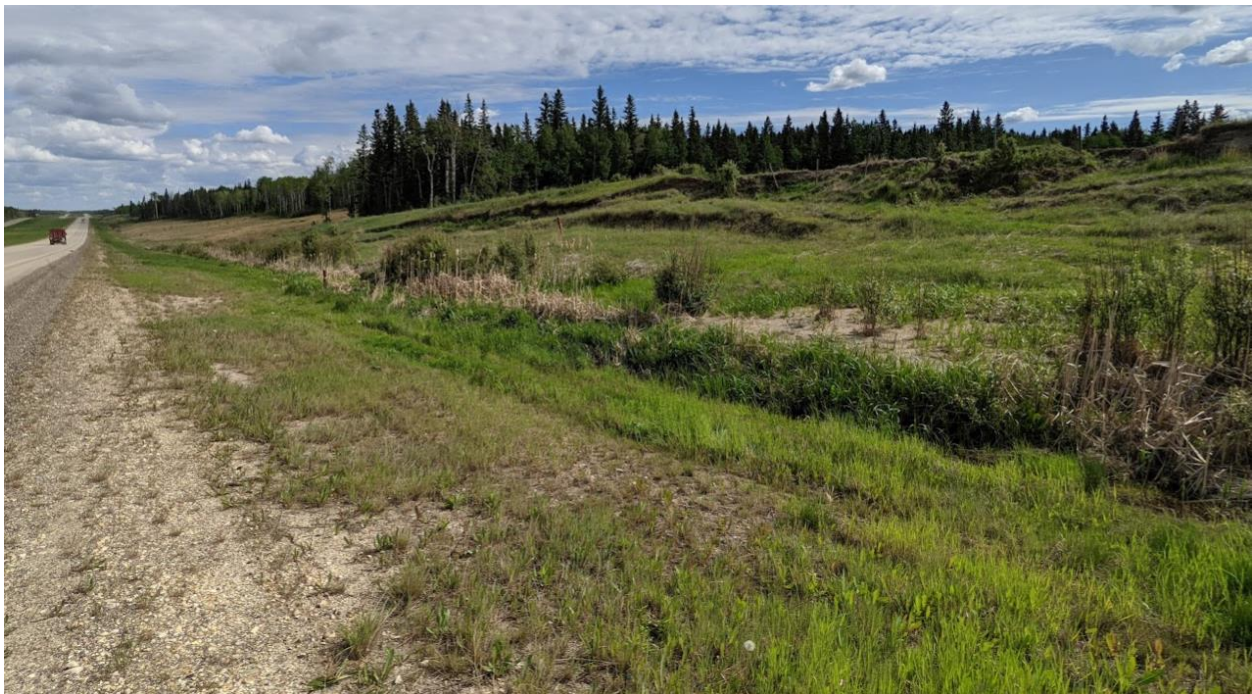
The landslide debris is partially blocking the highway ditch at both locations and hence impeding surface drainage in the highway ditch. This may result in elevated groundwater levels in the highway embankment and potential instabilities in the future.

Photo No. 6 – NC091-1: Looking north at a distinct toe roll in the ditch

(a) undertake slight grading of the highway ditch at the slump locations, as needed, to promote surface drainage. Excavated material from the ditch should be pushed back against the toe of the slope. Excessive removal of landslide debris from the toe of the slope could result in accelerated movement,

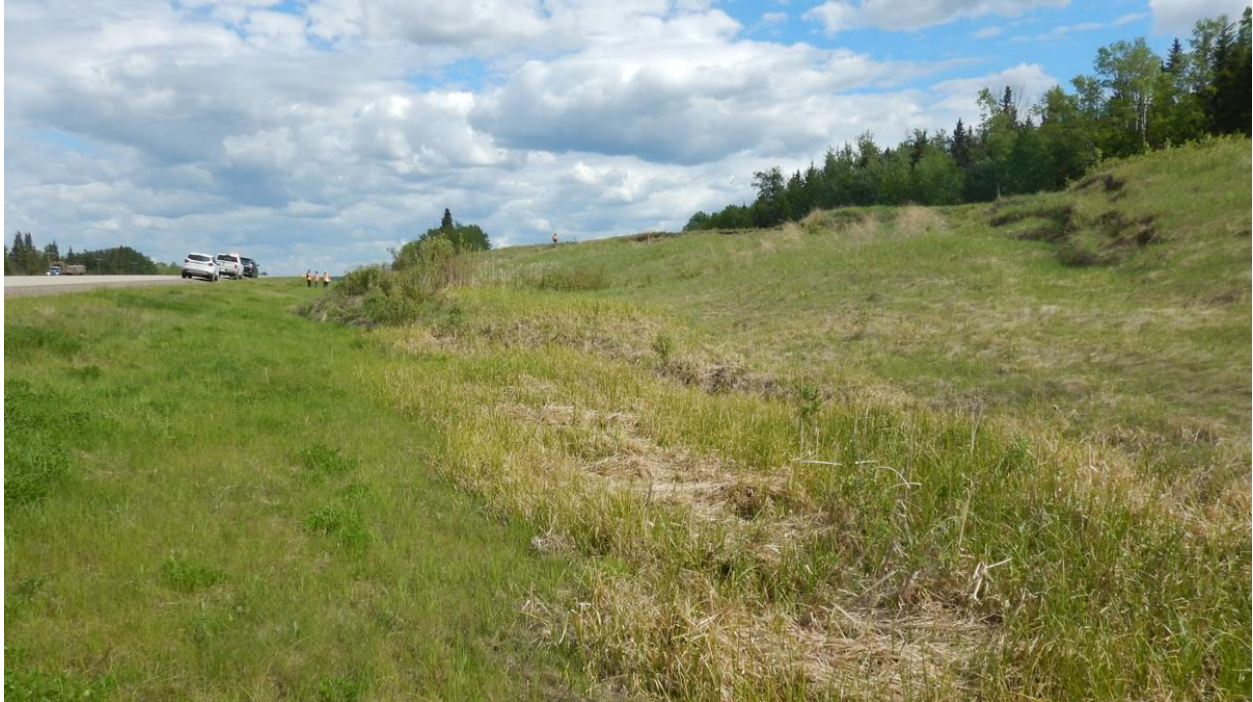
Photo No. 7 – NC091-2: Looking north at the landslide mass; note the presence of a distinct toe roll in the ditch

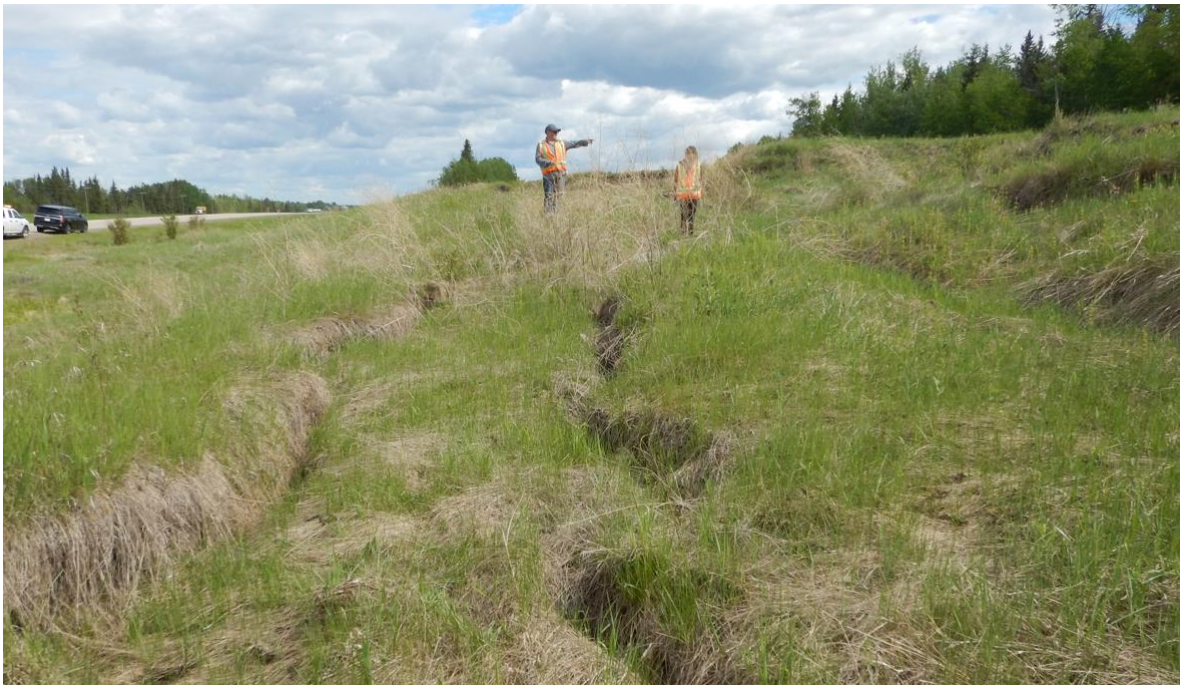
Photo No. 8– NC091-2: Looking northeast at the southern flank of the landslide mass; note the presence of multiple tension cracks within the backslope

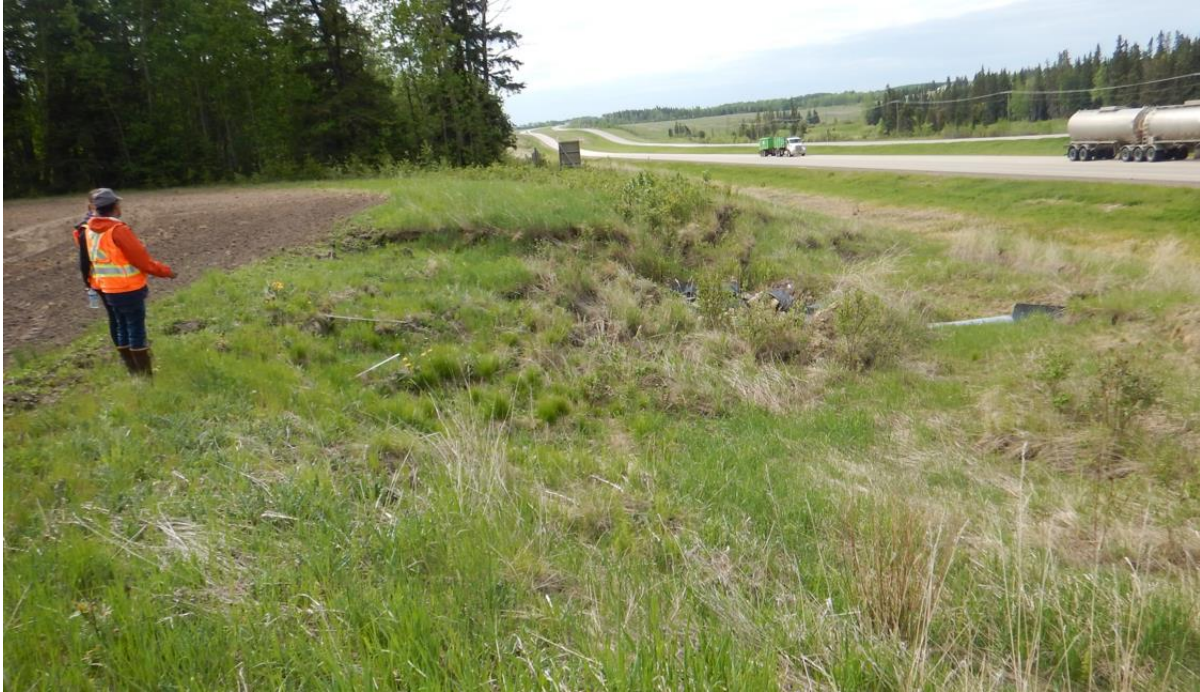
Photo No. 9 – NC091-2: Looking south at scarp crack developed within the crest of the backslope

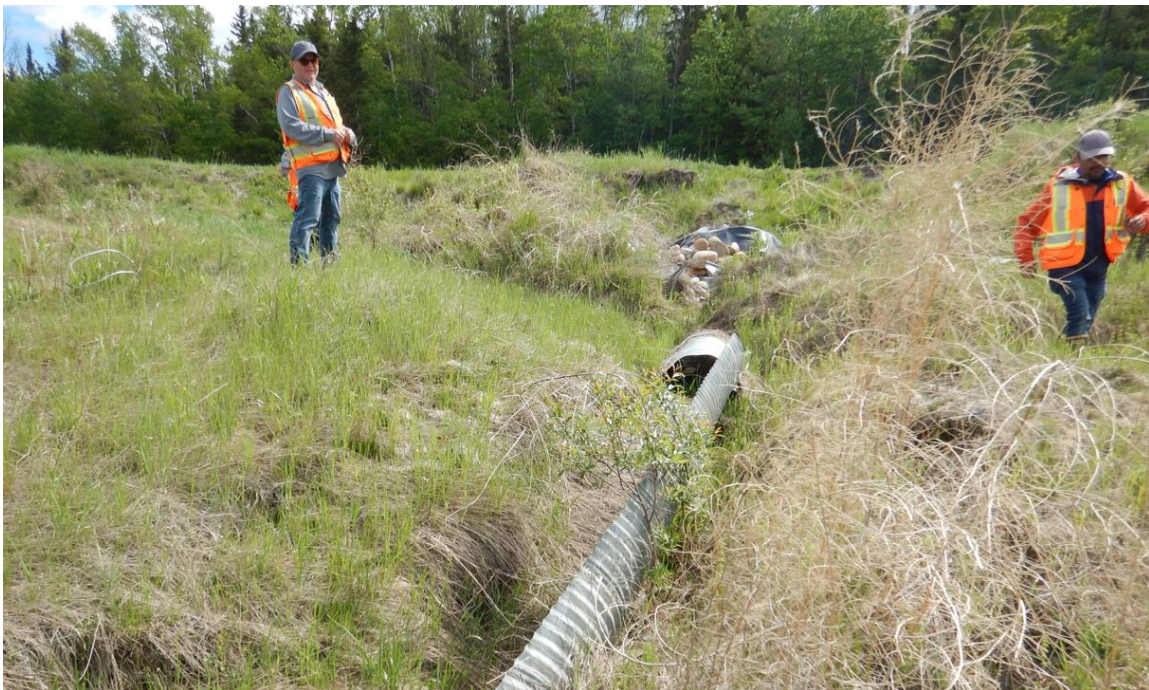
Photo No. 10 – NC091-2: Looking northeast at a scarp crack through the riprap apron and into the adjacent field (south scarp)

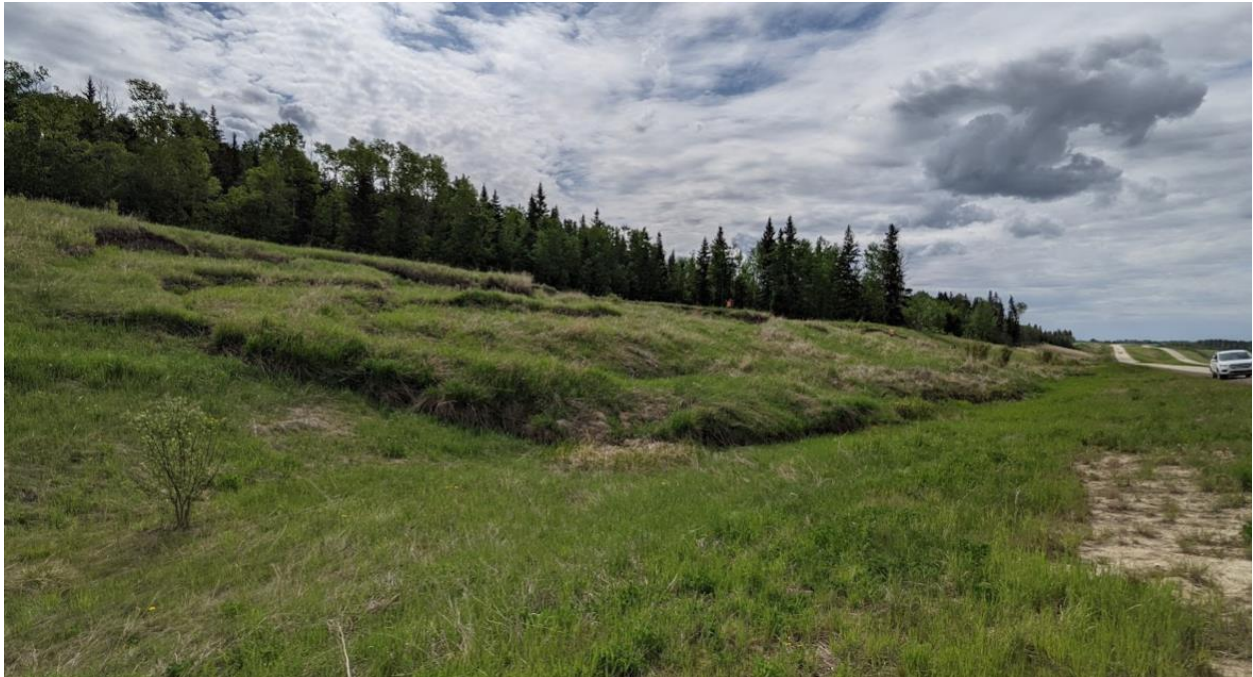
Photo No. 11 – NC091-2: Looking south at landslide features; note the well-defined toe roll at the ditch and the presence of multiple tension cracks within the backslope; landslide appears to be more vegetated than in 2020

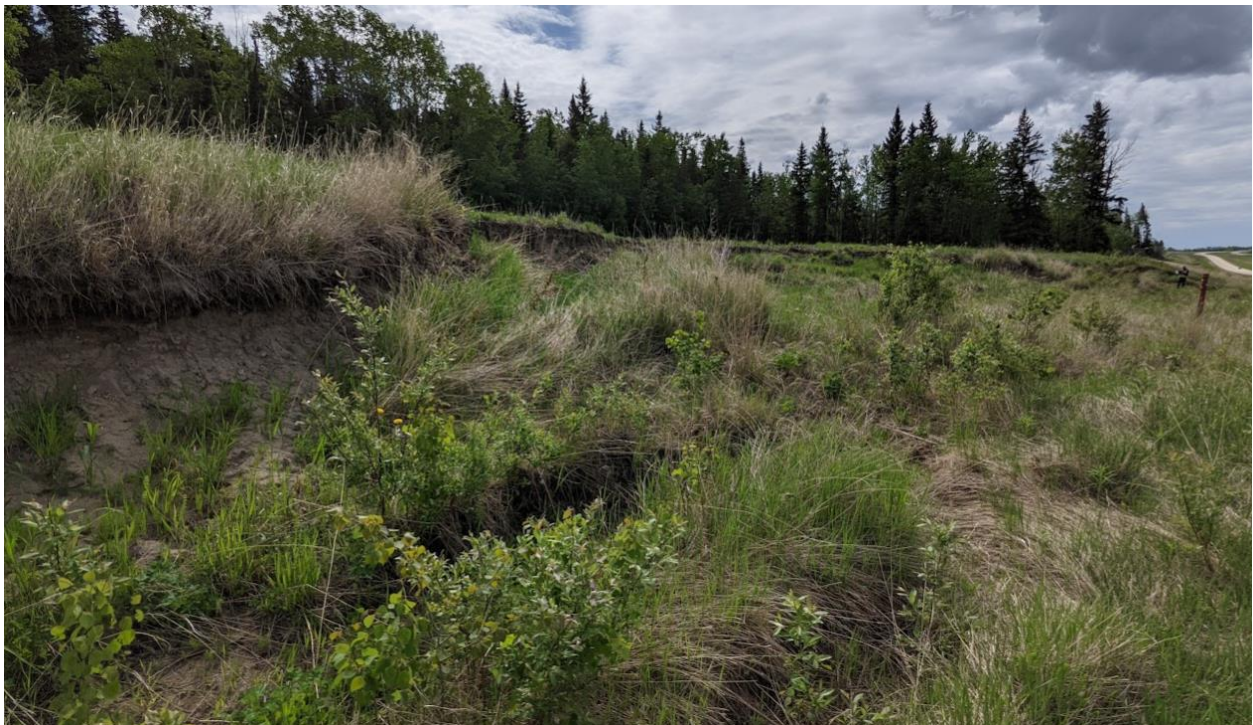
Photo No. 12 – NC091-2: Looking south at the northern flank of the landslide
