**ALBERTA TRANSPORTATION GRMP (CON0022163)  
NORTH CENTRAL (ATHABASCA AND FORT McMURRAY DISTRICTS)  
INSTRUMENTATION MONITORING RESULTS – SPRING 2022**

**SECTION C**

**SITE NC091: HWY 63:02 BACKSLOPE SLUMPS (km 39.35 and 40.37)**

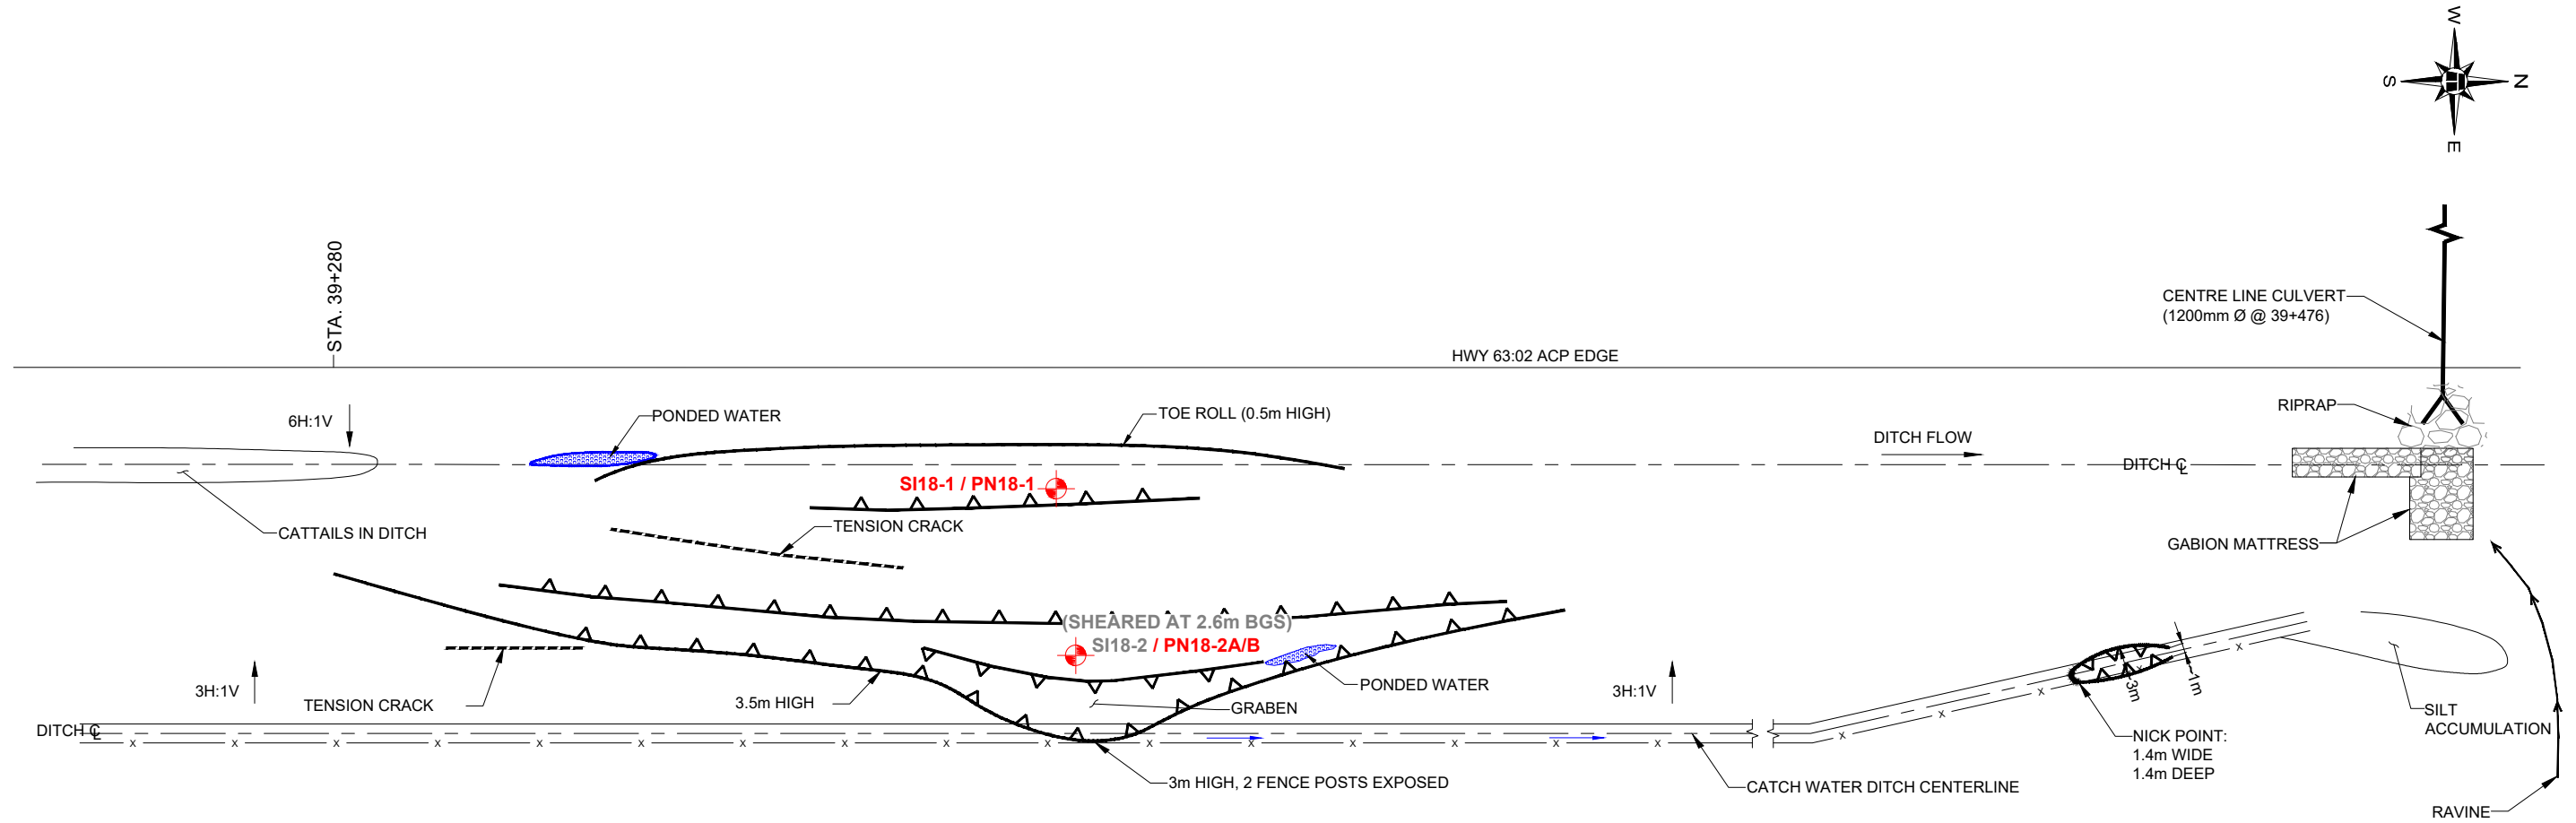
**DWG No. 32122-NC091-1**

**NORTH CENTRAL  
(ATHABASCA AND FORT MCMURRAY DISTRICTS)  
NC091: HWY 63:02 km 39.35 - BACKSLOPE SLUMP  
SITE PLAN SHOWING APPROXIMATE  
INSTRUMENT LOCATIONS**

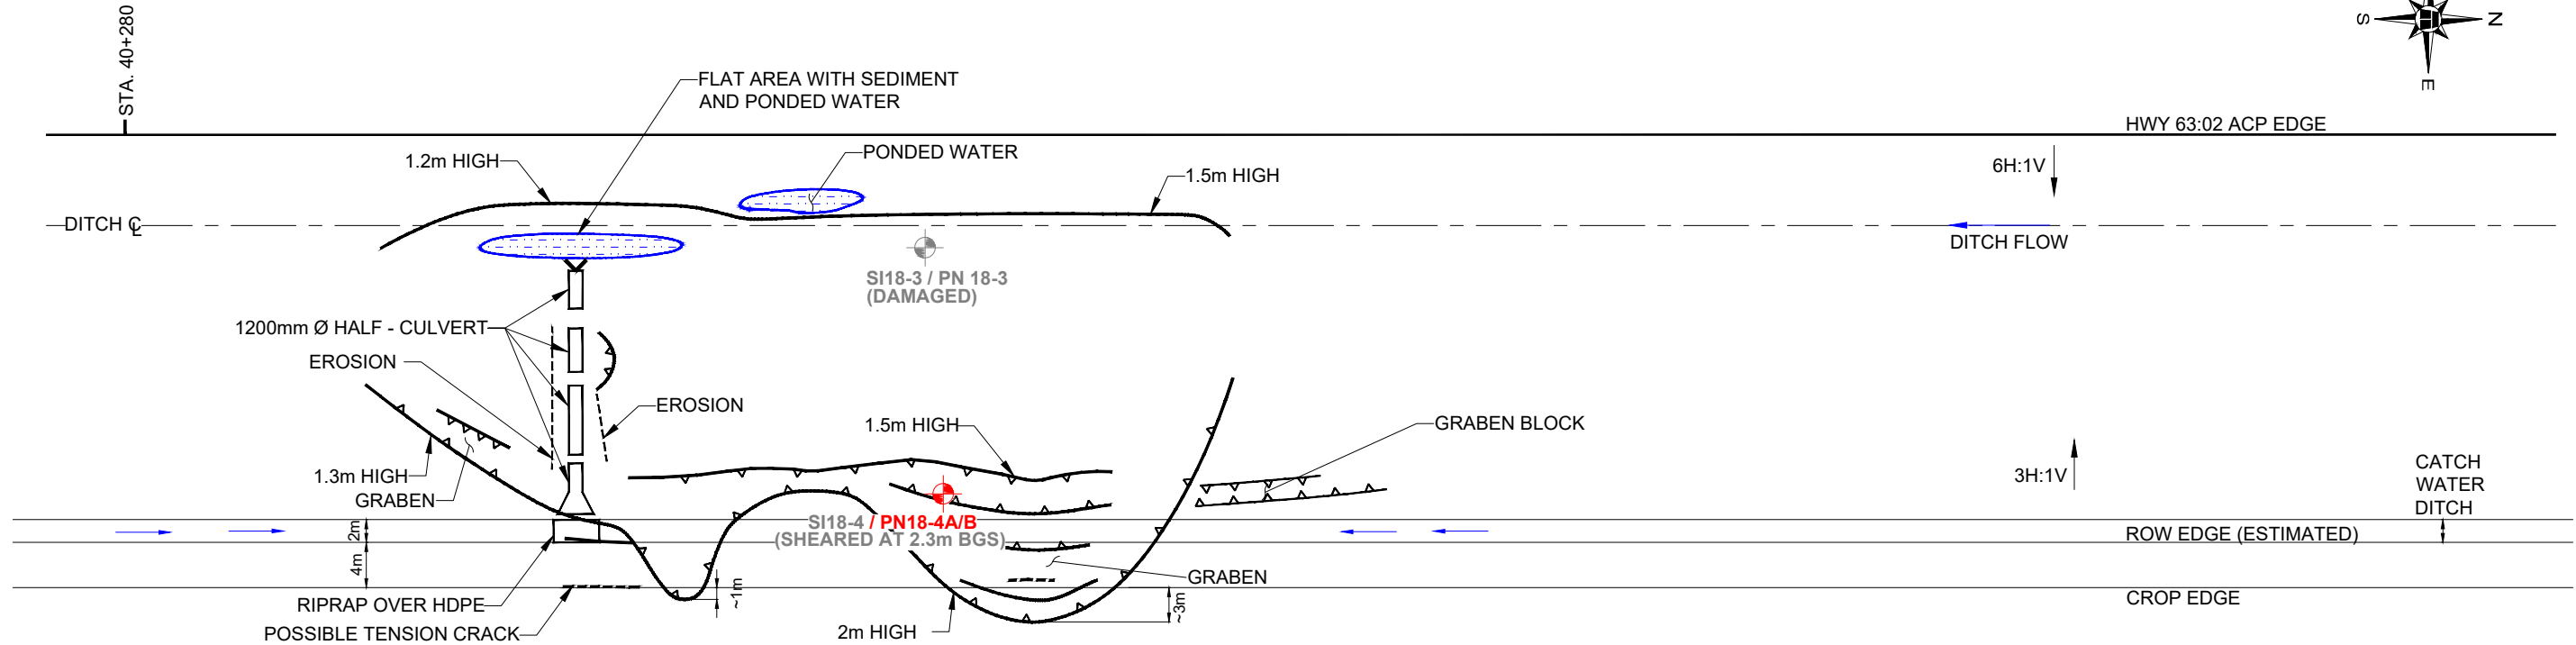
**DWG No. 13357-NC091-2**

SI18-3 broken at surface at 2ft 9" below ground. Need mechanical excavator or hydrovac to repair. Not repairable by hand.
PN 18-2A, Reading keeps fluctuating when bypass is open. Between 40.0 kpa to 50.0 kpa. When bypass closed reading drops down to 1.3 and keeps climbing up. Possibly damaged.
PN 18-3 buried under slide debris.

**NORTH CENTRAL  
(ATHABASCA AND FORT MCMURRAY DISTRICTS)  
NC091: HWY 63:02 km 40.37 - BACKSLOPE SLUMP  
SITE PLAN SHOWING APPROXIMATE  
INSTRUMENT LOCATIONS**

SI18-3 and PN18-3 should be repaired in the spring of 2023 so that readings for these instruments can resume. These instruments are damaged below ground surface and require mechanical or hydrovac excavation to complete the repair.

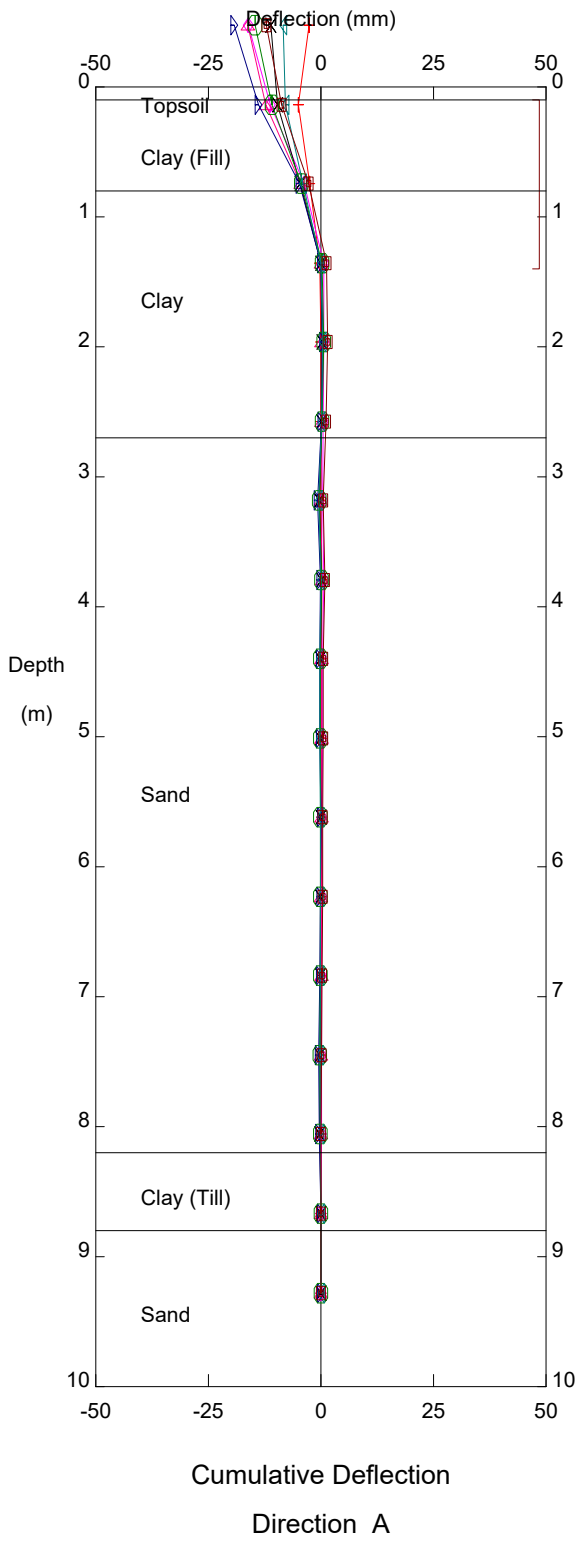
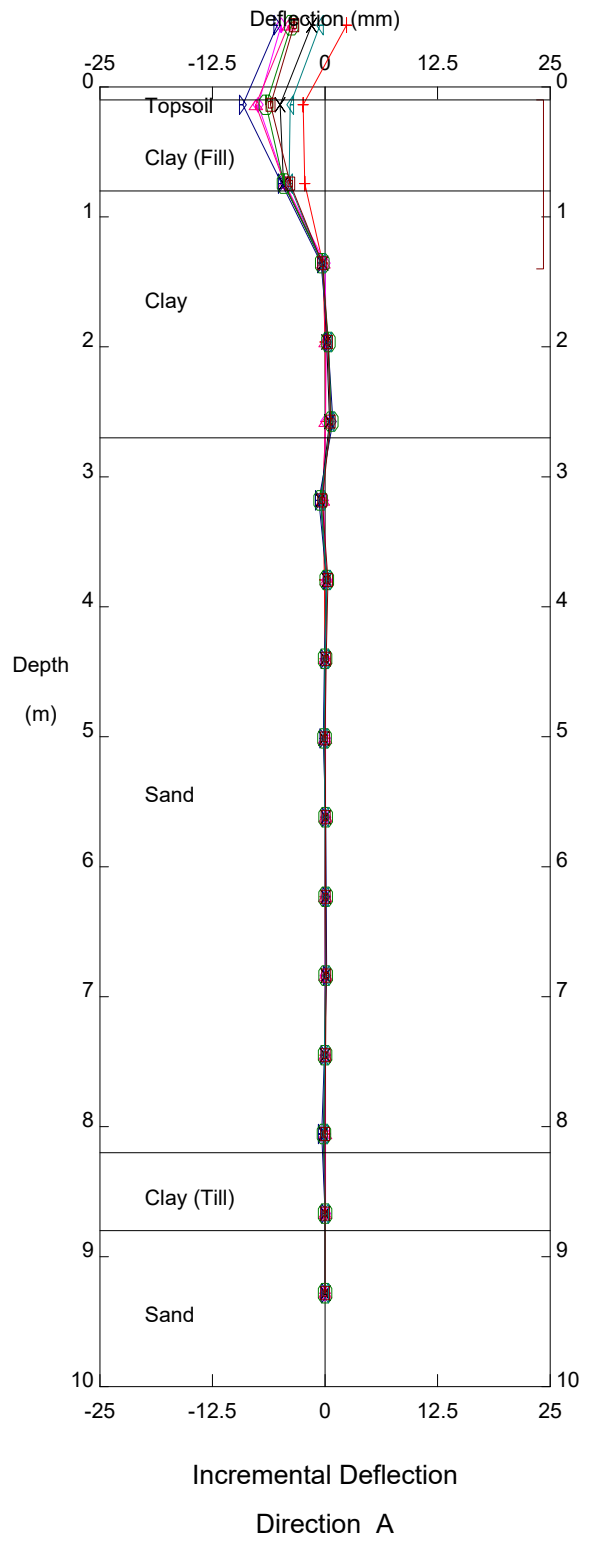
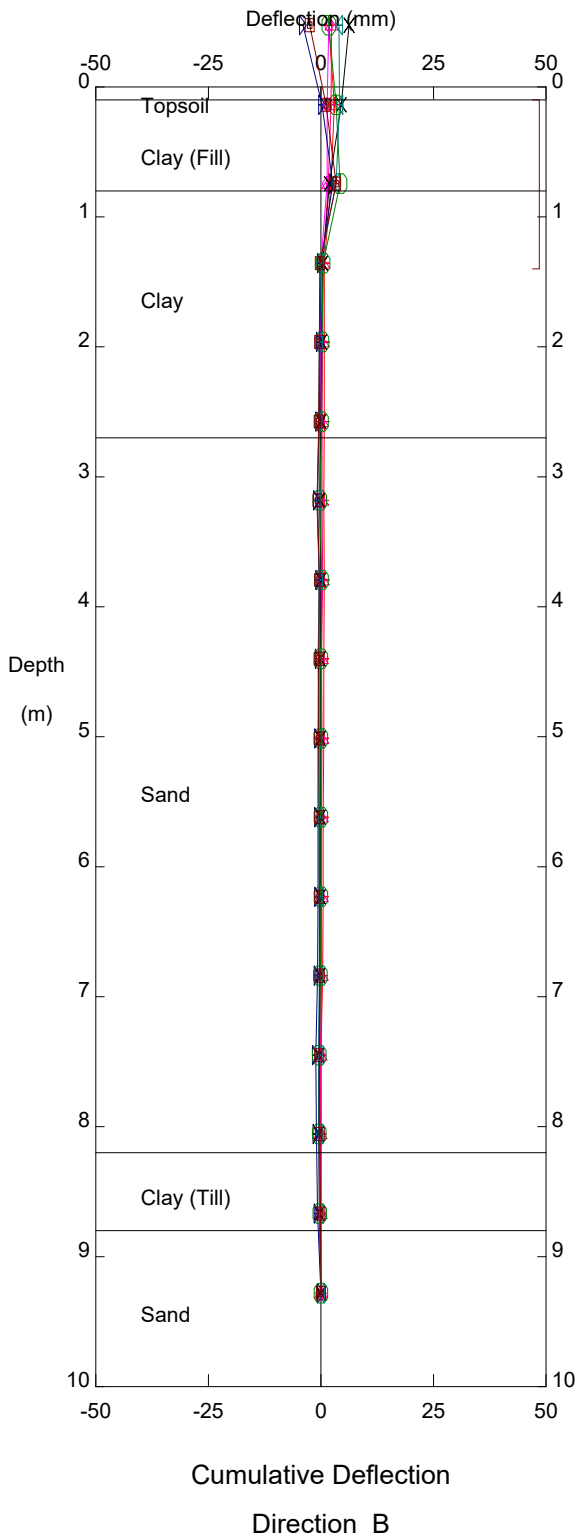
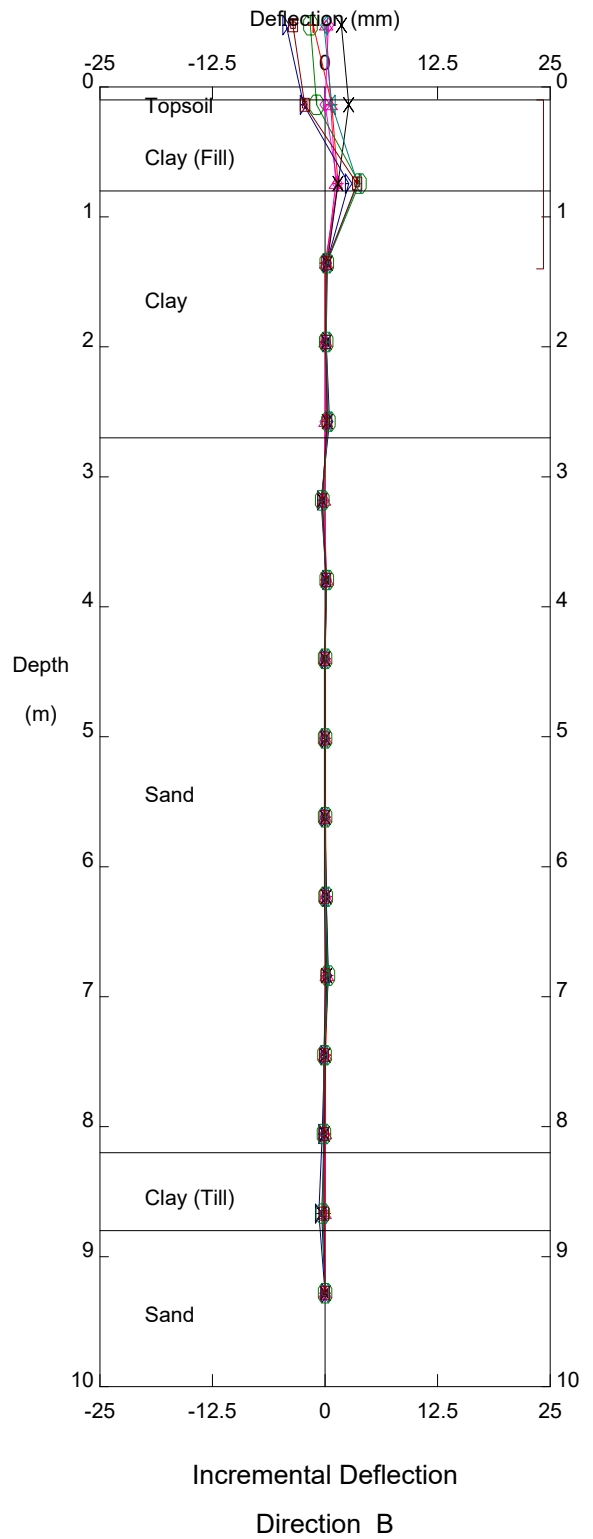
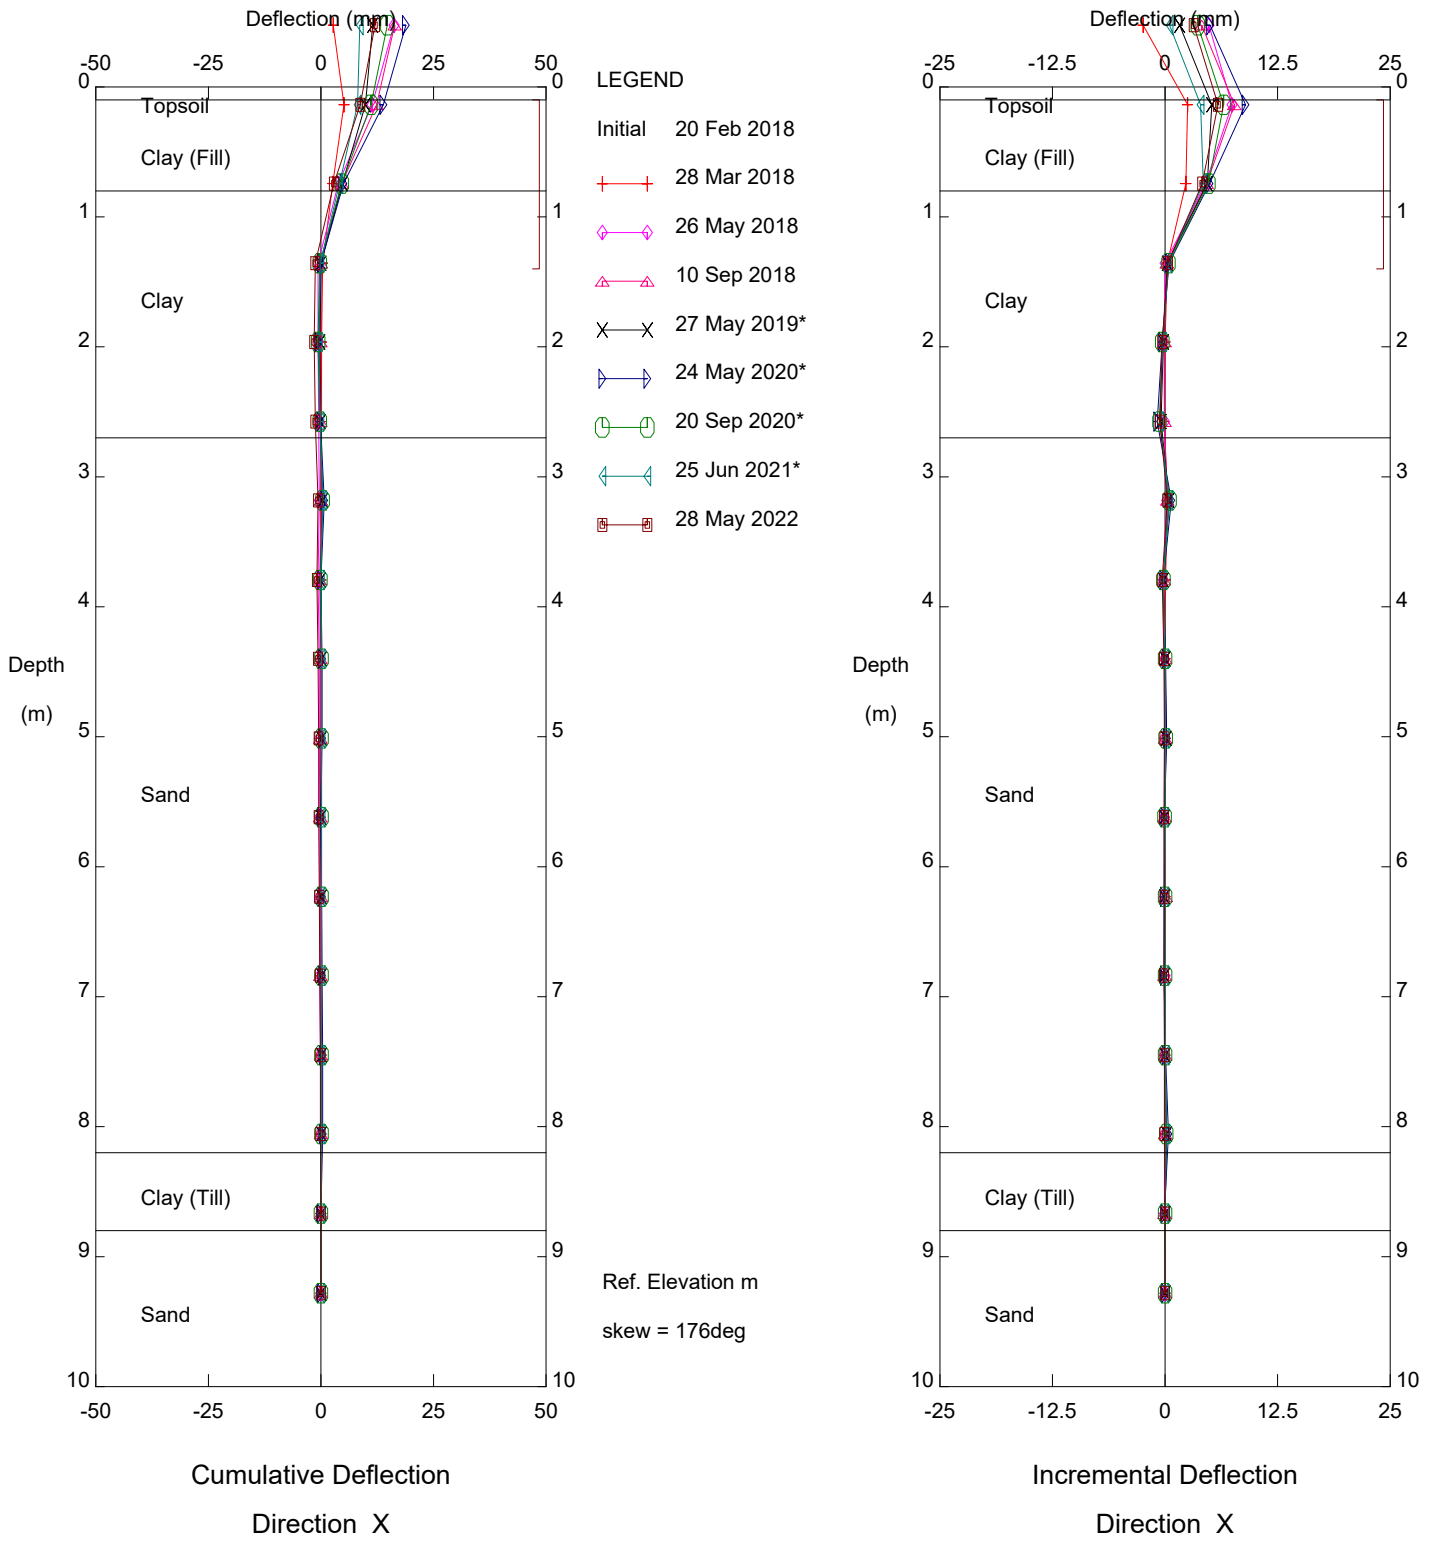
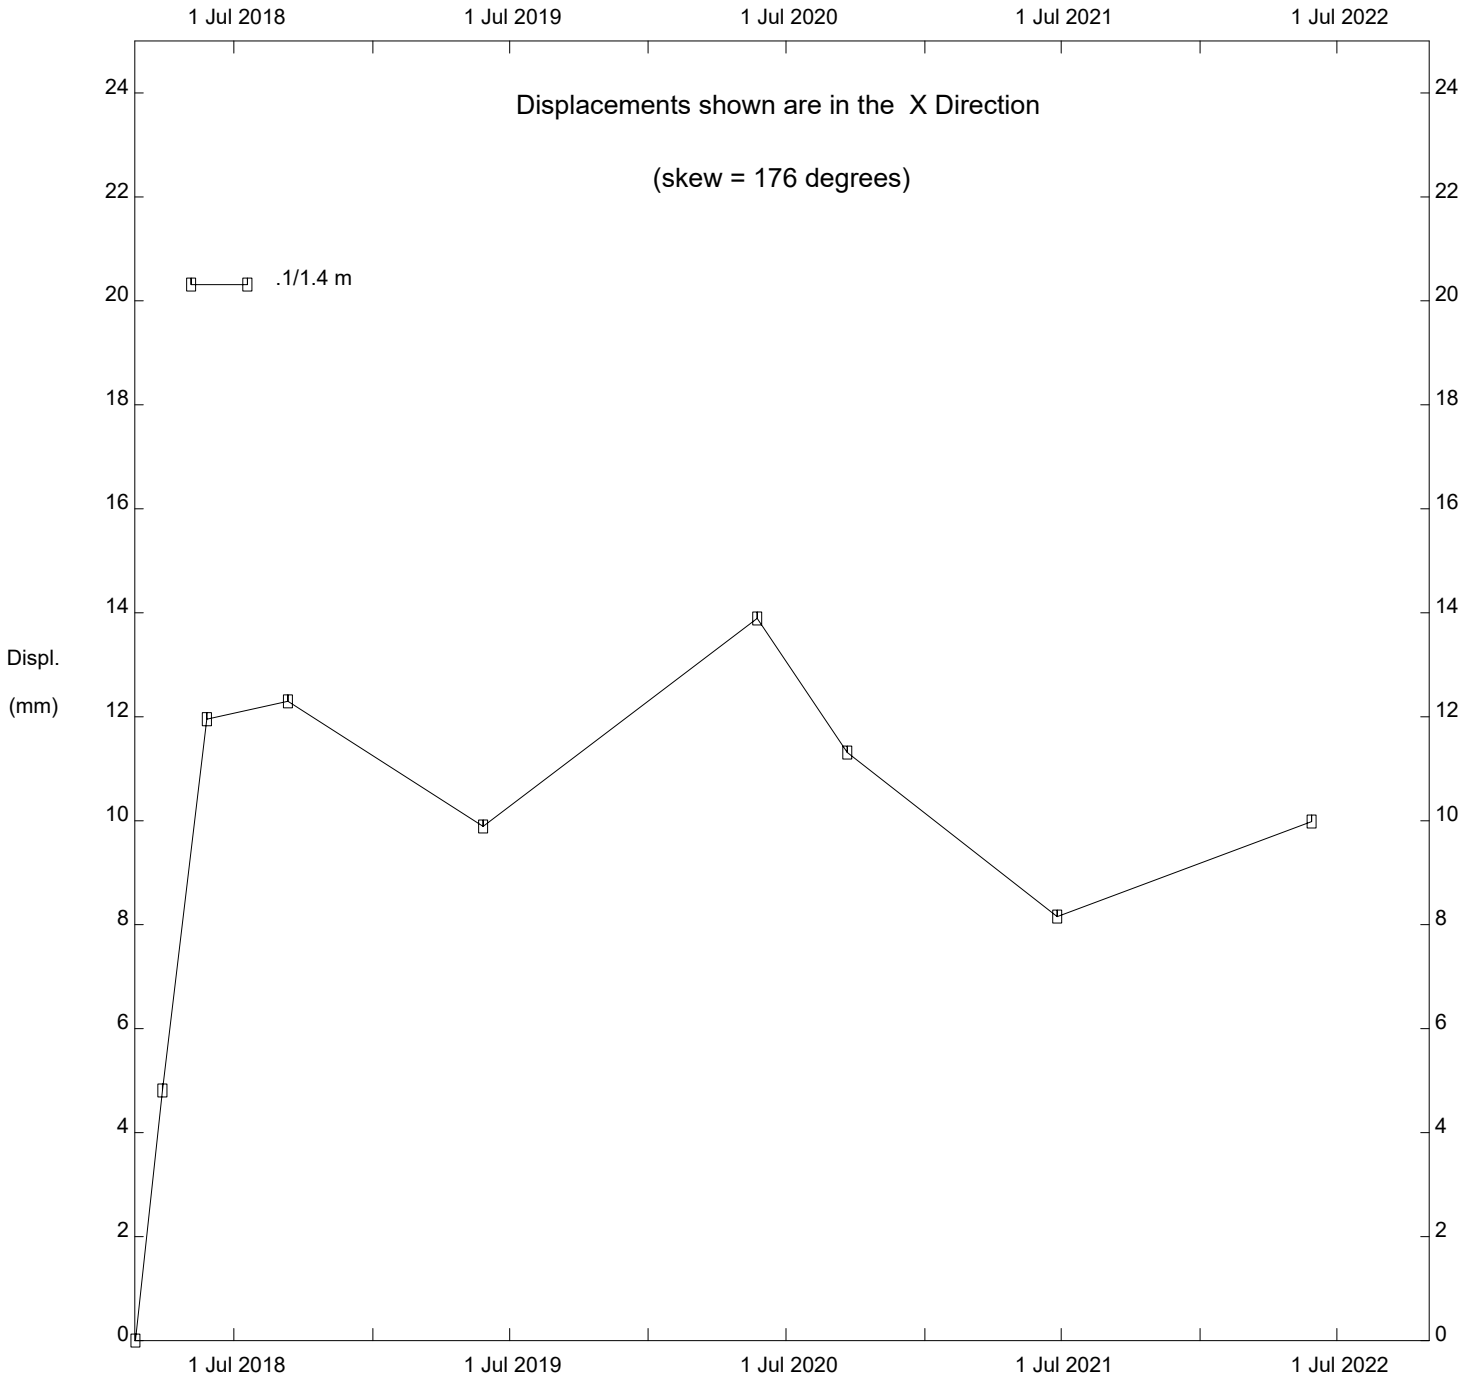
NC091 - km 39.35 Backslope Slump, Inclinometer SI18-1

No zones of new movement were observed in the SI18-1 since the spring of 2021 readings.

Slope inclinometer SI18-1 showed a rate of movement of 2.0 mm/yr over 0.1 to 1.4 m depth since the spring of 2021 readings.

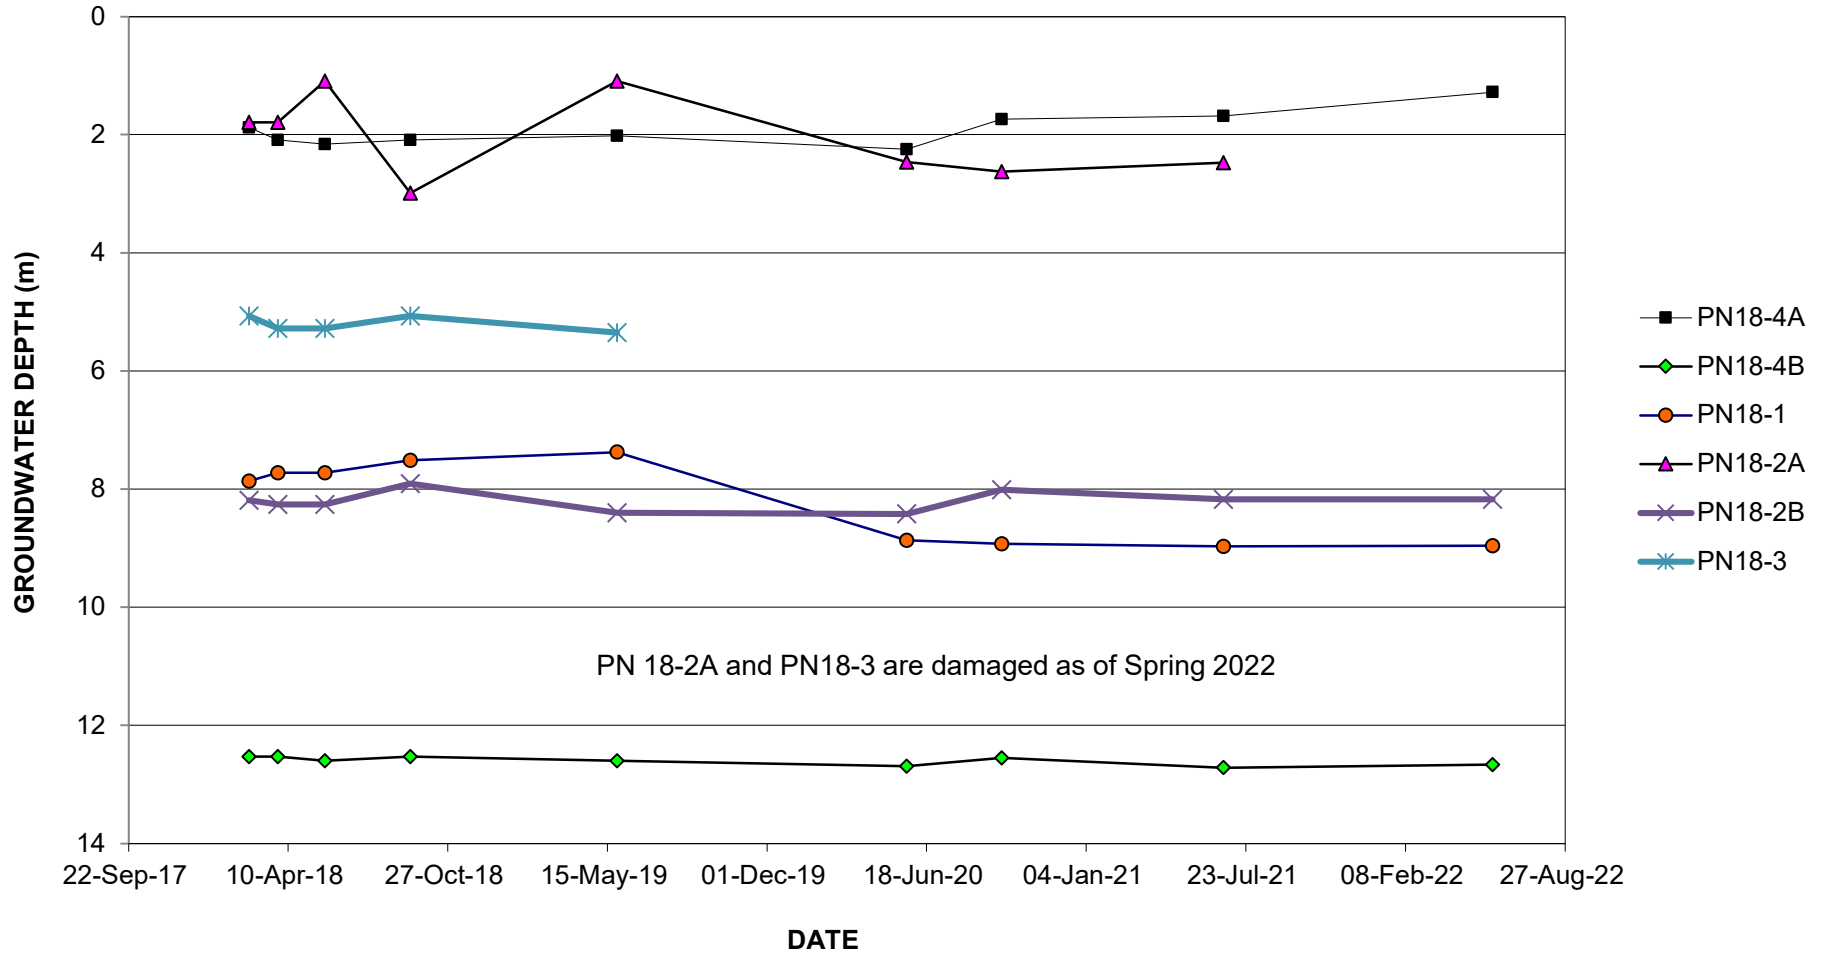
**FIGURE NC091-1  
PIEZOMETER DATA FOR HWY 63:02 BACKSLOPE SLUMPS**

One slope inclinometer (SI18-1) and five pneumatic piezometers (PN18-1, PN18-2A, PN18-2B, PN18-4A, and PN18-4B) were read at the HWY 63:02 Backslope Slumps sites on May 28, 2022 by Mr. Niraj Regmi, G.I.T. and Mr. Jayden Del Cid, both of Thurber Engineering Ltd. PN18-2A showed a fluctuating reading, indicating damage to the piezometer.

The groundwater level increased in PN18-1 by 0.01 m since the spring of 2021 readings. The groundwater level in PN18-2B showed no change since the spring of 2021 readings. Table NC090-2 summarizes the pneumatic piezometer readings. The pneumatic piezometer readings are also plotted on Figure NC091-1 included in Appendix A.

The groundwater level increased in PN18-4A and PN18-4B by 0.41 m and 0.06 m, respectively, since the spring of 2021 readings. PN18-4A showed the highest groundwater elevation recorded on the instrument since initialization. Table NC090-1-2 summarizes the pneumatic piezometer readings. The pneumatic piezometer readings are also plotted on Figure NC091-1 included in Appendix A.

The instruments at this site should be read again in the spring of 2023. Another attempt will be made to read PN18-2A at that time. If no readings can be obtained, the instrument will be removed from the geohazard readings program.
