ALBERTA TRANSPORTATION AND  
ECONOMIC CORRIDORS GRMP  
NORTH CENTRAL (ATHABASCA AND FORT  
McMURRAY DISTRICTS)  
INSTRUMENTATION MONITORING- SPRING 2024

Site Number	Location	Name	Hwy	km
NC091	HWY 63:02	Backslope Slumps	63:02	Km 39.4 and Km 40.4
<b>Legal Description:</b> 7-13-71-17 W4		<b>UTM Co-ordinates</b>		
		12U E 405719	N	6112165

**ALBERTA TRANSPORTATION AND ECONOMIC CORRIDORS GRMP (CON0022163)  
NORTH CENTRAL (ATHABASCA AND FORT McMURRAY DISTRICTS)  
INSTRUMENTATION MONITORING RESULTS**

**SITE NC091: HWY 63:02 BACKSLOPE SLUMPS (km 39.35 and 40.37)**

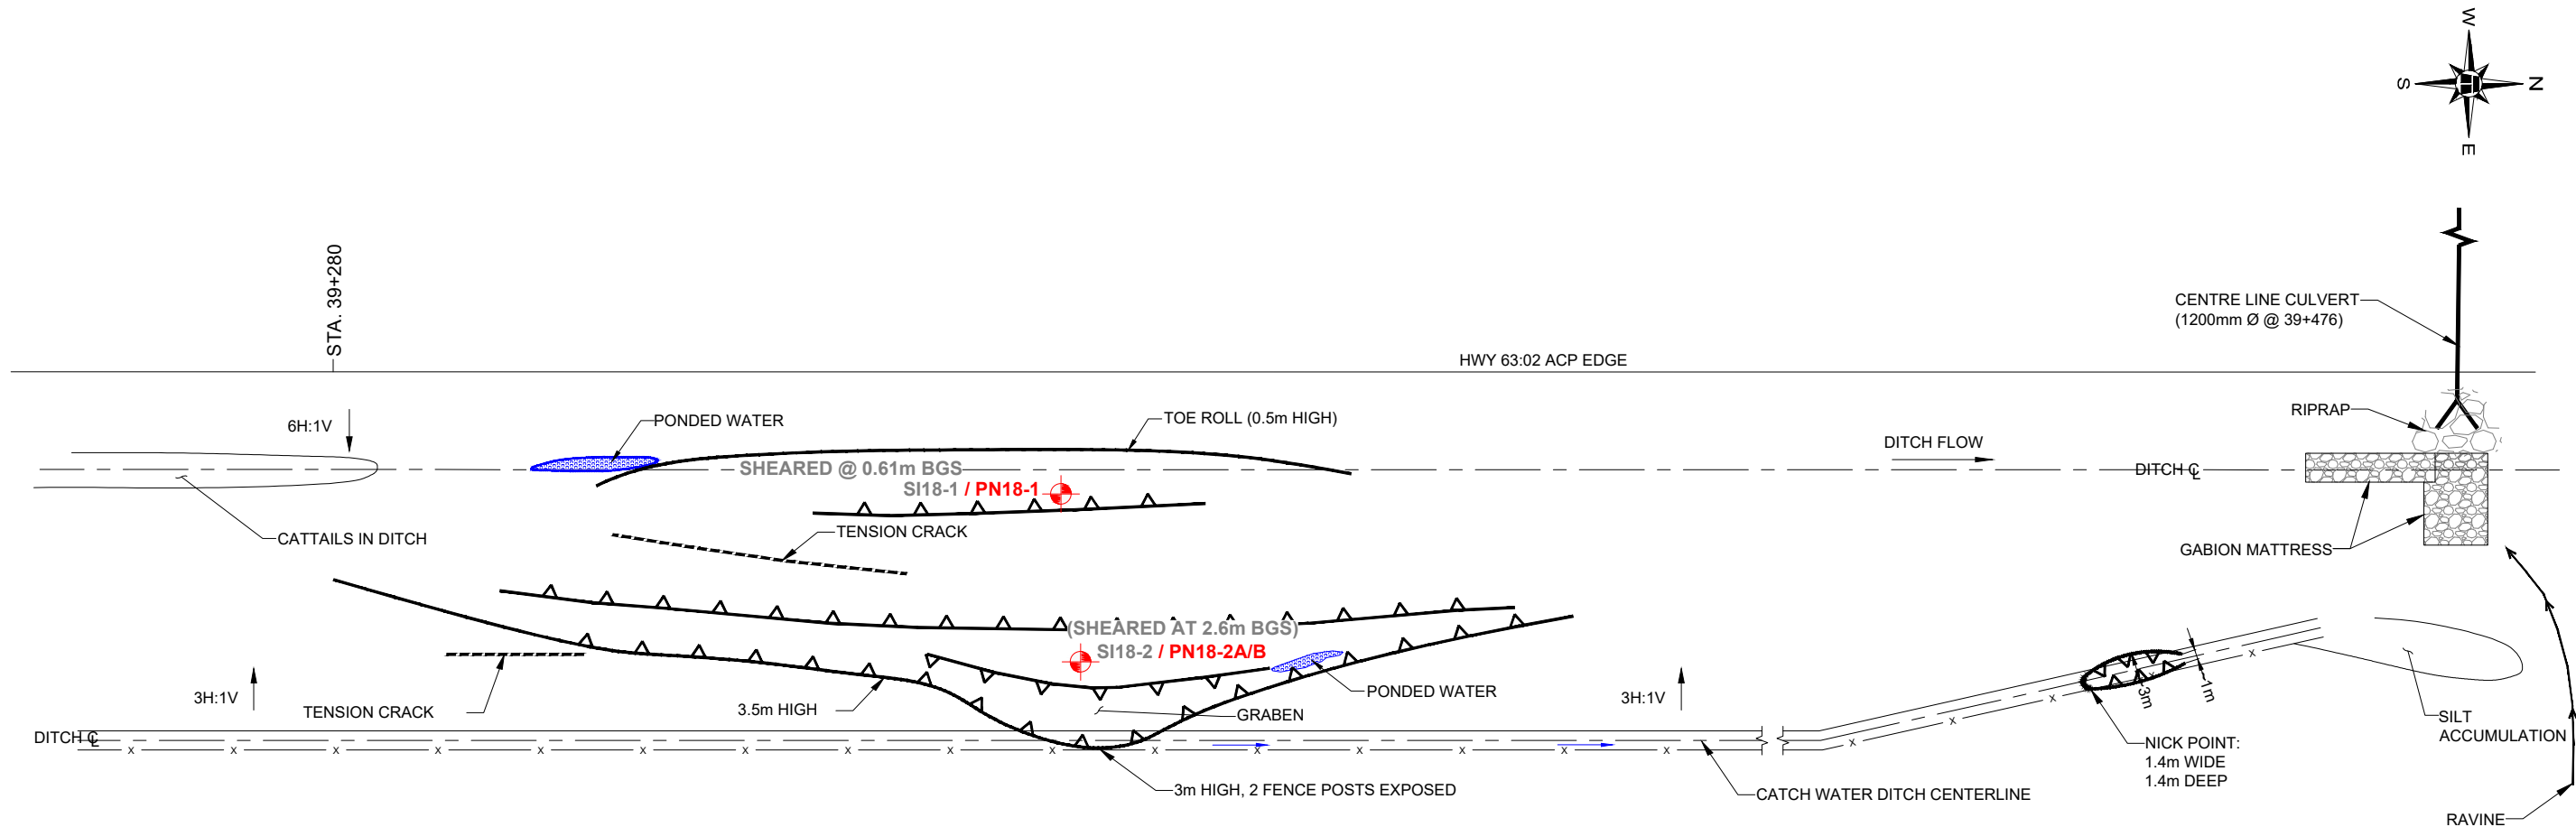
**DWG No. 32122-NC091-1**

**NORTH CENTRAL  
(ATHABASCA AND FORT MCMURRAY DISTRICTS)  
NC091: HWY 63:02 km 39.35 - BACKSLOPE SLUMP  
SITE PLAN SHOWING APPROXIMATE  
INSTRUMENT LOCATIONS**

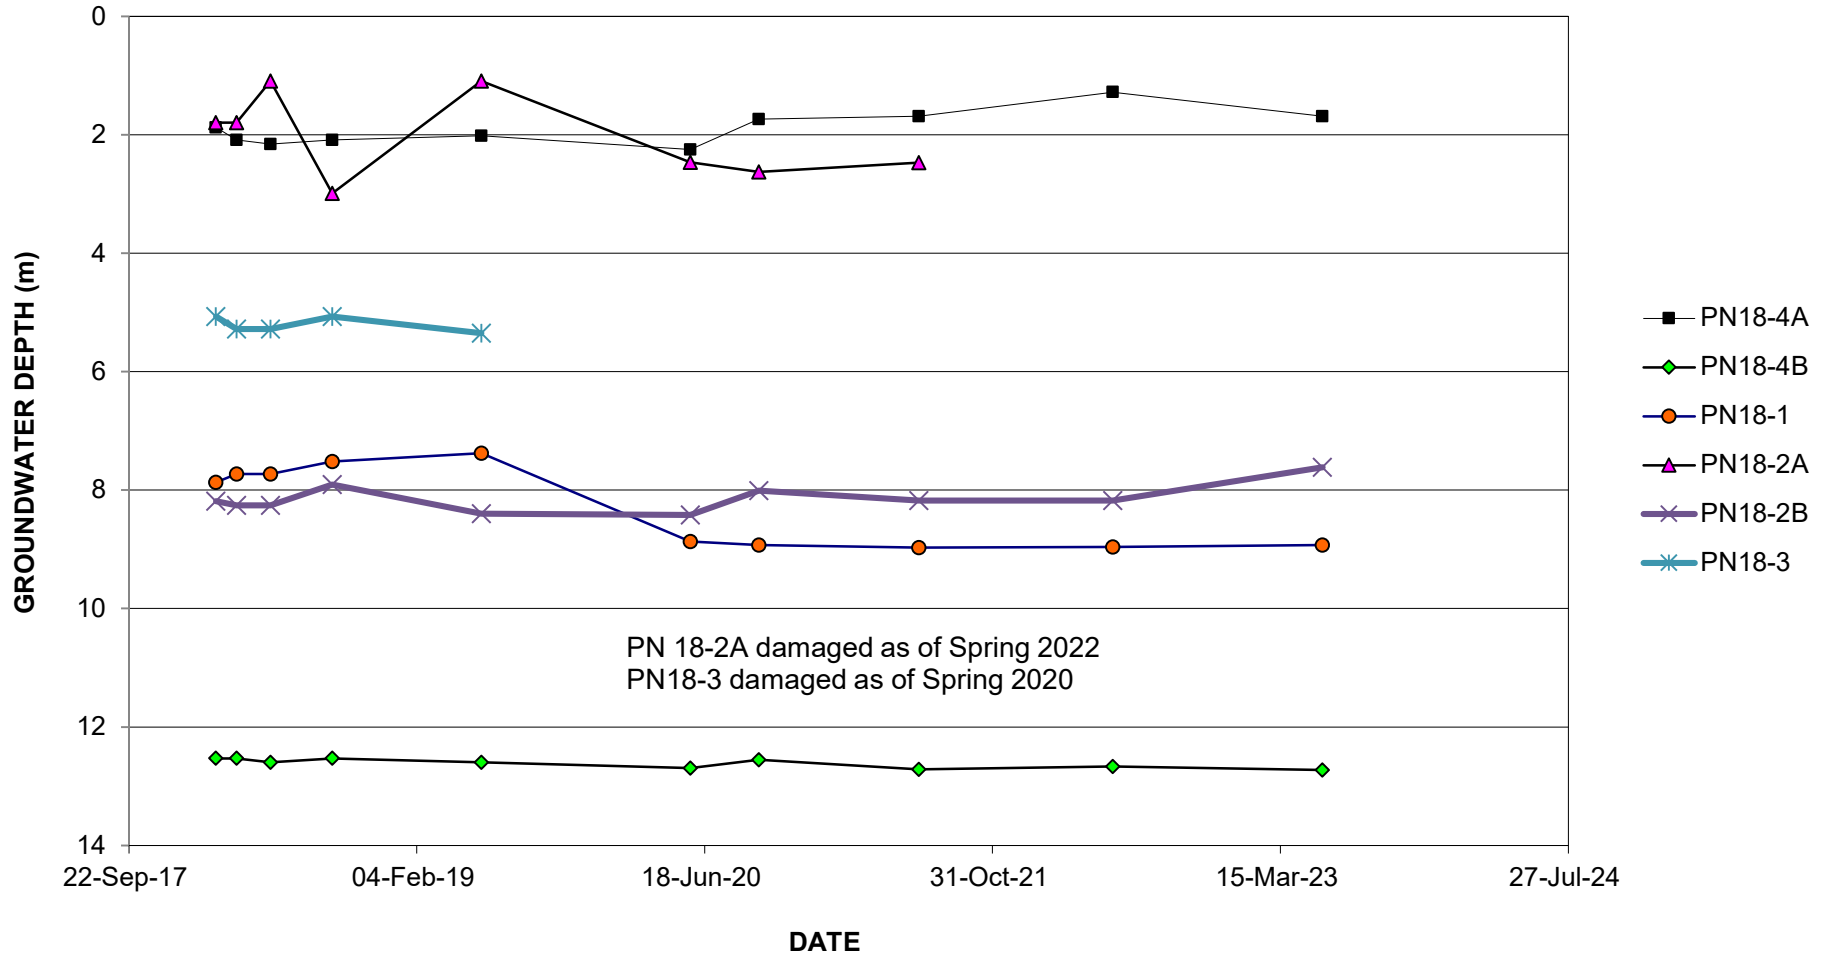
**FIGURE NC091-1  
PIEZOMETER DATA FOR HWY 63:02 BACKSLOPE SLUMPS**

Discussion	
<b>Zones of New Movement:</b>	None
<b>Interpretation of Monitoring Results:</b>	<p><b>NC091-1 (km 39.35)</b></p> <p>Slope inclinometer SI18-1 was sheared off at 1.2 m below the top of the inclinometer casing.</p> <p>The groundwater level in PN18-1 and PN18-2B decreased by 0.03 m and 0.64 m, respectively since the spring of 2023 readings.</p>
	<p><b>NC091-2 (km 40.37)</b></p> <p>The groundwater level increased in PN18-4A by 0.46 m and decreased in PN18-4B by 0.06 m since the spring of 2023 readings. The groundwater level in PN18-4A is at the highest level ever recorded in this instrument since initialization.</p>
<b>Future Work:</b>	The operational instruments at this site should be read again in the spring of 2025.
<b>Instrumentation Repairs:</b>	SI18-3 is broken at 0.8 m below ground. The repair will require a mechanical excavator or a hydrovac unit, and hence it is anticipated
