**ALBERTA TRANSPORTATION AND
ECONOMIC CORRIDORS GRMP
NORTH CENTRAL (ATHABASCA AND FORT
McMURRAY DISTRICTS)
2024 SITE INSPECTION**

| Site Number | Location | Name | Hwy | km |
|--|--|---|---|---|
| NC091-1 NC091-2 | NBL - 5 to 6 Km south of Wandering River | HWY 63-02 BACKSLOPE SLUMPS | 63:02 | 39.27 and 40.28 |

**NORTH CENTRAL REGION
(ATHABASCA AND FORT McMURRAY DISTRICTS)
2024 GEOHAZARD ASSESSMENT
NC091-1: HWY 63:02 KM 39.35 - BACKSLOPE SLUMP
SKETCH SHOWING SITE FEATURES**

**NC091-2: HWY 63:02 KM 40.37 - BACKSLOPE SLUMP
SKETCH SHOWING SITE FEATURES**

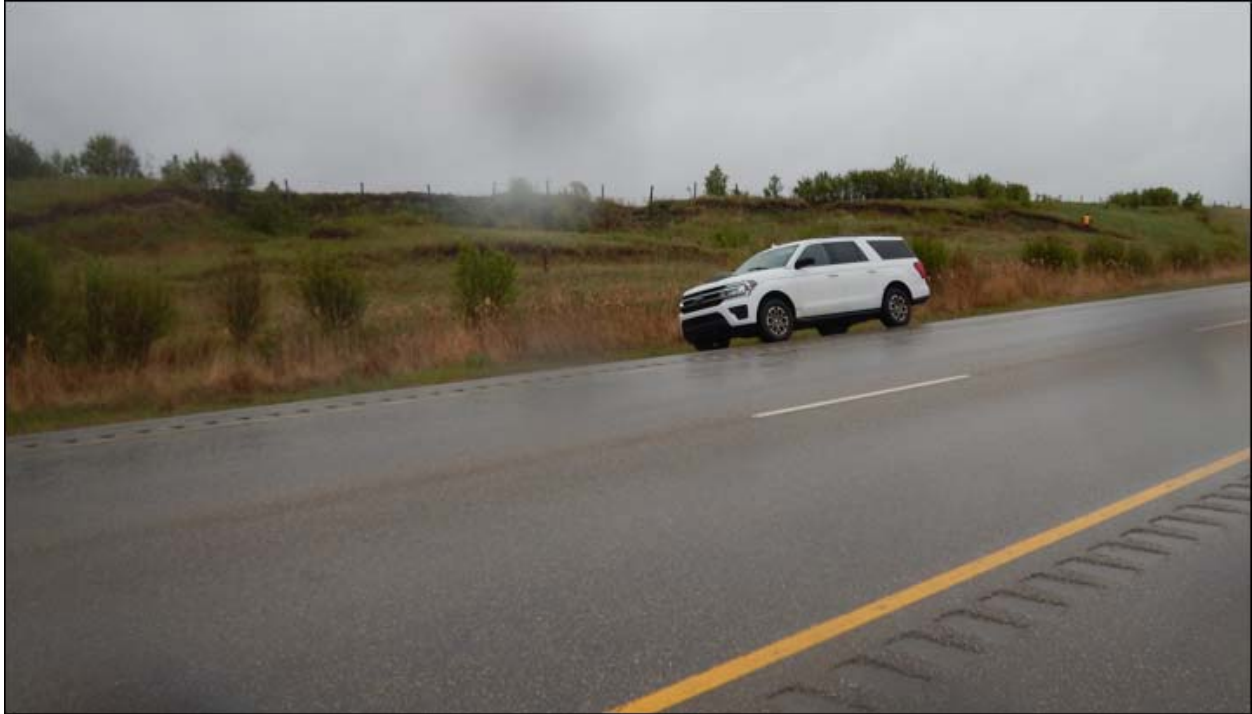
Photo No. 1- NC091-1: Looking southeast at the landslide area

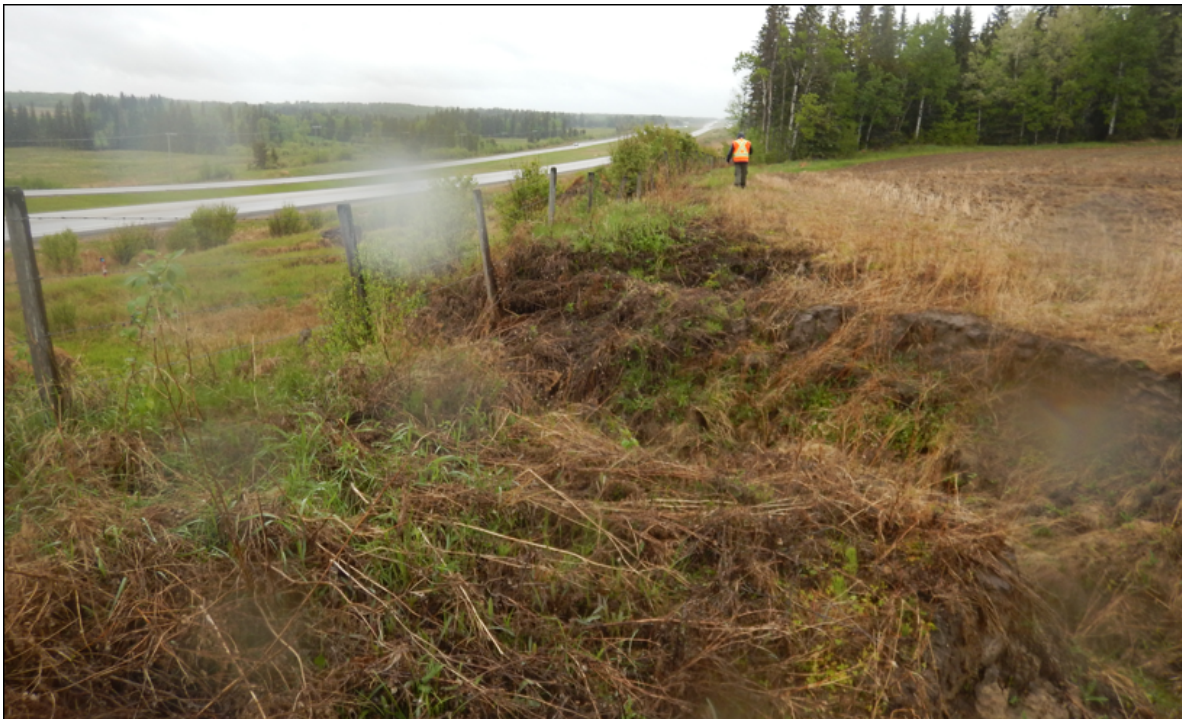
| <input checked="" type="checkbox"/> Other | <p>NC091-1: A severe erosion gully developed within the farmer's field; the gully is about 12 m long x 12 m wide with 1.5 m drop at the deepest location.</p> <p>NC091-2: Severe erosion around the half pipe and the riprap apron; erosion extended to the south of the catch water ditch into private land; half pipe got completely separated from culvert near the top of the slope.</p> | <input checked="" type="checkbox"/> |

Photo No. 2- NC091-1: Looking north at an erosion gully developed within the farmer's field; vegetation grew within the gully

(c) place a snow fence around areas impacted by the landslide within the private lands or backfill these areas to eliminate existing hazard. However, this can only take place after consultation with the landowner(s).

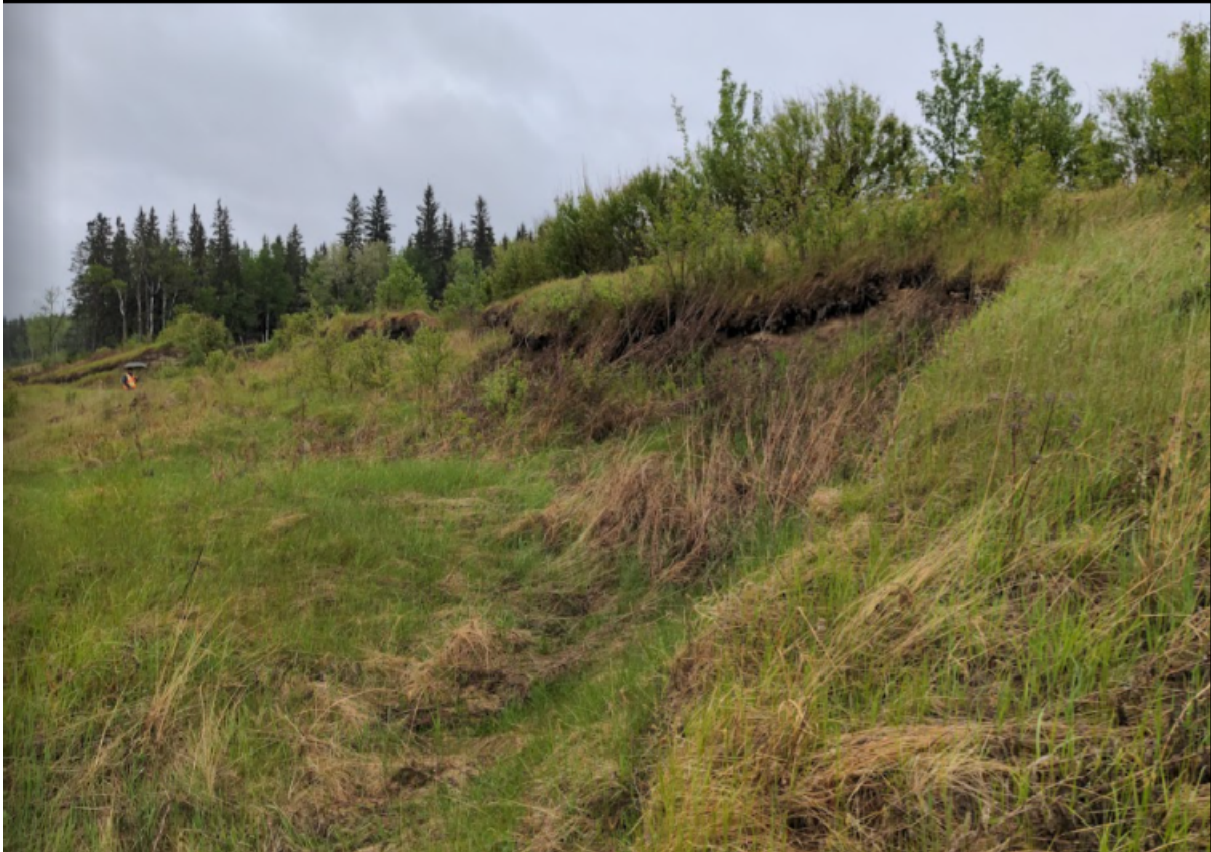
Photo No. 3- NC091-1: Looking north at landslide backscarp crack showing a 2.2 m drop approximately 5 m west of the upslope ditch

(b) seal open cracks in the slope surface to reduce surface water infiltration into the slide mass. A small track mounted equipment could be used to smoothen the slope surface and fill in any dips without causing significant changes in grade, and

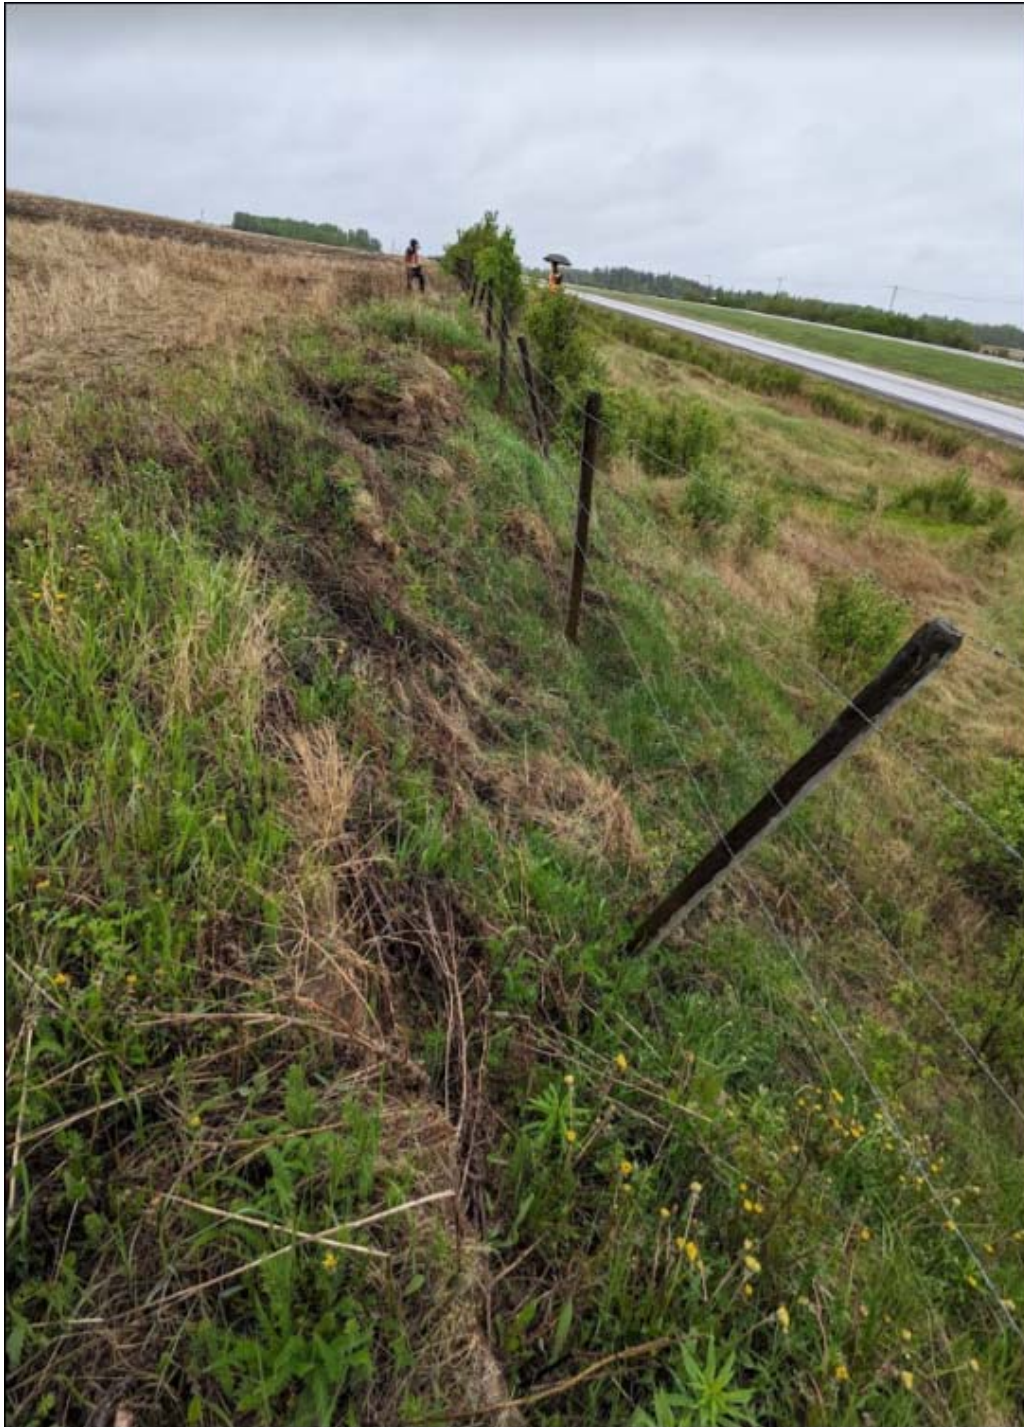
| Observations: | Description | Worse? |
|--|---|---|
| <input checked="" type="checkbox"/> Slope Movement | <p>NC091-1: Up to 3.5 m high head scarp crack in the farmer's field; eight fence posts hanging. Multiple tension cracks up to 500 mm wide and 1.8 m deep. The toe roll is partially blocking the ditch and it is about 1 m high. Some retrogression of the head scarp crack noted in 2024.</p> <p>NC091-2: 1 Head scarp crack showed some retrogression during the 2024 inspection. The depth of tension cracks ranged between 200 mm and 1.8 m and the width ranged between 600 mm and 700 mm. The toe of the landslide is about 1.8 m high, and it is partially blocking the ditch. Some retrogression of the head scarp crack noted in 2024.</p> | <input checked="" type="checkbox"/> |

Photo No.4 - NC091-1: Looking south at a backscarp crack retrogressing into the farmer's field. Eight barbed wire posts were hanging in 2024.

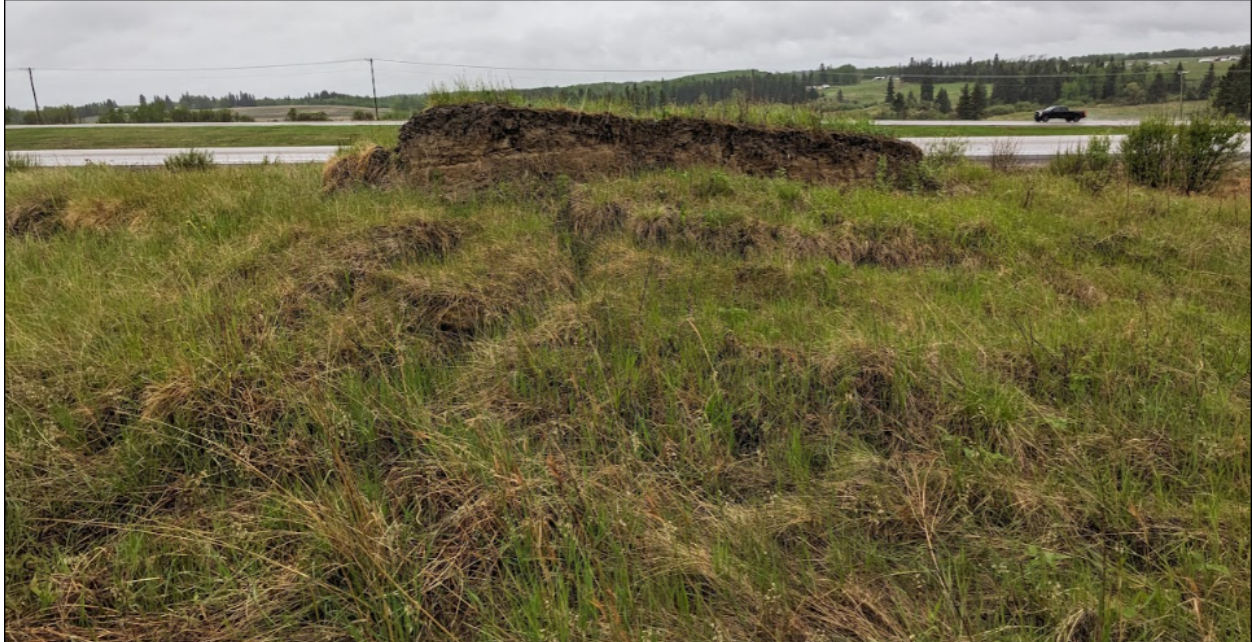
Photo No. 5 - NC091-1: Looking west at graben feature developed in the middle of the landslide mass

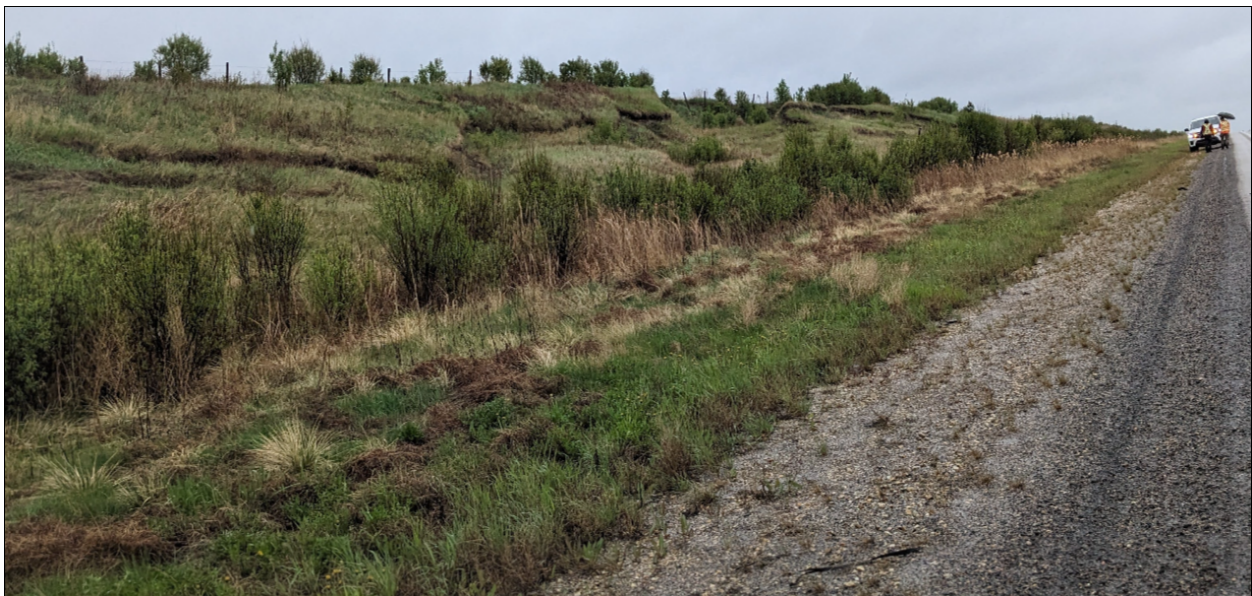
Photo No. 6 – NC091-1: Looking south at landslide features. The north flank extended further north in 2024

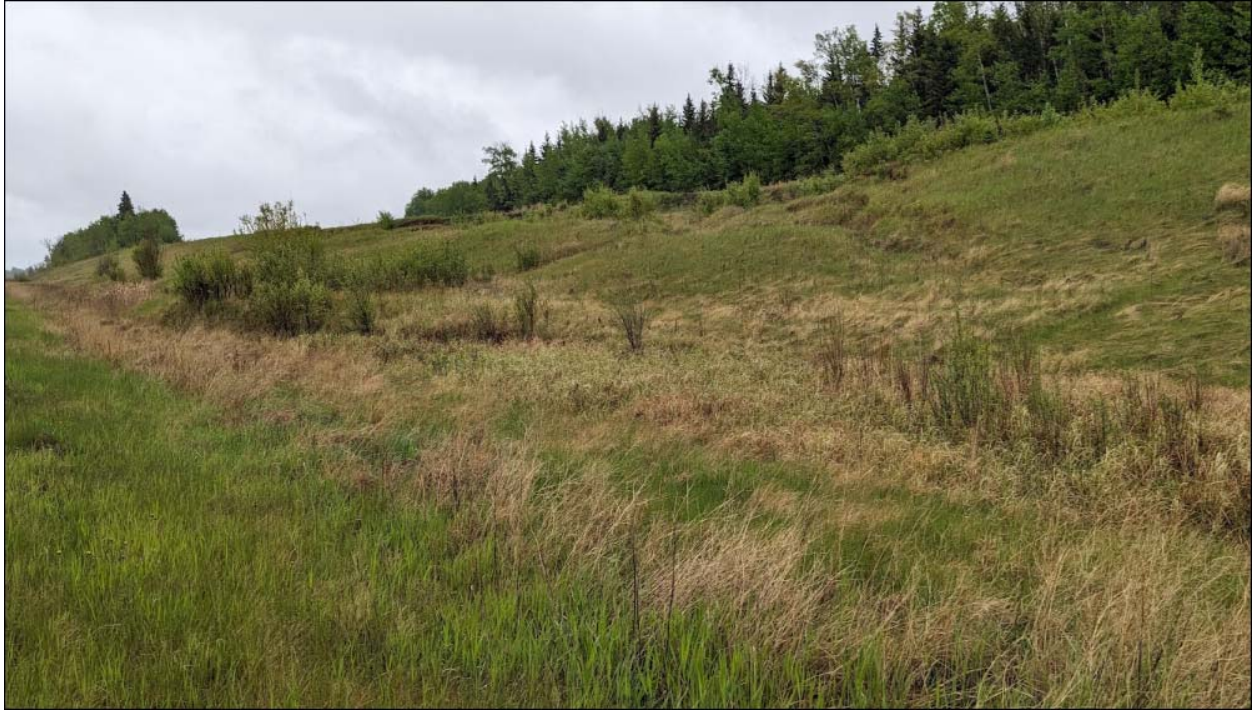
The landslide debris is partially blocking the highway ditch at both locations and hence impeding surface drainage in the highway ditch. This may result in elevated groundwater levels in the highway embankment and potential instabilities in the future.

Photo No. 7 – NC091-2: Looking north at the landslide mass; note the presence of a distinct toe roll in the ditch

(a) undertake slight grading of the highway ditch at the slump locations, as needed, to promote surface drainage. Excavated material from the ditch should be pushed back against the toe of the slope. Excessive removal of landslide debris from the toe of the slope could result in accelerated movement,

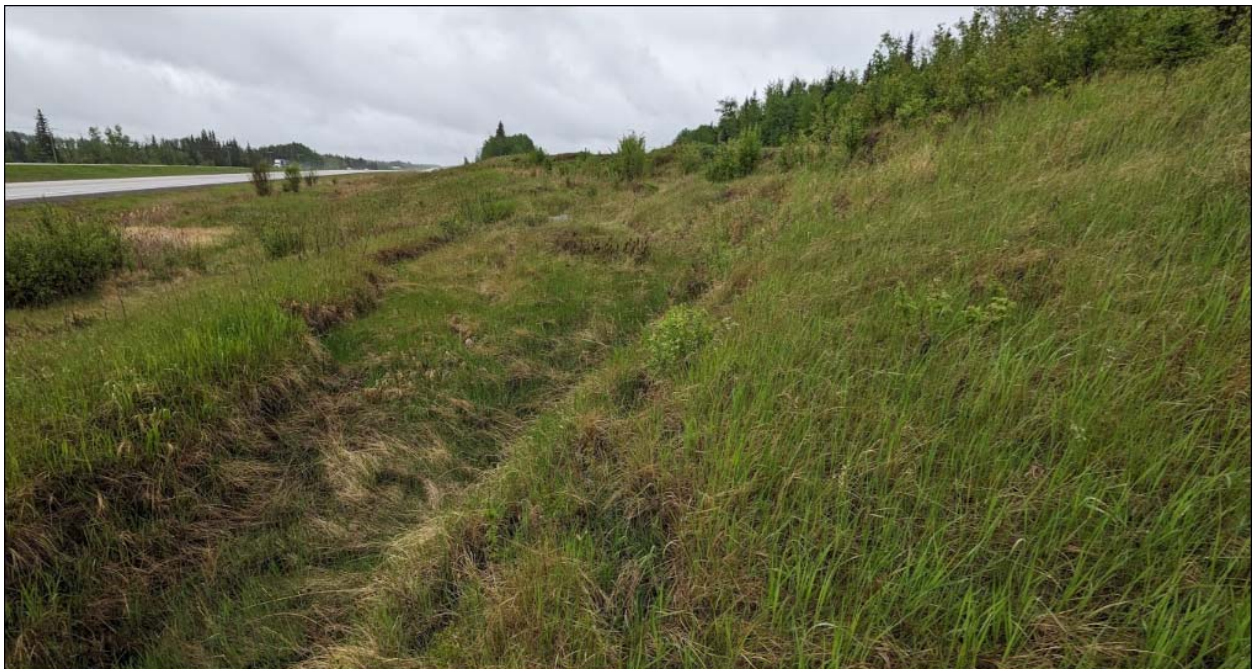
Photo No. 8 – NC091-2: Looking northeast at the southern flank of the landslide mass; note the presence of multiple tension cracks within the backslope

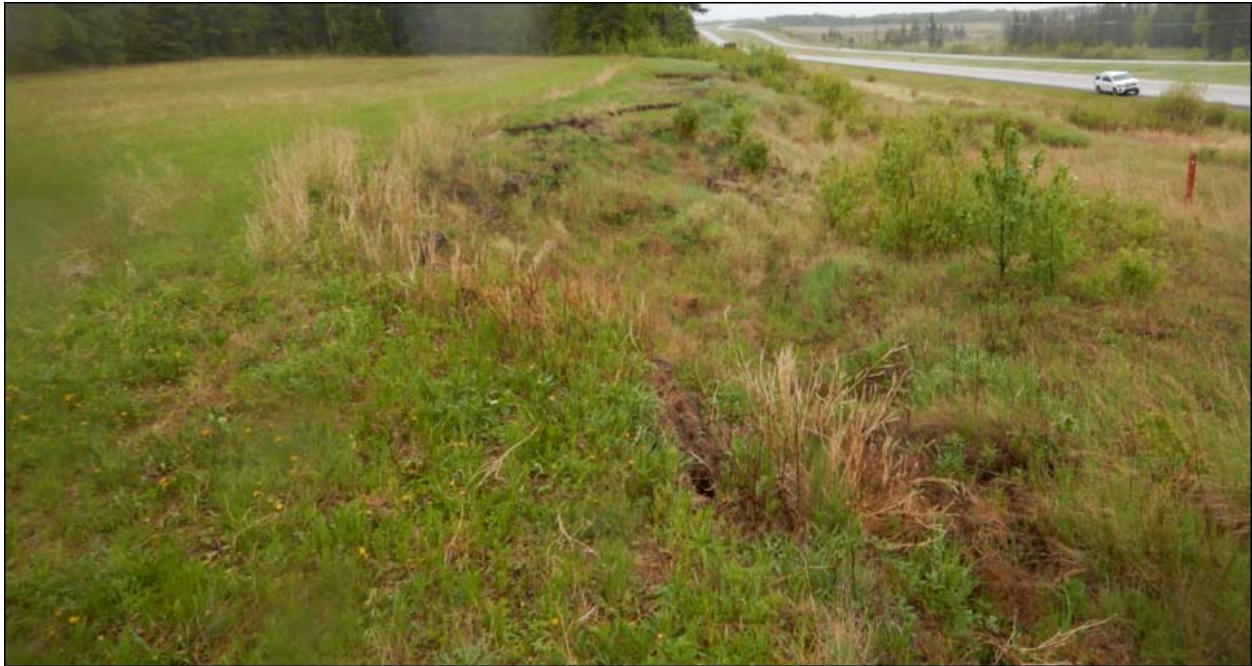
Photo No. 9 – NC091-2: Looking south at a scarp crack developed within the crest of the backslope

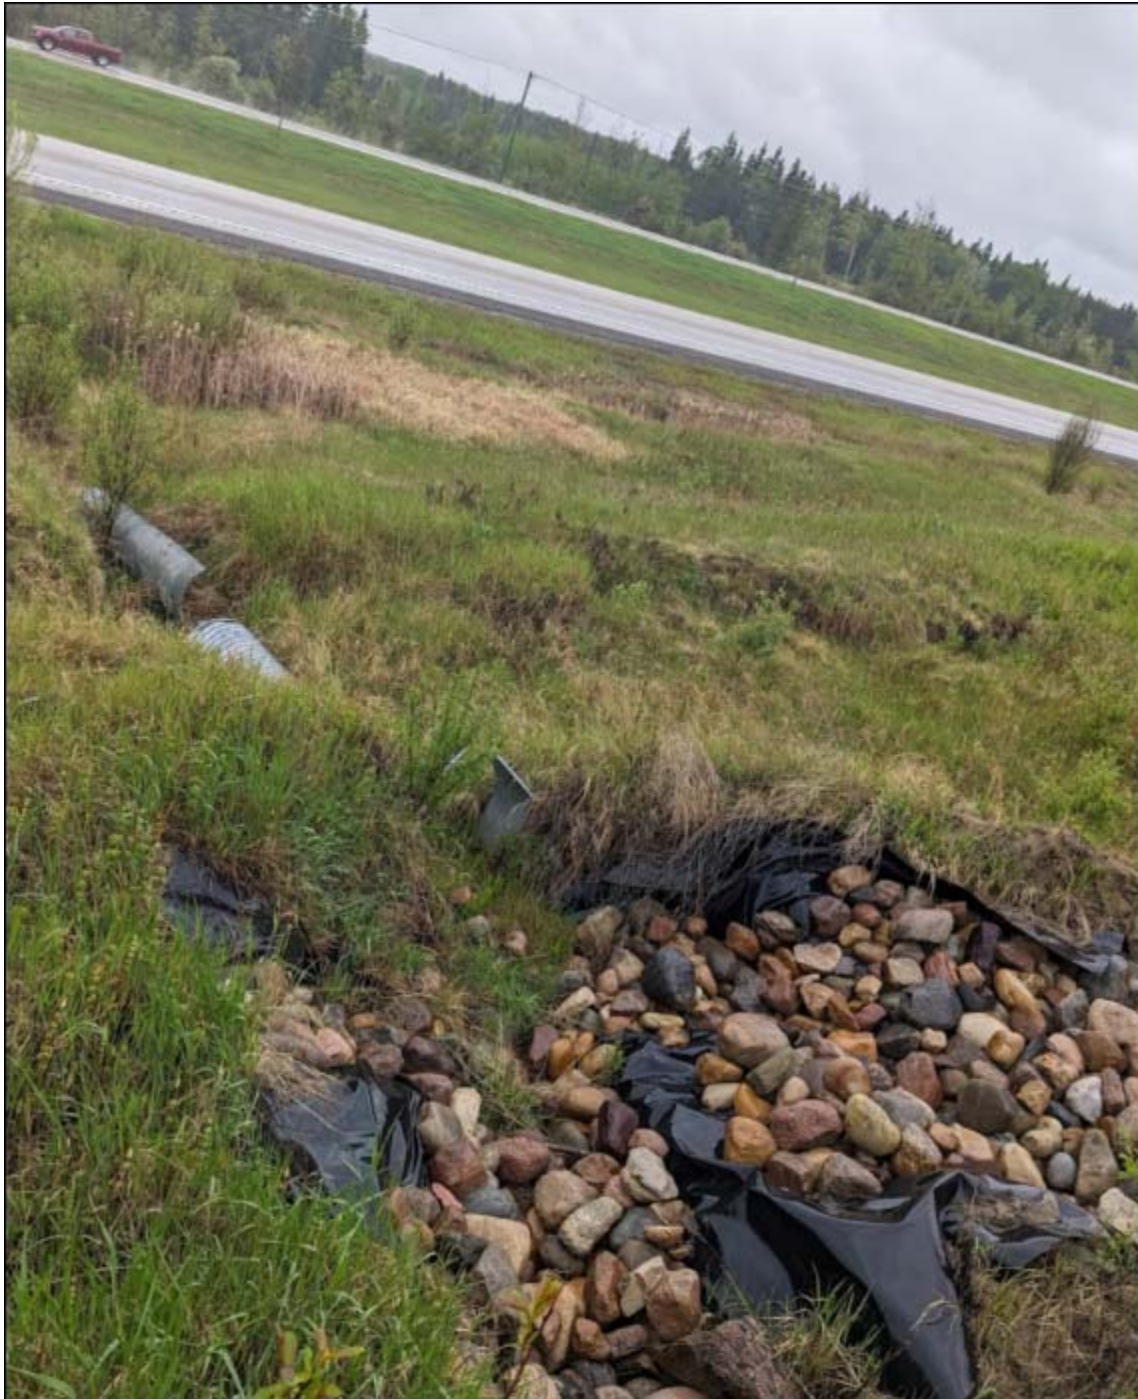
Photo No. 10 – NC091-2: Looking at the failed riprap apron

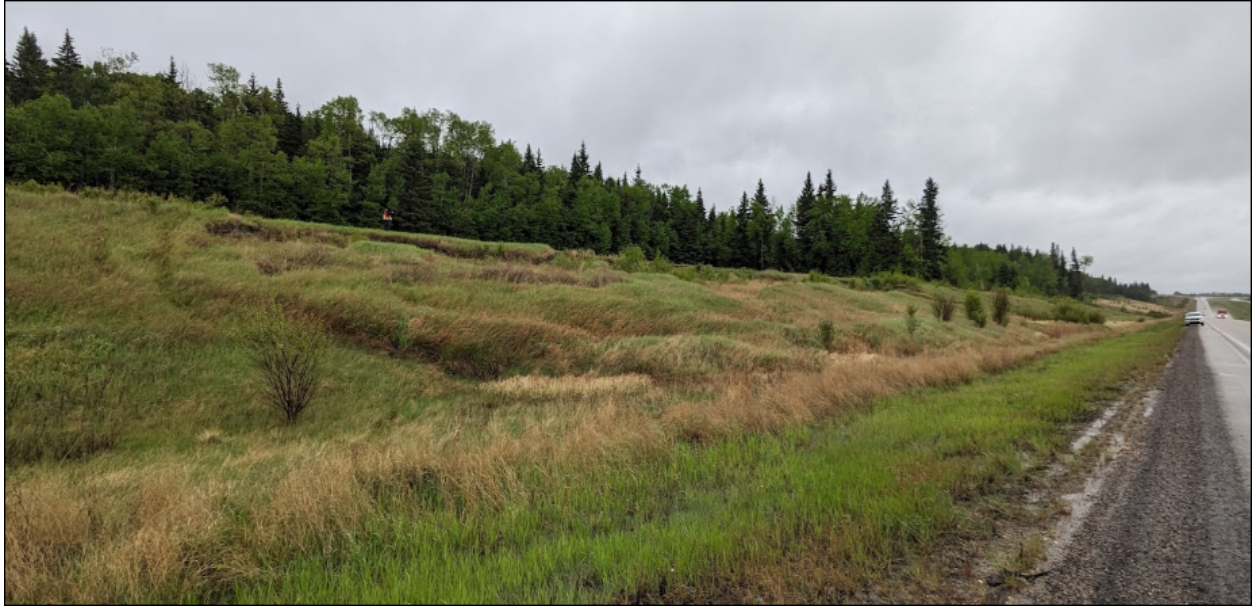
Photo No. 11 – NC091- 2: Looking south at landslide features; note the well-defined toe roll at the ditch and the presence of multiple tension cracks within the backslope

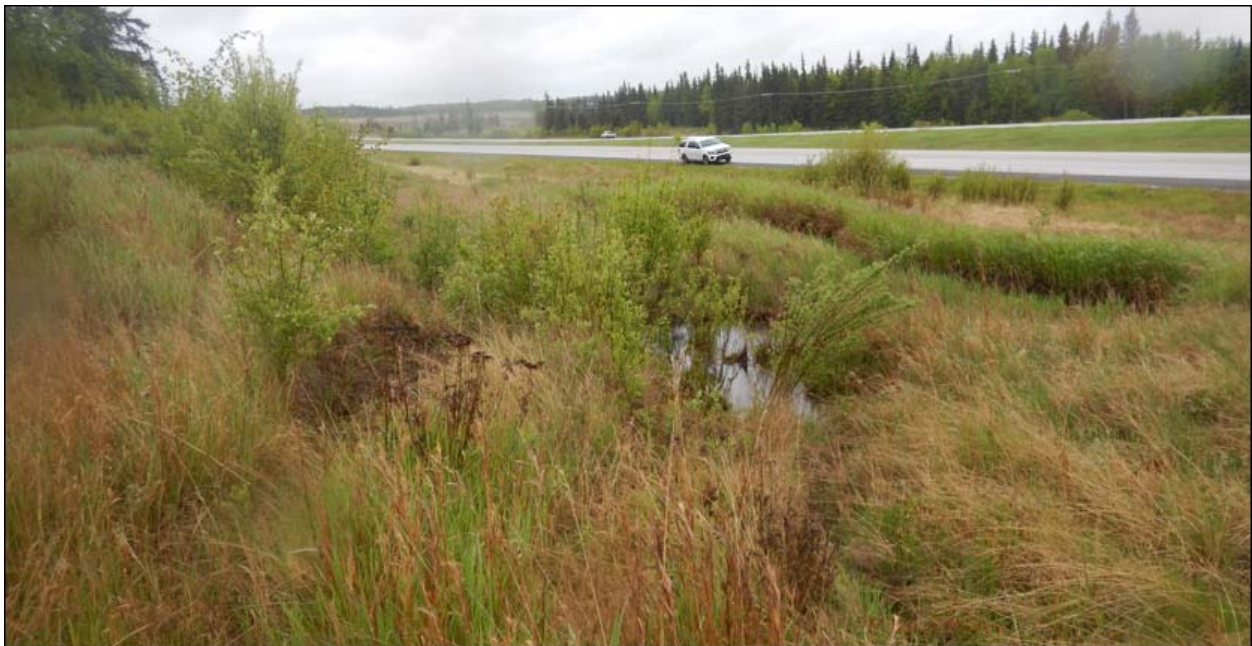
| Observations: | Description | Worse? |
|--|---|---|
| <input checked="" type="checkbox"/> Seepage | NC091-1 and NC091-2: wet landslide mass; ponding water within few locations of the landslide mass; toe roll partially blocking water flow along the ditch; catch water ditch near the crest of both slides was impacted by the landslide movement and water from the catch water ditch saturated the landslides. | <input checked="" type="checkbox"/> |

Photo No. 12 – NC091-2: Looking south at water ponding within the landslide mass
