**ALBERTA TRANSPORTATION
GEOHAZARD ASSESSMENT PROGRAM
NORTH CENTRAL REGION – ATHABASCA
2021 SITE INSPECTION**

Site Number	Location	Name	Hwy	km
NC096	13 Km north of Wandering River	Wandering River Bridge (75731N)	63:04	2.85
Legal Description		UTM Co-ordinates (NAD 83)		
NW 12-73-17 W4		12	N6130357.92	E405776.13

Date	PF	CF	Total
Previous Inspection:	September 9, 2020	13	5	65
Current Inspection	June 24, 2021	15	5	75
Road AADT:	3,730	Year:	2020	
Inspected By:	José Pineda, Tarek Abdelaziz (Thurber) Arthur Kavulok, Kristen Tappenden, Bernard Ching (Alberta Transportation)			
Report Attachments:	<input checked="" type="checkbox"/> Photographs <input checked="" type="checkbox"/> Plans <input checked="" type="checkbox"/> Maintenance Items

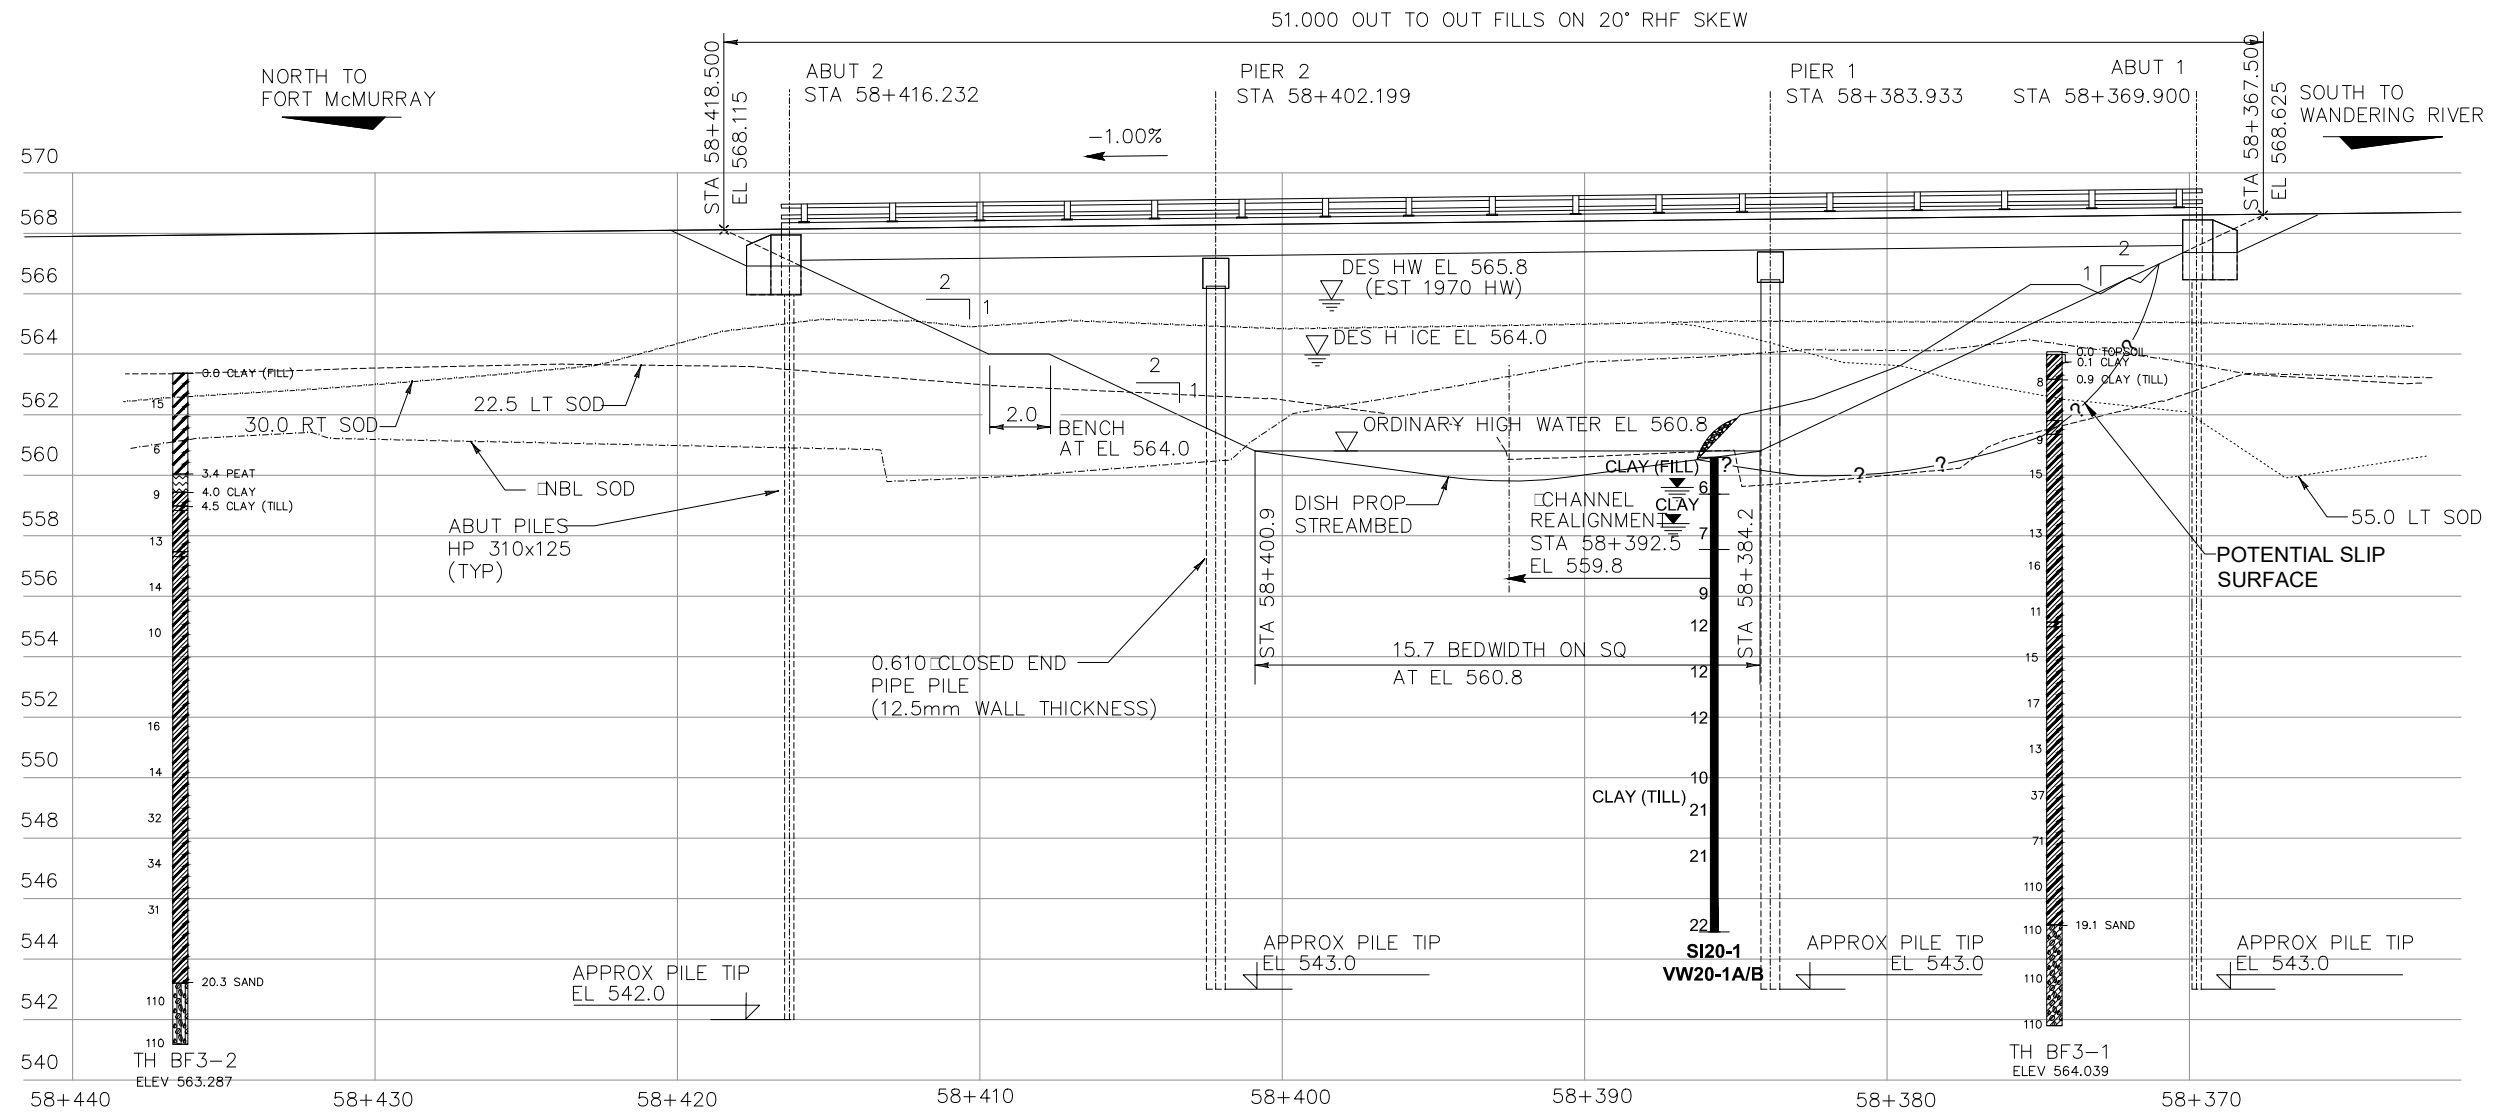
FIGURE 2

1. JUNE 24, 2021 OBSERVATIONS ARE SHOWN IN RED.
2. SLUMP 1 IS WITHIN THE RIVERBANK SLOPE TO THE EAST OF THE BRIDGE HEADSLOPE.

CROSS - SECTION A - A'
SHOWING SLUMP 1 - EAST OF BRIDGE HEADSLOPE

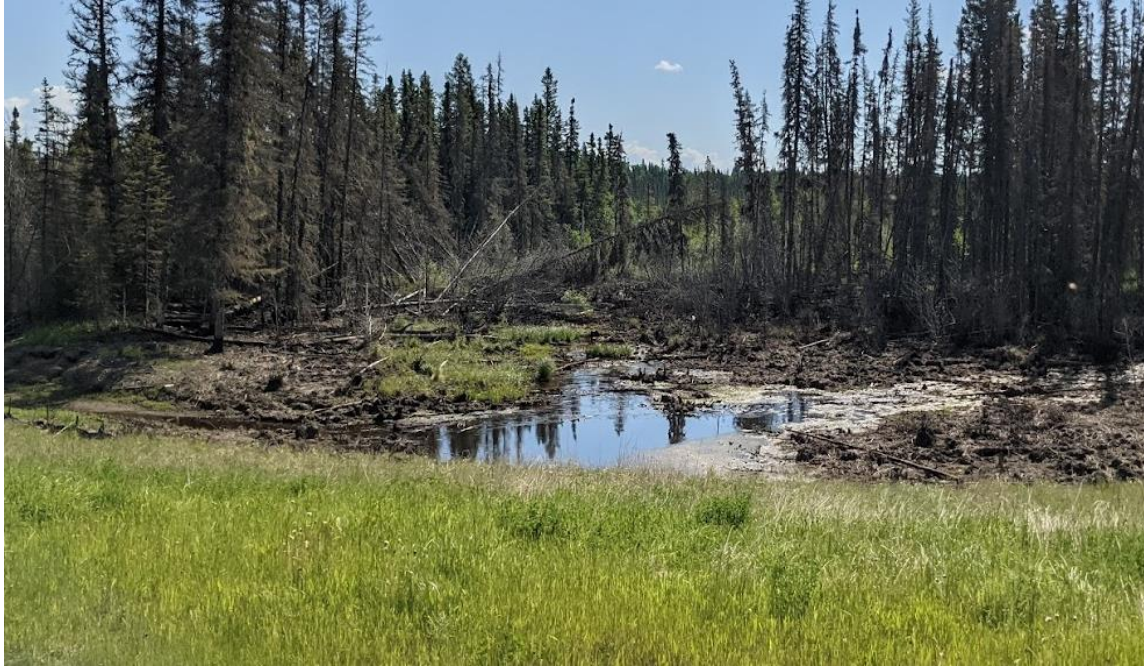
Photo No. 1 – Looking southeast from the south side of the bridge at the low lying area within the bush. This area was noted to be flooded in 2020, but it is currently drained due to beaver dam removal by AT in the fall of 2020

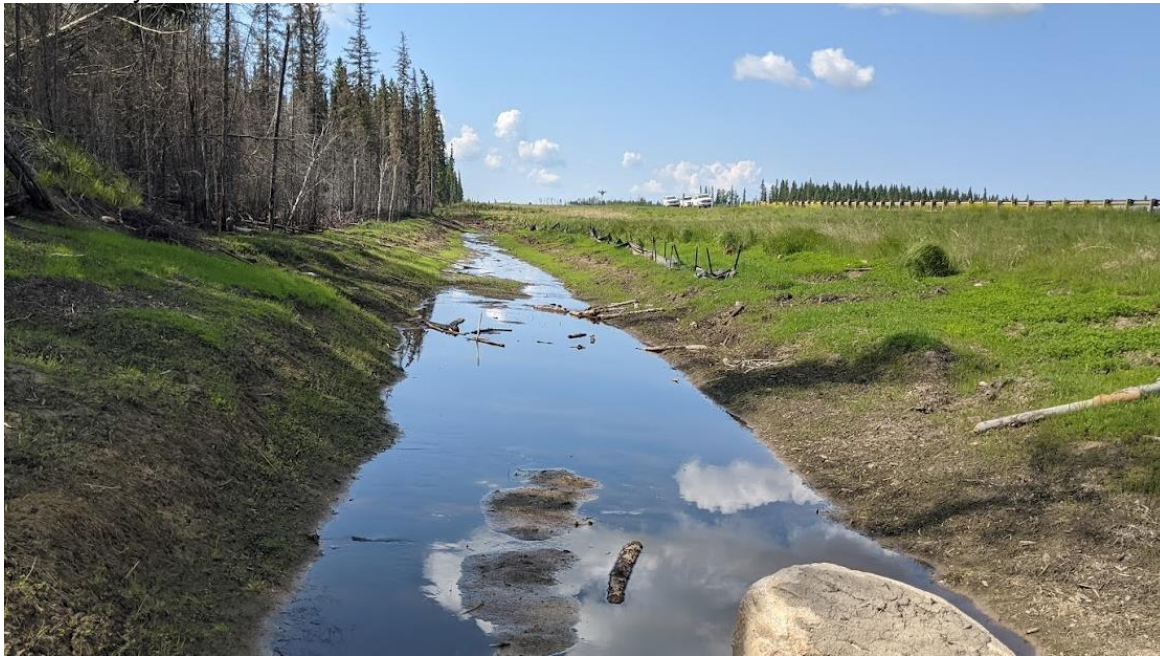
Photo No. 2 – Looking south at the highway west ditch; water is draining towards the eroded riprap channel to the east of the bridge

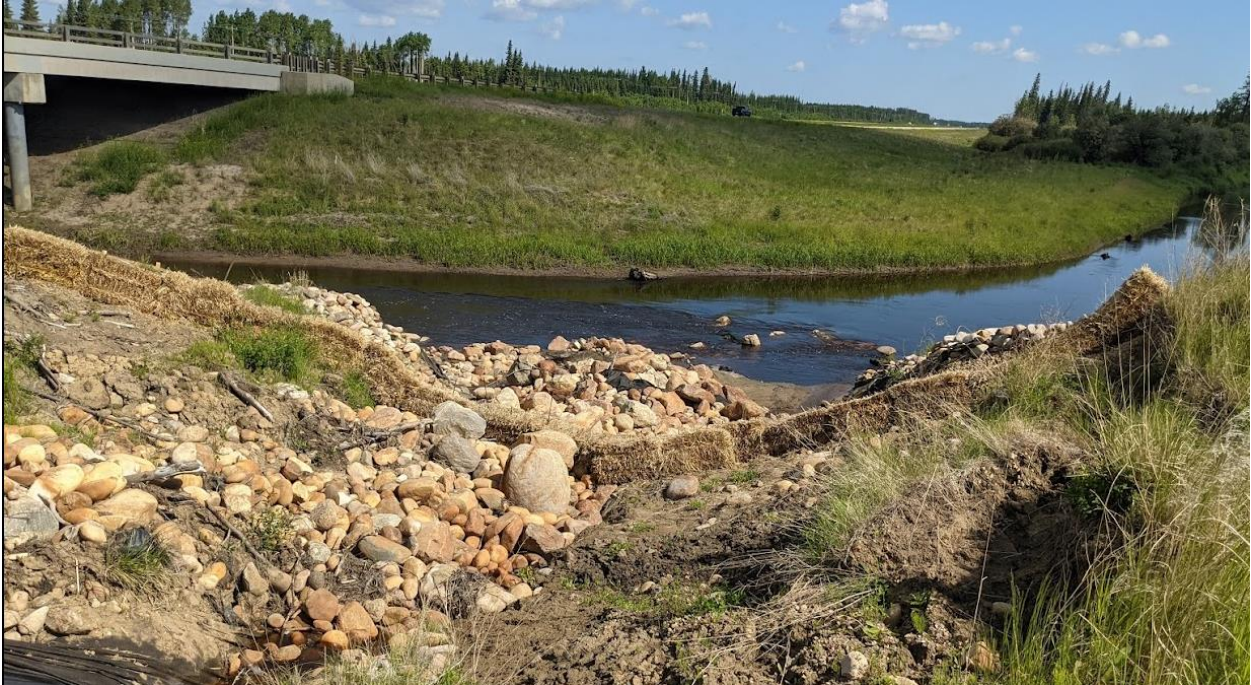
Photo No. 3 – Looking north at north facing riprap channel to the east of the bridge location. Note erosion along the channel. Beaver dam noted in this area in 2020 was removed.

- Reshape the failed riprap-lined channel and add heavy rock riprap (Min Class 1) to armor the re-graded channel.
- Undertake slight grading to seal open cracks within landslide masses.

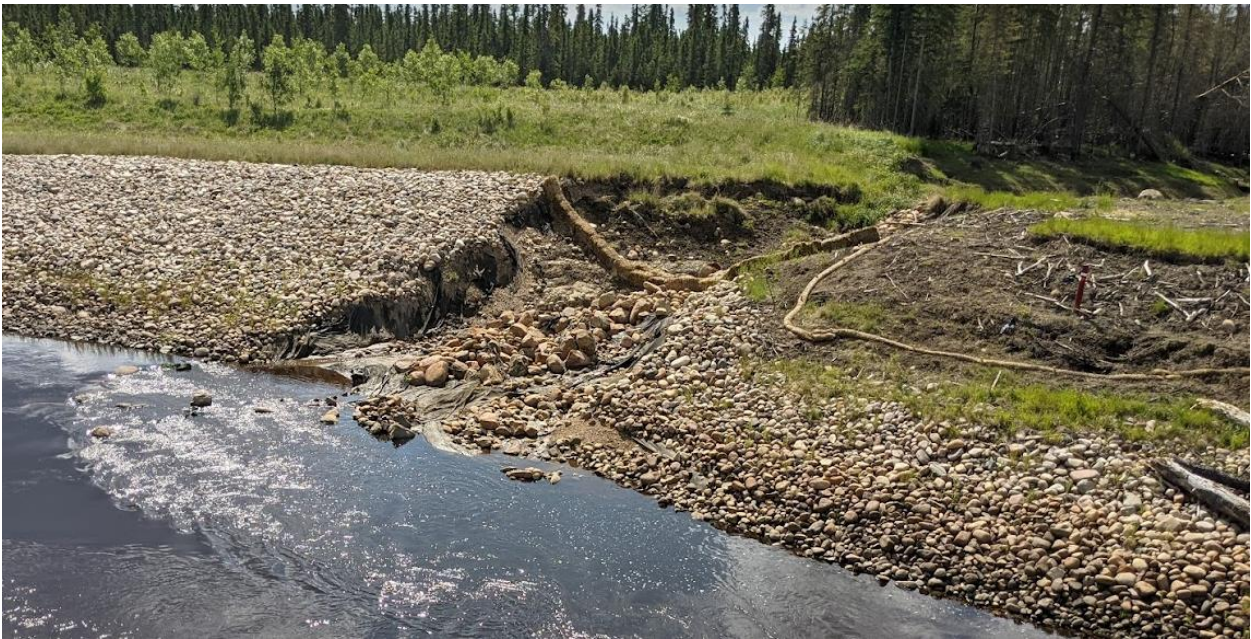
Photo No. 4 – Looking southeast at the same area in Photo No. 3.

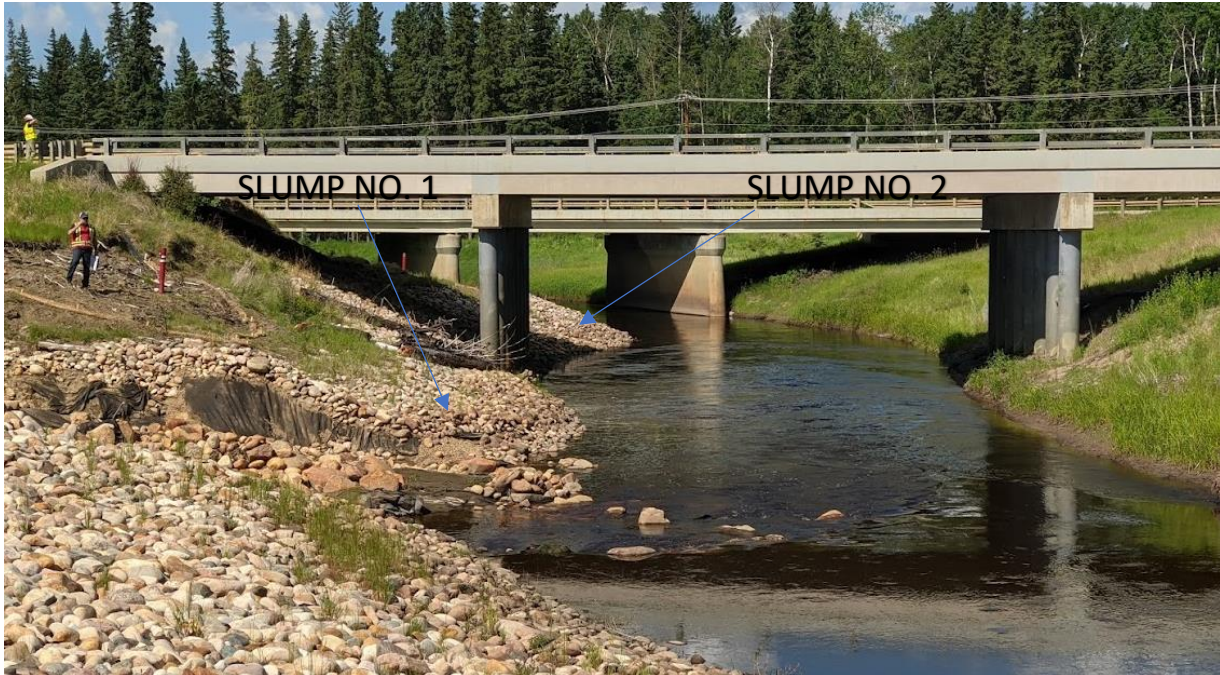
Photo No. 5 – Looking west at river channel; Note slumping within the riverbanks to the east (slump 1) and the west (slump 2) of the south headslope location and the distinct toe rolls in the river channel.

- Place heavy rock riprap (Min. Class 1) at the base of the slumps (near the river location) to provide additional buttress and erosion protection.
- Remove the debris left in place at the location of the old beaver dam to improve surface draining and allow lowering groundwater levels within the highway embankment and direct the water away from Slump 1 location.

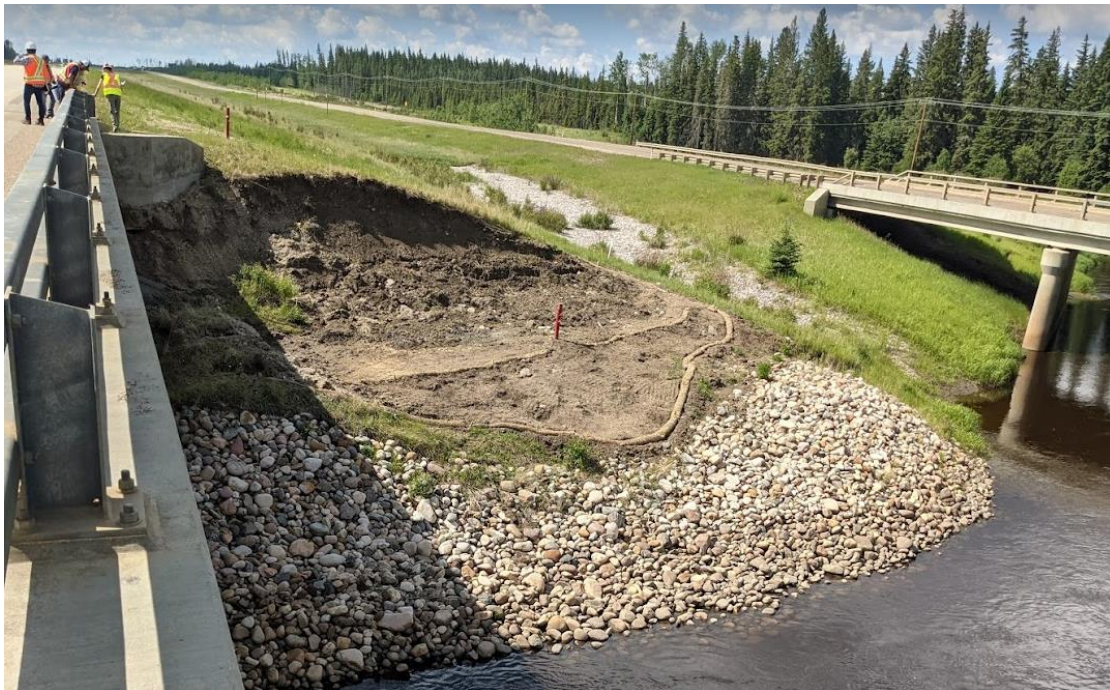
Photo No. 6 – Looking southwest at Slump No. 2

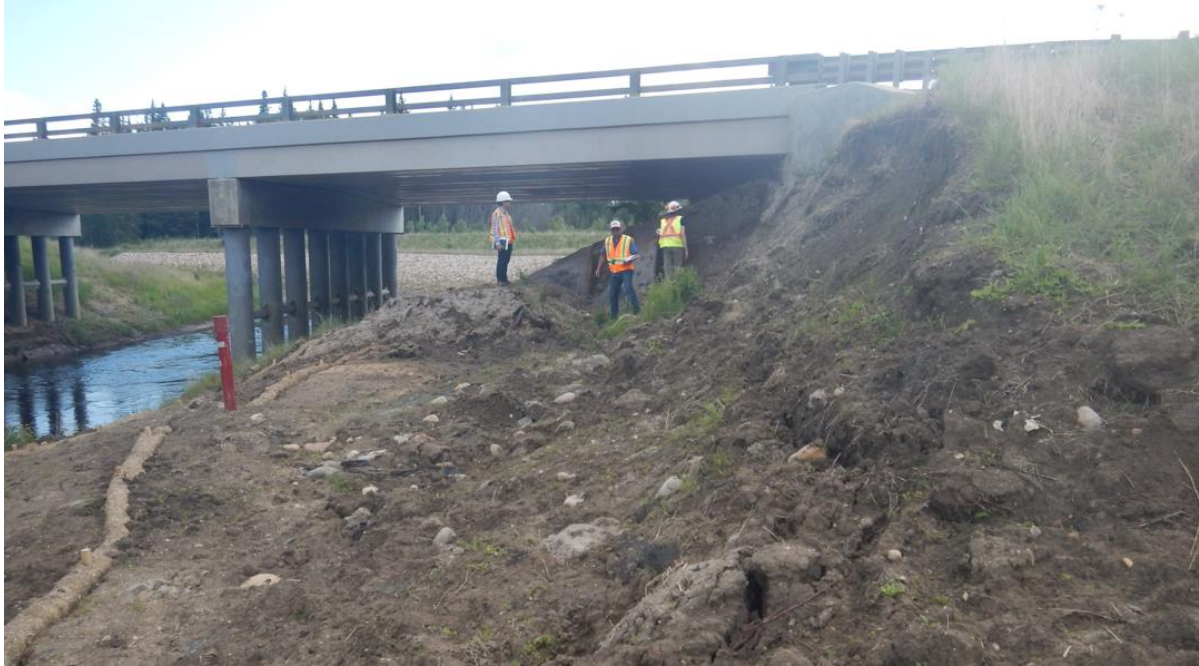
Photo No. 7 – Looking east at the head scarp of Slump No. 2

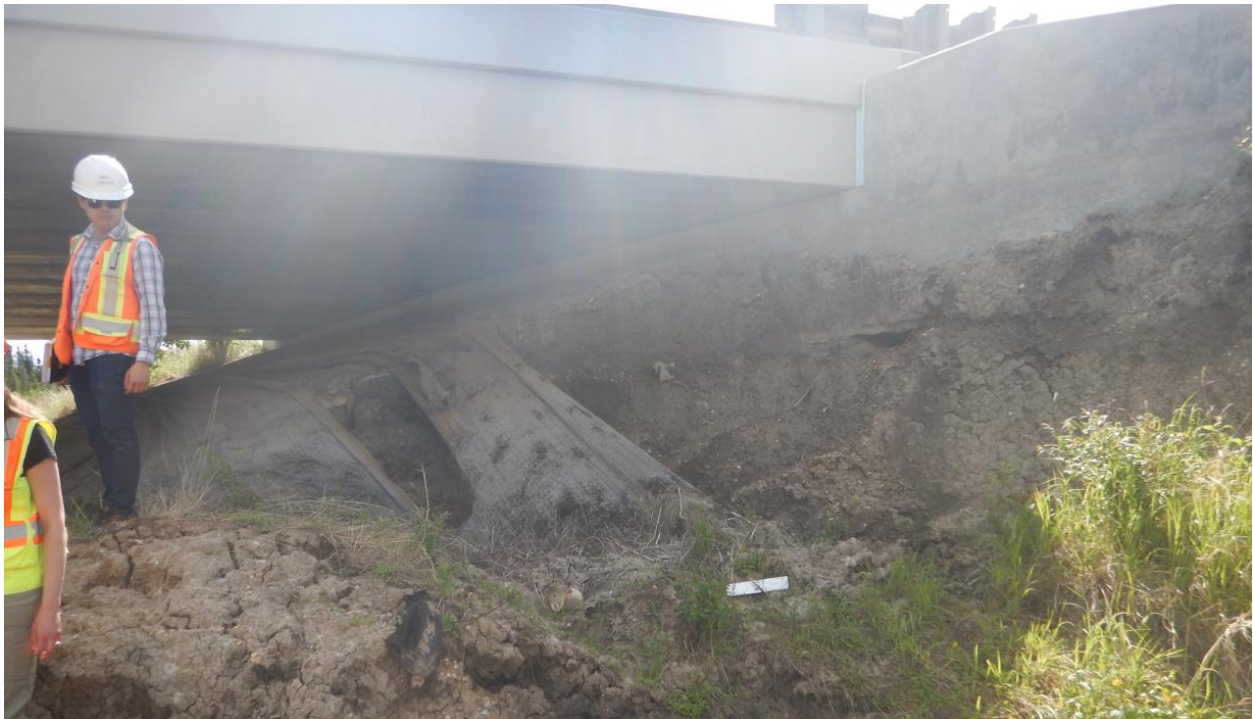
The slumps did not appear to have yet impacted the integrity of the bridge and the highway. However, Slump 2 has exposed the base of the NW wing wall and its flank extended below the headslope of the bridge downslope of the abutment location. Slump 2 is considered more critical than Slump 1 in terms of its potential impact on the highway and the bridge conditions.

Photo No. 8 – Looking southeast at Slump No. 2 head scarp. Note (a) void developed under wing wall, (b) change in soil type between the area under the bridge and the area beyond (west of) the wing wall, and (c) eastern flank of slump extending below the bridge headslope

- Insert a flexible HDPE pipe into the void below the NW wing wall to convey as much flow as possible from the location of the sheared off subdrain pipe to the creek channel.

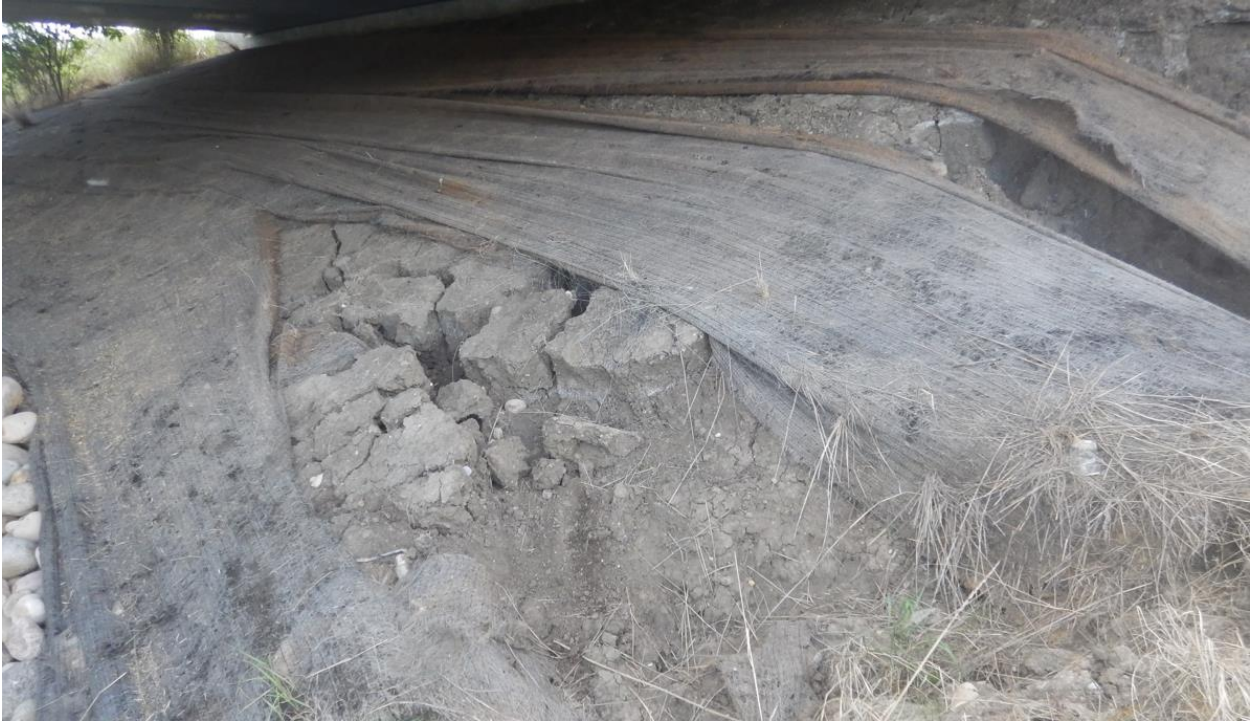
Photo No. 9 – Looking east at the portion of the head slope impacted by Slump No. 2

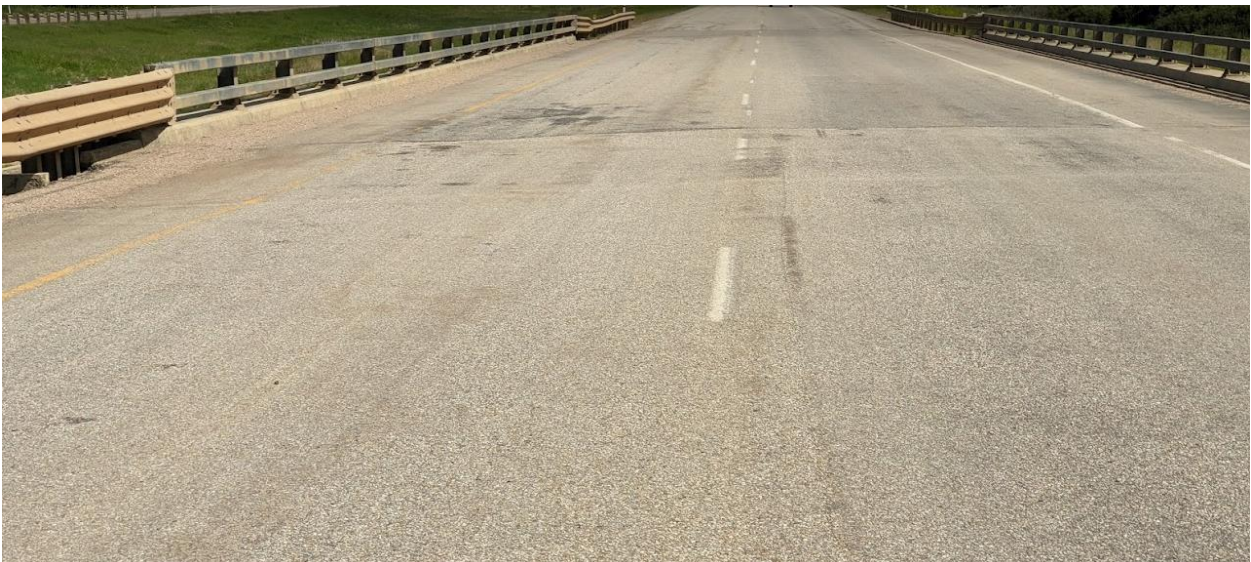
Photo No. 10 – Looking north at the northbound lane bridge south approach slab; there is a slight dip in the highway surface, and it is more noticeable within the western half between the yellow line and the edge of pavement above Slump 2
