**ALBERTA TRANSPORTATION
GEOHAZARD ASSESSMENT PROGRAM
NORTH CENTRAL REGION – ATHABASCA &
FORT MCMURRAY DISTRICTS
2022 SITE INSPECTION**

Site Number	Location	Name	Hwy	km
NC096	13 Km north of Wandering River	Wandering River Bridge (75731N)	63:04	2.85
Legal Description		UTM Co-ordinates (NAD 83)		
NW 12-73-17 W4		12	N6130357.92	E405776.13

**NORTH CENTRAL REGION
 (ATHABASCA AND FORT McMURRAY DISTRICTS)
 2022 GEOHAZARD ASSESSMENT**

**NC096: HWY 63:04 WANDERING RIVER BRIDGE (km 2.85)
 SITE PLAN SHOWING APPROXIMATE SITE FEATURES**

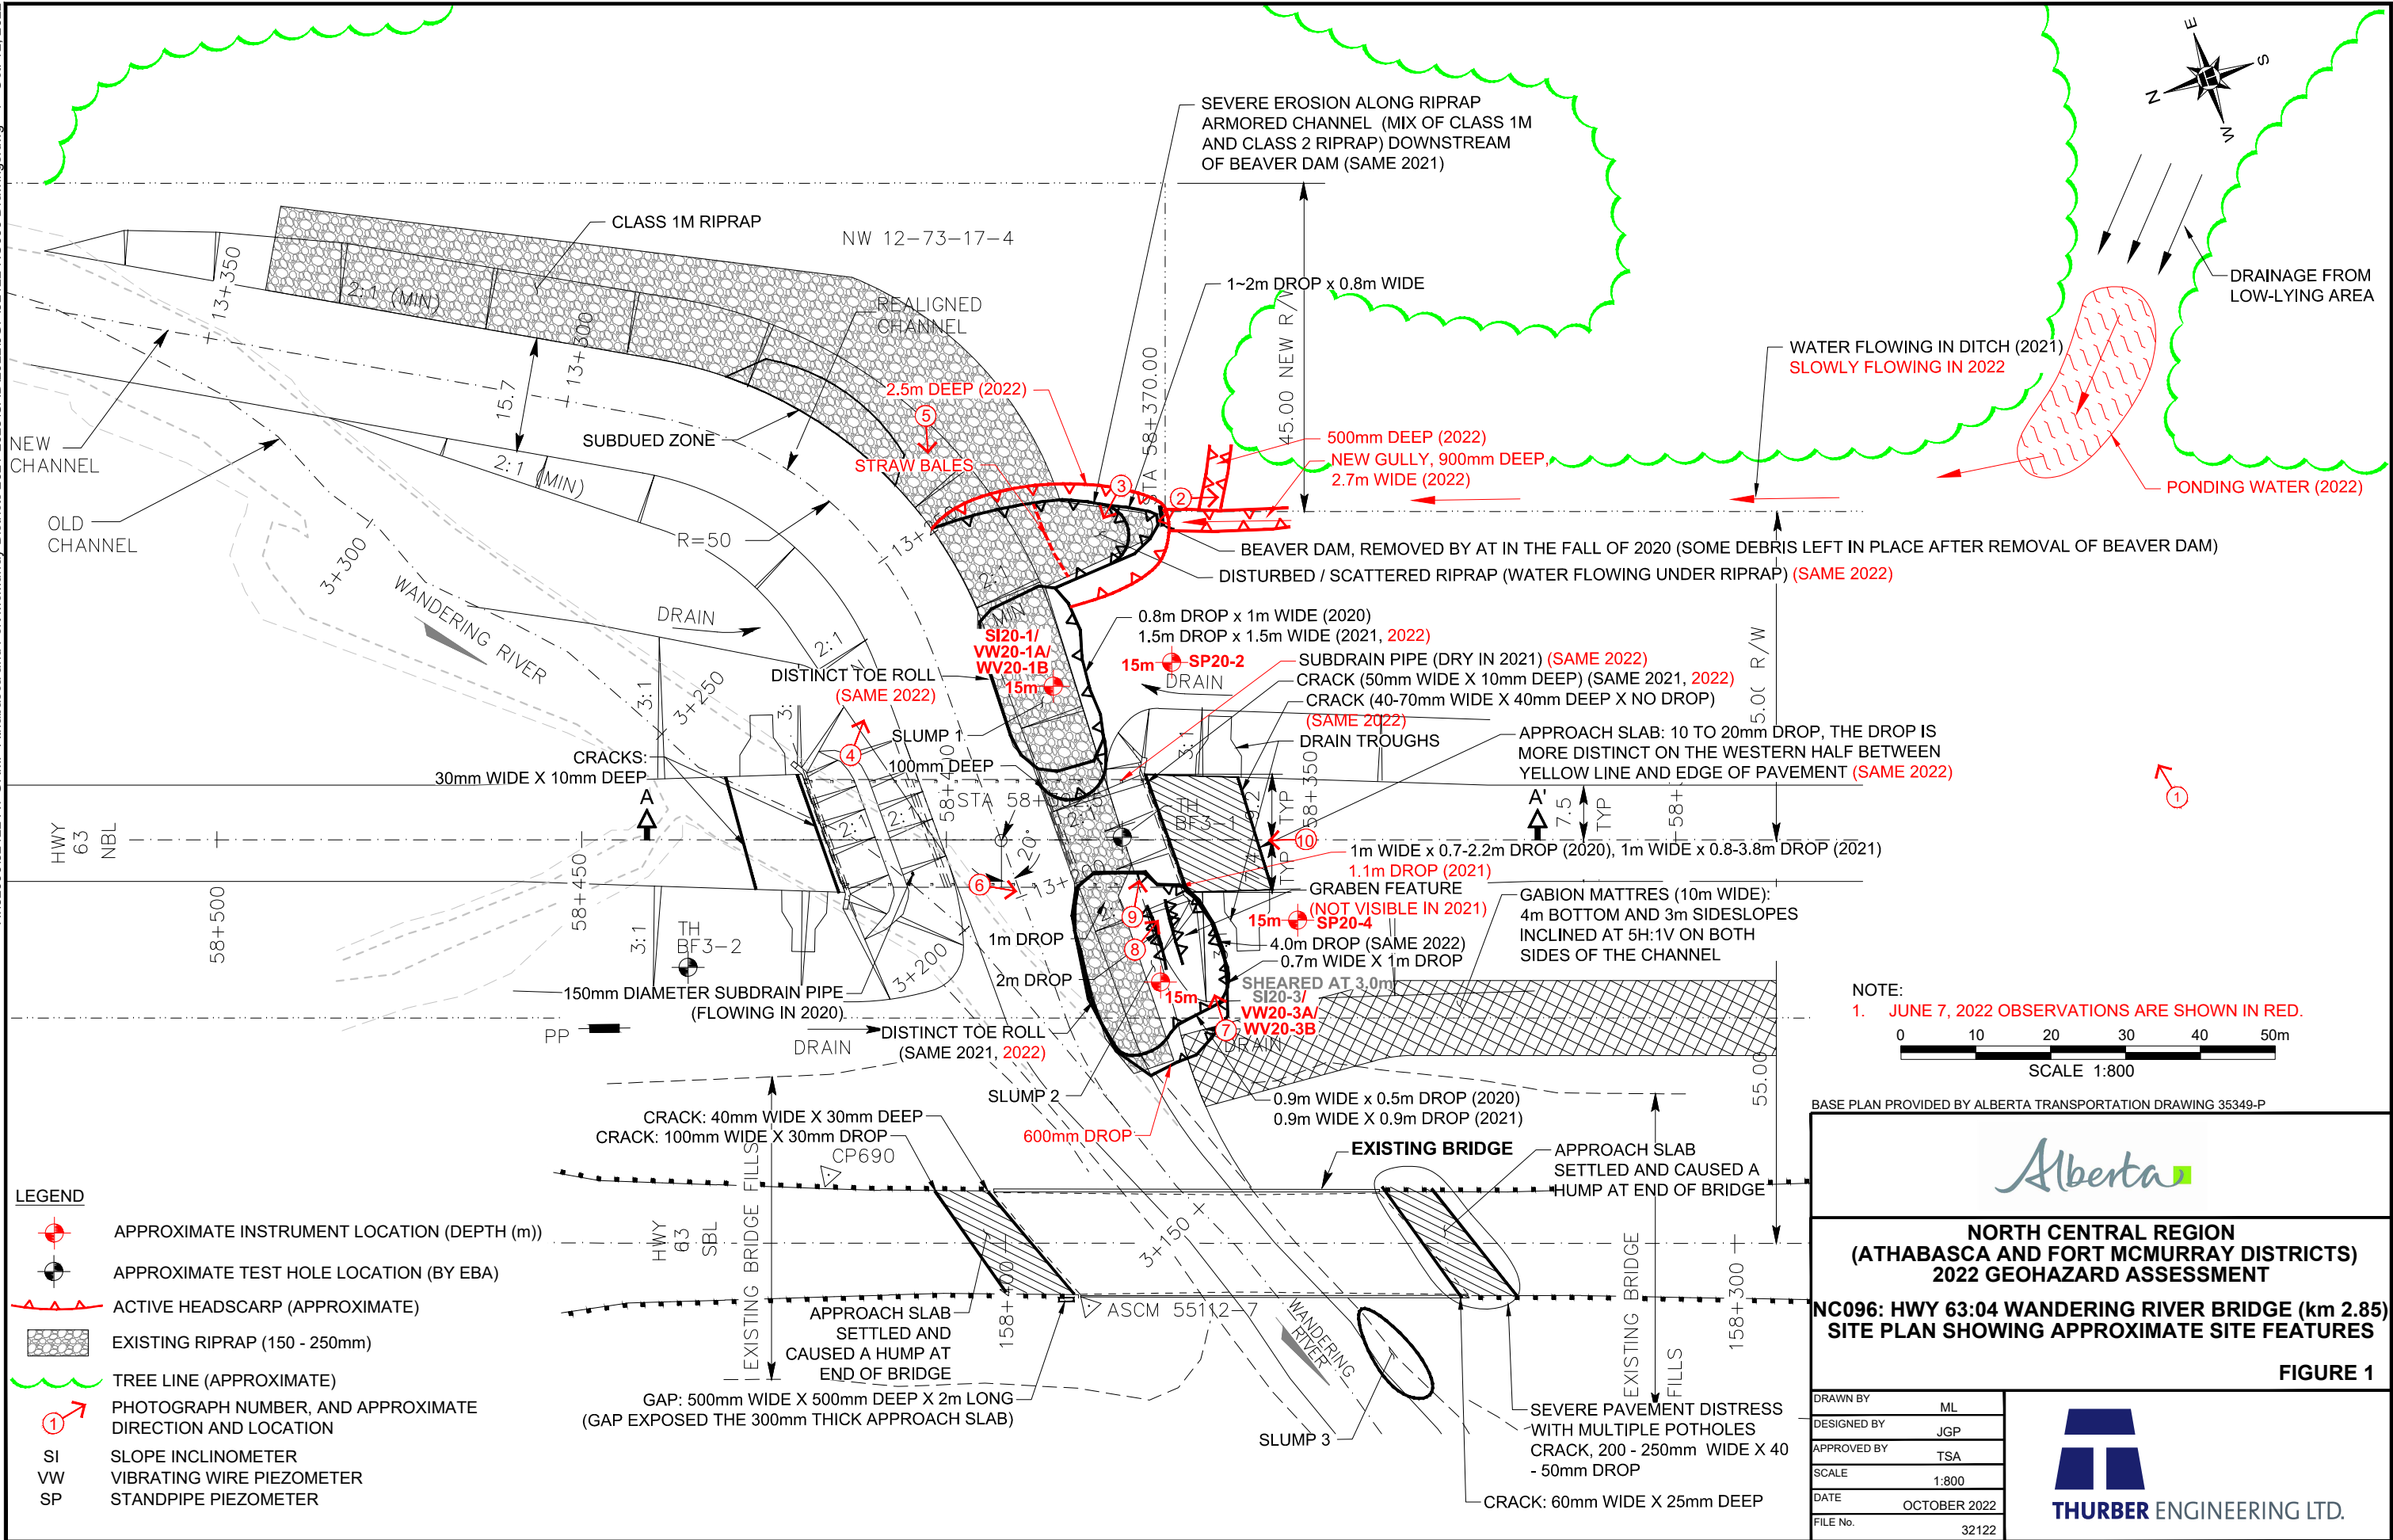
FIGURE 1

NOTE:
 1. JUNE 7, 2022 OBSERVATIONS ARE SHOWN IN RED.
 0 10 20 30 40 50m
 SCALE 1:800

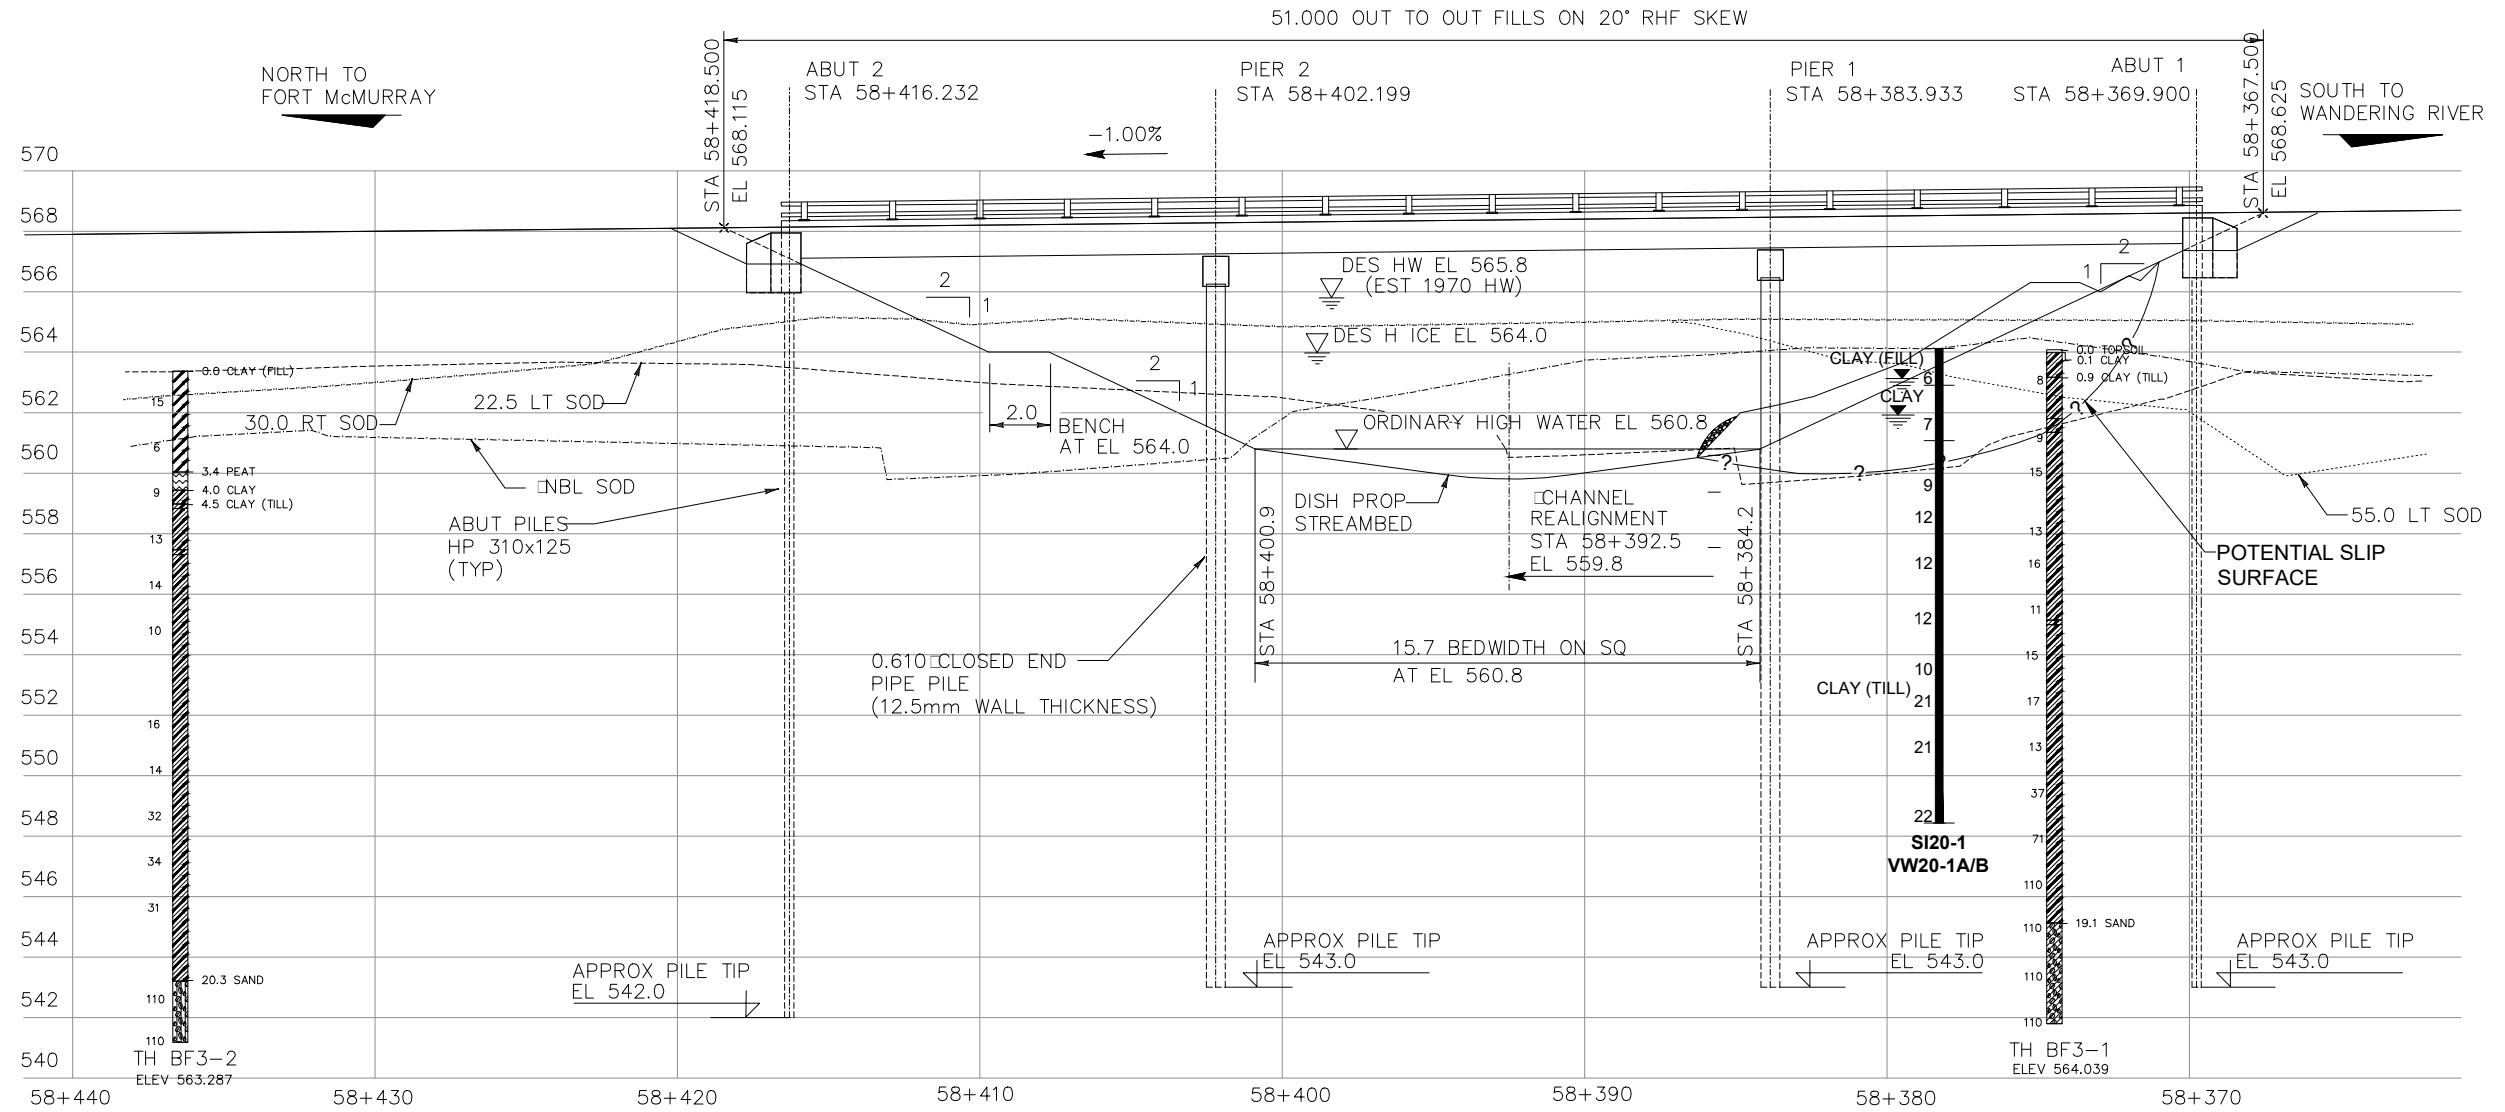
FIGURE 2

1. JUNE 7, 2022 OBSERVATIONS ARE SHOWN IN RED.
2. SLUMP 1 IS WITHIN THE RIVERBANK SLOPE TO THE EAST OF THE BRIDGE HEADSLOPE.

**CROSS - SECTION A - A'
SHOWING SLUMP 1 - EAST OF BRIDGE HEADSLOPE**

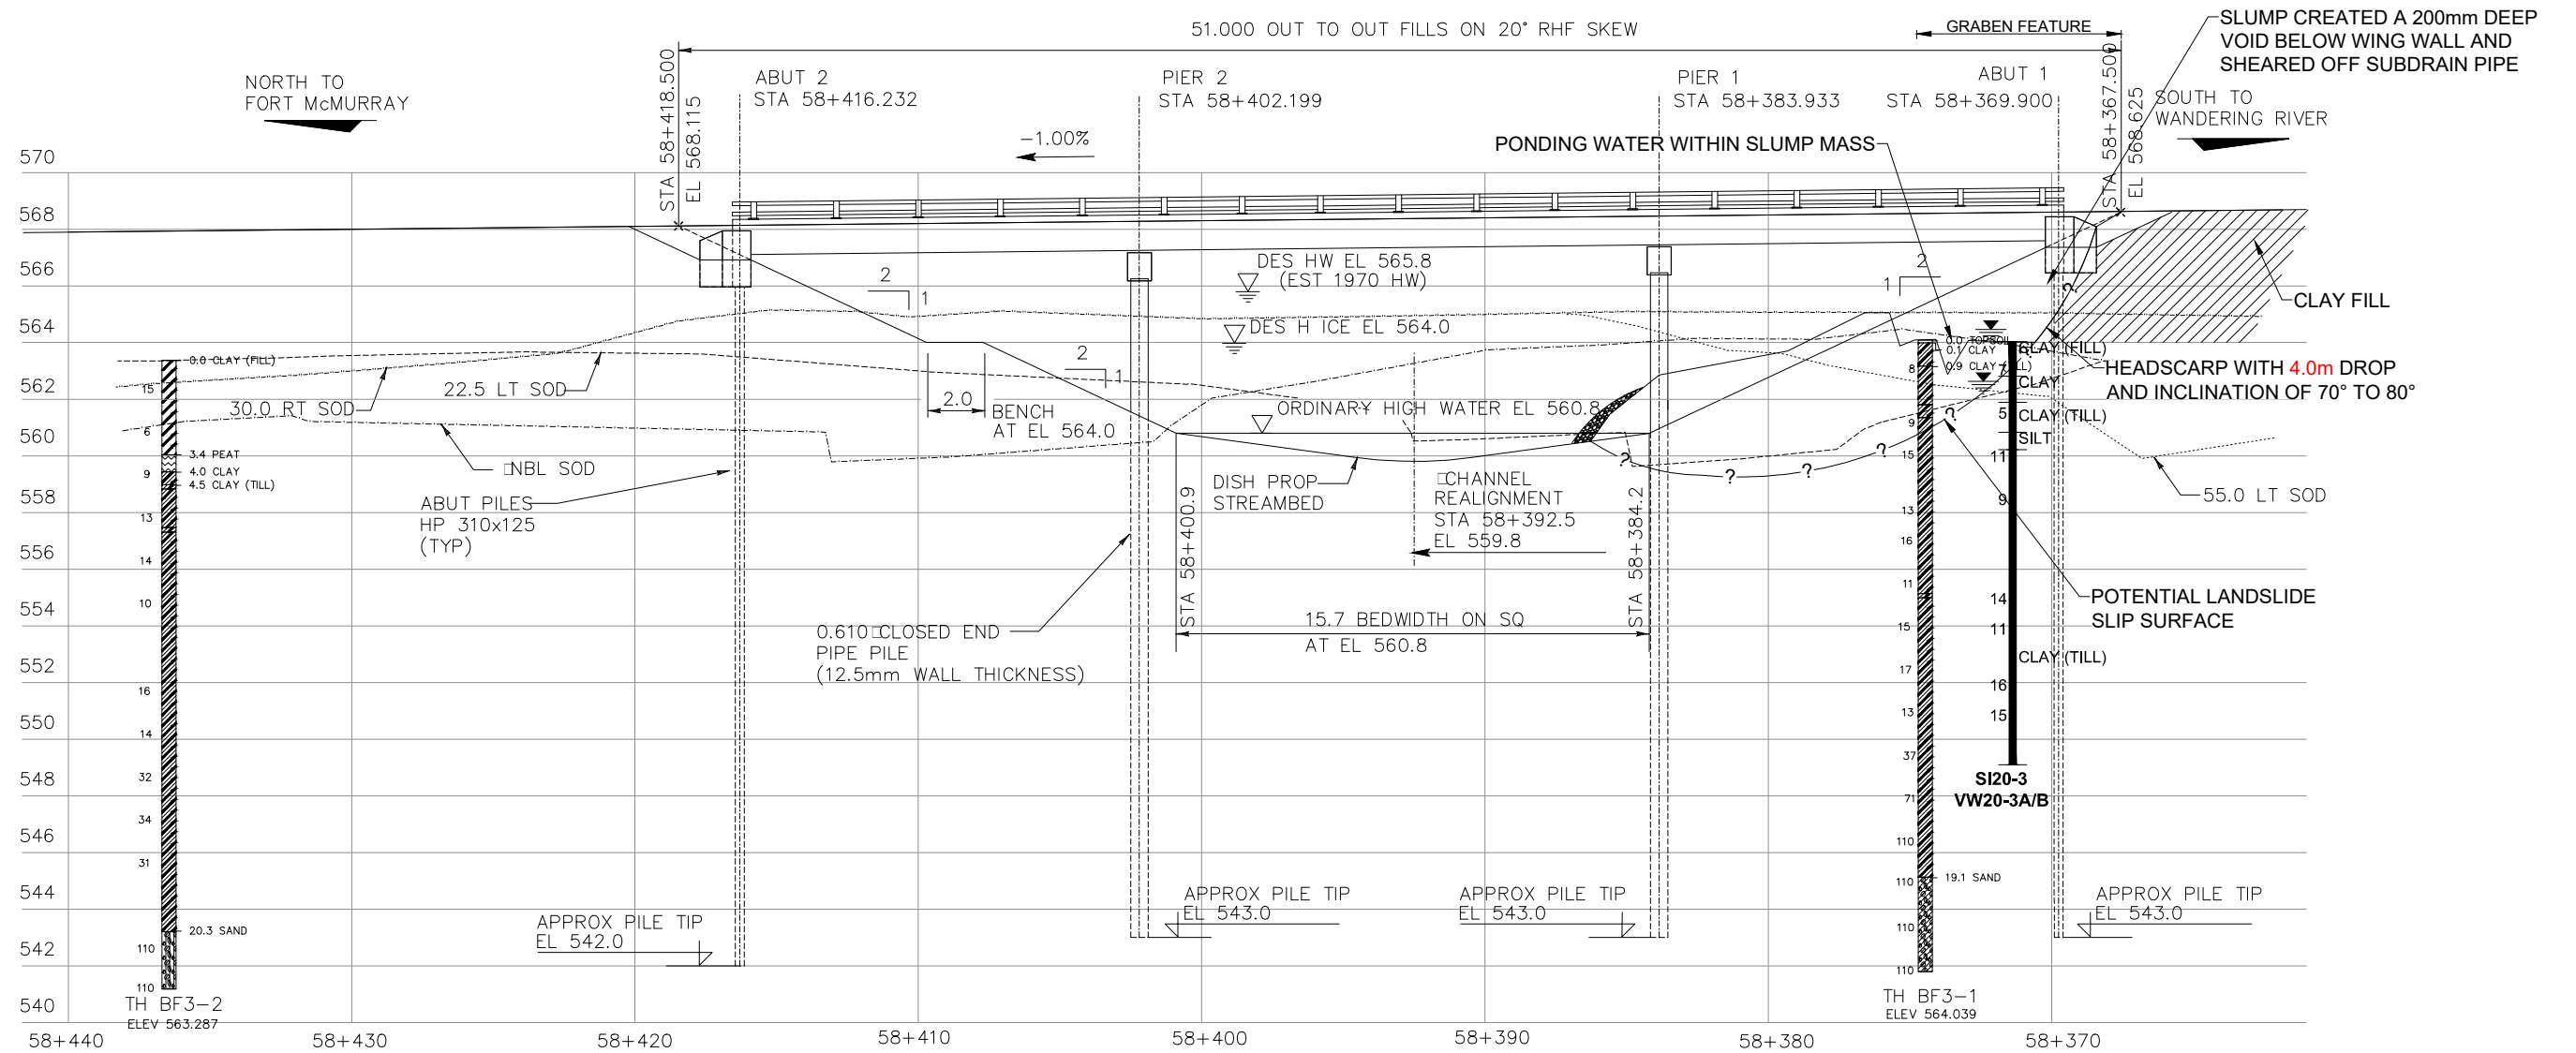
FIGURE 3

The slumps did not appear to have yet impacted the integrity of the bridge and the highway. However, Slump 2 has exposed the base of the NW wing wall and its flank extended below the headslope of the bridge downslope of the abutment location. Slump 2 is considered more critical than Slump 1 in terms of its potential impact on the highway and the bridge conditions.

1. JUNE 7, 2022 OBSERVATIONS ARE SHOWN IN RED.
2. SLUMP 2 IS WITHIN NORTHWEST APPROACH FILL TO THE WEST OF BRIDGE HEADSLOPE. THE EASTERN FLANK OF THE SLUMP EXTENDS INTO BRIDGE HEADSLOPE.
3. SLUMP 2 IS TOEING OUT NEAR THE MOST WESTERN BRIDGE PIER SUPPORT.

CROSS - SECTION A - A'
SHOWING SLUMP 2 - WEST OF BRIDGE HEADSLOPE

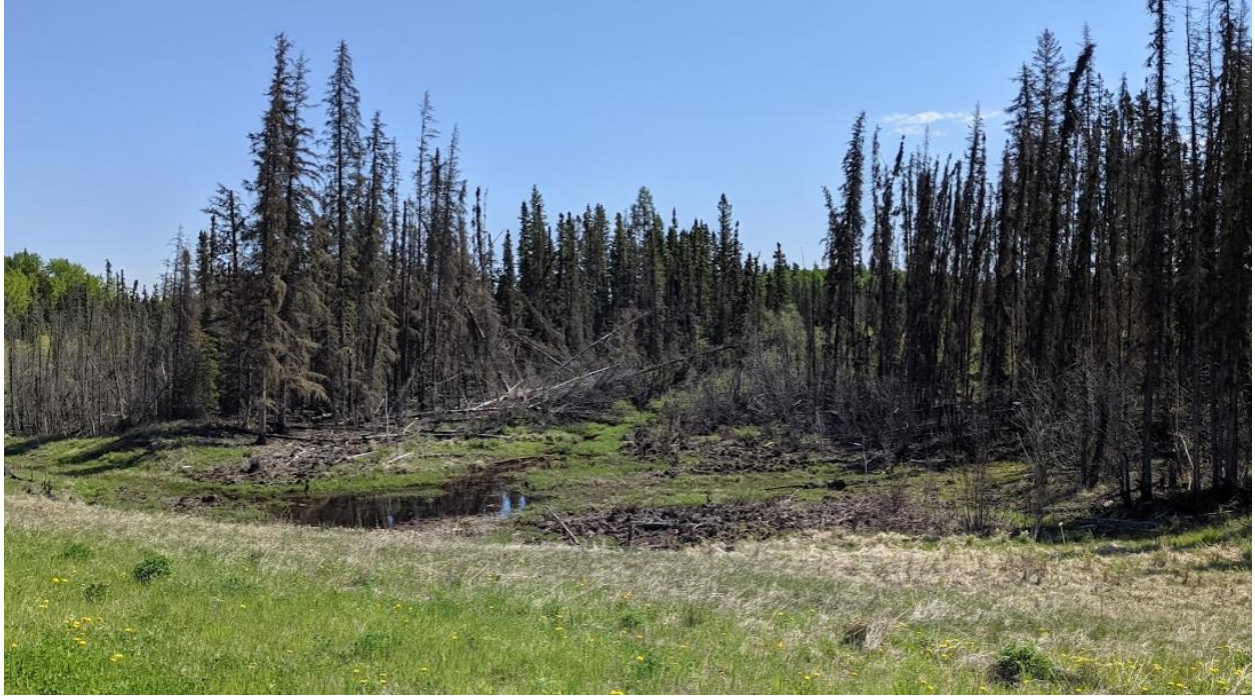
The presence of a beaver dam and ponding water to the east of the highway may have resulted in saturation of the highway embankment and riverbank slopes to the east of the bridge. Field observations from the 2020 inspection indicated that ponded water may have overtopped/breached the dam during a prolonged heavy rainfall event and high flow velocities may have caused the severe erosion to the east of the bridge and saturated the east slump (Slump1). Removal of the beaver pond helped reducing groundwater levels within the mass of Slump1.

Photo No. 1 – Looking northeast from the south side of the bridge at the low lying area within the bush. This area was flooded in 2020, but it is currently drained due to beaver dam removal by AT in the fall of 2020

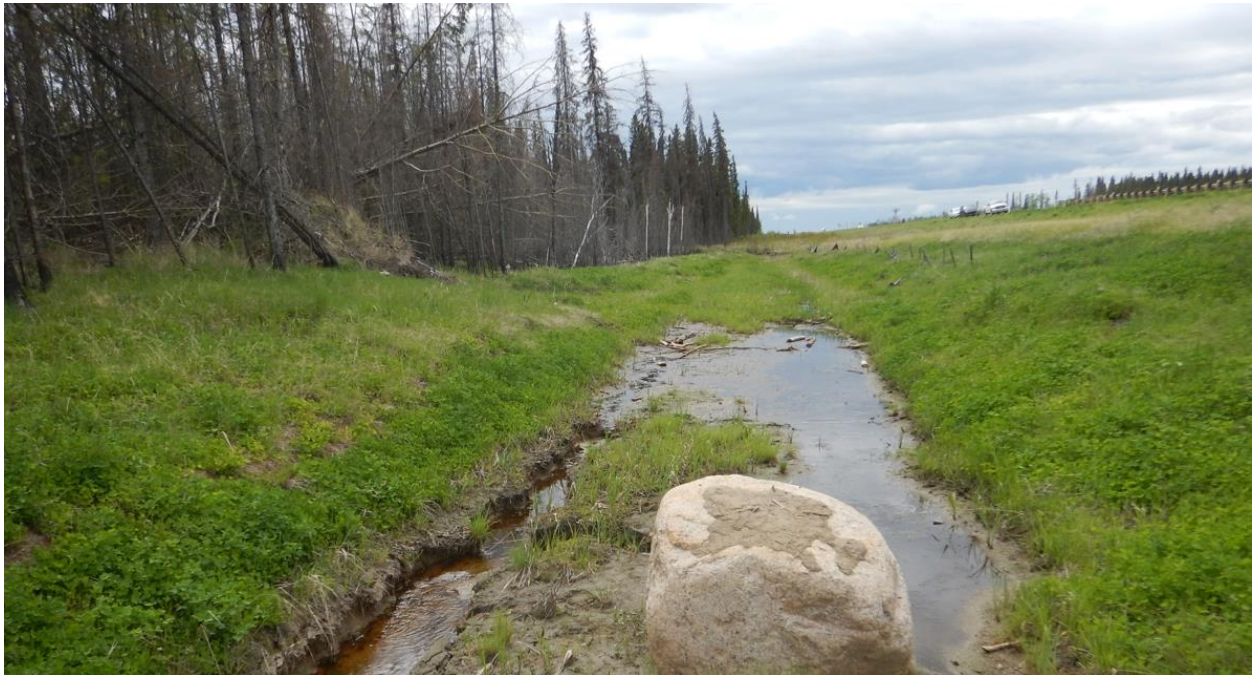
Photo No. 2 – Looking south at the highway west ditch; water is draining towards the eroded ditch to the east of the bridge location

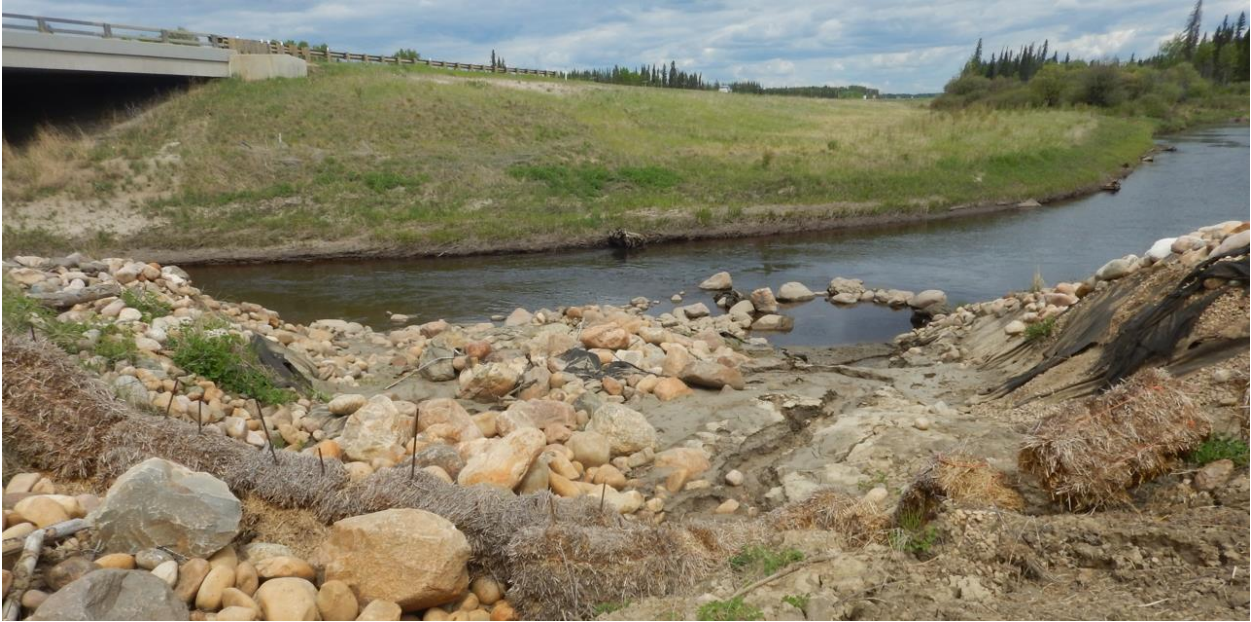
<input checked="" type="checkbox"/> Erosion	Erosion developed east of Slump 1 at the mouth of the north facing riprap lined channel. Erosion became worse in 2022 and it is approximately 2.5 m deep and has distorted the existing riprap within the channel. Scattered and subdued riprap areas along the outside bend of the river channel	<input checked="" type="checkbox"/>
<input checked="" type="checkbox"/> Seepage	Seepage along exposed scarp crack surfaces not observed during the 2022 inspection; ground within the landslide areas was dry. Beaver dam that used to block muskeg terrain drainage path located east of the highway southbound lanes was removed and did not	<input type="checkbox"/>

Photo No. 3 – Looking north at north facing riprap channel to the east of the bridge location. Note erosion along the channel.

Any of the above measures will include re-shaping and armoring the eroded gully and failed banks with heavy rock riprap (at least Class 1), subject to the completion of a hydrotechnical study. The installation of soil nails under the bridge to enhance the FOS of the bridge headslope is also recommended. The additional cost to install and place soil nails (10 m deep, 1.5 m apart) will be in the range of \$400,000.

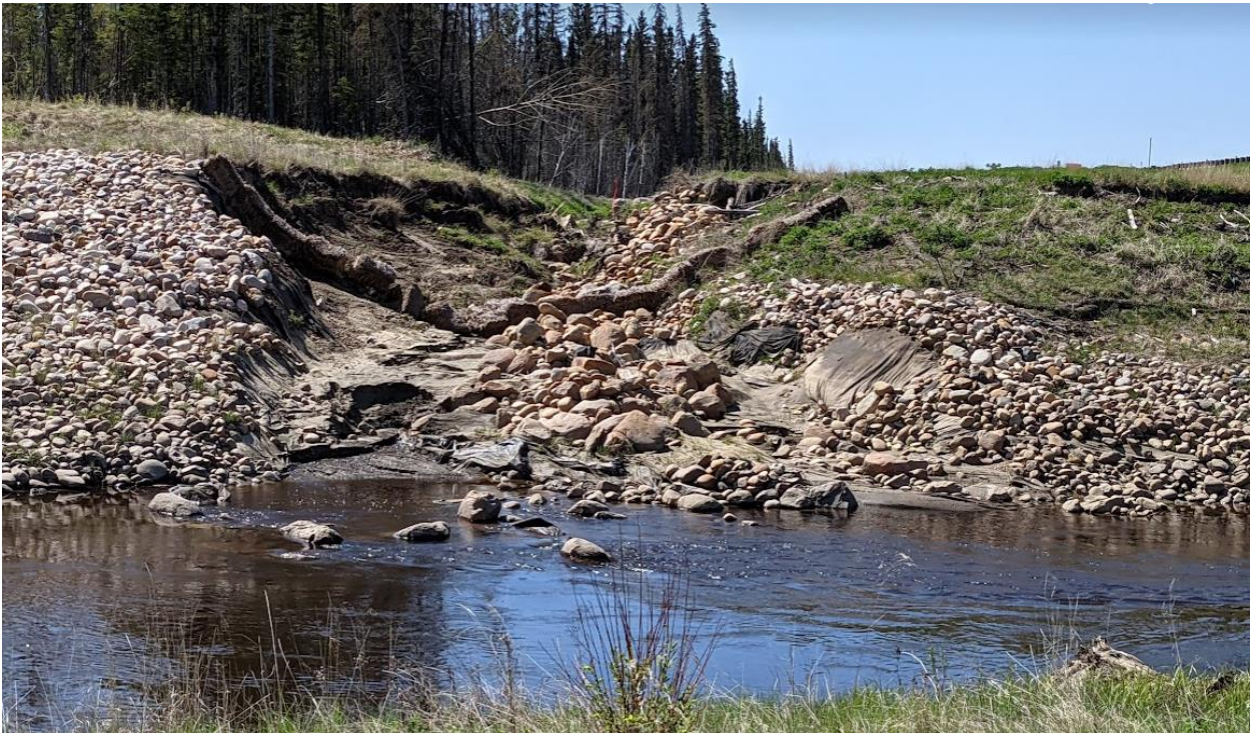
Photo No. 4 – Looking southeast at the same area in Photo No. 3

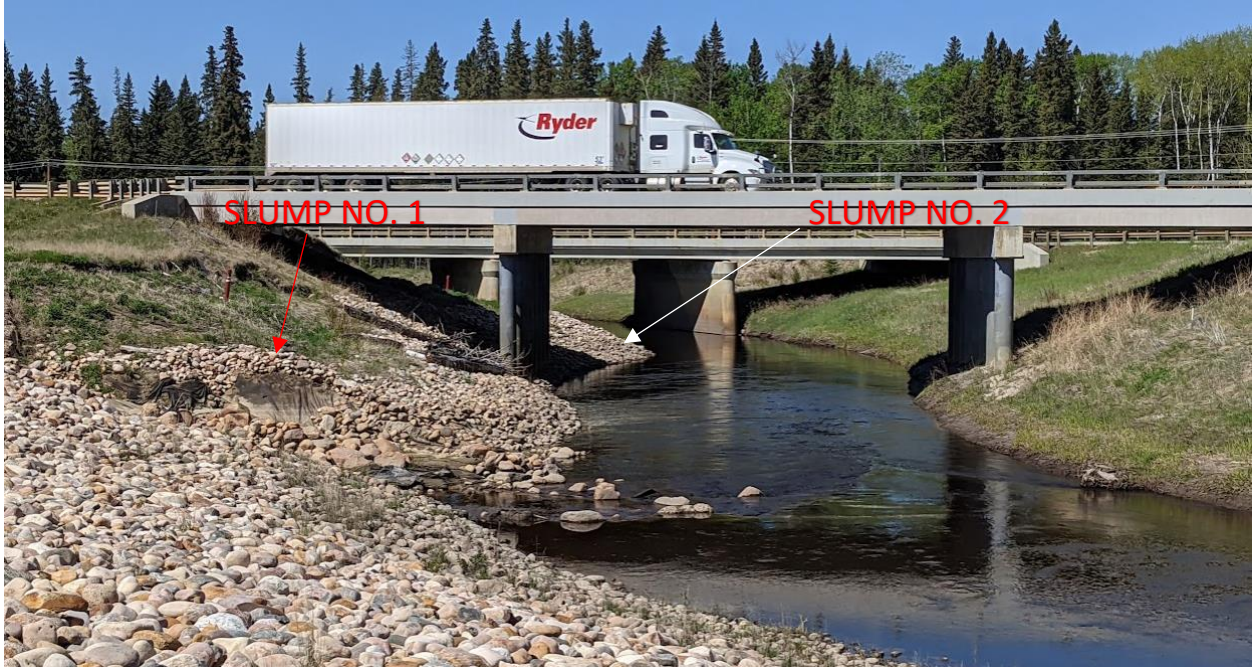
Photo No. 5 – Looking west at river channel; Note slumping within the riverbanks to the east (slump 1) and the west (slump 2) of the south headslope location and the distinct toe rolls in the river channel.

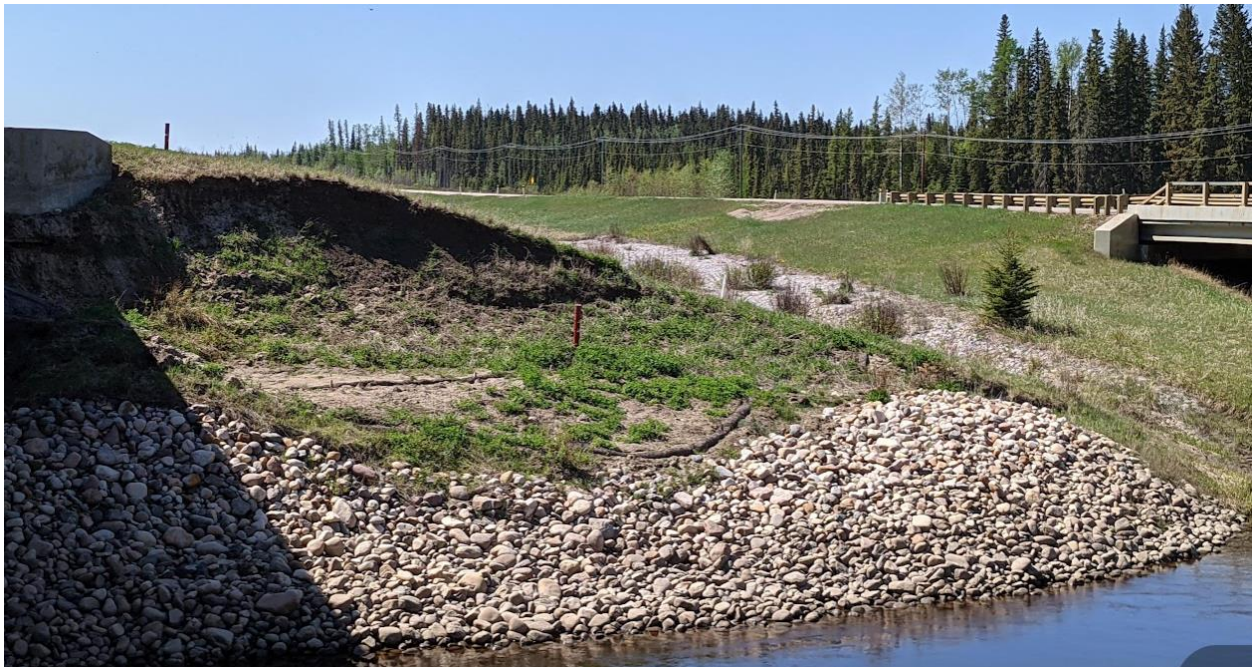
Photo No. 6 – Looking southwest at Slump No. 2

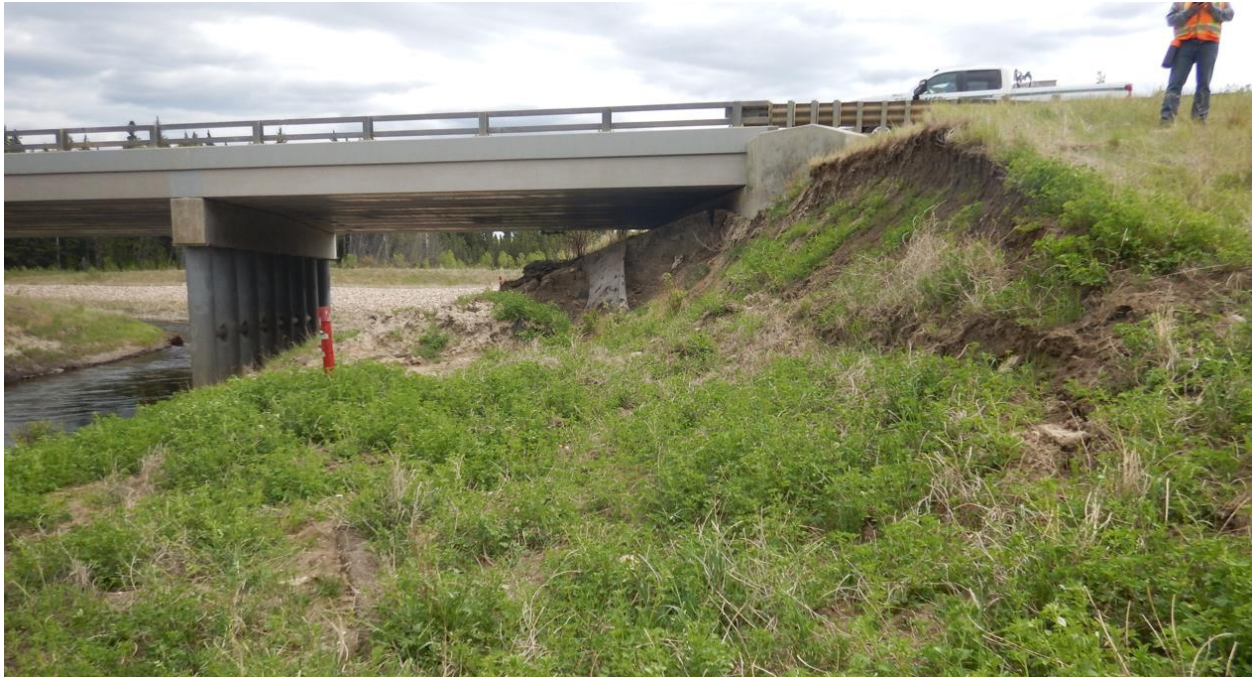
Photo No. 7 – Looking east at the head scarp crack of Slump No. 2

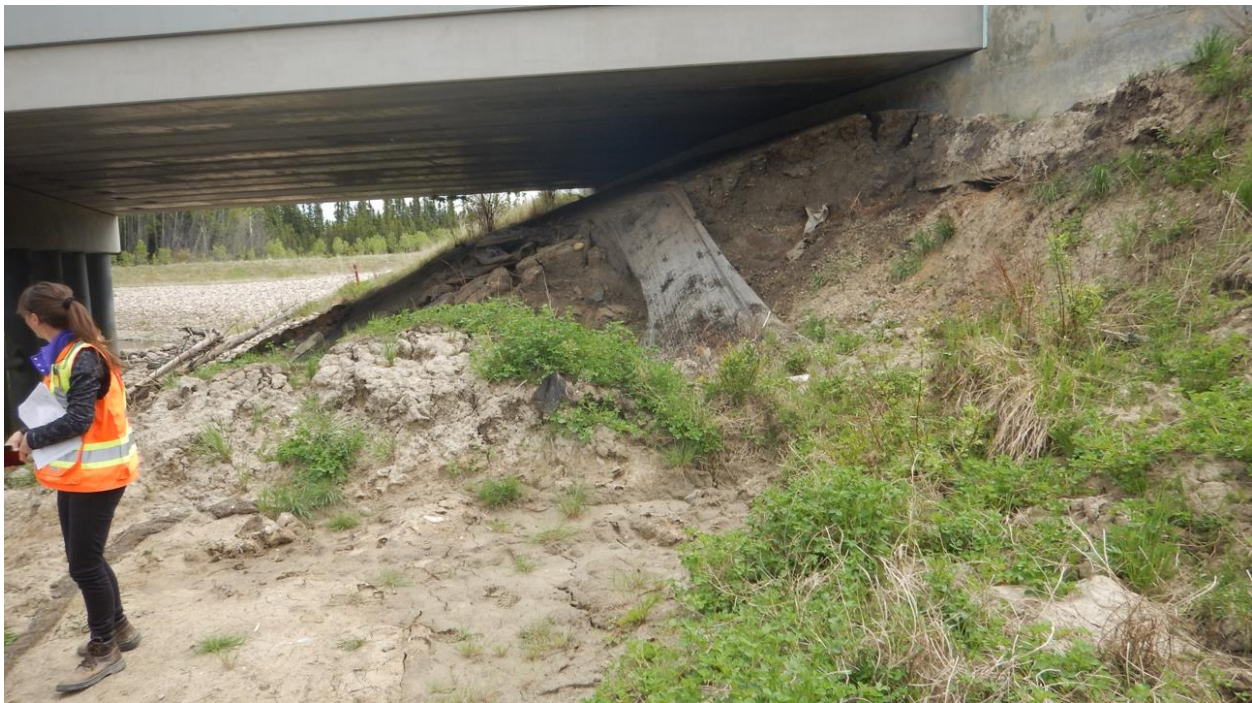
Photo No. 8 – Looking southeast at Slump No. 2 flank. Note: (a) void developed under wingwall, (b) change in soil type between the area under the bridge and the area beyond (west of) the wing wall, and (c) eastern flank of slump extending below the bridge headslope

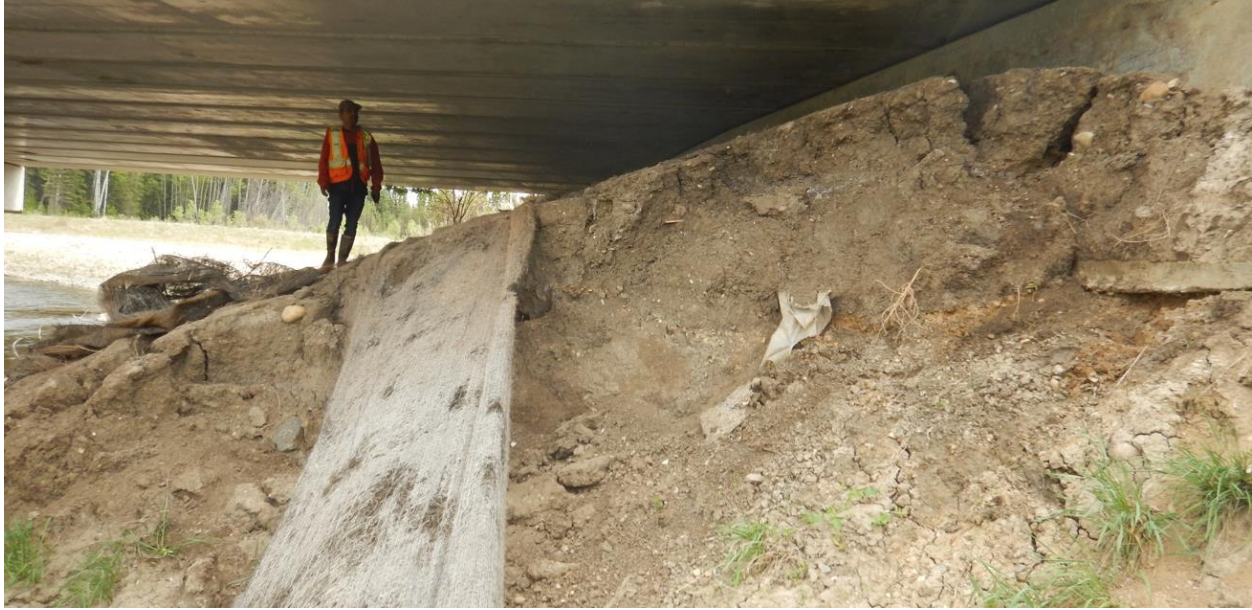
Photo No. 9 – Looking east at the portion of the head slope impacted by Slump No. 2

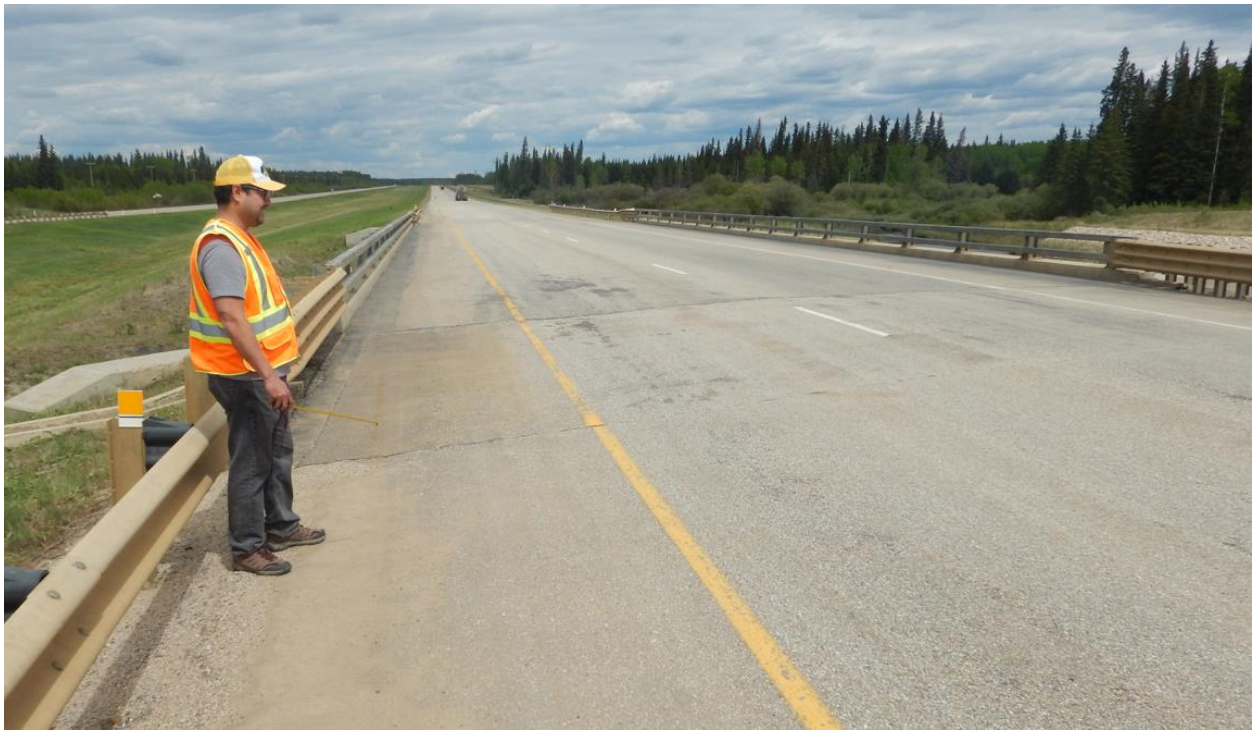
Maintenance /Repairs	None	
Observations:	Description	Worse?
<input checked="" type="checkbox"/> Pavement Distress	10 to 20 mm dip within the south approach slab; worse area within the western lanes	<input type="checkbox"/>
<input checked="" type="checkbox"/> Slope Movement	A slump developing on each side of the bridge headslope. Slump 1 on the east side of the highway: head scarp cracks up to 1.5 deep and 1.5 m wide. Slump 2 on the west side of the highway: head scarp cracks up to 4 m deep and 1 m wide; multiple tension cracks within the Slump 2 slide area. The eastern flank of Slump 2 extends under the bridge by at least 2 m, but it is not exposing the abutment or pile supports. Slump 2 sheared off existing 150 mm diameter subdrain pipe and developed a 200 mm gap under the southwest wing wall. Both slumps 1 and 2 are toeing out into the river channel and are narrowing the river channel by approximately 1.2 m.	<input type="checkbox"/>

Photo No. 10 – Looking north at the bridge south approach slab; there is a slight dip in the highway surface, and it is more noticeable within the western half between the yellow line and the edge of pavement above Slump 2
