**ALBERTA TRANSPORTATION AND ECONOMIC CORRIDORS
GEOHAZARD ASSESSMENT PROGRAM
NORTH CENTRAL REGION – ATHABASCA &
FORT MCMURRAY DISTRICTS
2023 SITE INSPECTION**

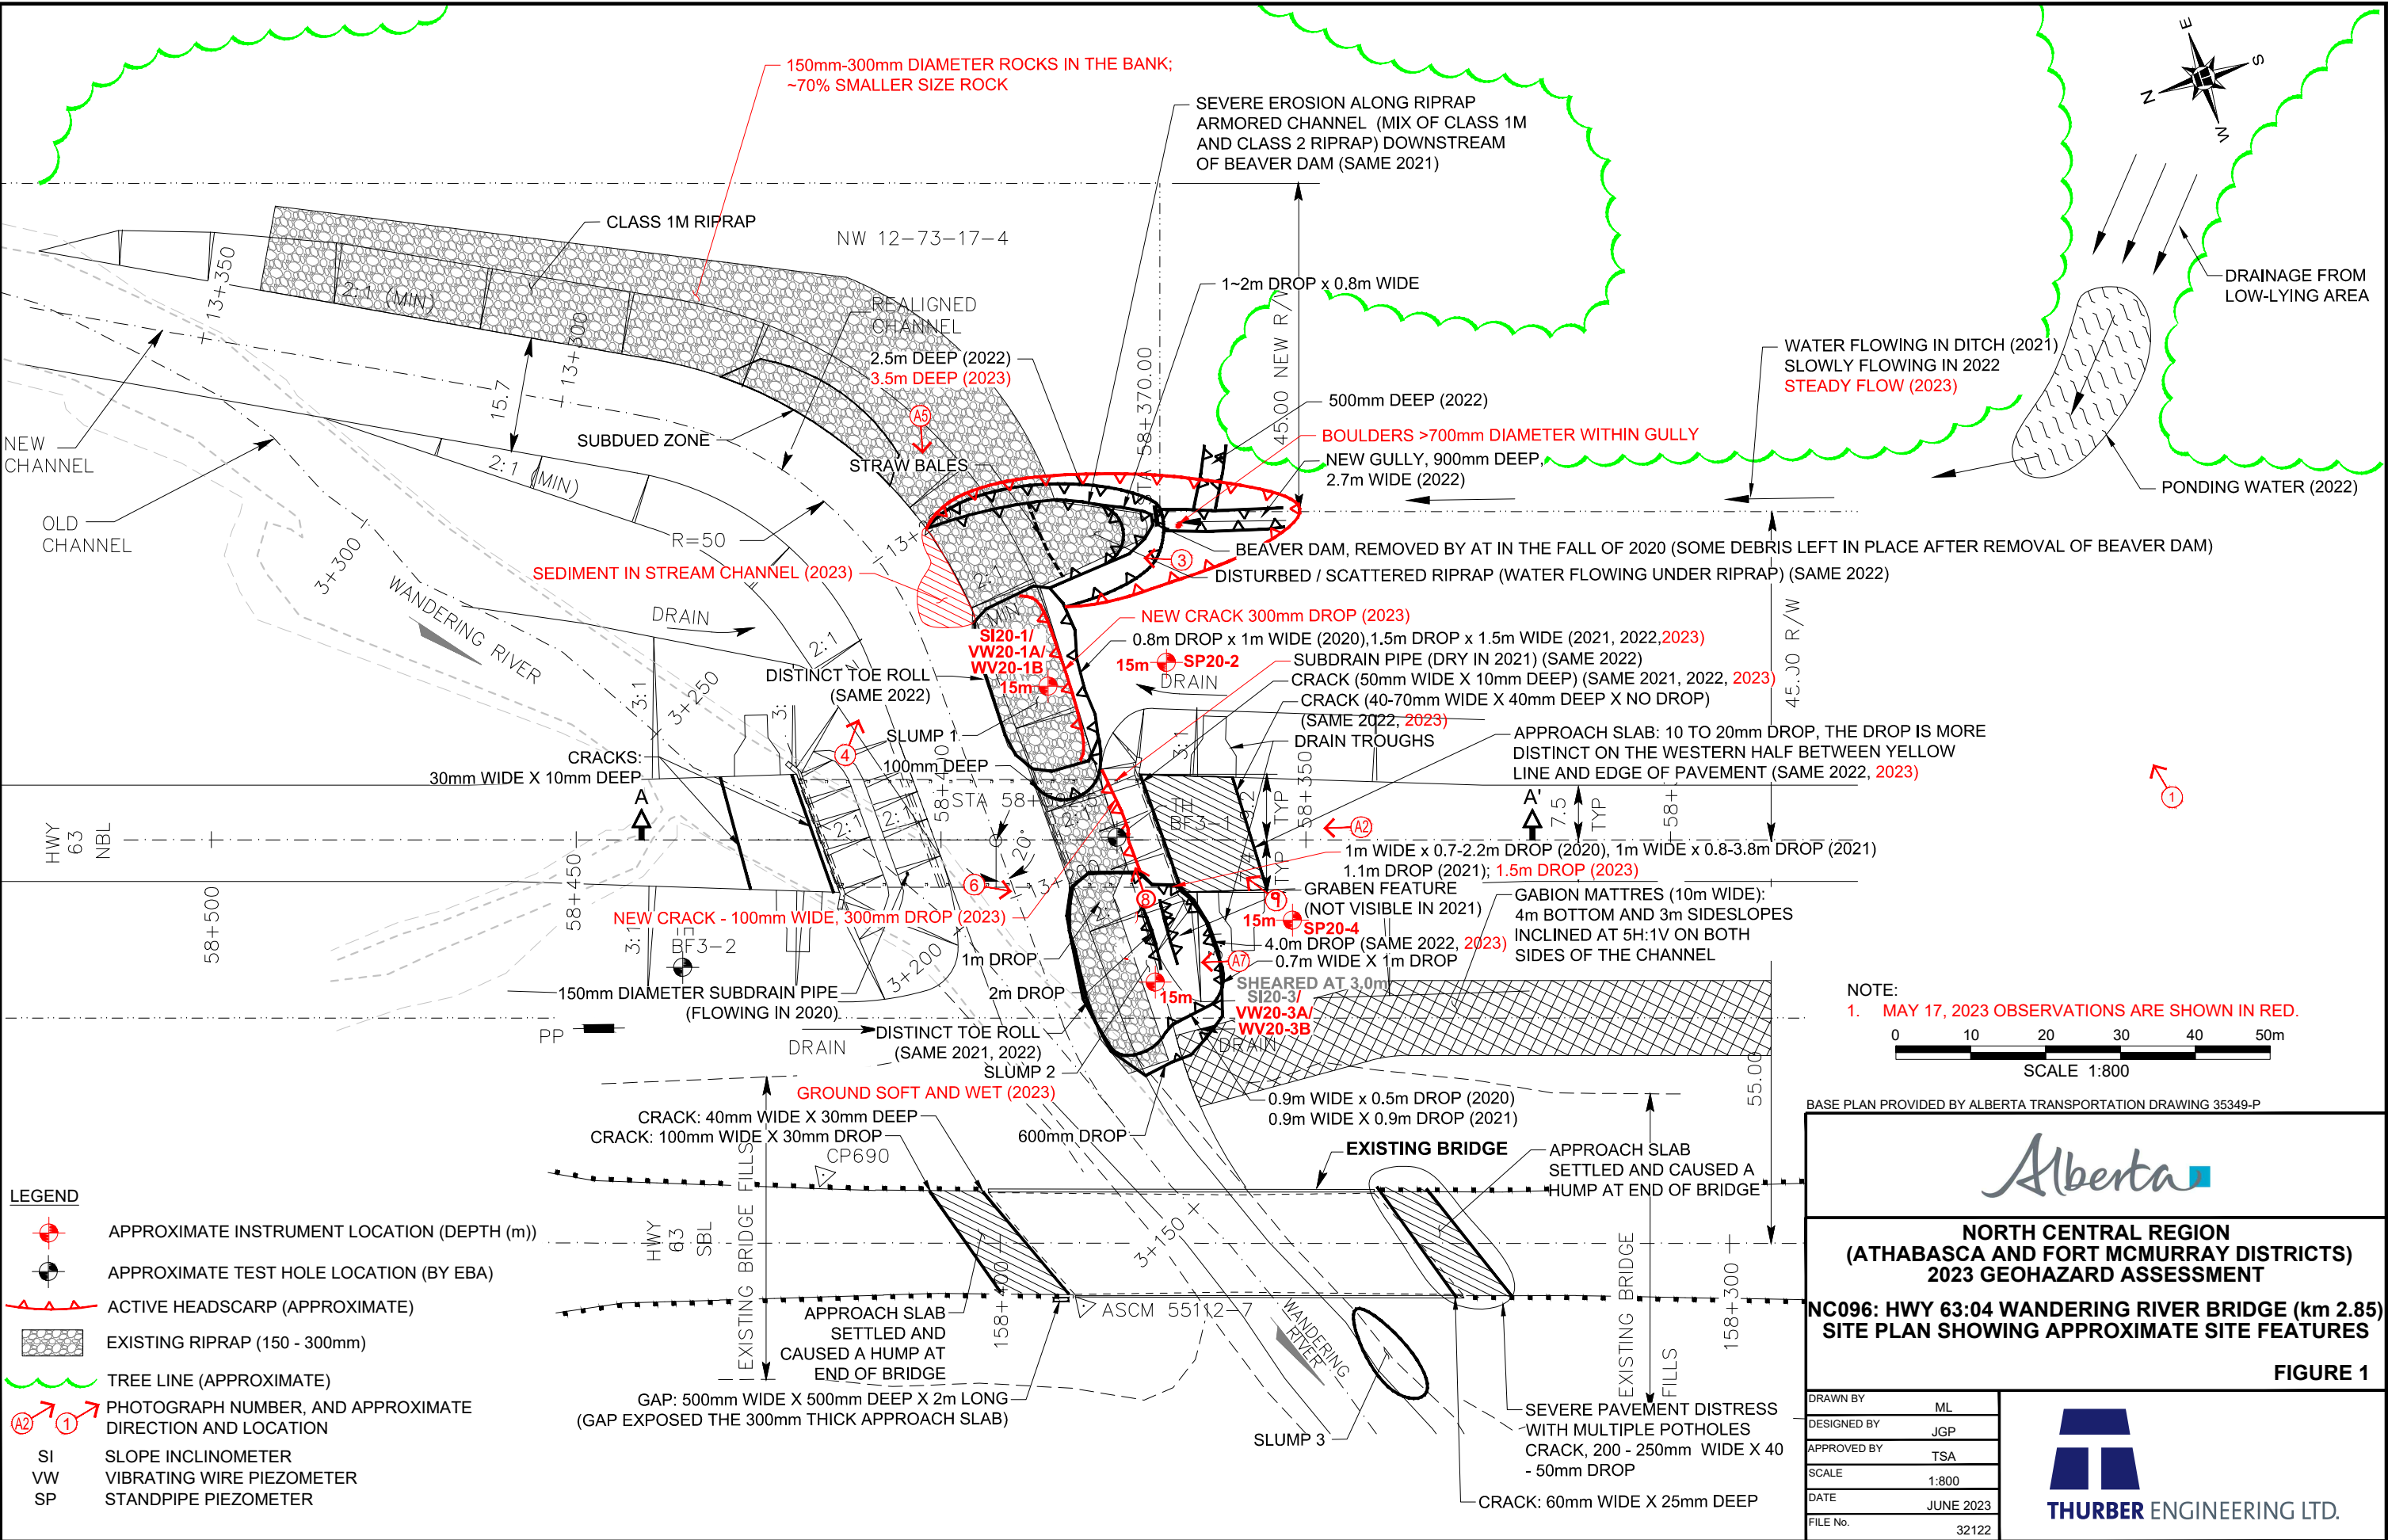
NOTE:
 1. MAY 17, 2023 OBSERVATIONS ARE SHOWN IN RED.

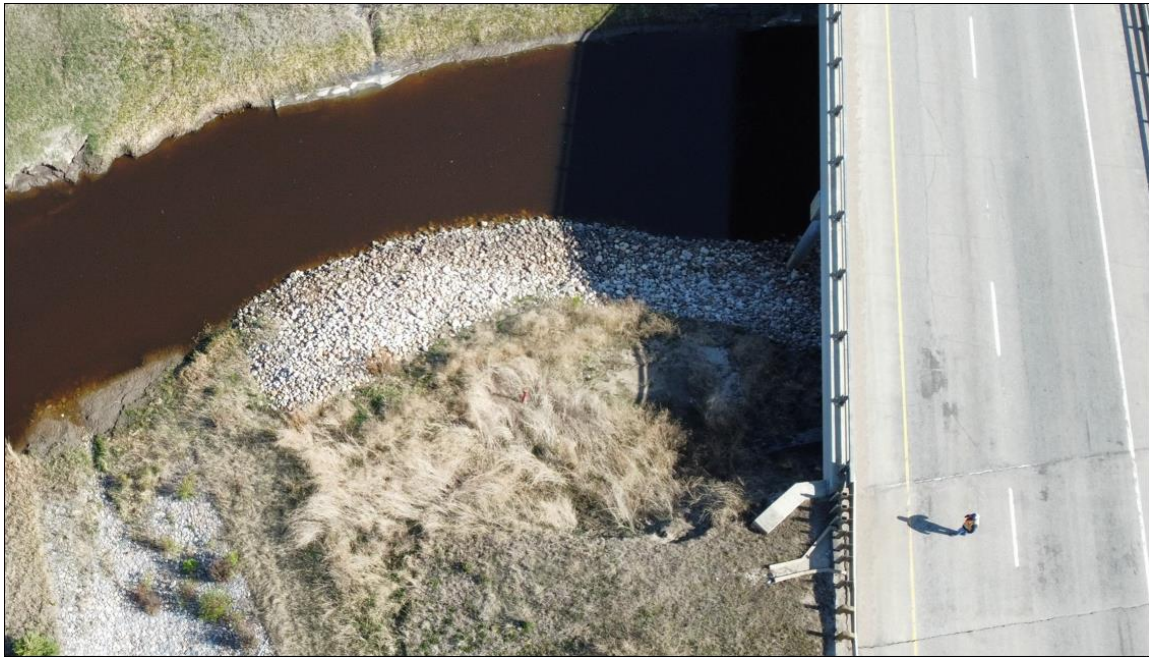
Photo No. A7 (Aerial photo) – Looking at the head scarp crack of Slump No. 2

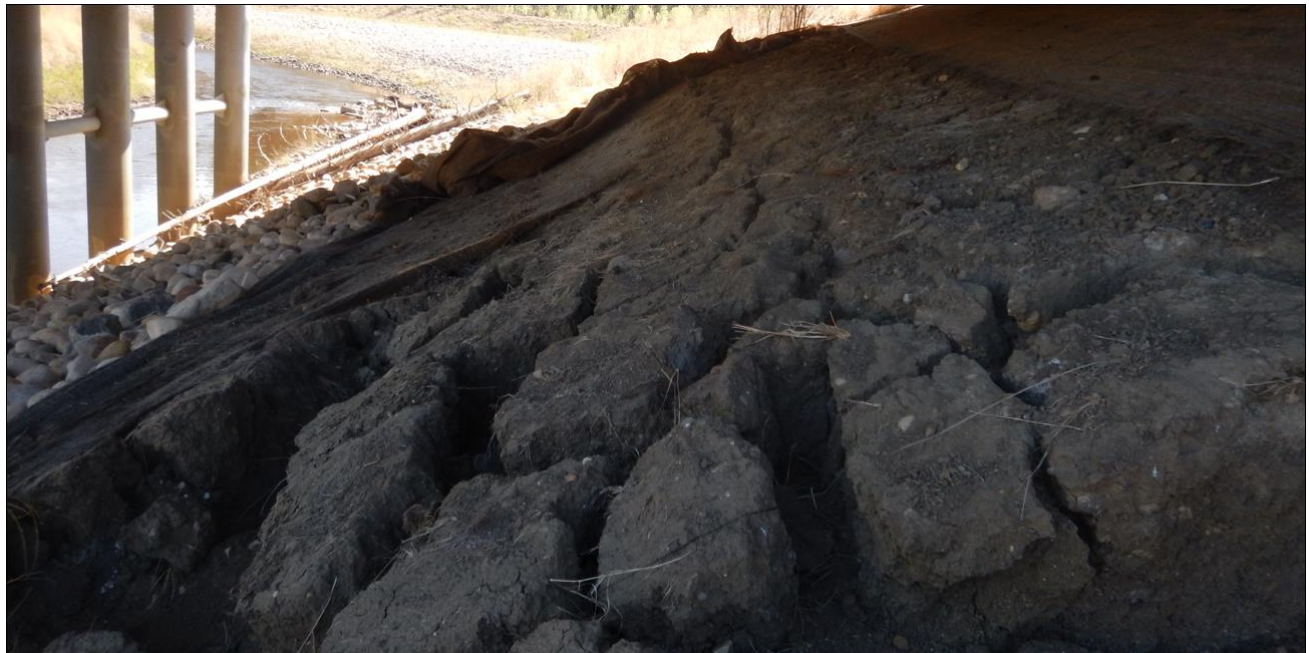
Photo No. 8 – Looking southeast at Slump No. 2 flank. Note: (a) void developed under wingwall, (b) change in soil type between the area under the bridge and the area beyond (west of) the wing wall, and (c) eastern flank of slump extending below the bridge headslope
