**ALBERTA TRANSPORTATION AND
ECONOMIC CORRIDORS GRMP
NORTH CENTRAL (ATHABASCA AND FORT
McMURRAY DISTRICTS)
2024 SITE INSPECTION**

Site Number	Location	Name			Hwy	km
NC096	13 Km north of Wandering River	Wandering River Bridge (75731N)			63:04	2.85
Legal Description		UTM Co-ordinates (NAD 83)				
NW 12-73-17 W4		12	N6130357.92	E405776.13		
	Date	PF	CF	Total		
Previous Inspection:	May 17, 2023	15	5	75		
Current Inspection	June 4, 2024	15	5	75		
Road WAADT:	3,920	Year:	2023			
Inspected By:	José Pineda, Tarek Abdelaziz (Thurber) Rocky Wang (TEC)					
Report Attachments:	<input checked="" type="checkbox"/> Photographs <input checked="" type="checkbox"/> Plans <input checked="" type="checkbox"/> Maintenance Items					
Primary Site Issue	Two slumps developed beside the NBL bridge south headslope. The west slump exposed NW wing wall and extended below bridge headslope.					
Dimensions:	<p>The slump on the east side of the bridge (Slump 1) is approximately 25 m wide (perpendicular to bridge alignment) and 13 m long (parallel to bridge alignment); the erosion gully to the east of Slump 1 is about 10 m wide, 20 m long, and up to 2.5 m deep.</p> <p>The slump on the west side of the bridge (Sl

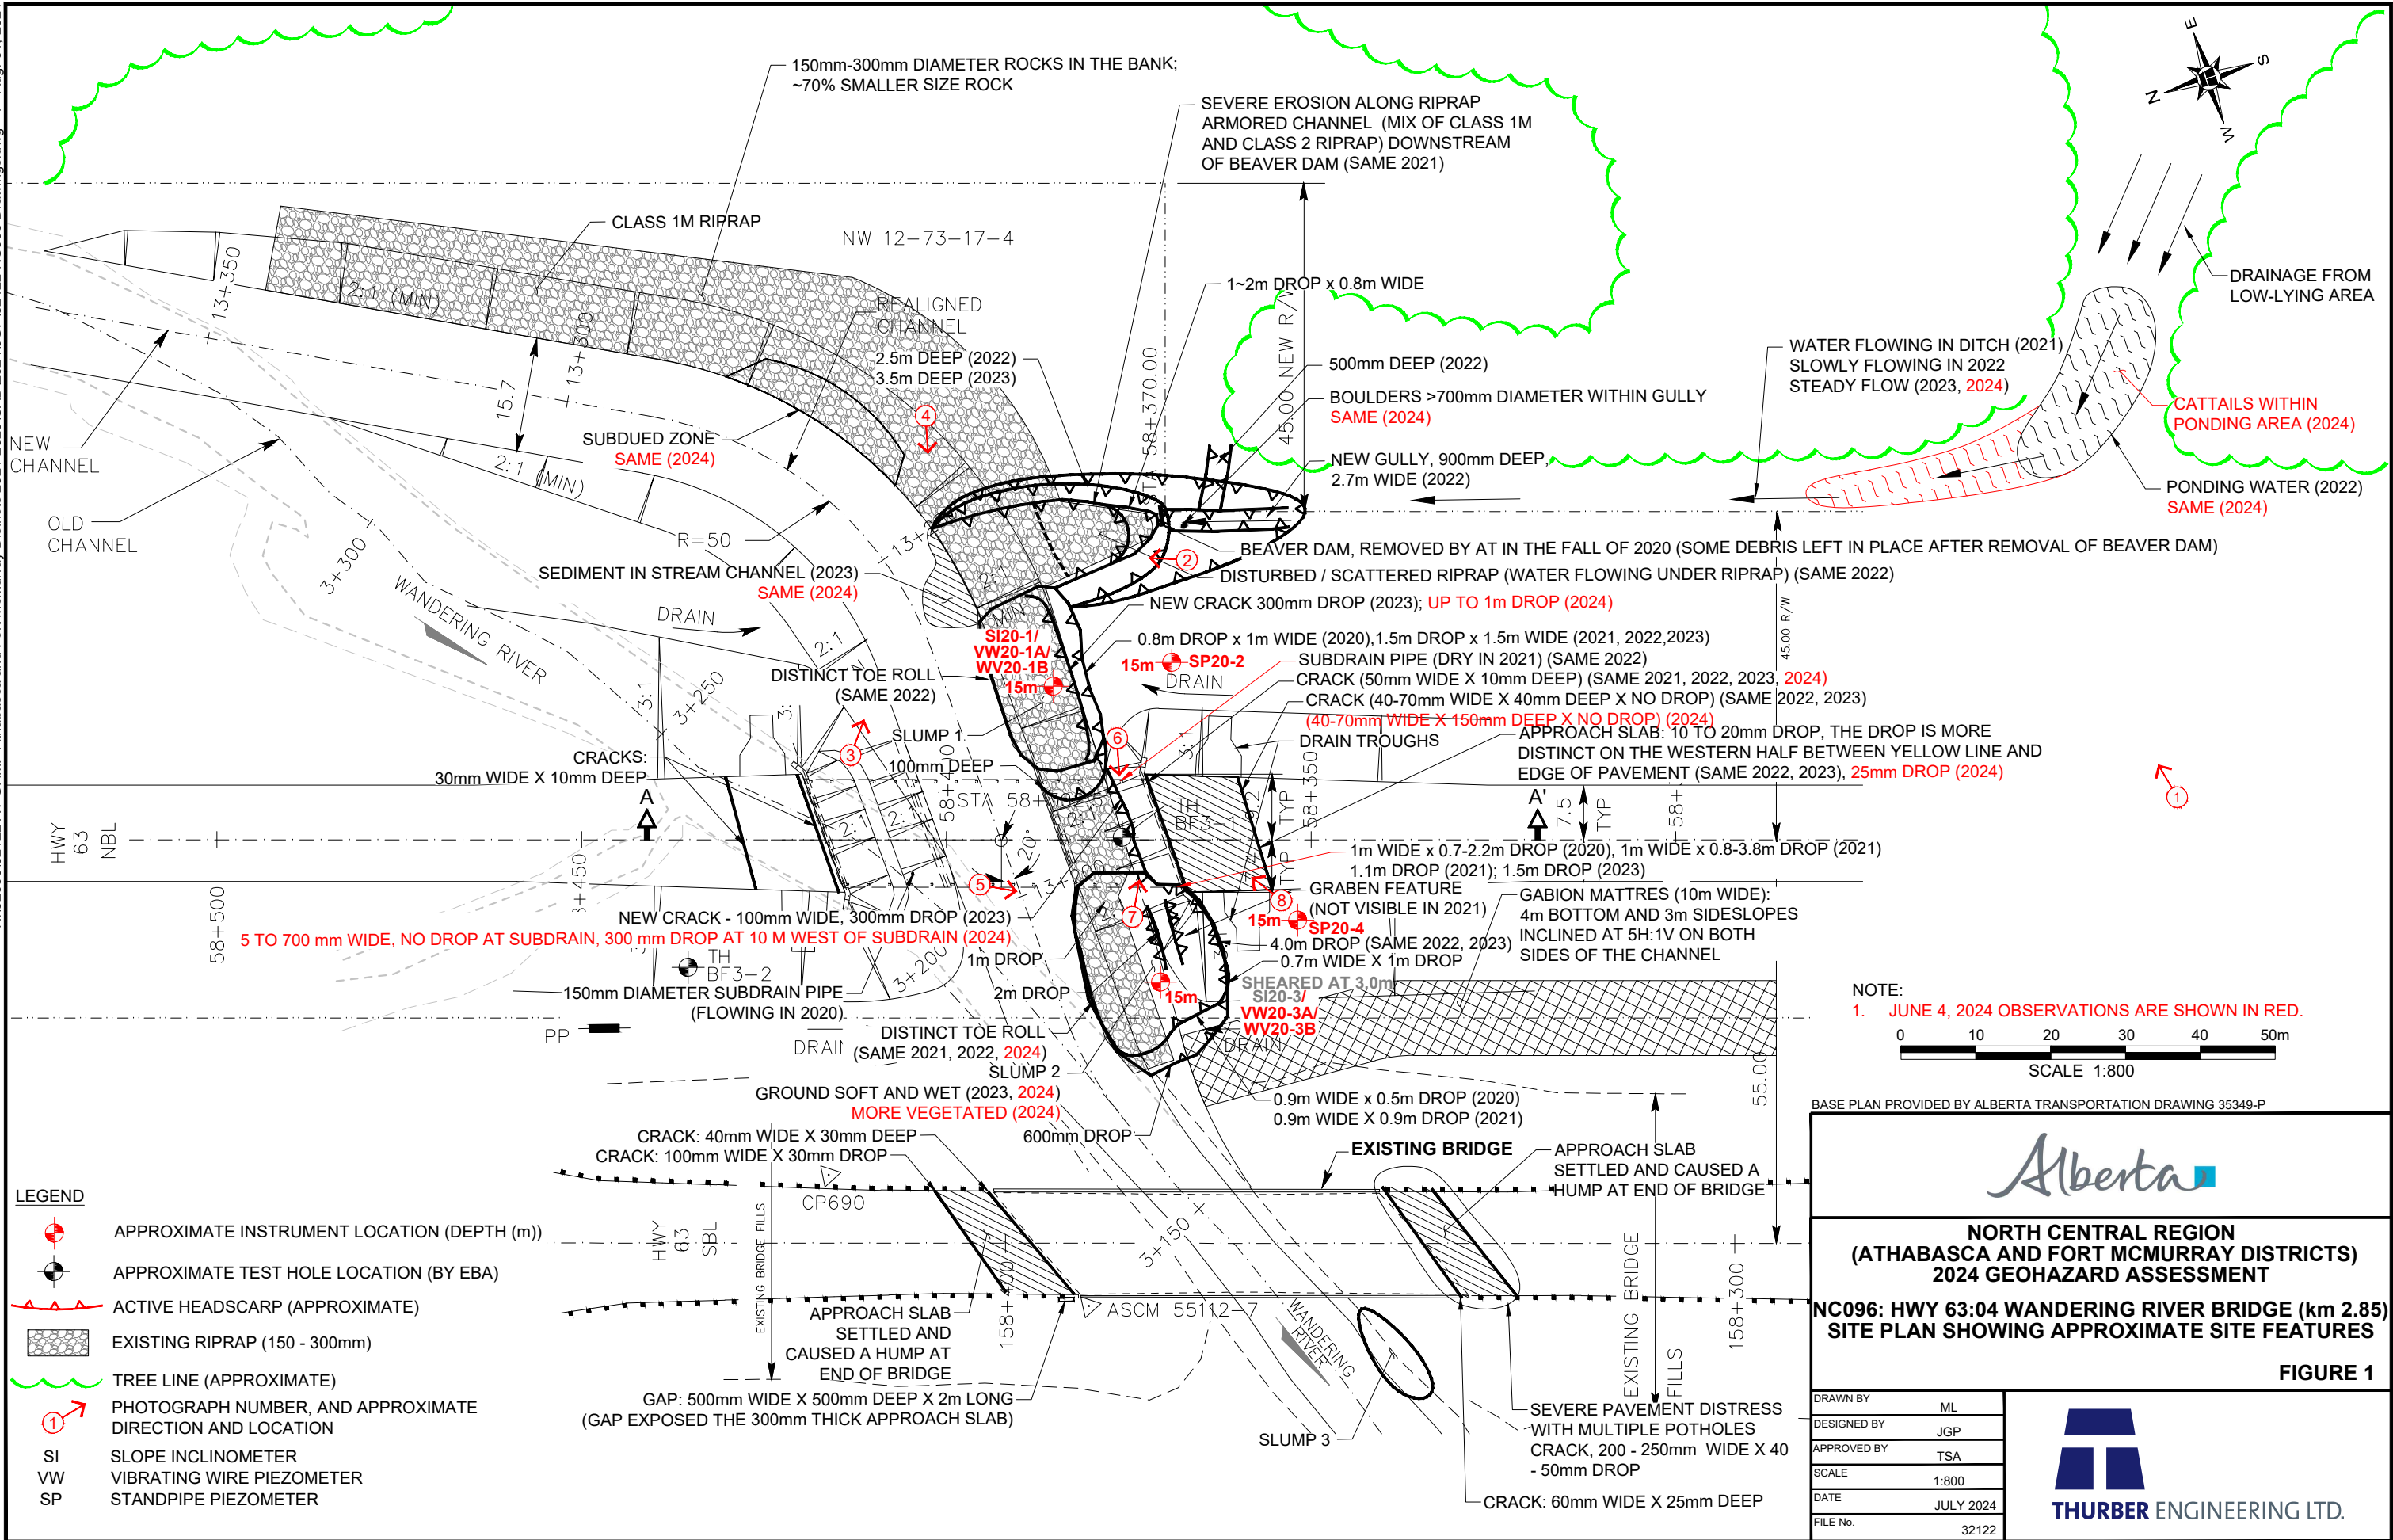
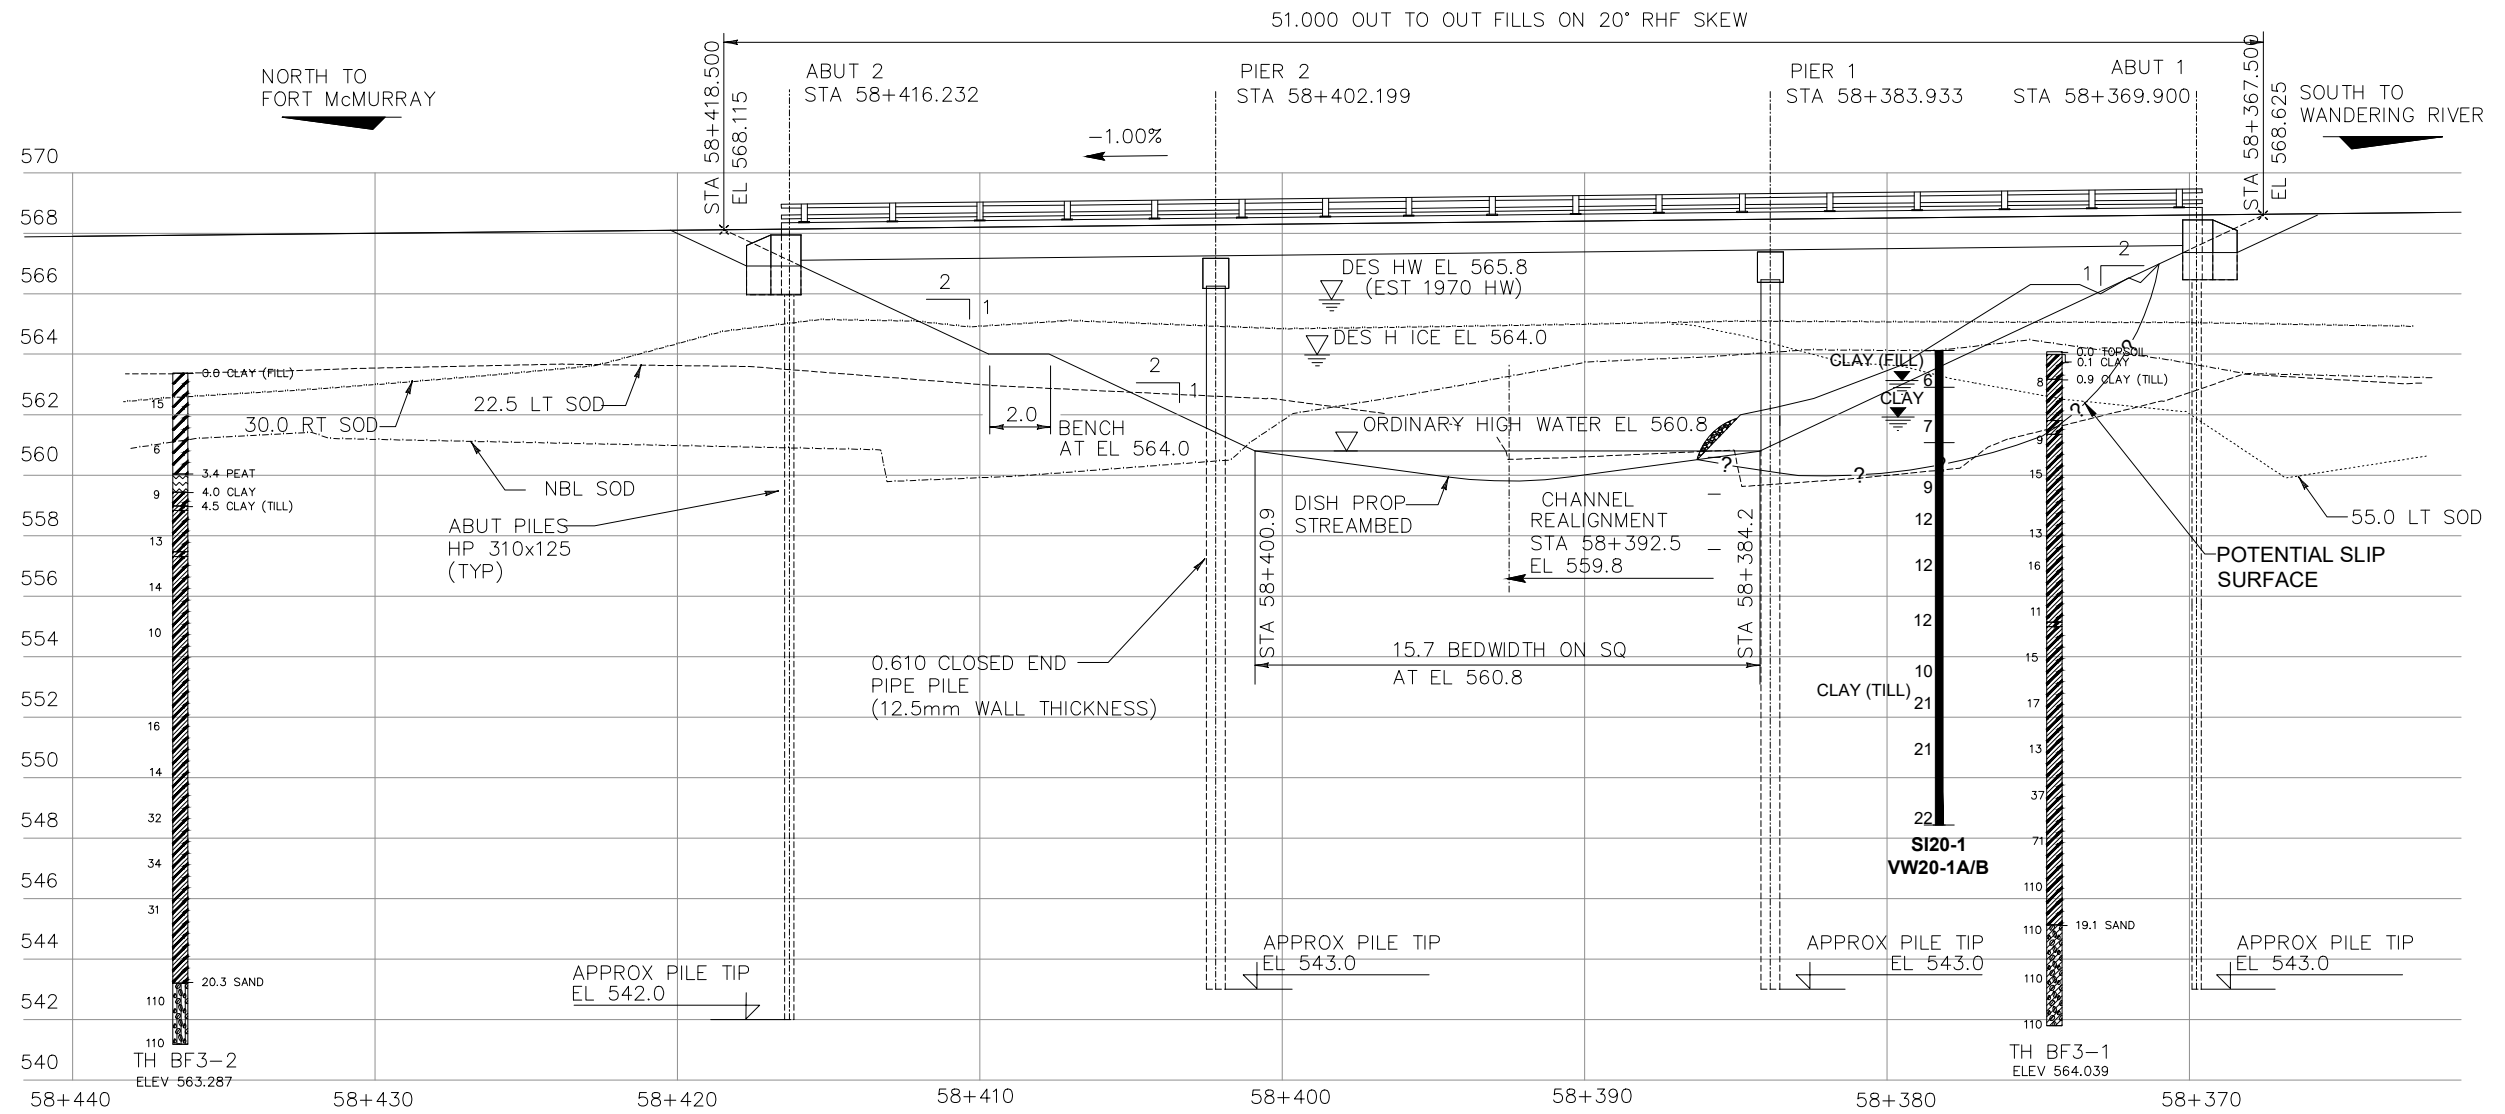
FIGURE 2

1. JUNE 4, 2024 OBSERVATIONS ARE SHOWN IN RED.
2. SLUMP 1 IS WITHIN THE RIVERBANK SLOPE TO THE EAST OF THE BRIDGE HEADSLOPE.

**CROSS - SECTION A - A'
SHOWING SLUMP 1 - EAST OF BRIDGE HEADSLOPE**

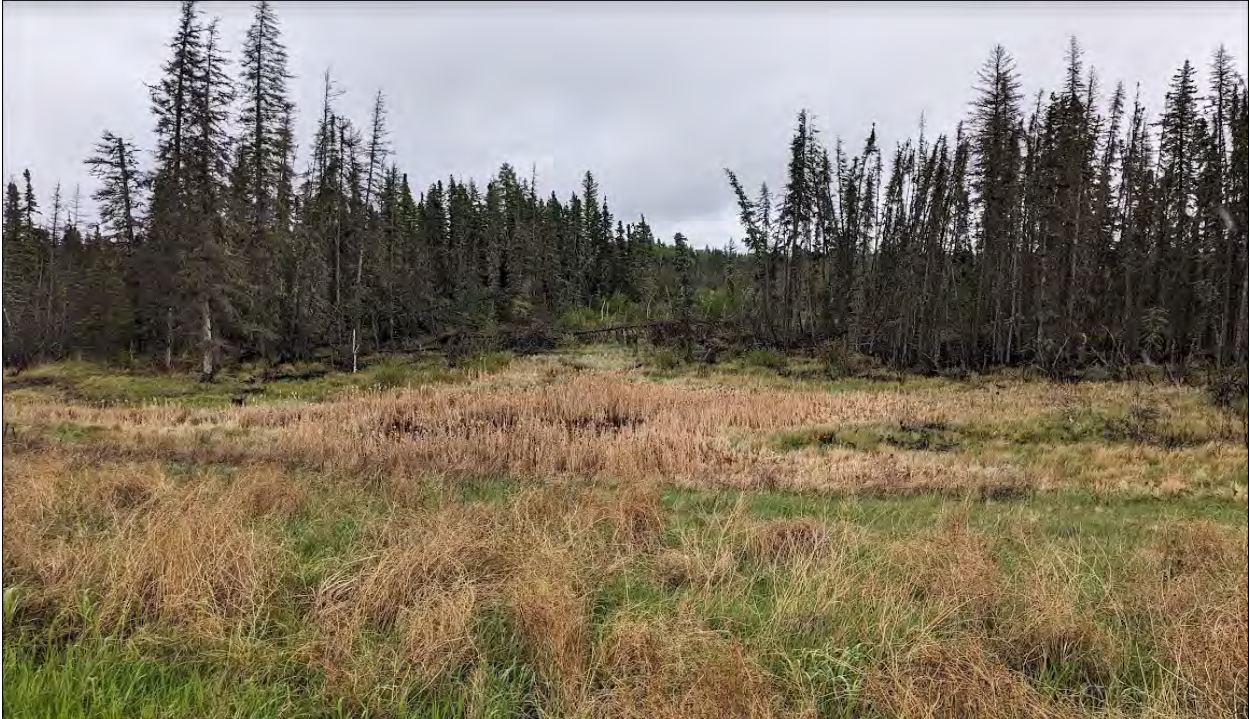
Photo No. 1 – Looking northeast at the low-lying area south of the Bridge

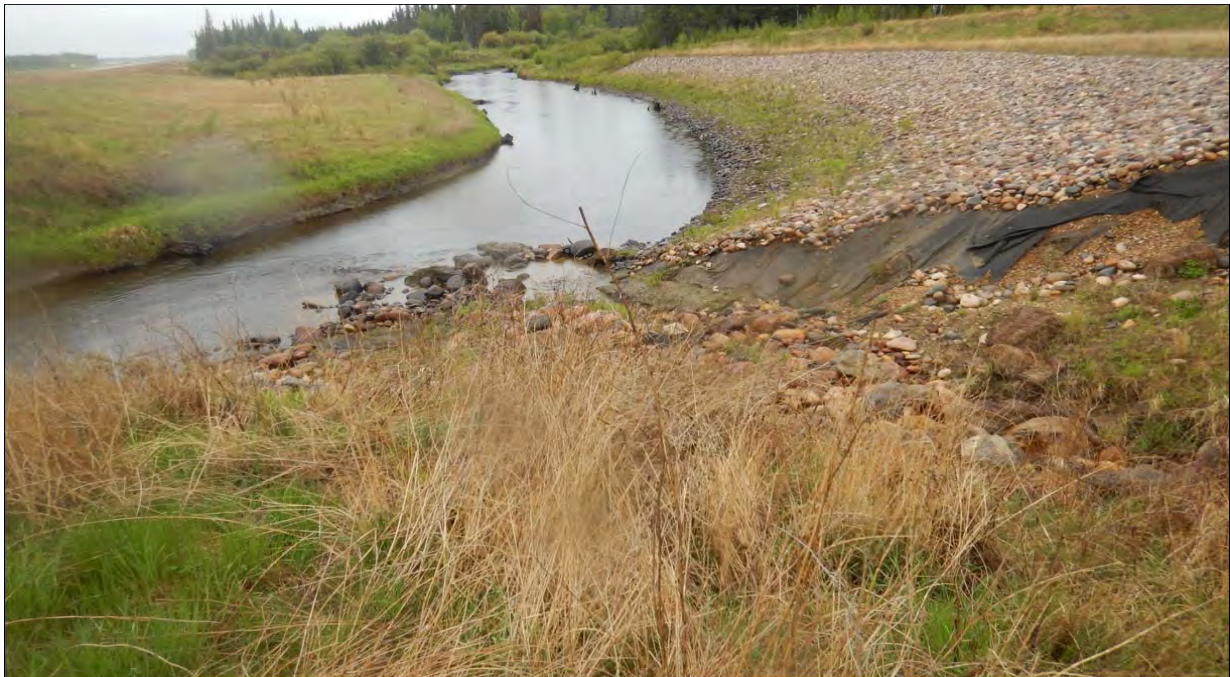
<input checked="" type="checkbox"/> Erosion	Erosion developed east of Slump 1 at the mouth of the north facing riprap lined channel. Erosion became worse in 2023 and it is at least 3.5 m deep and has distorted the existing riprap within the channel. Scattered and subdued riprap areas along the outside bend of the river channel	<input checked="" type="checkbox"/>
<input checked="" type="checkbox"/> Seepage	Ground surface within Slumps was soft and wet (particularly at Slump 2 location); a steady flow in the highway east ditch originating from the low-lying area located to the south of the bridge location; seepage from	<input type="checkbox"/>

Photo No. 2 – Looking north at north facing riprap channel to the east of the bridge location. Note the deep erosion along the channel.

- Place heavy rock riprap (Min. Class 1) at the base of the slumps (near the river location) to provide additional buttress and erosion protection.
- Reshape the failed riprap-lined channel within the east ditch and add heavy rock riprap (Min Class 2) to armor the re-graded channel. This should prevent future accumulation of sediment in the river channel and reduce the probably of further loss of land/trees to the east of the gully location.

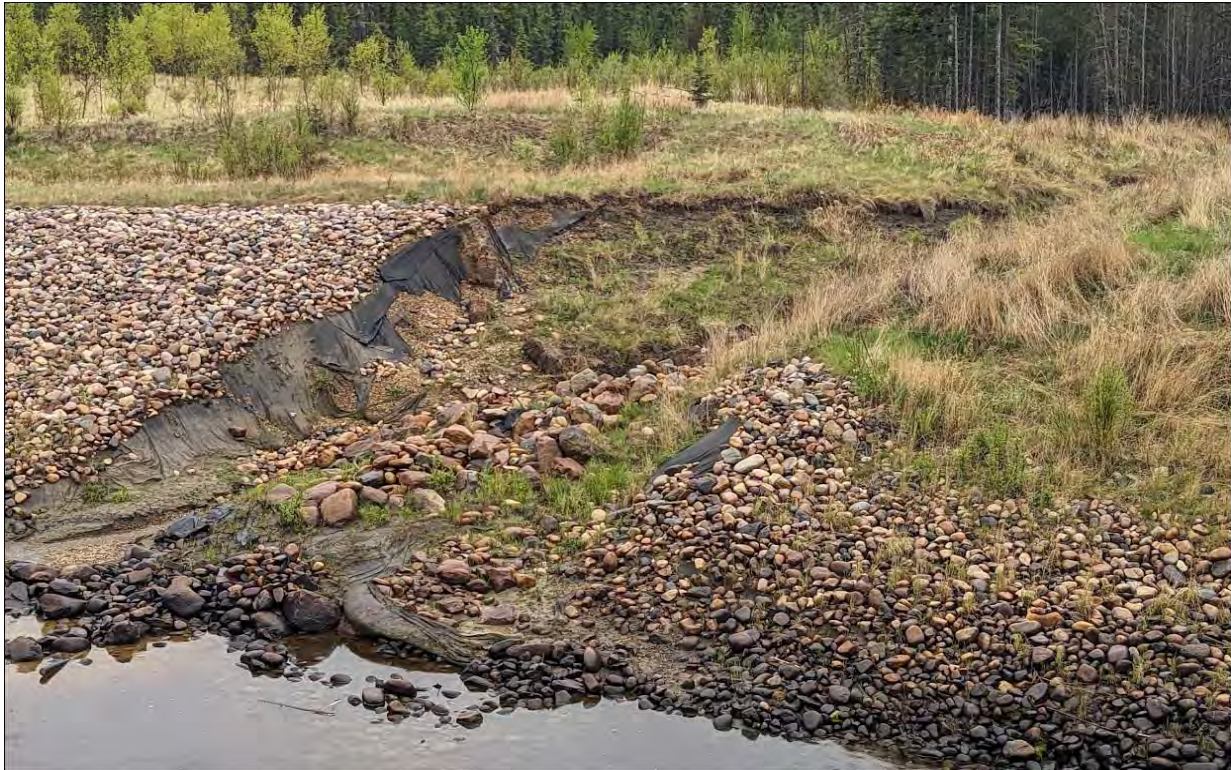
Photo No. 3 – Looking southeast at the same area in Photo No. 2

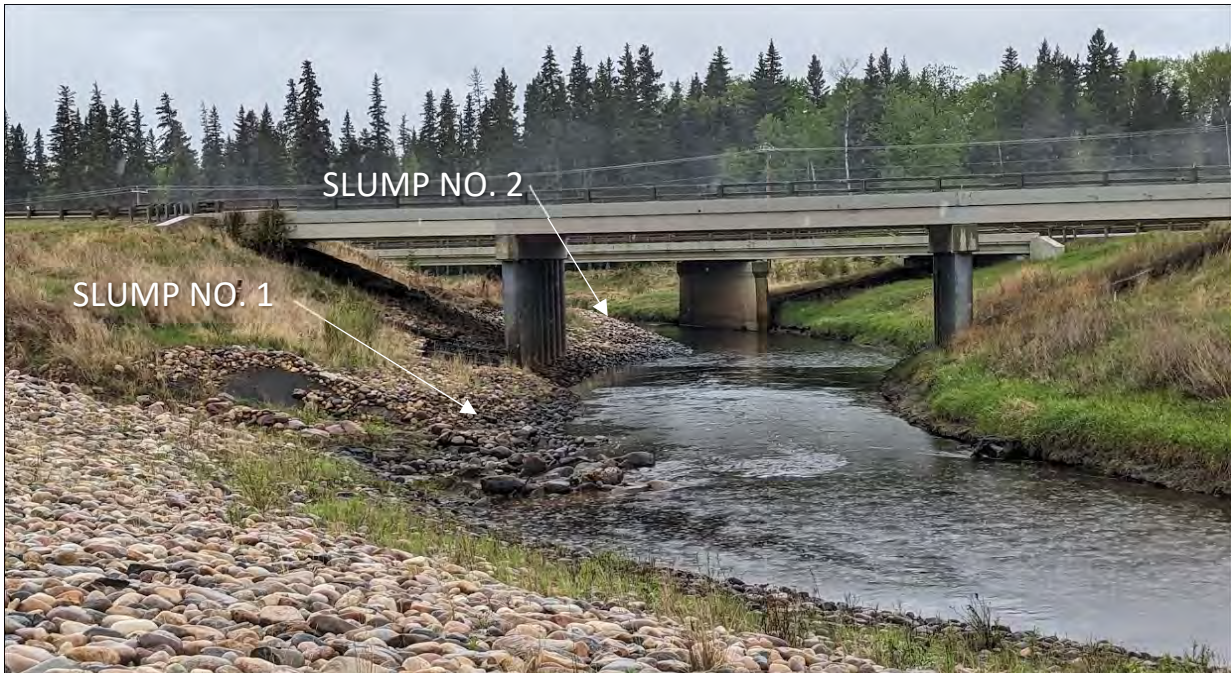
Photo No. 4 – Slumping within the riverbanks to the east of the Hwy (slump 1) and to the west of the Hwy (slump 2). Note distinct toe rolls in the river channel.

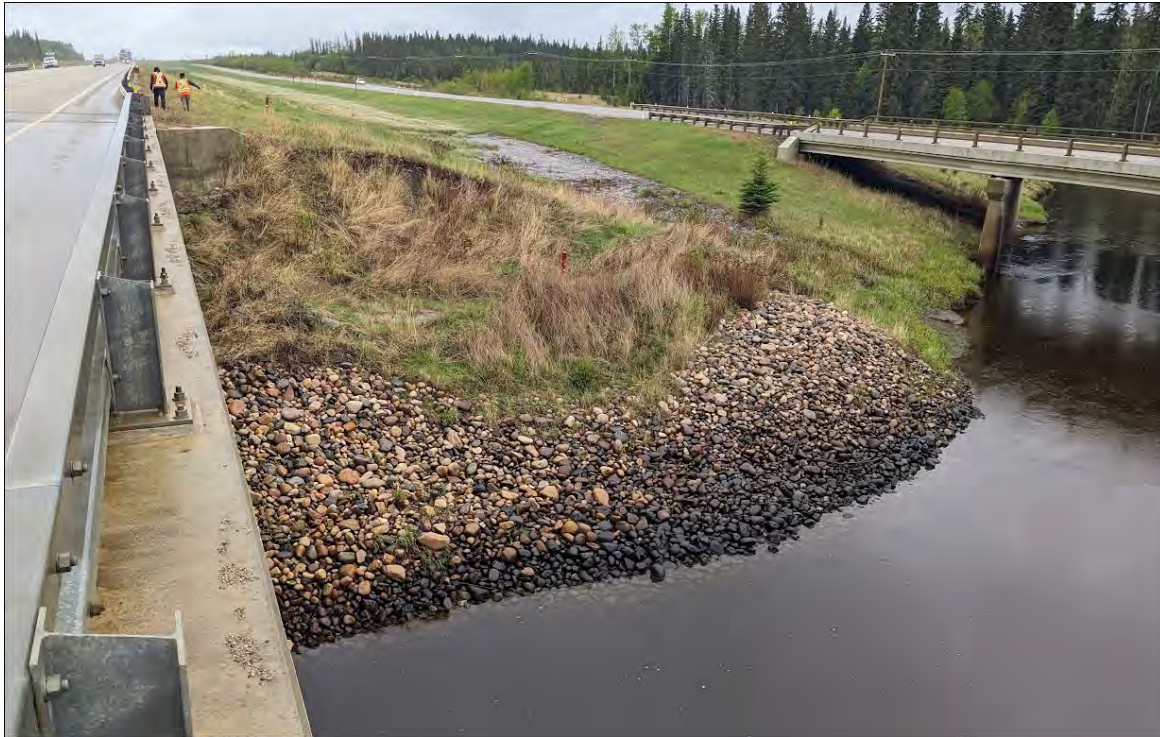
Photo No. 5 – Looking southwest at Slump No. 2. Vegetation has grown within the slump since the 2023 inspection.

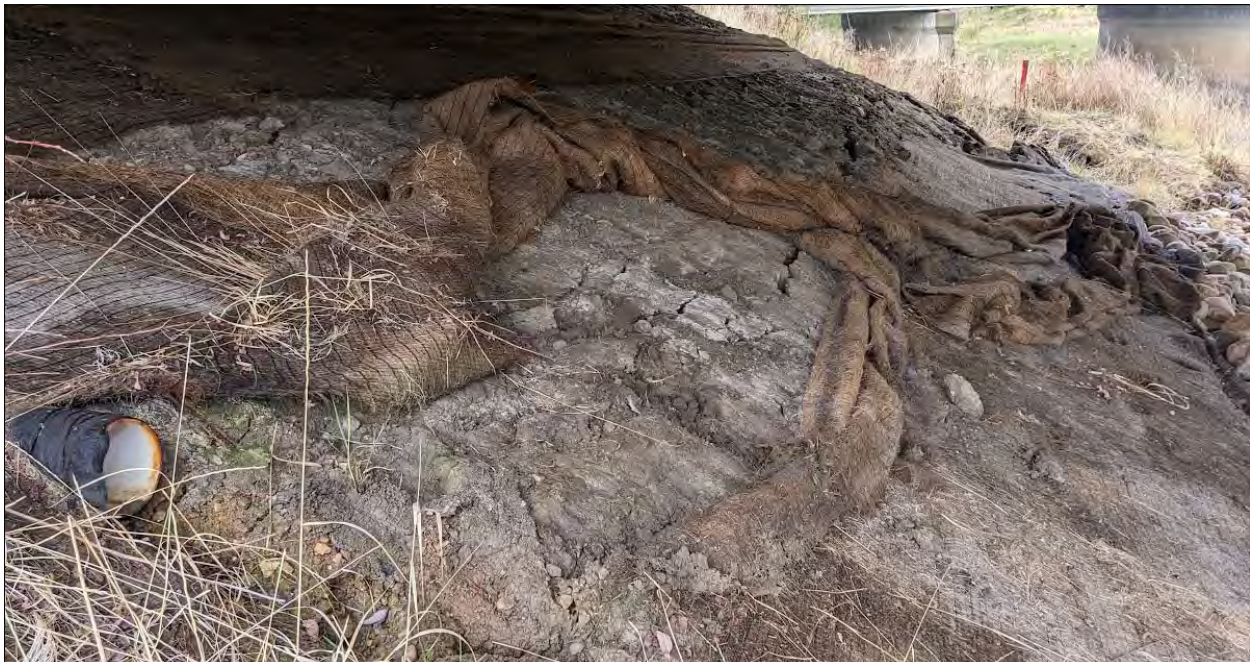
Photo No. 6 – Looking at Crack on head slope extending to the subdrain on the east side of the bridge. Crack is 5 mm wide at the subdrain and 700 mm wide at 10 m west of the subdrain.

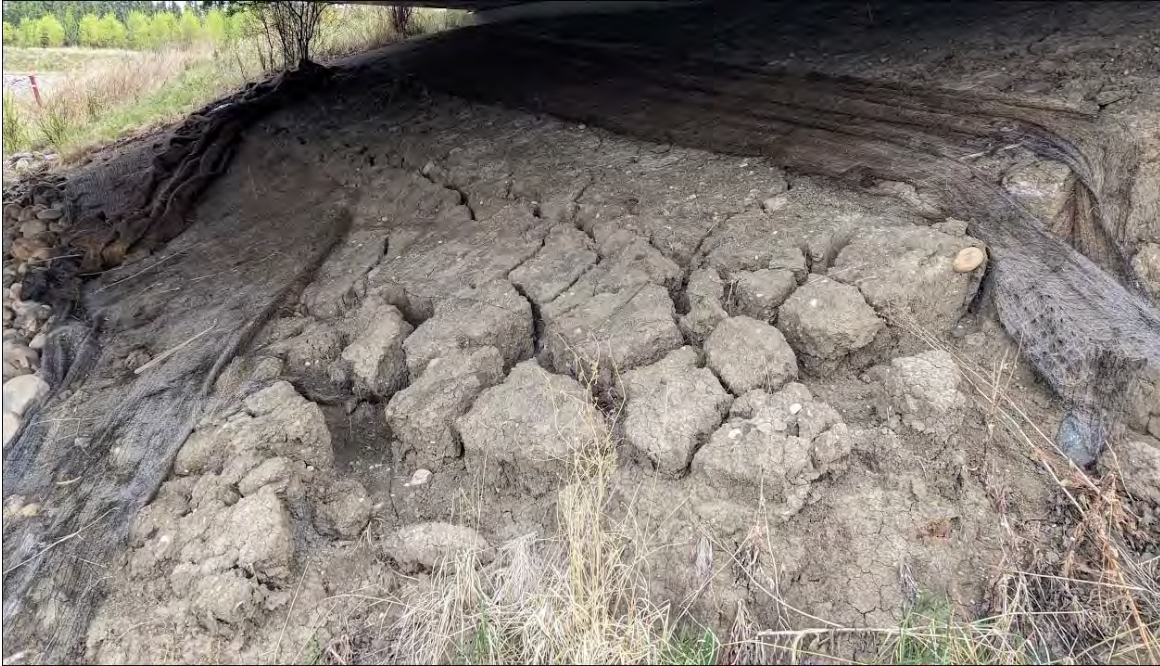
The bridge headslope, between the two slumps, is likely in a meta-stable condition and the complete failure of the headslope may take place abruptly similar to the currently active slumps. The observed cracks within the headslope may reflect a slope movement. The dip noted on the highway approach slab could be a reflection of the headslope movement.

Photo No. 7 – Looking southeast at Slump No. 2 flank. Note: (a) eastern flank of slump extending below the bridge headslope and (b) extensive cracking and presence of a distinct longitudinal crack below bridge headslope

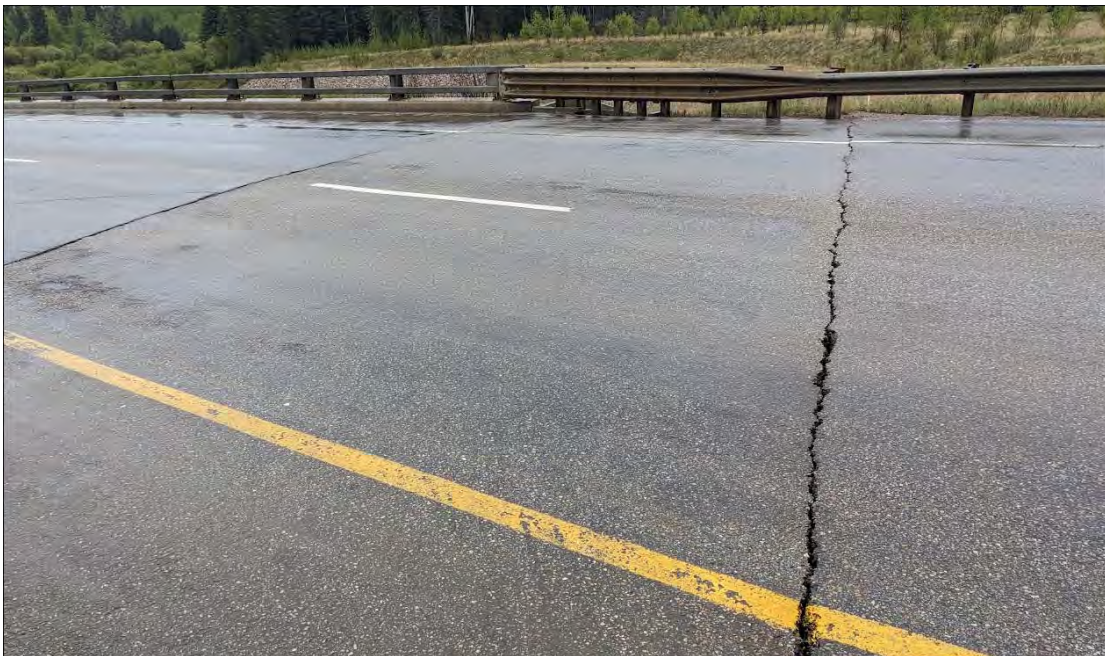
Photo No. 8 – Dip at the bridge south approach slab appears to have dropped more; and it is more noticeable within the western half between the yellow line and the edge of pavement above Slump 2
