**ALBERTA TRANSPORTATION  
GEOHAZARD ASSESSMENT PROGRAM  
NORTH CENTRAL REGION – ATHABASCA  
2018 INSPECTION**

Site Number	Location	Name	Hwy	km
NC088	62 Km N of Wandering River	<b>NBL Pavement Distress</b>	63:06	6.0
Legal Description		UTM Co-ordinates (NAD 83)		
S-30-77-14-W4M		12	6172629	E 426672

Date	PF	CF	Total
<b>Previous Inspection:</b>	October 16, 2017 (Call Out)	13	5	65 (Highway 63 NBL)
<b>Current Inspection:</b>	May 8, 2018	13	6	78 (Highway 63 NBL)
<b>Road AADT:</b>	4,970	<b>Year:</b>		2017
<b>Inspected By:</b>	Tarek Abdelaziz and José Pineda (Thurber) Arthur Kavoluk and Rocky Wang (TRANS)

<b>Primary Site Issue</b>	<p><b>Major issue:</b> A landslide above the old pipe alignment causing a severe pavement distress on the highway lanes.</p> <p><b>Other issues:</b> Winter 2018 deficiencies identified during the May 2018 site inspection visit.</p>
---------------------------	---

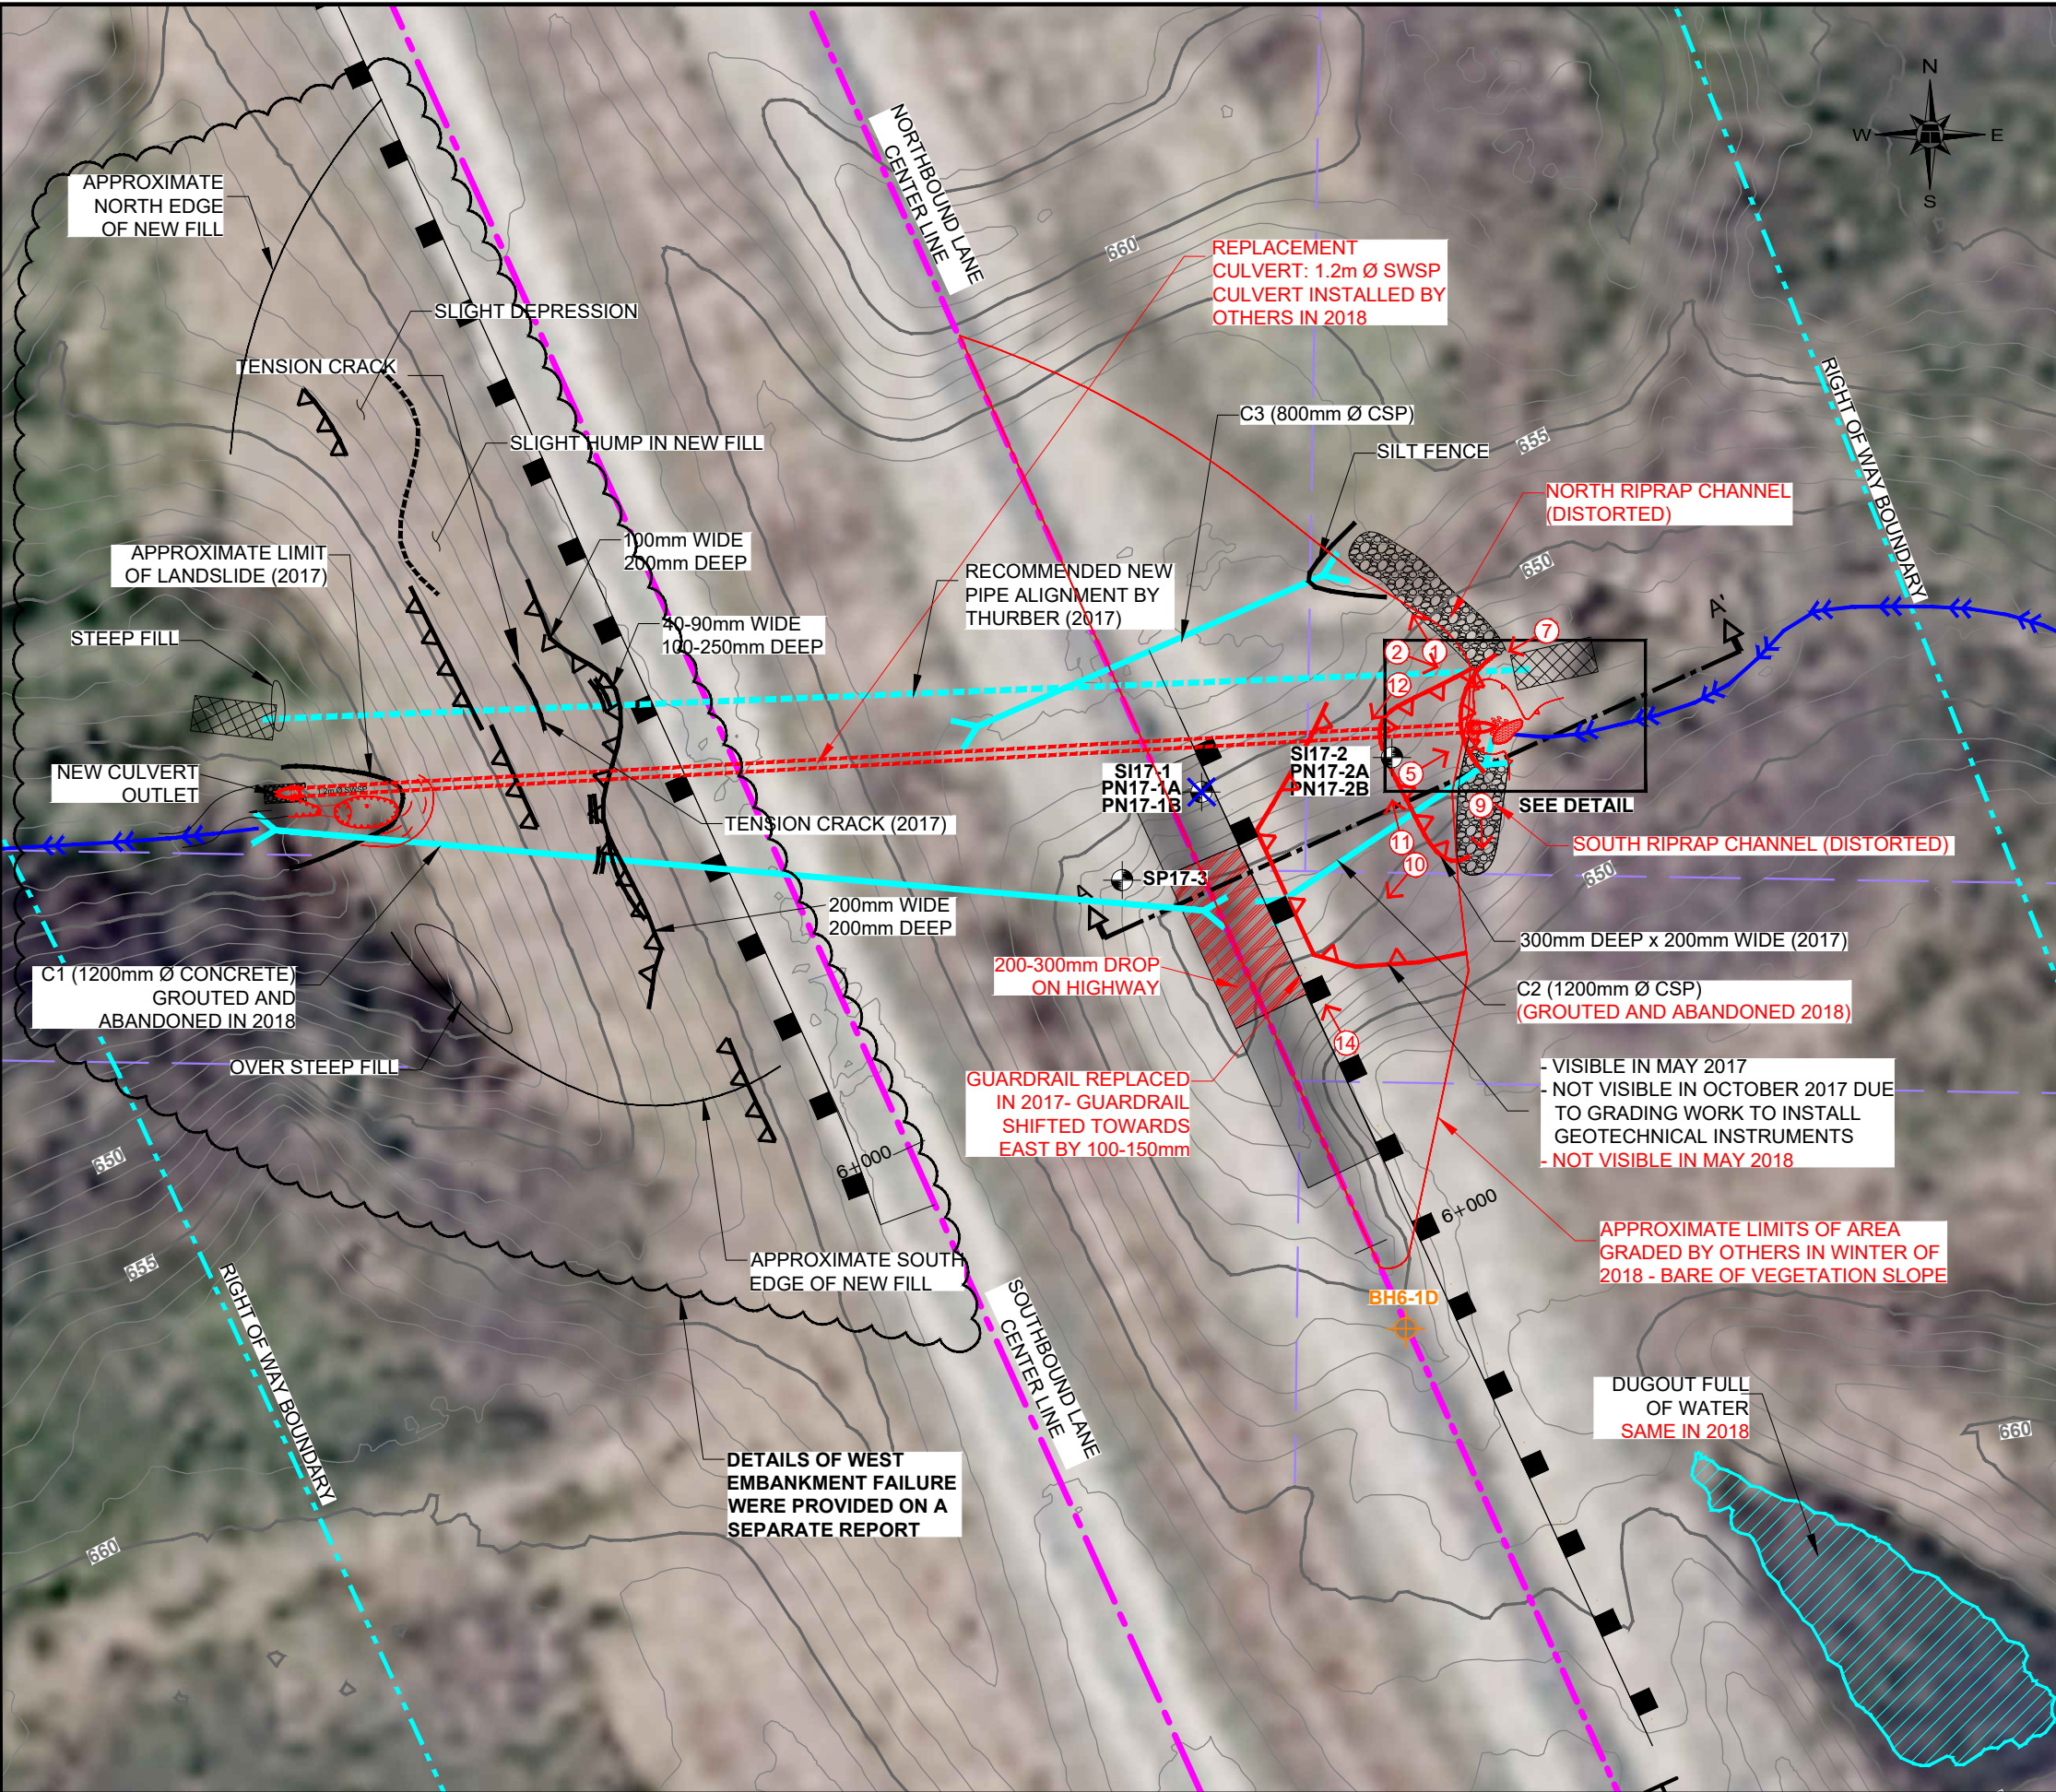
DWG No. 13357-NC088-1-1

**2018 GEOHAZARD ASSESSMENT  
NORTH CENTRAL REGION (ATHABASCA AREA)  
NC88: HWY 63:06 NBL PAVEMENT DISTRESS  
SKETCH SHOWING SITE FEATURES  
(MAY 8, 2018 GEOHAZARD INSPECTION)**

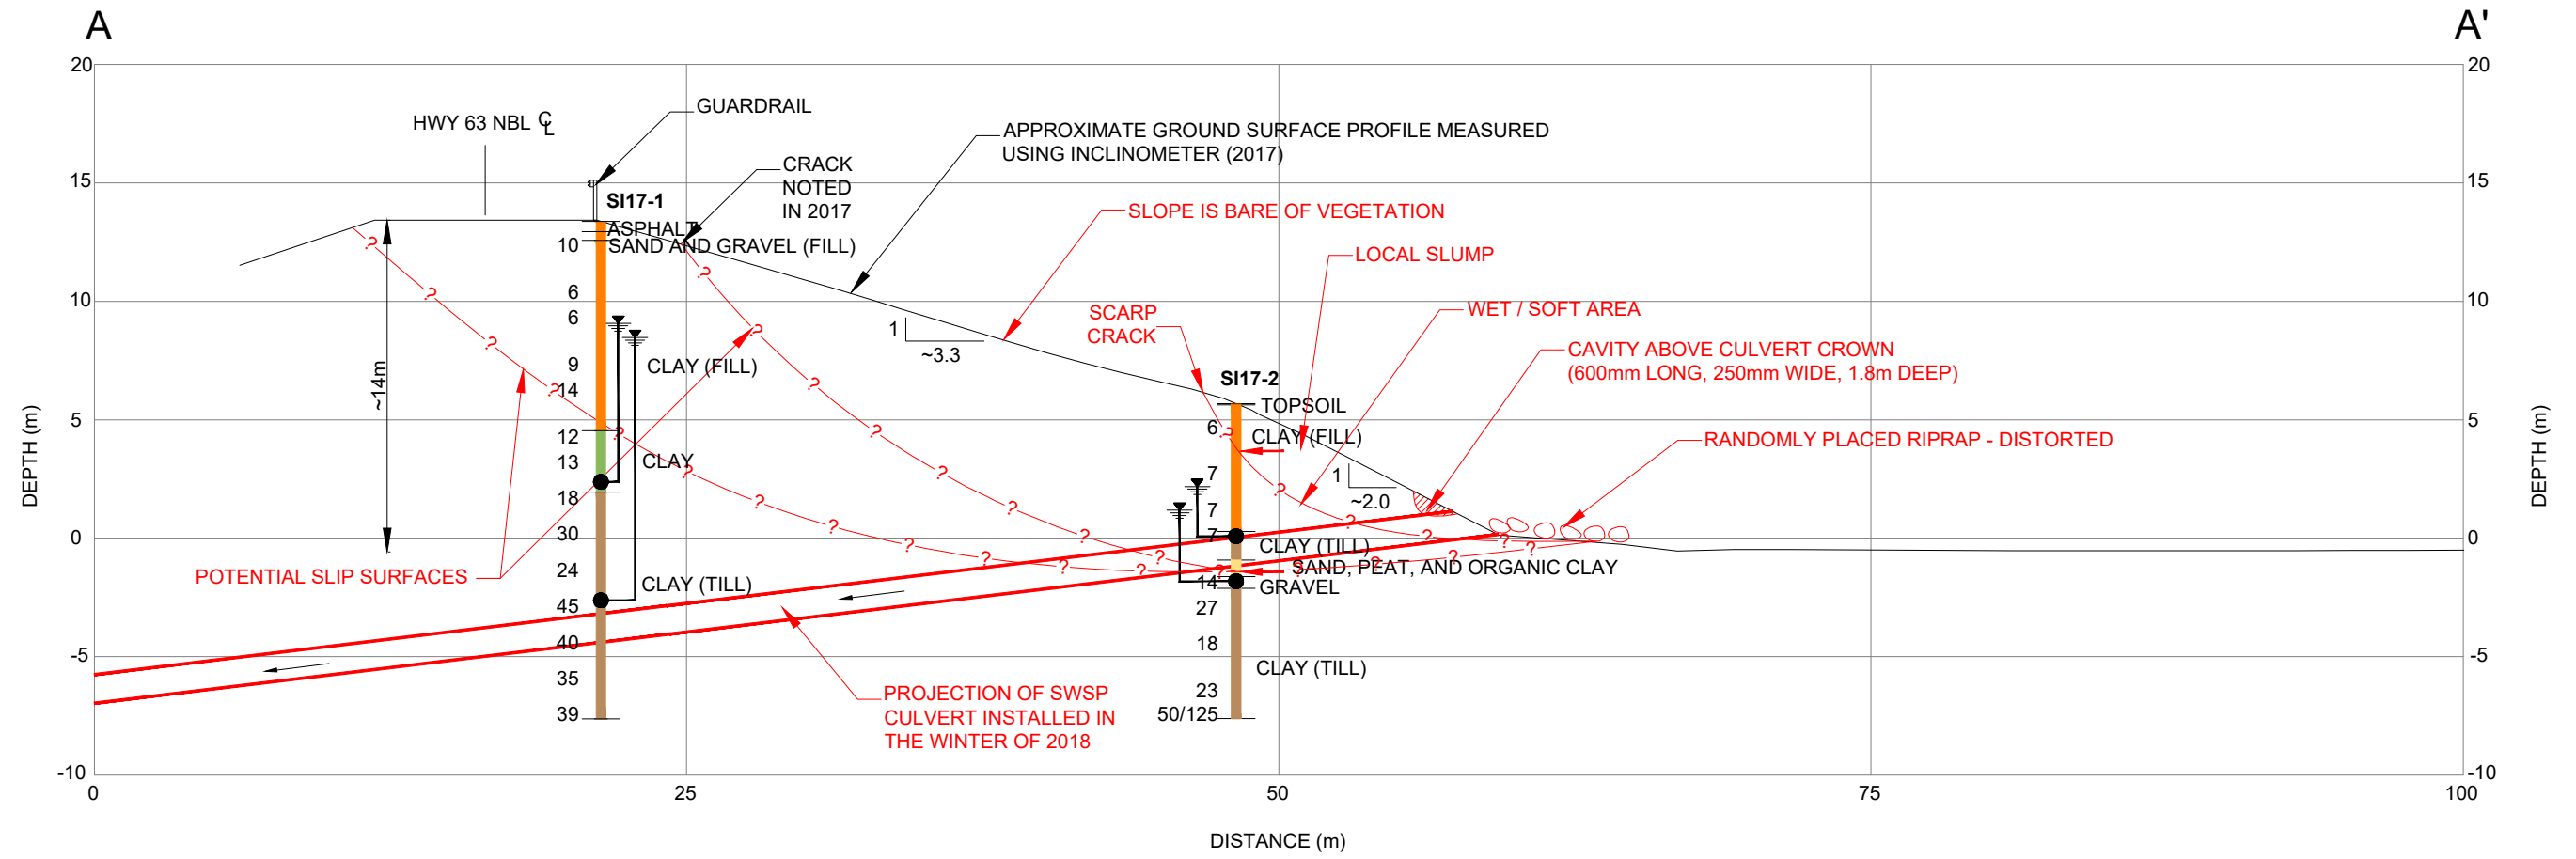
**DWG No. 13357-NC088-1-2**

The site observations and instrumentations indicate the potential presence of a deep-seated landslide below the 14 m high highway embankment. Near the bottom of the slope, the slip surface is located within the organic deposits underlying the clay fill. It appears that the failure of the original pipe as well as inadequate subgrade preparation below the new fill are the main triggers for the landslide movement.

**NC088: HWY 63:06 NBL PAVEMENT DISTRESS  
CROSS - SECTION A - A'**

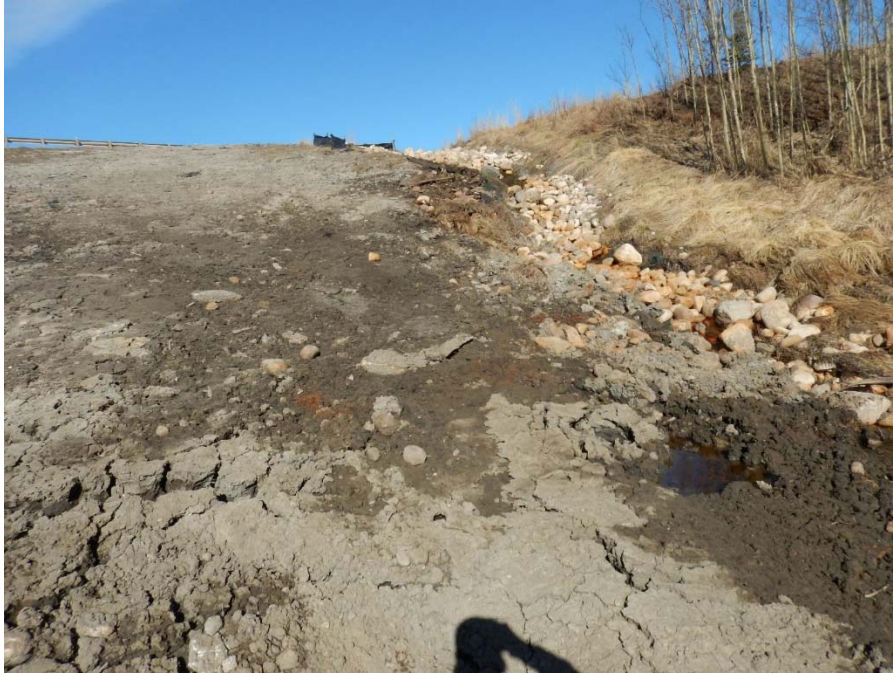
The existing slump above the culvert inlet may have been triggered due to improper placement of fill around and above the new inlet of the culvert, and the erosion of the creek banks. The erosion issues along the creek banks above and around the culvert inlet are due to the steepness of the slopes, inadequate protection of the creek banks and bed, and uncontrolled discharge of surface water from the disturbed north riprap-lined channel.

Photo No. 1 - North riprap lined channel leading to the inlet of the new pipe (looking north). Note the presence of disturbed riprap, seeping/ponding water into the slope beside and above the culvert inlet location, and existing cracks.

- The disturbed riprap-lined north and south channels should be slightly regraded to contain the highway ditch flow and armored with additional riprap that daylight into the banks of the creek.

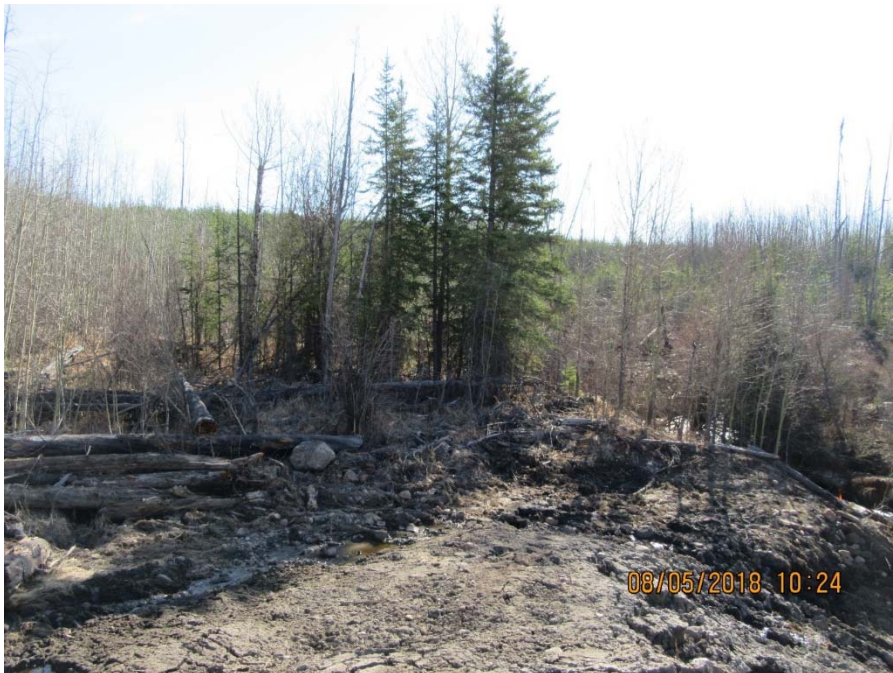
Photo No. 2 - Water Flowing in an uncontrolled manner from the mouth of the north riprap lined channel to the creek bank

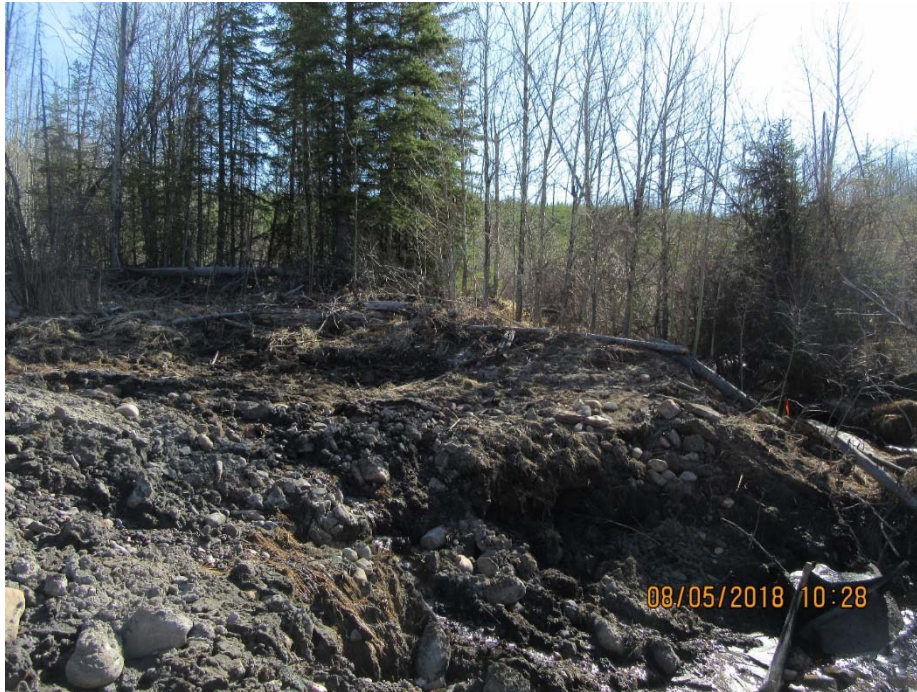
Photo No. 3 - Uncontrolled discharge of surface flow from the north channel into the slope (looking east)

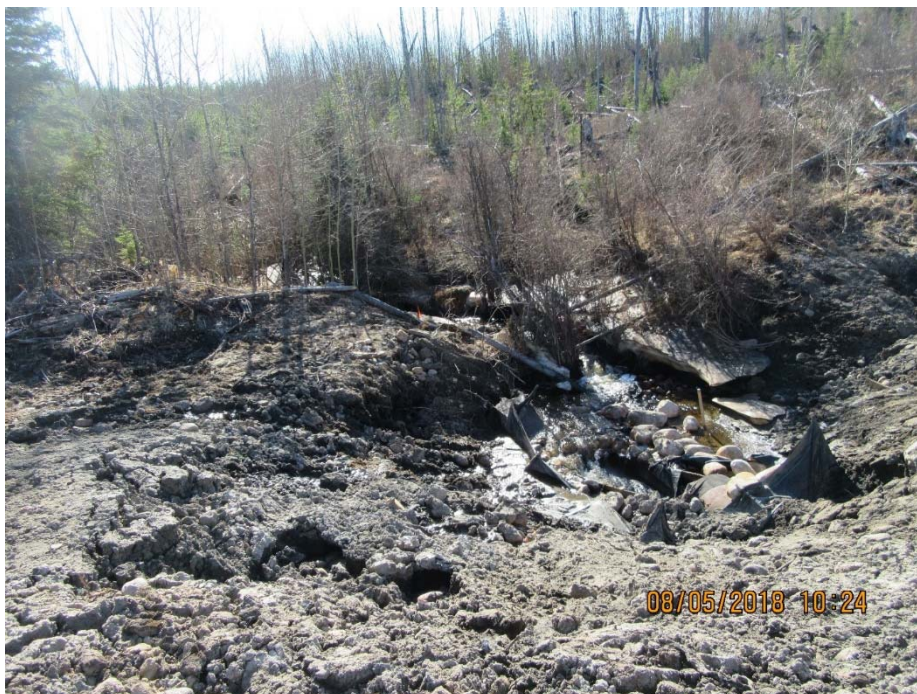
Photo No. 4 - New pipe Inlet Area (looking east) – Disturbed bank slopes, riprap, and silt fences. The banks are not armored and there is not enough riprap at the inlet location

- The bank slopes around the new pipe inlet should be reshaped, flattened (as needed), and armored with riprap underlain by a non-woven geotextile. Armoring the creek bed is also recommended.

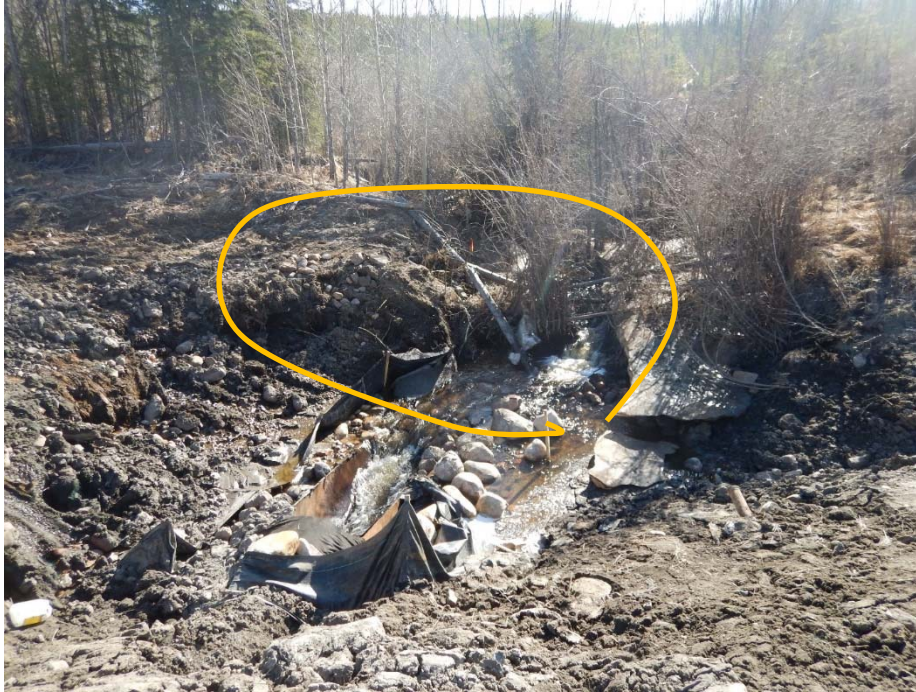
Photo No. 5 - New pipe Inlet Area (looking east) – Restricted flow to the culvert inlet, partially due to caved in bank slope (note the presence of deadfall). Creek flow is partially ponding to the south of the culvert inlet

- Remove the debris from the channel to allow unrestricted flow into the culvert and reshape the creek banks to direct flow into the pipe.
- Track pack, topsoil and seed the slope.

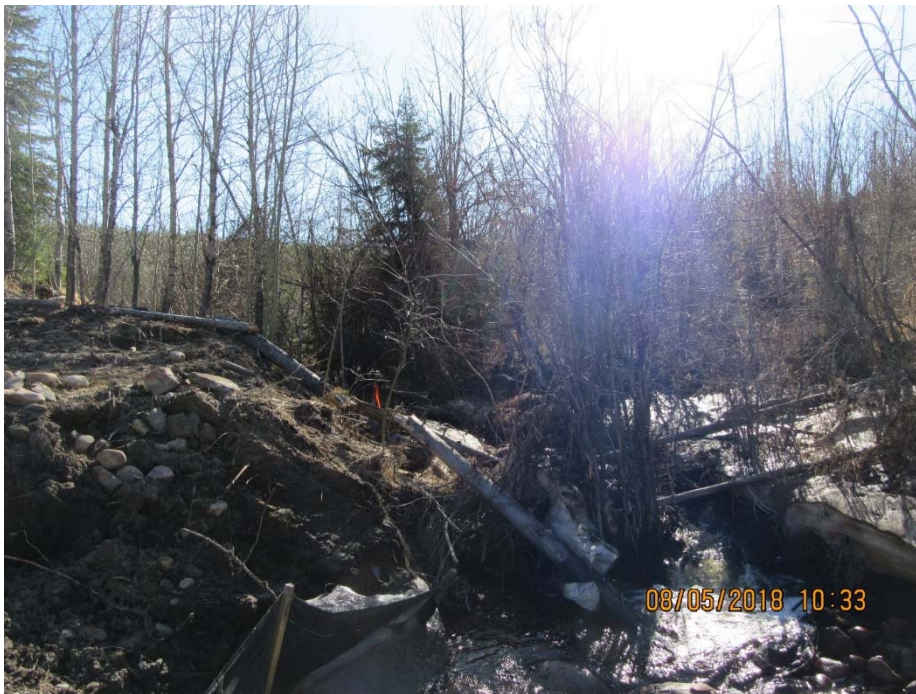
Photo No. 6 - Caved in Bank with trees partially blocking the new pipe

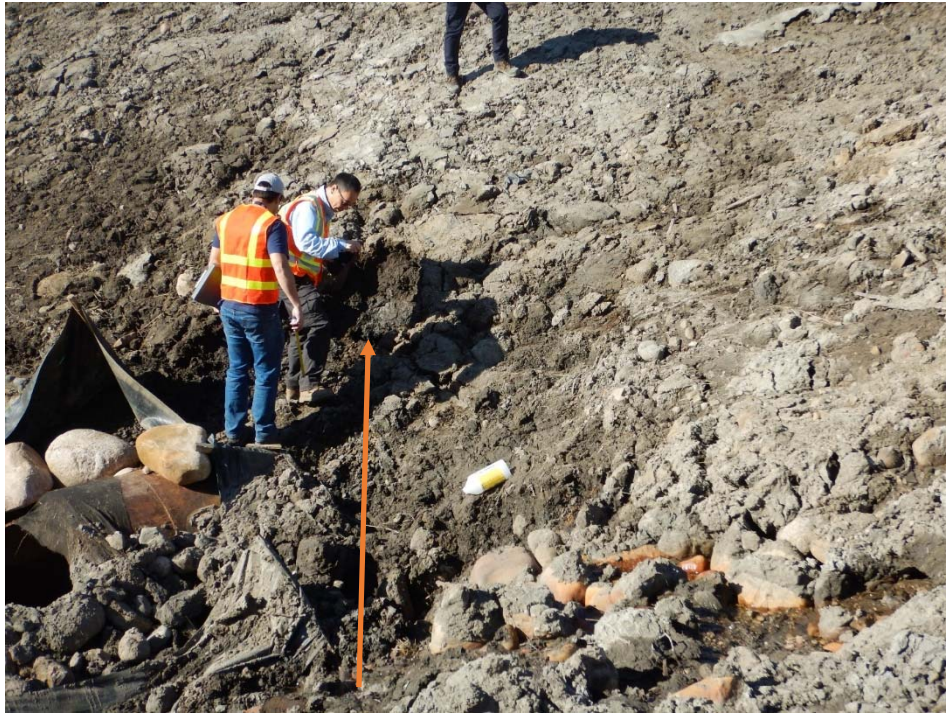
Photo No. 7 - Cavity noted above the crown of the new pipe.

- The cavity adjacent to the new pipe should be backfilled and sealed unless excavated during slump repair. The cavity may have been developed due to improper placement of backfill or in response to the creek flow bypassing the new culvert inlet at some point during or shortly after construction.

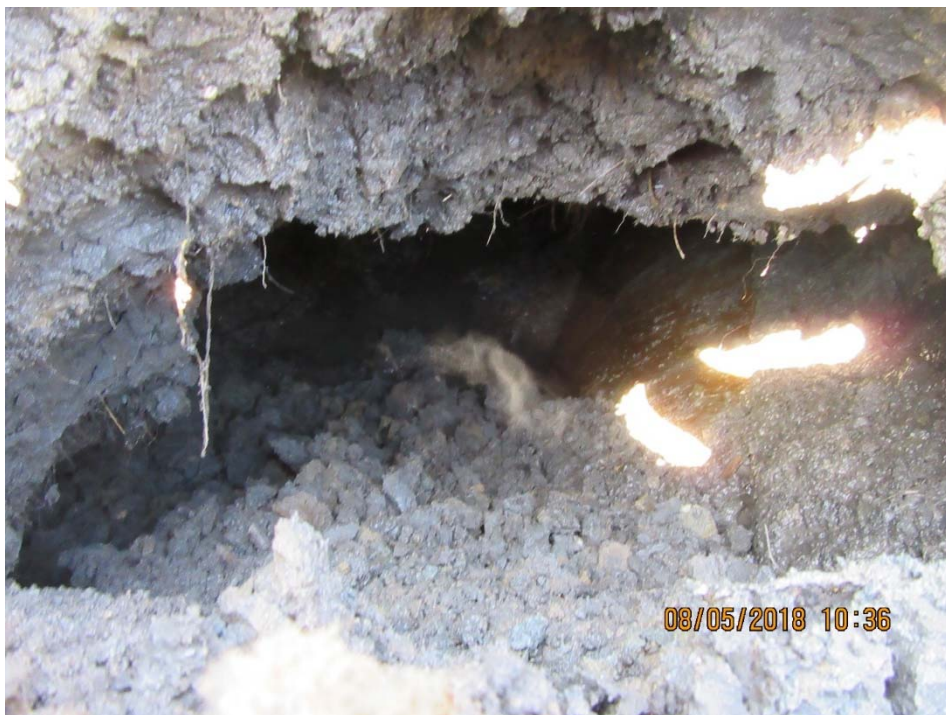
Photo No. 8 - Water seeping into the cavity

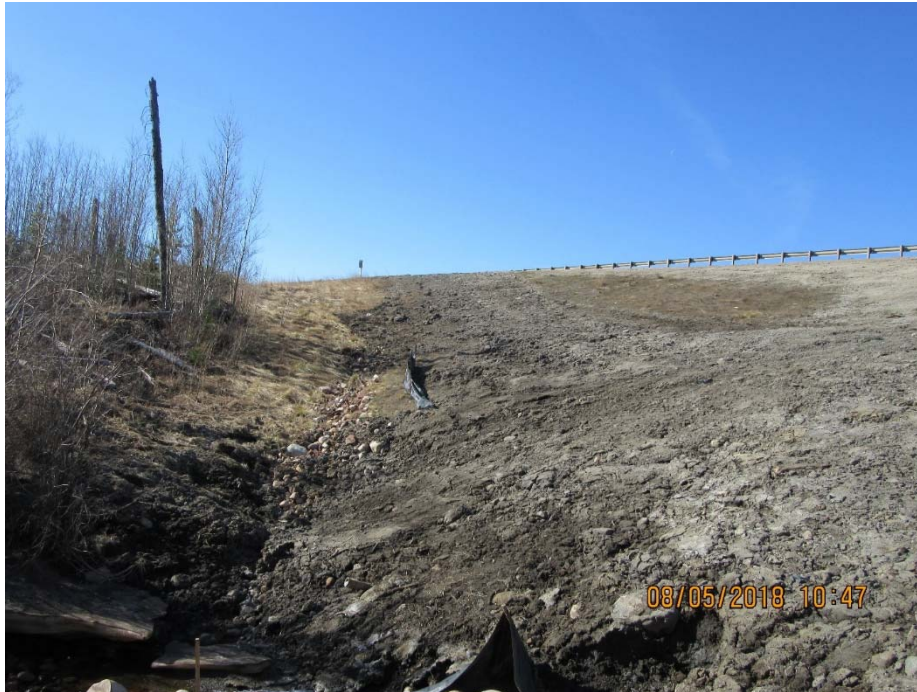
Photo No. 9 – Disturbed riprap in the south riprap lined channel leading to the new pipe inlet (looking south)

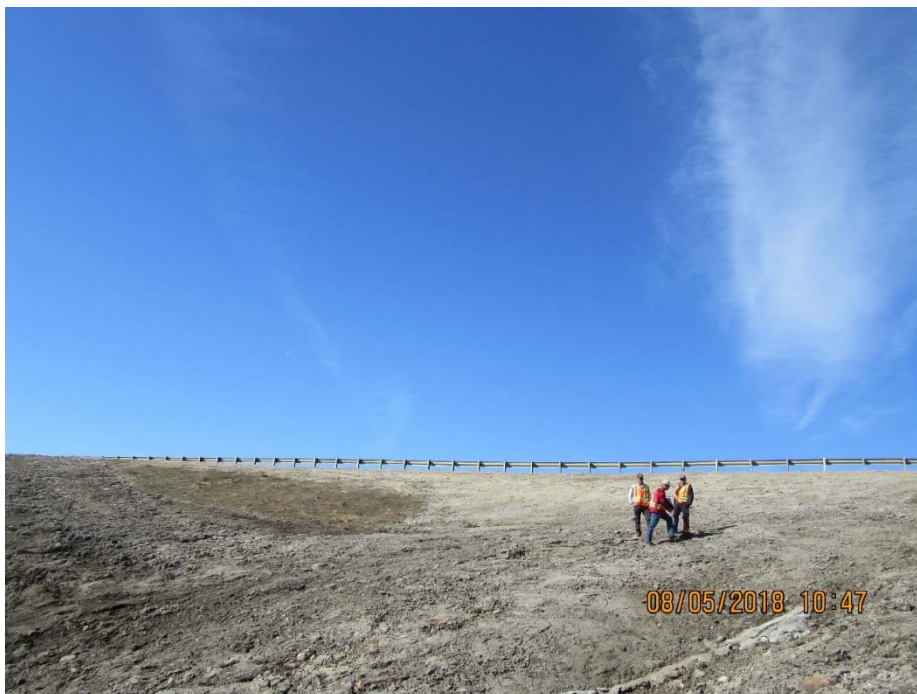
The highway embankment side slopes are bare of vegetation; making them more prone to erosion and slumping.

Photo No. 10 - Looking West at the highway embankment side slope. Note that the slope is bare of vegetation

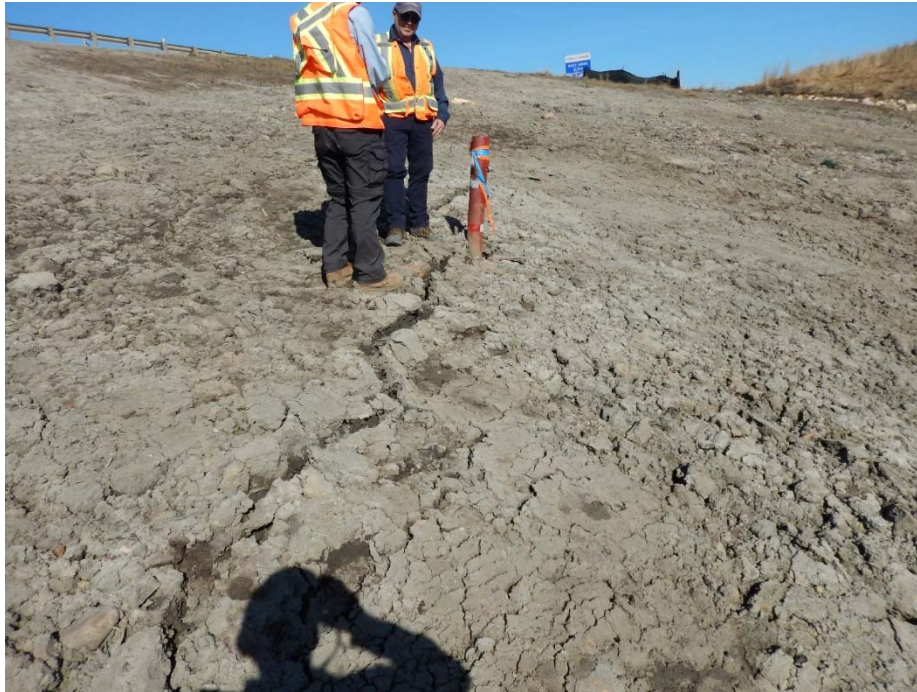
The existing slump near the bottom of the slope is anticipated to get bigger with time and it may eventually fail, impact the integrity of the pipe, and block the stream channel. Blockage of the culvert inlet and the stream channel may result in the saturation of the embankment fill. The loss of lateral toe support near the bottom of the embankment and the saturation of the embankment fill, if occur, will result in accelerated movement of the major landslide.

Photo No. 11 – Looking north at new cracks developed on the east embankment side slope (about 25 m above the culvert location)– Signs of localized slump above the culvert location

- Excavate the existing slump near the bottom of the slope and replace it with granular fill. Since the excavation will take place at the toe of the unstable slope, it is recommended that the slump be excavated and backfilled in small sections. Each section should be excavated and backfilled before the next section is excavated. Uncontrolled excavations will cause massive movement in the side slope.

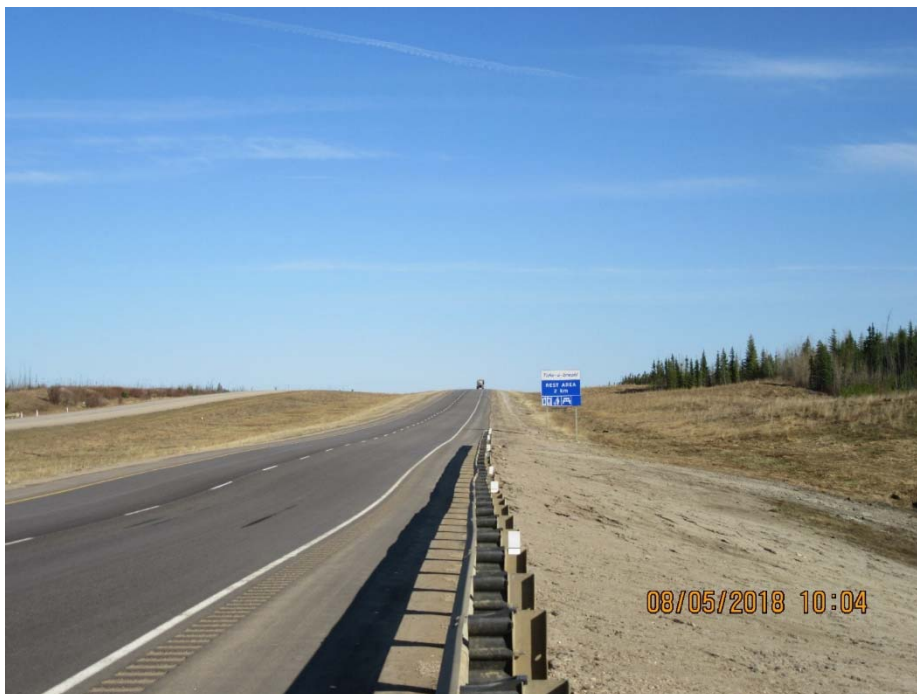
It is anticipated the landslide will continue to impact the highway conditions and the observed dip will continue to get worse with time. The landslide is moving at a very high rate and there is a risk of losing the highway lanes and the failure may have an impact the new pipe.

The existing pavement distress is a major hazard to motorists and is causing a rough ride to motorists.

Photo No. 12 – Looking north at the highway surface. Note the pavement distress and the distortion of the guardrail within the dip area

In the short term, the MCI should periodically monitor the highway for additional movement. Speed reduction and landslide warning signs should be placed along the highway at this location. If the dip becomes severe, ACP patch should be placed on the highway surface. The thickness of the patch should be kept to the minimum needed to provide a smooth ride to travellers. This is to avoid excessive loading of the crest of the slope at the landslide location.
