**ALBERTA TRANSPORTATION  
GEOHAZARD ASSESSMENT PROGRAM  
NORTH CENTRAL REGION – ATHABASCA  
2020 INSPECTION**

Site Number	Location	Name	Hwy	km
NC088	62 Km N of Wandering River	<b>Km 108 Settlement</b>	63:06	6.0
Legal Description		UTM Co-ordinates (NAD 83)		
S-30-77-14-W4M		12	6172629	E 426672

**NC088: HWY 63:06 NBL (km 4.9) PAVEMENT DISTRESS  
SKETCH SHOWING SITE FEATURES**

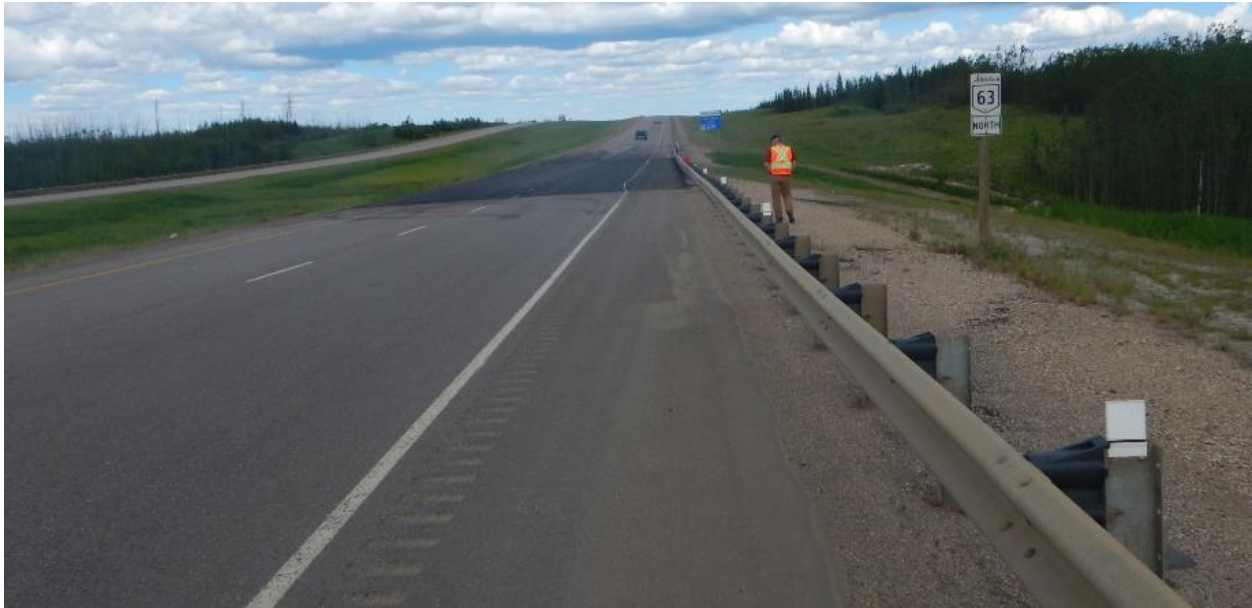
Photo No. 1 – Looking north at ACP patch recently placed along the north bound lanes (NBLs)

The MCI should periodically monitor the highway lanes and the slopes for signs of movement. If the dip re-appears on the highway NBLs, additional ACP patch should be placed to eliminate the dip and provide a smooth ride to motorists.

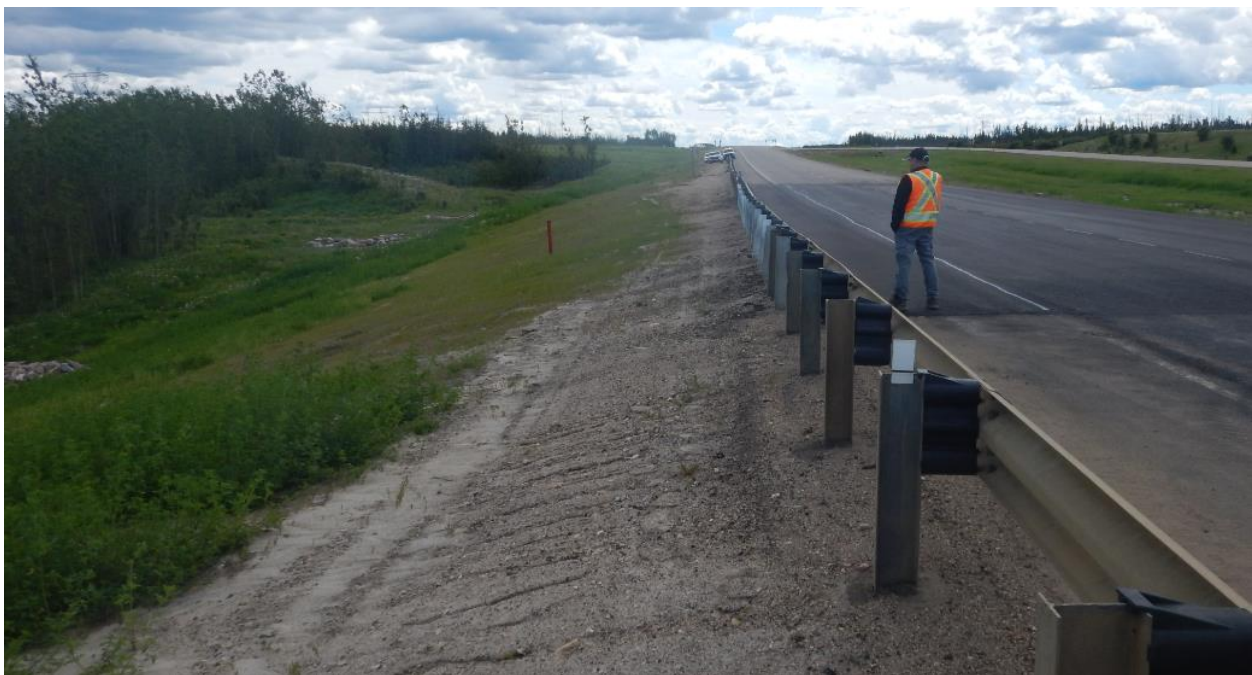
Photo No. 2 – Looking south at NBL embankment side slope; note minor rills near the guardrail

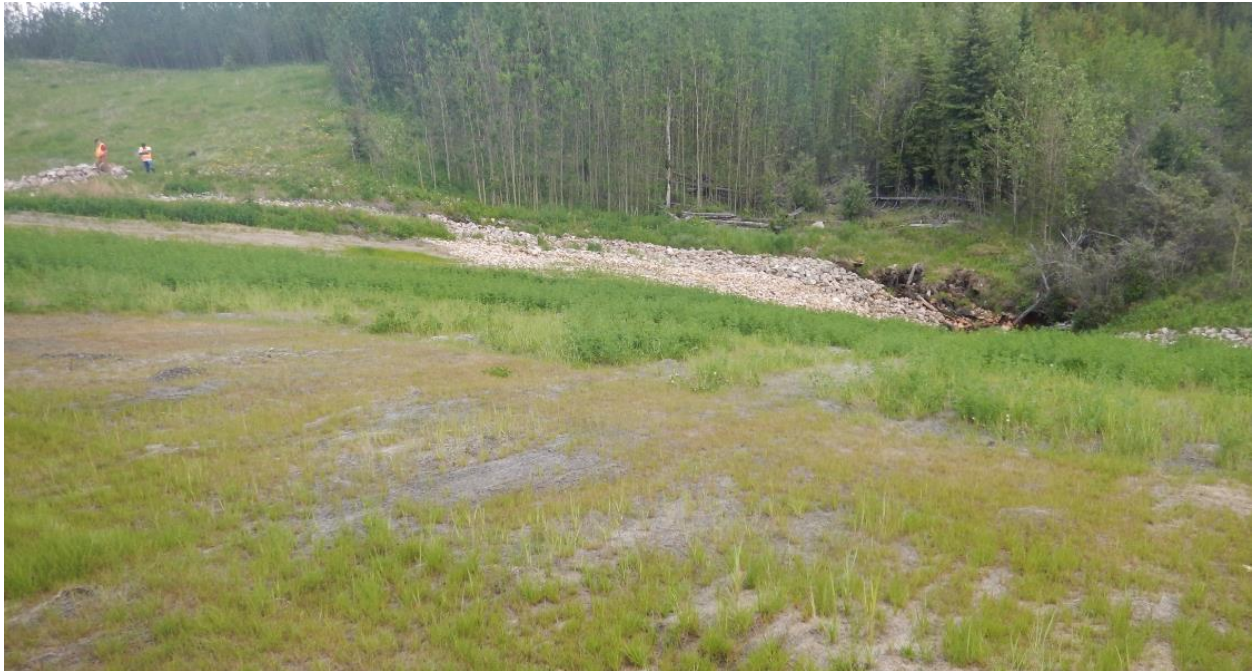
Photo No. 3 – NBL Embankment side slope; note vegetation growth and erosion of the creek bank at the toe of the slope

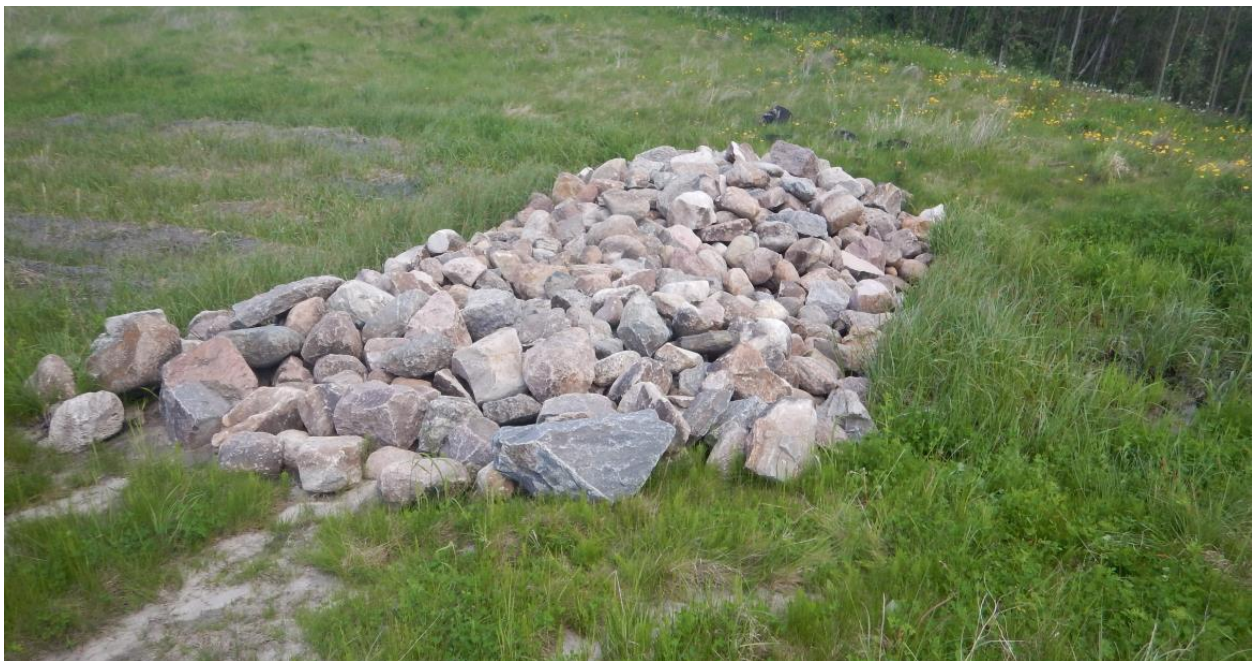
Photo No. 4 - New rock check dam located in the northeast ditch of the highway

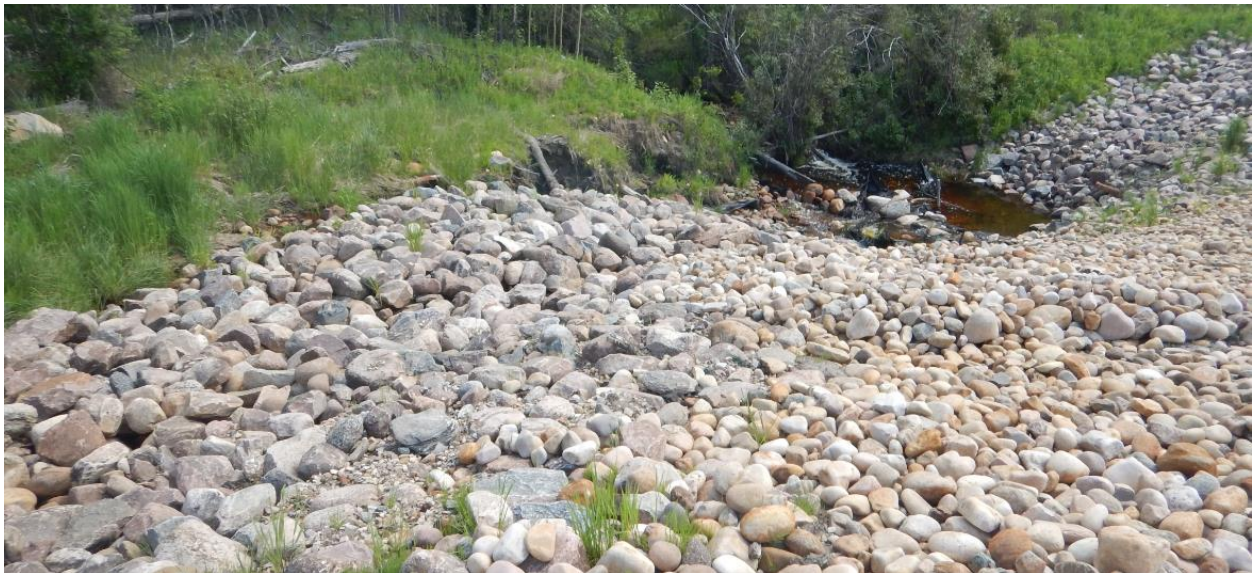
Permanent erosion control measures installed during the 2018-2019 repairs have some deficiencies that need to be addressed to prevent further erosion and future slumping issues. The erosion control measures deficiencies include bare vegetation zone above the SWSP culvert inlet, and localized erosion gullies along the south facing riprap channel of the east slope.

Photo No. 6 – Looking southeast toward the 1.2 m SWSP inlet; note erosion along the south facing riprap channel and deadfall accumulation near the inlet

Erosion gullies within the south facing channel of the east slope will need to be repaired. This will require salvaging existing riprap, excavating eroded areas, reshaping the channel to have well defined sides and bottom, placement of salvaged riprap and additional riprap (as needed) over non-woven geotextile fabric (to be keyed in at least 300 mm at the top of the channel) along the sides and the bottom of the channel.

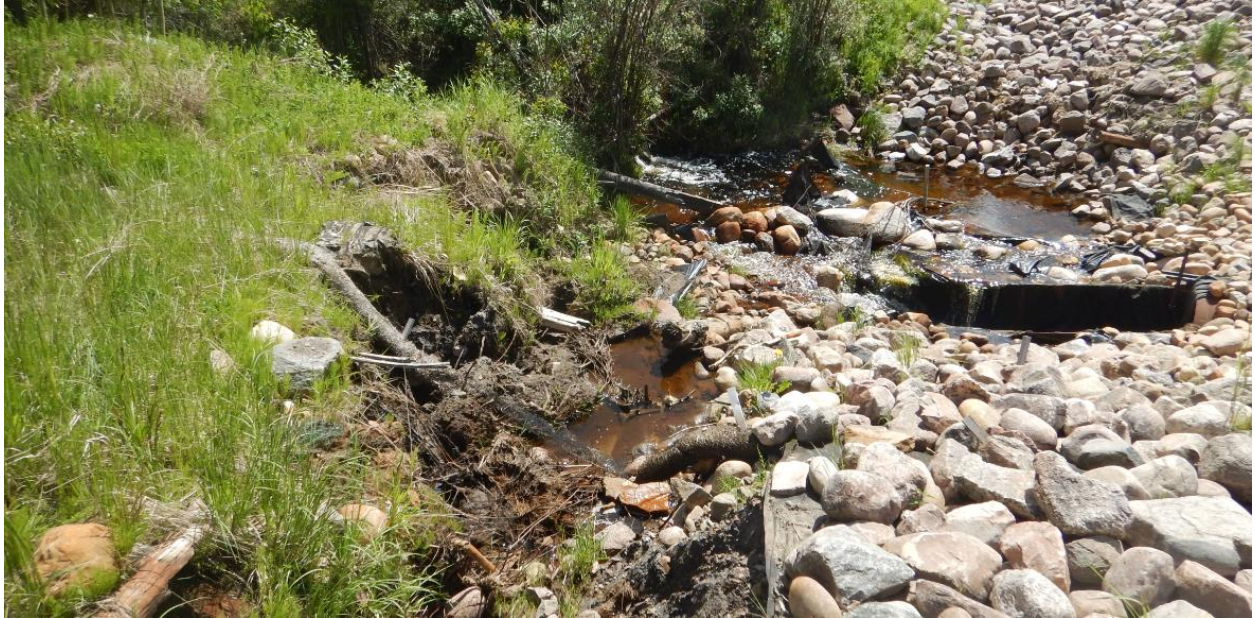
Photo No. 7 – Riprap channel erosion and debris accumulation near the 1.2 m SWSP culvert inlet

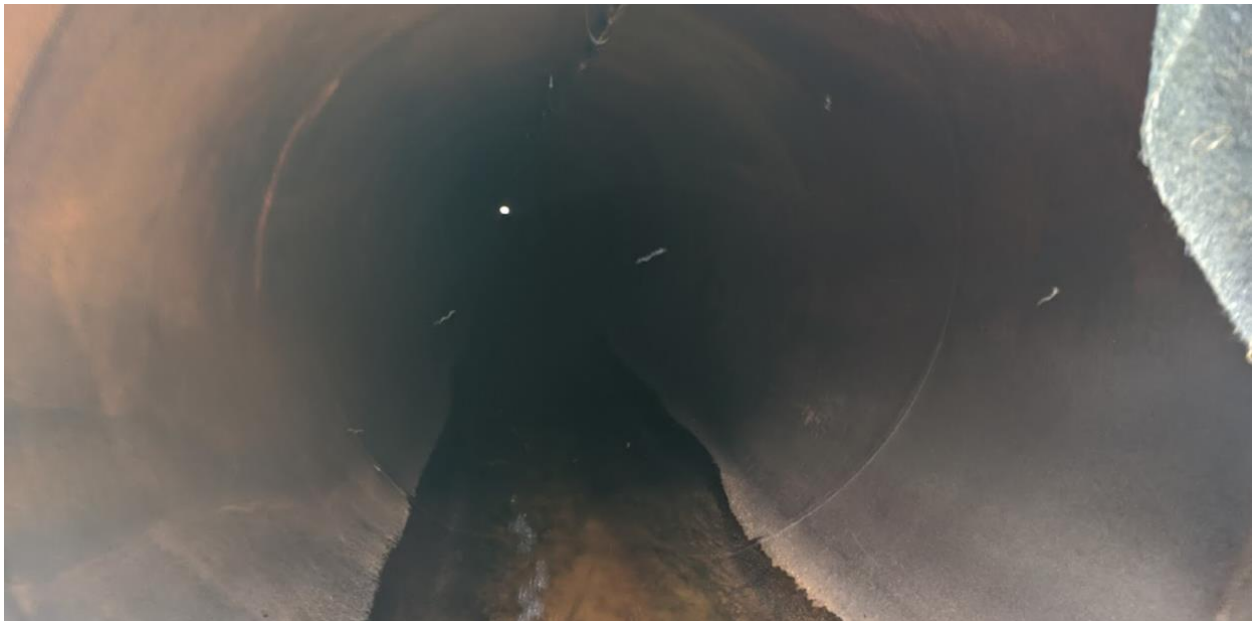
Photo No. 8 – Looking inside the SWSP culvert from inlet location

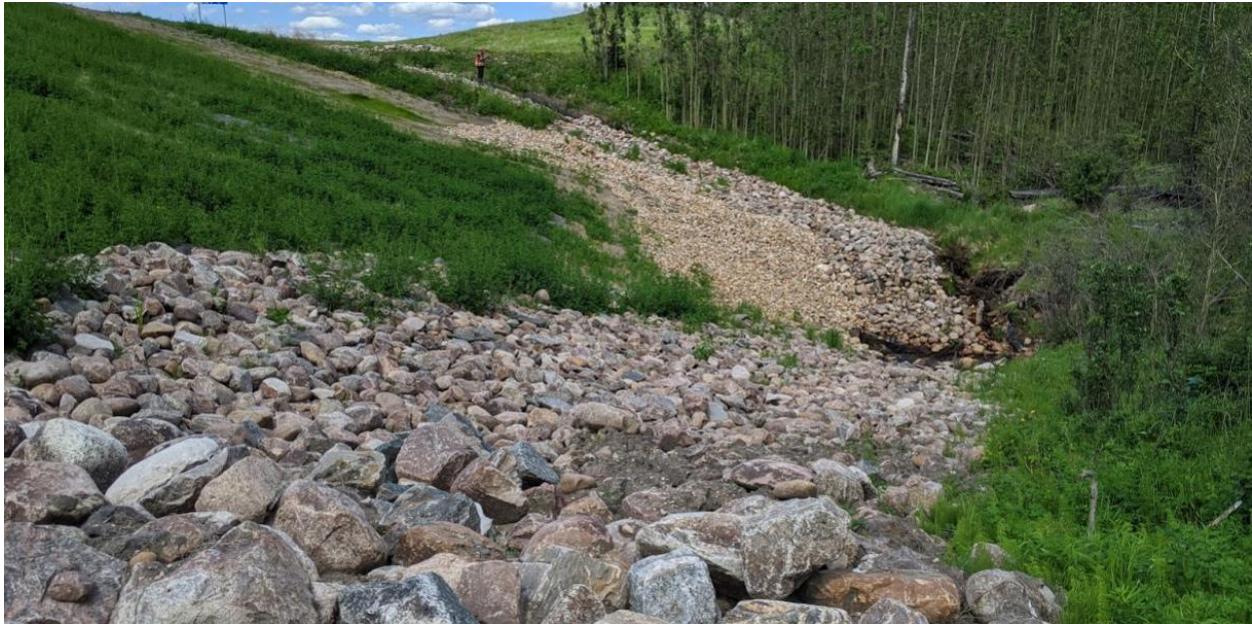
Photo No. 9 – NBL embankment east side slope; note poor vegetation growth upslope of the centre portion of the riprap

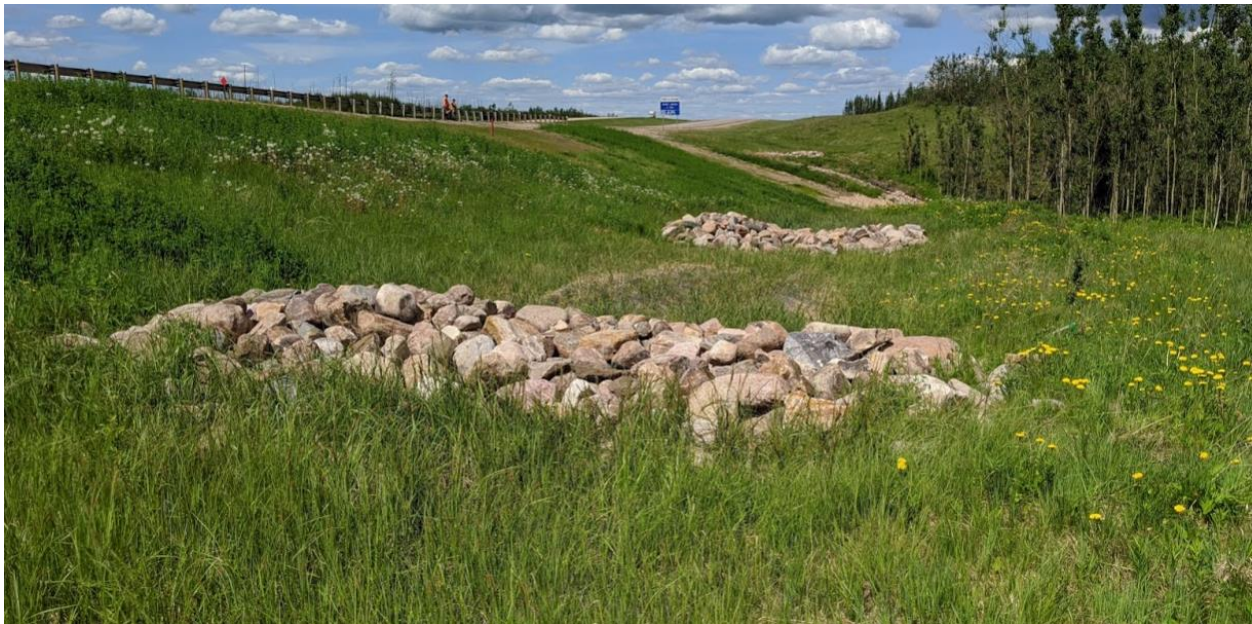
Photo No. 10 – Rock check dams located along NBL southeast ditch

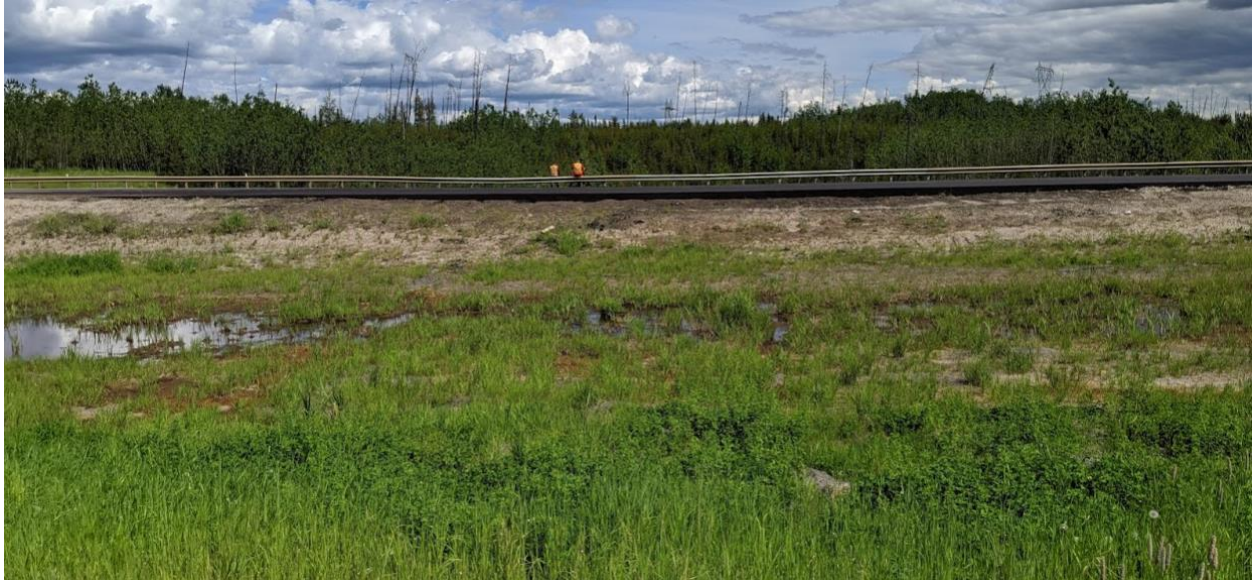
movement will take place, resulting in re-appearance of a dip in the highway surface. Water ponding in the median ditch will continue to elevate groundwater levels in the east slope and this may result in future accelerated movement of the landslide.

Photo No. 11 – Median ponding water; note recently placed ACP patch on the NBL

The median ditch should be slightly graded to prevent ponding of water in the ditch.

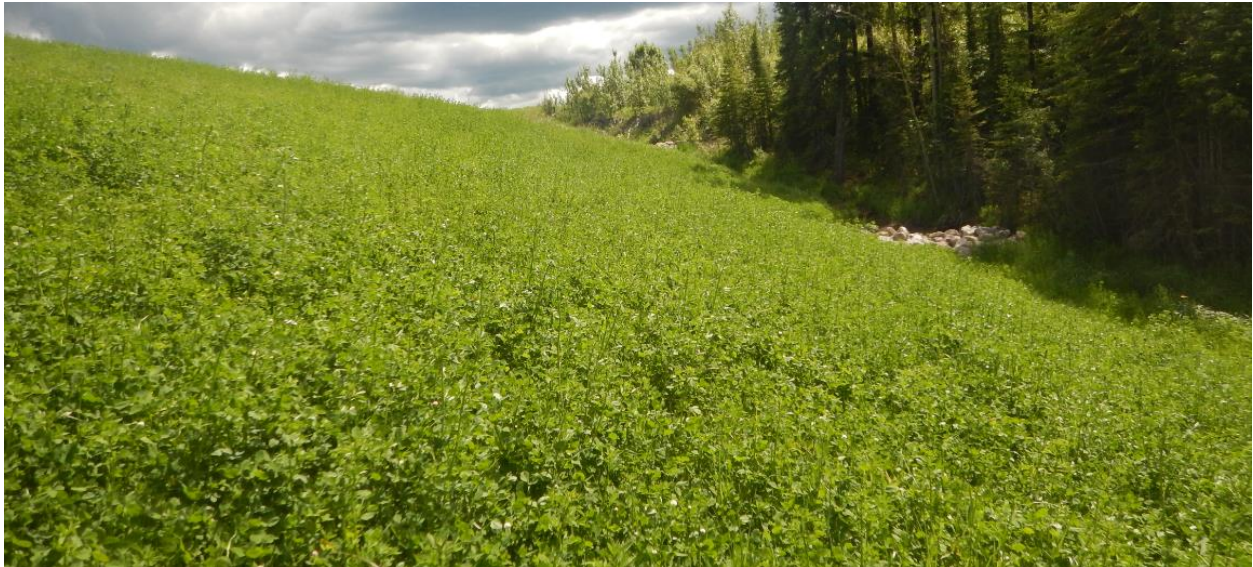
Photo No. 12 – Looking south at SBL west side slope; note good vegetation growth within recently repaired area

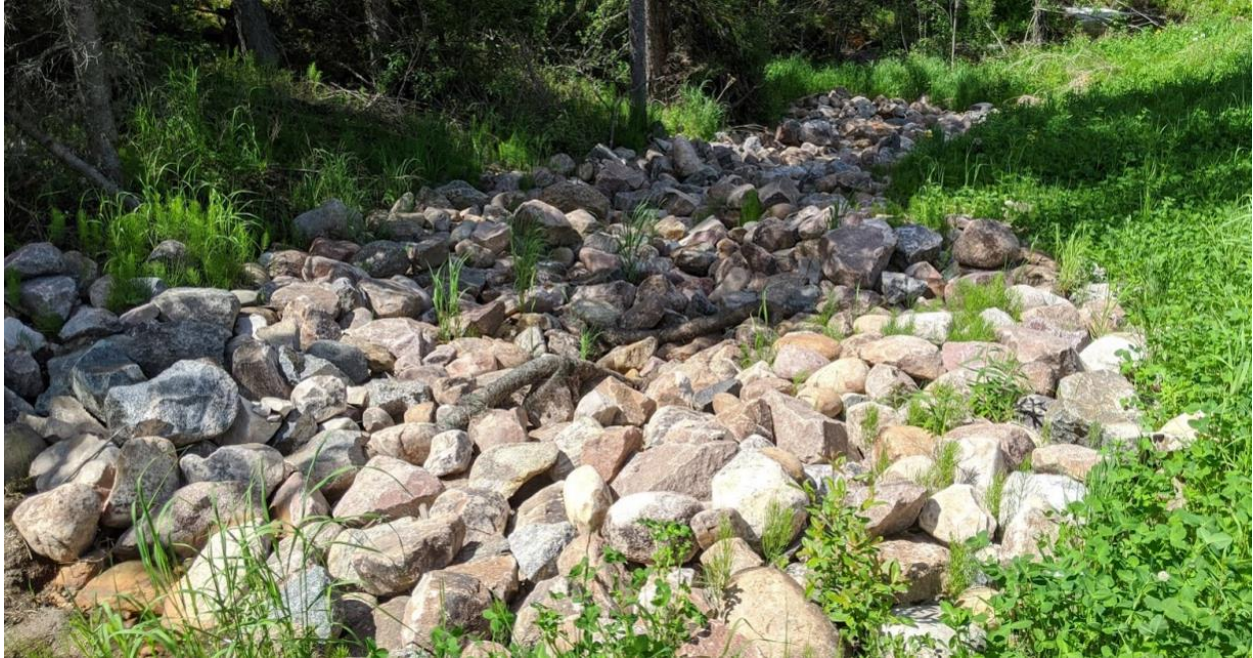
Photo No. 13 – New north facing riprap channel along the SBL west side slope

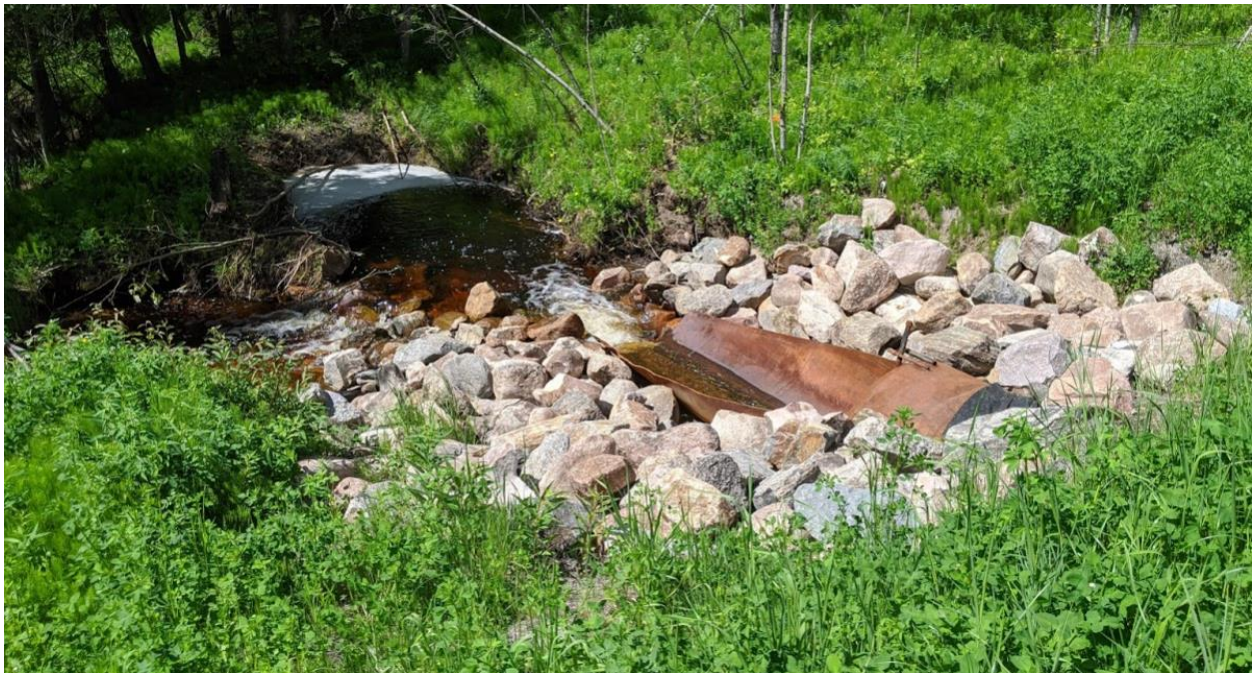
Photo No. 14 – New SWSP outlet; note water flow and minor erosion downstream of the outlet

It is recommended to get the creek channel slightly realigned at the SWSP culvert outlet to prevent ponding of water at the toe of the slope. Additional riprap armoring of the creek channel (for at least 5 to 10 m beyond the outlet location) is also recommended to reduce the likelihood of future toe erosion issues.
