**ALBERTA TRANSPORTATION GRMP (CON0022163)
NORTH CENTRAL (ATHABASCA AND FORT McMURRAY DISTRICTS)
INSTRUMENTATION MONITORING RESULTS – FALL 2022**

SITE NC088: HWY 63:06 km 108 SETTLEMENT

**ALBERTA TRANSPORTATION GRMP (CON0022163)
NORTH CENTRAL (ATHABASCA AND FORT McMURRAY DISTRICTS)
INSTRUMENTATION MONITORING RESULTS**

**NORTH CENTRAL
(ATHABASCA AND FORT MCMURRAY DISTRICTS)
NC088: HWY 63:06 EAST AND WEST
EMBANKMENT FAILURES (km 4.9)
SITE PLAN SHOWING APPROXIMATE
INSTRUMENT LOCATIONS
DWG No. 32122-NC088**

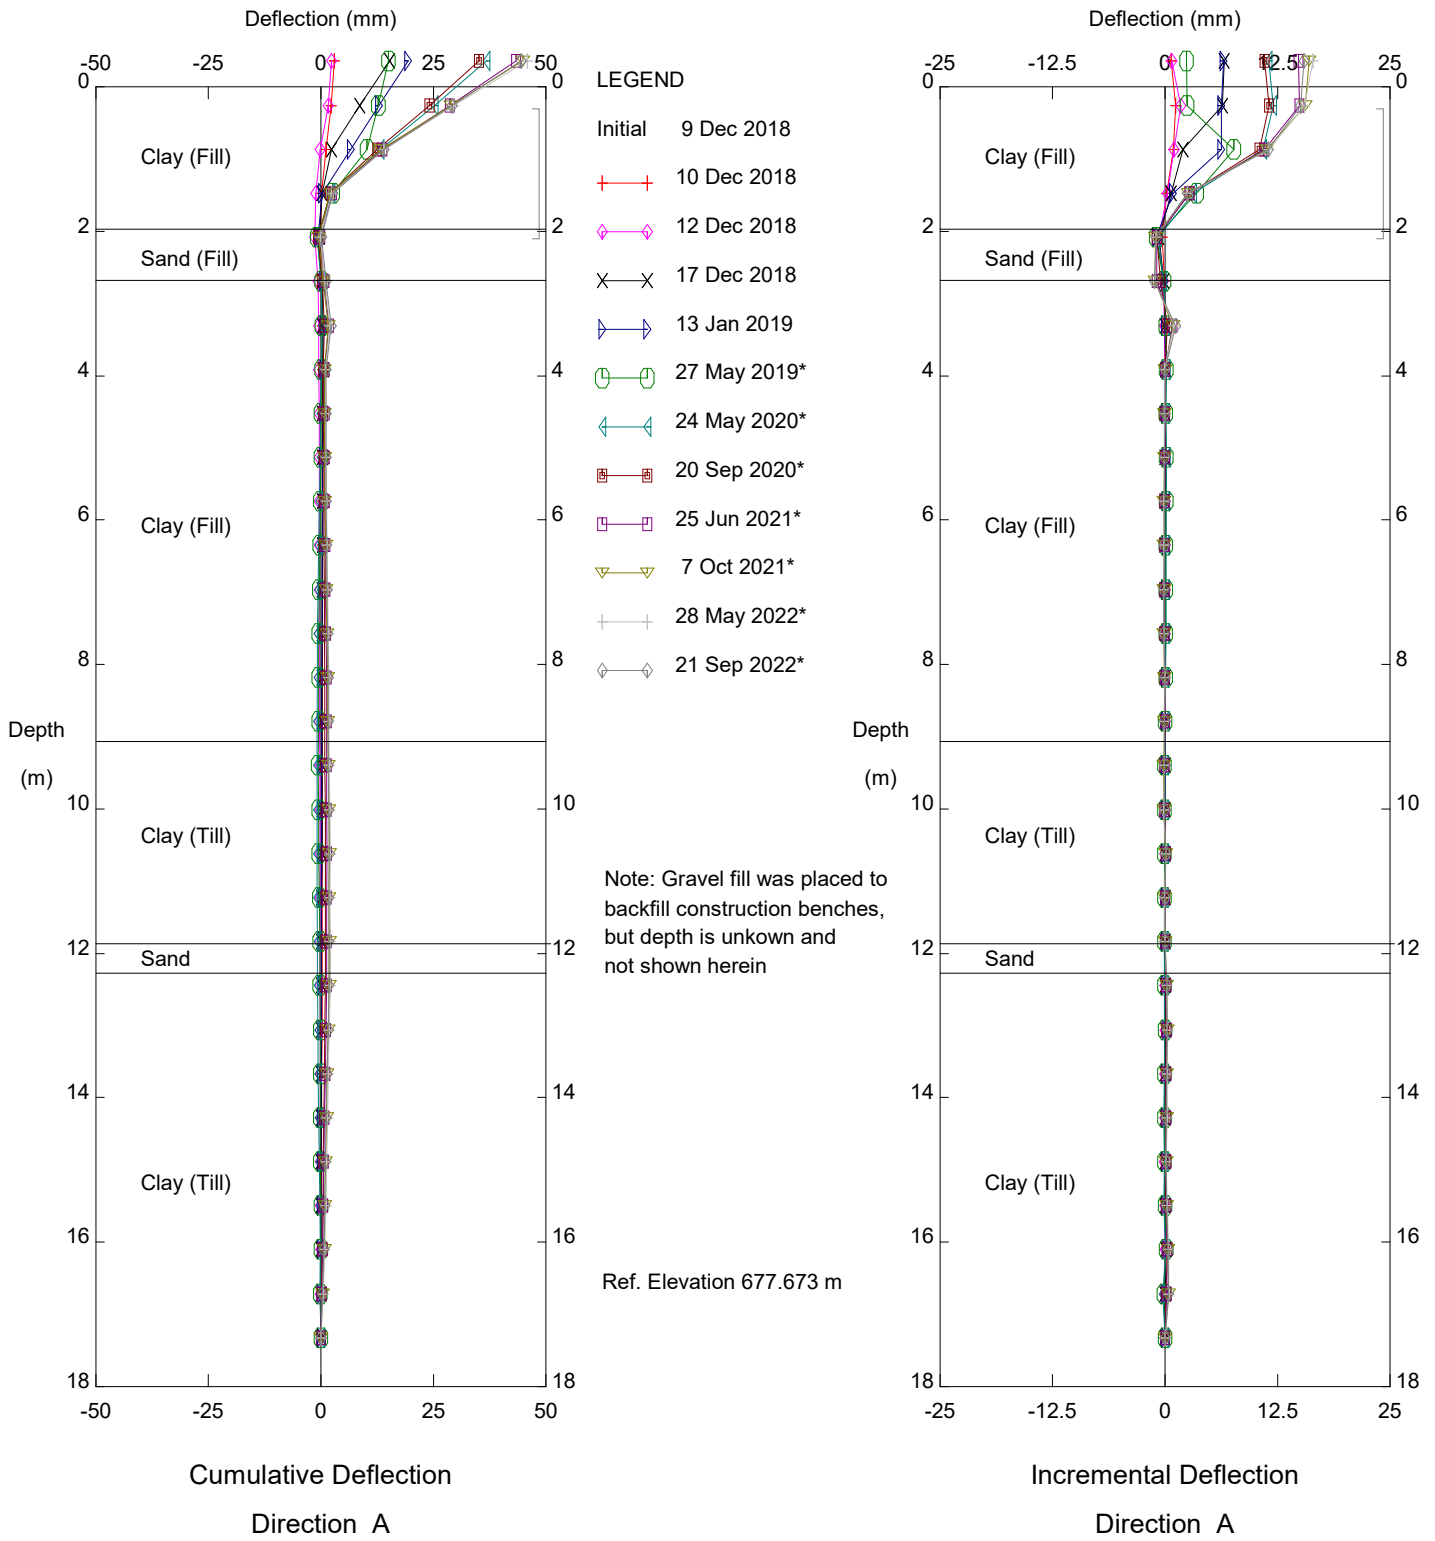
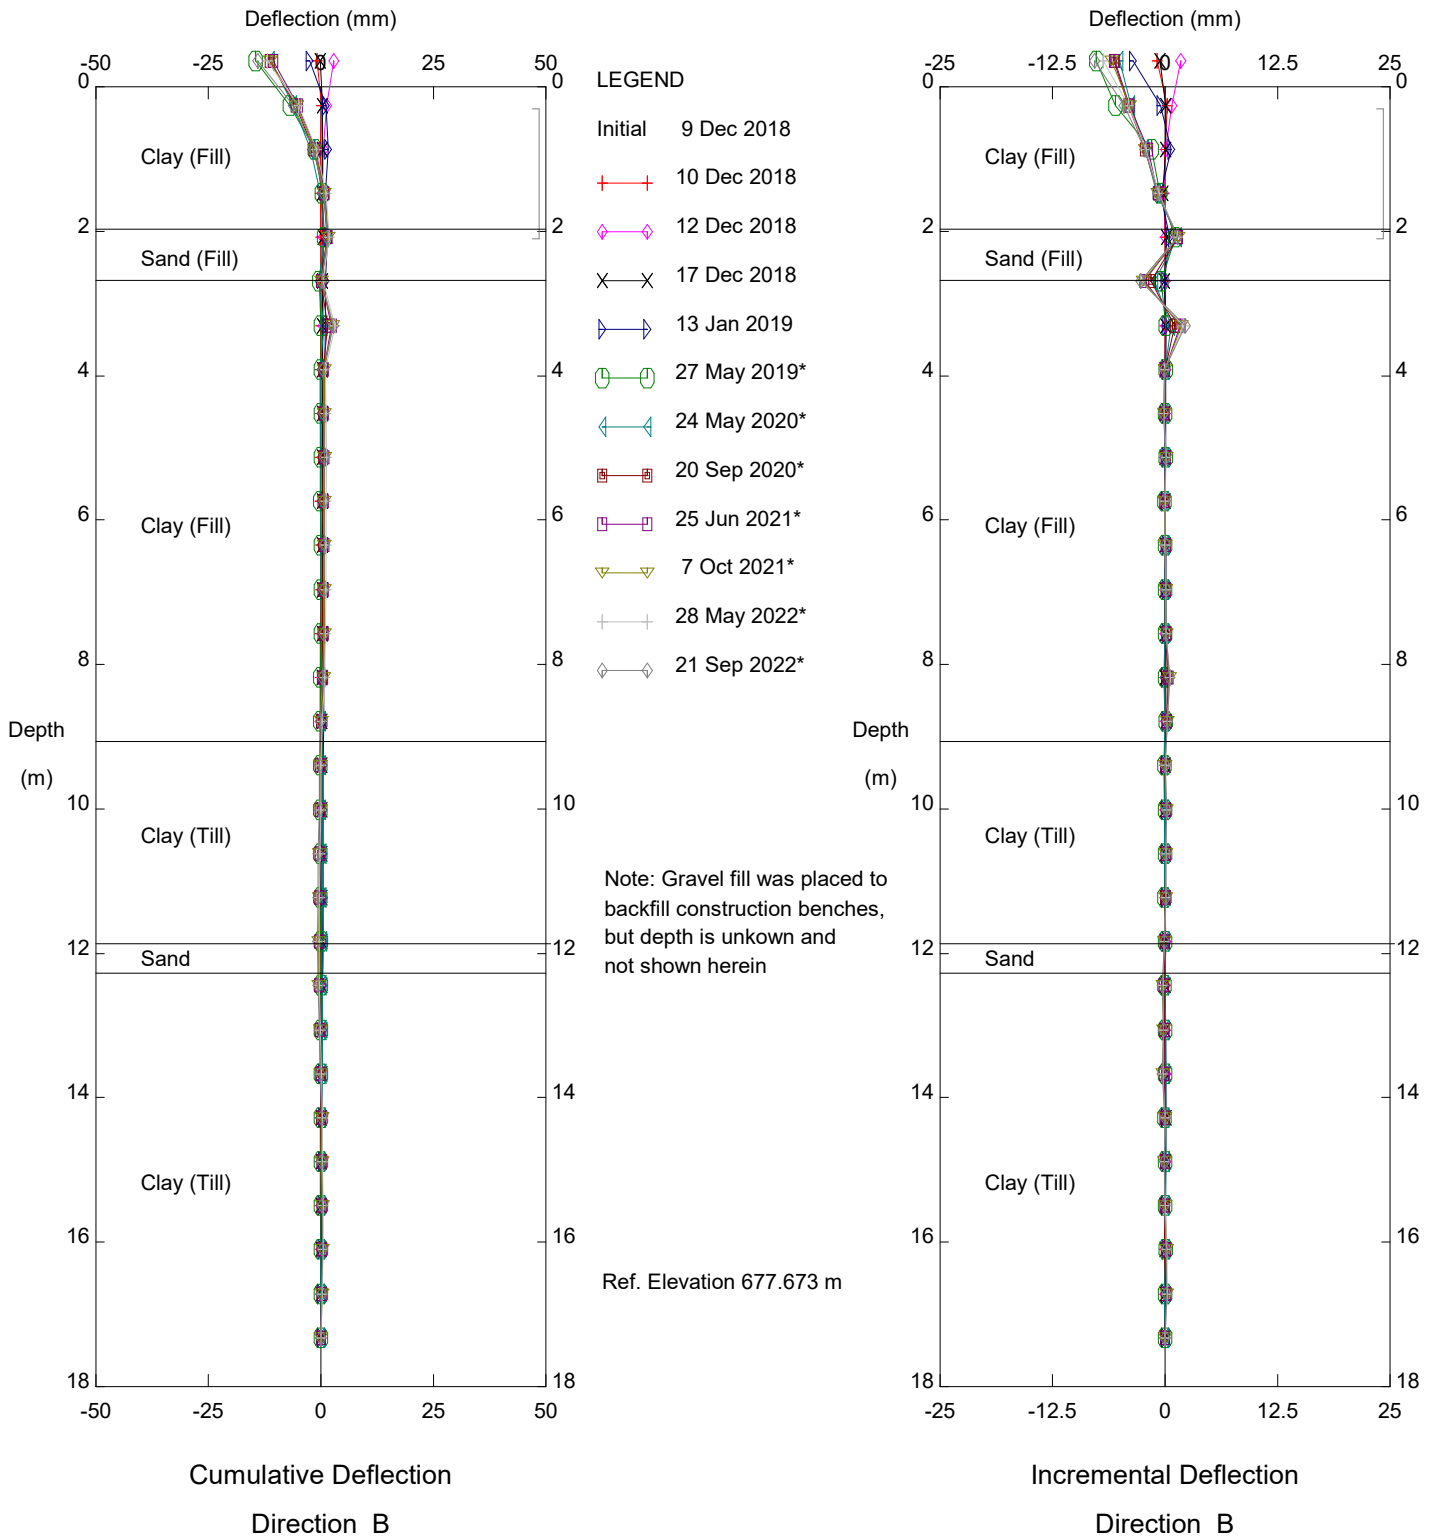
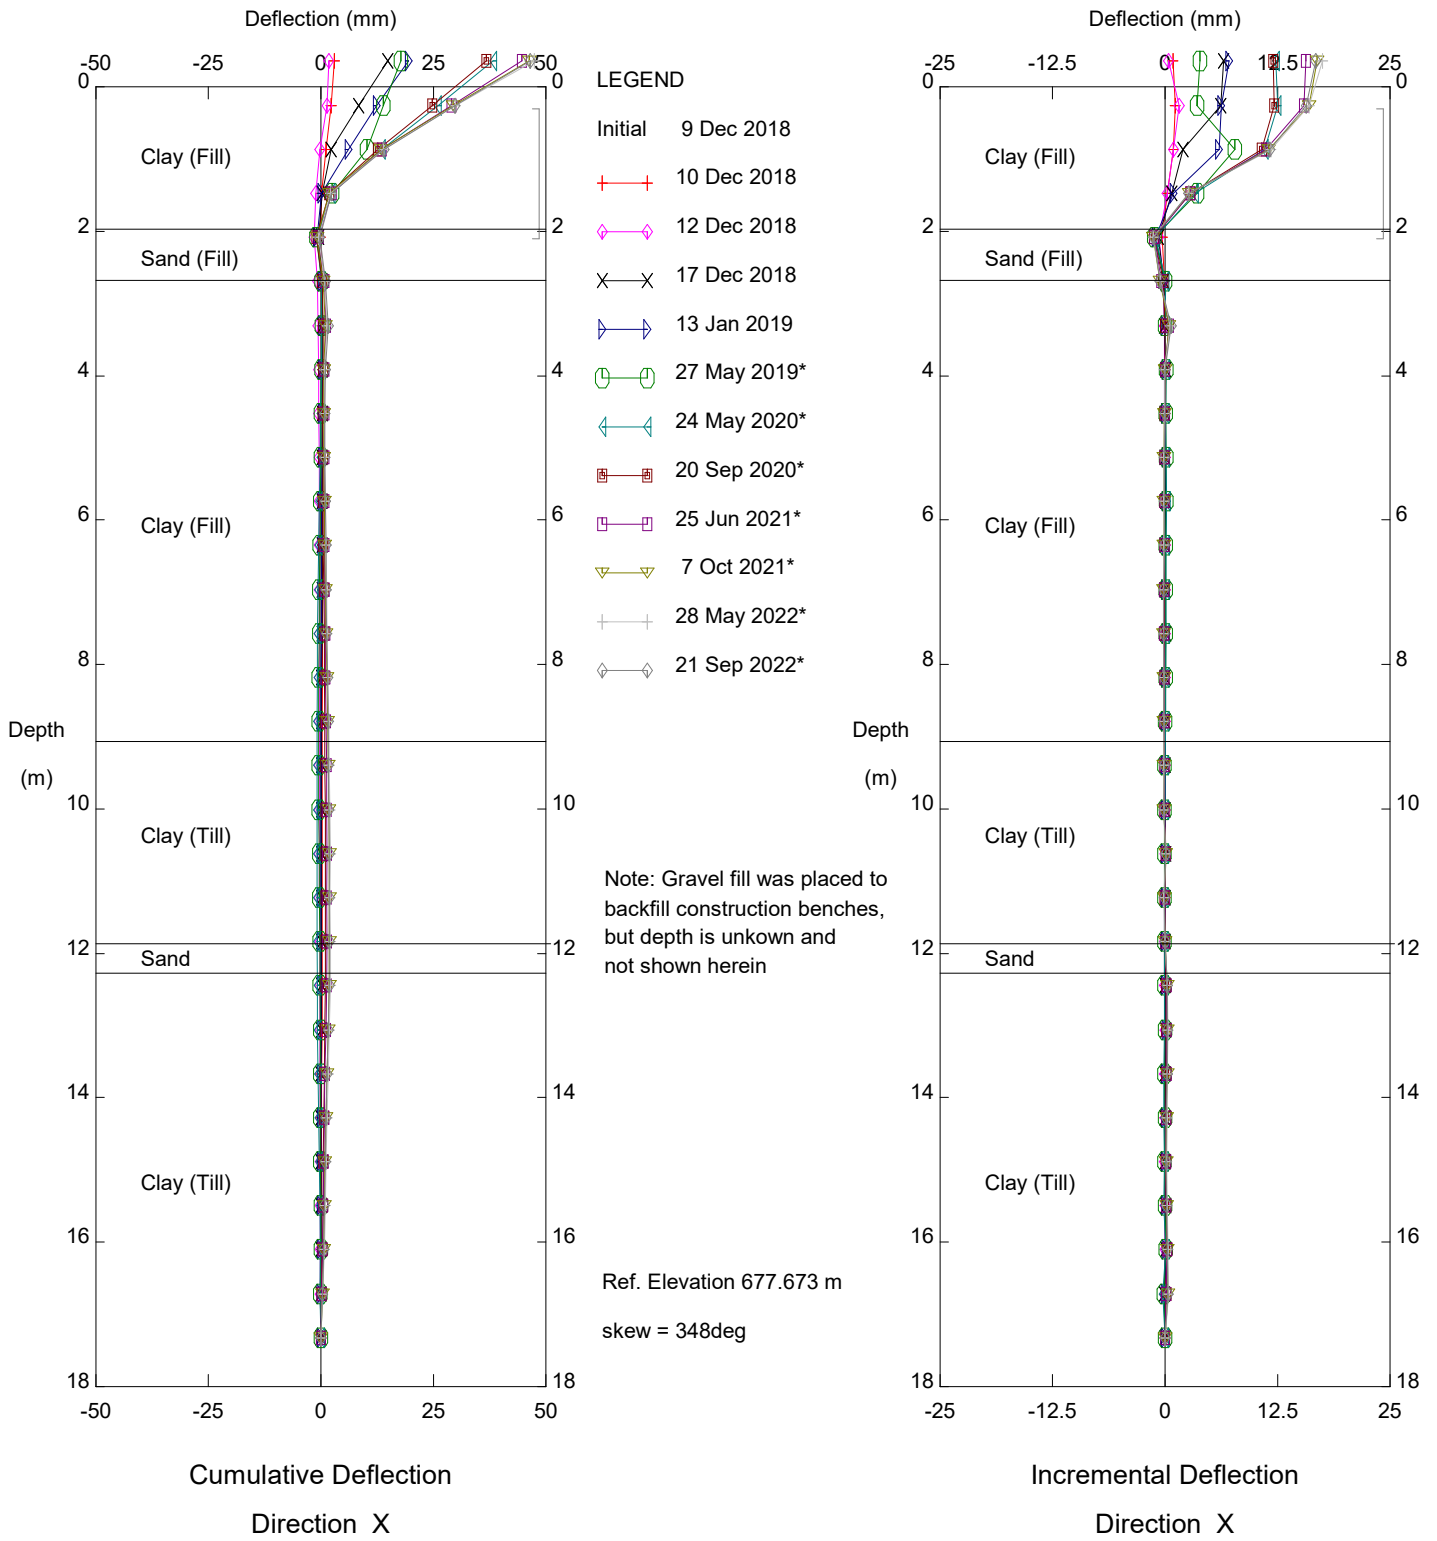
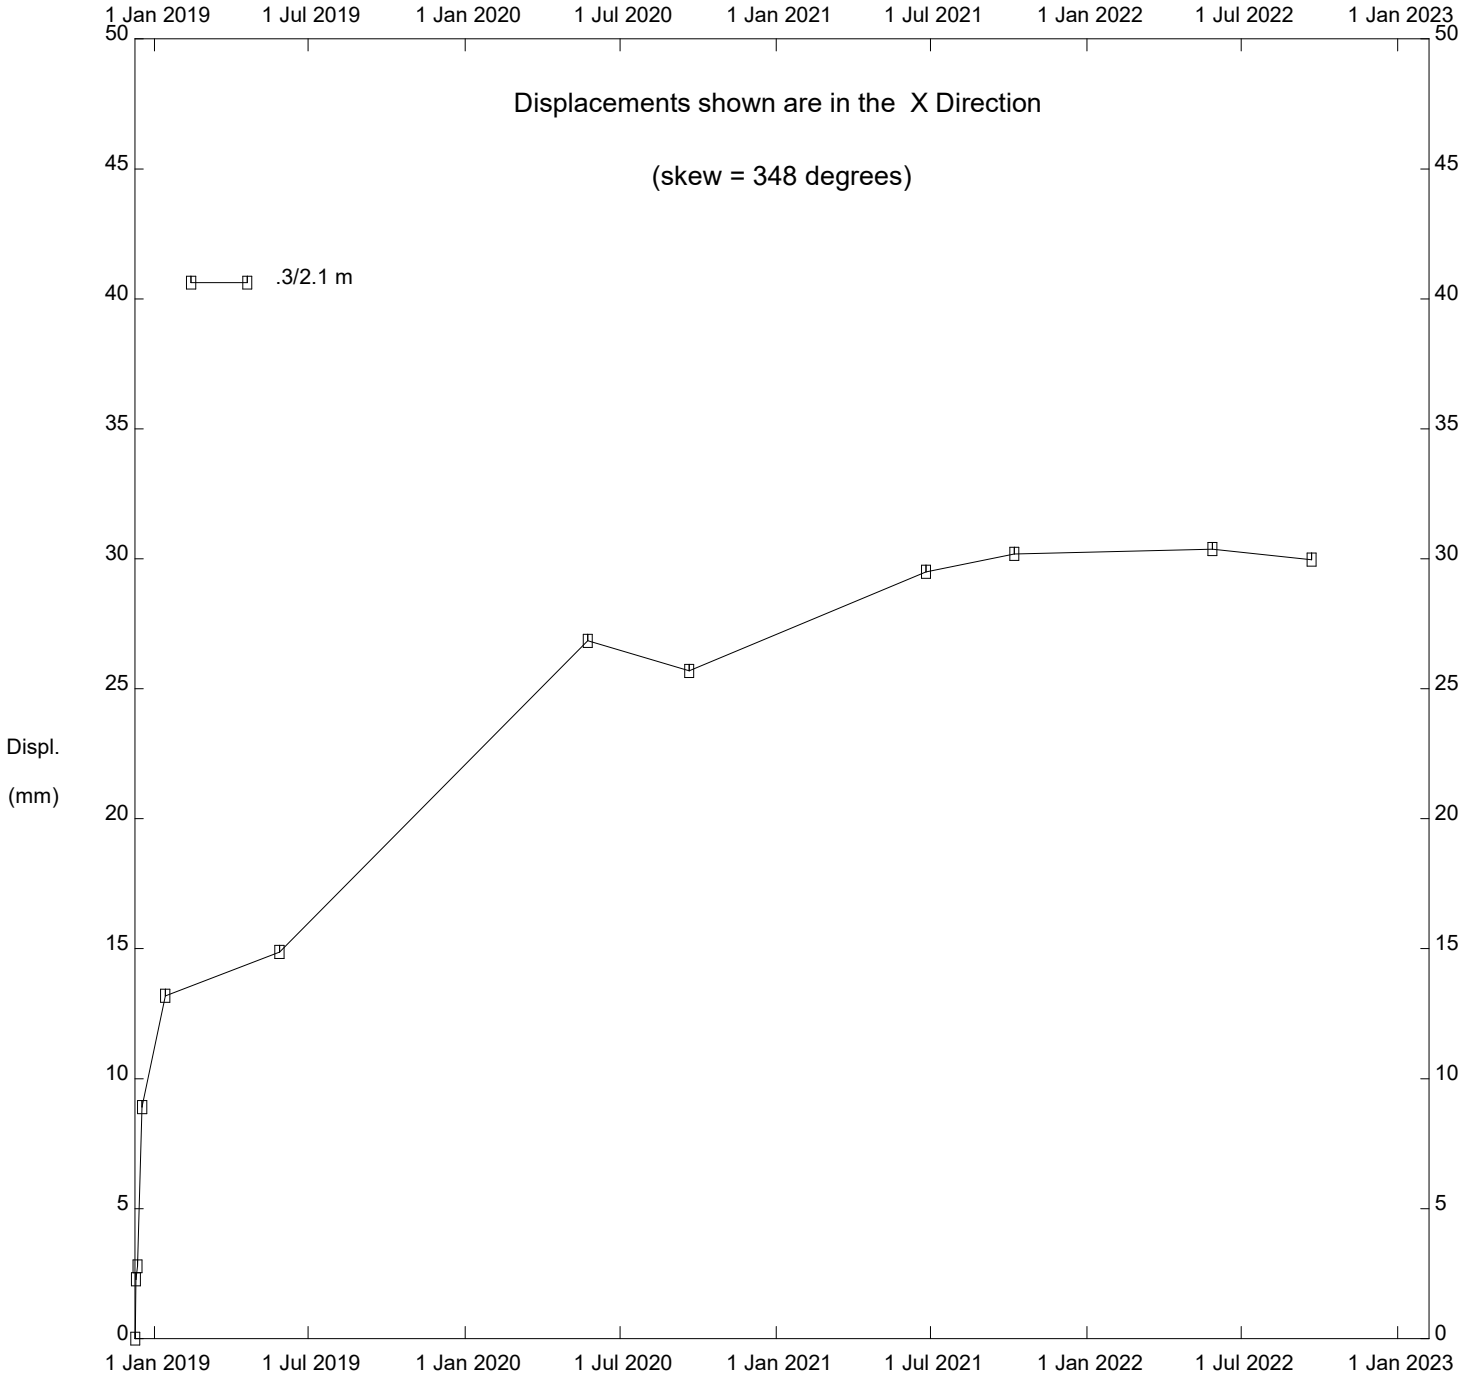
NC088 - West Embankment, Inclinometer SI18-4

SI18-4 showed no discernible movement over 0.3 m to 2.1 m depth since the spring of 2022 readings. The movement rate of the west landslide appears to have reduced significantly since the completion of the interim repair measures.

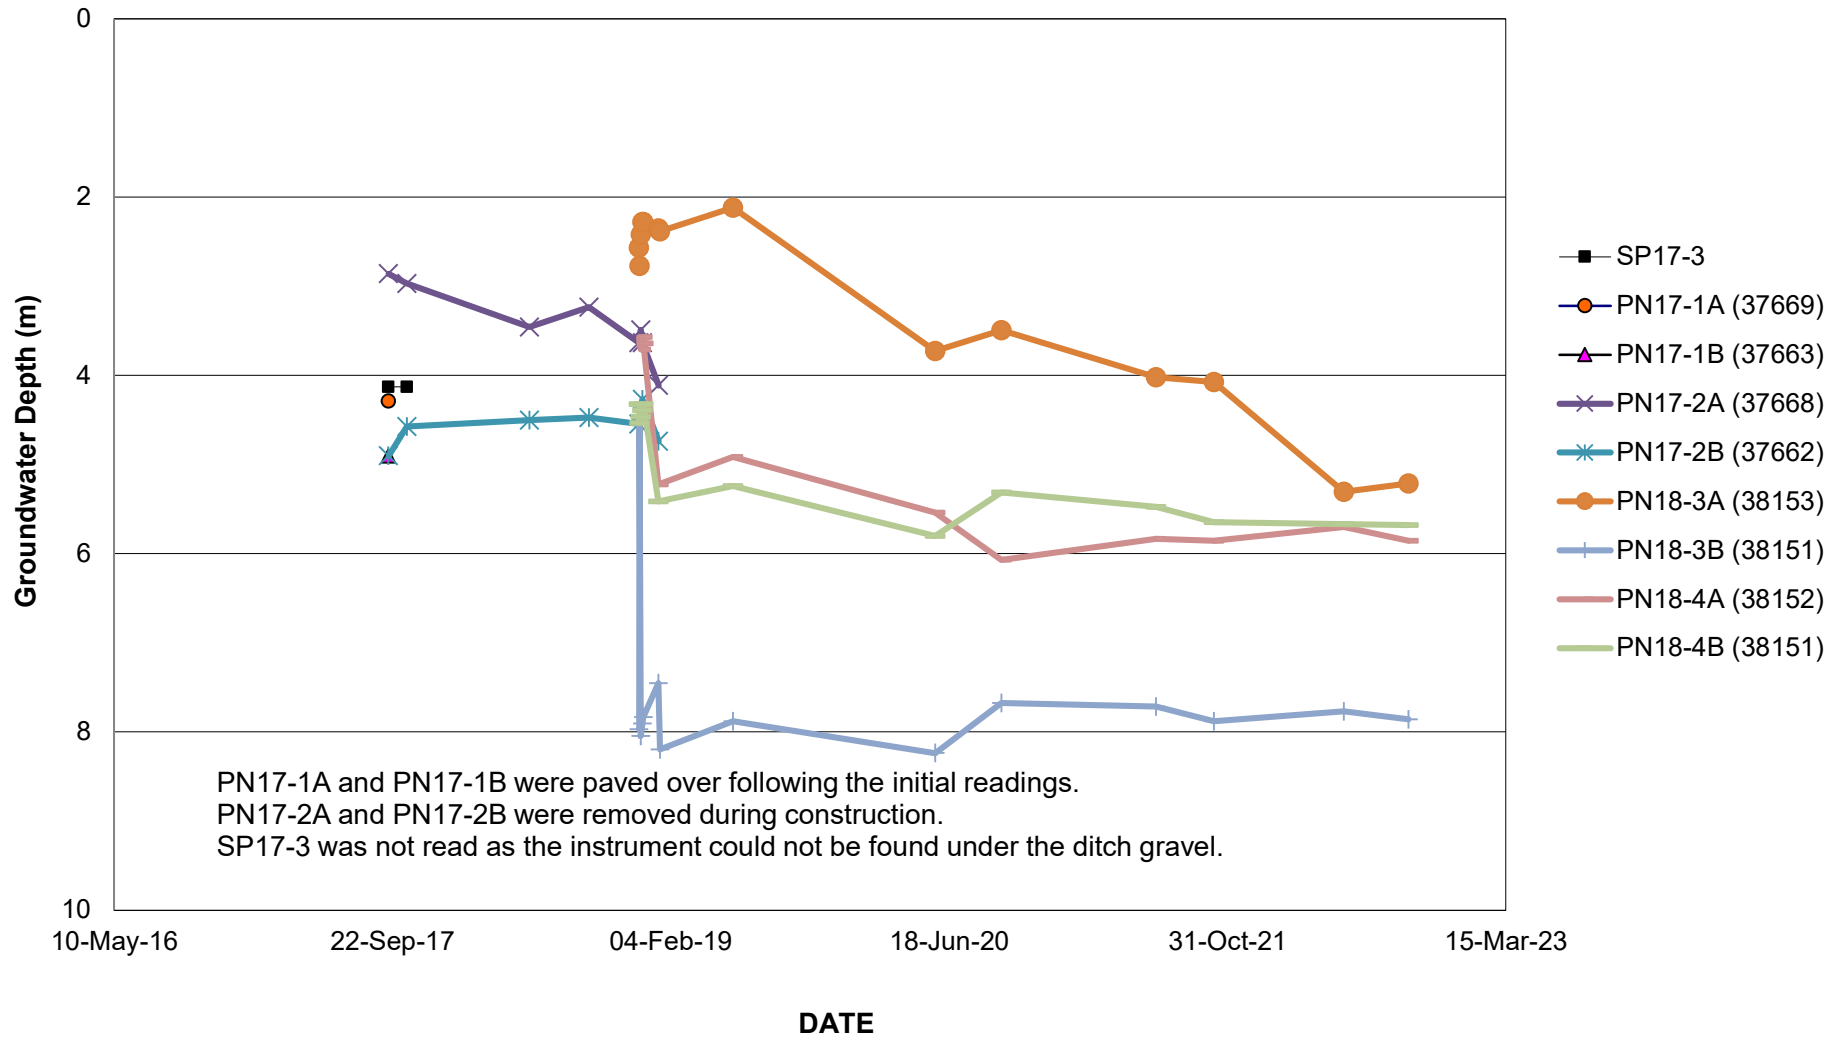
**FIGURE NC088-1
PIEZOMETER DATA FOR HWY 63:06 EAST AND WEST EMBANKMENT
FAILURES (km 4.90)**

Pneumatic piezometer PN18-3A showed an increase in groundwater level of 0.09 m since the spring of 2022 readings. PN18-3B, PN18-4A, and PN18-4B showed decreases in groundwater level of 0.09 m, 0.16 m, and 0.01 m, respectively, since the spring of 2022 readings. PN18-3A has shown a trend of gradually decreasing groundwater level since the spring of 2019. The pneumatic piezometer readings are summarized in Table NC088-2, and are plotted on Figure NC088-1, included in Appendix A.
