**ALBERTA TRANSPORTATION AND
ECONOMIC CORRIDORS GRMP
NORTH CENTRAL (ATHABASCA AND FORT
McMURRAY DISTRICTS)
INSTRUMENTATION MONITORING- FALL 2024**

| Site Number | Location | Name | Hwy | km |
|---|---|---|---|---|
| NC088 | km 108 Settlement | HWY 63:06 km 108 Settlement | 63:06 | km 108 |

| Current Monitoring: | 16-Sep-2024 | Previous Monitoring | 08-Jun-2024 |

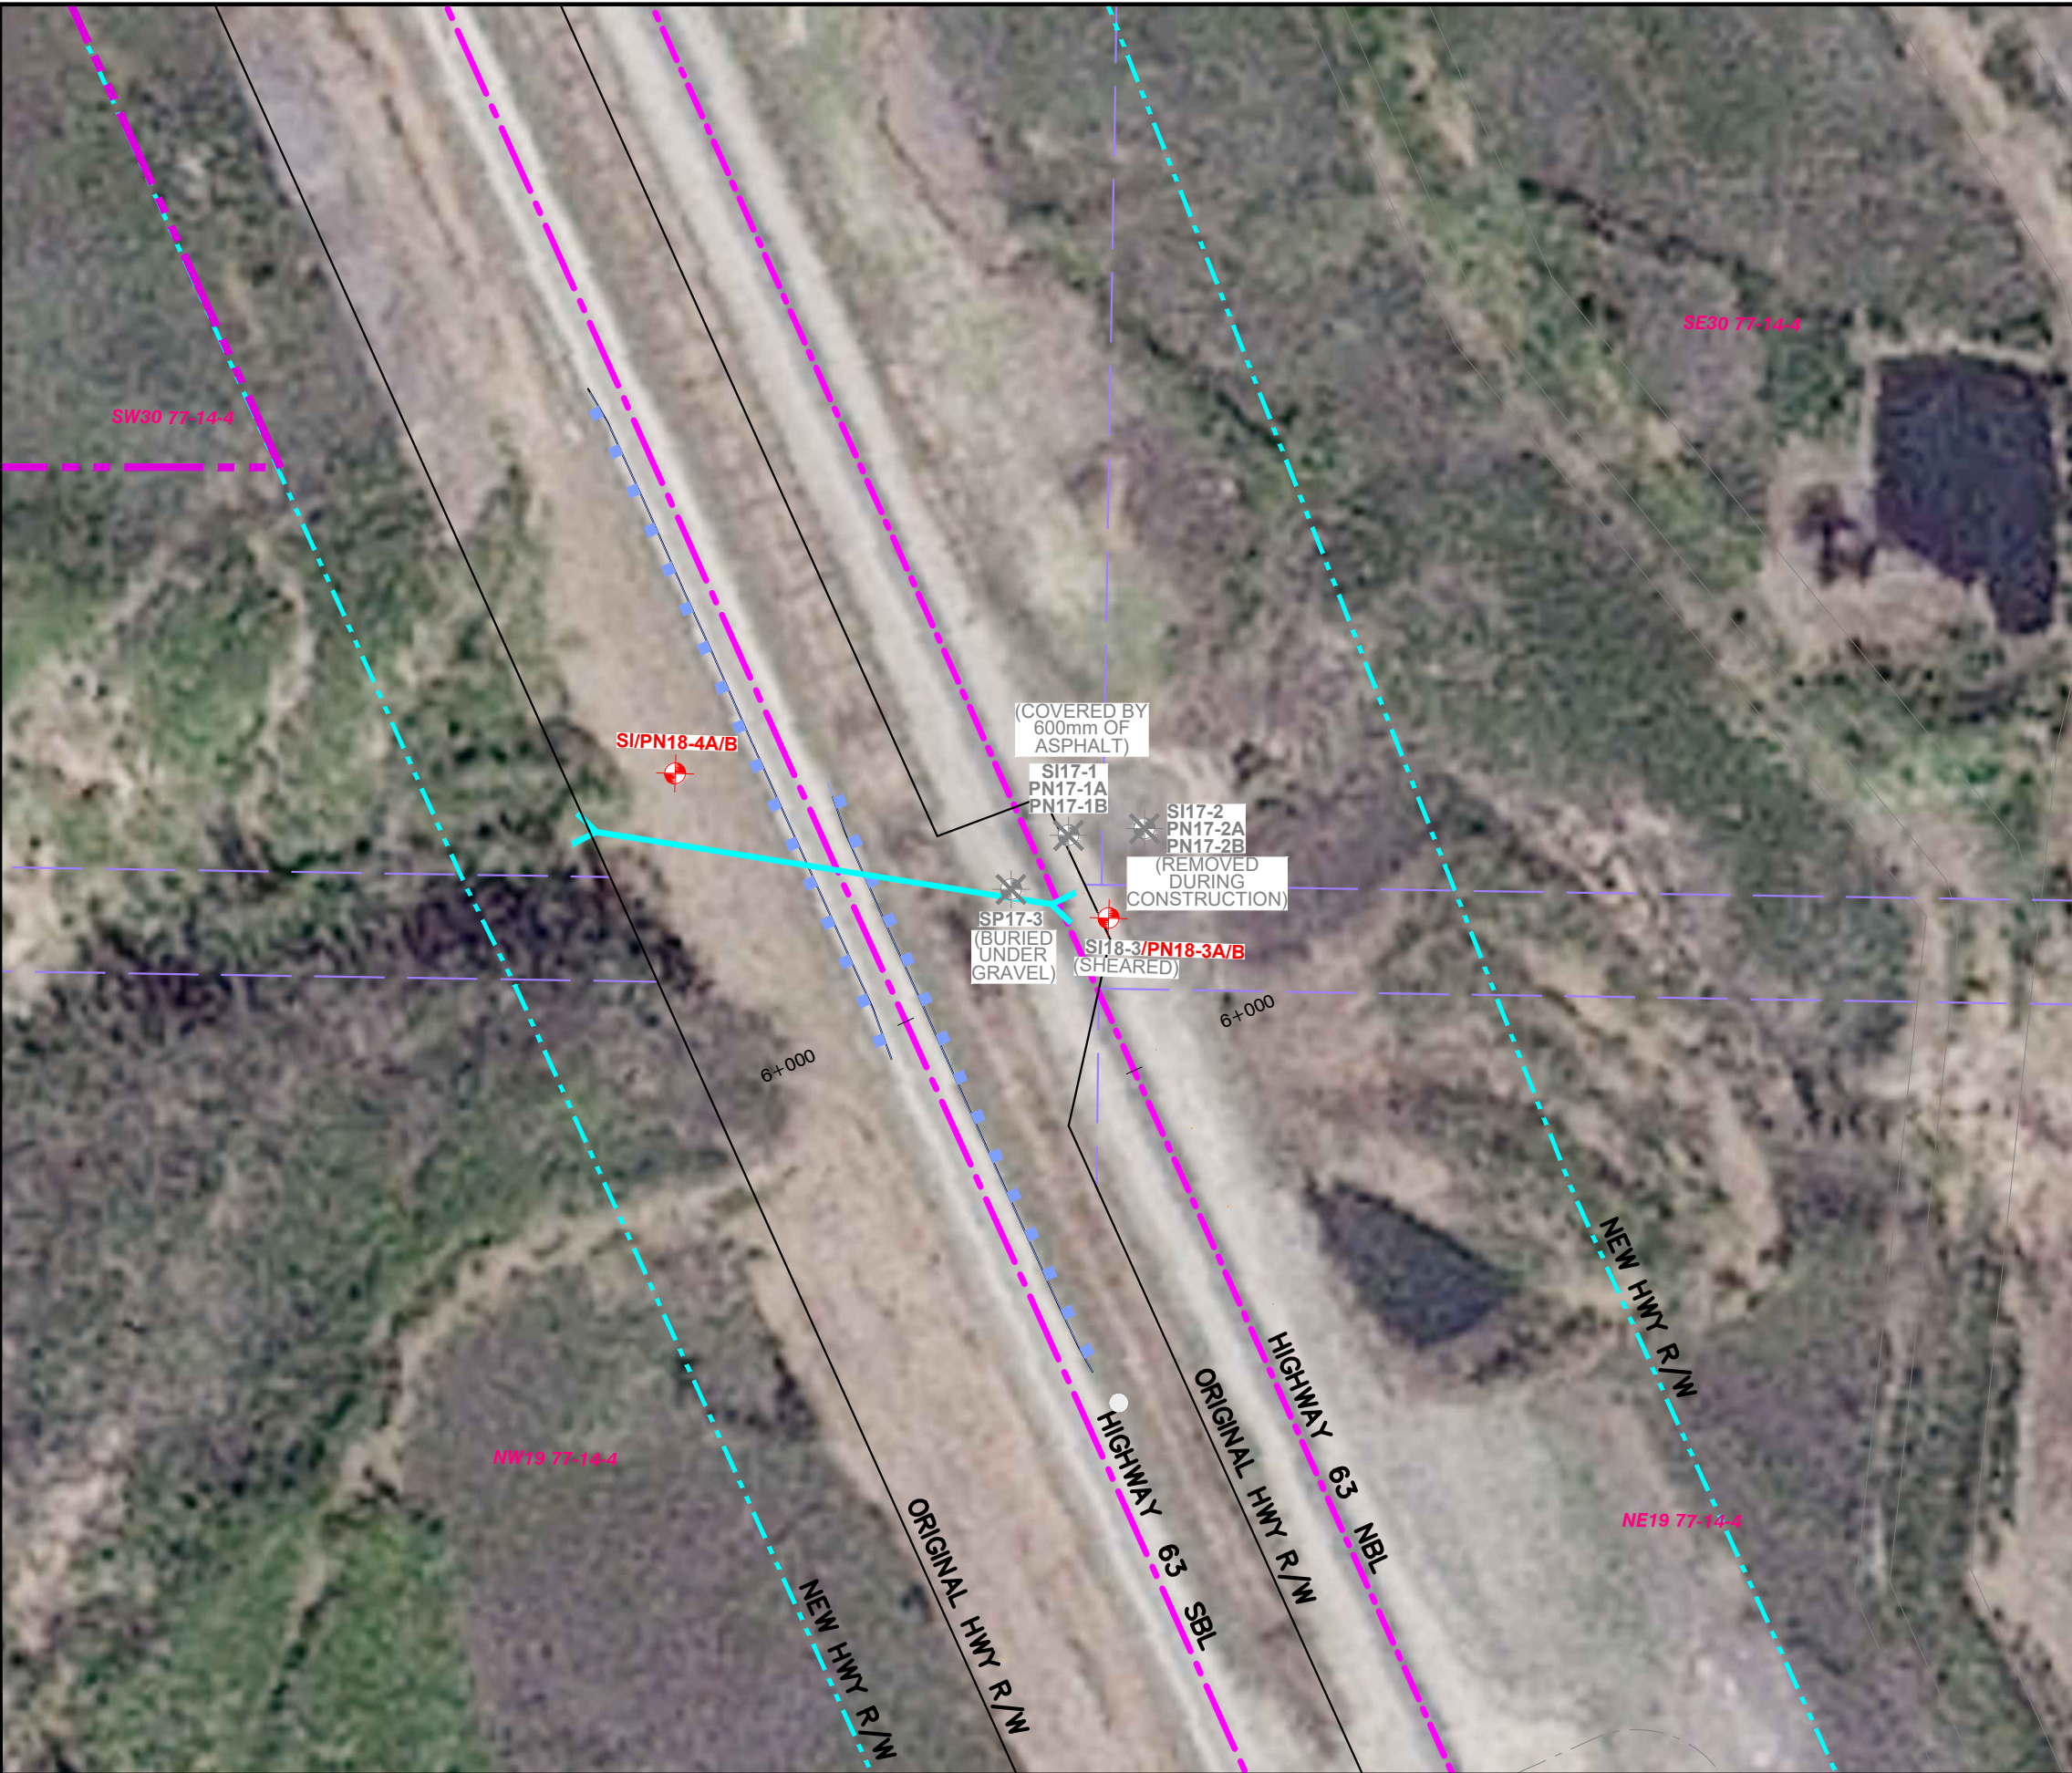
**NORTH CENTRAL
(ATHABASCA AND FORT McMURRAY DISTRICTS)
NC088: HWY 63:06 EAST AND WEST
EMBANKMENT FAILURES (km 4.9)
SITE PLAN SHOWING APPROXIMATE
INSTRUMENT LOCATIONS
DWG No. 32122-NC088**

| Discussion | |
|--|--|
| Instrumentation Repairs: | No instrument repairs are required at this time. However, it is recommended to replace SI18-3 to continue monitoring the movement rate of the northbound lanes landslide. |

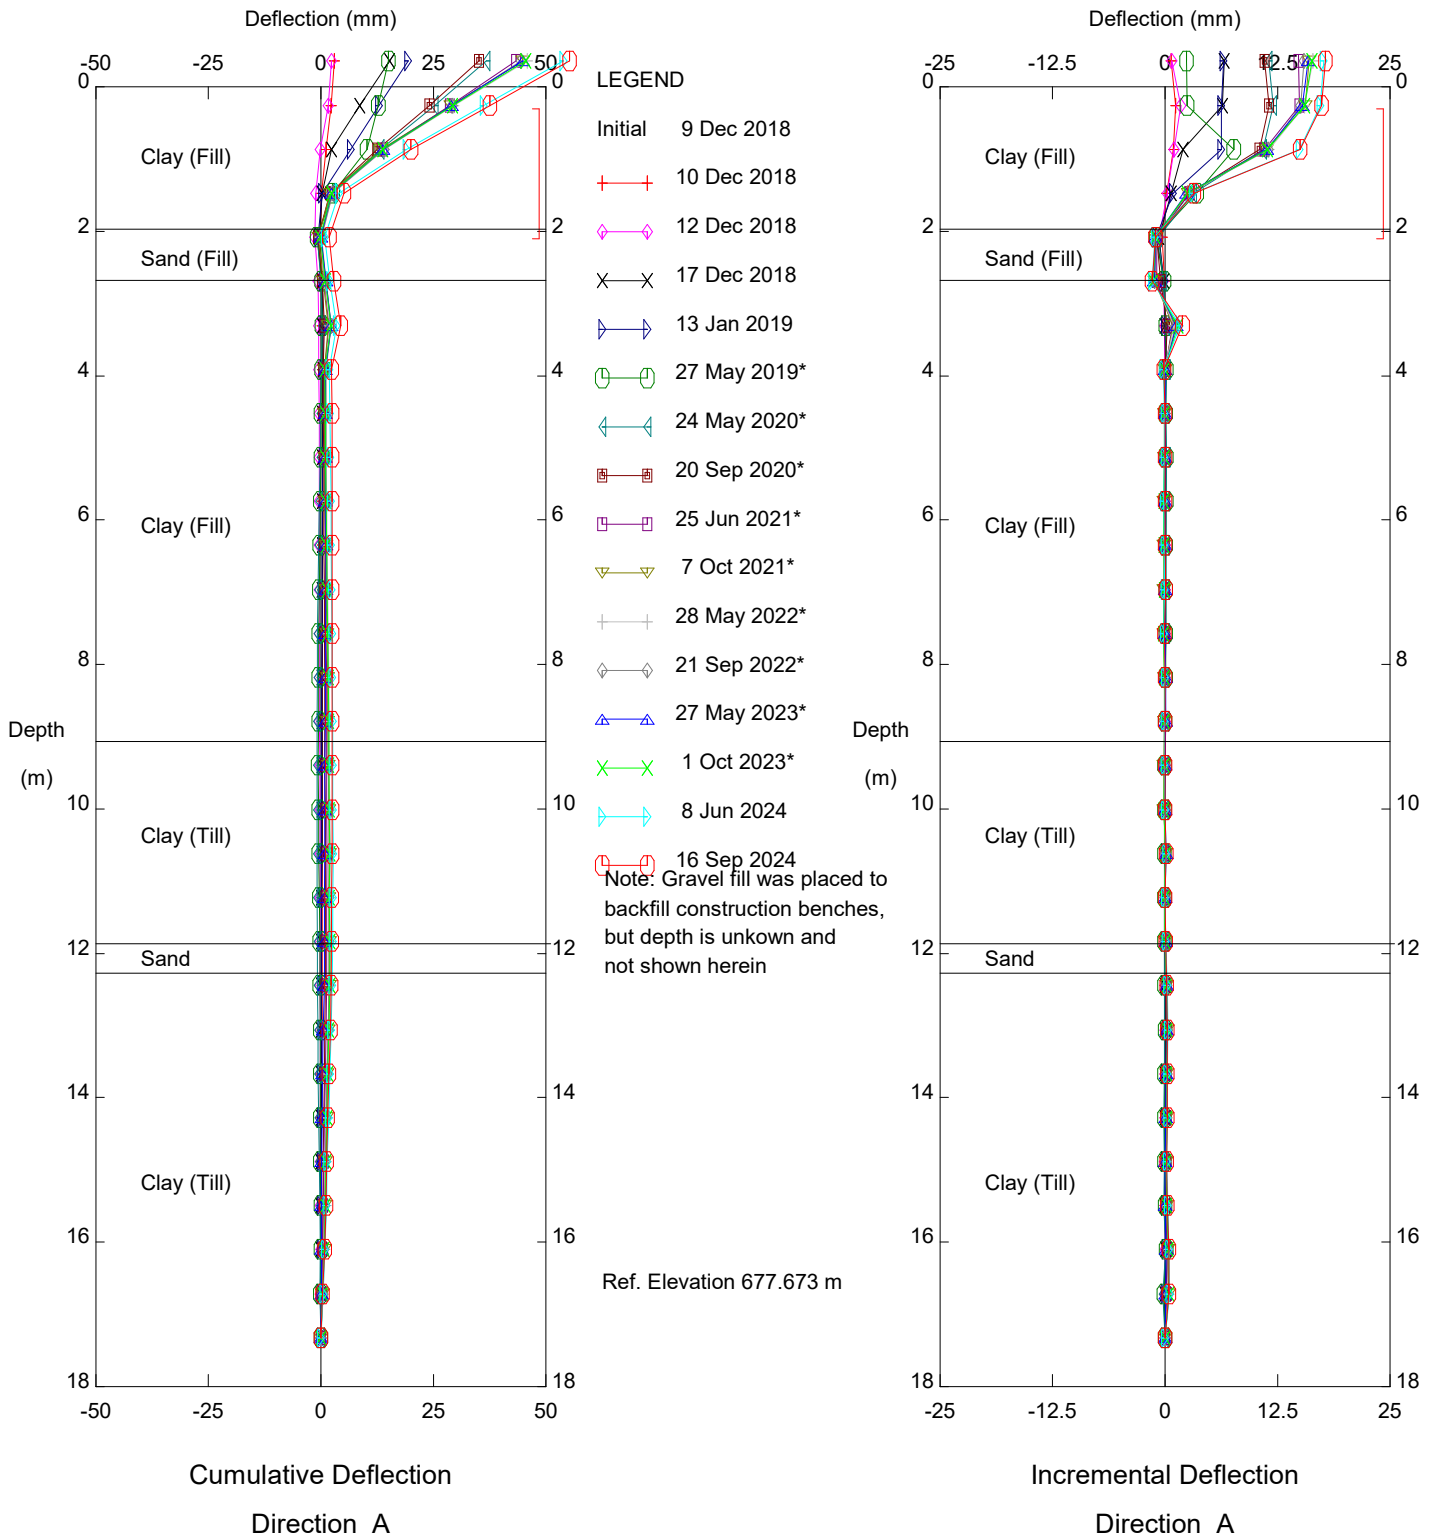
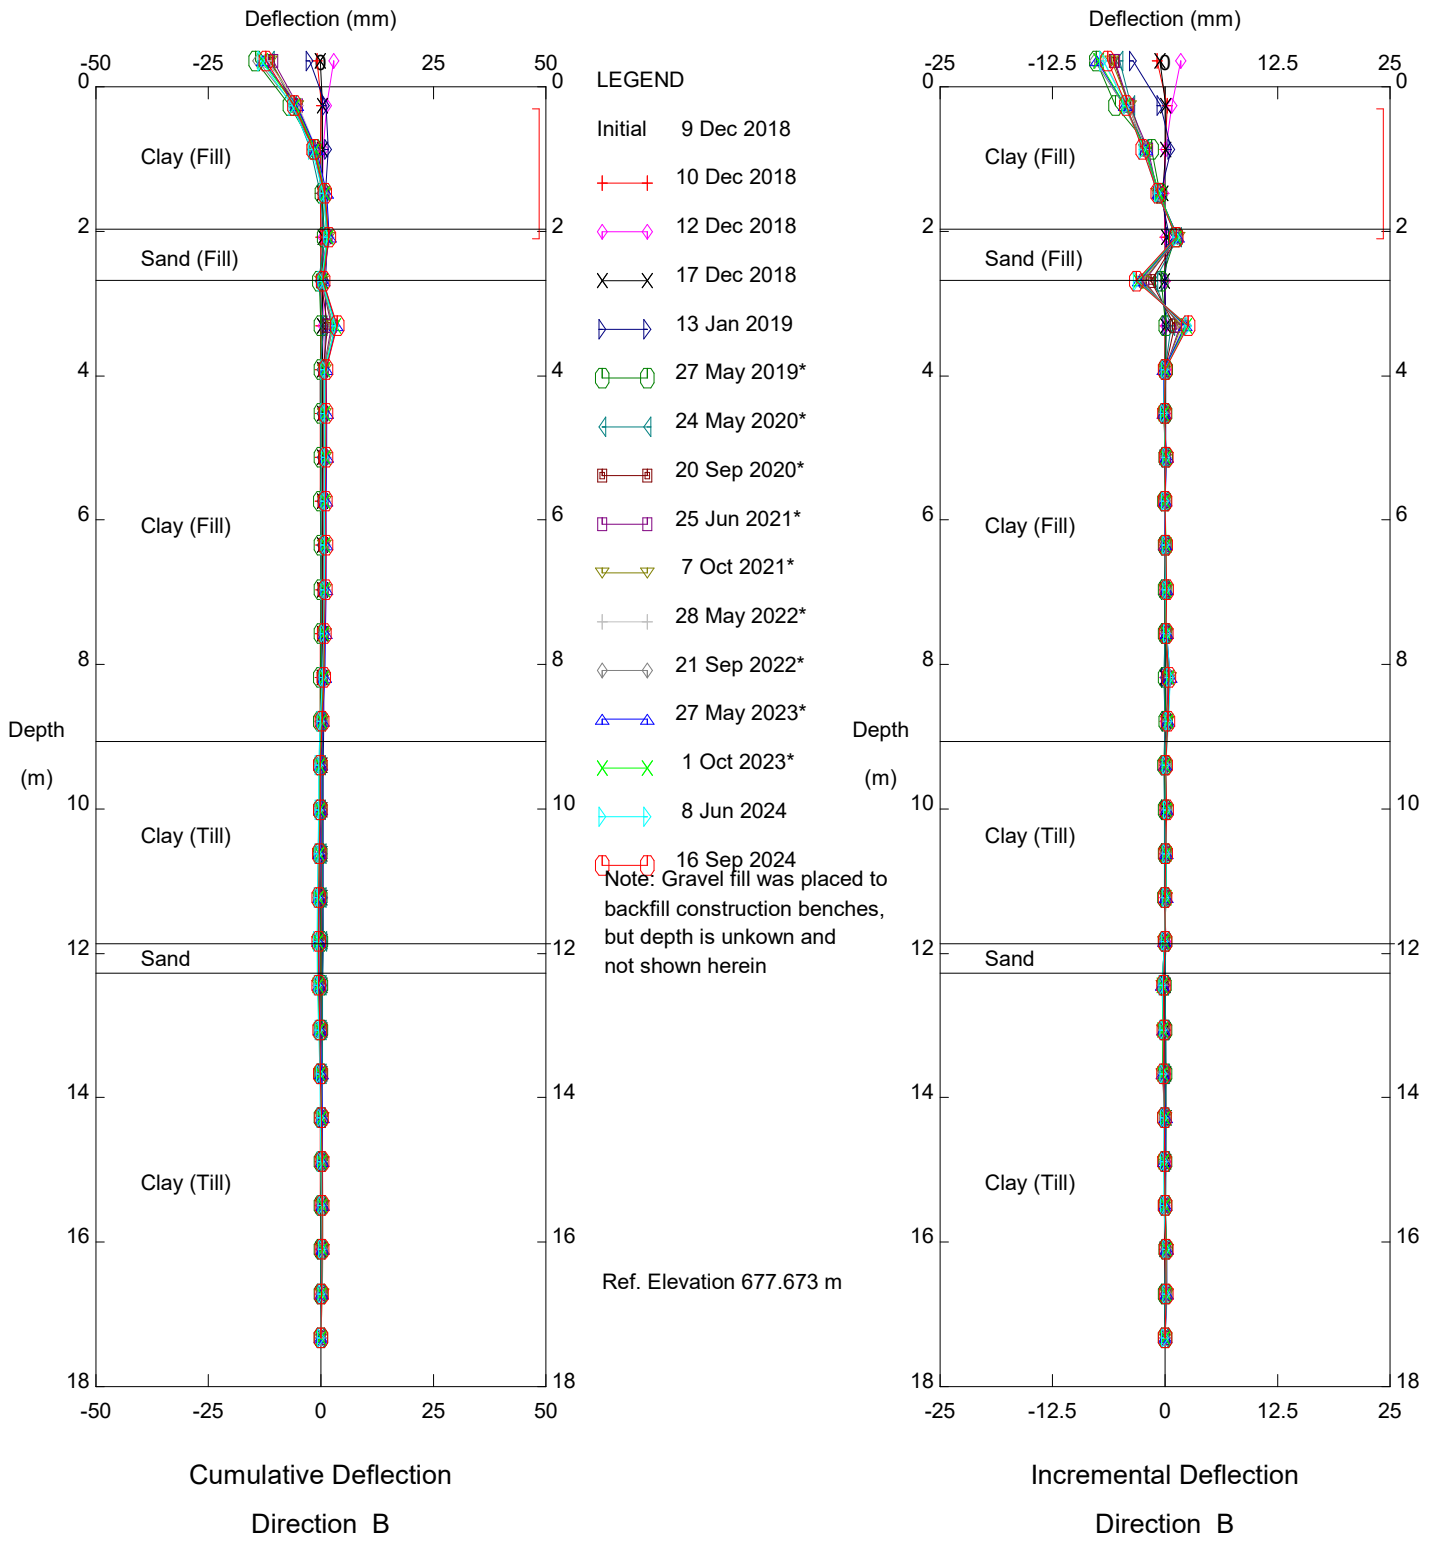
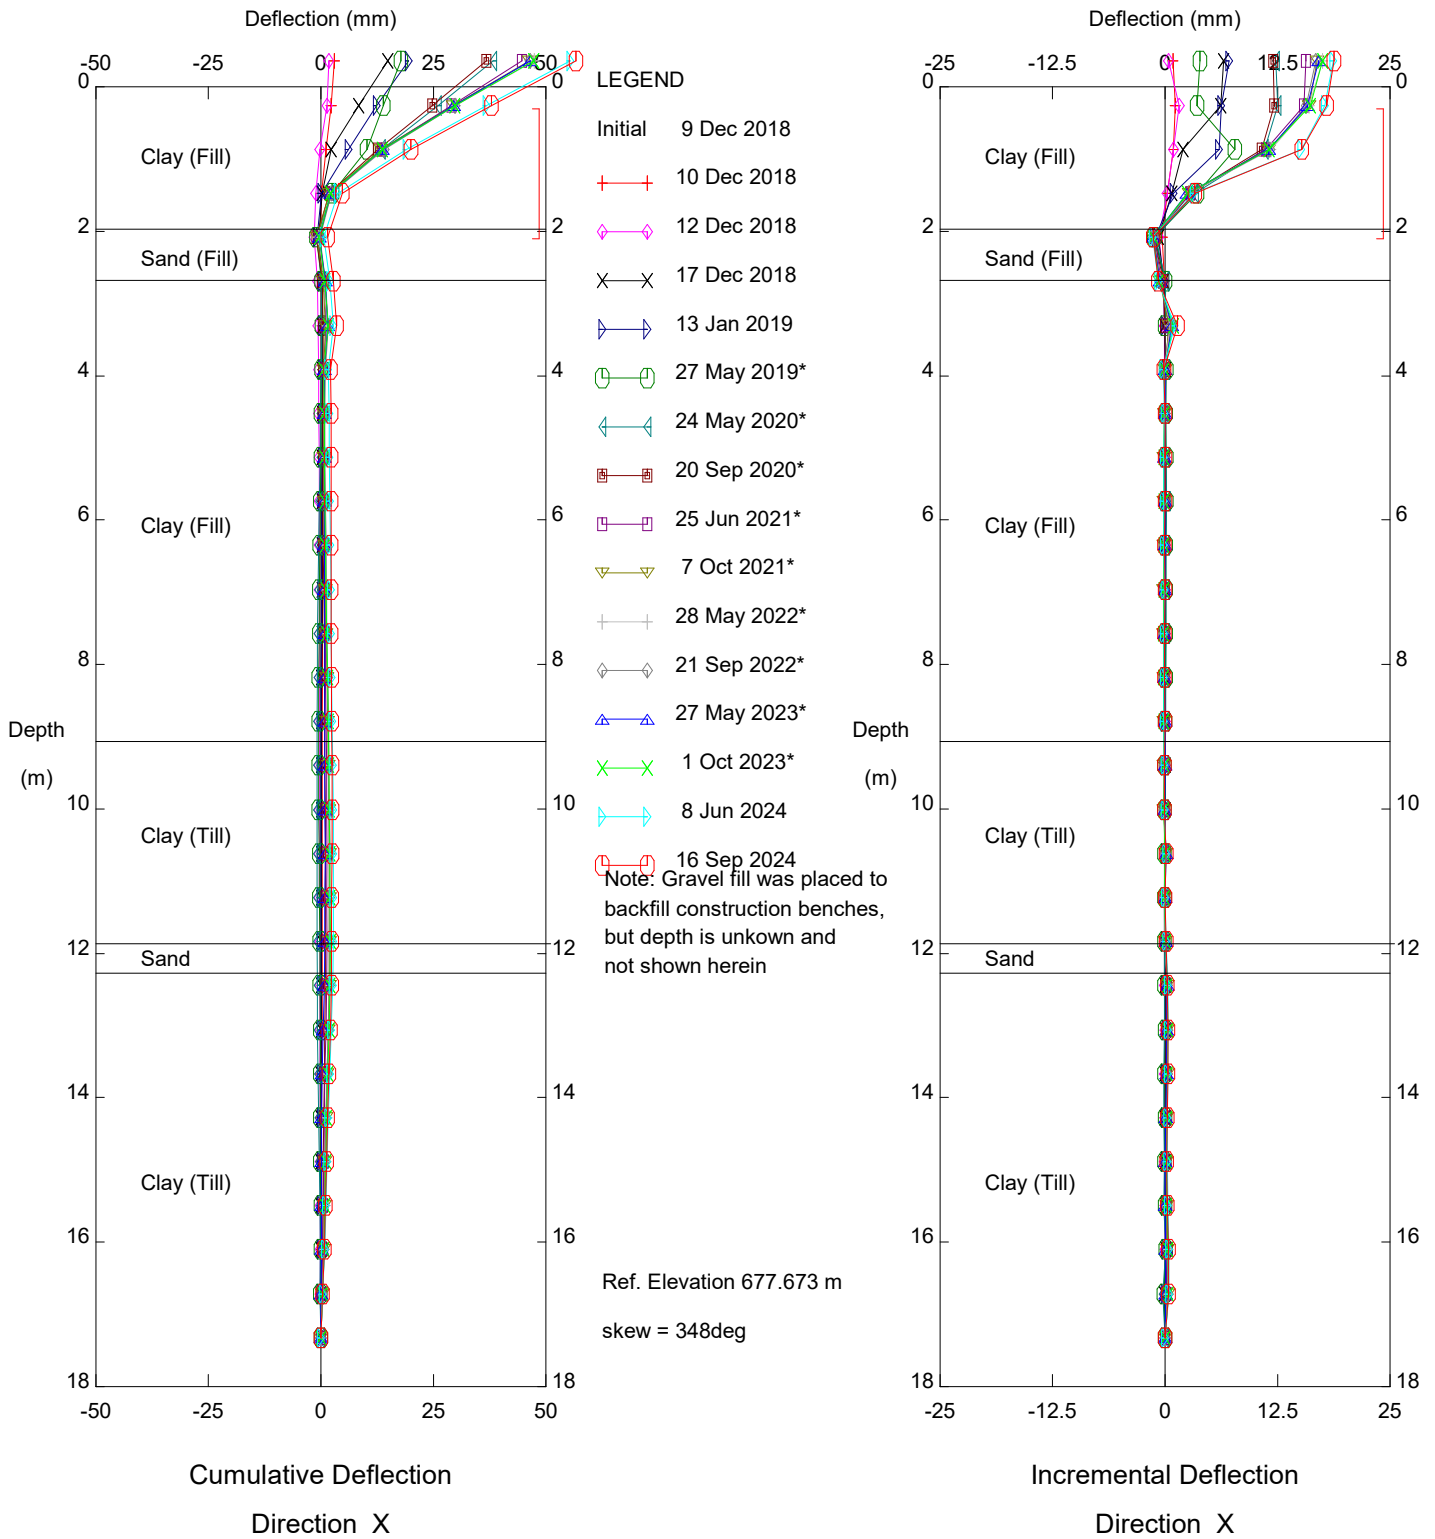
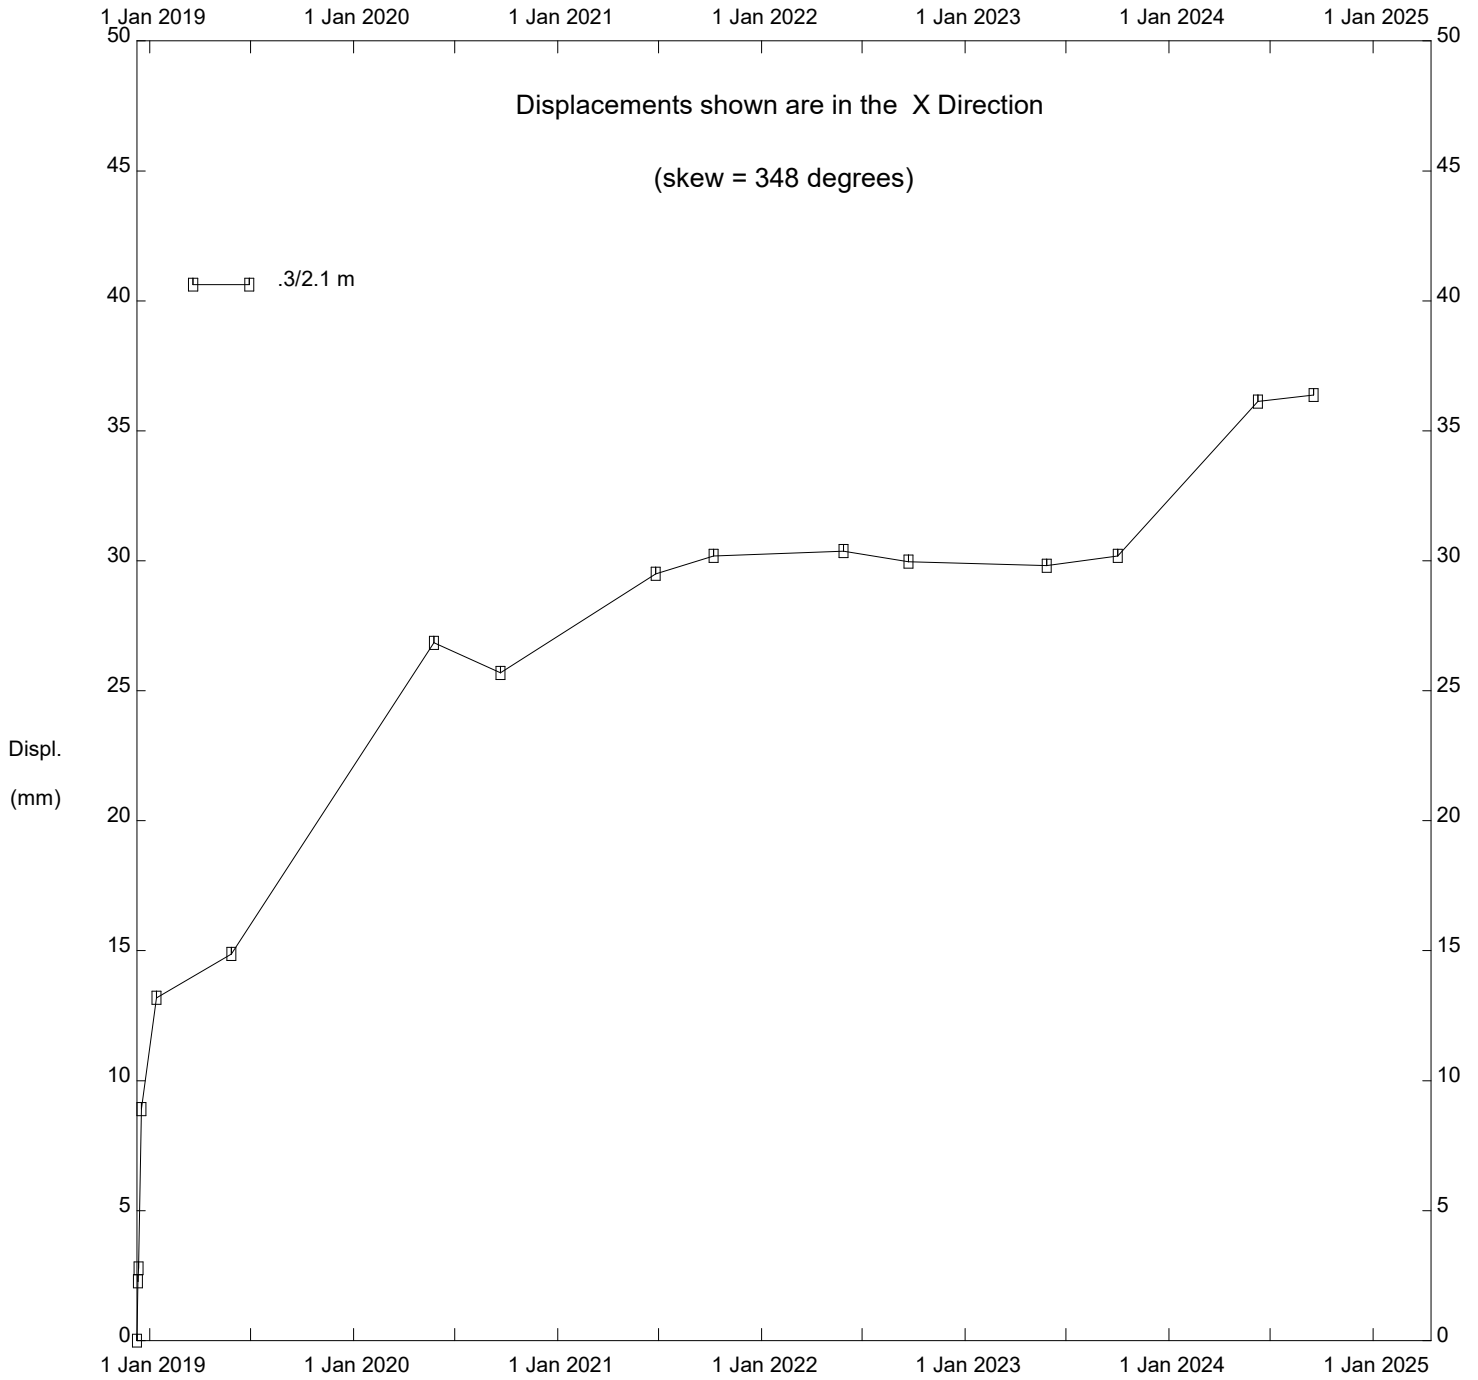
NC088 - West Embankment, Inclinometer SI18-4

| Discussion | |
|--|--|
| Interpretation of Monitoring Results: | SI18-4 showed a rate of movement of 0.9 mm/yr over 0.3 m to 2.1 m depth since the spring of 2024 readings. This corresponds to a decrease in the rate of movement by 7.7 mm/yr since the spring of 2024 readings. Pneumatic piezometer PN18-3A, PN18-3B PN14-4A, and PN18-4B showed increases in groundwater levels of 0.49 m, 0.46 m, 0.17 m, and 0.14 m, respectively, since the spring of 2024 readings. |

| INSTRUMENT # | DATE INITIALIZED | TOTAL CUMULATIVE RESULTANT MOVEMENT AND DEPTH OF MOVEMENT TO DATE (mm) | MAXIMUM RATE OF MOVEMENT (mm/yr.) | CURRENT STATUS OF SI | DATE OF PREVIOUS READING | INCREMENTAL MOVEMENT SINCE PREVIOUS READING (mm) | CURRENT RATE OF MOVEMENT (mm/yr.) | CHANGE IN RATE OF MOVEMENT SINCE PREVIOUS READING (mm/yr.) |
|---|---|---|--|--|---|---|--|---|
| <i>SI18-4</i> | <i>December 9, 2018</i> | <i>36.4 over 0.3 to 2.1 m depth in 272° direction</i> | <i>729.4 on December 10, 2018</i> | <i>Operational</i> | <i>June 8, 2024</i> | <i>0.3</i> | <i>0.9</i> | <i>-7.7</i> |
