ALBERTA TRANSPORTATION AND  
ECONOMIC CORRIDORS GRMP  
NORTH CENTRAL (ATHABASCA AND FORT  
McMURRAY DISTRICTS)  
INSTRUMENTATION MONITORING- SPRING 2024

Site Number	Location	Name	Hwy	km
NC088	Km 108 Settlement	HWY 63:06 km 108 Settlement	63:06	Km 108
<b>Legal Description:</b> 3-30-77-14 W4		<b>UTM Co-ordinates</b>		
		12U E 426558	N	6172648

<b>Current Monitoring:</b>	08-Jun-2024	<b>Previous Monitoring</b>	1-Oct-2023
<b>Instruments Read By:</b>	Mr. Niraj Regmi, G.I.T and Mr. Nixson Matong, of Thurber

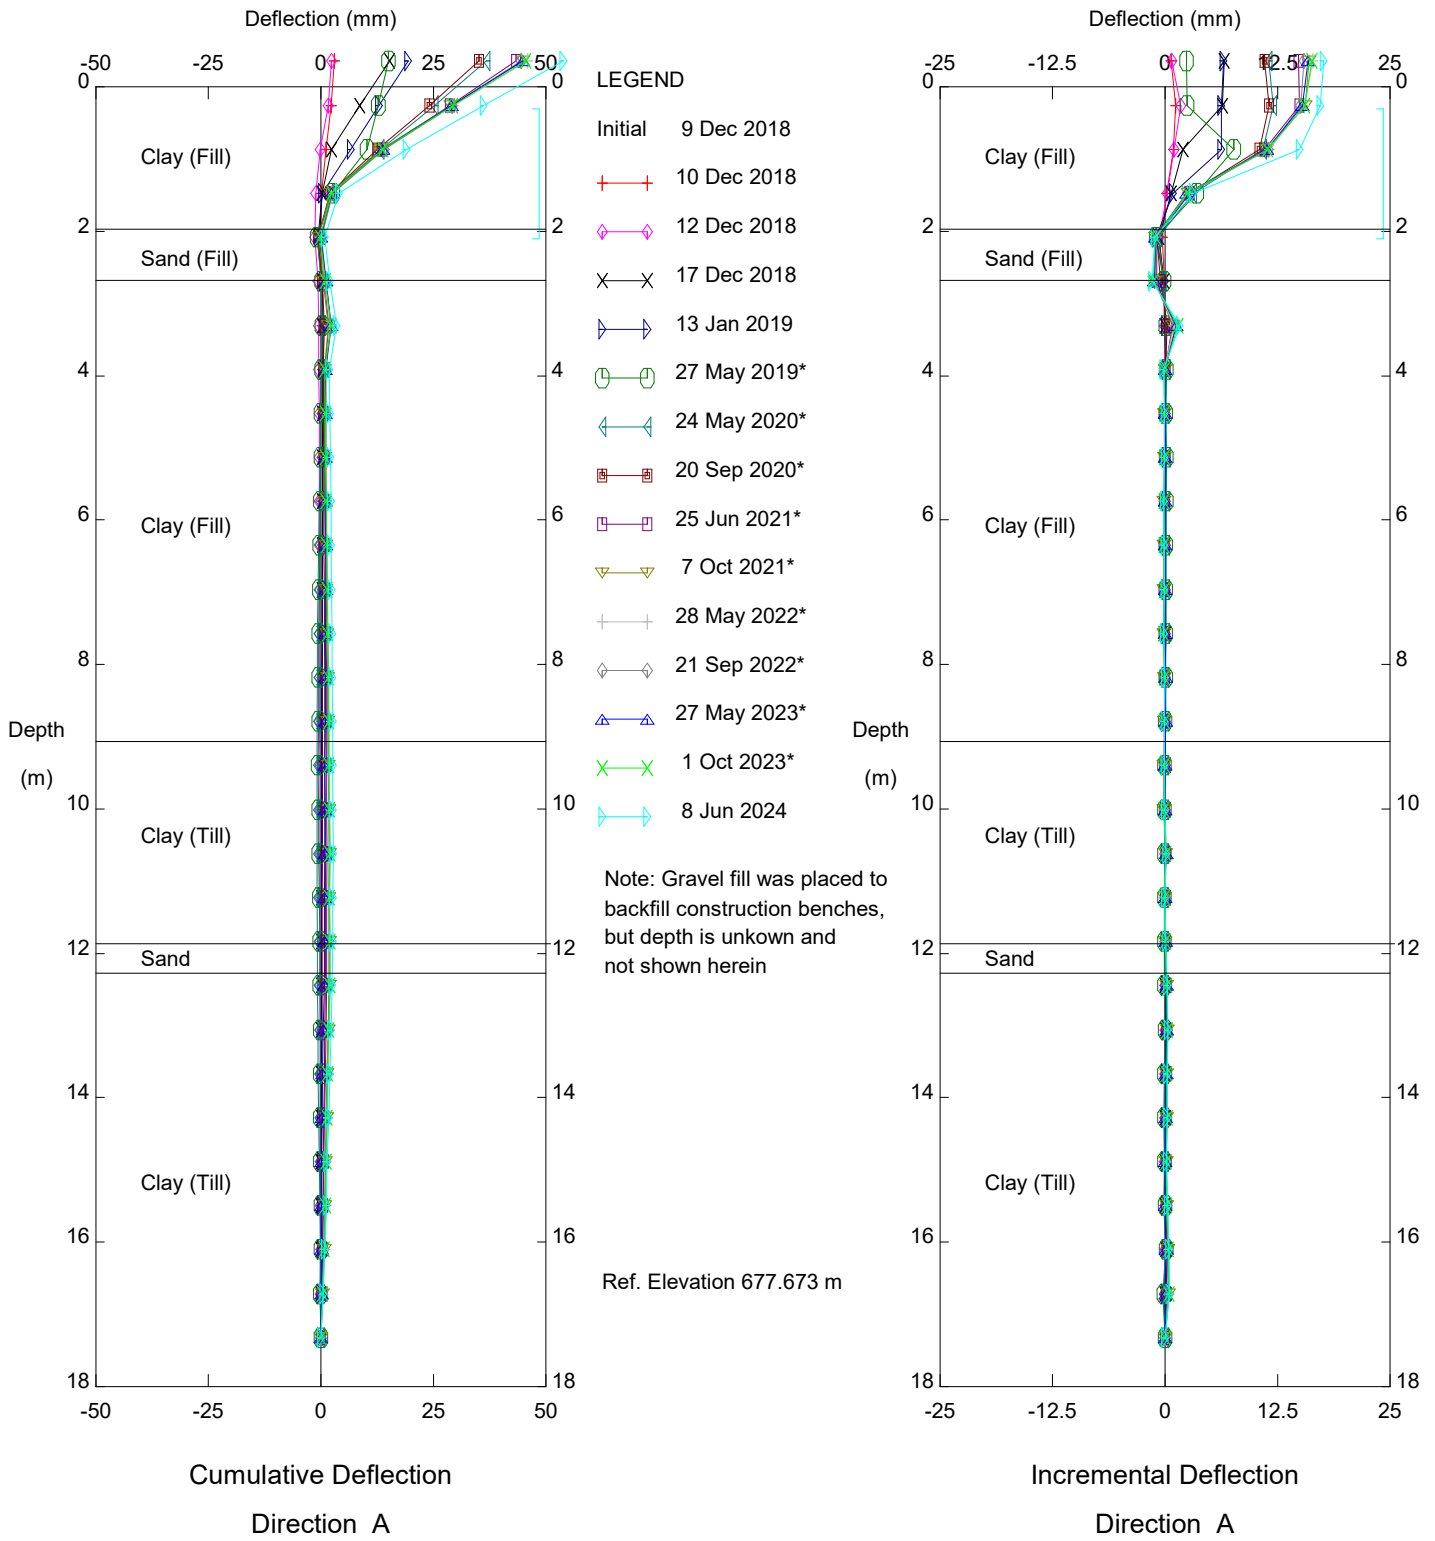
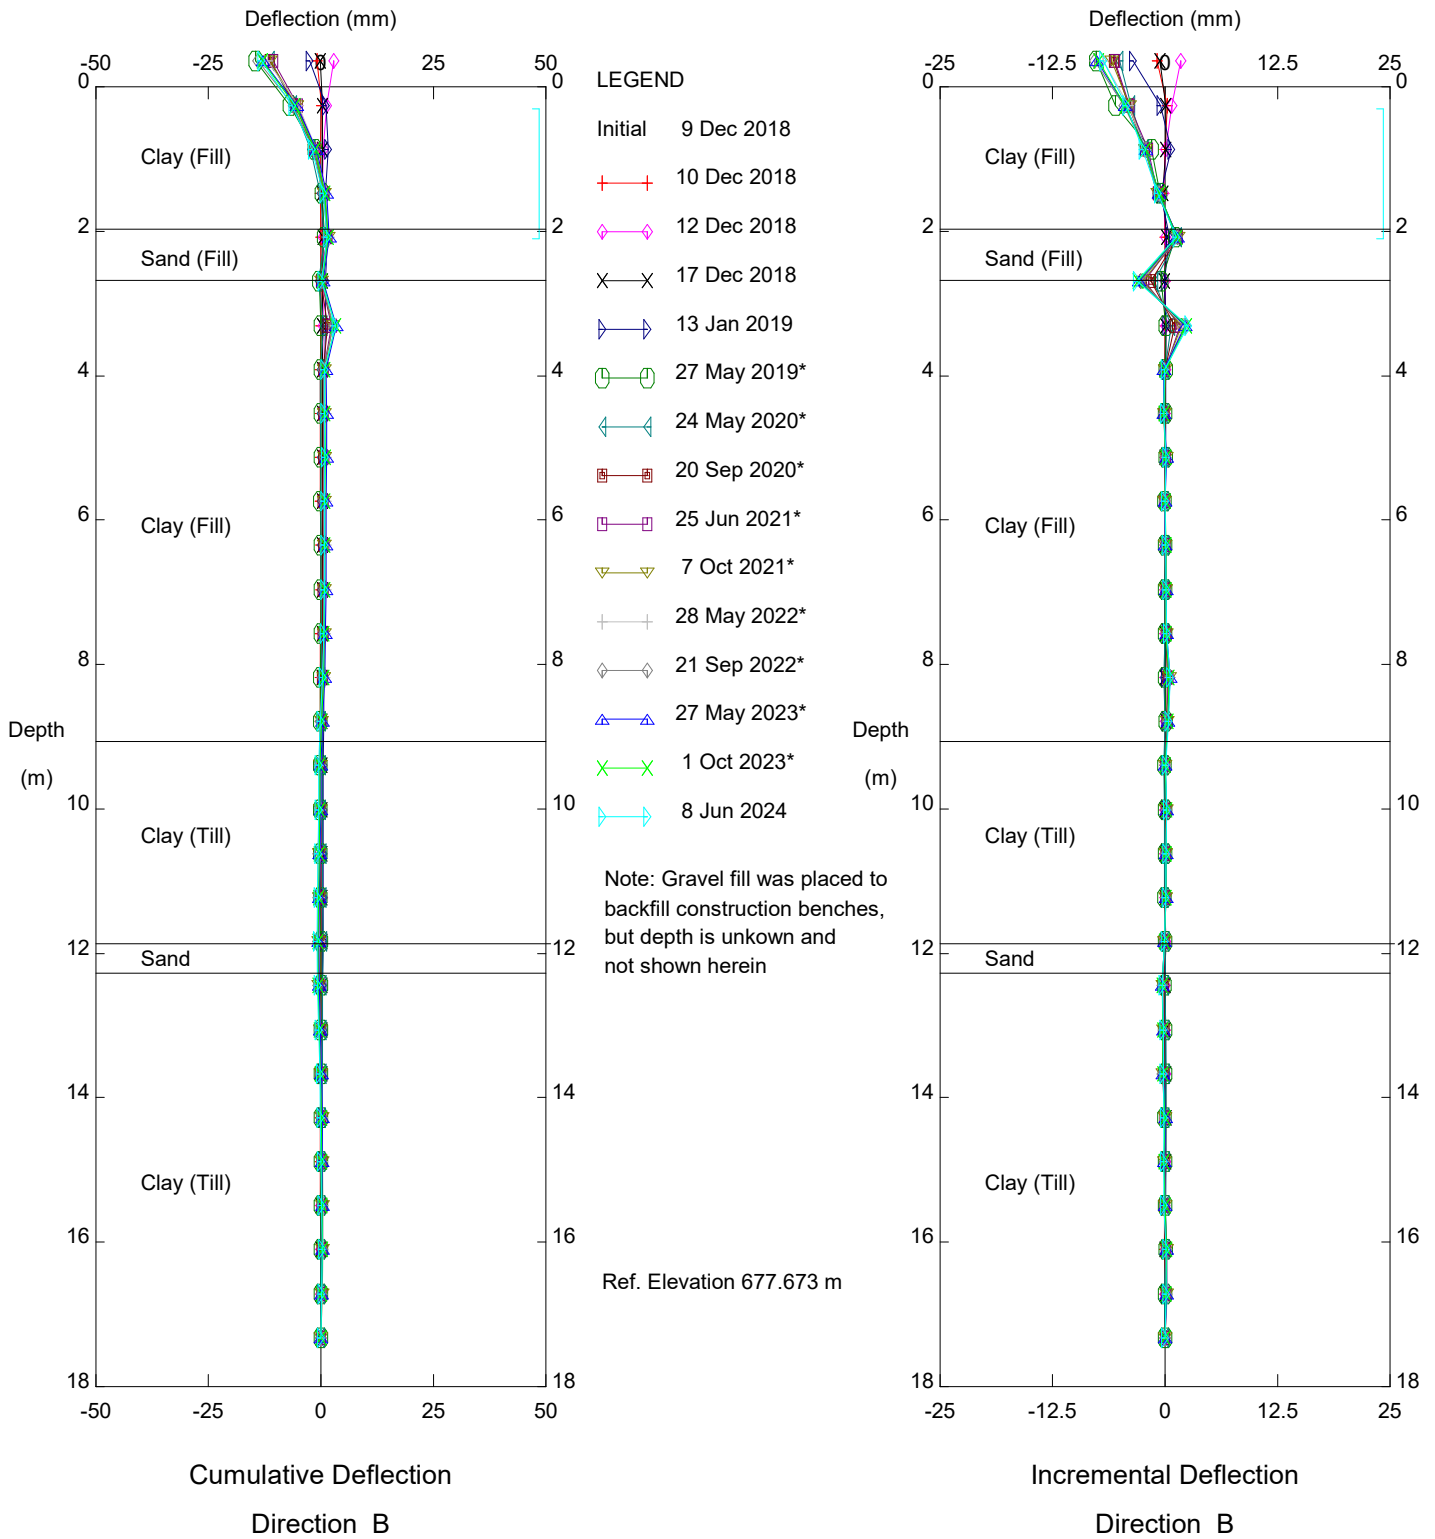
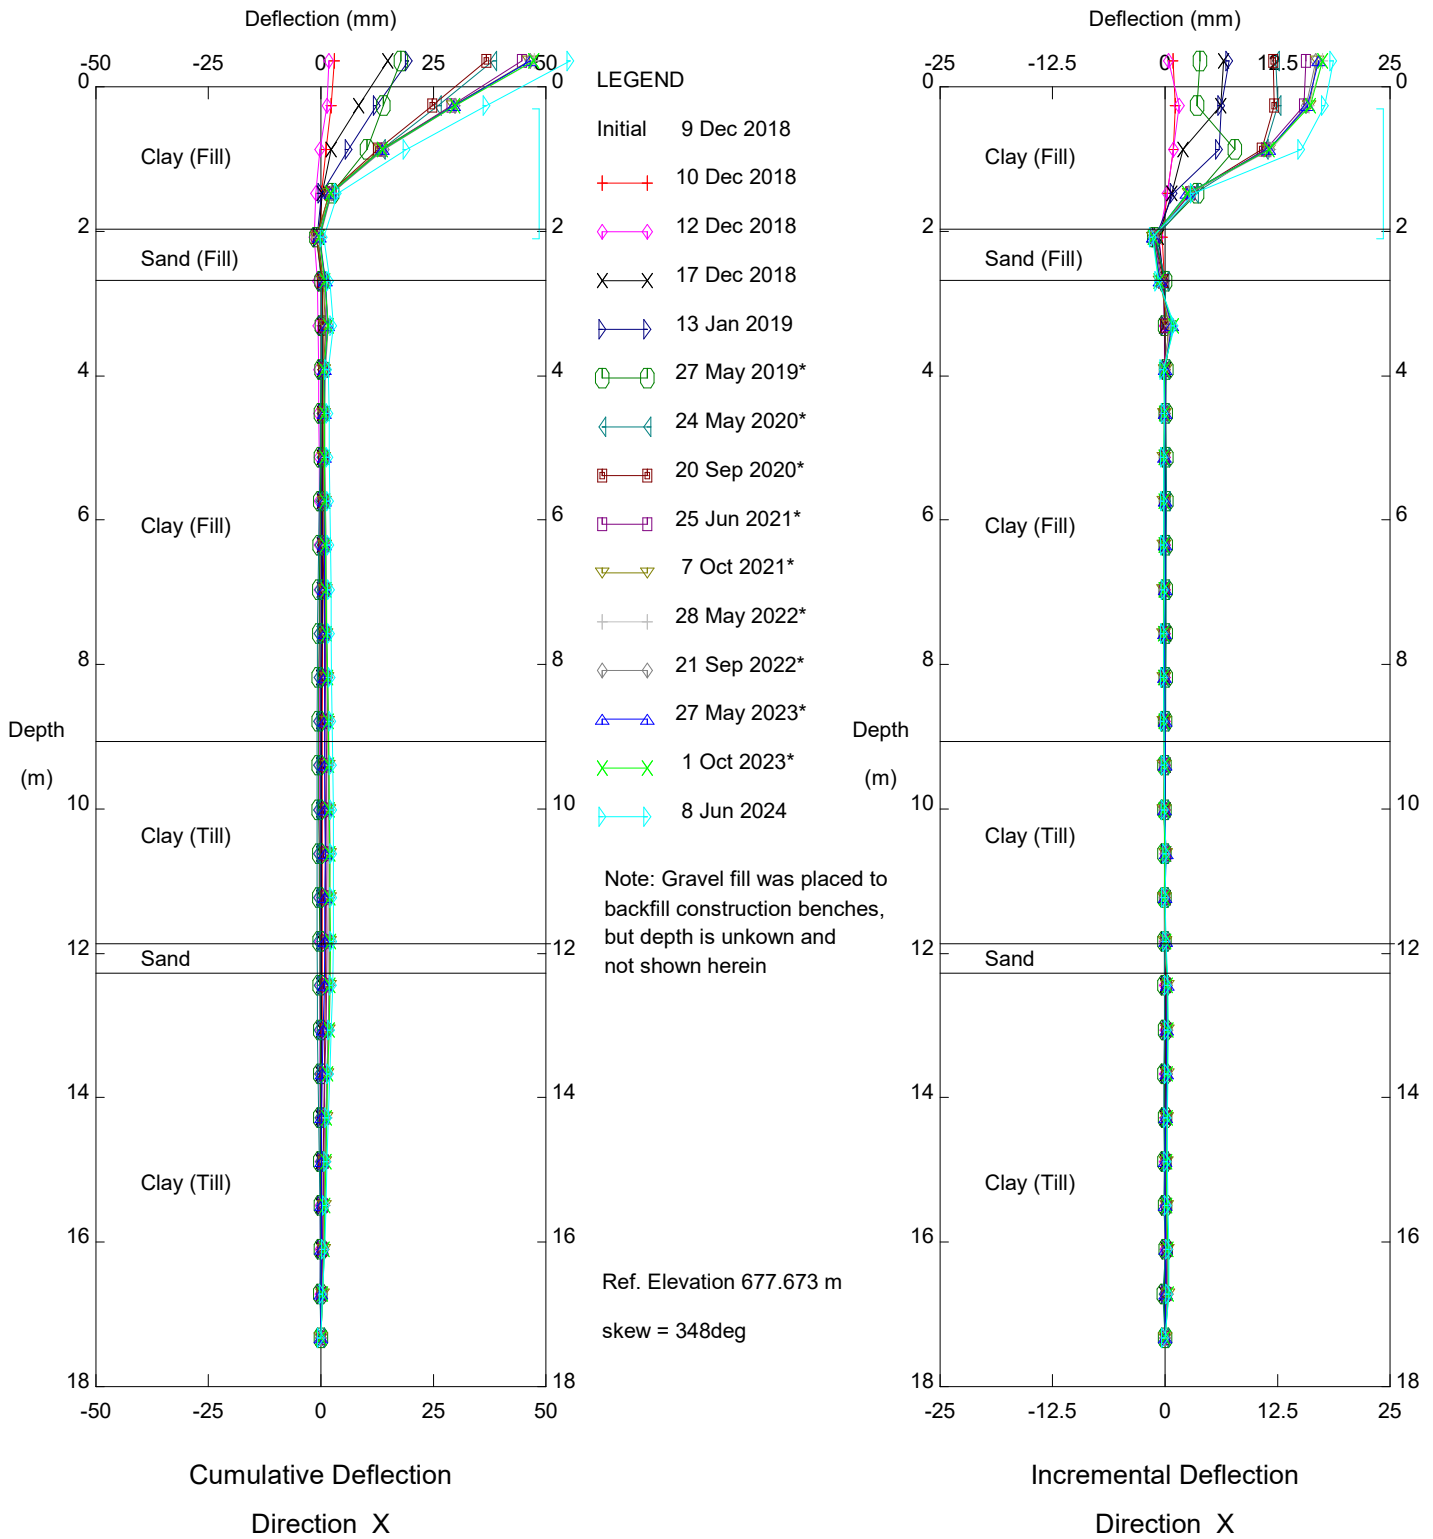
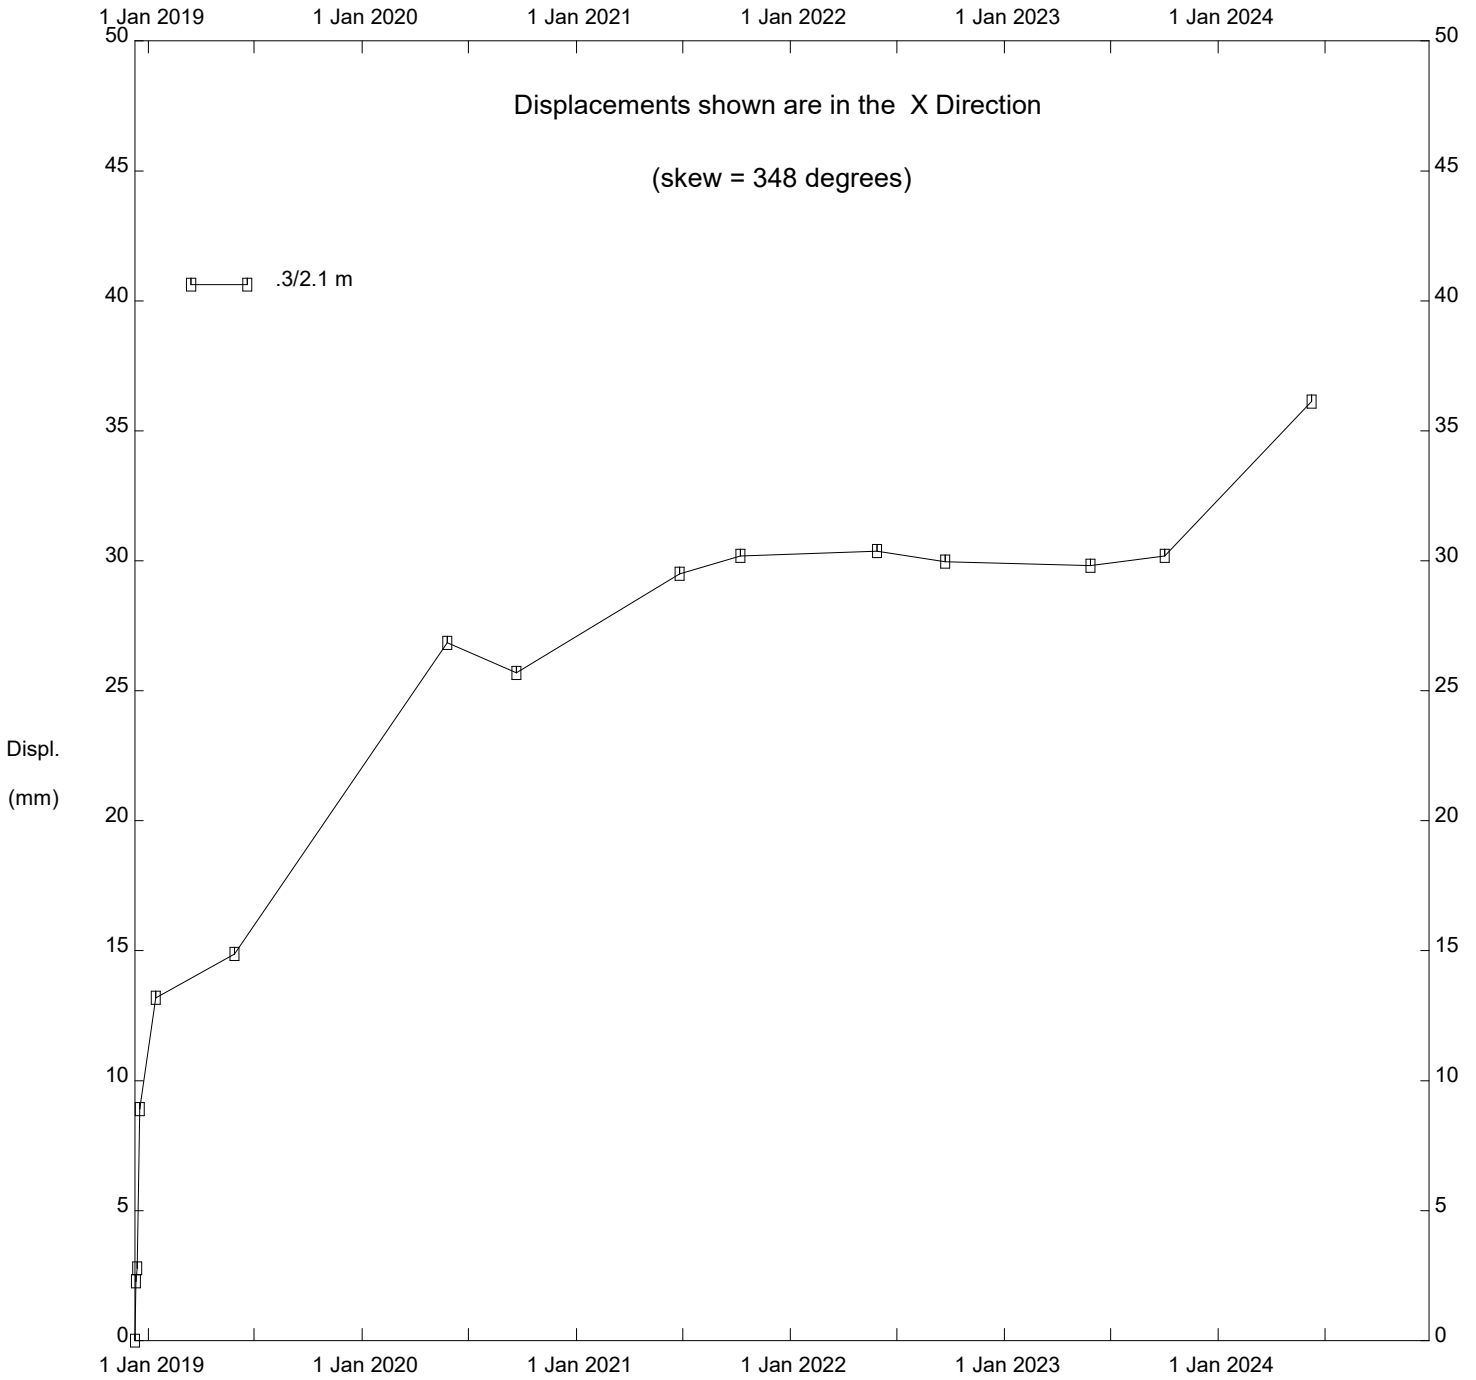
NC088 - West Embankment, Inclinator SI18-4

Discussion	
<b>Zones of New Movement:</b>	None
<b>Interpretation of Monitoring Results:</b>	SI18-4 showed a rate of movement of 8.7 mm/yr over 0.3 m to 2.1 m depth since the fall of 2023 readings. This corresponds to an increase in rate of movement of 7.6 mm/yr since the fall of 2023 readings.  Pneumatic piezometer PN18-3A, PN18-3B PN14-4A, and PN18-4B showed decreases in groundwater levels of 0.34 m, 0.28 m, 0.09 m, and 0.12 m, respectively, since the fall of 2023 readings.
<b>Future Work:</b>	The instruments should be read again in the fall of 2024.
<b>Instrumentation Repairs:</b>	No instrument repairs are required at this time. However, it is recommended to replace SI18-3 to continue monitoring the movement rate of the northbound lanes landslide.

<i>SI18-4</i>	<i>December 9, 2018</i>	<i>36.1 over 0.3 to 2.1 m depth in 272° direction</i>	<i>729.4 on December 10, 2018</i>	<i>Operational</i>	<i>October 1, 2023</i>	<i>5.9</i>	<i>8.7</i>	<i>7.6</i>

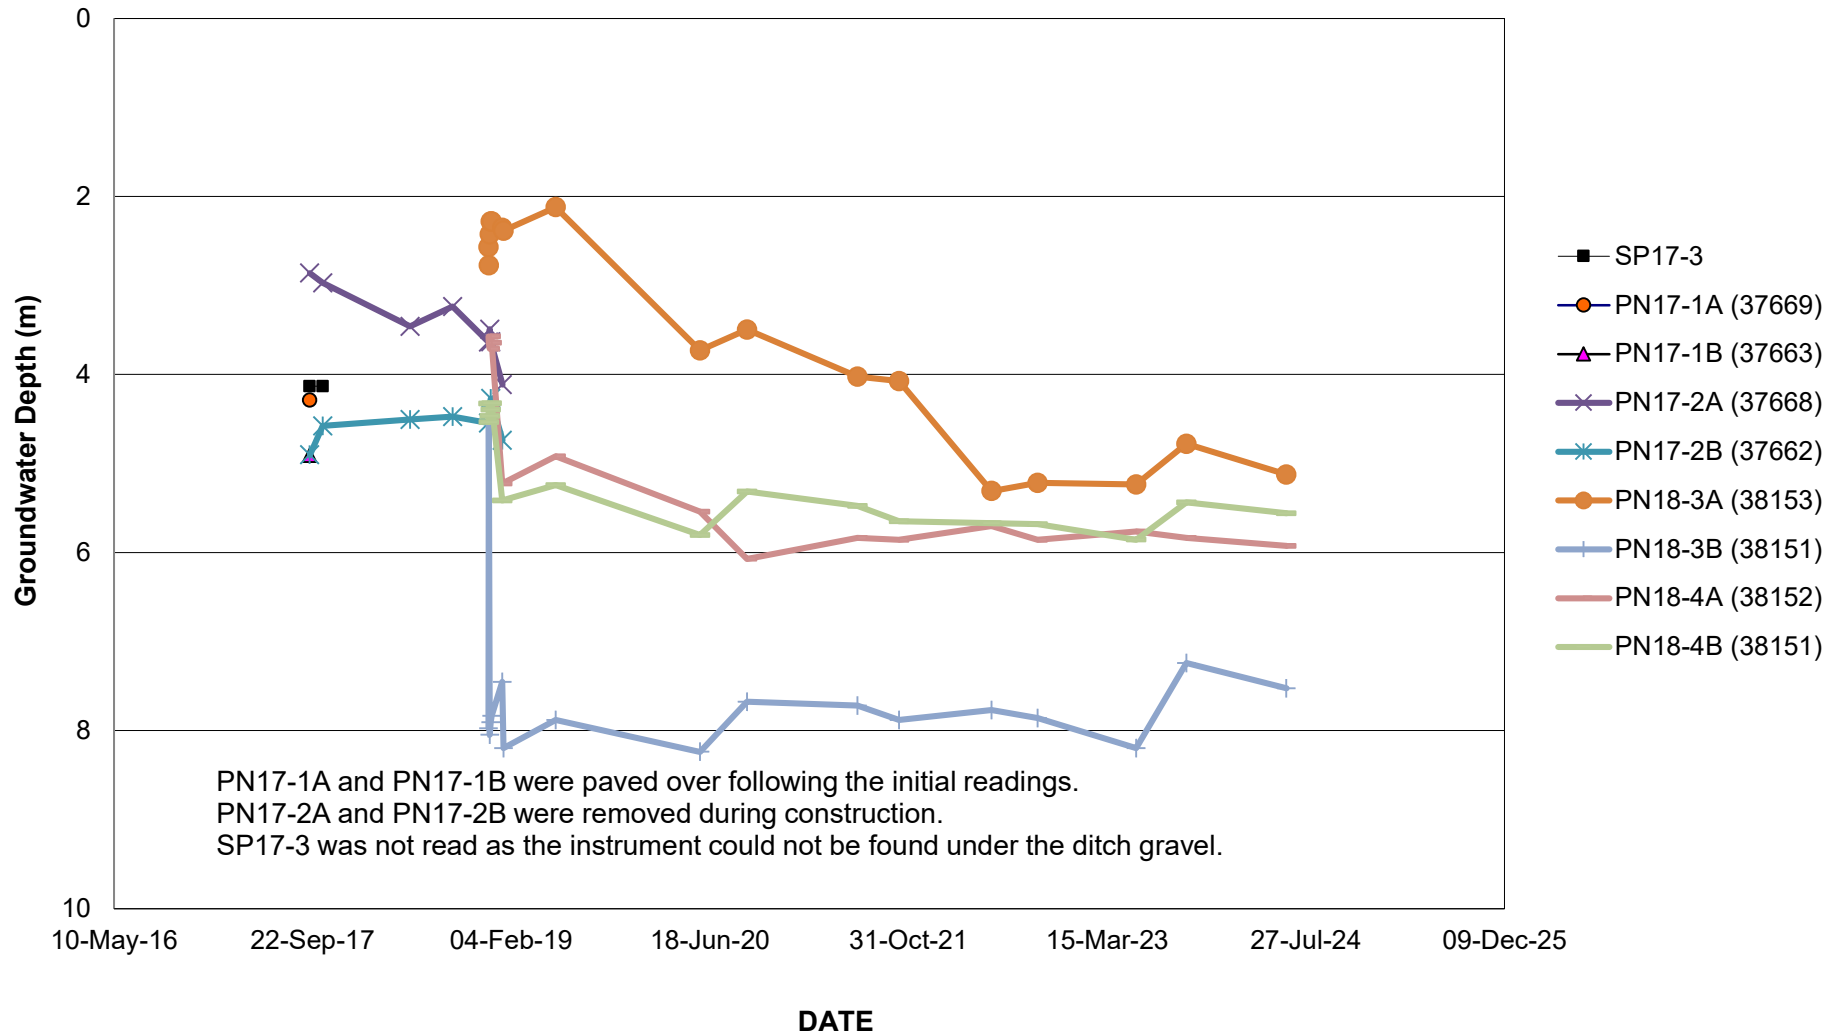
**FIGURE NC088-1  
PIEZOMETER DATA FOR HWY 63:06 EAST AND WEST EMBANKMENT  
FAILURES (km 4.90)**

INSTRUMENT #	DATE INITIALIZED	TIP DEPTH (m)	CURRENT STATUS	HIGHEST MEASURED GROUNDWATER DEPTH (m)	MEASURED PORE PRESSURE (kPa)	CURRENT GROUNDWATER DEPTH (m)	PREVIOUS GROUNDWATER DEPTH (m)	CHANGE IN WATER LEVEL SINCE PREVIOUS READING (m)
PN17-1A (37669)	September 15, 2017	11.00	Paved Over	4.29 on September 15, 2017	N/A	N/A	N/A	N/A
PN17-1B (37663)	September 15, 2017	16.00	Paved Over	4.91 on September 15, 2017	N/A	N/A	N/A	N/A
PN17-2A (37668)	September 15, 2017	5.60	Damaged during construction	2.86 on September 15, 2017	N/A	N/A	4.11 (Jan. 13, 2019)	N/A
PN17-2B (37662)	September 15, 2017	7.50	Damaged during construction	4.51 on May 26, 2018	N/A	N/A	4.74 (Jan. 13, 2019)	N/A
PN18-3A (38153)	December 9, 2018	7.62	Operational	2.12 on May 27, 2019	24.5	5.12	4.78	-0.34
PN18-3B (38150)	December 9, 2018	12.19	Operational	4.53 on December 10, 2018	45.8	7.52	7.24	-0.28
PN18-4A (38152)	December 9, 2018	6.10	Operational	3.57 on December 15, 2018	1.70	5.93	5.84	-0.09

PN18-4B (28151)	December 9, 2018	12.19	Operational	4.32 on December 17, 2018	65.1	5.56	5.44	-0.12
SP17-3	August 24, 2017	15.19	Could not be located	4.13 on October 18, 2017	N/A	N/A	4.13 (October 18, 2017)	N/A
