**ALBERTA TRANSPORTATION AND
ECONOMIC CORRIDORS GRMP
NORTH CENTRAL (ATHABASCA AND FORT
MCMURRAY DISTRICTS)
2024 SITE INSPECTION**

Site Number	Location	Name	Hwy	km
NC088	62 Km N of Wandering River	Km 108 Settlement	63:06	6.0
Legal Description		UTM Co-ordinates (NAD 83)		
S-30-77-14-W4M		12	6172629	E 426672

**NC088: HWY 63:06 NBL (km 4.9) PAVEMENT DISTRESS
SKETCH SHOWING SITE FEATURES**

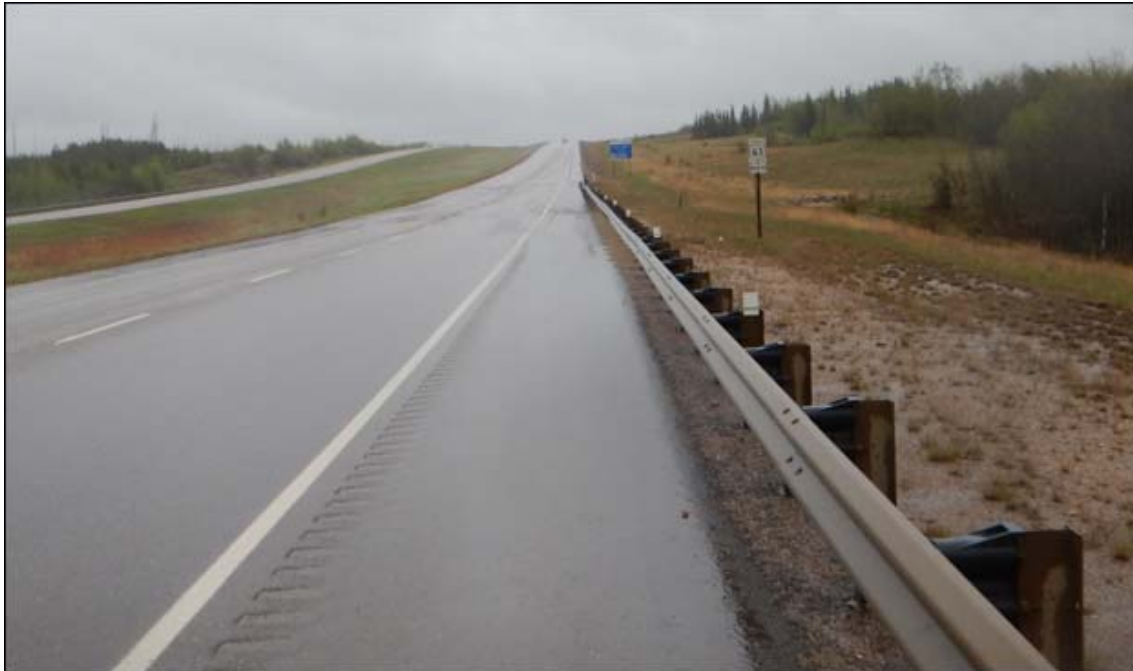
The northbound lanes had an ACP patch recently placed. Therefore, cracks and dips noted in the past in response to the slope movement/highway settlement were not visible on the highway surface. A minor tension crack was however noted near the top of the east slope, and the guardrail was a bit bent and showed signs of distress. It appears that the interim repairs were not sufficient to reduce the settlement and/or the movement of the east side slope.

Photo No. 1 – Looking north at ACP patch recently placed along the north bound lanes (NBLs)

The MCI should periodically monitor the highway lanes and the slopes for signs of movement. If the dip re-appears on the highway NBLs, additional ACP patch should be placed to eliminate the dip and provide a smooth ride to motorists. In addition, the MCI should attempt to backfill the minor crack developed on the top of the east slope to reduce the likelihood of surface water infiltration into the slope.

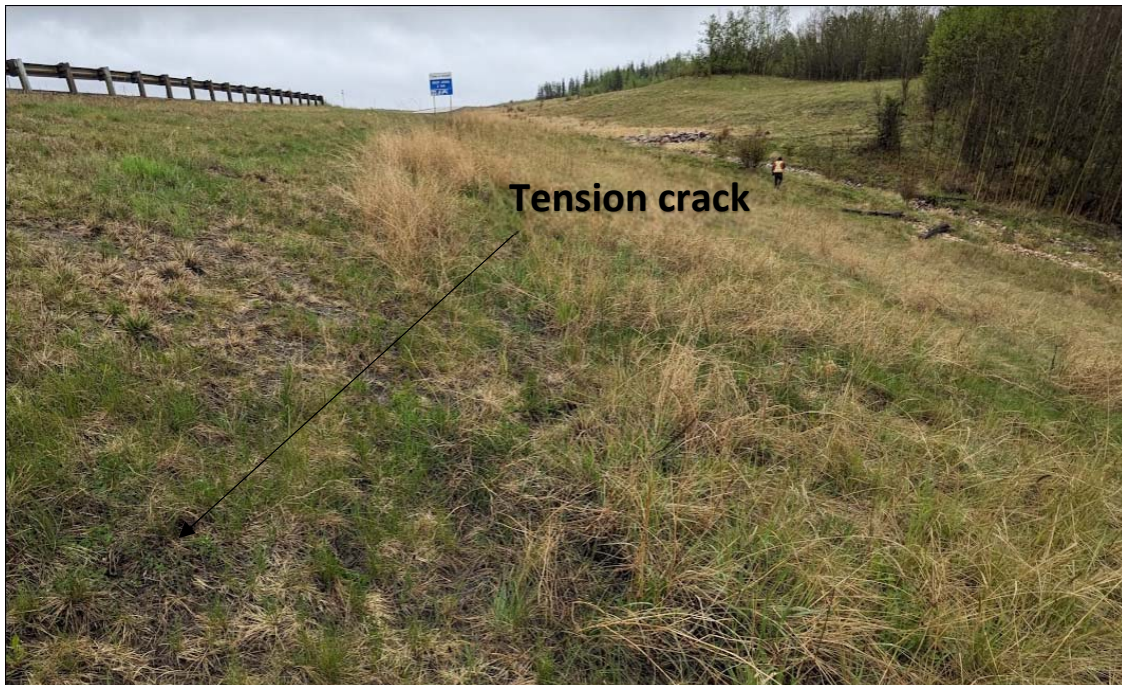
Photo No. 2 – Looking north at NBL embankment side slope. Note minor tension crack 50 mm wide and 50 mm deep

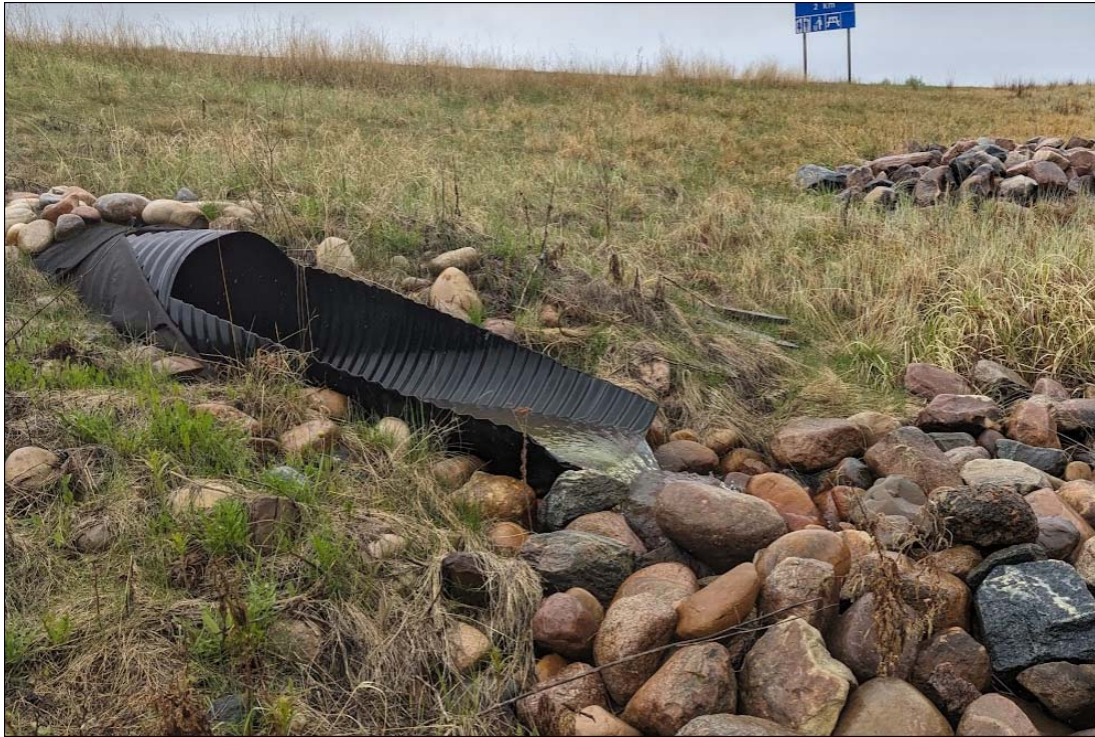
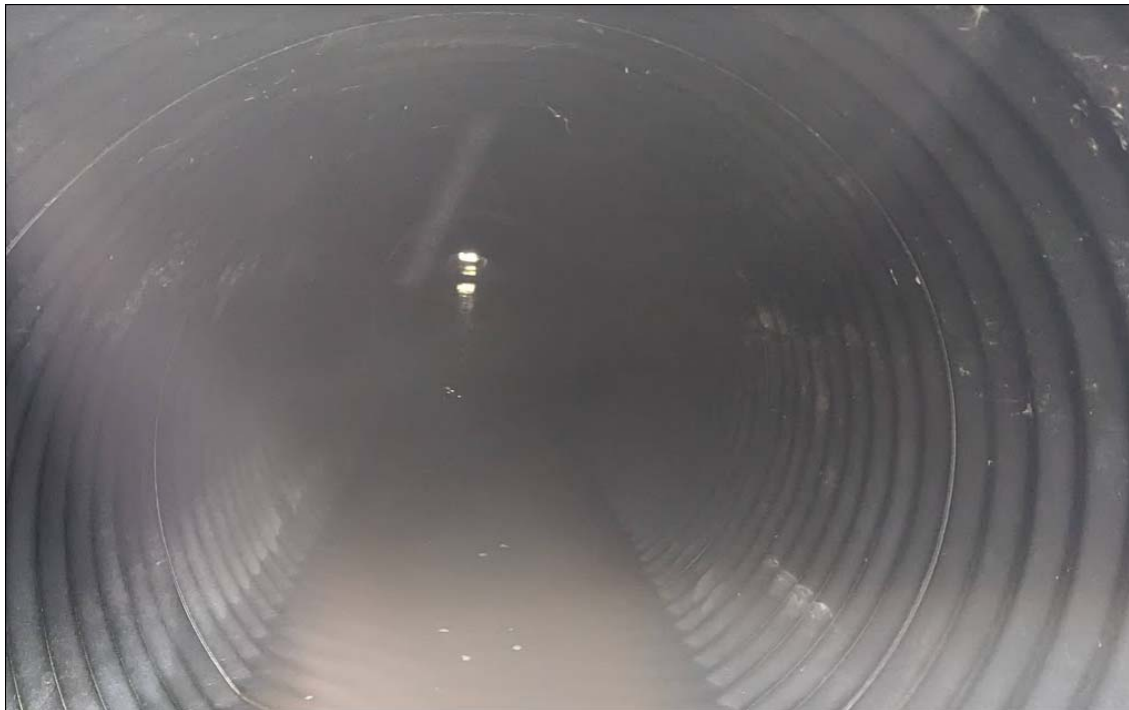
Photo No. 3 – CSP culvert C3 outlet showing heavy flow. Lower photo showing the condition inside the CSP culvert

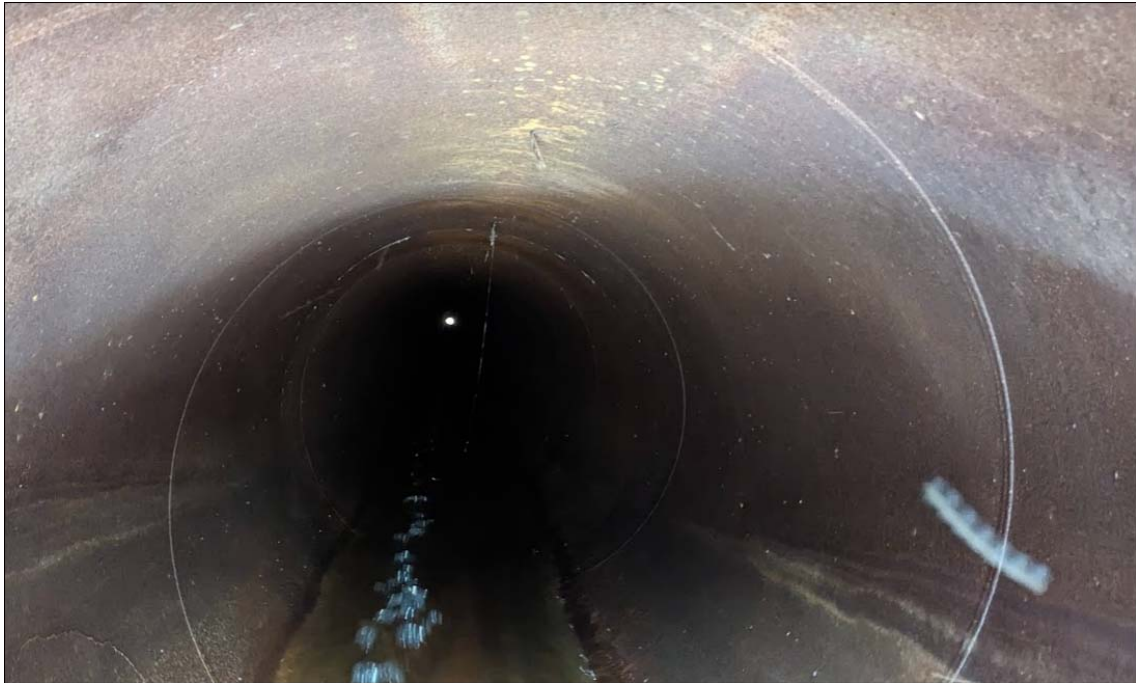
Photo No. 4 – SWSP Culvert Inlet inner condition

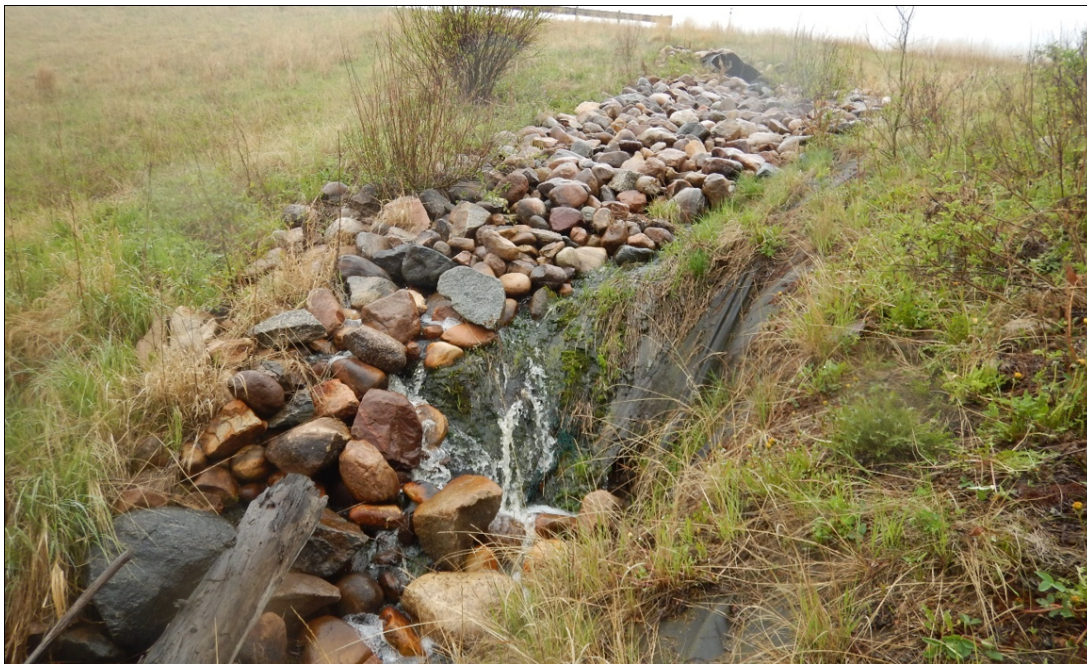
Localized erosion gullies along the south facing riprap channel of the east slope are expected to keep getting larger until suitable erosion control measures are in place.

Photo No. 5 – Severe erosion within the riprap channel located downslope of the C3 culvert outlet

Erosion gullies within the south facing channel of the east slope will need to be repaired. This will require salvaging existing riprap, excavating eroded areas, reshaping the channel to have well defined sides and bottom, placement of salvaged riprap and additional riprap (as needed) over non-woven geotextile fabric (to be keyed in at least 300 mm at the top of the channel) along the sides and the bottom of the channel.

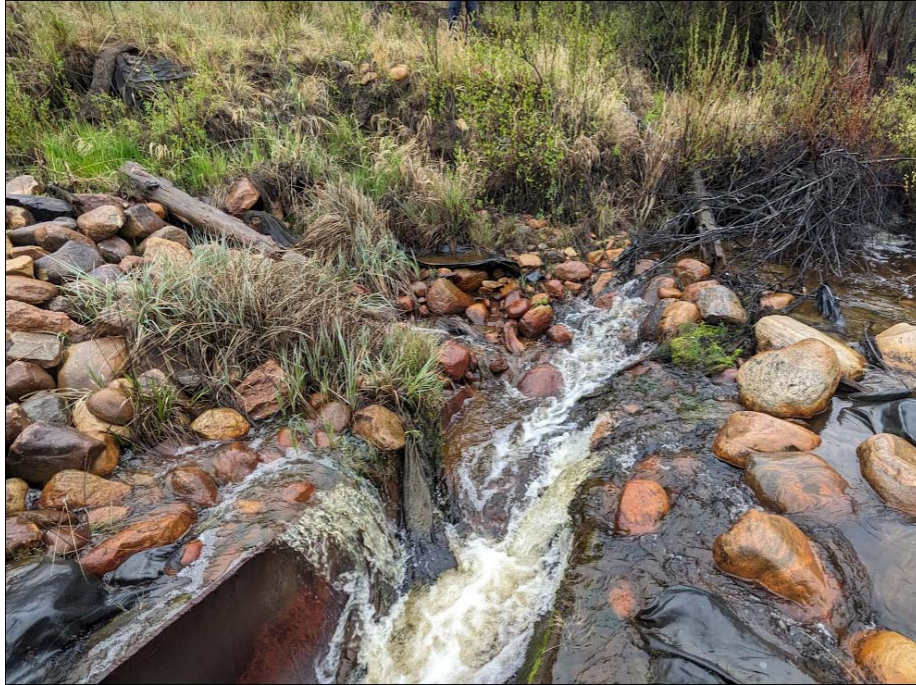
Photo No. 5a – Riprap channel erosion and debris accumulation near the 1.2 m SWSP culvert inlet

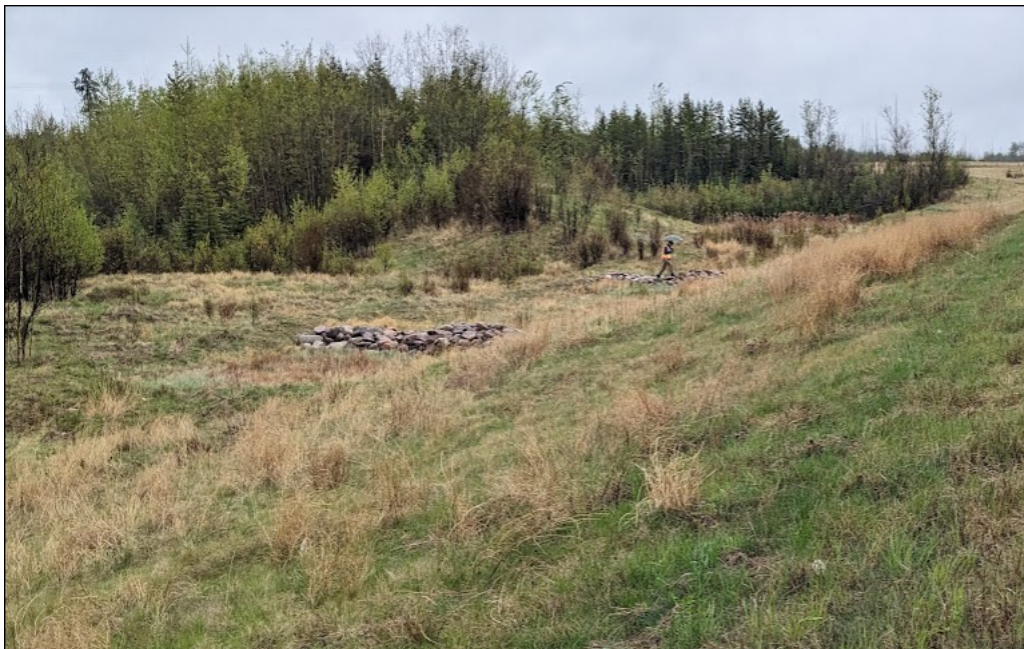
Photo No. 6 – Rock check dams located along NBL southeast ditch

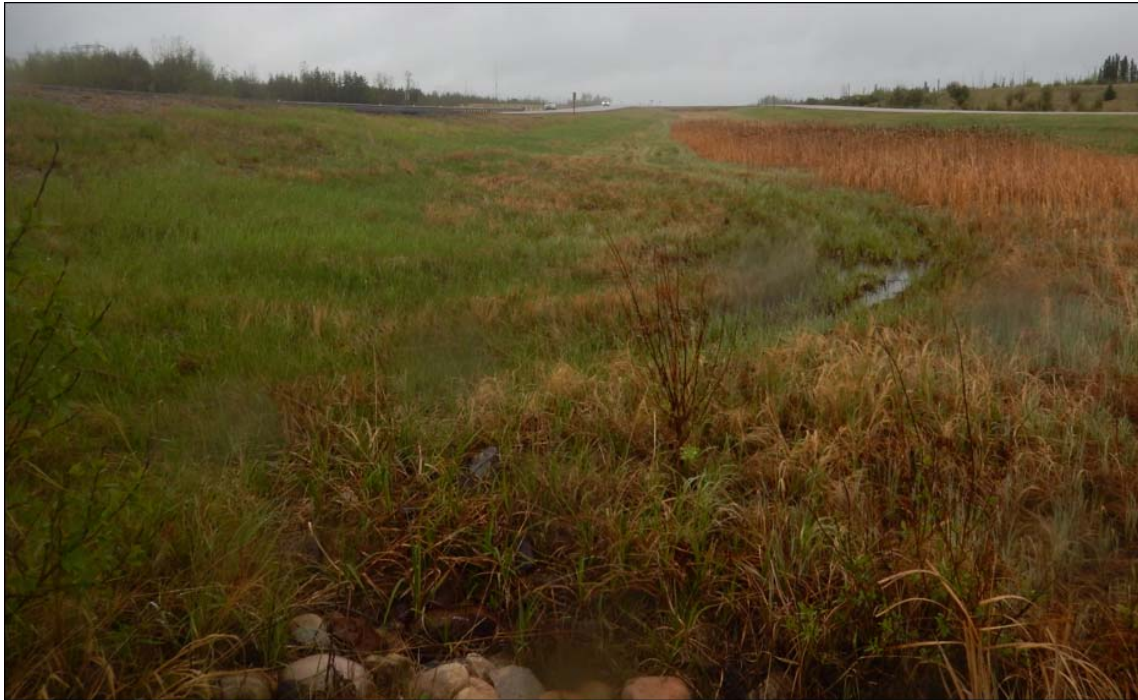
Photo No. 7 – Median ponding water

The median ditch should be slightly graded to prevent ponding of water in the ditch.

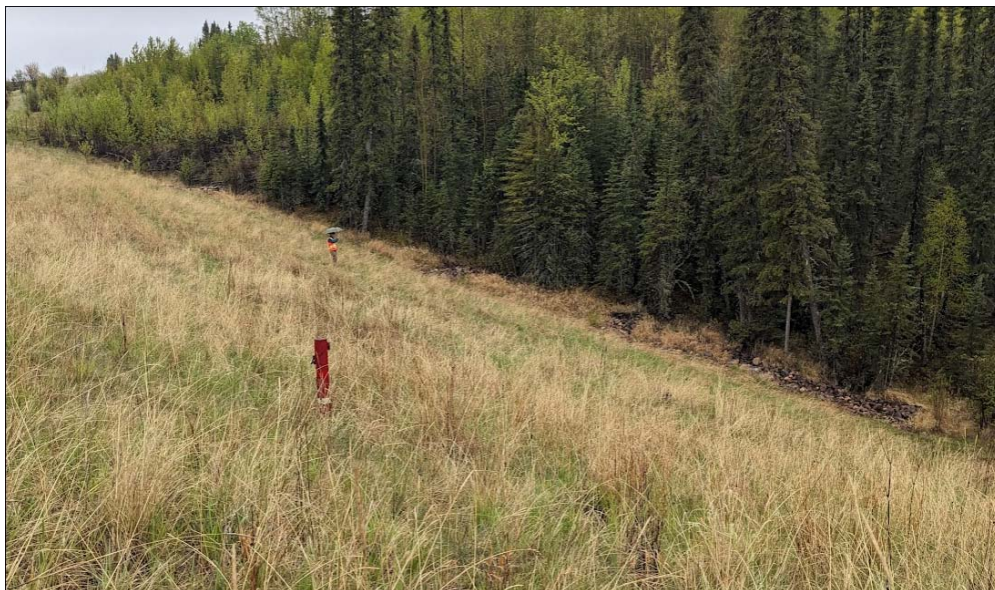
The interim repairs appear to be more effective on the west side of the highway southbound lanes.

Photo No. 8 – Looking south at SBL west side slope; note good vegetation growth within repaired area

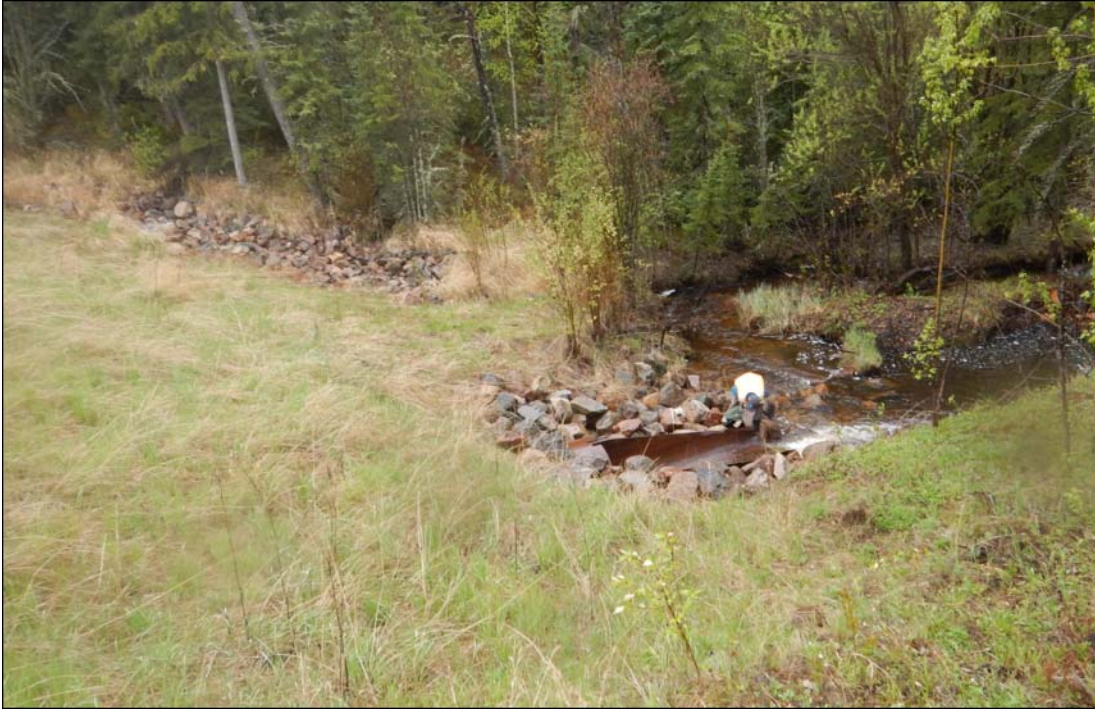
Photo No. 9 – SWSP outlet; note heavy water flow in 2024

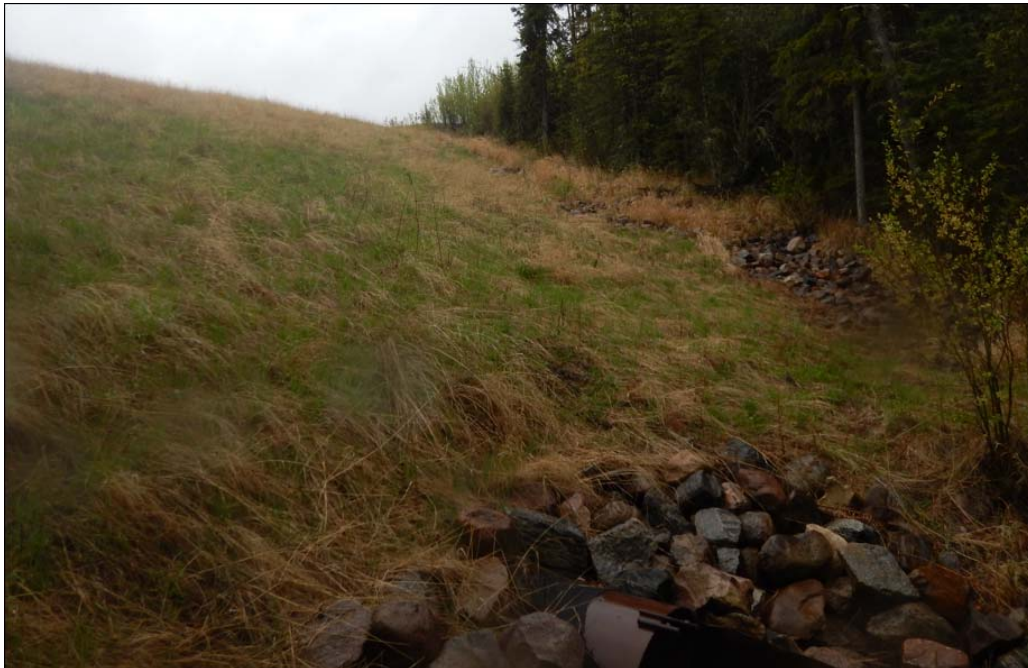
Photo No. 10 – North facing riprap channel along the SBL west side slope

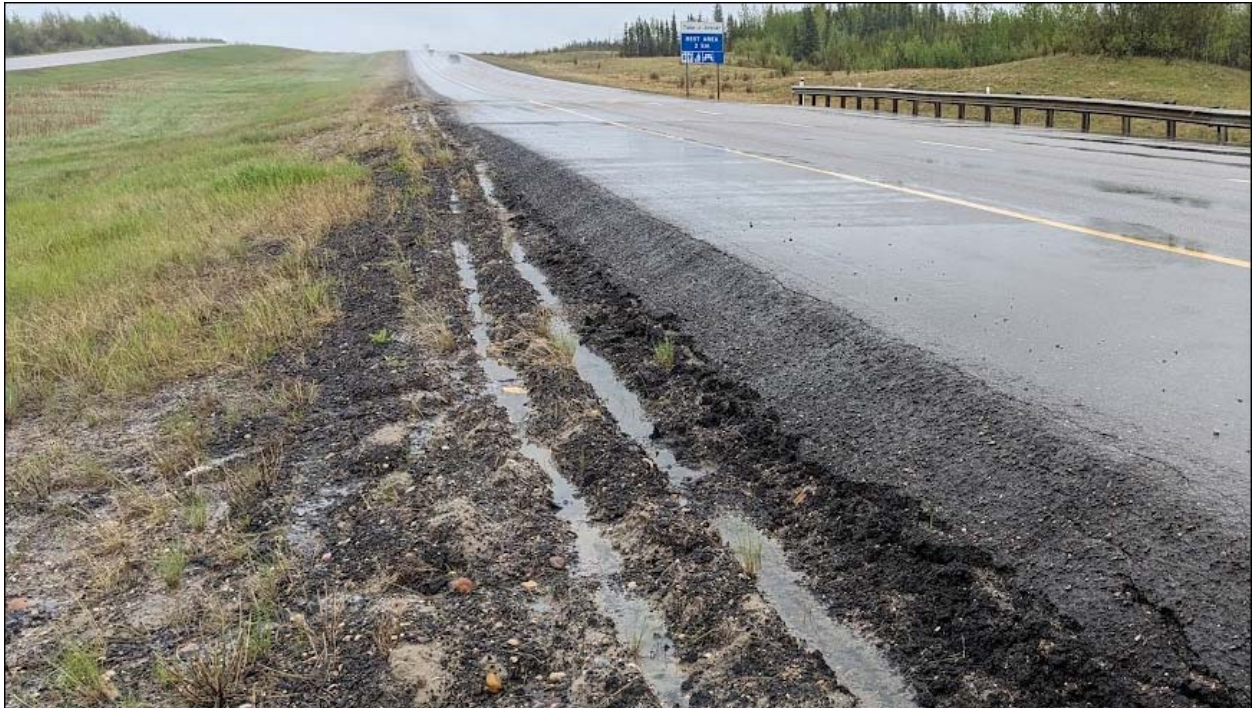
Photo No. 11 – Sharp Drop off 500 mm high on the NBL; significant thickness of ACP has been placed on the highway NBLs to remove the dip developed in response to slope movement
