**ALBERTA TRANSPORTATION
GEOHAZARD ASSESSMENT PROGRAM
NORTH CENTRAL REGION – ATHABASCA
2019 INSPECTION**

Site Number	Location	Name	Hwy	km
NC070-1	Approximately 2 km northeast of Hangingstone River and 40 km south of Fort McMurray	Truck Staging Area	63:10	18.8
Legal Description		UTM Co-ordinates (NAD 83)		
SE ¼ and SW¼ -3-86-9-W4M		12 N 6253630	E 478921

NORTH CENTRAL REGION (ATHABASCA AREA) 2019 GEOHAZARD ASSESSMENT

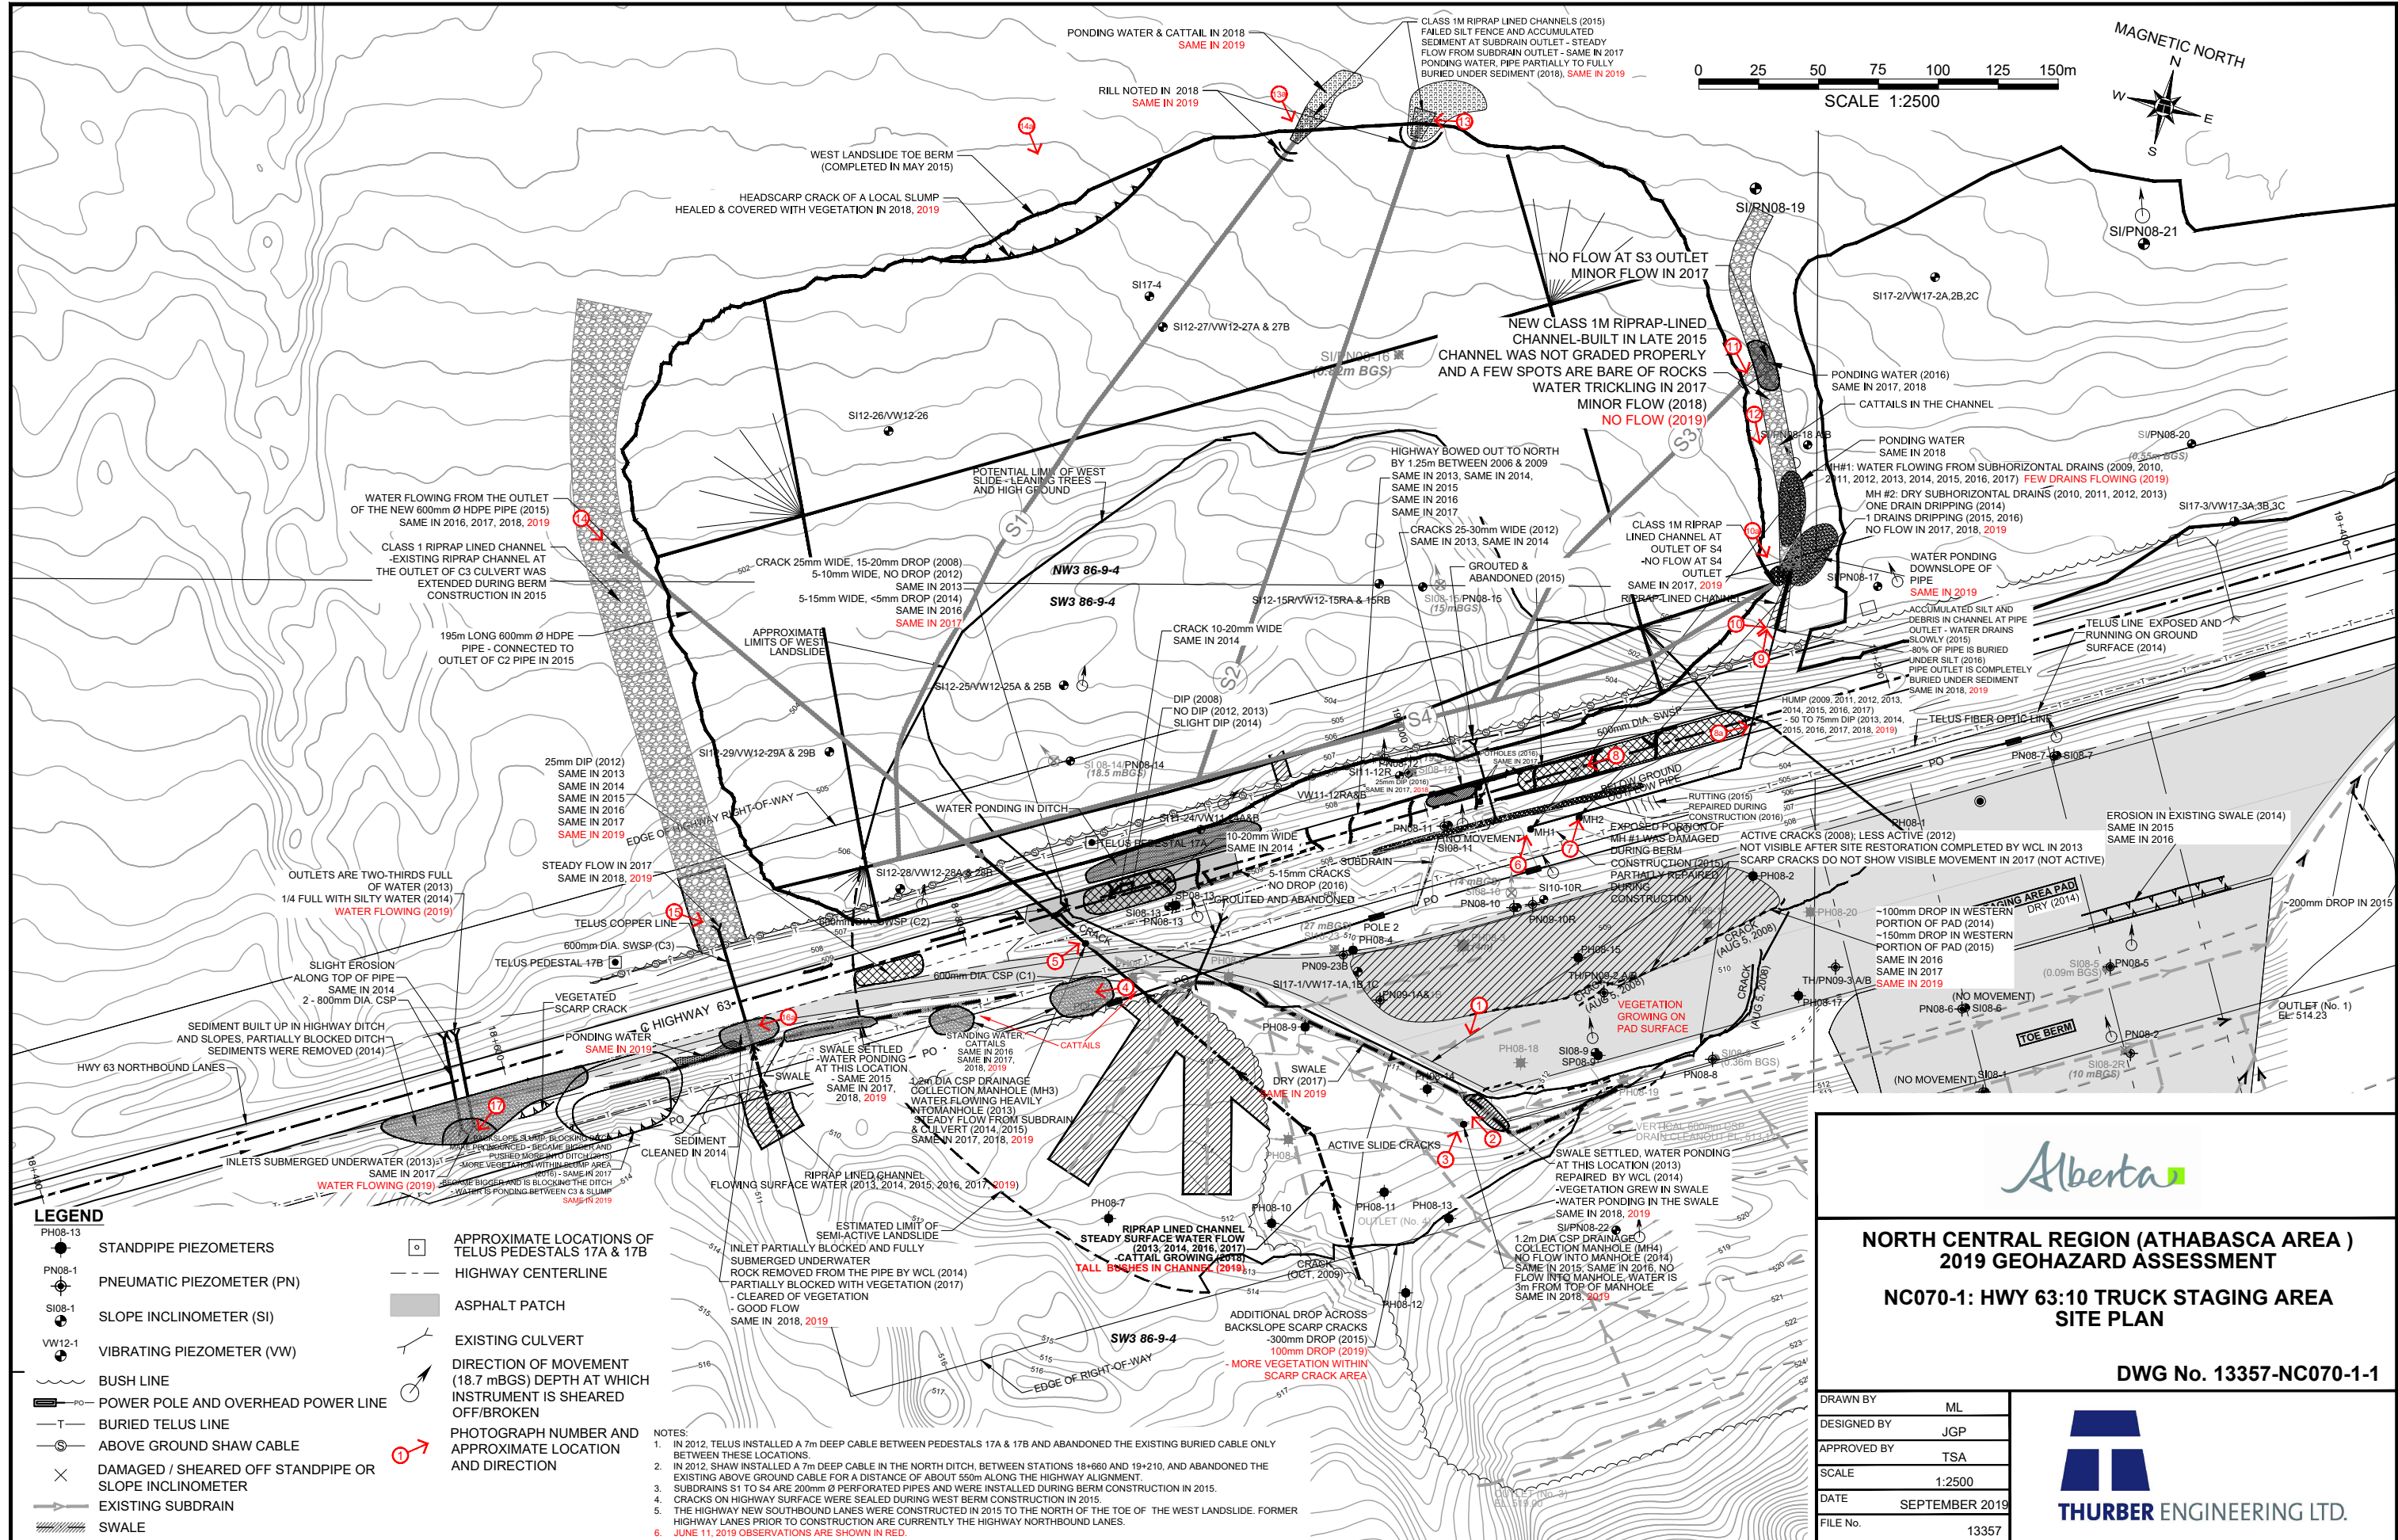
DWG No. 13357-NC070-1-1

NC070-1: HWY 63:10 TRUCK STAGING AREA SITE PLAN

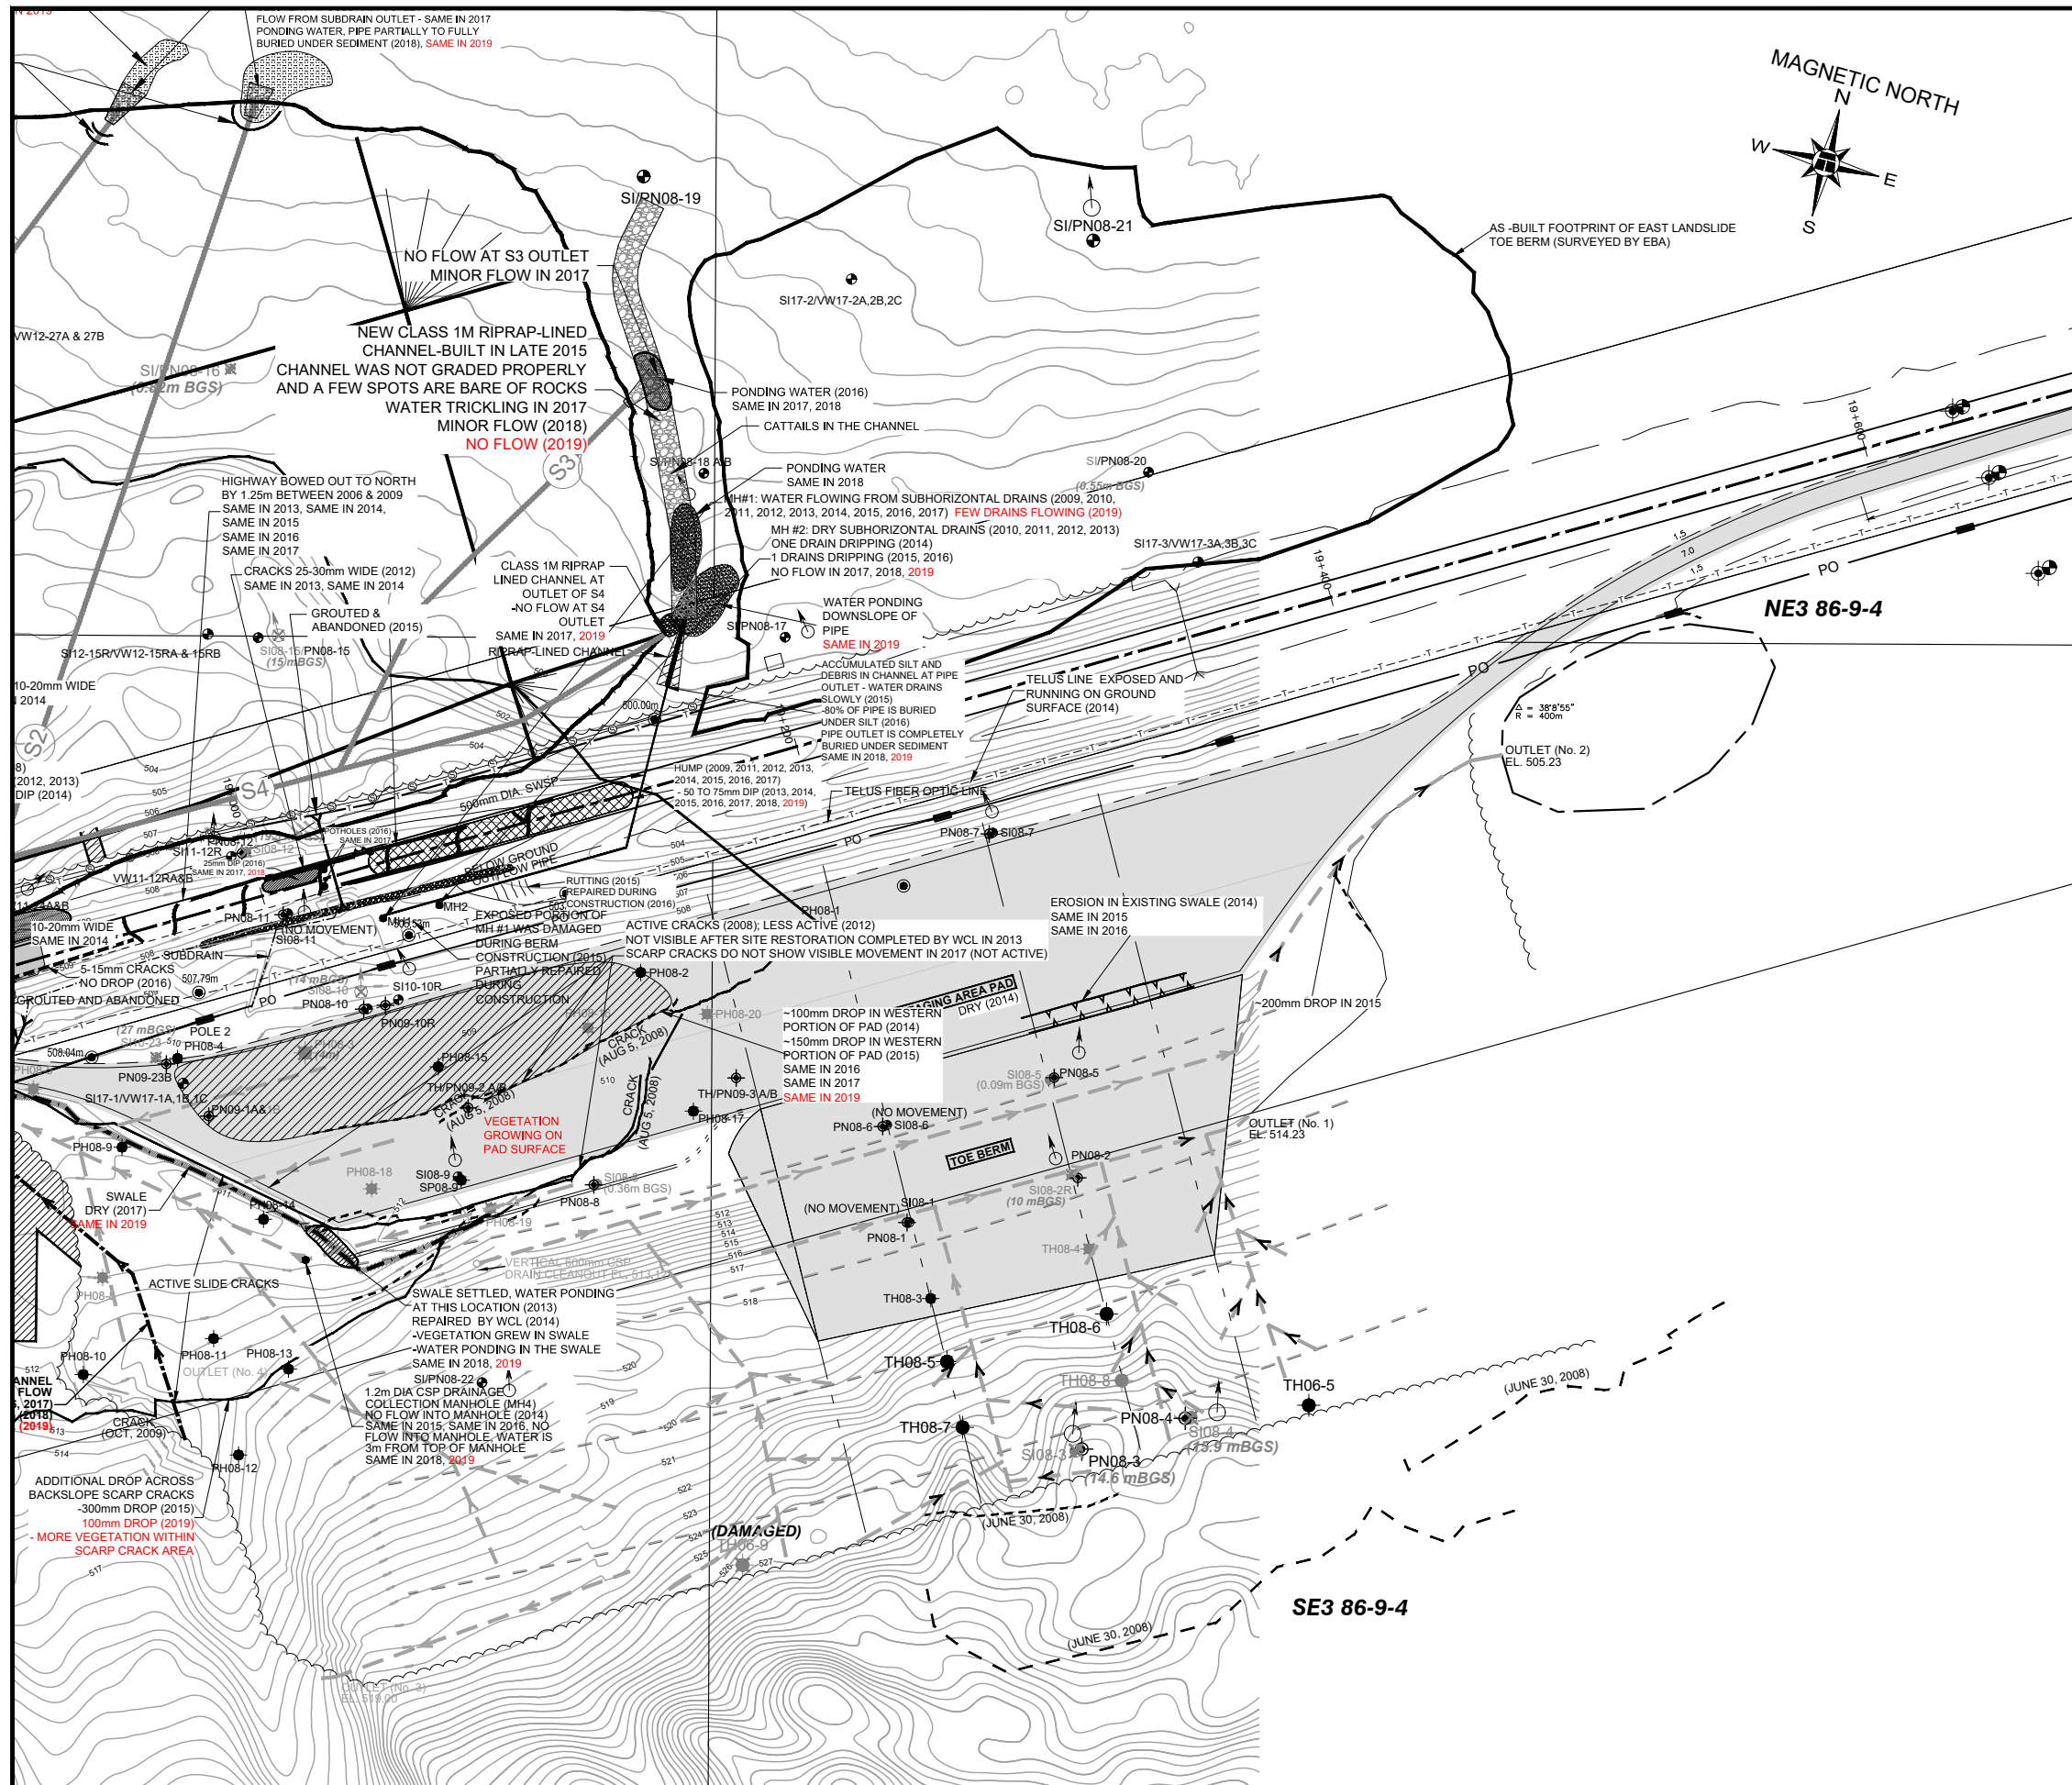
DWG No. 13357-NC070-1-2

**NC070-1: HWY 63:10 TRUCK STAGING AREA
SITE PLAN SHOWING EXISTING
INSTRUMENT LOCATIONS**

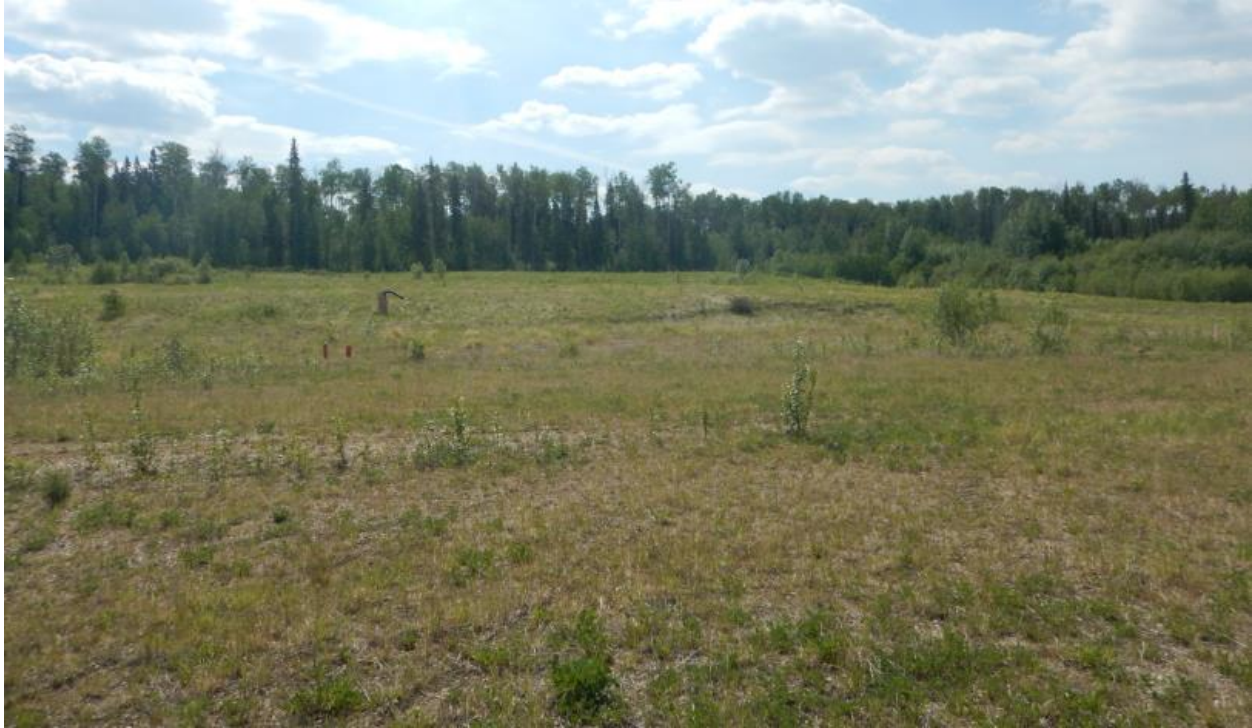
Photo No.1 – West landslide vegetated head scarp crack (Looking South)

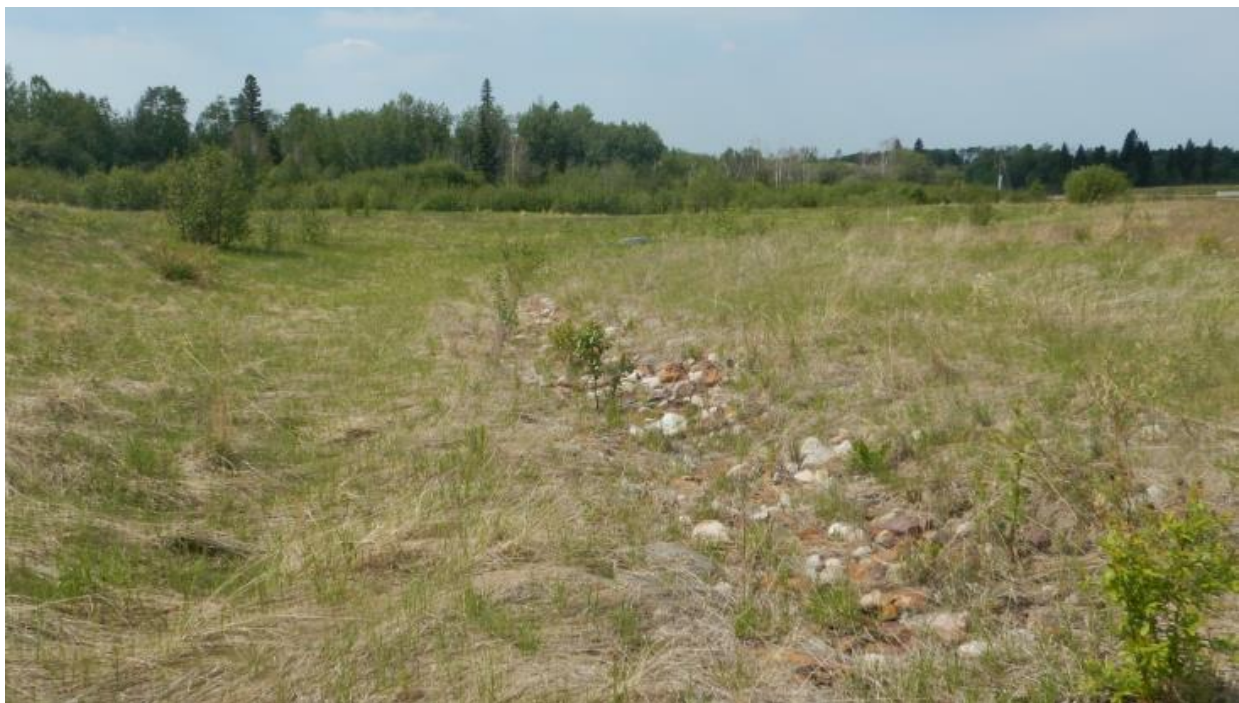
Photo No.2 – Looking west at the riprap-lined swale to the south of the TSA pad; minor water ponding within the swale

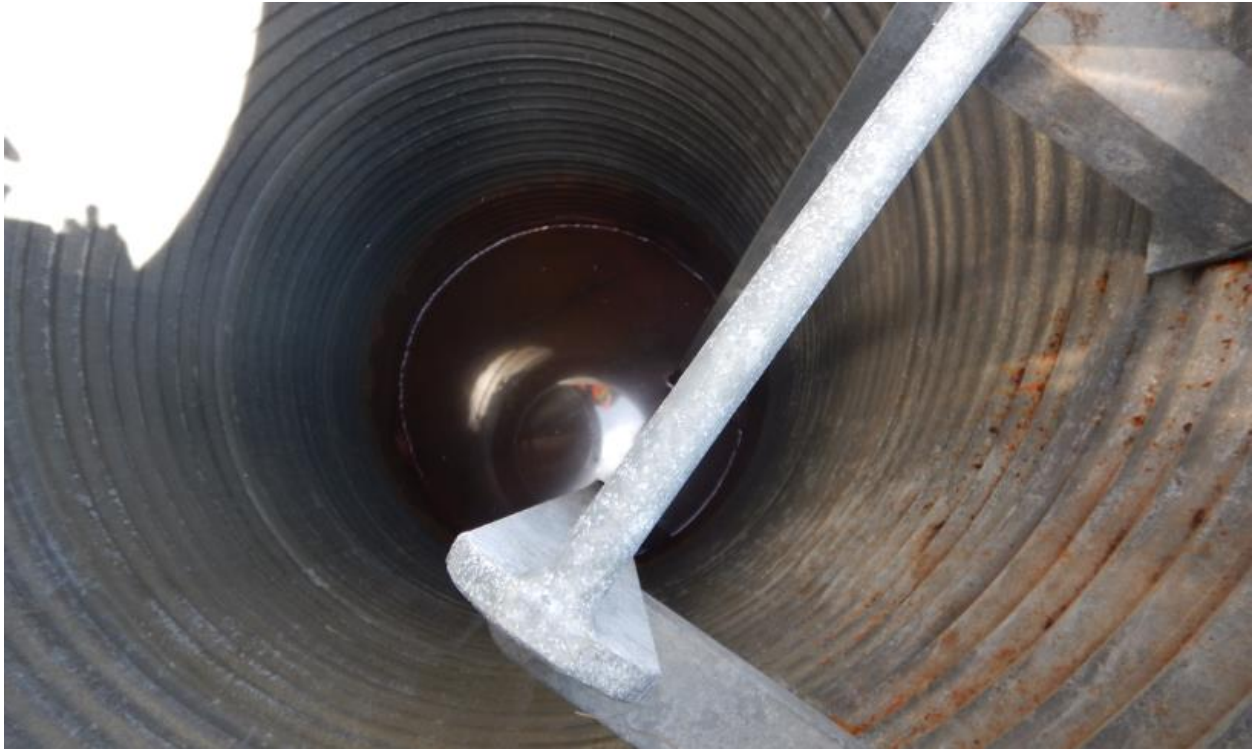
The sub-drain pipe connected to MH#4 is not draining and this may result in further increase in ground water levels to the south of the TSA pad.

Photo No.3 – Manhole # 4; note that no flow was observed, and water was measured at 3 m from top of manhole

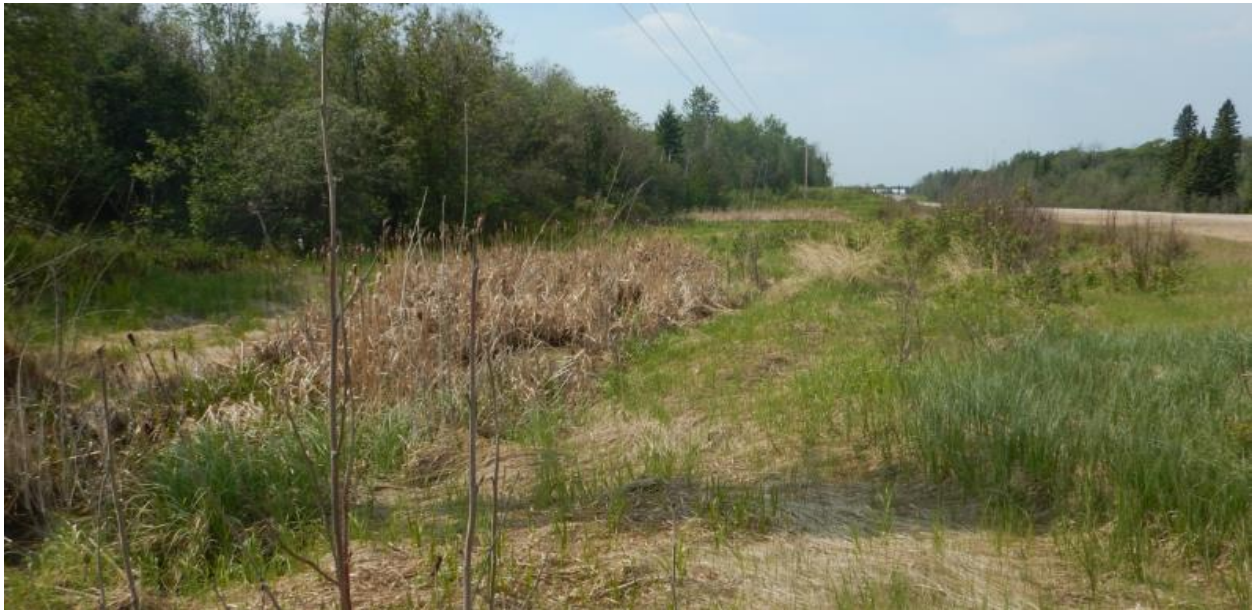
Photo No.4 – Looking at highway south ditch to the west of the TSA pad; note standing water and cattail vegetation (Looking West)

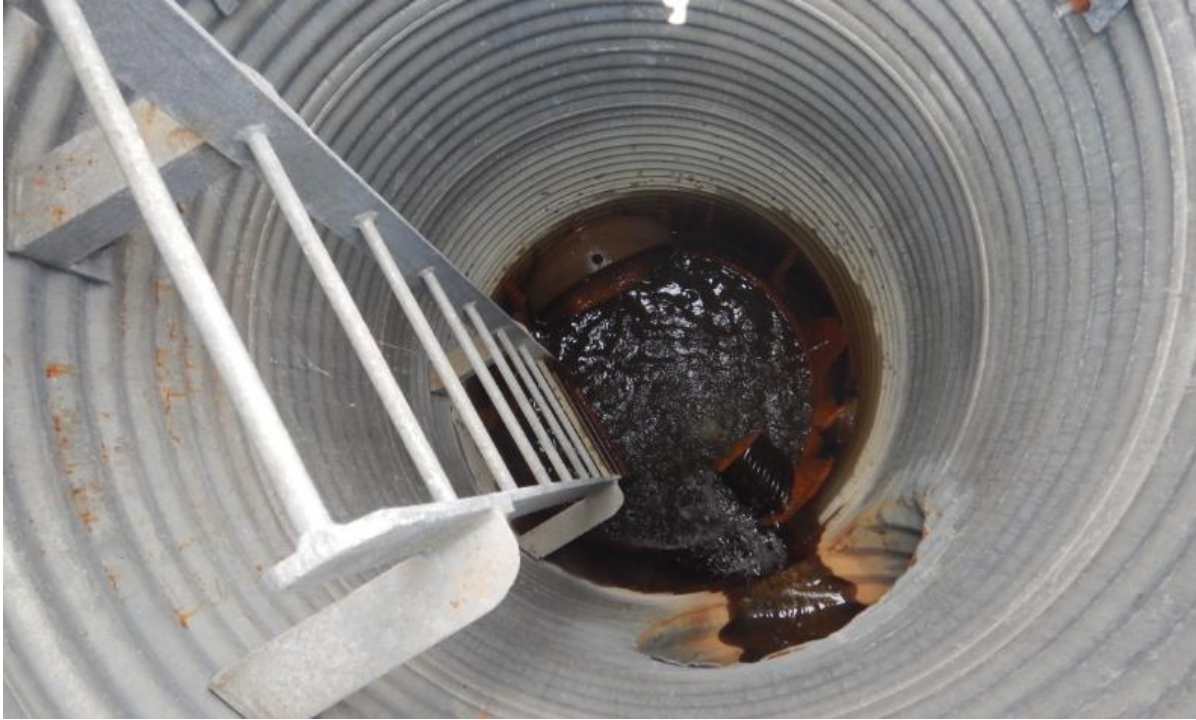
Photo No.5 – Manhole #3; note steady flow from the subdrain and culvert pipes

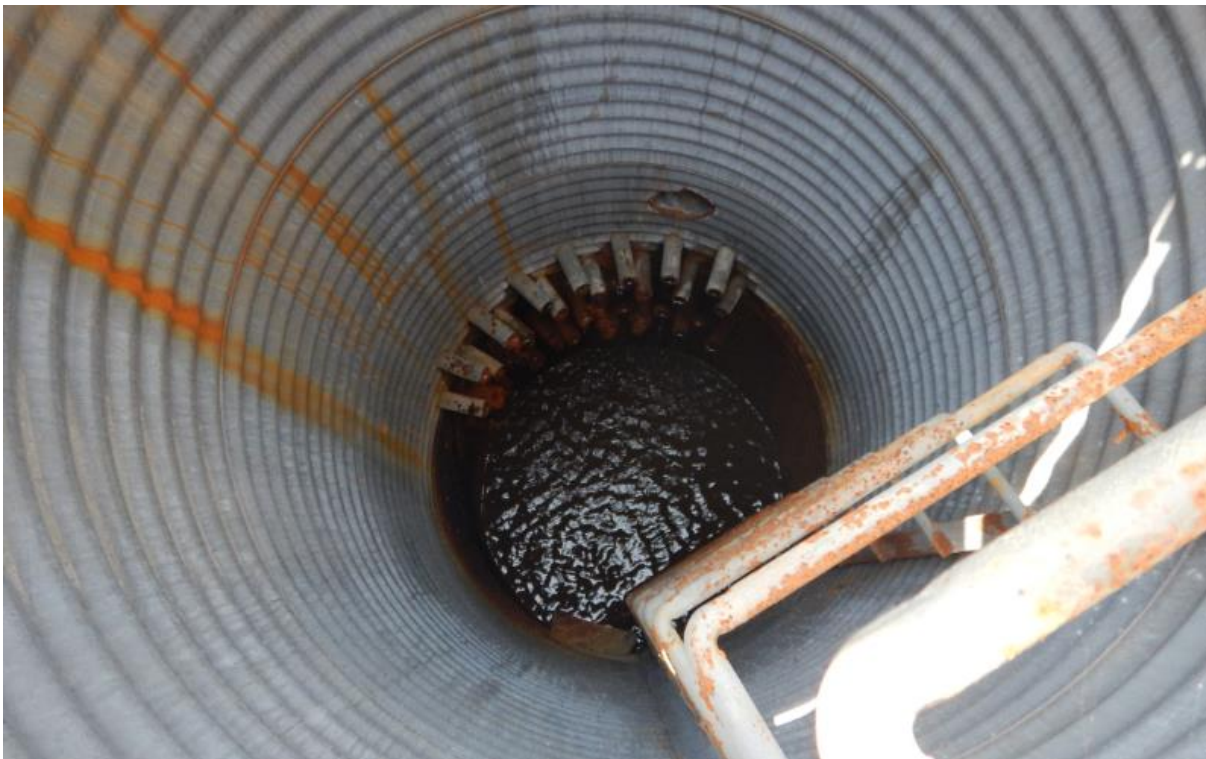
Four of the MH#1 sub-horizontal drains were flowing at a total flow rate of 2.24 L/min. Three sub-horizontal drains in MH#2 were showing slow drips. The total flow rate increased by 1.16 L/min since the previous monitoring event in the fall of 2018.

Photo No.6 – Manhole 1; note water flowing from sub-horizontal drains

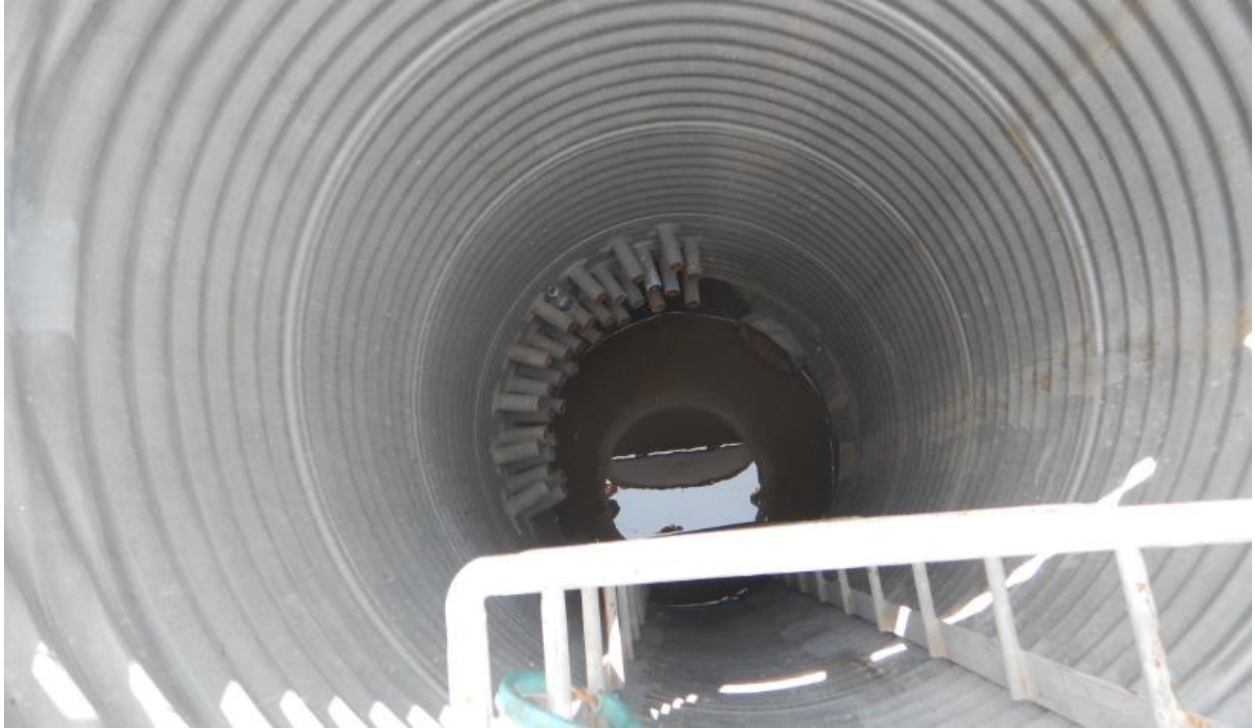
Photo No.7 – Manhole 2; no water was observed

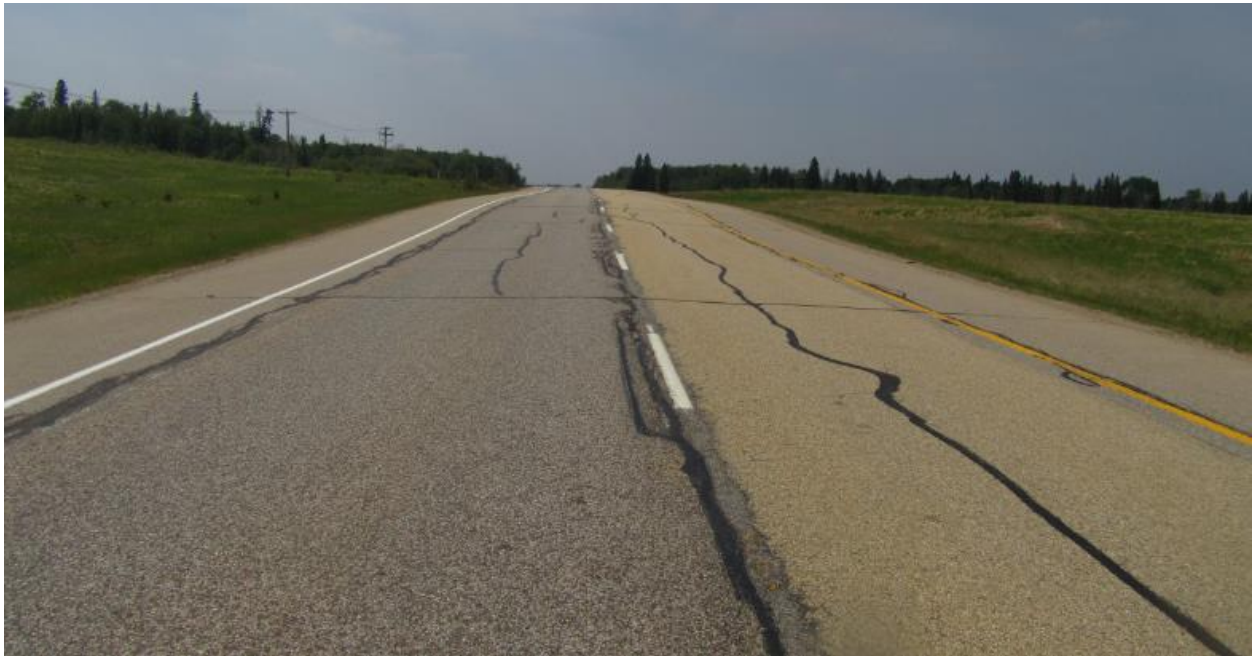
Photo No.8 – HWY 63 NBL; note presence of a hump and dip on highway lanes near the western flank of landslide (Looking West); highway cracks did not open since they were sealed in 2017

Since the posted speed on the highway northbound lanes (i.e. former highway 63 northbound and southbound lanes) was increased to 110 km per hour, it is recommended that ACP overlay be placed at this location to smoothen the roadway surface.

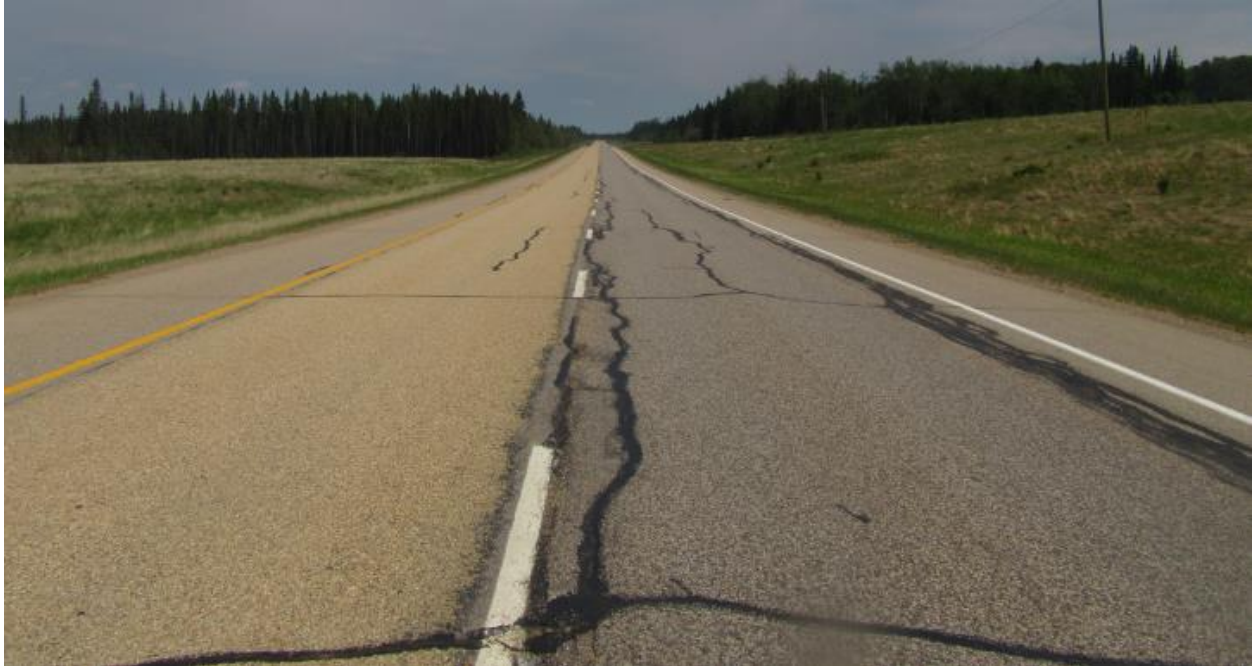
Photo No.8a – HWY 63 NBLs; not presence of a hump and dip on highway lands near the eastern flank of landslide (Looking East); highway cracks did not open since they were sealed in 2017

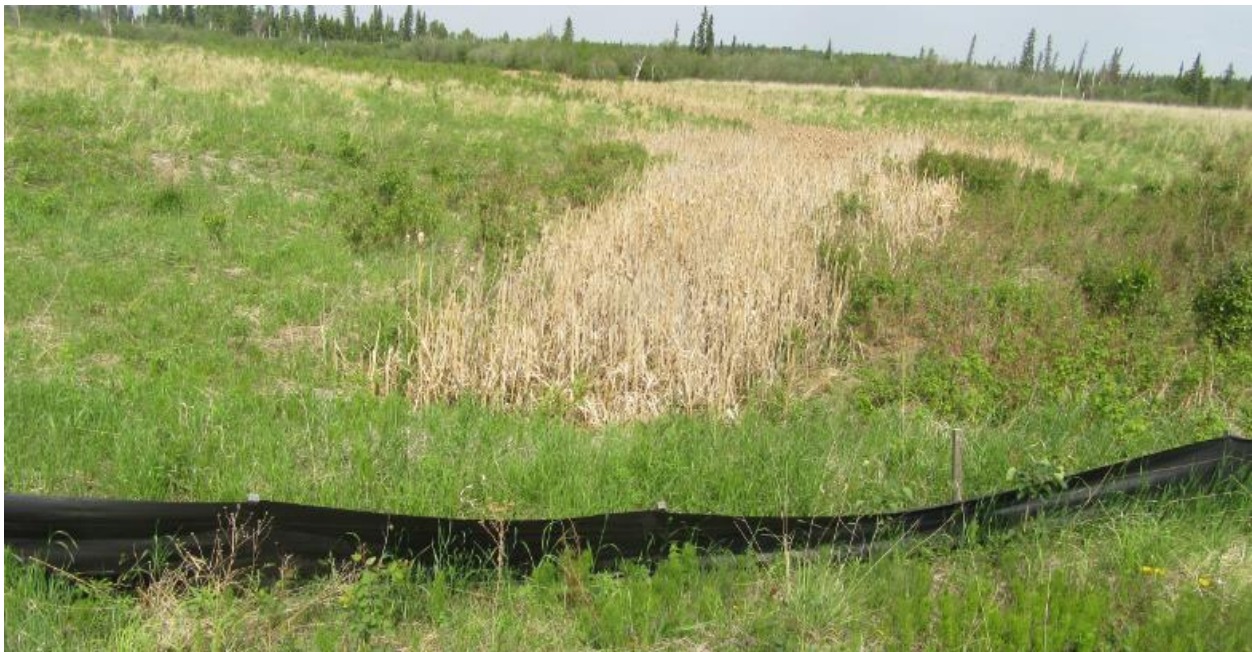
Photo No.9 – Water Ponding in the riprap channel located downslope of the 500 mm outflow pipe (Looking North)

It is crucial to expose the outlet of the 500 mm diameter outflow pipe, remove accumulated sediment at the outlet, and to regrade the riprap channel at the outlet of the pipe between the east and west landslide toe berms to enhance surface drainage.

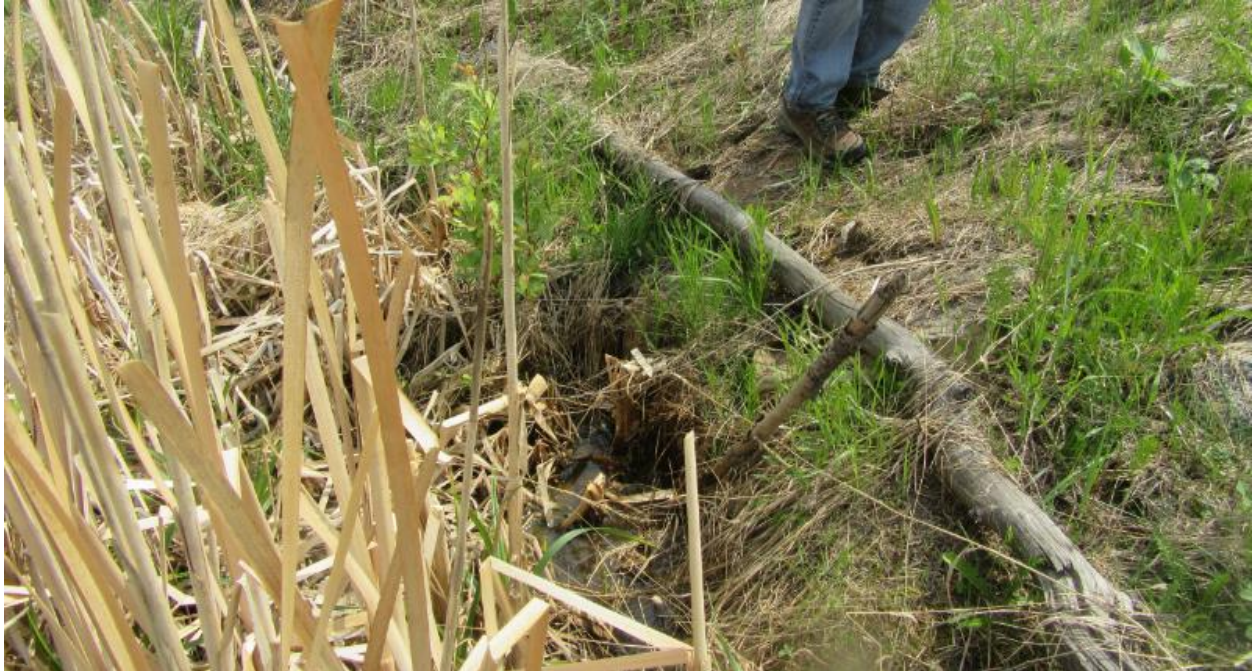
The outlets of the flowing sub-horizontal drains show silt accumulation, and the reduction in the flow rates from the sub-horizontal drain pipes indicates that the drains may get plugged in the future. In addition, the outlet of the outflow pipe is buried under silt, which could impede the drainage from the manholes, resulting in accelerated landslide movement if left untreated.

Photo No.10 – Ponding water, accumulated silt and debris at the outflow pipe outlet. Pipe is buried under sediment

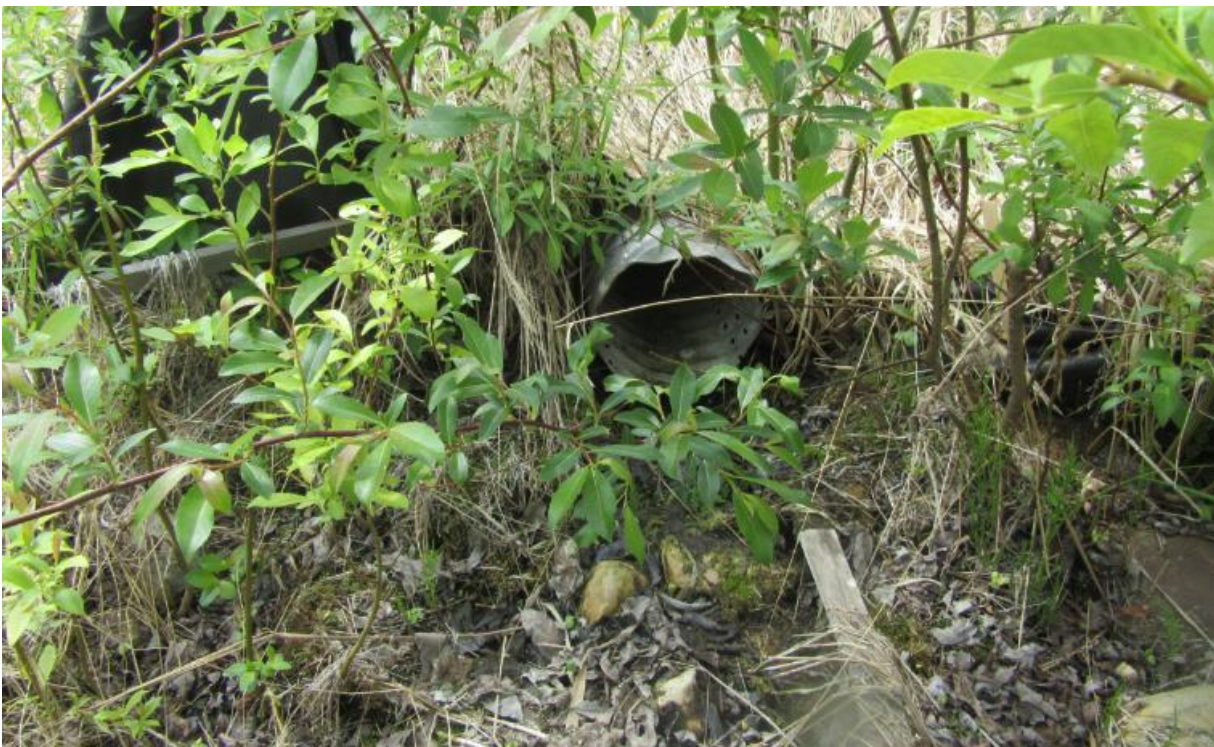
Subdrain pipes S1, S2, S3, and S4 may have been plugged and this may result in increase in groundwater levels below the west landslide toe berm.

Photo No.10a – Subdrain S4; no flow observed

located to the north side of the highway, and to expose the outlets of these pipes. Flushing of subdrain pipes S1 to S4 is also recommended to enhance sub-surface drainage below the west landslide toe berm.

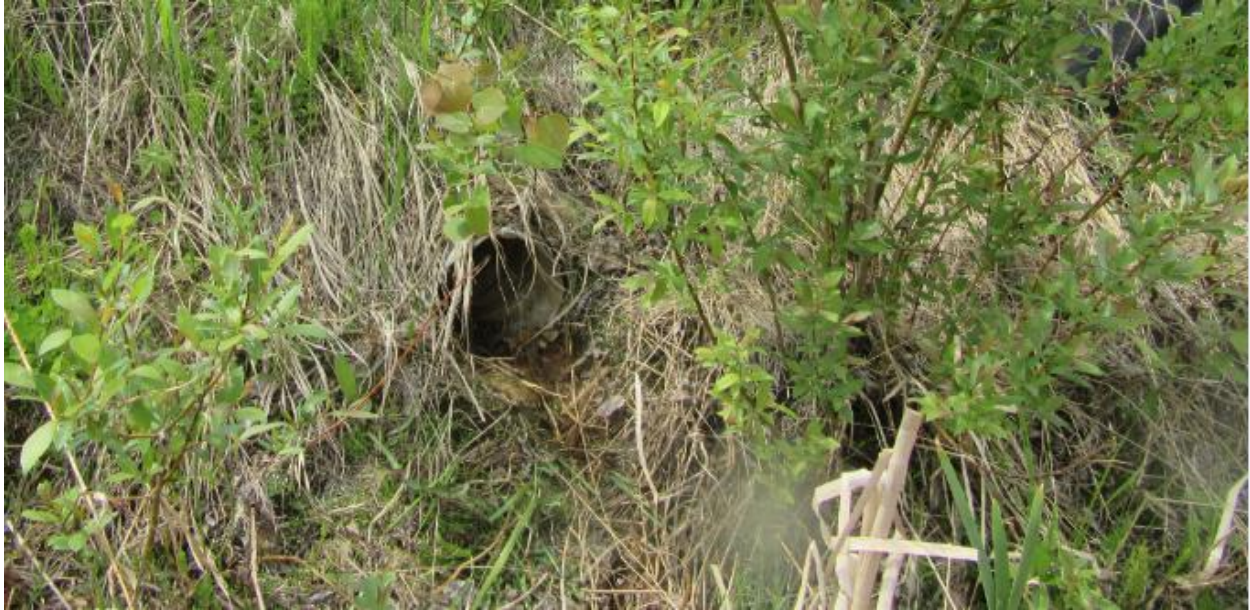
Photo No.11 – Subdrain S3; no flow observed

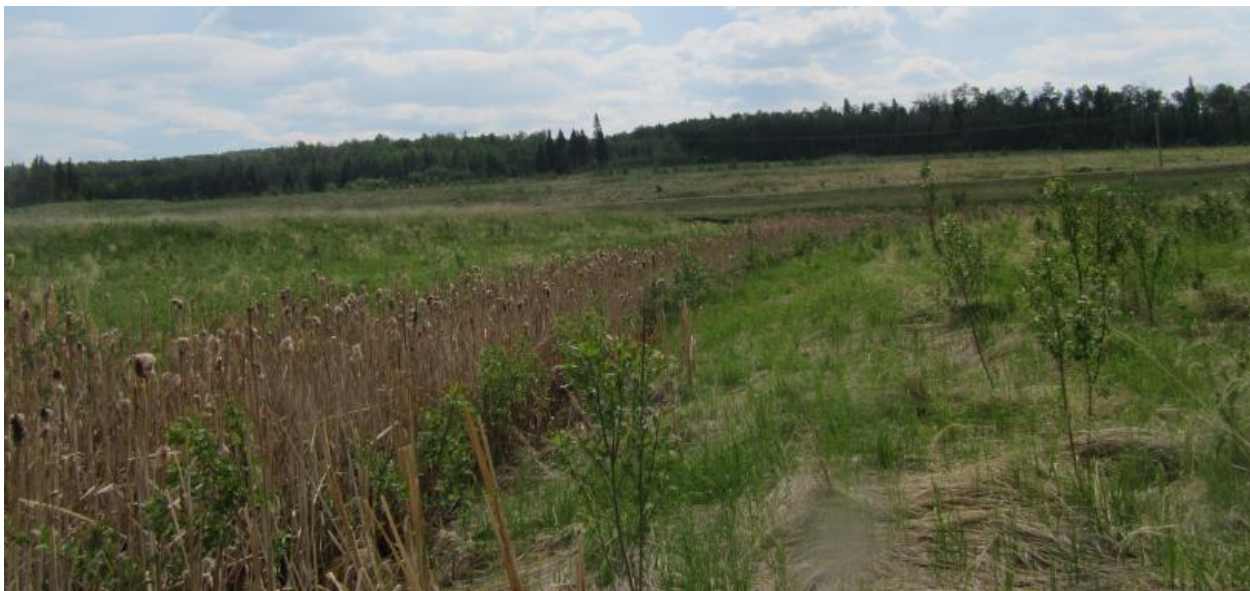
Photo No.12 – Water Ponding within the riprap lined channel located between the east and west landslide berms (Looking South)

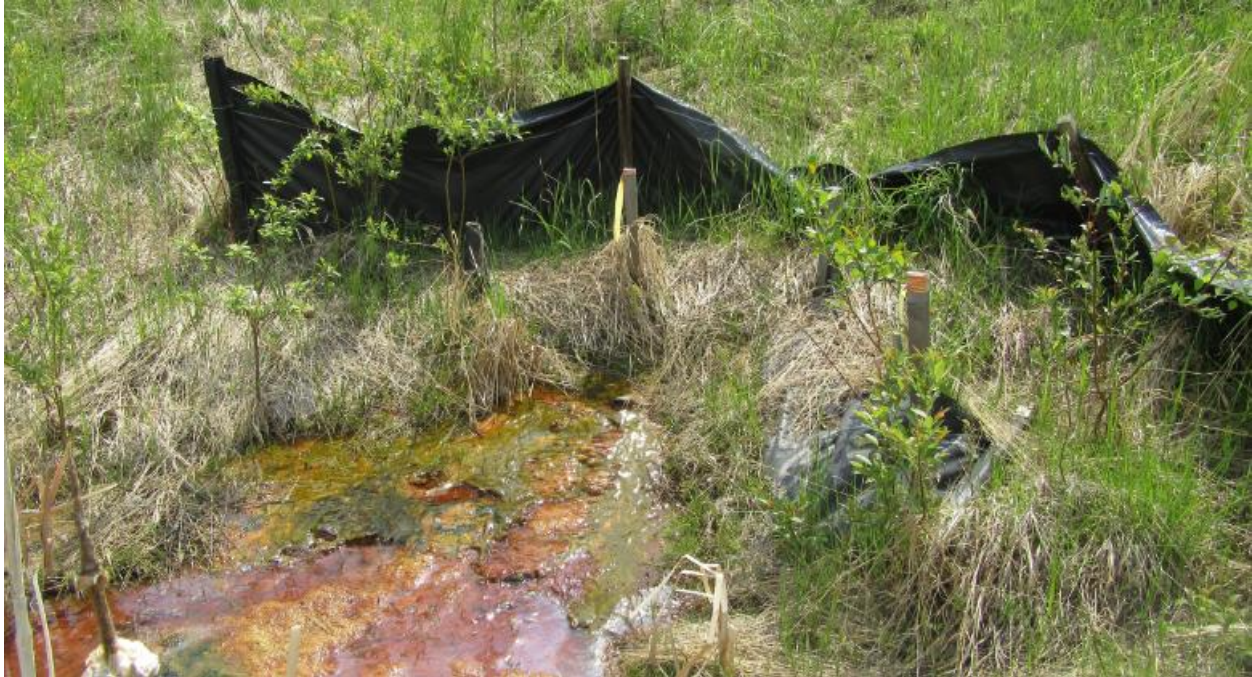
Photo No.13 – Subdrain pipe outlet S2; pipe was completely buried under silt; water was ponding at the outlet of the pipe

It is also necessary to remove accumulated sediment at the outlets of subdrain pipes S1 and S2,

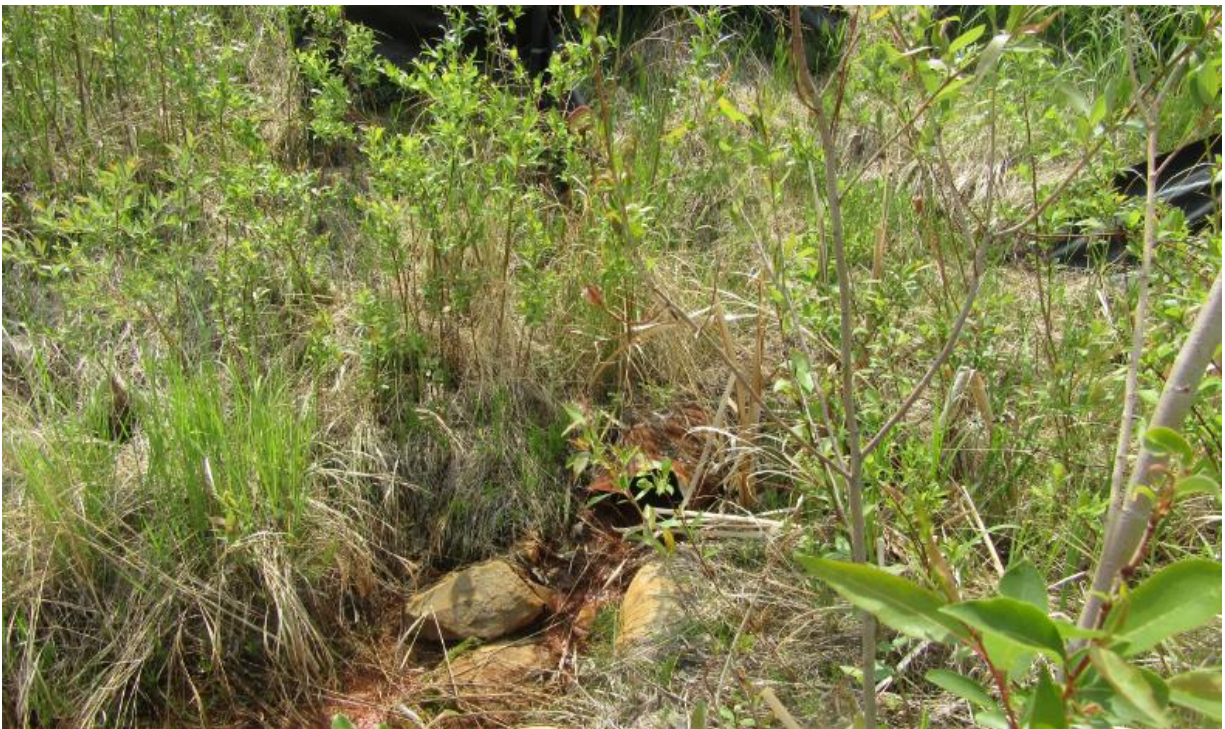
Photo No.13a – Subdrain pipe outlet S1; pipe was partially buried under silt; water was ponding at the outlet of the pipe

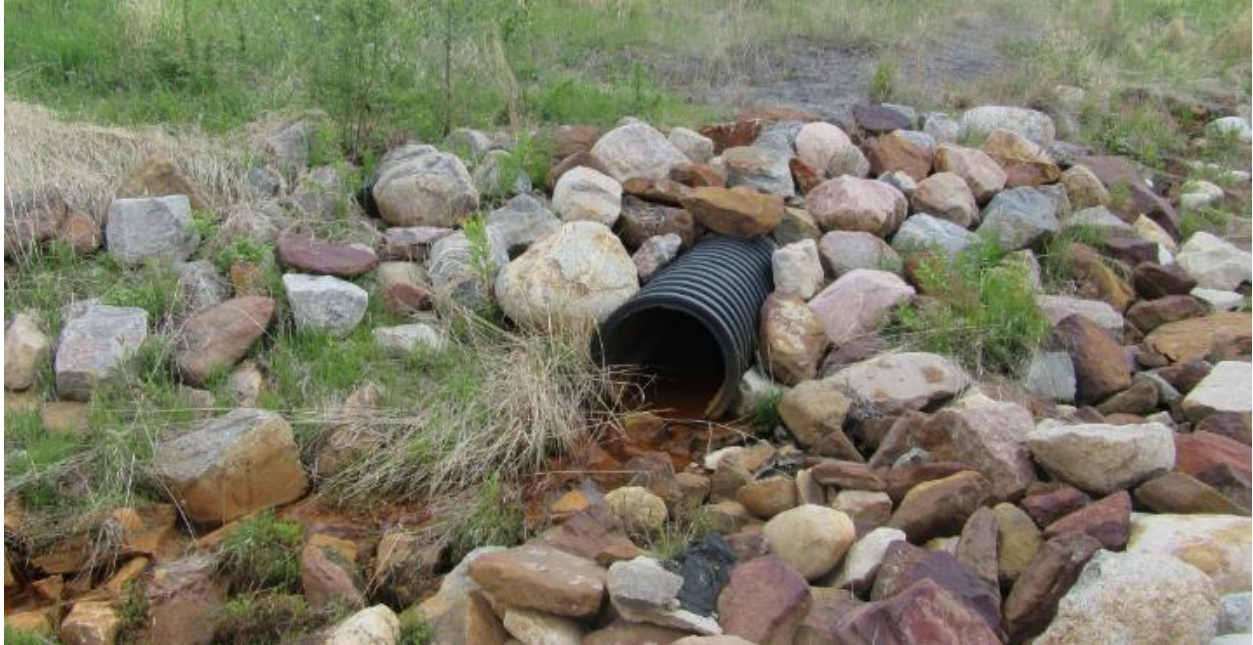
Photo No.14 – C2 extension (600 mm HDPE pipe outlet); water is flowing out of the pipe
