**ALBERTA TRANSPORTATION
GEOHAZARD ASSESSMENT PROGRAM
NORTH CENTRAL REGION – ATHABASCA
2019 INSPECTION**

Site Number	Location	Name	Hwy	km
NC070-1	Approximately 2 km northeast of Hangingstone River and 40 km south of Fort McMurray	Truck Staging Area	63:10	18.8
Legal Description		UTM Co-ordinates (NAD 83)		
SE ¼ and SW¼ -3-86-9-W4M		12 N 6253630	E 478921

NORTH CENTRAL REGION (ATHABASCA AREA) 2019 GEOHAZARD ASSESSMENT

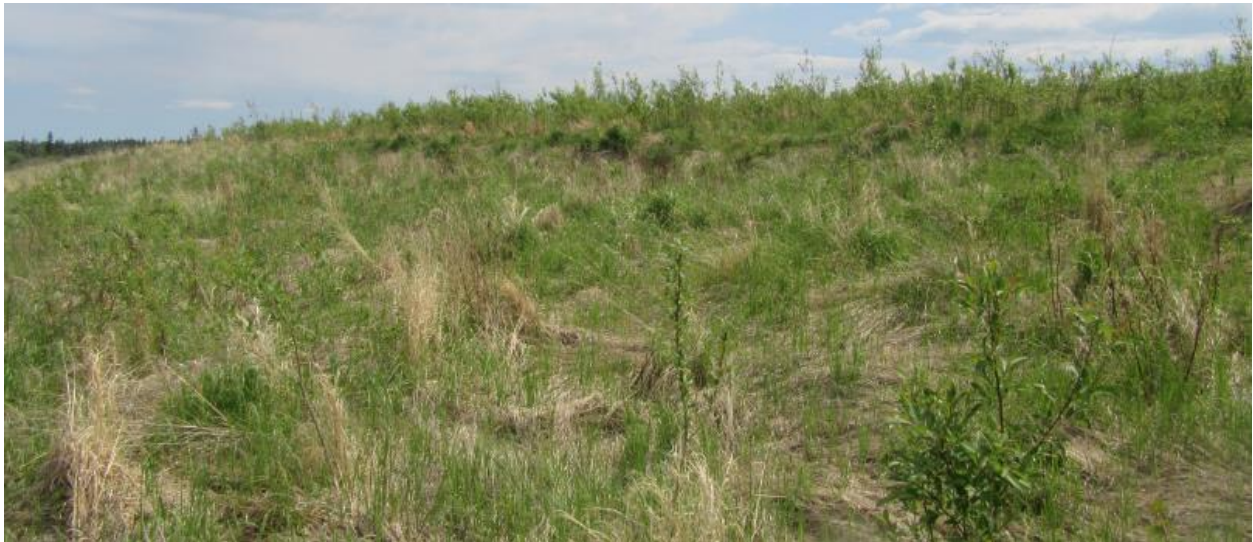
Photo No.14a – Vegetated head scarp crack of an old local slump on the north side of the western toe berm (Looking South)

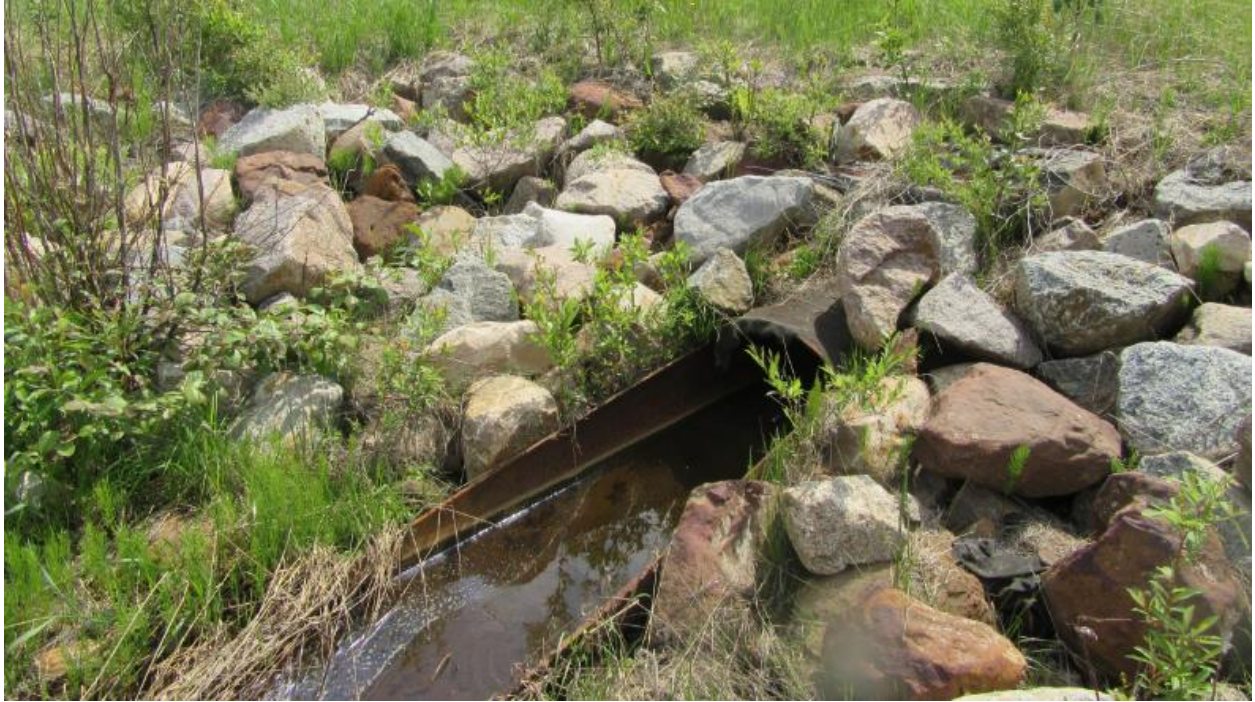
Photo No.15 – C3 culvert outlet; water is flowing out of the pipe

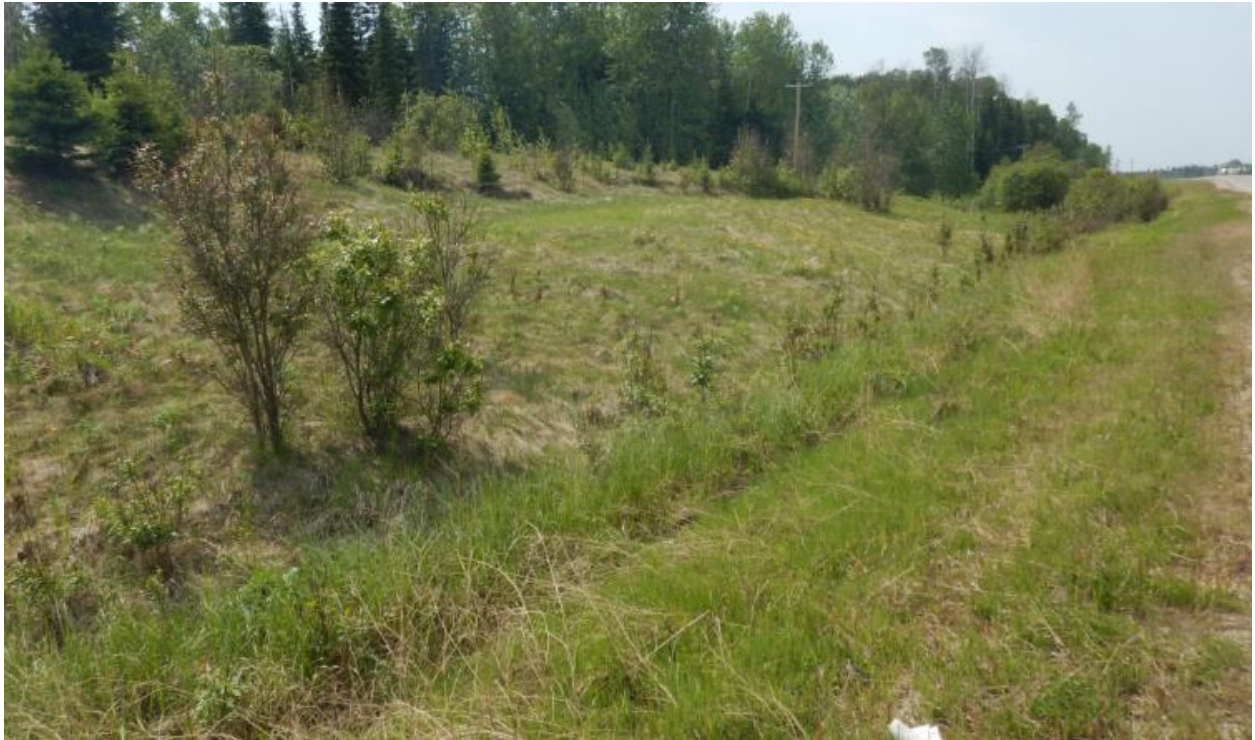
The highway back slope slump continues to block surface water flow in the south ditch of the highway. The existing slump may eventually affect the integrity of the existing power poles along the crest of the slope.

Photo No.16 – Looking south at the highway back slope slump; note that the toe is blocking the ditch flow

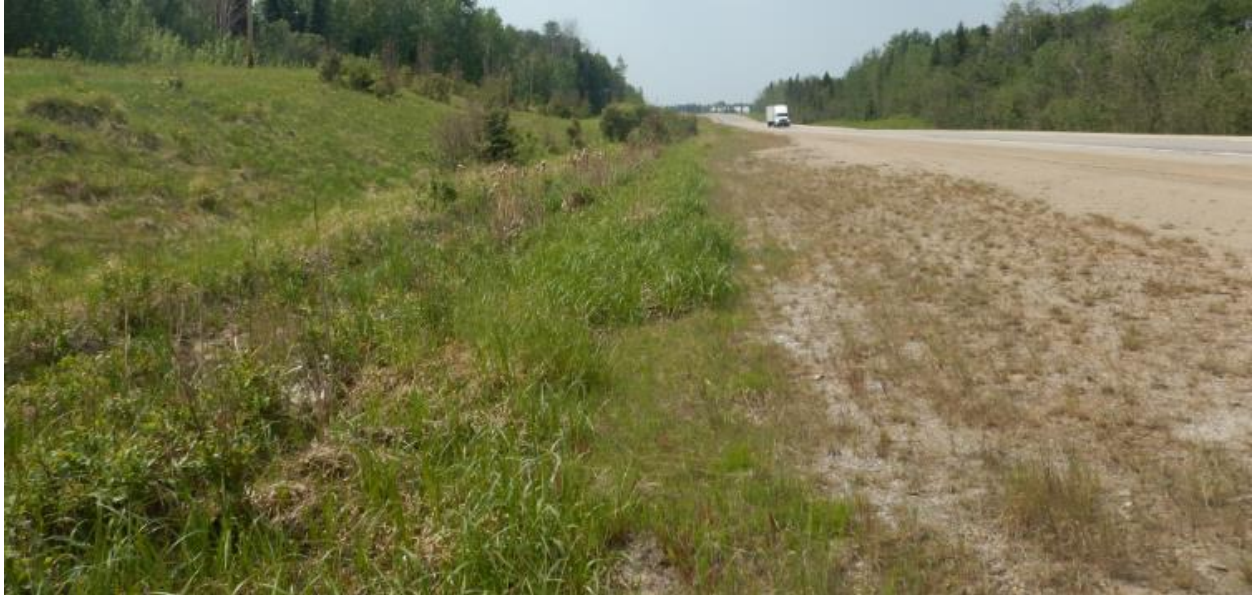
Photo No.16a –Water ponding within the section of the vegetated riprap -lined swale located to the east of the backslope slump (looking west from the east of the slump)

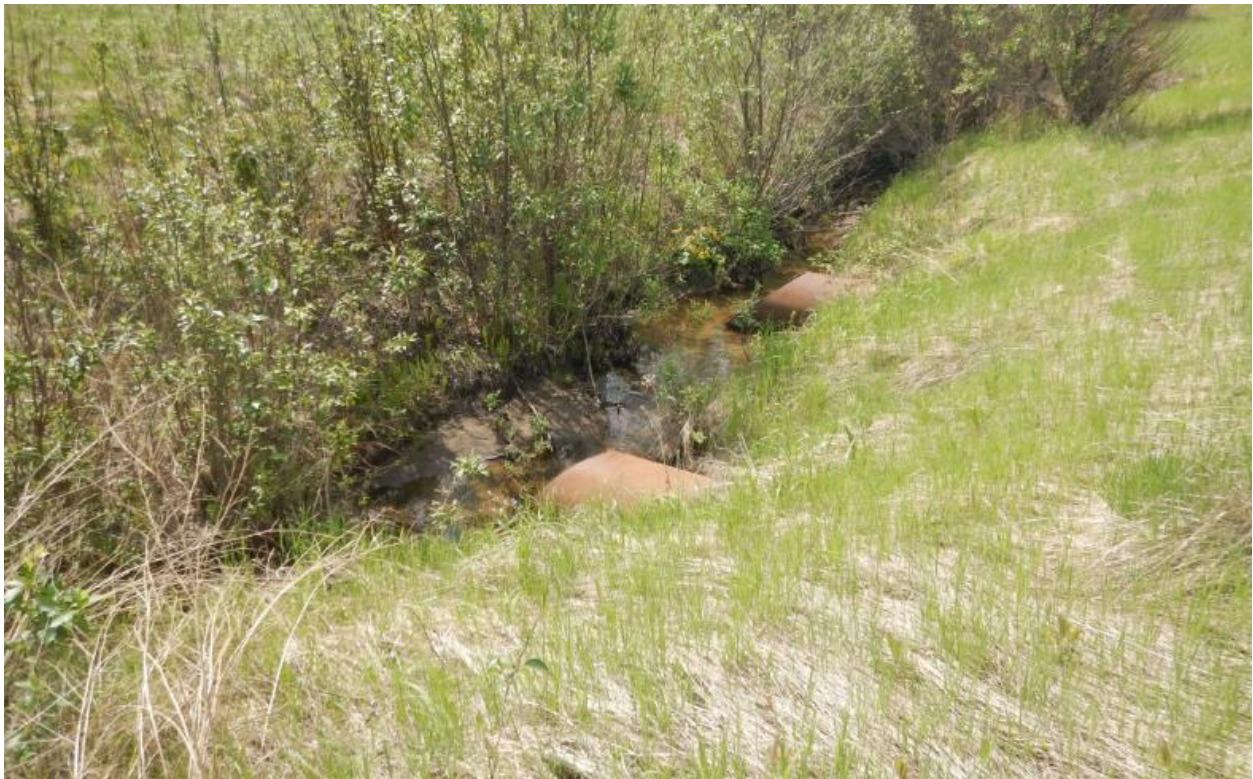
Photo No.17 – Two 800 mm SWSP culvert inlets; note existing erosion around the SWSP inlets (looking south)
