**ALBERTA TRANSPORTATION  
GEOHAZARD ASSESSMENT PROGRAM  
NORTH CENTRAL REGION – ATHABASCA  
2020 INSPECTION**

Site Number	Location	Name	Hwy	km
NC070-1	Approximately 2 km northeast of Hangingstone River and 40 km south of Fort McMurray	Truck Staging Area	63:10	18.8
<b>Legal Description</b>		<b>UTM Co-ordinates (NAD 83)</b>		
SE ¼ and SW¼ -3-86-9-W4M		12 N 6253630	E 478921

**NORTH CENTRAL REGION (ATHABASCA AREA)**  
**2020 GEOHAZARD ASSESSMENT**  
**NC070-1: HWY 63:10 TRUCK STAGING AREA**  
**SITE PLAN**

**NC070-1: HWY 63:10 TRUCK STAGING AREA SITE PLAN SHOWING EXISTING INSTRUMENT LOCATIONS**

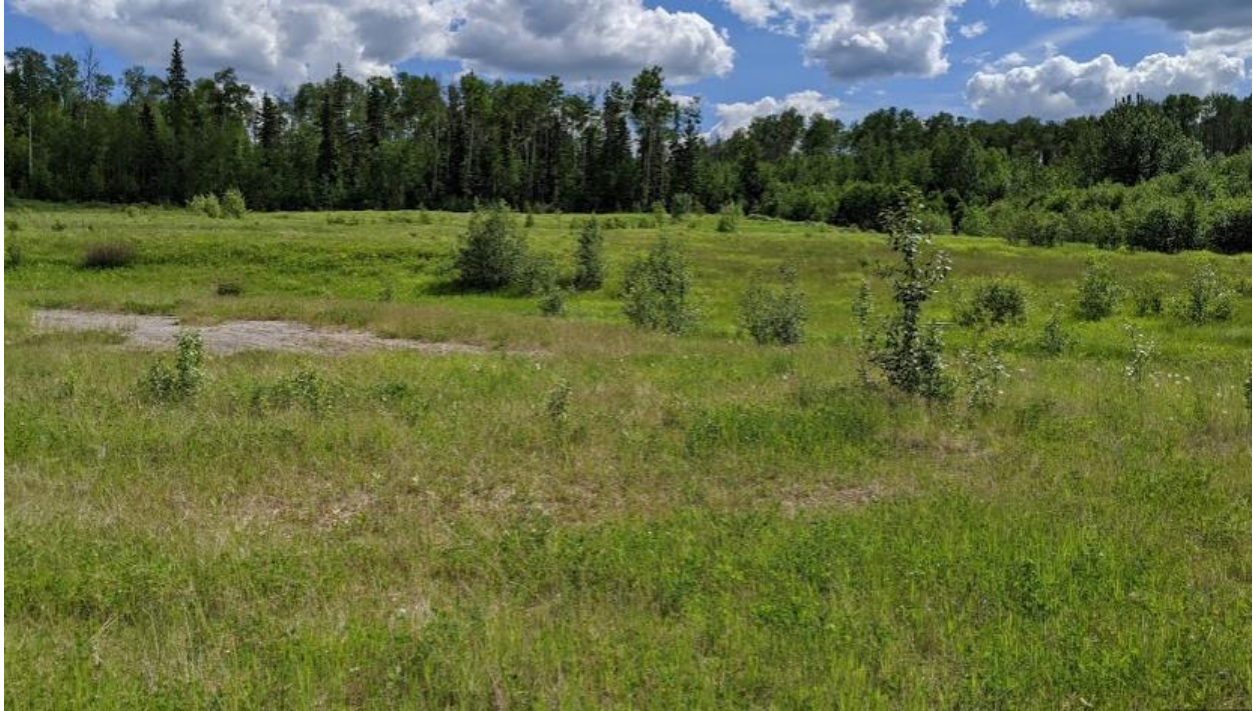
Photo No.1 – West landslide vegetated head scarp crack (Looking South)

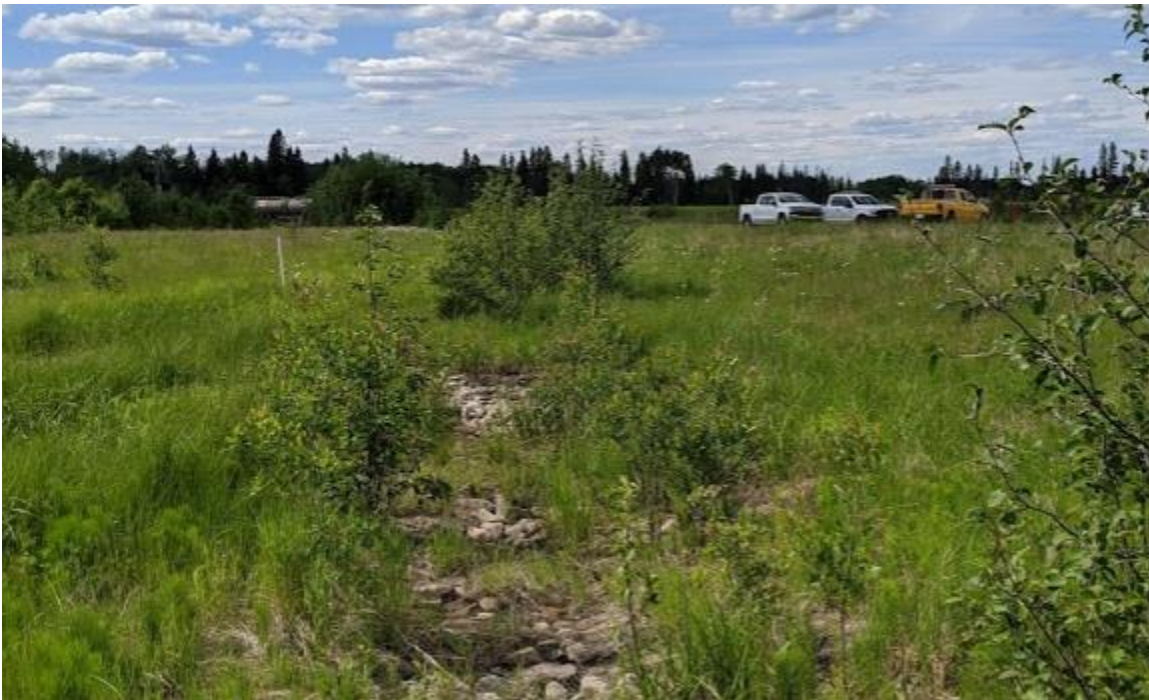
Photo No.2 – Looking west at the riprap-lined swale to the south of the TSA pad; minor water ponding within the swale

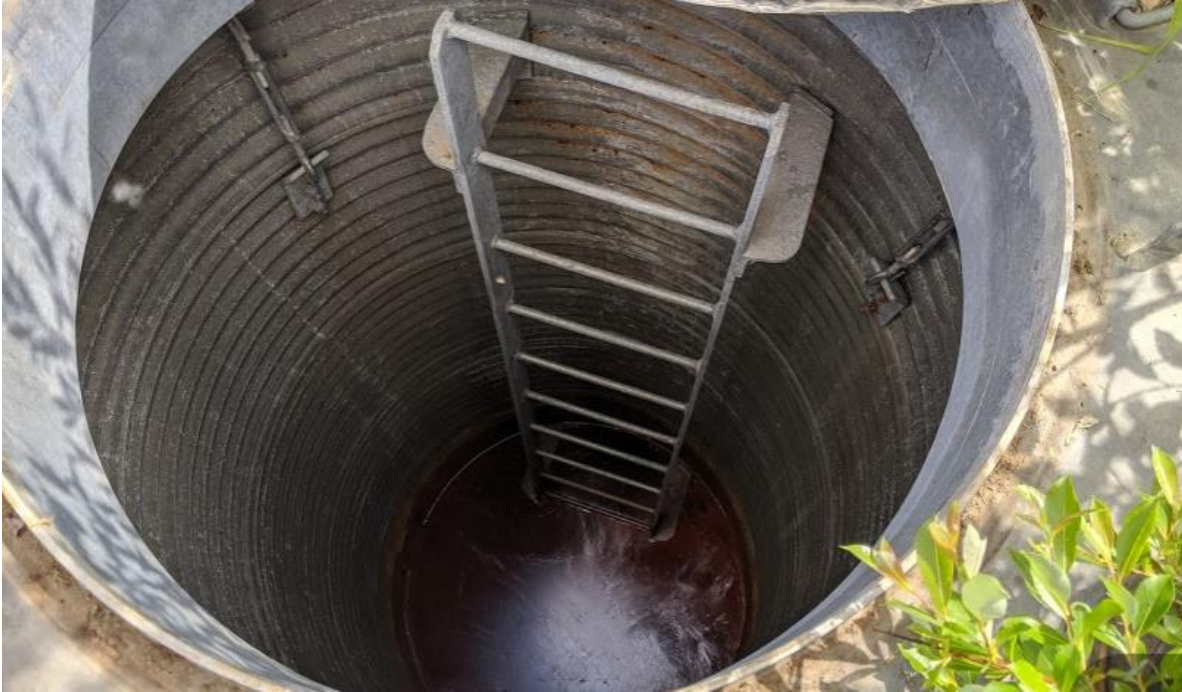
The sub-drain pipe connected to MH#4 is not draining and this may result in further increase in ground water levels to the south of the TSA pad.

Photo No.3 – Manhole # 4; note that no flow was observed, and water was measured at 3 m from top of manhole

It is necessary to establish a periodic maintenance protocol to flush the sub-horizontal drains and sub-drains installed below the pad to prevent increases in ground water levels in response to progressive plugging of the drain pipes (guidelines to do this work were provided to the local MCI). In addition, the flow from the C3 culvert pipe will need to be monitored and the pipe should be steamed, as required, so that the surface water can drain freely during wintertime. The inability to maintain the C3 culvert may result in flooding the highway surface during the spring season and elevated ground water levels to the south side of the highway.

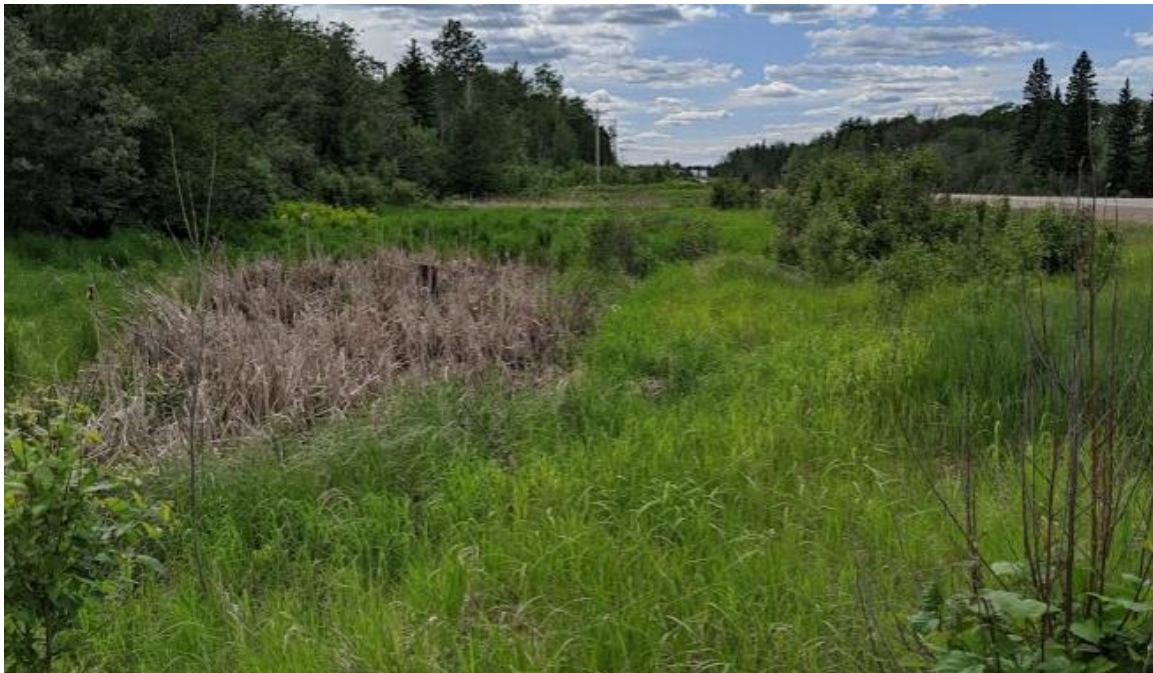
The highway back slope slump continues to block surface water flow in the south ditch of the highway. The existing slump may eventually affect the integrity of the existing power poles along the crest of the slope.

Poor surface water drainage within the ditch located to the south side of the entrance ramp may result in elevated ground water levels within the highway and is probably the main reason for the icing issue within the entrance ramp.

Photo No.4 – Looking at highway south ditch to the west of the TSA pad; note standing water and cattail vegetation (Looking West)

Consideration should be given for enhancing the surface drainage characteristics of the swale/ditch located to the south of the entrance ramp between the C1 culvert and the highway twin culverts. It is recommended to drain the standing water to the south of the ramp into the existing swale. In addition,

minor grading of the bottom of the ditch is recommended at the slump location (i.e. remove the least amount of dirt) to improve the drainage in the ditch. Alternatively, consideration may be given for auger boring a smooth wall steel pipe below the toe of the slump. This will require salvaging existing riprap from the existing swale, re-shaping/deepening of the existing swale/ditch, armoring the new ditch, and negotiations with TELUS.

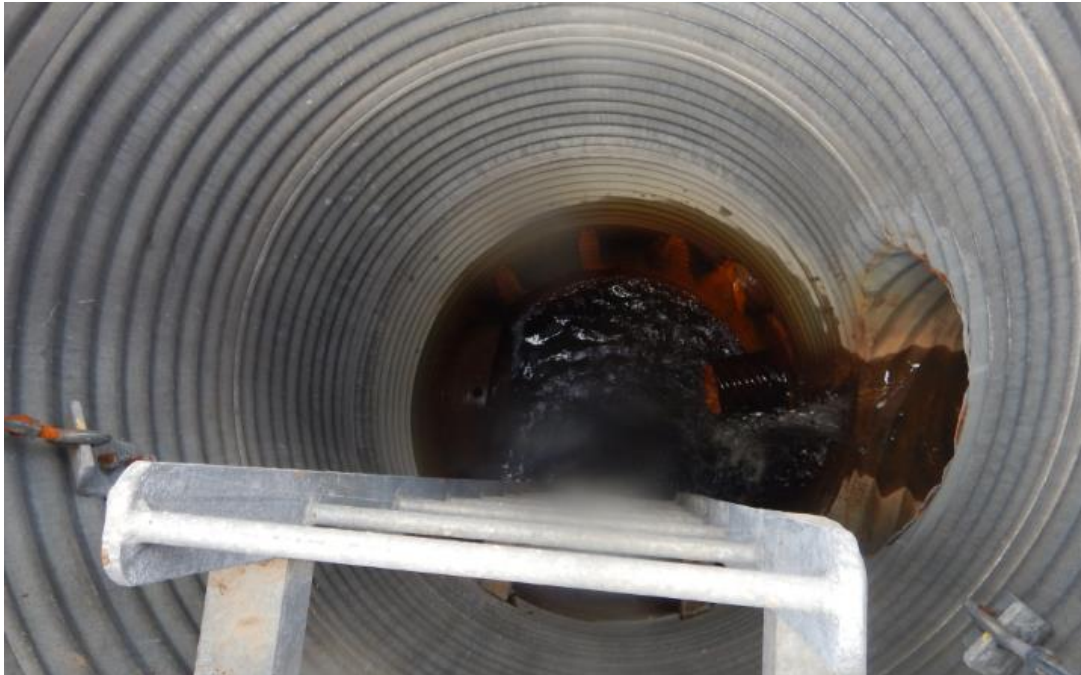
Photo No.5 – Manhole #3; note steady flow from the subdrain and culvert pipes

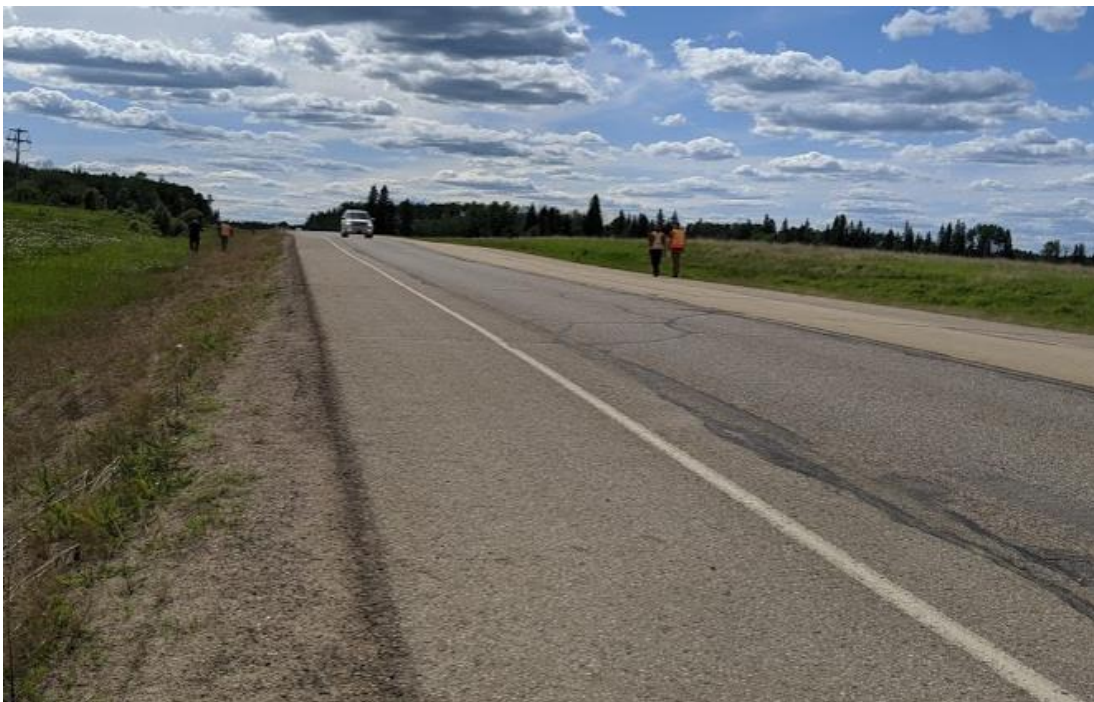
Photo No.6 – HWY 63 NBL; note presence of a hump and dip on highway lanes near the western flank of landslide (Looking West); highway cracks did not open since they were sealed in 2017

Since the posted speed on the highway northbound lanes (i.e. former highway 63 northbound and southbound lanes) was increased to 110 km per hour, it is recommended that an ACP overlay be placed at this location to smoothen the roadway surface.

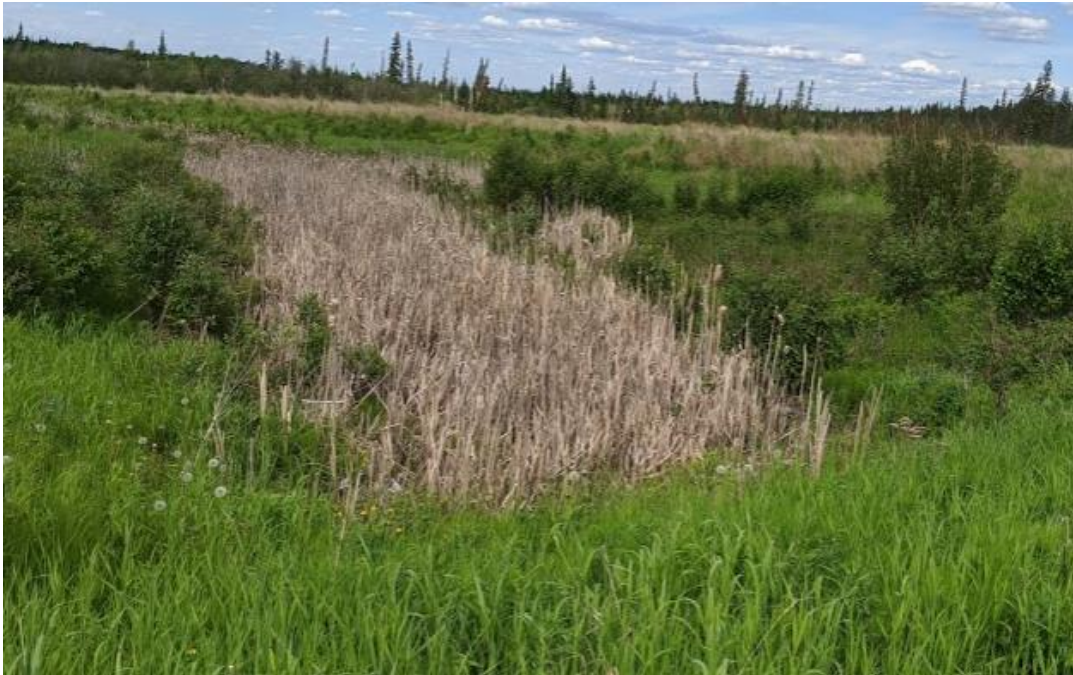
Photo No.7 – Water Ponding in the riprap channel located downslope of the 500 mm outflow pipe (Looking North)

It is crucial to expose the outlet of the 500 mm diameter outflow pipe, remove accumulated sediment at the outlet, and to regrade the riprap channel, located between the east and west landslide toe berms at the outlet of the pipe, to enhance surface drainage.

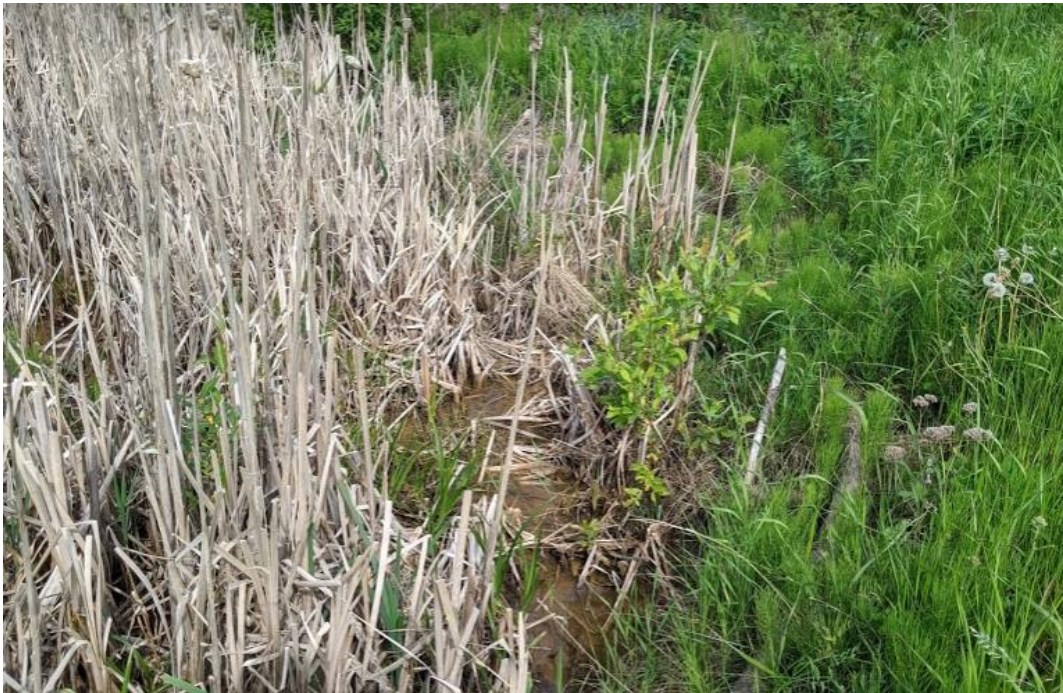
Photo No.8 – Ponding water, accumulated silt and debris at the outflow pipe outlet. Pipe is buried under sediment

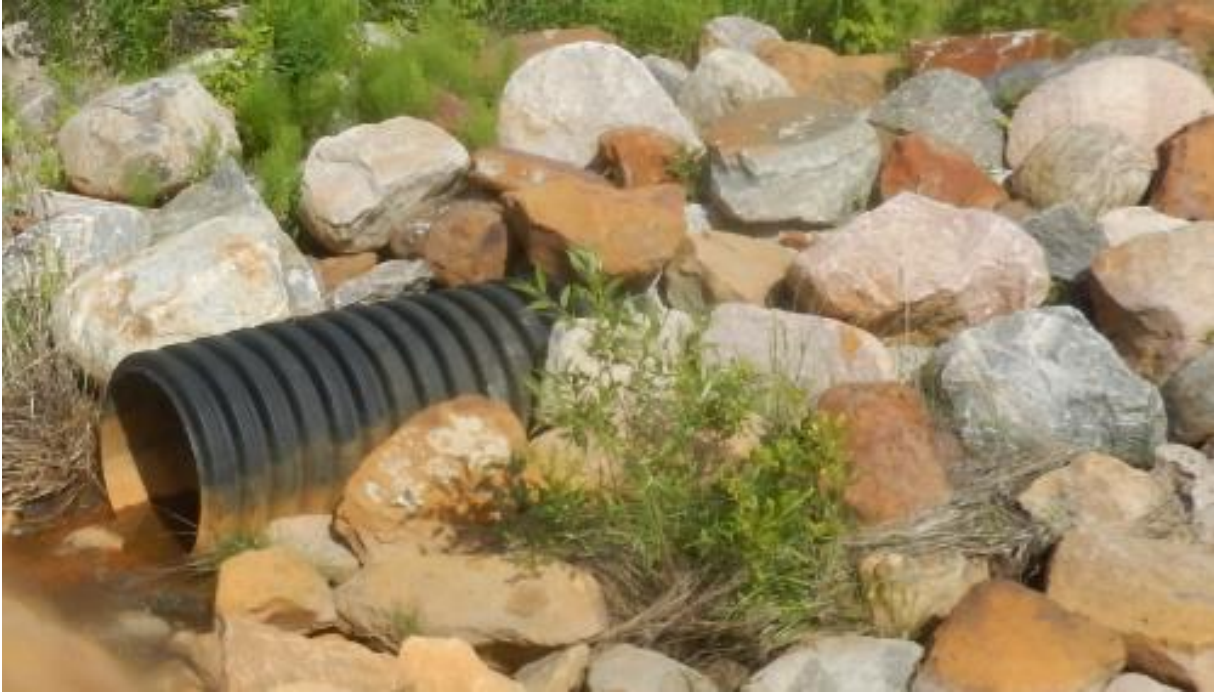
Photo No.9 – C2 extension (600 mm HDPE pipe outlet); water is flowing out of the pipe

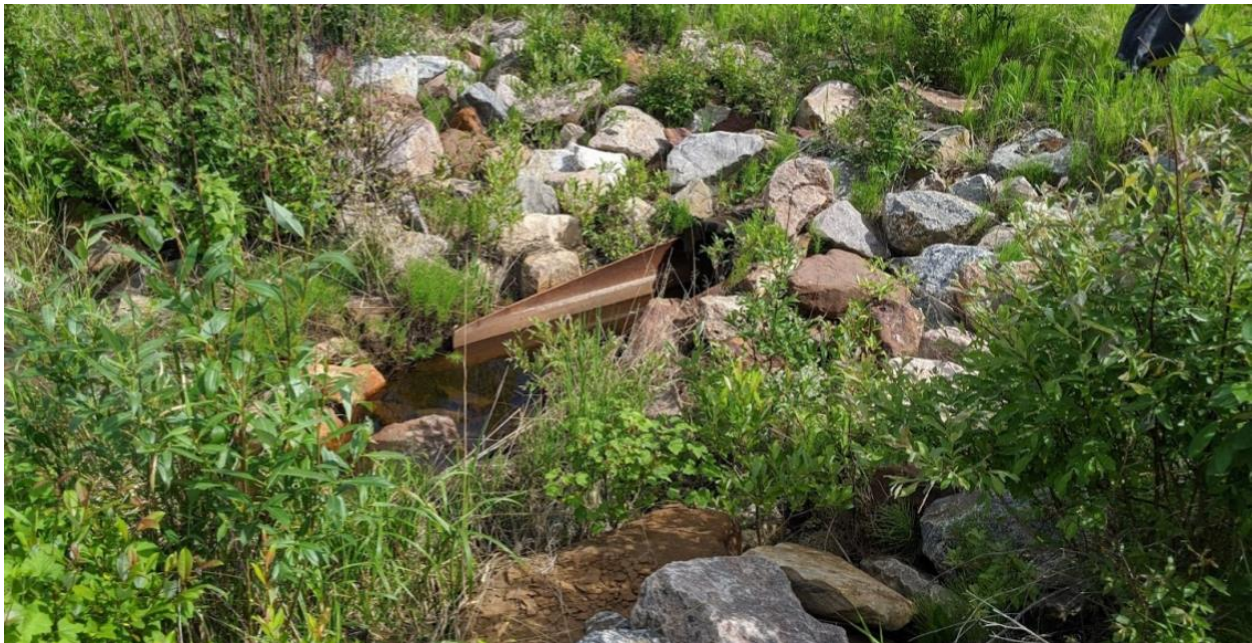
Photo No.10 – C3 culvert outlet; water is flowing out of the pipe but slightly ponding at outlet
