**ALBERTA TRANSPORTATION GRMP (CON0022163)  
NORTH CENTRAL (ATHABASCA AND FORT McMURRAY DISTRICTS)  
INSTRUMENTATION MONITORING RESULTS – FALL 2022**

**SECTION C**

**SITE NC070: HWY 63:10 TRUCK STAGING AREA**

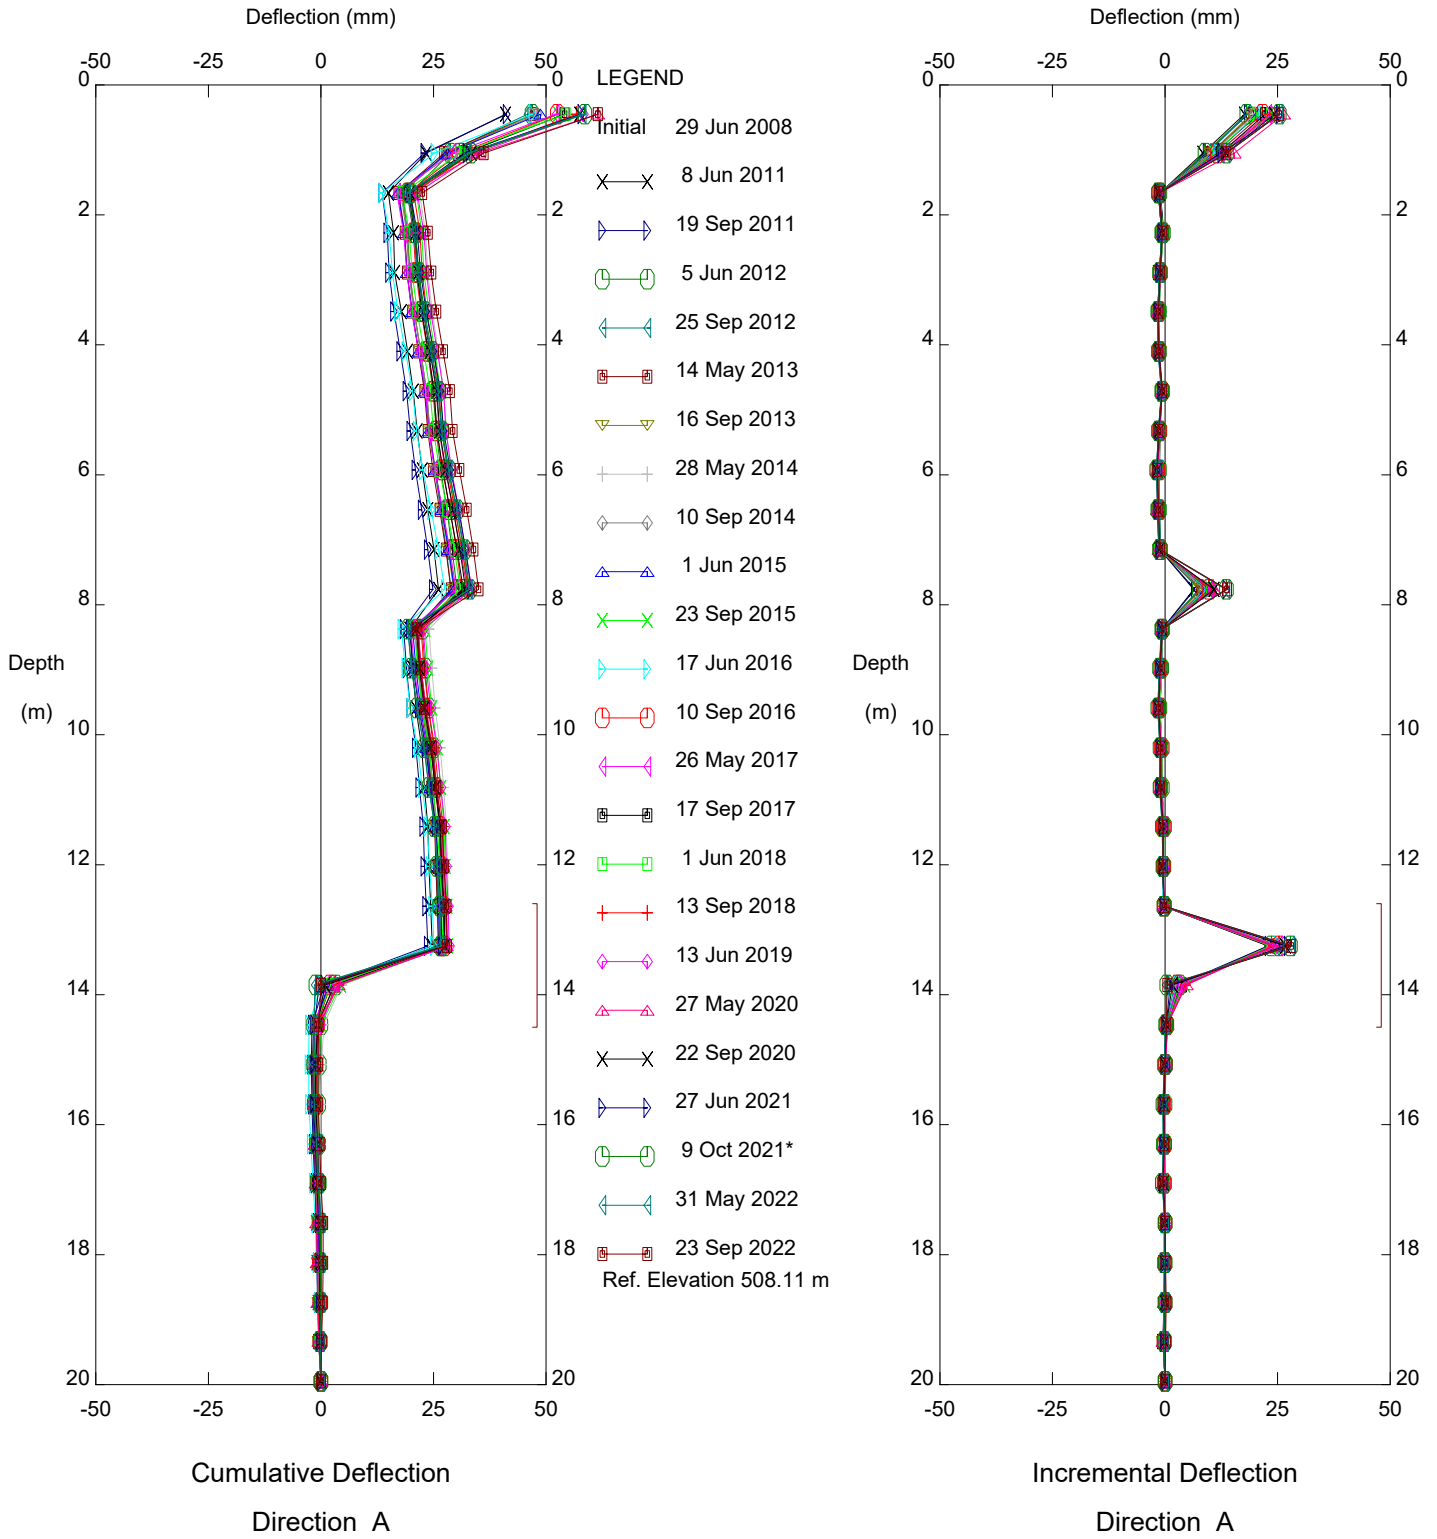
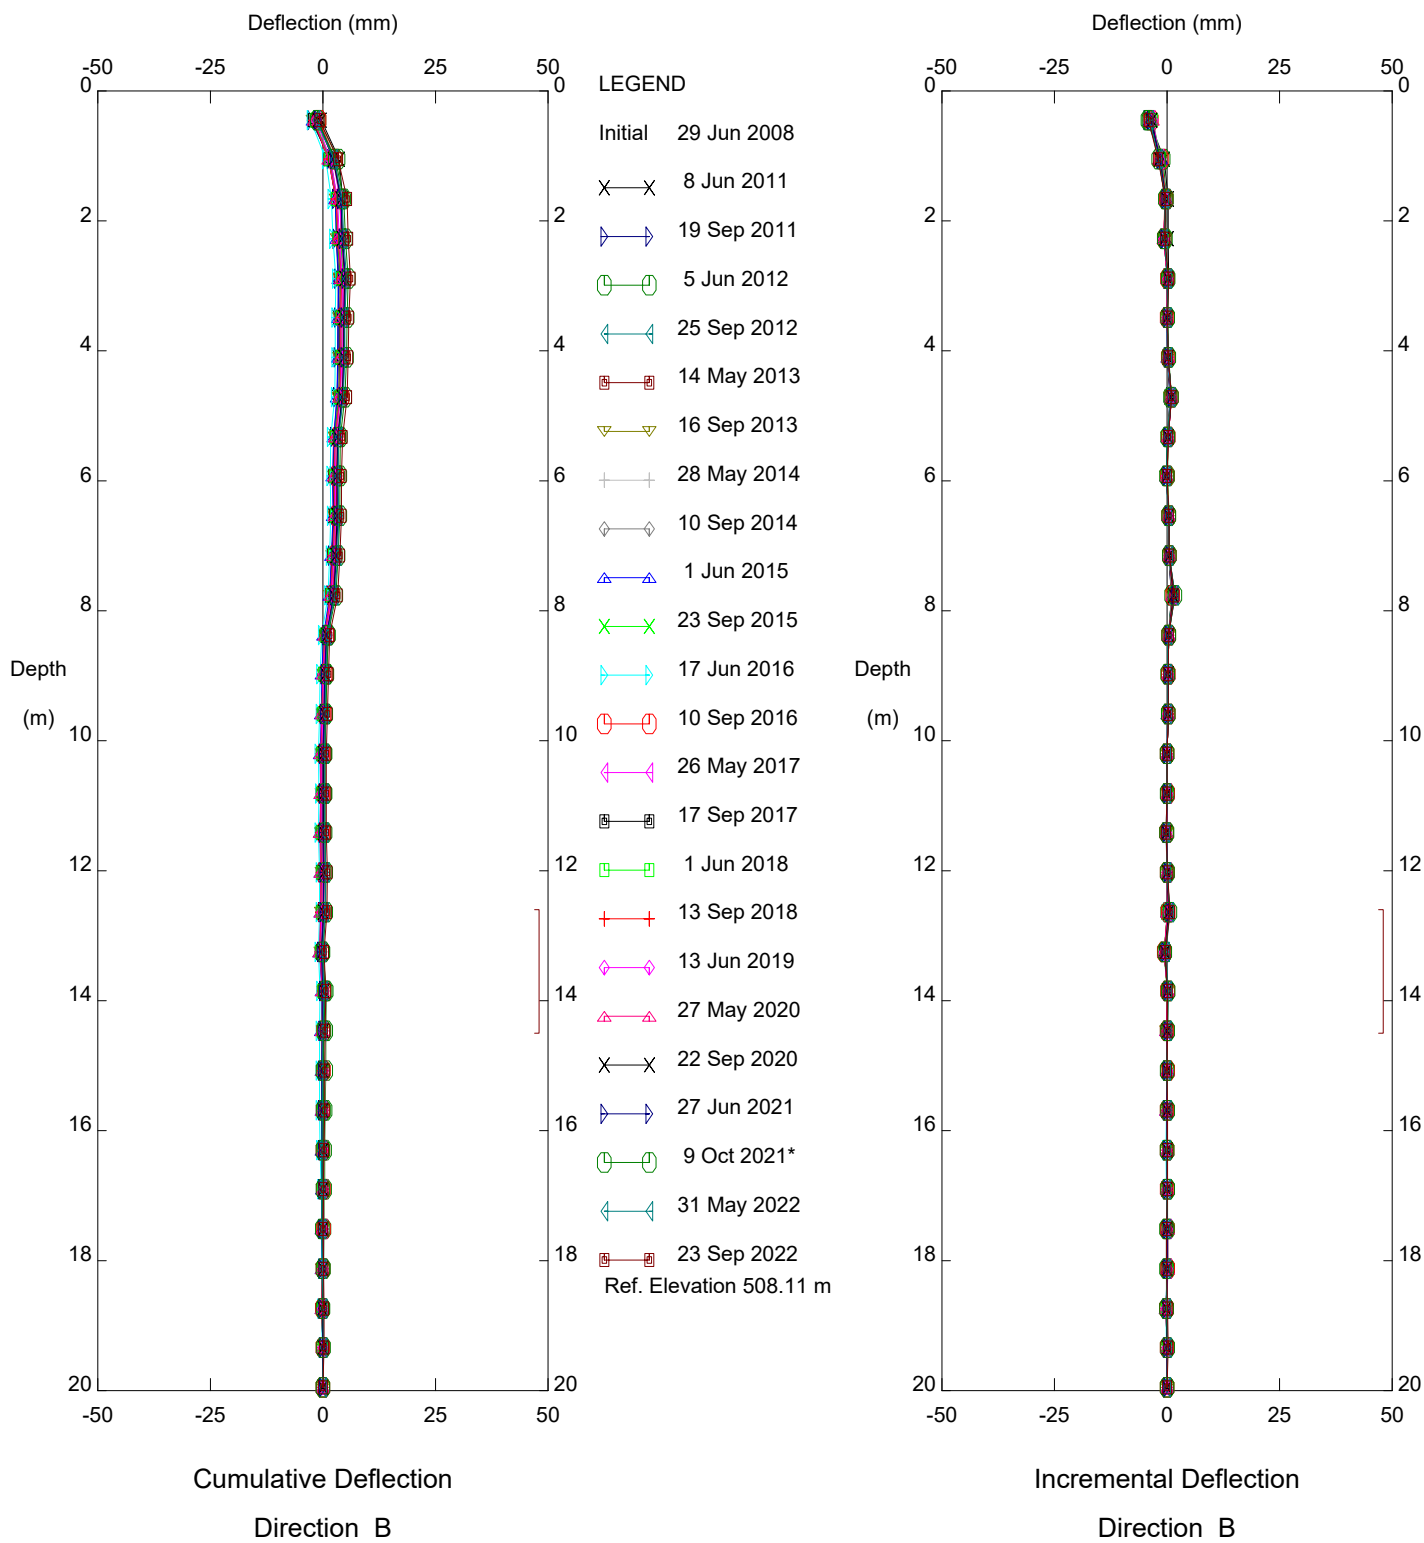
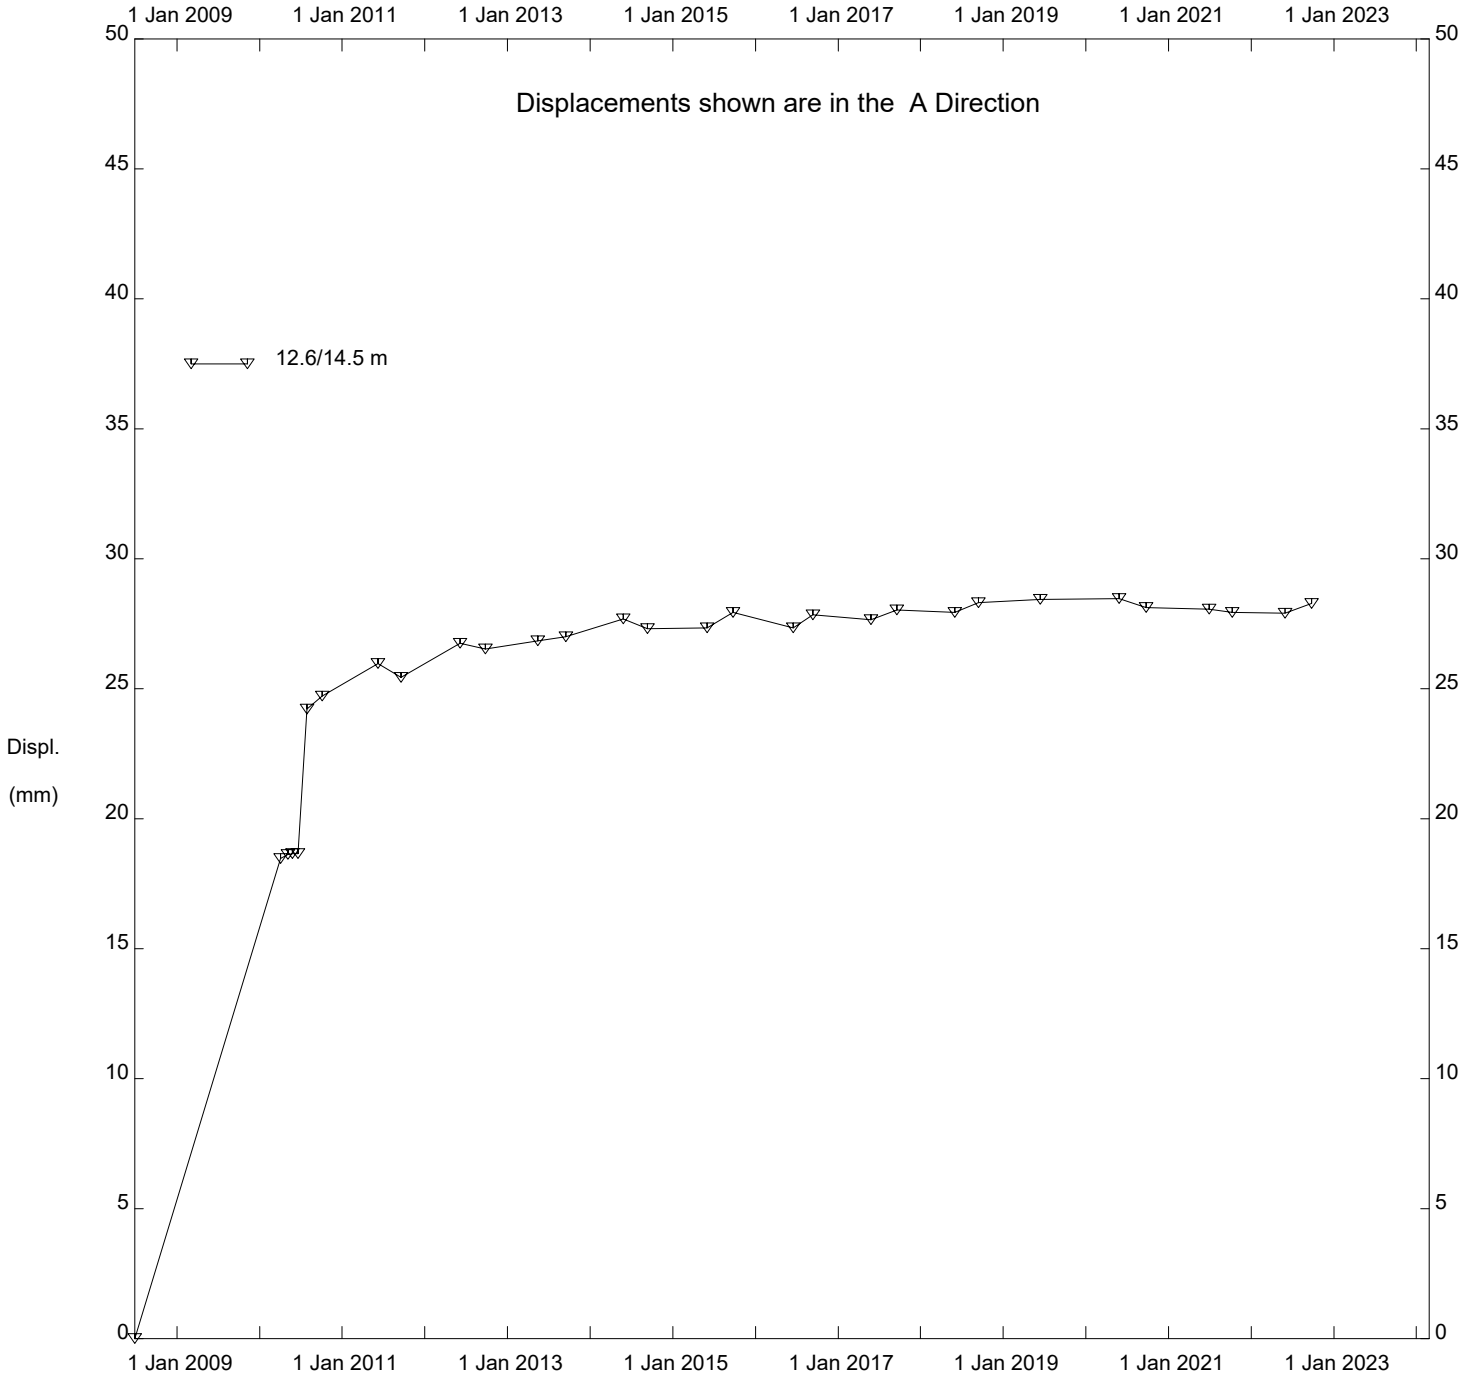
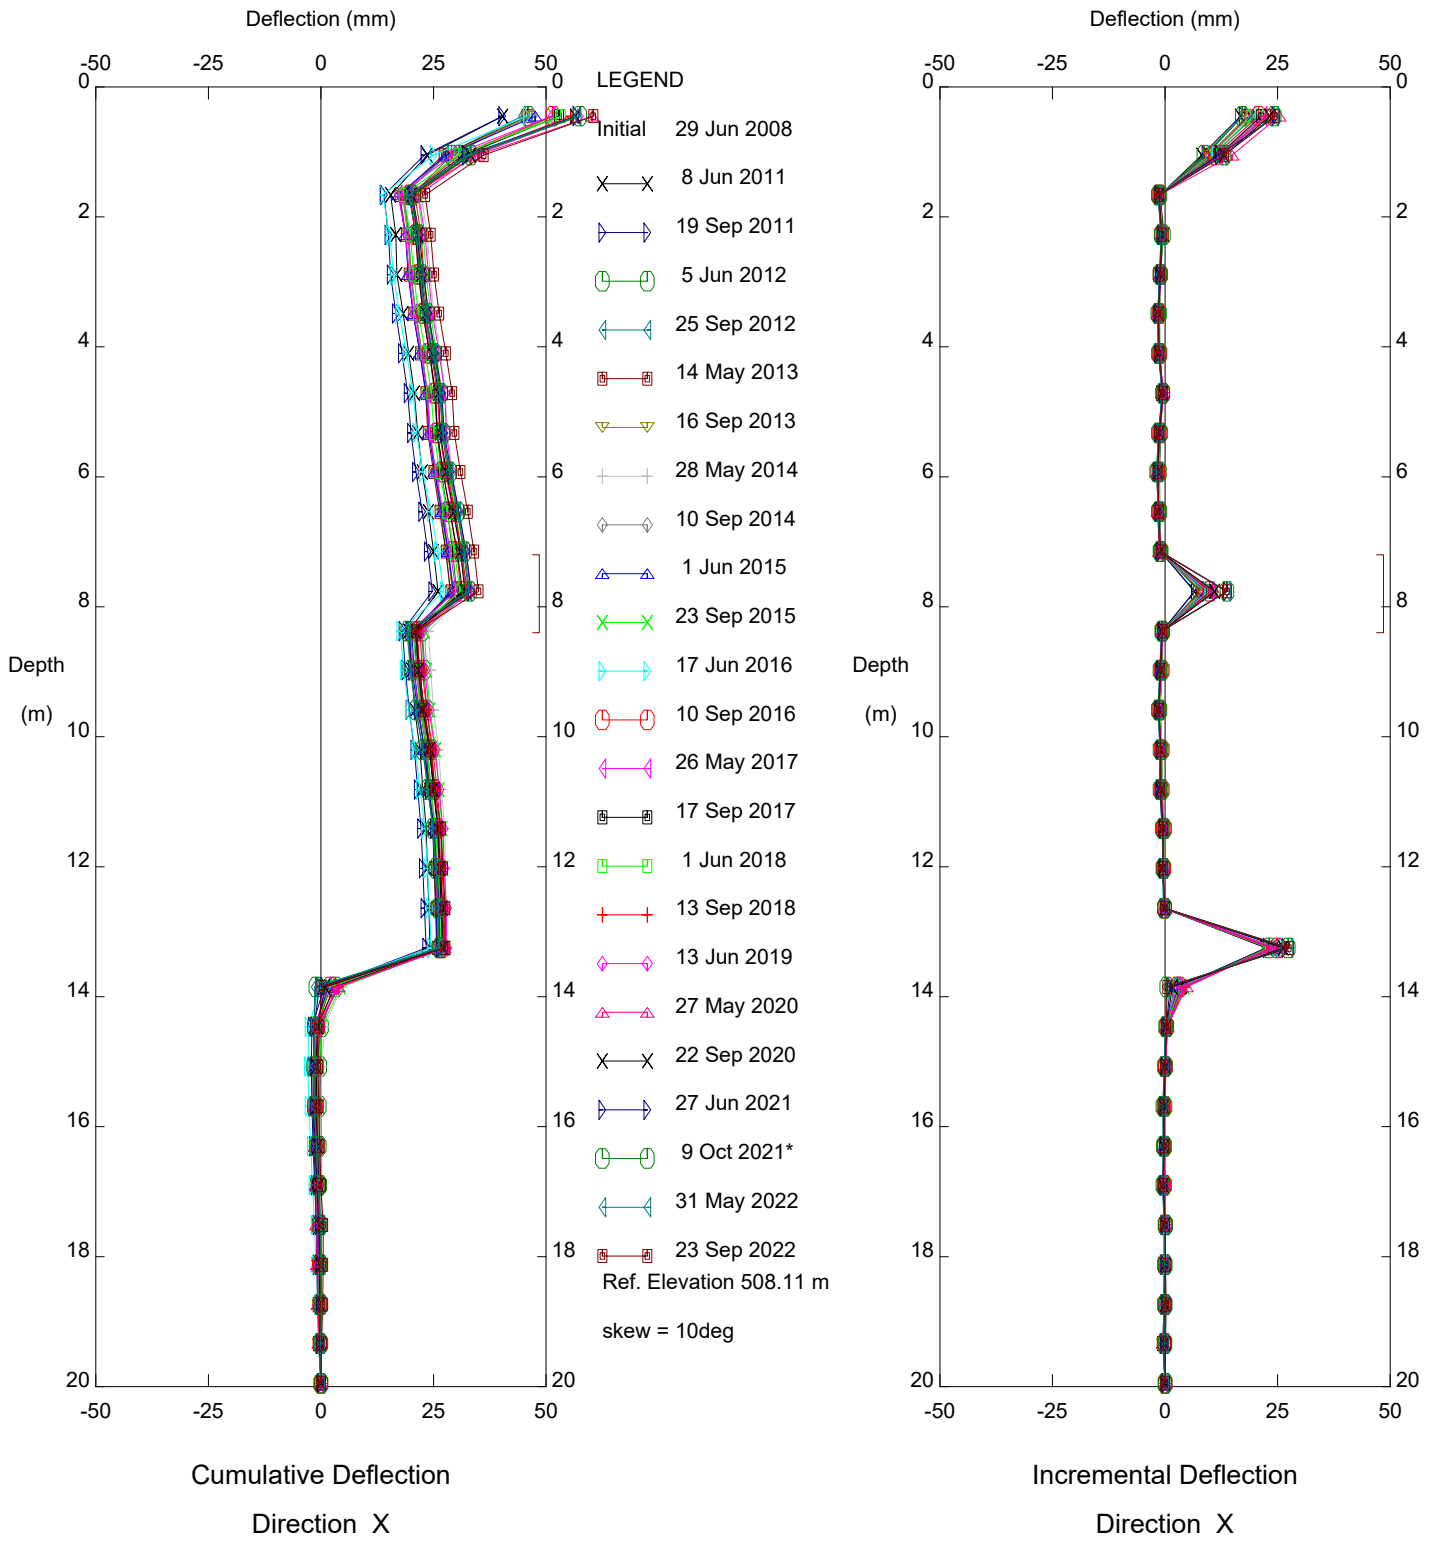
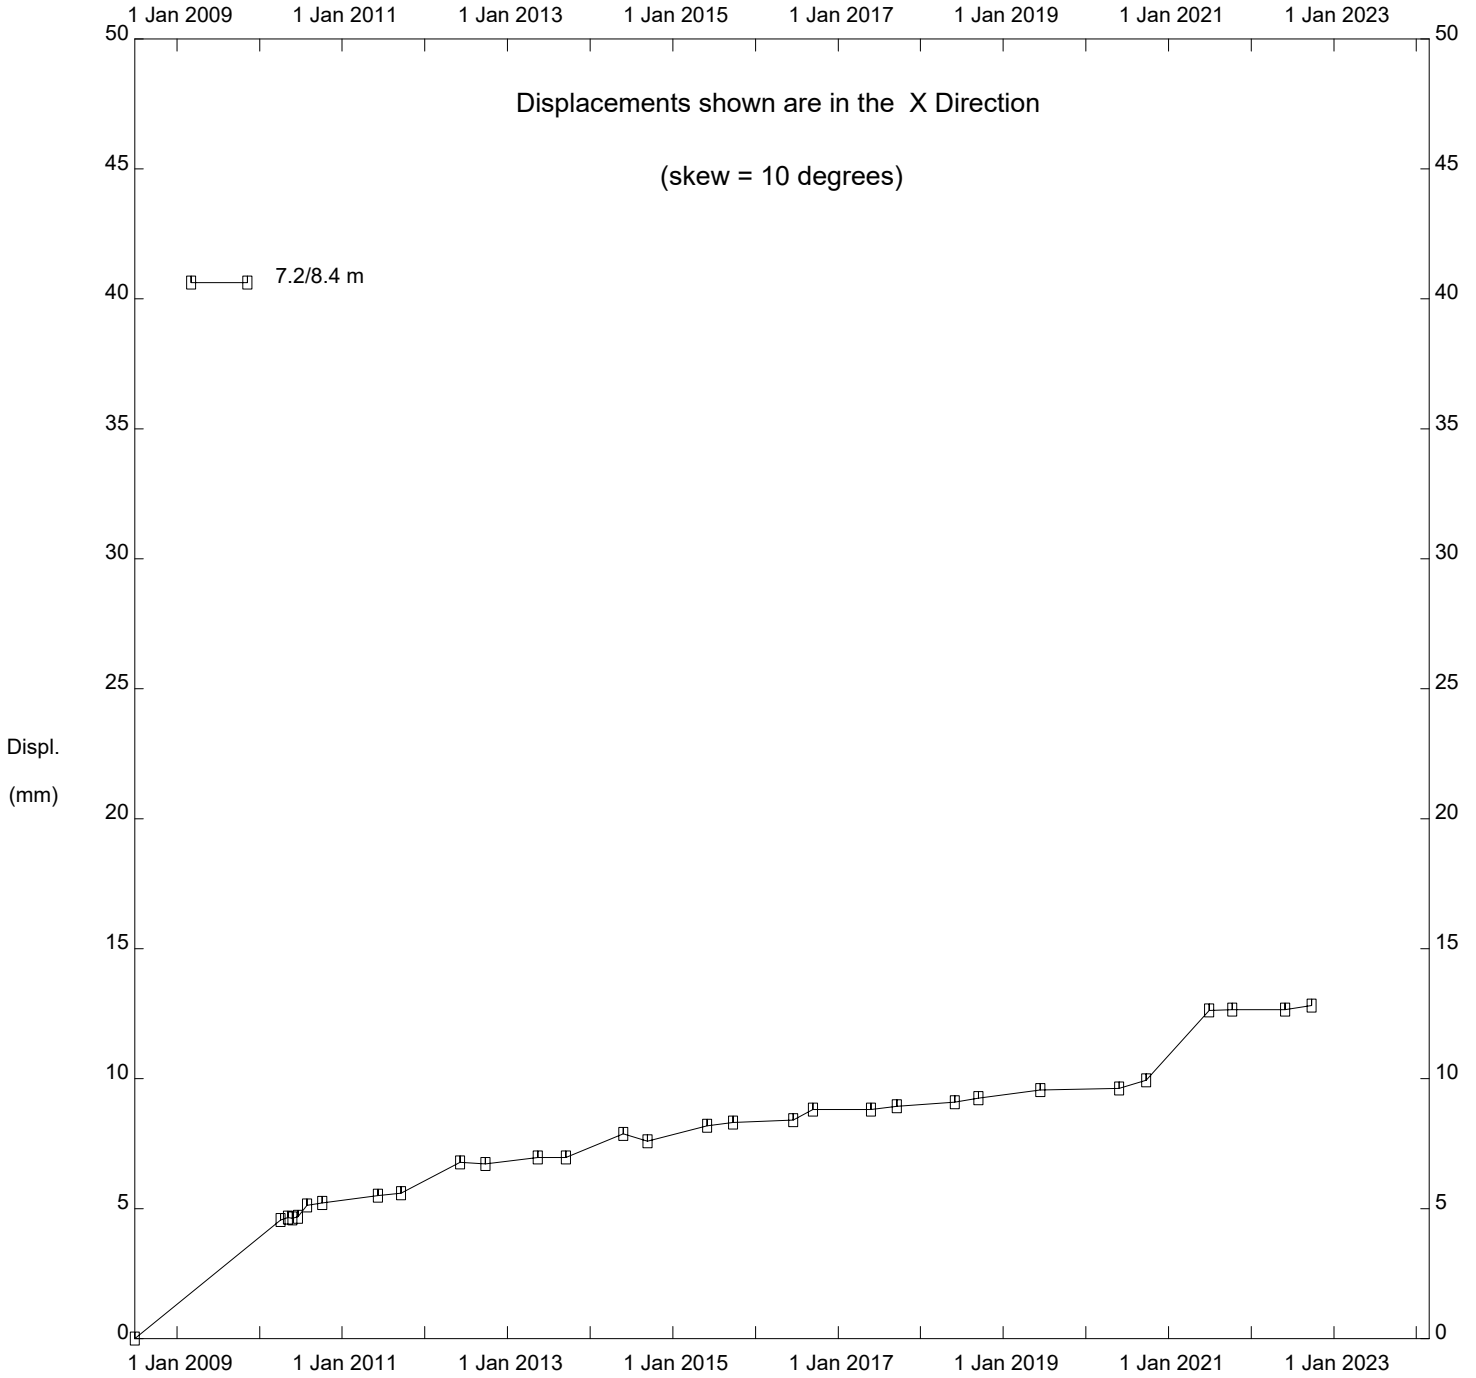
Hwy 63 TSA (East Slide), Inclinometer 08-7

SI08-7 showed rates of movement of 0.5 mm/yr and 1.2 mm/yr over 7.2 m to 8.4 m depth and 12.6 m to 14.5 m depth, respectively, since the spring of 2022 readings. SI10-10R showed a rate of movement of 1.1 mm/yr over 10.9 m to 14.0 m depth, a rate of movement of 0.4 mm/yr over 22.5 m to 24.3 m depth and a rate of movement of 0.5 mm/yr over 24.3 m to 26.2 m depth. SI08-13 showed no discernible movement over 5.0 m to 8.7 m depth and a rate of movement of 0.2 mm/yr over 13.0 m to 14.8 m depth. SI11-12R showed no discernible movement over 14.1 m to 15.3 m depth and a rate of movement of less than 0.1 mm/yr over 15.3 m to 20.2 m depth.

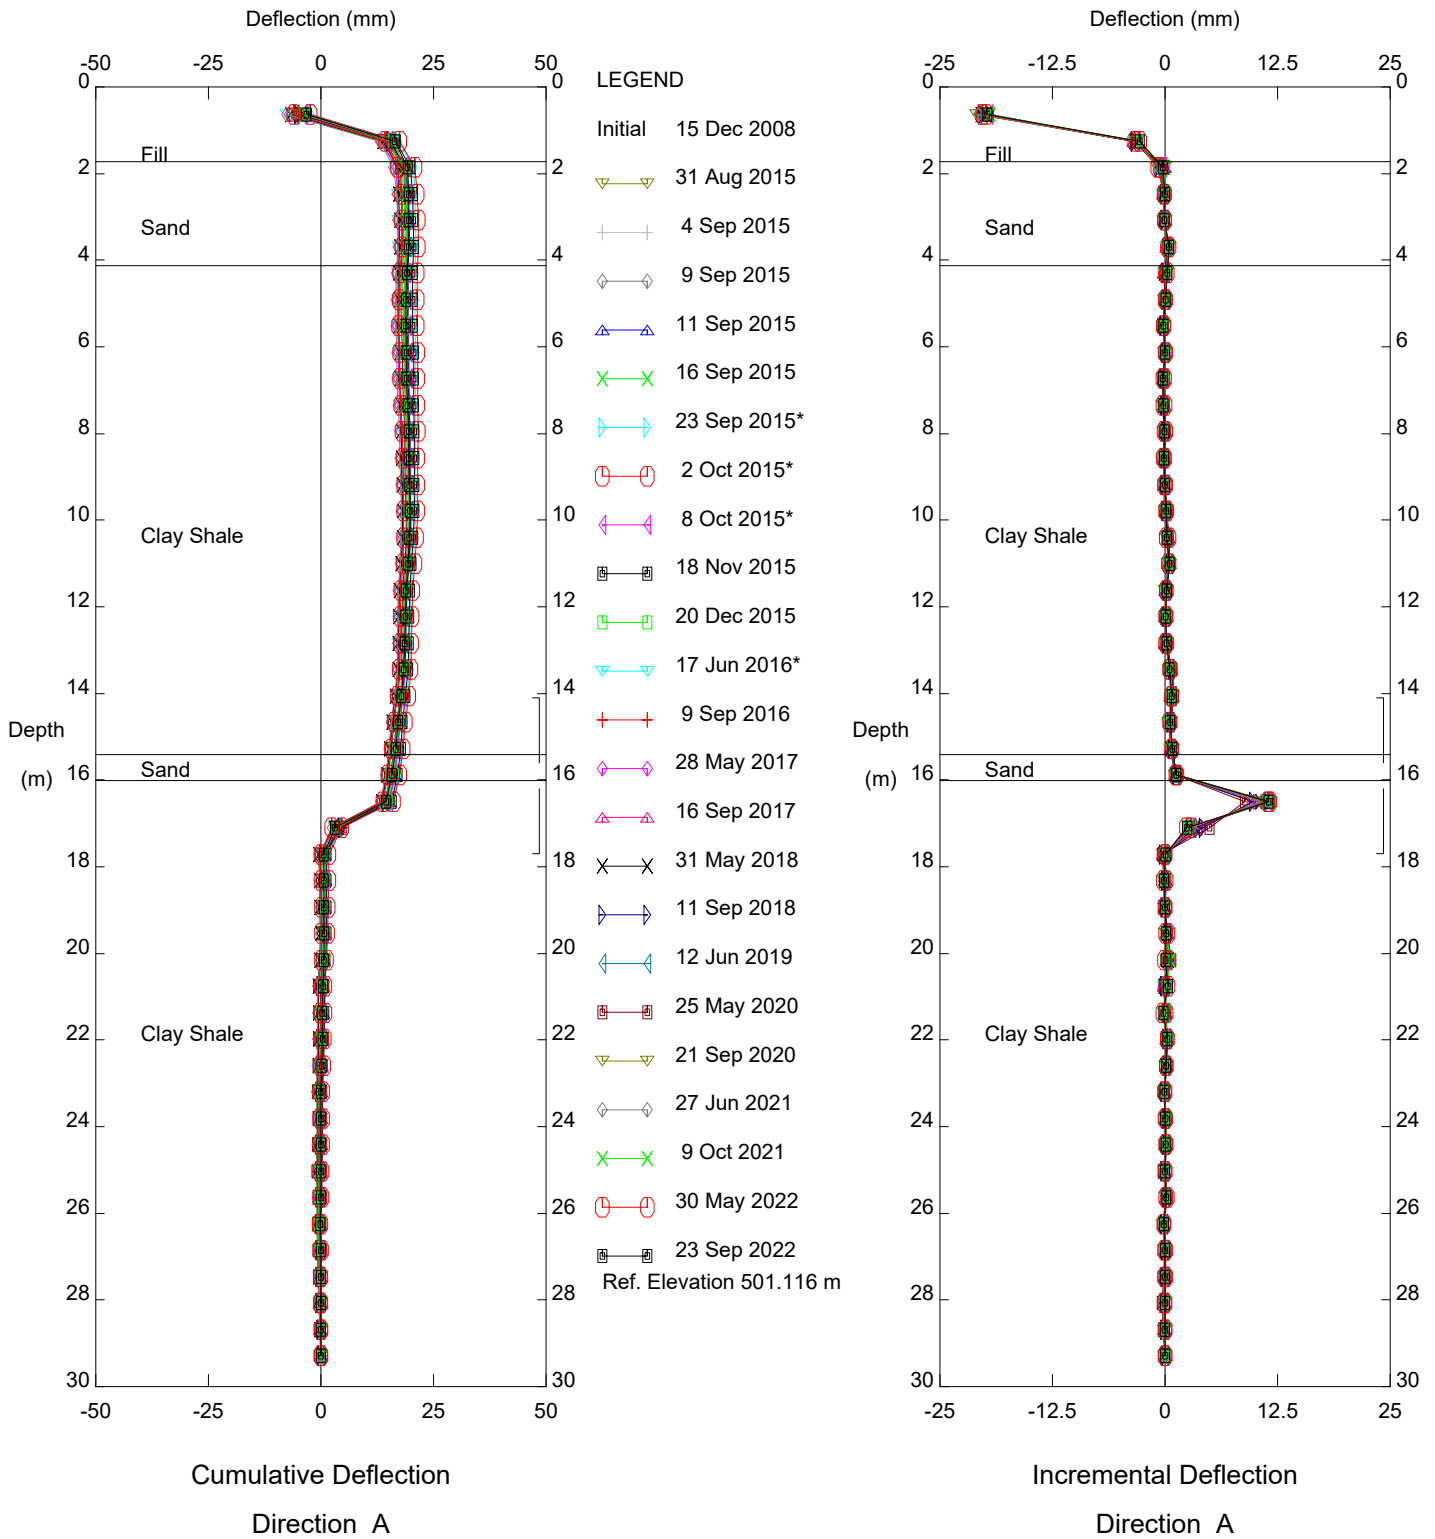
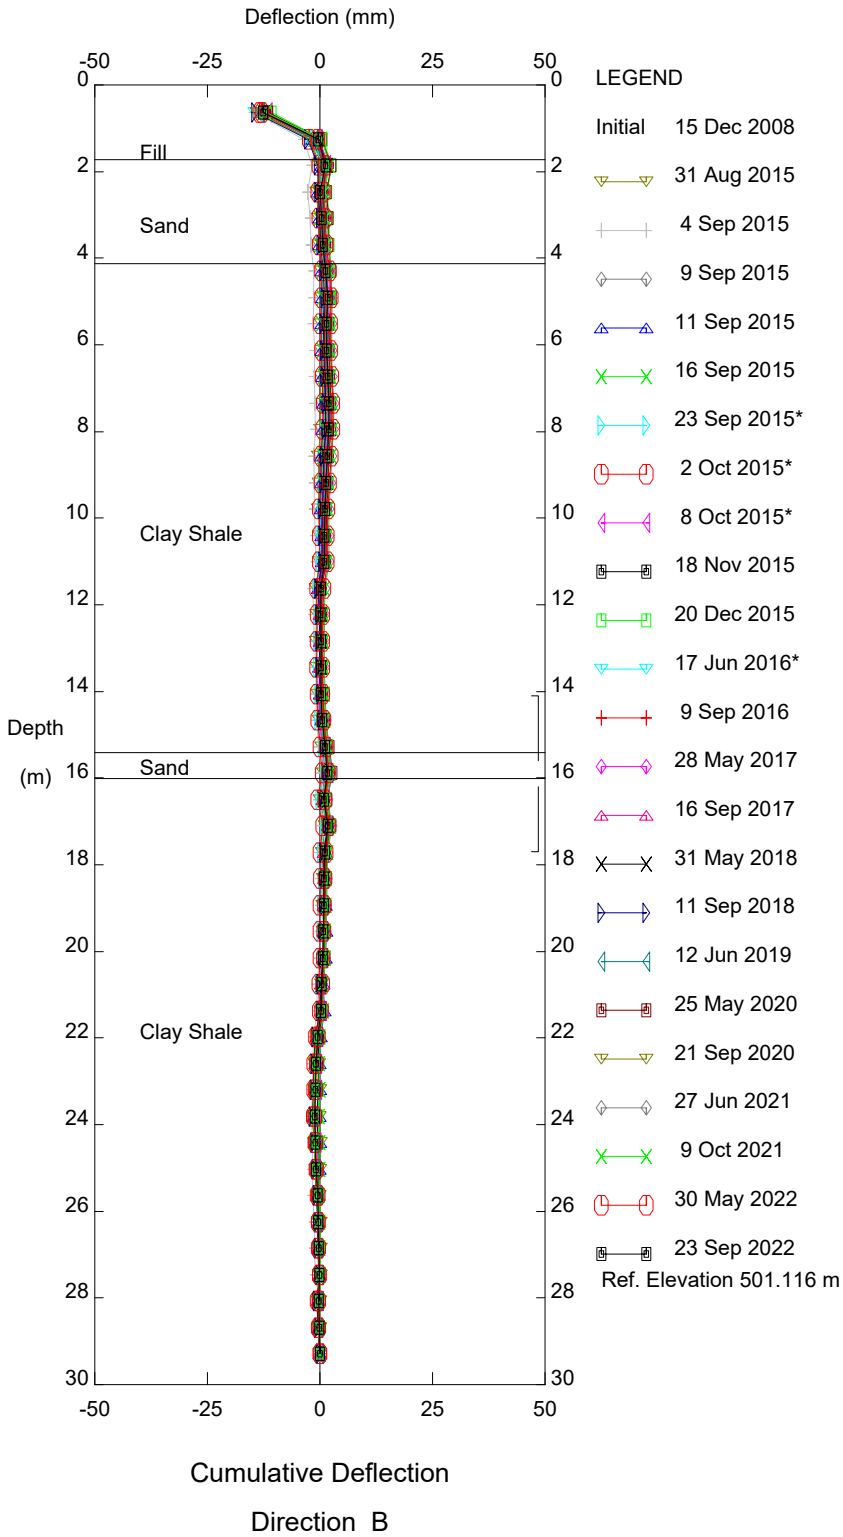
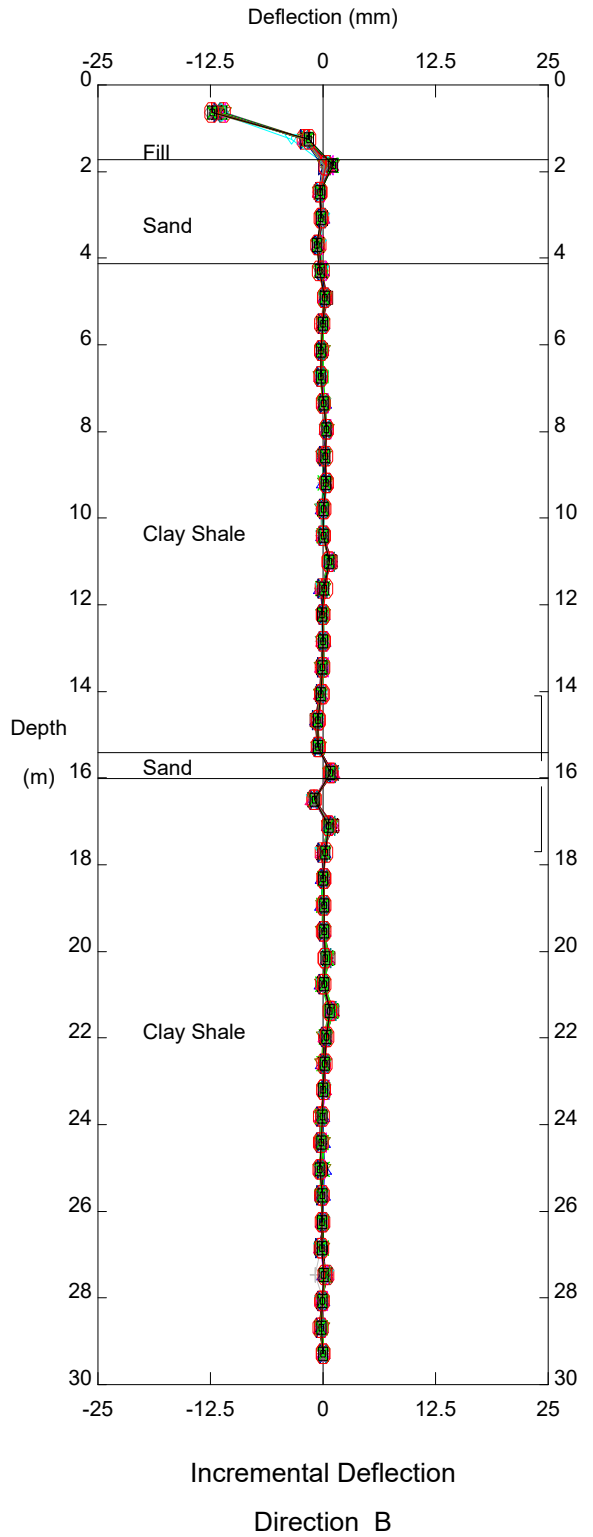
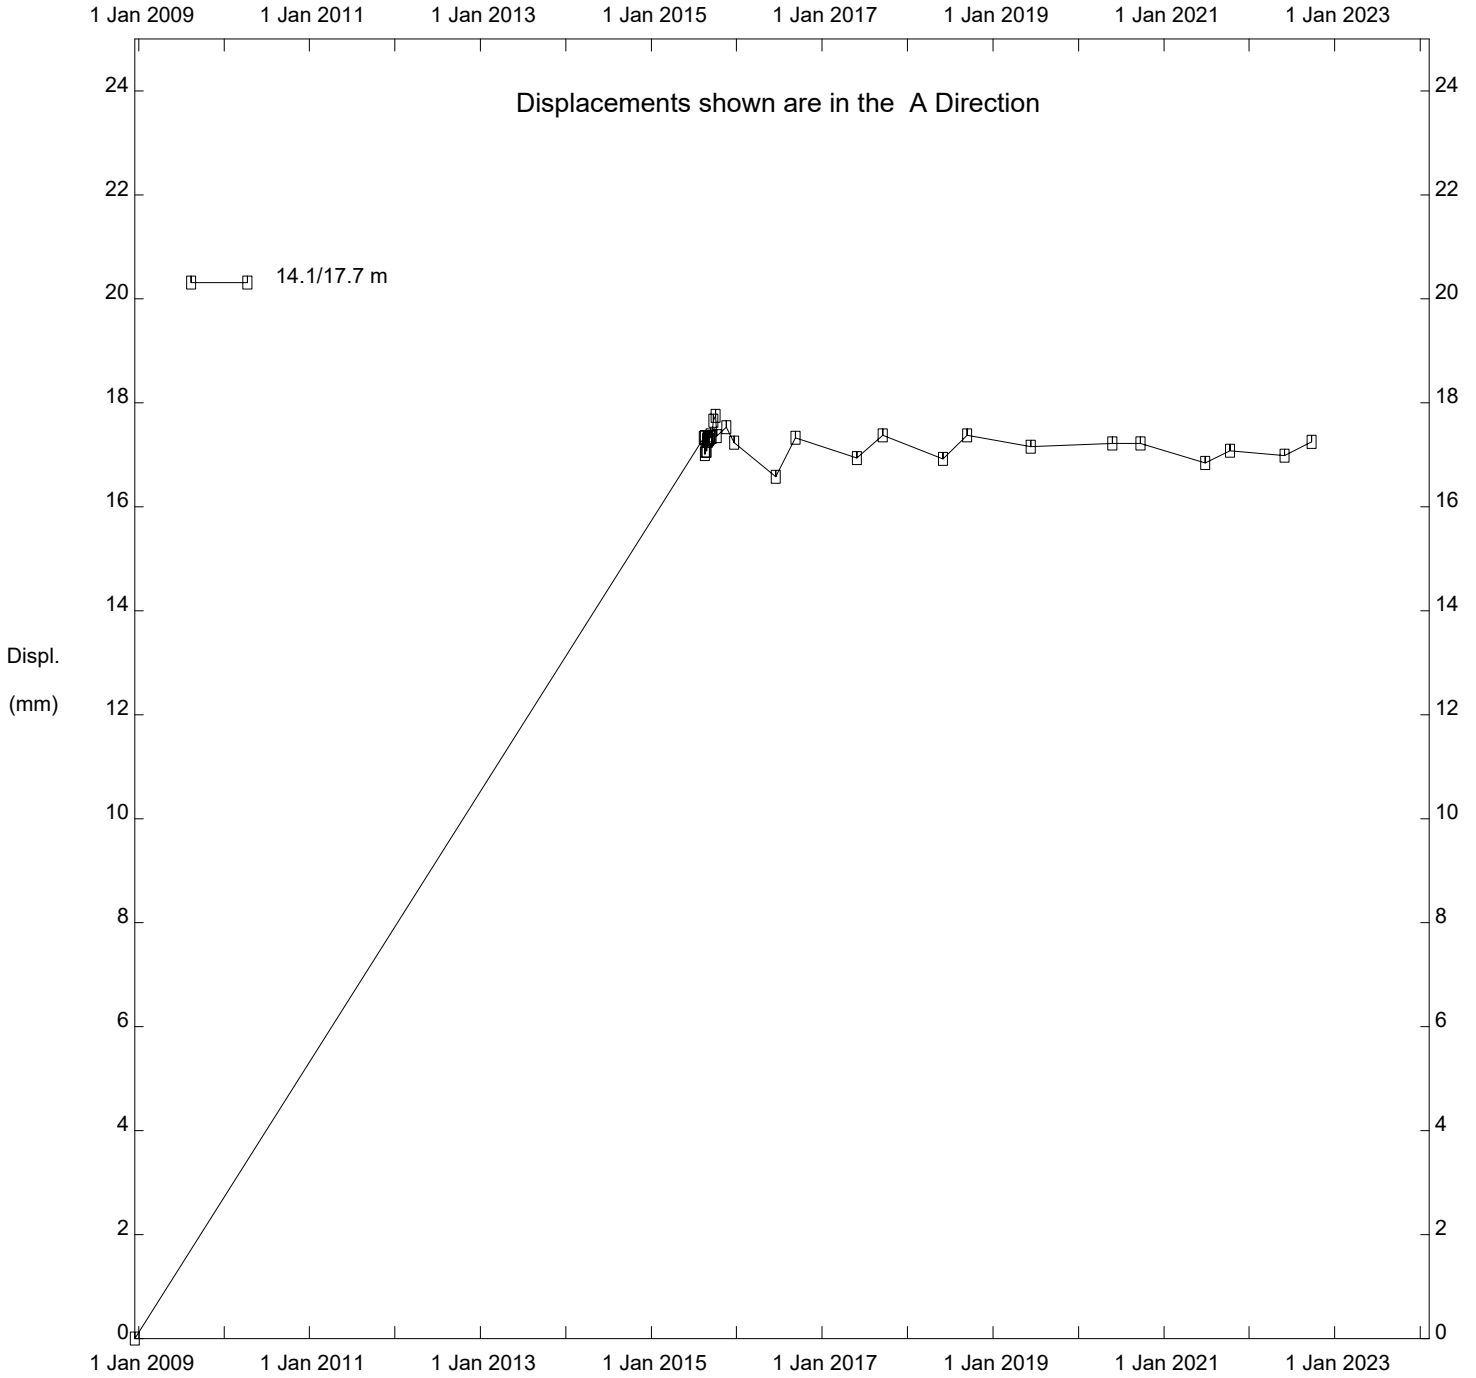
HWY 63 TSA (East Slide), Inclinometer SI08-17

The remainder of the SIs fall within the footprint of the east landslide toe berm. SI17-3 and SI18-7 have both shown no discernible movement since they were initialized. SI08-17 showed a rate of movement of 0.9 mm/yr over 14.1 m to 17.7 m since the spring of 2022 readings. SI08-21 showed a rate of movement of 1.2 mm/yr over 0.3 m to 2.7 m depth, no discernible movement over 4.6 m to 6.4 m depth and a rate of movement of 0.2 mm/yr over 12.5 m to 14.9 m depth. SI18-5 showed a rate of movement of 3.6 mm/yr over 4.8 m to 9.7 m depth. SI18-5 has been showing a pattern of gradually decelerating movement rates since completion of the east toe berm expansion in 2021. SI18-8 showed a rate of movement of 26.4 mm/yr over 0.9 m to 2.7 m depth. The spring of 2022 reading for SI18-8 showed a sharp deceleration in movement, and the current reading of the instrument represents an increase in movement rate of 23.7 mm/yr compared to the spring reading. However, the current movement rate for SI18-8 is well below the high movement rates observed in the instrument during the toe berm construction.

SI 17-3 Casing breaking off at 9 ft.
SI8-17 Casing breaking off at 9 ft.
