**ALBERTA TRANSPORTATION GRMP (CON0022163)  
NORTH CENTRAL (ATHABASCA AND FORT McMURRAY DISTRICTS)  
INSTRUMENTATION MONITORING RESULTS – FALL 2022**

**SECTION C**

**SITE NC070: HWY 63:10 TRUCK STAGING AREA**

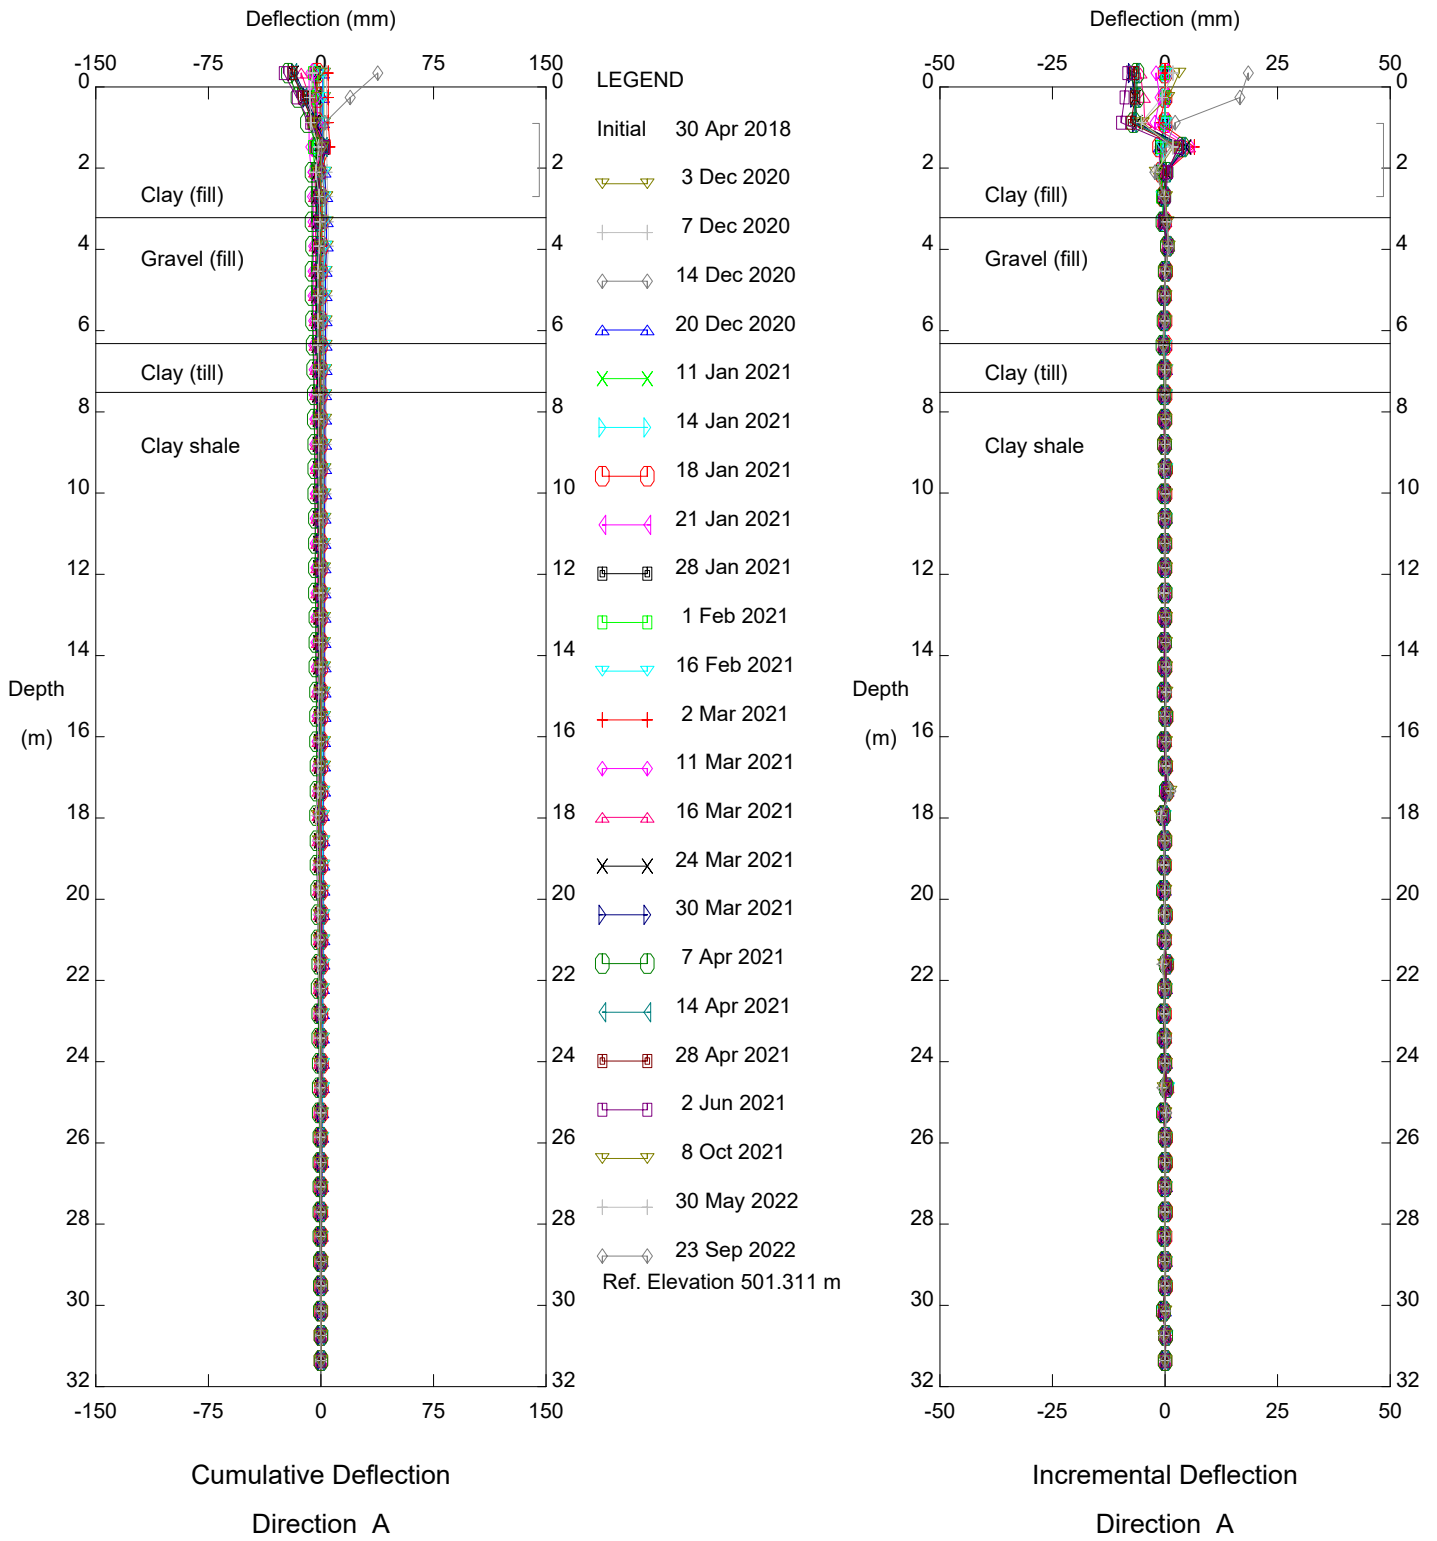
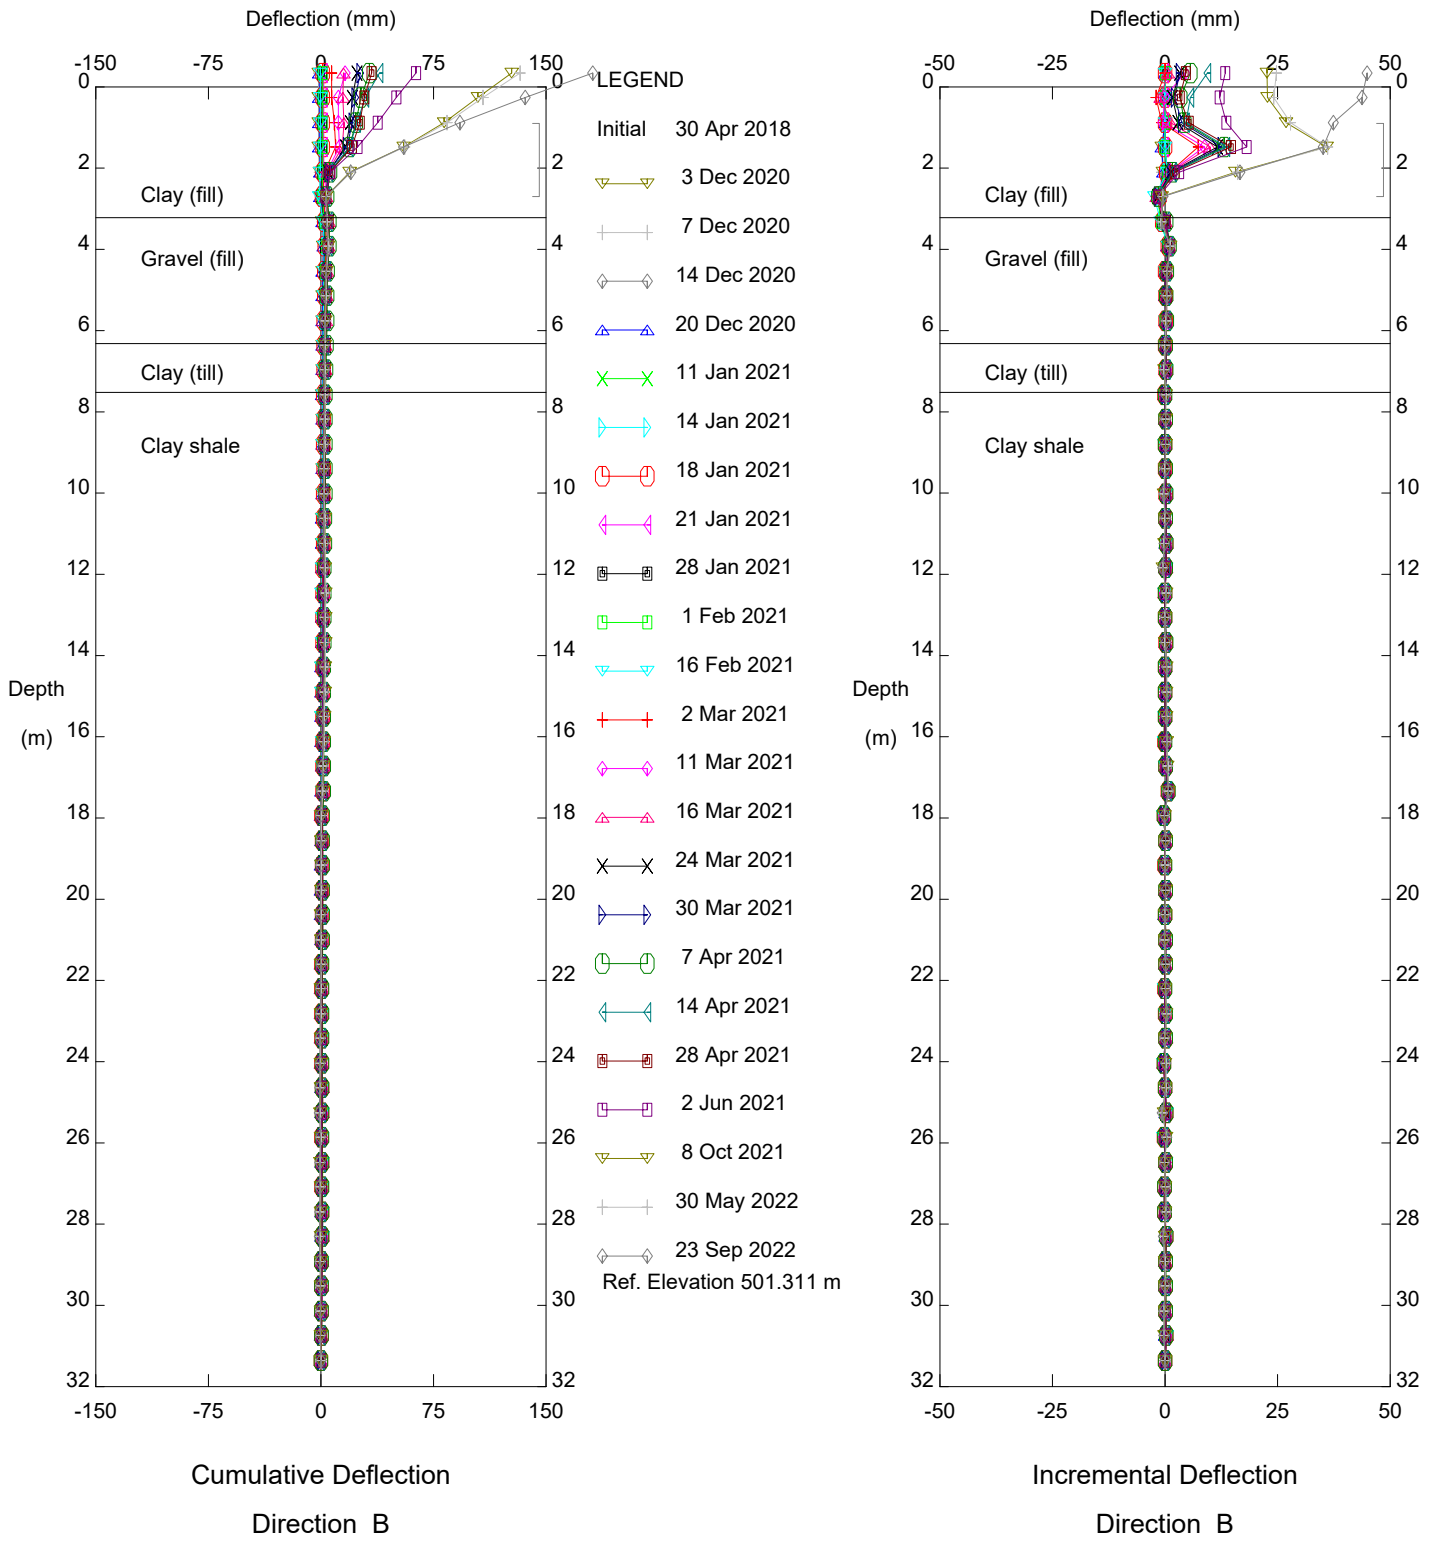
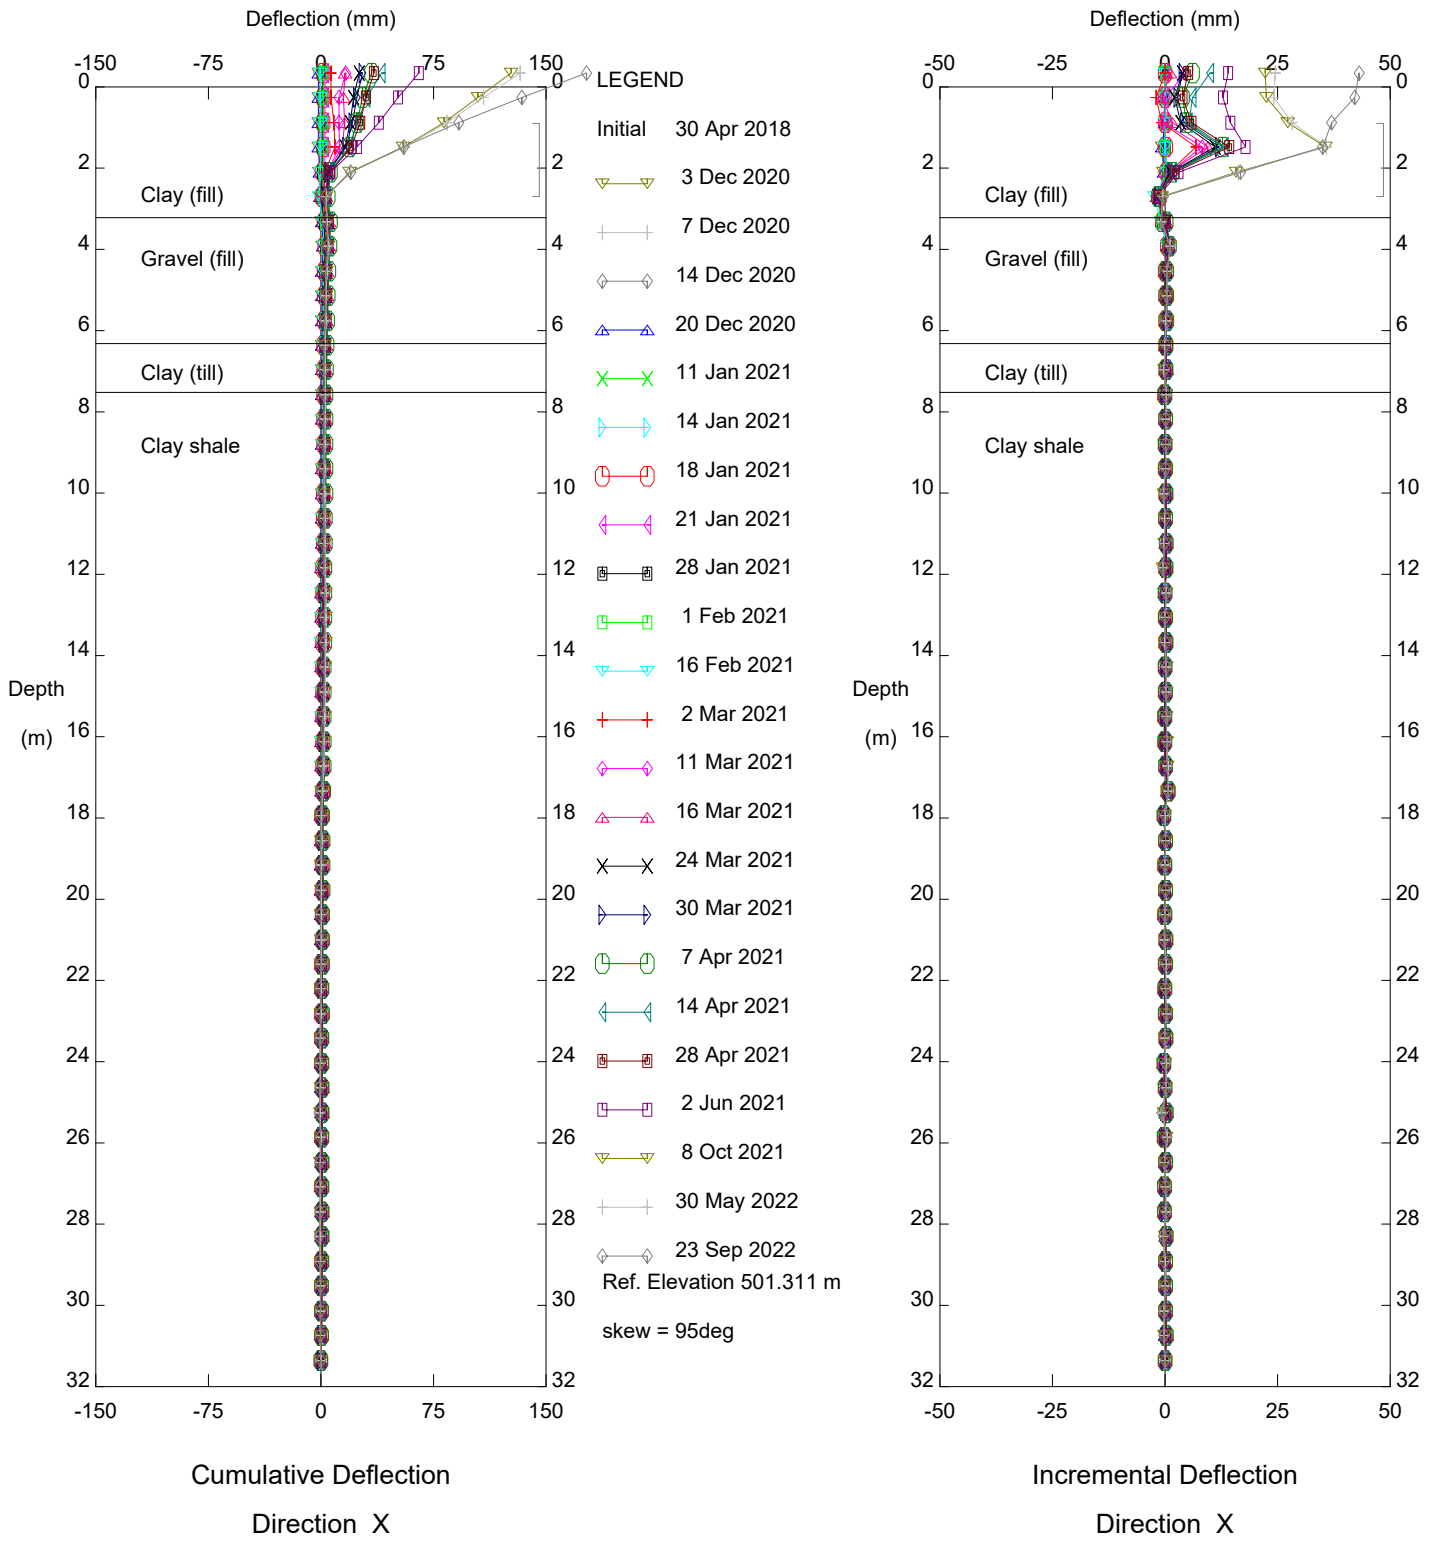
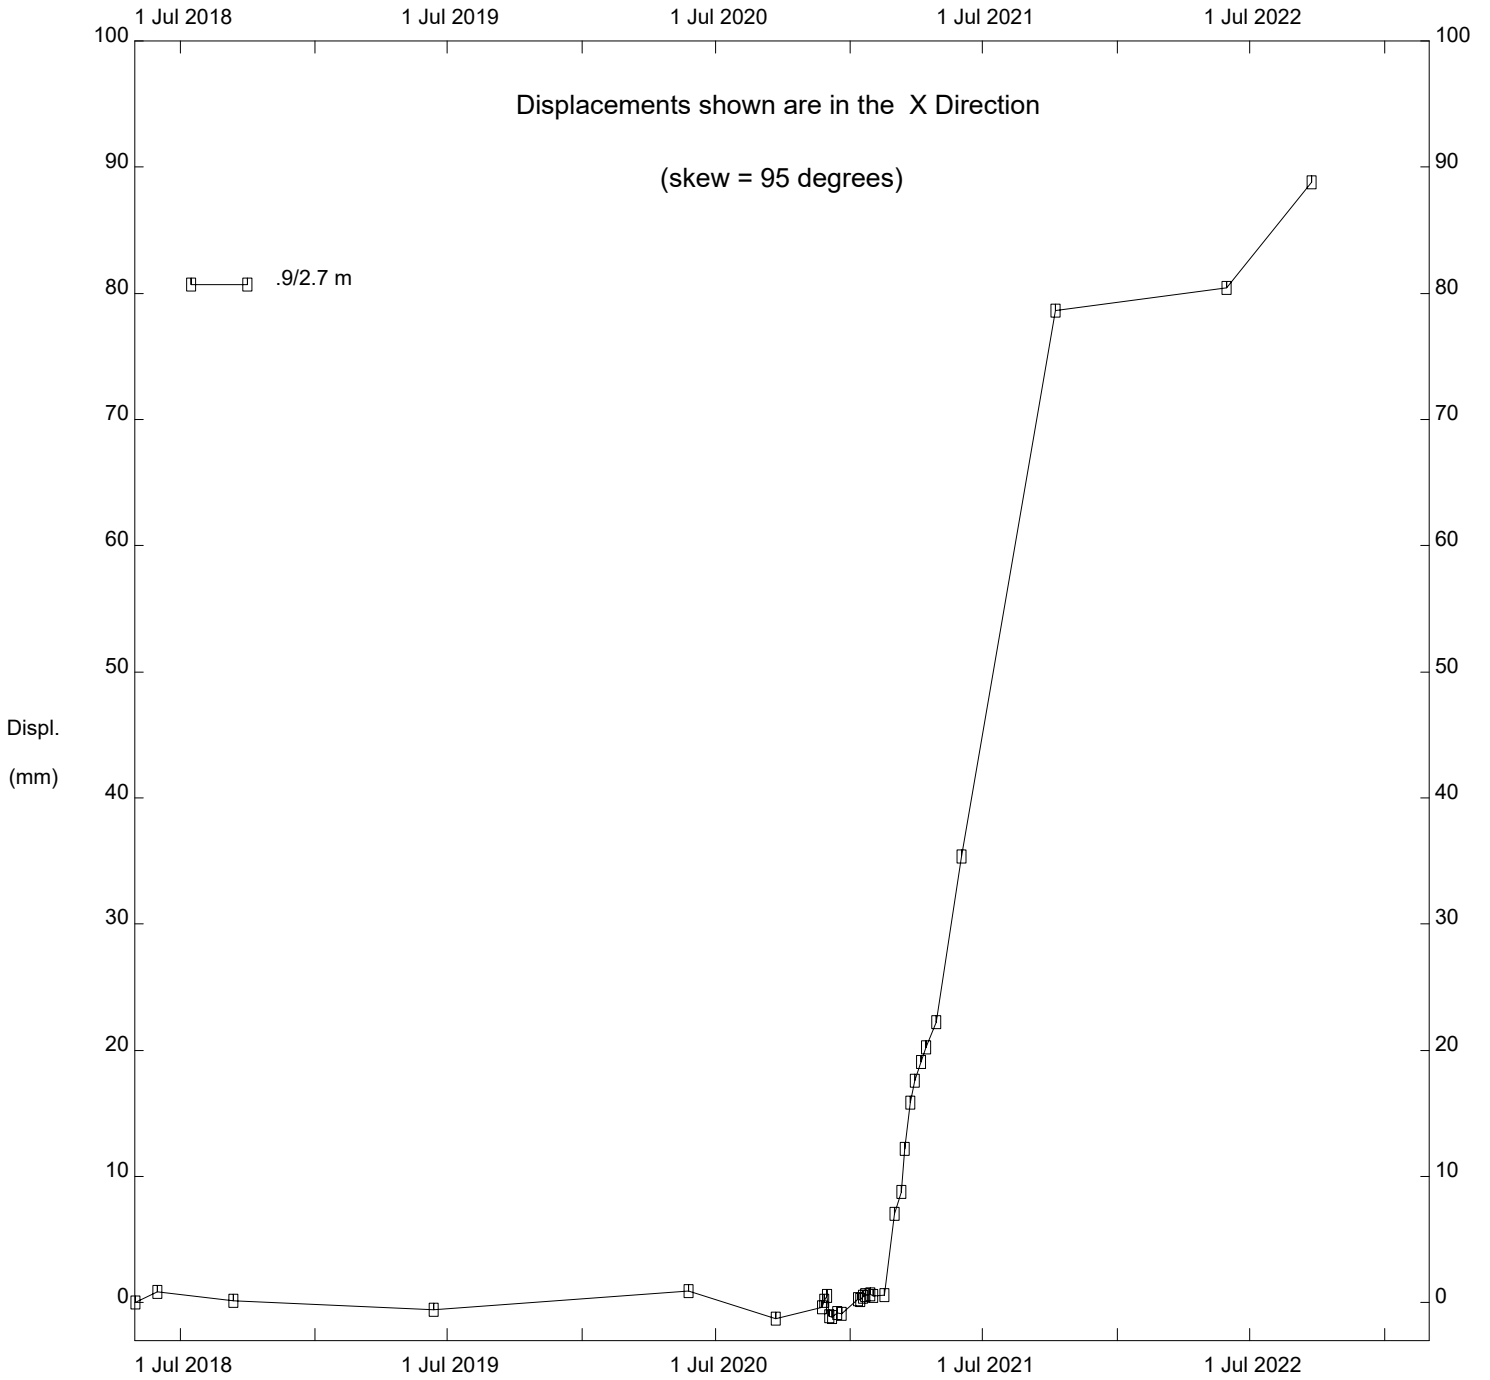
HWY 63 TSA (East Slide), Inclinometer SI18-8

Overall, the SIs within the east toe berm expansion area showed decreases in rates of movement since the end of the recent construction, with the exception of SI18-8. The movement rates in the SIs within the east landslide toe berm should continue to be closely monitored to determine if the movement rates continue to decelerate.

The instruments should be read again in the spring of 2023.

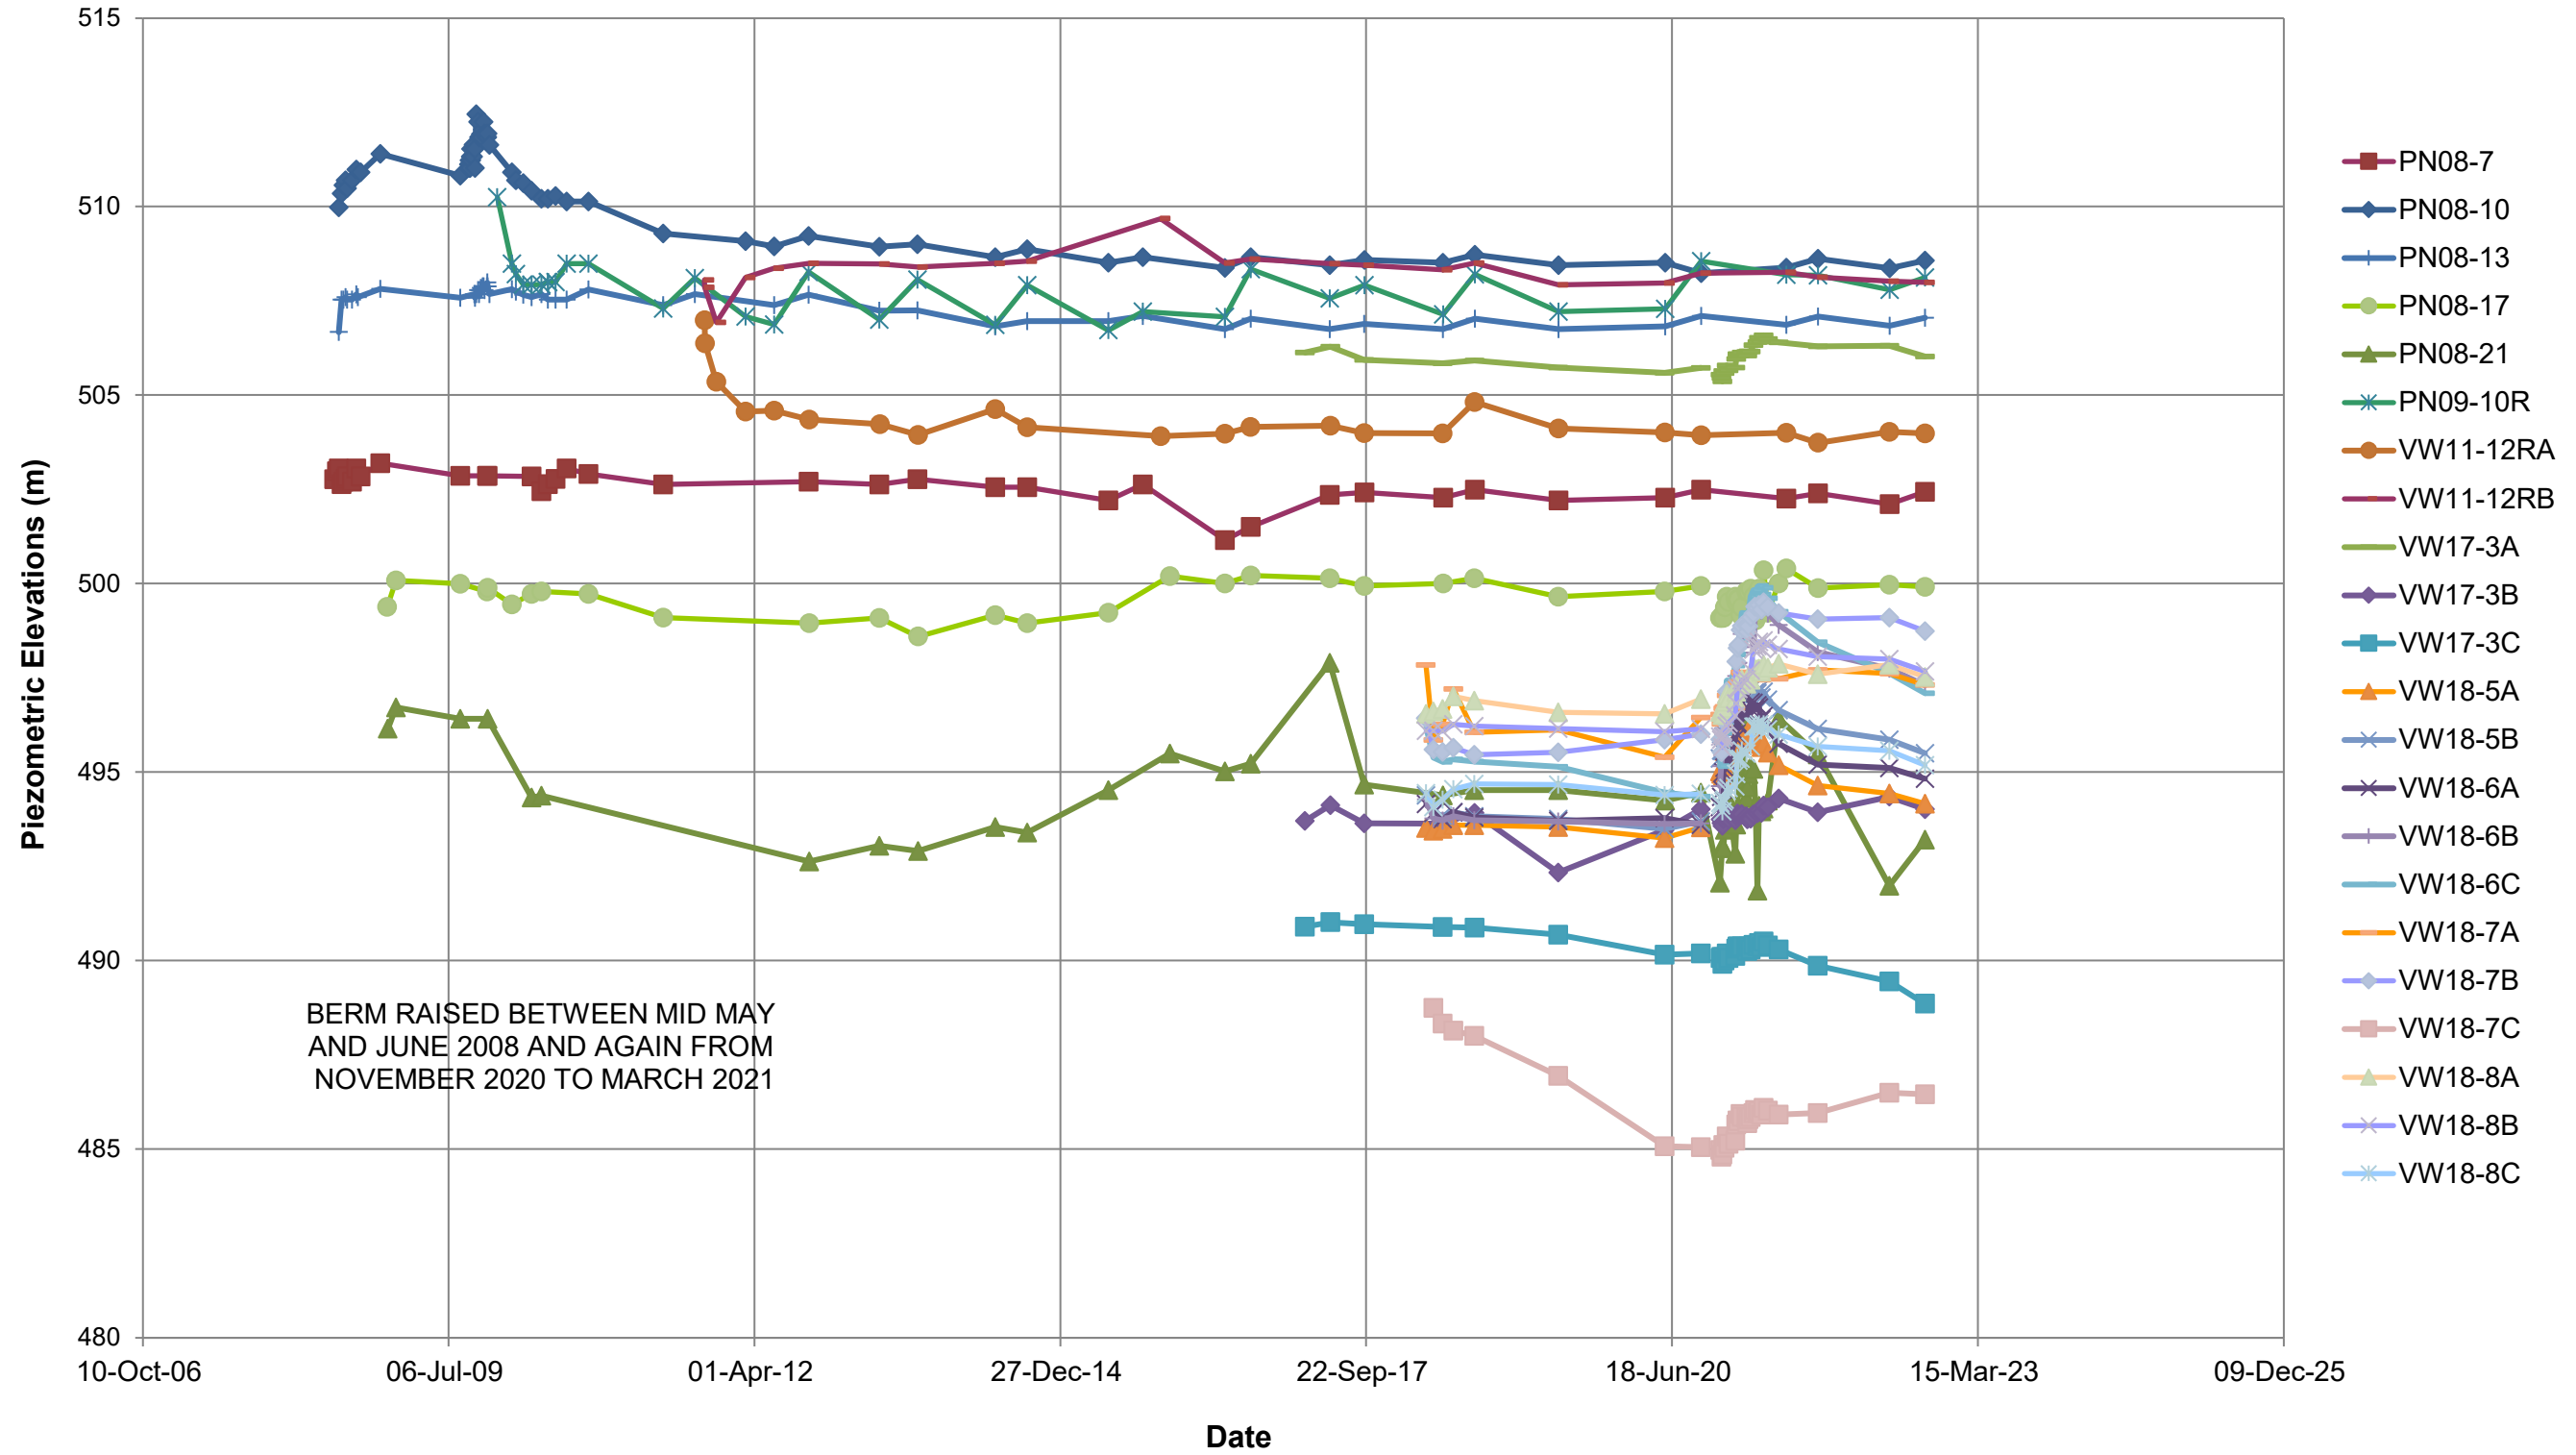
**FIGURE NC070-1  
PIEZOMETRIC ELEVATIONS FOR HWY 63:10 TRUCK STAGING AREA**

Pneumatic piezometers PN08-7, PN08-10, PN08-13, PN08-21 and PN09-10R showed increases in groundwater level of 0.33 m, 0.21 m, 0.21 m, 1.22 m, and 0.32 m, respectively, since the spring of 2022 readings. PN08-17 showed a decrease in groundwater level of 0.06 m since the spring of 2022 reading. The pneumatic piezometer readings are summarized in Table NC070-2 above.

All of the vibrating wire piezometers showed decreases in groundwater level compared to the spring of 2022 readings, ranging from a decrease of 0.03 m in VW11-12RA and VW11-12RB, to a decrease of 0.59 m in VW17-3C. VW11-12RB and VW17-3A show artesian groundwater levels of 0.13 m and 6.16 m, respectively.

Vibrating wire piezometers VW11-12RB, VW17-3C, VW18-5A, VW18-5B, VW18-5C, VW18-6A, VW18-6B, VW18-6C, VW18-7A, VW18-8B, and VW18-8C showed decreases in water levels ranging from 0.06 m in VW18-8B to 0.82 m in VW18-6C since the fall of 2021 readings.

The majority of the piezometer readings appear to have remained relatively stable since completion of the toe berm extension in 2021.
