**ALBERTA TRANSPORTATION
GEOHAZARD ASSESSMENT PROGRAM
NORTH CENTRAL REGION – ATHABASCA &
FORT MCMURRAY DISTRICTS
2021 INSPECTION**

Site Number	Location	Name	km
NC084	To the south of the King Street Interchange in Fort McMurray	Hwy 63:11 Beacon Hill Erosion	9.1
Legal Description		UTM Co-ordinates	
5-10-089-09 W4M		12U E 478509	N 6284231

Date	PF	CF	Total
Previous Inspection:	June 11, 2019	16	4	64 (Erosion)
Current Inspection:	June 24, 2021	16	4	64 (Erosion)
Road AADT:	29,050		Year:	2020
Inspected By:	José Pineda, Tarek Abdelaziz (Thurber) Kristen Tappenden, Bernard Ching (Alberta Transportation)			
Report Attachments:	<input checked="" type="checkbox"/> Photographs <input type="checkbox"/> Plans <input type="checkbox"/> Maintenance Items

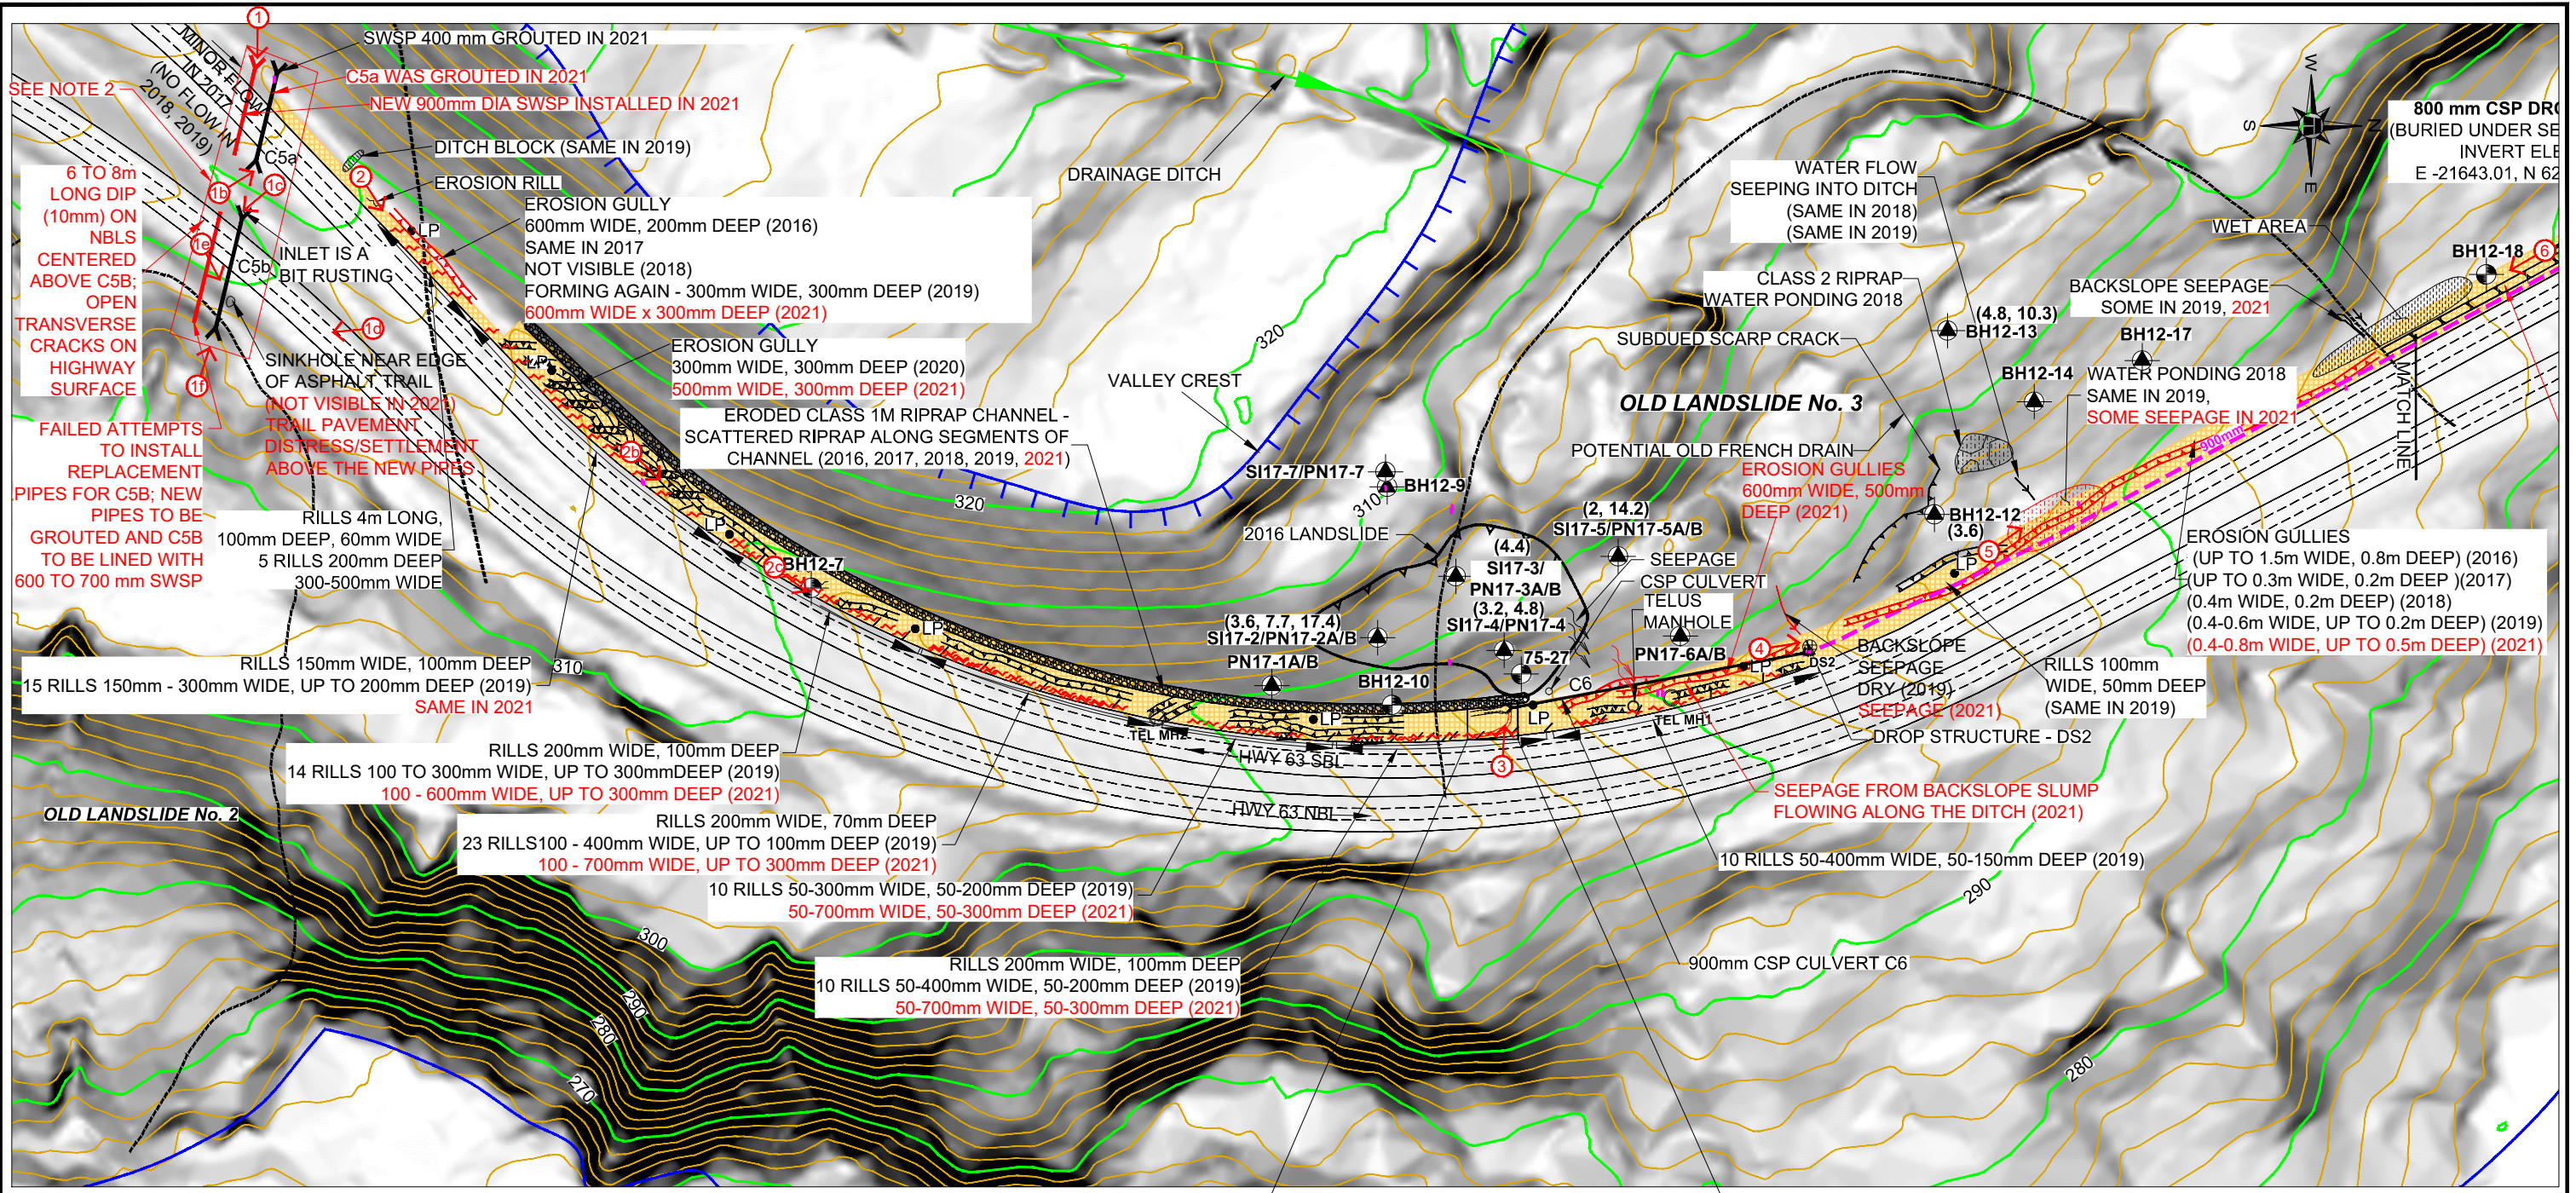
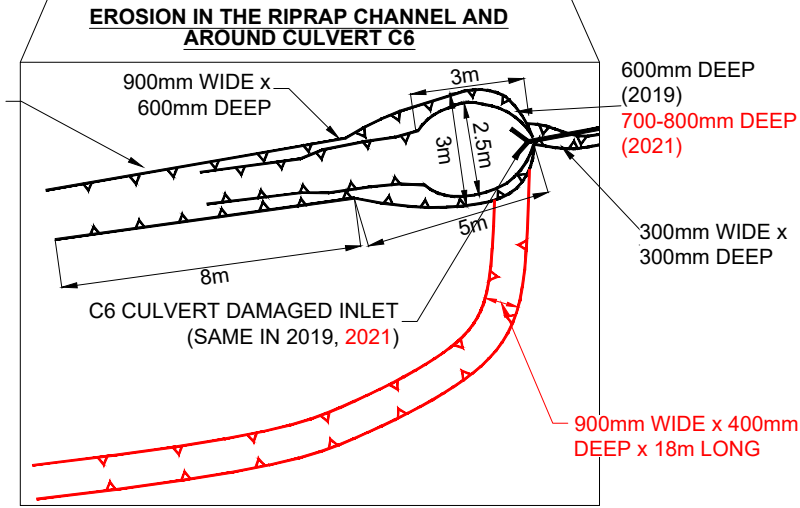
FIGURE 2

NOTES:
 1. JUNE 24, 2021 OBSERVATIONS SHOWN IN RED.
 2. INLINE CONTRACTING WAS WORKING ON THE REPLACEMENT OF CULVERT C5a AND C5b; TETRA TECH WAS THE CONSULTANT OVERSEEING THE CULVERT REPLACEMENT WORK. TETRA TECH INDICATED THAT THE CONTRACTOR HAD MULTIPLE UNSUCCESSFUL ATTEMPTS TO REPLACE THE C5b CULVERT.

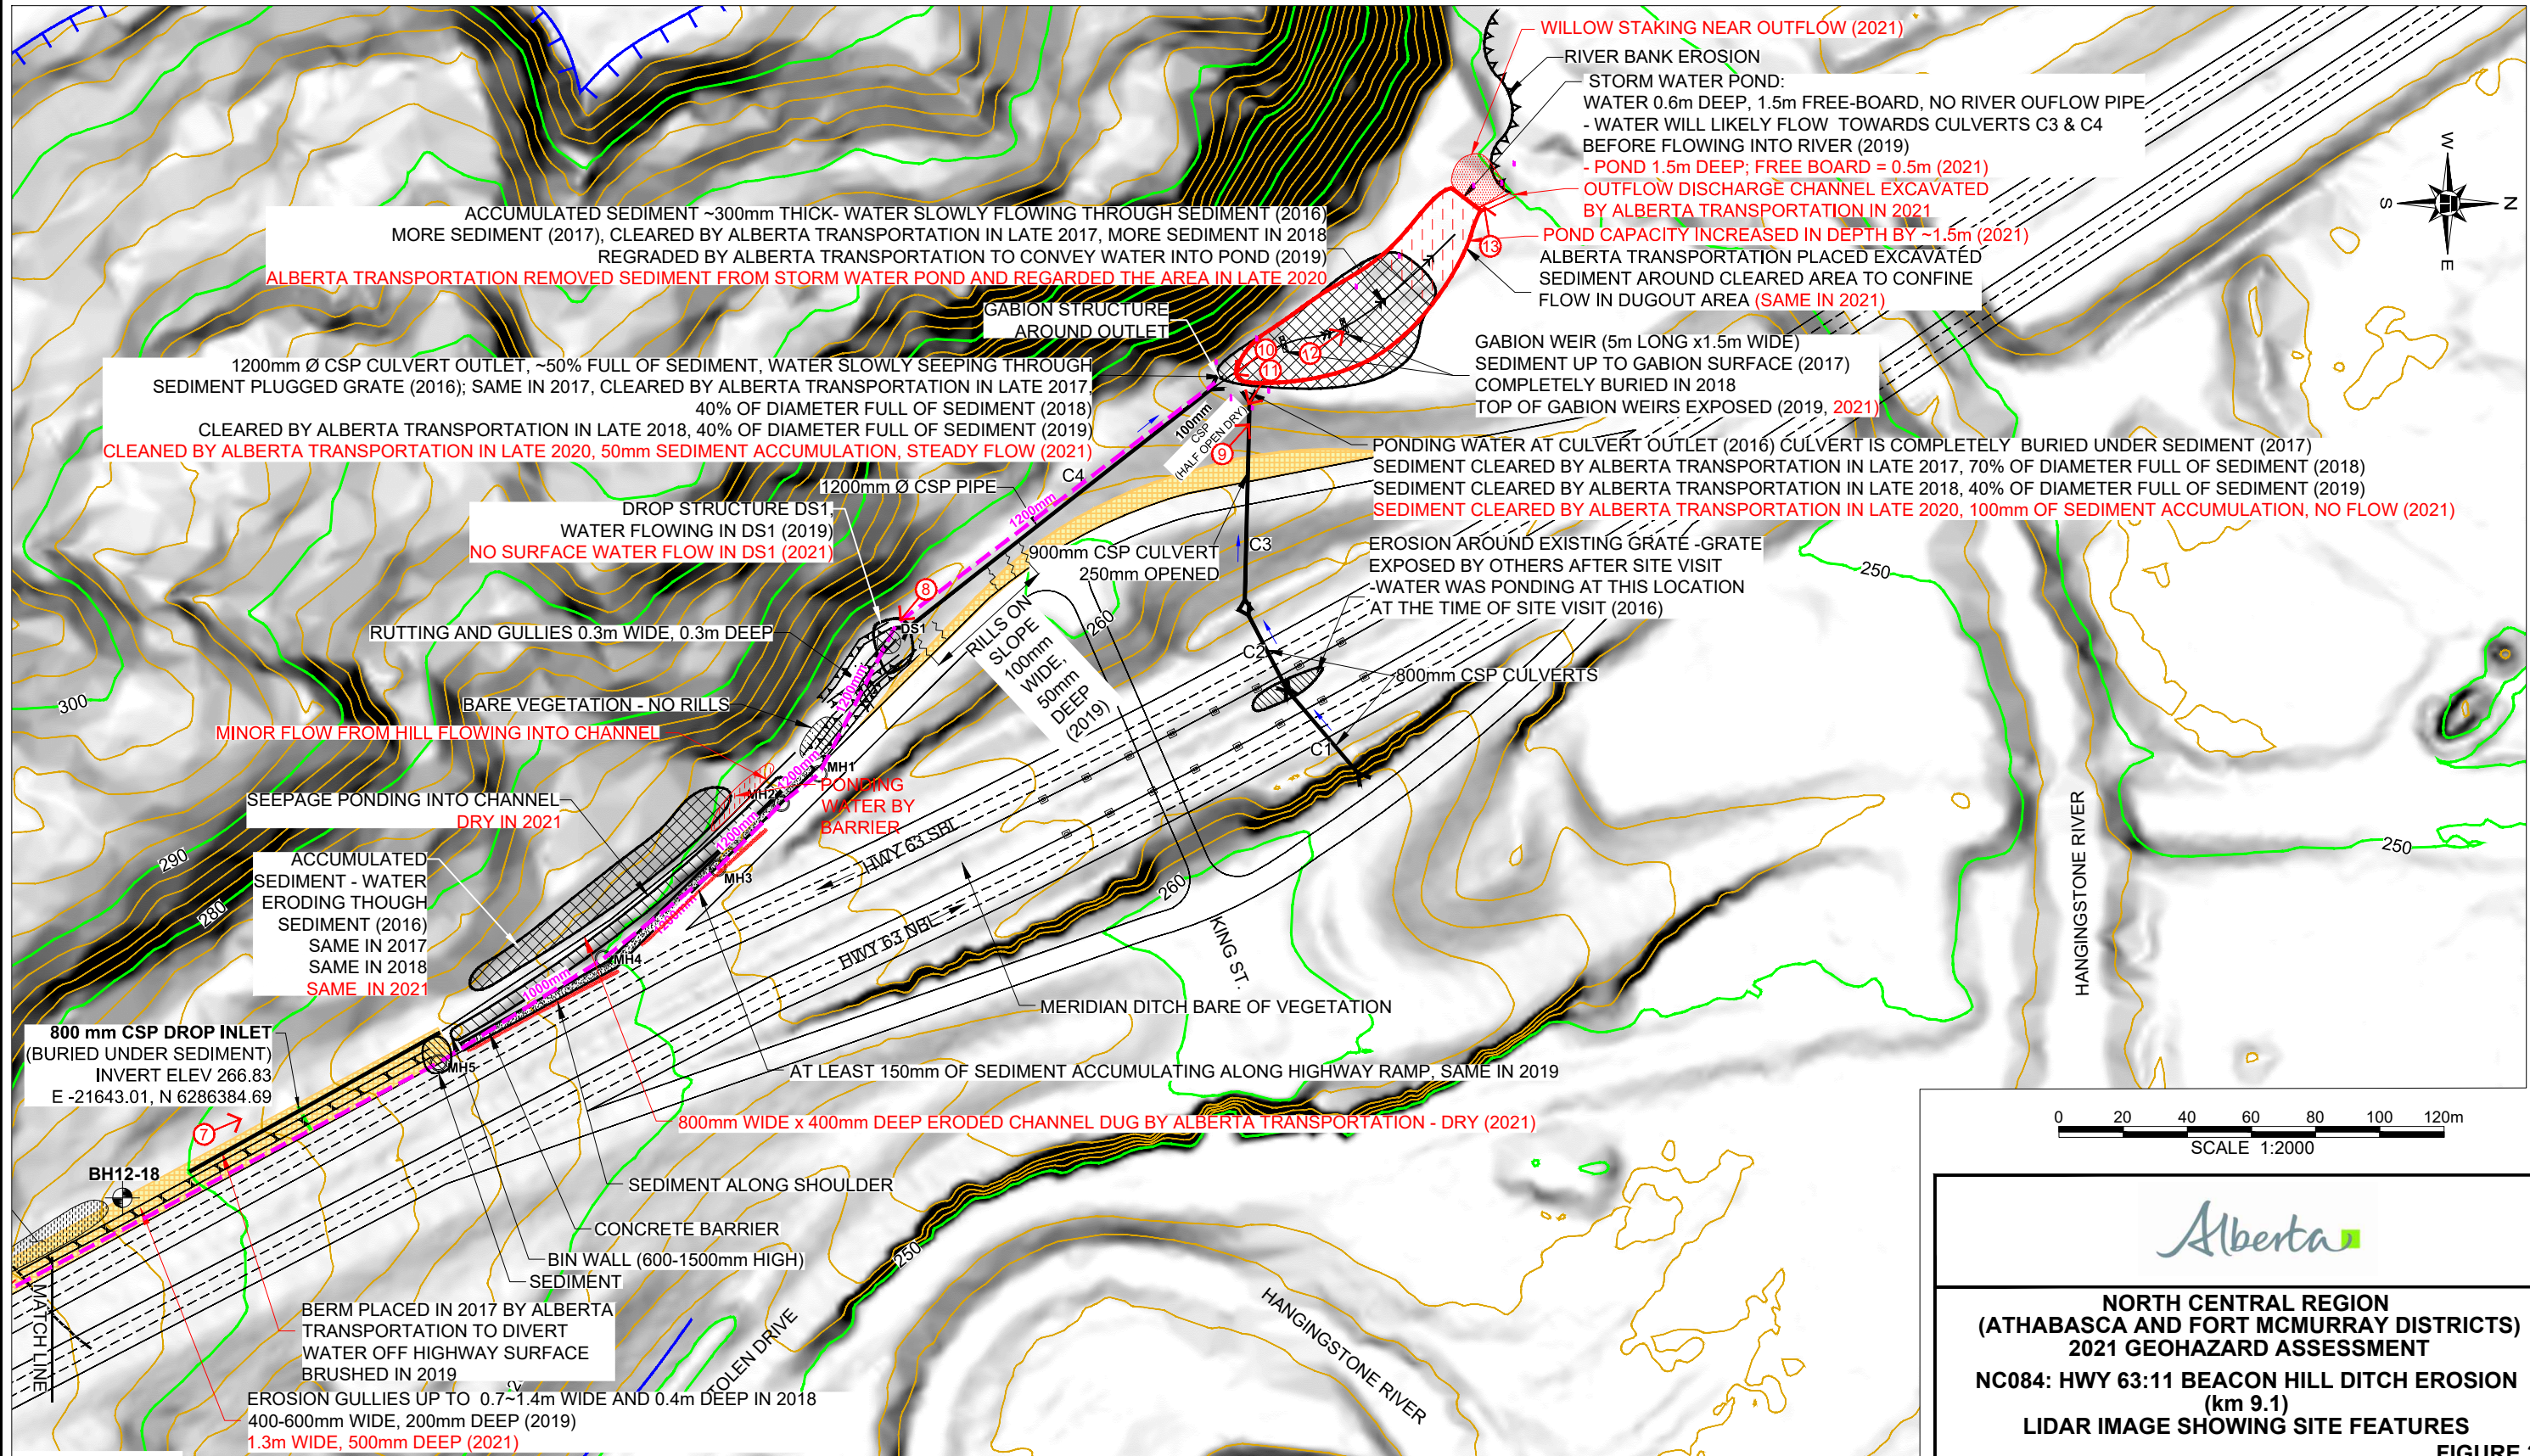
FIGURE 3

- NOTES:**
1. MH2 TO MH5 ARE BURIED UNDER SEDIMENT.
 2. JUNE 24, 2021 OBSERVATIONS SHOWN IN RED.

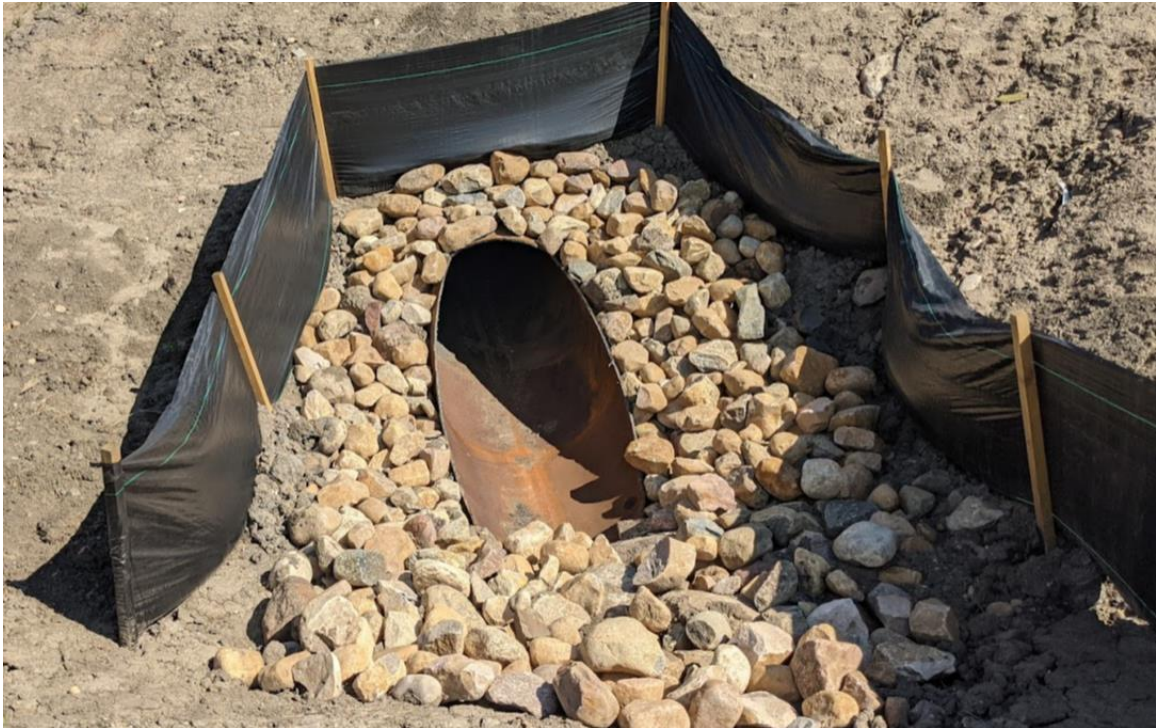
Photo 1 – Looking at the inlet of a new 900 mm diameter SWSP culvert (C5a replacement)

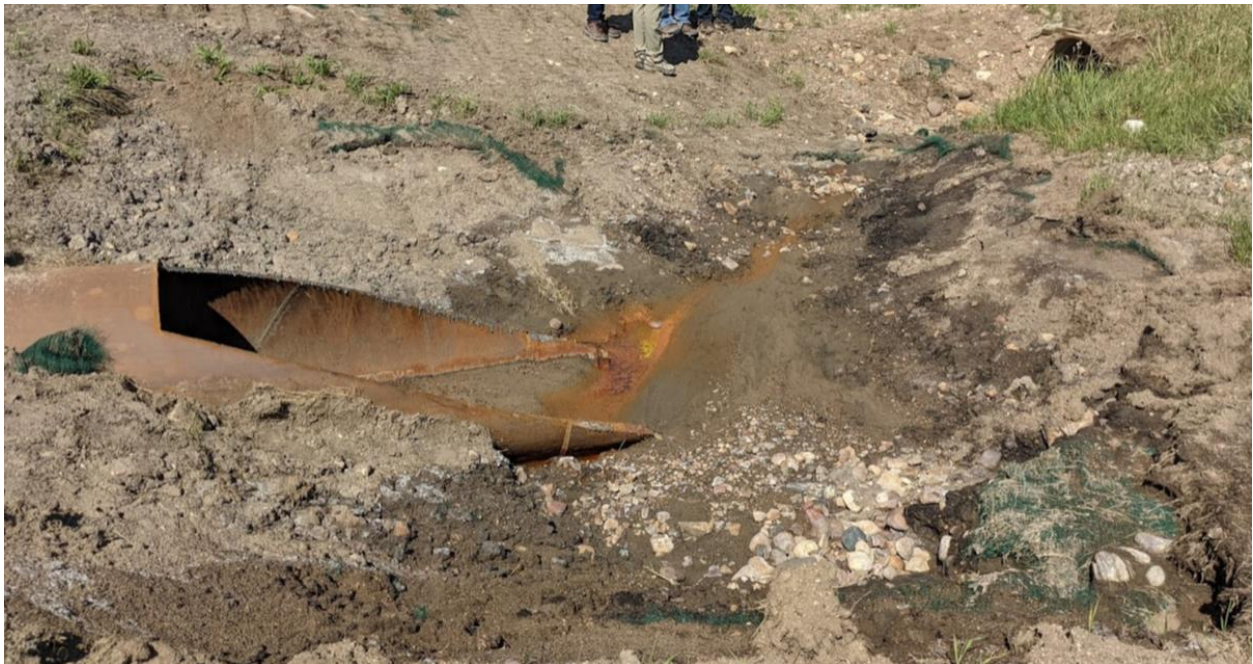
Photo 1b – Looking at the outlet of a new 900 mm diameter SWSP culvert (C5a replacement)

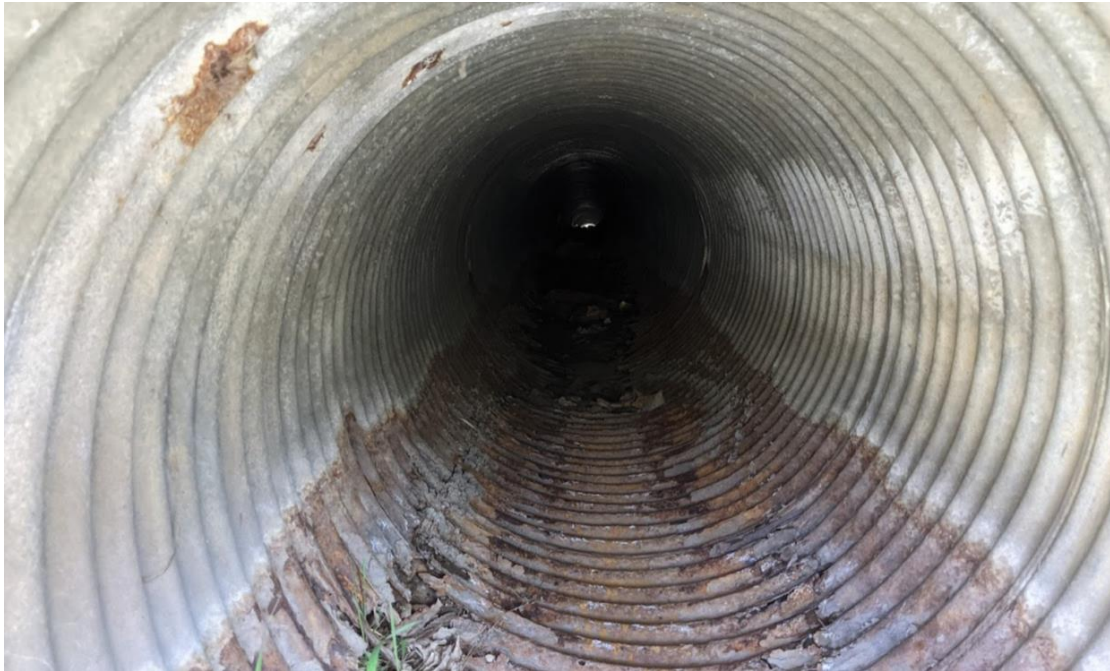
Photo 1c - 900 mm diameter CSP culvert (C5b) inlet. This culvert will be lined in 2021

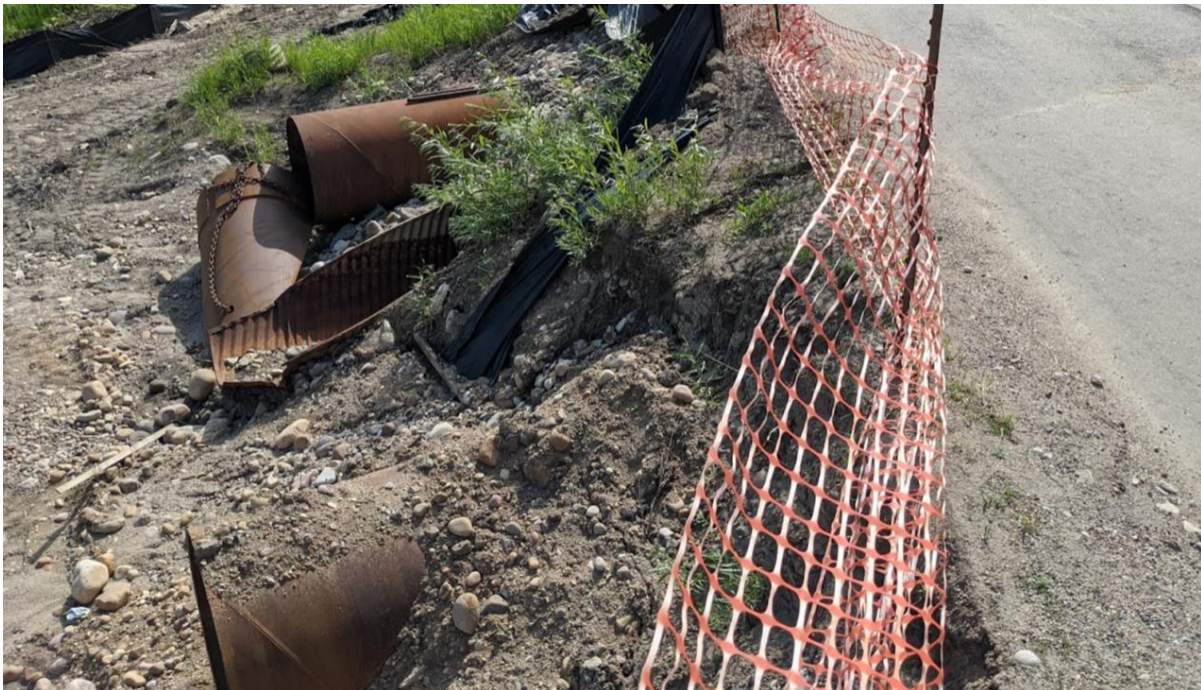
Failed attempts to replace C5b culvert by Inline Contracting resulted in pavement distress/settlement (about 6 to 8 m wide zone) of the walking trail and the highway northbound lanes (about 10 mm dip) above the alignment of the C5b pipe. Open transverse cracks were also noted on the highway NBLs near the ends of the dip zone. Based on onsite discussions with TetraTech (i.e., consultant overseeing the work), it is understood that: (a) the highway NBLs and the walking trail surfaces will be periodically monitored to assess whether further deterioration takes place, (b) the C5b culvert will be lined as soon as possible to reduce the likelihood of further deterioration of the highway condition, (c) the ditch block to the north of the inlet of C5b culvert will be removed so that the flow from the C5a pipe can be accommodated through the C5b liner and an existing 600 mm diameter culvert (below the NBLs) to the north of C5b pipe. The cracks developed in the highway NBLs should also be sealed and ACP patches should be placed as needed to repair the developed dip on the trail and the highway surfaces.

Photo 1d – 900 mm diameter CSP culvert (C5b) outlet. Inline Contracting had two unsuccessful attempts to replace the CSP culvert with a SWSP. The first attempt was to install the pipe 2m to the south of C5b, and the second attempt was to install the pipe 4 m to the north of C5b

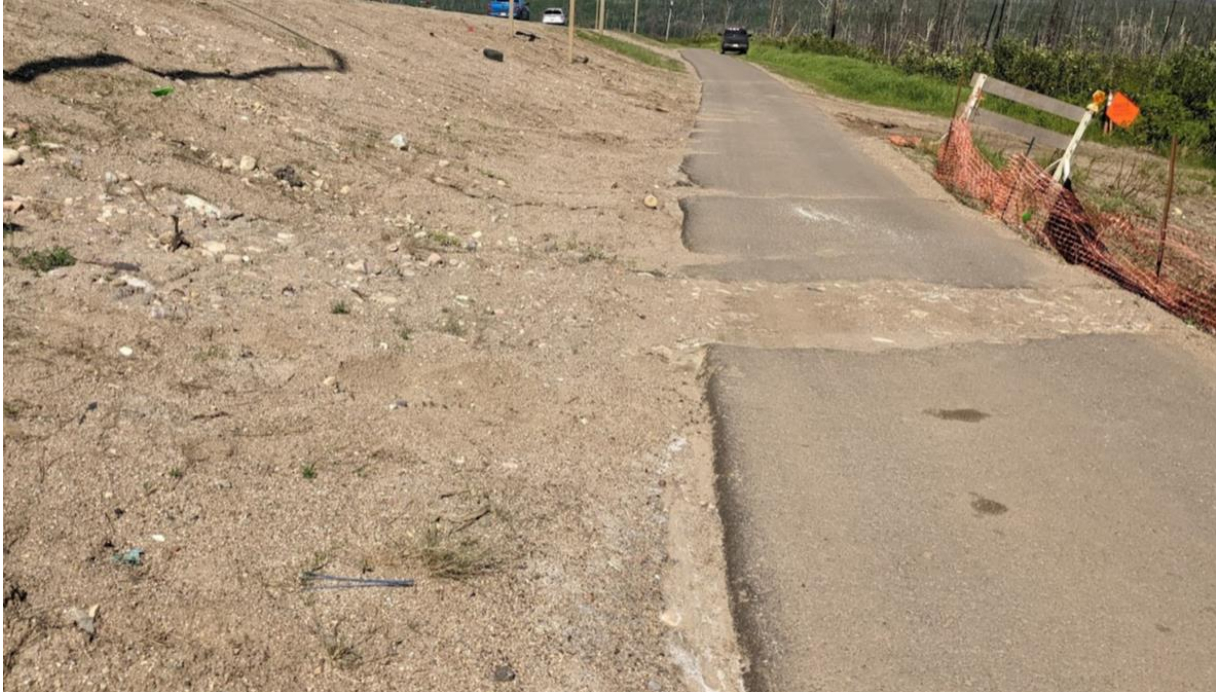
Photo 1e –Asphalt walking trail settlement/distress in response to the failed attempts to replace C5b

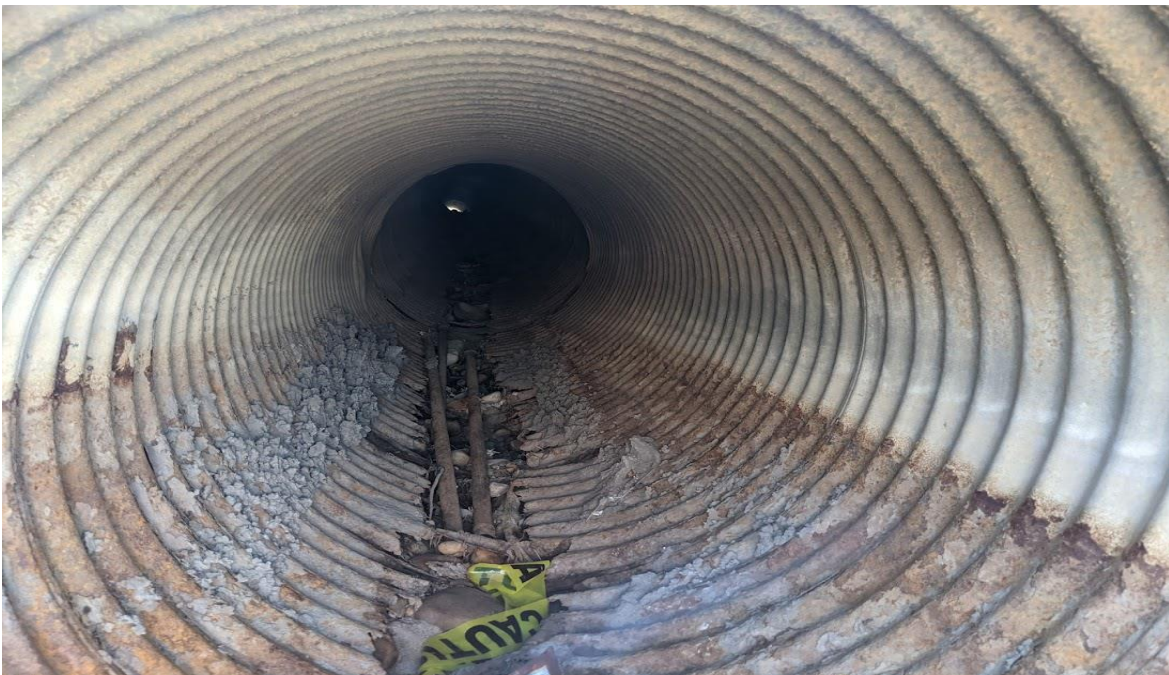
Photo 1f –Looking inside the C5b culvert from the outlet location; the culvert floor is excessively damaged, and rocks/debris are present within the culvert floor; the integrity of this culvert is questionable, and it will be lined in 2021 by Inline Contracting

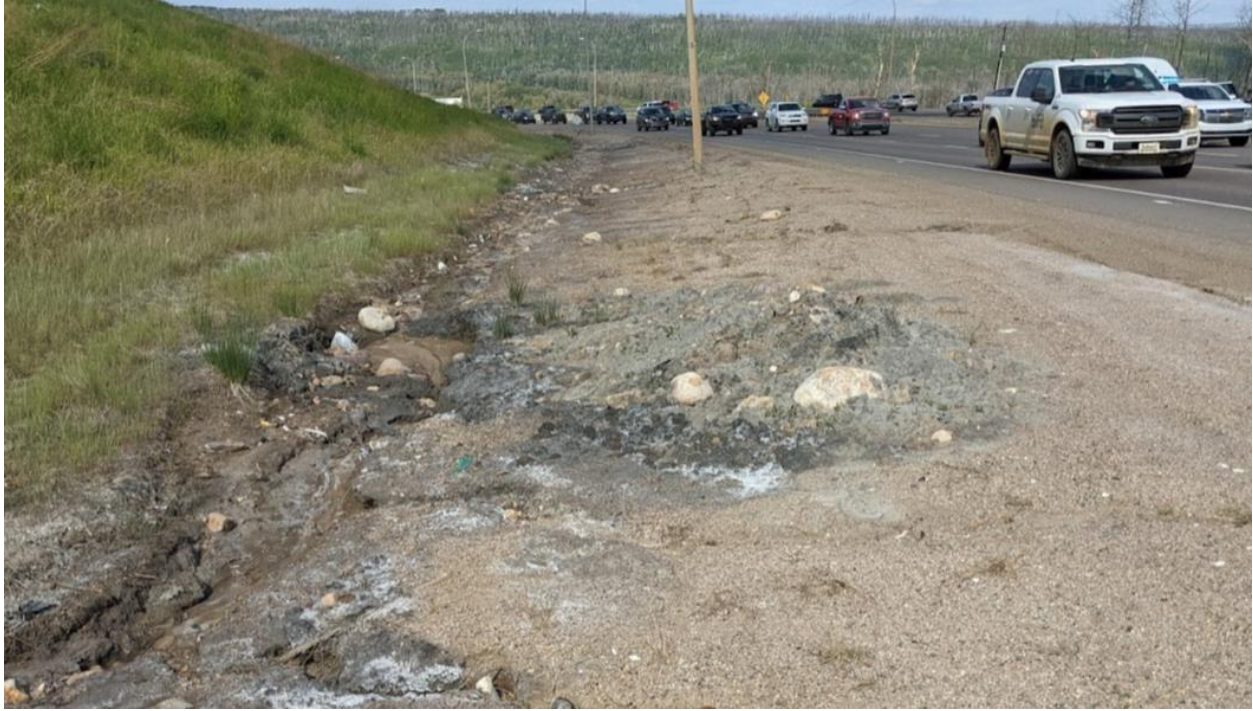
Photo 2 – Bare side slopes with erosion rills

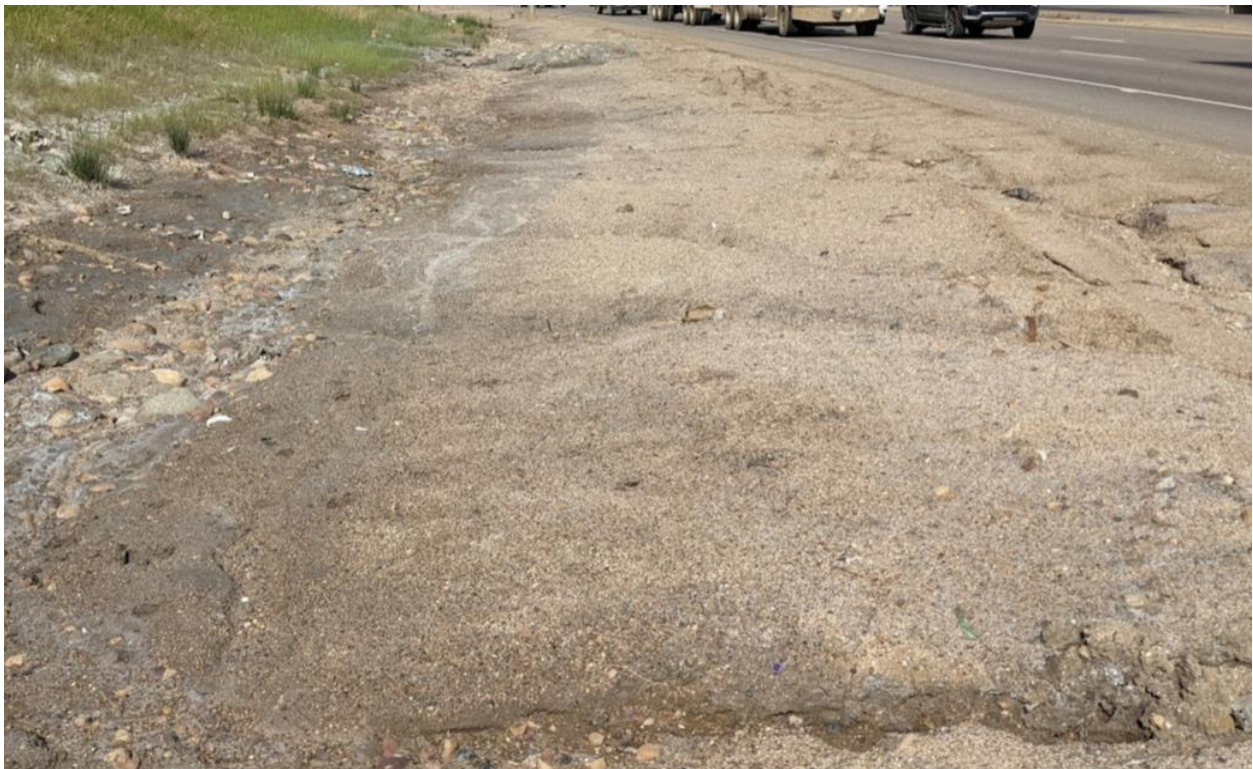
Photo 2b – Bare side slopes and erosion rills

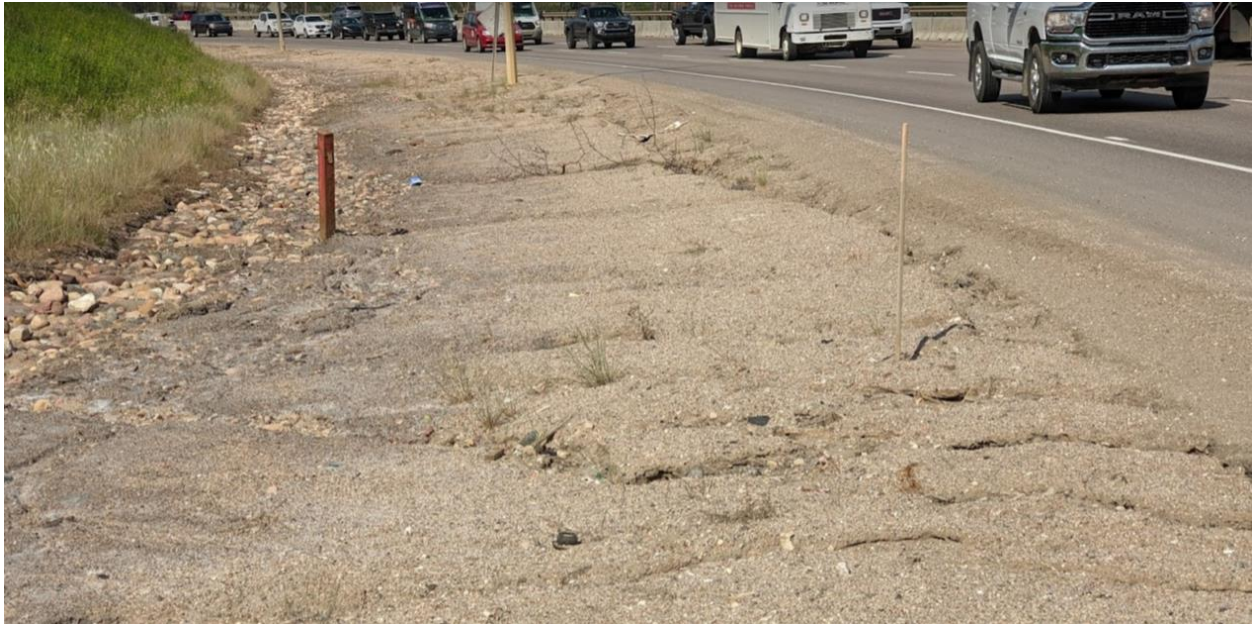
Photo 2c – Bare side slopes and erosion rills

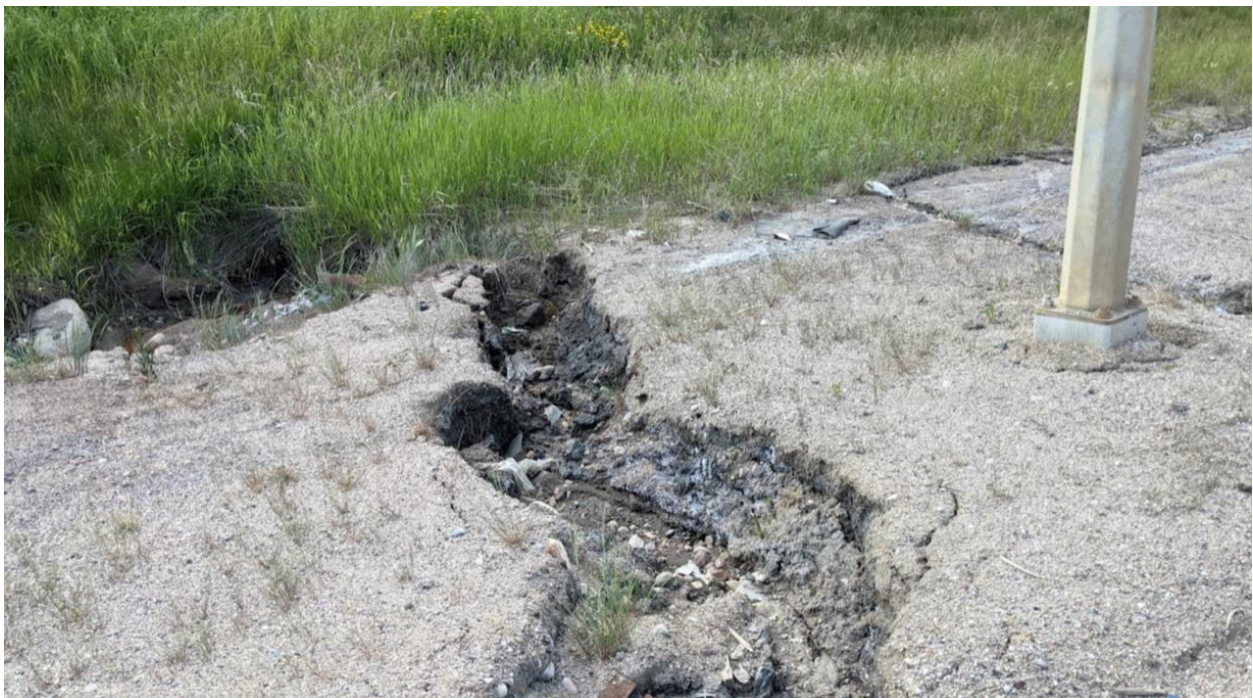
Photo 3 – Severe sediment accumulation and excessive erosion developed on the highway side slope near culvert C6 inlet location

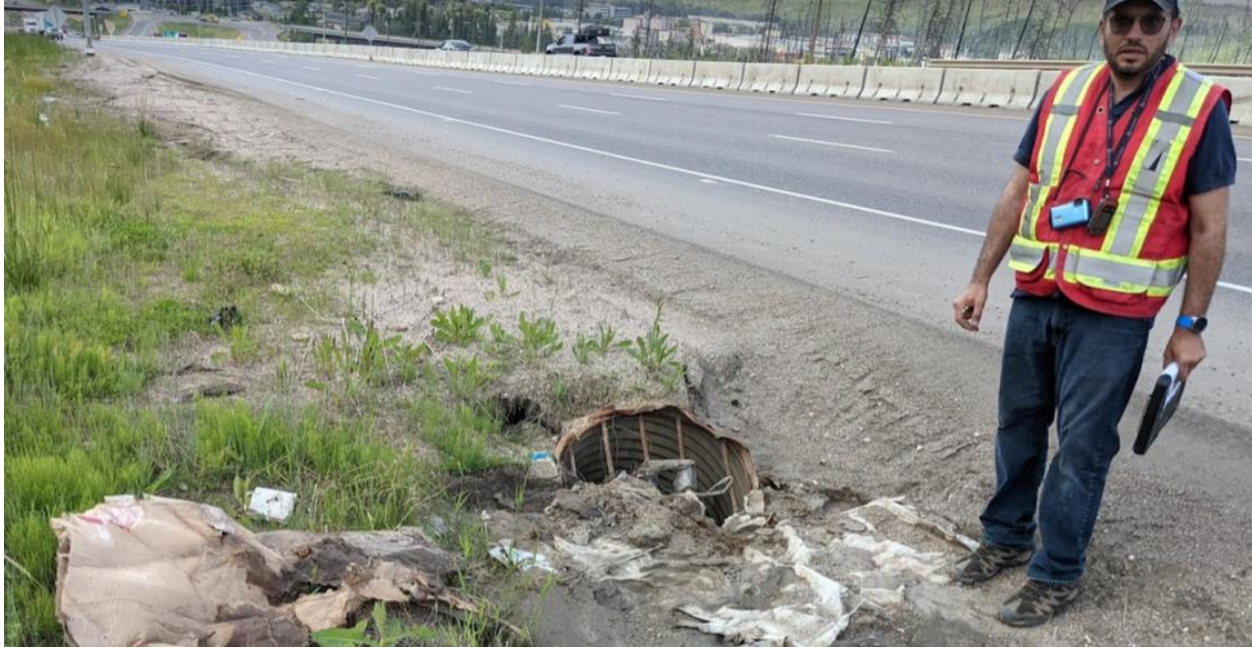
Photo 4 – Erosion , bare slopes, and debris near Drop structure DS2

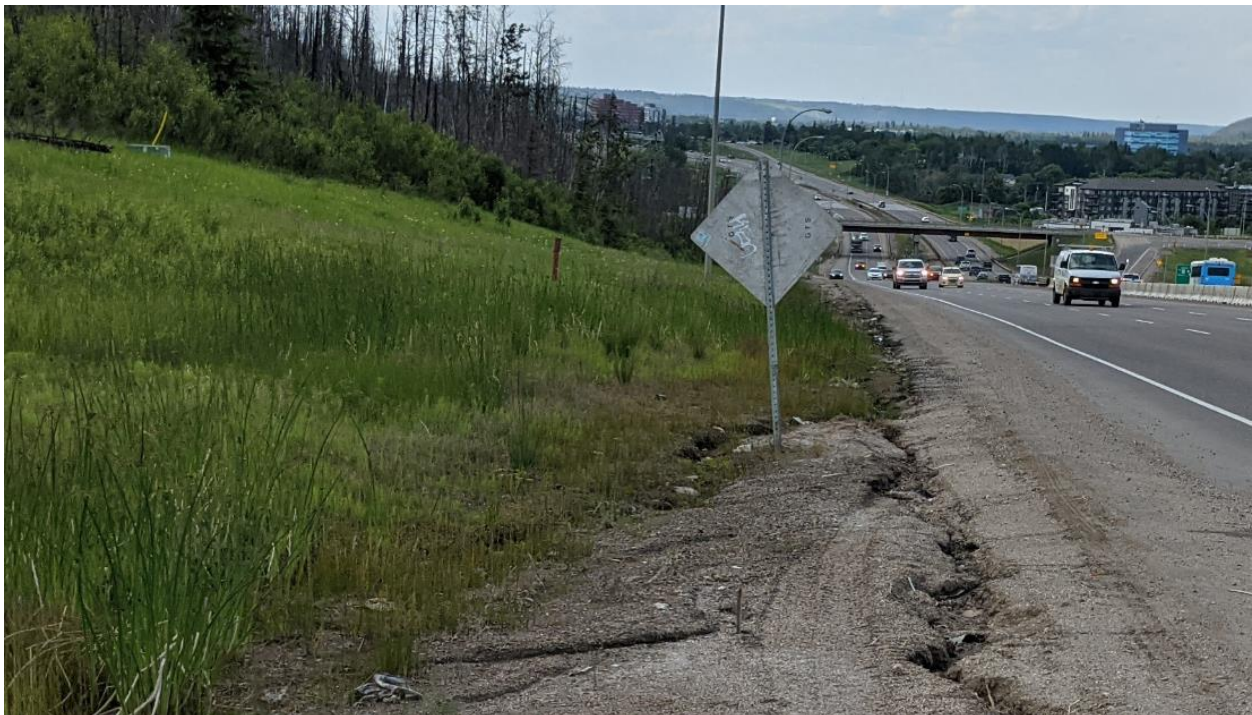
Photo 5 – Some seepage from the colluvium backslope flowing into eroded ditch

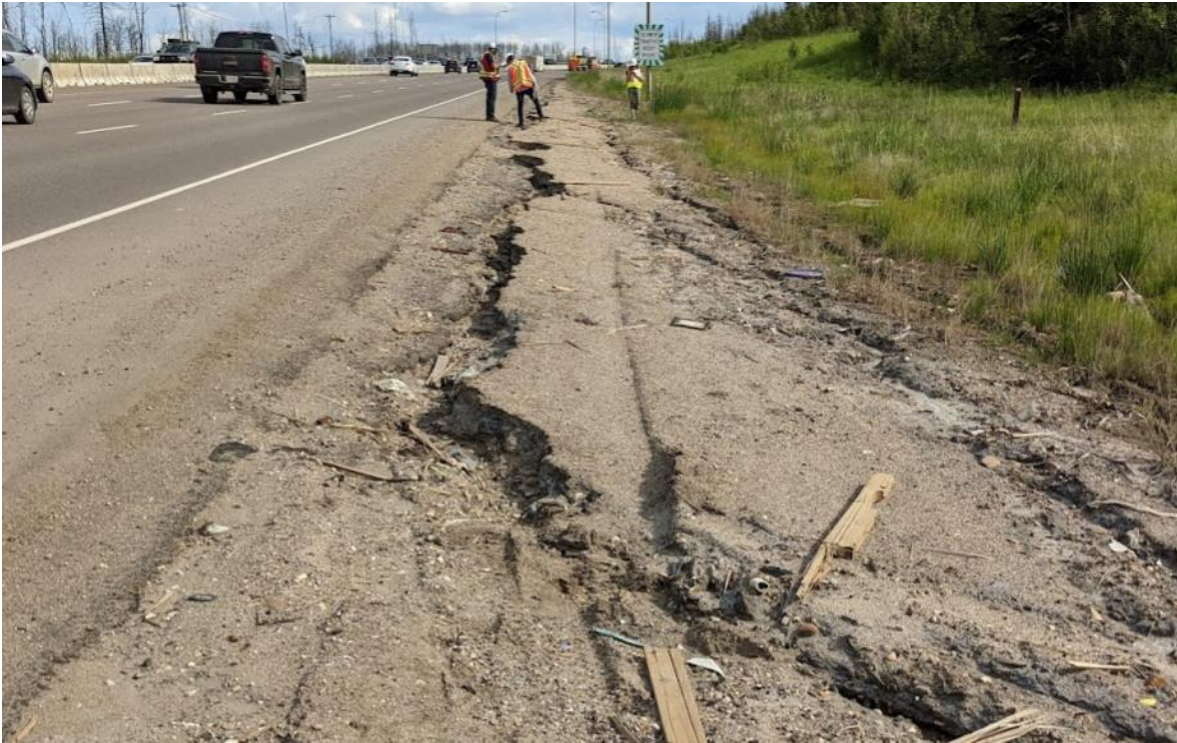
Photo 6 – Sediment accumulation in the highway side slope

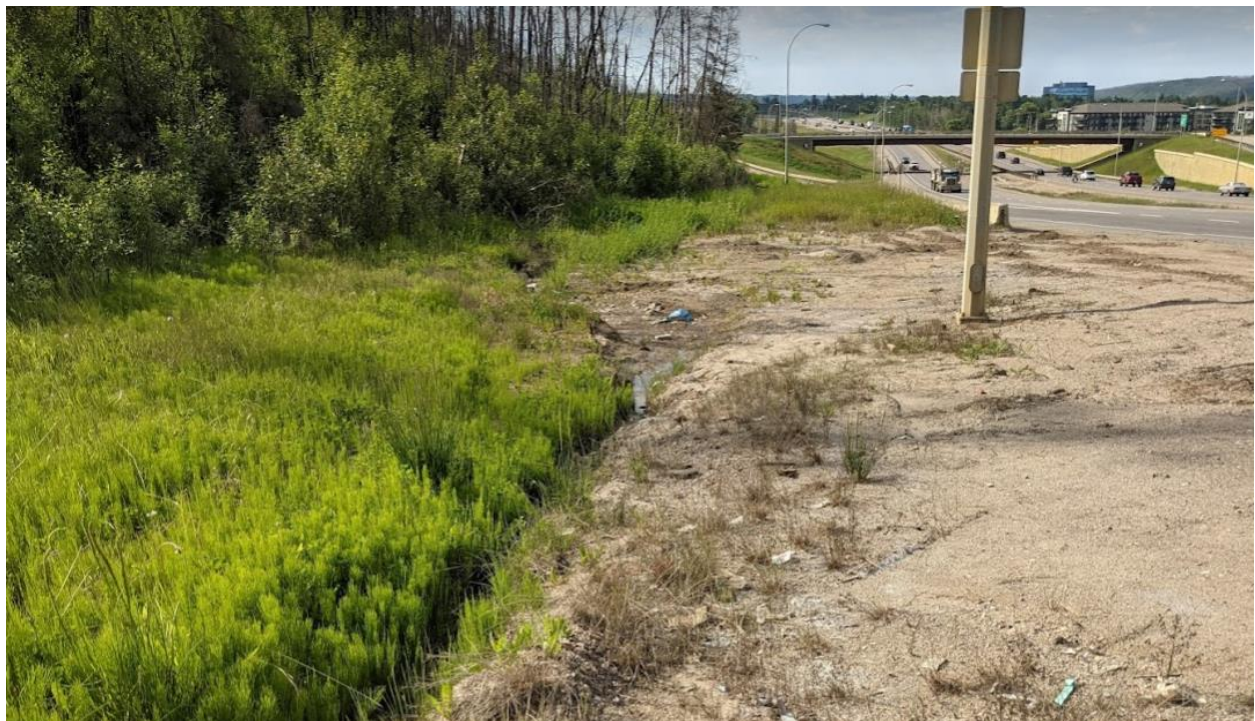
Photo 7 – Temporary berm and erosion gully along the back of bin and jersey walls

The temporary small berm and channel constructed by AT south of the bin wall to prevent sediment accumulation on the highway should be maintained. Consideration may be given to increasing the size of the berm to reduce surface water runoff from the ditch into the highway lanes.

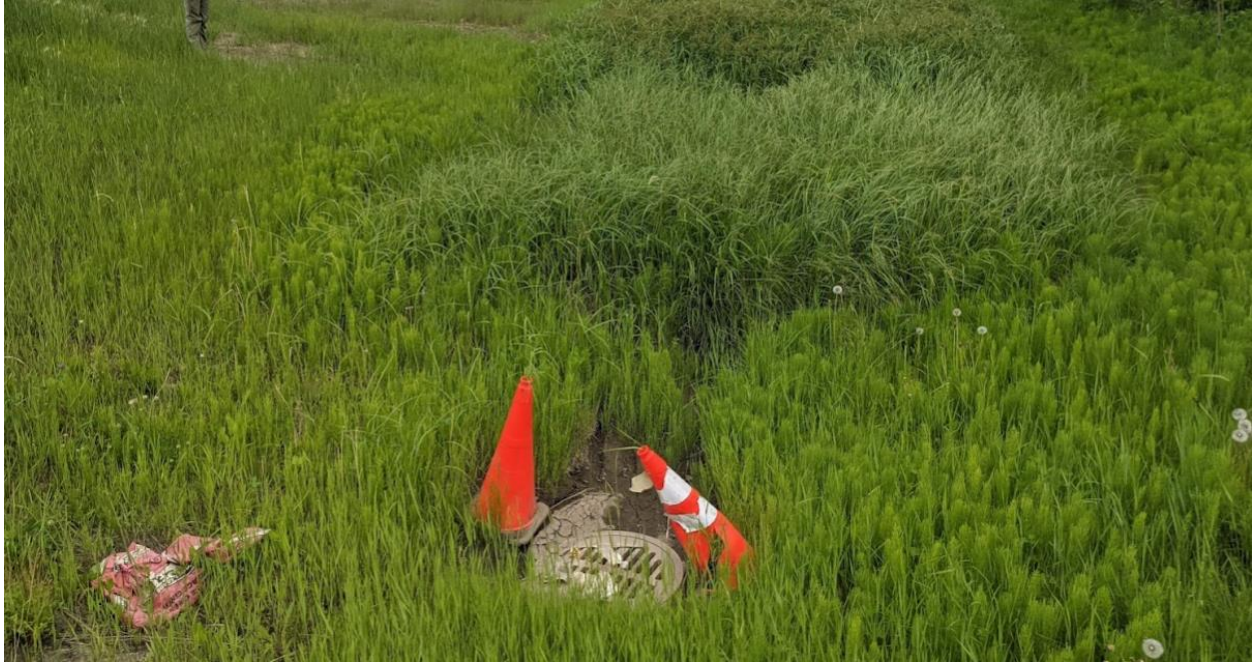
Photo 8 – Drop Structure DS1; note lush vegetation possible due to seepage and surface water flowing from the hill

Consideration should be given for clearing any accumulated sediment around the drop structure DS1; and placing a silt fence around the drop structure, near the edge of the pond, and at the inlets of the median culverts. Synthetic permeable ditch barriers should also be placed at key locations along the west and median ditches to trap sediments.

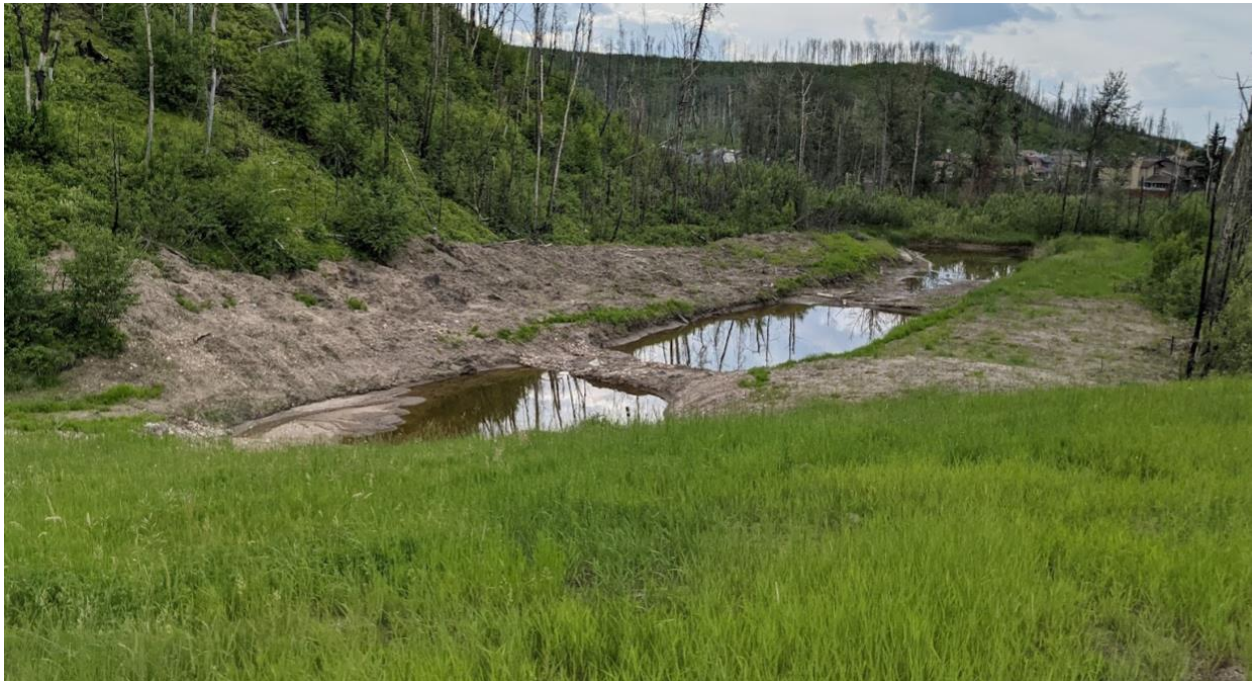
Photo 9 – Substantial sediment was removed increasing pond capacity by approximately 1.5m

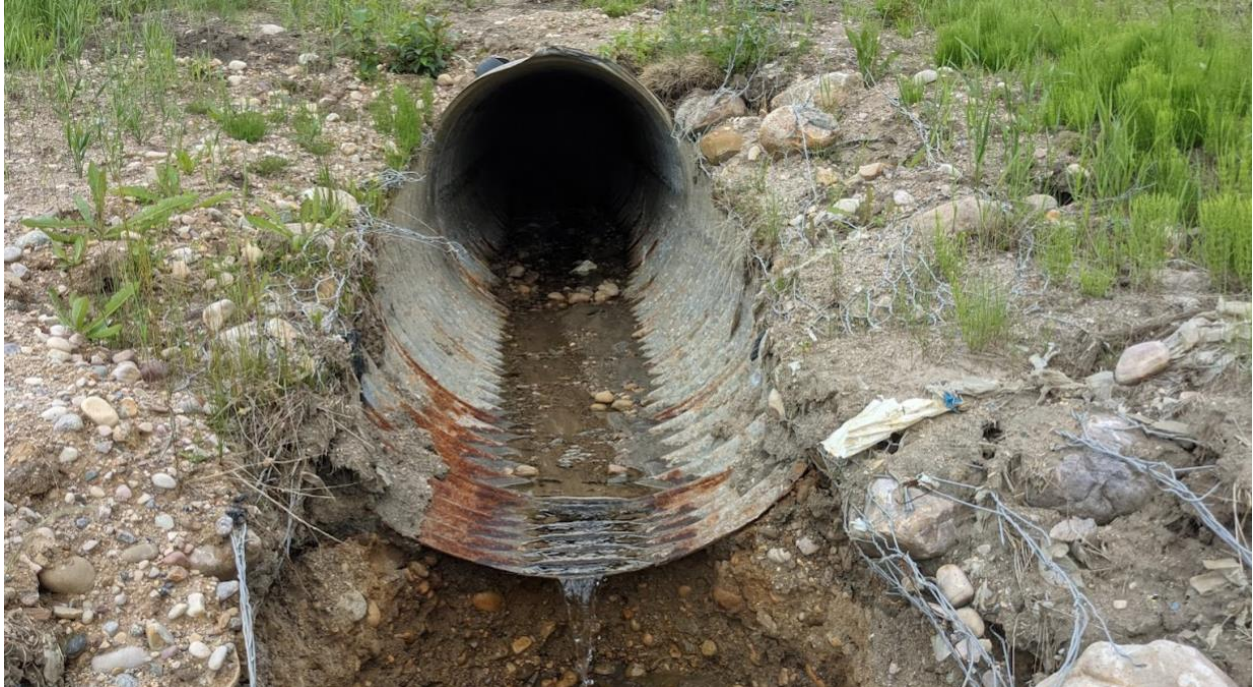
Photo 10 – Culvert C4 (1200 mm outlet); sediment removed from the culvert; steady flow from the outlet
