**ALBERTA TRANSPORTATION
GEOHAZARD ASSESSMENT PROGRAM
NORTH CENTRAL REGION – ATHABASCA &
FORT MCMURRAY DISTRICTS
2021 INSPECTION**

Site Number	Location	Name	km
NC084	To the south of the King Street Interchange in Fort McMurray	Hwy 63:11 Beacon Hill Erosion	9.1
Legal Description		UTM Co-ordinates	
5-10-089-09 W4M		12U E 478509	N 6284231

Date	PF	CF	Total
Previous Inspection:	June 11, 2019	16	4	64 (Erosion)
Current Inspection:	June 24, 2021	16	4	64 (Erosion)
Road AADT:	29,050		Year:	2020
Inspected By:	José Pineda, Tarek Abdelaziz (Thurber) Kristen Tappenden, Bernard Ching (Alberta Transportation)			
Report Attachments:	<input checked="" type="checkbox"/> Photographs <input type="checkbox"/> Plans <input type="checkbox"/> Maintenance Items

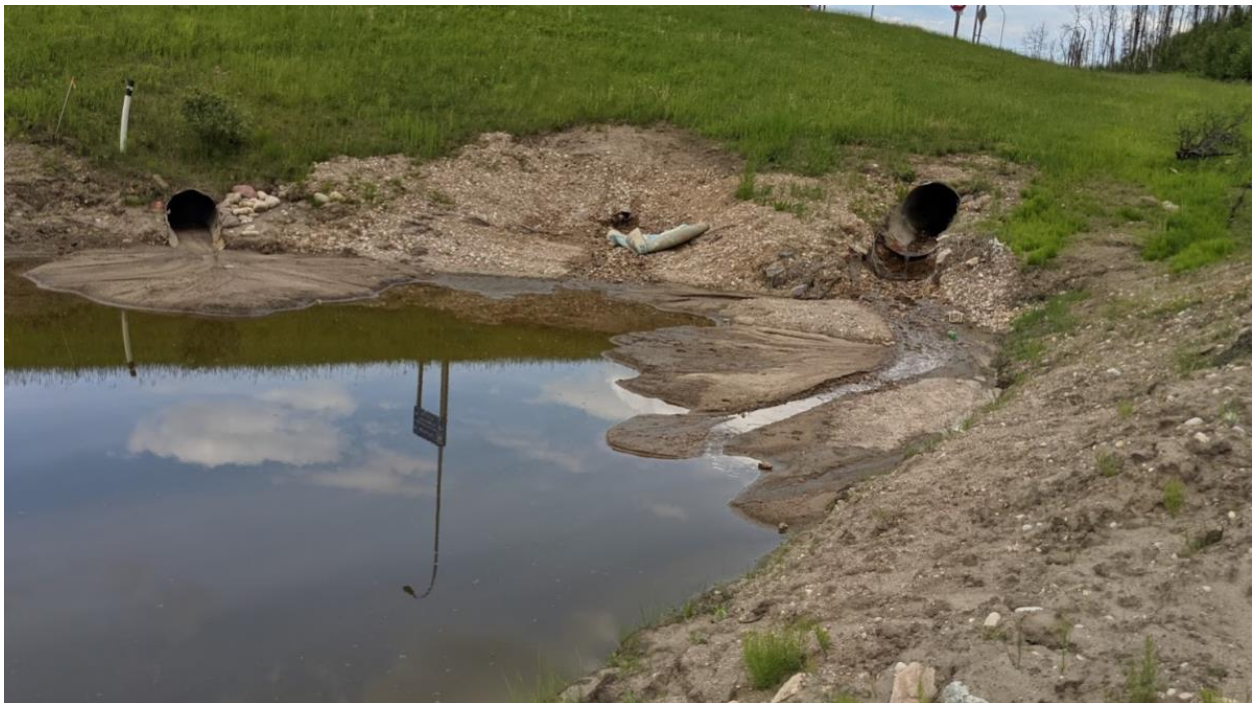
Photo 11 – Culvert C4 and C3 outlets; note sediment accumulation was partially removed from the inside of C4 (small culvert on the LHS of the photo); no flow on C4

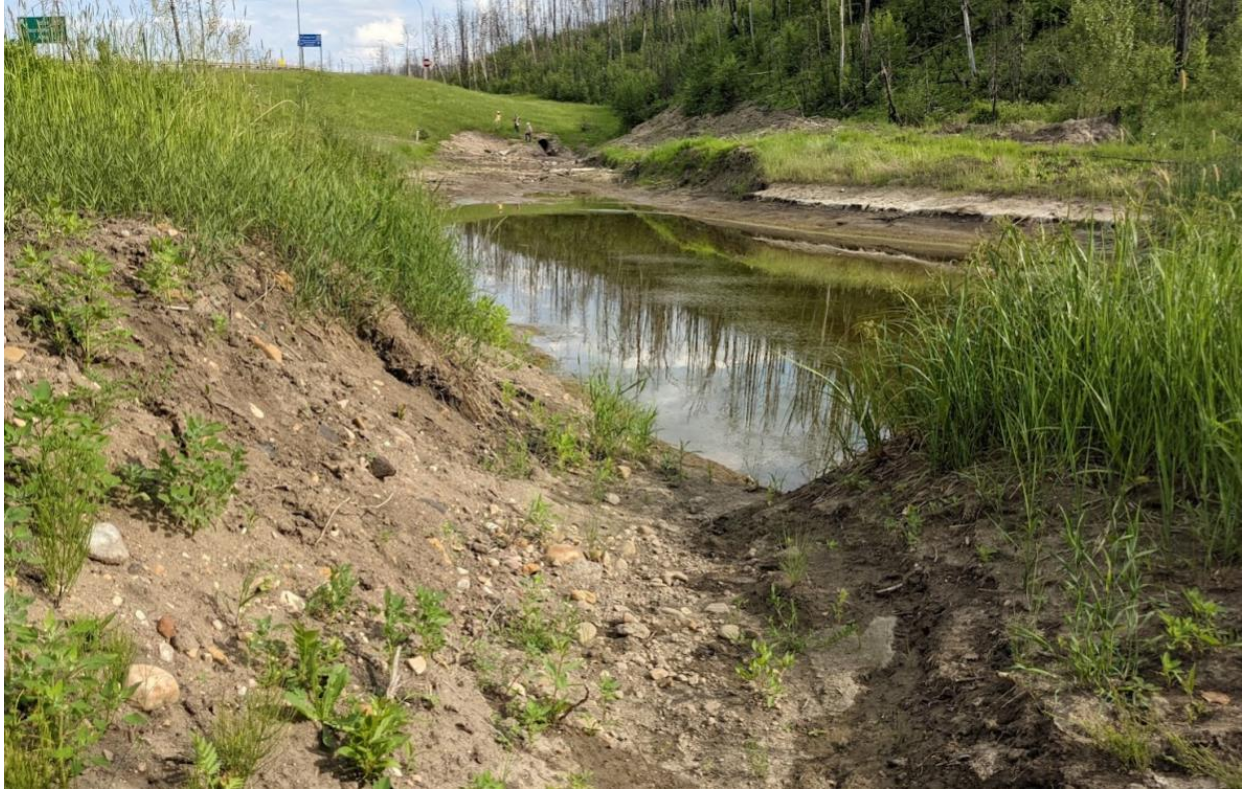
Photo 12 – Pond outflow discharge channel; approximately 0.5 m freeboard

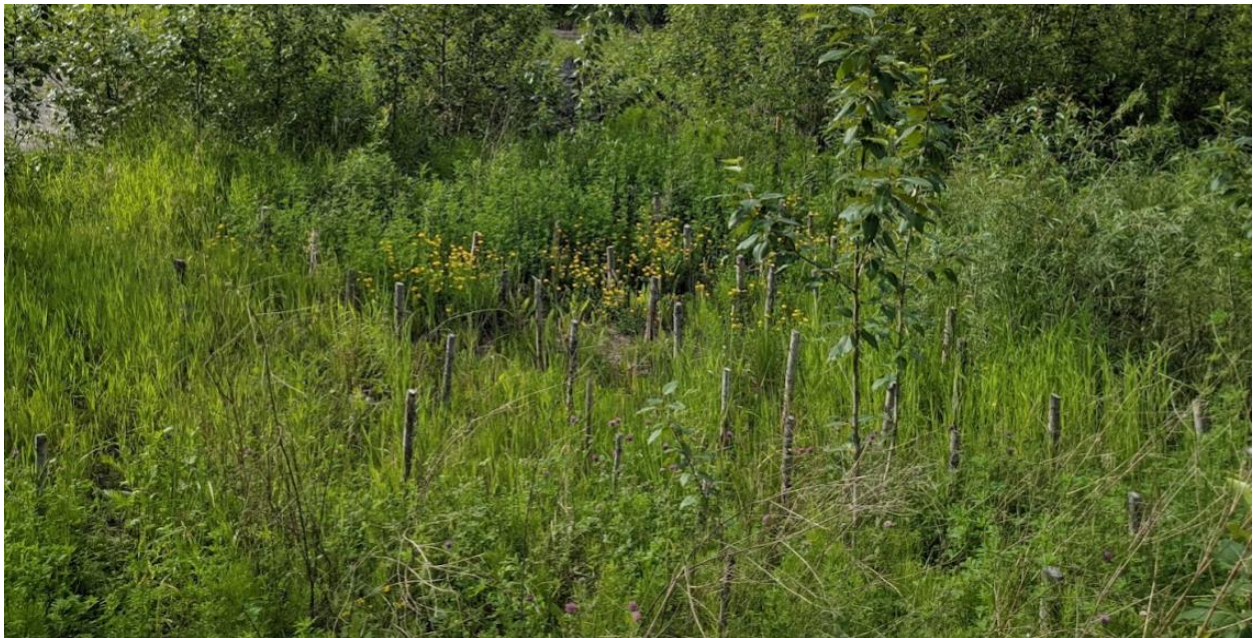
Photo 13 – Willow staking within the vegetation buffer zone between the pond and the river
