**ALBERTA TRANSPORTATION  
GEOHAZARD ASSESSMENT PROGRAM  
NORTH CENTRAL REGION – ATHABASCA &  
FORT MCMURRAY DISTRICTS  
2022 INSPECTION**

Site Number	Location	Name	km
NC084	To the south of the King Street Interchange in Fort McMurray	Hwy 63:11 Beacon Hill Erosion	9.1
Legal Description		UTM Co-ordinates	
5-10-089-09 W4M		12U E 478509	N 6284231

Date	PF	CF	Total
<b>Previous Inspection:</b>	June 24, 2021	16	4	64 (Ditch Erosion)
<b>Current Inspection:</b>	June 8, 2021	16	4	64 (Ditch Erosion)
<b>Road AADT:</b>	28,690	<b>Year:</b>	2022	
<b>Inspected By:</b>	José Pineda, Tarek Abdelaziz (Thurber) Arthur Kavulok, Rishi Adhikari, Amy Driessen (Alberta Transportation)			
<b>Report Attachments:</b>	<input checked="" type="checkbox"/> Photographs <input checked="" type="checkbox"/> Plans <input type="checkbox"/> Maintenance Items

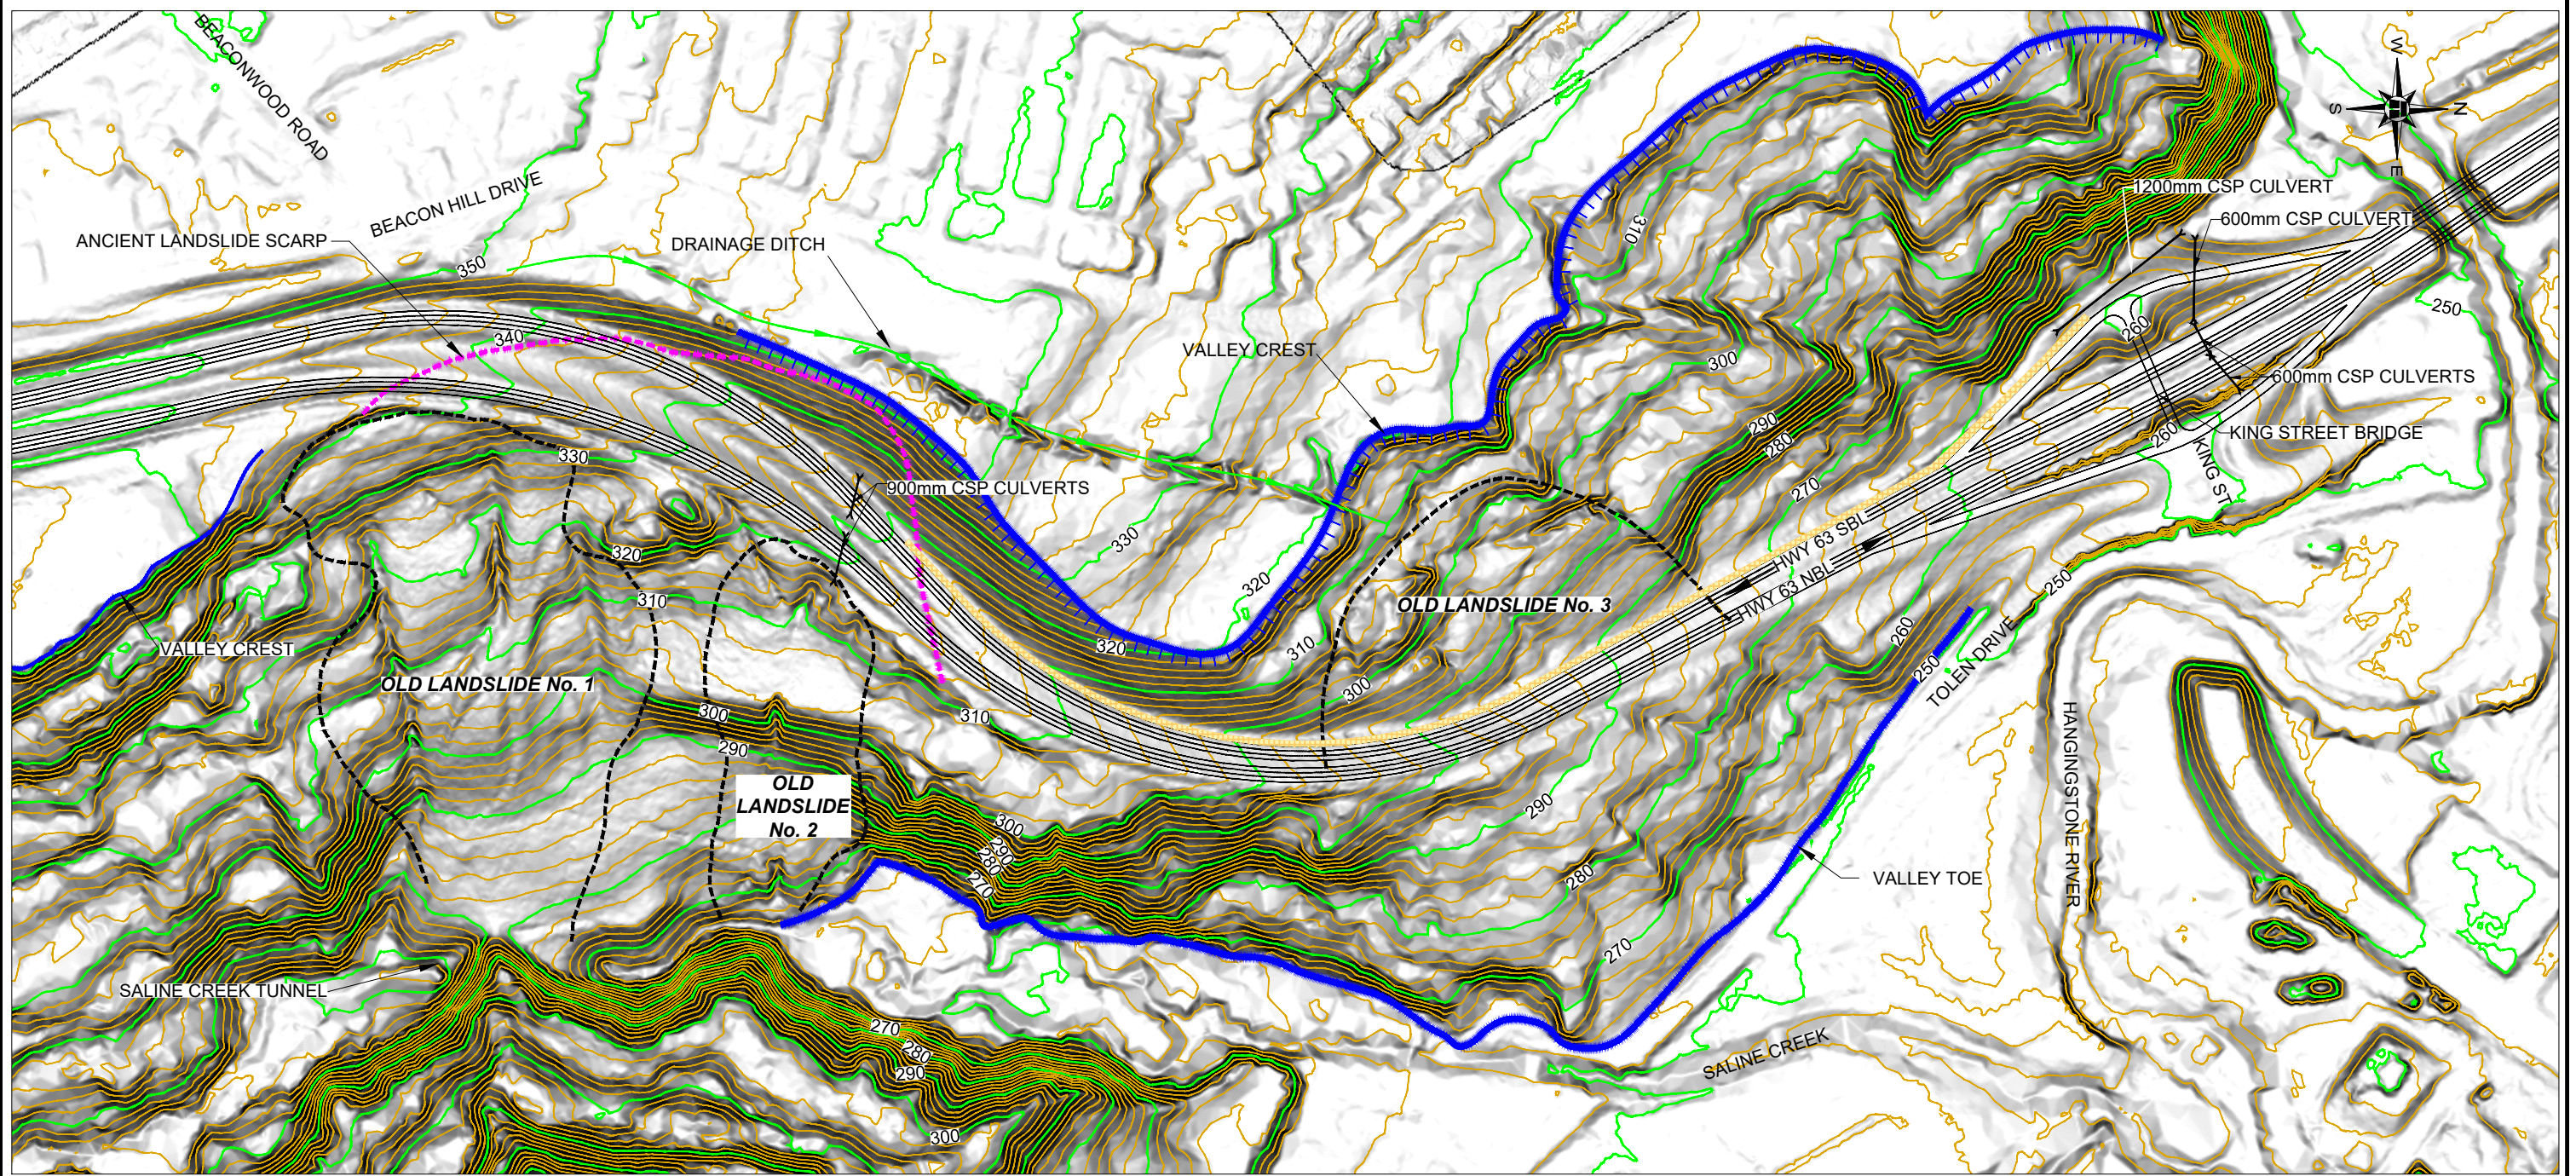
**FIGURE 1**

**NORTH CENTRAL REGION  
(ATHABASCA AND FORT MCMURRAY DISTRICTS)  
2022 GEOHAZARD ASSESSMENT  
NC084: HWY 63:11 BEACON HILL EROSION ISSUES  
(km 9.1)  
LIDAR IMAGE SHOWING SITE FEATURES**

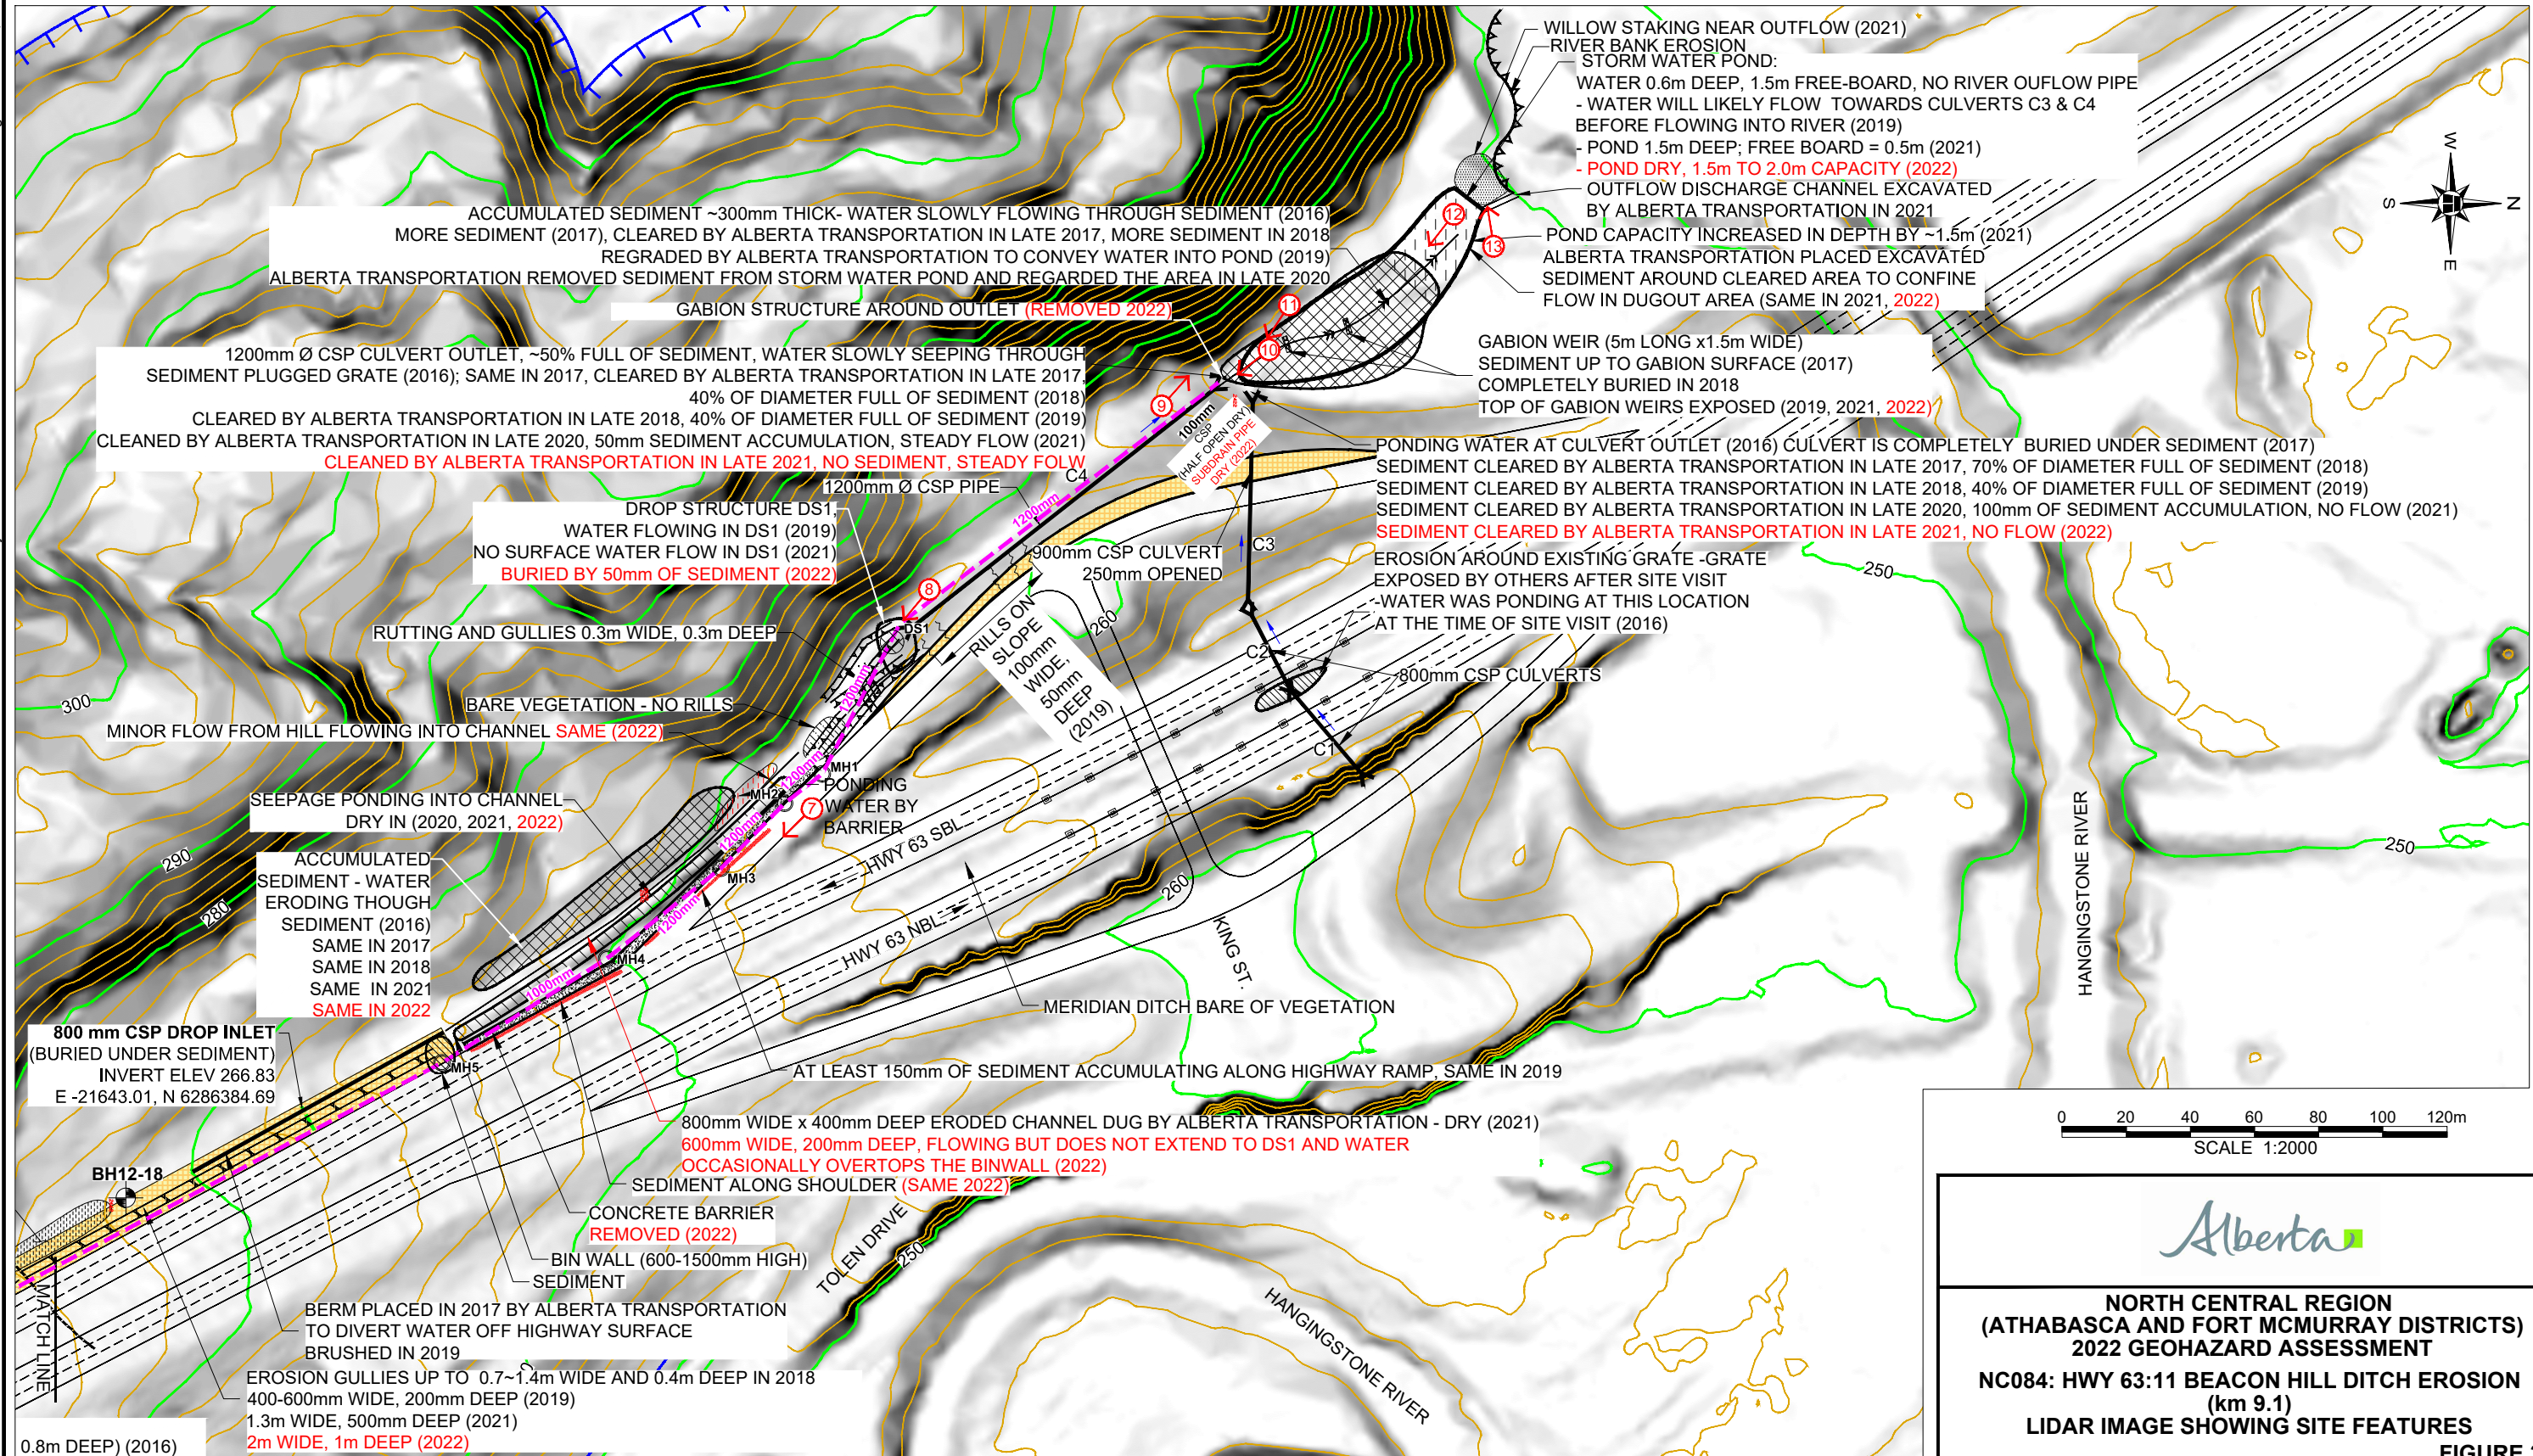
**FIGURE 3**

**NC084: HWY 63:11 BEACON HILL DITCH EROSION  
(km 9.1)  
LIDAR IMAGE SHOWING SITE FEATURES**

**NOTES:**  
 1. MH2 TO MH5 ARE BURIED UNDER SEDIMENT.  
 2. JUNE 8, 2022 OBSERVATIONS SHOWN IN RED.

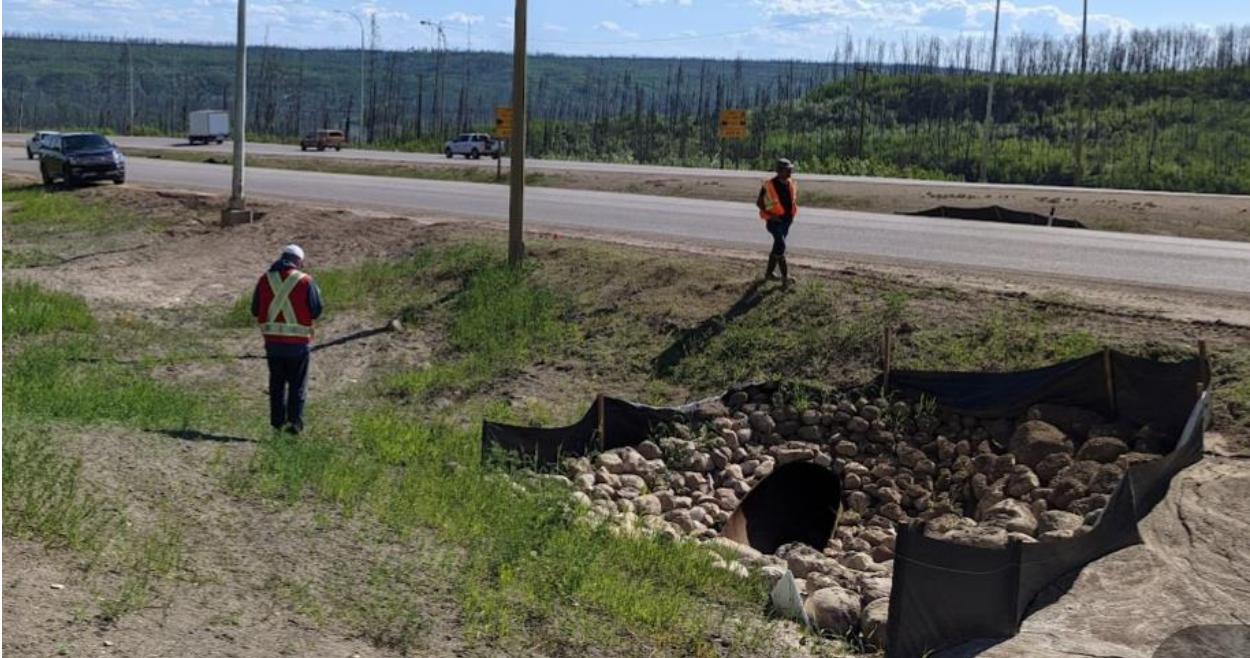
Photo 1 – Looking at the inlet of a new 900 mm diameter SWSP culvert (C5a replacement).

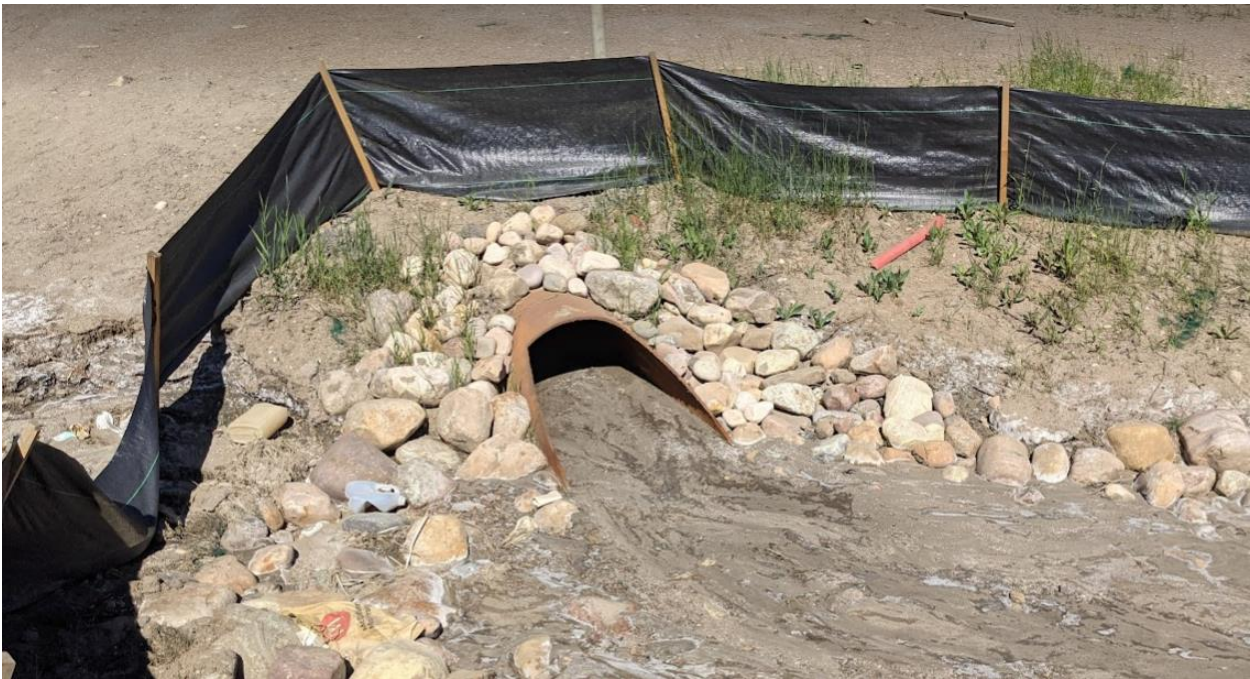
Photo 1b – Looking at the outlet of a new 900 mm diameter SWSP culvert (C5a replacement); Note the presence of sediment at the outlet of the new pipe; sediment covers a portion of the median ditch between the outlet of C5a and the inlet of C5b.

- The C5a culvert should be cleaned of accumulated sediment, and the erosion developed in the median ditch immediately downstream of the inlet of C5b should be repaired before it becomes bigger in size.

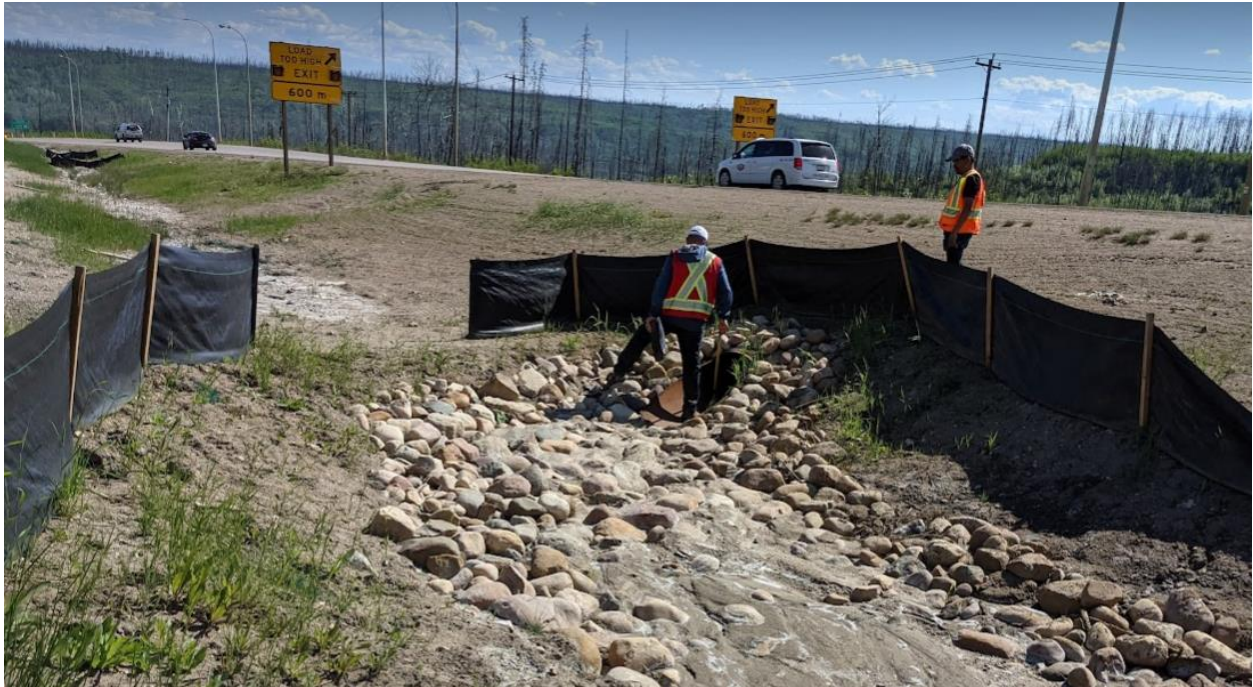
C5b culvert is currently undersized, and this may result in future flooding of the highway or erosion of the median ditch.

Photo 1c - 600 mm diameter SWSP culvert inlet (C5b; liner installed within the original C3b pipe).

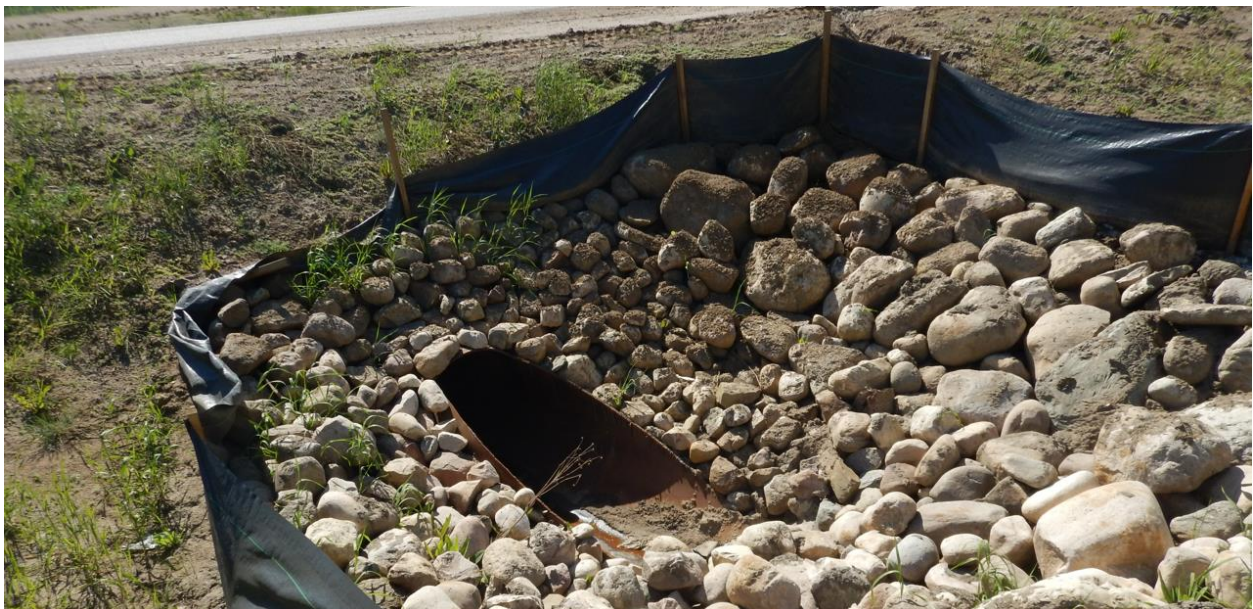
Photo 1d –Looking at the outlet of the C5b liner.

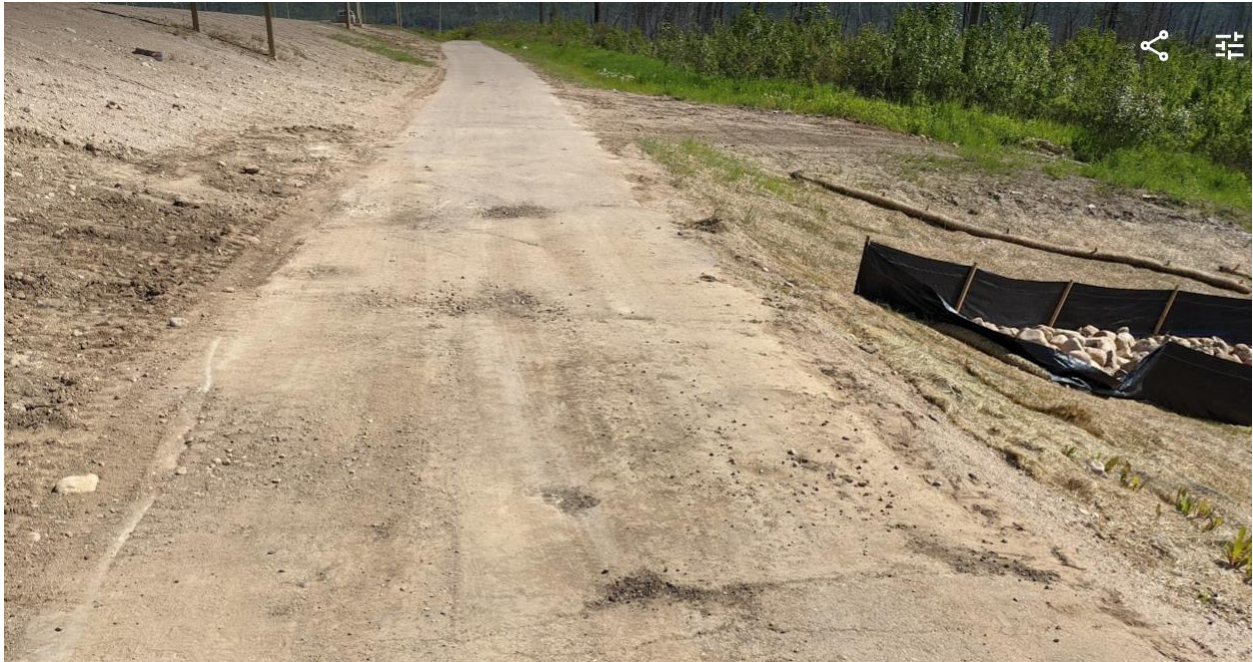
Photo 1e –Asphalt walking trail settlement/distress in response to the failed attempts to replace C5b.

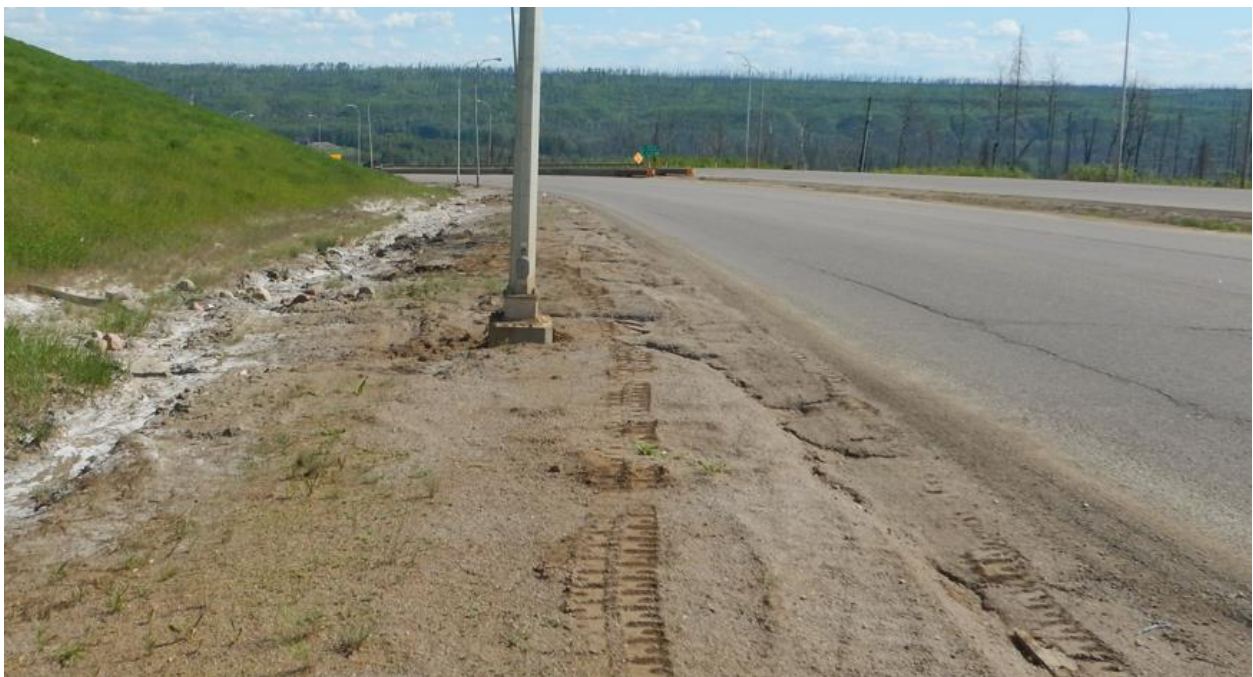
The erosion that has been occurring on the west side of Hwy 63 is due to high runoff flowing over bare side slopes and a steep unprotected undefined "ditch". The side slopes and ditch bottom are generally bare of vegetation for the most part of the alignment, possibly due to excessive salting and sanding of this section of the highway during wintertime. Ground water seepage from the marginally stable backslopes above the ditch have aggravated the situation. The highway backslope extending up to Beacon Hill Drive also appears to provide a source for excessive fine sediment accumulation behind the bin wall and in the area surrounding DS1.

Photo 2 – Bare side slopes with erosion rills (looking north).

- Consideration should be given to blading and track packing rilled and bare side slopes of the highway and interchange ramp in a direction perpendicular to the flow direction (i.e., up and down the side slope surface to deal with side slope rills). Minor contouring should be undertaken to re-establish ditch grade and profile. The ditch should have at least 1 m wide flat bottom, 4H:1V side slopes and provided with a minimum height of 300 mm. Grading work should be carefully undertaken particularly where the toe of the valley is abutting the highway surface to avoid slope instability issues. The re-constructed ditch should be connected to the inlet drop structure located to the north of the interchange west ramp bin wall through the construction of a narrow/shallow channel by the tree line behind the bin wall.

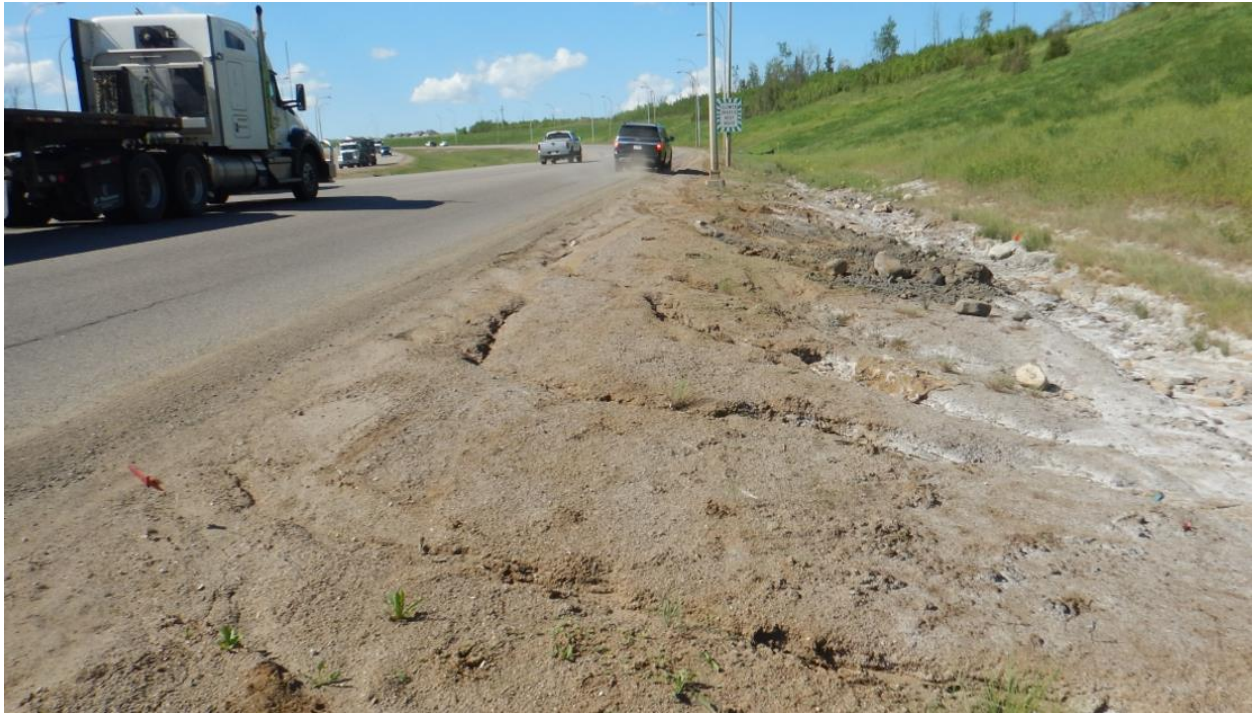
Photo 2b – Bare side slopes and erosion rills.

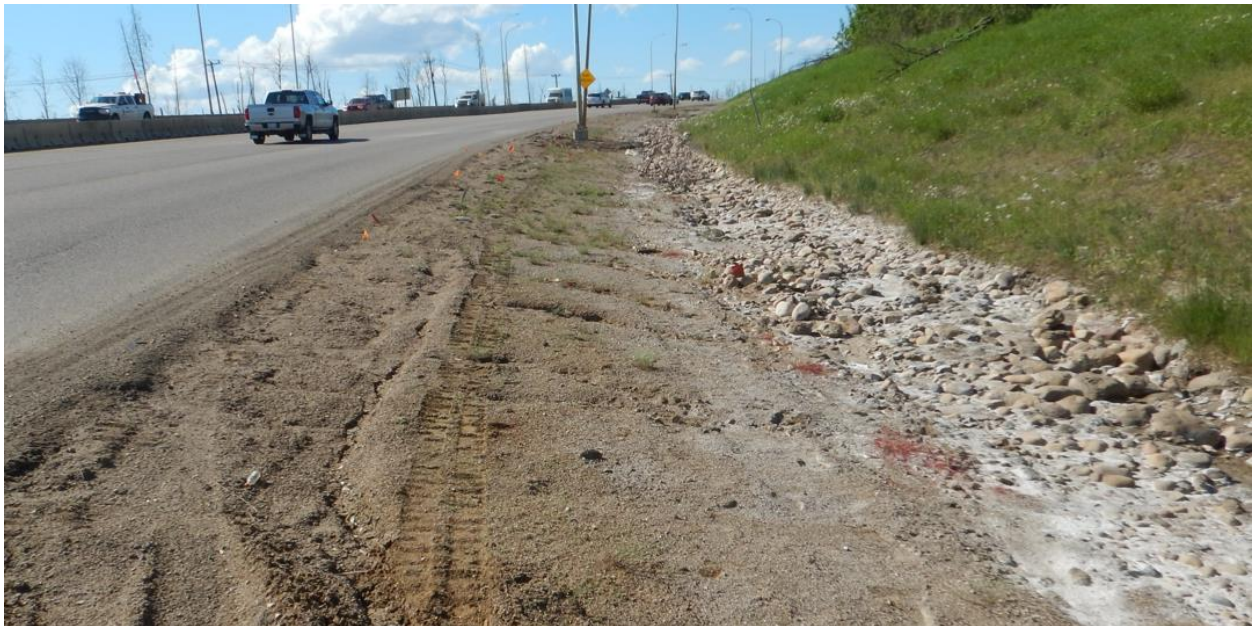
Photo 2c – Bare side slopes and erosion rills.

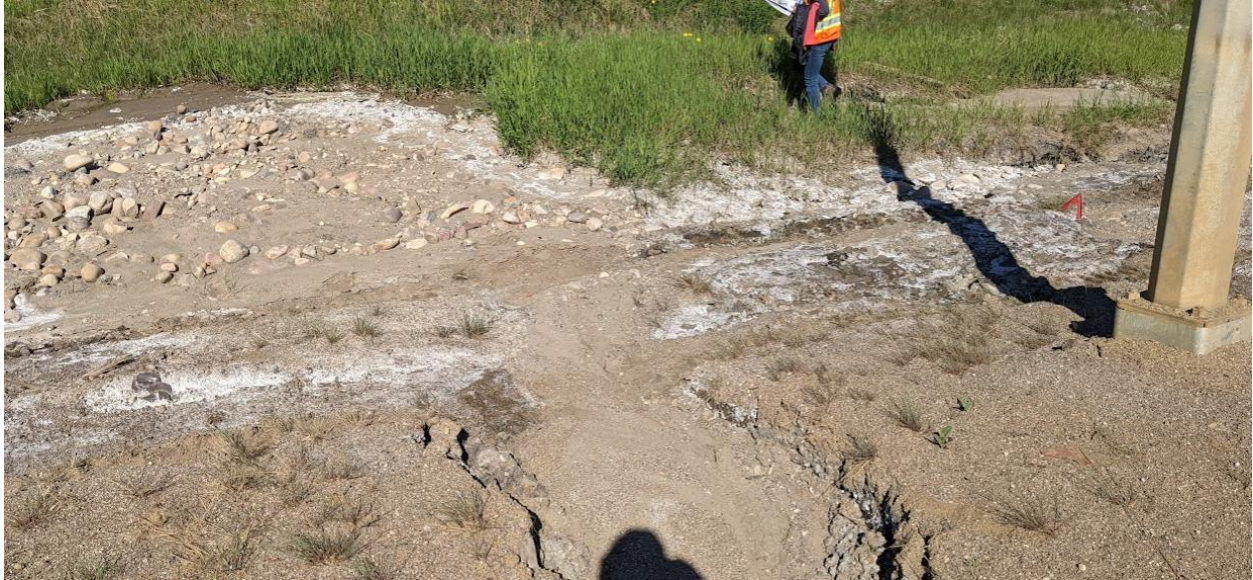
Photo 3 – Erosion developed on the highway side slope. Culvert C6 inlet buried under sediment.

- Locate and plug the inlets of C6 and DS2.
- A temporary small berm should be constructed to the south of the bin wall to divert the ditch flow towards the small channel by the tree line and prevent sediment from spilling on the highway surface, and accordingly plugging of existing manholes.

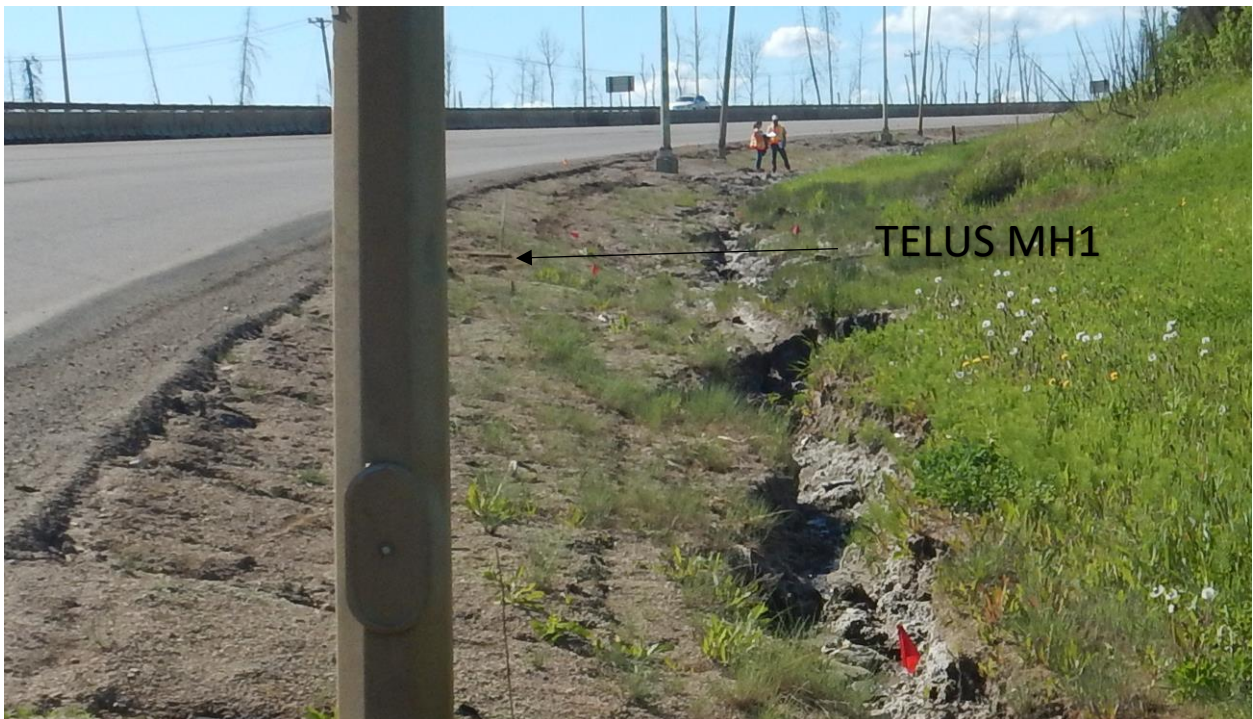
Photo 4 – Erosion, bare slopes. Drop structure DS2 completely buried under sediment.

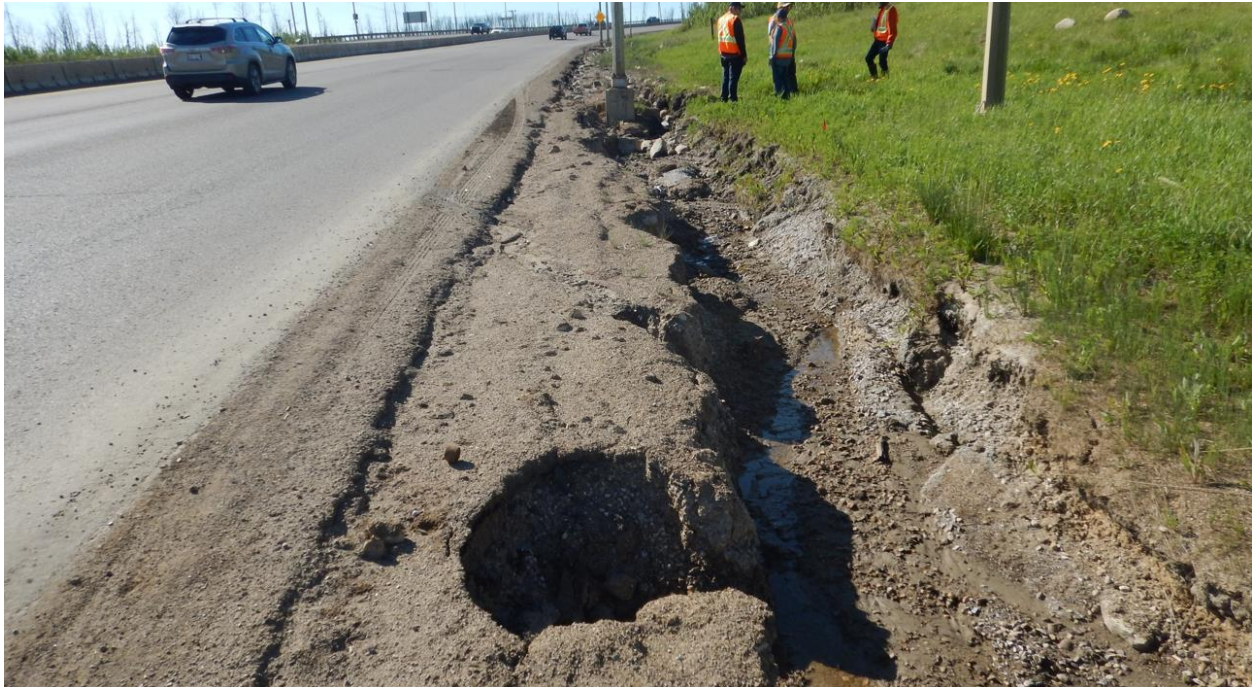
The severe erosion gullies developed near the edge of pavement constitutes a safety hazard to motorists.

Photo 5 – Sinkhole 1m diameter by 0.6m deep and gully 3m wide by 1m deep.

- As a minimum, and where severe erosion gullies developed in the highway side slope and the ditch, the gullies should be backfilled with well compacted crushed gravel. Backfilling gullies near the edge of the road should be the priority to eliminate existing safety hazard to motorists.

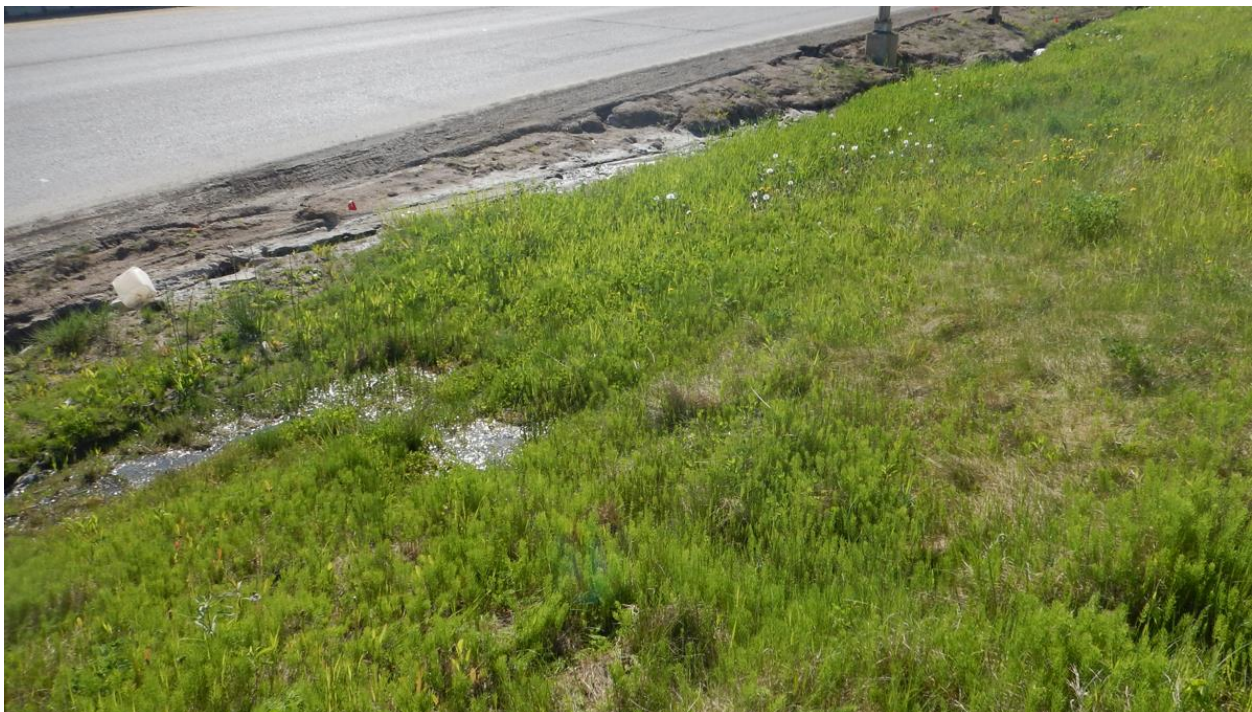
Photo 6 – Some seepage from the colluvium backslope flowing into eroded ditch.

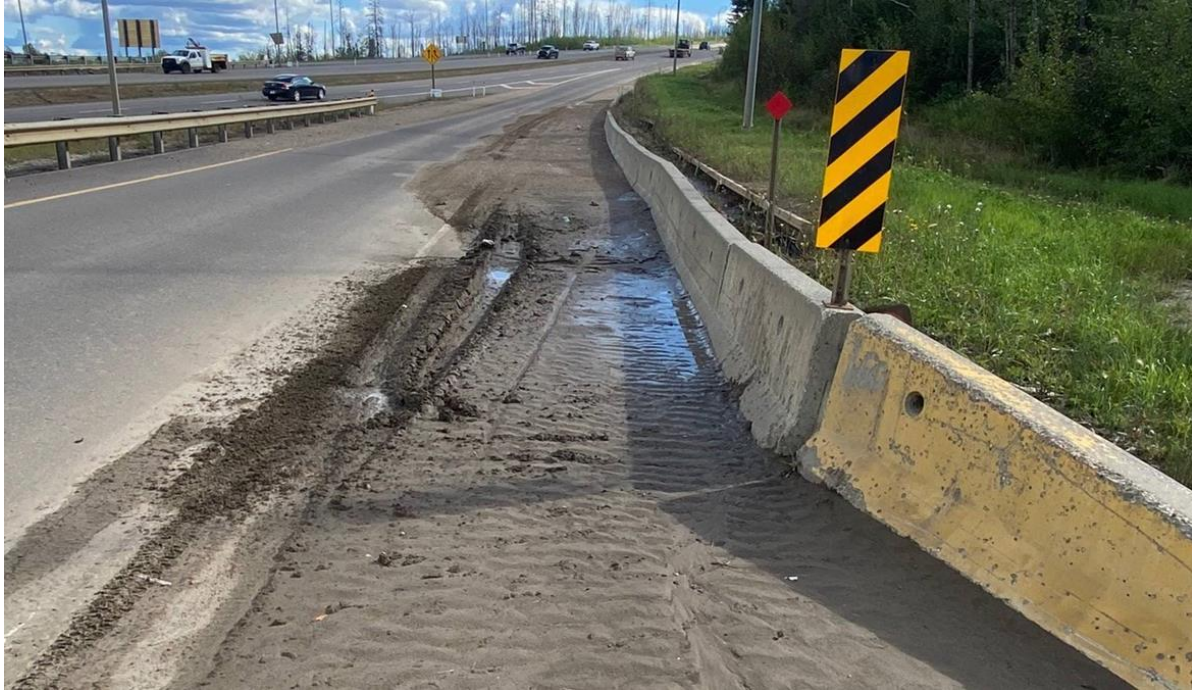
Sediment accumulation along the bin wall between Manholes MH#1 and MH#5 will continue to provide poor driving conditions at the King Street Interchange west ramp. This may also result in flooding of the highway. Further sediment accumulation to the north of C4 pipe and within the pond may result in further loss of the pond's storage capacity and backing up of water towards the C3 and C4 culverts and the king street embankment. Ponding of water, if occurs, at the King Street Interchange west ramp may impact the integrity of the ramp.

Photo 7 – Sediment accumulation on the highway by the Jersey barriers buried Manholes MH#1 and MH#5 (Photo received from AT after the June 8, 2022's site visit).

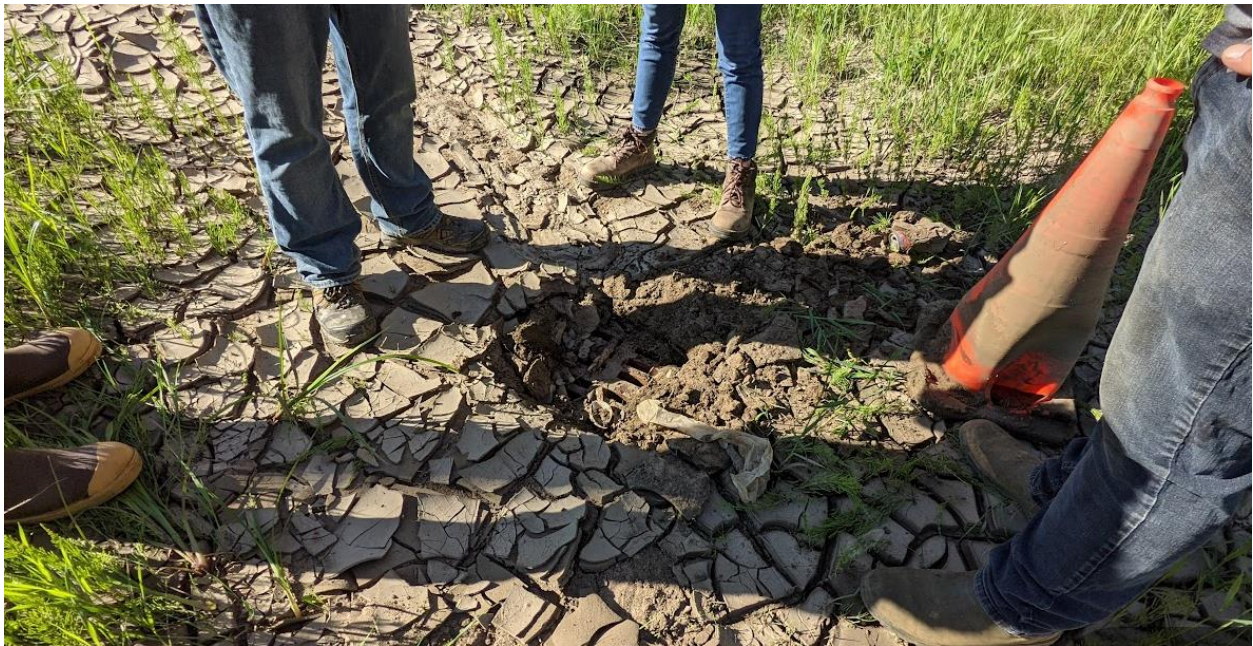
Photo 8 – Drop Structure DS1; note sediment accumulation around drop structure.

- Accumulated sediment around the drop structure DS1 should be cleared.
- If funds are available, it is recommended that the new ditch/channel be lined with either heavy rick riprap over a non-woven geotextile fabric or a High Performance TRM. This should reduce the frequency of future ditch maintenance work.

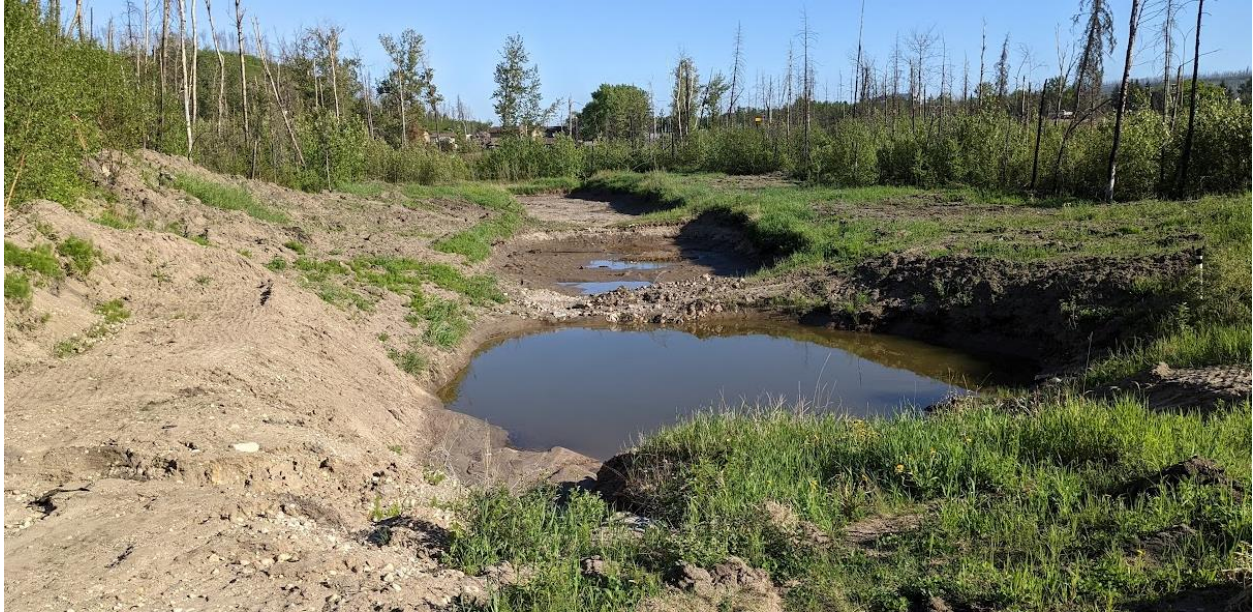
The ongoing cleanup work by AT has been effective in maintaining the capacity of the pond.

Photo 9 –AT cleaned the pond in the fall of 2021; substantial sediment removed to increase pond capacity.

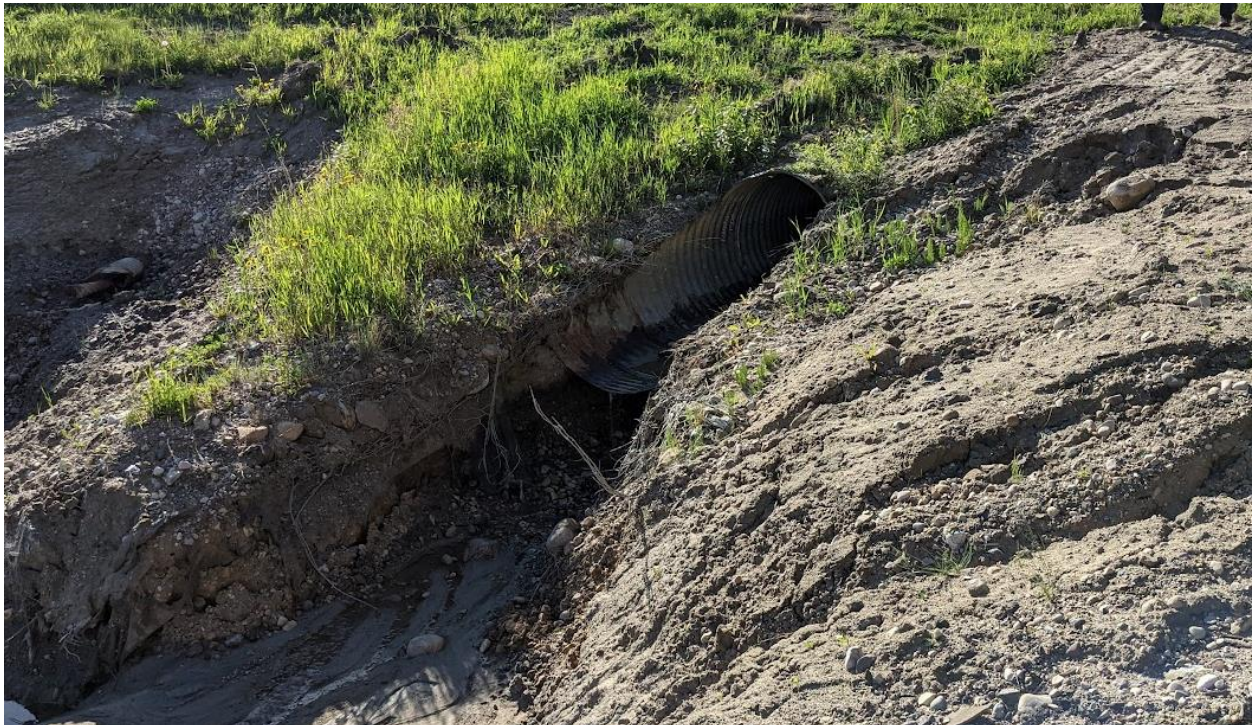
Photo 10 – Culvert C4 (1200 mm outlet); scour under the culvert; steady flow from the outlet.

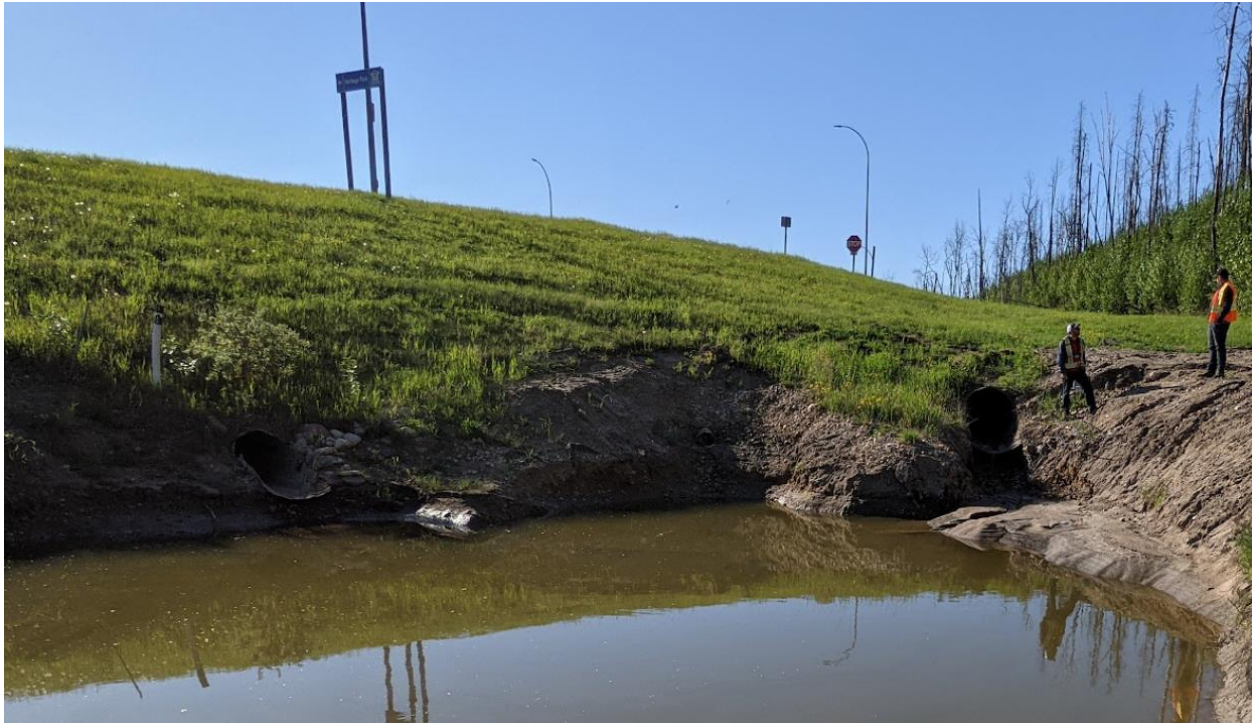
Photo 11 – Culvert C3 and C4 outlets; no flow from C3.
